## Accessibility Survey

### City of Downey De Palma Street - Downey Avenue To Paramount Boulevard

Date of Inspection  
1/31/2017

**Disability Access Consultants**

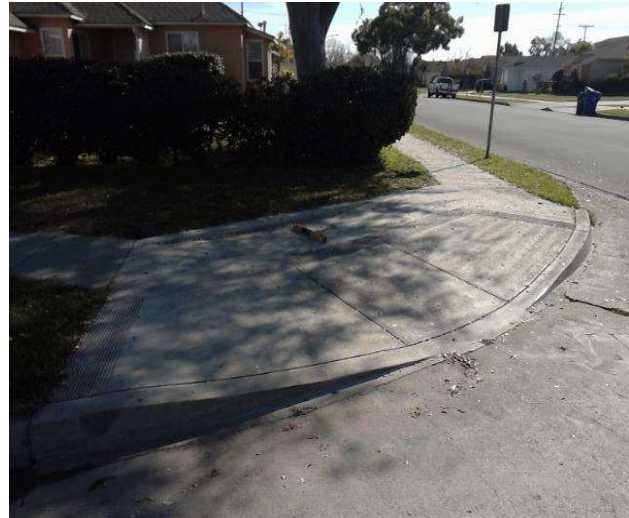
**On-Site Finding** Not Found

Recommendation See Recommendation

Provide detectable warning to surface \$248

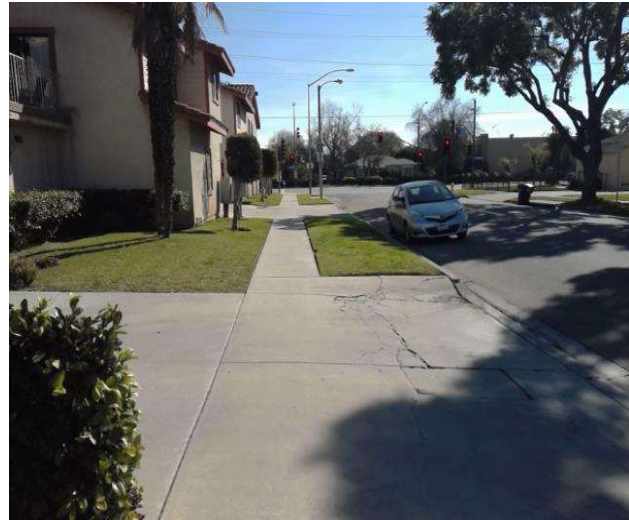
**On-Site Finding** Not Found

Recommendation See Recommendation

Install compliant detectable warnings \$190

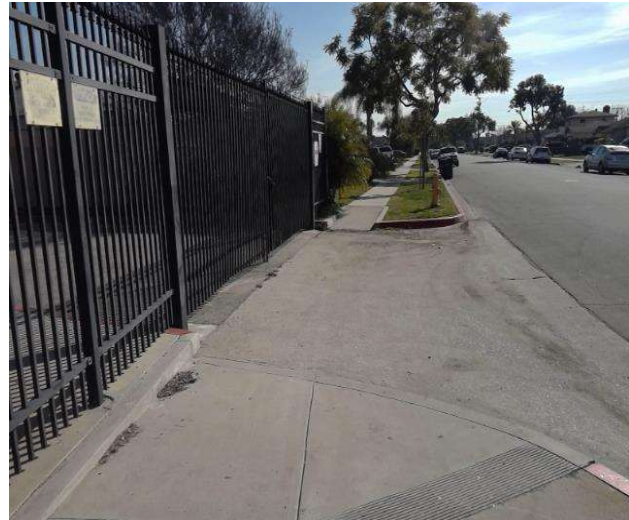
**On-Site Finding** Not Found

Recommendation See Recommendation

Install compliant detectable warnings \$190

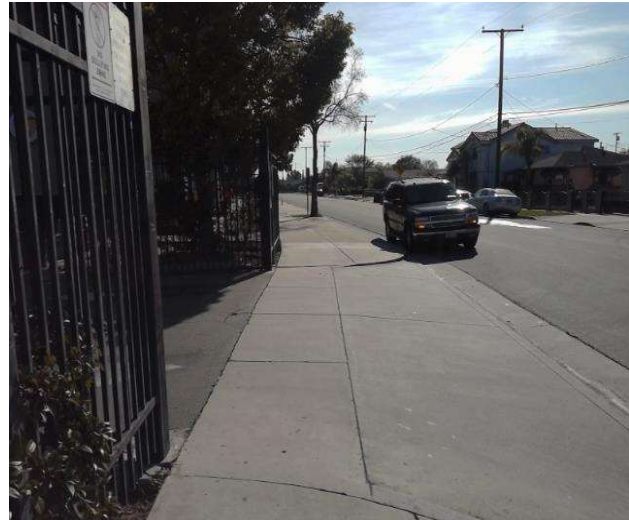
**On-Site Finding** Not Found

Recommendation See Recommendation

Install compliant detectable warnings \$190

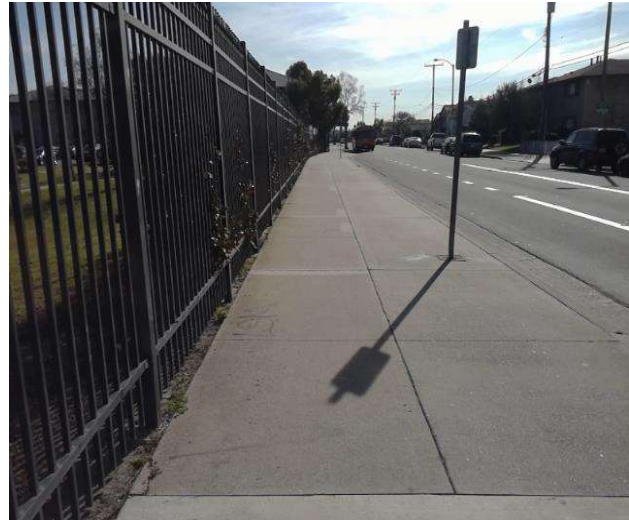
Notes : Has 8 Openings Within 150 Feet Of Initiating Point

Repave the sidewalk surface with the recommended cross slope.

Recommendation Up to 2.08 percent

Repave surface \$1,092

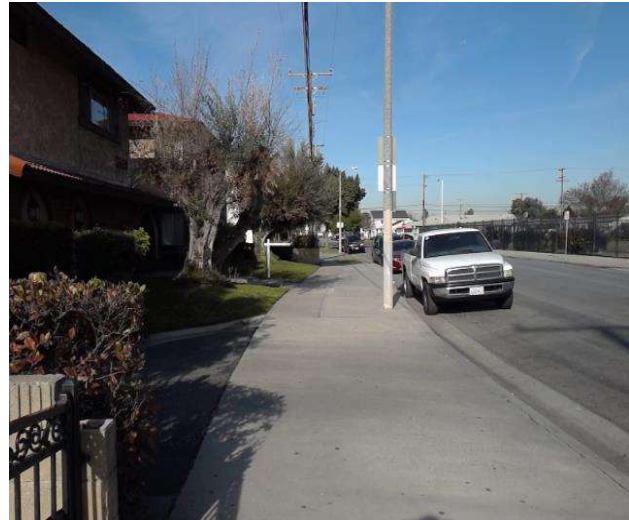
**On-Site Finding** Not Found

Recommendation See Recommendation

Install compliant detectable warnings \$190

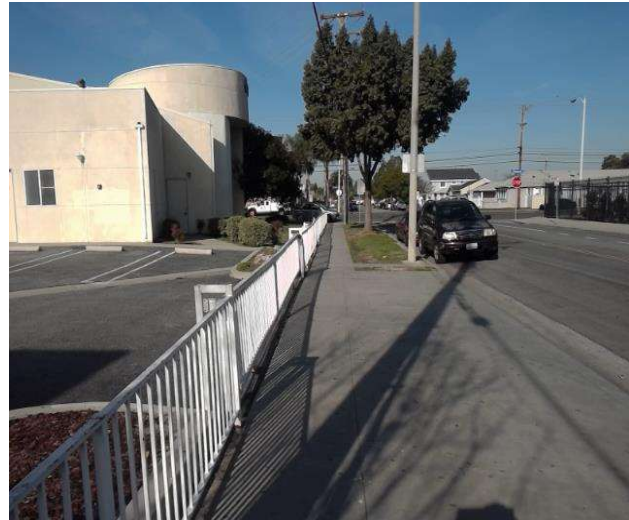
**On-Site Finding** Not Found

Recommendation See Recommendation

Install compliant detectable warnings \$190

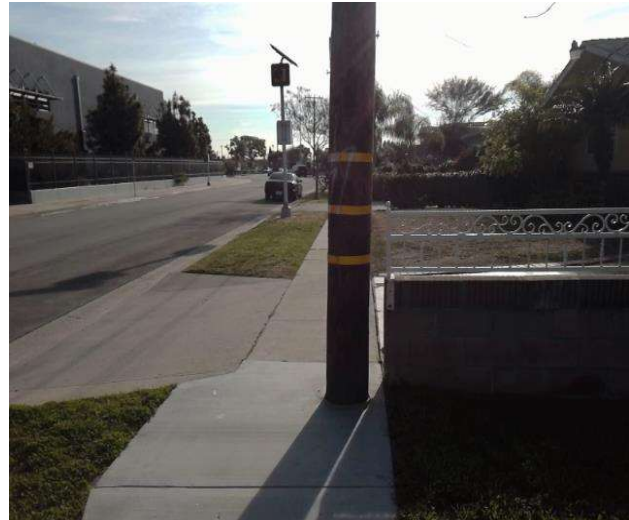
Sidewalks , Hazards & Gratings : Sidewalk Width at Obstruction

Sidewalk width at the obstruction shall have the recommended value.

Recommendation At least 48.00 inches

\$1,260

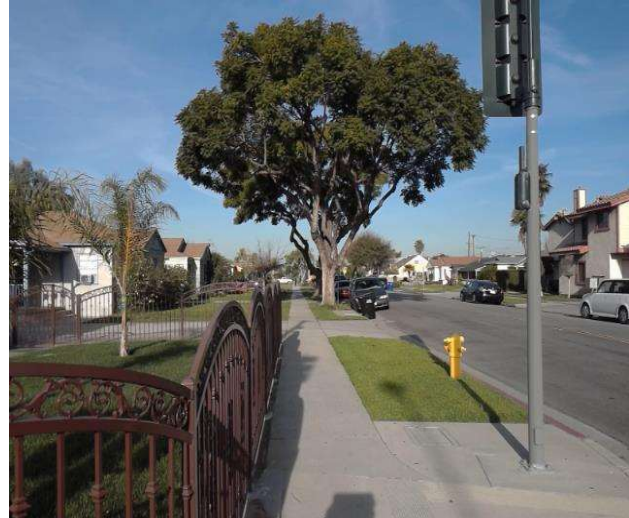
**On-Site Finding** Not Found

Recommendation See Recommendation

\$2,400

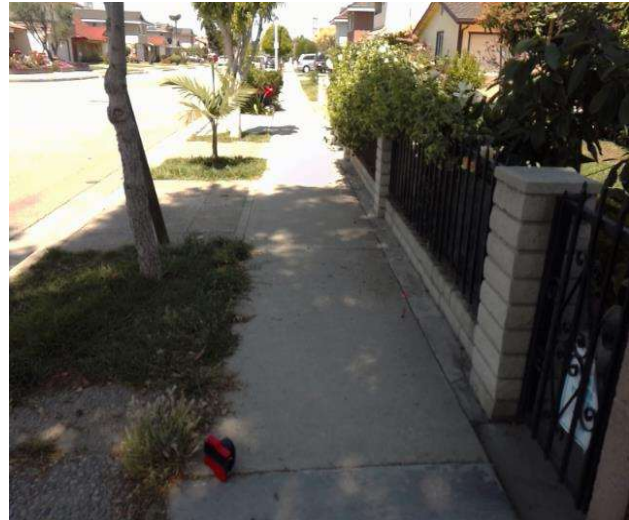
There is a change in elevation greater than recommended value.

Ensure that the change in elevation is within the recommended value.

Recommendation Up to 0.25 inches

Remove tripping hazards \$198

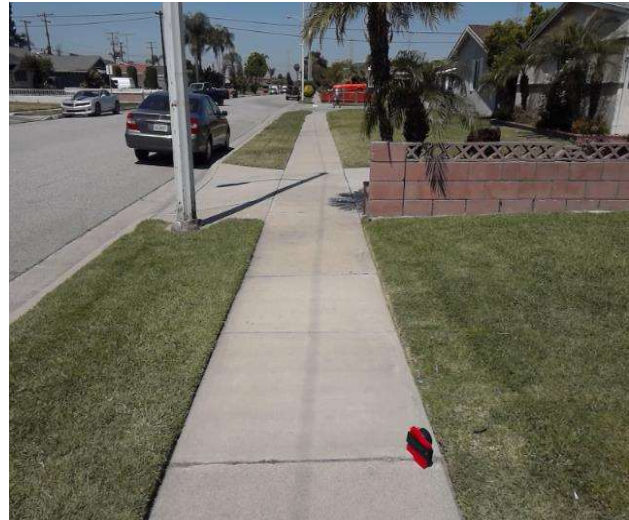
There is a change in elevation greater than recommended value.

Ensure that the change in elevation is within the recommended value.

Recommendation Up to 0.25 inches

Remove tripping hazards \$198

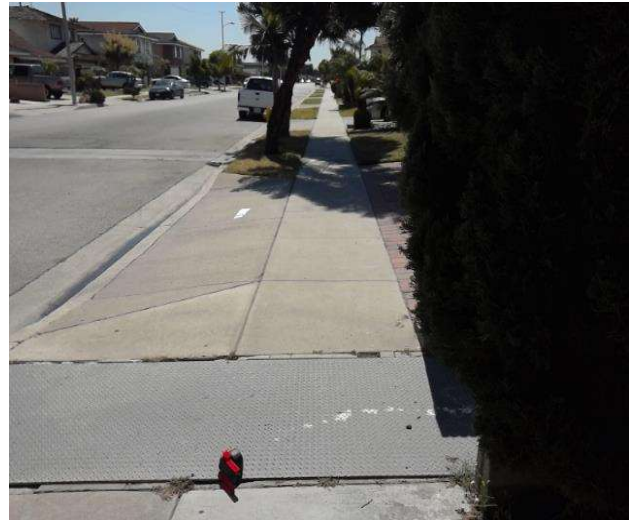
There is a change in elevation greater than recommended value.

Ensure that the change in elevation is within the recommended value.

Recommendation Up to 0.25 inches

Remove tripping hazards \$198

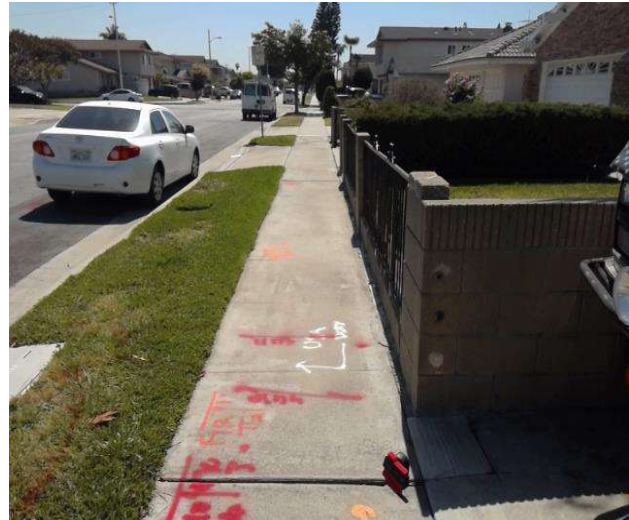
There is a change in elevation greater than recommended value.

Ensure that the change in elevation is within the recommended value.

Recommendation Up to 0.25 inches

Remove tripping hazards \$198

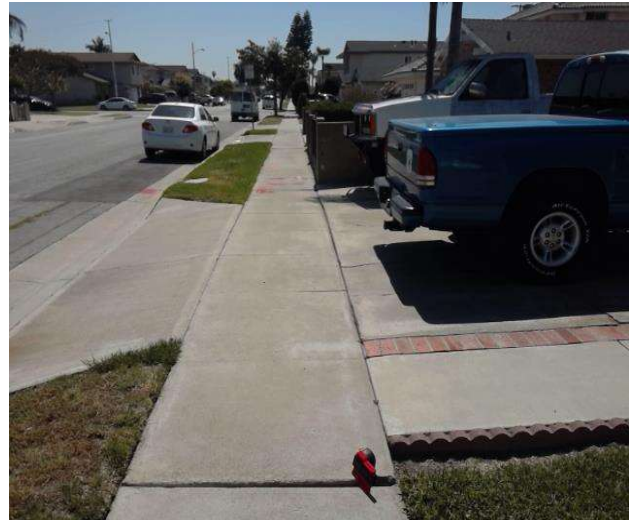
There is a change in elevation greater than recommended value.

Ensure that the change in elevation is within the recommended value.

Recommendation Up to 0.25 inches

Remove tripping hazards \$198

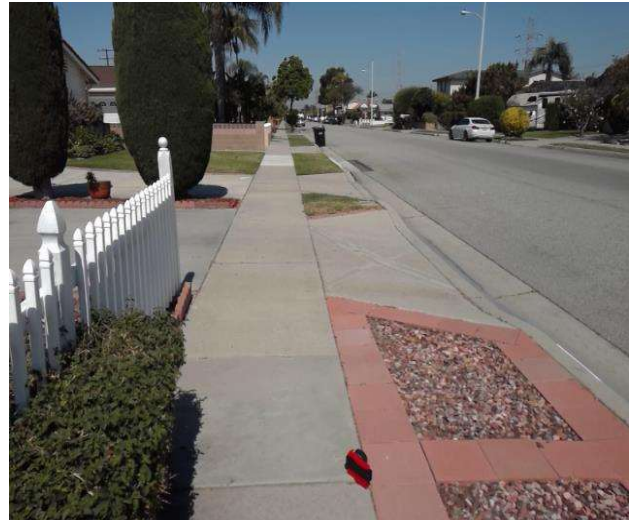
There is a change in elevation greater than recommended value.

Ensure that the change in elevation is within the recommended value.

Recommendation Up to 0.25 inches

Remove tripping hazards \$198

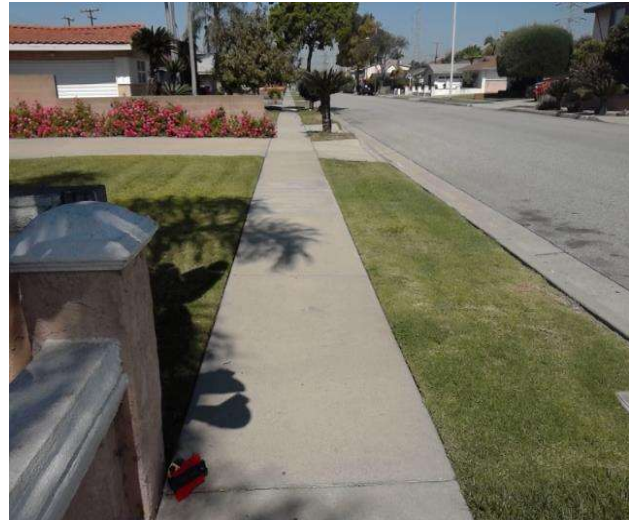
There is a change in elevation greater than recommended value.

Ensure that the change in elevation is within the recommended value.

Recommendation Up to 0.25 inches

Remove tripping hazards \$198

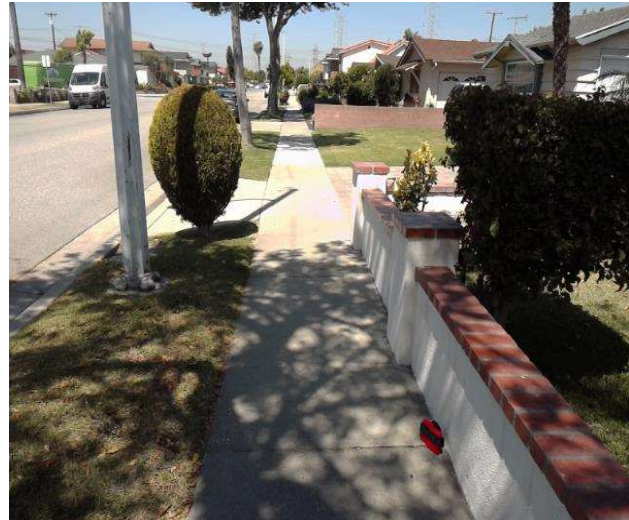
There is a change in elevation greater than recommended value.

Ensure that the change in elevation is within the recommended value.

Recommendation Up to 0.25 inches

Remove tripping hazards \$198

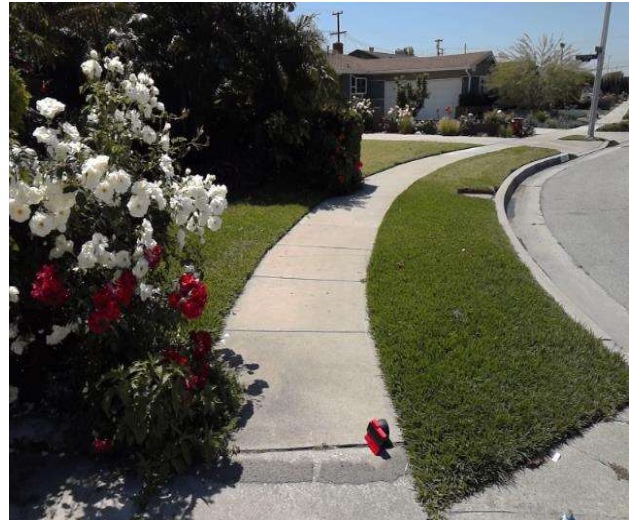
There is a change in elevation greater than recommended value.

Ensure that the change in elevation is within the recommended value.

Recommendation Up to 0.25 inches

Remove tripping hazards \$198

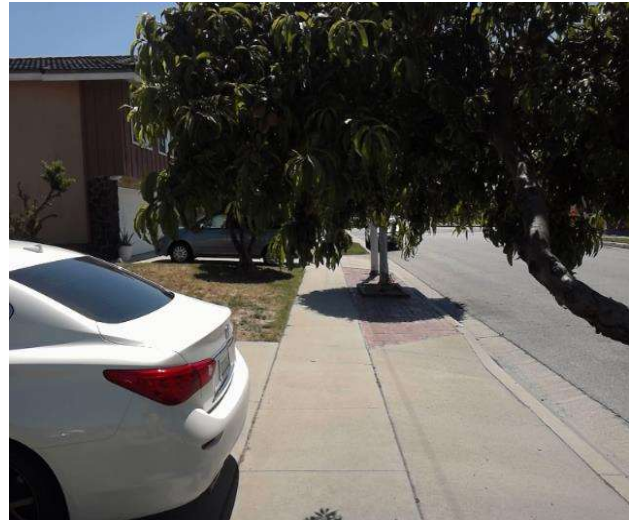
Sidewalks , Hazards & Gratings : Overhead Obstruction Height

Recommendation At least 80.00 inches

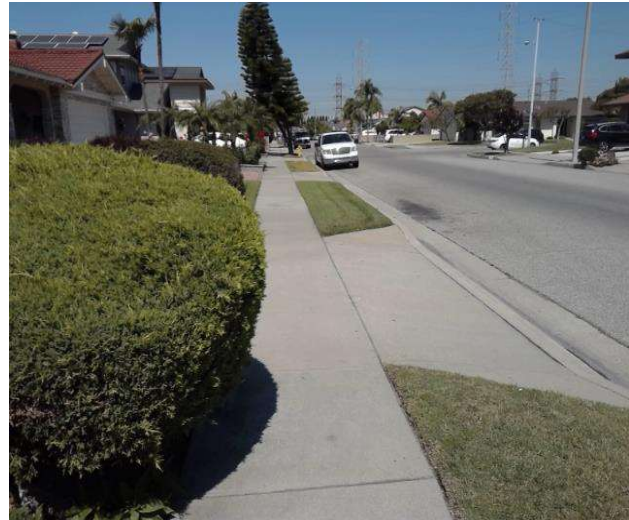
Sidewalks , Hazards & Gratings : Sidewalk Width at Obstruction

Sidewalk width at the obstruction shall have the recommended value.

Recommendation At least 48.00 inches

\$1,260

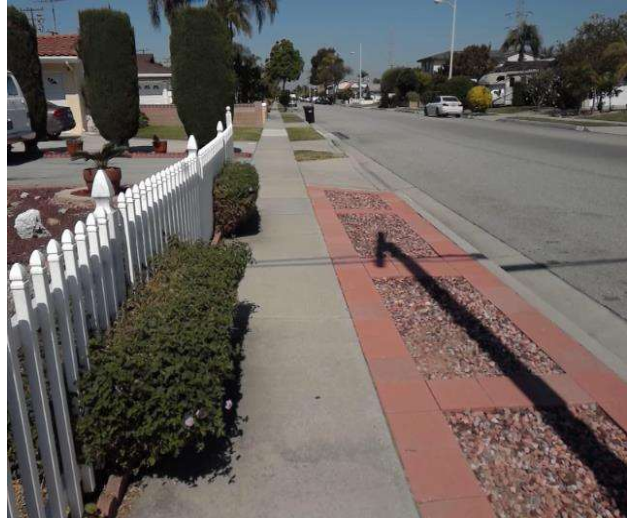
Sidewalks , Hazards & Gratings : Sidewalk Width at Obstruction

Sidewalk width at the obstruction shall have the recommended value.

Recommendation At least 48.00 inches

\$1,260

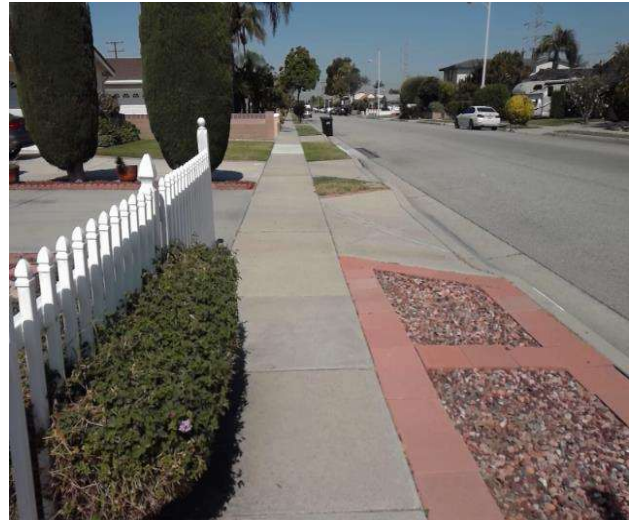
Sidewalks , Hazards & Gratings : Sidewalk Width at Obstruction

Sidewalk width at the obstruction shall have the recommended value.

Recommendation At least 48.00 inches

\$1,260

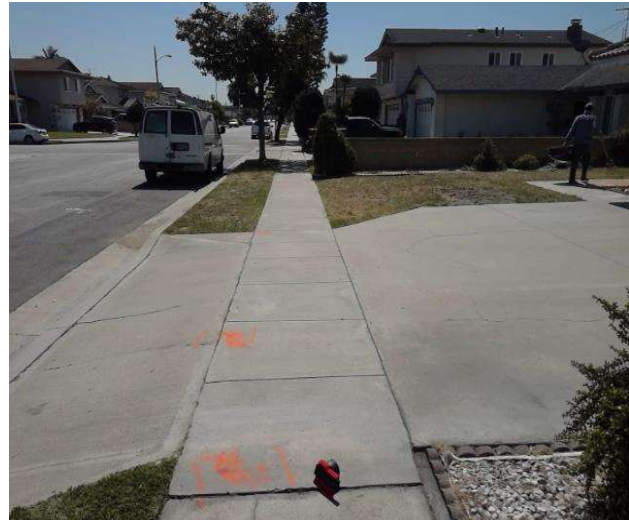
There is a change in elevation greater than recommended value.

Ensure that the change in elevation is within the recommended value.

Recommendation Up to 0.25 inches

Remove tripping hazards \$198

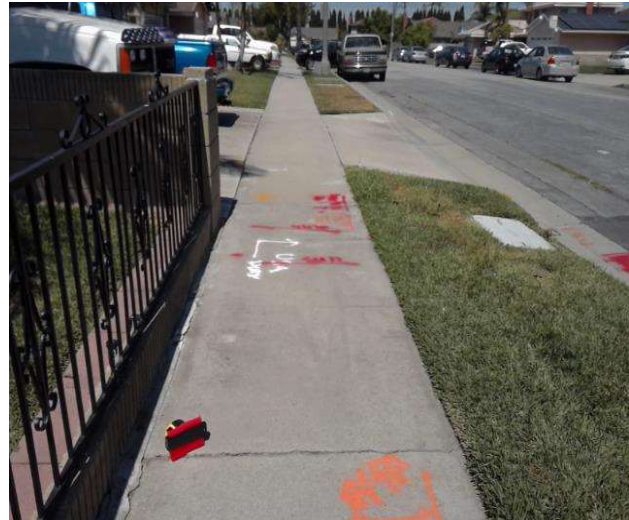
There is a change in elevation greater than recommended value.

Ensure that the change in elevation is within the recommended value.

Recommendation Up to 0.25 inches

Remove tripping hazards \$198

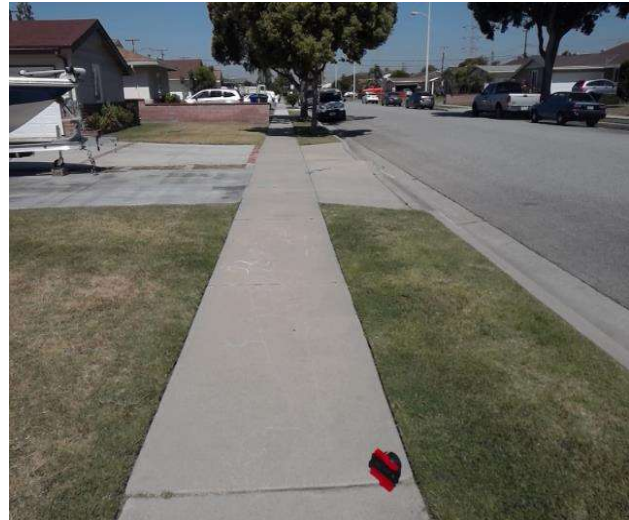
There is a change in elevation greater than recommended value.

Ensure that the change in elevation is within the recommended value.

Recommendation Up to 0.25 inches

Remove tripping hazards \$198

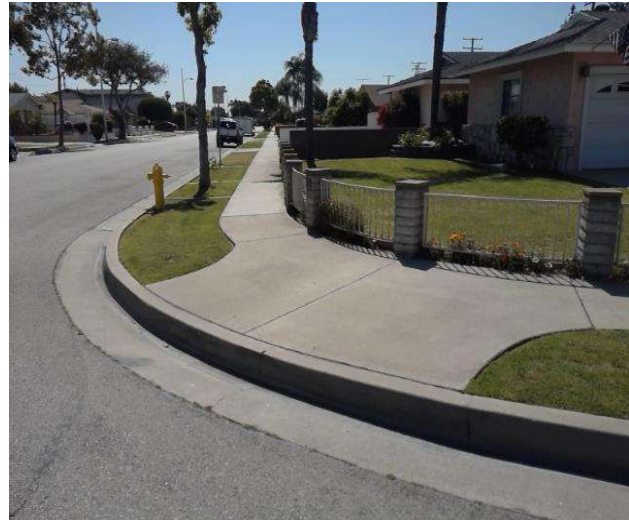
Sidewalks , Hazards & Gratings : Curb is on Path of Travel

Install curb ramp \$2,500

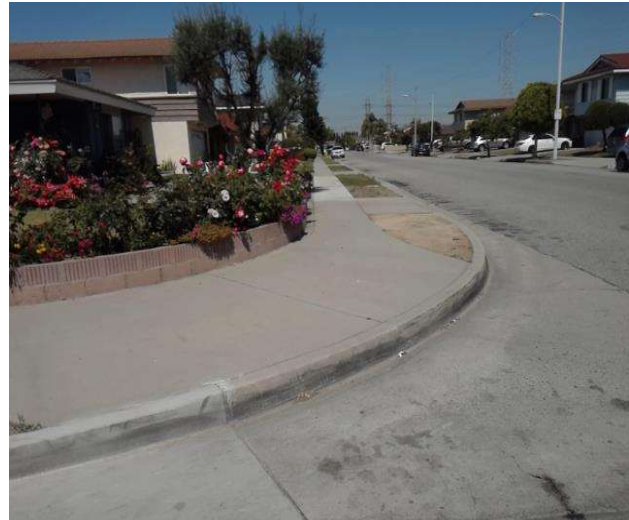
Sidewalks , Hazards & Gratings : Curb is on Path of Travel

Install curb ramp \$2,500

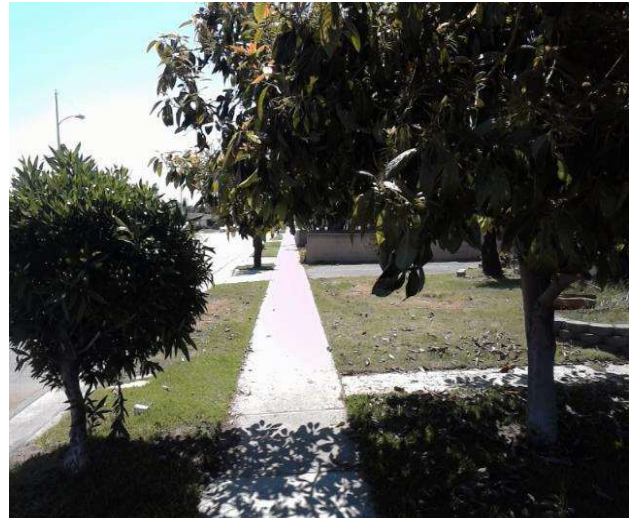
Sidewalks , Hazards & Gratings : Overhead Obstruction Height

Recommendation At least 80.00 inches
