# Accessibility Survey

# City of Downey La Reina Avenue - 5th Street to Firestone Boulevard

5th Street to Firestone Boulevard Downey, CA 90242

> Date of Inspection 7/24/2017

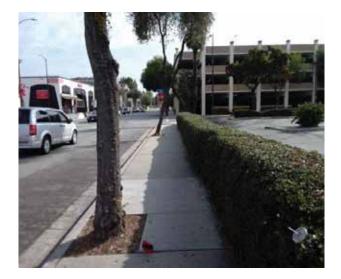
#### Change in Level South of 2nd Street @ 33.941587609160, -118.134374320507

Sidewalks , Change in Level : Change in Level Non Beveled

There is a change in elevation greater than recommended value.

**On-Site Finding** 0.62 inches

Ensure that the change in elevation is within the recommended value.

Recommendation Up to 0.25 inches

Remove tripping hazards \$198

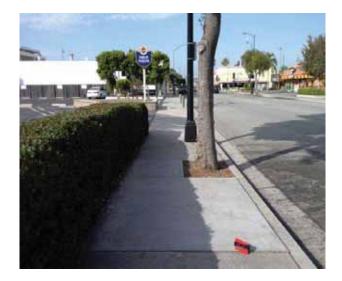
#### Change in Level South of 2nd Street @ 33.941613198726, -118.134356886148

Sidewalks, Change in Level : Change in Level Non Beveled

There is a change in elevation greater than recommended value.

**On-Site Finding** 0.75 inches

Ensure that the change in elevation is within the recommended value.

Recommendation Up to 0.25 inches

Remove tripping hazards \$198

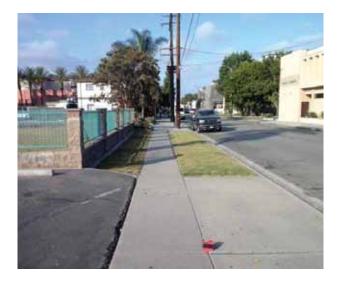
There is a change in elevation greater than recommended value.

Ensure that the change in elevation is within the recommended value.

Recommendation Up to 0.25 inches

Remove tripping hazards \$198

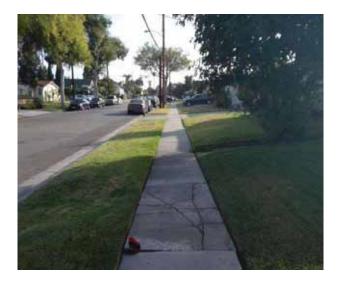
There is a change in elevation greater than recommended value.

Ensure that the change in elevation is within the recommended value.

Recommendation Up to 0.25 inches

Remove tripping hazards \$198

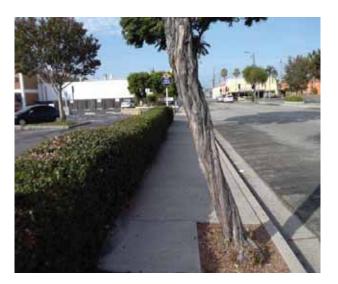
Sidewalks , Hazards & Gratings : Overhead Obstruction Height

At least 80.00 inches Recommendation Costing Info (Estimated)

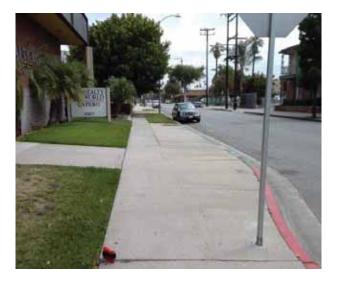
There is a change in elevation greater than recommended value.

Ensure that the change in elevation is within the recommended value.

Recommendation Up to 0.25 inches

Remove tripping hazards \$198

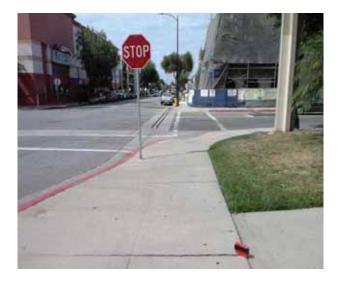
There is a change in elevation greater than recommended value.

Ensure that the change in elevation is within the recommended value.

Recommendation Up to 0.25 inches

Remove tripping hazards \$198

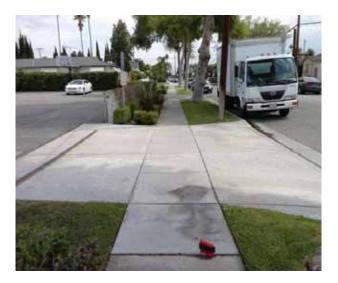
There is a change in elevation greater than recommended value.

Ensure that the change in elevation is within the recommended value.

Recommendation Up to 0.25 inches

Remove tripping hazards \$198

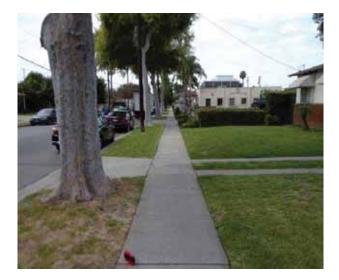
There is a change in elevation greater than recommended value.

Ensure that the change in elevation is within the recommended value.

Recommendation Up to 0.25 inches

Remove tripping hazards \$198

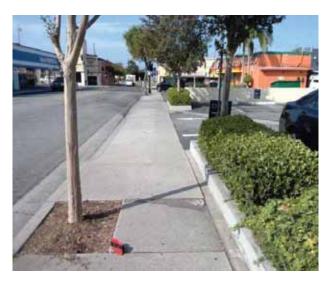
There is a change in elevation greater than recommended value.

Sidewalks , Change in Level : Change in Level Non Beveled

Ensure that the change in elevation is within the recommended value.

Recommendation Up to 0.25 inches

Remove tripping hazards \$198

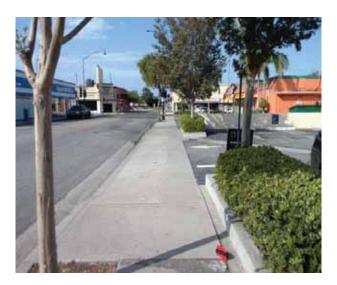
There is a change in elevation greater than recommended value.

Ensure that the change in elevation is within the recommended value.

Recommendation Up to 0.25 inches

Remove tripping hazards \$198

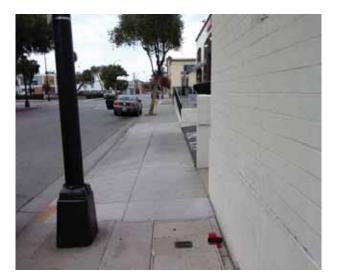
There is a change in elevation greater than recommended value.

Sidewalks , Change in Level : Change in Level Non Beveled

Ensure that the change in elevation is within the recommended value.

Recommendation Up to 0.25 inches

Remove tripping hazards \$198

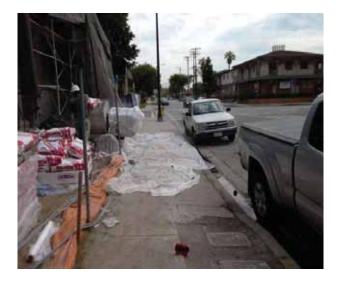
There is a change in elevation greater than recommended value.

Ensure that the change in elevation is within the recommended value.

Recommendation Up to 0.25 inches

Remove tripping hazards \$198

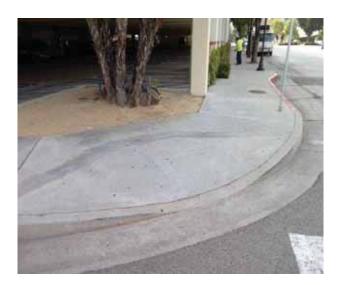
On-Site Finding Not Found

Recommendation See Recommendation

Provide detectable warning to \$248 surface

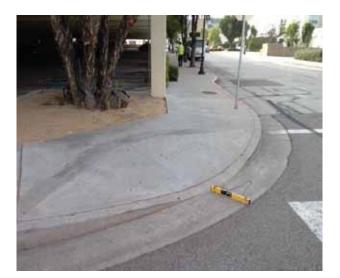
Curb Ramp, Landings and Transitions : Top Landing Slope

Recommendation Up to 2.08 percent

Provide compliant landing \$1,260

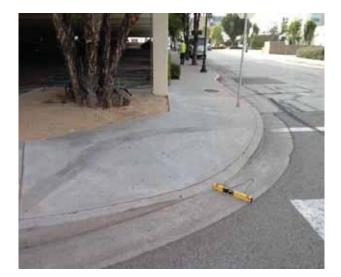
Curb Ramp, Landings and Transitions : Top Landing Clear Length -

Recommendation At least 48.00 inches

Provide compliant landing \$240

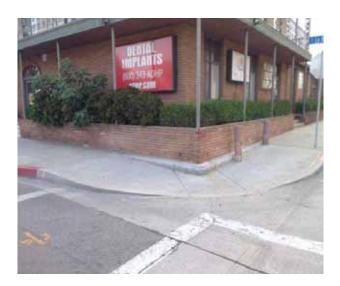
On-Site Finding Not Found

Recommendation See Recommendation

Provide detectable warning to \$248 surface

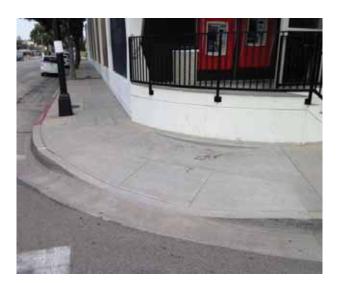
**On-Site Finding** Not Found

Recommendation See Recommendation

Provide detectable warning to \$248 surface

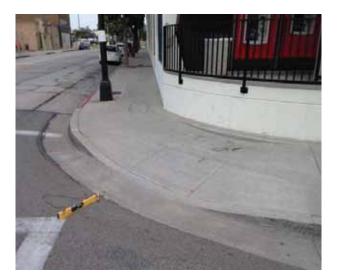
Curb Ramp , Landings and Transitions : Top Landing Clear Length -

At least 48.00 inches Recommendation

Provide compliant landing \$240

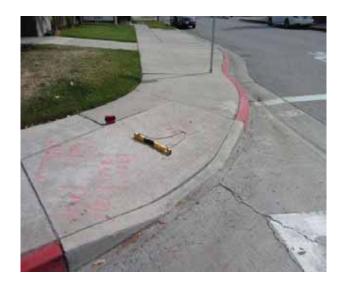
On-Site Finding Not Found

Recommendation See Recommendation

Provide detectable warning to \$248 surface

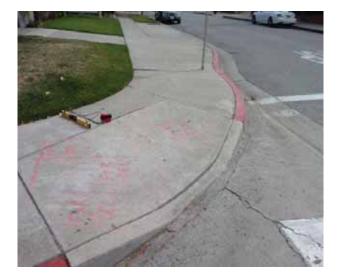
Curb Ramp, Landings and Transitions : Top Landing Slope

Recommendation Up to 2.08 percent

Provide compliant landing \$1,260

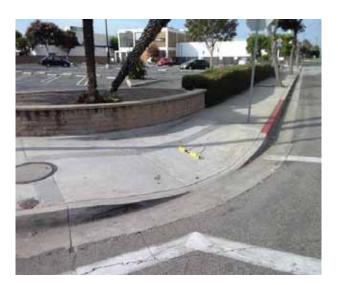
On-Site Finding Not Found

Recommendation See Recommendation

Provide detectable warning to \$248 surface

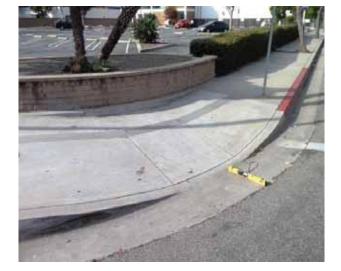
Curb Ramp , Landings and Transitions : Top Landing Clear Length -

Recommendation At least 48.00 inches

Provide compliant landing \$240

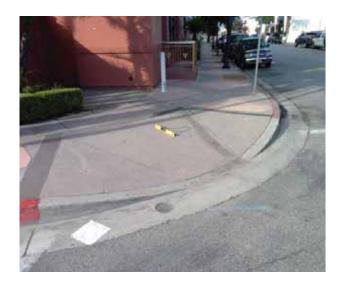
On-Site Finding Not Found

Recommendation See Recommendation

Provide detectable warning to \$248 surface

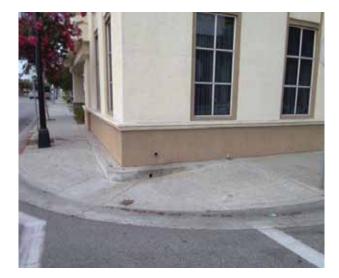
**On-Site Finding** Not Found

Recommendation See Recommendation

Provide detectable warning to \$248 surface

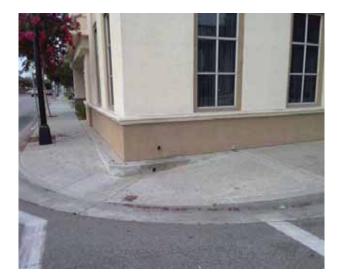
Curb Ramp , Landings and Transitions  $\ : \ \mbox{Top}$  Landing Slope

Recommendation Up to 2.08 percent

Provide compliant landing \$1,260

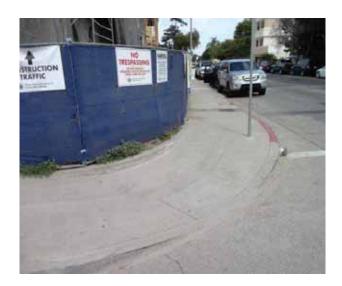
On-Site Finding Not Found

Recommendation See Recommendation

Provide detectable warning to \$248 surface

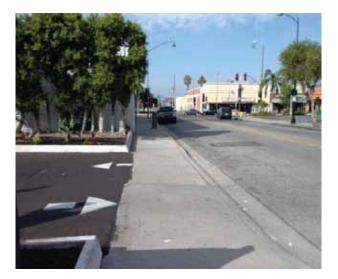
**On-Site Finding** Not Found

Provide detectable warnings.

Recommendation	See Recom	mendation
Costing Info (Estim	ated)	
Install compliant dete	ectable	\$190
warnings

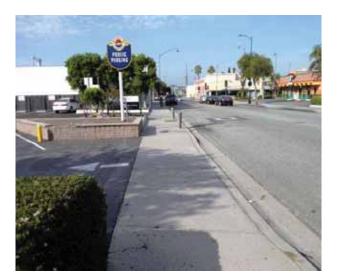
**On-Site Finding** Not Found

Provide detectable warnings.

Recommendation	See Recom	mendation
Costing Info (Estim	ated)	
Install compliant dete warnings	ectable	\$190

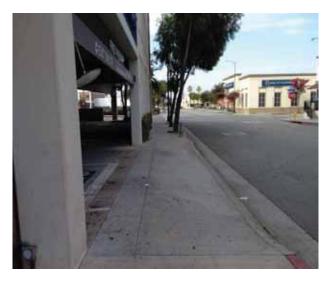
**On-Site Finding** Not Found

Provide detectable warnings.

Recommendation See Recommendation **Costing Info (Estimated)** Install compliant detectable \$190 warnings

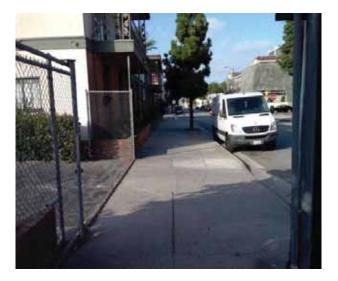
**On-Site Finding** Not Found

Provide detectable warnings.

Recommendation	See Recom	mendation
Costing Info (Estim	ated)	
Install compliant dete	ctable	\$190
warnings

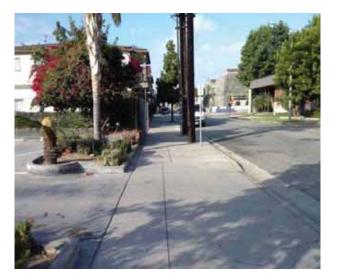
**On-Site Finding** Not Found

Provide detectable warnings.

Recommendation	See Recom	mendation
Costing Info (Estim	ated)	
Install compliant dete warnings	ectable	\$190

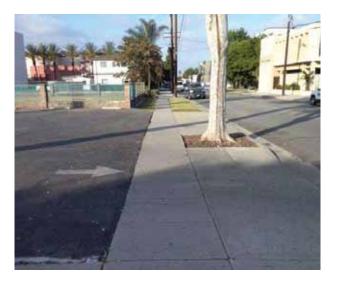
**On-Site Finding** Not Found

Provide detectable warnings.

Recommendation	See Recom	mendation
Costing Info (Estim	ated)	
Install compliant dete warnings	ectable	\$190

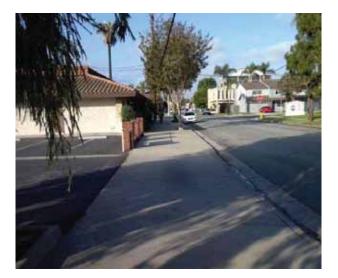
**On-Site Finding** Not Found

Provide detectable warnings.

Recommendation	See Recom	mendation
Costing Info (Estim	ated)	
Install compliant dete warnings	ectable	\$190

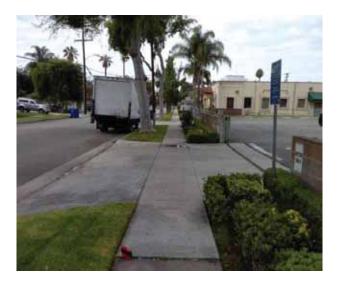
There is a change in elevation greater than recommended value.

Ensure that the change in elevation is within the recommended value.

Recommendation Up to 0.25 inches

Remove tripping hazards \$198

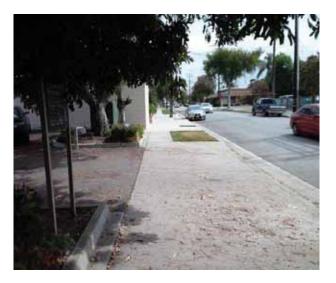
**On-Site Finding** Not Found

Provide detectable warnings.

Recommendation	See Recom	mendation
Costing Info (Estim	ated)	
Install compliant dete warnings	ectable	\$190

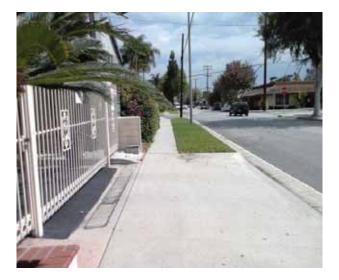
**On-Site Finding** Not Found

Provide detectable warnings.

Recommendation	See Recom	mendation
Costing Info (Estim	ated)	
Install compliant dete warnings	ectable	\$190

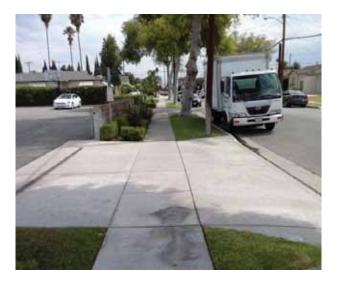
**On-Site Finding** Not Found

Provide detectable warnings.

Recommendation	See Recom	mendation
Costing Info (Estim	ated)	
Install compliant dete warnings	ectable	\$190

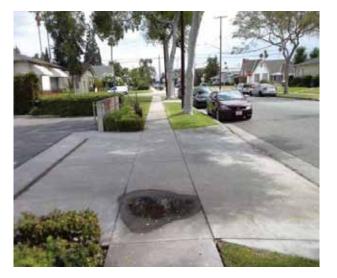
**On-Site Finding** Not Found

Provide detectable warnings.

Recommendation	See Recom	mendation
Costing Info (Estim	ated)	
Install compliant dete warnings	ectable	\$190

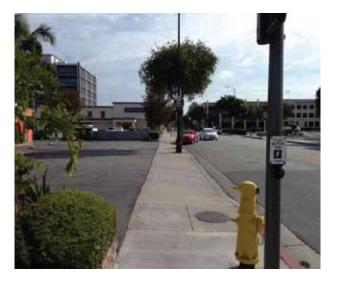
**On-Site Finding** Not Found

Provide detectable warnings.

Recommendation	See Recom	mendation
Costing Info (Estim	ated)	
Install compliant dete warnings	ectable	\$190

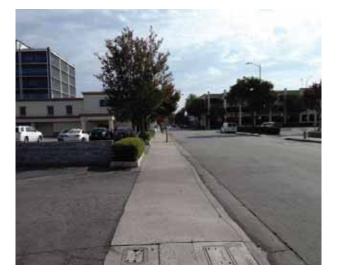
**On-Site Finding** Not Found

Provide detectable warnings.

Recommendation	See Recom	mendation
Costing Info (Estim	ated)	
Install compliant dete warnings	ectable	\$190

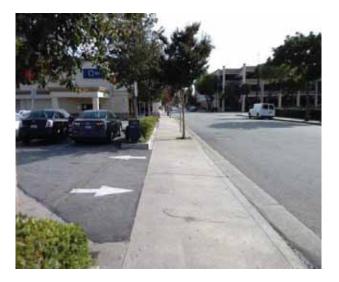
**On-Site Finding** Not Found

Provide detectable warnings.

Recommendation	See Recom	mendation
Costing Info (Estim	ated)	
Install compliant dete warnings	ectable	\$190

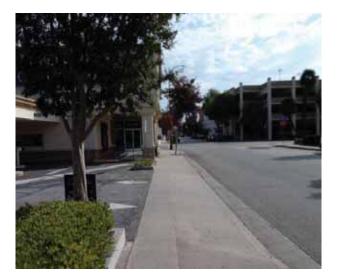
**On-Site Finding** Not Found

Provide detectable warnings.

Recommendation	See Recom	mendation
Costing Info (Estim	ated)	
Install compliant dete warnings	ectable	\$190

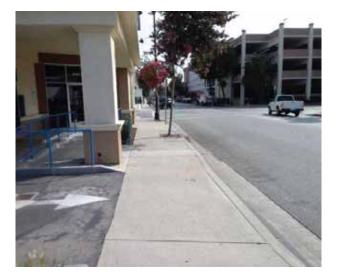
**On-Site Finding** Not Found

Provide detectable warnings.

Recommendation	See Recom	mendation
Costing Info (Estim	ated)	
Install compliant dete warnings	ectable	\$190

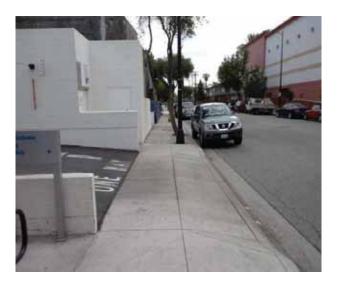
**On-Site Finding** Not Found

Provide detectable warnings.

Recommendation	See Recom	mendation
Costing Info (Estim	ated)	
Install compliant dete warnings	ectable	\$190

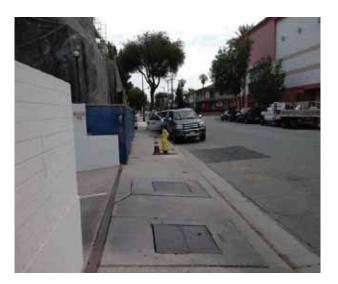
**On-Site Finding** Not Found

Provide detectable warnings.

Recommendation	See Recom	mendation
Costing Info (Estim	ated)	
Install compliant dete warnings	ectable	\$190

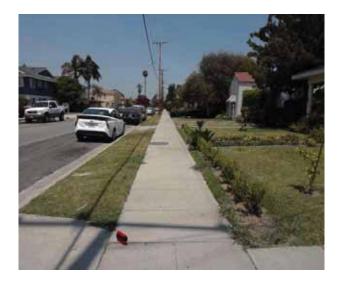
There is a change in elevation greater than recommended value.

Ensure that the change in elevation is within the recommended value.

Recommendation Up to 0.25 inches

Remove tripping hazards \$198

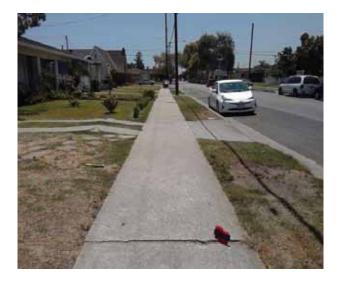
There is a change in elevation greater than recommended value.

Ensure that the change in elevation is within the recommended value.

Recommendation Up to 0.25 inches

Remove tripping hazards \$198

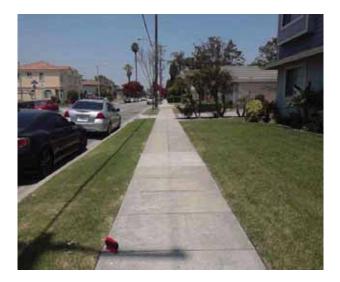
There is a change in elevation greater than recommended value.

Ensure that the change in elevation is within the recommended value.

Recommendation Up to 0.25 inches

Remove tripping hazards \$198

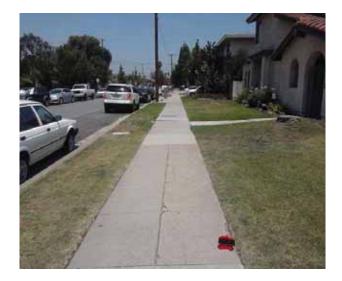
There is a change in elevation greater than recommended value.

Ensure that the change in elevation is within the recommended value.

Recommendation Up to 0.25 inches

Remove tripping hazards \$198

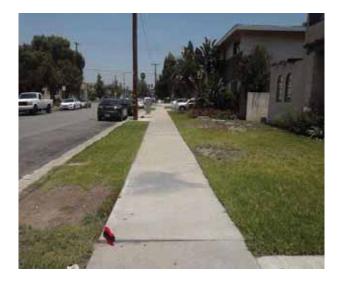
There is a change in elevation greater than recommended value.

Ensure that the change in elevation is within the recommended value.

Recommendation Up to 0.25 inches

Remove tripping hazards \$198

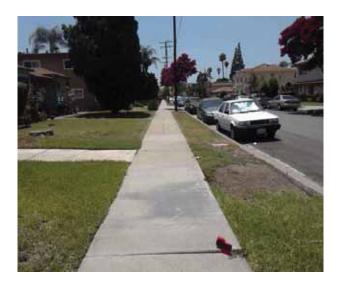
There is a change in elevation greater than recommended value.

Ensure that the change in elevation is within the recommended value.

Recommendation Up to 0.25 inches

Remove tripping hazards \$198

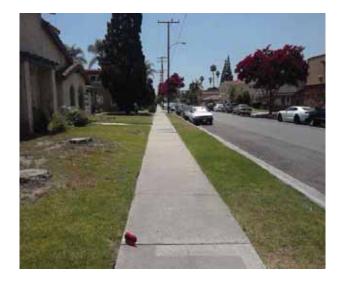
There is a change in elevation greater than recommended value.

Ensure that the change in elevation is within the recommended value.

Recommendation Up to 0.25 inches

Remove tripping hazards \$198

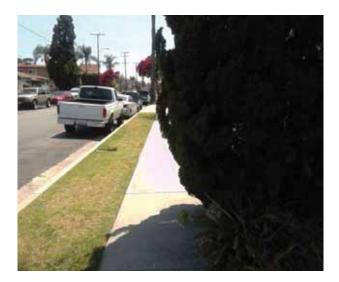
Sidewalks, Hazards & Gratings : Sidewalk Width at Obstruction

Sidewalk width at the obstruction shall have the recommended value.

Recommendation At least 48.00 inches

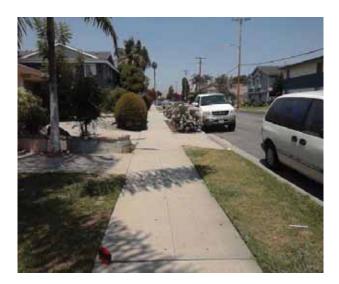
There is a change in elevation greater than recommended value.

Ensure that the change in elevation is within the recommended value.

Recommendation Up to 0.25 inches

Remove tripping hazards \$198

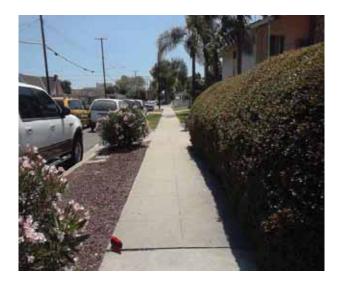
There is a change in elevation greater than recommended value.

Ensure that the change in elevation is within the recommended value.

Recommendation Up to 0.25 inches

Remove tripping hazards \$198

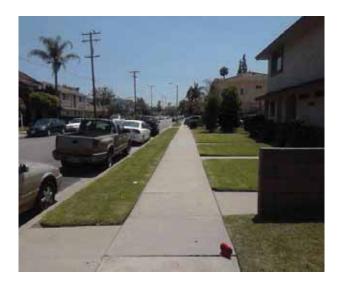
There is a change in elevation greater than recommended value.

Ensure that the change in elevation is within the recommended value.

Recommendation Up to 0.25 inches

Remove tripping hazards \$198

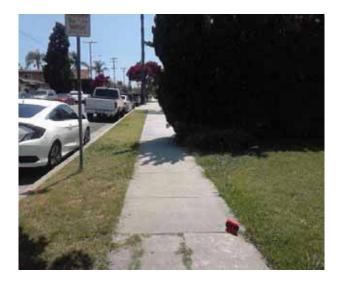
There is a change in elevation greater than recommended value.

Ensure that the change in elevation is within the recommended value.

Recommendation Up to 0.25 inches

Remove tripping hazards \$198

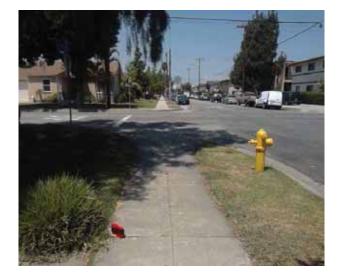
There is a change in elevation greater than recommended value.

Ensure that the change in elevation is within the recommended value.

Recommendation Up to 0.25 inches

Remove tripping hazards \$198

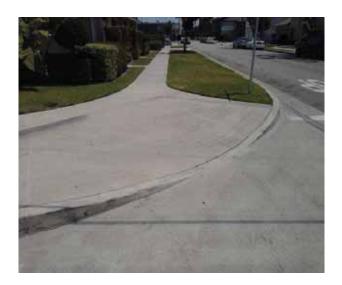
On-Site Finding Not Found

Provide detectable warning to \$248 surface

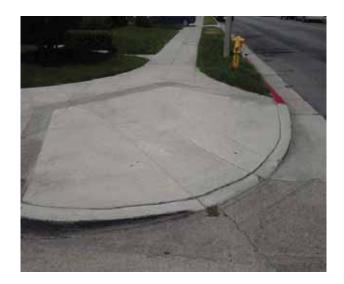
**On-Site Finding** Not Found

Provide detectable warning to \$248 surface

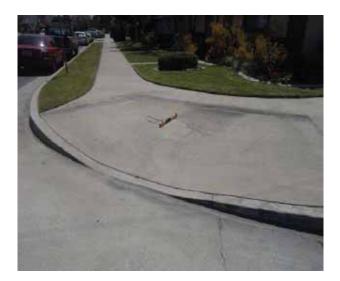
**On-Site Finding** Not Found

Provide detectable warning to \$248 surface

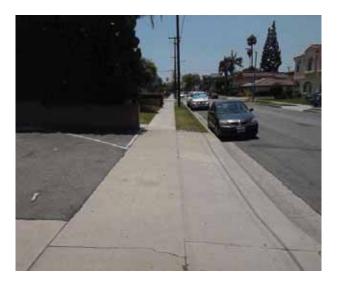
**On-Site Finding** Not Found

Provide detectable warnings.

Recommendation See Recommendation **Costing Info (Estimated)** Install compliant detectable \$190 warnings

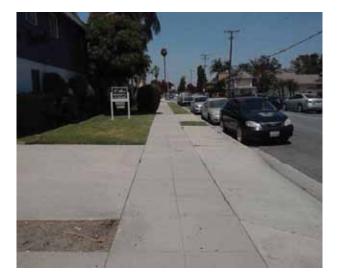
**On-Site Finding** Not Found

Provide detectable warnings.

Recommendation	See Recom	mendation
Costing Info (Estim	ated)	
Install compliant dete	ectable	\$190
warnings

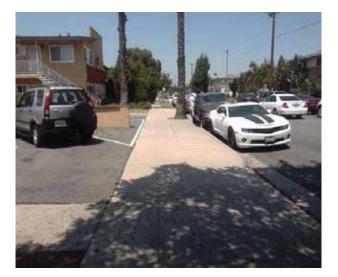
**On-Site Finding** Not Found

Provide detectable warnings.

Recommendation	See Recom	mendation
Costing Info (Estim	ated)	
Install compliant dete warnings	ectable	\$190

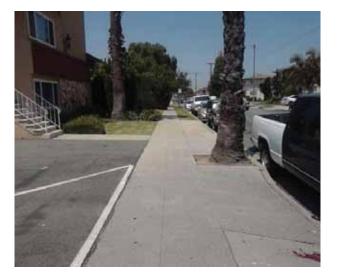
**On-Site Finding** Not Found

Provide detectable warnings.

Recommendation	See Recom	mendation	
Costing Info (Estimated)			
Install compliant detectable		\$190	
warnings

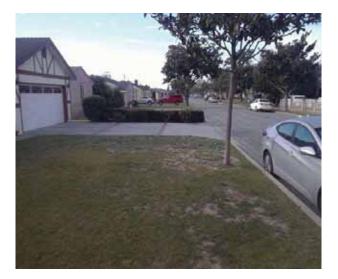
Sidewalks : Missing Sidewalk

Section of sidewalk is missing and consists of dirt, grass or gravel.

Provide a compliant sidewalk for the missing section.

\$1,260

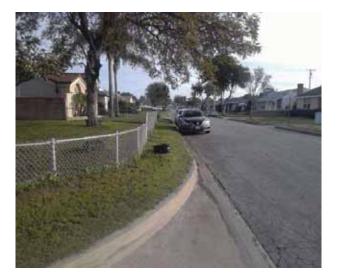
Sidewalks : Missing Sidewalk

Section of sidewalk is missing and consists of dirt, grass or gravel.

Provide a compliant sidewalk for the missing section.

\$1,260

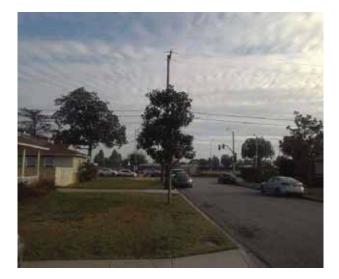
Sidewalks : Missing Sidewalk

Section of sidewalk is missing and consists of dirt, grass or gravel.

Provide a compliant sidewalk for the missing section.

\$1,260

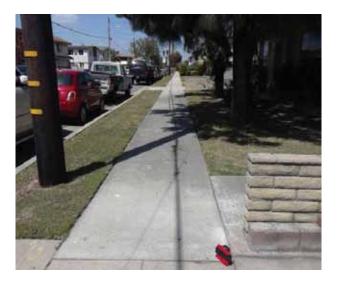
There is a change in elevation greater than recommended value.

Ensure that the change in elevation is within the recommended value.

Recommendation Up to 0.25 inches

Remove tripping hazards \$198

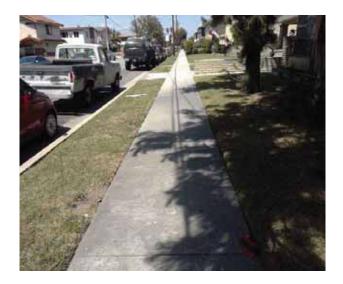
There is a change in elevation greater than recommended value.

Ensure that the change in elevation is within the recommended value.

Recommendation Up to 0.25 inches

Remove tripping hazards \$198

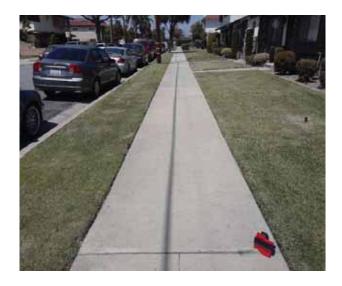
There is a change in elevation greater than recommended value.

Ensure that the change in elevation is within the recommended value.

Recommendation Up to 0.25 inches

Remove tripping hazards \$198

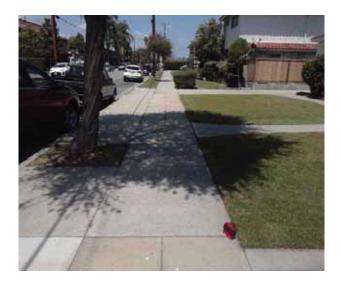
There is a change in elevation greater than recommended value.

Ensure that the change in elevation is within the recommended value.

Recommendation Up to 0.25 inches

Remove tripping hazards \$198

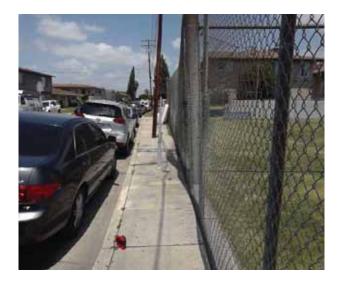
There is a change in elevation greater than recommended value.

Ensure that the change in elevation is within the recommended value.

Recommendation Up to 0.25 inches

Remove tripping hazards \$198

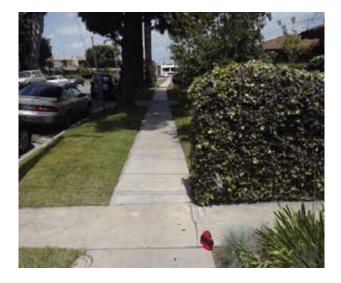
There is a change in elevation greater than recommended value.

Ensure that the change in elevation is within the recommended value.

Recommendation Up to 0.25 inches

Remove tripping hazards \$198

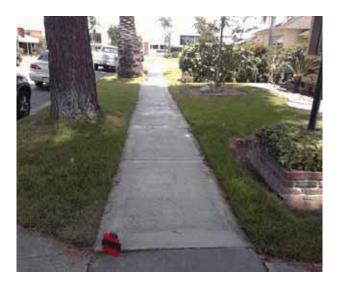
There is a change in elevation greater than recommended value.

Ensure that the change in elevation is within the recommended value.

Recommendation Up to 0.25 inches

Remove tripping hazards \$198

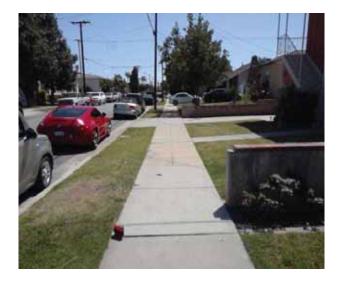
There is a change in elevation greater than recommended value.

Ensure that the change in elevation is within the recommended value.

Recommendation Up to 0.25 inches

Remove tripping hazards \$198

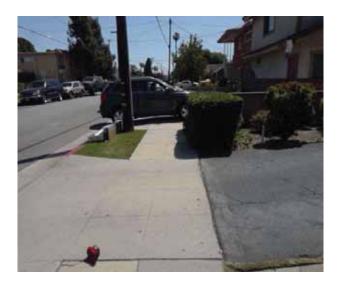
There is a change in elevation greater than recommended value.

Ensure that the change in elevation is within the recommended value.

Recommendation Up to 0.25 inches

Remove tripping hazards \$198

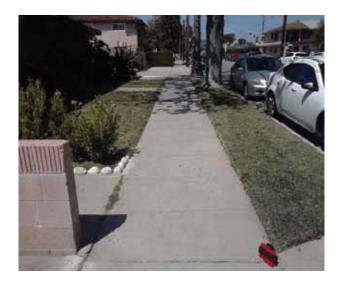
There is a change in elevation greater than recommended value.

Ensure that the change in elevation is within the recommended value.

Recommendation Up to 0.25 inches

Remove tripping hazards \$198

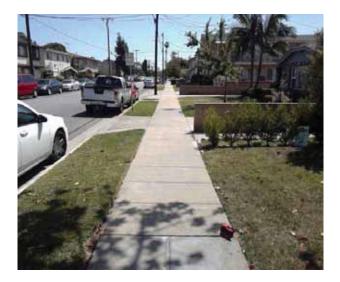
There is a change in elevation greater than recommended value.

Ensure that the change in elevation is within the recommended value.

Recommendation Up to 0.25 inches

Remove tripping hazards \$198

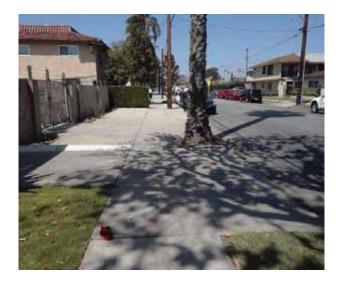
There is a change in elevation greater than recommended value.

Ensure that the change in elevation is within the recommended value.

Recommendation Up to 0.25 inches

Remove tripping hazards \$198

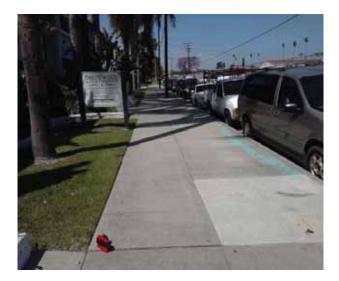
There is a change in elevation greater than recommended value.

Ensure that the change in elevation is within the recommended value.

Recommendation Up to 0.25 inches

Remove tripping hazards \$198

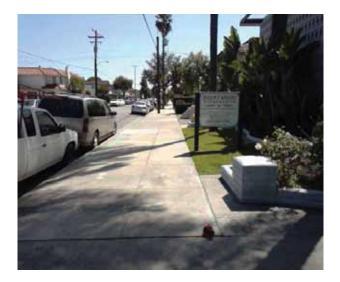
There is a change in elevation greater than recommended value.

Ensure that the change in elevation is within the recommended value.

Recommendation Up to 0.25 inches

Remove tripping hazards \$198

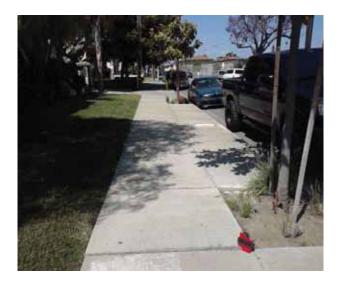
There is a change in elevation greater than recommended value.

Ensure that the change in elevation is within the recommended value.

Recommendation Up to 0.25 inches

Remove tripping hazards \$198

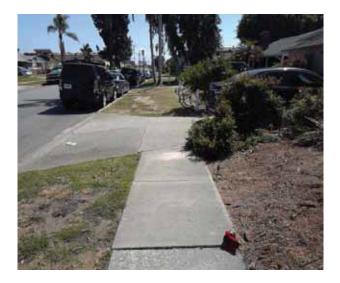
There is a change in elevation greater than recommended value.

Ensure that the change in elevation is within the recommended value.

Recommendation Up to 0.25 inches

Remove tripping hazards \$198

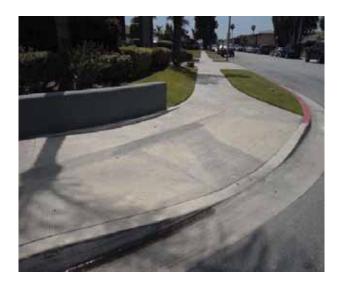
**On-Site Finding** Not Found

Provide detectable warning to \$248 surface

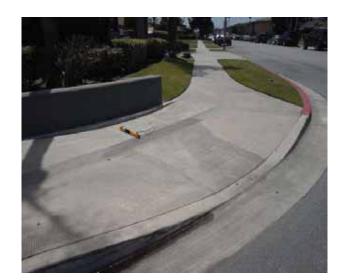
Curb Ramp , Landings and Transitions : Top Landing Slope

Recommendation Up to 2.08 percent

Provide compliant landing \$1,260

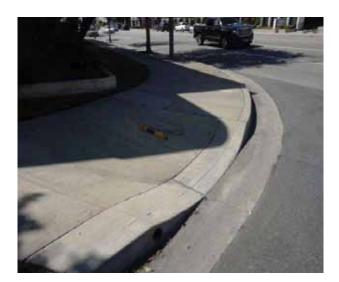
**On-Site Finding** Not Found

Provide detectable warning to \$248 surface

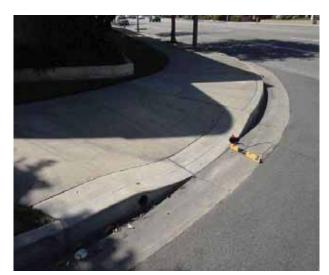
Curb Ramp : Bottom Landing Slope

Recommendation Up to 5.00 percent

Repave landing \$1,260

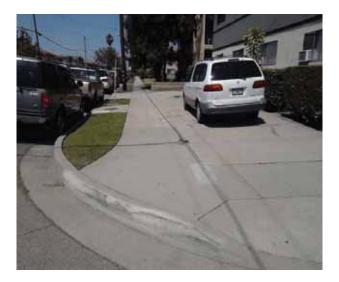
Sidewalks , Hazards & Gratings : Curb is on Path of Travel

Provide a compliant curb ramp.

Recommendation See Recommendation Costing Info (Estimated) Install curb ramp \$2,500

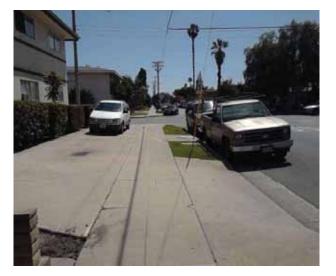
**On-Site Finding** Not Found

Provide detectable warnings.

Recommendation	See Recom	mendation
Costing Info (Estim	ated)	
Install compliant dete warnings	ectable	\$190

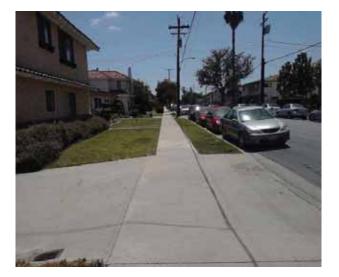
**On-Site Finding** Not Found

Provide detectable warnings.

Recommendation	See Recom	mendation
Costing Info (Estim	ated)	
Install compliant dete warnings	ectable	\$190

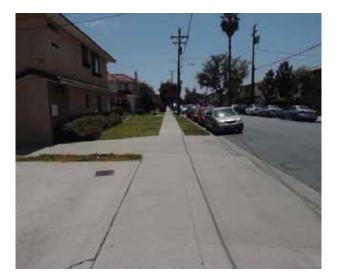
**On-Site Finding** Not Found

Provide detectable warnings.

Recommendation	See Recom	mendation
Costing Info (Estim	ated)	
Install compliant dete warnings	ectable	\$190

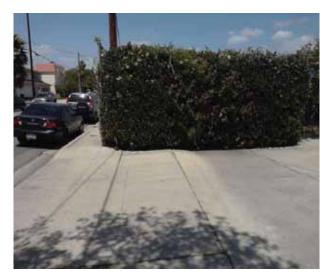
**On-Site Finding** Not Found

Provide detectable warnings.

Recommendation	See Recom	mendation
Costing Info (Estim	ated)	
Install compliant dete warnings	ectable	\$190

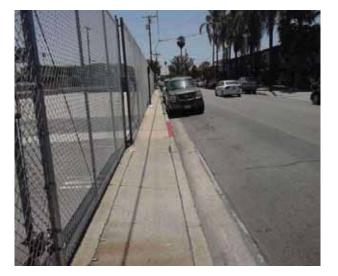
**On-Site Finding** Not Found

Provide detectable warnings.

Recommendation	See Recom	mendation
Costing Info (Estim	ated)	
Install compliant dete warnings	ectable	\$190

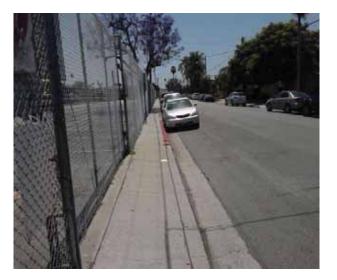
**On-Site Finding** Not Found

Provide detectable warnings.

Recommendation	See Recom	mendation
Costing Info (Estim	ated)	
Install compliant dete warnings	ectable	\$190

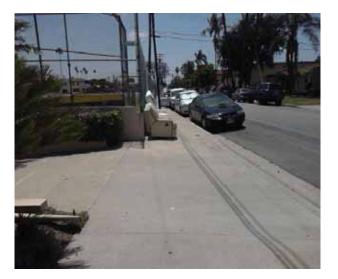
**On-Site Finding** Not Found

Provide detectable warnings.

Recommendation	See Recom	mendation
Costing Info (Estim	ated)	
Install compliant dete warnings	ectable	\$190

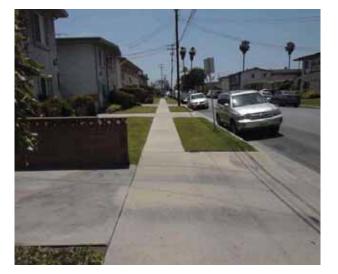
**On-Site Finding** Not Found

Provide detectable warnings.

Recommendation	See Recom	mendation
Costing Info (Estim	ated)	
Install compliant dete warnings	ectable	\$190

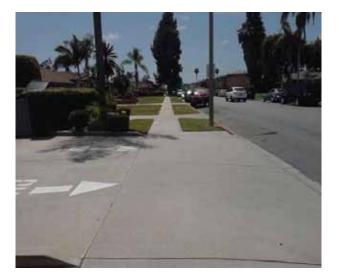
**On-Site Finding** Not Found

Provide detectable warnings.

Recommendation	See Recom	mendation
Costing Info (Estim	ated)	
Install compliant dete	ctable	\$190
warnings

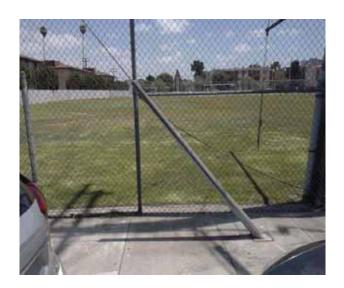
Sidewalks , Hazards & Gratings : Overhead Obstruction Height

At least 80.00 inches Recommendation Costing Info (Estimated)

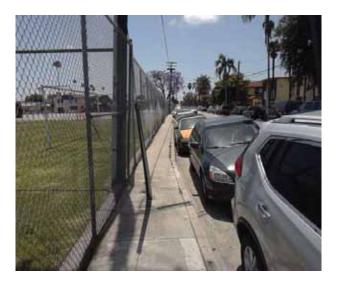
Sidewalks , Hazards & Gratings : Sidewalk Width at Obstruction

Sidewalk width at the obstruction shall have the recommended value.

Recommendation At least 48.00 inches

\$1,260

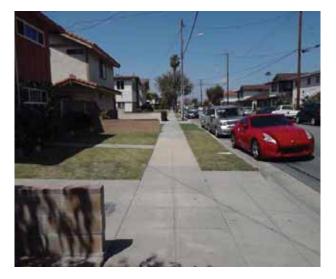
**On-Site Finding** Not Found

Provide detectable warnings.

Recommendation	See Recom	mendation
Costing Info (Estim	ated)	
Install compliant dete warnings	ectable	\$190

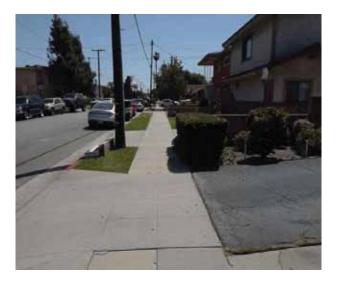
**On-Site Finding** Not Found

Provide detectable warnings.

Recommendation	See Recom	mendation
Costing Info (Estim	ated)	
Install compliant dete warnings	ectable	\$190

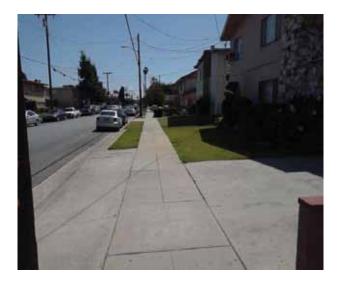
**On-Site Finding** Not Found

Provide detectable warnings.

Recommendation	See Recom	mendation
Costing Info (Estim	ated)	
Install compliant dete warnings	ectable	\$190

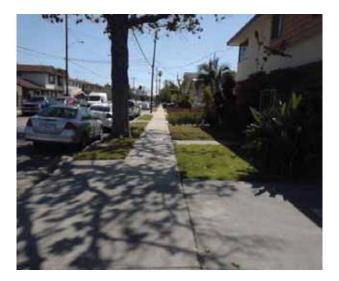
**On-Site Finding** Not Found

Provide detectable warnings.

Recommendation	See Recom	mendation
Costing Info (Estim	ated)	
Install compliant dete	ectable	\$190
warnings

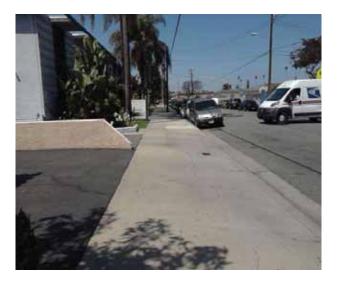
**On-Site Finding** Not Found

Provide detectable warnings.

Recommendation	See Recom	mendation
Costing Info (Estim	ated)	
Install compliant dete warnings	ectable	\$190

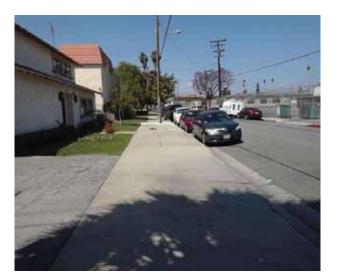
**On-Site Finding** Not Found

Provide detectable warnings.

Recommendation	See Recom	mendation
Costing Info (Estim	ated)	
Install compliant dete	ectable	\$190
warnings

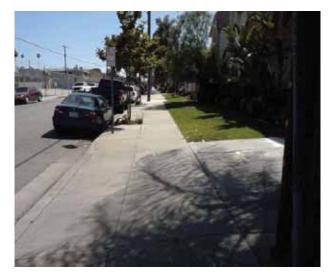
**On-Site Finding** Not Found

Provide detectable warnings.

Recommendation	See Recom	mendation
Costing Info (Estim	ated)	
Install compliant dete warnings	ectable	\$190

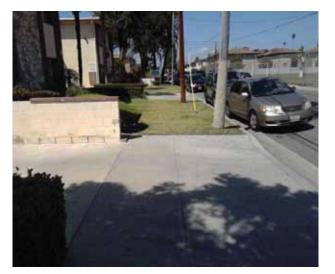
**On-Site Finding** Not Found

Provide detectable warnings.

Recommendation	See Recom	mendation
Costing Info (Estim	ated)	
Install compliant dete warnings	ectable	\$190

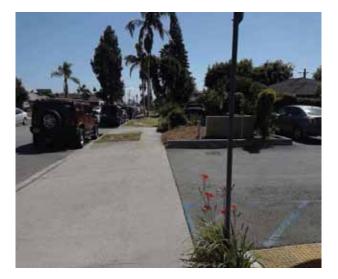
**On-Site Finding** Not Found

Provide detectable warnings.

Recommendation	See Recom	mendation
Costing Info (Estim	ated)	
Install compliant dete warnings	ectable	\$190

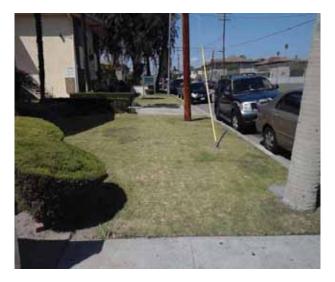
Sidewalks : Missing Sidewalk

Section of sidewalk is missing and consists of dirt, grass or gravel.

Provide a compliant sidewalk for the missing section.

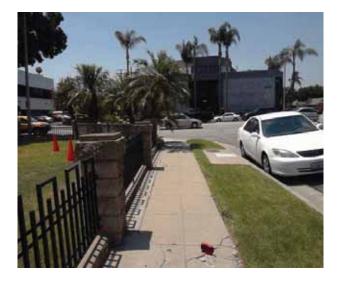
There is a change in elevation greater than recommended value.

Ensure that the change in elevation is within the recommended value.

Recommendation Up to 0.25 inches

Remove tripping hazards \$198

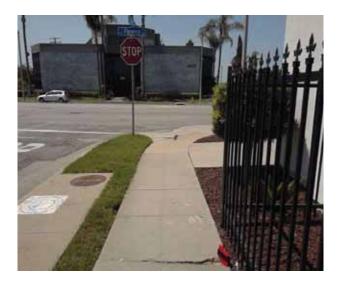
There is a change in elevation greater than recommended value.

Ensure that the change in elevation is within the recommended value.

Recommendation Up to 0.25 inches

Remove tripping hazards \$198

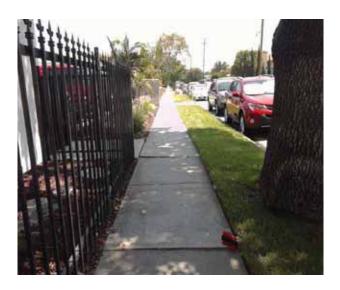
There is a change in elevation greater than recommended value.

Ensure that the change in elevation is within the recommended value.

Recommendation Up to 0.25 inches

Remove tripping hazards \$198

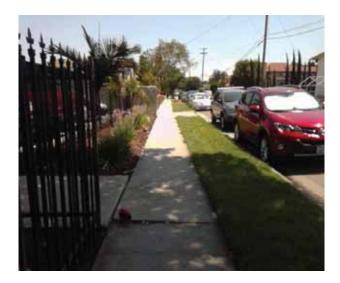
There is a change in elevation greater than recommended value.

Ensure that the change in elevation is within the recommended value.

Recommendation Up to 0.25 inches

Remove tripping hazards \$198

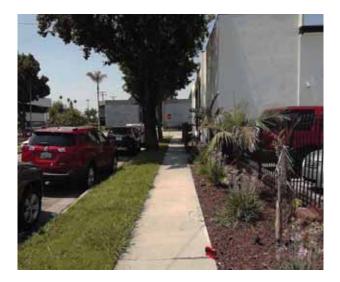
There is a change in elevation greater than recommended value.

Ensure that the change in elevation is within the recommended value.

Recommendation Up to 0.25 inches

Remove tripping hazards \$198

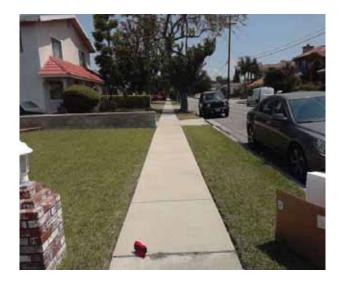
There is a change in elevation greater than recommended value.

Ensure that the change in elevation is within the recommended value.

Recommendation Up to 0.25 inches

Remove tripping hazards \$198

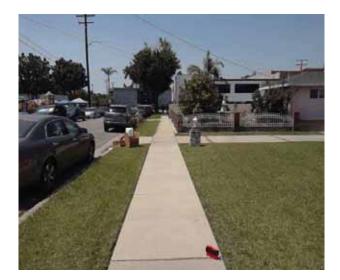
There is a change in elevation greater than recommended value.

Ensure that the change in elevation is within the recommended value.

Recommendation Up to 0.25 inches

Remove tripping hazards \$198

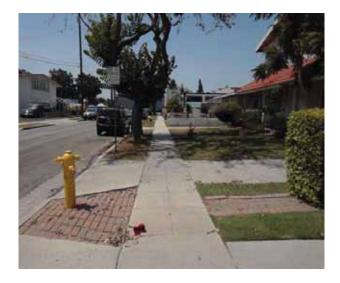
There is a change in elevation greater than recommended value.

Ensure that the change in elevation is within the recommended value.

Recommendation Up to 0.25 inches

Remove tripping hazards \$198

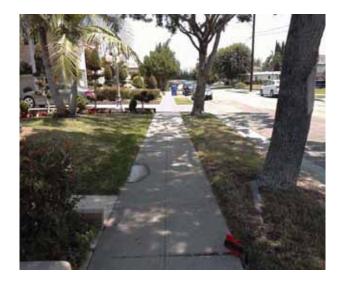
There is a change in elevation greater than recommended value.

Ensure that the change in elevation is within the recommended value.

Recommendation Up to 0.25 inches

Remove tripping hazards \$198

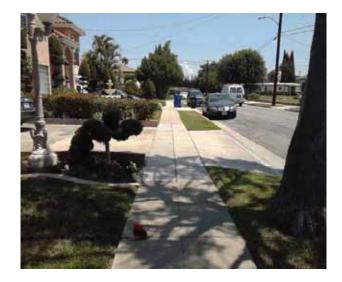
There is a change in elevation greater than recommended value.

Ensure that the change in elevation is within the recommended value.

Recommendation Up to 0.25 inches

Remove tripping hazards \$198

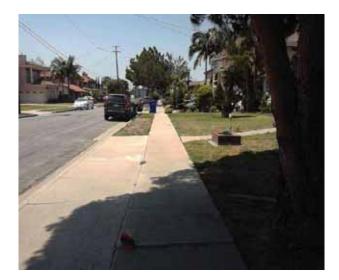
There is a change in elevation greater than recommended value.

Ensure that the change in elevation is within the recommended value.

Recommendation Up to 0.25 inches

Remove tripping hazards \$198

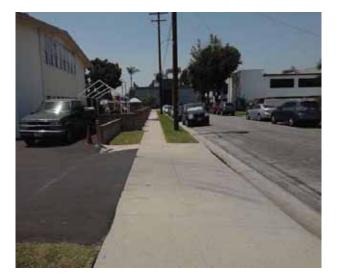
**On-Site Finding** Not Found

Provide detectable warnings.

Recommendation	See Recom	mendation
Costing Info (Estim	ated)	
Install compliant dete warnings	ectable	\$190

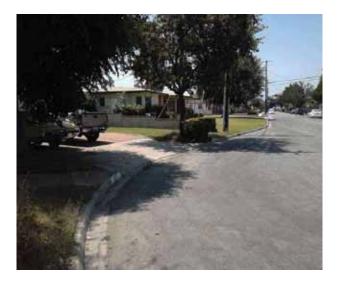
Sidewalks : Missing Sidewalk

Section of sidewalk is missing and consists of dirt, grass or gravel.

Provide a compliant sidewalk for the missing section.

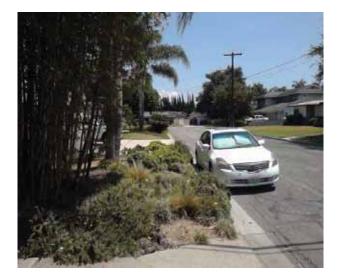
Sidewalks : Missing Sidewalk

Section of sidewalk is missing and consists of dirt, grass or gravel.

#### Recommendation

Provide a compliant sidewalk for the missing section.

\$1,260

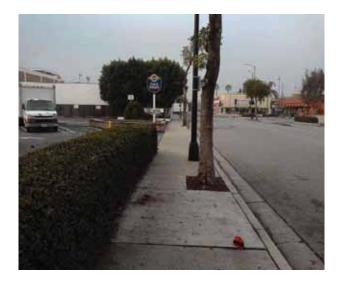
There is a change in elevation greater than recommended value.

Ensure that the change in elevation is within the recommended value.

Recommendation Up to 0.25 inches

Remove tripping hazards \$198

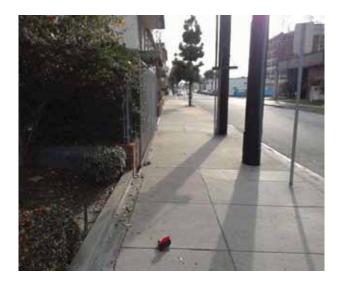
There is a change in elevation greater than recommended value.

Ensure that the change in elevation is within the recommended value.

Recommendation Up to 0.25 inches

Remove tripping hazards \$198

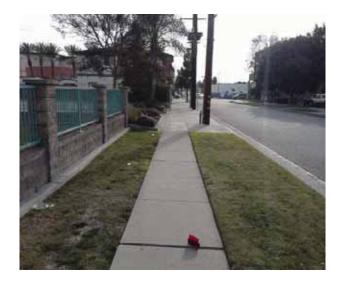
There is a change in elevation greater than recommended value.

Ensure that the change in elevation is within the recommended value.

Recommendation Up to 0.25 inches

Remove tripping hazards \$198

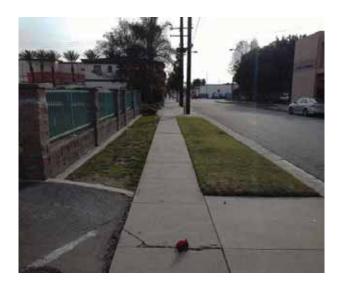
There is a change in elevation greater than recommended value.

Ensure that the change in elevation is within the recommended value.

Recommendation Up to 0.25 inches

Remove tripping hazards \$198

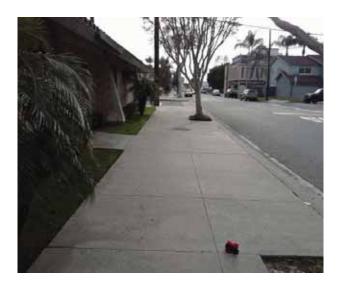
There is a change in elevation greater than recommended value.

Ensure that the change in elevation is within the recommended value.

Recommendation Up to 0.25 inches

Remove tripping hazards \$198

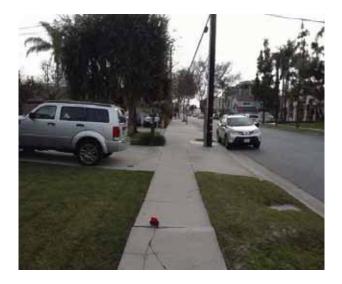
There is a change in elevation greater than recommended value.

Ensure that the change in elevation is within the recommended value.

Recommendation Up to 0.25 inches

Remove tripping hazards \$198

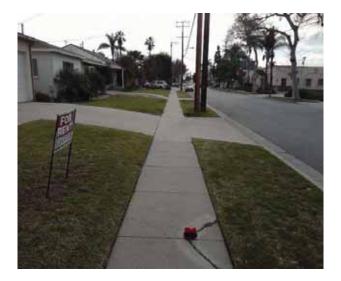
There is a change in elevation greater than recommended value.

Ensure that the change in elevation is within the recommended value.

Recommendation Up to 0.25 inches

Remove tripping hazards \$198

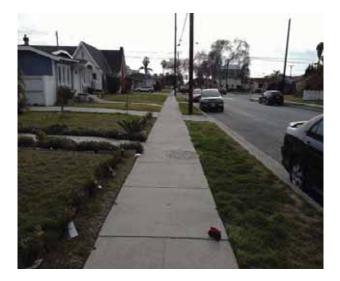
There is a change in elevation greater than recommended value.

Ensure that the change in elevation is within the recommended value.

Recommendation Up to 0.25 inches

Remove tripping hazards \$198

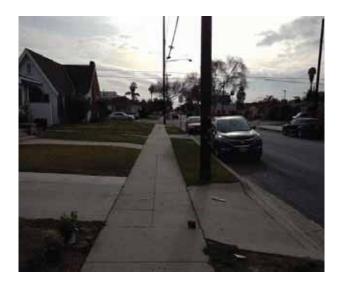
There is a change in elevation greater than recommended value.

Ensure that the change in elevation is within the recommended value.

Recommendation Up to 0.25 inches

Remove tripping hazards \$198

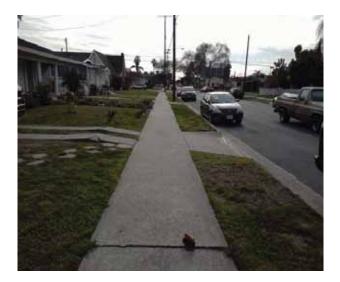
There is a change in elevation greater than recommended value.

Ensure that the change in elevation is within the recommended value.

Recommendation Up to 0.25 inches

Remove tripping hazards \$198

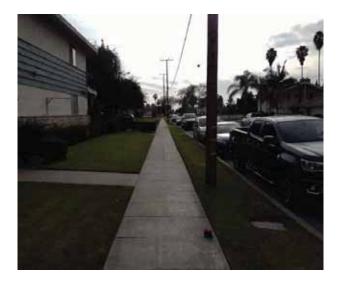
There is a change in elevation greater than recommended value.

Ensure that the change in elevation is within the recommended value.

Recommendation Up to 0.25 inches

Remove tripping hazards \$198

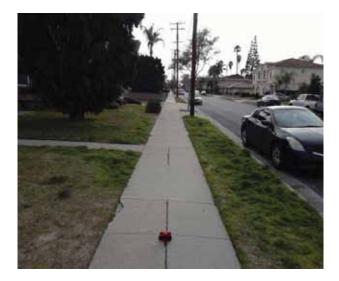
There is a change in elevation greater than recommended value.

Ensure that the change in elevation is within the recommended value.

Recommendation Up to 0.25 inches

Remove tripping hazards \$198

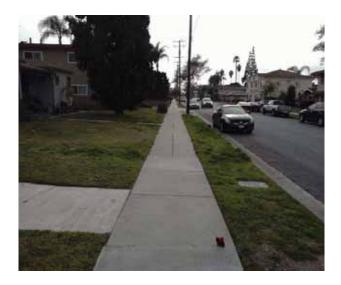
There is a change in elevation greater than recommended value.

Ensure that the change in elevation is within the recommended value.

Recommendation Up to 0.25 inches

Remove tripping hazards \$198

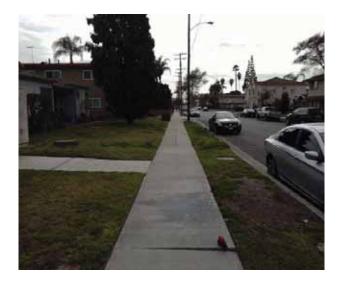
There is a change in elevation greater than recommended value.

Ensure that the change in elevation is within the recommended value.

Recommendation Up to 0.25 inches

Remove tripping hazards \$198

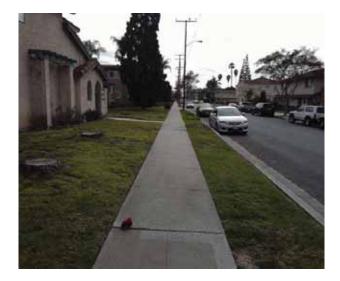
There is a change in elevation greater than recommended value.

Ensure that the change in elevation is within the recommended value.

Recommendation Up to 0.25 inches

Remove tripping hazards \$198

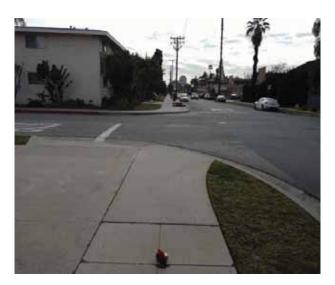
There is a change in elevation greater than recommended value.

Ensure that the change in elevation is within the recommended value.

Recommendation Up to 0.25 inches

Remove tripping hazards \$198

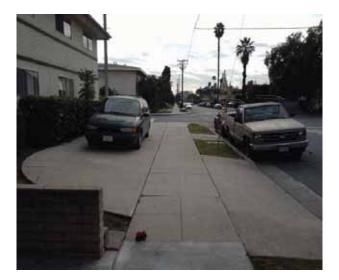
There is a change in elevation greater than recommended value.

Sidewalks , Change in Level : Change in Level Non Beveled

Ensure that the change in elevation is within the recommended value.

Recommendation Up to 0.25 inches Costing Info (Estimated)

Remove tripping hazards \$198

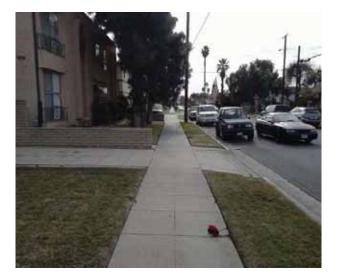
There is a change in elevation greater than recommended value.

Sidewalks , Change in Level : Change in Level Non Beveled

Ensure that the change in elevation is within the recommended value.

Recommendation Up to 0.25 inches
Costing Info (Estimated)

Remove tripping hazards \$198

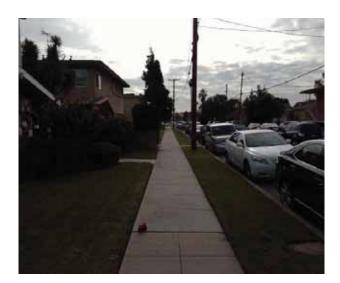
There is a change in elevation greater than recommended value.

Sidewalks , Change in Level : Change in Level Non Beveled

Ensure that the change in elevation is within the recommended value.

Recommendation Up to 0.25 inches

Remove tripping hazards \$198

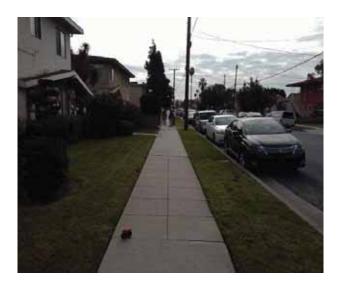
There is a change in elevation greater than recommended value.

Sidewalks , Change in Level : Change in Level Non Beveled

Ensure that the change in elevation is within the recommended value.

Recommendation Up to 0.25 inches Costing Info (Estimated)

Remove tripping hazards \$198

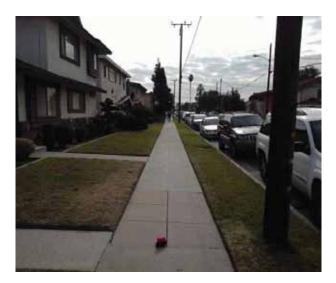
There is a change in elevation greater than recommended value.

Sidewalks , Change in Level : Change in Level Non Beveled

Ensure that the change in elevation is within the recommended value.

Recommendation Up to 0.25 inches

Remove tripping hazards \$198

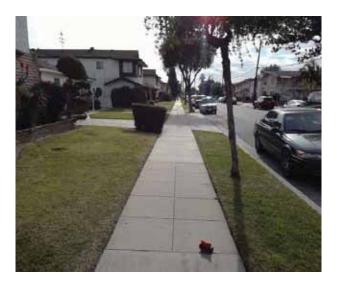
There is a change in elevation greater than recommended value.

Ensure that the change in elevation is within the recommended value.

Recommendation Up to 0.25 inches

Remove tripping hazards \$198

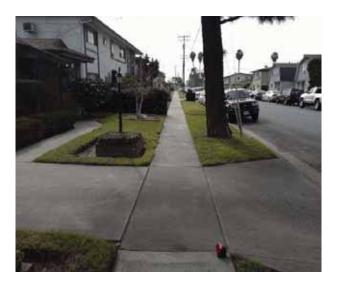
There is a change in elevation greater than recommended value.

Sidewalks , Change in Level : Change in Level Non Beveled

Ensure that the change in elevation is within the recommended value.

Recommendation Up to 0.25 inches

Remove tripping hazards \$198

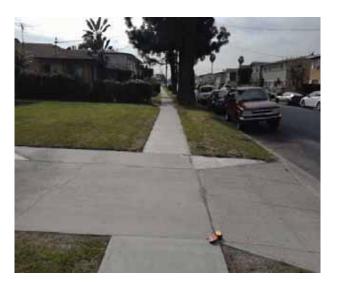
There is a change in elevation greater than recommended value.

Sidewalks , Change in Level : Change in Level Non Beveled

Ensure that the change in elevation is within the recommended value.

Recommendation Up to 0.25 inches

Remove tripping hazards \$198

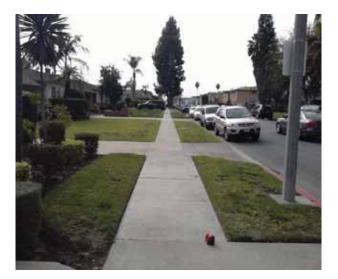
There is a change in elevation greater than recommended value.

Sidewalks , Change in Level : Change in Level Non Beveled

Ensure that the change in elevation is within the recommended value.

Recommendation Up to 0.25 inches Costing Info (Estimated)

Remove tripping hazards \$198

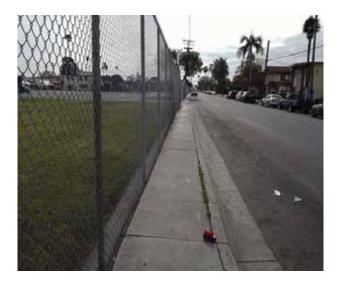
There is a change in elevation greater than recommended value.

Ensure that the change in elevation is within the recommended value.

Recommendation Up to 0.25 inches

Remove tripping hazards \$198

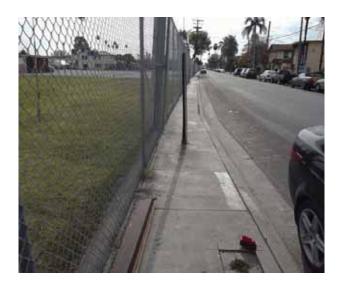
There is a change in elevation greater than recommended value.

Ensure that the change in elevation is within the recommended value.

Recommendation Up to 0.25 inches

Remove tripping hazards \$198

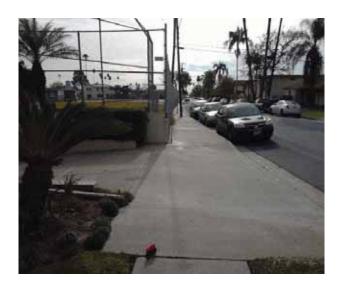
There is a change in elevation greater than recommended value.

Ensure that the change in elevation is within the recommended value.

Recommendation Up to 0.25 inches

Remove tripping hazards \$198
