# Accessibility Survey

# City of Downey La Reina Avenue - 5th Street to Firestone Boulevard

5th Street to Firestone Boulevard Downey, CA 90242

> Date of Inspection 7/24/2017

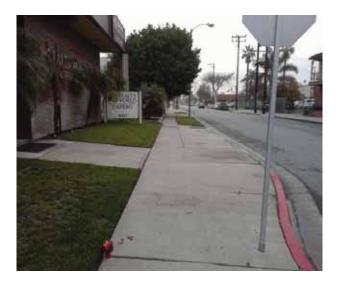
There is a change in elevation greater than recommended value.

Ensure that the change in elevation is within the recommended value.

Recommendation Up to 0.25 inches

Remove tripping hazards \$198

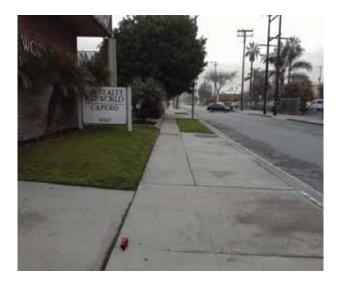
There is a change in elevation greater than recommended value.

Ensure that the change in elevation is within the recommended value.

Recommendation Up to 0.25 inches

Remove tripping hazards \$198

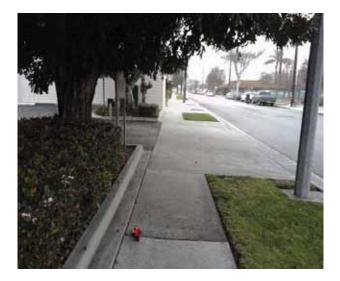
There is a change in elevation greater than recommended value.

Ensure that the change in elevation is within the recommended value.

Recommendation Up to 0.25 inches

Remove tripping hazards \$198

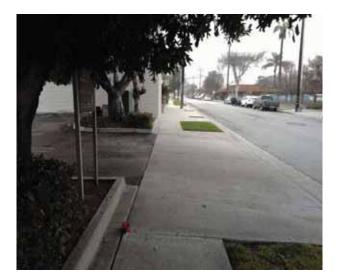
There is a change in elevation greater than recommended value.

Ensure that the change in elevation is within the recommended value.

Recommendation Up to 0.25 inches

Remove tripping hazards \$198

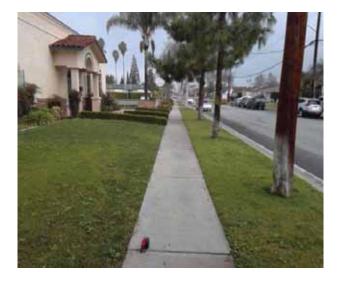
There is a change in elevation greater than recommended value.

Ensure that the change in elevation is within the recommended value.

Recommendation Up to 0.25 inches

Remove tripping hazards \$198

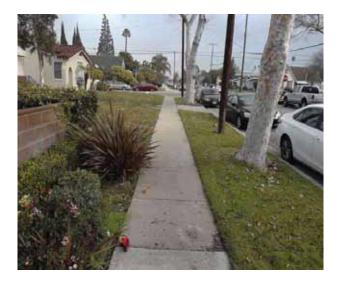
There is a change in elevation greater than recommended value.

Ensure that the change in elevation is within the recommended value.

Recommendation Up to 0.25 inches

Remove tripping hazards \$198

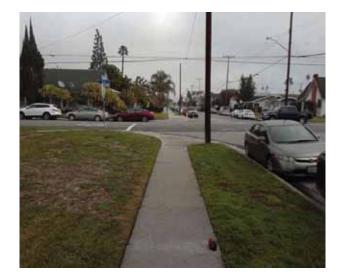
There is a change in elevation greater than recommended value.

Ensure that the change in elevation is within the recommended value.

Recommendation Up to 0.25 inches

Remove tripping hazards \$198

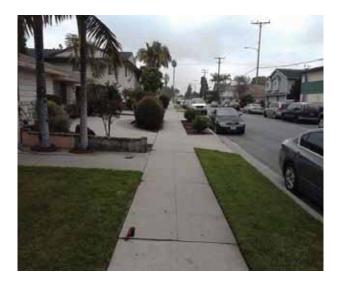
There is a change in elevation greater than recommended value.

Ensure that the change in elevation is within the recommended value.

Recommendation Up to 0.25 inches

Remove tripping hazards \$198

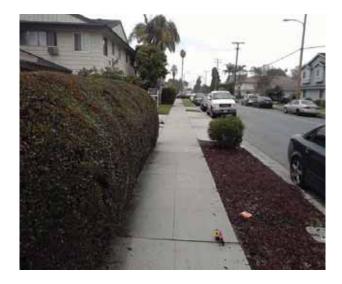
There is a change in elevation greater than recommended value.

Ensure that the change in elevation is within the recommended value.

Recommendation Up to 0.25 inches

Remove tripping hazards \$198

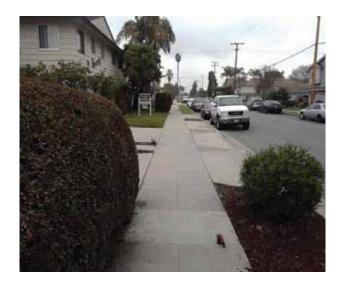
There is a change in elevation greater than recommended value.

Ensure that the change in elevation is within the recommended value.

Recommendation Up to 0.25 inches

Remove tripping hazards \$198

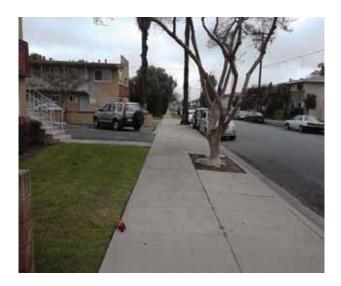
There is a change in elevation greater than recommended value.

Ensure that the change in elevation is within the recommended value.

Recommendation Up to 0.25 inches

Remove tripping hazards \$198

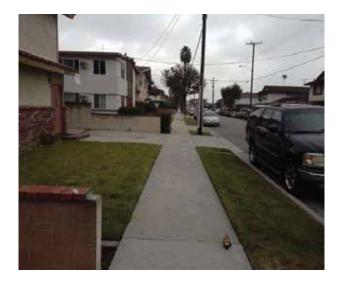
There is a change in elevation greater than recommended value.

Ensure that the change in elevation is within the recommended value.

Recommendation Up to 0.25 inches

Remove tripping hazards \$198

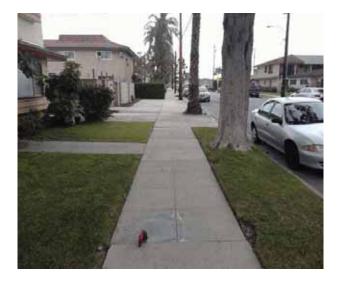
There is a change in elevation greater than recommended value.

Ensure that the change in elevation is within the recommended value.

Recommendation Up to 0.25 inches

Remove tripping hazards \$198

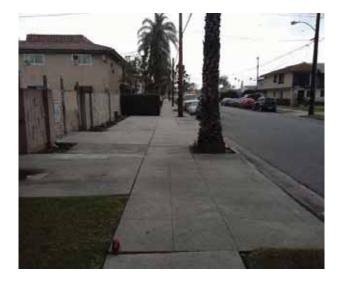
There is a change in elevation greater than recommended value.

Ensure that the change in elevation is within the recommended value.

Recommendation Up to 0.25 inches

Remove tripping hazards \$198

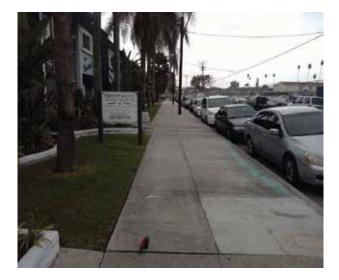
There is a change in elevation greater than recommended value.

Ensure that the change in elevation is within the recommended value.

Recommendation Up to 0.25 inches

Remove tripping hazards \$198

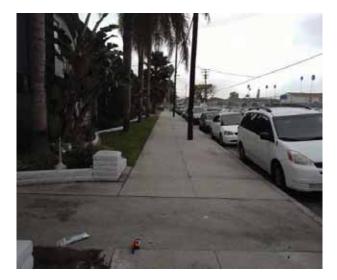
There is a change in elevation greater than recommended value.

Ensure that the change in elevation is within the recommended value.

Recommendation Up to 0.25 inches

Remove tripping hazards \$198

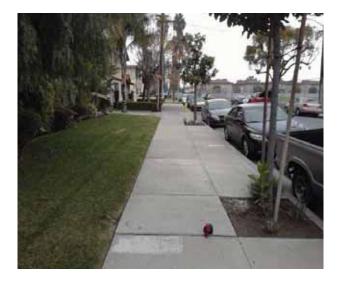
There is a change in elevation greater than recommended value.

Ensure that the change in elevation is within the recommended value.

Recommendation Up to 0.25 inches

Remove tripping hazards \$198

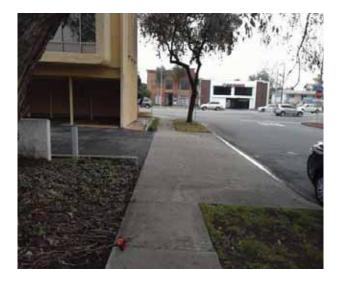
There is a change in elevation greater than recommended value.

Ensure that the change in elevation is within the recommended value.

Recommendation Up to 0.25 inches

Remove tripping hazards \$198

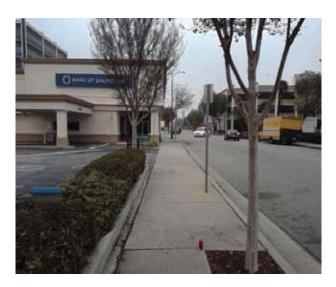
There is a change in elevation greater than recommended value.

Ensure that the change in elevation is within the recommended value.

Recommendation Up to 0.25 inches

Remove tripping hazards \$198

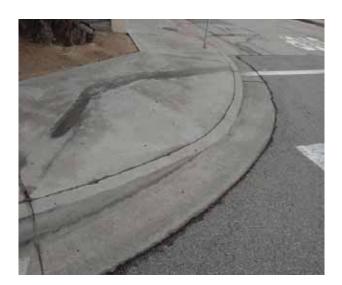
**On-Site Finding** Not Found

Provide detectable warning to \$248 surface

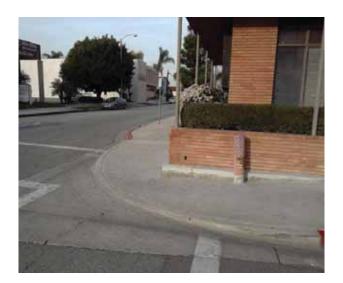
**On-Site Finding** Not Found

Provide detectable warning to \$248 surface

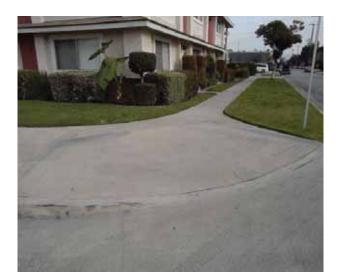
On-Site Finding Not Found

Provide detectable warning to \$248 surface

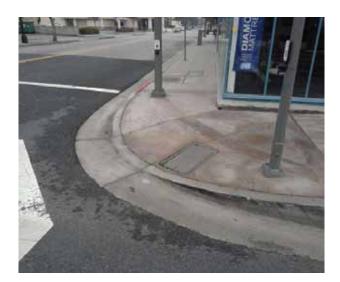
**On-Site Finding** Not Found

Provide detectable warning to \$248 surface

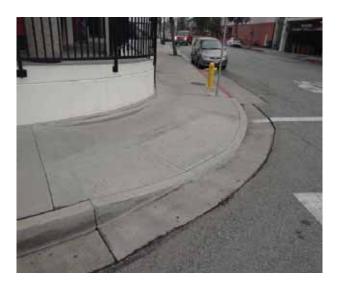
**On-Site Finding** Not Found

Provide detectable warning to \$248 surface

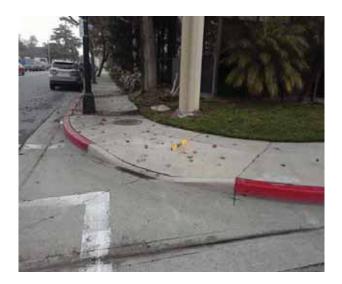
On-Site Finding Not Found

Provide detectable warning to \$248 surface

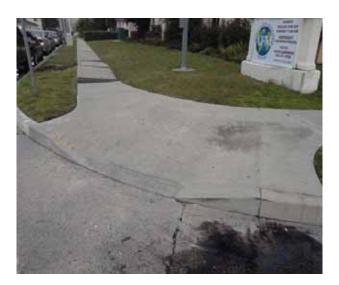
On-Site Finding Not Found

Provide detectable warning to \$248 surface

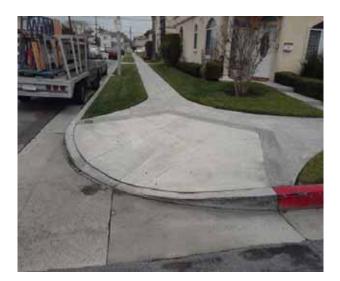
On-Site Finding Not Found

Code Refe	erence	СА	11	1B-	406	.5.	12

Provide detectable warning to \$248 surface

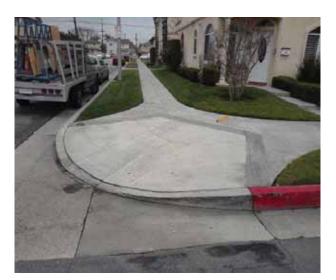
**Code Reference** ADA 402, 406.4, 403.3, 406.1, CA 11B-406.5.3

Recommendation Up to 2.08 percent

Provide compliant landing \$1,260

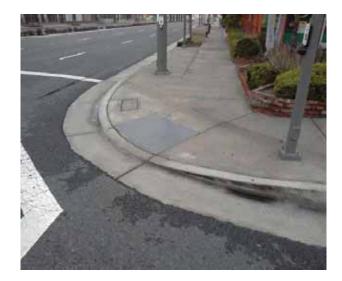
Code Reference ADA 303.3,CA 11B-303.3

Install curb ramp \$1,440

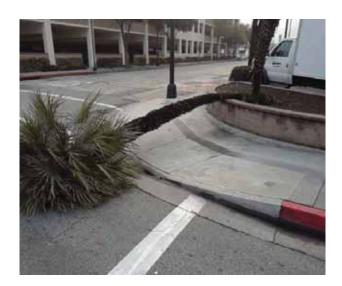
On-Site Finding Not Found

Code Reference	CA 11B-406.5.12

Provide detectable warning to \$248 surface

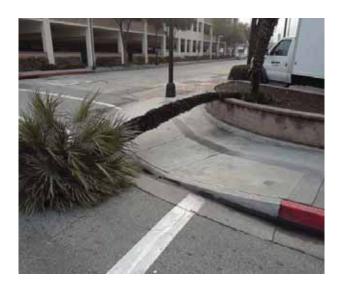
**On-Site Finding** Not Found

~ .	5		40 (	404 5
Code	Reference	ADA	406,	406.5

Install crosswalk \$800

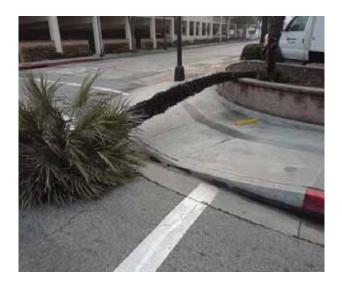
Curb Ramp , Landings and Transitions : Top Landing Clear Length -Landings

Code Reference ADA 406, 406.4, CA 11B-406.5.3

At least 48.00 inches Recommendation

Provide compliant landing \$240

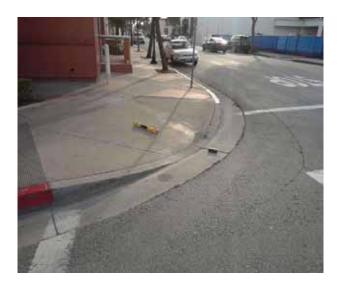
Code Reference ADA 406, 406.1, 405.2, CA 11B-406

Provide a compliant curb ramp.

RecommendationUp to 8.33 percentCosting Info (Estimated)Install curb ramp\$1,300

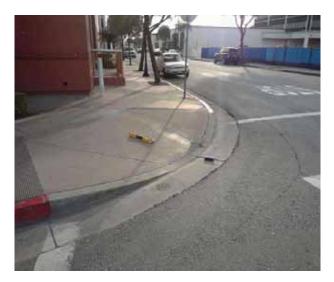
ADA 406, 406.2, CA 11B-406.5.8

Recommendation Up to 5.00 percent
Costing Info (Estimated)

Repave landing \$1,260

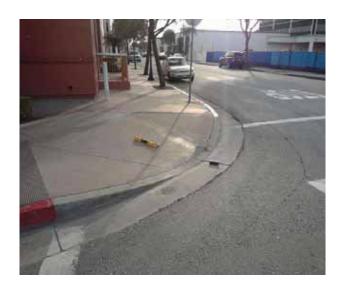
**Code Reference** ADA 402, 406.4, 403.3, 406.1, CA 11B-406.5.3

Recommendation Up to 2.08 percent

Provide compliant landing \$1,260

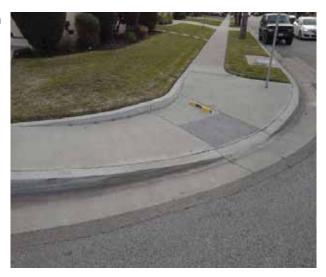
ADA 402, 406.4, 406.2, 403.3, 406.1, CA 11B-406.5.3

Recommendation Up to 2.08 percent

Provide compliant landing \$240

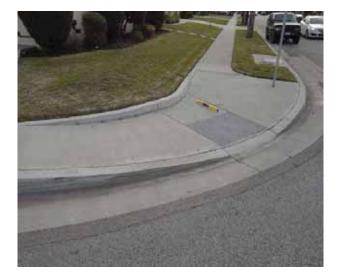
Code Reference ADA 406.4, 403.3, 406.1, CA 11B-406.5.3

Recommendation Up to 2.08 percent

Provide compliant landing \$1,260 Curb Ramp, Landings and Transitions : Top Landing Right Side Slope - Parallel Curb Ramp

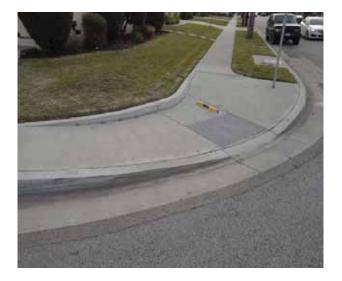
Code Reference ADA 406.1,CA 11B-406.5.2,CA 11B-406

Provide a compliant curb ramp.

RecommendationAt least 48.00 inchesCosting Info (Estimated)Install curb ramp\$1,300

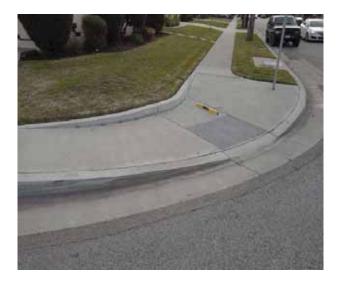
Code Reference ADA 303.3,CA 11B-303.3

Install curb ramp \$1,440

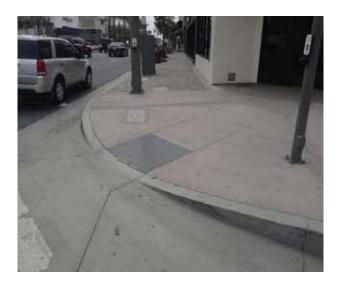
Code Reference ADA 303.3,CA 11B-303.3

Install curb ramp \$1,440

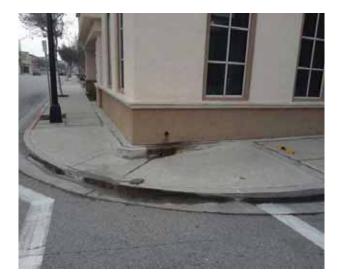
Curb Ramp , Landings and Transitions  $\ : \$  Top Landing Slope

**Code Reference** ADA 402, 406.4, 403.3, 406.1, CA 11B-406.5.3

Recommendation Up to 2.08 percent

Provide compliant landing \$1,260

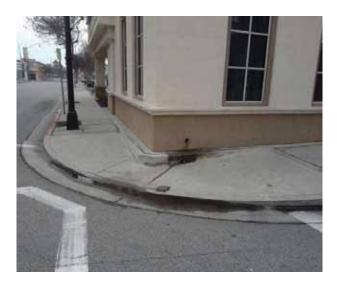
**On-Site Finding** Not Found

Code Reference	CA 11B-406.5.12

Provide detectable warning to \$248 surface

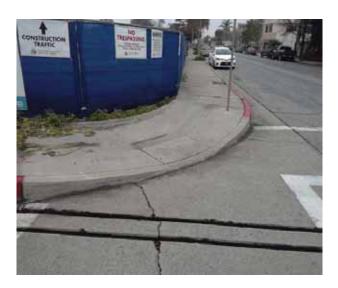
**On-Site Finding** Not Found

Code Reference	CA 11B-406.5.12

Provide detectable warning to \$248 surface

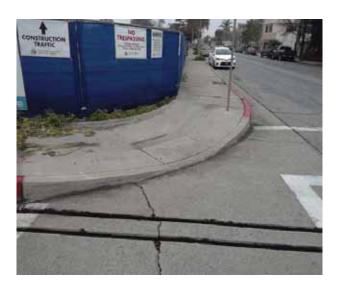
Code Reference ADA 303.3,CA 11B-303.3

Install curb ramp \$1,440

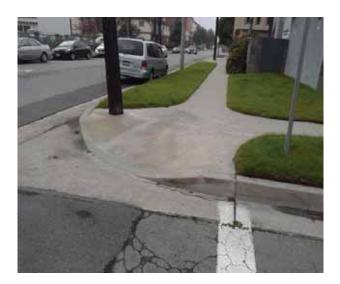
On-Site Finding Not Found

Code Reference	CA 11B-406.5.12
	0// 110 100.0.12

Provide detectable warning to \$248 surface

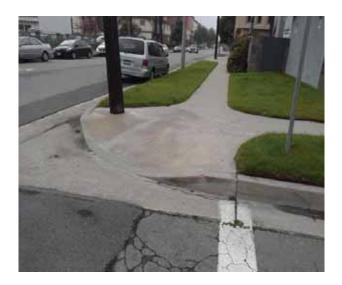
Code Reference ADA 303.3,CA 11B-303.3

Install curb ramp \$1,440

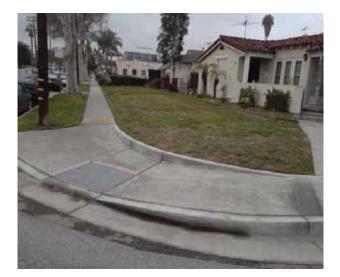
Code Reference ADA 406.4, 403.3, 406.1, CA 11B-406.5.3

Recommendation Up to 2.08 percent

Provide compliant landing \$1,260 Curb Ramp, Landings and Transitions : Top Landing Right Side Slope - Parallel Curb Ramp

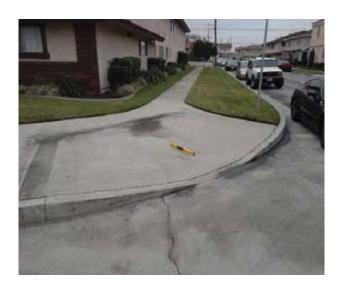
On-Site Finding Not Found

Code Reference	CA 11B-406.5.12
	0/11/10/100/01/12

Provide detectable warning to \$248 surface

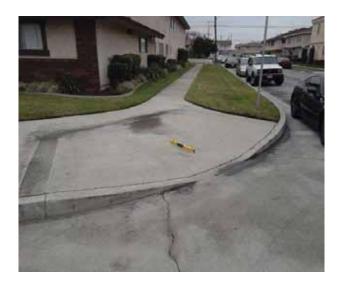
Code Reference ADA 406, 406.1, 405.2, CA 11B-406

Provide a compliant curb ramp.

RecommendationUp to 8.33 percentCosting Info (Estimated)Install curb ramp\$1,300

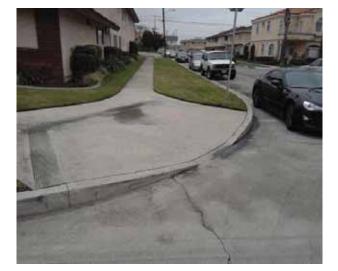
Curb Ramp , Landings and Transitions : Top Landing Clear Length -

**Code Reference** ADA 406, 406.4, CA 11B-406.5.3

Recommendation At least 48.00 inches

Provide compliant landing \$240

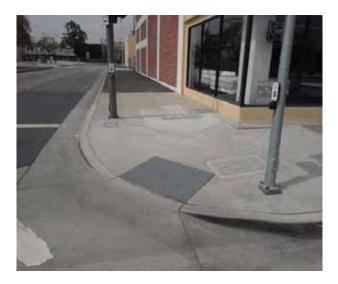
Code Reference ADA 303.3,CA 11B-303.3

Install curb ramp \$1,440

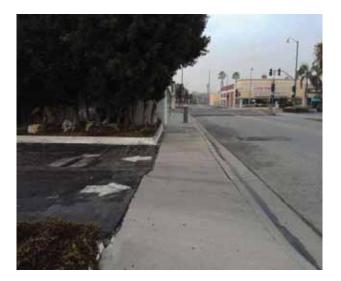
**On-Site Finding** Not Found

Code Reference ADA 705,CA 11B-705.1.2.5,CA 11B-247.1.2.5

Provide detectable warnings.

Recommendation	See Recom	mendation
Costing Info (Estim	ated)	
Install compliant dete	ectable	\$190
warnings

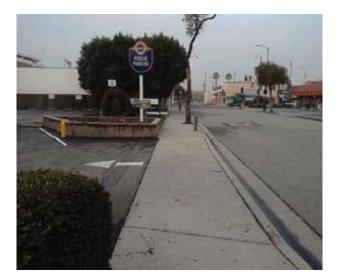
**On-Site Finding** Not Found

ADA 705,CA 11B-705.1.2.5,CA 11B-247.1.2.5

Provide detectable warnings.

Recommendation	See Recom	mendation
Costing Info (Estim	ated)	
Install compliant dete	ctable	\$190
warnings

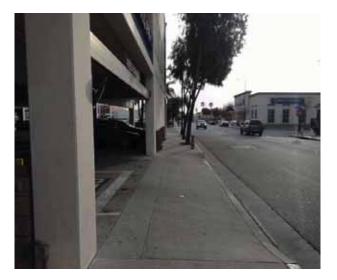
**On-Site Finding** Not Found

ADA 705, CA 11B-705.1.2.5, CA 11B-247.1.2.5

Provide detectable warnings.

Recommendation See Recommendation **Costing Info (Estimated)** Install compliant detectable \$190 warnings

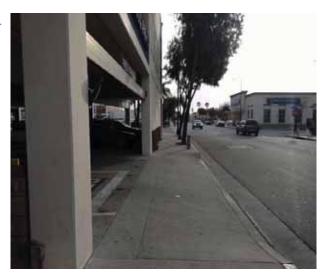
**Code Reference** ADA 206, 302,CA 11B-403.3

Recommendation Up to 2.08 percent

Repave surface \$1,092

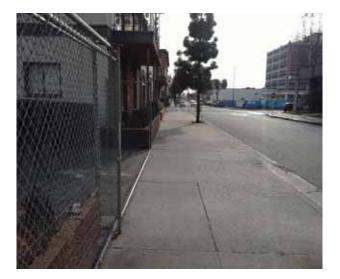
**On-Site Finding** Not Found

Code Reference ADA 705,CA 11B-705.1.2.5,CA 11B-247.1.2.5

Provide detectable warnings.

Recommendation	See Recom	mendation
Costing Info (Estim	ated)	
Install compliant dete	ectable	\$190
warnings

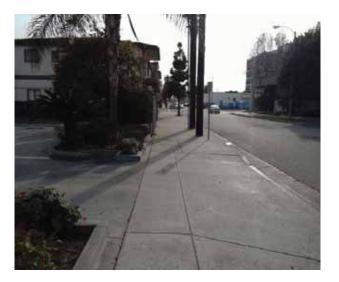
**On-Site Finding** Not Found

ADA 705,CA 11B-705.1.2.5,CA 11B-247.1.2.5

Provide detectable warnings.

Recommendation	See Recom	mendation
Costing Info (Estim	ated)	
Install compliant dete	ectable	\$190
warnings

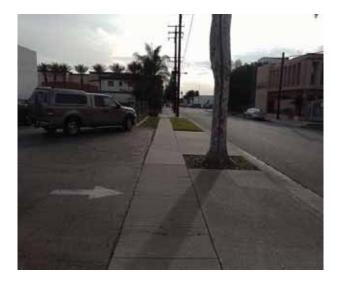
**On-Site Finding** Not Found

ADA 705, CA 11B-705.1.2.5, CA 11B-247.1.2.5

Provide detectable warnings.

Recommendation See Recommendation **Costing Info (Estimated)** Install compliant detectable \$190 warnings

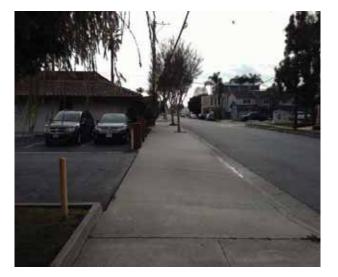
**On-Site Finding** Not Found

Code Reference ADA 705,CA 11B-705.1.2.5,CA 11B-247.1.2.5

Provide detectable warnings.

Recommendation	See Recom	mendation
Costing Info (Estim	ated)	
Install compliant dete	ectable	\$190
warnings

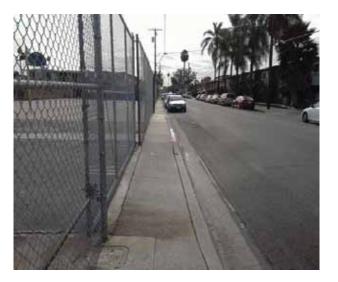
**On-Site Finding** Not Found

Code Reference ADA 705,CA 11B-705.1.2.5,CA 11B-247.1.2.5

Provide detectable warnings.

Recommendation	See Recom	mendation
Costing Info (Estim	ated)	
Install compliant dete	ectable	\$190
warnings

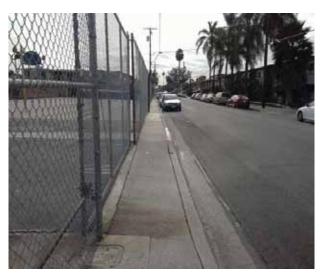
**Code Reference** ADA 206, 302,CA 11B-403.3

Recommendation Up to 2.08 percent

Repave surface \$1,092

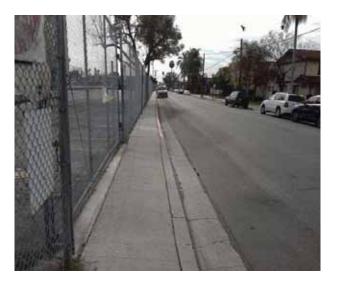
**On-Site Finding** Not Found

Code Reference ADA 705,CA 11B-705.1.2.5,CA 11B-247.1.2.5

Provide detectable warnings.

Recommendation	See Recom	mendation
Costing Info (Estim	ated)	
Install compliant dete	ectable	\$190
warnings

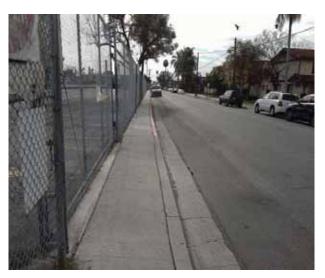
**Code Reference** ADA 206, 302,CA 11B-403.3

Recommendation Up to 2.08 percent

Repave surface \$1,092

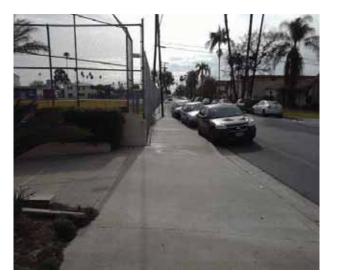
**On-Site Finding** Not Found

ADA 705, CA 11B-705.1.2.5, CA 11B-247.1.2.5

Provide detectable warnings.

Recommendation	See Recom	mendation
Costing Info (Estim	ated)	
Install compliant dete	ectable	\$190
warnings

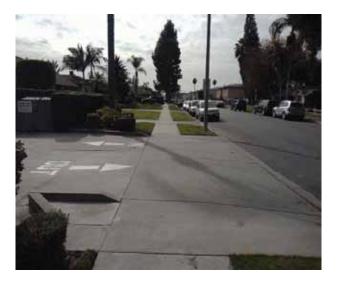
**On-Site Finding** Not Found

ADA 705, CA 11B-705.1.2.5, CA 11B-247.1.2.5

Provide detectable warnings.

Recommendation	See Recom	mendation
Costing Info (Estim	ated)	
Install compliant dete	ctable	\$190
warnings

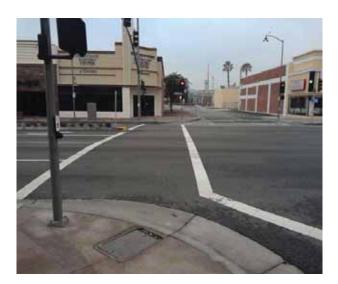
Recommendation Up to 5.00 percent

Repave surface \$1,092

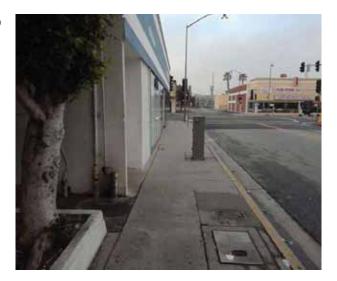
Sidewalks , Hazards & Gratings : Grate Opening

Recommendation See Recommendation

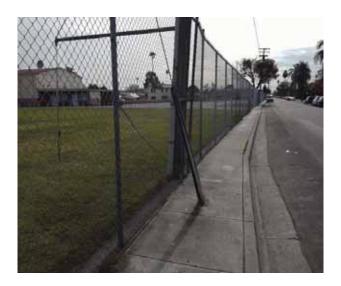
Sidewalks , Hazards & Gratings : Overhead Obstruction Height

At least 80.00 inches Recommendation Costing Info (Estimated)

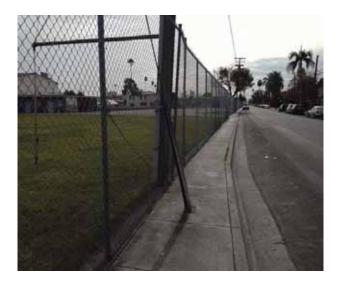
Sidewalks , Hazards & Gratings : Sidewalk Width at Obstruction

Sidewalk width at the obstruction shall have the recommended value.

At least 48.00 inches Recommendation

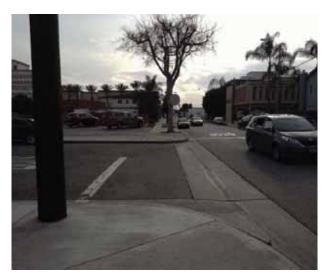
Sidewalks, Hazards & Gratings: Curb is on Path of Travel

Provide a compliant curb ramp.

RecommendationSee RecommendationCosting Info (Estimated)Install curb ramp\$2,500

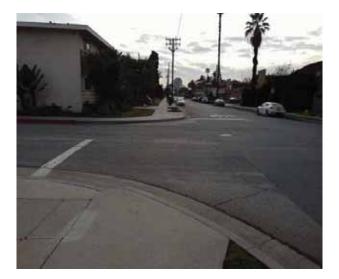
Sidewalks, Hazards & Gratings: Curb is on Path of Travel

Provide a compliant curb ramp.

RecommendationSee RecommendationCosting Info (Estimated)Install curb ramp\$2,500

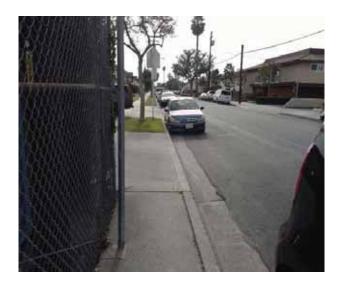
Sidewalks , Hazards & Gratings : Sidewalk Width at Obstruction

Sidewalk width at the obstruction shall have the recommended value.

Recommendation At least 48.00 inches

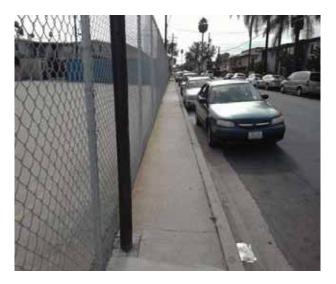
Sidewalks , Hazards & Gratings : Sidewalk Width at Obstruction

Sidewalk width at the obstruction shall have the recommended value.

Recommendation At least 48.00 inches

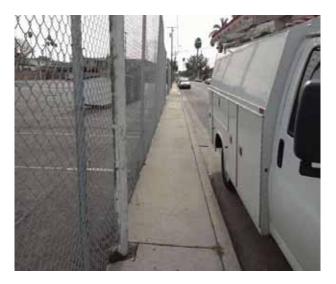
Sidewalks , Hazards & Gratings : Sidewalk Width at Obstruction

Sidewalk width at the obstruction shall have the recommended value.

At least 48.00 inches Recommendation

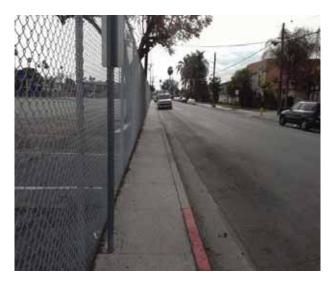
Sidewalks , Hazards & Gratings : Sidewalk Width at Obstruction

Sidewalk width at the obstruction shall have the recommended value.

Recommendation At least 48.00 inches

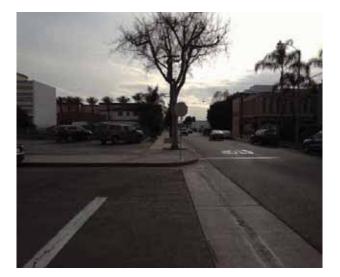
Sidewalks, Hazards & Gratings : Curb is on Path of Travel

Provide a compliant curb ramp.

Recommendation See Recommendation Costing Info (Estimated) Install curb ramp \$2,500

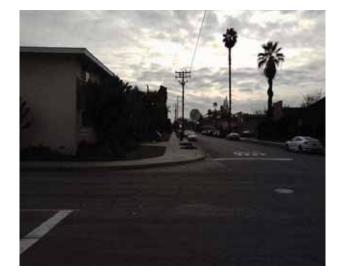
Sidewalks, Hazards & Gratings: Curb is on Path of Travel

Provide a compliant curb ramp.

RecommendationSee RecommendationCosting Info (Estimated)Install curb ramp\$2,500

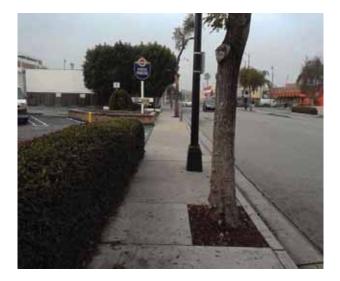
Sidewalks, Hazards & Gratings: Sidewalk Width at Obstruction

Sidewalk width at the obstruction shall have the recommended value.

Recommendation At least 48.00 inches

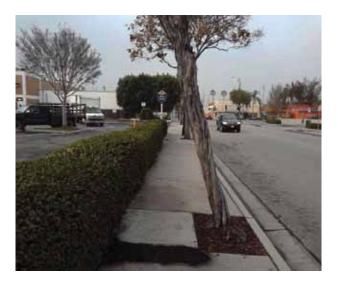
Sidewalks , Hazards & Gratings : Sidewalk Width at Obstruction

Sidewalk width at the obstruction shall have the recommended value.

Recommendation At least 48.00 inches

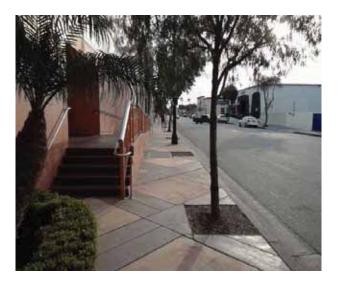
Sidewalks , Hazards & Gratings : Overhead Obstruction Height

At least 80.00 inches Recommendation Costing Info (Estimated)

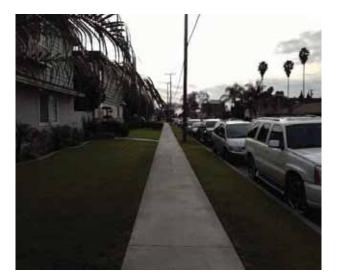
Sidewalks , Hazards & Gratings : Overhead Obstruction Height

At least 80.00 inches Recommendation Costing Info (Estimated)

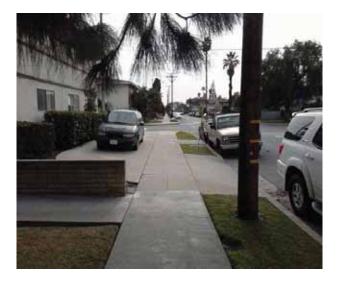
Sidewalks , Hazards & Gratings : Overhead Obstruction Height

At least 80.00 inches Recommendation Costing Info (Estimated)

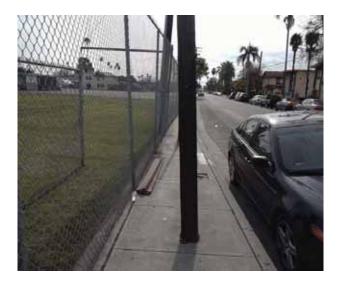
Sidewalks, Hazards & Gratings : Sidewalk Width at Obstruction

Sidewalk width at the obstruction shall have the recommended value.

At least 48.00 inches Recommendation

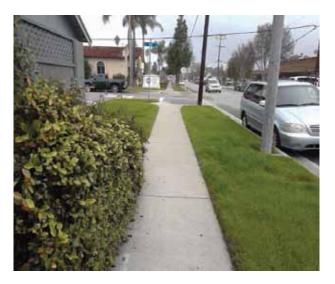
Sidewalks, Hazards & Gratings : Sidewalk Width at Obstruction

Sidewalk width at the obstruction shall have the recommended value.

Recommendation At least 48.00 inches

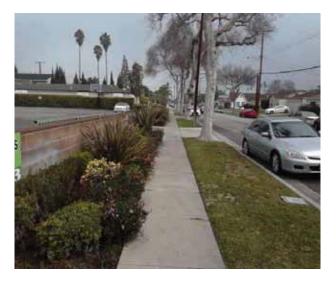
Sidewalks , Hazards & Gratings : Sidewalk Width at Obstruction

Sidewalk width at the obstruction shall have the recommended value.

At least 48.00 inches Recommendation

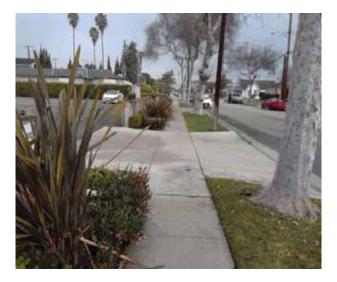
Sidewalks , Hazards & Gratings : Sidewalk Width at Obstruction

Sidewalk width at the obstruction shall have the recommended value.

Recommendation At least 48.00 inches

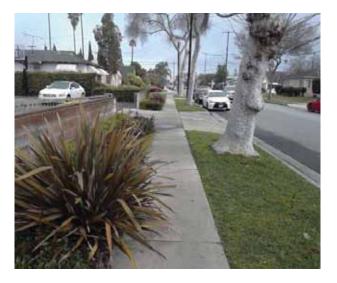
Sidewalks , Hazards & Gratings : Sidewalk Width at Obstruction

Sidewalk width at the obstruction shall have the recommended value.

Recommendation At least 48.00 inches

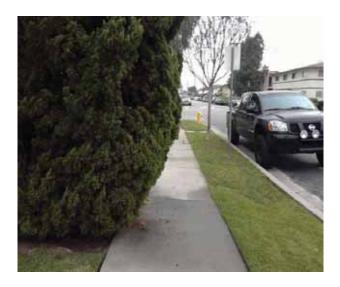
Sidewalks, Hazards & Gratings : Sidewalk Width at Obstruction

Sidewalk width at the obstruction shall have the recommended value.

At least 48.00 inches Recommendation

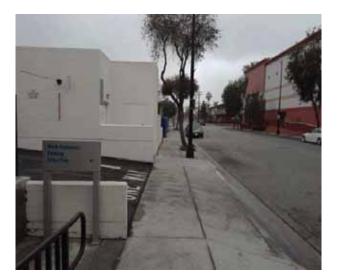
**On-Site Finding** Not Found

Provide detectable warnings.

Recommendation	See Recom	mendation
Costing Info (Estim	ated)	
Install compliant dete warnings	ectable	\$190

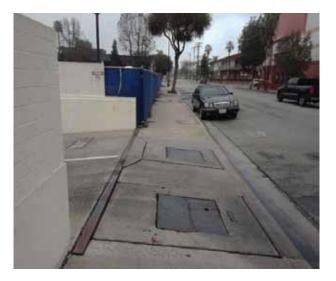
**On-Site Finding** Not Found

Provide detectable warnings.

Recommendation See Recommendation **Costing Info (Estimated)** Install compliant detectable \$190 warnings

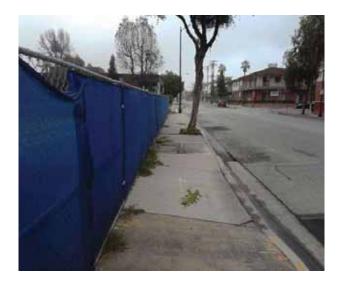
**On-Site Finding** Not Found

Provide detectable warnings.

Recommendation See Recommendation **Costing Info (Estimated)** Install compliant detectable \$190 warnings

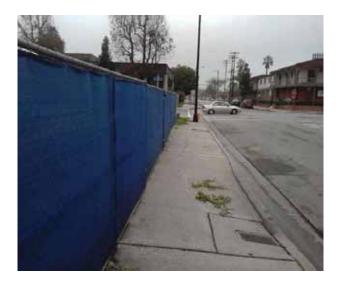
**On-Site Finding** Not Found

Provide detectable warnings.

Recommendation See Recommendation **Costing Info (Estimated)** Install compliant detectable \$190 warnings

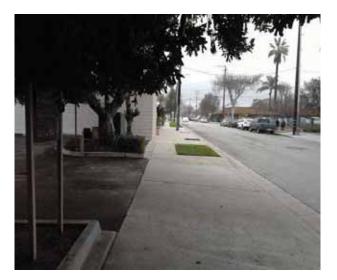
**On-Site Finding** Not Found

Provide detectable warnings.

Recommendation See Recommendation **Costing Info (Estimated)** Install compliant detectable \$190 warnings

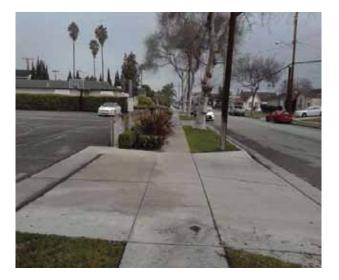
**On-Site Finding** Not Found

Provide detectable warnings.

Recommendation	See Recom	mendation
Costing Info (Estim	ated)	
Install compliant dete warnings	ectable	\$190

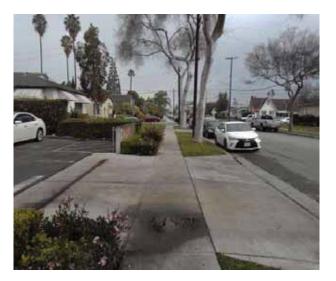
**On-Site Finding** Not Found

Provide detectable warnings.

Recommendation	See Recom	mendation
Costing Info (Estim	ated)	
Install compliant dete warnings	ectable	\$190

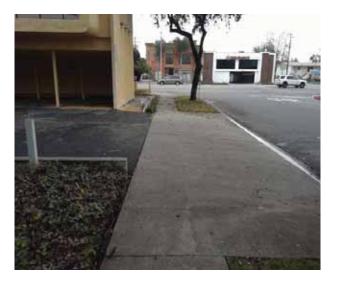
**On-Site Finding** Not Found

Provide detectable warnings.

Recommendation See Recommendation **Costing Info (Estimated)** Install compliant detectable \$190 warnings

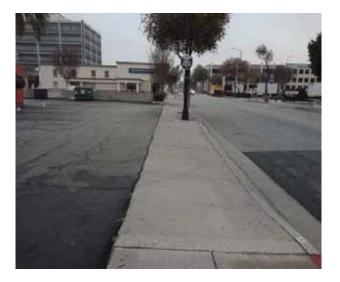
**On-Site Finding** Not Found

Provide detectable warnings.

Recommendation	See Recom	mendation
Costing Info (Estim	ated)	
Install compliant dete	ectable	\$190
warnings

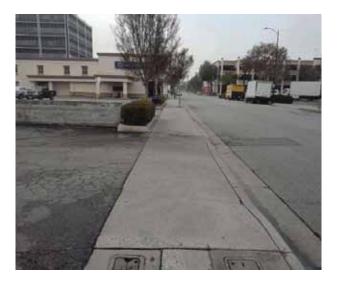
**On-Site Finding** Not Found

Provide detectable warnings.

RecommendationSee RecommendationCosting Info (Estimated)Install compliant detectable\$190warnings

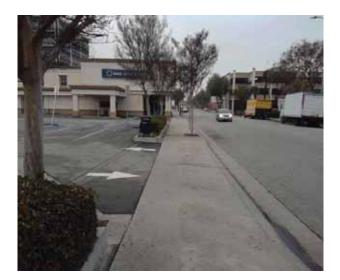
**On-Site Finding** Not Found

Provide detectable warnings.

Recommendation See Recommendation **Costing Info (Estimated)** Install compliant detectable \$190 warnings

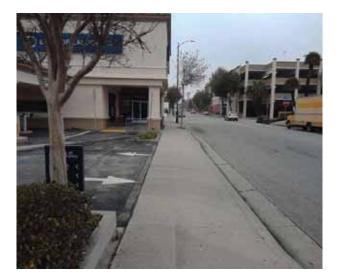
**On-Site Finding** Not Found

Provide detectable warnings.

Recommendation	See Recom	mendation
Costing Info (Estim	ated)	
Install compliant dete warnings	ectable	\$190

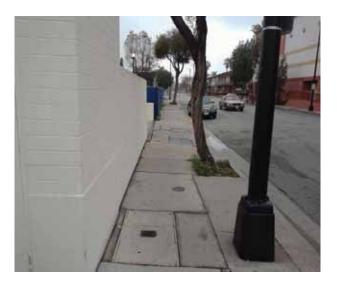
Sidewalks , Hazards & Gratings : Grate Opening

Recommendation See Recommendation

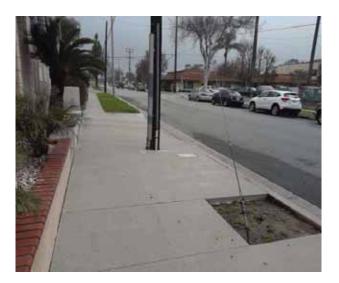
Sidewalks , Hazards & Gratings : Overhead Obstruction Height

At least 80.00 inches Recommendation Costing Info (Estimated)

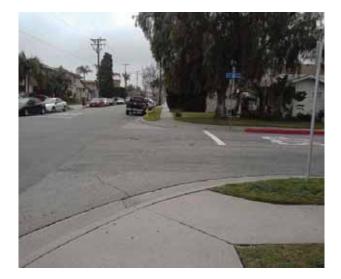
Sidewalks , Hazards & Gratings : Curb is on Path of Travel

Provide a compliant curb ramp.

Recommendation See Recommendation Costing Info (Estimated) Install curb ramp \$2,500

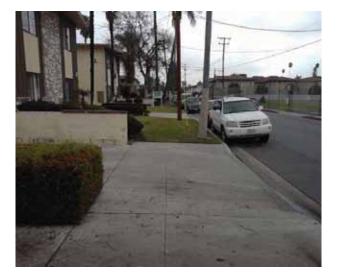
Sidewalks : Missing Sidewalk

Section of sidewalk is missing and consists of dirt, grass or gravel.

Provide a compliant sidewalk for the missing section.

\$1,260

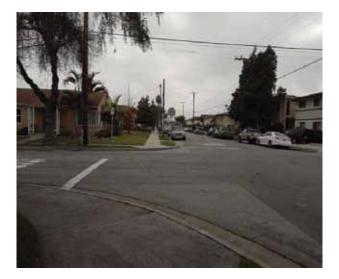
Sidewalks, Hazards & Gratings: Curb is on Path of Travel

Provide a compliant curb ramp.

RecommendationSee RecommendationCosting Info (Estimated)Install curb ramp\$2,500

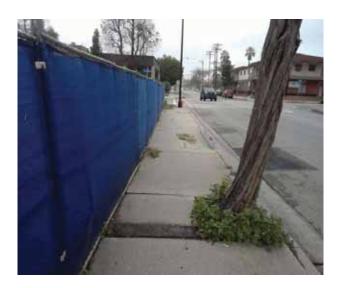
Sidewalks , Hazards & Gratings : Sidewalk Width at Obstruction

Sidewalk width at the obstruction shall have the recommended value.

Recommendation At least 48.00 inches

\$1,260

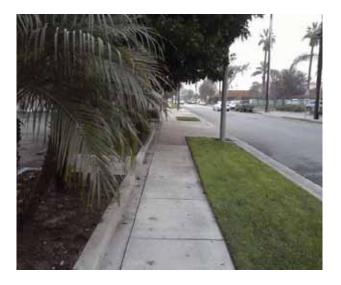
Sidewalks , Hazards & Gratings : Overhead Obstruction Height

At least 80.00 inches Recommendation Costing Info (Estimated)

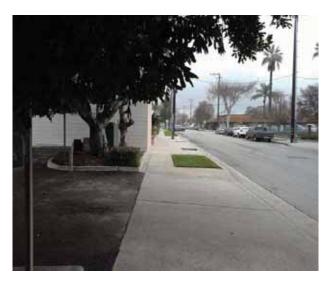
Sidewalks , Hazards & Gratings : Overhead Obstruction Height

At least 80.00 inches Recommendation Costing Info (Estimated)

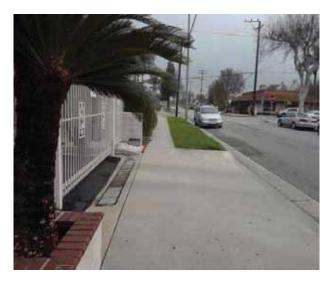
Sidewalks , Hazards & Gratings : Overhead Obstruction Height

At least 80.00 inches Recommendation Costing Info (Estimated)

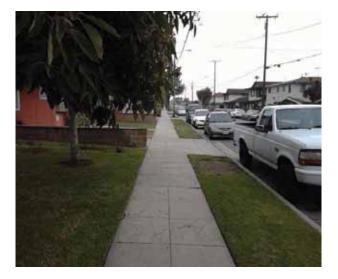
Sidewalks , Hazards & Gratings : Overhead Obstruction Height

At least 80.00 inches Recommendation Costing Info (Estimated)

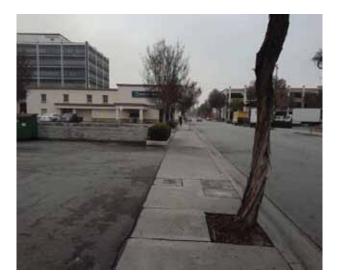
Sidewalks, Hazards & Gratings : Sidewalk Width at Obstruction

Sidewalk width at the obstruction shall have the recommended value.

At least 48.00 inches Recommendation

\$1,260

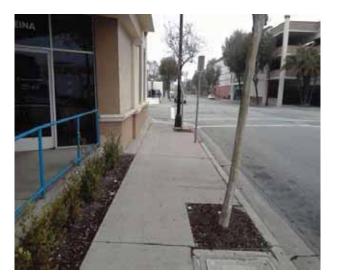
Sidewalks , Hazards & Gratings : Sidewalk Width at Obstruction

Sidewalk width at the obstruction shall have the recommended value.

Recommendation At least 48.00 inches

\$1,260

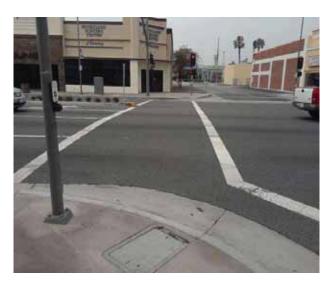
**On-Site Finding** Not Found

Recommendation See Recommendation

\$240

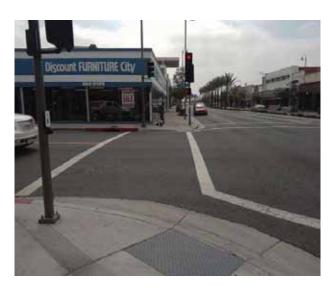
**On-Site Finding** Not Found

Recommendation See Recommendation

\$240

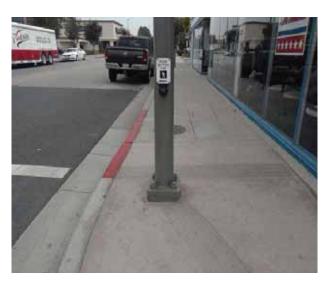
On-Site Finding Not Found

**Recommendation** Provide a compliant tactile arrow at the signal.

RecommendationSee RecommendationCosting Info (Estimated)

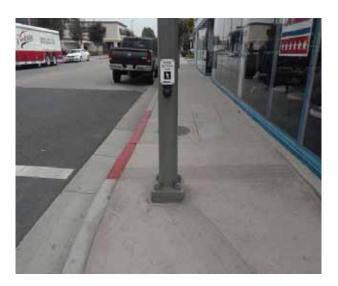
**On-Site Finding** Not Found

# Recommendation Provide a crosswalk map.

Recommendation See Recommendation Costing Info (Estimated)

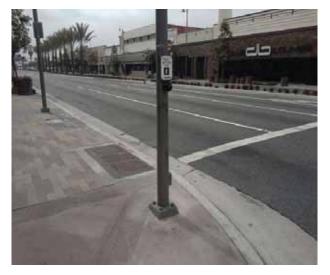
On-Site Finding Not Found

**Recommendation** Provide a compliant tactile arrow at the signal.

Recommendation See Recommendation
Costing Info (Estimated)
\$900

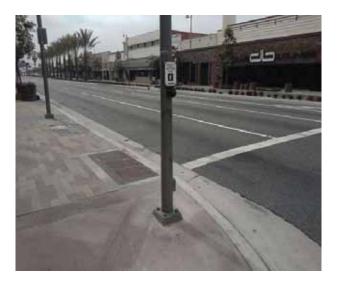
**On-Site Finding** Not Found

# Recommendation Provide a crosswalk map.

Recommendation See Recommendation Costing Info (Estimated)

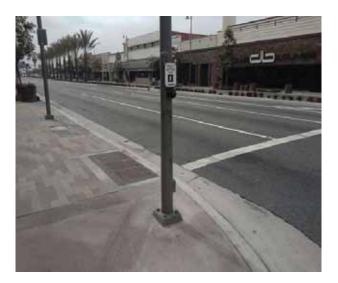
**On-Site Finding** Not Found

# Recommendation Provide compliant walk interval tone.

Recommendation See Recommendation Costing Info (Estimated)

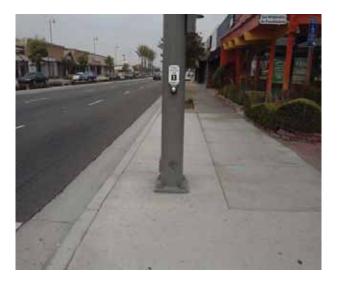
**On-Site Finding** Not Found

# Recommendation Provide a crosswalk map.

Recommendation See Recommendation Costing Info (Estimated)

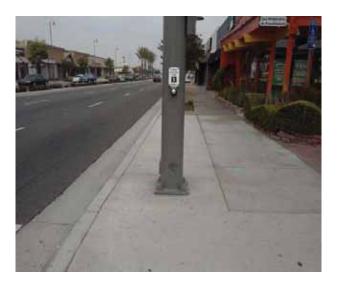
**On-Site Finding** Not Found

# **Recommendation** Provide compliant walk interval tone.

RecommendationSee RecommendationCosting Info (Estimated)

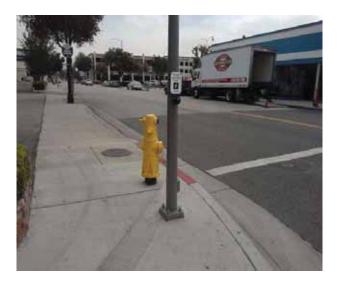
**On-Site Finding** Not Found

# Recommendation Provide a crosswalk map.

See Recommendation Recommendation Costing Info (Estimated)

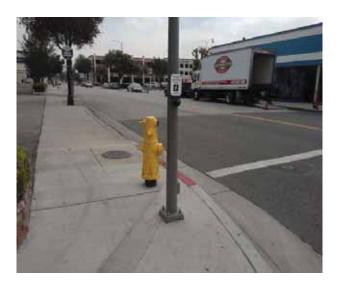
**On-Site Finding** Not Found

## Recommendation Provide compliant walk interval tone.

Recommendation See Recommendation

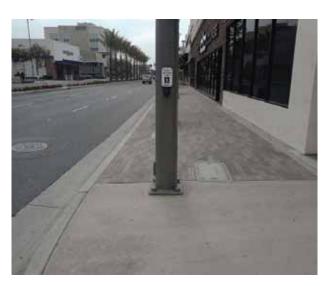
On-Site Finding Not Found

**Recommendation** Provide a compliant tactile arrow at the signal.

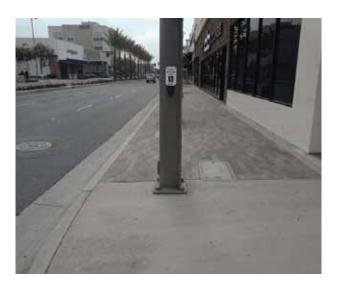
**On-Site Finding** Not Found

## Recommendation Provide a crosswalk map.

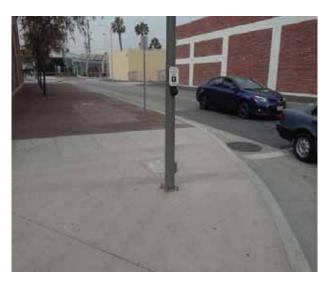
On-Site Finding Not Found

**Recommendation** Provide a compliant tactile arrow at the signal.

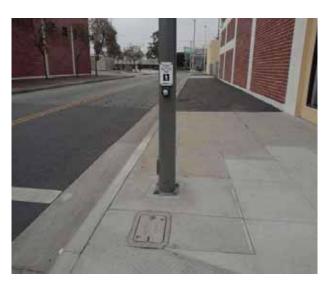
On-Site Finding Not Found

**Recommendation** Provide a compliant tactile arrow at the signal.

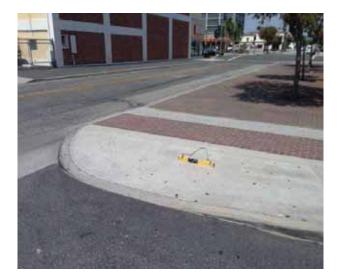
**On-Site Finding** Not Found

Provide detectable warning to \$248 surface

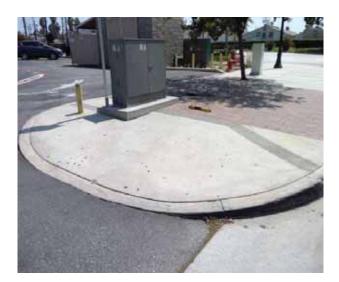
Curb Ramp , Landings and Transitions : Top Landing Slope

Provide compliant landing \$1,260

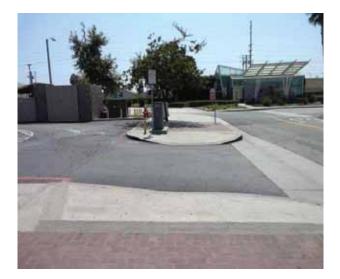
**On-Site Finding** Not Found

Provide detectable warnings.

Recommendation	See Recom	mendation
Costing Info (Estim	ated)	
Install compliant dete warnings	ectable	\$190

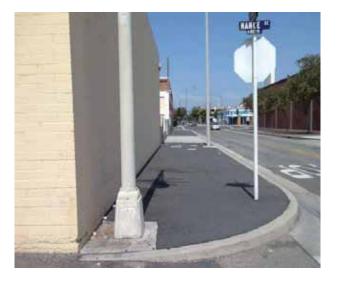
Sidewalks, Hazards & Gratings : Curb is on Path of Travel

Provide a compliant curb ramp.

Recommendation See Recommendation Costing Info (Estimated) Install curb ramp \$2,500

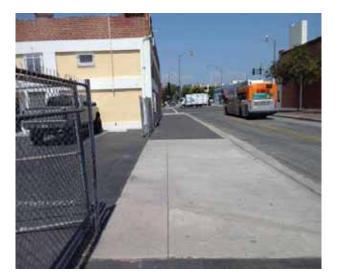
**On-Site Finding** Not Found

Provide detectable warnings.

Recommendation	See Recom	mendation
Costing Info (Estim	ated)	
Install compliant dete	ctable	\$190
warnings

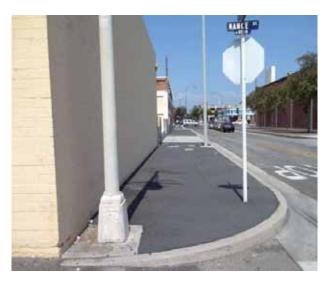
Notes : Surface is Rough And Uneven

Repave the sidewalk surface with the recommended cross slope.

Repave surface \$1,092
