Accessibility Survey

6th Street - Brookshire Avenue to Downey Avenue

Date of Inspection
7/18/2017

Disability Access Consultants

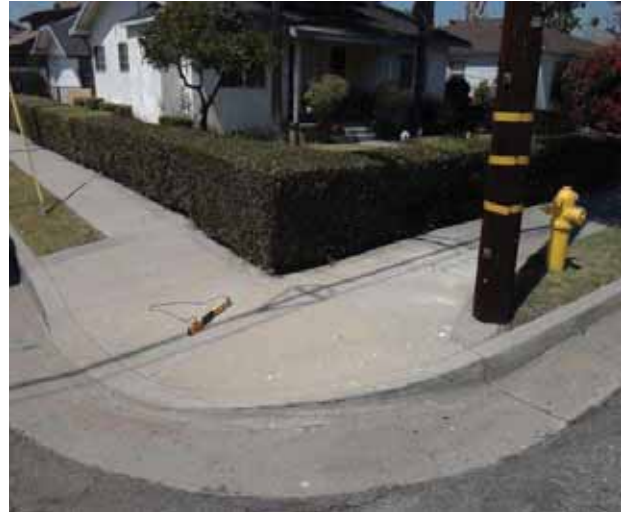
Recommendation Up to 2.08 percent

Curb Ramp , Landings and Transitions : Top Landing Right Side Slope - Parallel Curb Ramp

Provide compliant landing \$1,260
