Accessibility Survey

Adwen Street & Old River School Road

Date of Inspection 4/11/2017

Disability Access Consultants

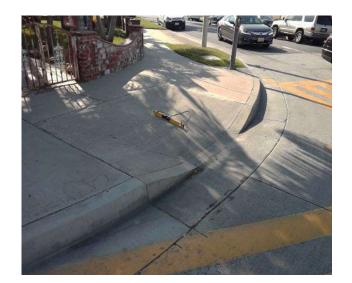
Curb Ramp : No Detectable Warnings

The curb ramp does not provide a detectable warning surface which includes truncated domes.

On-Site Finding Not Found

Provide compliant detectable warnings to surface.

Provide detectable warning to \$248 surface

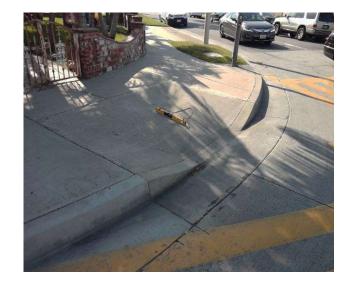
Curb Ramp : Curb Ramp Slope

The running slope is greater than allowed.

On-Site Finding 14.60 percent

Provide a compliant curb ramp.

Recommendation Up to 8.33 percent

Install curb ramp \$1,300

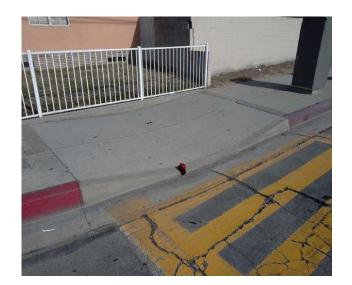
On-Site Finding Not Found

Provide detectable warning to \$248 surface

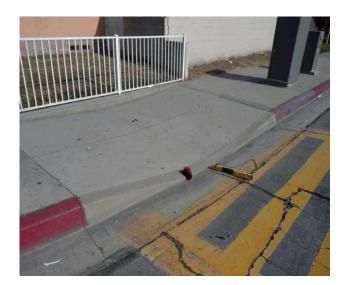
Curb Ramp , Landings And Transitions : Bottom Landing Change in

Recommendation Up to 0.50 inches

Patch lip at curb ramp \$255

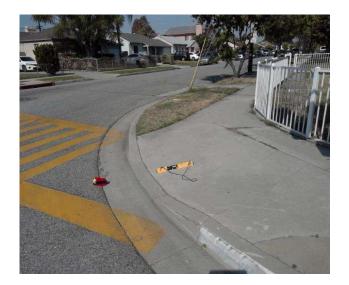
On-Site Finding Not Found

Provide detectable warning to \$248 surface

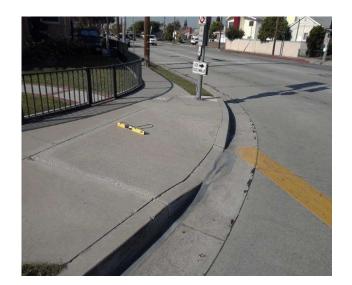
On-Site Finding Not Found

Provide detectable warning to \$248 surface

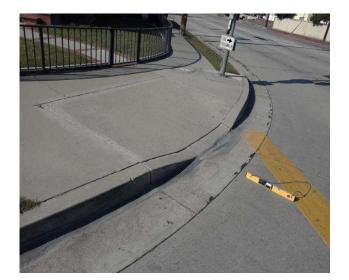
Curb Ramp , Landings and Transitions : Top Landing Clear Length -

Recommendation At least 48.00 inches

Provide compliant landing \$240

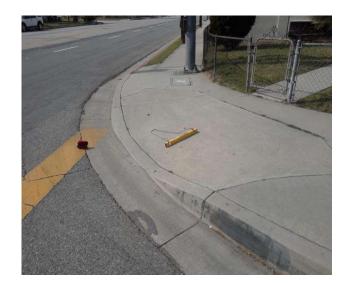
On-Site Finding Not Found

Provide detectable warning to \$248 surface

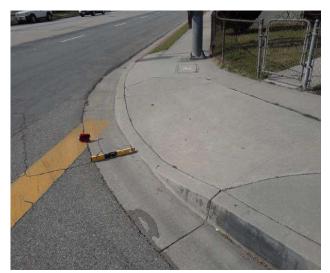
Curb Ramp , Landings and Transitions : Bottom Landing Of Diagonal

Curb Ramp - Clear Space

Recommendation At least 48.00 inches

Provide compliant landing \$255

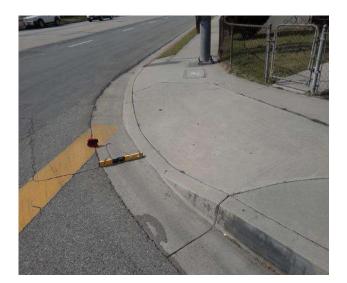
Curb Ramp , Landings and Transitions : Bottom Landing Change in

Level - Curb Ramps

Patch lip at curb ramp \$255

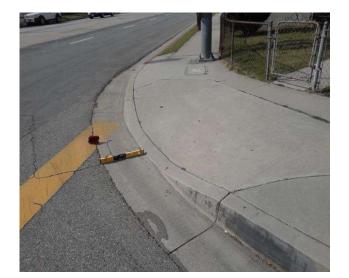
Curb Ramp , Landings and Transitions : Top Landing Clear Length -

Recommendation At least 48.00 inches

Provide compliant landing \$240

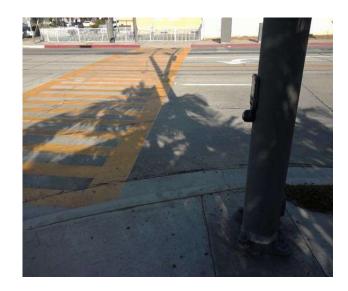
On-Site Finding Not Found

Recommendation See Recommendation

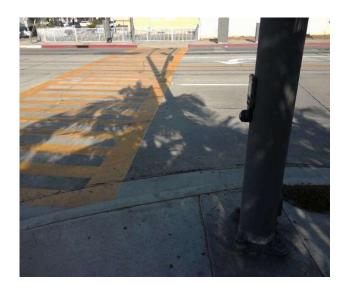
On-Site Finding Not Found

Recommendation See Recommendation

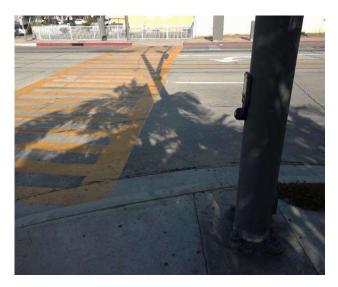
On-Site Finding Not Found

Recommendation See Recommendation

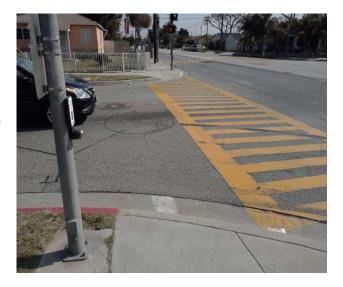
On-Site Finding Not Found

\$900

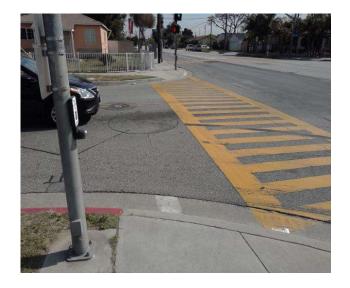
On-Site Finding Not Found

\$900

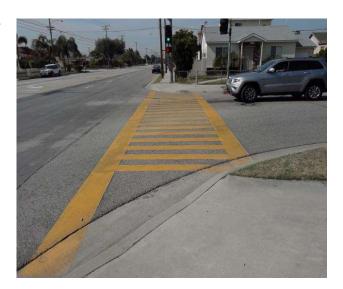
On-Site Finding Not Found

\$240

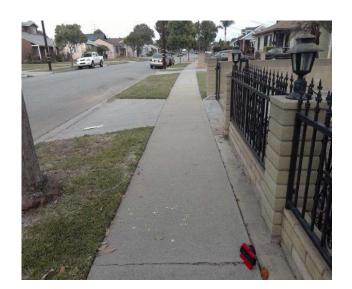
There is a change in elevation greater than recommended value.

Ensure that the change in elevation is within the recommended value.

Recommendation Up to 0.25 inches

Remove tripping hazards \$198

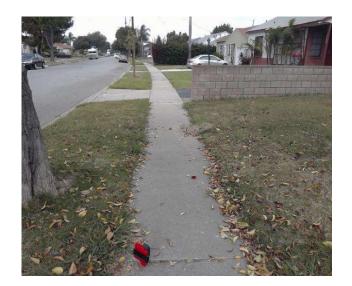
There is a change in elevation greater than recommended value.

Ensure that the change in elevation is within the recommended value.

Recommendation Up to 0.25 inches

Remove tripping hazards \$198

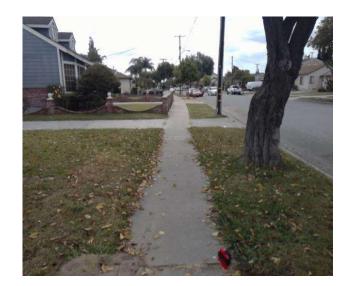
There is a change in elevation greater than recommended value.

Ensure that the change in elevation is within the recommended value.

Recommendation Up to 0.25 inches

Remove tripping hazards \$198

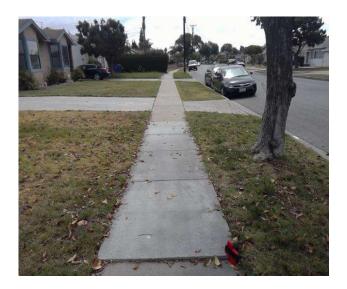
There is a change in elevation greater than recommended value.

Ensure that the change in elevation is within the recommended value.

Recommendation Up to 0.25 inches

Remove tripping hazards \$198

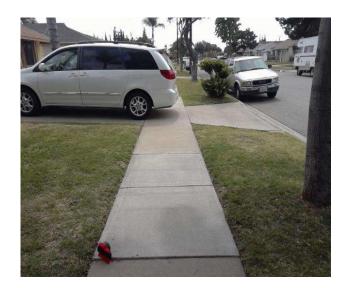
There is a change in elevation greater than recommended value.

Ensure that the change in elevation is within the recommended value.

Recommendation Up to 0.25 inches

Remove tripping hazards \$198

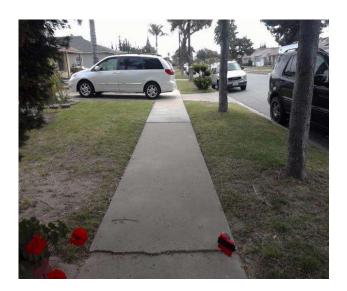
There is a change in elevation greater than recommended value.

Ensure that the change in elevation is within the recommended value.

Recommendation Up to 0.25 inches

Remove tripping hazards \$198

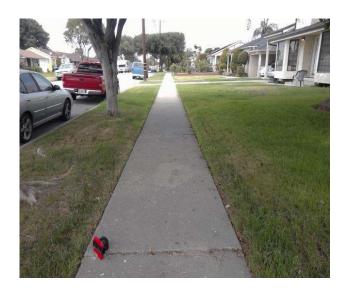
There is a change in elevation greater than recommended value.

Ensure that the change in elevation is within the recommended value.

Recommendation Up to 0.25 inches

Remove tripping hazards \$198

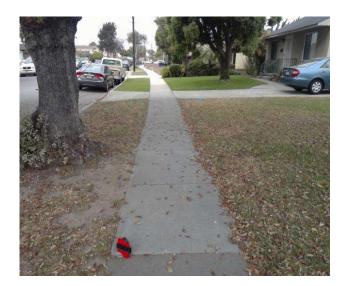
There is a change in elevation greater than recommended value.

Ensure that the change in elevation is within the recommended value.

Recommendation Up to 0.25 inches

Remove tripping hazards \$198

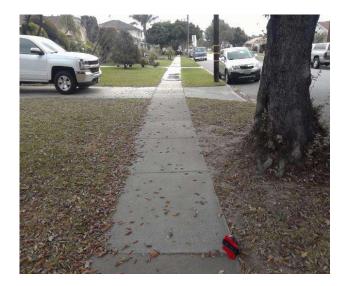
There is a change in elevation greater than recommended value.

Ensure that the change in elevation is within the recommended value.

Recommendation Up to 0.25 inches

Remove tripping hazards \$198

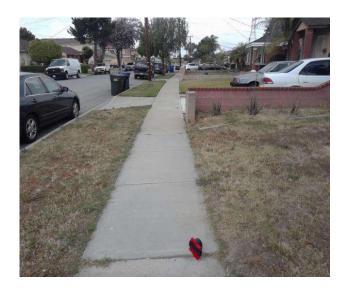
There is a change in elevation greater than recommended value.

Ensure that the change in elevation is within the recommended value.

Recommendation Up to 0.25 inches

Remove tripping hazards \$198

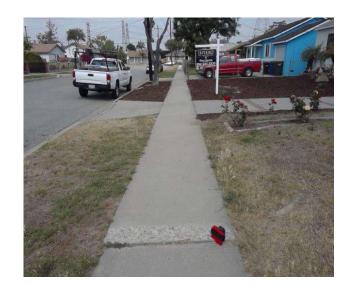
There is a change in elevation greater than recommended value.

Ensure that the change in elevation is within the recommended value.

Recommendation Up to 0.25 inches

Remove tripping hazards \$198

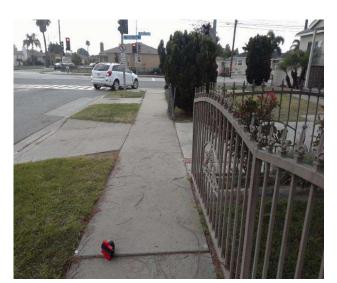
There is a change in elevation greater than recommended value.

Ensure that the change in elevation is within the recommended value.

Recommendation Up to 0.25 inches

Remove tripping hazards \$198

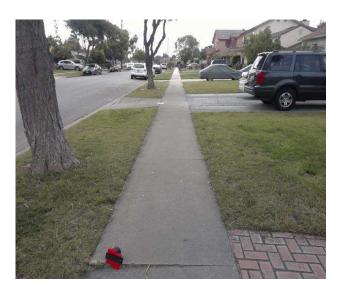
There is a change in elevation greater than recommended value.

Ensure that the change in elevation is within the recommended value.

Recommendation Up to 0.25 inches

Remove tripping hazards \$198

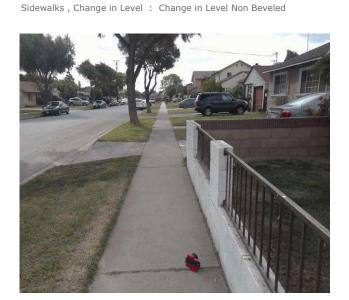
There is a change in elevation greater than recommended value.

Ensure that the change in elevation is within the recommended value.

Recommendation Up to 0.25 inches

Remove tripping hazards \$198

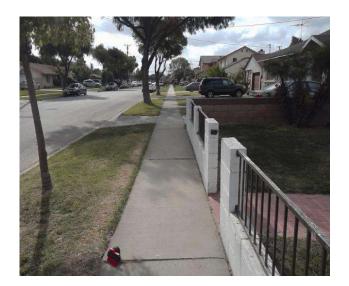
There is a change in elevation greater than recommended value.

Ensure that the change in elevation is within the recommended value.

Recommendation Up to 0.25 inches

Remove tripping hazards \$198

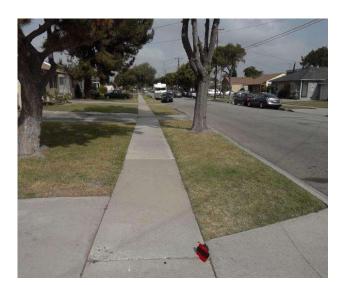
There is a change in elevation greater than recommended value.

Ensure that the change in elevation is within the recommended value.

Recommendation Up to 0.25 inches

Remove tripping hazards \$198

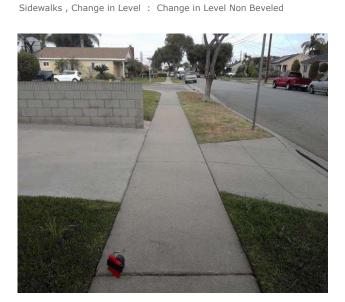
There is a change in elevation greater than recommended value.

Ensure that the change in elevation is within the recommended value.

Recommendation Up to 0.25 inches

Remove tripping hazards \$198

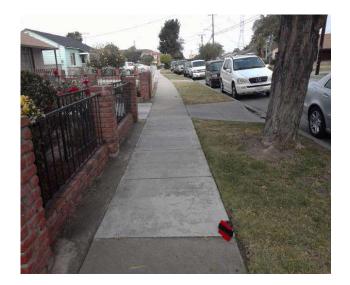
There is a change in elevation greater than recommended value.

Ensure that the change in elevation is within the recommended value.

Recommendation Up to 0.25 inches

Remove tripping hazards \$198

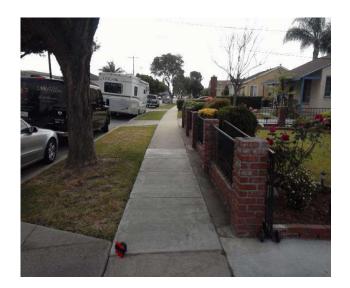
There is a change in elevation greater than recommended value.

Ensure that the change in elevation is within the recommended value.

Recommendation Up to 0.25 inches

Remove tripping hazards \$198

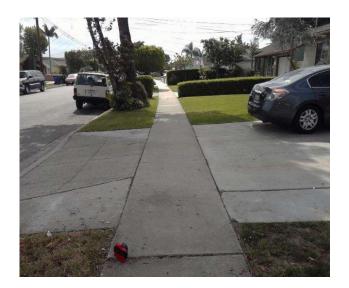
There is a change in elevation greater than recommended value.

Ensure that the change in elevation is within the recommended value.

Recommendation Up to 0.25 inches

Remove tripping hazards \$198

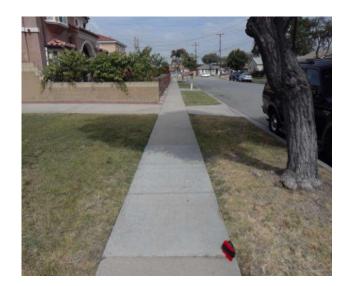
There is a change in elevation greater than recommended value.

Ensure that the change in elevation is within the recommended value.

Recommendation Up to 0.25 inches

Remove tripping hazards \$198

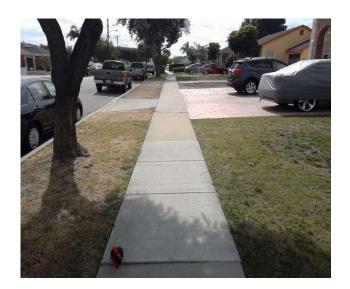
There is a change in elevation greater than recommended value.

Ensure that the change in elevation is within the recommended value.

Recommendation Up to 0.25 inches

Remove tripping hazards \$198

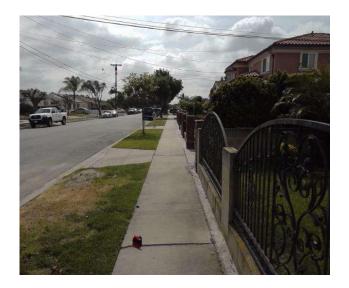
There is a change in elevation greater than recommended value.

Ensure that the change in elevation is within the recommended value.

Recommendation Up to 0.25 inches

Remove tripping hazards \$198

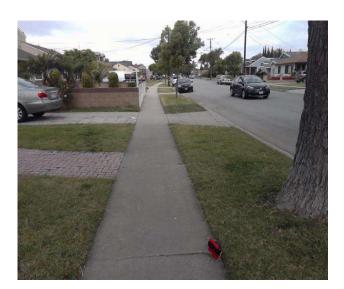
There is a change in elevation greater than recommended value.

Ensure that the change in elevation is within the recommended value.

Recommendation Up to 0.25 inches

Remove tripping hazards \$198

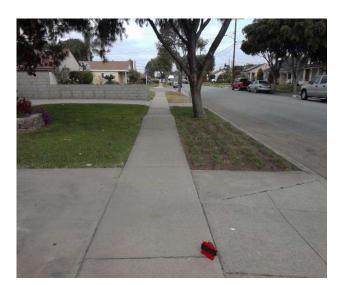
There is a change in elevation greater than recommended value.

Ensure that the change in elevation is within the recommended value.

Recommendation Up to 0.25 inches

Remove tripping hazards \$198

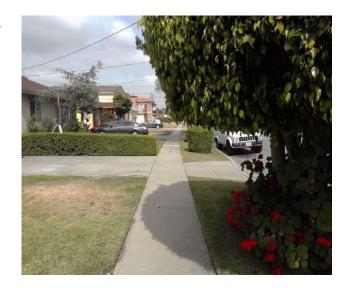
Sidewalks , Hazards & Gratings : Overhead Obstruction Height

Recommendation At least 80.00 inches

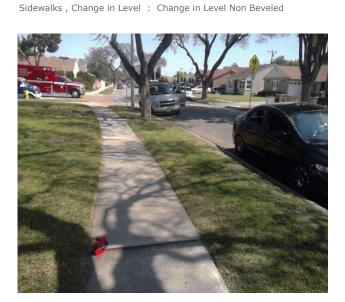
There is a change in elevation greater than recommended value.

Ensure that the change in elevation is within the recommended value.

Recommendation Up to 0.25 inches

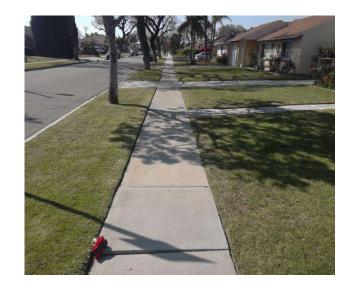
There is a change in elevation greater than recommended value.

Ensure that the change in elevation is within the recommended value.

Recommendation Up to 0.25 inches

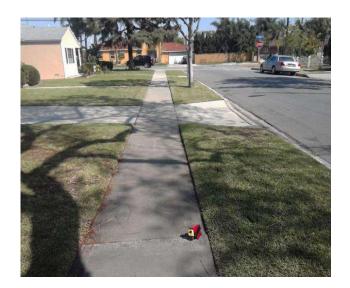
There is a change in elevation greater than recommended value.

Ensure that the change in elevation is within the recommended value.

Recommendation Up to 0.25 inches

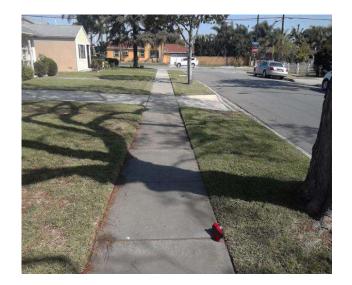
There is a change in elevation greater than recommended value.

Ensure that the change in elevation is within the recommended value.

Recommendation Up to 0.25 inches

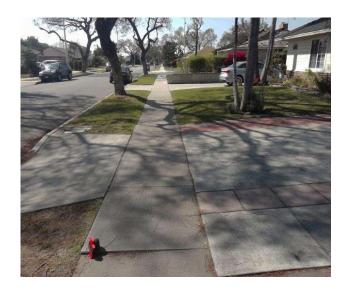
There is a change in elevation greater than recommended value.

Ensure that the change in elevation is within the recommended value.

Recommendation Up to 0.25 inches

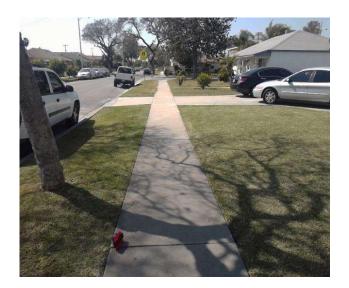
There is a change in elevation greater than recommended value.

Ensure that the change in elevation is within the recommended value.

Recommendation Up to 0.25 inches

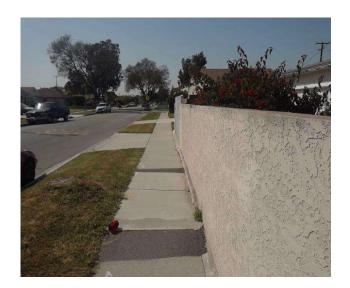
There is a change in elevation greater than recommended value.

Ensure that the change in elevation is within the recommended value.

Recommendation Up to 0.25 inches

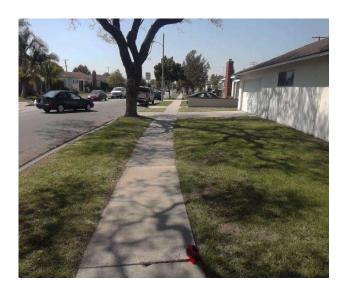
There is a change in elevation greater than recommended value.

Ensure that the change in elevation is within the recommended value.

Recommendation Up to 0.25 inches

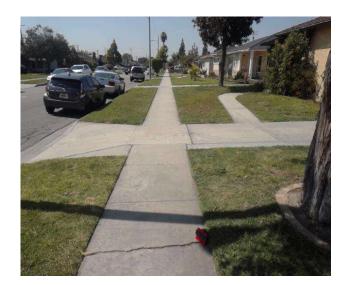
There is a change in elevation greater than recommended value.

Ensure that the change in elevation is within the recommended value.

Recommendation Up to 0.25 inches

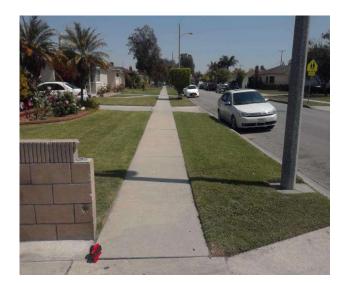
There is a change in elevation greater than recommended value.

Ensure that the change in elevation is within the recommended value.

Recommendation Up to 0.25 inches

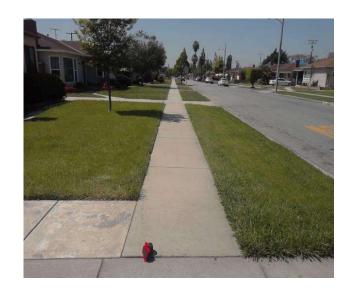
There is a change in elevation greater than recommended value.

Ensure that the change in elevation is within the recommended value.

Recommendation Up to 0.25 inches

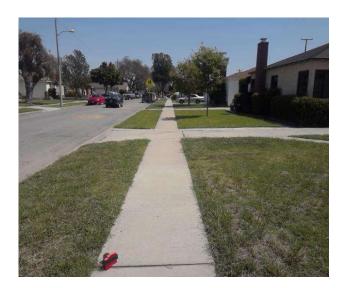
There is a change in elevation greater than recommended value.

Ensure that the change in elevation is within the recommended value.

Recommendation Up to 0.25 inches

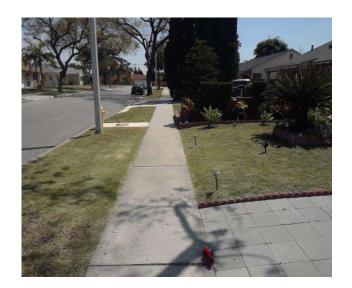
There is a change in elevation greater than recommended value.

Ensure that the change in elevation is within the recommended value.

Recommendation Up to 0.25 inches

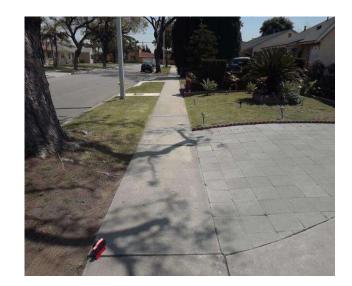
There is a change in elevation greater than recommended value.

Ensure that the change in elevation is within the recommended value.

Recommendation Up to 0.25 inches

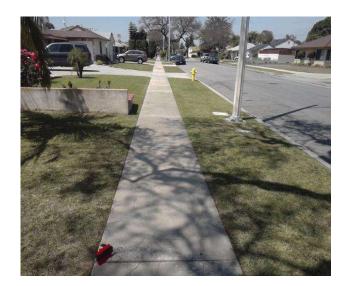
There is a change in elevation greater than recommended value.

Ensure that the change in elevation is within the recommended value.

Recommendation Up to 0.25 inches

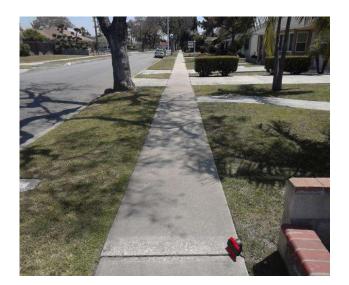
There is a change in elevation greater than recommended value.

Ensure that the change in elevation is within the recommended value.

Recommendation Up to 0.25 inches

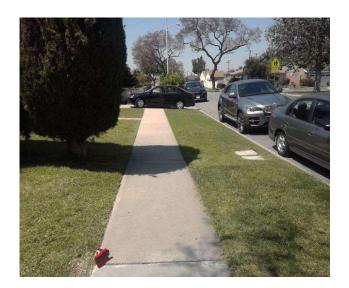
There is a change in elevation greater than recommended value.

Ensure that the change in elevation is within the recommended value.

Recommendation Up to 0.25 inches

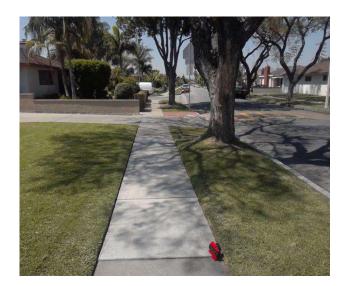
There is a change in elevation greater than recommended value.

Ensure that the change in elevation is within the recommended value.

Recommendation Up to 0.25 inches

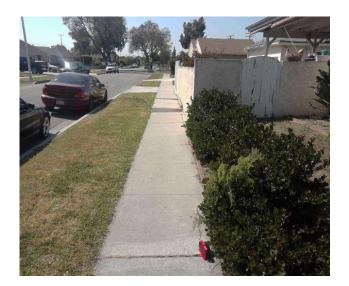
There is a change in elevation greater than recommended value.

Ensure that the change in elevation is within the recommended value.

Recommendation Up to 0.25 inches

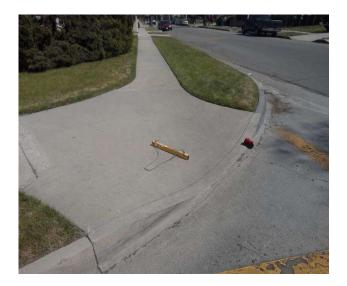
Recommendation Up to 2.08 percent

Install curb ramp \$1,300

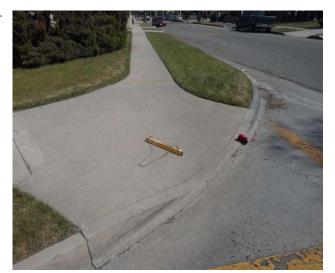
Recommendation Up to 10.00 percent

Install flared sides \$1,300

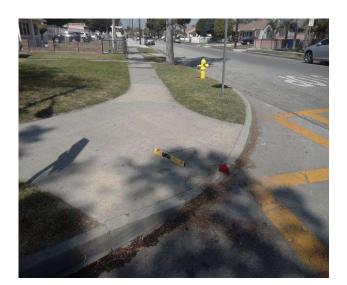
On-Site Finding Not Found

Provide detectable warning to \$248 surface

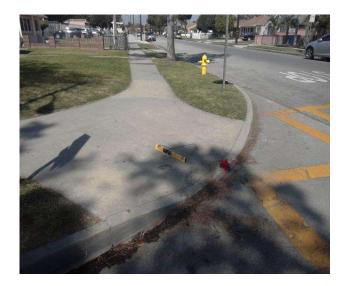
Recommendation Up to 8.33 percent

Install curb ramp \$1,300

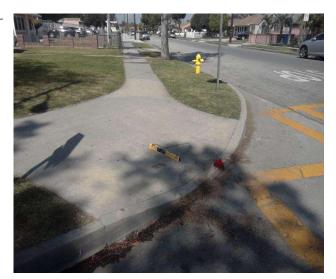
Recommendation Up to 10.00 percent

Install flared sides \$1,300

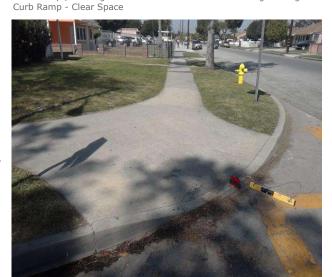
Curb Ramp , Landings and Transitions : Bottom Landing Of Diagonal

Recommendation At least 48.00 inches

Provide compliant landing \$255

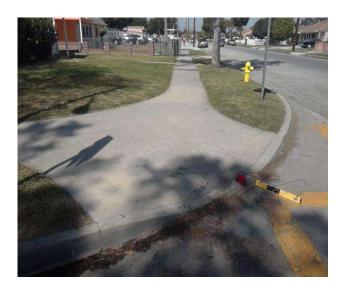
Curb Ramp , Landings and Transitions : Top Landing Slope

Recommendation Up to 2.08 percent

Provide compliant landing \$1,260

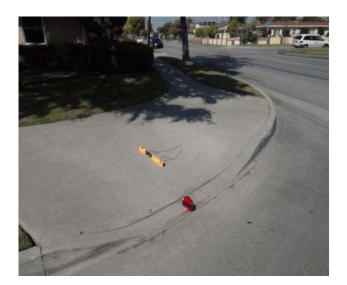
On-Site Finding Not Found

Provide detectable warning to \$248 surface

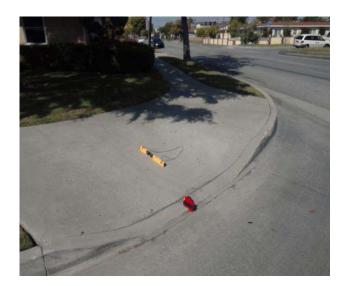
Recommendation Up to 8.33 percent

Install curb ramp \$1,300

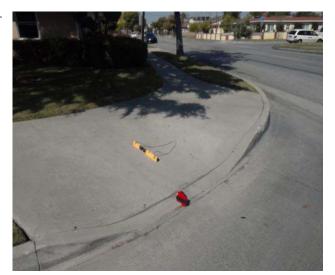
Recommendation Up to 10.00 percent

Install flared sides \$1,300

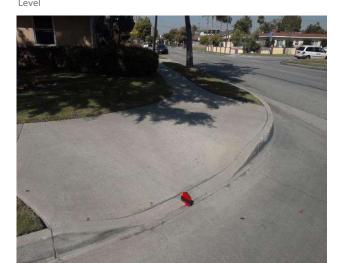
Curb Ramp , Landings And Transitions : Bottom Landing Change in

Recommendation Up to 0.50 inches

Patch lip at curb ramp \$255

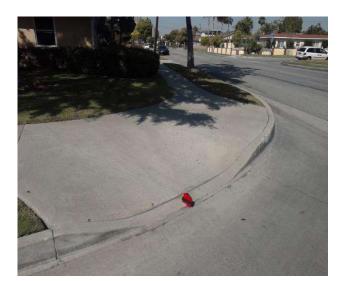
Curb Ramp , Landings and Transitions : Top Landing Slope

Recommendation Up to 2.08 percent

Provide compliant landing \$1,260

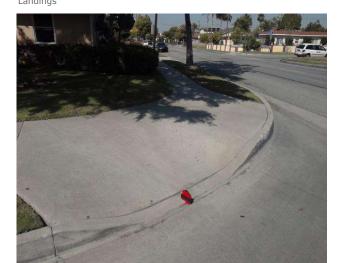
Curb Ramp , Landings and Transitions : Top Landing Clear Length -

Recommendation At least 48.00 inches

Provide compliant landing \$240

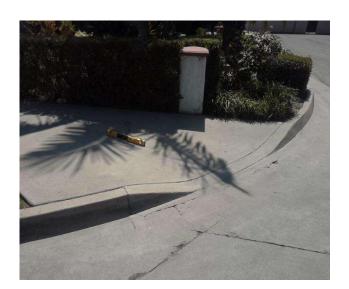
On-Site Finding Not Found

Provide detectable warning to \$248 surface

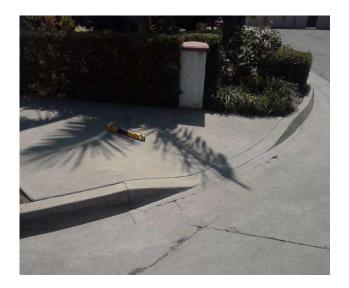
Recommendation Up to 8.33 percent

Install curb ramp \$1,300

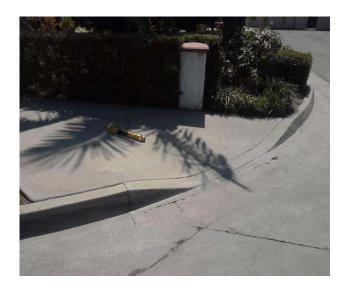
Recommendation Up to 2.08 percent

Install curb ramp \$1,300

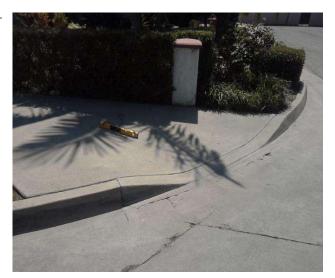
Recommendation Up to 10.00 percent

Install flared sides \$1,300

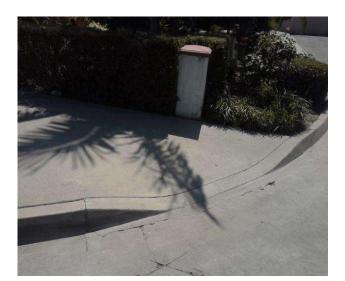
Curb Ramp , Landings and Transitions : Top Landing Slope

Recommendation Up to 2.08 percent

Provide compliant landing \$1,260

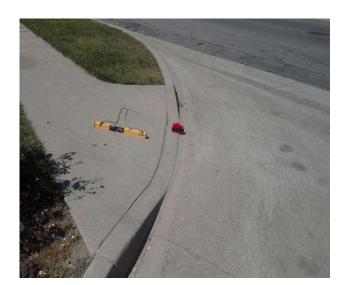
On-Site Finding Not Found

Provide detectable warning to \$248 surface

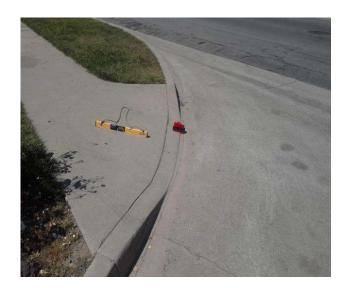
Recommendation Up to 8.33 percent

Install curb ramp \$1,300

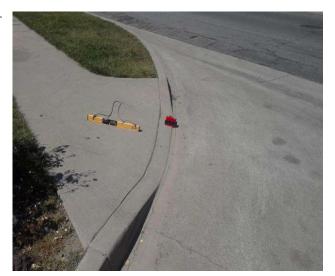
Recommendation Up to 10.00 percent

Install flared sides \$1,300

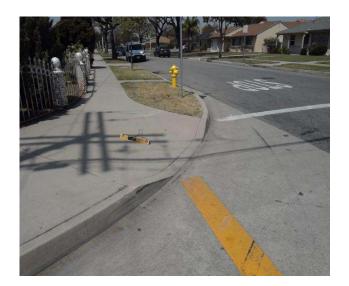
On-Site Finding Not Found

Provide detectable warning to \$248 surface

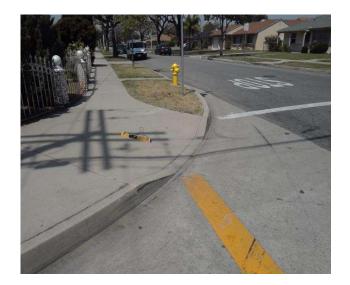
On-Site Finding Not Found

Install crosswalk \$800

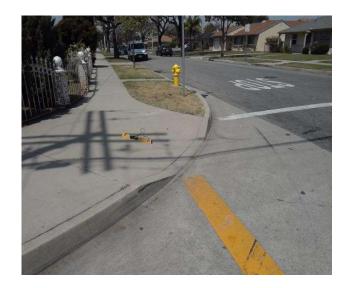
Recommendation Up to 8.33 percent

Install curb ramp \$1,300

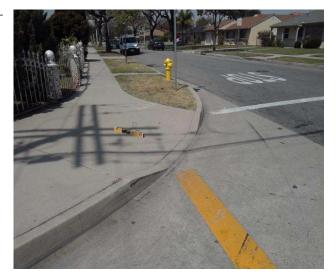
Recommendation Up to 10.00 percent

Install flared sides \$1,300

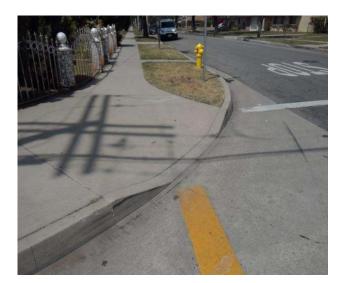
Curb Ramp , Landings and Transitions : Top Landing Slope

Recommendation Up to 2.08 percent

Provide compliant landing \$1,260

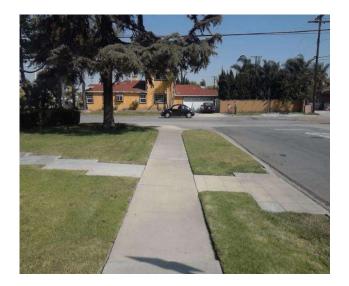
Recommendation Up to 2.08 percent

Repave the sidewalk surface with the recommended cross slope.

Repave surface \$1,092

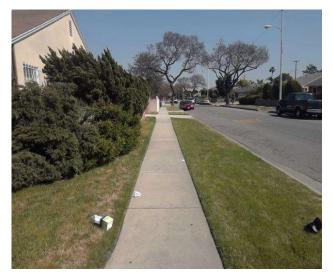
Recommendation Up to 2.08 percent

Repave the sidewalk surface with the recommended cross slope.

Repave surface \$1,092

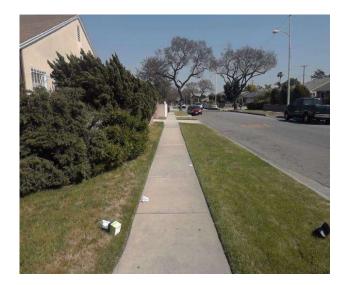
Recommendation Up to 5.00 percent

Repave the sidewalk surface with the recommended running slope.

Repave surface \$1,184

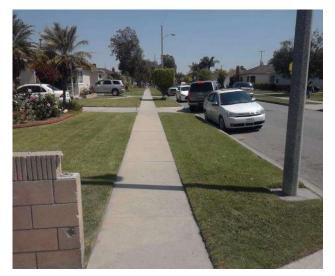
Recommendation Up to 2.08 percent

Repave the sidewalk surface with the recommended cross slope.

Repave surface \$1,092

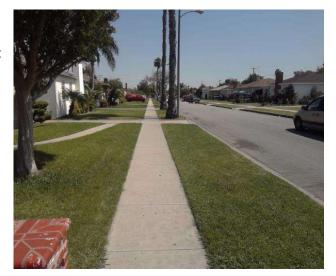
Recommendation Up to 2.08 percent

Repave the sidewalk surface with the recommended cross slope.

Repave surface \$1,092

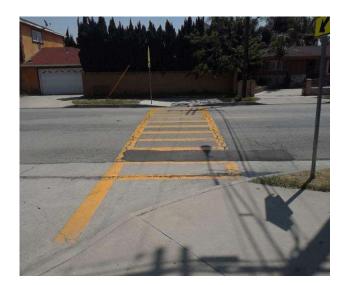
Recommendation Up to 5.00 percent

Repave surface \$1,092

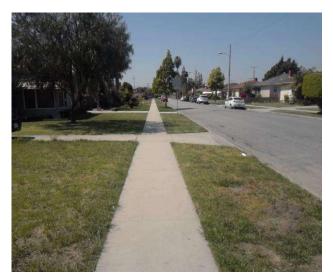
Recommendation Up to 2.08 percent

Repave the sidewalk surface with the recommended cross slope.

Repave surface \$1,092

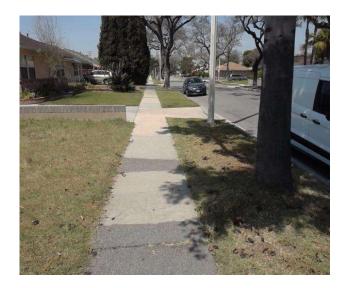
Recommendation Up to 2.08 percent

Notes: Surface is rough and uneven for 6 feet.

Repave the sidewalk surface with the recommended cross slope.

Repave surface \$1,092

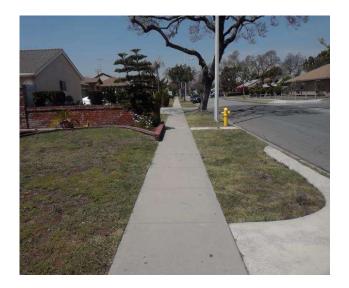
Recommendation Up to 2.08 percent

Repave the sidewalk surface with the recommended cross slope.

Repave surface \$1,092

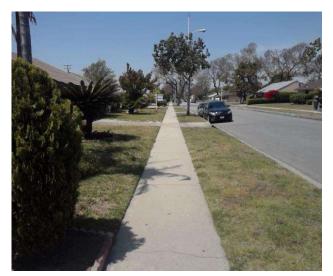
Recommendation Up to 2.08 percent

Repave the sidewalk surface with the recommended cross slope.

Repave surface \$1,092

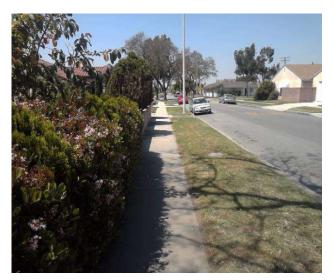
Recommendation Up to 2.08 percent

Repave the sidewalk surface with the recommended cross slope.

Repave surface \$1,092

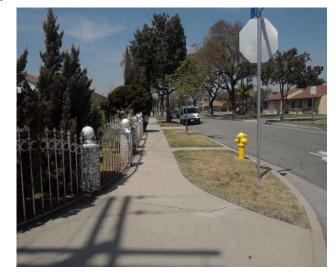
On-Site Finding Not Found

Code Reference ADA 206, 302

Recommendation See Recommendation
