# Accessibility Survey

## City of Downey Studebaker Road & I-5 on Ramp

Studebaker Road & I-5 on Ramp  
Downey, CA 90424

Date of Inspection  
2/5/2017

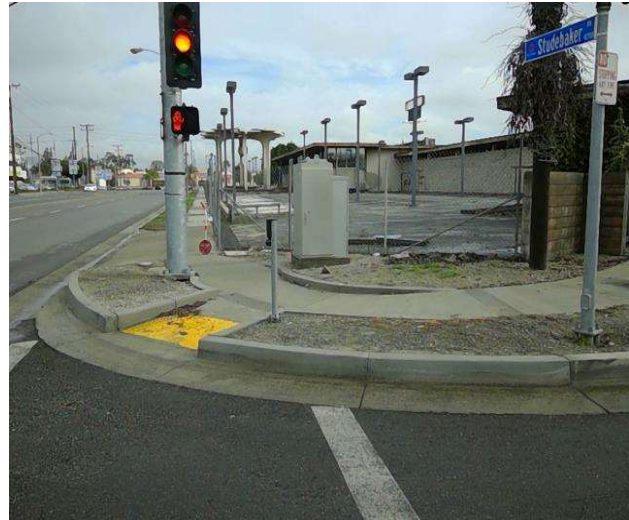
Curb Ramp , Ramp Run : Grade Break

Curb ramp run surface has a grade break.

**On-Site Finding** Not Compliant

**Code Reference** CA 11B-406.5.6

Notes : Slope on ramp from bottom landing to crossing is 6.6%

Provide a compliant curb ramp.

Install curb ramp \$1,440

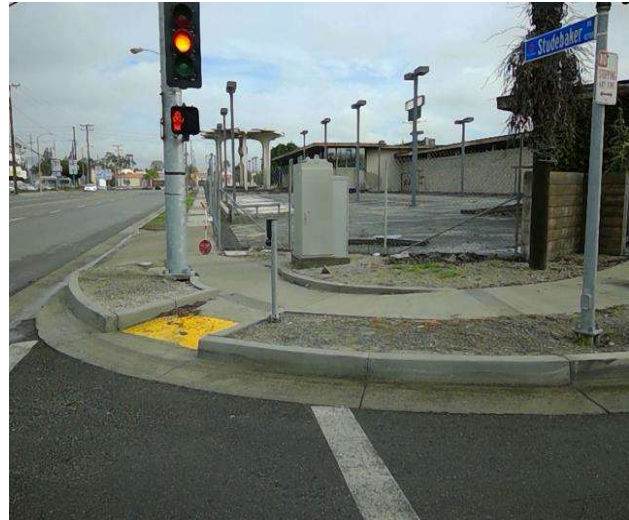
Curb Ramp : Appurtenances

**Code Reference** ADA 303.3, CA 11B-303.3

Notes : Slope on ramp from bottom landing to crossing is 6.6%

Install curb ramp \$1,440

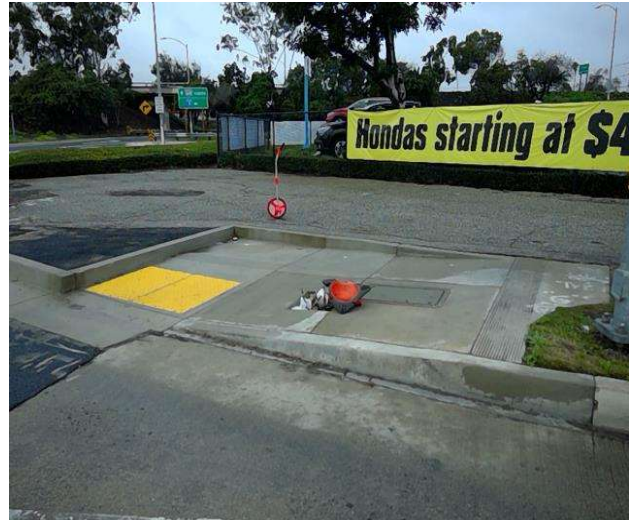
**Code Reference** CA 11B-406.5.6

Install curb ramp \$1,440

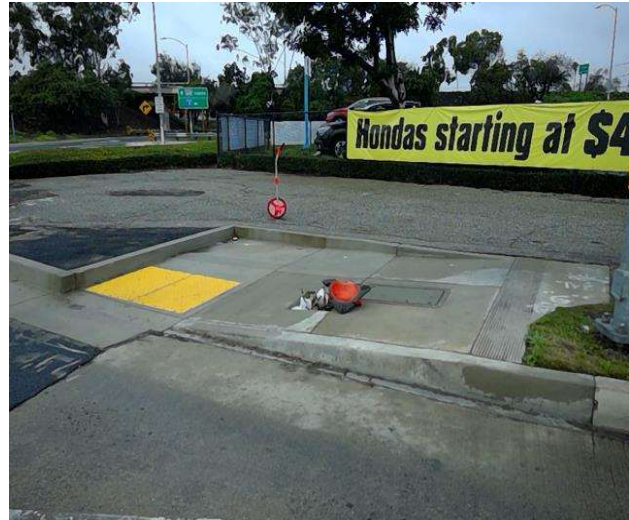
**Code Reference** ADA 303.3,CA 11B-303.3

Install curb ramp \$1,440

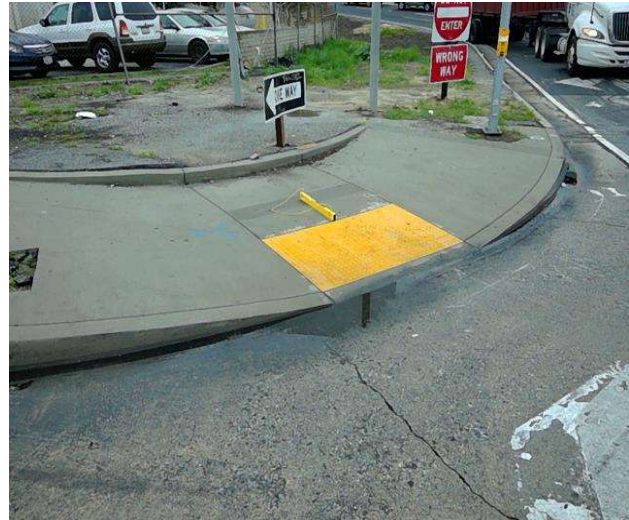
**Code Reference** ADA 406, 406.1, 405.2, CA 11B-406

Recommendation Up to 8.33 percent

Install curb ramp \$1,300

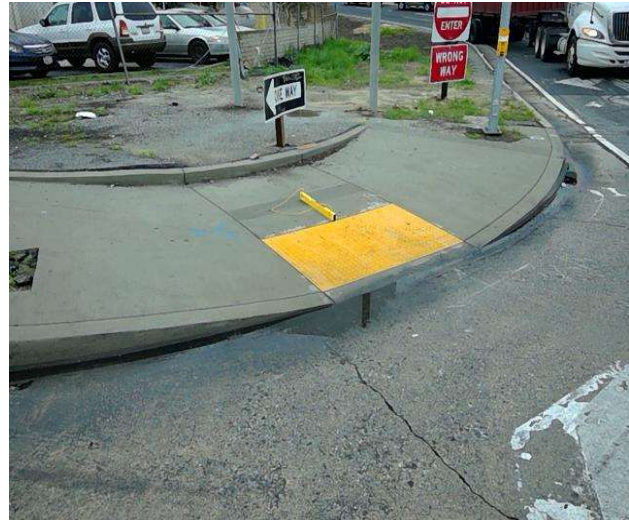
**Code Reference** CA 11B-406.5.6

Install curb ramp \$1,440

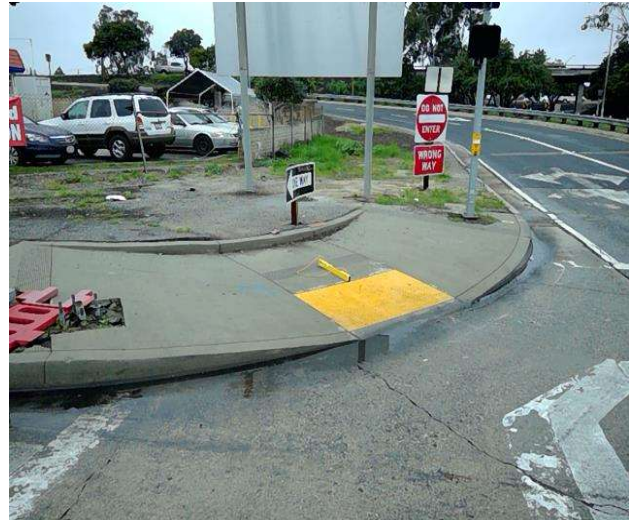
Curb Ramp , Landings and Transitions : Landing Accumulates Water  
- Wet Conditions

**Code Reference** ADA 405, 406.1, 405.10

Provide compliant landing \$255

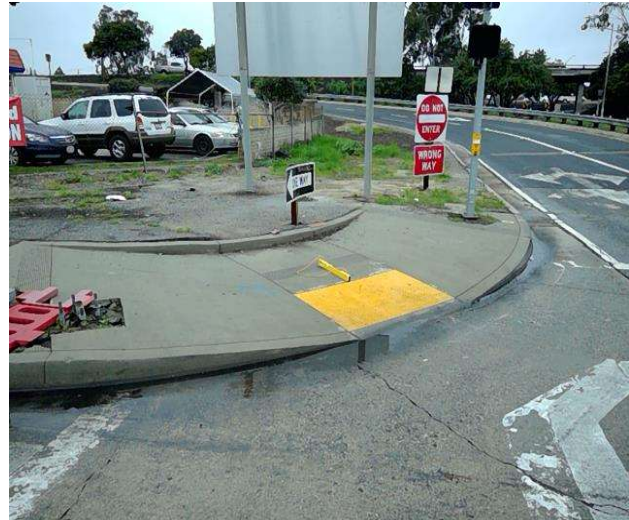
**Code Reference** ADA 402, 406.4, 403.3, 406.1, CA 11B-406.5.3

Recommendation Up to 2.08 percent

Provide compliant landing \$1,260

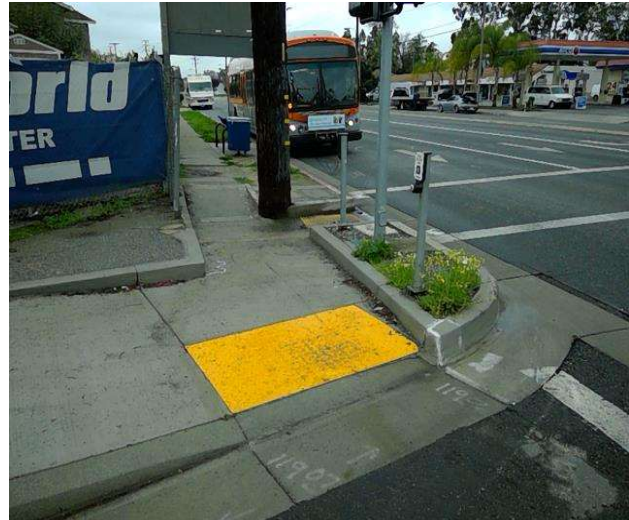
**Code Reference** ADA 206, 302, CA 11B-406.6

Readjust the median cut through width to recommended value.

Recommendation At least 60.00 inches

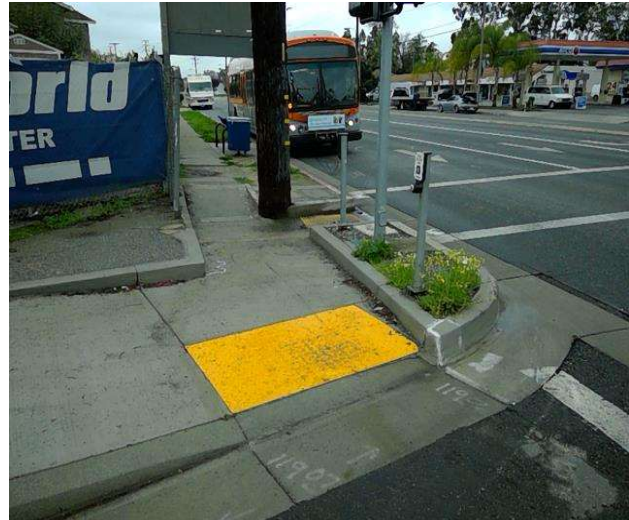
**Code Reference** ADA 206, 302, 1104, 1103

Readjust the median cut through slope to recommended value.

Recommendation Up to 5.00 inches

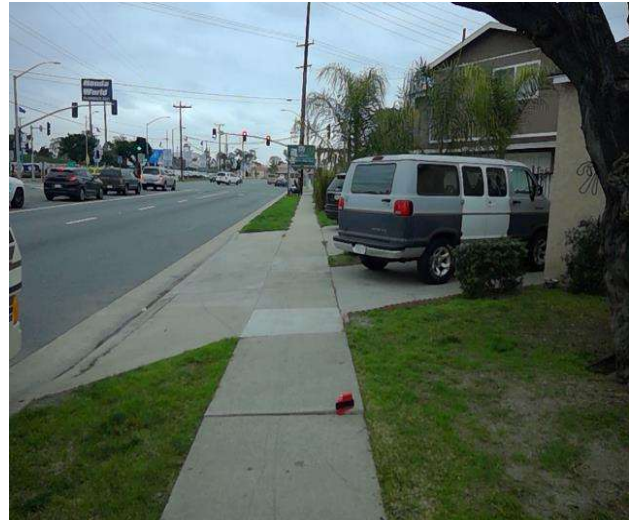
There is a change in elevation greater than recommended value.

**Code Reference** ADA 206, 302

Ensure that the change in elevation is within the recommended value.

Recommendation Up to 0.25 inches

Remove tripping hazards \$198

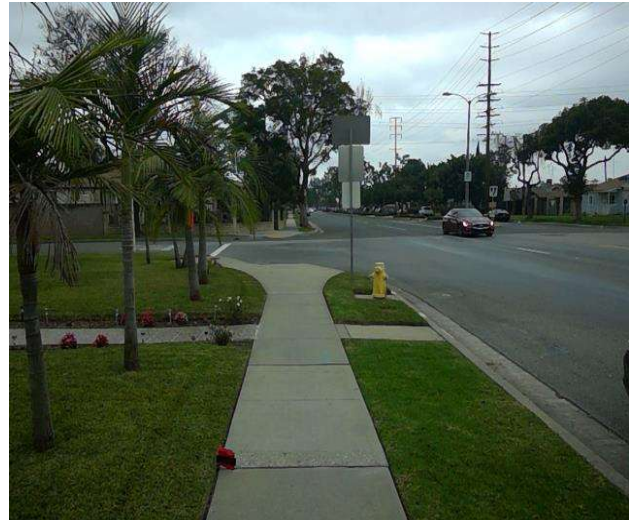
There is a change in elevation greater than recommended value.

**Code Reference** ADA 206, 302

Ensure that the change in elevation is within the recommended value.

Recommendation Up to 0.25 inches

Remove tripping hazards \$198

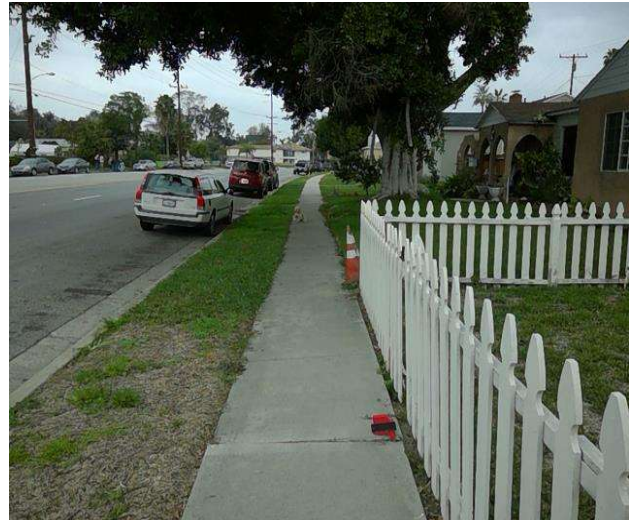
There is a change in elevation greater than recommended value.

**Code Reference** ADA 206, 302

Ensure that the change in elevation is within the recommended value.

Recommendation Up to 0.25 inches

Remove tripping hazards \$198

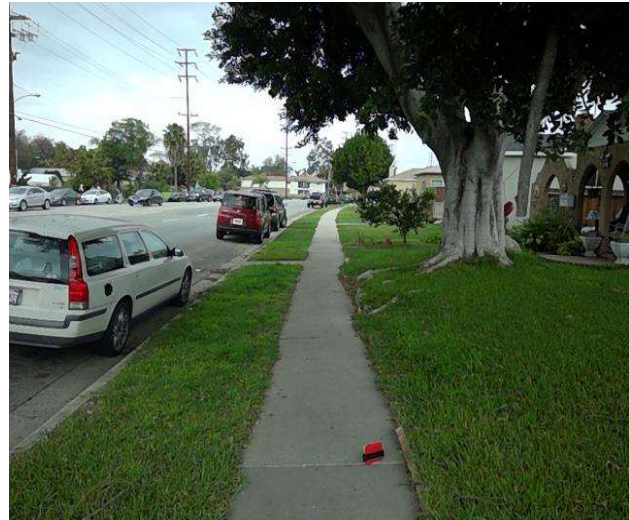
There is a change in elevation greater than recommended value.

**Code Reference** ADA 206, 302

Ensure that the change in elevation is within the recommended value.

Recommendation Up to 0.25 inches

Remove tripping hazards \$198

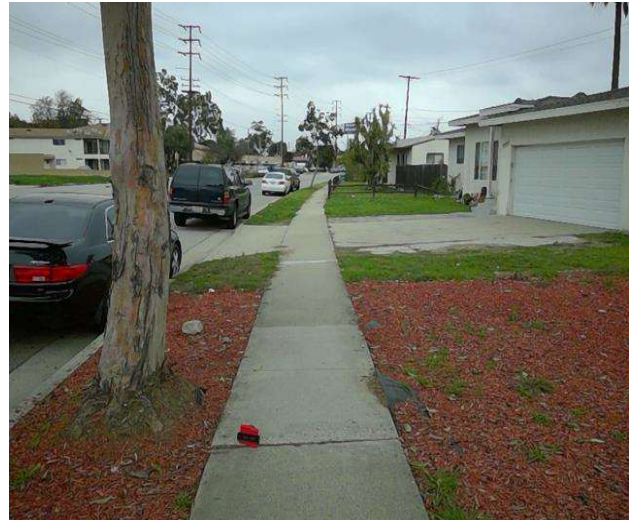
There is a change in elevation greater than recommended value.

**Code Reference** ADA 206, 302

Ensure that the change in elevation is within the recommended value.

Recommendation Up to 0.25 inches

Remove tripping hazards \$198

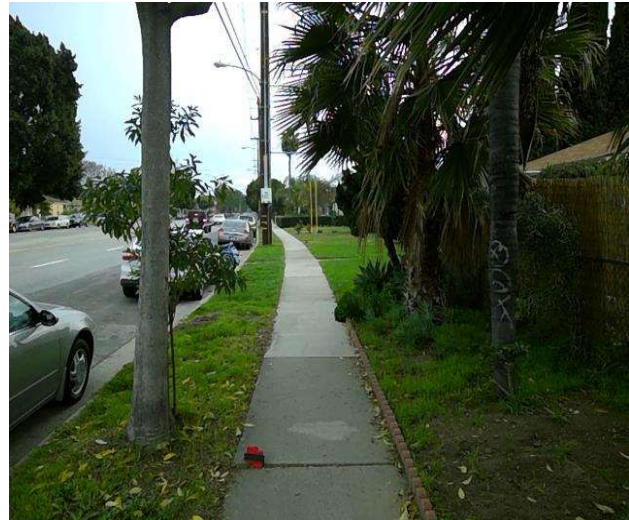
There is a change in elevation greater than recommended value.

**Code Reference** ADA 206, 302

Ensure that the change in elevation is within the recommended value.

Recommendation Up to 0.25 inches

Remove tripping hazards \$198

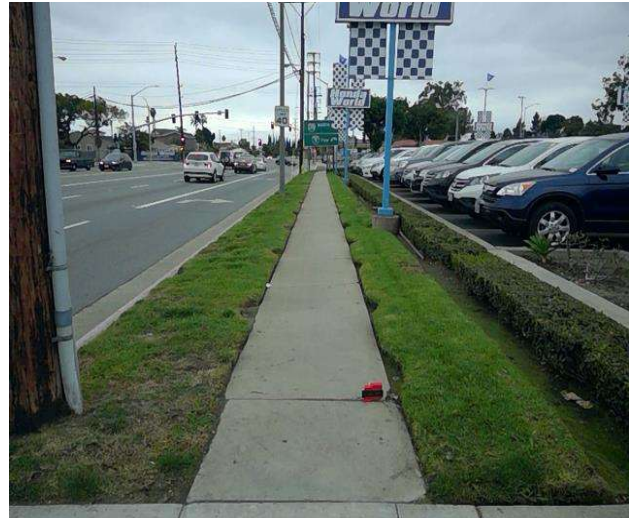
There is a change in elevation greater than recommended value.

**Code Reference** ADA 206, 302

Ensure that the change in elevation is within the recommended value.

Recommendation Up to 0.25 inches

Remove tripping hazards \$198

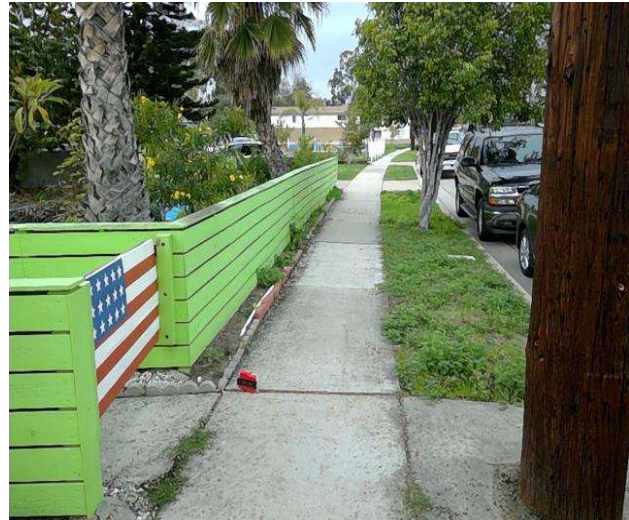
There is a change in elevation greater than recommended value.

**Code Reference** ADA 206, 302

Ensure that the change in elevation is within the recommended value.

Recommendation Up to 0.25 inches

Remove tripping hazards \$198

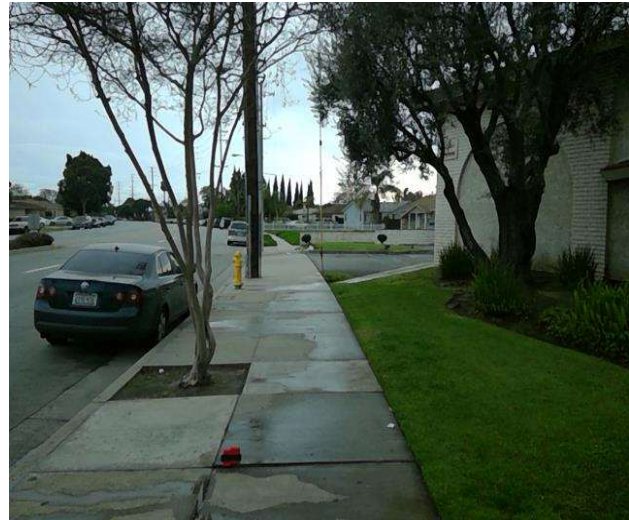
There is a change in elevation greater than recommended value.

**Code Reference** ADA 206, 302

Ensure that the change in elevation is within the recommended value.

Recommendation Up to 0.25 inches

Remove tripping hazards \$198
