Accessibility Survey

City of Downey Little Lake Road & Florence Avenue

Date of Inspection
2/3/2017

Prepared By
Disability Access Consultants
(800) 743-7067

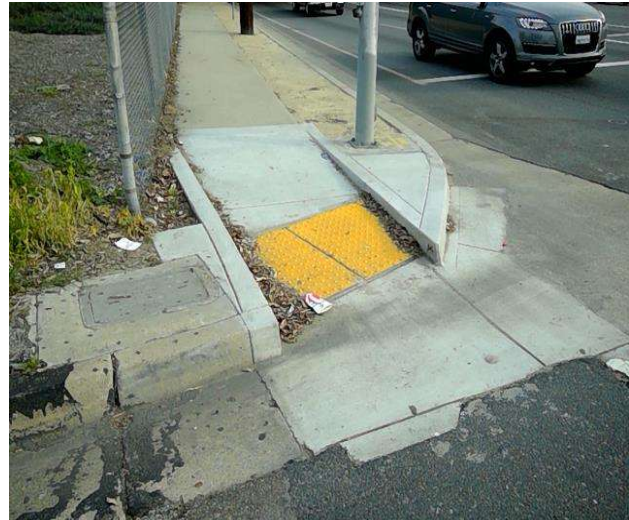
Northeast Corner @ 33.938268688502, -118.098939657211

Curb Ramp : Detectable Warning Domes Direction

Detectable warning domes are not aligned in the direction of travel.

On-Site Finding Not Compliant

Provide compliant detectable warnings with domes aligned in the direction of travel.

Recommendation See Recommendation

Install compliant detectable warnings \$190

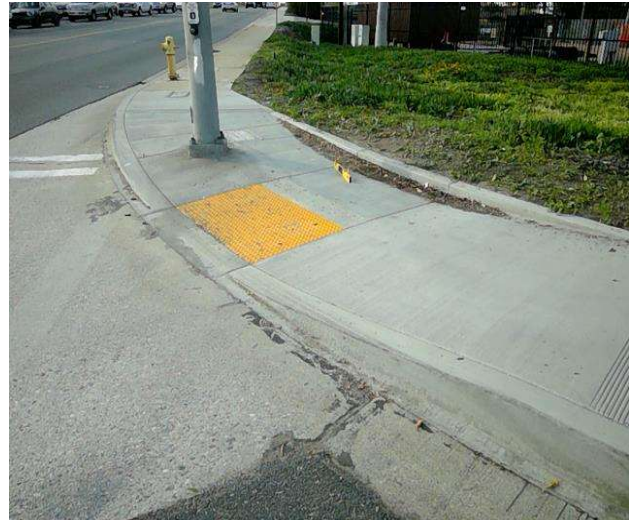
Northwest Corner @ 33.938268688502, -118.098939657211

Curb Ramp , Landings and Transitions : Top Landing Slope

The slope at the top landing is greater than allowed.

On-Site Finding 3.00 percent

Provide a top landing surface that does not exceed the maximum slope and cross slope. Provide a sufficient maneuvering clearance that does not accumulate water.

Recommendation Up to 2.08 percent

Provide compliant landing \$1,260

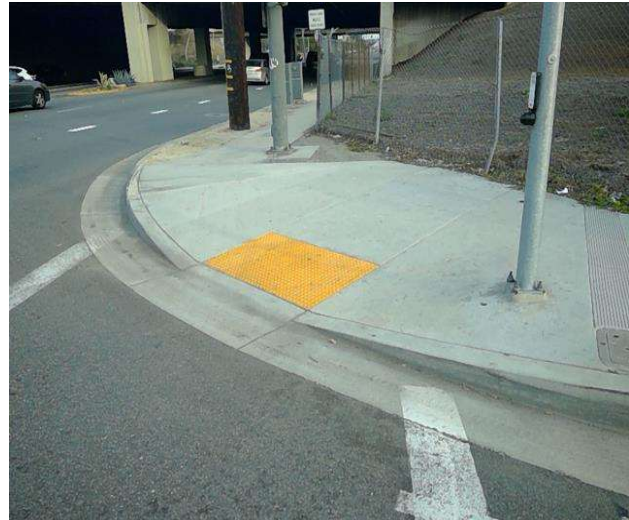
Southeast Corner @ 33.938268688502, -118.098939657211

Curb Ramp : No Contrasting Finish

The surface of the curb ramp does not have a finish that contrasts with the adjacent sidewalk.

On-Site Finding Not Found

Provide the surface on the curb ramp that contrasts with the adjacent sidewalk.

Apply contrasting finish to surface \$155

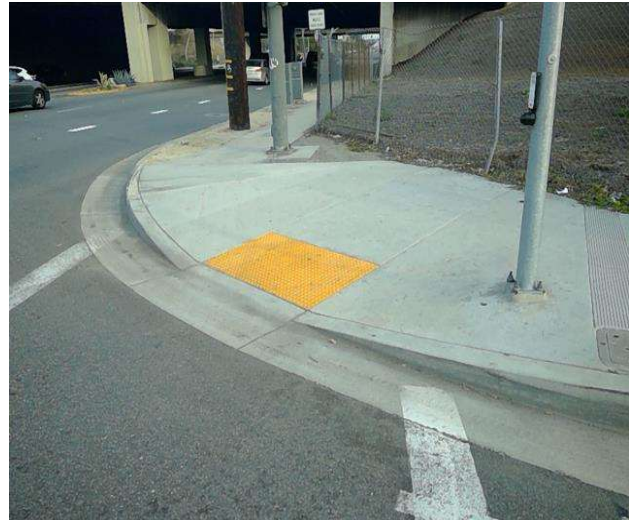
Southeast Corner @ 33.938268688502, -118.098939657211

Curb Ramp : Appurtenances

Utilities, gratings or other appurtenances are located on the curb ramp.

On-Site Finding Not Compliant

Provide a compliant curb ramp free of appurtenances.

Install curb ramp \$1,440

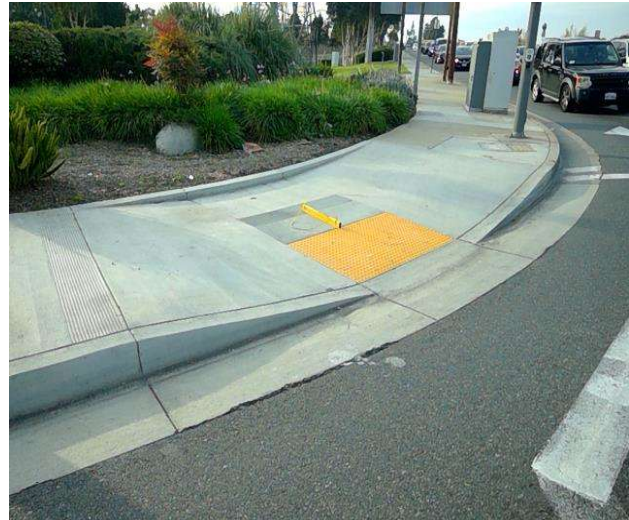
Southwest Corner @ 33.938268688502, -118.098939657211

Curb Ramp : Curb Ramp Slope

The running slope is greater than allowed.

On-Site Finding 9.20 percent

Provide a compliant curb ramp.

Recommendation Up to 8.33 percent

Install curb ramp \$1,300

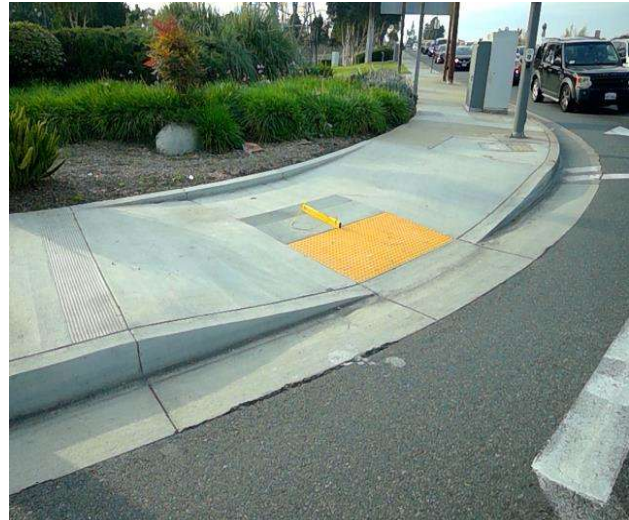
Southwest Corner @ 33.938268688502, -118.098939657211

Curb Ramp : Curb Ramp - Cross Slope

The cross slope is greater than allowed.

On-Site Finding 2.60 percent

Provide a compliant curb ramp.

Recommendation Up to 2.08 percent

Install curb ramp \$1,300

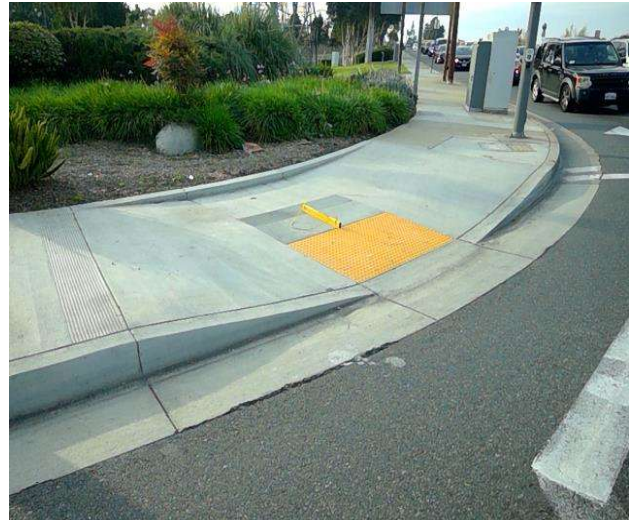
Southwest Corner @ 33.938268688502, -118.098939657211

Curb Ramp : Side Flare Slope

Recommendation Up to 10.00 percent

Install flared sides \$1,300

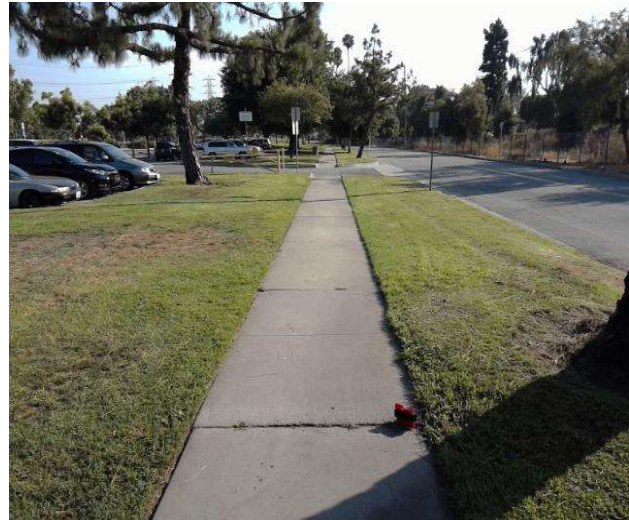
There is a change in elevation greater than recommended value.

Ensure that the change in elevation is within the recommended value.

Recommendation Up to 0.25 inches

Remove tripping hazards \$198

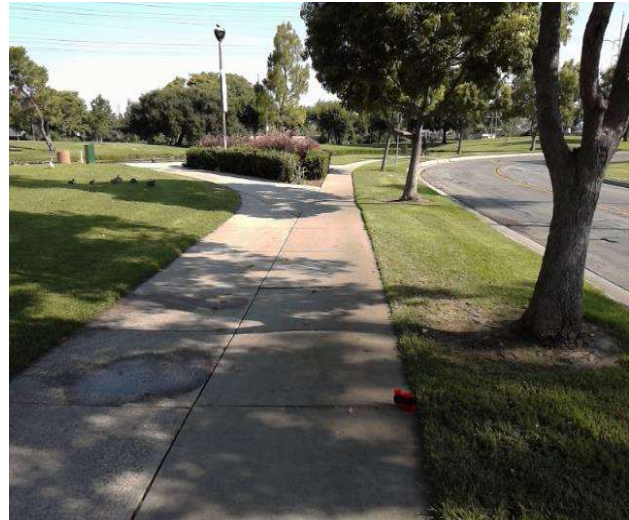
There is a change in elevation greater than recommended value.

Ensure that the change in elevation is within the recommended value.

Recommendation Up to 0.25 inches

Remove tripping hazards \$198

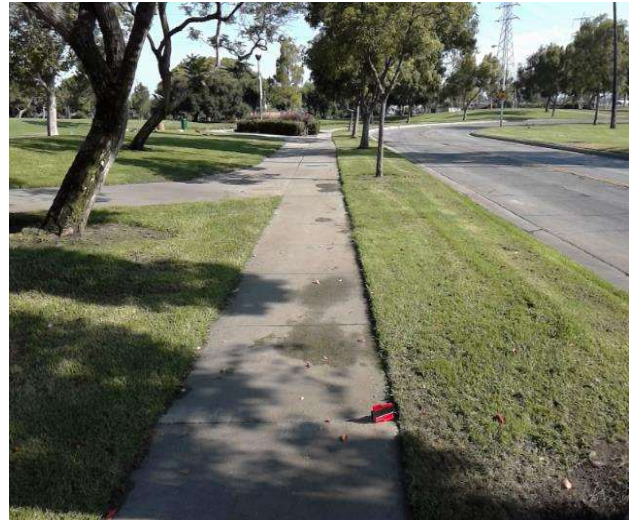
There is a change in elevation greater than recommended value.

Ensure that the change in elevation is within the recommended value.

Recommendation Up to 0.25 inches

Remove tripping hazards \$198

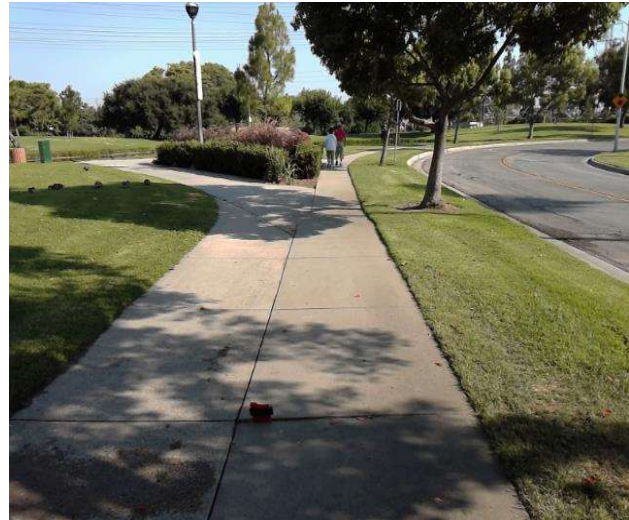
There is a change in elevation greater than recommended value.

Ensure that the change in elevation is within the recommended value.

Recommendation Up to 0.25 inches

Remove tripping hazards \$198

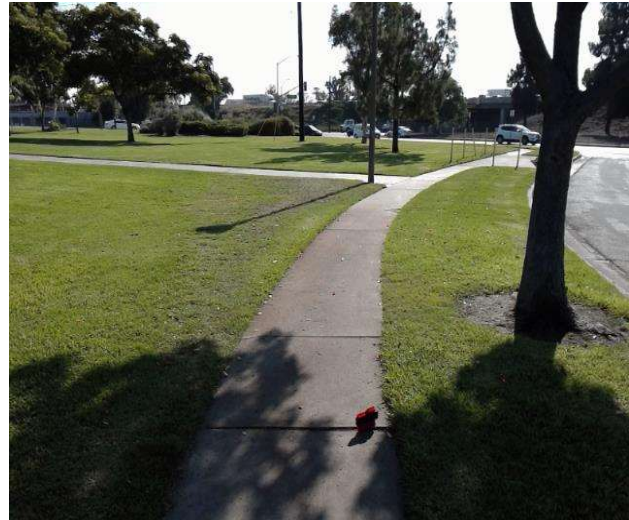
There is a change in elevation greater than recommended value.

Ensure that the change in elevation is within the recommended value.

Recommendation Up to 0.25 inches

Remove tripping hazards \$198

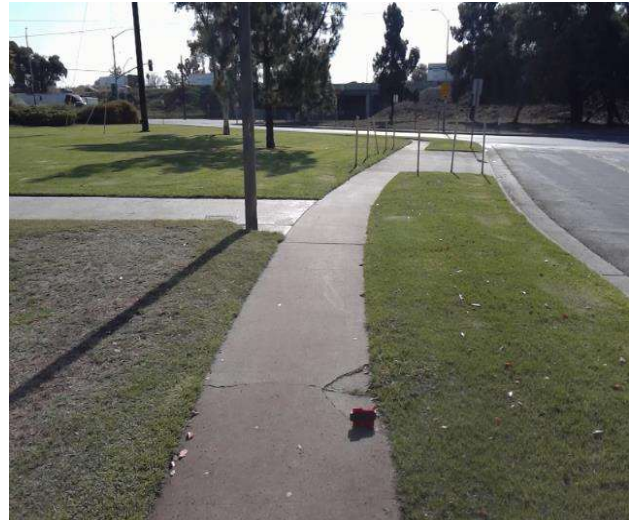
There is a change in elevation greater than recommended value.

Ensure that the change in elevation is within the recommended value.

Recommendation Up to 0.25 inches

Remove tripping hazards \$198

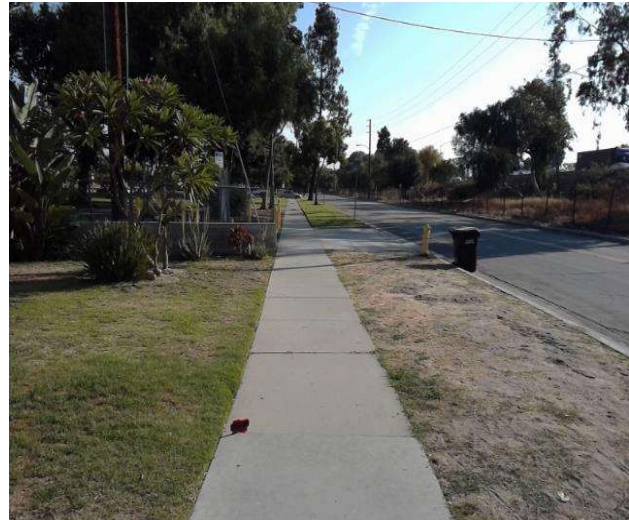
There is a change in elevation greater than recommended value.

Ensure that the change in elevation is within the recommended value.

Recommendation Up to 0.25 inches

Remove tripping hazards \$198

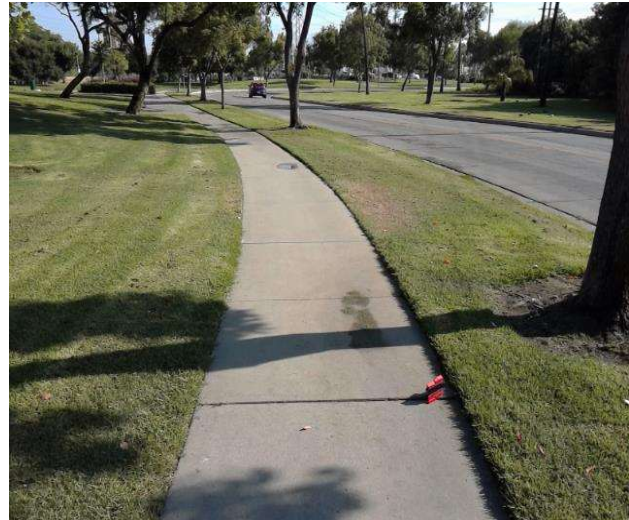
There is a change in elevation greater than recommended value.

Ensure that the change in elevation is within the recommended value.

Recommendation Up to 0.25 inches

Remove tripping hazards \$198

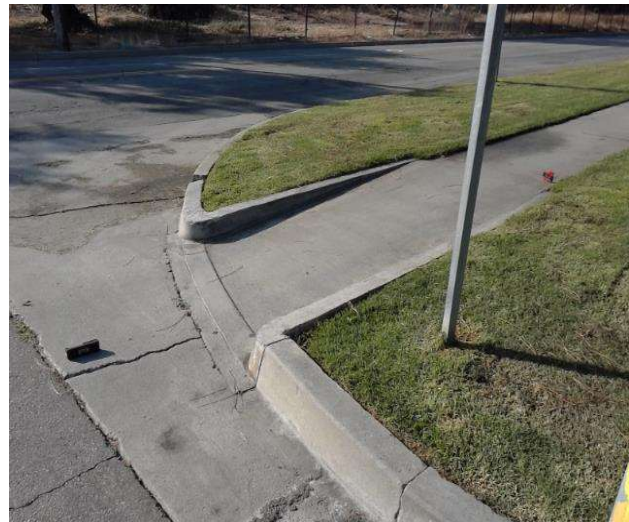
On-Site Finding Not Found

Recommendation See Recommendation

Provide detectable warning to surface \$248
