Accessibility Survey

City of Downey Charloma Drive - Birchdale Avenue to Cul-De-Sac

Date of Inspection
7/13/2017

City of Downey Charloma Drive - Brookshire Avenue to Stamps Avenue

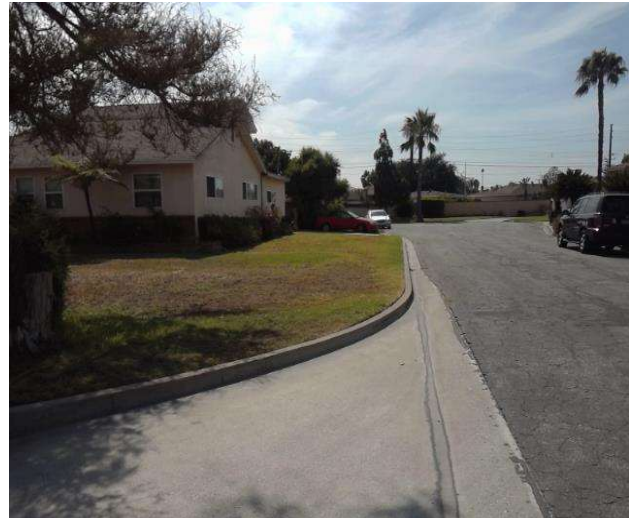
North Side @ 33.952393509890, -118.116137981415

Sidewalks : No Sidewalk

No sidewalk exists at the location.

On-Site Finding Not Found

No action necessary until a sidewalk is provided.

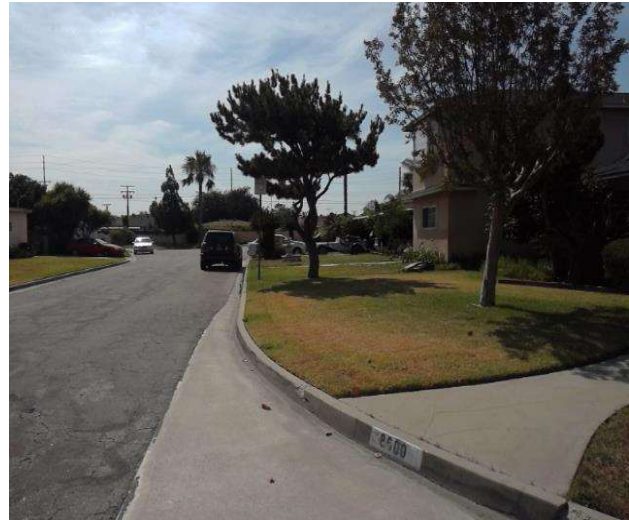
South Side @ 33.952330100287, -118.116296231747

Sidewalks : No Sidewalk

No sidewalk exists at the location.

On-Site Finding Not Found

No action necessary until a sidewalk is provided.

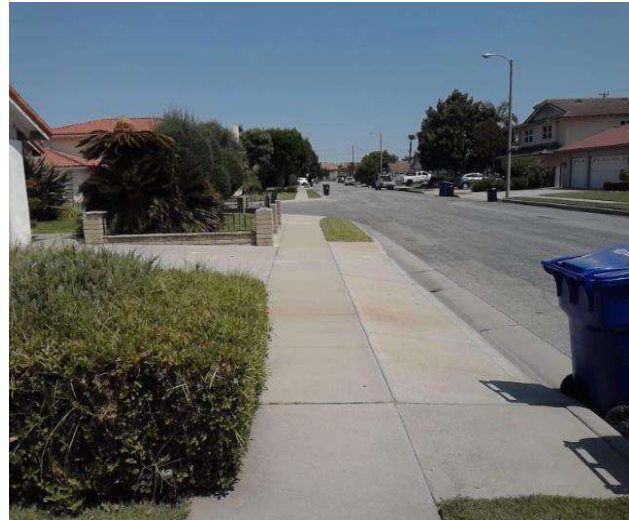
Bush East of Stamps Avenue @ 33.954790803190, -118.121156394482

Sidewalks , Hazards & Gratings : Sidewalk Width at Obstruction

Sidewalk width at the obstruction is not compliant.

On-Site Finding 39.00 inches

Sidewalk width at the obstruction shall have the recommended value.

Recommendation At least 48.00 inches

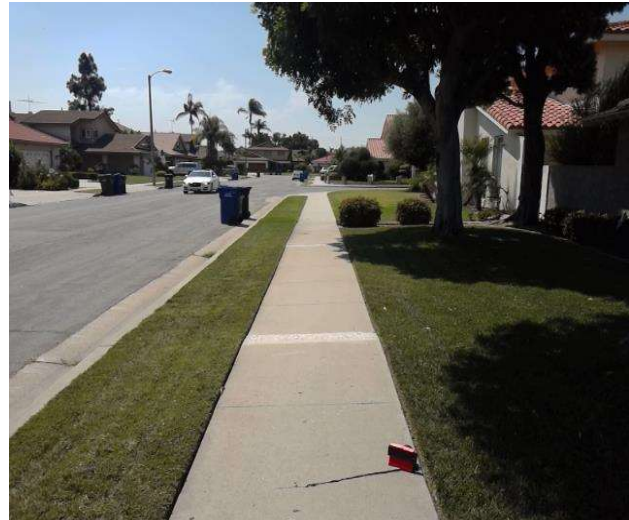
Change in Level East of Dolan Avenue @ 33.954447065515, -118.120479136705

Sidewalks , Change in Level : Change in Level Non Beveled

There is a change in elevation greater than recommended value.

On-Site Finding 0.50 inches

Ensure that the change in elevation is within the recommended value.

Recommendation Up to 0.25 inches

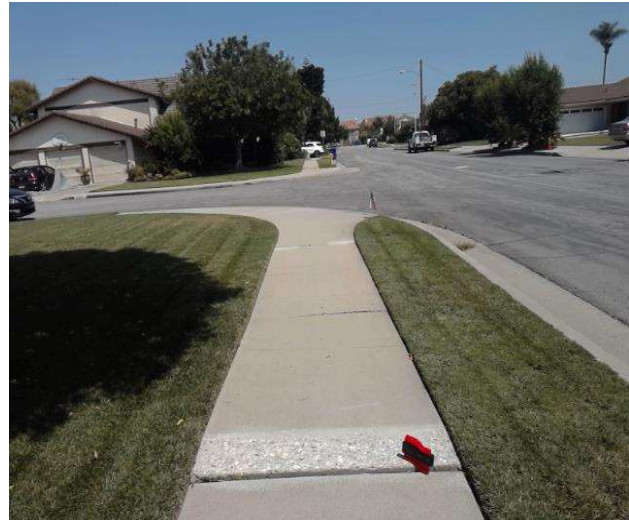
Change in Level East of Dolan Avenue @ 33.954455964889, -118.120500594378

Sidewalks , Change in Level : Change in Level Non Beveled

There is a change in elevation greater than recommended value.

On-Site Finding 0.75 inches

Ensure that the change in elevation is within the recommended value.

Recommendation Up to 0.25 inches

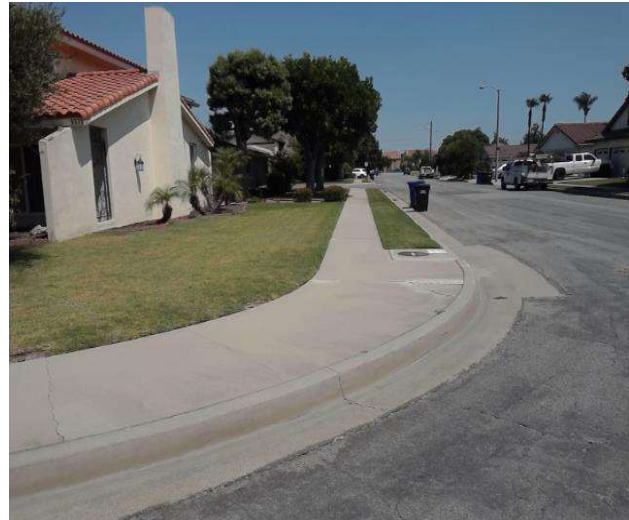
Curb Northeast Corner of Dolan Avenue @ 33.954619490736, -118.120818436146

Sidewalks , Hazards & Gratings : Curb is on Path of Travel

There is a curb on the designated path of travel.

On-Site Finding Not Compliant

Provide a compliant curb ramp.

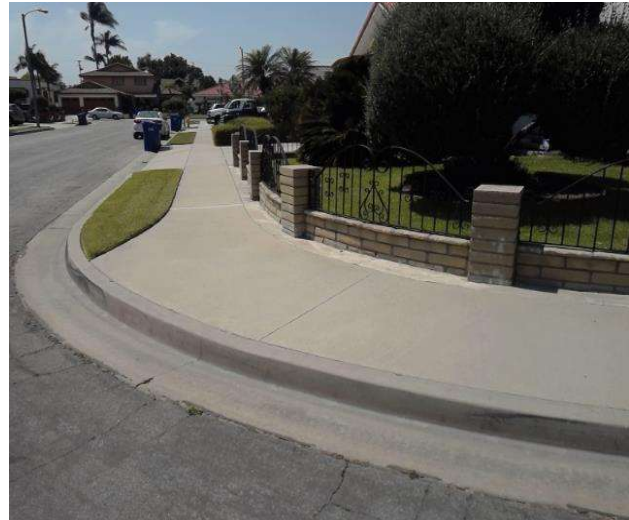
Curb Northeast Corner of Dolan Avenue @ 33.954696247658, -118.120944499969

Sidewalks , Hazards & Gratings : Curb is on Path of Travel

There is a curb on the designated path of travel.

On-Site Finding Not Compliant

Provide a compliant curb ramp.

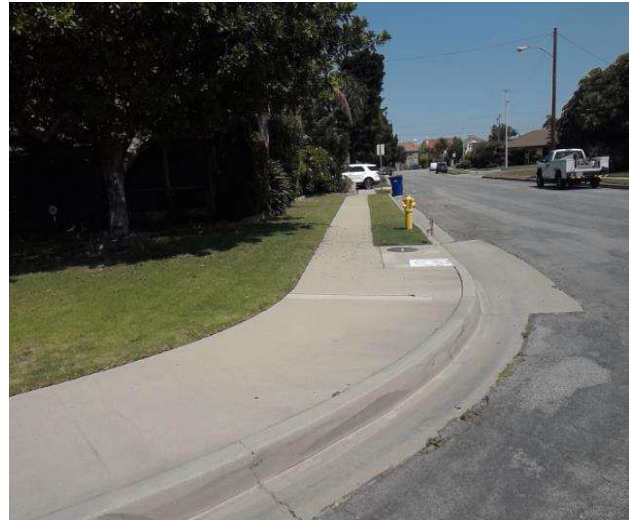
Curb Northeast Corner of Meldar Avenue @ 33.954332485981, -118.120261877775

Sidewalks , Hazards & Gratings : Curb is on Path of Travel

There is a curb on the designated path of travel.

On-Site Finding Not Compliant

Provide a compliant curb ramp.

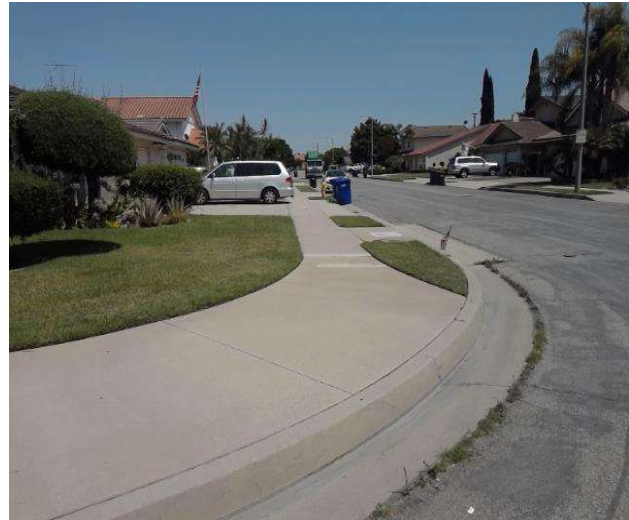
Curb Northeast Corner of Stamps Avenue @ 33.954988813260, -118.121557384729

Sidewalks , Hazards & Gratings : Curb is on Path of Travel

There is a curb on the designated path of travel.

On-Site Finding Not Compliant

Provide a compliant curb ramp.

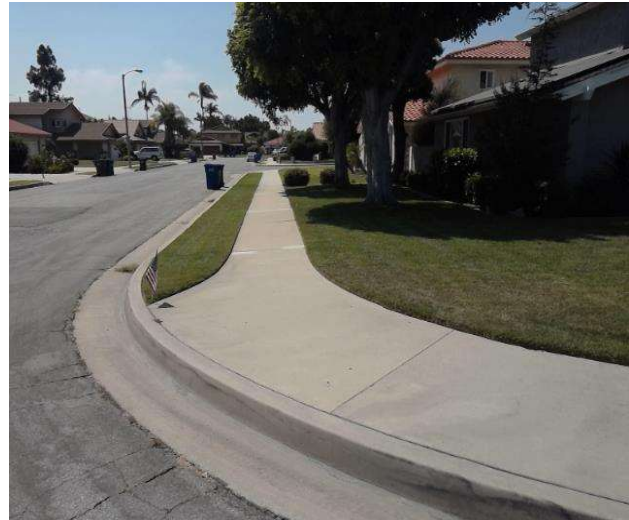
Curb Northwest Corner of Meldar Avenue @ 33.954415917695, -118.120405375957

Sidewalks , Hazards & Gratings : Curb is on Path of Travel

There is a curb on the designated path of travel.

On-Site Finding Not Compliant

Provide a compliant curb ramp.

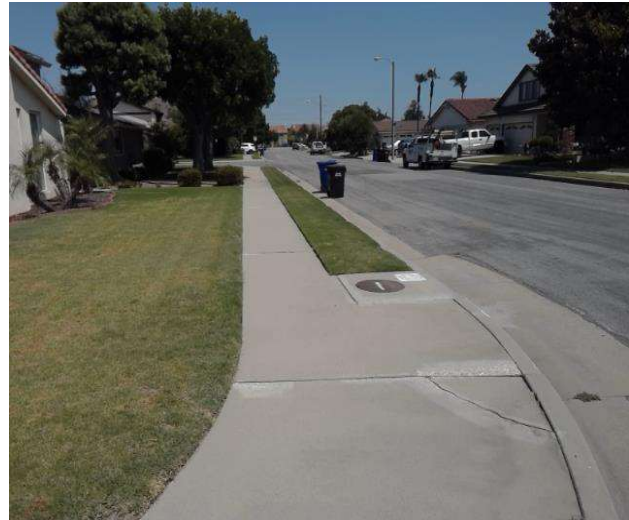
Sidewalk East of Dolan Avenue @ 33.954610591378, -118.120796978474

Sidewalks , Surface : Cross Slope

Sidewalk cross slope is not compliant.

On-Site Finding 5.80 percent for 141.00 feet

Repave the sidewalk surface with the recommended cross slope.

Recommendation Up to 2.08 percent

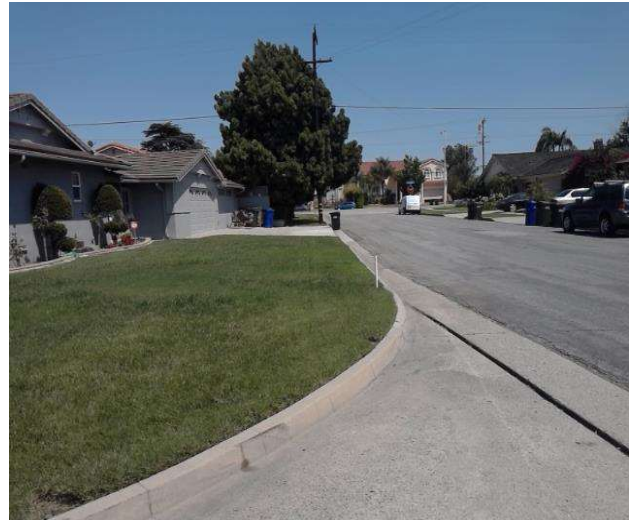
Sidewalk East of Meldar Avenue @ 33.953975397318, -118.119557797909

Sidewalks : Missing Sidewalk

Section of sidewalk is missing and consists of dirt, grass or gravel.

On-Site Finding 238.00 feet

Provide a compliant sidewalk for the missing section.

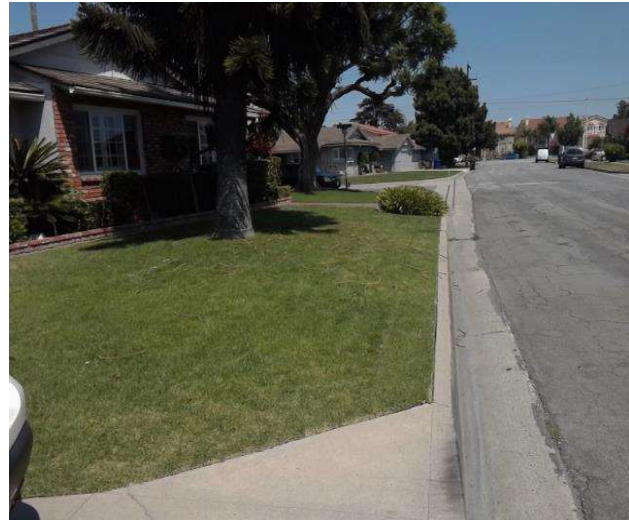
Sidewalk East of Meldar Avenue @ 33.954156722901, -118.119907826185

Sidewalks : Missing Sidewalk

Section of sidewalk is missing and consists of dirt, grass or gravel.

On-Site Finding 72.00 feet

Provide a compliant sidewalk for the missing section.

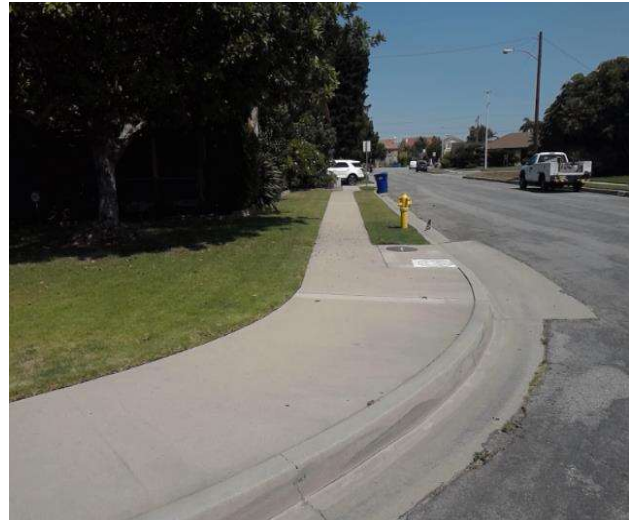
Sidewalk East of Meldar Avenue @ 33.954332485981, -118.120261877775

Sidewalks , Surface : Cross Slope

Sidewalk cross slope is not compliant.

On-Site Finding 5.00 percent for 100.00 feet

Repave the sidewalk surface with the recommended cross slope.

Recommendation Up to 2.08 percent

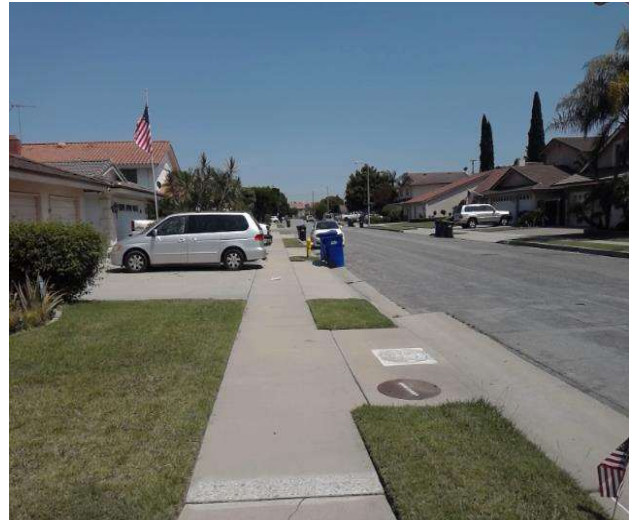
Sidewalk East of Stamps Avenue @ 33.954912056602, -118.121411204338

Sidewalks , Surface : Cross Slope

Sidewalk cross slope is not compliant.

On-Site Finding 3.60 percent for 193.00 feet

Repave the sidewalk surface with the recommended cross slope.

Recommendation Up to 2.08 percent

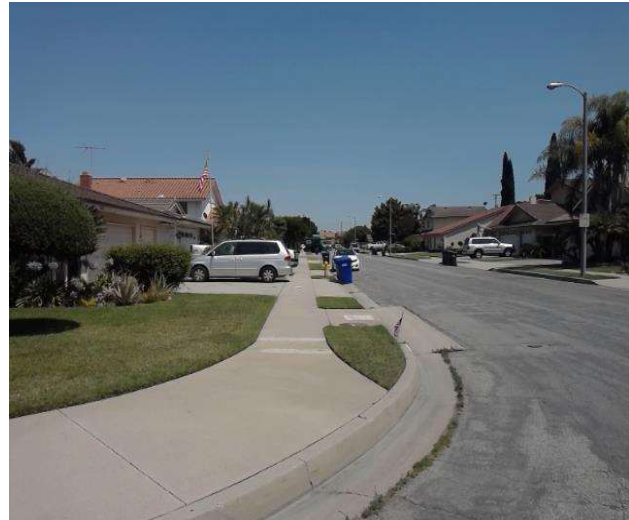
North Side @ 33.954988813260, -118.121557384729

Sidewalks : 60X60 Turn Area

There is no 60X60 turn area at every 200 feet.

On-Site Finding Not Found

Provide a 60X60 turn every 200 feet on the sidewalk.

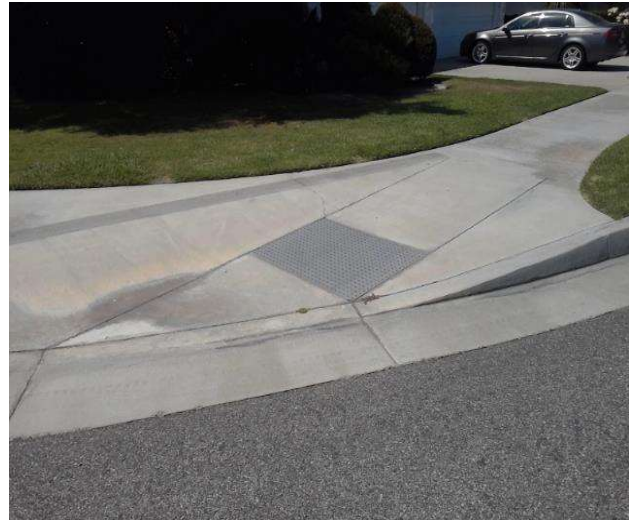
Northwest Corner of Brookshire Avenue @ 33.953610520126, - 118.118926137686

Curb Ramp : No Contrasting Finish

The surface of the curb ramp does not have a finish that contrasts with the adjacent sidewalk.

On-Site Finding Not Found

Provide the surface on the curb ramp that contrasts with the adjacent sidewalk.

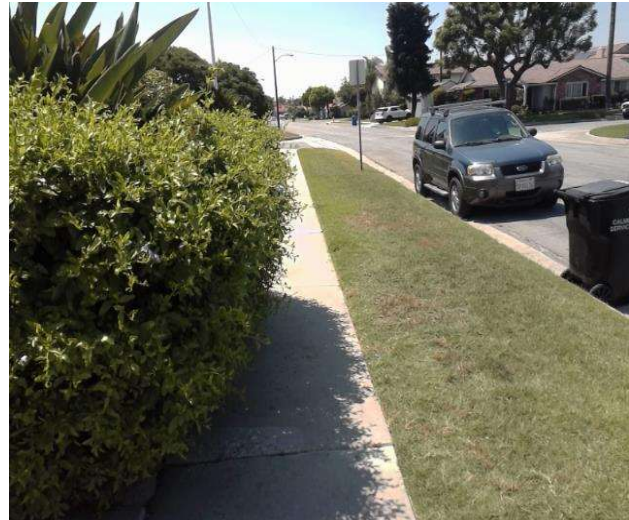
Bush West of Brookshire Avenue @ 33.953683940663, -118.119374066591

Sidewalks , Hazards & Gratings : Sidewalk Width at Obstruction

Sidewalk width at the obstruction is not compliant.

On-Site Finding 23.00 inches

Sidewalk width at the obstruction shall have the recommended value.

Recommendation At least 48.00 inches

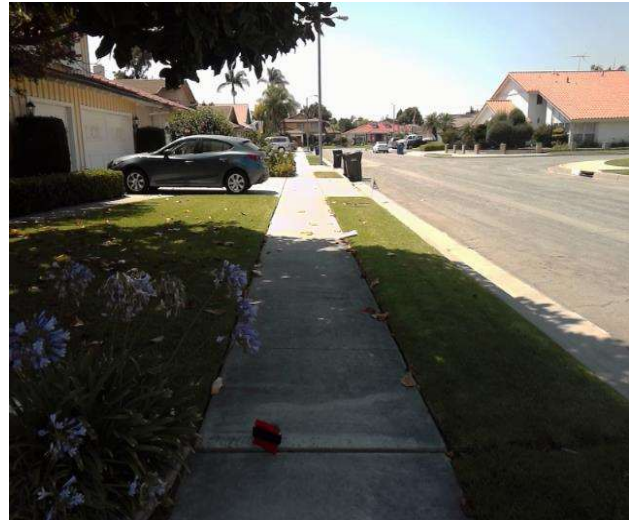
Change in Level West of Manzanar Avenue @ 33.954211231743, -118.120308816433

Sidewalks , Change in Level : Change in Level Non Beveled

There is a change in elevation greater than recommended value.

On-Site Finding 0.50 inches

Ensure that the change in elevation is within the recommended value.

Recommendation Up to 0.25 inches

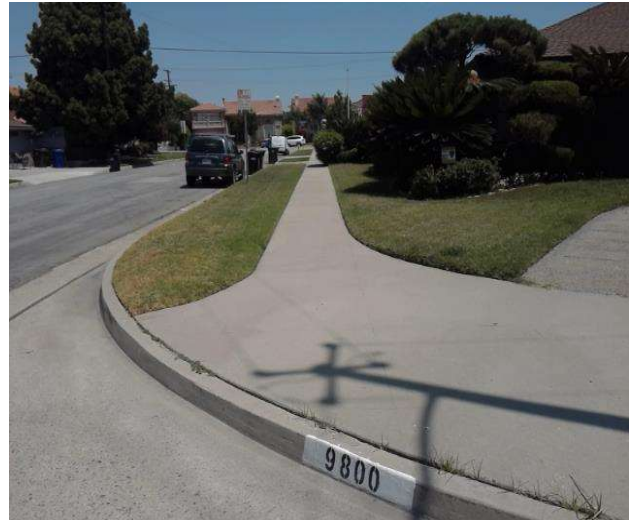
Curb Southeast Corner of Manzanar Avenue @ 33.953873053873, - 118.119698613882

Sidewalks , Hazards & Gratings : Curb is on Path of Travel

There is a curb on the designated path of travel.

On-Site Finding Not Compliant

Provide a compliant curb ramp.

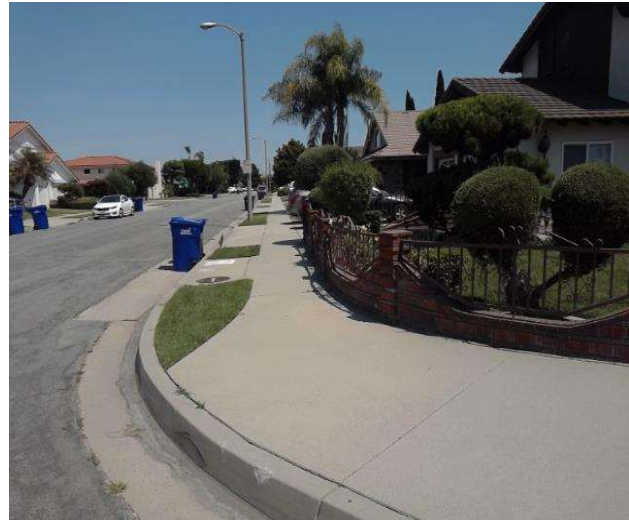
Curb Southeast Corner of Stamps Avenue @ 33.954875346872, -118.121670037508

Sidewalks , Hazards & Gratings : Curb is on Path of Travel

There is a curb on the designated path of travel.

On-Site Finding Not Compliant

Provide a compliant curb ramp.

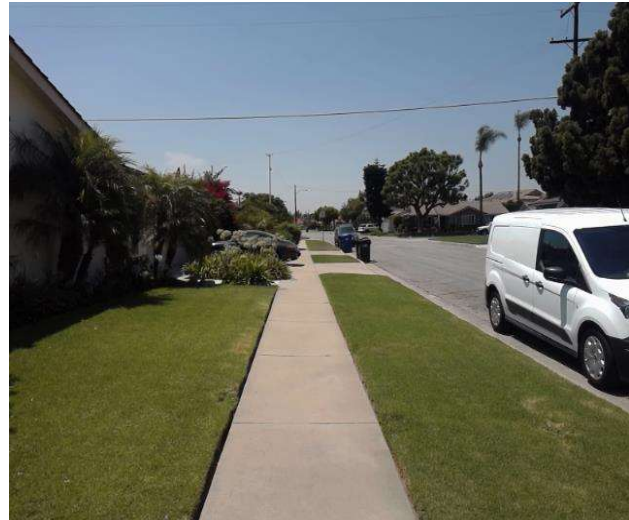
Sidewalk West of Brookshire Avenue @ 33.953523750320, -118.119123280048

Sidewalks , Surface : Cross Slope

Sidewalk cross slope is not compliant.

On-Site Finding 3.70 percent for 139.00 feet

Repave the sidewalk surface with the recommended cross slope.

Recommendation Up to 2.08 percent

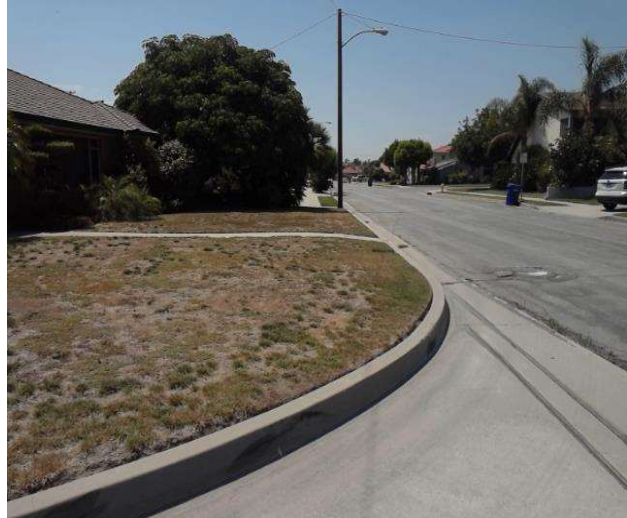
Sidewalk West of Manzanar Avenue @ 33.953947586611, -118.119820654392

Sidewalks : Missing Sidewalk

Section of sidewalk is missing and consists of dirt, grass or gravel.

On-Site Finding 84.00 feet

Provide a compliant sidewalk for the missing section.

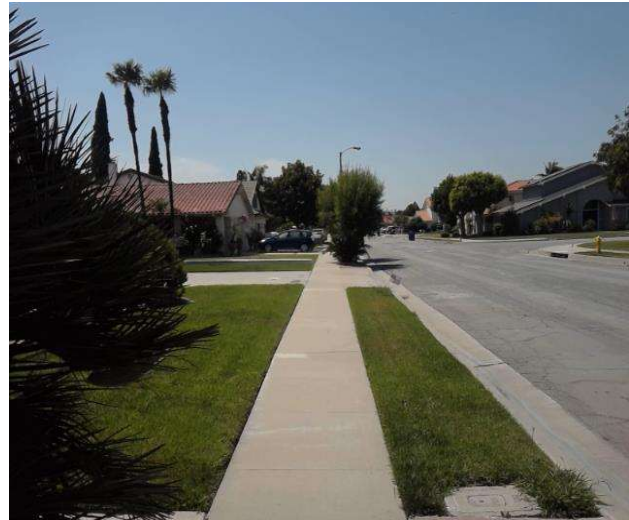
Sidewalk West of Manzanar Avenue @ 33.954059941809, -118.120033899

Sidewalks , Surface : Cross Slope

Sidewalk cross slope is not compliant.

On-Site Finding 3.90 percent for 579.00 feet

Repave the sidewalk surface with the recommended cross slope.

Recommendation Up to 2.08 percent

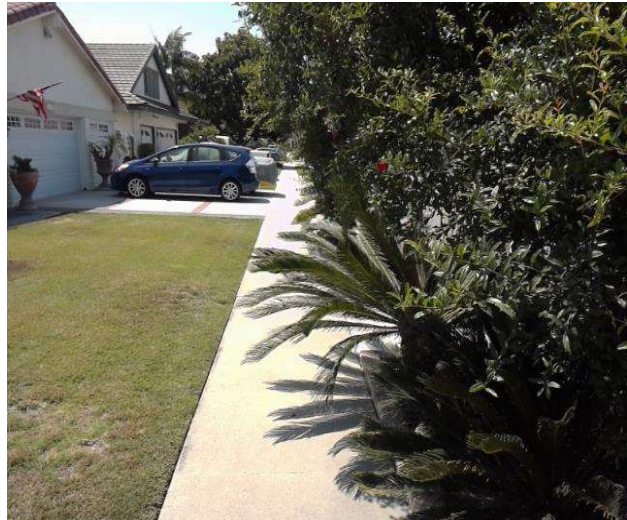
Tree West of Manzanar Avenue @ 33.954185645964, -118.120261877775

Sidewalks , Hazards & Gratings : Sidewalk Width at Obstruction

Sidewalk width at the obstruction is not compliant.

On-Site Finding 10.00 inches

Sidewalk width at the obstruction shall have the recommended value.

Recommendation At least 48.00 inches

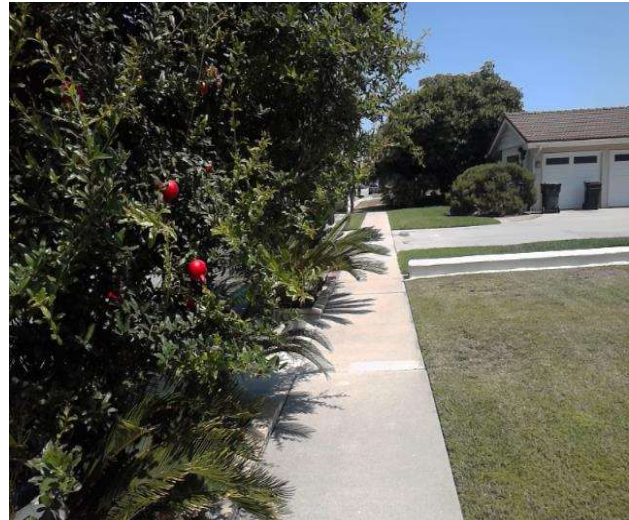
Sidewalks , Hazards & Gratings : Overhead Obstruction Height

Recommendation At least 80.00 inches

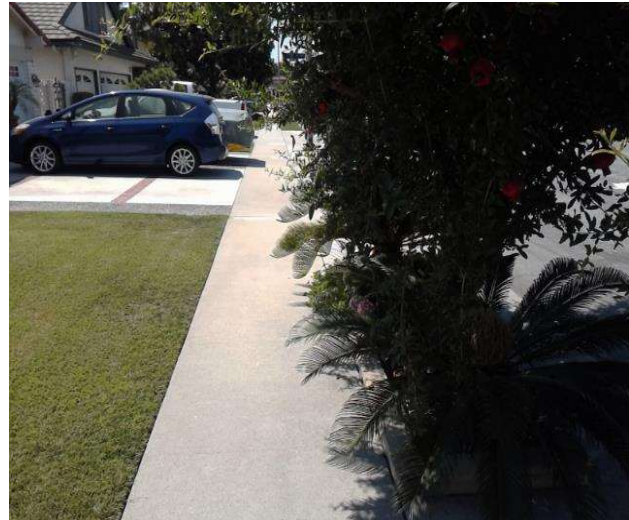
Sidewalks , Hazards & Gratings : Sidewalk Width at Obstruction

Sidewalk width at the obstruction shall have the recommended value.

Recommendation At least 48.00 inches

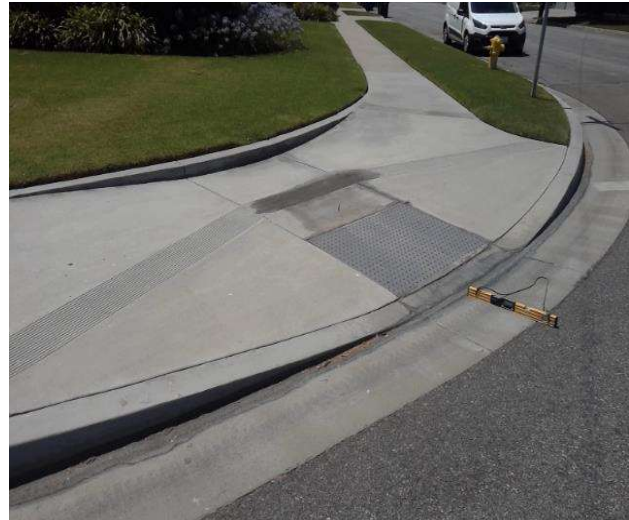
Curb Ramp , Landings and Transitions : Top Landing Clear Length - Landings

Recommendation At least 48.00 inches

Provide compliant landing \$240
