## Accessibility Survey

## City of Downey Arrington Avenue - Muller Street to Cul-De-Sac

Date of Inspection  
6/13/2017

Prepared By  
**Disability Access Consultants**  
(800) 743-7067

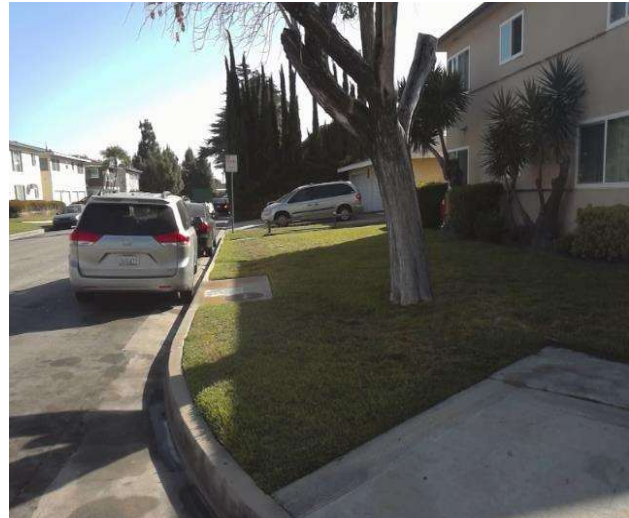
**East Side @ 33.940996821821, -118.119863569736**

Sidewalks : No Sidewalk

No sidewalk exists at the location.

**On-Site Finding** Not Found

No action necessary until a sidewalk is provided.

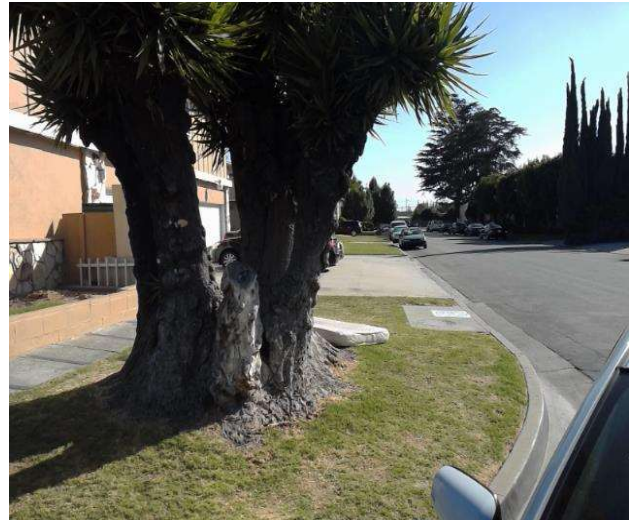
**West Side @ 33.941048001301, -118.120013773441**

Sidewalks : No Sidewalk

No sidewalk exists at the location.

**On-Site Finding** Not Found

No action necessary until a sidewalk is provided.

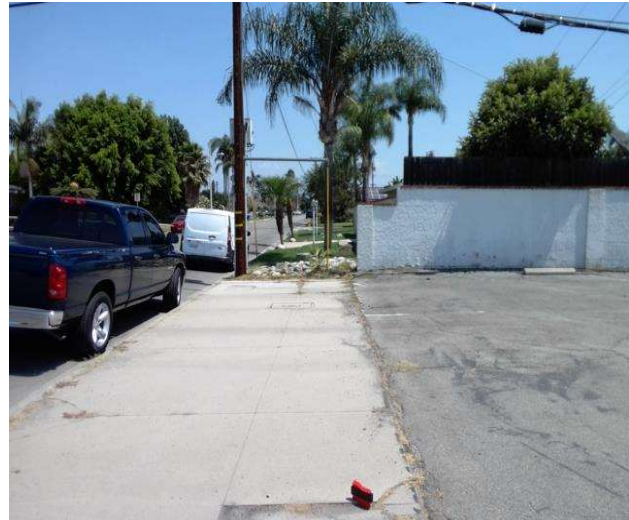
**Change in Level South of Otto Street @ 33.947675483936, -118.115417808294**

Sidewalks , Change in Level : Change in Level Non Beveled

There is a change in elevation greater than recommended value.

**On-Site Finding** 0.75 inches

Ensure that the change in elevation is within the recommended value.

Recommendation Up to 0.25 inches

Remove tripping hazards \$198

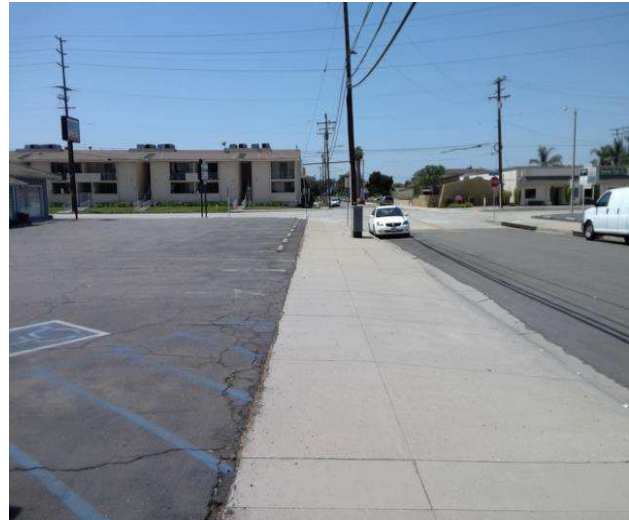
#### Driveway South of Otto Street @ 33.947349517756, -118.115663230419

Sidewalks , Vehicular Traffic : Cross Walks and Detectable Warnings

There are no detectable warnings where the pedestrian route crosses vehicular traffic.

**On-Site Finding** Not Found

Provide detectable warnings.

Install compliant detectable warnings \$190

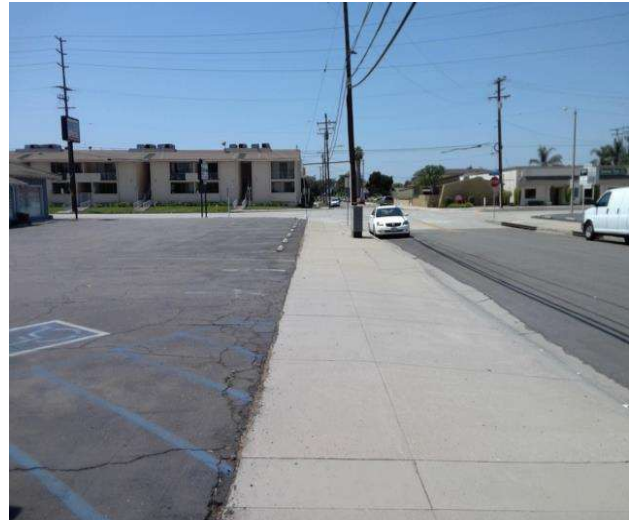
#### Driveway South of Otto Street @ 33.947349517756, -118.115663230419

Sidewalks : Vehicular Traffic Cross Slope

Cross slope at vehicular traffic is not compliant.

**On-Site Finding** 3.70 percent

Repave the surface to provide a compliant cross slope.

Recommendation Up to 2.08 percent

Repave surface \$1,092

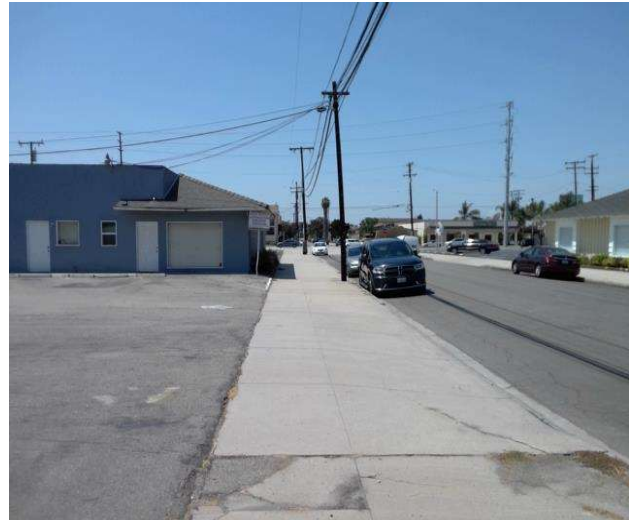
**Driveway South of Otto Street @ 33.947622083418, -118.115459382534**

Sidewalks , Vehicular Traffic : Cross Walks and Detectable Warnings

There are no detectable warnings where the pedestrian route crosses vehicular traffic.

**On-Site Finding** Not Found

Provide detectable warnings.

Install compliant detectable warnings \$190

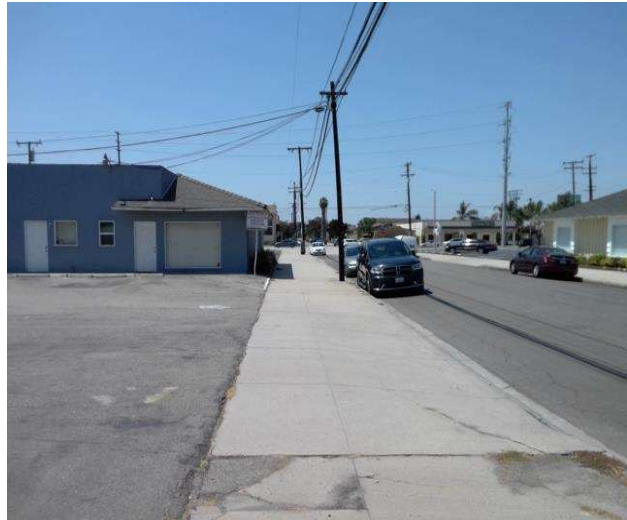
**Driveway South of Otto Street @ 33.947622083418, -118.115459382534**

Sidewalks : Vehicular Traffic Cross Slope

Cross slope at vehicular traffic is not compliant.

**On-Site Finding** 3.70 percent

Repave the surface to provide a compliant cross slope.

Recommendation Up to 2.08 percent

Repave surface \$1,092

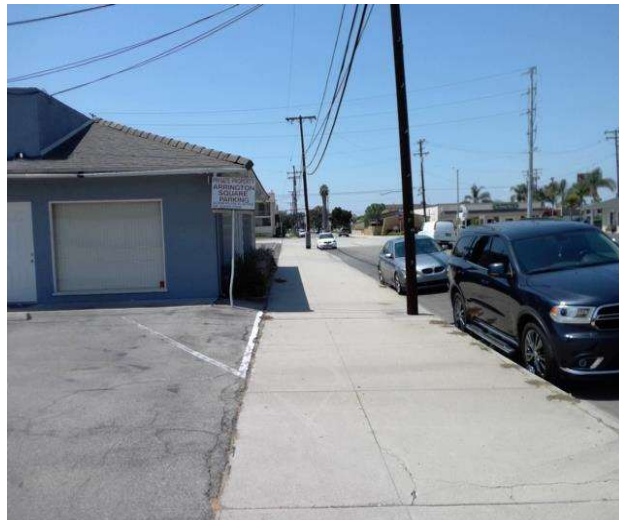
**Sidewalk South of Otto Street @ 33.947622083418, -118.115459382534**

Sidewalks , Surface : Cross Slope

Sidewalk cross slope is not compliant.

**On-Site Finding** 3.30 percent for 232.00 feet

Repave the sidewalk surface with the recommended cross slope.

Recommendation Up to 2.08 percent

Repave surface \$1,092

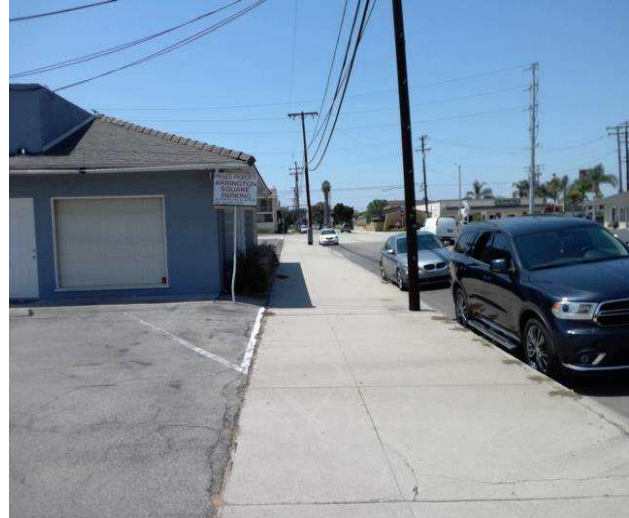
**Sidewalk South of Otto Street @ 33.947622083418, -118.115459382534**

Sidewalks : Opening

Ground surface has an opening that is not compliant.

**On-Site Finding** Not Compliant

Make sure that the surface opening does not allow passage of a sphere more than 1/2 inch in diameter.

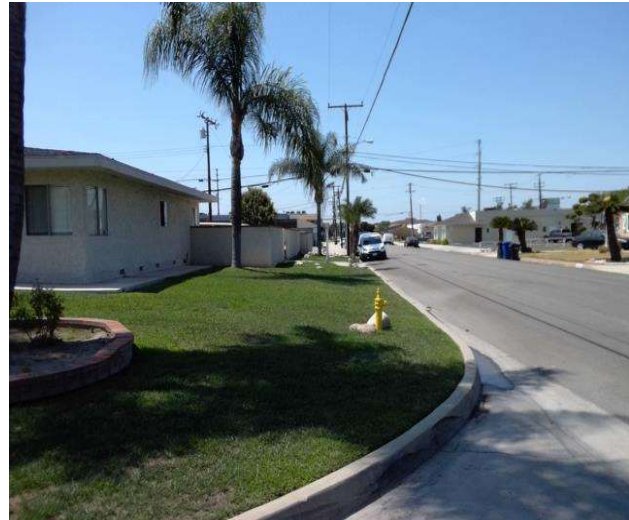
**Sidewalk South of Otto Street @ 33.948069311717, -118.115130811930**

Sidewalks : Missing Sidewalk

Section of sidewalk is missing and consists of dirt, grass or gravel.

**On-Site Finding** 150.00 feet

Provide a compliant sidewalk for the missing section.

\$1,260

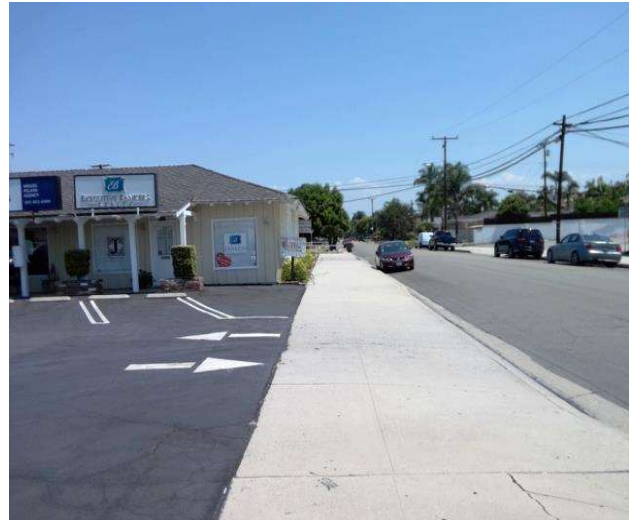
**Driveway North of Otto Street @ 33.947367317989, -118.115837574005**

Sidewalks , Vehicular Traffic : Cross Walks and Detectable Warnings

There are no detectable warnings where the pedestrian route crosses vehicular traffic.

**On-Site Finding** Not Found

Provide detectable warnings.

Install compliant detectable warnings \$190

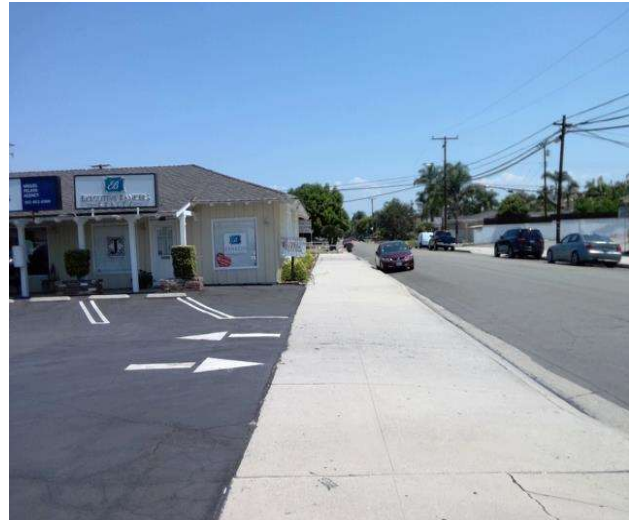
**Driveway North of Otto Street @ 33.947367317989, -118.115837574005**

Sidewalks : Vehicular Traffic Cross Slope

Cross slope at vehicular traffic is not compliant.

**On-Site Finding** 5.60 percent

Repave the surface to provide a compliant cross slope.

Recommendation Up to 2.08 percent

Repave surface \$1,092

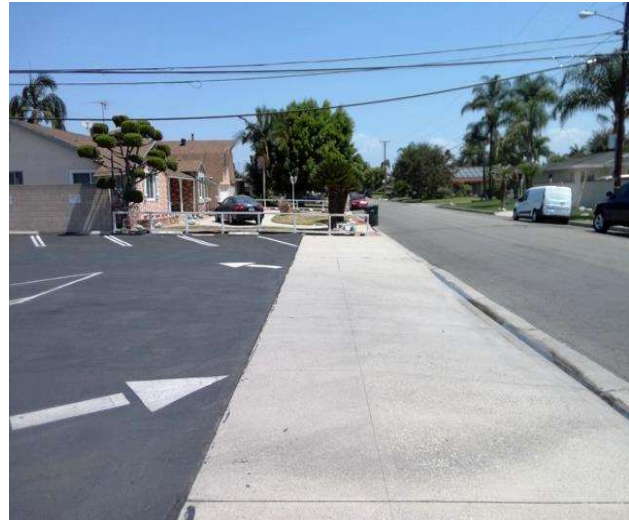
#### Driveway North of Otto Street @ 33.947424056207, -118.115809410810

Sidewalks , Vehicular Traffic : Cross Walks and Detectable Warnings

There are no detectable warnings where the pedestrian route crosses vehicular traffic.

**On-Site Finding** Not Found

Provide detectable warnings.

Install compliant detectable warnings \$190

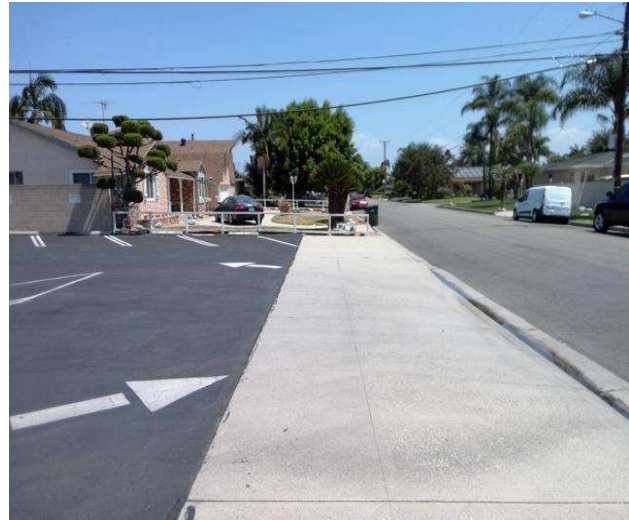
#### Driveway North of Otto Street @ 33.947424056207, -118.115809410810

Sidewalks : Vehicular Traffic Cross Slope

Cross slope at vehicular traffic is not compliant.

**On-Site Finding** 3.30 percent

Repave the surface to provide a compliant cross slope.

Recommendation Up to 2.08 percent

Repave surface \$1,092

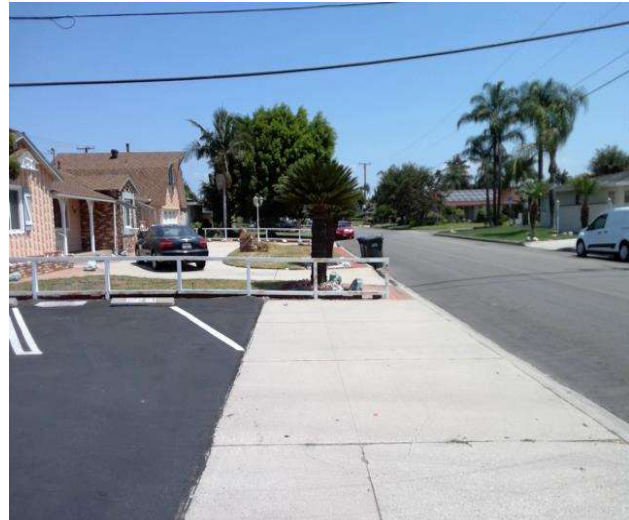
**Sidewalk North of Otto Street @ 33.947693284101, -118.115601539612**

Sidewalks , Surface : Cross Slope

Sidewalk cross slope is not compliant.

**On-Site Finding** 3.50 percent for 33.00 feet

Repave the sidewalk surface with the recommended cross slope.

Recommendation Up to 2.08 percent

Repave surface \$1,092

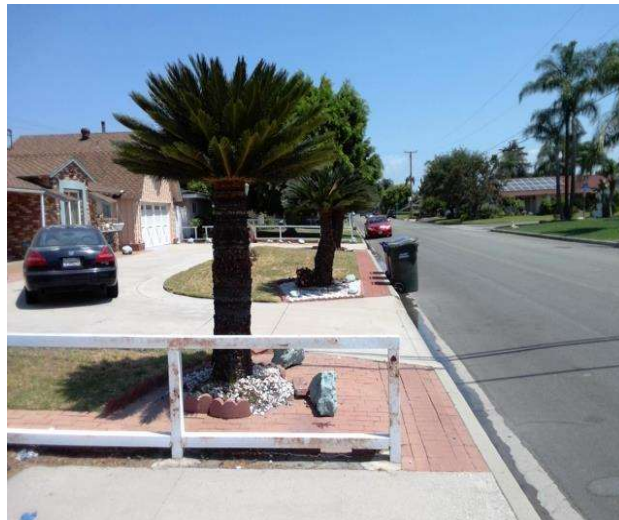
#### Sidewalk North of Otto Street @ 33.947790072433, -118.115526437759

Sidewalks : Missing Sidewalk

Section of sidewalk is missing and consists of dirt, grass or gravel.

**On-Site Finding** 194.00 feet

Provide a compliant sidewalk for the missing section.

\$1,260

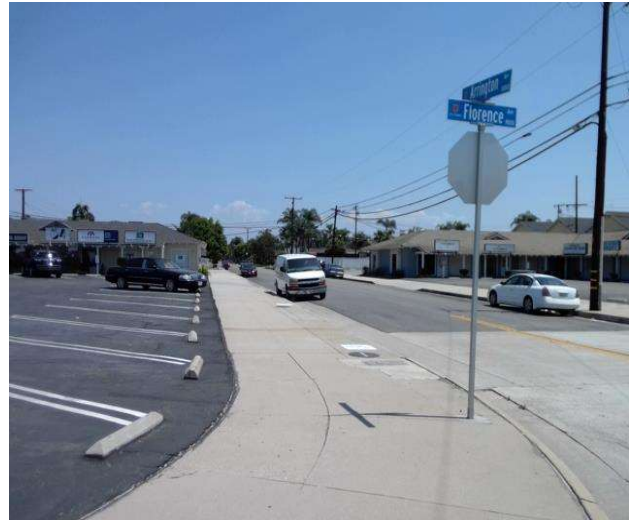
**West Side @ 33.947098089064, -118.116074949503**

Sidewalks : Turn Area

Turn area is not level.

**On-Site Finding** Not Level

Make sure that the turn area is level.

\$1,260

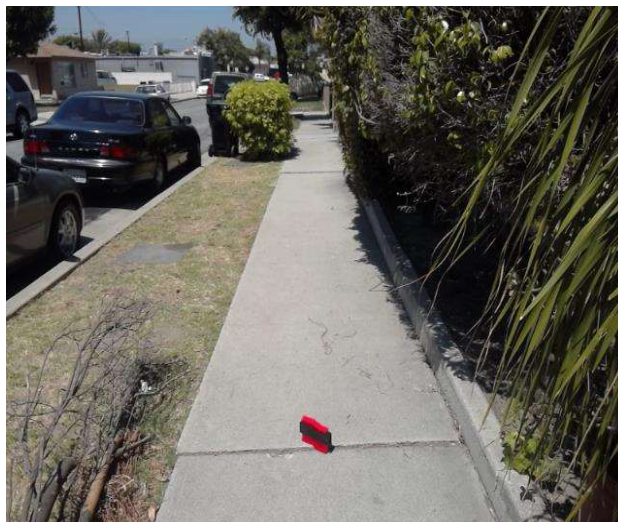
#### Change in Level South of Telegraph Road @ 33.958561814662, -118.108591586351

Sidewalks , Change in Level : Change in Level Non Beveled

There is a change in elevation greater than recommended value.

**On-Site Finding** 0.50 inches

Ensure that the change in elevation is within the recommended value.

Recommendation Up to 0.25 inches

Remove tripping hazards \$198

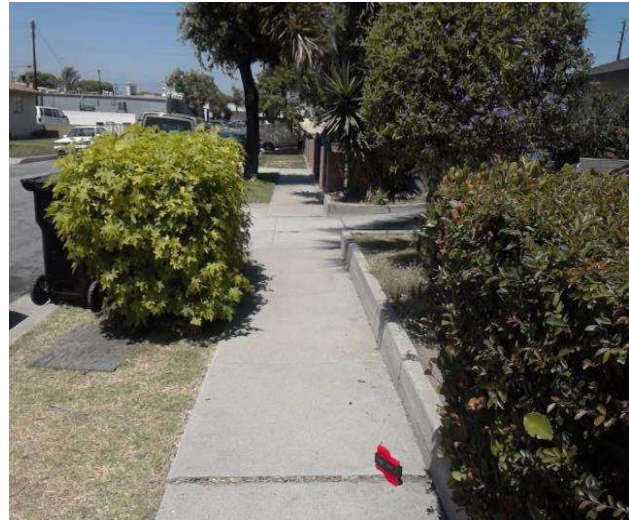
#### Change in Level South of Telegraph Road @ 33.958584062022, -118.108571469784

Sidewalks , Change in Level : Change in Level Non Beveled

There is a change in elevation greater than recommended value.

**On-Site Finding** 1.00 inches

Ensure that the change in elevation is within the recommended value.

Recommendation Up to 0.25 inches

Remove tripping hazards \$198

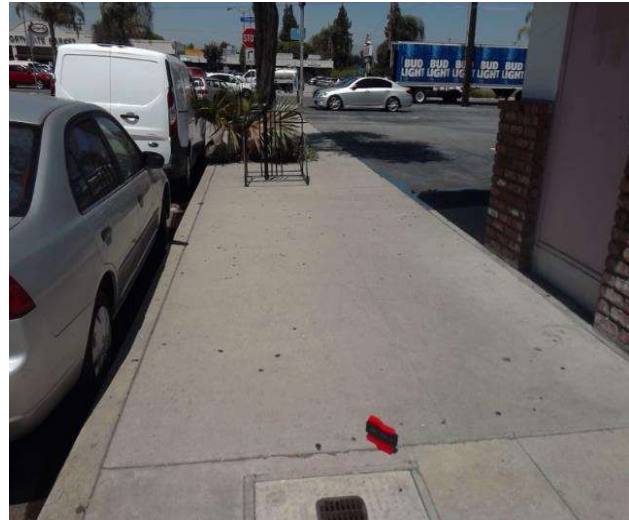
#### Change in Level South of Telegraph Road @ 33.959085738430, -118.108098059893

Sidewalks , Change in Level : Change in Level Non Beveled

There is a change in elevation greater than recommended value.

**On-Site Finding** 0.62 inches

Ensure that the change in elevation is within the recommended value.

Recommendation Up to 0.25 inches

Remove tripping hazards \$198

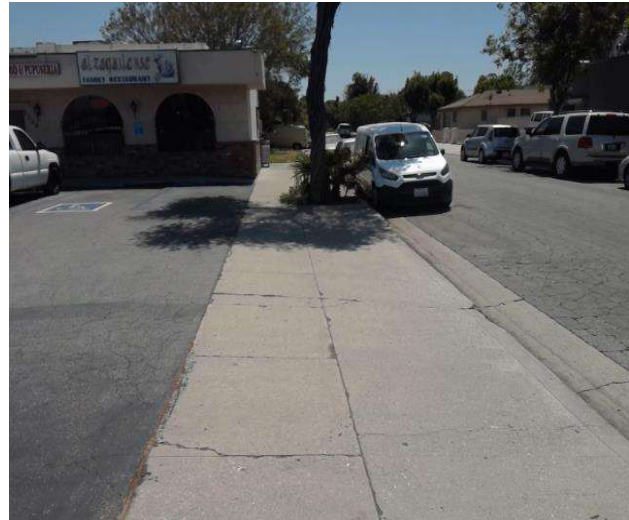
**On-Site Finding** Not Found

Install compliant detectable warnings \$190

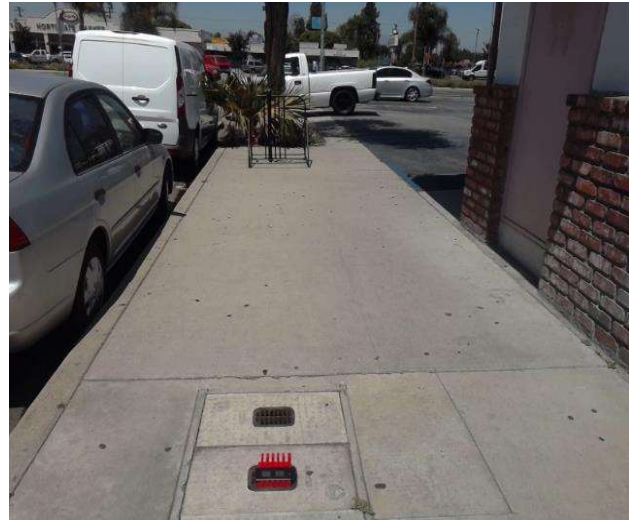
Sidewalks , Hazards & Gratings : Grate Opening

Notes : 5 Grates Between 7 Feet

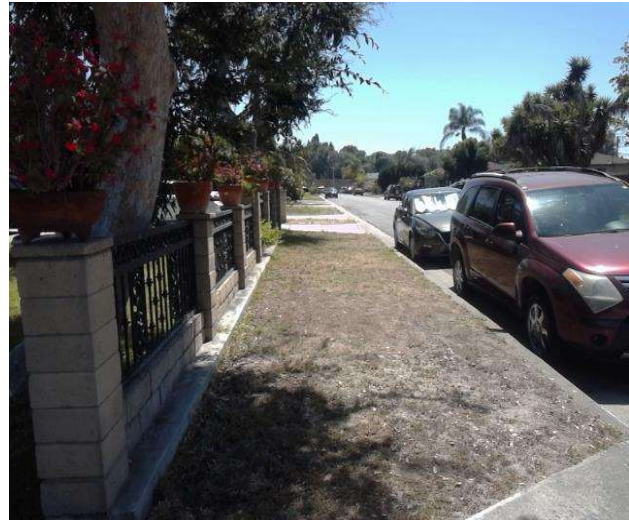
Sidewalks : Missing Sidewalk

Section of sidewalk is missing and consists of dirt, grass or gravel.

Provide a compliant sidewalk for the missing section.

\$1,260

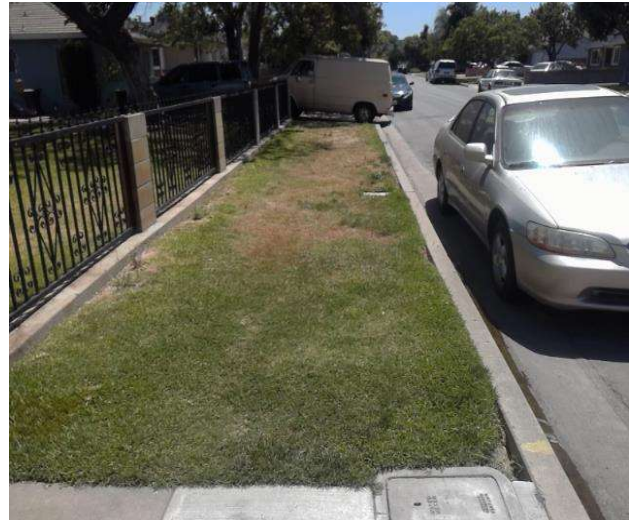
Sidewalks : Missing Sidewalk

Section of sidewalk is missing and consists of dirt, grass or gravel.

Provide a compliant sidewalk for the missing section.

\$1,260

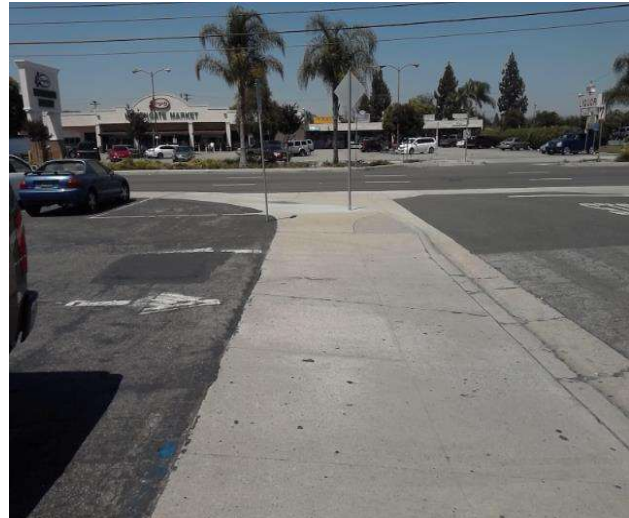
**On-Site Finding** Not Found

Install compliant detectable warnings \$190

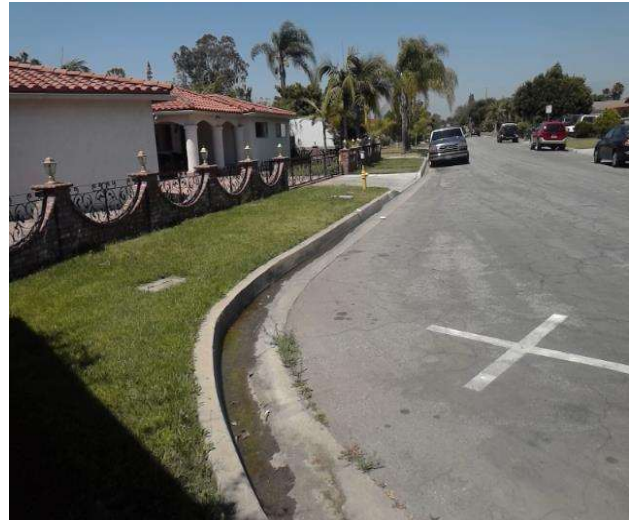
Sidewalks : Missing Sidewalk

Section of sidewalk is missing and consists of dirt, grass or gravel.

Provide a compliant sidewalk for the missing section.

\$1,260

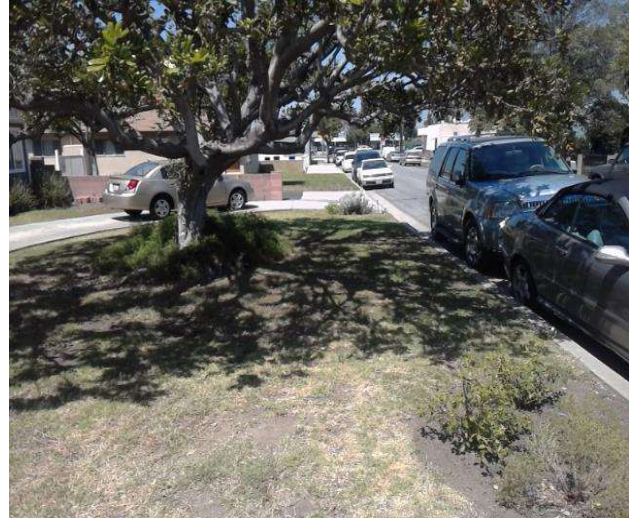
Sidewalks : Missing Sidewalk

Section of sidewalk is missing and consists of dirt, grass or gravel.

Provide a compliant sidewalk for the missing section.

\$1,260
