Accessibility Survey

City of Downey Vultee Avenue - Buckles Street to Stewart & Gray Road

Date of Inspection
8/7/2017

City of Downey Vultee Avenue - Florance Avenue to Baysinger Street

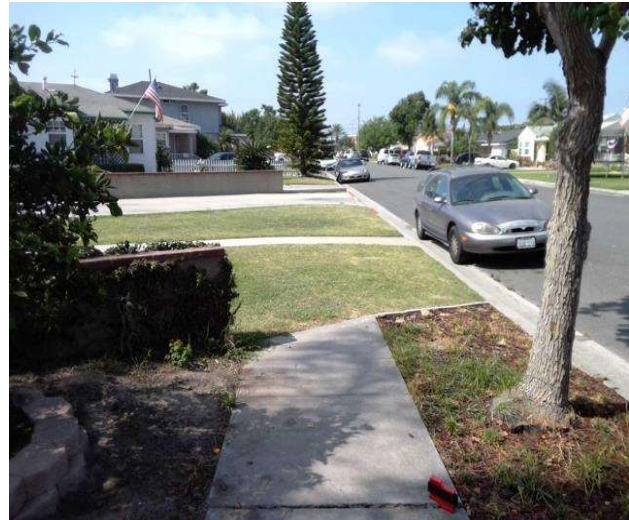
Change in Level South of Buckles Street @ 33.929233626204, -118.127120286226

Sidewalks , Change in Level : Change in Level Non Beveled

There is a change in elevation greater than recommended value.

On-Site Finding 0.62 inches

Ensure that the change in elevation is within the recommended value.

Recommendation Up to 0.25 inches

Remove tripping hazards \$198

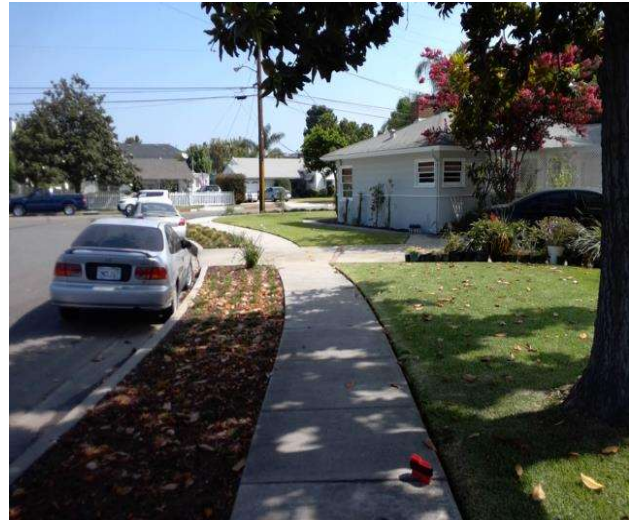
Change in Level South of Buckles Street @ 33.929341563024, -118.127042502165

Sidewalks , Change in Level : Change in Level Non Beveled

There is a change in elevation greater than recommended value.

On-Site Finding 0.50 inches

Ensure that the change in elevation is within the recommended value.

Recommendation Up to 0.25 inches

Remove tripping hazards \$198

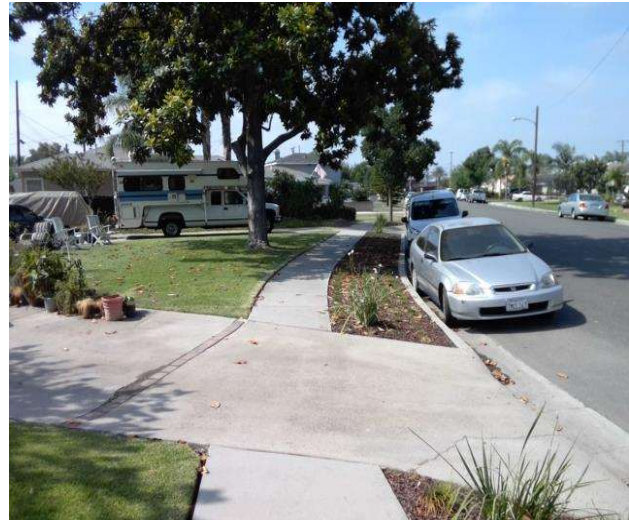
Driveway South of Buckles Street @ 33.929430582979, -118.126987516880

Sidewalks , Vehicular Traffic : Cross Walks and Detectable Warnings

There are no detectable warnings where the pedestrian route crosses vehicular traffic.

On-Site Finding Not Found

Provide detectable warnings.

Install compliant detectable warnings \$190

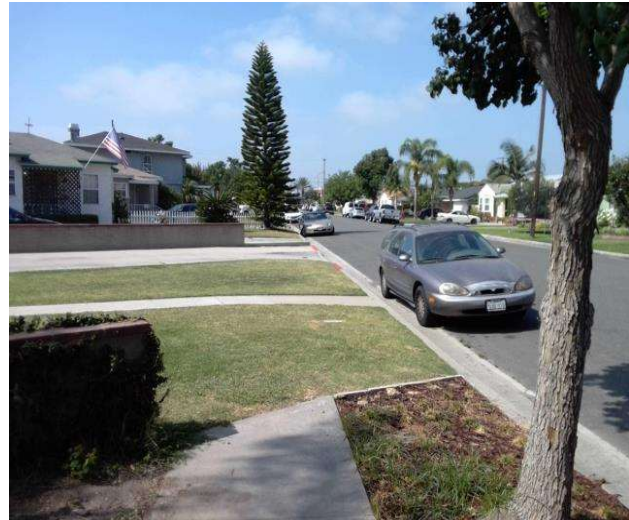
Sidewalk South of Buckles Street @ 33.929229175198, -118.127140402794

Sidewalks : Missing Sidewalk

Section of sidewalk is missing and consists of dirt, grass or gravel.

On-Site Finding 325.00 feet

Provide a compliant sidewalk for the missing section.

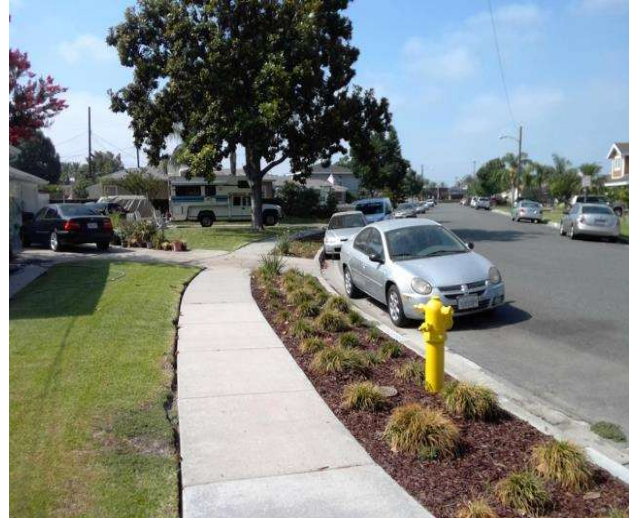
Sidewalk South of Buckles Street @ 33.929588593170, -118.126949965954

Sidewalks , Surface : Cross Slope

Sidewalk cross slope is not compliant.

On-Site Finding 5.20 percent for 90.00 feet

Repave the sidewalk surface with the recommended cross slope.

Recommendation Up to 2.08 percent

Repave surface \$1,092

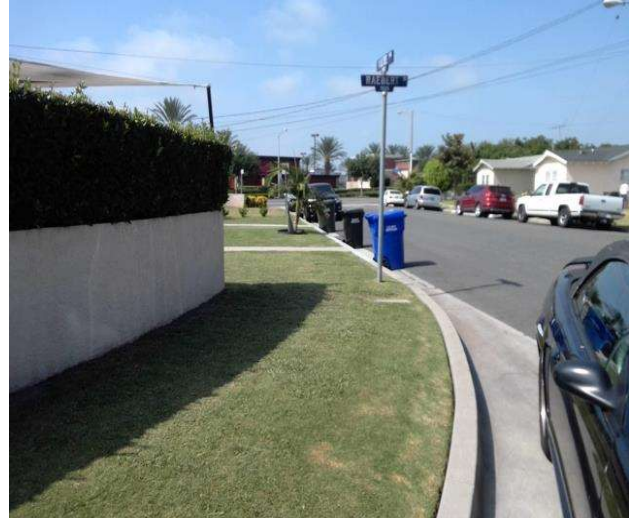
Sidewalk South of Raebert Street @ 33.928294458821, -118.127809613943

Sidewalks : Missing Sidewalk

Section of sidewalk is missing and consists of dirt, grass or gravel.

On-Site Finding 156.00 feet

Provide a compliant sidewalk for the missing section.

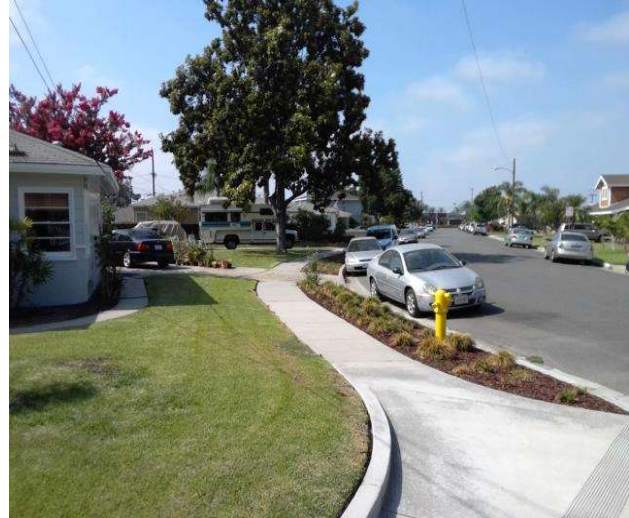
East Side @ 33.929588593170, -118.126949965954

Sidewalks : 60X60 Turn Area

There is no 60X60 turn area at every 200 feet.

On-Site Finding Not Found

Provide a 60X60 turn every 200 feet on the sidewalk.

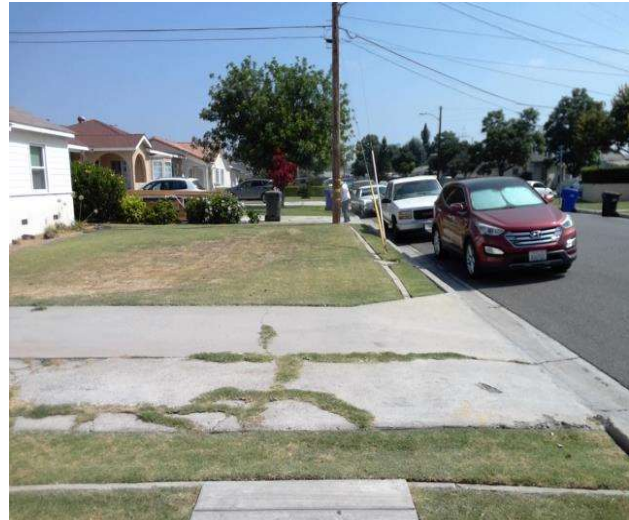
Sidewalk North of Raebert Street @ 33.928104176016, -118.128166347742

Sidewalks : Missing Sidewalk

Section of sidewalk is missing and consists of dirt, grass or gravel.

On-Site Finding 645.00 feet

Provide a compliant sidewalk for the missing section.

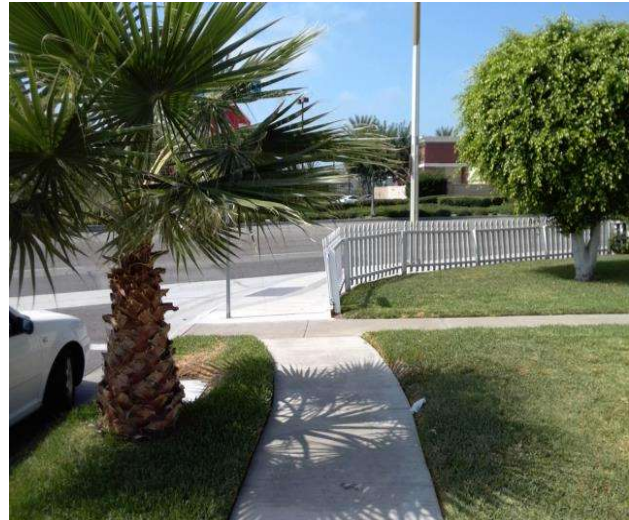
Tree North of Raebert Street @ 33.927976207809, -118.128258883953

Sidewalks , Hazards & Gratings : Overhead Obstruction Height

Overhead obstruction height is not compliant.

On-Site Finding 59.00 inches

Provide a compliant vertical clearance height.

Recommendation At least 80.00 inches

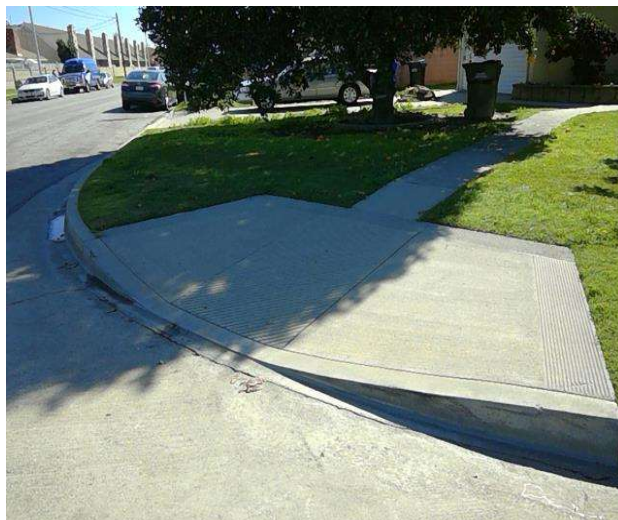
Southeast Corner of Baysinger Street @ 33.945938837438, - 118.116711974144

Curb Ramp : No Detectable Warnings

The curb ramp does not provide a detectable warning surface which includes truncated domes.

On-Site Finding Not Found

Provide compliant detectable warnings to surface.

Provide detectable warning to surface \$248

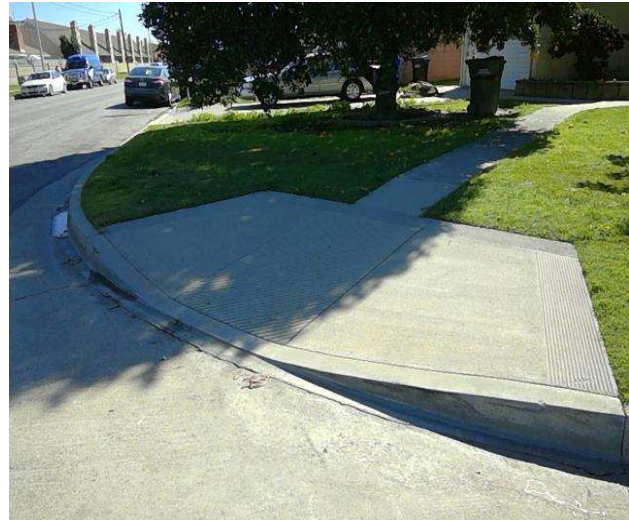
Southeast Corner of Baysinger Street @ 33.945938837438, - 118.116711974144

Curb Ramp : Curb Ramp Slope

The running slope is greater than allowed.

On-Site Finding 10.00 percent

Provide a compliant curb ramp.

Recommendation Up to 8.33 percent

Install curb ramp \$1,300

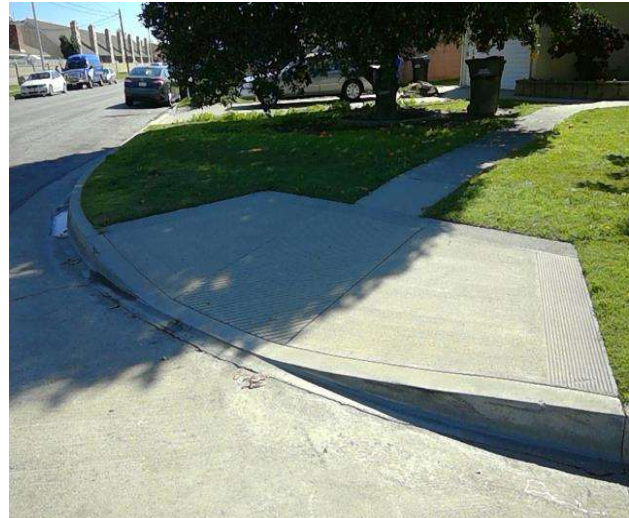
Southeast Corner of Baysinger Street @ 33.945938837438, - 118.116711974144

Curb Ramp : Side Flare Slope

The slope of the curb ramp side flare is greater than allowed.

On-Site Finding 13.70 percent

Provide curb ramp side flares with a compliant slope.

Recommendation Up to 10.00 percent

Install flared sides \$1,300

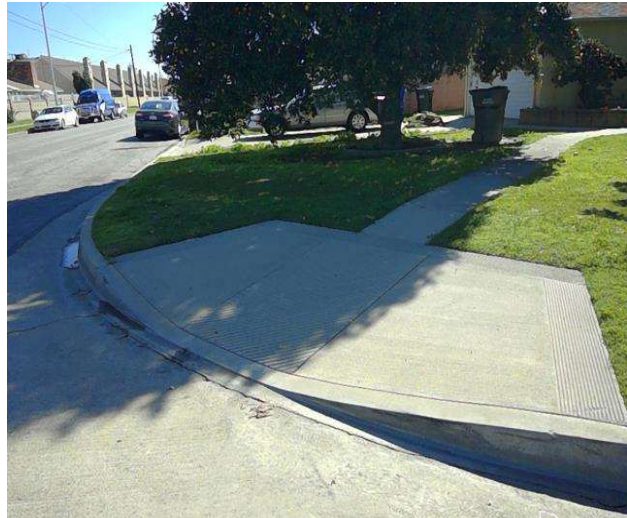
Southeast Corner of Baysinger Street @ 33.945938837438, - 118.116711974144

Bottom Landing

The transition from the bottom of the curb ramp to the walk, gutter, or street is abrupt.

On-Site Finding Not Beveled

Curb Ramp , Landings and Transitions : Bottom Landing Change in Level - Curb Ramps

Patch the transition area at the bottom of the curb ramp so that the transition is flush and free of abrupt changes.

Patch lip at curb ramp \$255

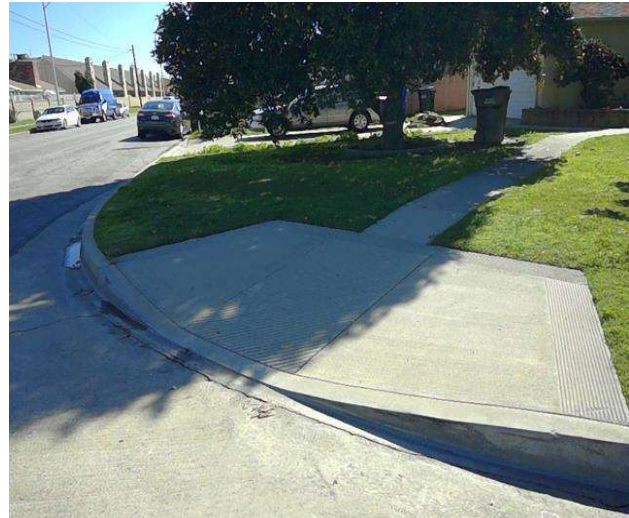
Southeast Corner of Baysinger Street @ 33.945938837438, - 118.116711974144

Curb Ramp , Landings and Transitions : Top Landing Clear Length - Landings

There is not enough top landing clear length.

On-Site Finding 0.00 inches

Provide a level top landing with enough clear length.

Recommendation At least 48.00 inches

Provide compliant landing \$240

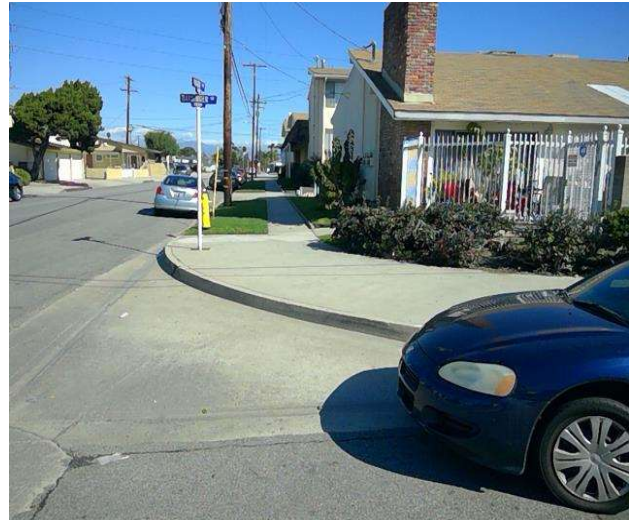
Baysinger Street Northeast Corner @ 33.946066778652, -118.116602003574

Sidewalks , Hazards & Gratings : Curb is on Path of Travel

There is a curb on the designated path of travel.

Provide a compliant curb ramp.

Install curb ramp \$2,500

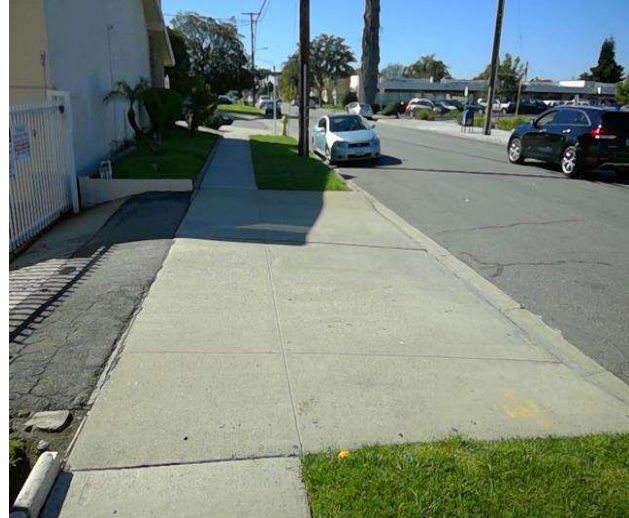
Driveway South of Florance Avenue @ 33.946247008557, -118.116445094347

Sidewalks , Vehicular Traffic : Cross Walks and Detectable Warnings

There are no detectable warnings where the pedestrian route crosses vehicular traffic.

Provide detectable warnings.

Install compliant detectable warnings \$190

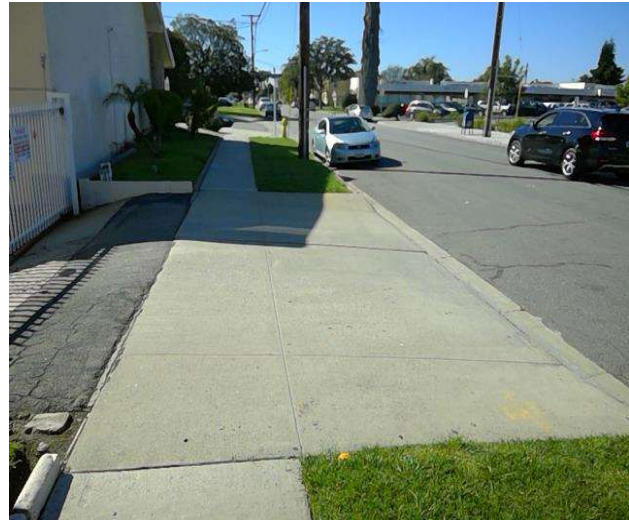
Driveway South of Florance Avenue @ 33.946247008557, -118.116445094347

Sidewalks : Vehicular Traffic Cross Slope

Cross slope at vehicular traffic is not compliant.

On-Site Finding 6.30 percent

Repave the surface to provide a compliant cross slope.

Recommendation Up to 2.08 percent

Repave surface \$1,092

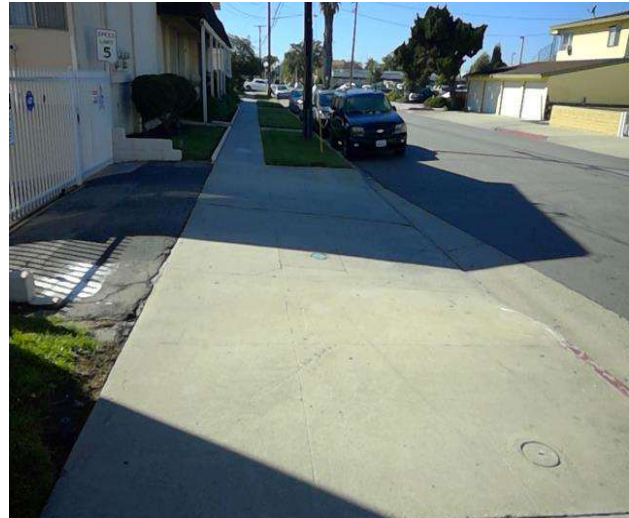
Driveway South of Florance Avenue @ 33.946601904600, -118.116218447685

Sidewalks , Vehicular Traffic : Cross Walks and Detectable Warnings

There are no detectable warnings where the pedestrian route crosses vehicular traffic.

Provide detectable warnings.

Install compliant detectable warnings \$190

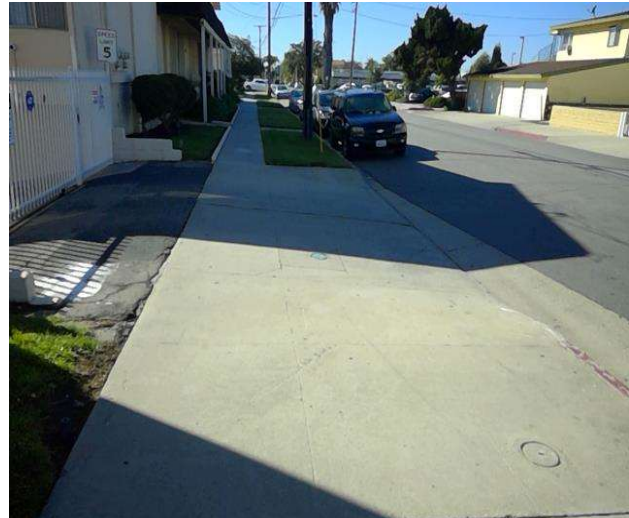
Driveway South of Florance Avenue @ 33.946601904600, -118.116218447685

Sidewalks : Vehicular Traffic Cross Slope

Cross slope at vehicular traffic is not compliant.

On-Site Finding 8.60 percent

Repave the surface to provide a compliant cross slope.

Recommendation Up to 2.08 percent

Repave surface \$1,092

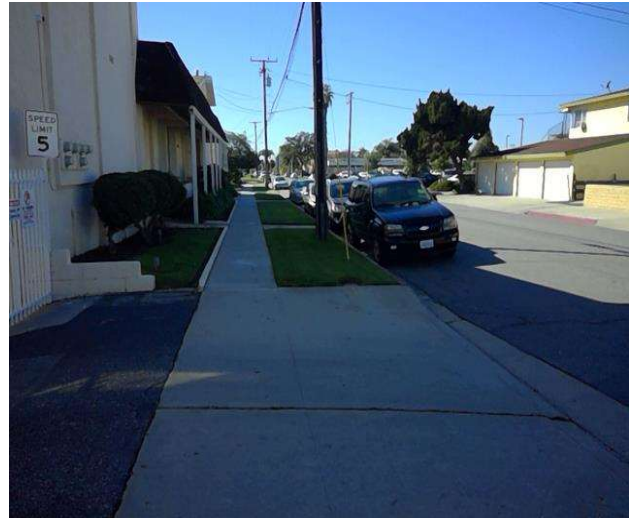
Sidewalk South of Florance Avenue @ 33.946601904600, -118.116218447685

Sidewalks : Opening

Ground surface has an opening that is not compliant.

Make sure that the surface opening does not allow passage of a sphere more than 1/2 inch in diameter.

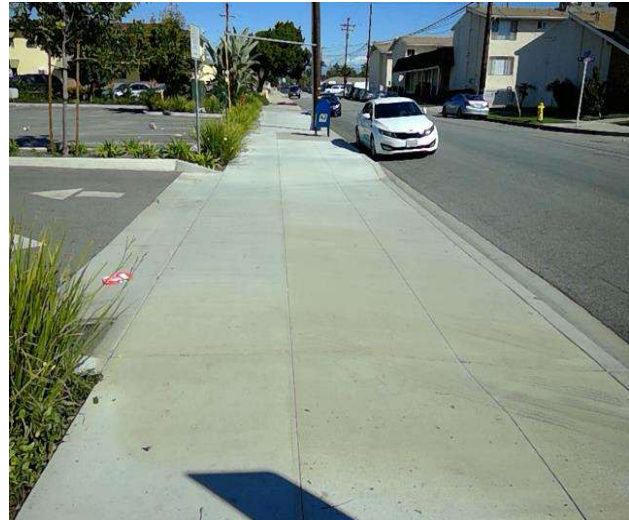
Driveway North of Baysinger Street @ 33.946070116246, -118.116812556982

Sidewalks , Vehicular Traffic : Cross Walks and Detectable Warnings

There are no detectable warnings where the pedestrian route crosses vehicular traffic.

Provide detectable warnings.

Install compliant detectable warnings \$190

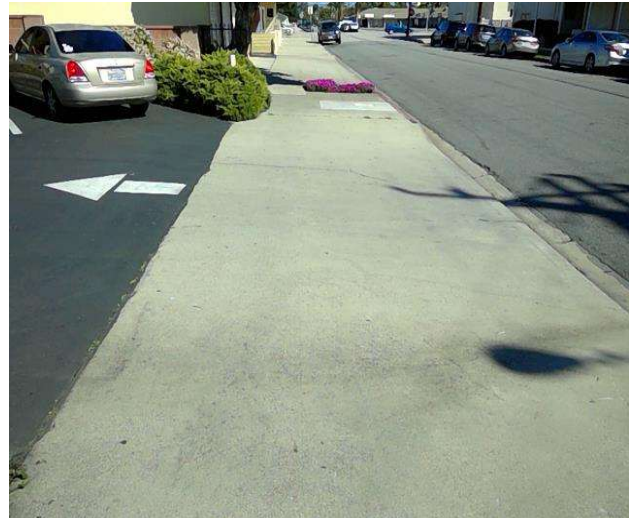
Driveway North of Baysinger Street @ 33.946329335670, -118.116646260023

Sidewalks , Vehicular Traffic : Cross Walks and Detectable Warnings

There are no detectable warnings where the pedestrian route crosses vehicular traffic.

Provide detectable warnings.

Install compliant detectable warnings \$190

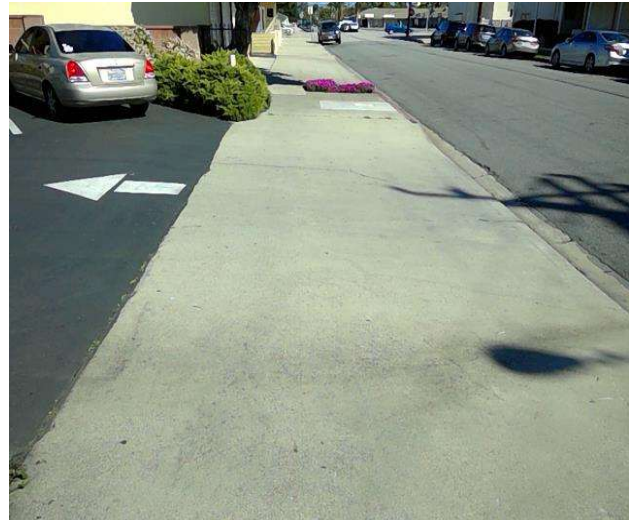
Driveway North of Baysinger Street @ 33.946329335670, -118.116646260023

Sidewalks : Vehicular Traffic Cross Slope

Cross slope at vehicular traffic is not compliant.

On-Site Finding 3.80 percent

Repave the surface to provide a compliant cross slope.

Recommendation Up to 2.08 percent

Repave surface \$1,092

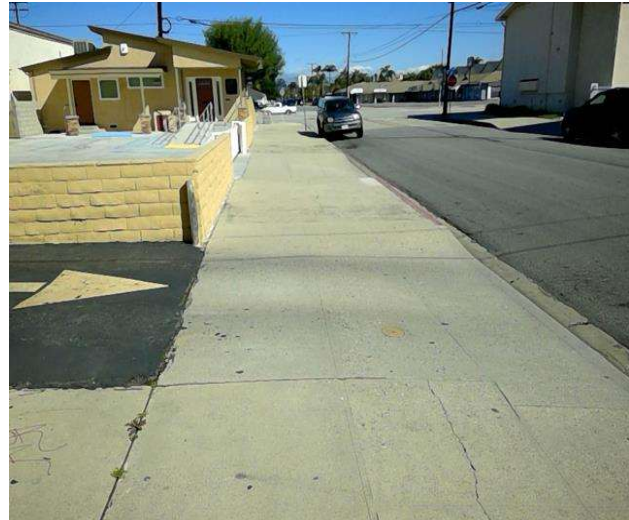
Driveway North of Baysinger Street @ 33.946529590479, -118.116465210915

Sidewalks , Vehicular Traffic : Cross Walks and Detectable Warnings

There are no detectable warnings where the pedestrian route crosses vehicular traffic.

Provide detectable warnings.

Install compliant detectable warnings \$190

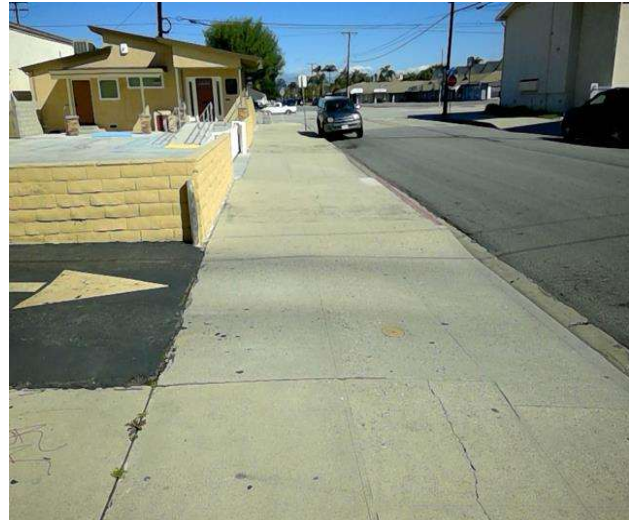
Driveway North of Baysinger Street @ 33.946529590479, -118.116465210915

Sidewalks : Vehicular Traffic Cross Slope

Cross slope at vehicular traffic is not compliant.

On-Site Finding 3.60 percent

Repave the surface to provide a compliant cross slope.

Recommendation Up to 2.08 percent

Repave surface \$1,092

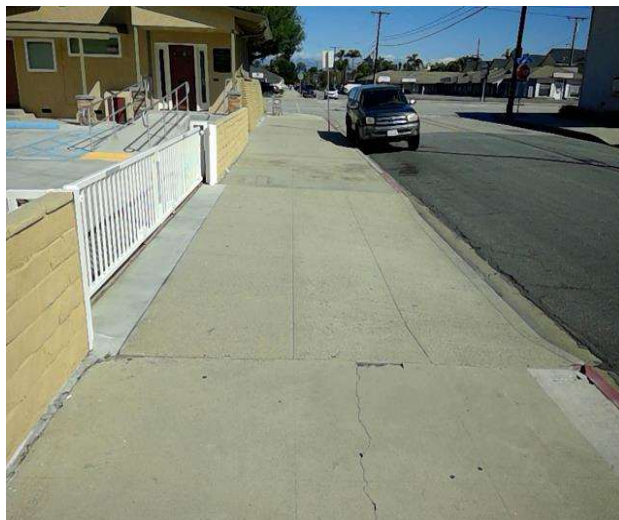
On-Site Finding Not Found

Install compliant detectable warnings \$190
