Accessibility Survey

City of Downey Haledon Avenue - Cecilia Street to Baysinger Street

Date of Inspection
6/12/2017

Disability Access Consultants

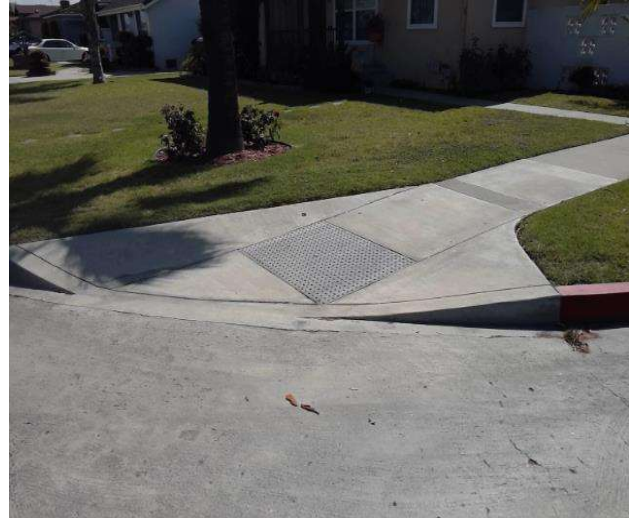
Northeast Corner of Cecilia Street @ 33.937653424, -118.118985146284

Curb Ramp : Side Flare Slope

The slope of the curb ramp side flare is greater than allowed.

On-Site Finding 21.30 percent

Code Reference ADA 406, 406.3, CA 11B-406.2.2

Provide curb ramp side flares with a compliant slope.

Recommendation Up to 10.00 percent

Install flared sides \$1,300

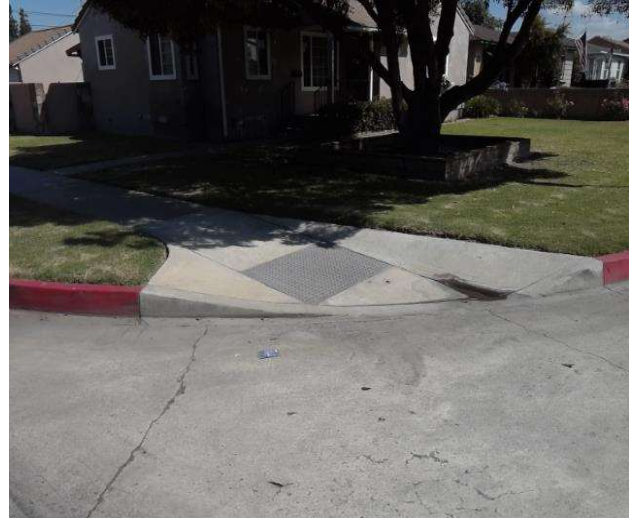
Northwest Corner of Cecilia Street @ 33.937726834326, - 118.119125962257

Curb Ramp : Side Flare Slope

The slope of the curb ramp side flare is greater than allowed.

On-Site Finding 14.80 percent

Code Reference ADA 406, 406.3, CA 11B-406.2.2

Provide curb ramp side flares with a compliant slope.

Recommendation Up to 10.00 percent

Install flared sides \$1,300

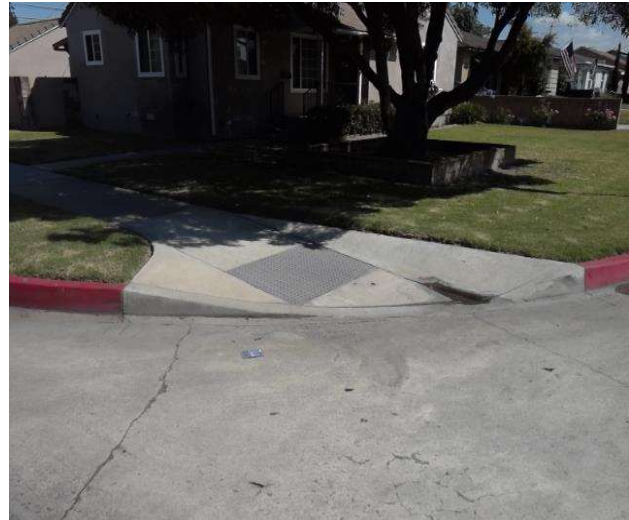
**Northwest Corner of Cecilia Street @ 33.937726834326, -
118.119125962257**

Curb Ramp , Landings and Transitions : Top Landing Slope

The slope at the top landing is greater than allowed.

On-Site Finding 3.20 percent

Code Reference ADA 402, 406.4, 403.3, 406.1, CA 11B-406.5.3

Provide a top landing surface that does not exceed the maximum slope and cross slope. Provide a sufficient maneuvering clearance that does not accumulate water.

Recommendation Up to 2.08 percent

Provide compliant landing \$1,260

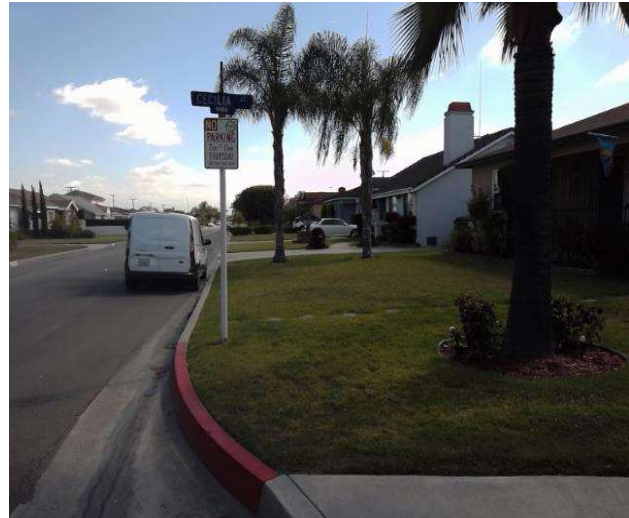
East Side @ 33.937676765491, -118.118993192911

Sidewalks : No Sidewalk

No sidewalk exists at the location.

On-Site Finding Not Found

No action necessary until a sidewalk is provided.

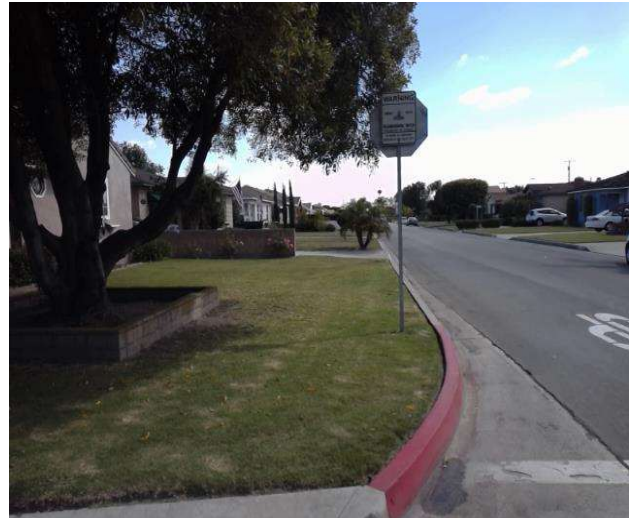
West Side @ 33.937737960730, -118.119116574526

Sidewalks : No Sidewalk

No sidewalk exists at the location.

On-Site Finding Not Found

No action necessary until a sidewalk is provided.

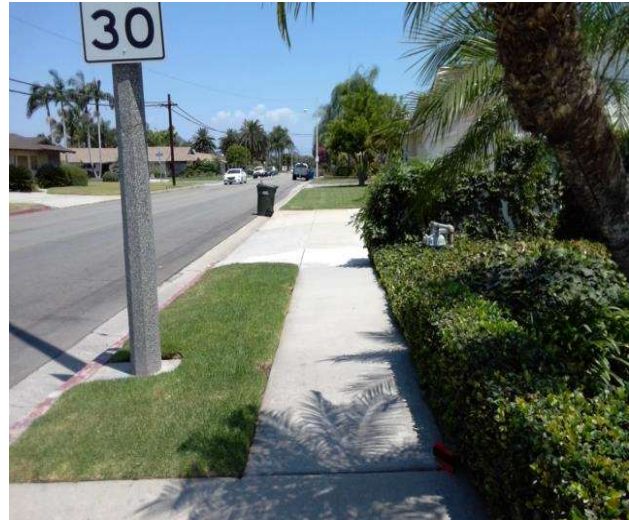
Change in Level South of Dinsdale Street @ 33.946312647748, -118.112975656986

Sidewalks , Change in Level : Change in Level Non Beveled

There is a change in elevation greater than recommended value.

On-Site Finding 0.75 inches

Code Reference ADA 206, 302

Ensure that the change in elevation is within the recommended value.

Recommendation Up to 0.25 inches

Remove tripping hazards \$198

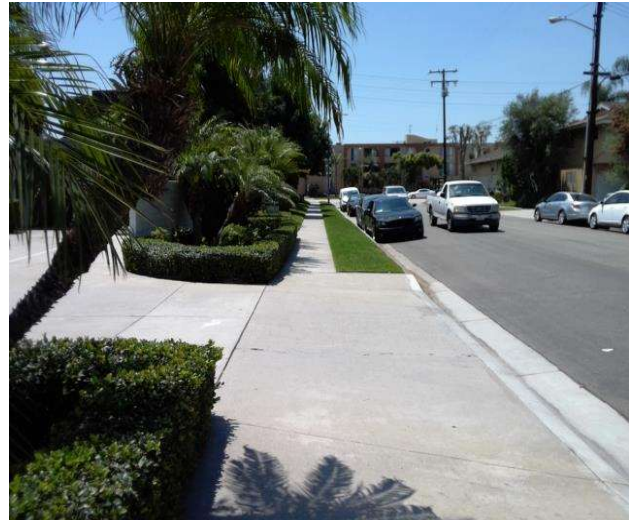
Driveway South of Dinsdale Street @ 33.946279271895, -118.112998455763

Sidewalks , Vehicular Traffic : Cross Walks and Detectable Warnings

There are no detectable warnings where the pedestrian route crosses vehicular traffic.

Code Reference ADA 705,CA 11B-705.1.2.5,CA 11B-247.1.2.5

Provide detectable warnings.

Install compliant detectable warnings \$190

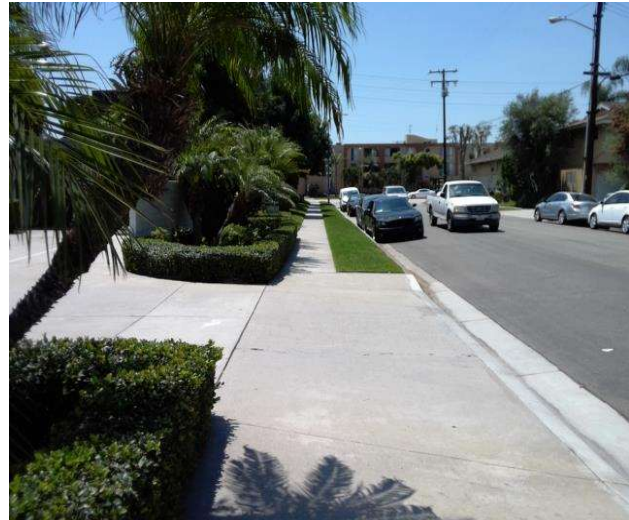
Driveway South of Dinsdale Street @ 33.946279271895, -118.112998455763

Sidewalks : Vehicular Traffic Cross Slope

Cross slope at vehicular traffic is not compliant.

On-Site Finding 5.00 percent

Code Reference ADA 206, 302,CA 11B-403.3

Repave the surface to provide a compliant cross slope.

Recommendation Up to 2.08 percent

Repave surface \$1,092

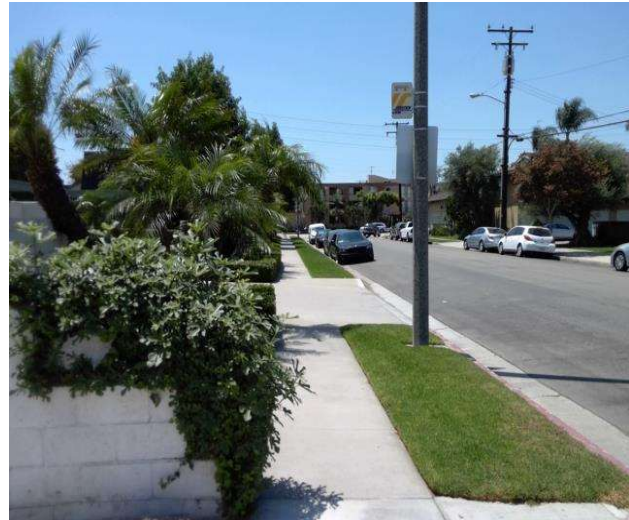
Sidewalk South of Dinsdale Street @ 33.946349361173, -118.112944811583

Sidewalks , Surface : Cross Slope

Sidewalk cross slope is not compliant.

On-Site Finding 8.60 percent for 261.00 feet

Code Reference ADA 206, 302, CA 11B-403.3

Repave the sidewalk surface with the recommended cross slope.

Recommendation Up to 2.08 percent

Repave surface \$1,092

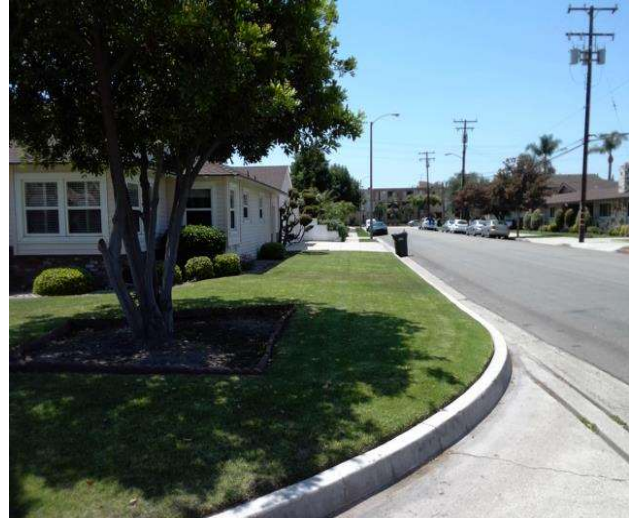
Sidewalk South of Dinsdale Street @ 33.946634167803, -118.112738281488

Sidewalks : Missing Sidewalk

Section of sidewalk is missing and consists of dirt, grass or gravel.

On-Site Finding 87.00 feet

Code Reference ADA 206, 302,CA 11B-302,CA 11B-206

Provide a compliant sidewalk for the missing section.

\$1,260

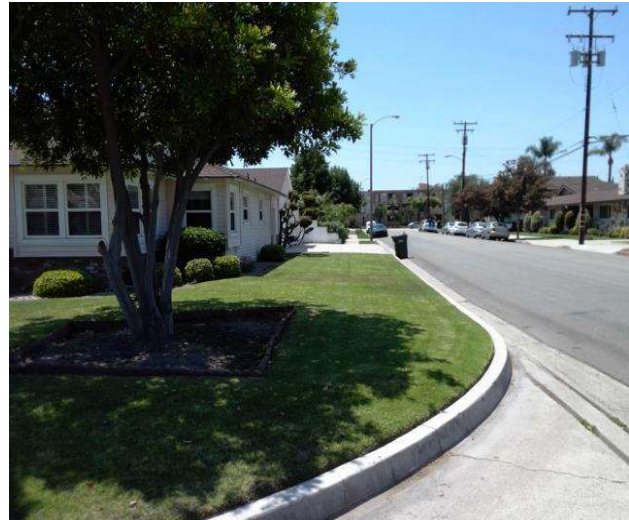
East Side @ 33.946634167803, -118.112738281488

Sidewalks : 60X60 Turn Area

There is no 60X60 turn area at every 200 feet.

Code Reference ADA 206, 302

Provide a 60X60 turn every 200 feet on the sidewalk.

\$2,400

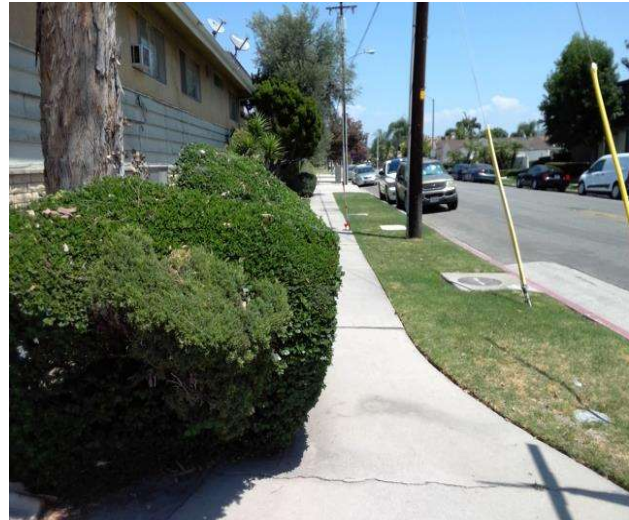
Bush North of Florence Avenue @ 33.945854284878, -118.113530874252

Sidewalks , Hazards & Gratings : Sidewalk Width at Obstruction

Sidewalk width at the obstruction is not compliant.

On-Site Finding 38.00 inches

Code Reference ADA 206, 302, 403.5.1, CA 11B-403.5

Sidewalk width at the obstruction shall have the recommended value.

Recommendation At least 48.00 inches

\$1,260

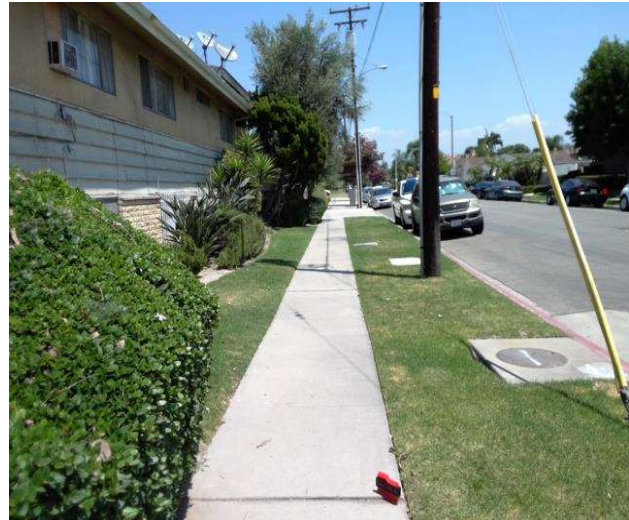
Change in Level North of Florence Avenue to Otto Street @ 33.945854284878, - 118.113530874252

Sidewalks , Change in Level : Change in Level Non Beveled

There is a change in elevation greater than recommended value.

On-Site Finding 0.62 inches

Code Reference ADA 206, 302

Ensure that the change in elevation is within the recommended value.

Recommendation Up to 0.25 inches

Remove tripping hazards \$198

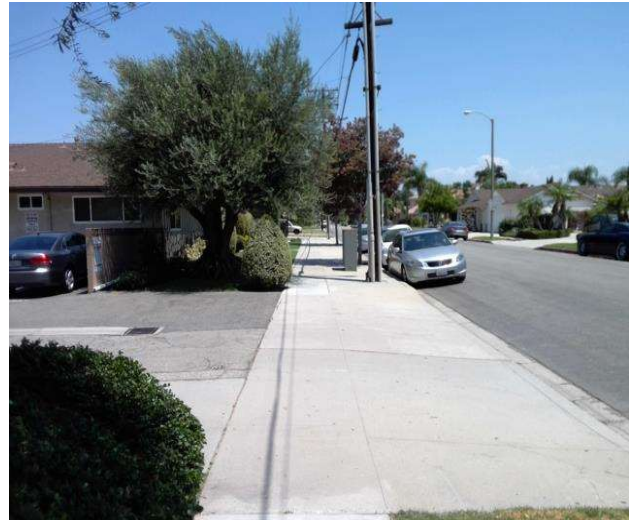
Driveway North of Florence Avenue @ 33.946137980635, -118.113310933113

Sidewalks , Vehicular Traffic : Cross Walks and Detectable Warnings

There are no detectable warnings where the pedestrian route crosses vehicular traffic.

Code Reference ADA 705,CA 11B-705.1.2.5,CA 11B-247.1.2.5

Provide detectable warnings.

Install compliant detectable warnings \$190

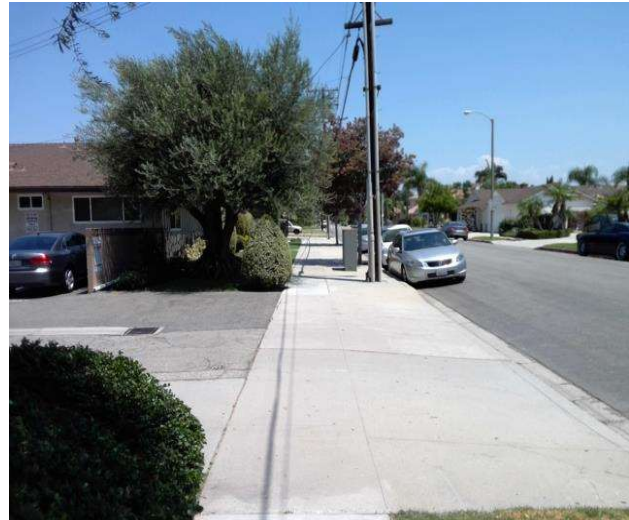
Driveway North of Florence Avenue @ 33.946137980635, -118.113310933113

Sidewalks : Vehicular Traffic Cross Slope

Cross slope at vehicular traffic is not compliant.

On-Site Finding 3.90 percent

Code Reference ADA 206, 302, CA 11B-403.3

Repave the surface to provide a compliant cross slope.

Recommendation Up to 2.08 percent

Repave surface \$1,092

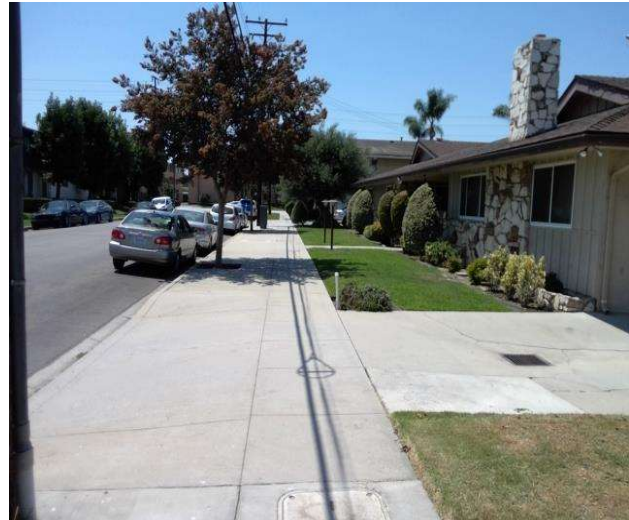
Driveway North of Florence Avenue @ 33.946448376086, -118.113081604242

Sidewalks , Vehicular Traffic : Cross Walks and Detectable Warnings

There are no detectable warnings where the pedestrian route crosses vehicular traffic.

Code Reference ADA 705,CA 11B-705.1.2.5,CA 11B-247.1.2.5

Provide detectable warnings.

Install compliant detectable warnings \$190

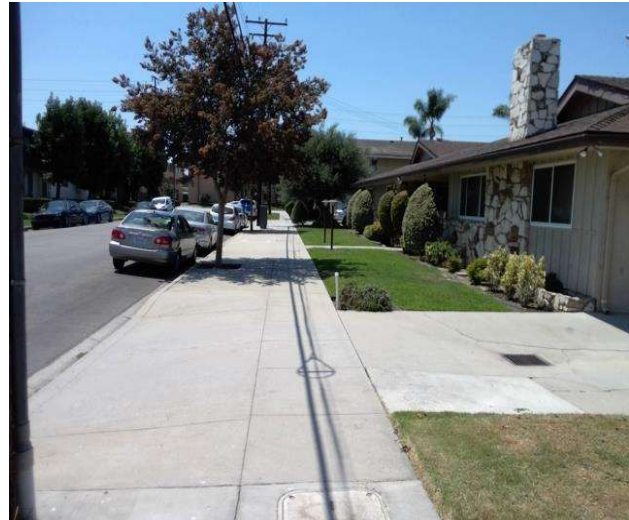
Driveway North of Florence Avenue @ 33.946448376086, -118.113081604242

Sidewalks : Vehicular Traffic Cross Slope

Cross slope at vehicular traffic is not compliant.

On-Site Finding 2.60 percent

Code Reference ADA 206, 302,CA 11B-403.3

Repave the surface to provide a compliant cross slope.

Recommendation Up to 2.08 percent

Repave surface \$1,092

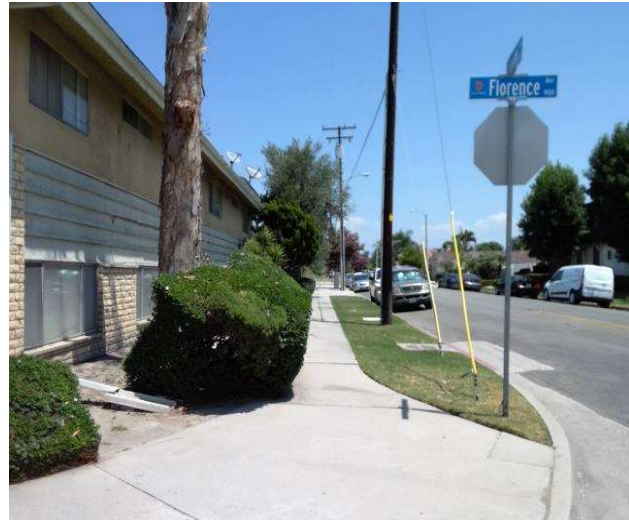
Sidewalk North of Florence Avenue @ 33.945854284878, -118.113530874252

Sidewalks , Surface : Cross Slope

Sidewalk cross slope is not compliant.

On-Site Finding 3.60 percent for 42.00 feet

Code Reference ADA 206, 302, CA 11B-403.3

Repave the sidewalk surface with the recommended cross slope.

Recommendation Up to 2.08 percent

Repave surface \$1,092

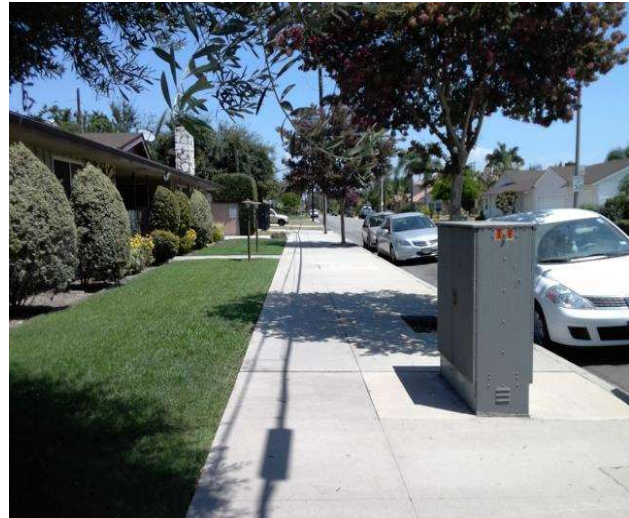
Sidewalk North of Florence Avenue @ 33.946188044494, -118.113262653351

Sidewalks , Surface : Cross Slope

Sidewalk cross slope is not compliant.

On-Site Finding 4.30 percent for 158.00 feet

Code Reference ADA 206, 302, CA 11B-403.3

Repave the sidewalk surface with the recommended cross slope.

Recommendation Up to 2.08 percent

Repave surface \$1,092

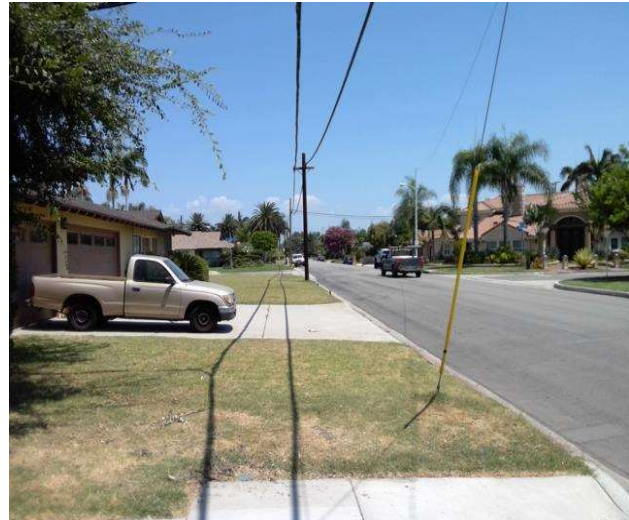
Sidewalk North of Florence Avenue @ 33.946526252903, -118.113018572330

Sidewalks : Missing Sidewalk

Section of sidewalk is missing and consists of dirt, grass or gravel.

On-Site Finding 158.00 feet

Code Reference ADA 206, 302,CA 11B-302,CA 11B-206

Provide a compliant sidewalk for the missing section.

\$1,260

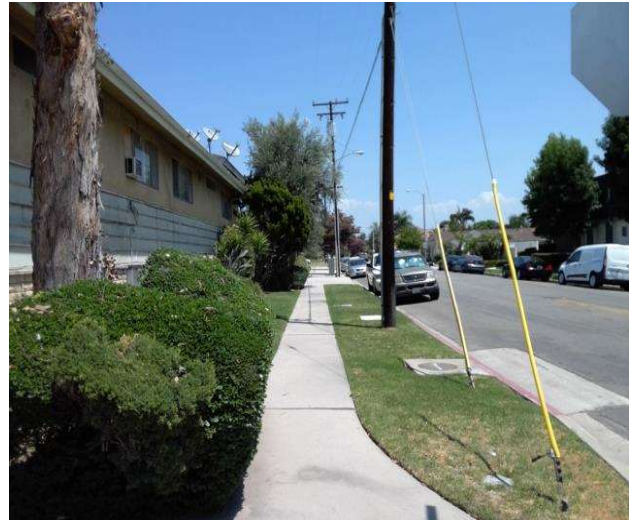
West Side @ 33.945854284878, -118.113530874252

Sidewalks : 60X60 Turn Area

There is no 60X60 turn area at every 200 feet.

Code Reference ADA 206, 302

Provide a 60X60 turn every 200 feet on the sidewalk.

\$2,400
