Accessibility Survey

City of Downey Angell Street - Carfax Avenue to Adenmoor Avenue

Date of Inspection
12/11/2016

Disability Access Consultants

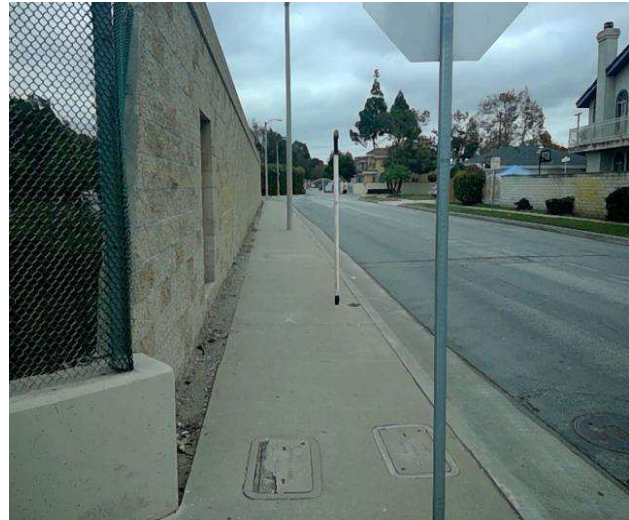
Change In Level East Of Woodruff Avenue @ 33.913313116707, -118.116433024406

Sidewalks , Change in Level : Change in Level Non Beveled

There is a change in elevation greater than recommended value.

On-Site Finding 0.50 inches

Ensure that the change in elevation is within the recommended value.

Recommendation Up to 0.25 inches

Remove tripping hazards \$198

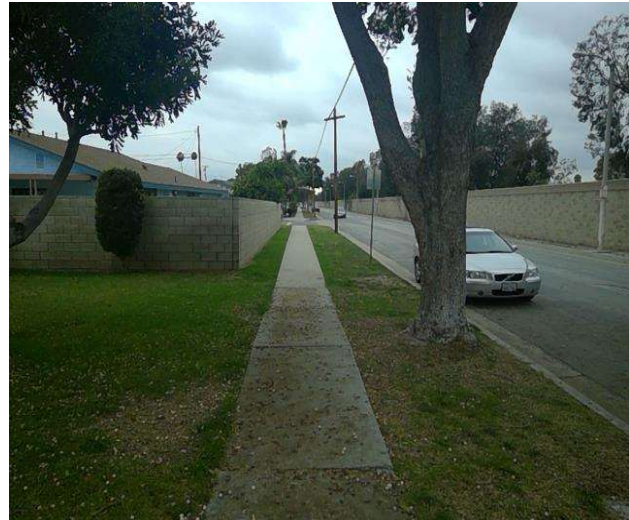
Change In Level West Of @ 33.913106106010, -118.117243051529

Sidewalks , Change in Level : Change in Level Non Beveled

There is a change in elevation greater than recommended value.

On-Site Finding 1.00 inches

Ensure that the change in elevation is within the recommended value.

Recommendation Up to 0.25 inches

Remove tripping hazards \$198

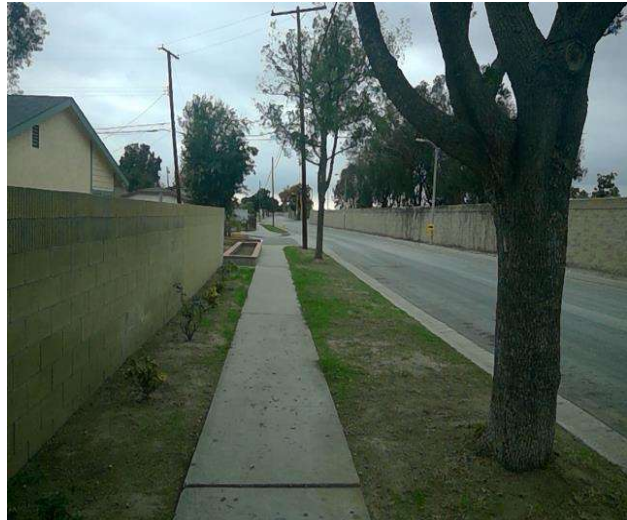
Change In Level West Of Cornuta Avenue @ 33.912936935605, -118.119539022446

Sidewalks , Change in Level : Change in Level Non Beveled

There is a change in elevation greater than recommended value.

On-Site Finding 0.75 inches

Ensure that the change in elevation is within the recommended value.

Recommendation Up to 0.25 inches

Remove tripping hazards \$198

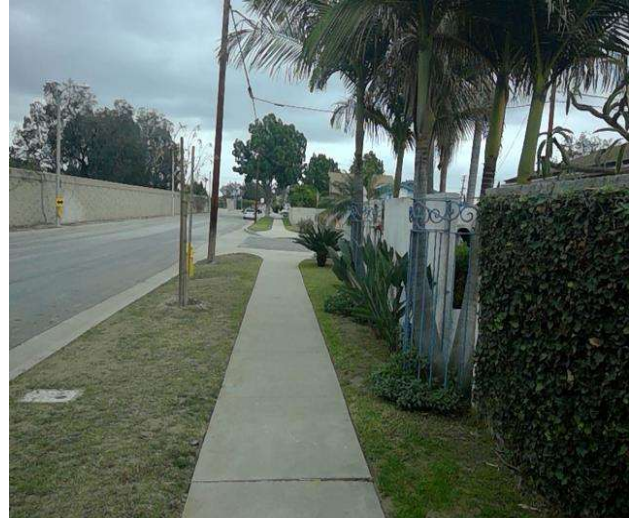
Change In Level West Of Ibbetson Avenue @ 33.913052683813, - 118.118152320385

Sidewalks , Change in Level : Change in Level Non Beveled

There is a change in elevation greater than recommended value.

On-Site Finding 0.62 inches

Ensure that the change in elevation is within the recommended value.

Recommendation Up to 0.25 inches

Remove tripping hazards \$198

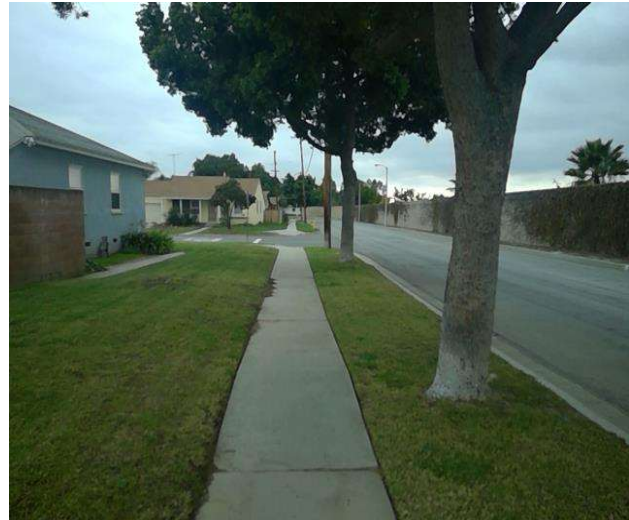
Change In Level West Of Izetta Avenue @ 33.912694309043, -118.122414350510

Sidewalks , Change in Level : Change in Level Non Beveled

There is a change in elevation greater than recommended value.

On-Site Finding 0.62 inches

Ensure that the change in elevation is within the recommended value.

Recommendation Up to 0.25 inches

Remove tripping hazards \$198

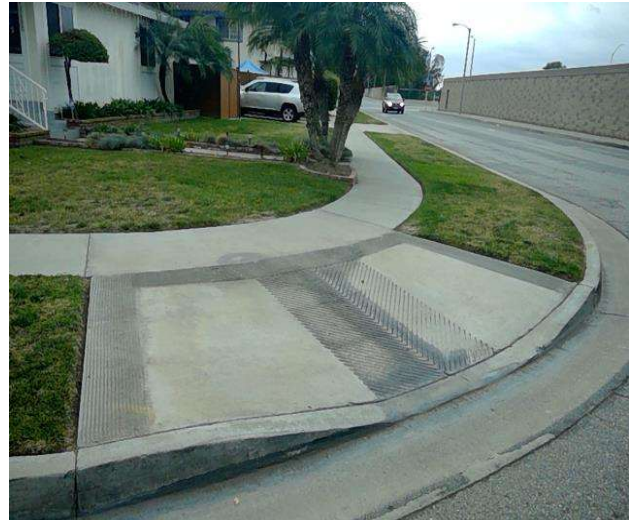
Southeast Corner Of Faust Avenue @ 33.913250790959, - 118.115703463554

Curb Ramp : Bottom Landing Slope

The bottom landing of the curb ramp is on the street, and the slope of the bottom landing is not compliant.

On-Site Finding 7.10 percent

Ensure the bottom landing slope is compliant and provides a smooth transition.

Recommendation Up to 5.00 percent

Repave landing \$1,260

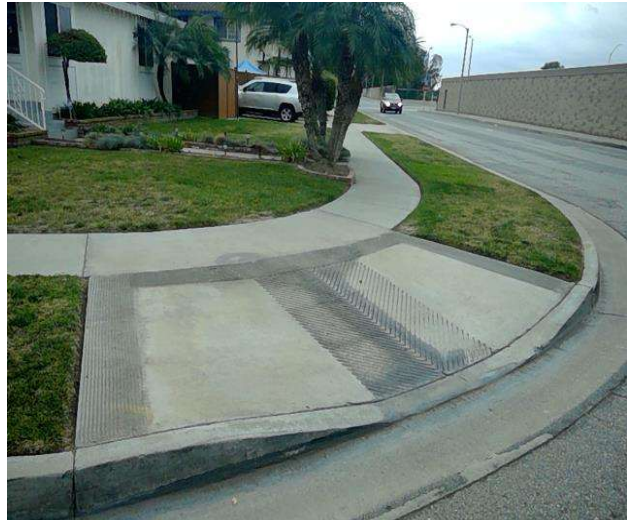
Southeast Corner Of Faust Avenue @ 33.913250790959, - 118.115703463554

The transition from the bottom of the curb ramp to the walk, gutter, or street is abrupt.

On-Site Finding Not Beveled

Curb Ramp , Landings and Transitions : Bottom Landing Change in Level - Curb Ramps

Patch the transition area at the bottom of the curb ramp so that the transition is flush and free of abrupt changes.

Patch lip at curb ramp \$255

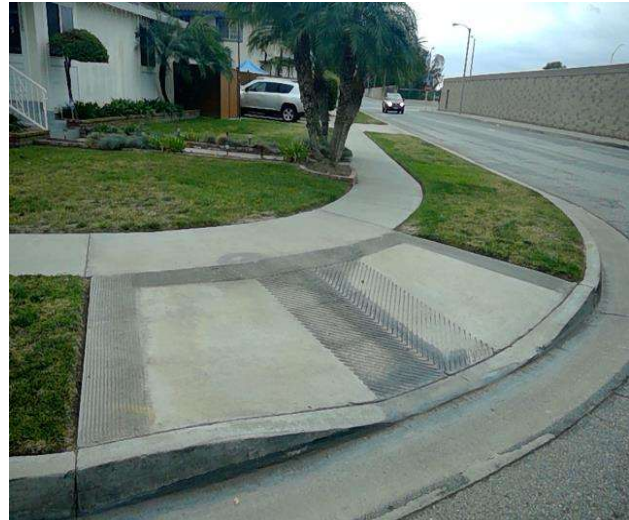
Southeast Corner Of Faust Avenue @ 33.913250790959, - 118.115703463554

There is not enough top landing clear length.

On-Site Finding 47.00 inches

Curb Ramp , Landings and Transitions : Top Landing Clear Length - Landings

Provide a level top landing with enough clear length.

Recommendation At least 48.00 inches

Provide compliant landing \$240

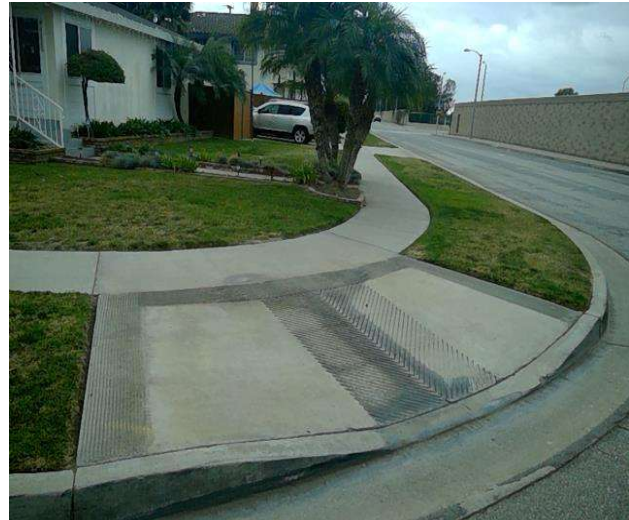
Southeast Corner Of Faust Avenue @ 33.913250790959, - 118.115703463554

Curb Ramp : No Detectable Warnings

The curb ramp does not provide a detectable warning surface which includes truncated domes.

On-Site Finding Not Found

Provide compliant detectable warnings to surface.

Provide detectable warning to surface \$248

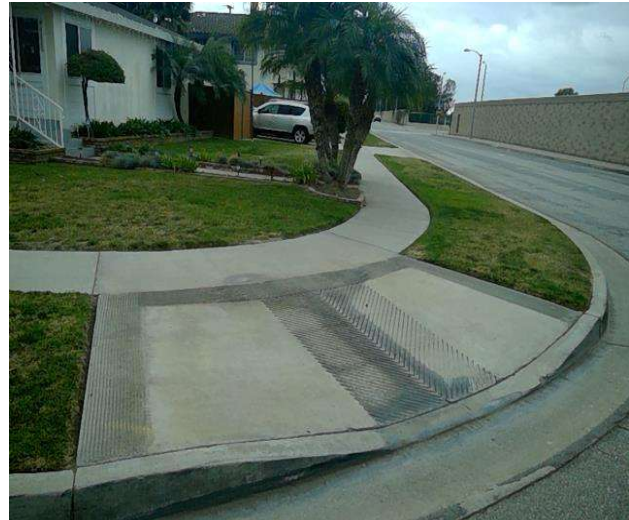
Southeast Corner Of Faust Avenue @ 33.913250790959, - 118.115703463554

Curb Ramp : Curb Ramp Slope

The running slope is greater than allowed.

On-Site Finding 12.50 percent

Provide a compliant curb ramp.

Recommendation Up to 8.33 percent

Install curb ramp \$1,300

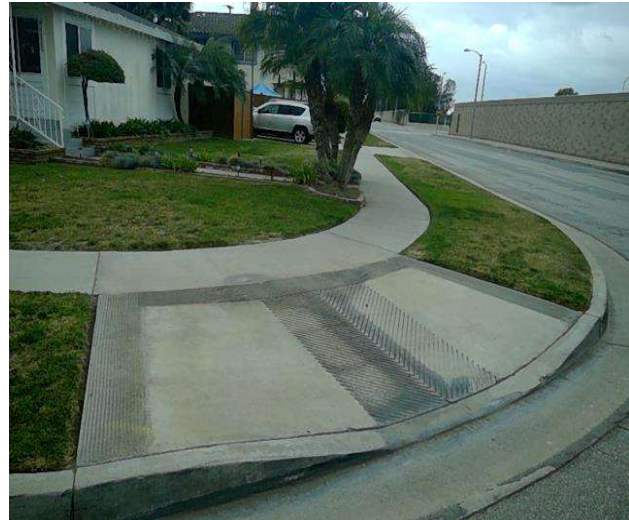
Southeast Corner Of Faust Avenue @ 33.913250790959, - 118.115703463554

Curb Ramp : Side Flare Slope

The slope of the curb ramp side flare is greater than allowed.

On-Site Finding 14.80 percent

Provide curb ramp side flares with a compliant slope.

Recommendation Up to 10.00 percent

Install flared sides \$1,300

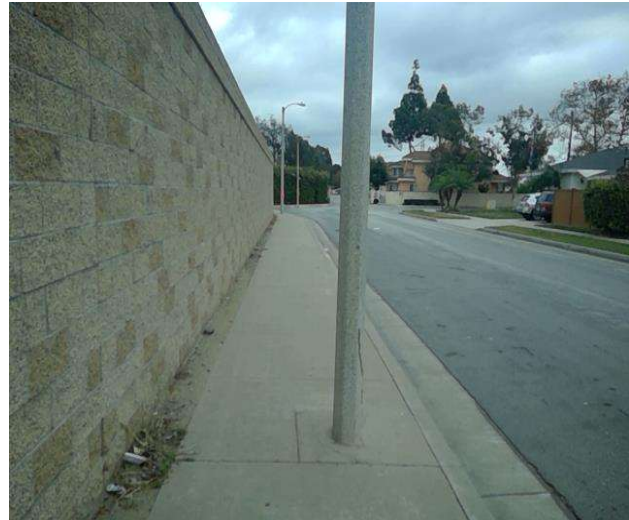
Light Pole East Of Woodruff Avenue @ 33.913326472219, -118.116239905357

Sidewalks , Hazards & Gratings : Sidewalk Width at Obstruction

Sidewalk width at the obstruction is not compliant.

On-Site Finding 43.00 inches

Sidewalk width at the obstruction shall have the recommended value.

Recommendation At least 48.00 inches

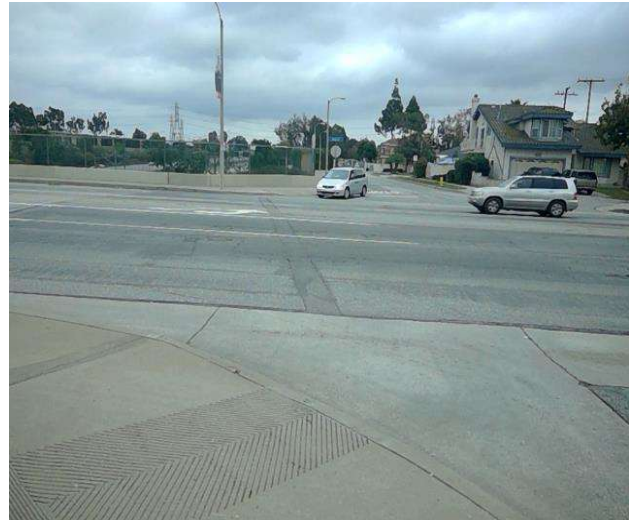
North Crossing Woodruff Avenue @ 33.913257468720, -118.116690516472

Sidewalks , Vehicular Traffic : Cross Walks and Detectable Warnings

There are no detectable warnings where the pedestrian route crosses vehicular traffic.

On-Site Finding Not Found

Provide detectable warnings.

Install compliant detectable warnings \$190

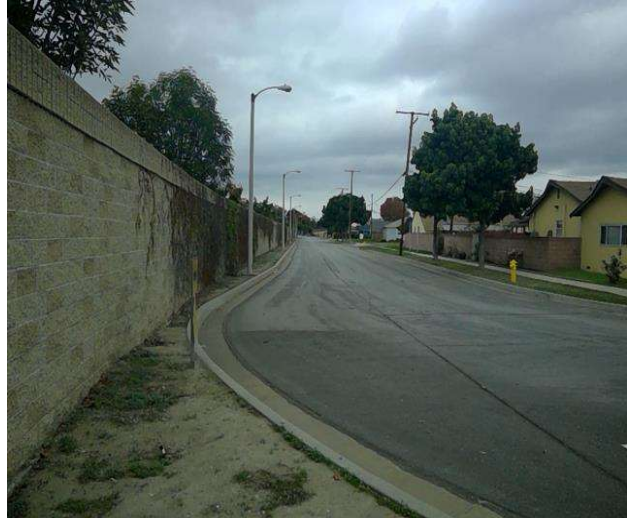
Sidewalk East Of Adenmoor Avenue @ 33.912727698060, -118.123672306538

Sidewalks : Missing Sidewalk

Section of sidewalk is missing and consists of dirt, grass or gravel.

On-Site Finding 2060.00 feet

Provide a compliant sidewalk for the missing section.

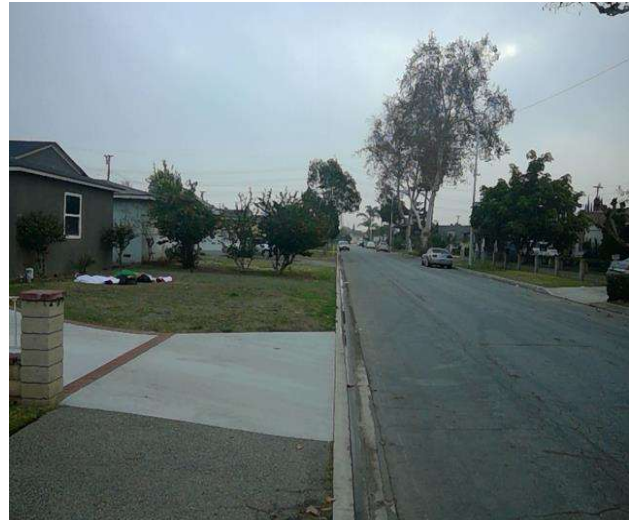
Sidewalk East Of Faust Avenue @ 33.912792250124, -118.114670813084

Sidewalks : Missing Sidewalk

Section of sidewalk is missing and consists of dirt, grass or gravel.

On-Site Finding 657.00 feet

Provide a compliant sidewalk for the missing section.

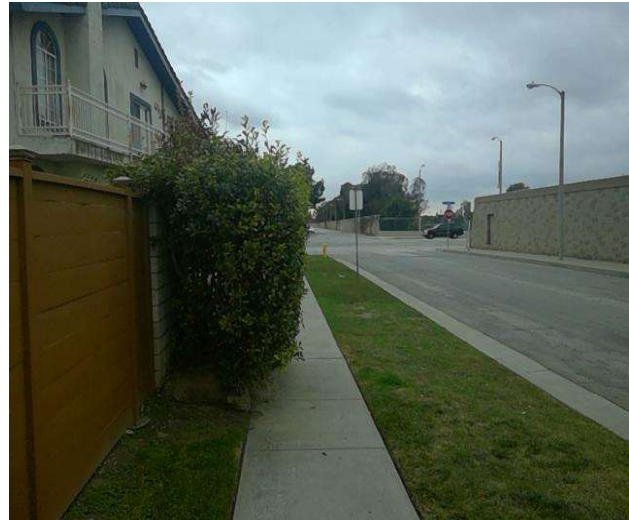
Bush West Of Faust Avenue @ 33.913230757673, -118.116033375263

Sidewalks , Hazards & Gratings : Sidewalk Width at Obstruction

Sidewalk width at the obstruction is not compliant.

On-Site Finding 28.00 inches

Sidewalk width at the obstruction shall have the recommended value.

Recommendation At least 48.00 inches

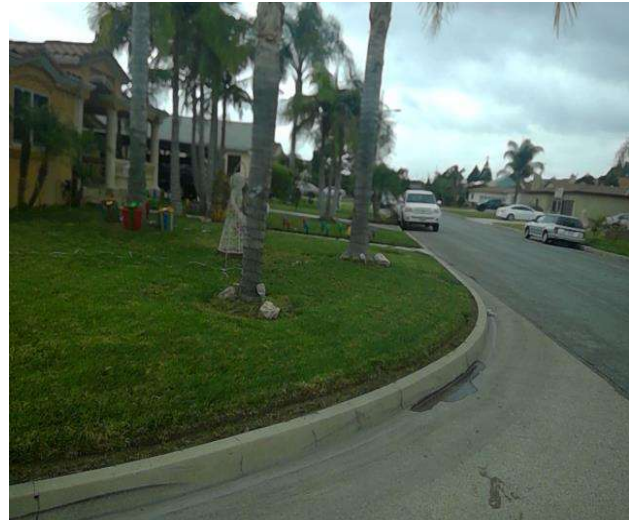
Sidewalk West Of Carfax Avenue @ 33.912656468141, -118.112522363663

Sidewalks : Missing Sidewalk

Section of sidewalk is missing and consists of dirt, grass or gravel.

On-Site Finding 945.00 feet

Provide a compliant sidewalk for the missing section.

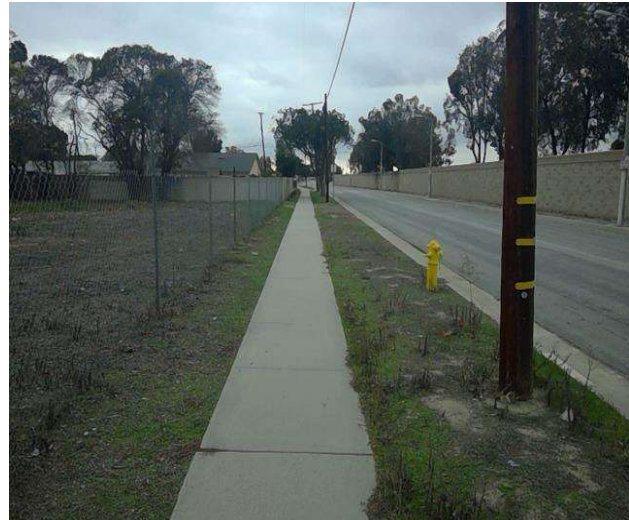
Sidewalk West Of Cornuta Avenue @ 33.912985906020, -118.119013309479

Sidewalks , Surface : Cross Slope

Sidewalk cross slope is not compliant.

On-Site Finding 3.50 percent for 220.00 feet

Repave the sidewalk surface with the recommended cross slope.

Recommendation Up to 2.08 percent

Repave surface \$1,092

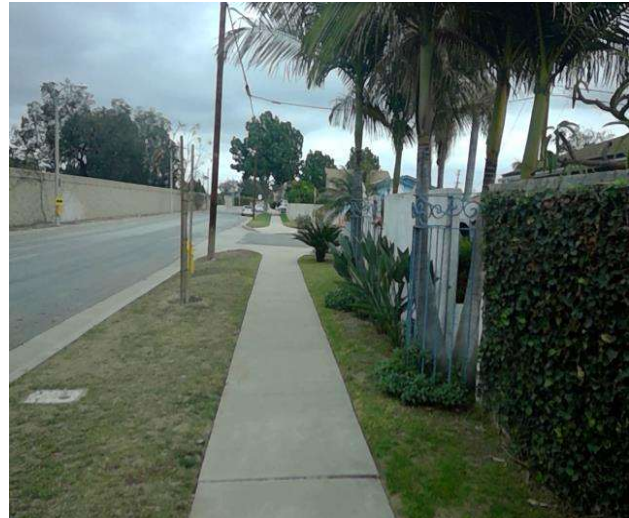
Sidewalk West Of Ibbetson Avenue @ 33.913086072691, -118.117980659008

Sidewalks , Surface : Cross Slope

Sidewalk cross slope is not compliant.

On-Site Finding 3.00 percent for 45.00 feet

Repave the sidewalk surface with the recommended cross slope.

Recommendation Up to 2.08 percent

Repave surface \$1,092

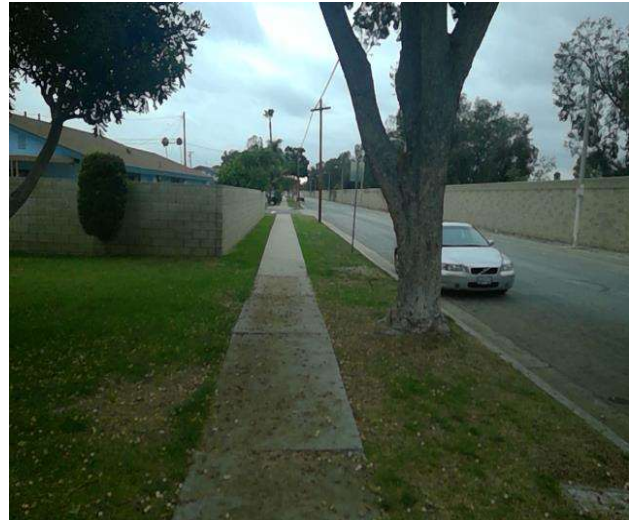
Sidewalk West Of Woodruff Avenue @ 33.913106106010, -118.117243051529

Sidewalks , Surface : Cross Slope

Sidewalk cross slope is not compliant.

On-Site Finding 3.00 percent for 150.00 feet

Repave the sidewalk surface with the recommended cross slope.

Recommendation Up to 2.08 percent

Repave surface \$1,092

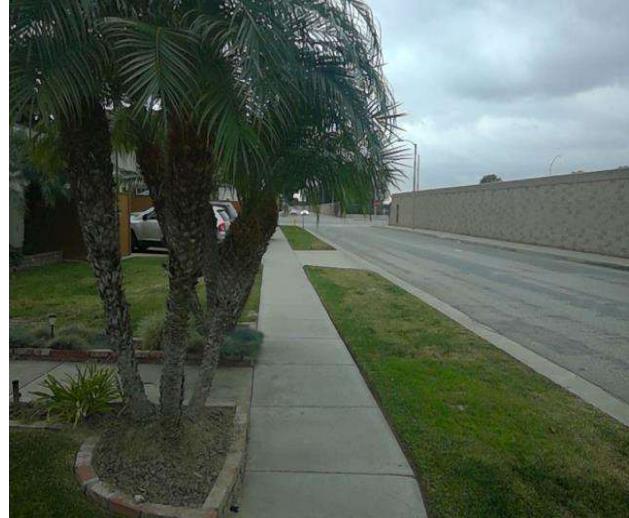
Tree West Of Faust Avenue @ 33.913253016879, -118.115770518780

Sidewalks , Hazards & Gratings : Overhead Obstruction Height

Overhead obstruction height is not compliant.

On-Site Finding 74.00 inches

Provide a compliant vertical clearance height.

Recommendation At least 80.00 inches
