Accessibility Survey

City of Downey Colombia Way - Foster Road to Lakewood Boulevard

Colombia Way - Foster Road to Lakewood Boulevard
Downey, CA 90706

Date of Inspection
11/30/2016

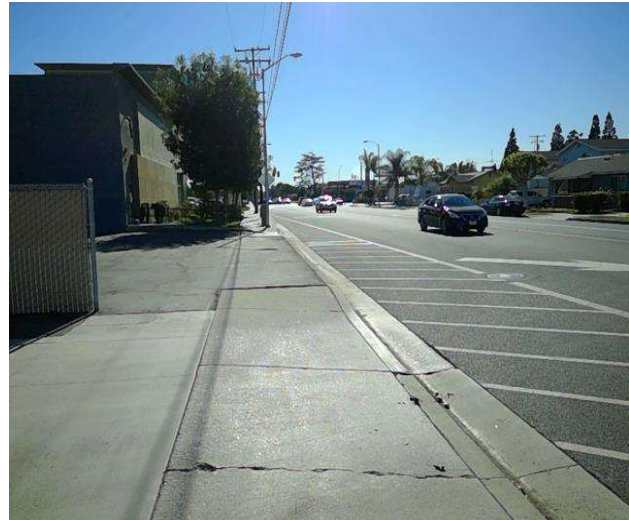
Change In Level South Of Congressman Steve Horn Way @ 33.918274545210, - 118.134009540081

Sidewalks , Change in Level : Change in Level Non Beveled

There is a change in elevation greater than recommended value.

On-Site Finding 0.87 inches

Ensure that the change in elevation is within the recommended value.

Recommendation Up to 0.25 inches

Remove tripping hazards \$198

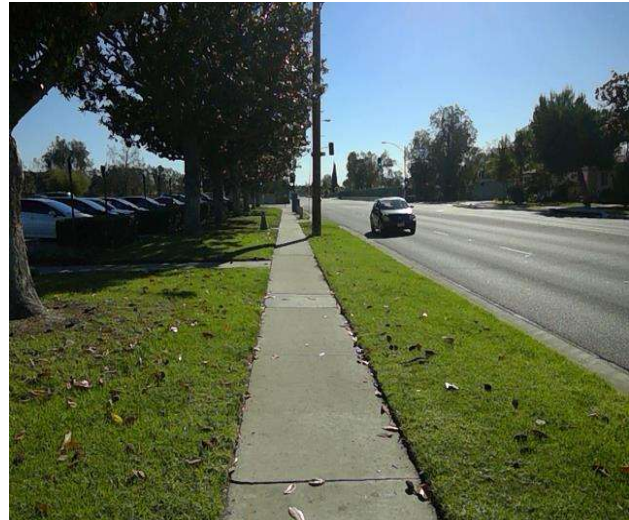
Change In Level South Of Imperial Way @ 33.914388228691, -118.134041726589

Sidewalks , Change in Level : Change in Level Non Beveled

There is a change in elevation greater than recommended value.

Ensure that the change in elevation is within the recommended value.

Recommendation Up to 0.25 inches

Remove tripping hazards \$198

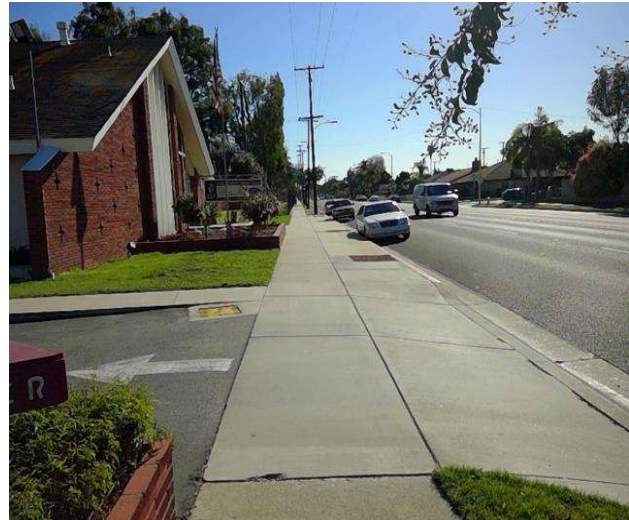
On-Site Finding Not Found

Recommendation See Recommendation

Install compliant detectable warnings \$190

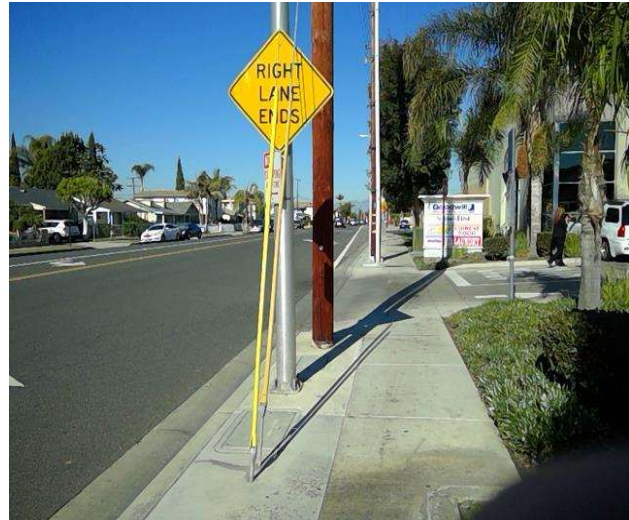
Sidewalks , Hazards & Gratings : Overhead Obstruction Height

Recommendation At least 80.00 inches

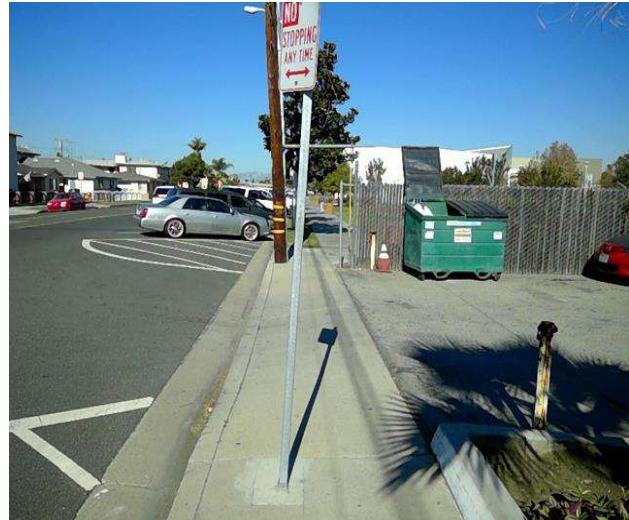
Sidewalks , Hazards & Gratings : Sidewalk Width at Obstruction

Sidewalk width at the obstruction shall have the recommended value.

Recommendation At least 48.00 inches

\$1,260

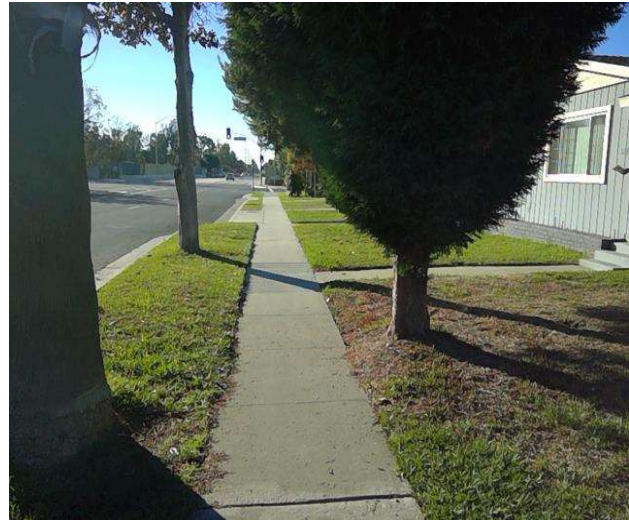
There is a change in elevation greater than recommended value.

Ensure that the change in elevation is within the recommended value.

Recommendation Up to 0.25 inches

Remove tripping hazards \$198

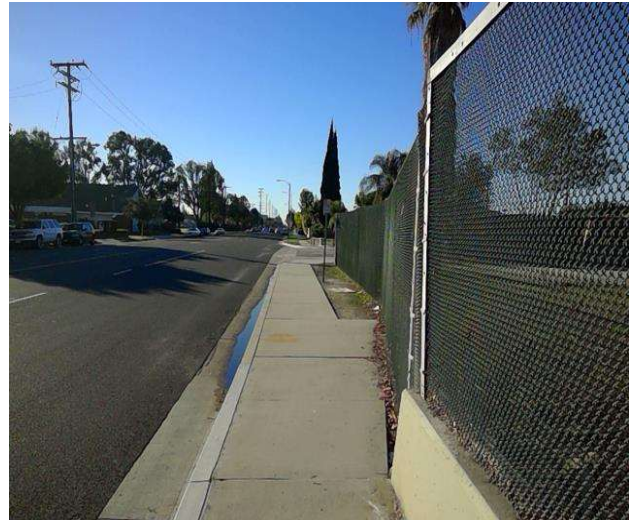
There is a change in elevation greater than recommended value.

Ensure that the change in elevation is within the recommended value.

Recommendation Up to 0.25 inches

Remove tripping hazards \$198

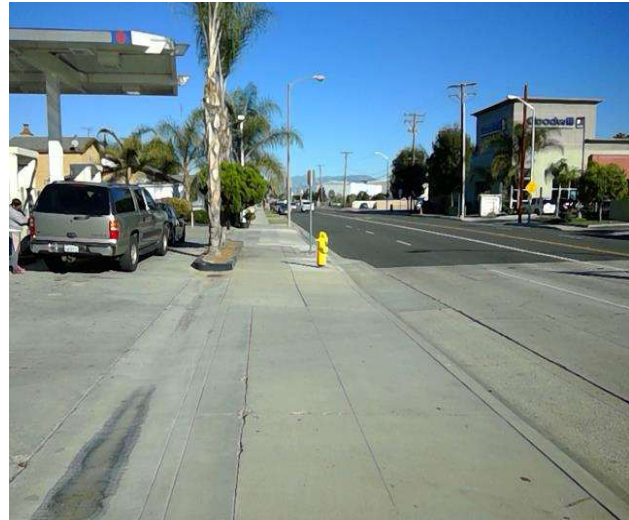
There is a change in elevation greater than recommended value.

Ensure that the change in elevation is within the recommended value.

Recommendation Up to 0.25 inches

Remove tripping hazards \$198
