Accessibility Survey

City of Downey Arnett Street - Downey Avenue to Mcgovern Avenue

Date of Inspection
6/13/2017

Disability Access Consultants

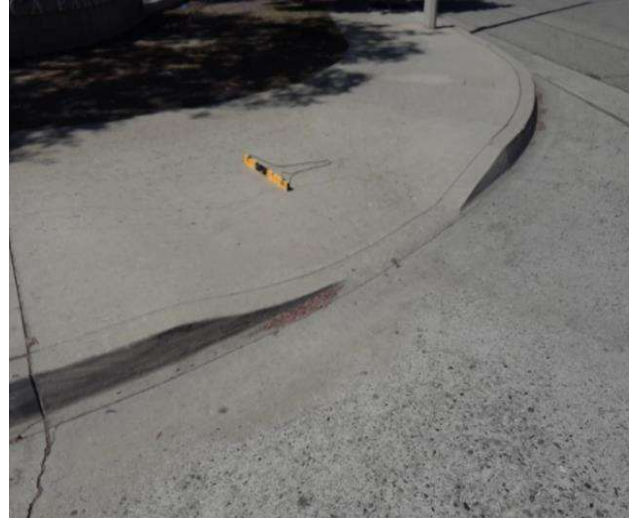
On-Site Finding Not Found

Provide detectable warning to surface \$248

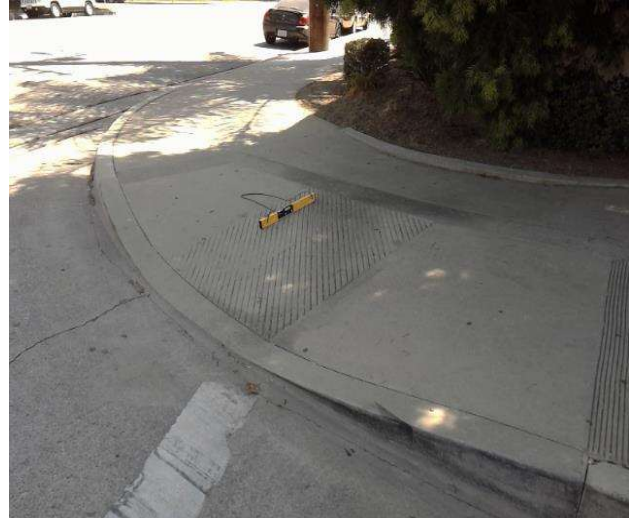
On-Site Finding Not Found

Provide detectable warning to surface \$248

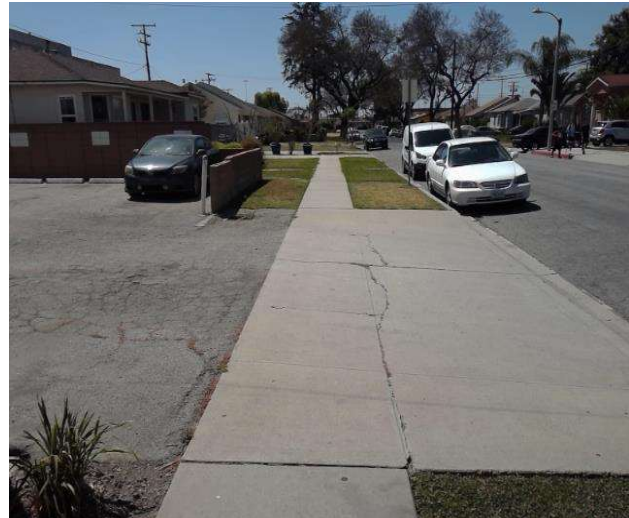
On-Site Finding Not Found

Install compliant detectable warnings \$190

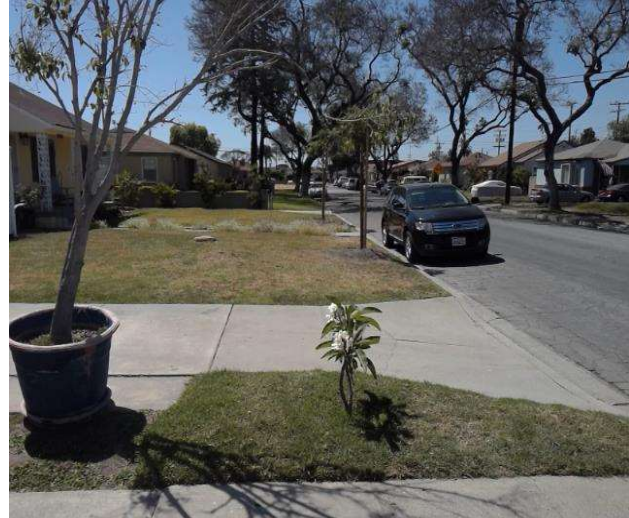
Sidewalks : Missing Sidewalk

Section of sidewalk is missing and consists of dirt, grass or gravel.

Provide a compliant sidewalk for the missing section.

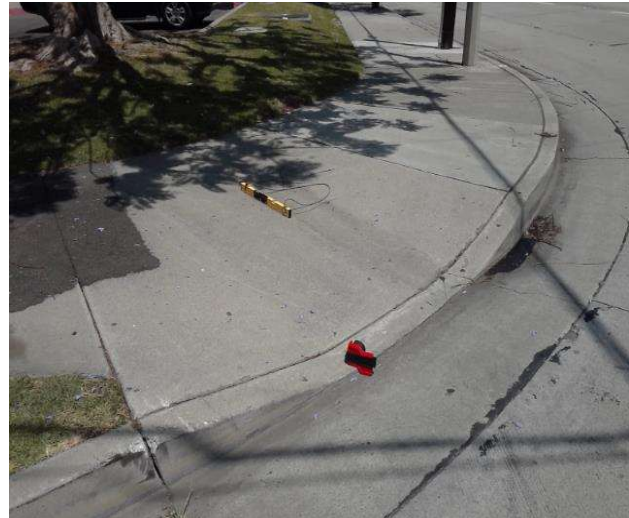
On-Site Finding Not Found

Provide detectable warning to surface \$248

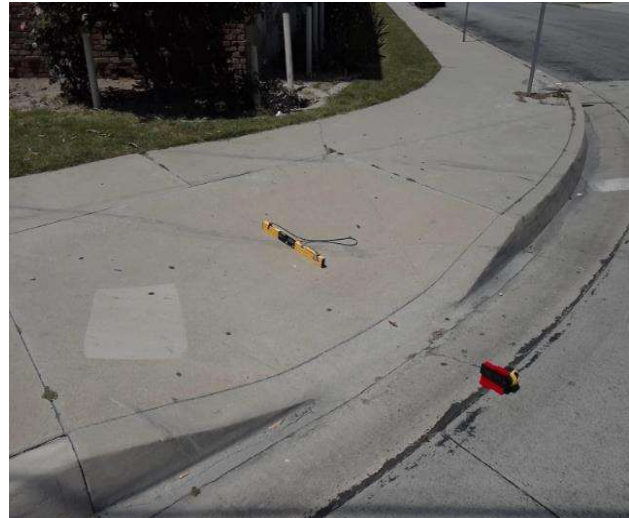
On-Site Finding Not Found

Provide detectable warning to surface \$248

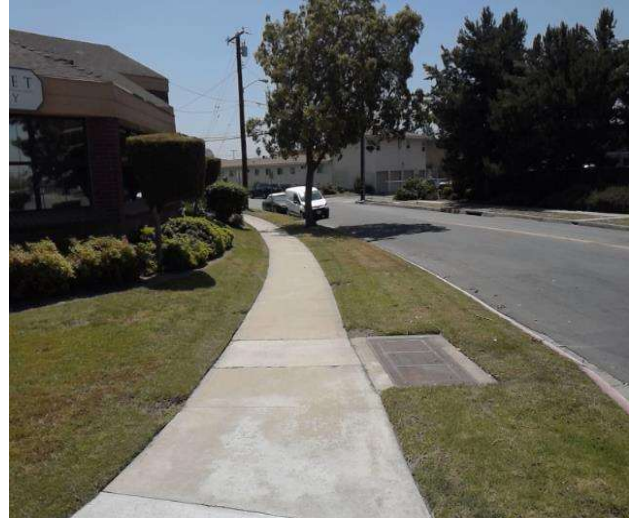
On-Site Finding Not Found

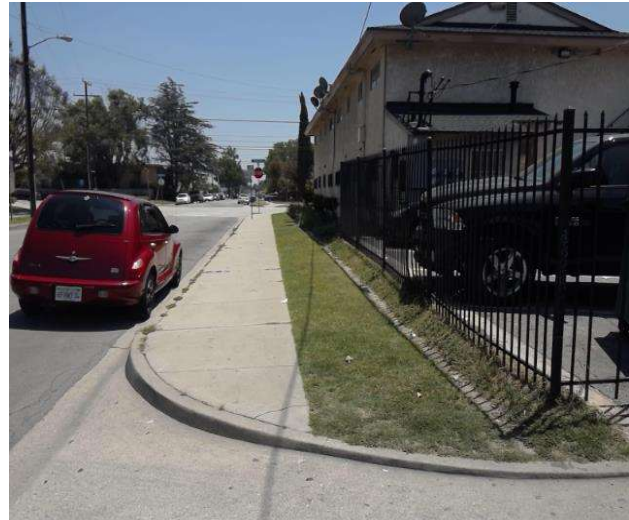
Sidewalks , Hazards & Gratings : Curb is on Path of Travel

Install curb ramp \$2,500

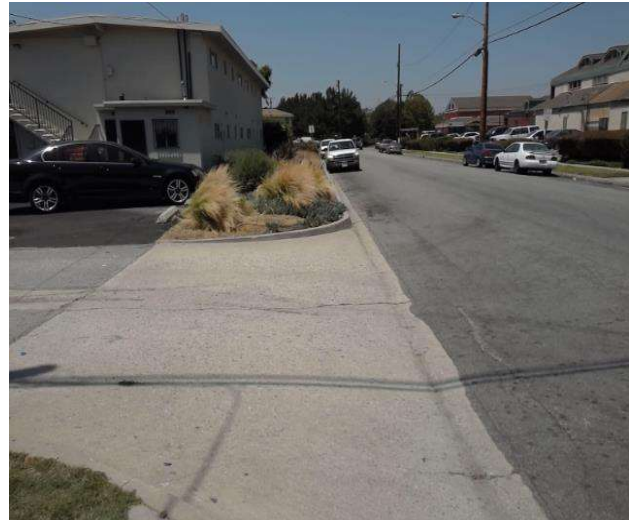
On-Site Finding Not Found

Install compliant detectable warnings \$190

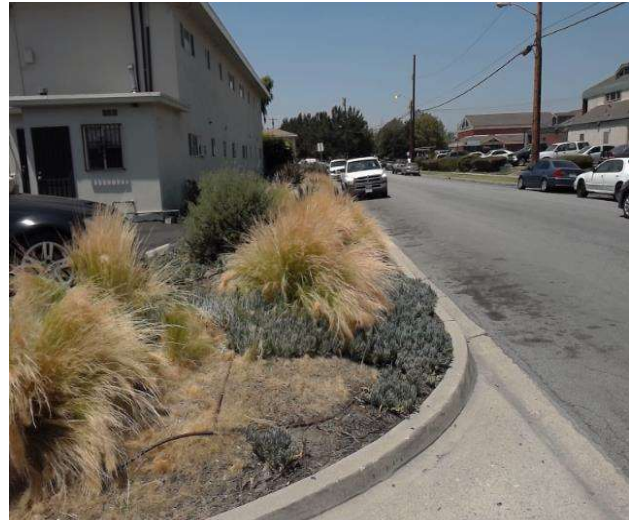
Sidewalks : Missing Sidewalk

Section of sidewalk is missing and consists of dirt, grass or gravel.

Provide a compliant sidewalk for the missing section.

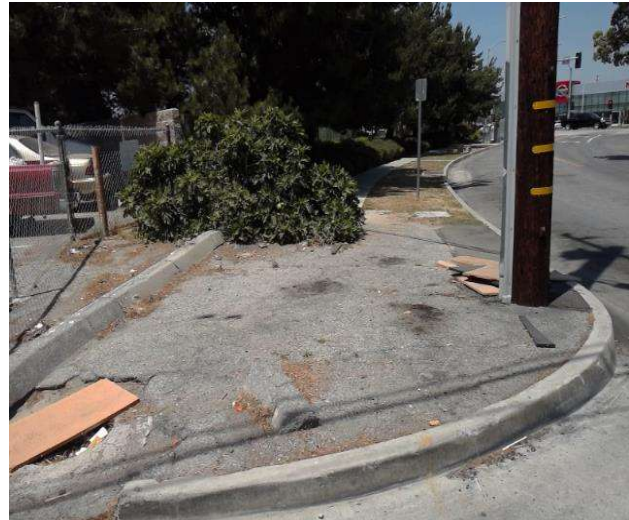
Sidewalks : Missing Sidewalk

Section of sidewalk is missing and consists of dirt, grass or gravel.

Provide a compliant sidewalk for the missing section.

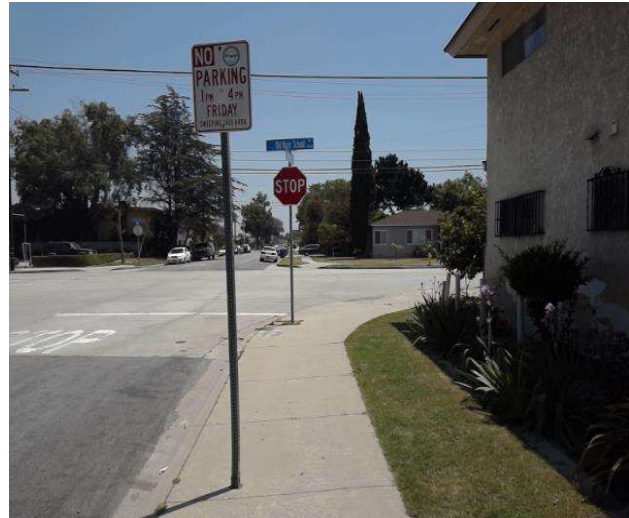
Sidewalks , Hazards & Gratings : Sidewalk Width at Obstruction

Sidewalk width at the obstruction shall have the recommended value.

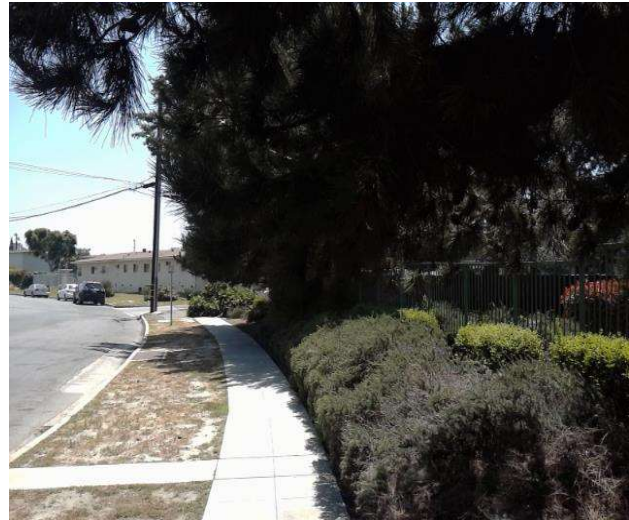
Sidewalks , Hazards & Gratings : Overhead Obstruction Height

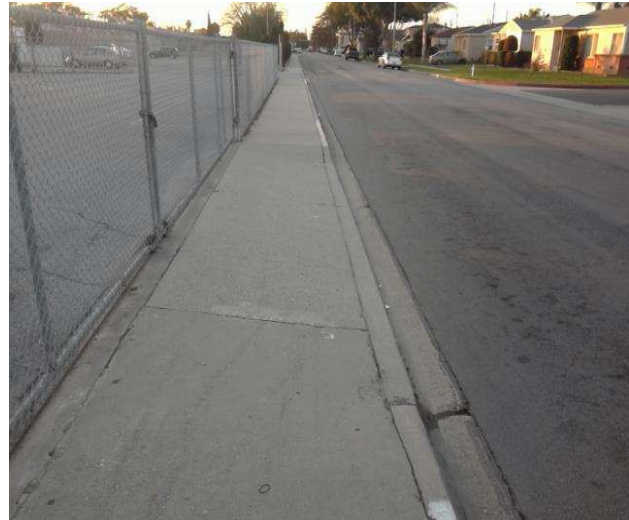
Recommendation Up to 2.08 percent

Repave surface \$1,092

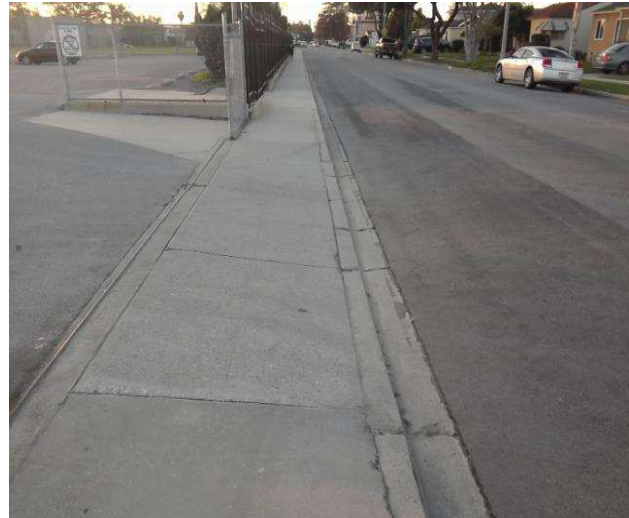
On-Site Finding Not Found

Install compliant detectable warnings \$190

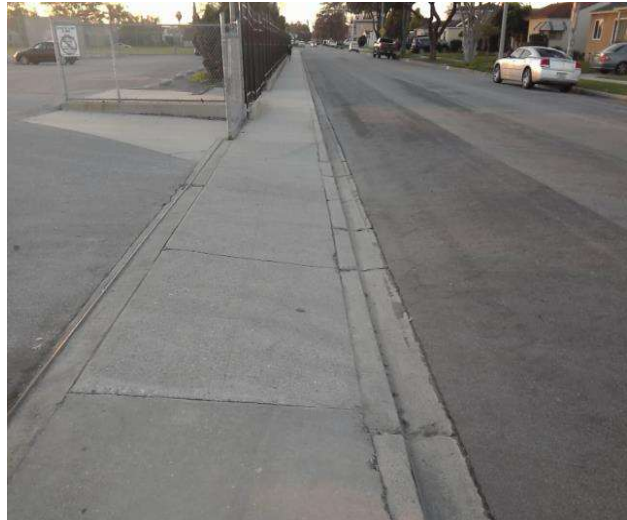
Recommendation Up to 2.08 percent

Repave surface \$1,092

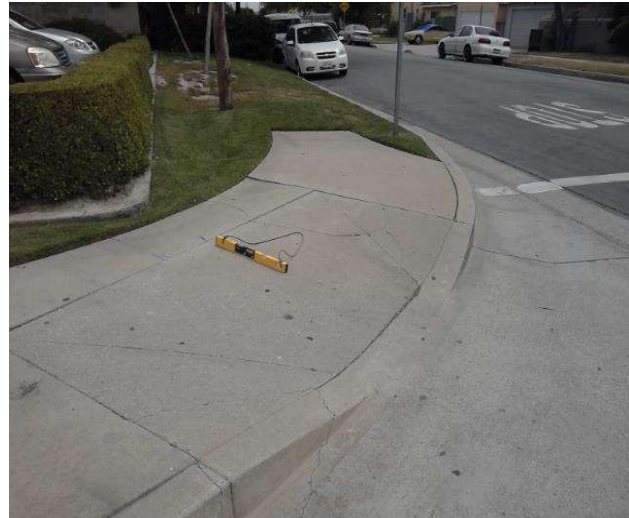
On-Site Finding Not Found

Provide detectable warning to surface \$248

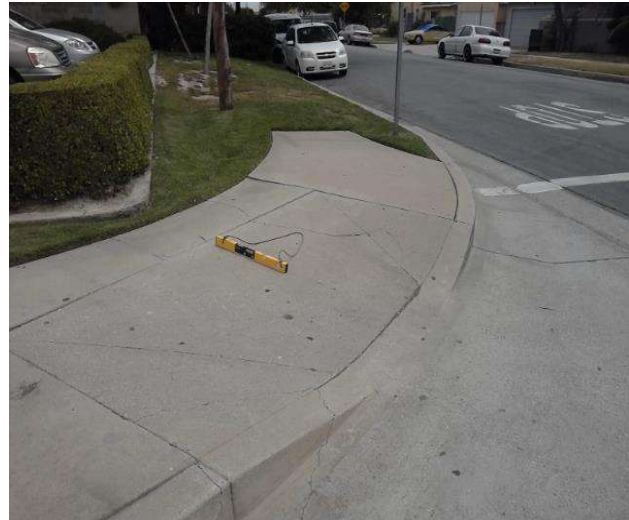
Recommendation Up to 10.00 percent

Install flared sides \$1,300

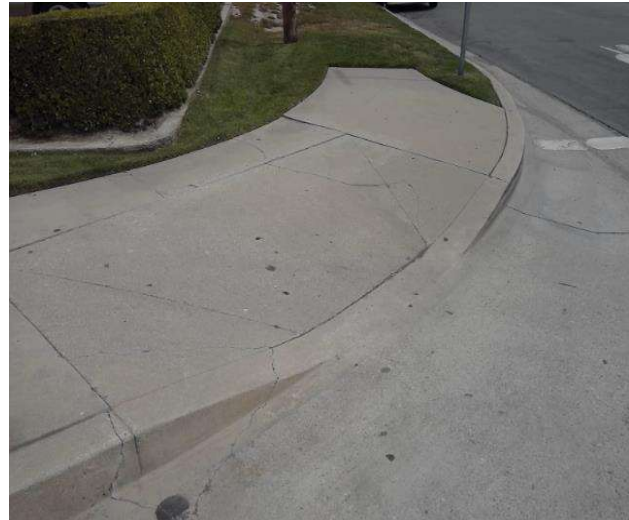
Recommendation At least 48.00 inches

Provide compliant landing \$240

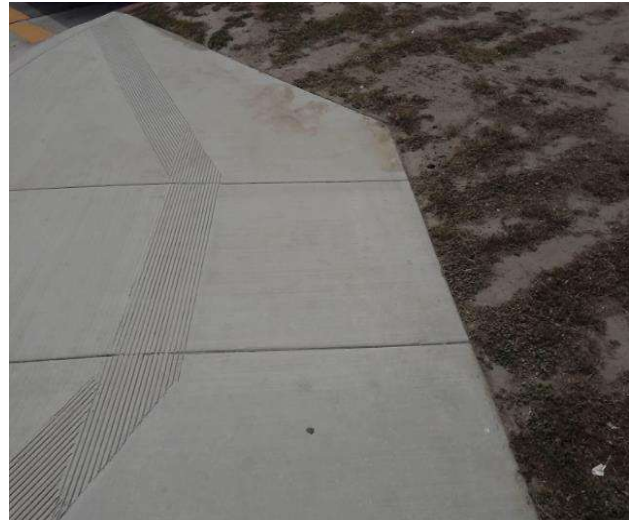
Recommendation At least 48.00 inches

Provide compliant landing \$255

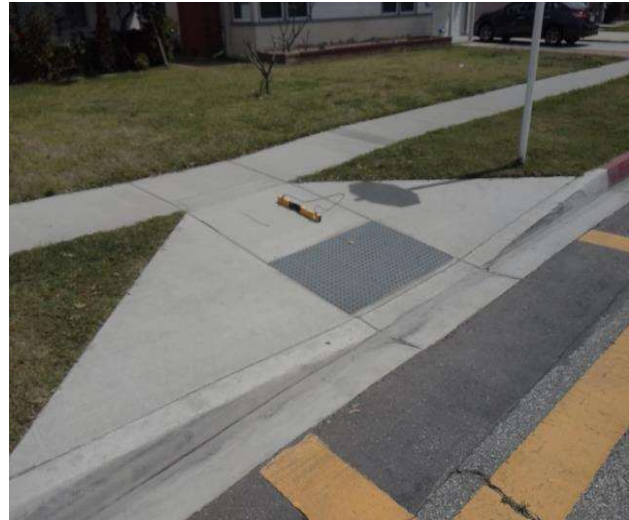
Recommendation Up to 8.33 percent

Install curb ramp \$1,300

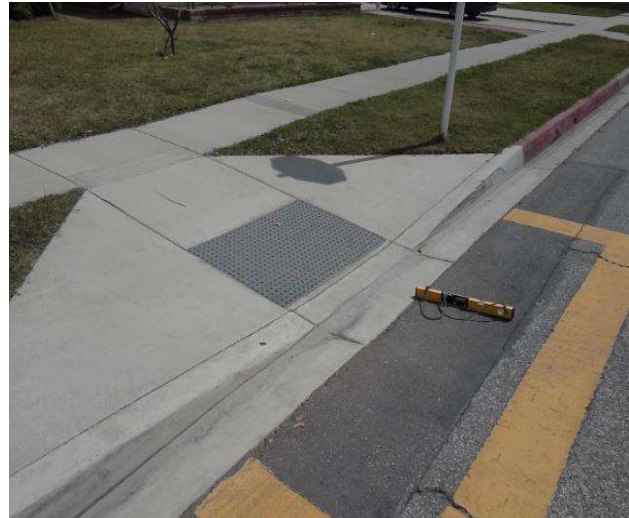
Recommendation Up to 5.00 percent

Repave landing \$1,260

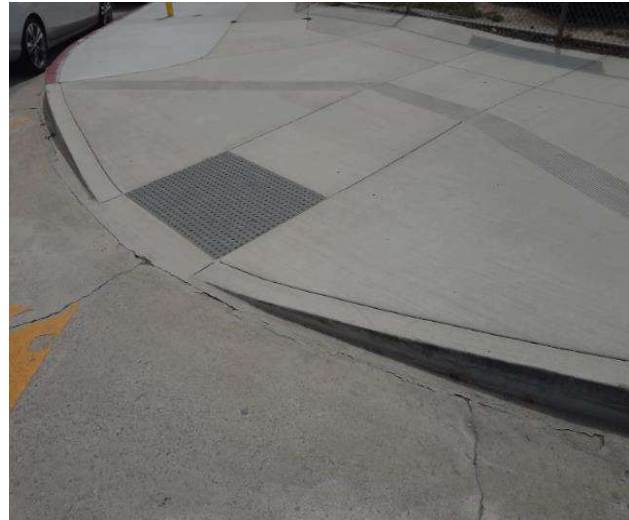
Recommendation At least 48.00 inches

Provide compliant landing \$255

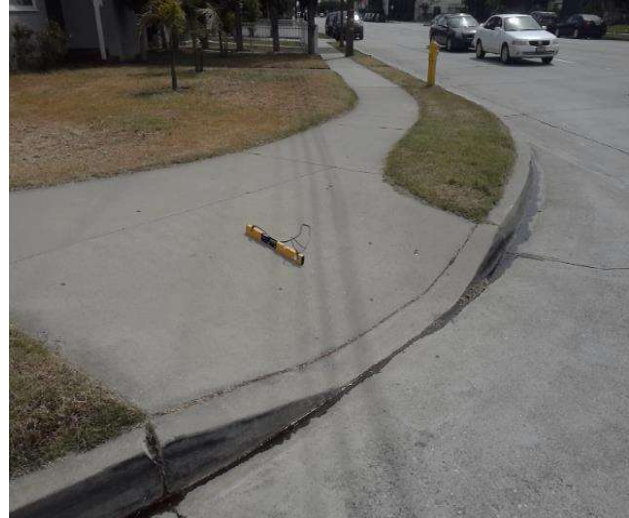
On-Site Finding Not Found

Provide detectable warning to surface \$248

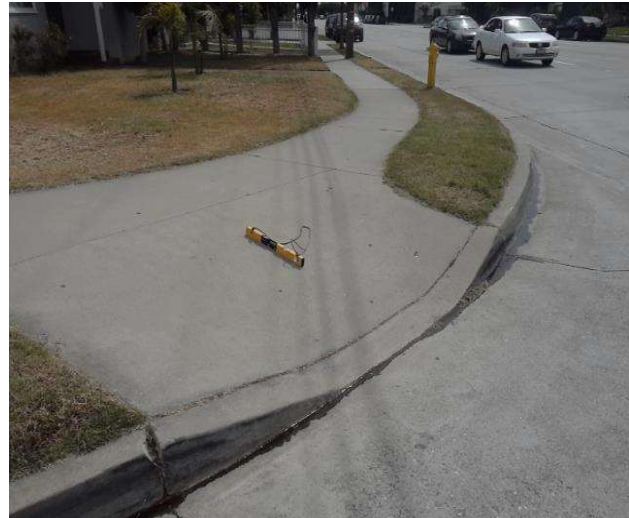
Recommendation At least 48.00 inches

Install curb ramp \$1,300

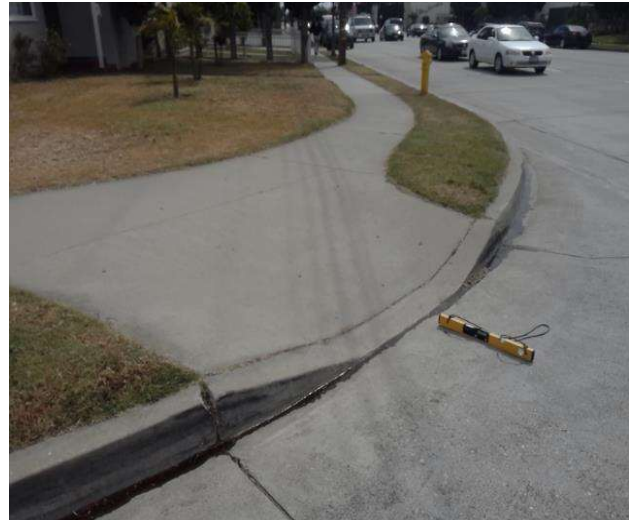
Recommendation Up to 5.00 percent

Repave landing \$1,260

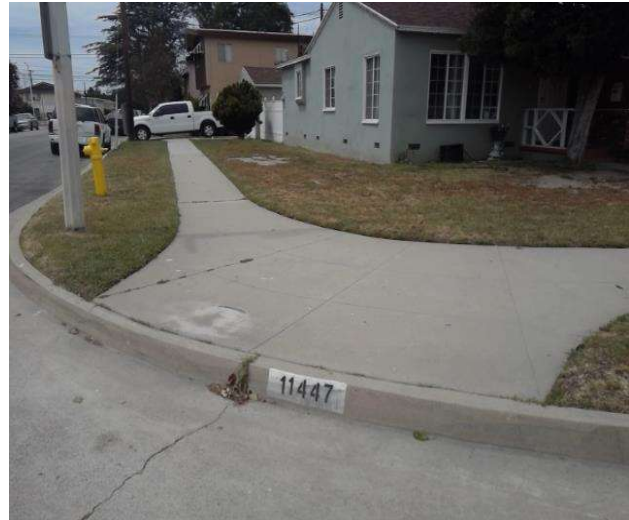
Sidewalks , Hazards & Gratings : Curb is on Path of Travel

Install curb ramp \$2,500

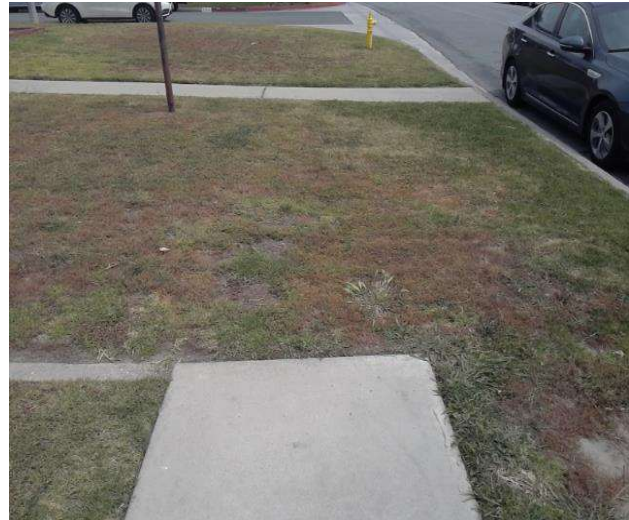
Sidewalks : Missing Sidewalk

Section of sidewalk is missing and consists of dirt, grass or gravel.

Provide a compliant sidewalk for the missing section.

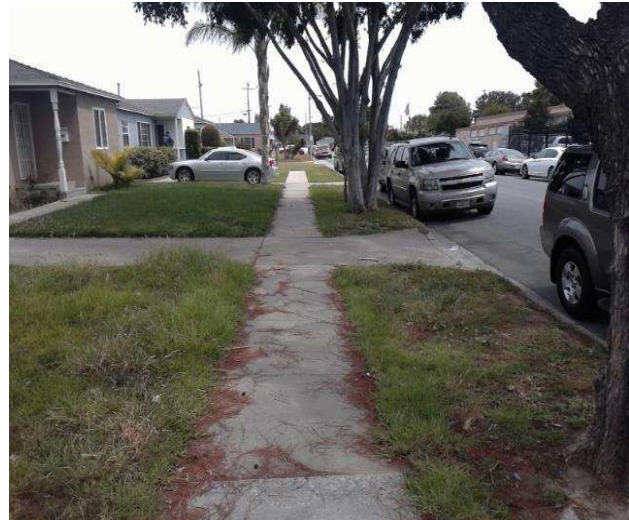
Recommendation Up to 2.08 percent

Repave the sidewalk surface with the recommended cross slope.

Repave surface \$1,092

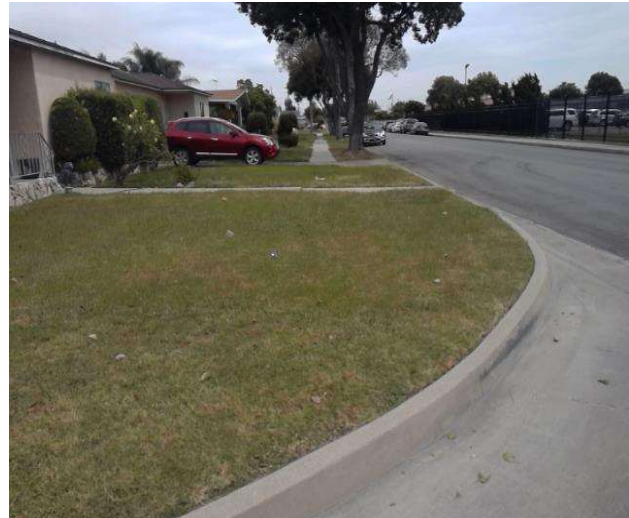
Sidewalks : Missing Sidewalk

Section of sidewalk is missing and consists of dirt, grass or gravel.

Provide a compliant sidewalk for the missing section.

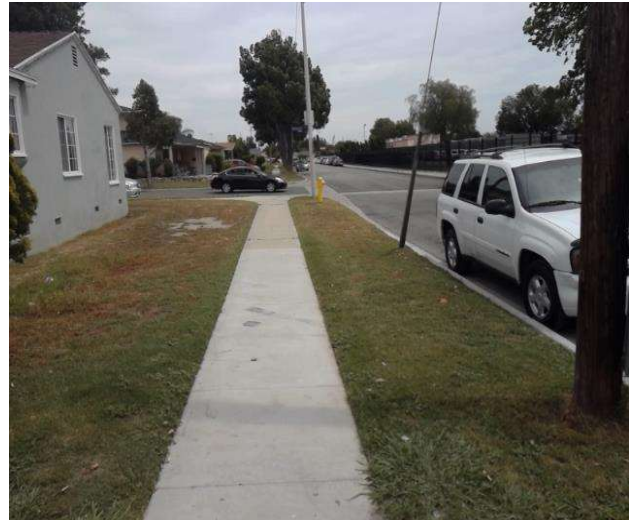
Recommendation Up to 2.08 percent

Repave the sidewalk surface with the recommended cross slope.

Repave surface \$1,092

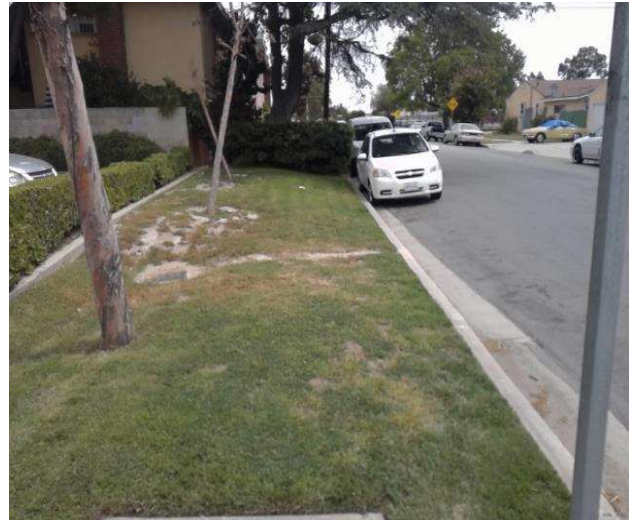
Sidewalks : Missing Sidewalk

Section of sidewalk is missing and consists of dirt, grass or gravel.

Provide a compliant sidewalk for the missing section.

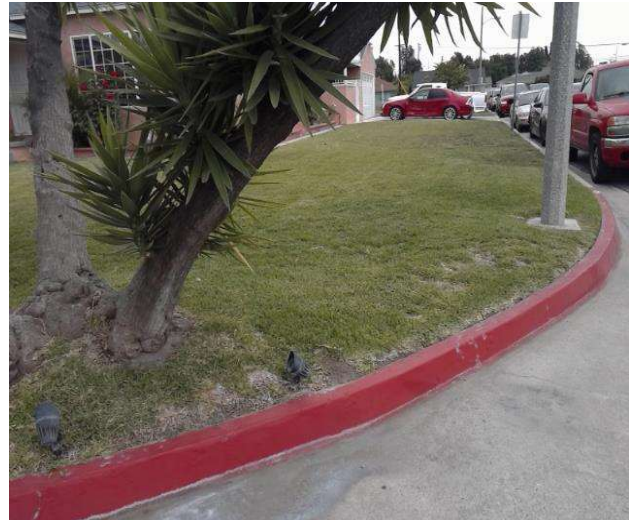
Sidewalks : Missing Sidewalk

Section of sidewalk is missing and consists of dirt, grass or gravel.

Provide a compliant sidewalk for the missing section.

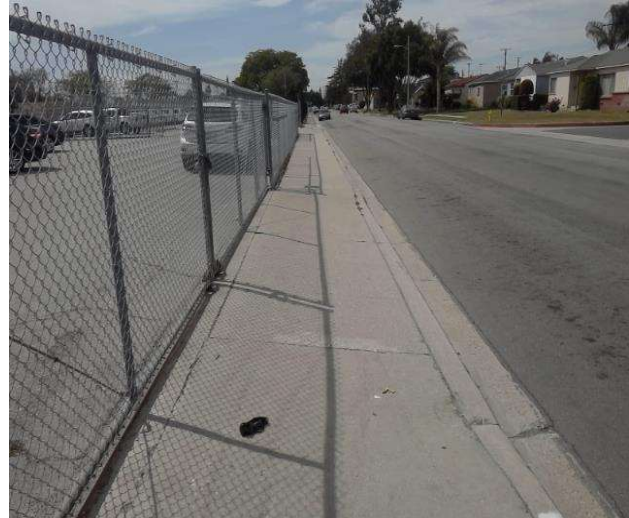
On-Site Finding Not Found

Install compliant detectable warnings \$190

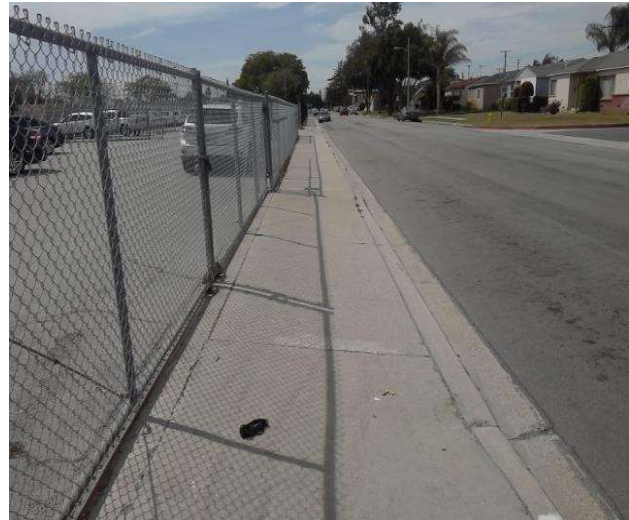
Recommendation Up to 2.08 percent

Repave surface \$1,092

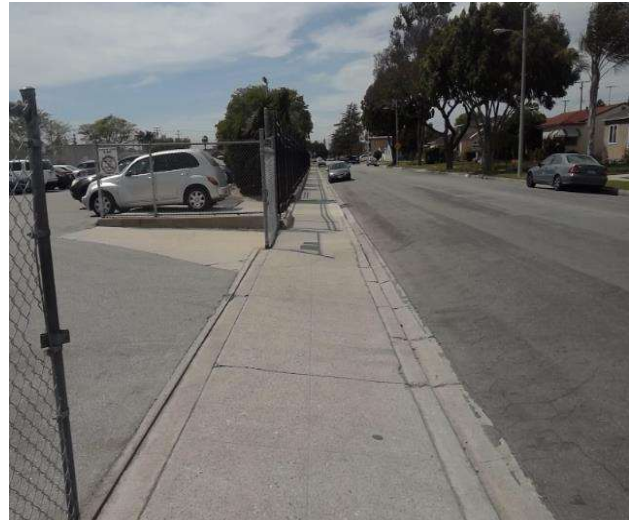
On-Site Finding Not Found

Install compliant detectable warnings \$190

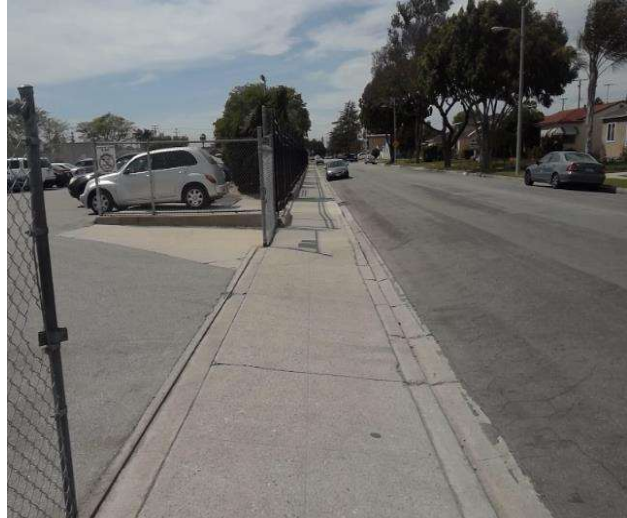
Recommendation Up to 2.08 percent

Repave surface \$1,092

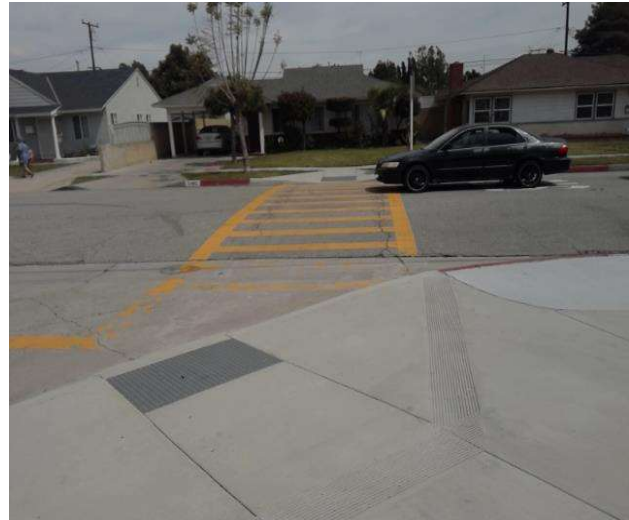
Recommendation Up to 5.00 percent

Repave surface \$1,092

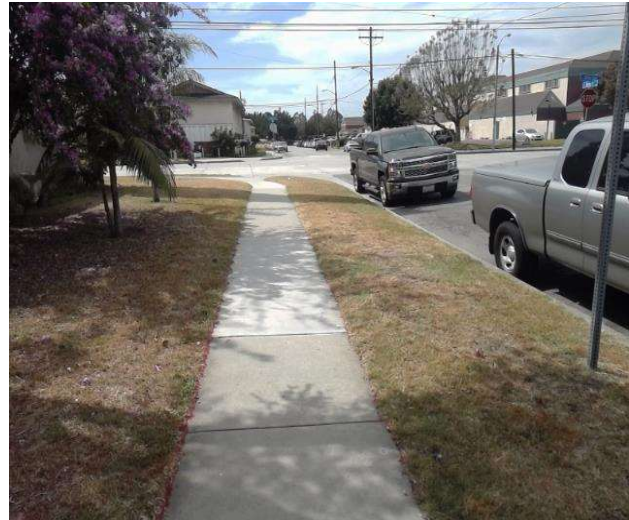
Recommendation At least 48.00 inches

Widen the sidewalk to the recommended value.

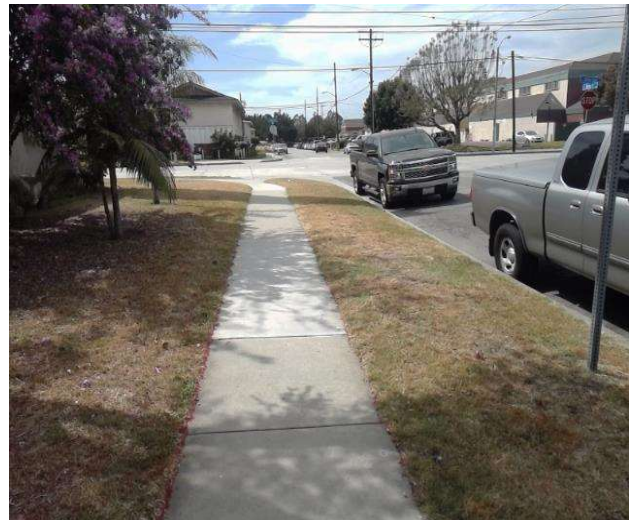
Recommendation Up to 2.08 percent

Repave the sidewalk surface with the recommended cross slope.

Repave surface \$1,092

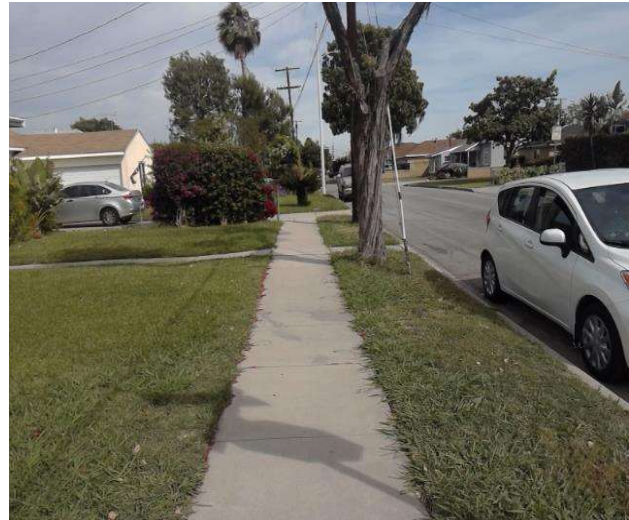
On-Site Finding Not Found

Recommendation See Recommendation

\$2,400

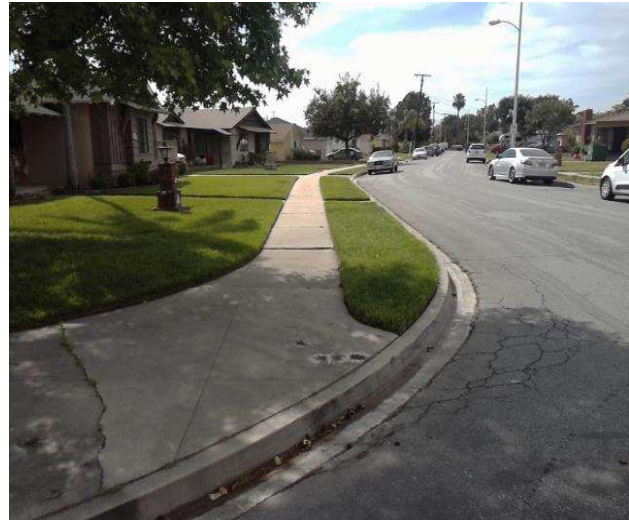
Sidewalks , Hazards & Gratings : Curb is on Path of Travel

Recommendation See Recommendation

Install curb ramp \$2,500

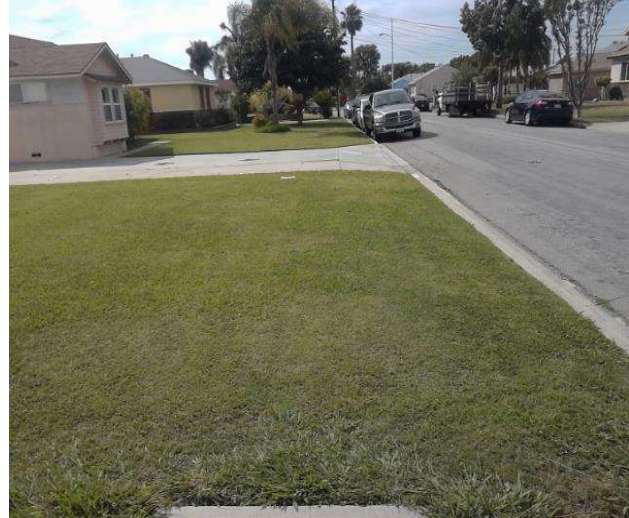
Sidewalks : Missing Sidewalk

Section of sidewalk is missing and consists of dirt, grass or gravel.

Provide a compliant sidewalk for the missing section.

\$1,260

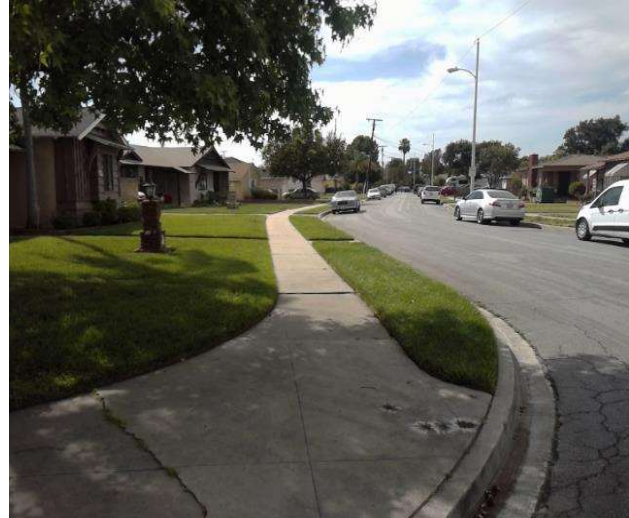
On-Site Finding Not Found

Recommendation See Recommendation

\$2,400

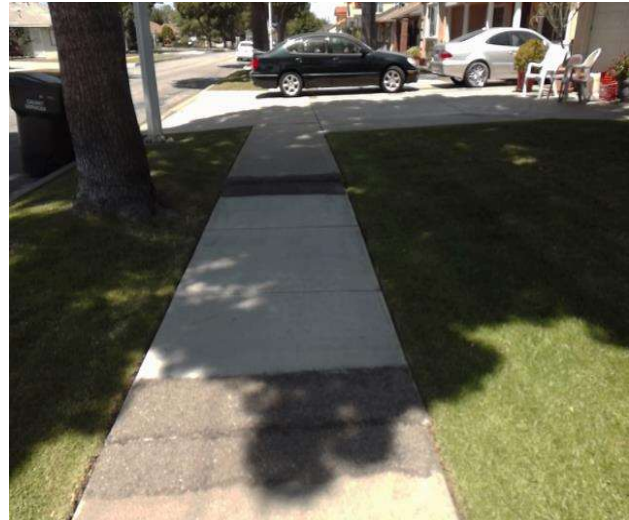
Notes : Surface is rough and uneven.

Repave surface \$1,184
