# Accessibility Survey

## City of Downey Brookshire Avenue & Civic Center Drive

Brookshire Avenue & Civic Center Drive  
Downey, CA 90240

Date of Inspection  
5/25/2017

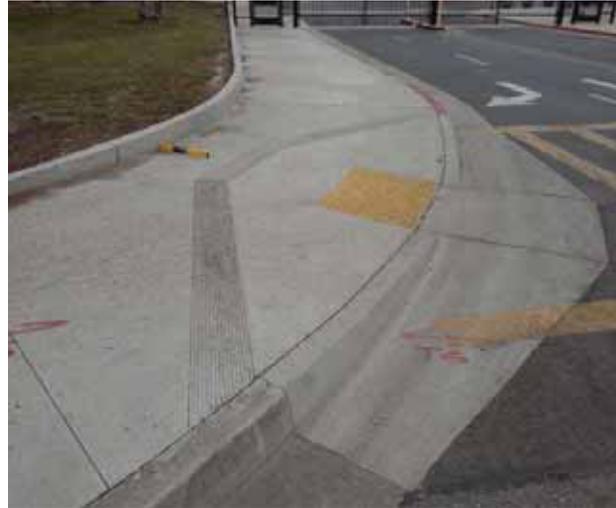
**Northeast Corner of Civic Center Drive @ 33.939946523095, - 118.128165006638**

Curb Ramp , Landings and Transitions : Top Landing Slope

The slope at the top landing is greater than allowed.

**On-Site Finding** 2.80 percent

Provide a top landing surface that does not exceed the maximum slope and cross slope. Provide a sufficient maneuvering clearance that does not accumulate water.

Recommendation Up to 2.08 percent

Provide compliant landing \$1,260

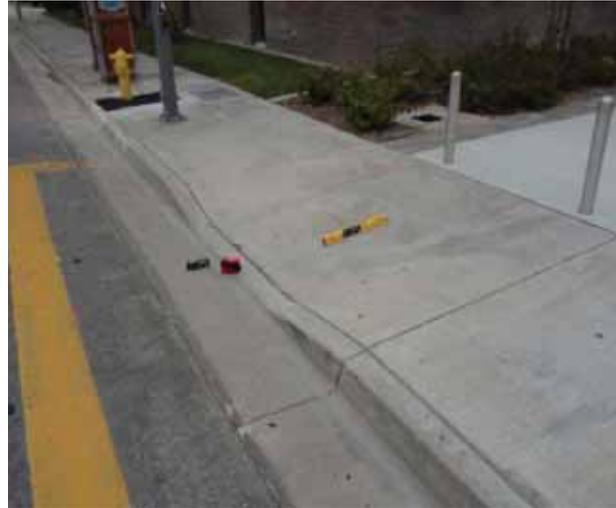
**On-Site Finding** Not Found

Provide detectable warning to surface \$248

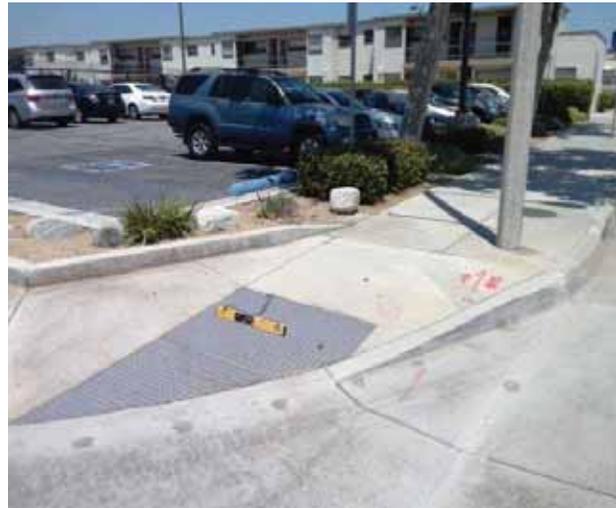
**On-Site Finding** Not Found

Install crosswalk \$800

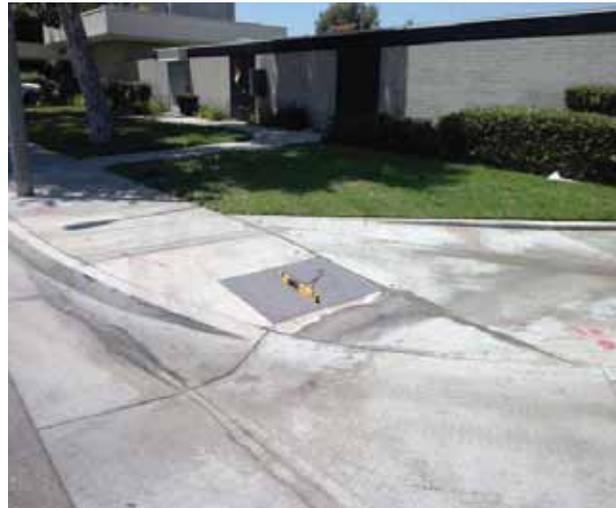
**On-Site Finding** Not Found

Install crosswalk \$800

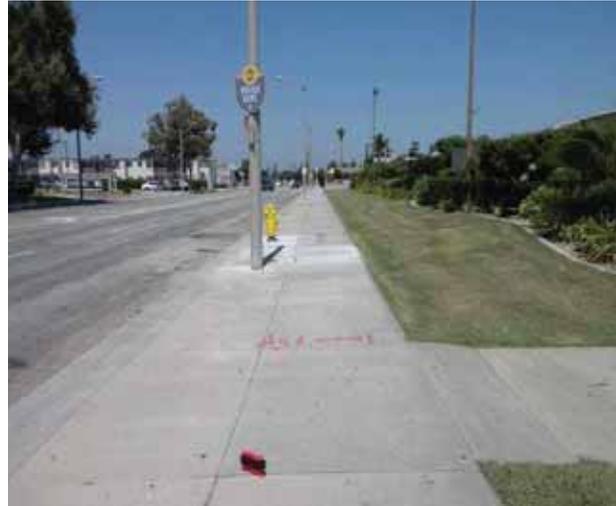
There is a change in elevation greater than recommended value.

Ensure that the change in elevation is within the recommended value.

Recommendation Up to 0.25 inches

Remove tripping hazards \$198

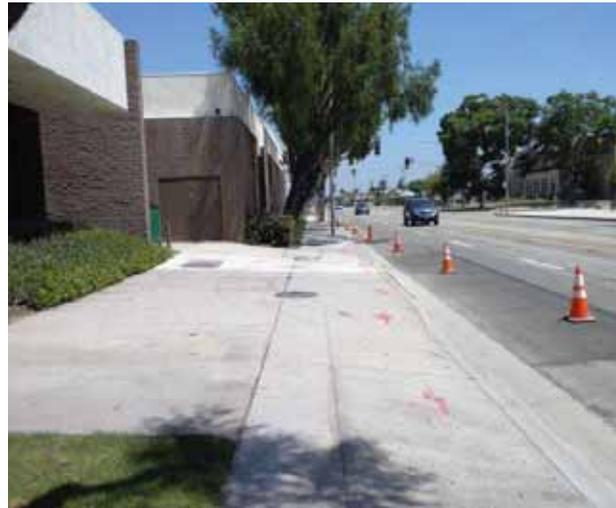
**On-Site Finding** Not Found

Install compliant detectable warnings \$190

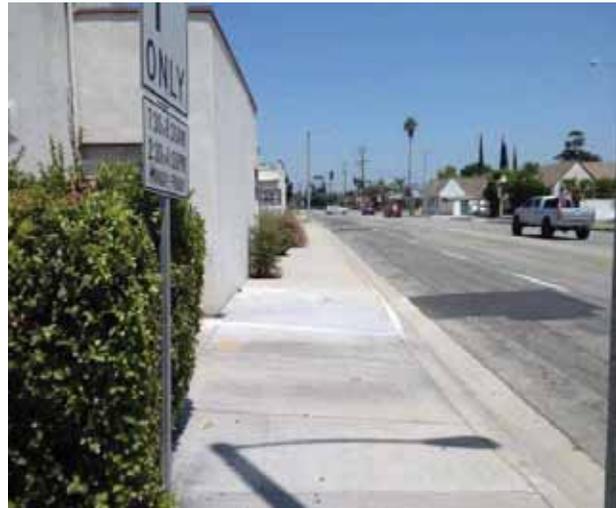
**On-Site Finding** Not Found

Install compliant detectable warnings \$190

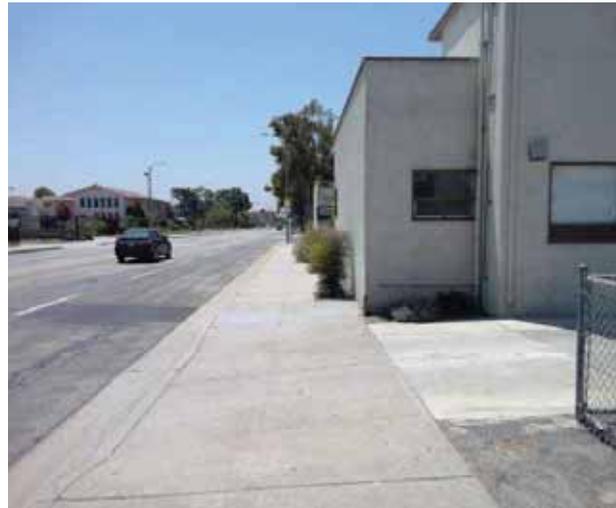
**On-Site Finding** Not Found

Install compliant detectable warnings \$190

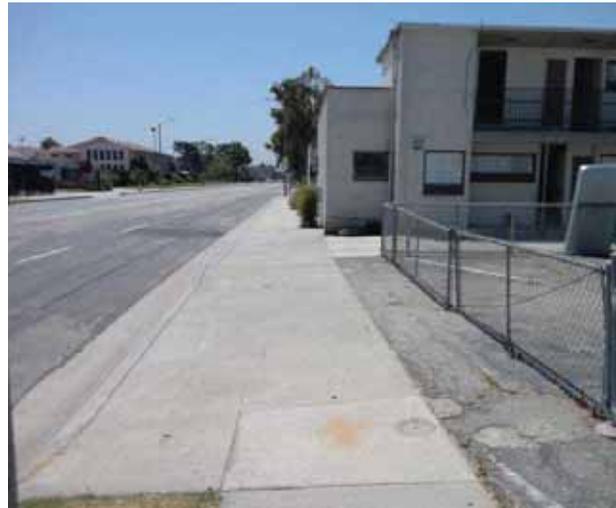
**On-Site Finding** Not Found

Install compliant detectable warnings \$190

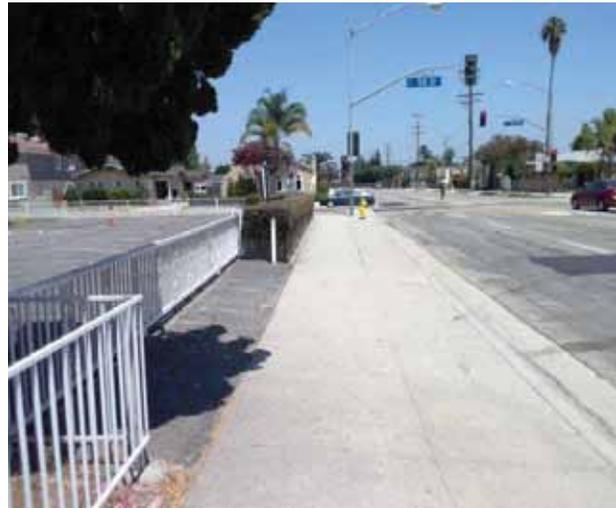
**On-Site Finding** Not Found

Install compliant detectable warnings \$190

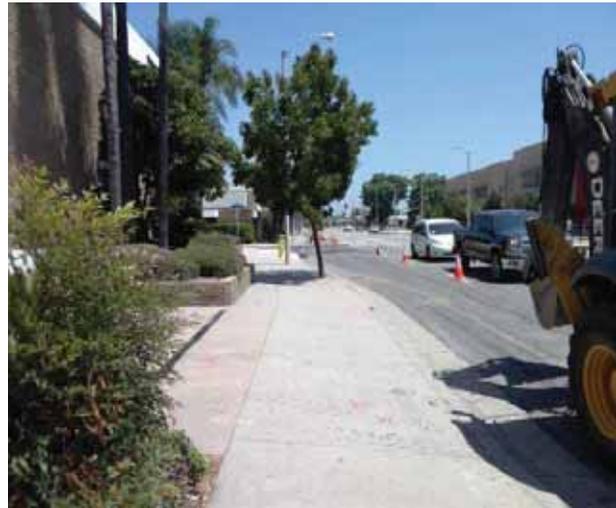
**On-Site Finding** Not Found

Install compliant detectable warnings \$190

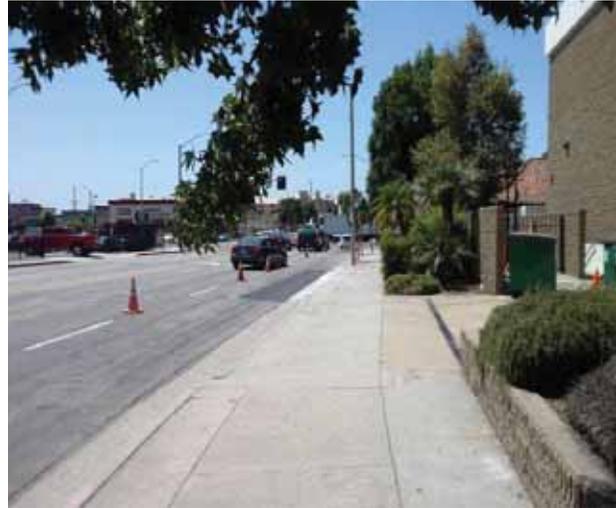
Sidewalks , Hazards & Gratings : Overhead Obstruction Height

Recommendation At least 80.00 inches

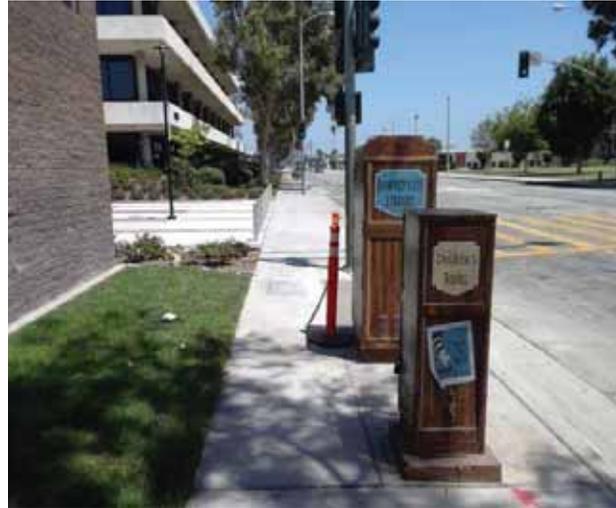
Sidewalks , Hazards & Gratings : Sidewalk Width at Obstruction

Sidewalk width at the obstruction shall have the recommended value.

Recommendation At least 48.00 inches

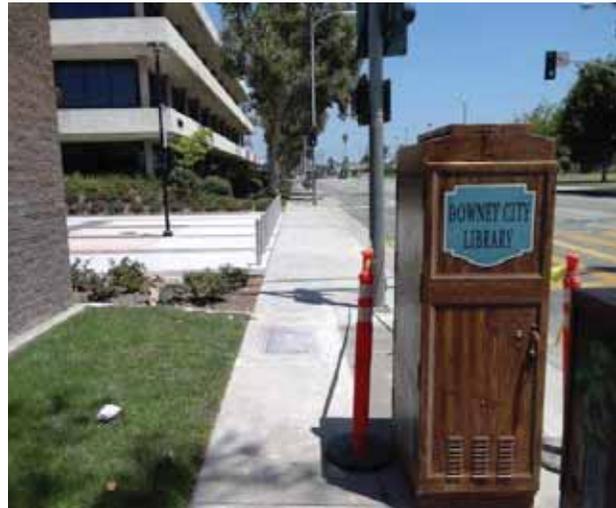
Sidewalks , Hazards & Gratings : Sidewalk Width at Obstruction

Sidewalk width at the obstruction shall have the recommended value.

Recommendation At least 48.00 inches

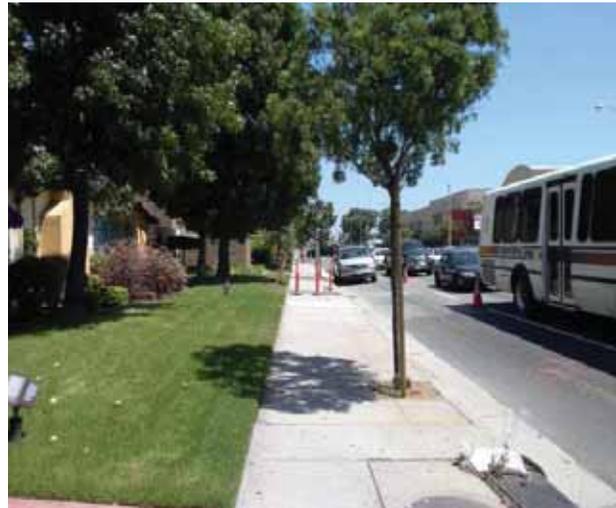
**On-Site Finding** Not Found

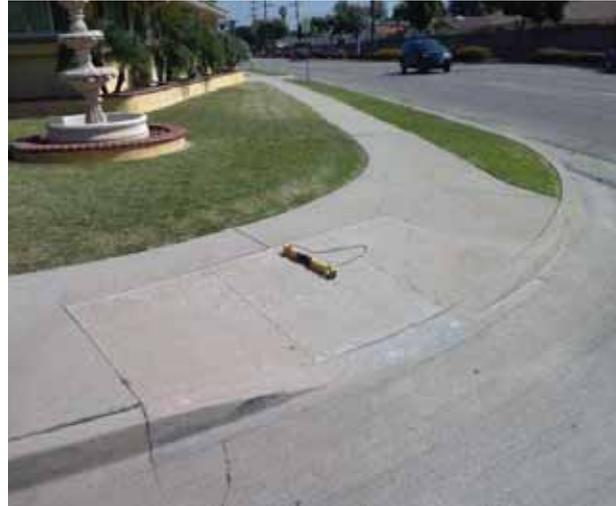
**On-Site Finding** Not Found

Provide detectable warning to surface \$248

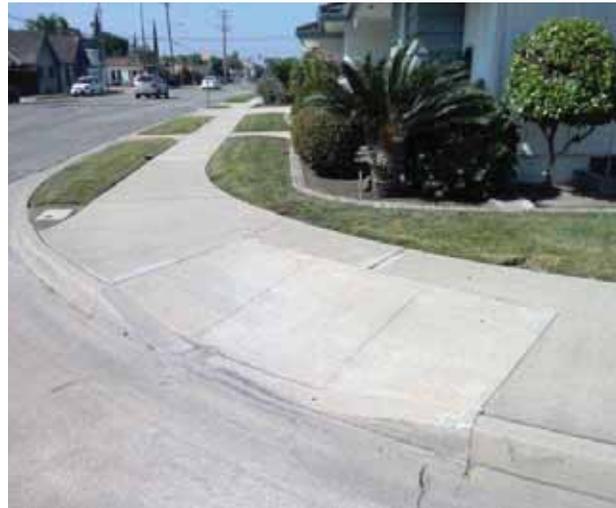
**On-Site Finding** Not Found

Provide detectable warning to surface \$248

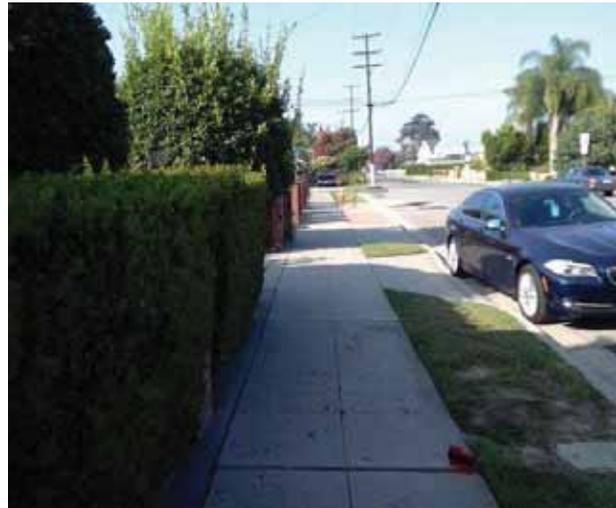
There is a change in elevation greater than recommended value.

Ensure that the change in elevation is within the recommended value.

Remove tripping hazards \$198

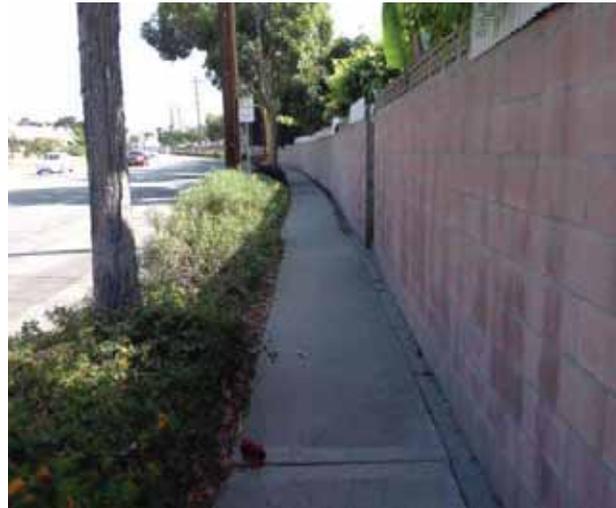
There is a change in elevation greater than recommended value.

Ensure that the change in elevation is within the recommended value.

Remove tripping hazards \$198

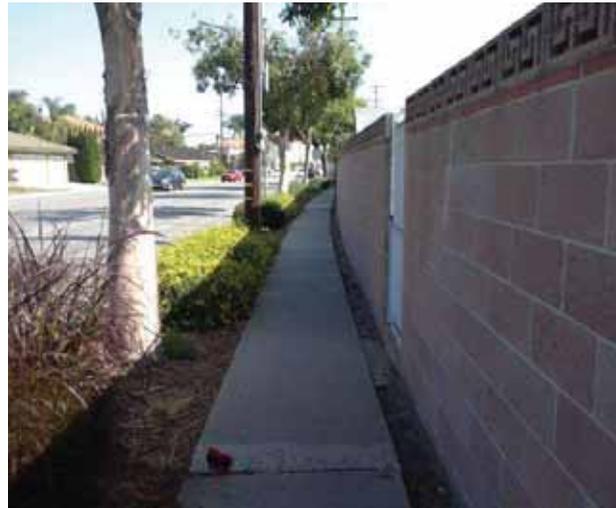
There is a change in elevation greater than recommended value.

Ensure that the change in elevation is within the recommended value.

Remove tripping hazards \$198

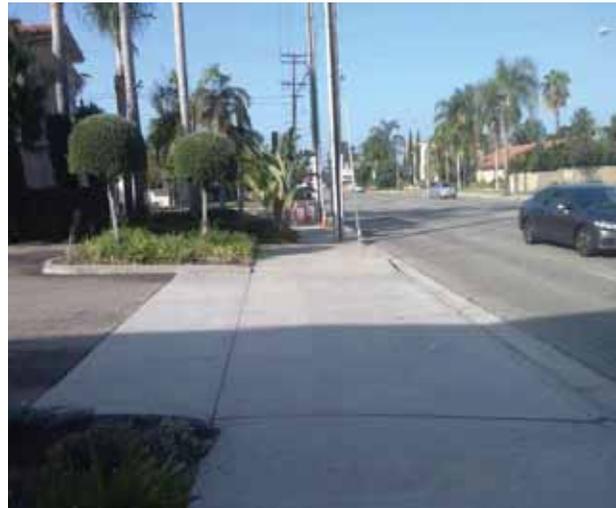
**On-Site Finding** Not Found

Install compliant detectable warnings \$190

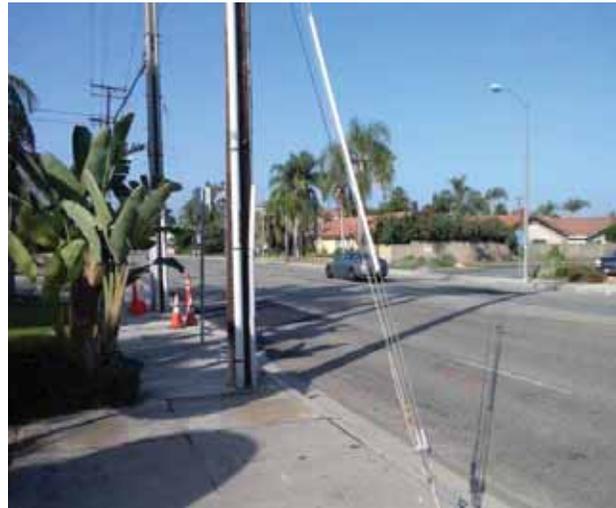
Sidewalks , Hazards & Gratings : Overhead Obstruction Height

Recommendation At least 80.00 inches

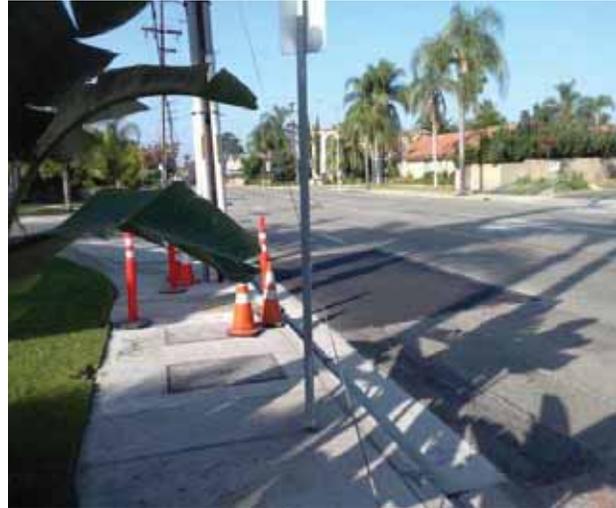
Sidewalks , Hazards & Gratings : Overhead Obstruction Height

Recommendation At least 80.00 inches

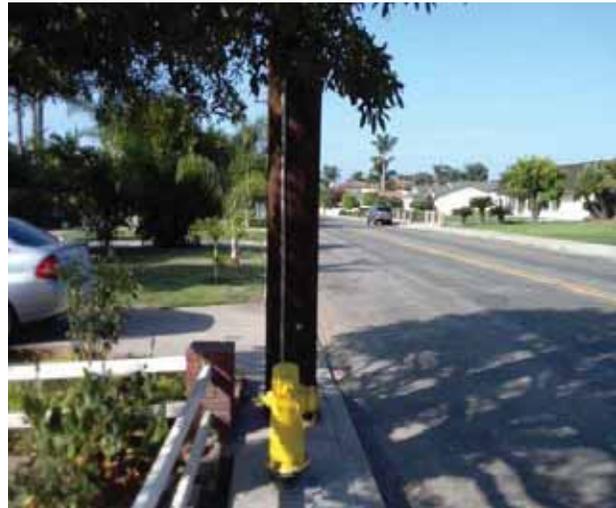
Sidewalks , Hazards & Gratings : Sidewalk Width at Obstruction

Sidewalk width at the obstruction shall have the recommended value.

Recommendation At least 48.00 inches

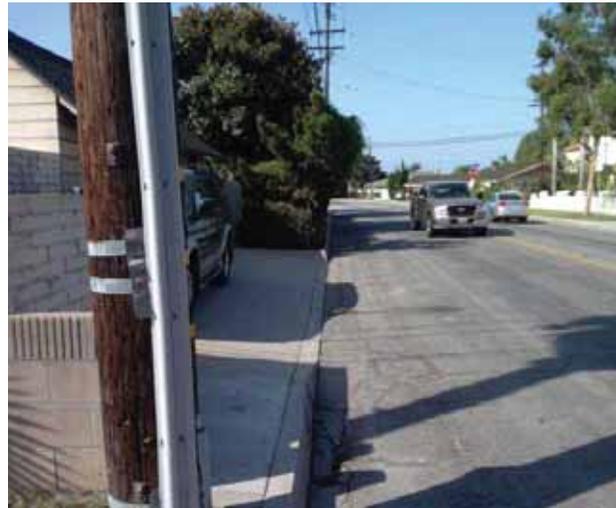
Sidewalks : Missing Sidewalk

Section of sidewalk is missing and consists of dirt, grass or gravel.

Provide a compliant sidewalk for the missing section.

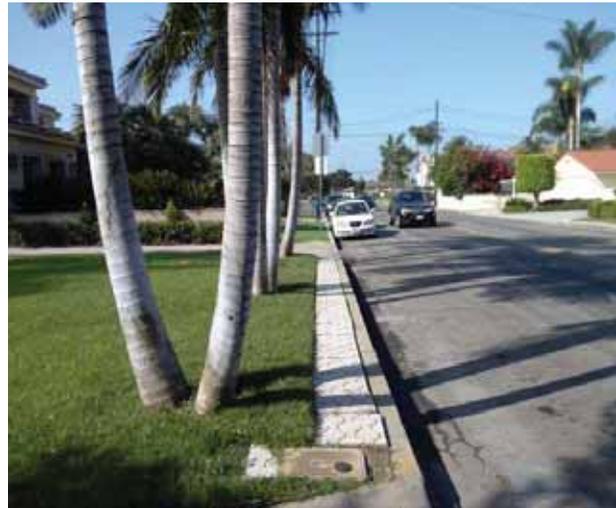
Sidewalks : Missing Sidewalk

Section of sidewalk is missing and consists of dirt, grass or gravel.

Provide a compliant sidewalk for the missing section.

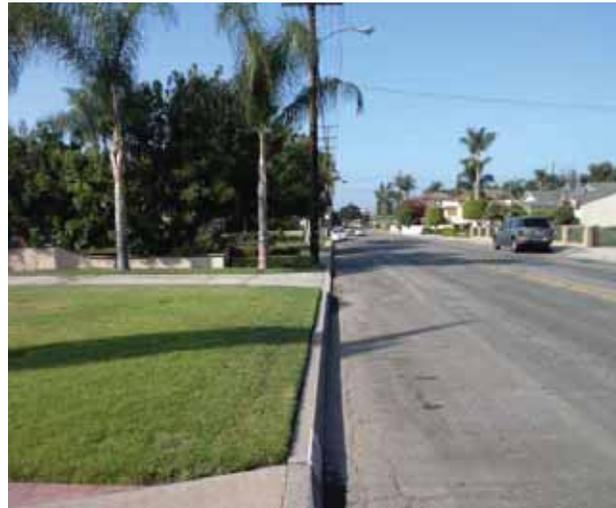
Sidewalks : Missing Sidewalk

Section of sidewalk is missing and consists of dirt, grass or gravel.

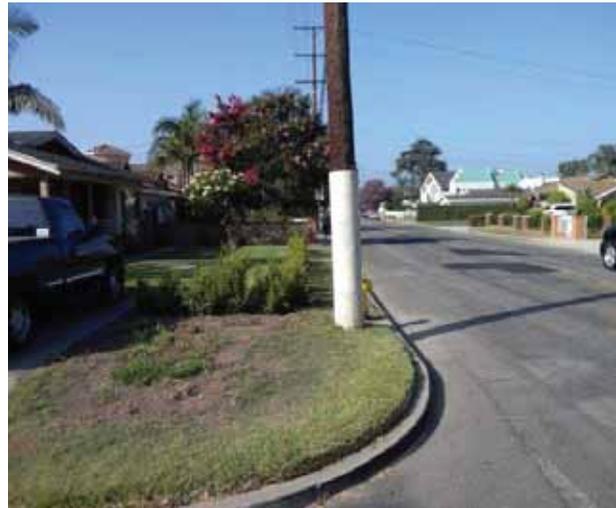
Sidewalks : Missing Sidewalk

Section of sidewalk is missing and consists of dirt, grass or gravel.

Provide a compliant sidewalk for the missing section.

\$1,260

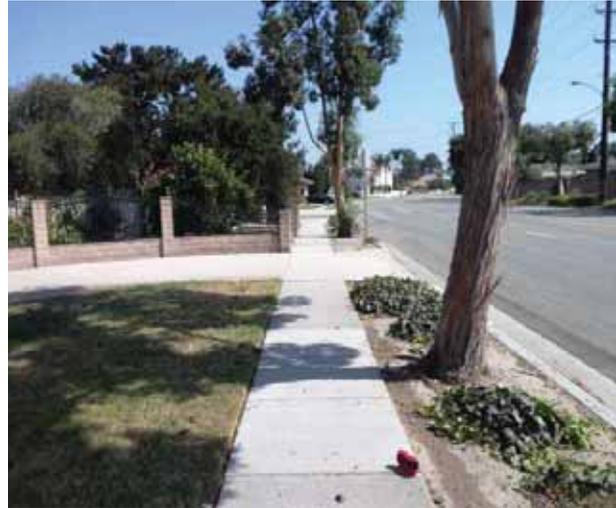
There is a change in elevation greater than recommended value.

Ensure that the change in elevation is within the recommended value.

Recommendation Up to 0.25 inches

Remove tripping hazards \$198

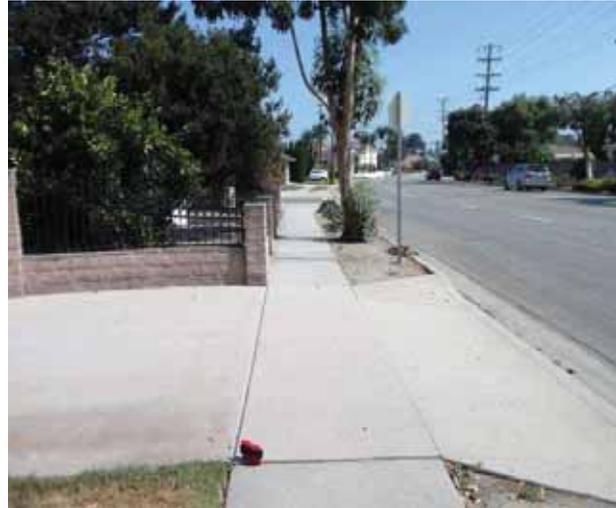
There is a change in elevation greater than recommended value.

Ensure that the change in elevation is within the recommended value.

Recommendation Up to 0.25 inches

Remove tripping hazards \$198

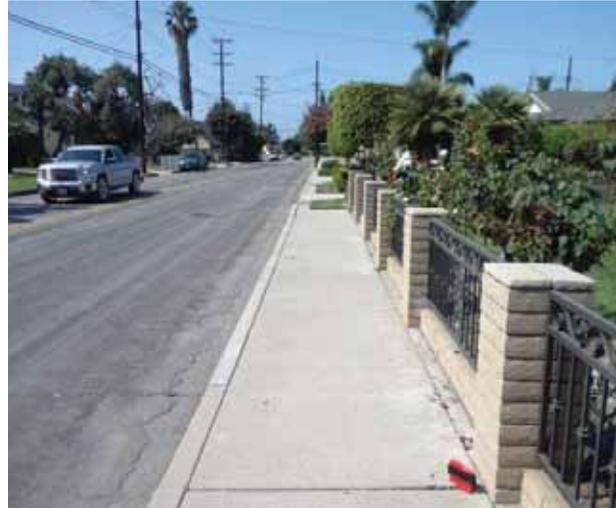
There is a change in elevation greater than recommended value.

Ensure that the change in elevation is within the recommended value.

Recommendation Up to 0.25 inches

Remove tripping hazards \$198

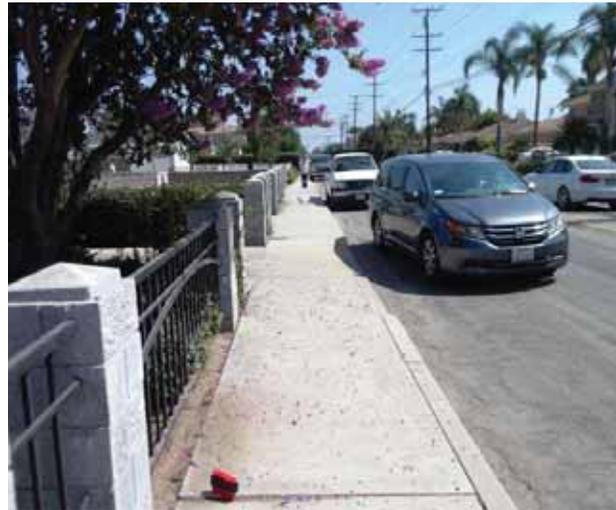
There is a change in elevation greater than recommended value.

Ensure that the change in elevation is within the recommended value.

Recommendation Up to 0.25 inches

Remove tripping hazards \$198

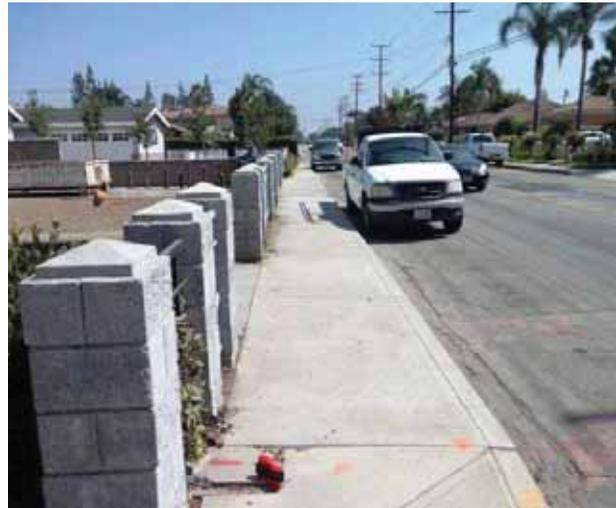
There is a change in elevation greater than recommended value.

Ensure that the change in elevation is within the recommended value.

Recommendation Up to 0.25 inches

Remove tripping hazards \$198

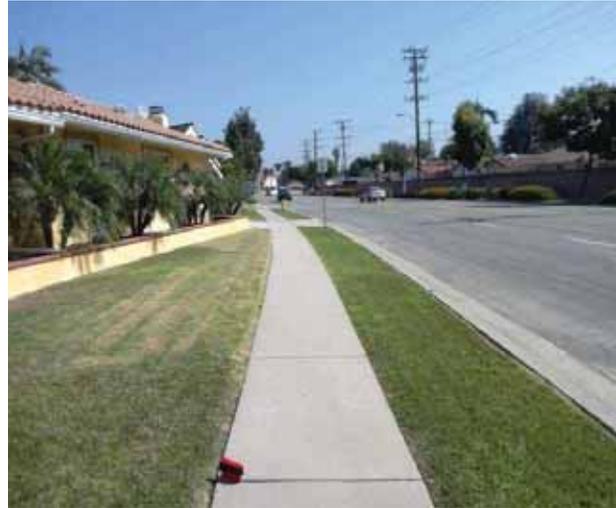
There is a change in elevation greater than recommended value.

Ensure that the change in elevation is within the recommended value.

Recommendation Up to 0.25 inches

Remove tripping hazards \$198

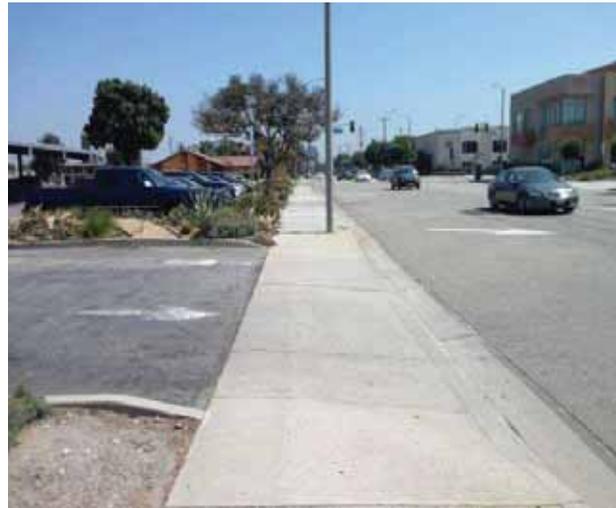
**On-Site Finding** Not Found

Install compliant detectable warnings \$190

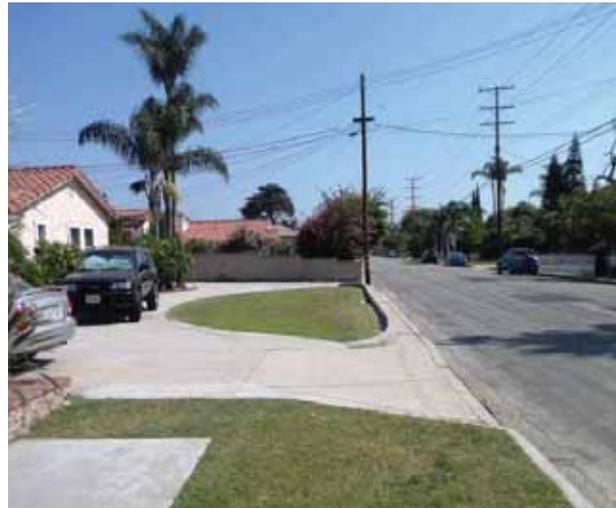
Sidewalks : Missing Sidewalk

Section of sidewalk is missing and consists of dirt, grass or gravel.

Provide a compliant sidewalk for the missing section.

\$1,260

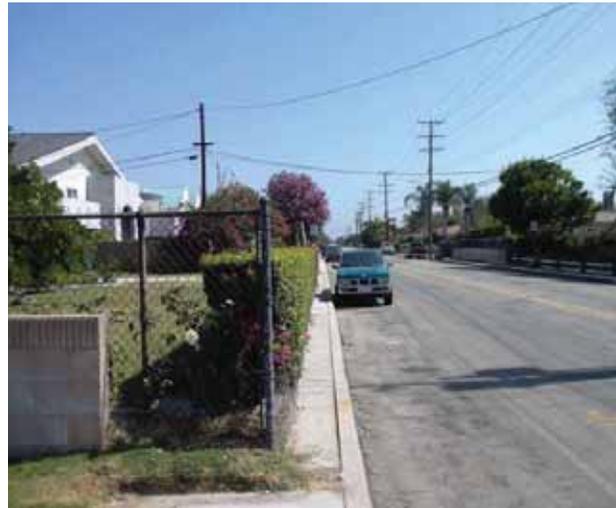
Sidewalks : Missing Sidewalk

Section of sidewalk is missing and consists of dirt, grass or gravel.

Provide a compliant sidewalk for the missing section.

\$1,260

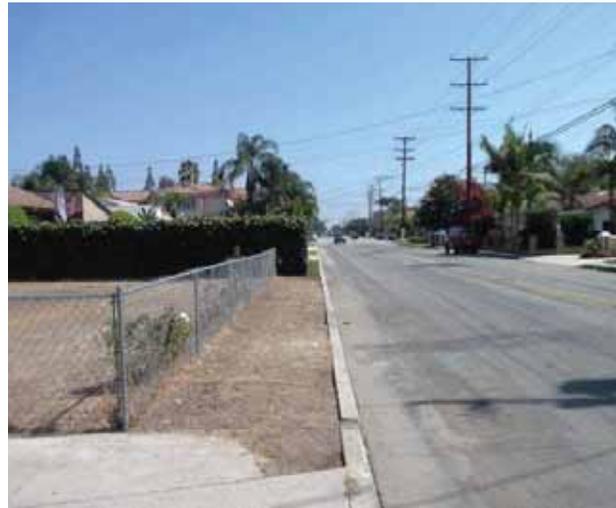
Sidewalks : Missing Sidewalk

Section of sidewalk is missing and consists of dirt, grass or gravel.

Provide a compliant sidewalk for the missing section.

\$1,260

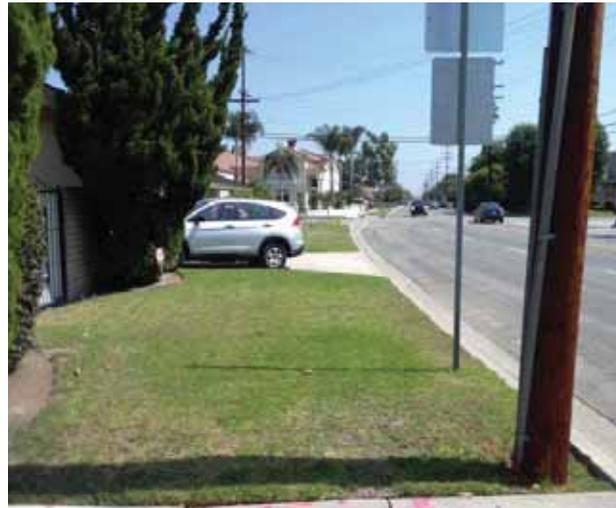
Sidewalks : Missing Sidewalk

Section of sidewalk is missing and consists of dirt, grass or gravel.

Provide a compliant sidewalk for the missing section.

\$1,260

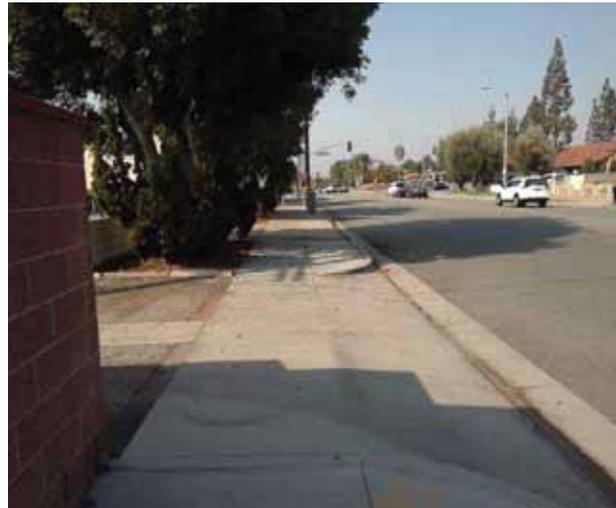
**On-Site Finding** Not Found

Install compliant detectable warnings \$190

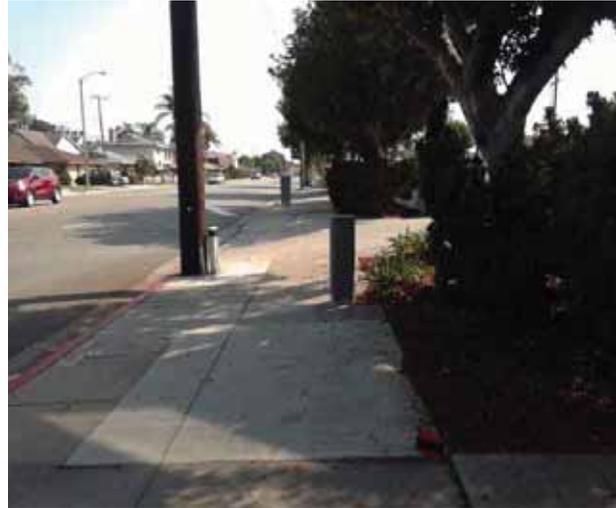
There is a change in elevation greater than recommended value.

Ensure that the change in elevation is within the recommended value.

Recommendation Up to 0.25 inches

Remove tripping hazards \$198

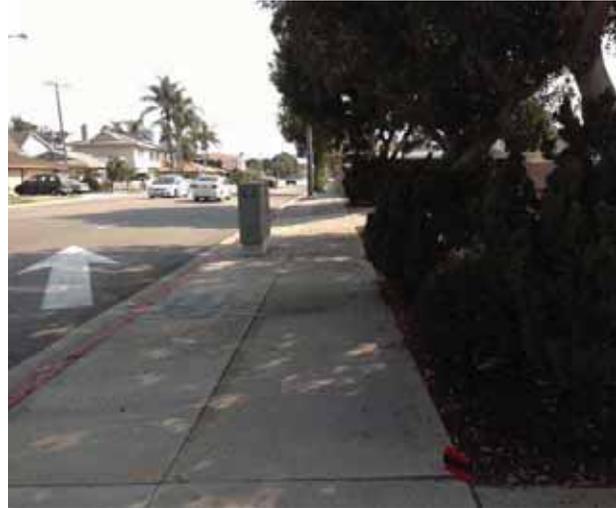
There is a change in elevation greater than recommended value.

Ensure that the change in elevation is within the recommended value.

Recommendation Up to 0.25 inches

Remove tripping hazards \$198

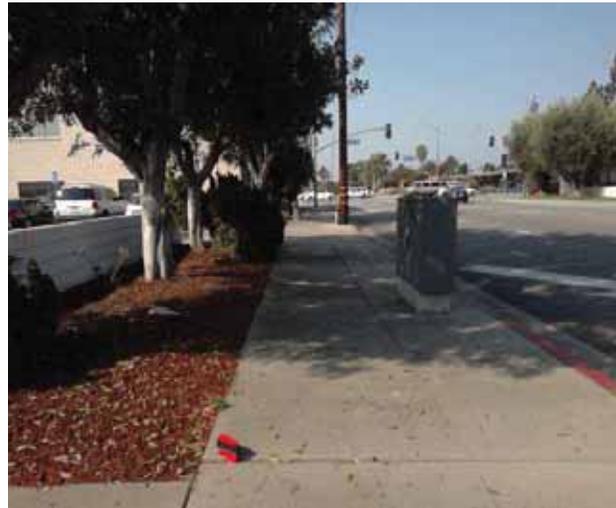
There is a change in elevation greater than recommended value.

Remove tripping hazards \$198

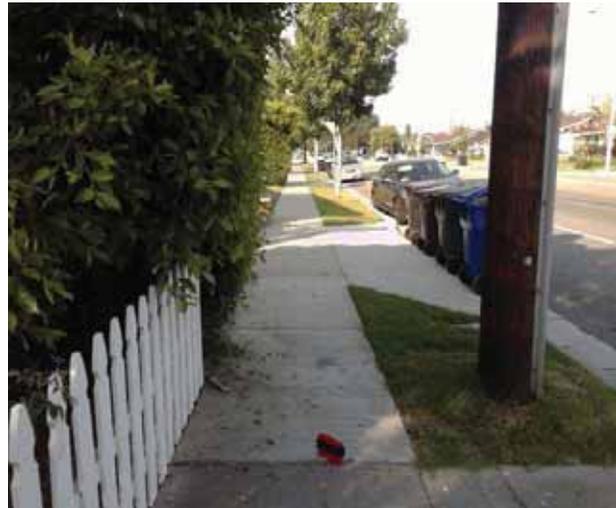
There is a change in elevation greater than recommended value.

Ensure that the change in elevation is within the recommended value.

Recommendation Up to 0.25 inches

Remove tripping hazards \$198

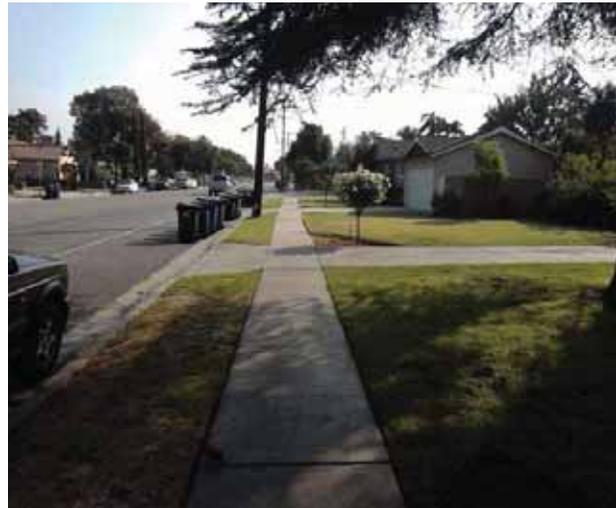
There is a change in elevation greater than recommended value.

Ensure that the change in elevation is within the recommended value.

Recommendation Up to 0.25 inches

Remove tripping hazards \$198

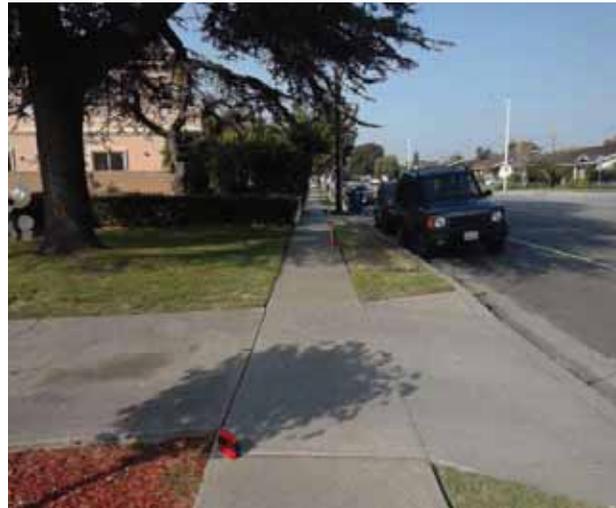
There is a change in elevation greater than recommended value.

Ensure that the change in elevation is within the recommended value.

Recommendation Up to 0.25 inches

Remove tripping hazards \$198

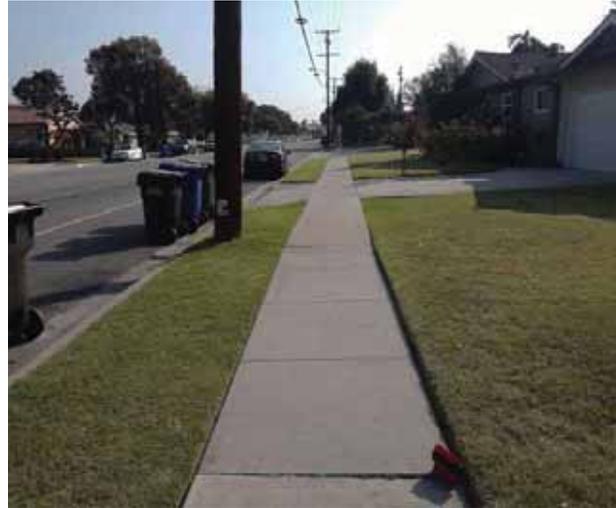
There is a change in elevation greater than recommended value.

Ensure that the change in elevation is within the recommended value.

Recommendation Up to 0.25 inches

Remove tripping hazards \$198

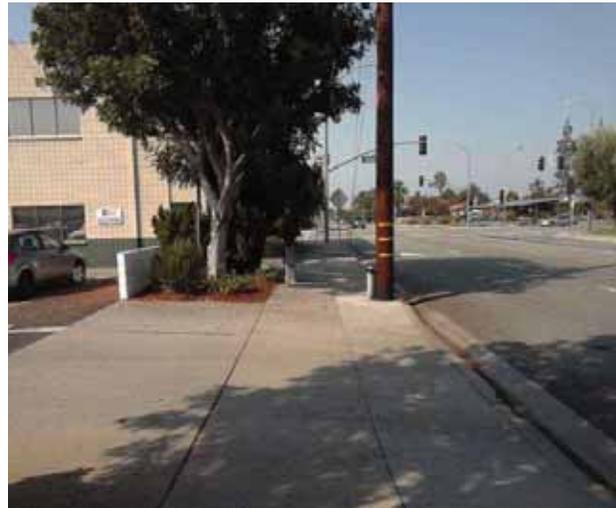
**On-Site Finding** Not Found

Install compliant detectable warnings \$190

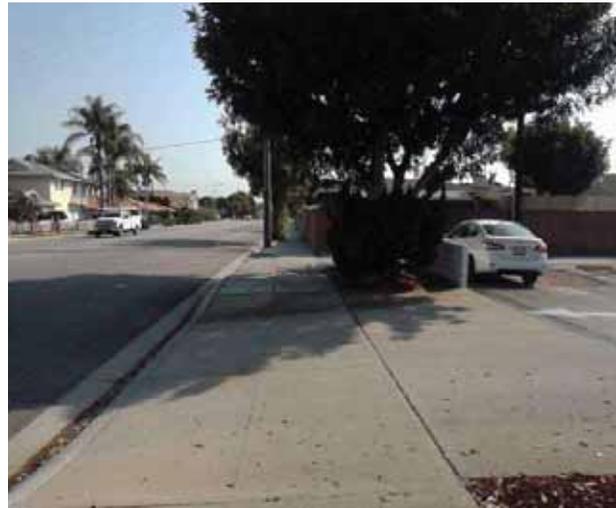
**On-Site Finding** Not Found

Install compliant detectable warnings \$190

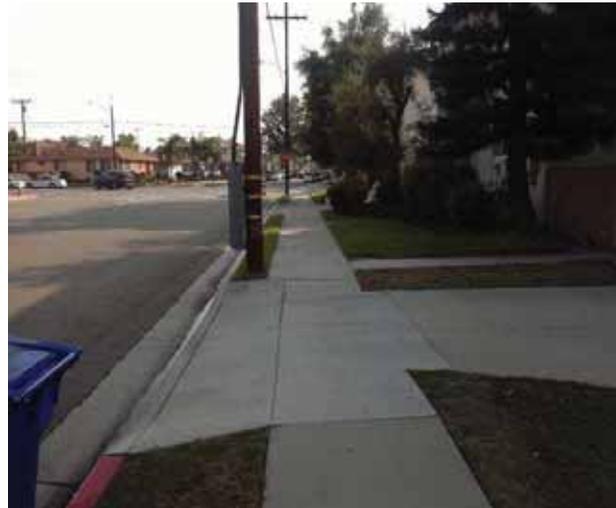
**On-Site Finding** Not Found

Install compliant detectable warnings \$190

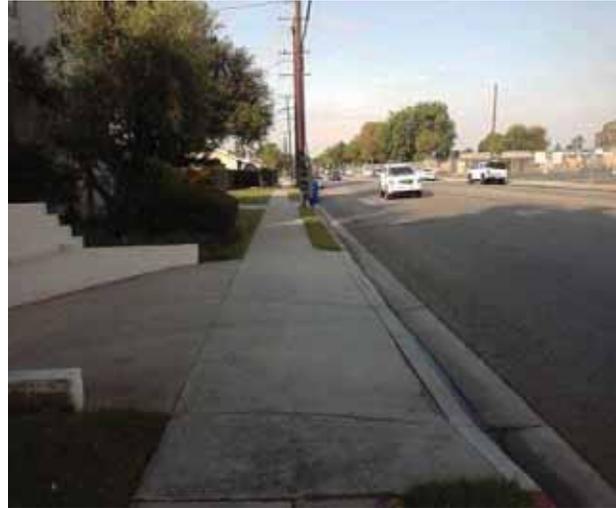
**On-Site Finding** Not Found

Install compliant detectable warnings \$190

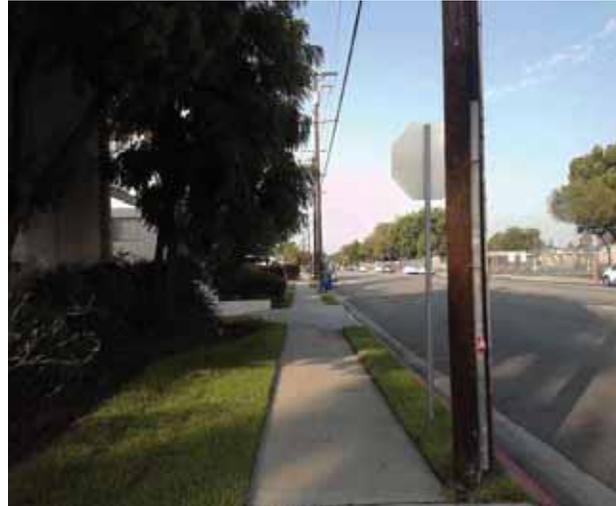
**On-Site Finding** Not Found

\$2,400

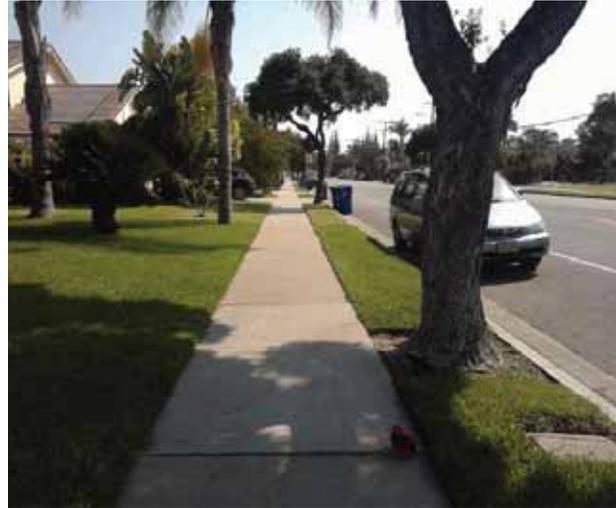
There is a change in elevation greater than recommended value.

Ensure that the change in elevation is within the recommended value.

Recommendation Up to 0.25 inches

Remove tripping hazards \$198

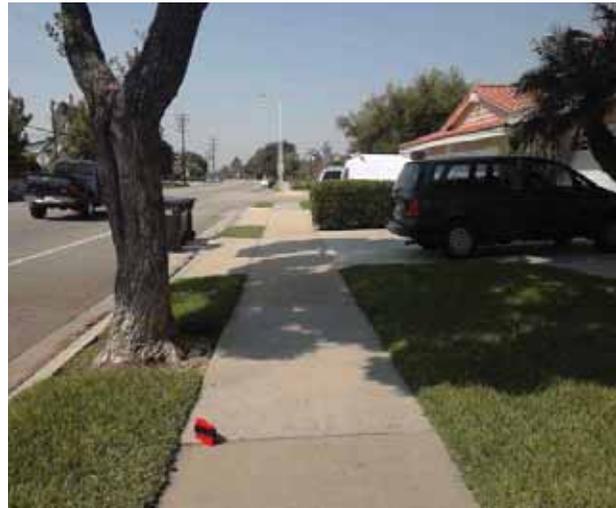
There is a change in elevation greater than recommended value.

Ensure that the change in elevation is within the recommended value.

Recommendation Up to 0.25 inches

Remove tripping hazards \$198

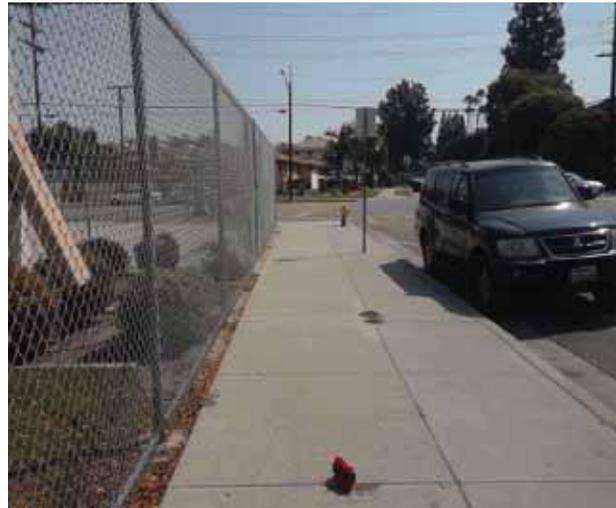
There is a change in elevation greater than recommended value.

Ensure that the change in elevation is within the recommended value.

Recommendation Up to 0.25 inches

Remove tripping hazards \$198

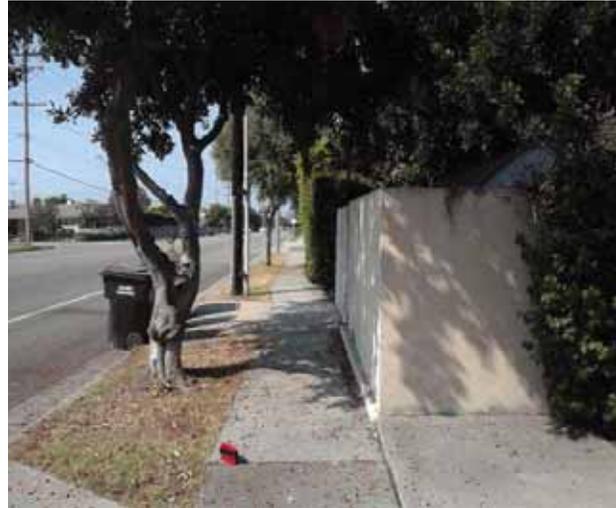
There is a change in elevation greater than recommended value.

Ensure that the change in elevation is within the recommended value.

Recommendation Up to 0.25 inches

Remove tripping hazards \$198

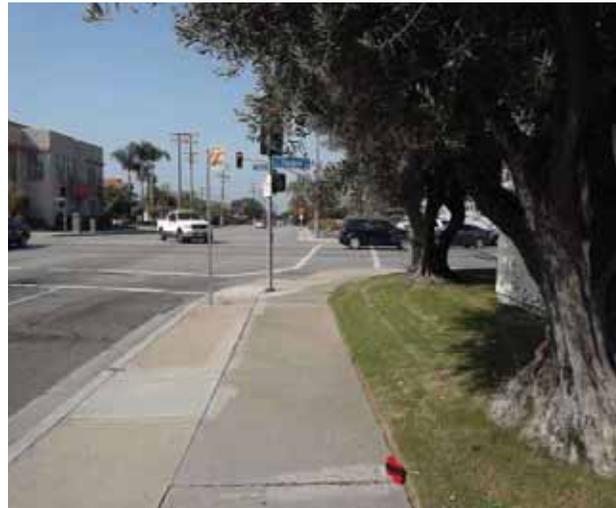
There is a change in elevation greater than recommended value.

Ensure that the change in elevation is within the recommended value.

Recommendation Up to 0.25 inches

Remove tripping hazards \$198

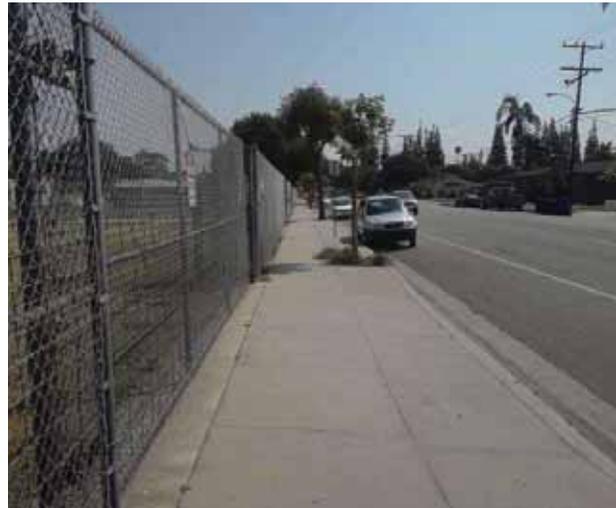
**On-Site Finding** Not Found

Install compliant detectable warnings \$190

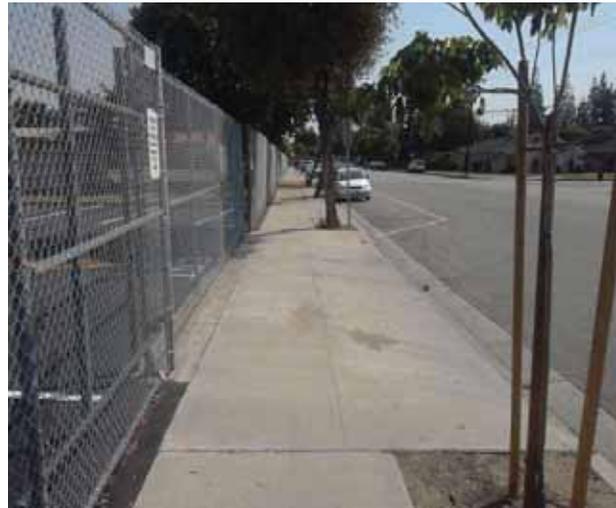
**On-Site Finding** Not Found

Install compliant detectable warnings \$190

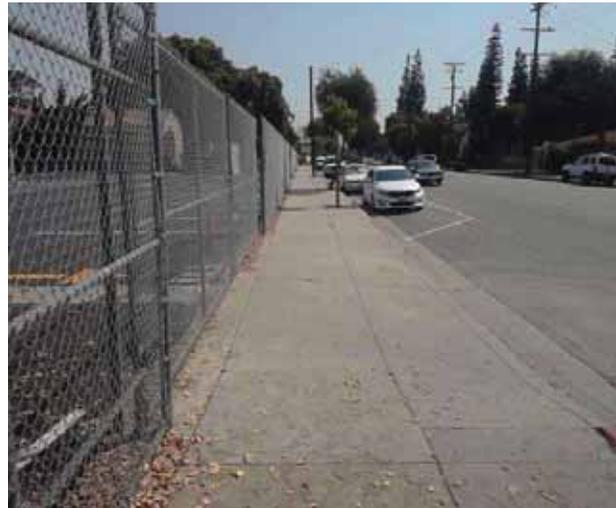
**On-Site Finding** Not Found

Install compliant detectable warnings \$190

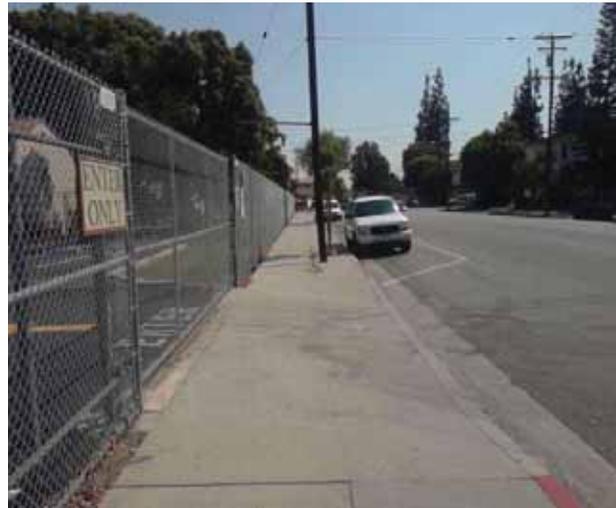
**On-Site Finding** Not Found

Install compliant detectable warnings \$190

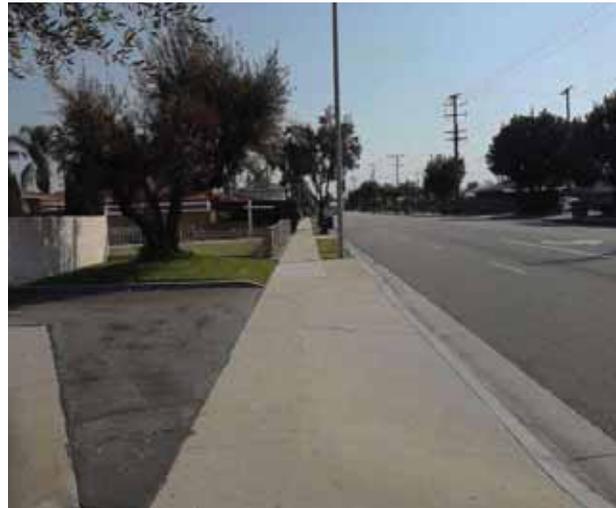
**On-Site Finding** Not Found

Install compliant detectable warnings \$190

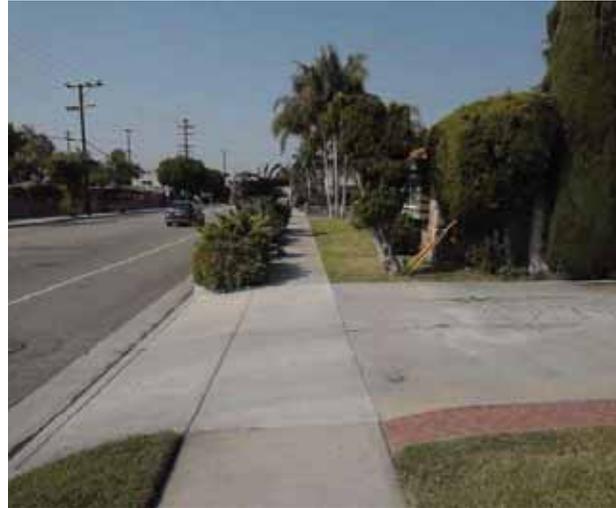
**On-Site Finding** Not Found

Install compliant detectable warnings \$190

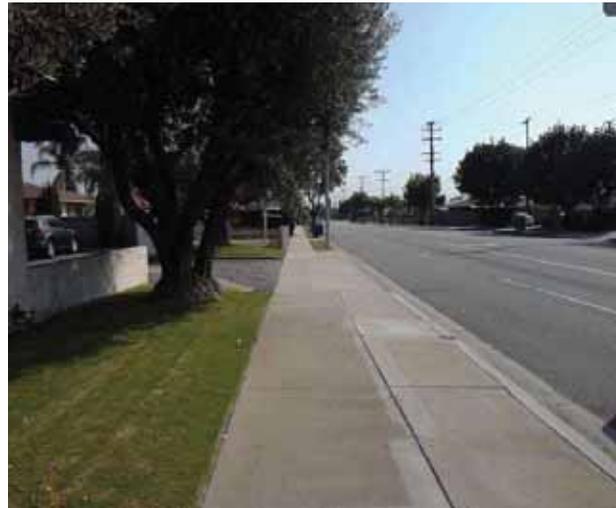
**On-Site Finding** Not Found

\$2,400

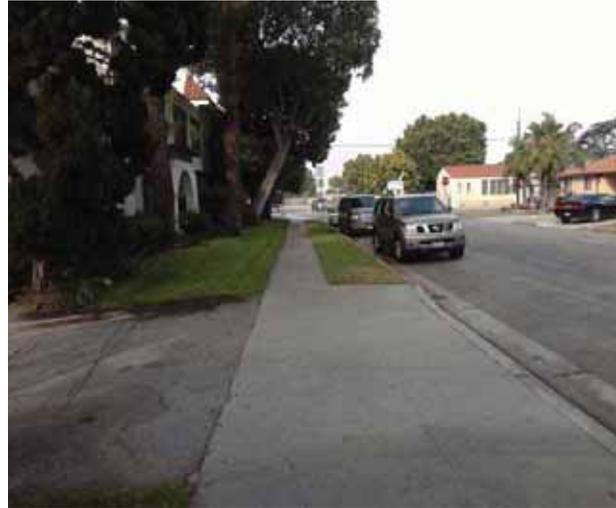
**On-Site Finding** Not Found

Install compliant detectable warnings \$190

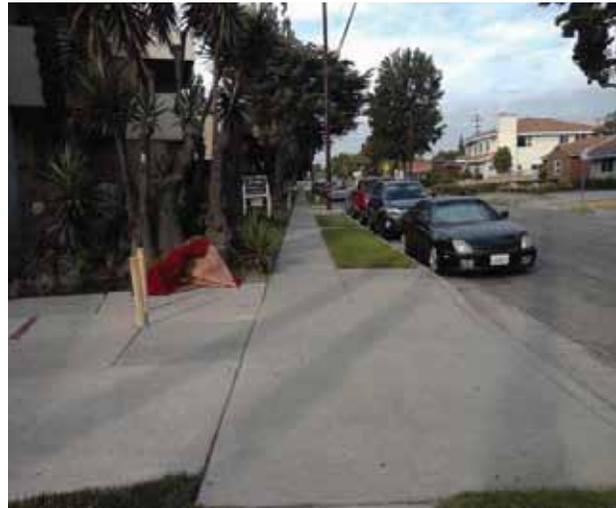
**On-Site Finding** Not Found

Install compliant detectable warnings \$190
