# Accessibility Survey

## City of Downey Brookshire Avenue & Civic Center Drive

Brookshire Avenue & Civic Center Drive  
Downey, CA 90240

Date of Inspection  
5/25/2017

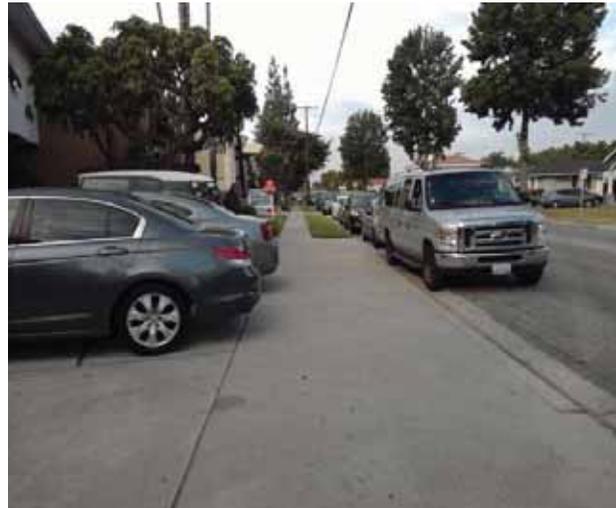
**On-Site Finding** Not Found

Install compliant detectable warnings \$190

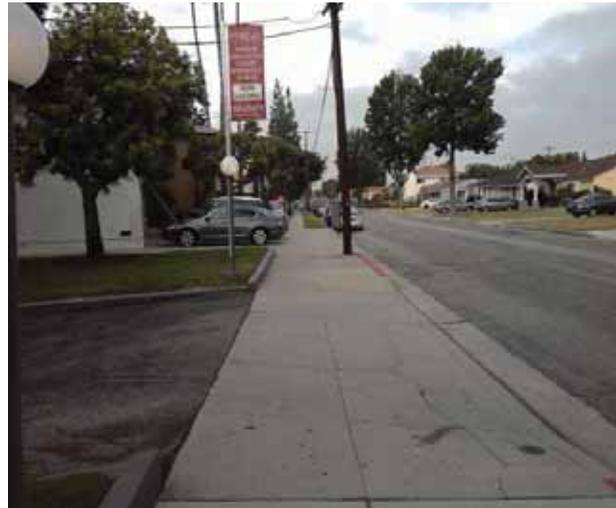
**On-Site Finding** Not Found

Install compliant detectable warnings \$190

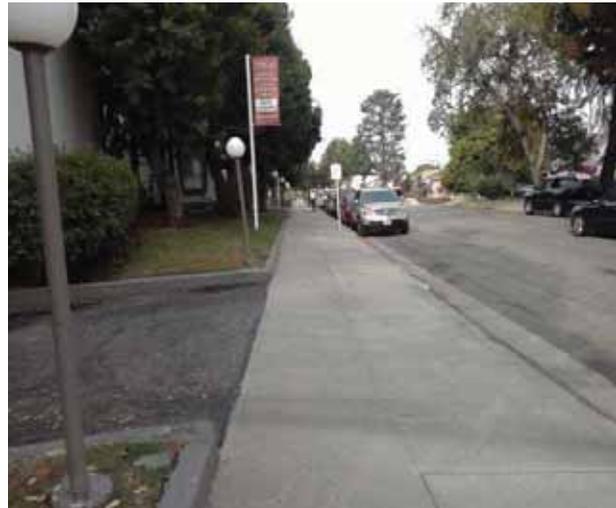
**On-Site Finding** Not Found

Install compliant detectable warnings \$190

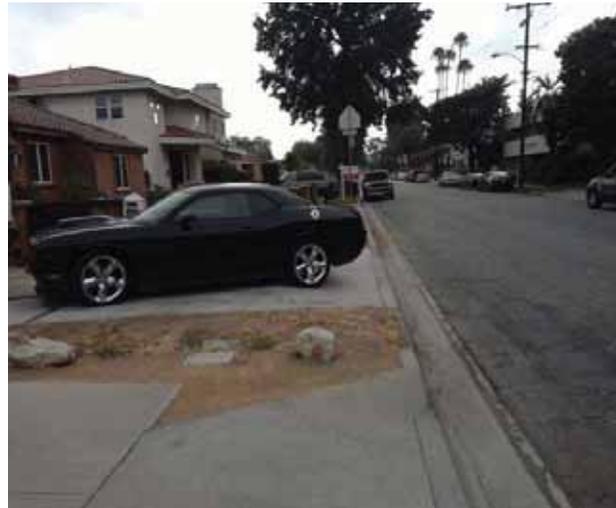
Sidewalks : Missing Sidewalk

Section of sidewalk is missing and consists of dirt, grass or gravel.

Provide a compliant sidewalk for the missing section.

\$1,260

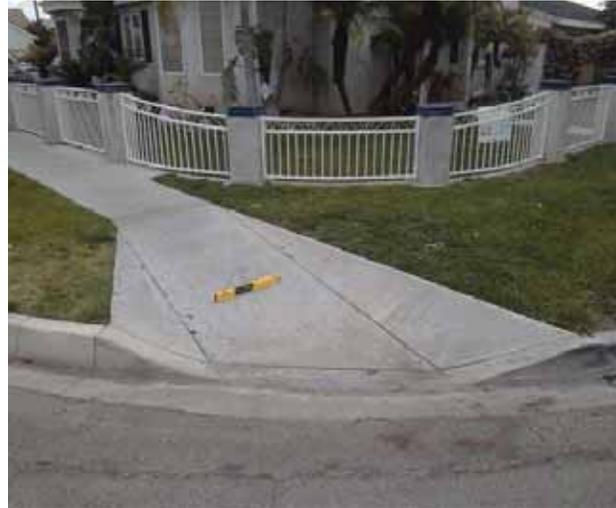
**On-Site Finding** Not Found

Provide detectable warning to surface \$248

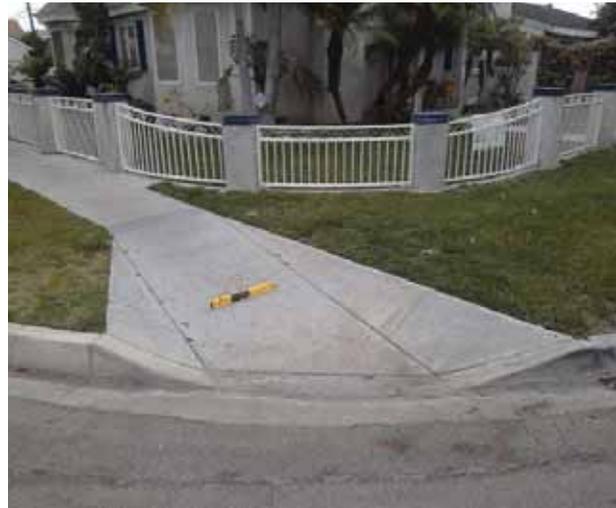
Curb Ramp , Landings and Transitions : Landing Accumulates Water - Wet Conditions

Provide compliant landing \$255

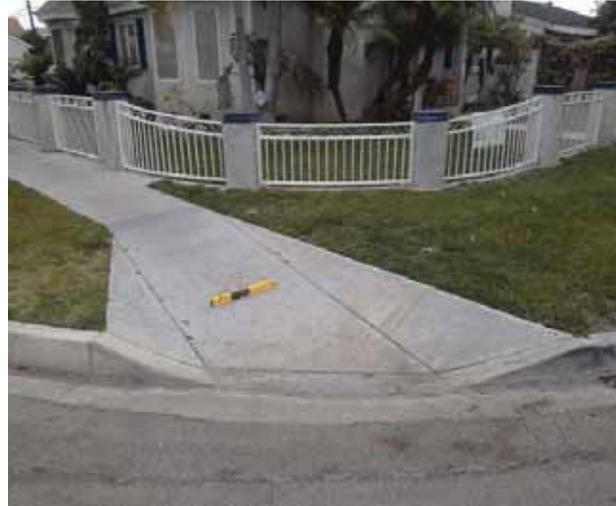
The overlayment causes a noncompliant change in level.

Ensure the change in elevation is within the recommended height.

Recommendation 0.25 - 0.50 inches

Provide smooth surface \$150

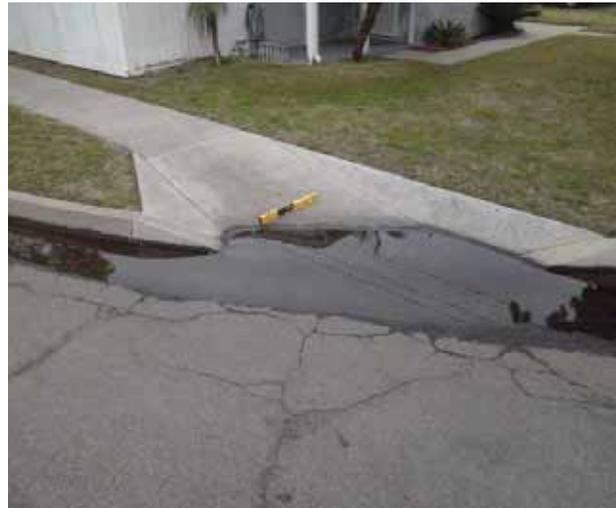
**On-Site Finding** Not Found

Provide detectable warning to surface \$248

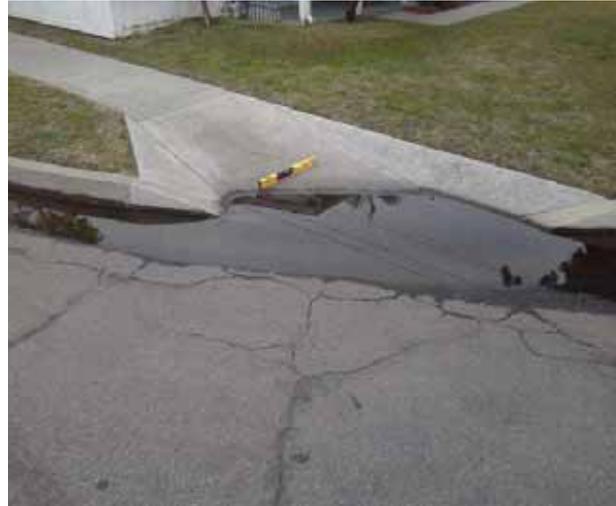
Curb Ramp , Landings and Transitions : Landing Accumulates Water - Wet Conditions

Provide compliant landing \$255

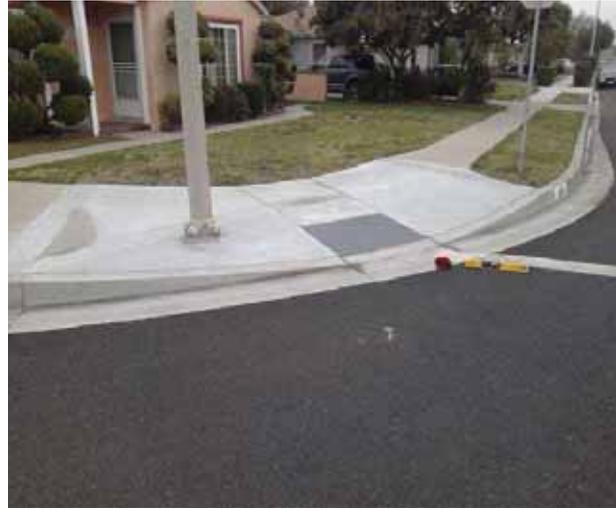
The overlayment causes a noncompliant change in level.

Ensure the change in elevation is within the recommended height.

Recommendation Up to 0.50 inches

Provide smooth surface \$150

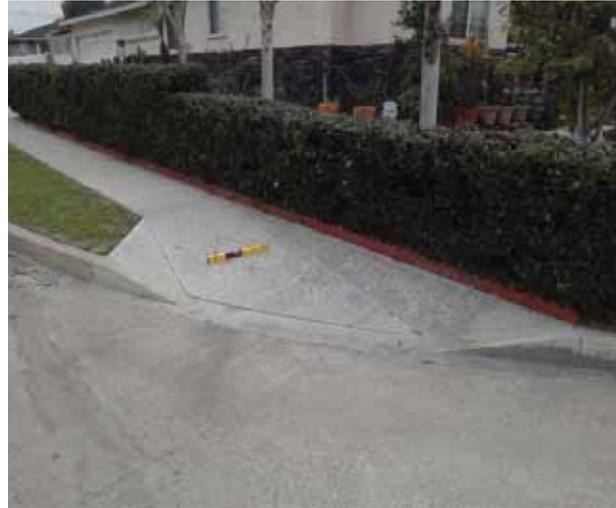
**On-Site Finding** Not Found

Provide detectable warning to surface \$248

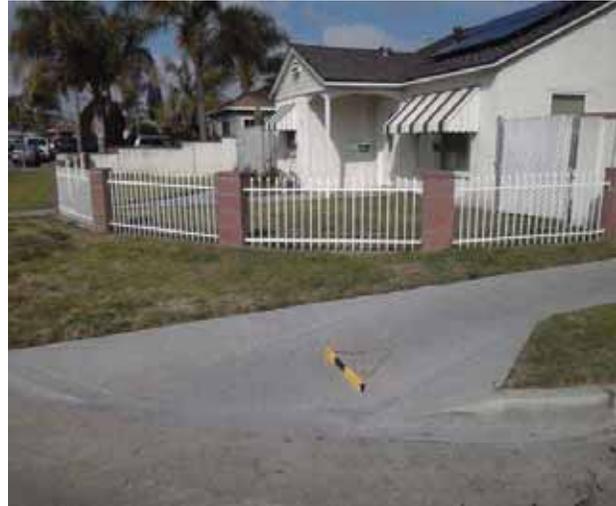
**On-Site Finding** Not Found

Provide detectable warning to surface \$248

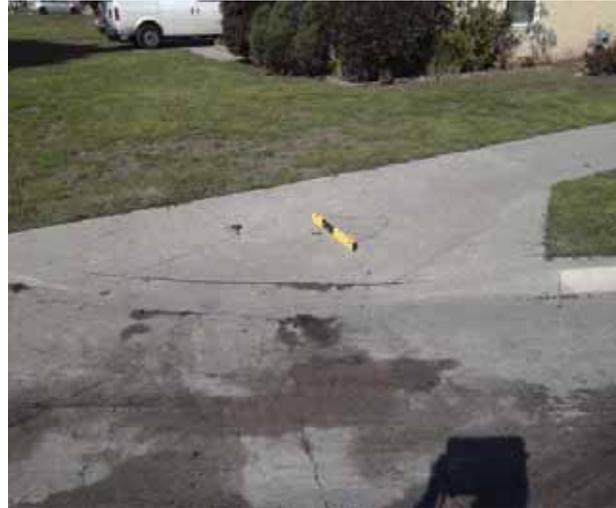
**On-Site Finding** Not Found

Provide detectable warning to surface \$248

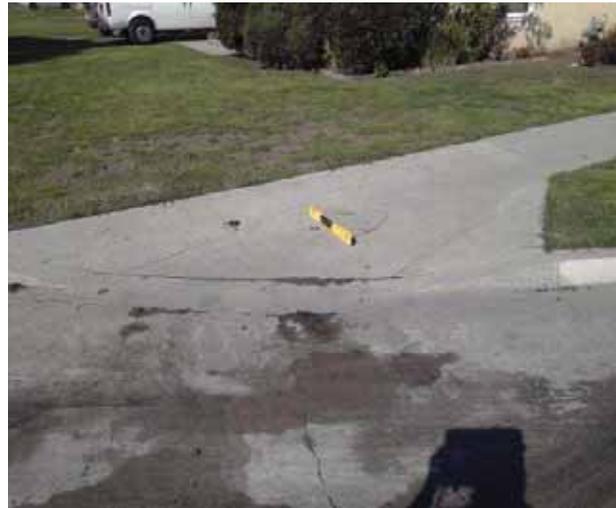
Curb Ramp , Landings and Transitions : Landing Accumulates Water - Wet Conditions

Provide compliant landing \$255

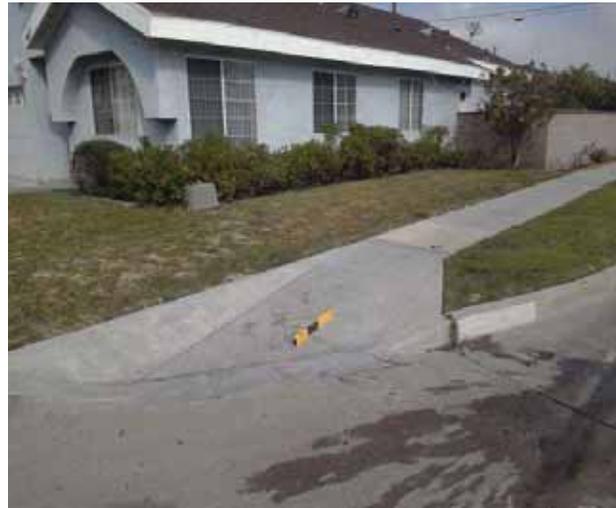
**On-Site Finding** Not Found

Provide detectable warning to surface \$248

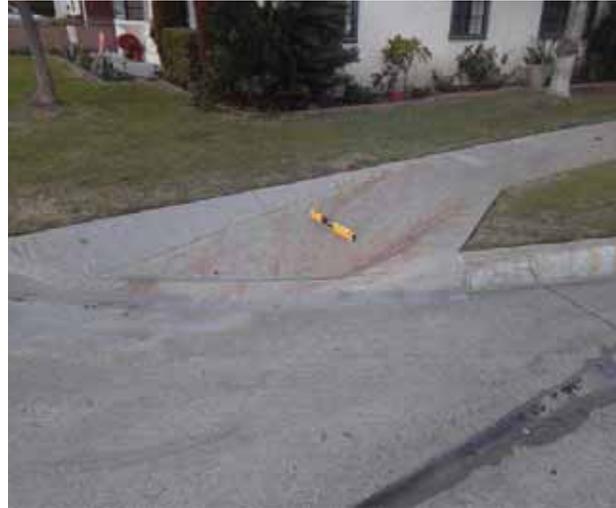
**On-Site Finding** Not Found

Provide detectable warning to surface \$248

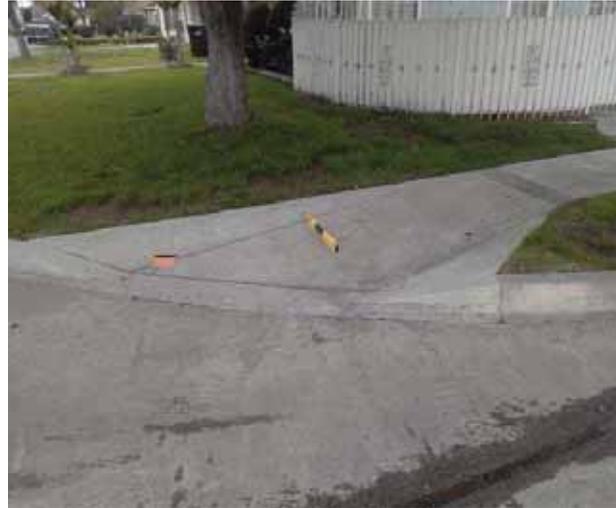
**On-Site Finding** Not Found

Provide detectable warning to surface \$248

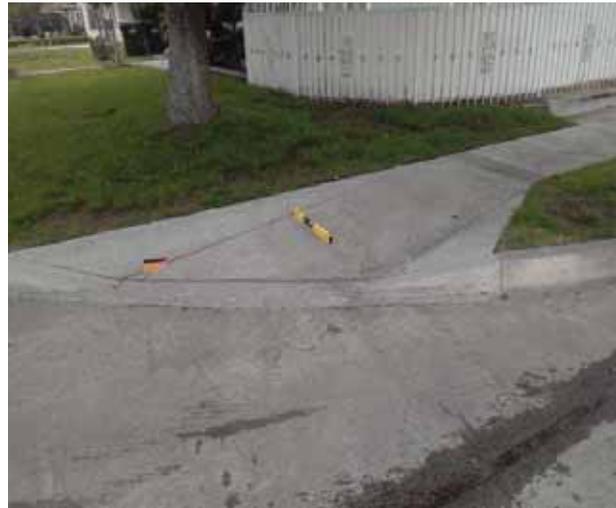
Recommendation Up to 5.00 percent

Repave landing \$1,260

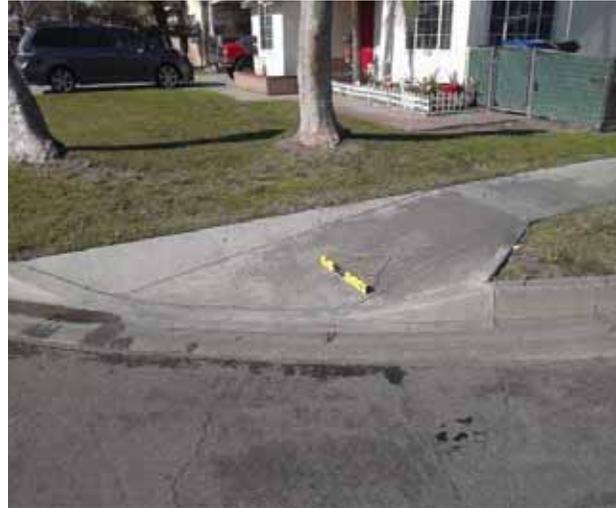
**On-Site Finding** Not Found

Provide detectable warning to surface \$248

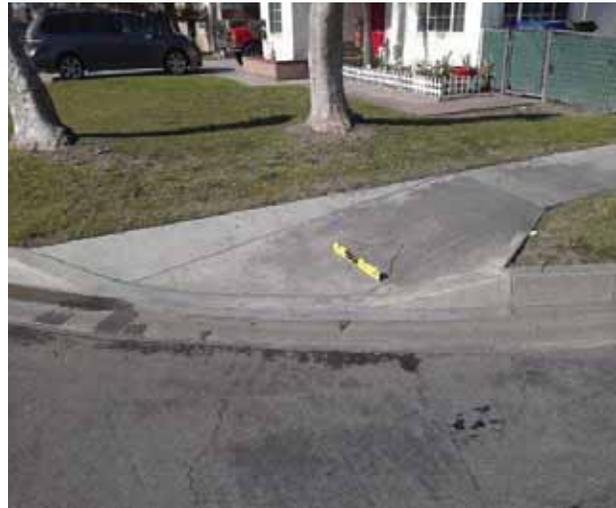
Recommendation Up to 5.00 percent

Repave landing \$1,260

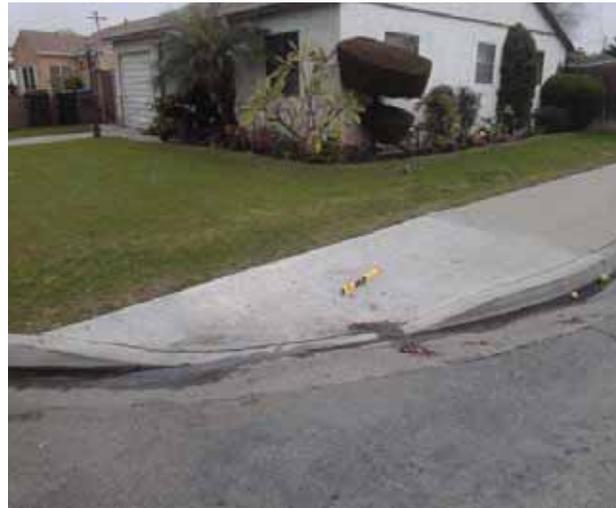
**On-Site Finding** Not Found

Provide detectable warning to surface \$248

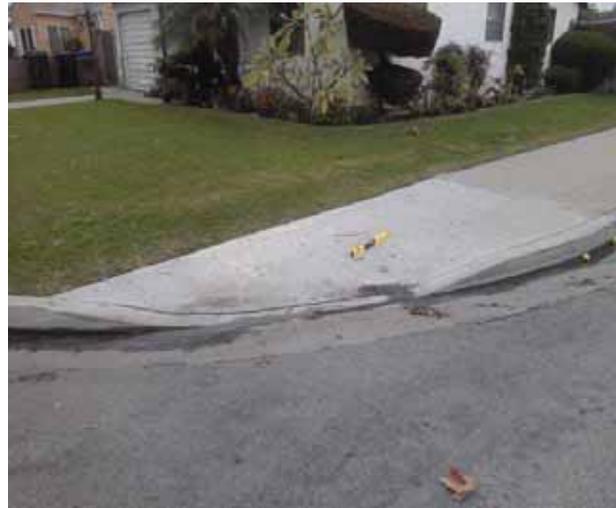
Recommendation Up to 5.00 percent

Repave landing \$1,260

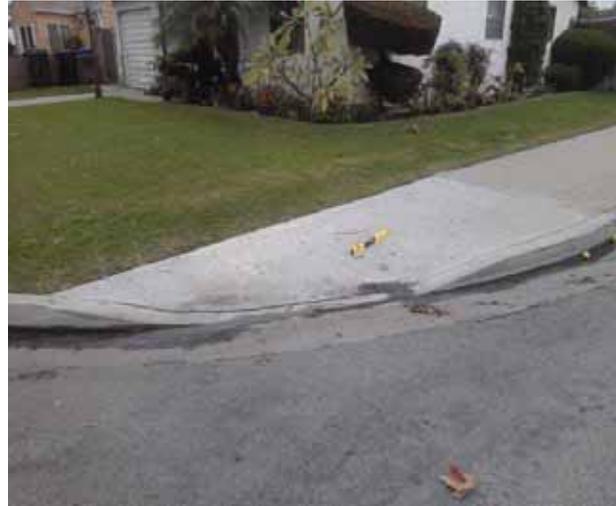
Curb Ramp , Landings and Transitions : Landing Accumulates Water  
- Wet Conditions

Provide compliant landing \$255

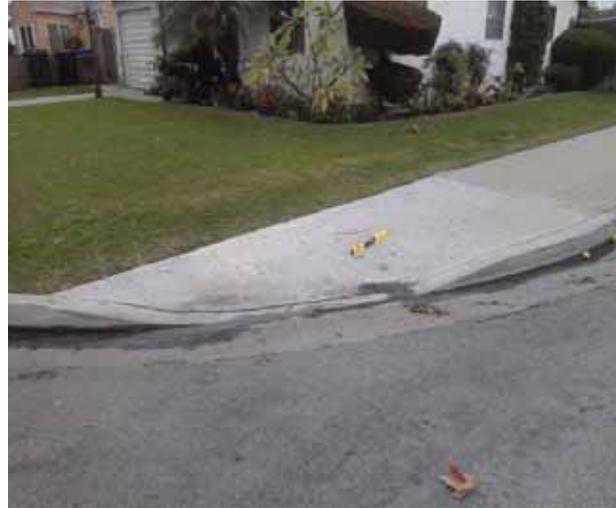
Recommendation Up to 2.08 percent

Provide compliant landing \$1,260

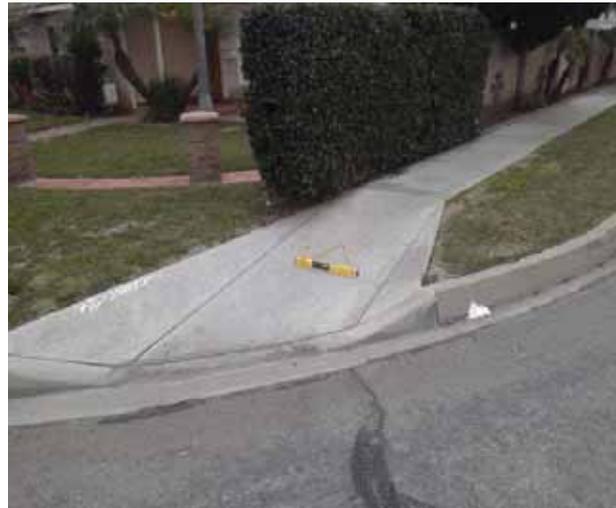
**On-Site Finding** Not Found

Provide detectable warning to surface \$248

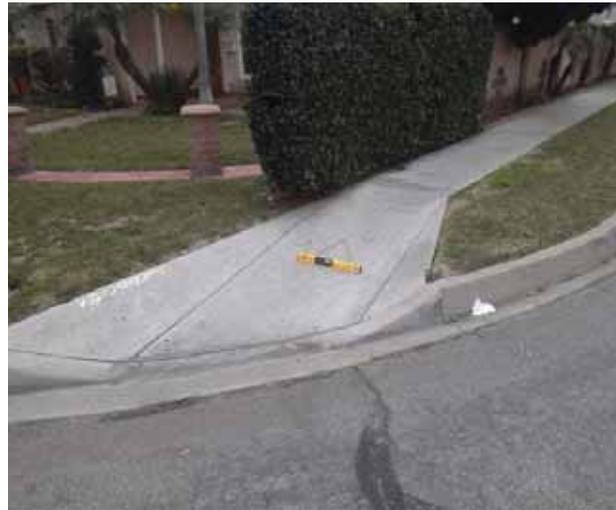
Recommendation Up to 2.08 percent

Provide compliant landing \$240

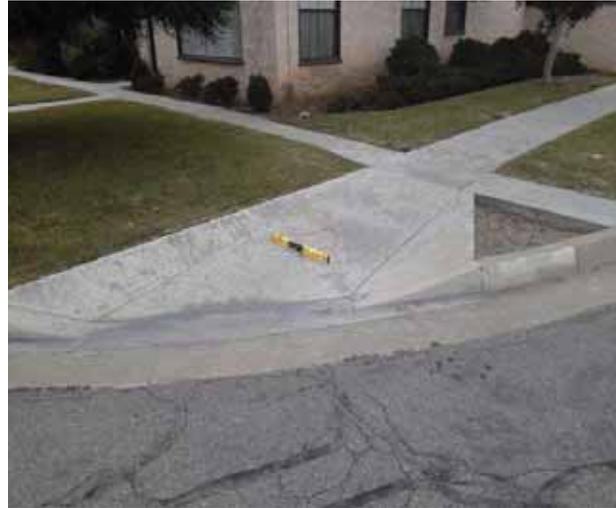
**On-Site Finding** Not Found

Provide detectable warning to surface \$248

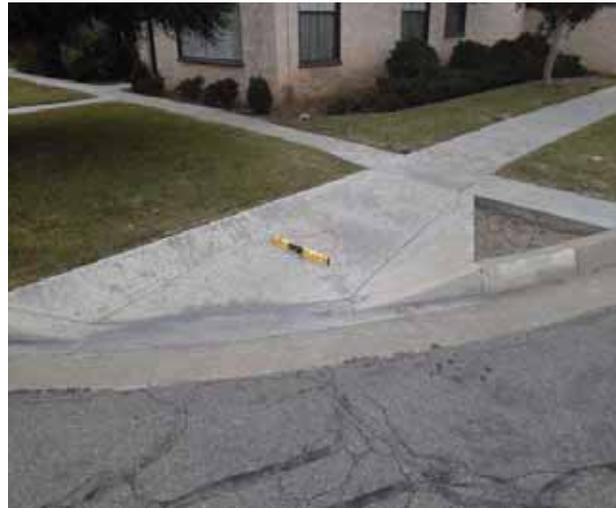
Recommendation Up to 2.08 percent

Install curb ramp \$1,300

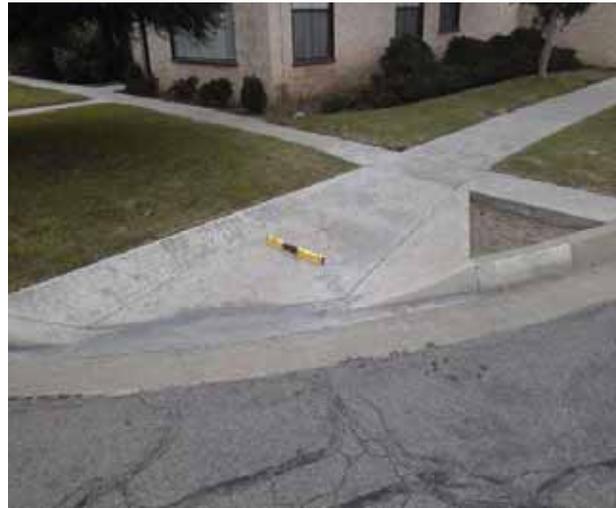
Recommendation Up to 5.00 percent

Repave landing \$1,260

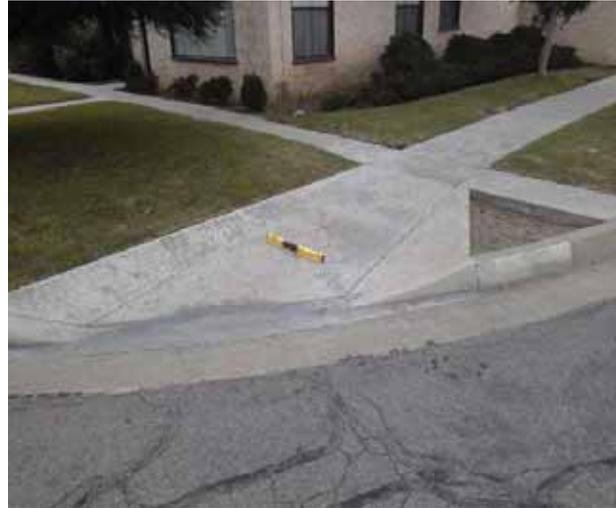
Recommendation At least 48.00 inches

Provide compliant landing \$240

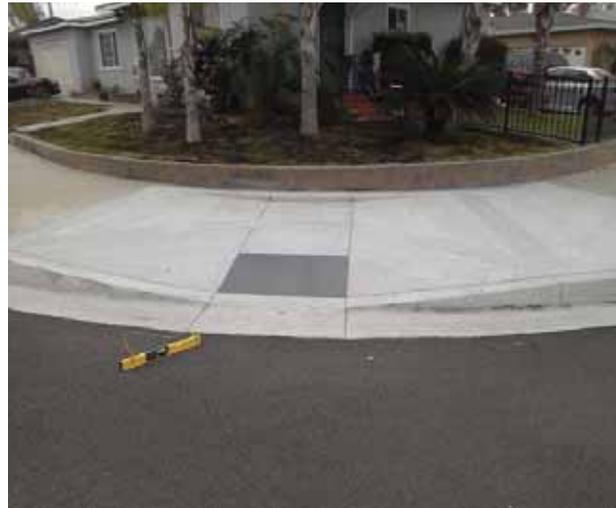
Recommendation Up to 2.08 percent

Provide compliant landing \$240

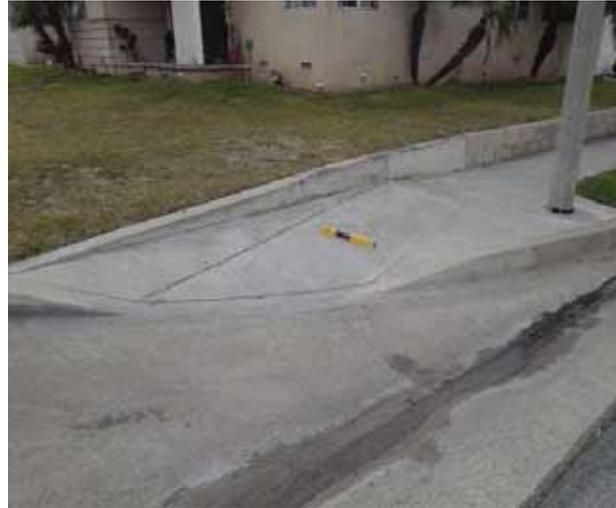
**On-Site Finding** Not Found

Provide detectable warning to surface \$248

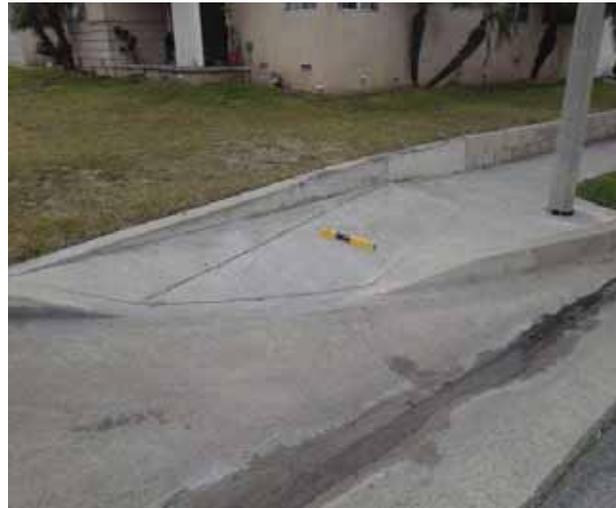
Recommendation Up to 2.08 percent

Install curb ramp \$1,300

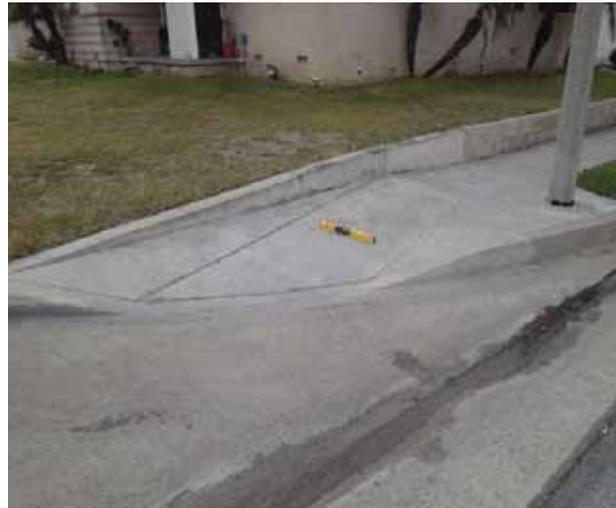
Curb Ramp , Landings and Transitions : Landing Accumulates Water  
- Wet Conditions

Provide compliant landing \$255

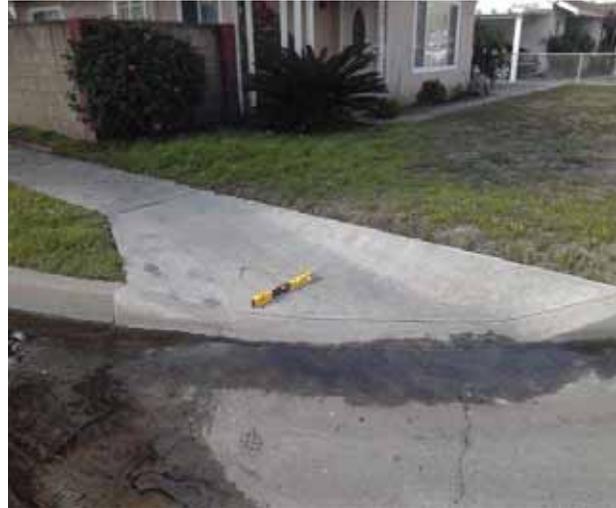
**On-Site Finding** Not Found

Provide detectable warning to surface \$248

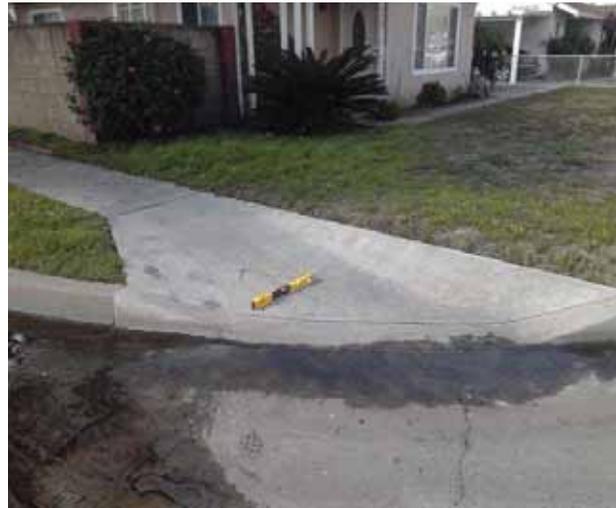
Recommendation Up to 2.08 percent

Install curb ramp \$1,300

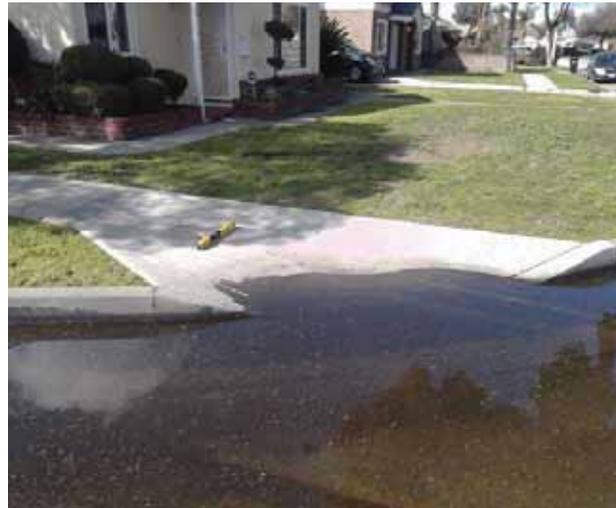
**On-Site Finding** Not Found

Provide detectable warning to surface \$248

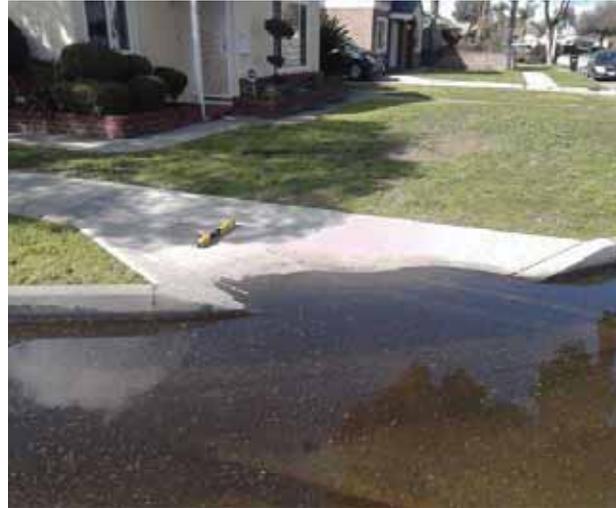
Recommendation Up to 2.08 percent

Install curb ramp \$1,300

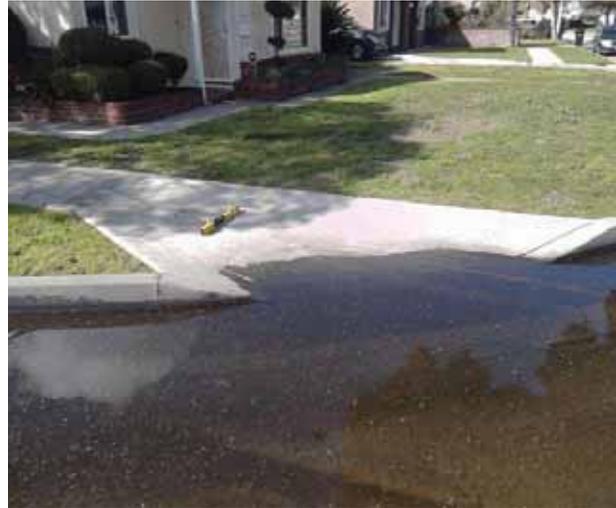
Curb Ramp , Landings and Transitions : Landing Accumulates Water - Wet Conditions

Provide compliant landing \$255

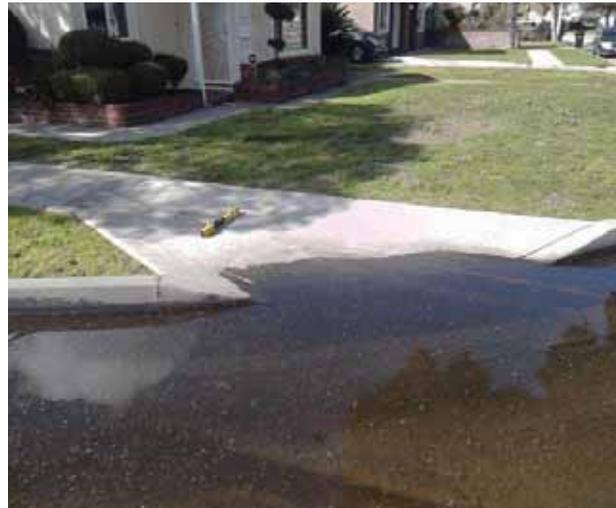
Recommendation Up to 2.08 percent

Provide compliant landing \$1,260

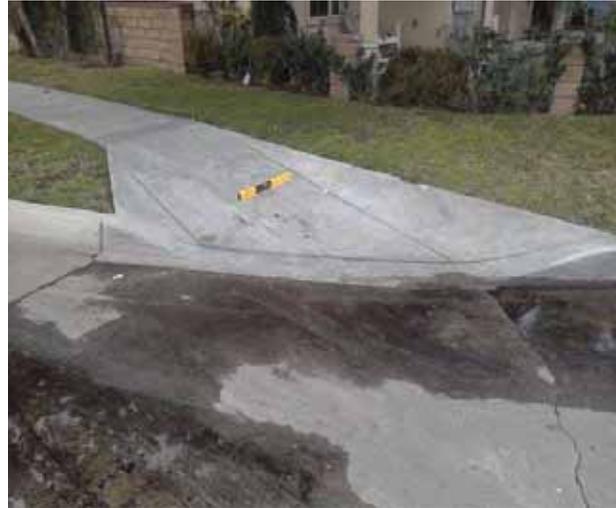
**On-Site Finding** Not Found

Provide detectable warning to surface \$248

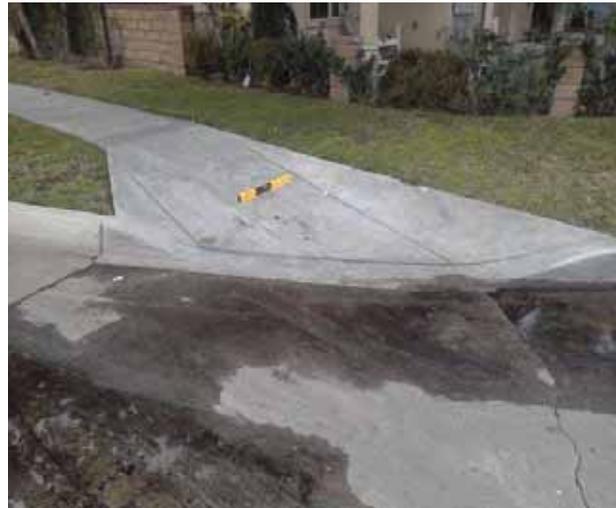
Recommendation Up to 8.33 percent

Install curb ramp \$1,300

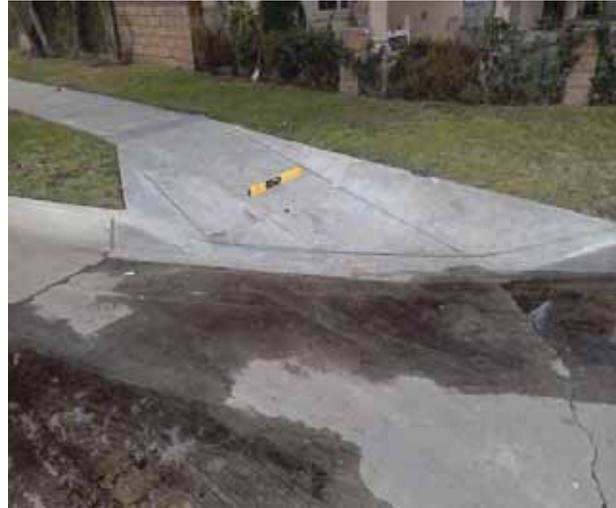
Curb Ramp , Landings and Transitions : Landing Accumulates Water - Wet Conditions

Provide compliant landing \$255

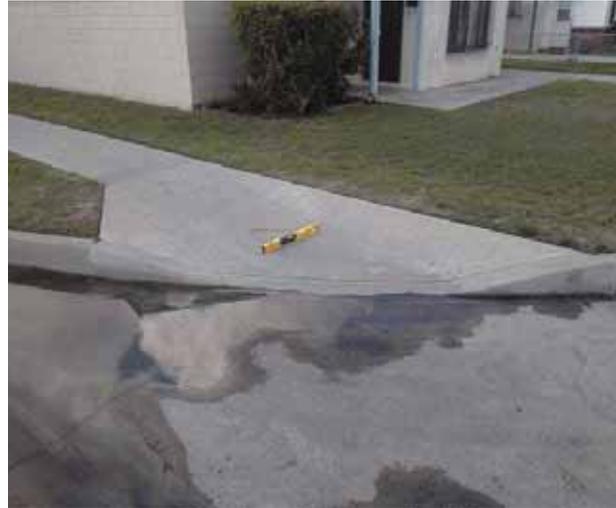
**On-Site Finding** Not Found

Provide detectable warning to surface \$248

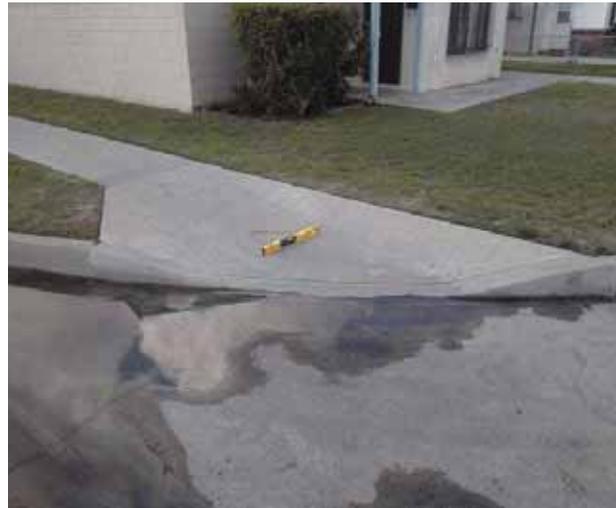
Recommendation Up to 2.08 percent

Install curb ramp \$1,300

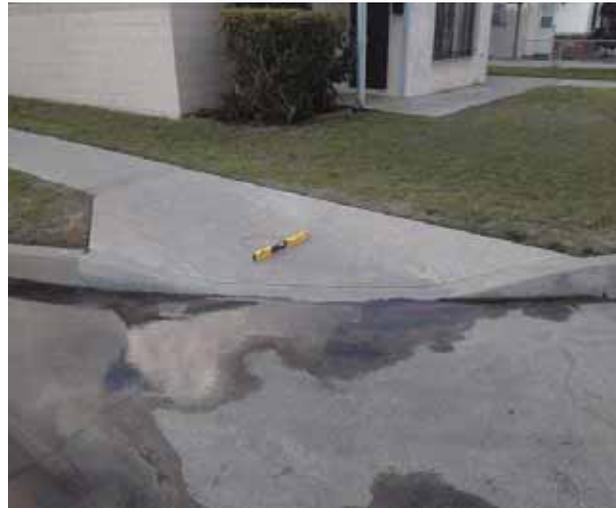
Curb Ramp , Landings and Transitions : Landing Accumulates Water  
- Wet Conditions

Provide compliant landing \$255

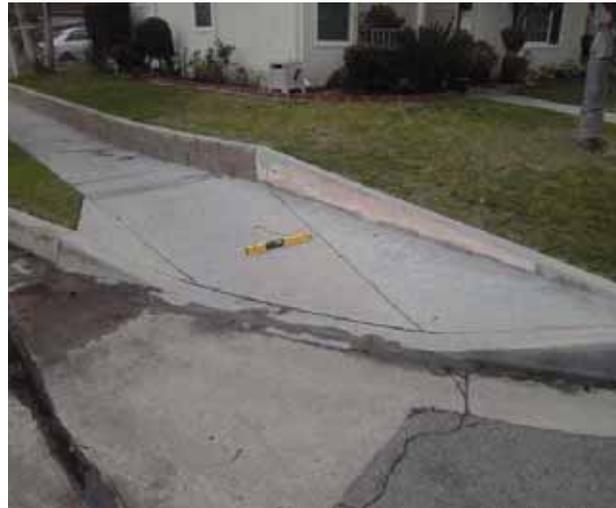
**On-Site Finding** Not Found

Provide detectable warning to surface \$248

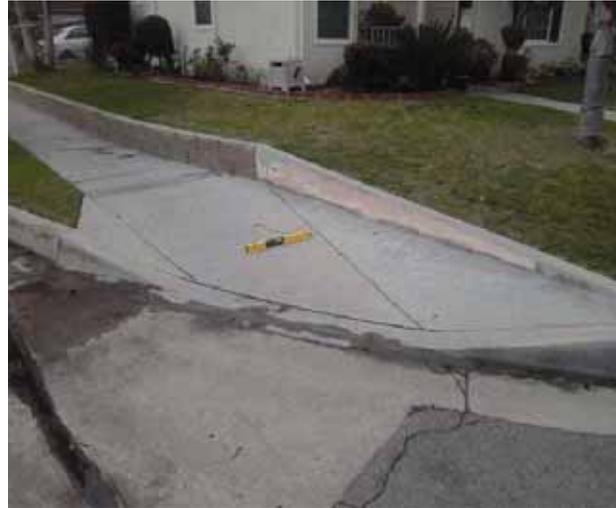
Recommendation Up to 2.08 percent

Install curb ramp \$1,300

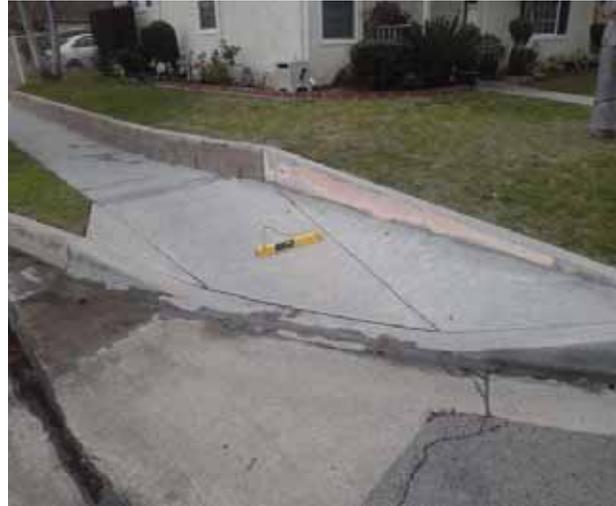
Curb Ramp , Landings and Transitions : Landing Accumulates Water  
- Wet Conditions

Provide compliant landing \$255

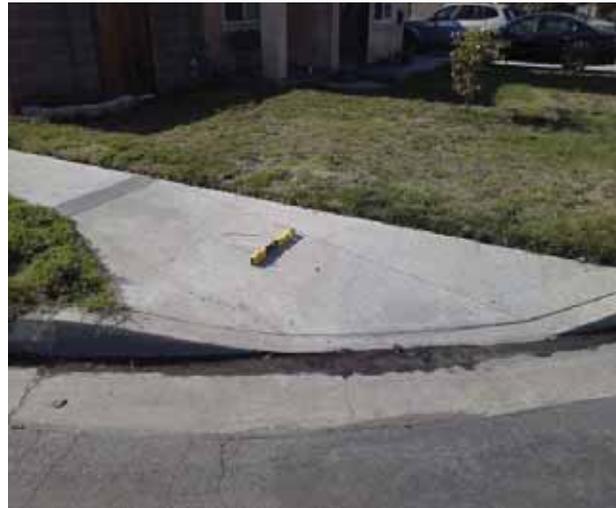
**On-Site Finding** Not Found

Provide detectable warning to surface \$248

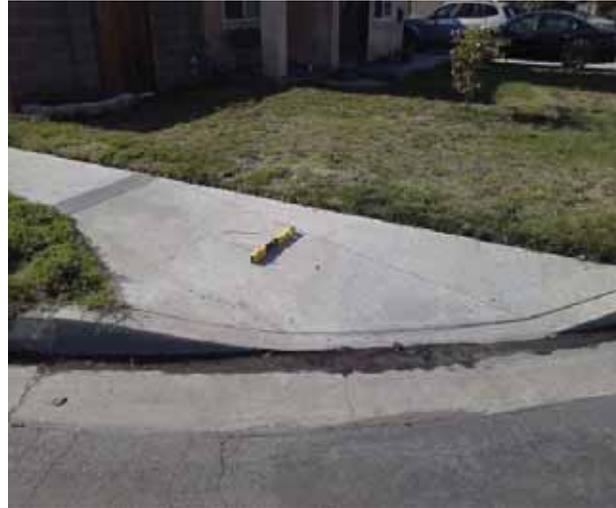
Recommendation Up to 2.08 percent

Install curb ramp \$1,300

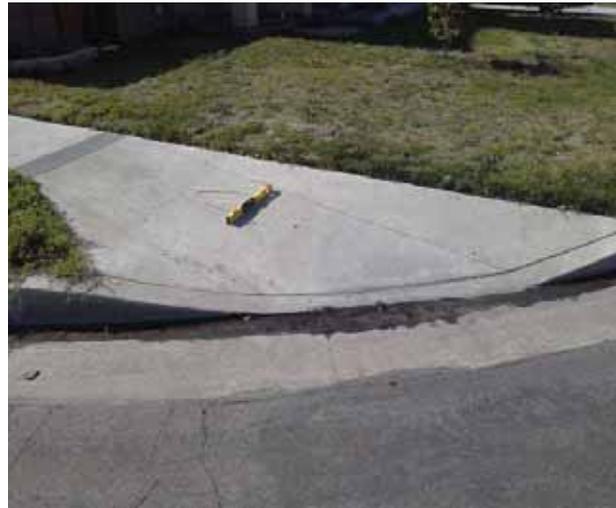
Recommendation Up to 5.00 percent

Repave landing \$1,260

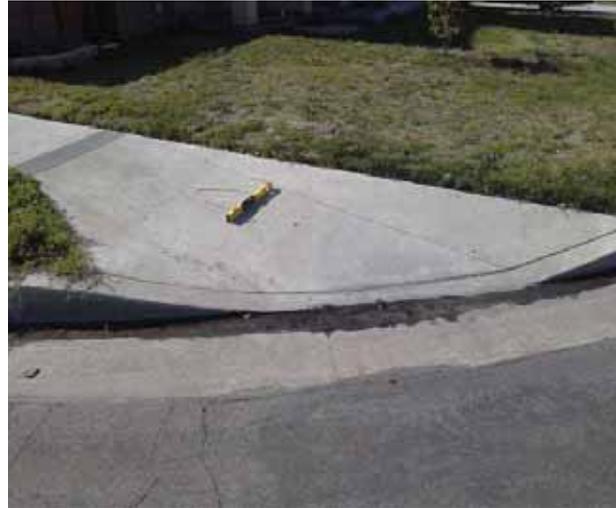
Curb Ramp , Landings and Transitions : Landing Accumulates Water  
- Wet Conditions

Provide compliant landing \$255

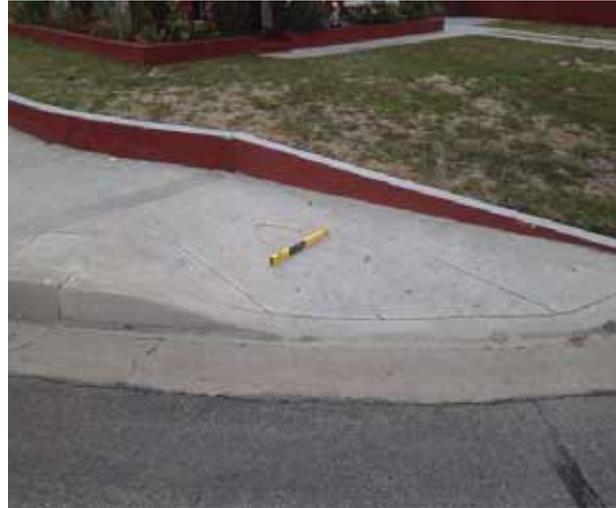
**On-Site Finding** Not Found

Provide detectable warning to surface \$248

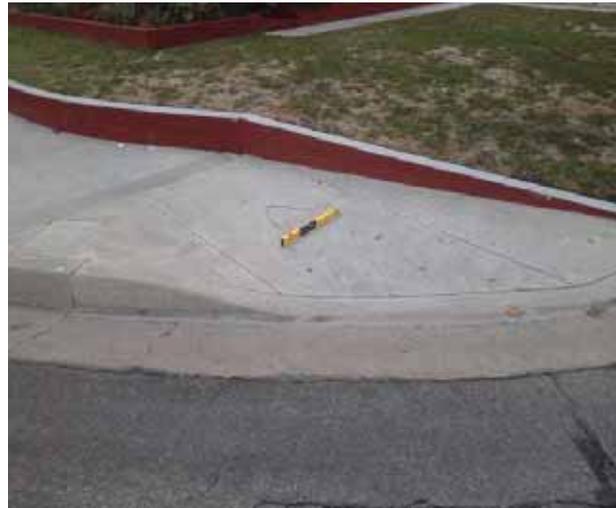
Recommendation Up to 5.00 percent

Repave landing \$1,260

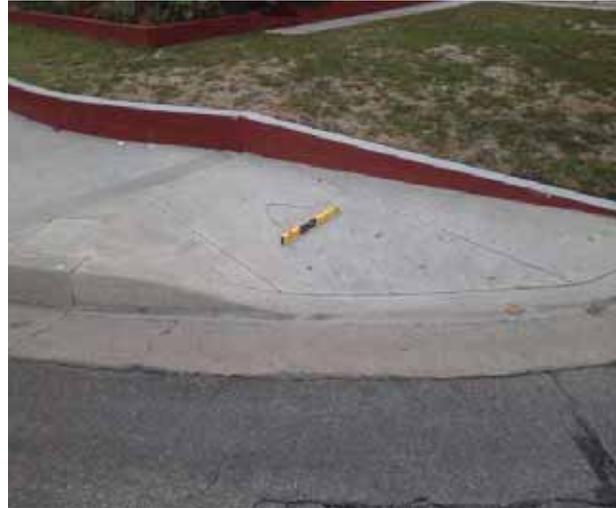
The overlayment causes a noncompliant change in level.

Ensure the change in elevation is within the recommended height.

Recommendation 0.25 - 0.50 inches

Provide smooth surface \$150

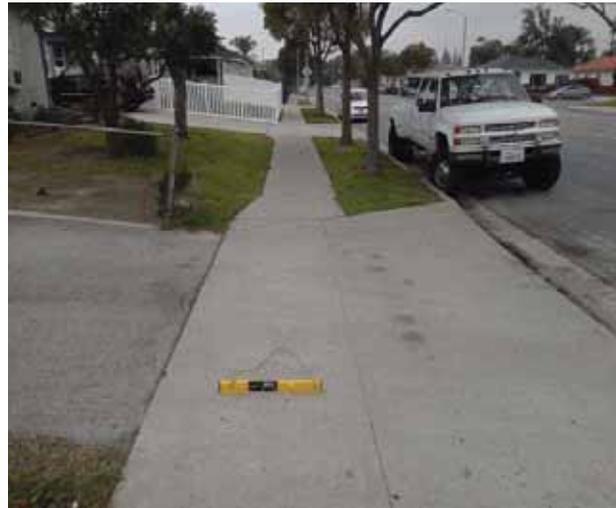
**On-Site Finding** Not Found

Install compliant detectable warnings \$190

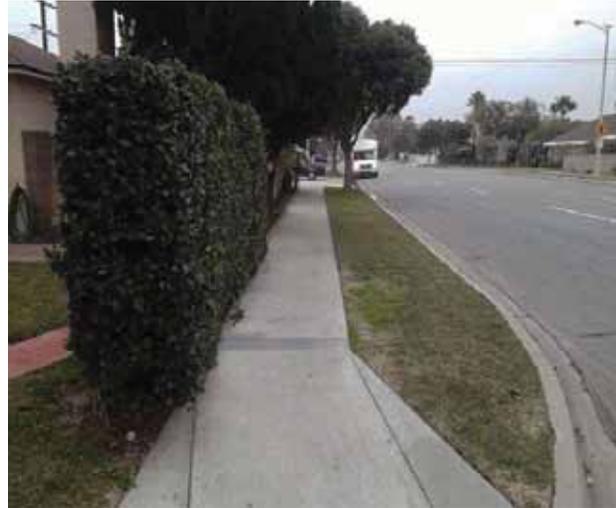
Sidewalks , Hazards & Gratings : Sidewalk Width at Obstruction

Sidewalk width at the obstruction shall have the recommended value.

Recommendation At least 48.00 inches

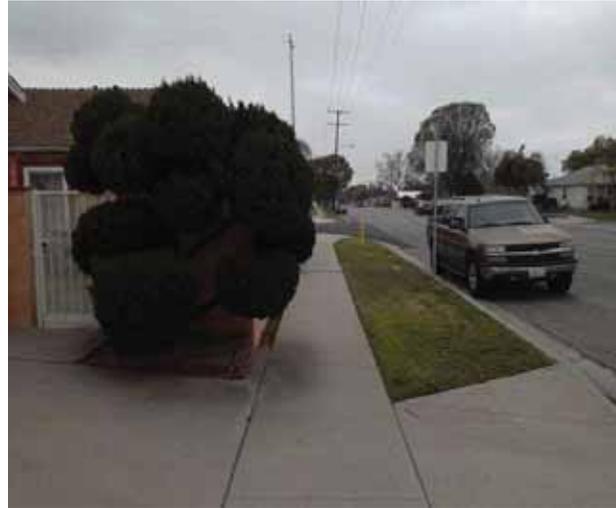
Sidewalks , Hazards & Gratings : Sidewalk Width at Obstruction

Sidewalk width at the obstruction shall have the recommended value.

Recommendation At least 48.00 inches

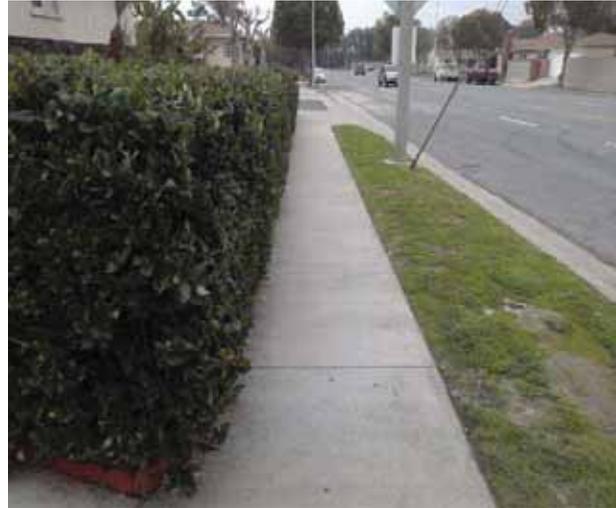
Sidewalks , Hazards & Gratings : Sidewalk Width at Obstruction

Sidewalk width at the obstruction shall have the recommended value.

Recommendation At least 48.00 inches

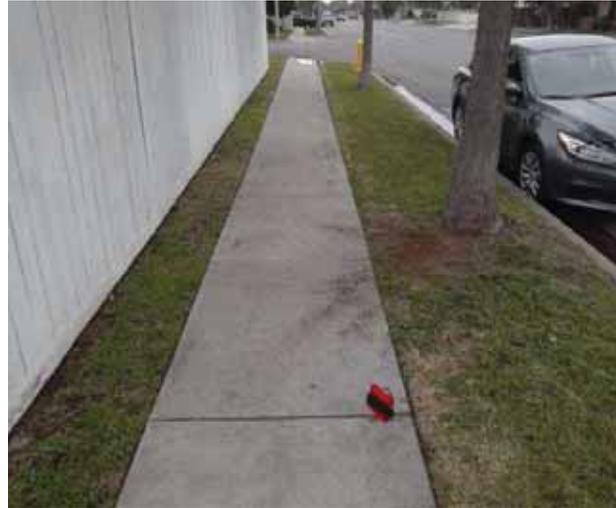
There is a change in elevation greater than recommended value.

Ensure that the change in elevation is within the recommended value.

Recommendation Up to 0.25 inches

Remove tripping hazards \$198

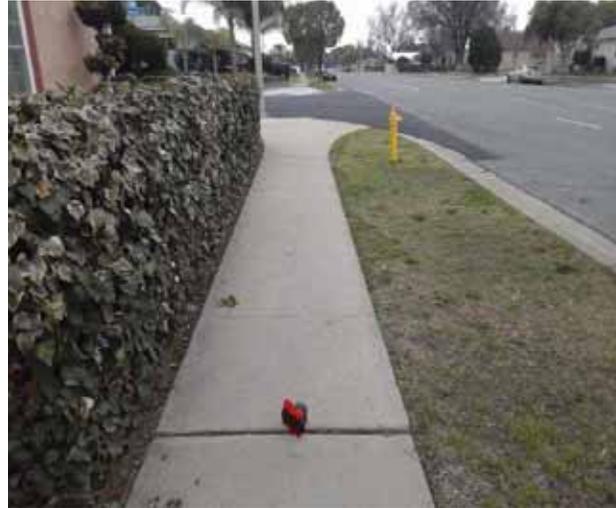
There is a change in elevation greater than recommended value.

Recommendation Up to 0.50 inches

Remove tripping hazards \$198

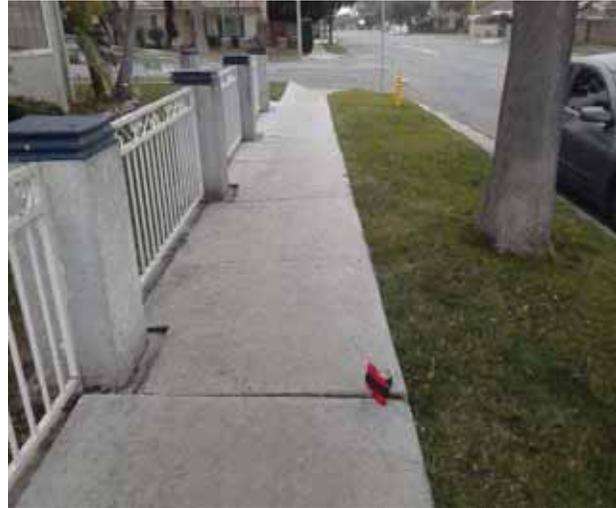
There is a change in elevation greater than recommended value.

Ensure that the change in elevation is within the recommended value.

Recommendation Up to 0.25 inches

Remove tripping hazards \$198

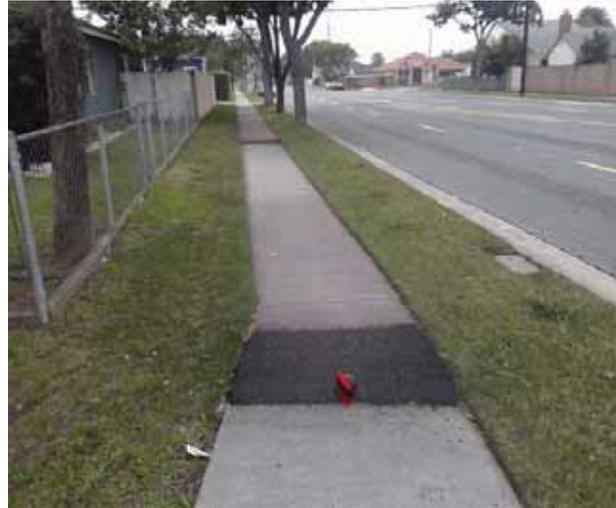
There is a change in elevation greater than recommended value.

Ensure that the change in elevation is within the recommended value.

Recommendation Up to 0.25 inches

Remove tripping hazards \$198

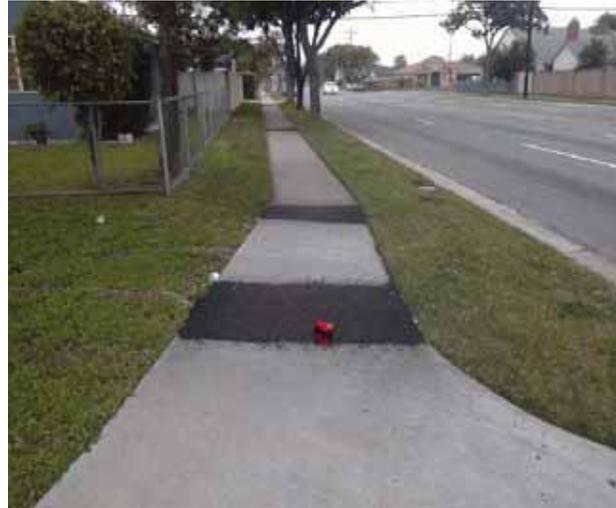
There is a change in elevation greater than recommended value.

Recommendation Up to 0.50 inches

Remove tripping hazards \$198

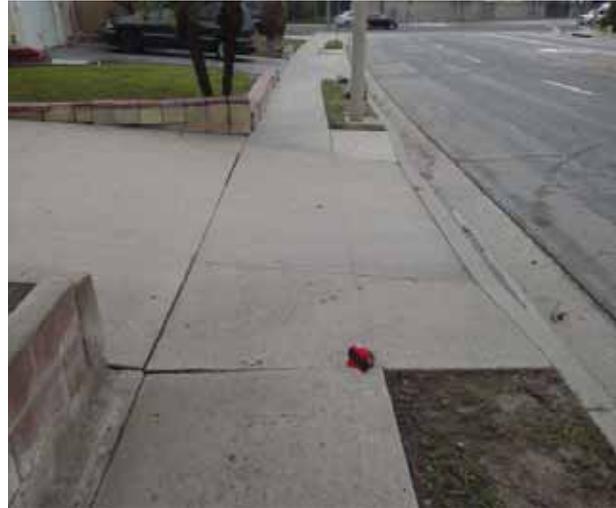
There is a change in elevation greater than recommended value.

Ensure that the change in elevation is within the recommended value.

Recommendation Up to 0.25 inches

Remove tripping hazards \$198

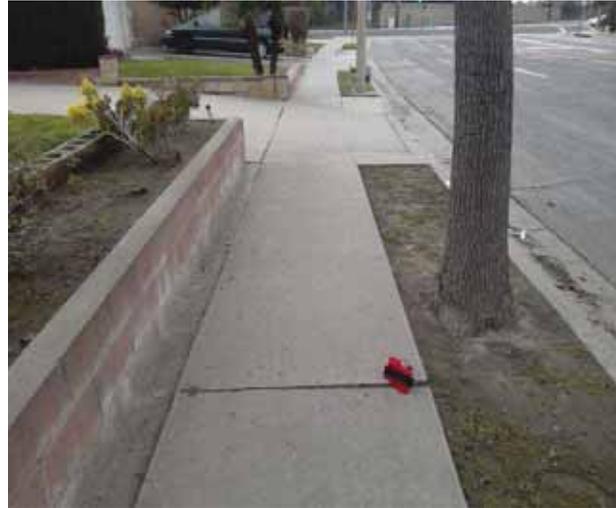
There is a change in elevation greater than recommended value.

Ensure that the change in elevation is within the recommended value.

Recommendation Up to 0.25 inches

Remove tripping hazards \$198

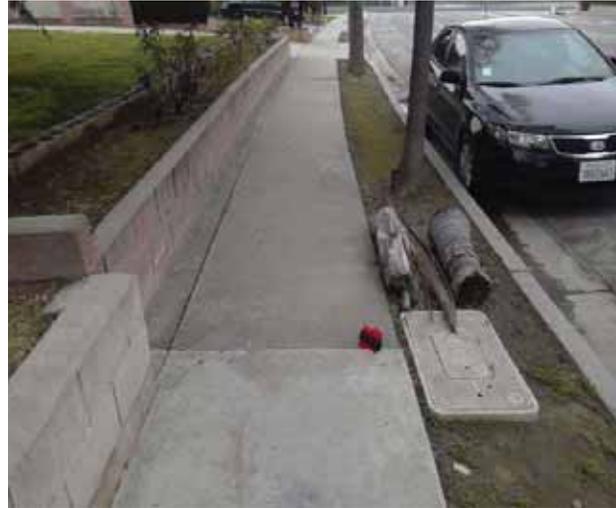
There is a change in elevation greater than recommended value.

Ensure that the change in elevation is within the recommended value.

Recommendation Up to 0.25 inches

Remove tripping hazards \$198
