# Accessibility Survey

## City of Downey Brookshire Avenue & Civic Center Drive

Brookshire Avenue & Civic Center Drive  
Downey, CA 90240

Date of Inspection  
5/25/2017

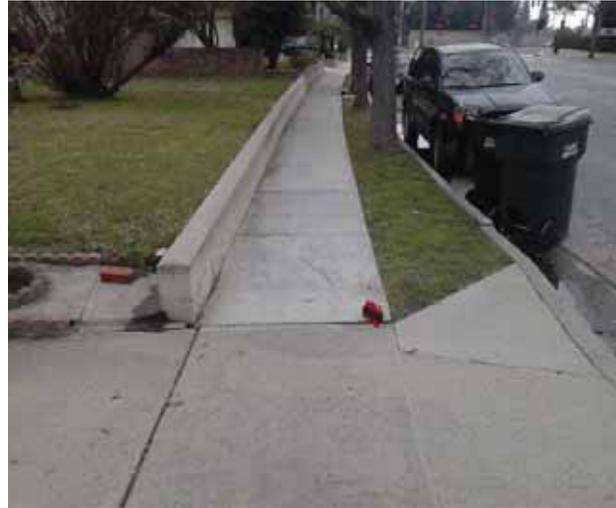
There is a change in elevation greater than recommended value.

Ensure that the change in elevation is within the recommended value.

Recommendation Up to 0.25 inches

Remove tripping hazards \$198

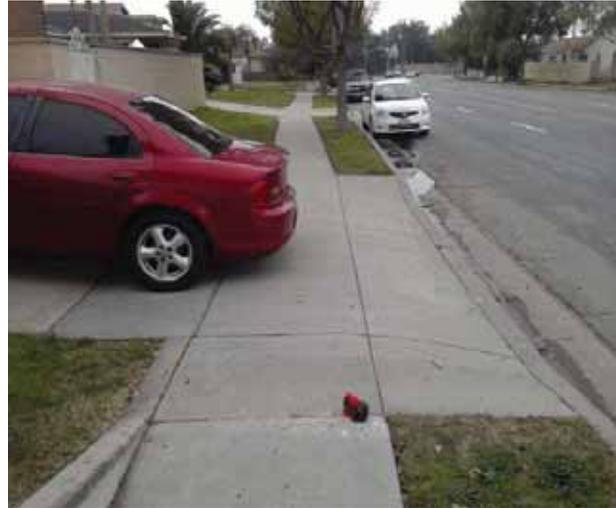
There is a change in elevation greater than recommended value.

Recommendation Up to 0.50 inches

Remove tripping hazards \$198

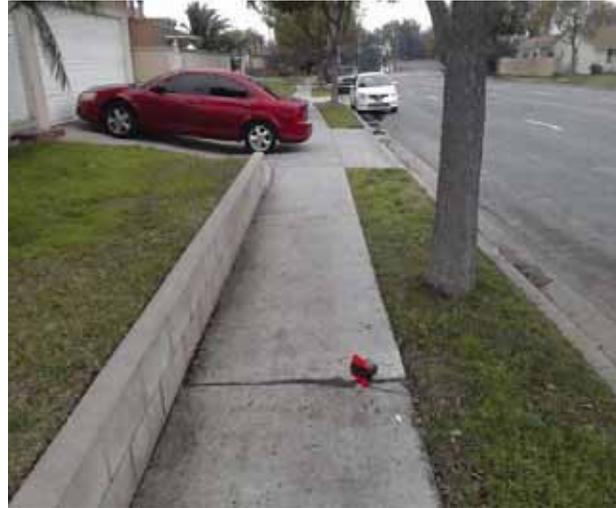
There is a change in elevation greater than recommended value.

Recommendation Up to 0.50 inches

Remove tripping hazards \$198

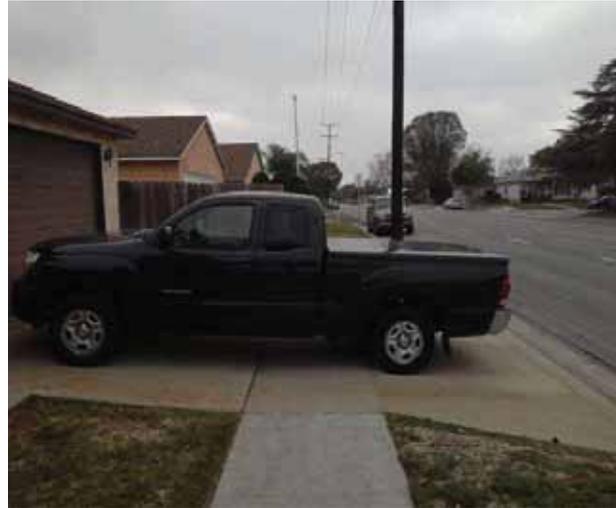
**On-Site Finding** Not Found

Install compliant detectable warnings \$190

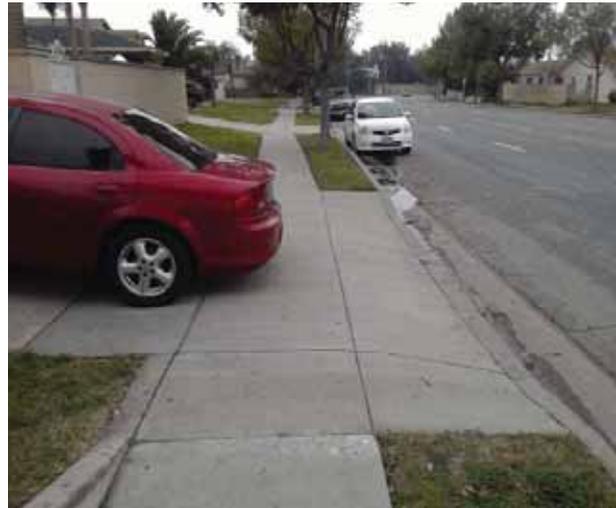
**On-Site Finding** Not Found

Install compliant detectable warnings \$190

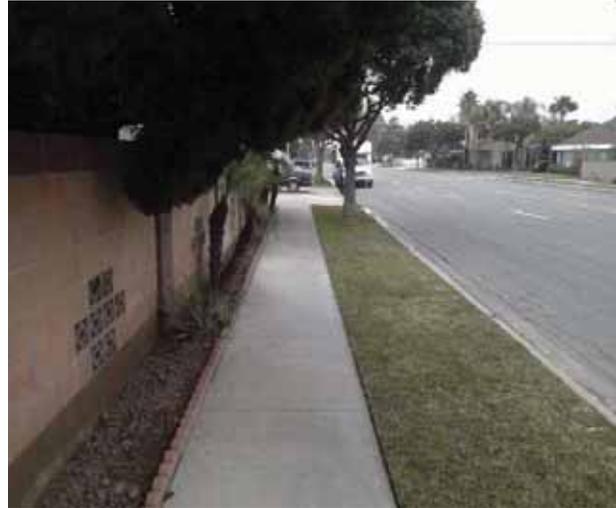
Sidewalks , Hazards & Gratings : Overhead Obstruction Height

Recommendation At least 80.00 inches

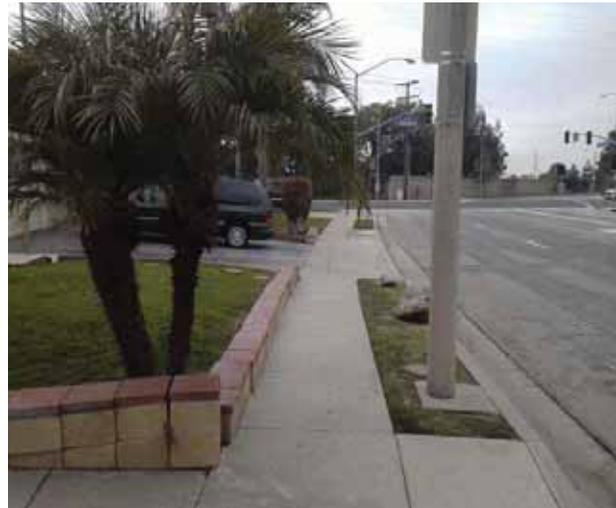
Sidewalks , Hazards & Gratings : Overhead Obstruction Height

Recommendation At least 80.00 inches

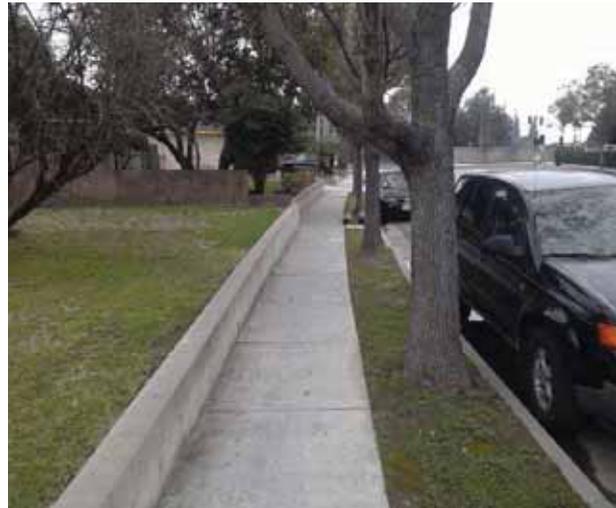
Sidewalks , Hazards & Gratings : Overhead Obstruction Height

Recommendation At least 80.00 inches

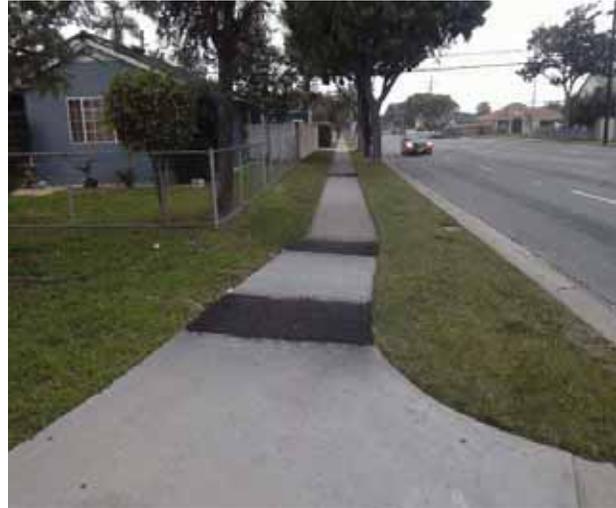
**On-Site Finding** Not Found

\$2,400

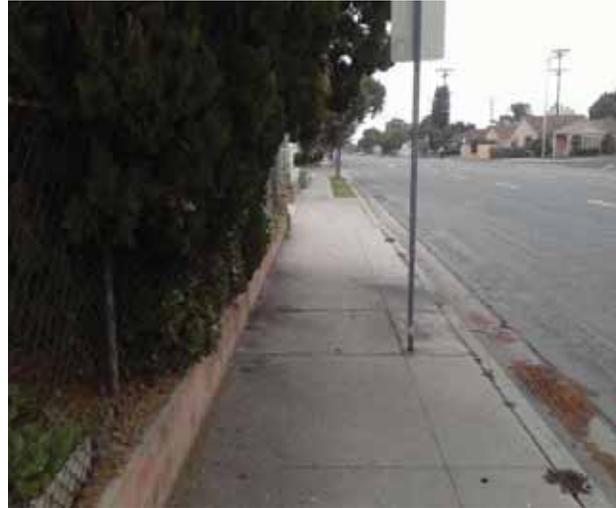
Sidewalks , Hazards & Gratings : Overhead Obstruction Height

Recommendation At least 80.00 inches

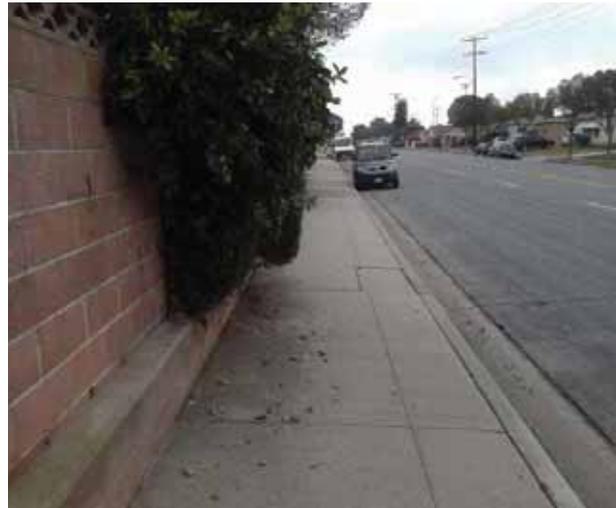
Sidewalks , Hazards & Gratings : Overhead Obstruction Height

Recommendation At least 80.00 inches

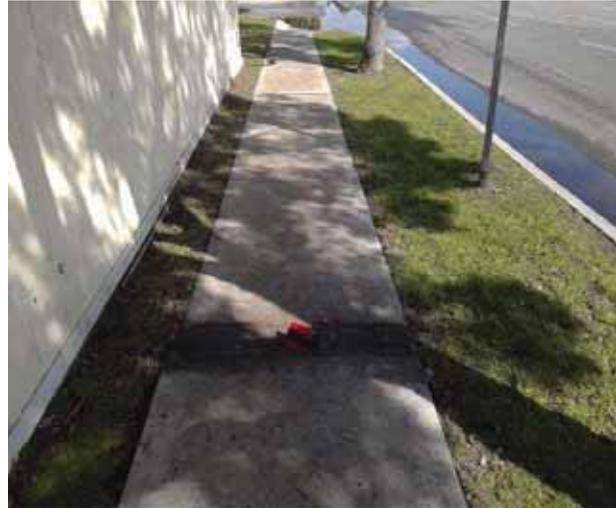
There is a change in elevation greater than recommended value.

Recommendation Up to 0.50 inches

Remove tripping hazards \$198

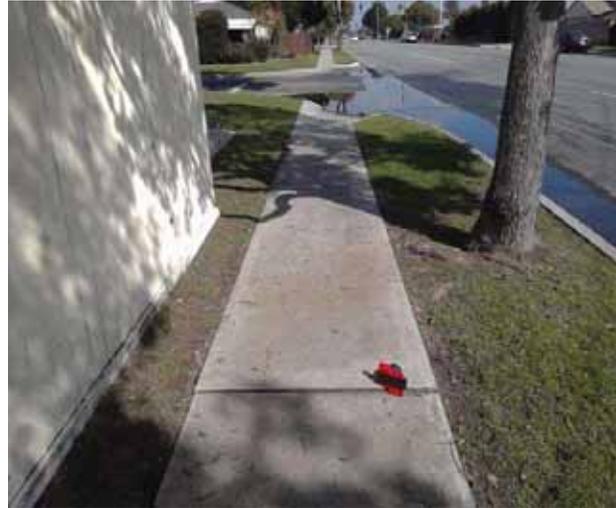
There is a change in elevation greater than recommended value.

Ensure that the change in elevation is within the recommended value.

Remove tripping hazards \$198

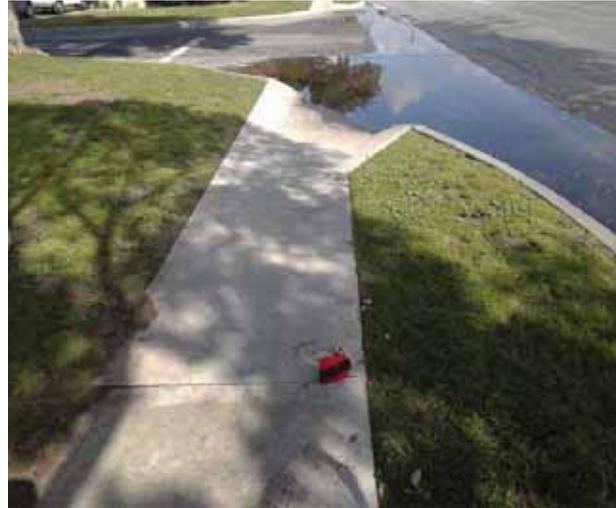
There is a change in elevation greater than recommended value.

Ensure that the change in elevation is within the recommended value.

Remove tripping hazards \$198

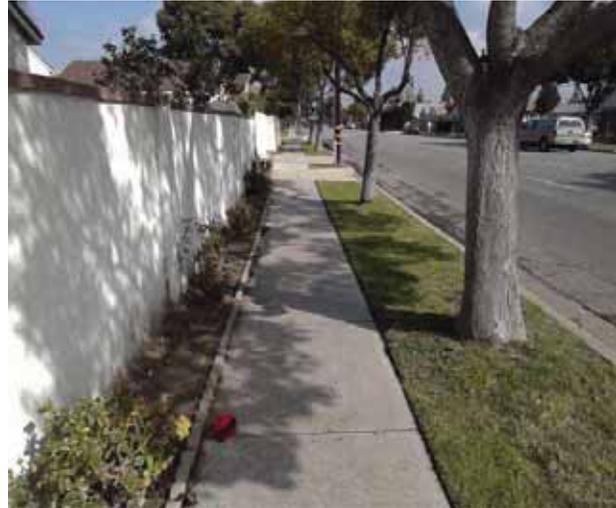
There is a change in elevation greater than recommended value.

Ensure that the change in elevation is within the recommended value.

Remove tripping hazards \$198

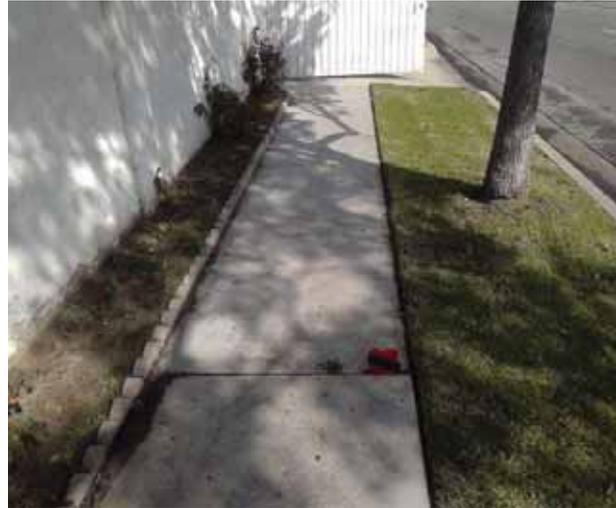
There is a change in elevation greater than recommended value.

Ensure that the change in elevation is within the recommended value.

Remove tripping hazards \$198

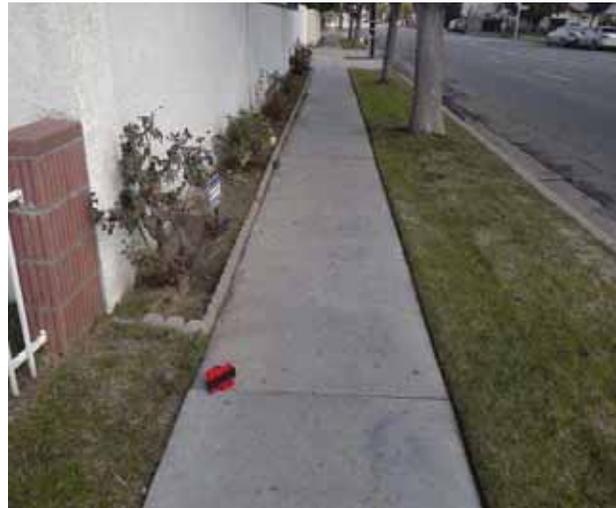
There is a change in elevation greater than recommended value.

Ensure that the change in elevation is within the recommended value.

Remove tripping hazards \$198

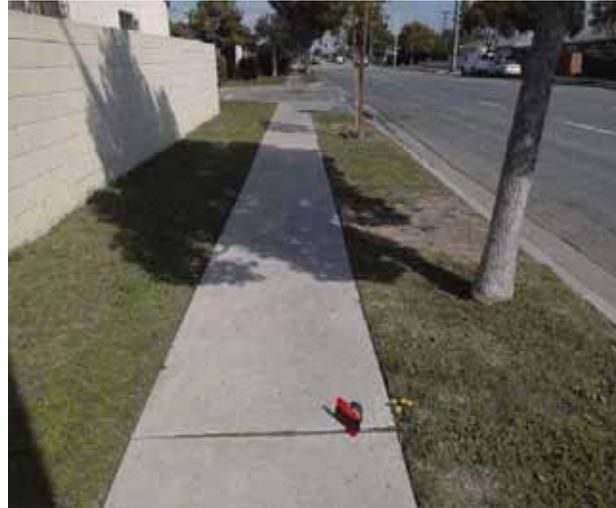
There is a change in elevation greater than recommended value.

Ensure that the change in elevation is within the recommended value.

Remove tripping hazards \$198

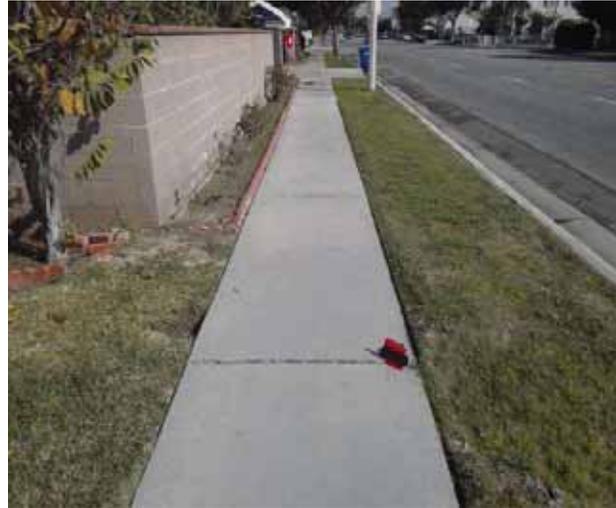
There is a change in elevation greater than recommended value.

Ensure that the change in elevation is within the recommended value.

Remove tripping hazards \$198

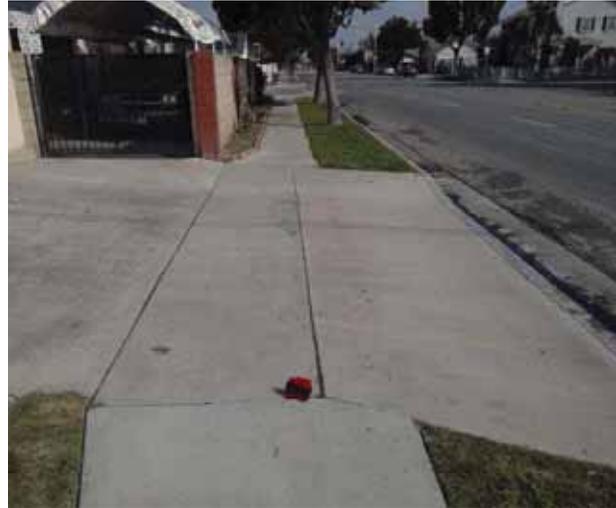
There is a change in elevation greater than recommended value.

Ensure that the change in elevation is within the recommended value.

Remove tripping hazards \$198

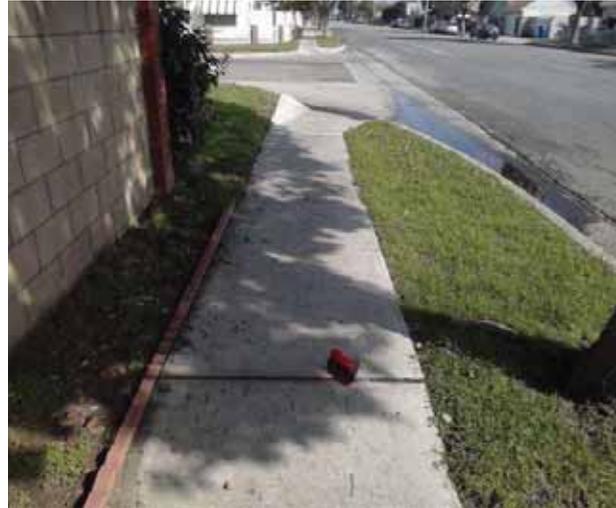
There is a change in elevation greater than recommended value.

Ensure that the change in elevation is within the recommended value.

Remove tripping hazards \$198

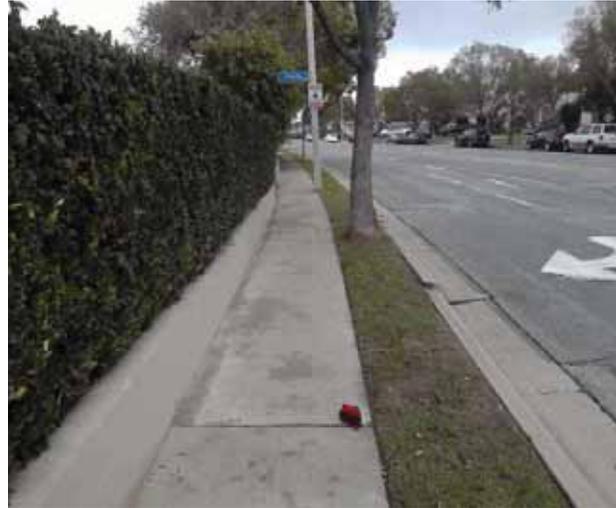
There is a change in elevation greater than recommended value.

Ensure that the change in elevation is within the recommended value.

Remove tripping hazards \$198

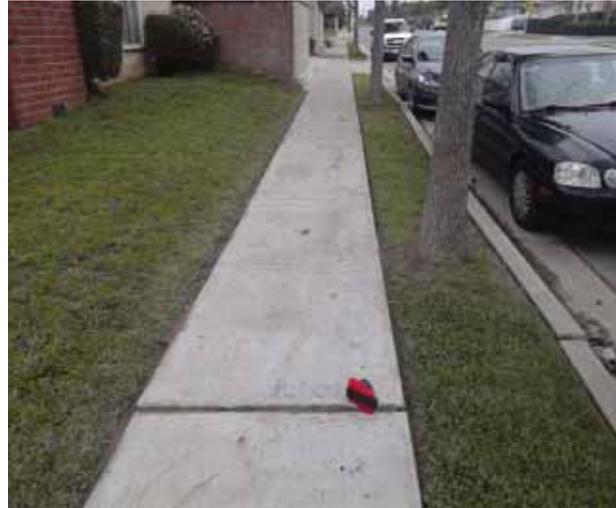
There is a change in elevation greater than recommended value.

Ensure that the change in elevation is within the recommended value.

Remove tripping hazards \$198

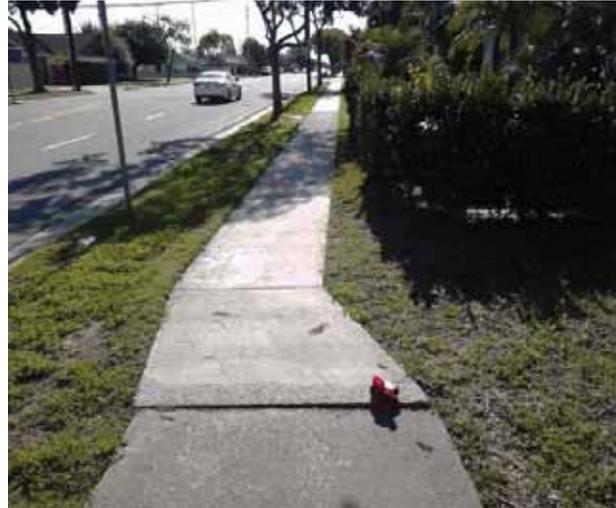
There is a change in elevation greater than recommended value.

Ensure that the change in elevation is within the recommended value.

Remove tripping hazards \$198

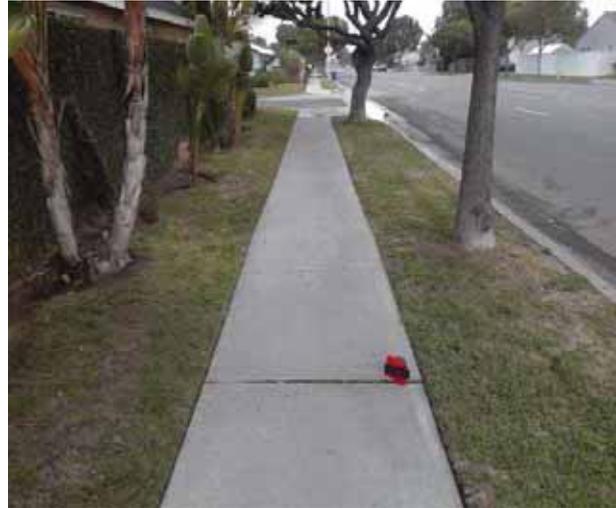
There is a change in elevation greater than recommended value.

Recommendation Up to 0.50 inches

Remove tripping hazards \$198

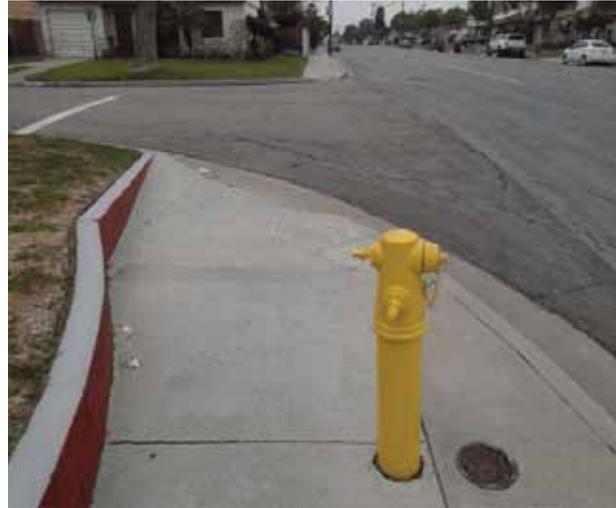
Sidewalks , Hazards & Gratings : Sidewalk Width at Obstruction

Sidewalk width at the obstruction shall have the recommended value.

Recommendation At least 48.00 inches

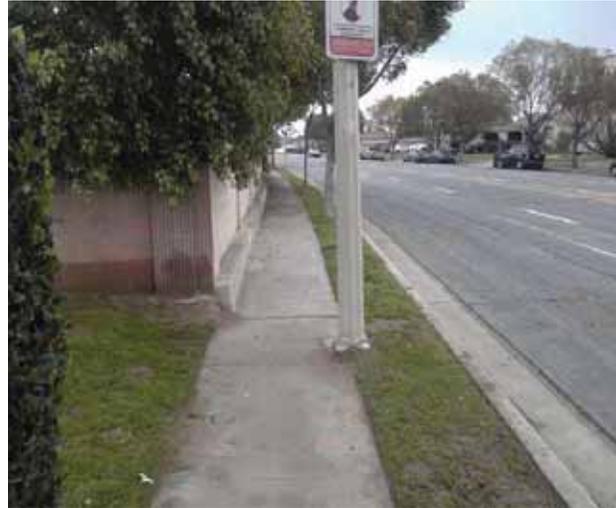
Sidewalks , Hazards & Gratings : Sidewalk Width at Obstruction

Sidewalk width at the obstruction shall have the recommended value.

Recommendation At least 48.00 inches

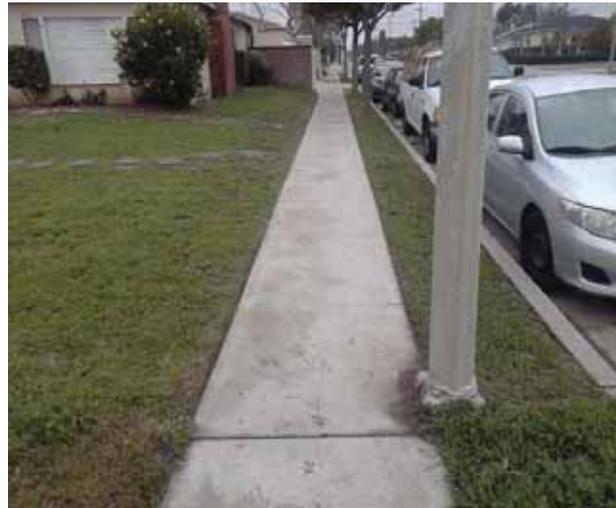
Sidewalks , Hazards & Gratings : Sidewalk Width at Obstruction

Sidewalk width at the obstruction shall have the recommended value.

Recommendation At least 48.00 inches

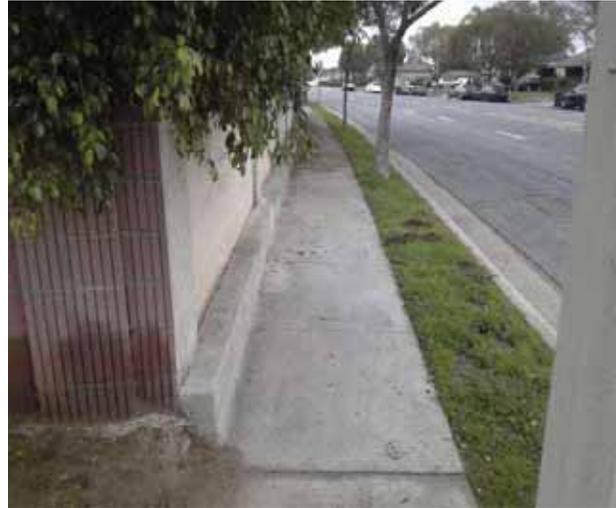
Sidewalks , Hazards & Gratings : Overhead Obstruction Height

Recommendation At least 80.00 inches

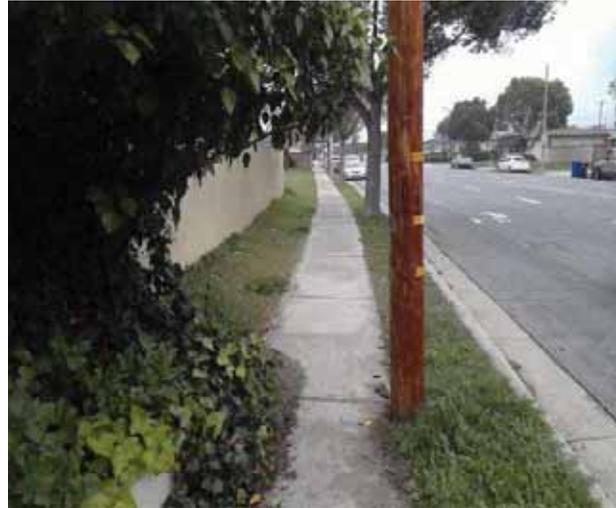
Sidewalks , Hazards & Gratings : Overhead Obstruction Height

Recommendation At least 80.00 inches

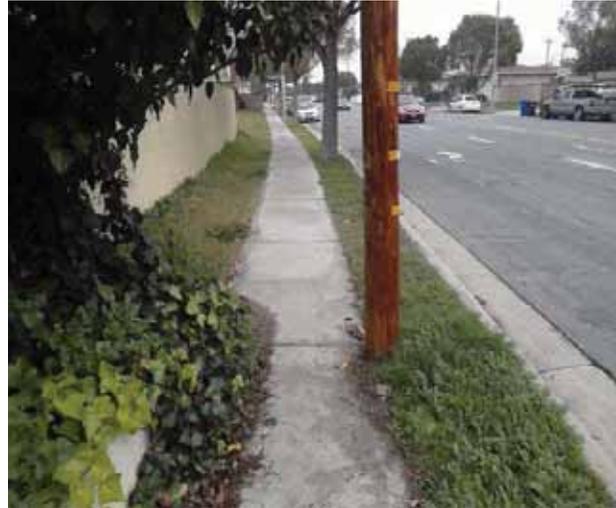
Sidewalks , Hazards & Gratings : Sidewalk Width at Obstruction

Sidewalk width at the obstruction shall have the recommended value.

Recommendation At least 48.00 inches

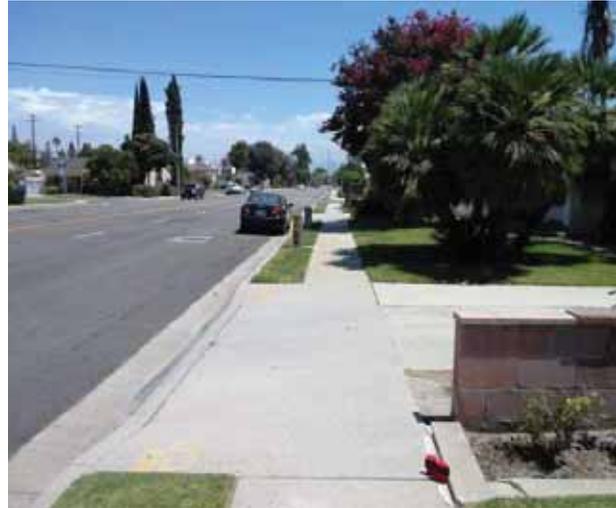
There is a change in elevation greater than recommended value.

Ensure that the change in elevation is within the recommended value.

Recommendation Up to 0.25 inches

Remove tripping hazards \$198

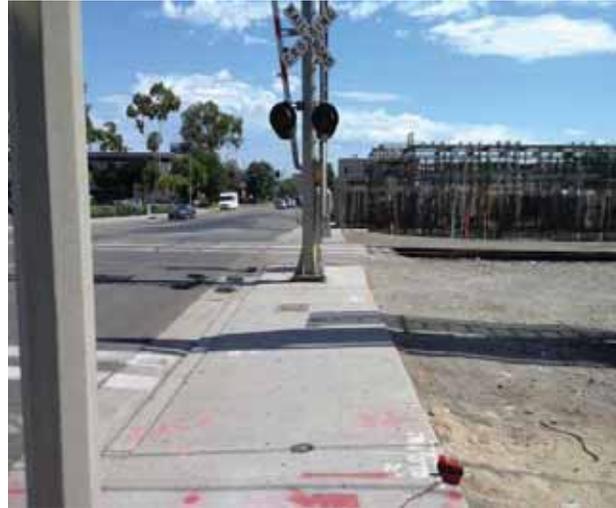
There is a change in elevation greater than recommended value.

Ensure that the change in elevation is within the recommended value.

Recommendation Up to 0.25 inches

Remove tripping hazards \$198

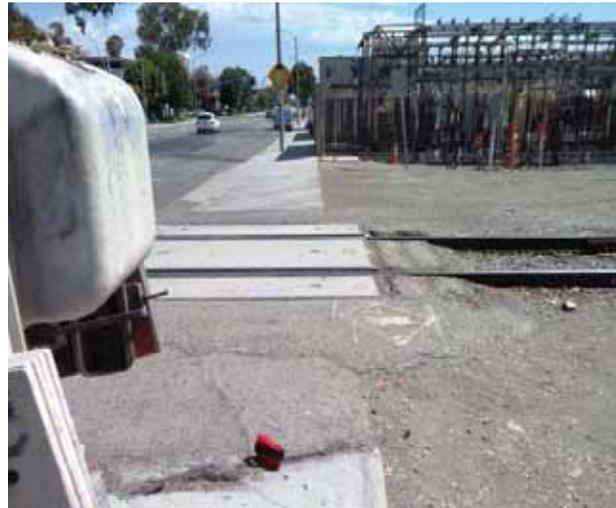
There is a change in elevation greater than recommended value.

Ensure that the change in elevation is within the recommended value.

Recommendation Up to 0.25 inches

Remove tripping hazards \$198

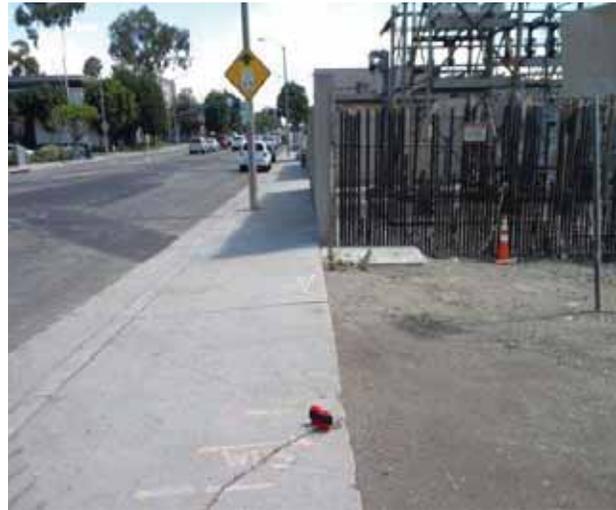
There is a change in elevation greater than recommended value.

Ensure that the change in elevation is within the recommended value.

Recommendation Up to 0.25 inches

Remove tripping hazards \$198

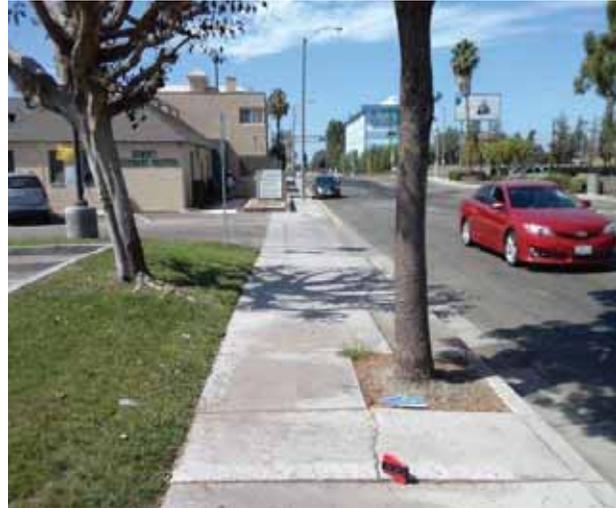
There is a change in elevation greater than recommended value.

Ensure that the change in elevation is within the recommended value.

Recommendation Up to 0.25 inches

Remove tripping hazards \$198

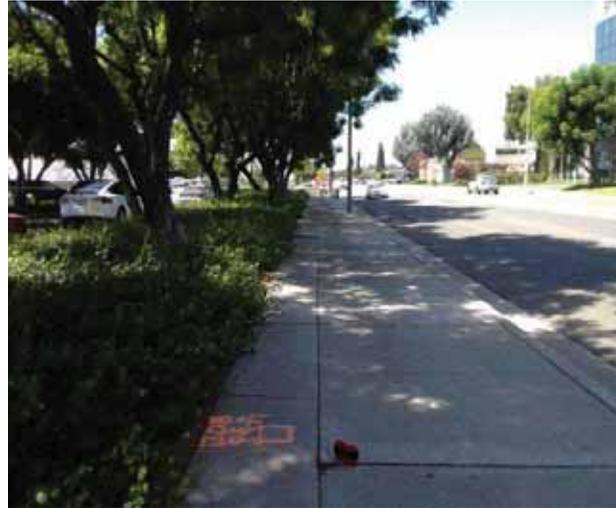
There is a change in elevation greater than recommended value.

Ensure that the change in elevation is within the recommended value.

Recommendation Up to 0.25 inches

Remove tripping hazards \$198

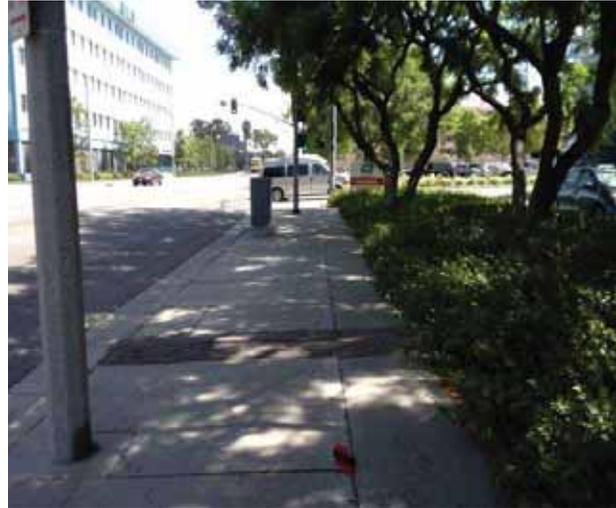
There is a change in elevation greater than recommended value.

Ensure that the change in elevation is within the recommended value.

Recommendation Up to 0.25 inches

Remove tripping hazards \$198

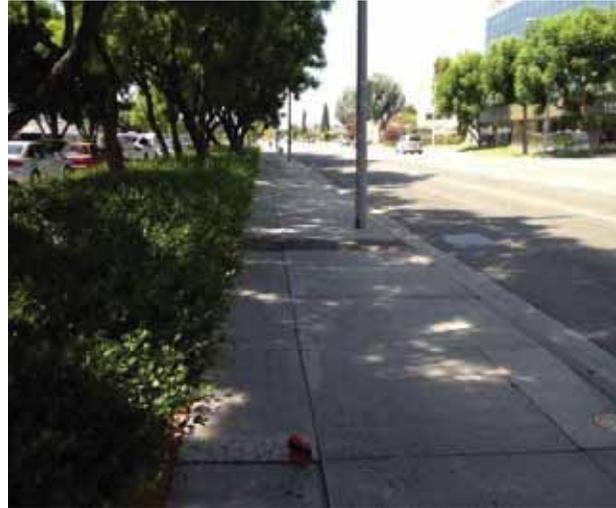
There is a change in elevation greater than recommended value.

Ensure that the change in elevation is within the recommended value.

Recommendation Up to 0.25 inches

Remove tripping hazards \$198

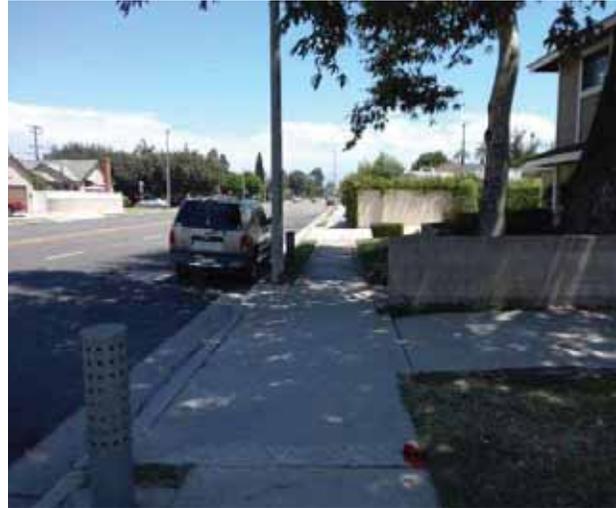
There is a change in elevation greater than recommended value.

Ensure that the change in elevation is within the recommended value.

Recommendation Up to 0.25 inches

Remove tripping hazards \$198

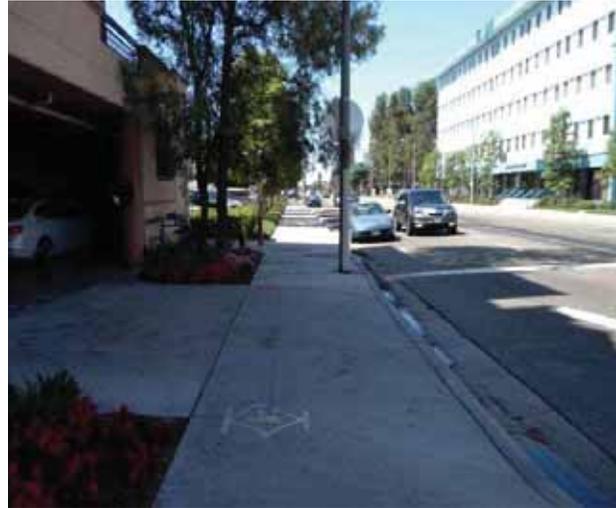
**On-Site Finding** Not Found

Install compliant detectable warnings \$190

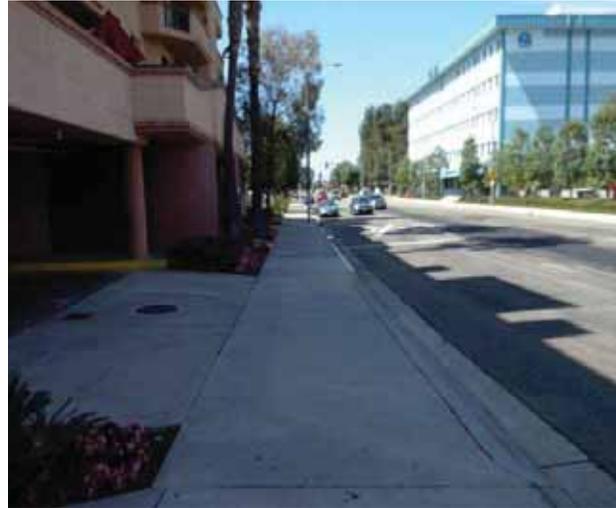
**On-Site Finding** Not Found

Install compliant detectable warnings \$190

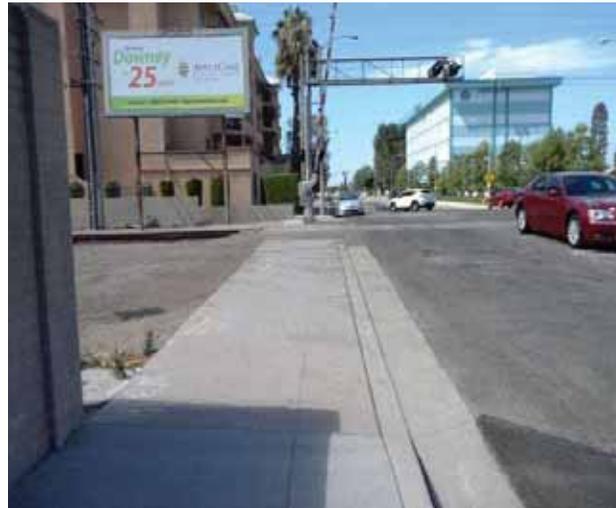
**On-Site Finding** Not Found

Install compliant detectable warnings \$190

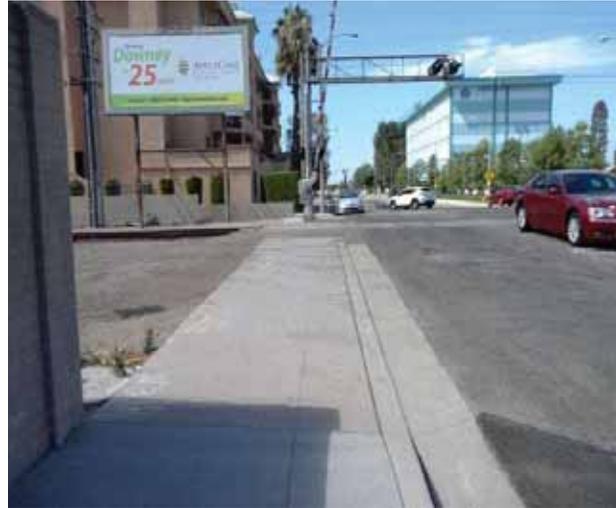
Notes : Spalled Concrete Continues For 9 Feet

Recommendation Up to 2.08 percent

Repave surface \$1,092

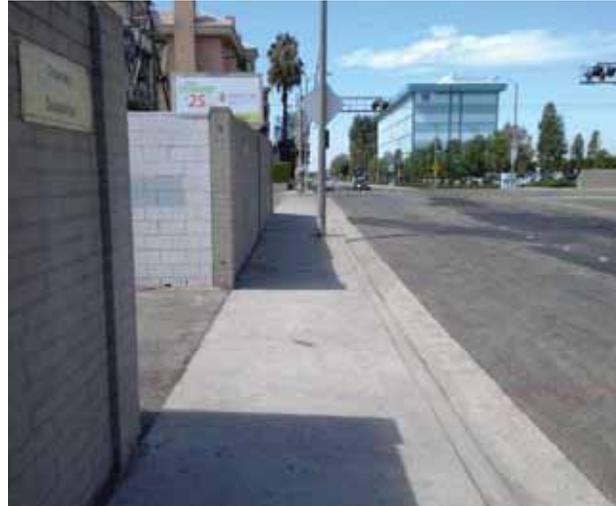
**On-Site Finding** Not Found

Install compliant detectable warnings \$190

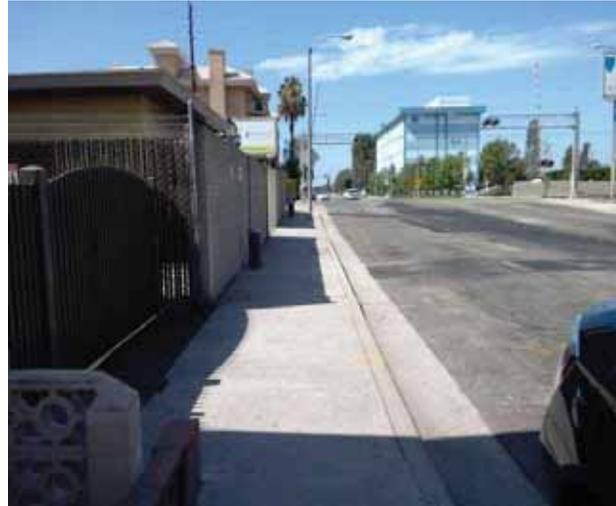
**On-Site Finding** Not Found

Install compliant detectable warnings \$190

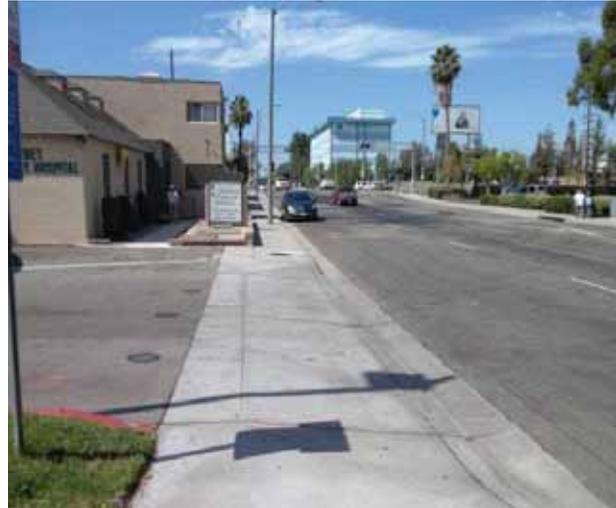
**On-Site Finding** Not Found

Install compliant detectable warnings \$190

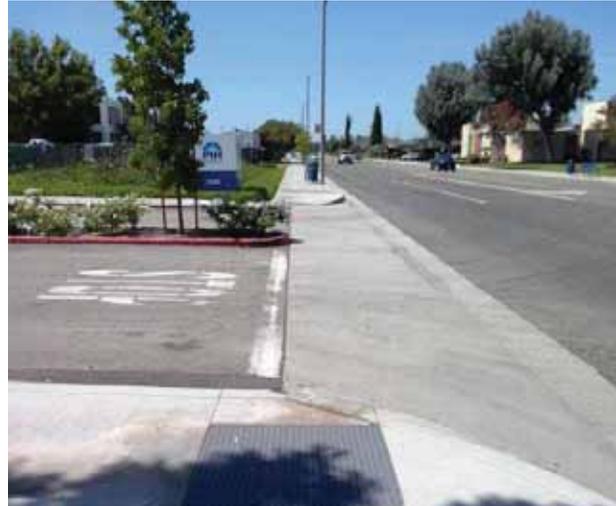
**On-Site Finding** Not Found

Install compliant detectable warnings \$190

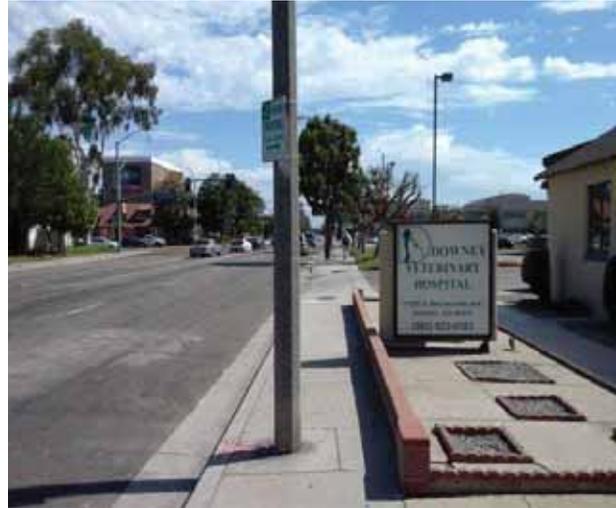
Sidewalks , Hazards & Gratings : Sidewalk Width at Obstruction

Sidewalk width at the obstruction shall have the recommended value.

Recommendation At least 48.00 inches

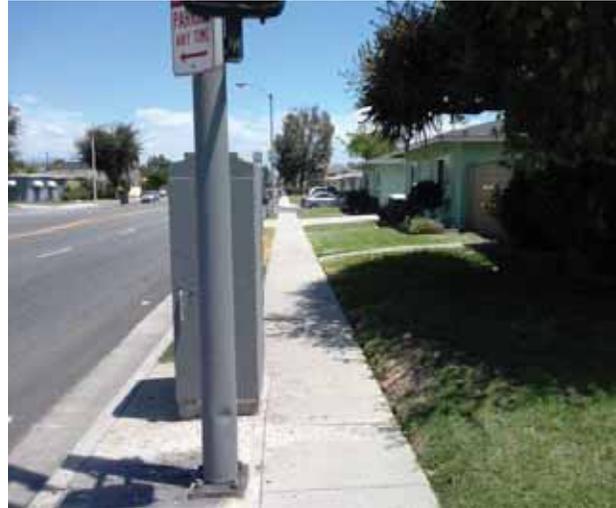
Sidewalks , Hazards & Gratings : Sidewalk Width at Obstruction

Sidewalk width at the obstruction shall have the recommended value.

Recommendation At least 48.00 inches

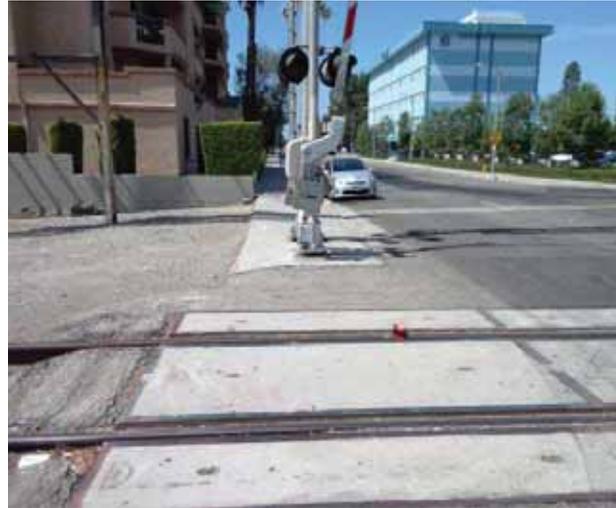
Notes : Surface is Rough And Uneven

Repave the sidewalk surface with the recommended cross slope.

Recommendation Up to 2.08 percent

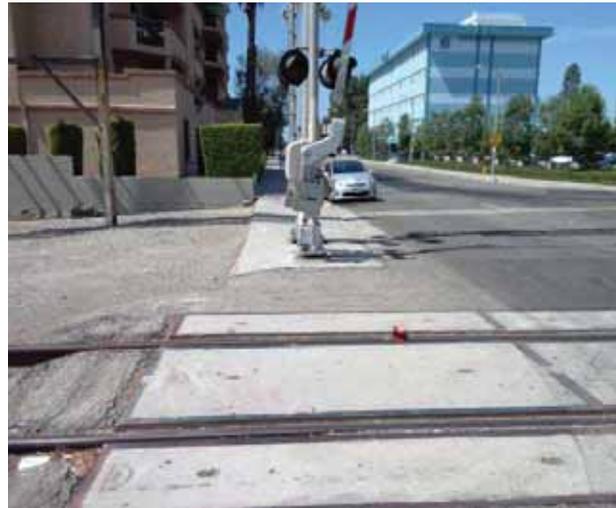
Notes : Surface is Rough And Uneven

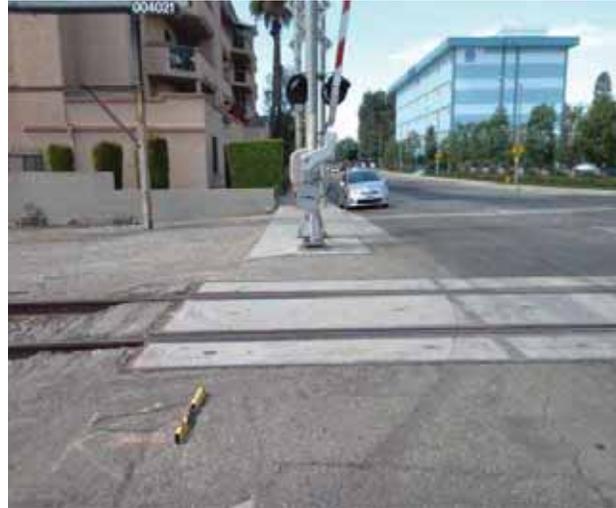
Notes : Surface is Rough And Uneven

Repave the sidewalk surface with the recommended running slope.

Recommendation Up to 5.00 percent

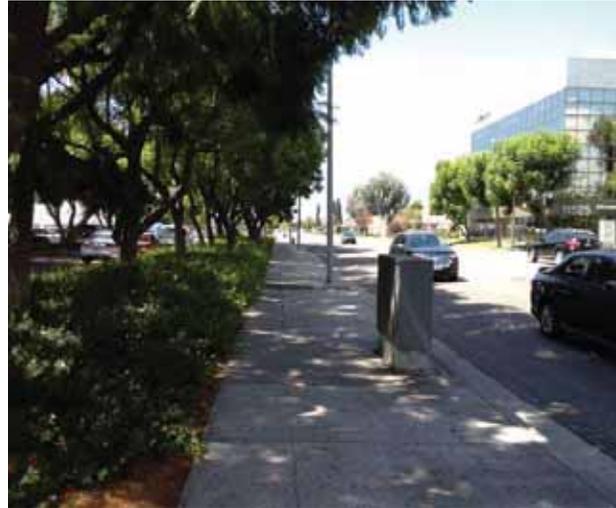
Notes : Surface is Rough And Uneven For 2 Feet

Repave the sidewalk surface with the recommended cross slope.

Recommendation Up to 2.08 percent

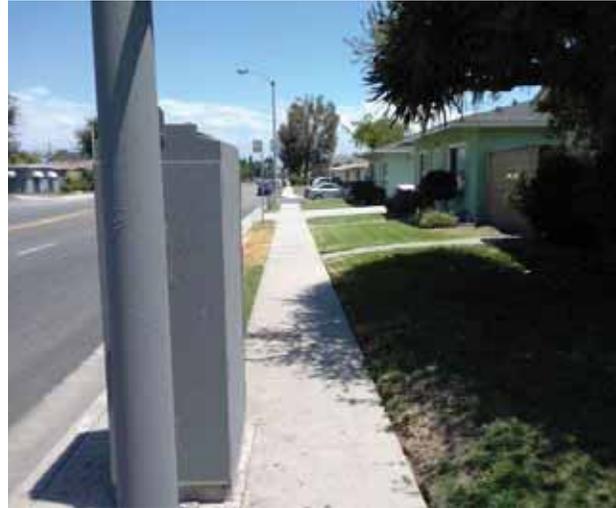
Sidewalks , Hazards & Gratings : Sidewalk Width at Obstruction

Sidewalk width at the obstruction shall have the recommended value.

Recommendation At least 48.00 inches

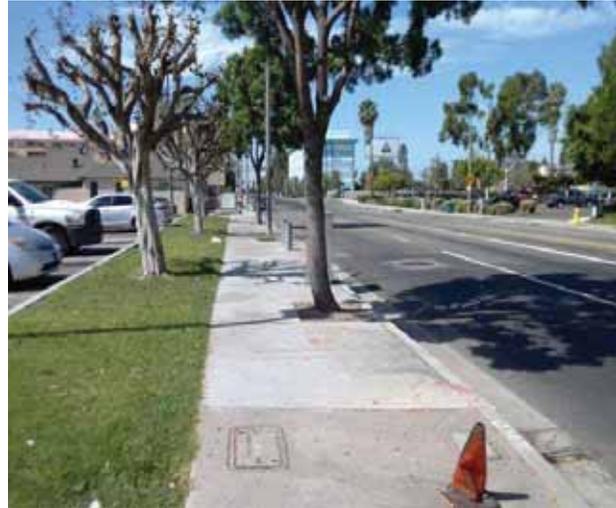
**On-Site Finding** Not Found

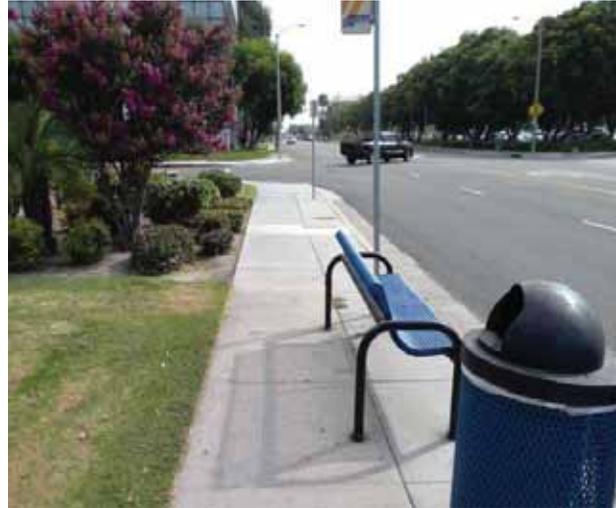
Sidewalks , Hazards & Gratings : Sidewalk Width at Obstruction

Sidewalk width at the obstruction shall have the recommended value.

Recommendation At least 48.00 inches

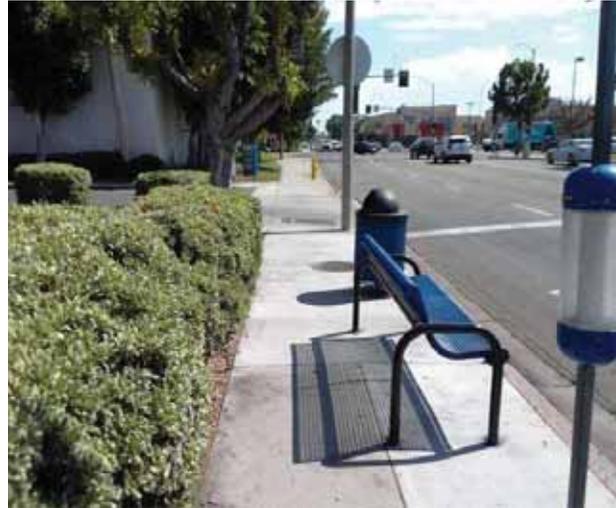
Sidewalks , Hazards & Gratings : Sidewalk Width at Obstruction

Sidewalk width at the obstruction shall have the recommended value.

Recommendation At least 48.00 inches

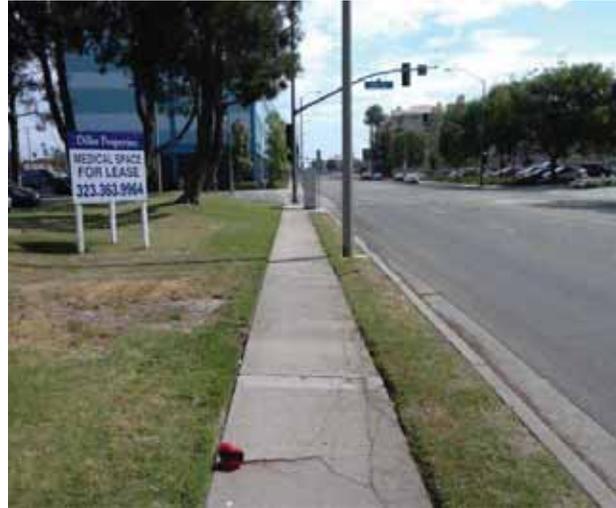
There is a change in elevation greater than recommended value.

Ensure that the change in elevation is within the recommended value.

Recommendation Up to 0.25 inches

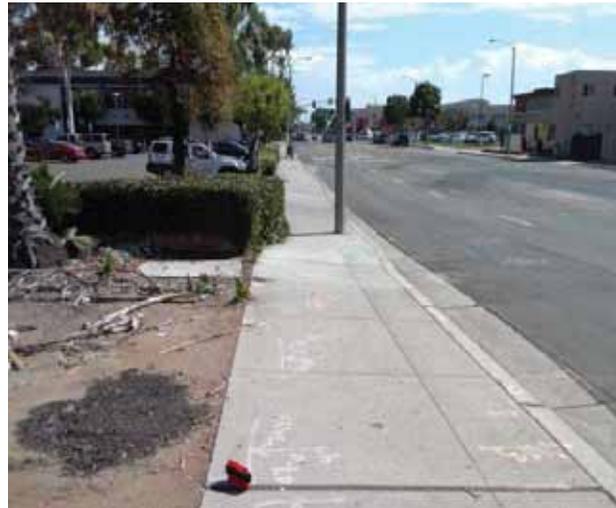
There is a change in elevation greater than recommended value.

Ensure that the change in elevation is within the recommended value.

Recommendation Up to 0.25 inches

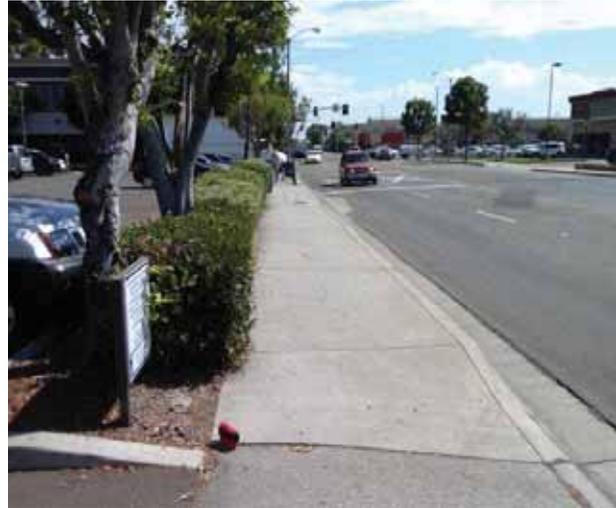
There is a change in elevation greater than recommended value.

Ensure that the change in elevation is within the recommended value.

Recommendation Up to 0.25 inches

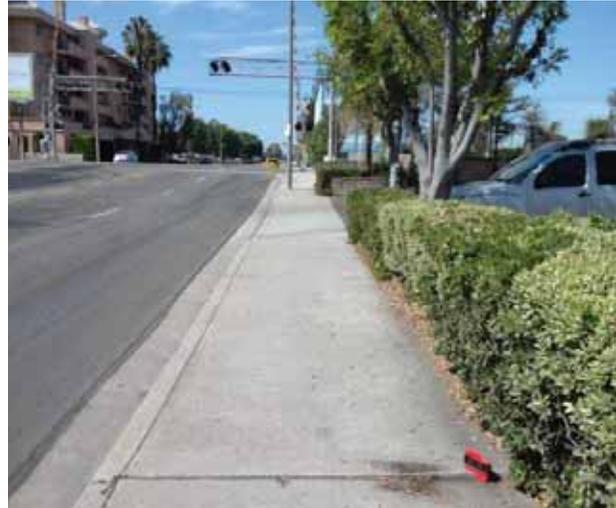
There is a change in elevation greater than recommended value.

Ensure that the change in elevation is within the recommended value.

Recommendation Up to 0.25 inches

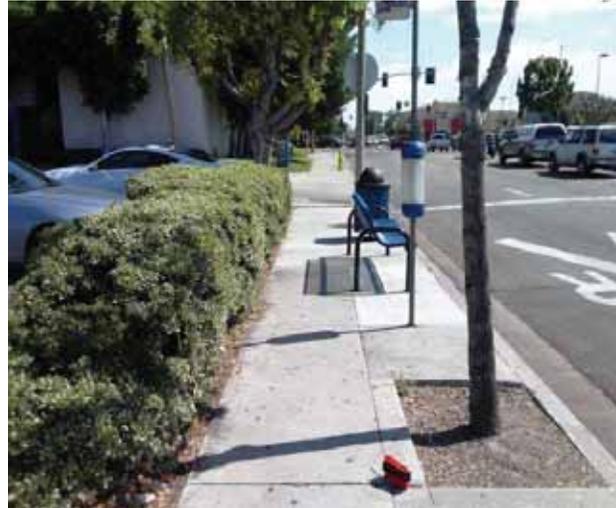
There is a change in elevation greater than recommended value.

Ensure that the change in elevation is within the recommended value.

Recommendation Up to 0.25 inches

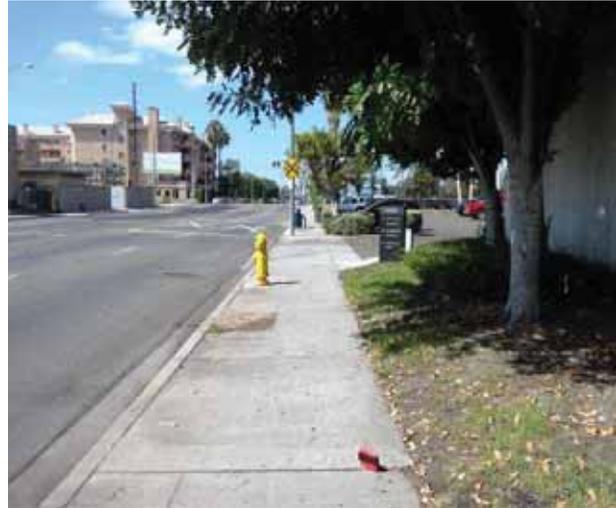
There is a change in elevation greater than recommended value.

Ensure that the change in elevation is within the recommended value.

Recommendation Up to 0.25 inches

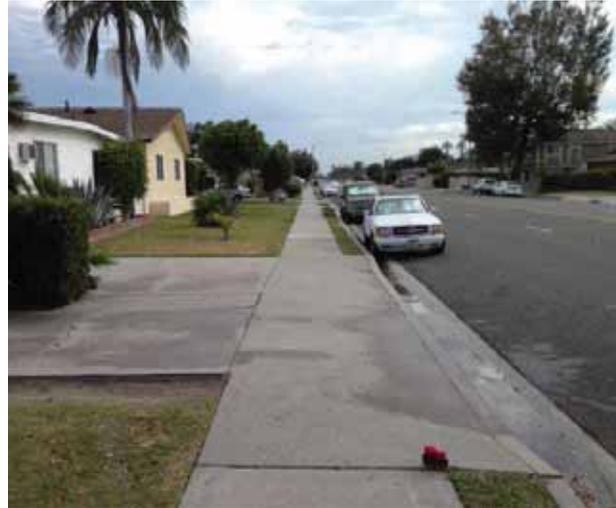
There is a change in elevation greater than recommended value.

Ensure that the change in elevation is within the recommended value.

Recommendation Up to 0.25 inches
