# Accessibility Survey

## City of Downey Brookshire Avenue & Civic Center Drive

Brookshire Avenue & Civic Center Drive  
Downey, CA 90240

Date of Inspection  
5/25/2017

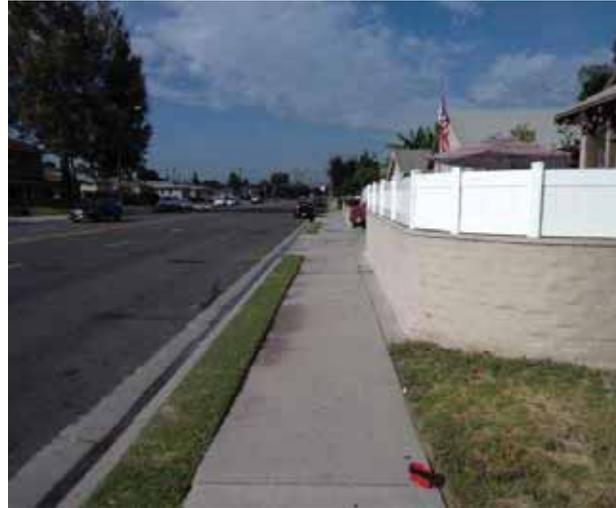
There is a change in elevation greater than recommended value.

Ensure that the change in elevation is within the recommended value.

Recommendation Up to 0.25 inches

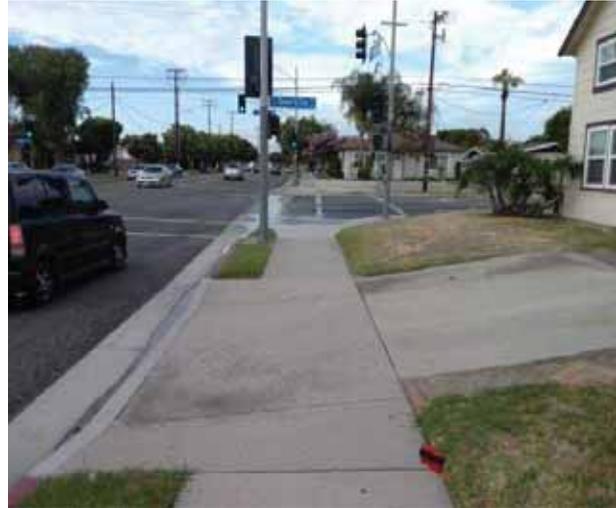
There is a change in elevation greater than recommended value.

Ensure that the change in elevation is within the recommended value.

Recommendation Up to 0.25 inches

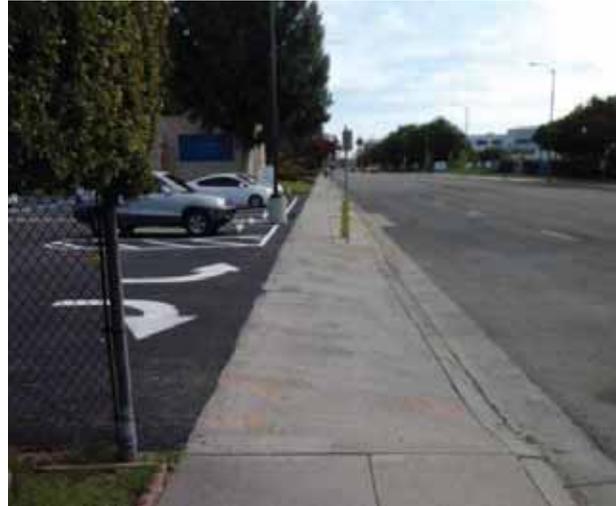
**On-Site Finding** Not Found

Install compliant detectable warnings \$190

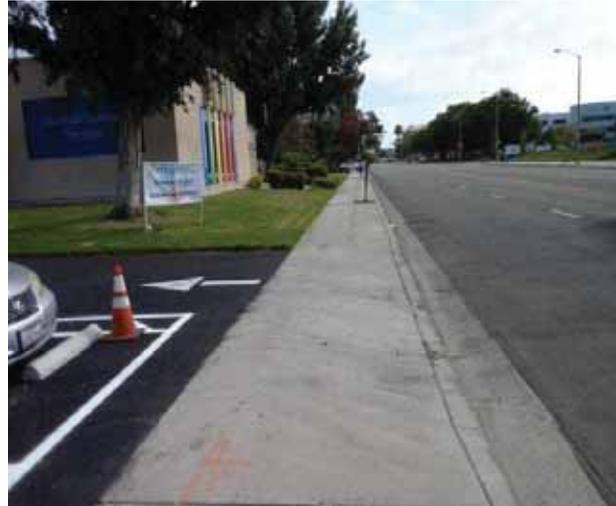
**On-Site Finding** Not Found

Install compliant detectable warnings \$190

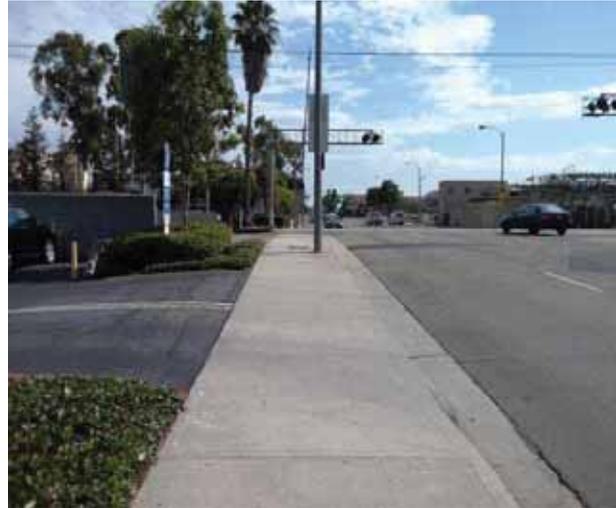
**On-Site Finding** Not Found

Install compliant detectable warnings \$190

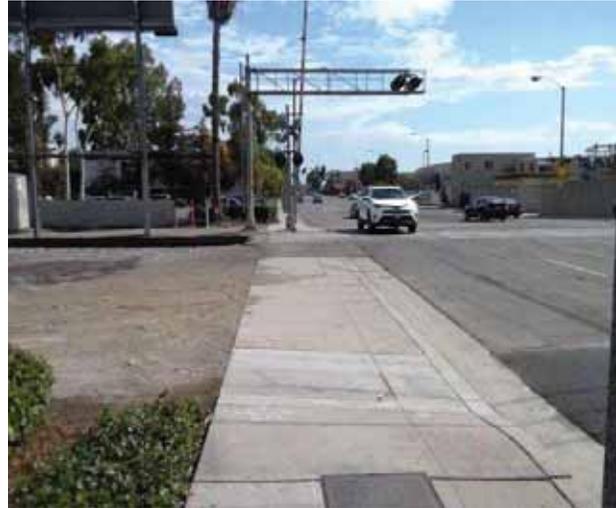
**On-Site Finding** Not Found

Install compliant detectable warnings \$190

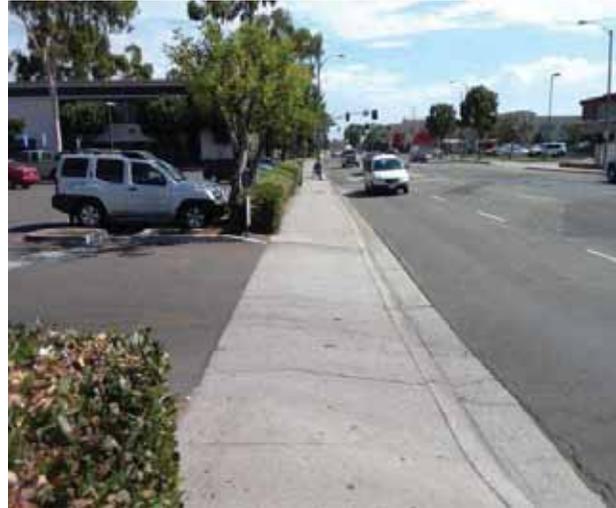
**On-Site Finding** Not Found

Install compliant detectable warnings \$190

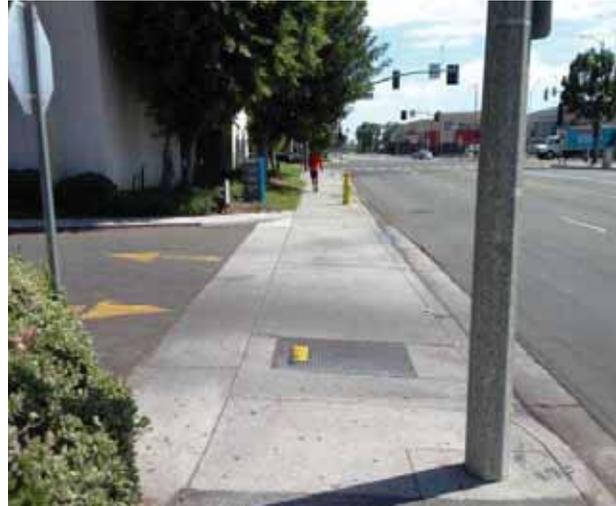
**On-Site Finding** Not Found

Install compliant detectable warnings \$190

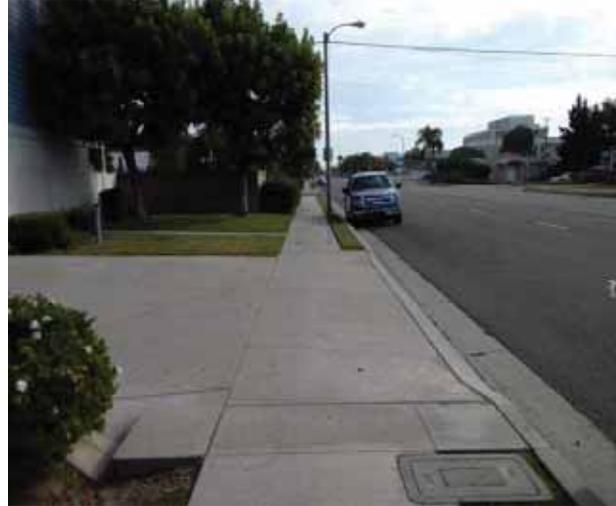
Recommendation Up to 2.08 percent

Repave surface \$1,092

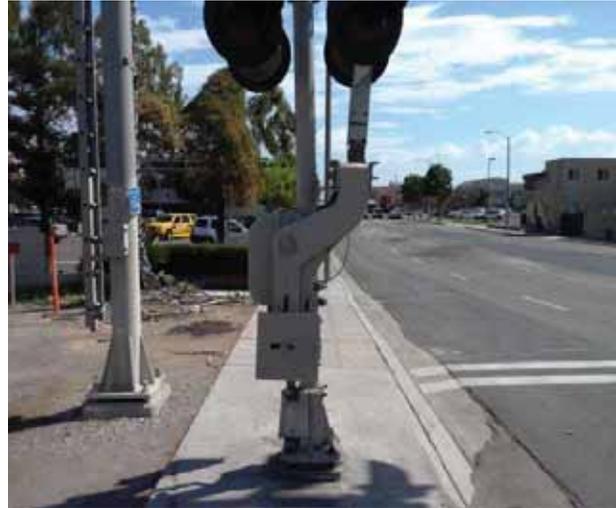
Sidewalks , Hazards & Gratings : Protruding Object Height

Recommendation Up to 4.00 inches

Install wing walls or relocate object \$640

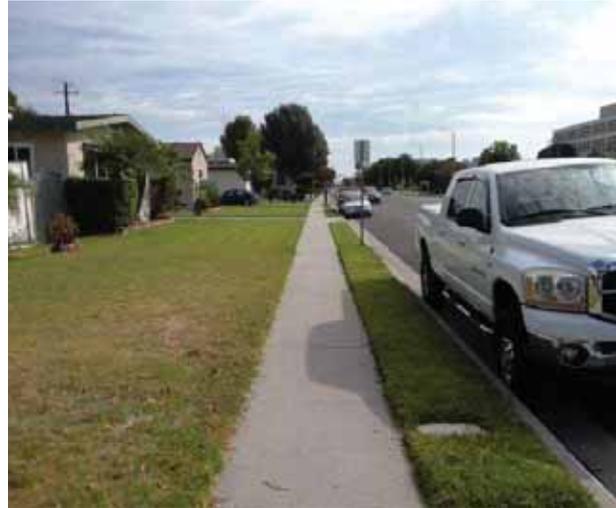
Recommendation Up to 2.08 percent

Repave the sidewalk surface with the recommended cross slope.

Repave surface \$1,092

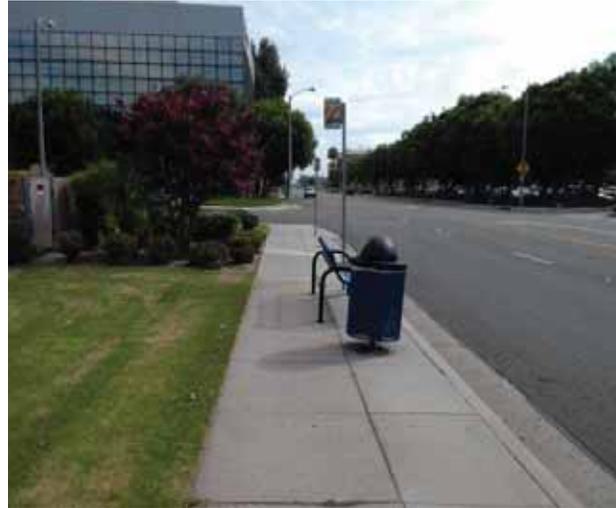
Recommendation Up to 2.08 percent

Repave the sidewalk surface with the recommended cross slope.

Repave surface \$1,092

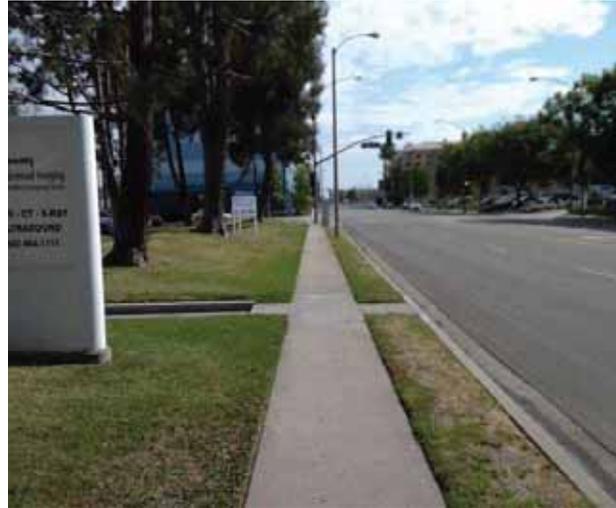
Recommendation Up to 2.08 percent

Repave the sidewalk surface with the recommended cross slope.

Repave surface \$1,092

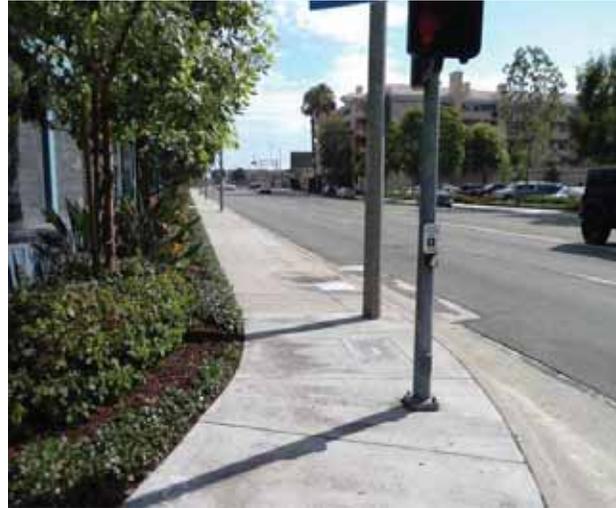
Recommendation Up to 2.08 percent

Repave the sidewalk surface with the recommended cross slope.

Repave surface \$1,092

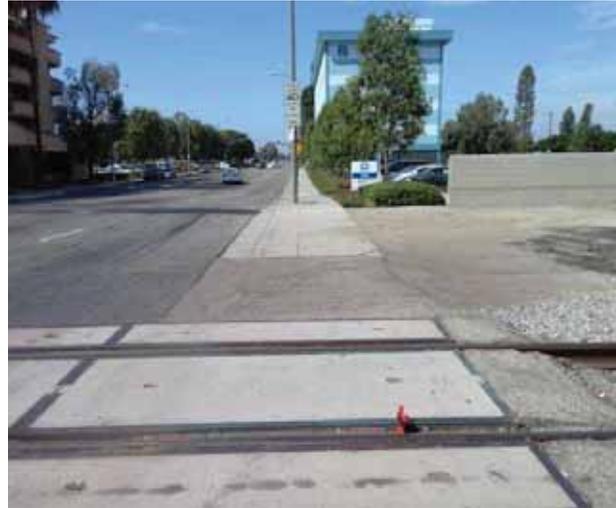
Notes : Railroad Crossing Opening = 3"

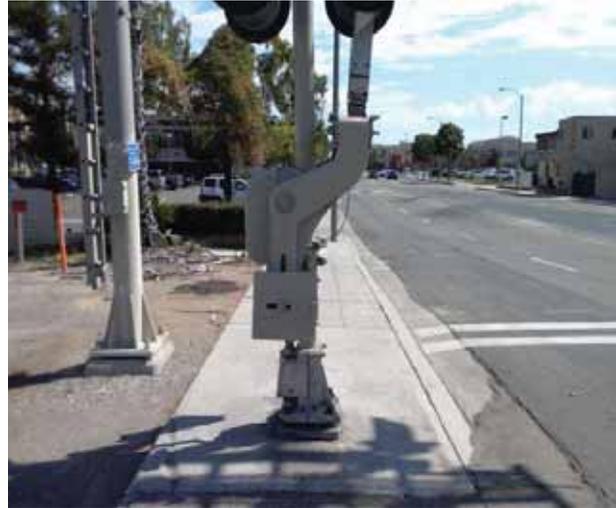
Recommendation At least 48.00 inches

Widen the sidewalk to the recommended value.

\$1,260

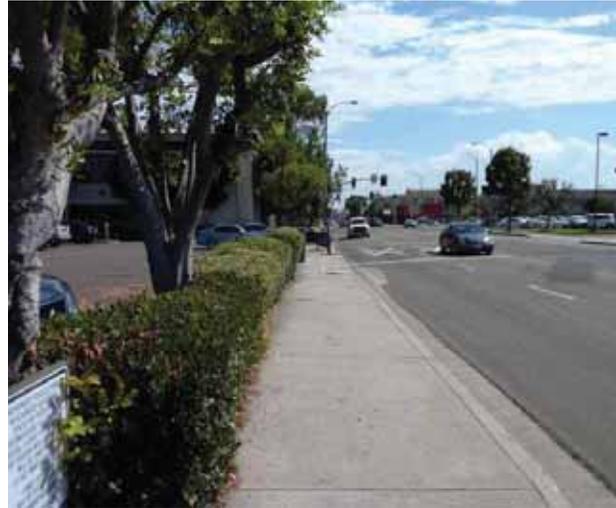
Recommendation Up to 2.08 percent

Repave the sidewalk surface with the recommended cross slope.

Repave surface \$1,092

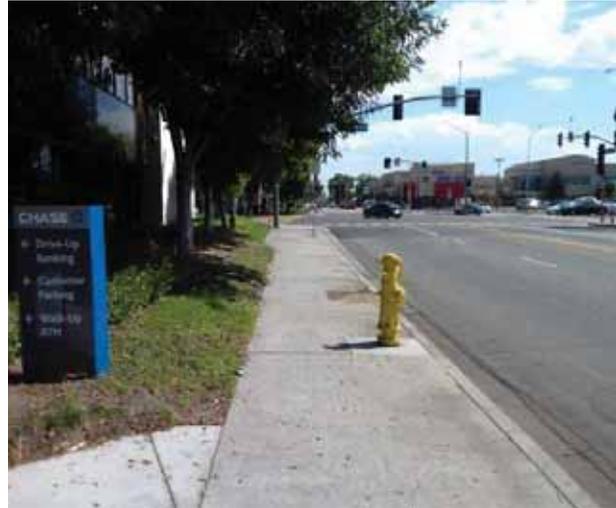
Recommendation Up to 2.08 percent

Repave the sidewalk surface with the recommended cross slope.

Repave surface \$1,092

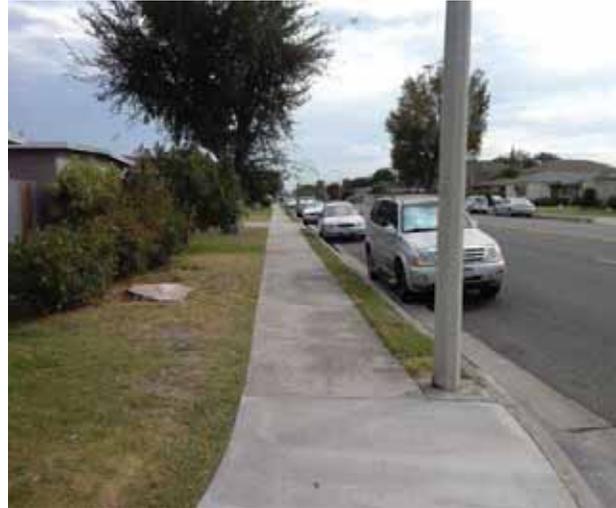
Recommendation Up to 2.08 percent

Repave the sidewalk surface with the recommended cross slope.

Repave surface \$1,092

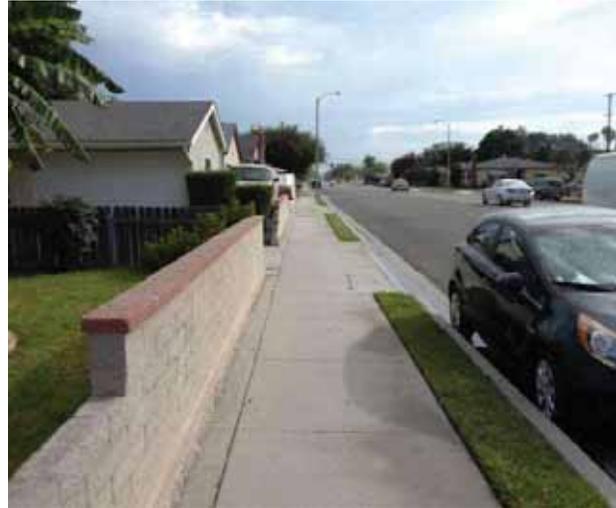
Recommendation Up to 2.08 percent

Repave the sidewalk surface with the recommended cross slope.

Repave surface \$1,092

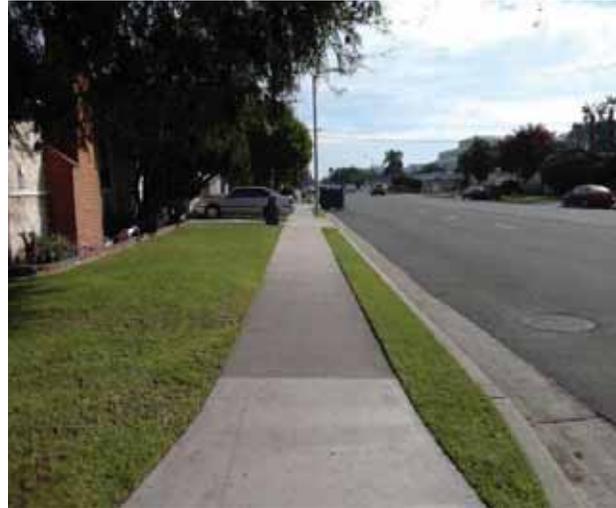
Recommendation Up to 2.08 percent

Repave the sidewalk surface with the recommended cross slope.

Repave surface \$1,092

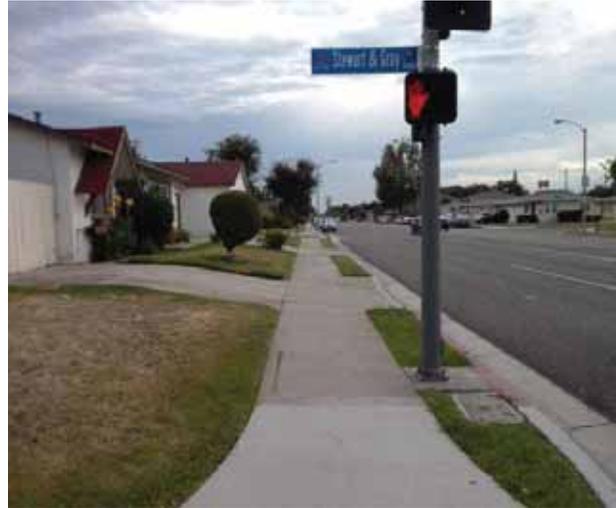
Recommendation Up to 2.08 percent

Repave the sidewalk surface with the recommended cross slope.

Repave surface \$1,092

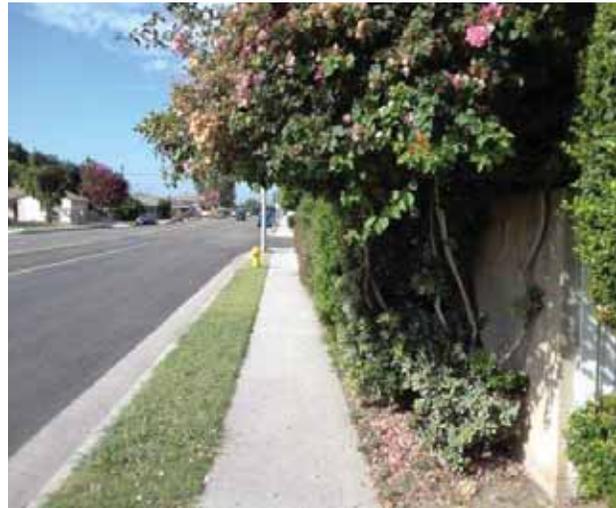
Sidewalks , Hazards & Gratings : Overhead Obstruction Height

Recommendation At least 80.00 inches

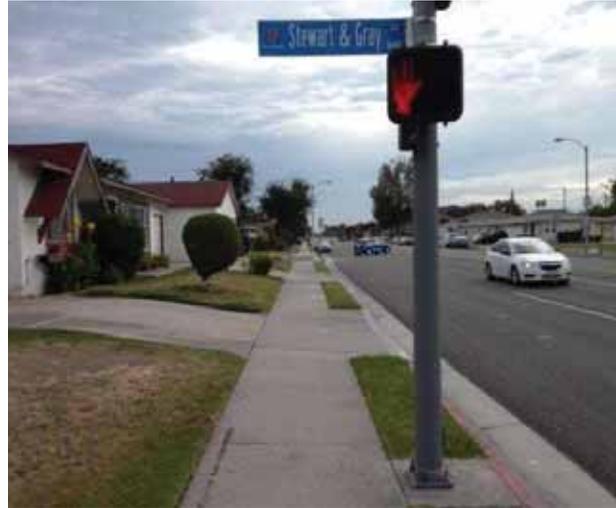
**On-Site Finding** Not Found

\$2,400

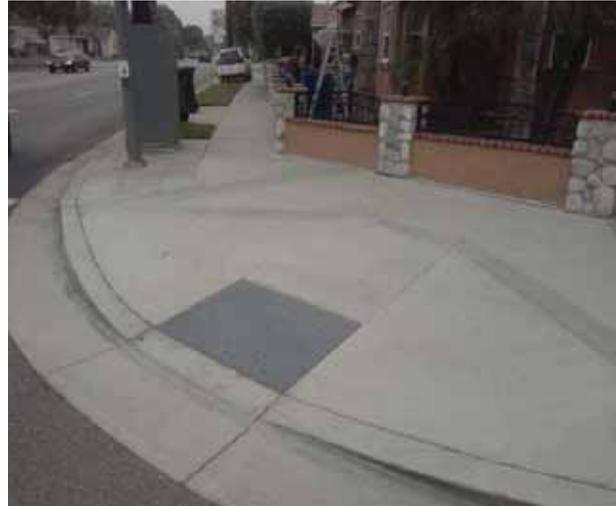
Recommendation Up to 5.00 percent

Repave landing \$1,260

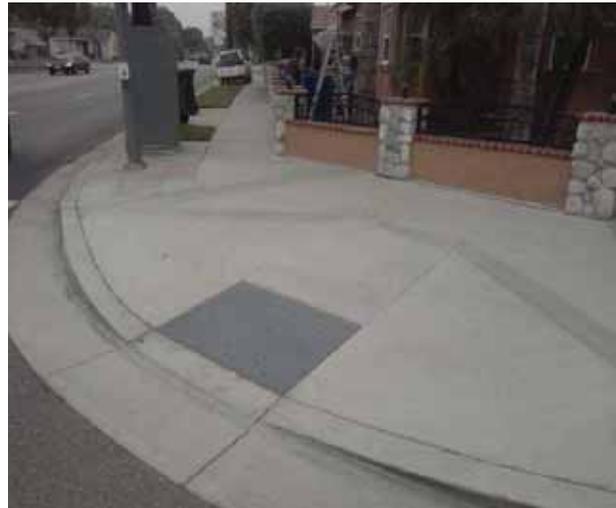
Recommendation Up to 2.08 percent

Provide compliant landing \$1,260

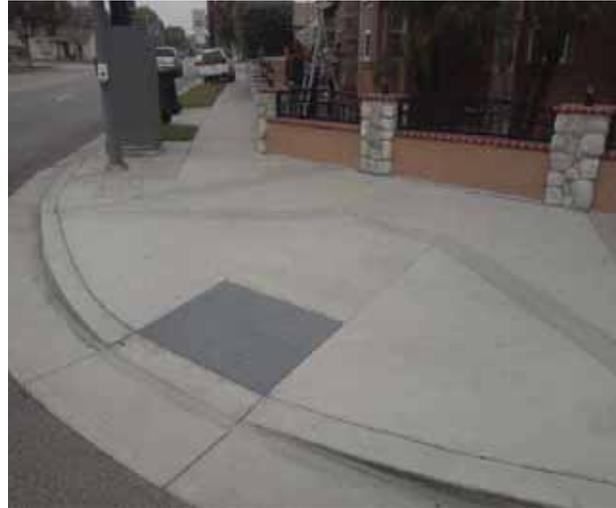
Recommendation Up to 8.33 percent

Install curb ramp \$1,300

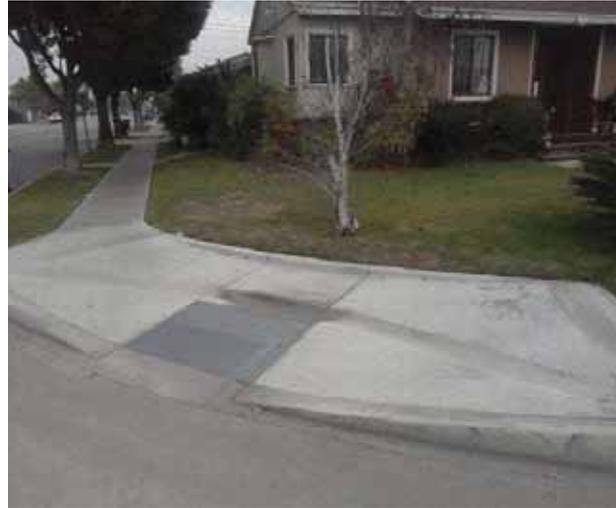
Recommendation Up to 2.08 percent

Install curb ramp \$1,300

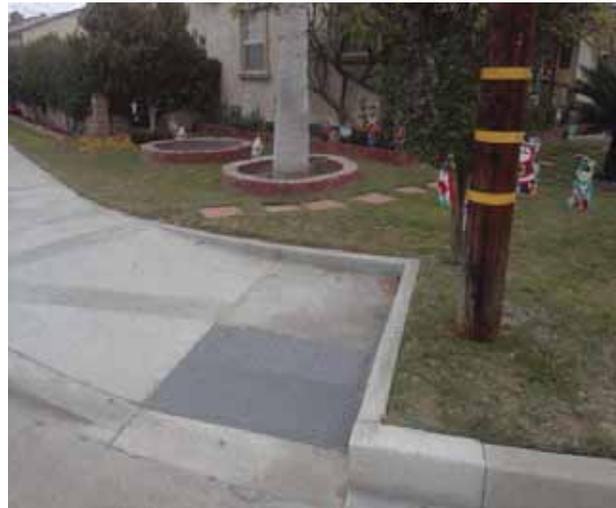
Recommendation Up to 8.33 percent

Install curb ramp \$1,300

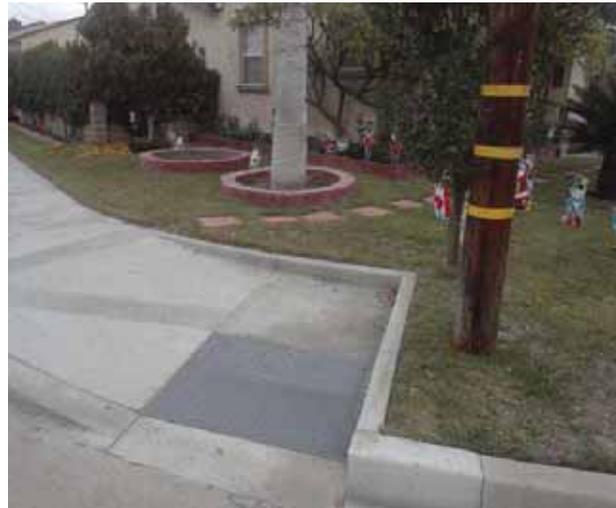
Recommendation Up to 2.08 percent

Provide compliant landing \$1,260

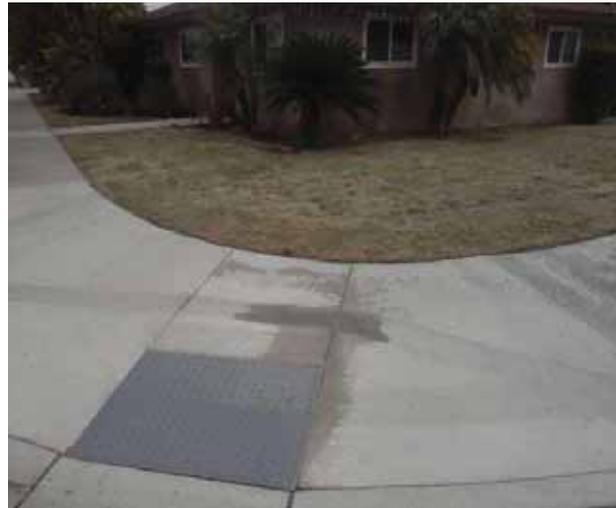
Recommendation Up to 8.33 percent

Install curb ramp \$1,300

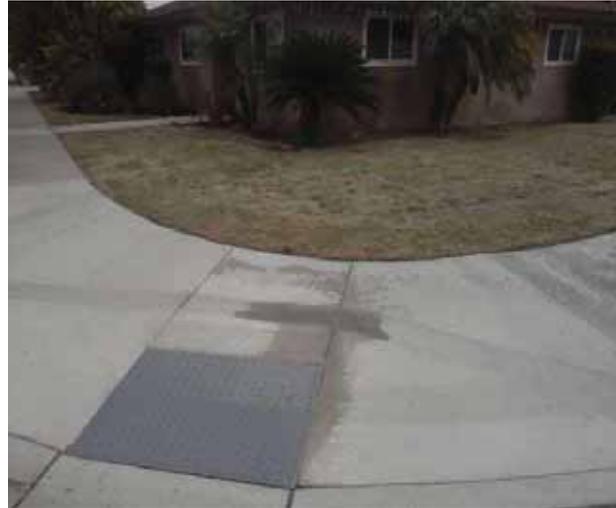
Recommendation Up to 2.08 percent

Install curb ramp \$1,300

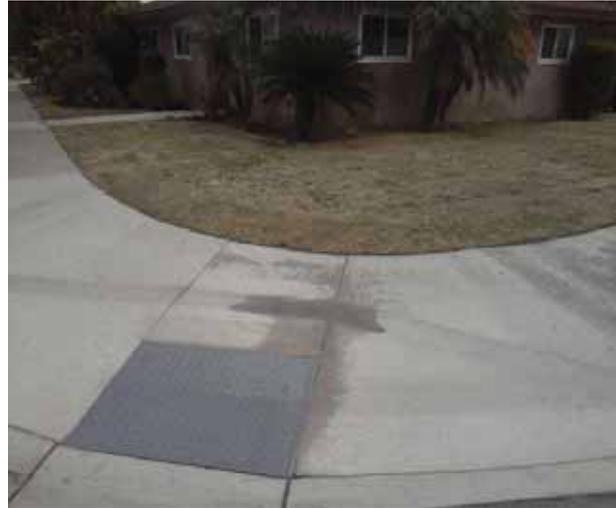
Recommendation Up to 5.00 percent

Repave landing \$1,260

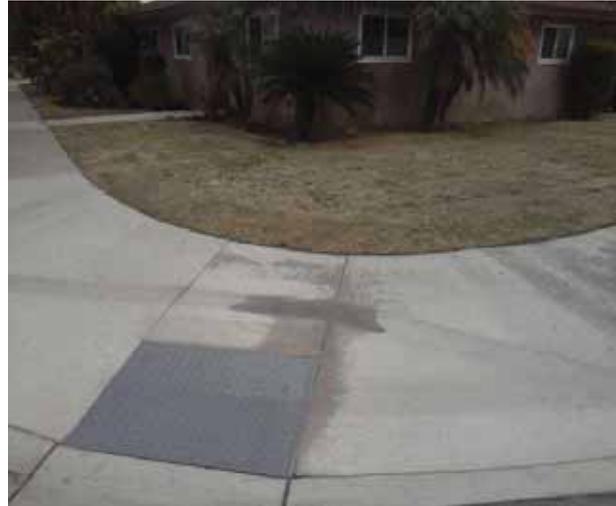
Recommendation Up to 2.08 percent

Provide compliant landing \$1,260

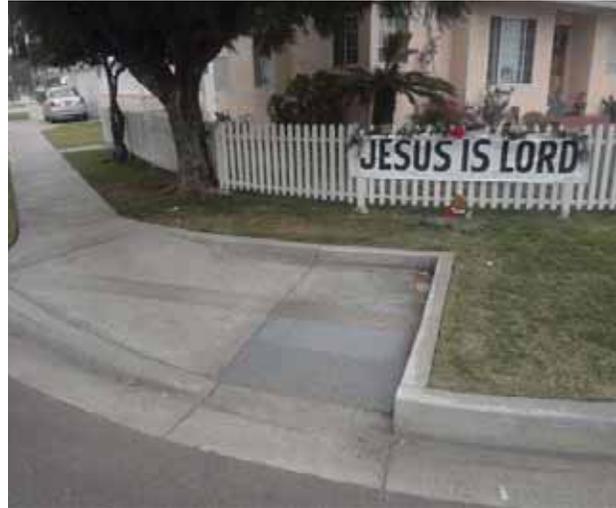
Recommendation Up to 8.33 percent

Install curb ramp \$1,300

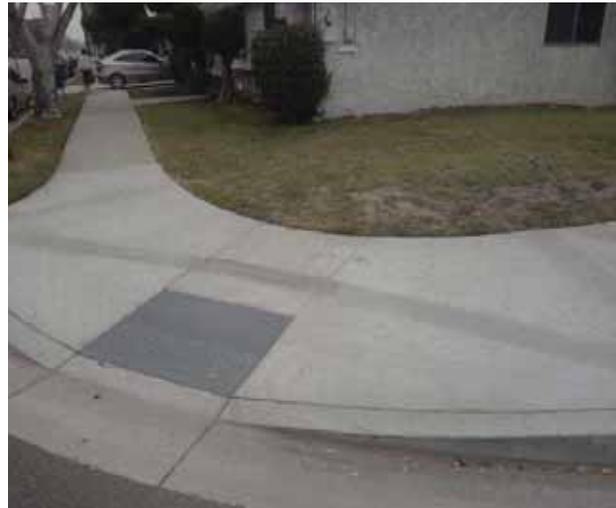
Recommendation Up to 5.00 percent

Repave landing \$1,260

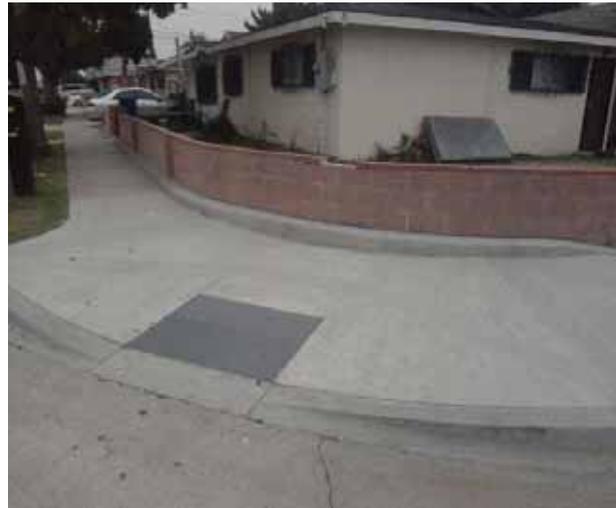
Recommendation Up to 8.33 percent

Install curb ramp \$1,300

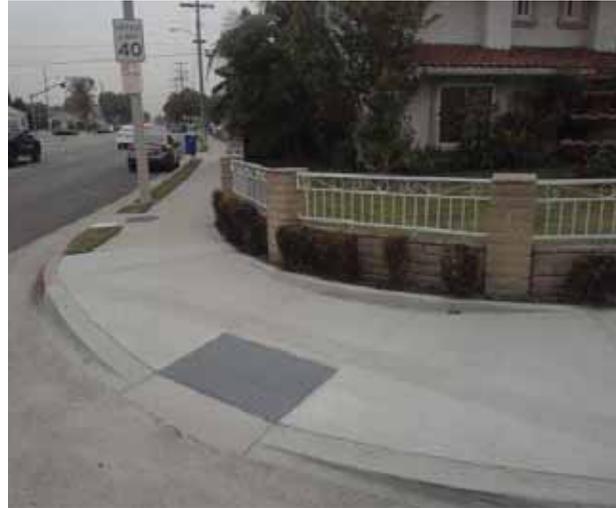
Recommendation Up to 8.33 percent

Install curb ramp \$1,300

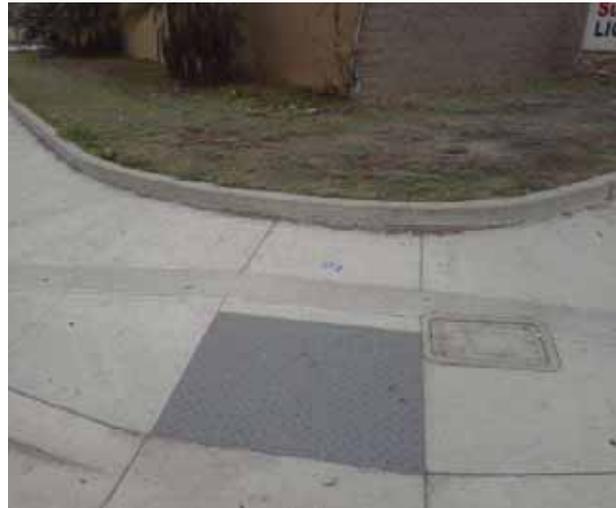
Recommendation Up to 2.08 percent

Provide compliant landing \$1,260

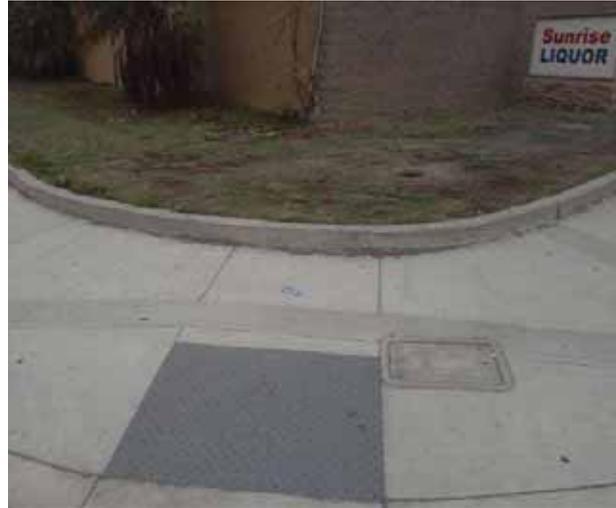
Recommendation Up to 8.33 percent

Install curb ramp \$1,300

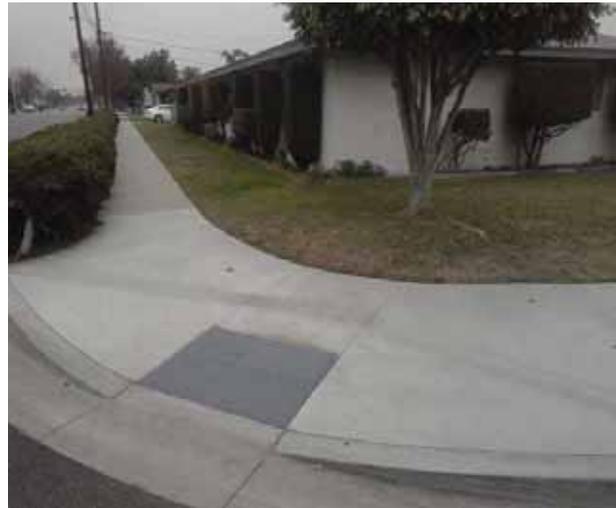
Recommendation Up to 8.33 percent

Install curb ramp \$1,300

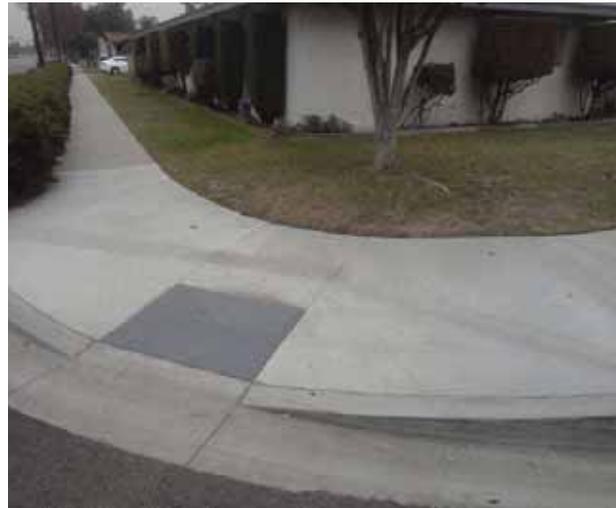
Recommendation Up to 5.00 percent

Repave landing \$1,260

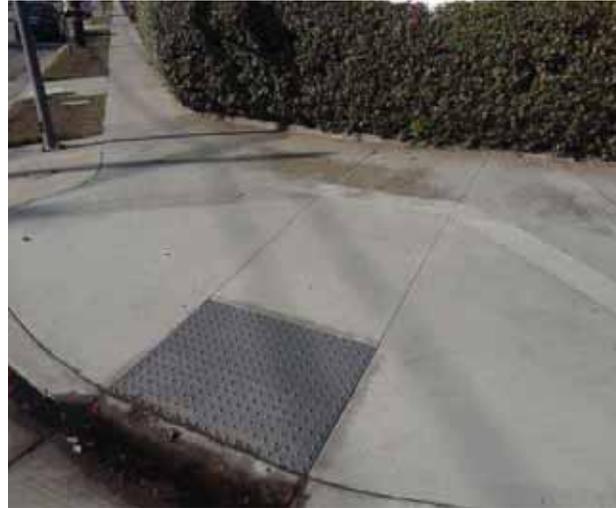
Recommendation Up to 8.33 percent

Install curb ramp \$1,300

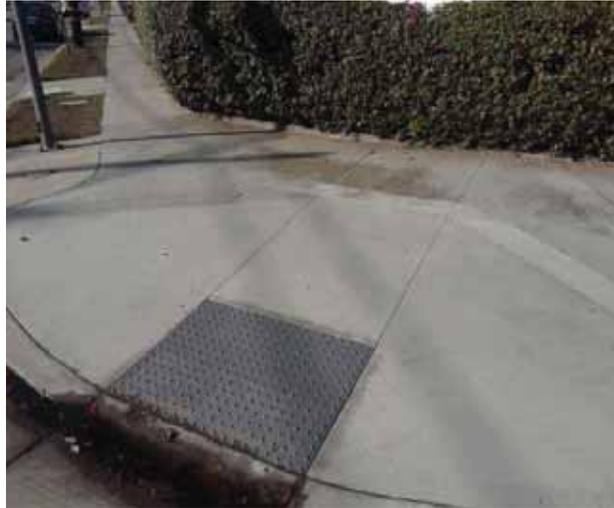
Recommendation Up to 2.08 percent

Install curb ramp \$1,300

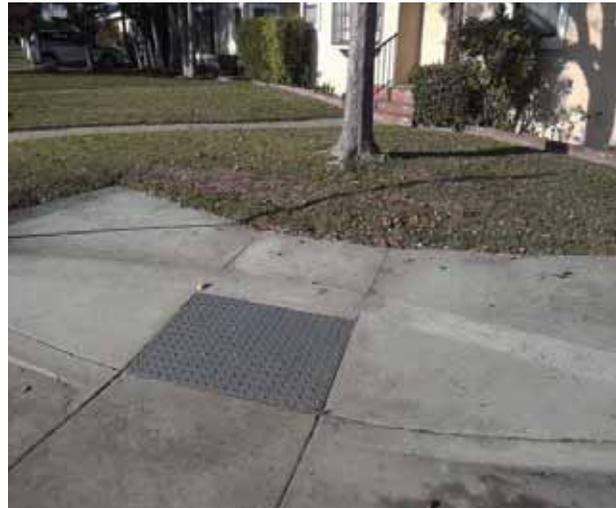
Recommendation Up to 2.08 percent

Provide compliant landing \$1,260

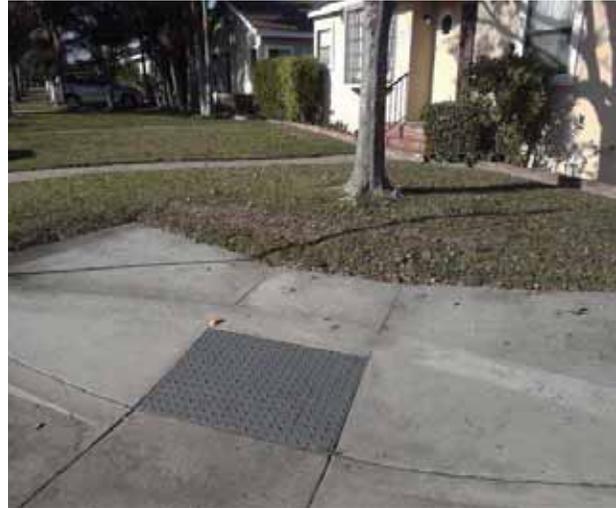
Recommendation Up to 8.33 percent

Install curb ramp \$1,300

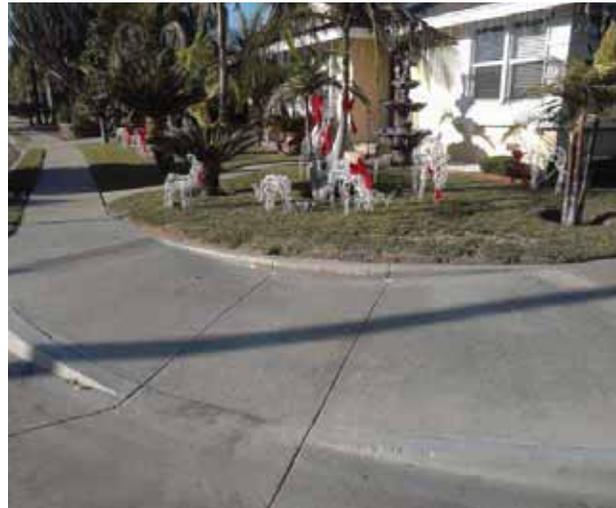
**On-Site Finding** Not Found

Recommendation See Recommendation

Provide detectable warning to surface \$248

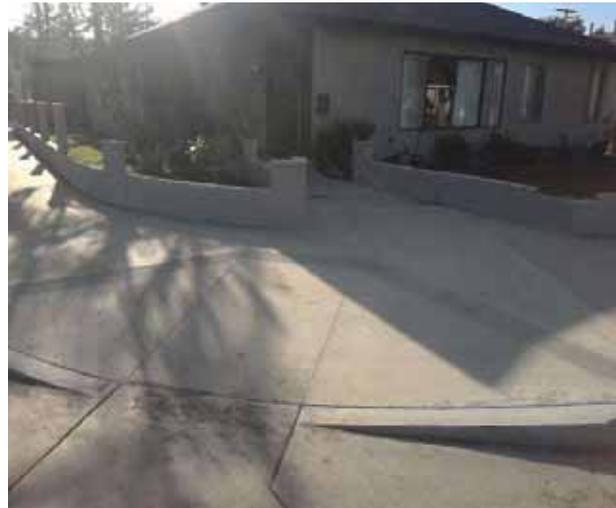
**On-Site Finding** Not Found

Recommendation See Recommendation

Provide detectable warning to surface \$248

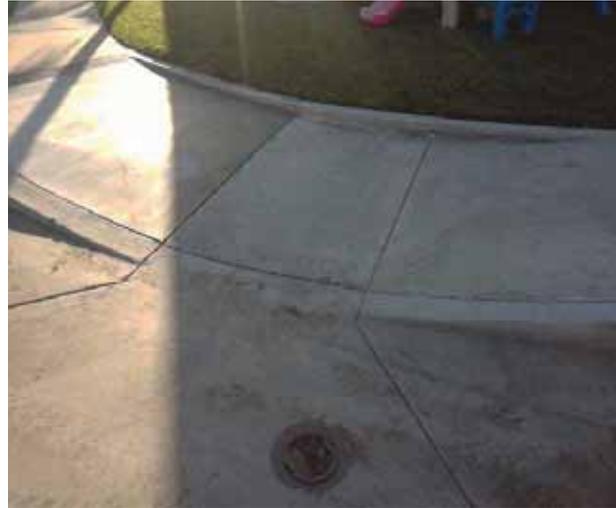
**On-Site Finding** Not Found

Recommendation See Recommendation

Provide detectable warning to surface \$248

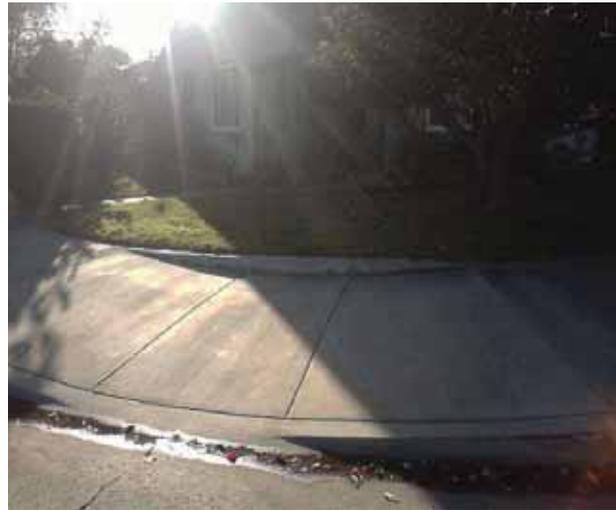
**On-Site Finding** Not Found

Recommendation See Recommendation

Provide detectable warning to surface \$248

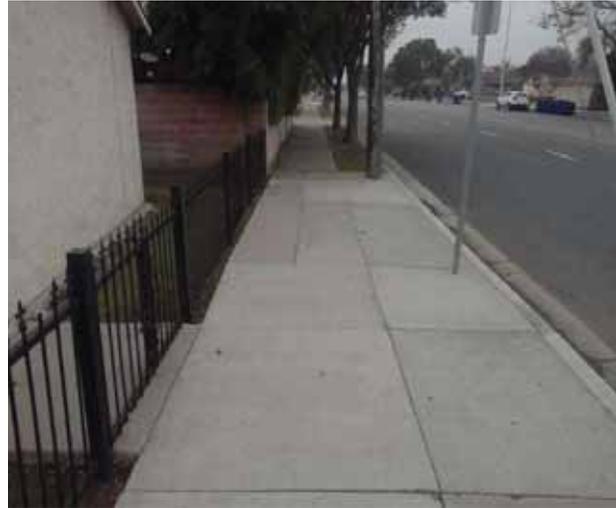
There is a change in elevation greater than recommended value.

Ensure that the change in elevation is within the recommended value.

Recommendation Up to 0.25 inches

Remove tripping hazards \$198

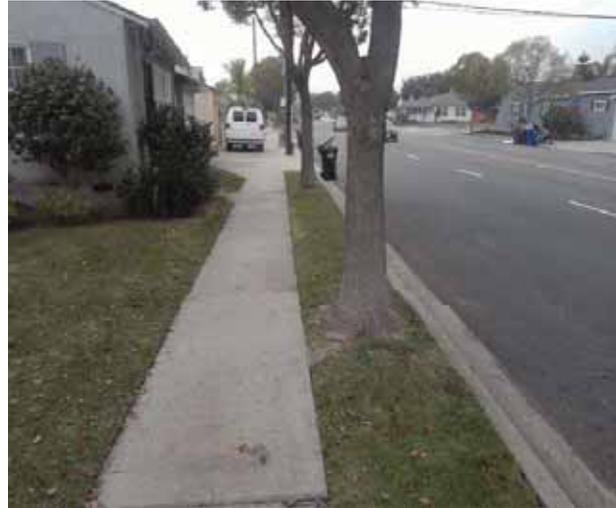
There is a change in elevation greater than recommended value.

Ensure that the change in elevation is within the recommended value.

Recommendation Up to 0.25 inches

Remove tripping hazards \$198

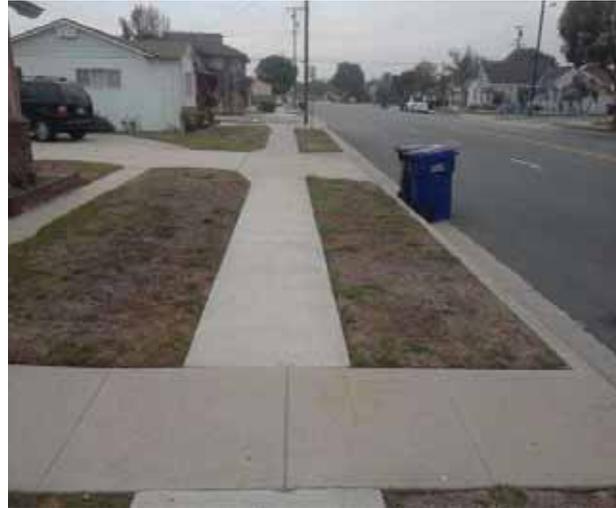
There is a change in elevation greater than recommended value.

Ensure that the change in elevation is within the recommended value.

Recommendation Up to 0.25 inches

Remove tripping hazards \$198

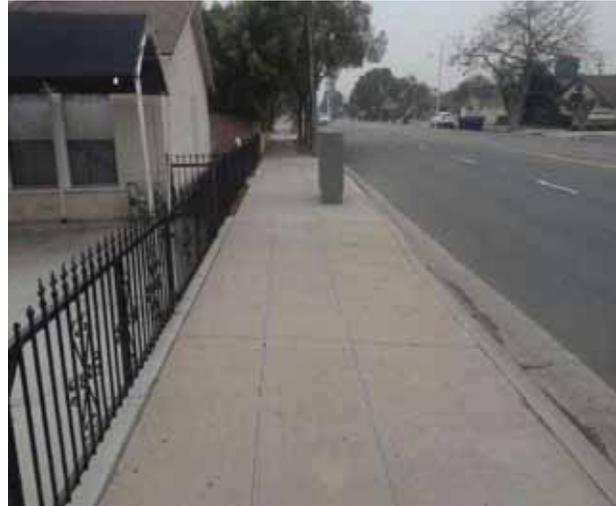
**On-Site Finding** Not Found

Install compliant detectable warnings \$190

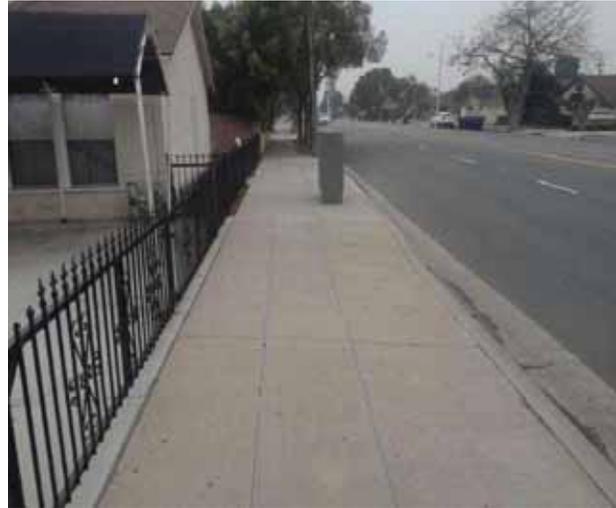
Recommendation Up to 2.08 percent

Repave surface \$1,092

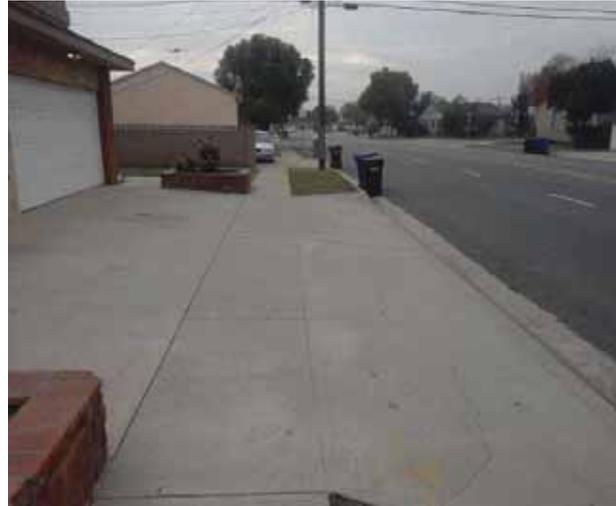
**On-Site Finding** Not Found

Install compliant detectable warnings \$190

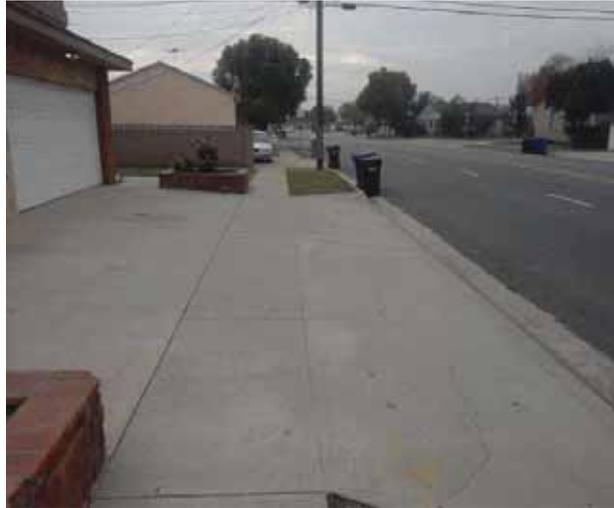
Recommendation Up to 2.08 percent

Repave surface \$1,092

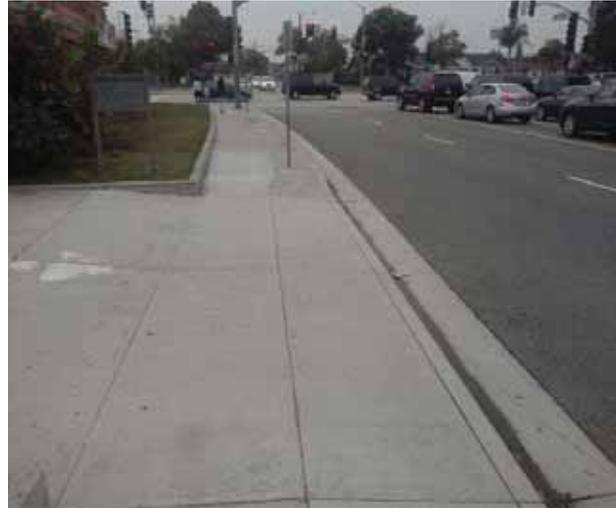
**On-Site Finding** Not Found

Install compliant detectable warnings \$190

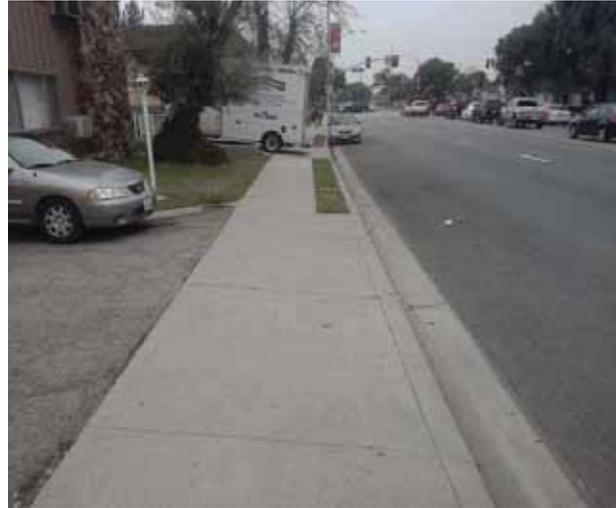
**On-Site Finding** Not Found

Install compliant detectable warnings \$190

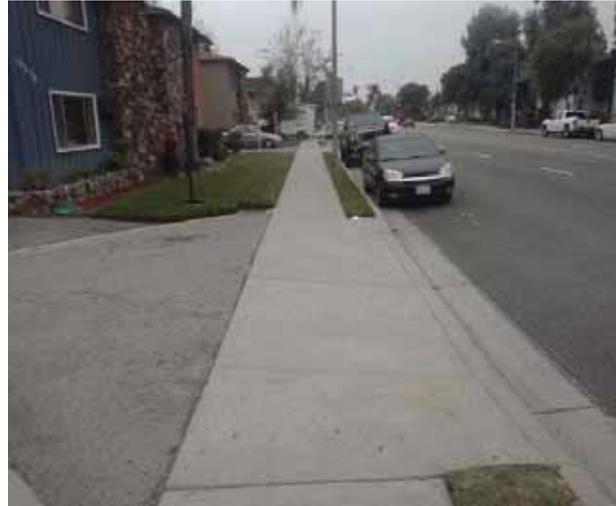
**On-Site Finding** Not Found

Install compliant detectable warnings \$190

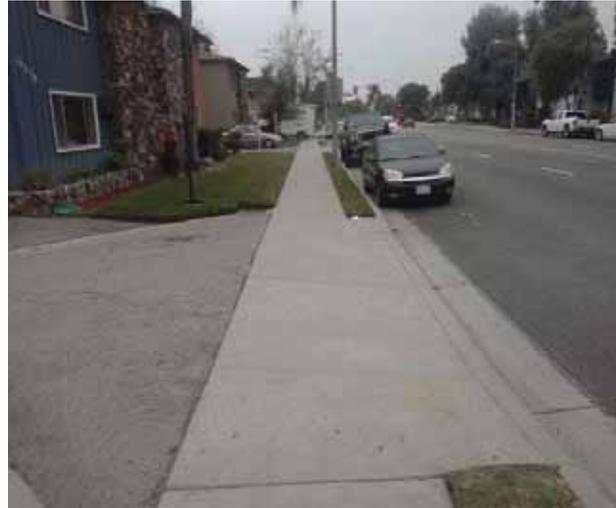
Recommendation Up to 2.08 percent

Repave surface \$1,092

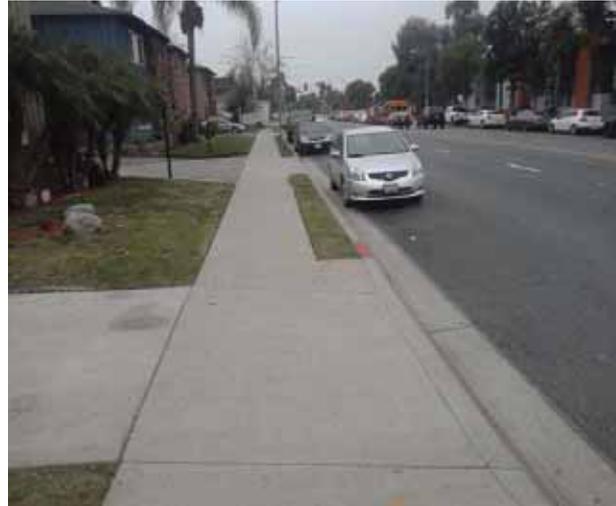
**On-Site Finding** Not Found

Install compliant detectable warnings \$190

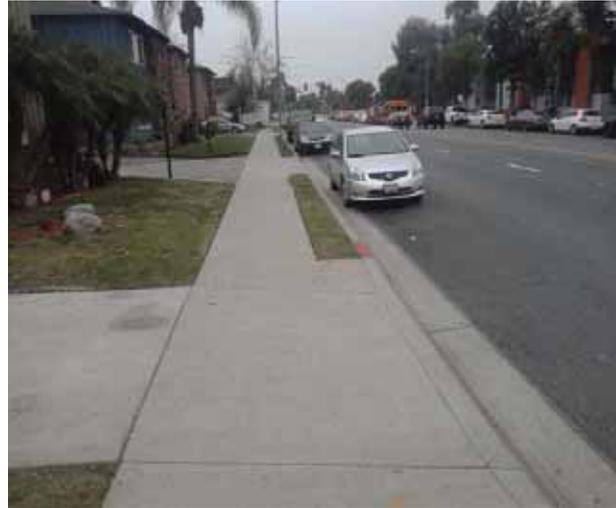
Recommendation Up to 2.08 percent

Repave surface \$1,092

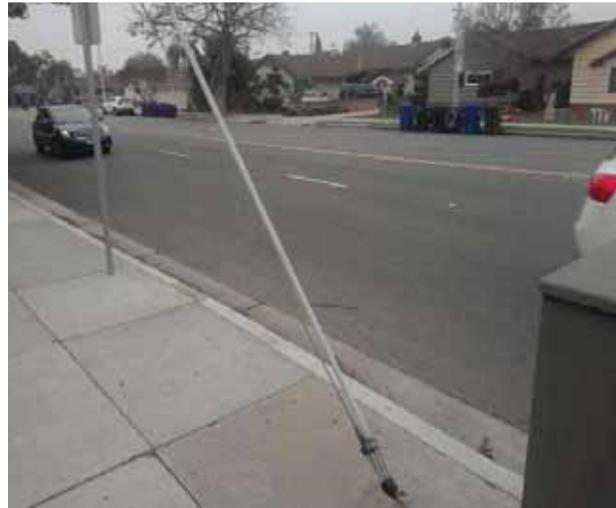
Sidewalks , Hazards & Gratings : Overhead Obstruction Height

Recommendation At least 80.00 inches

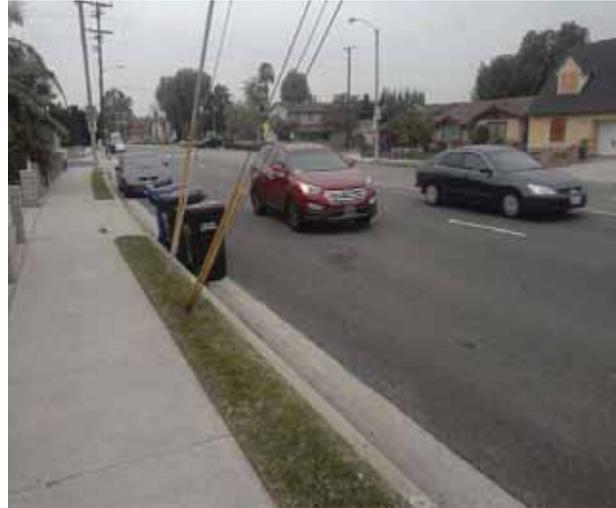
Sidewalks , Hazards & Gratings : Overhead Obstruction Height

Recommendation At least 80.00 inches

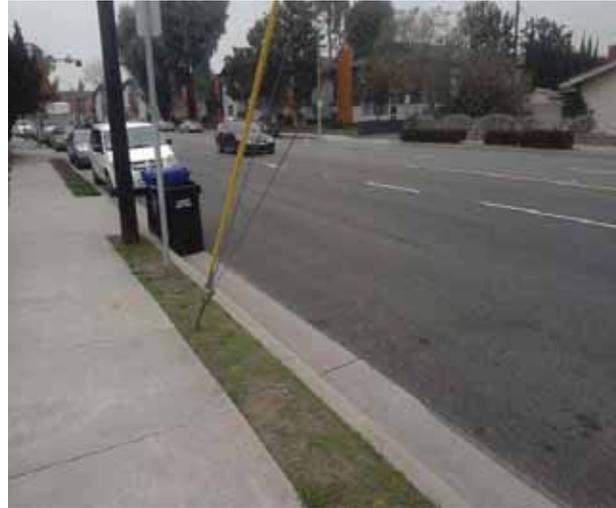
Sidewalks , Hazards & Gratings : Overhead Obstruction Height

Recommendation At least 80.00 inches

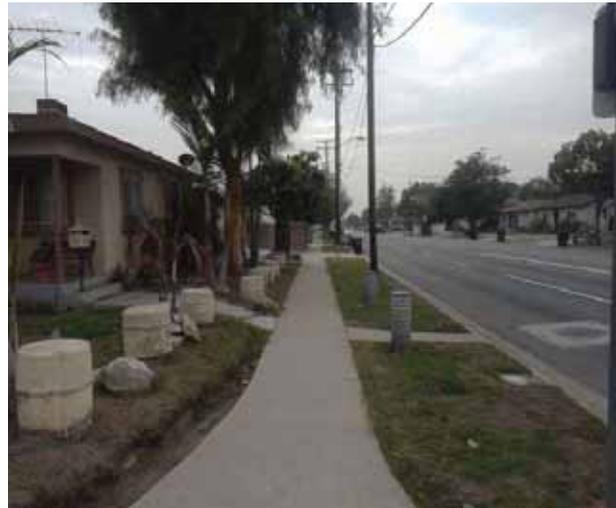
**On-Site Finding** Not Found

\$2,400

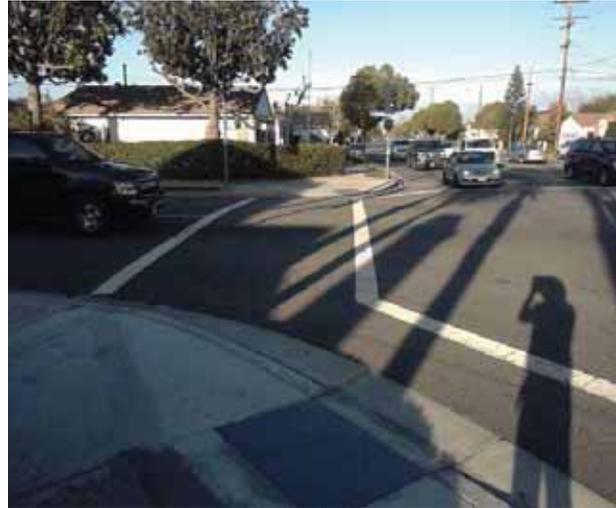
Recommendation Up to 5.00 percent

Repave surface \$1,092
