# Accessibility Survey

## City of Downey Brookshire Avenue & Civic Center Drive

Brookshire Avenue & Civic Center Drive  
Downey, CA 90240

Date of Inspection  
5/25/2017

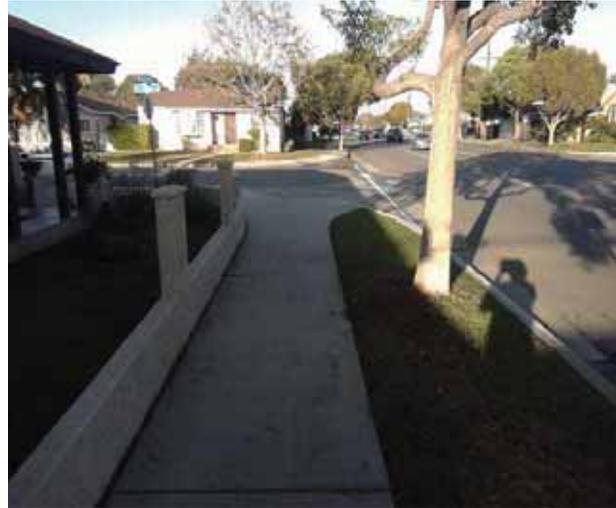
There is a change in elevation greater than recommended value.

Ensure that the change in elevation is within the recommended value.

Recommendation Up to 0.25 inches

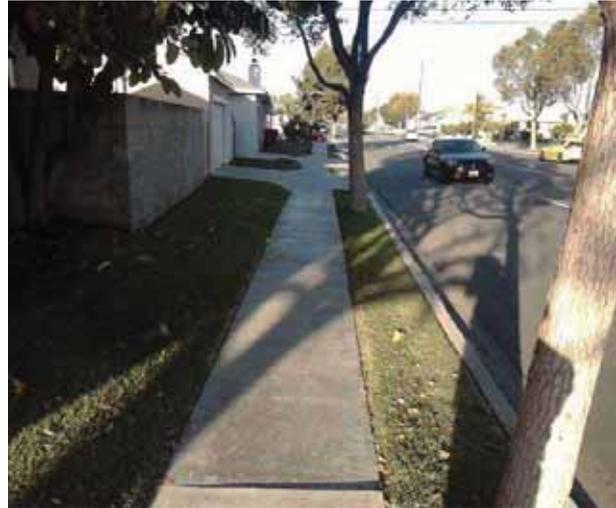
There is a change in elevation greater than recommended value.

Ensure that the change in elevation is within the recommended value.

Recommendation Up to 0.25 inches

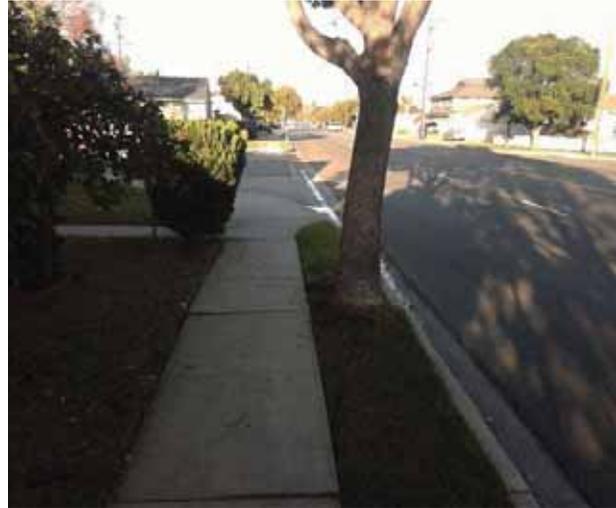
There is a change in elevation greater than recommended value.

Ensure that the change in elevation is within the recommended value.

Recommendation Up to 0.25 inches

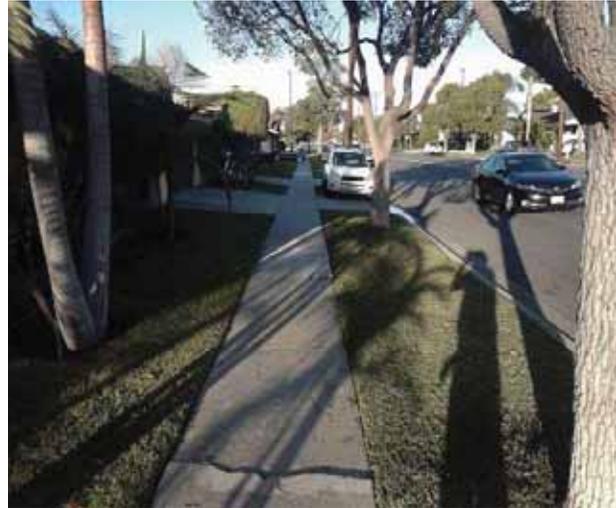
There is a change in elevation greater than recommended value.

Ensure that the change in elevation is within the recommended value.

Recommendation Up to 0.25 inches

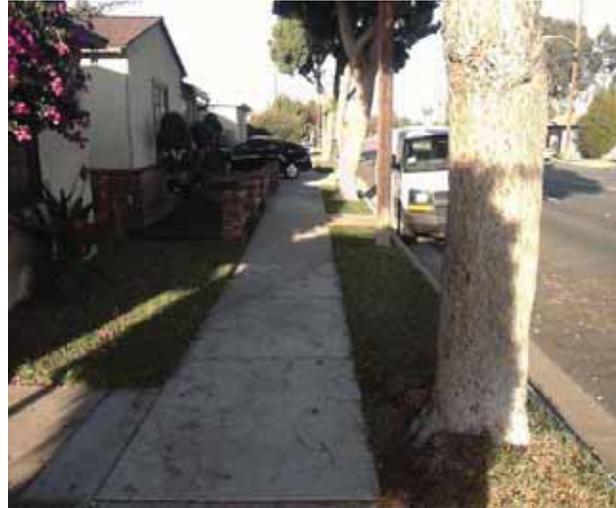
There is a change in elevation greater than recommended value.

Ensure that the change in elevation is within the recommended value.

Recommendation Up to 0.25 inches

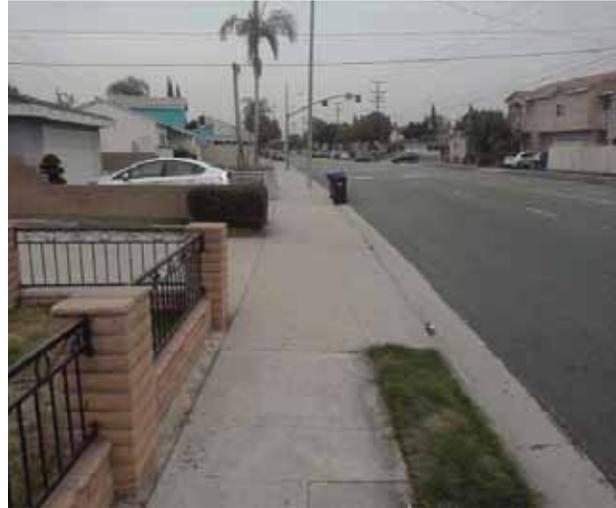
There is a change in elevation greater than recommended value.

Ensure that the change in elevation is within the recommended value.

Recommendation Up to 0.25 inches

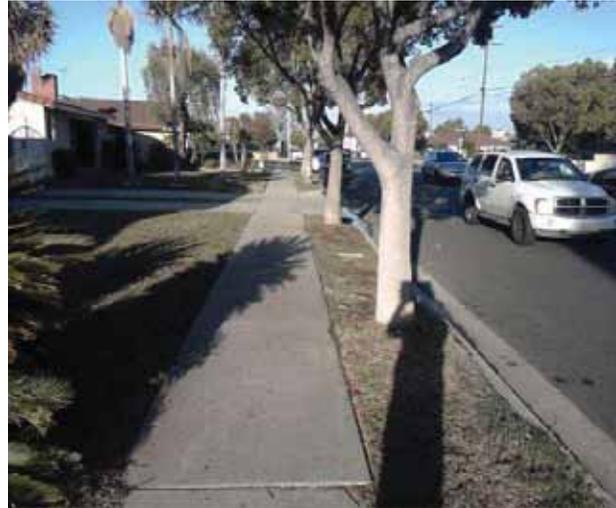
There is a change in elevation greater than recommended value.

Ensure that the change in elevation is within the recommended value.

Recommendation Up to 0.25 inches

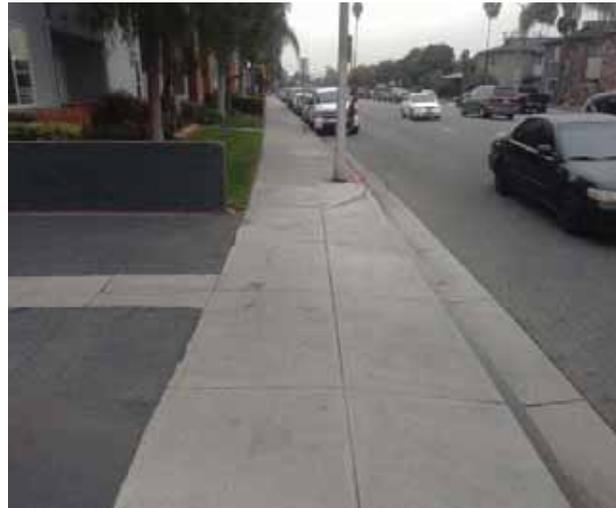
**On-Site Finding** Not Found

Install compliant detectable warnings \$190

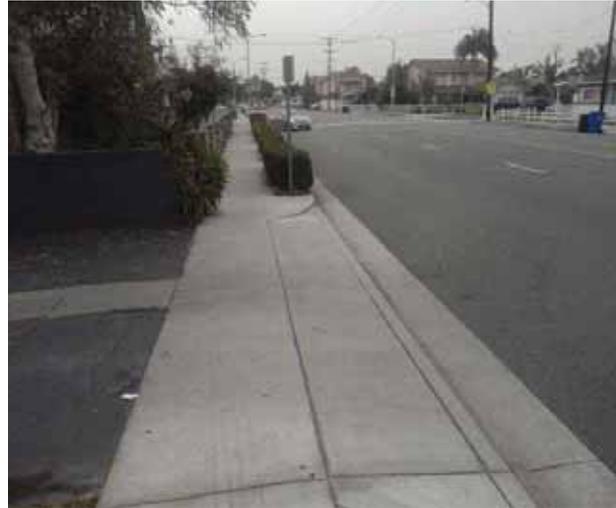
**On-Site Finding** Not Found

Install compliant detectable warnings \$190

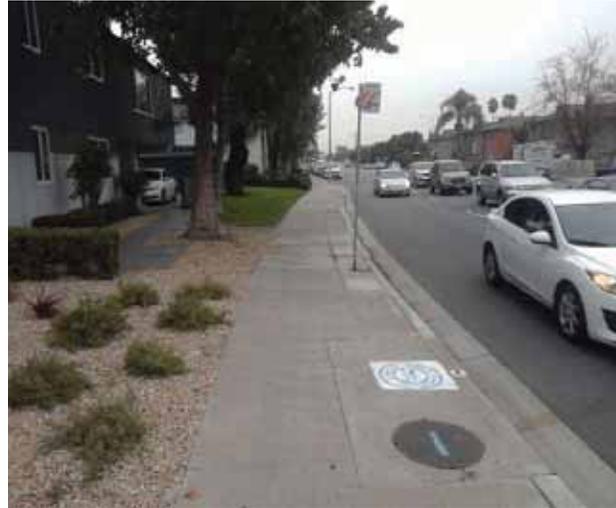
**On-Site Finding** Not Found

\$2,400
