Accessibility Survey

2nd Street - Brookshire Avenue to End

Date of Inspection
8/9/2017

Prepared By
Disability Access Consultants
(800) 743-7067

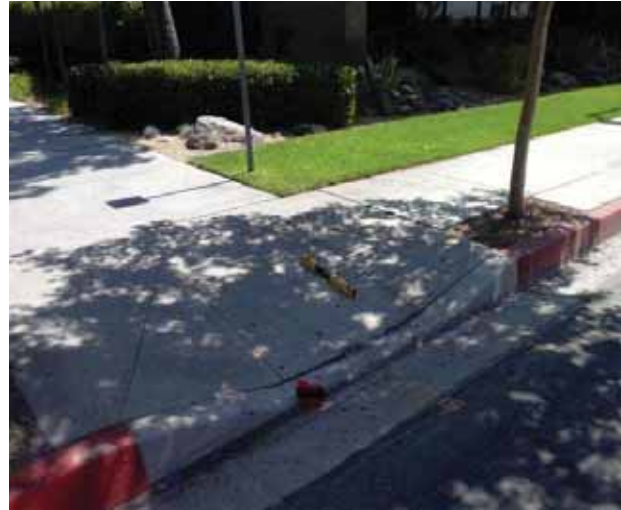
Recommendation Up to 10.00 percent

Install flared sides \$1,300

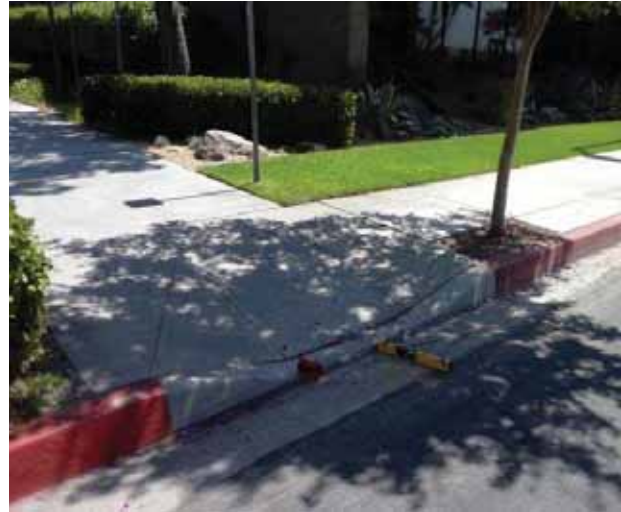
Recommendation Up to 5.00 percent

Repave landing \$1,260

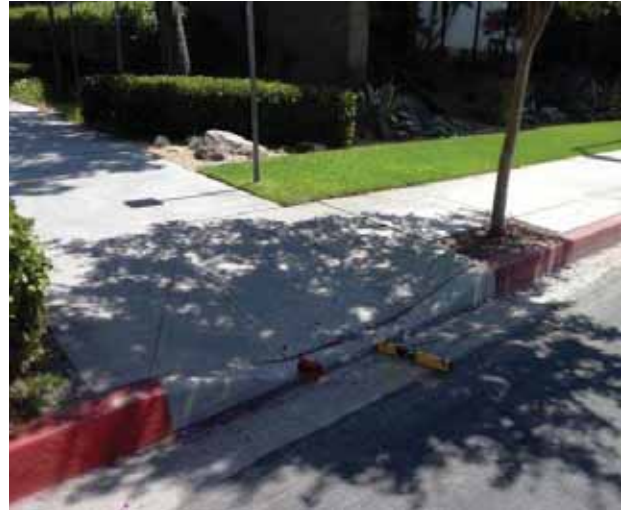
Recommendation Up to 0.50 inches

Patch lip at curb ramp \$255

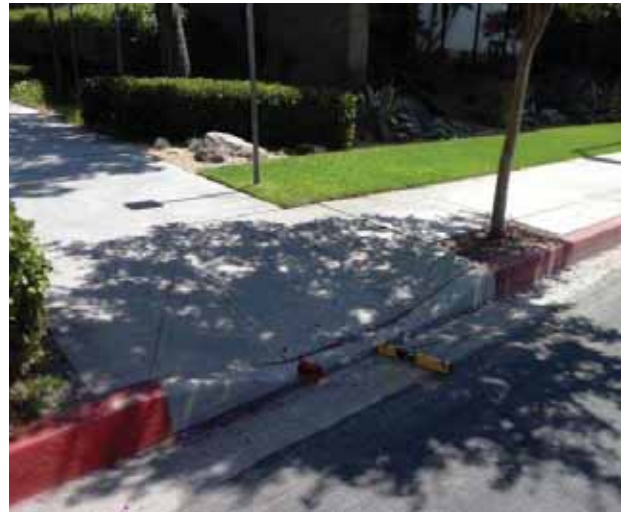
Recommendation Up to 2.08 percent

Provide compliant landing \$1,260

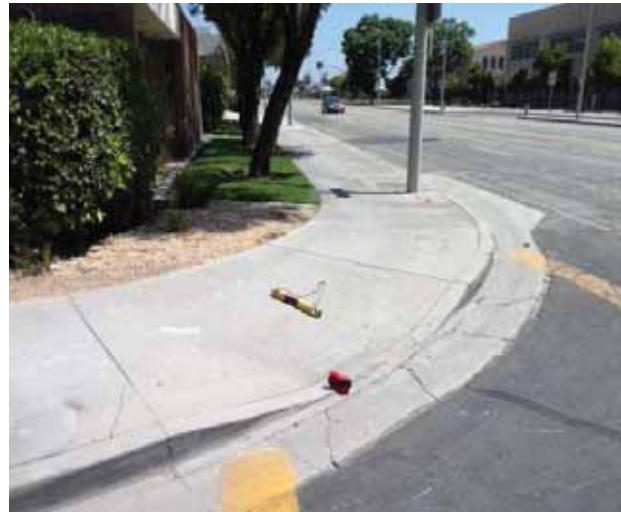
On-Site Finding Not Found

Provide detectable warning to surface \$248

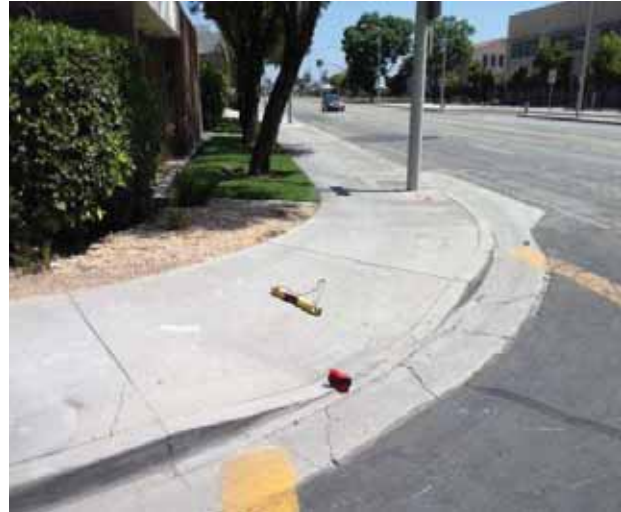
Recommendation Up to 10.00 percent

Install flared sides \$1,300

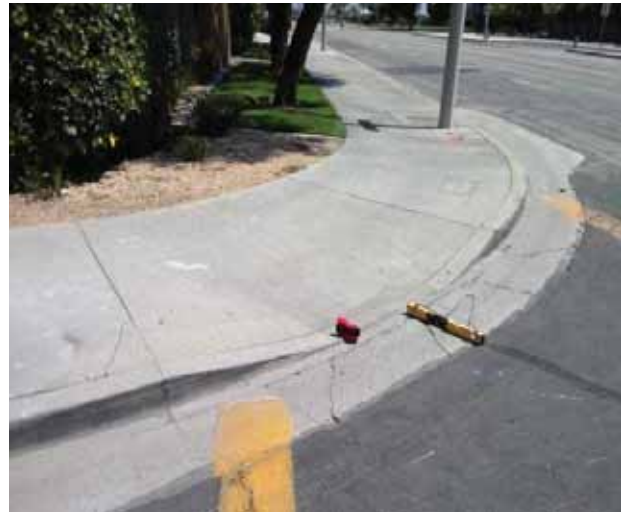
Recommendation Up to 5.00 percent

Repave landing \$1,260

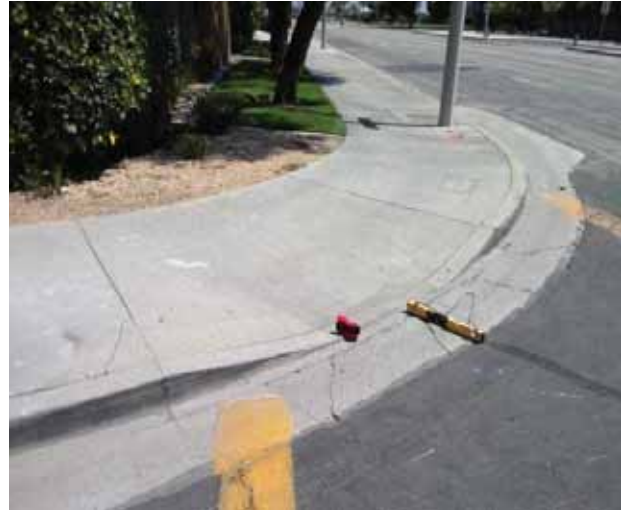
Recommendation Up to 0.50 inches

Patch lip at curb ramp \$255

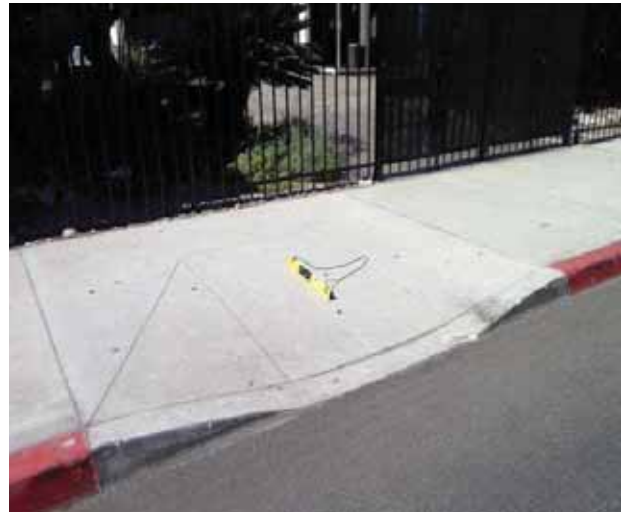
Recommendation Up to 8.33 percent

Install curb ramp \$1,300

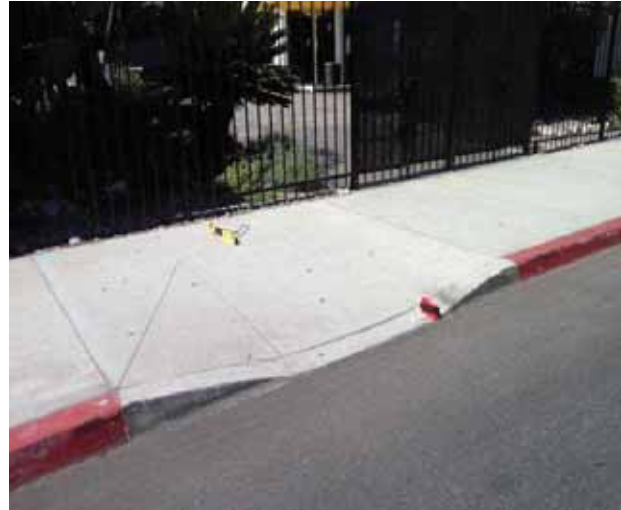
Recommendation Up to 0.50 inches

Patch lip at curb ramp \$255

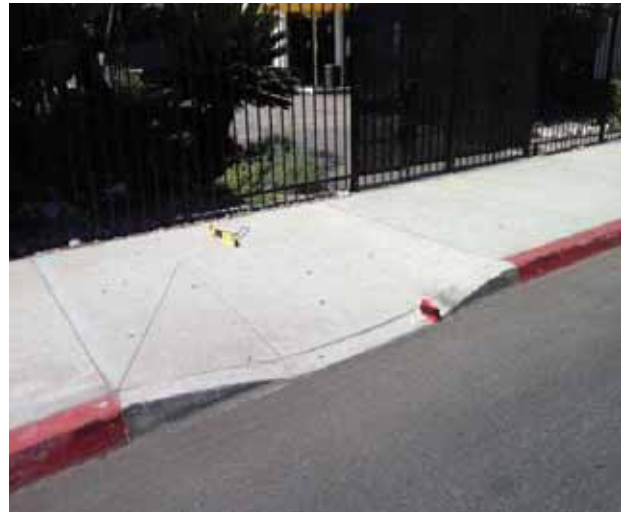
Recommendation Up to 2.08 percent

Provide compliant landing \$1,260

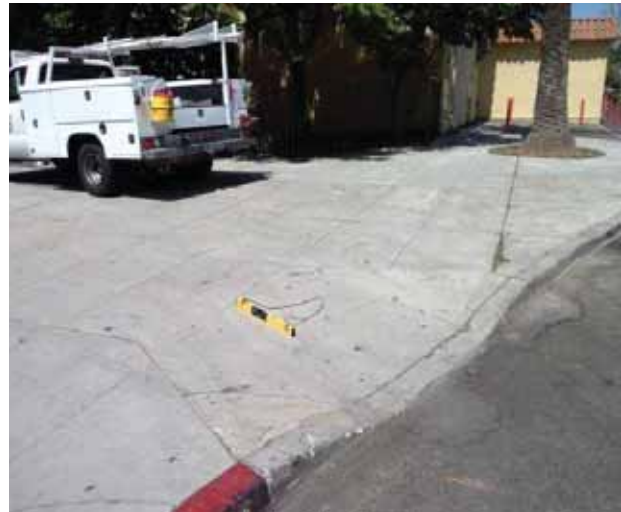
On-Site Finding Not Found

Provide detectable warning to surface \$248

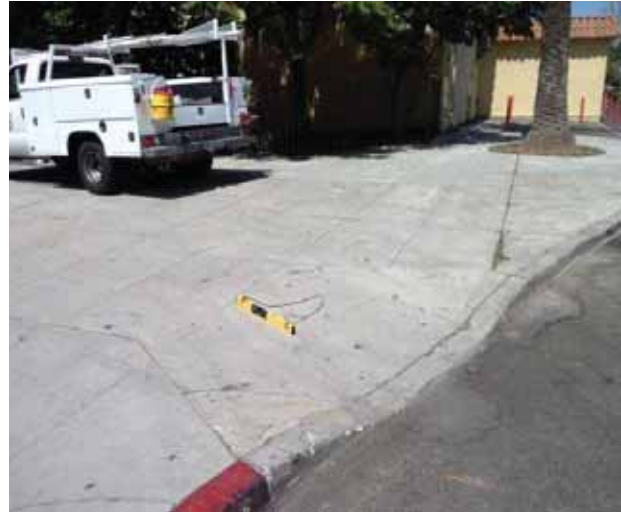
Recommendation Up to 2.08 percent

Install curb ramp \$1,300

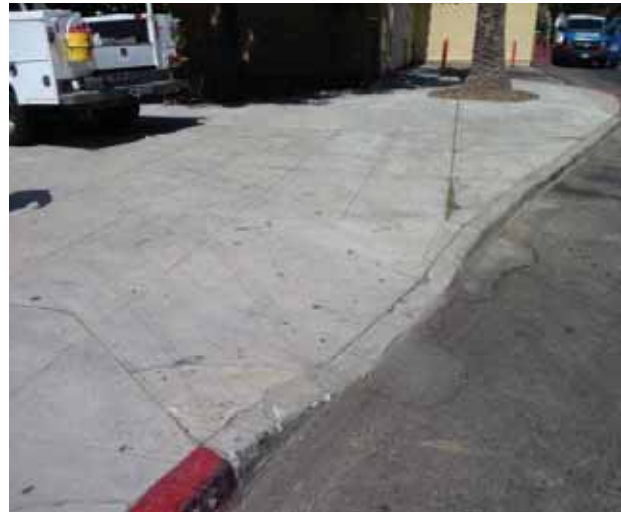
Recommendation Up to 0.50 inches

Patch lip at curb ramp \$255

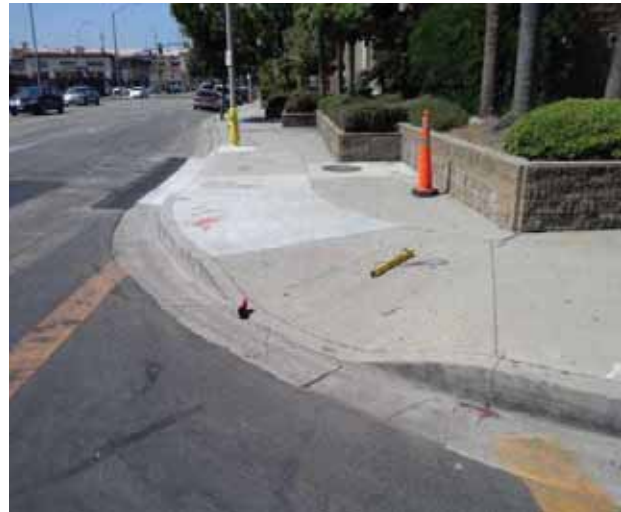
On-Site Finding Not Found

Provide detectable warning to surface \$248

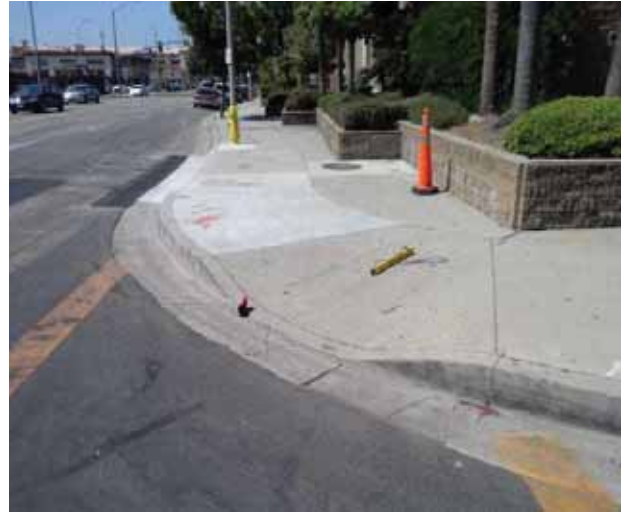
Recommendation Up to 8.33 percent

Install curb ramp \$1,300

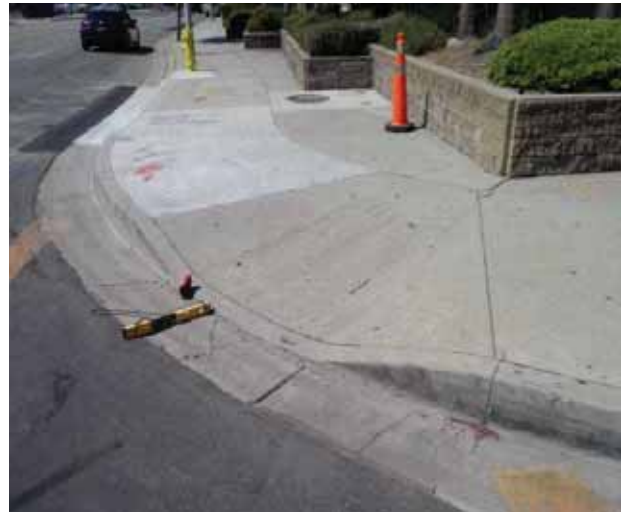
Recommendation Up to 5.00 percent

Repave landing \$1,260

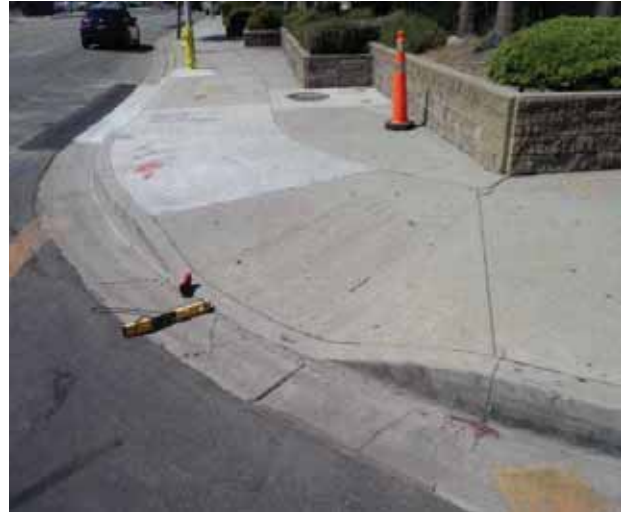
Recommendation Up to 0.50 inches

Patch lip at curb ramp \$255

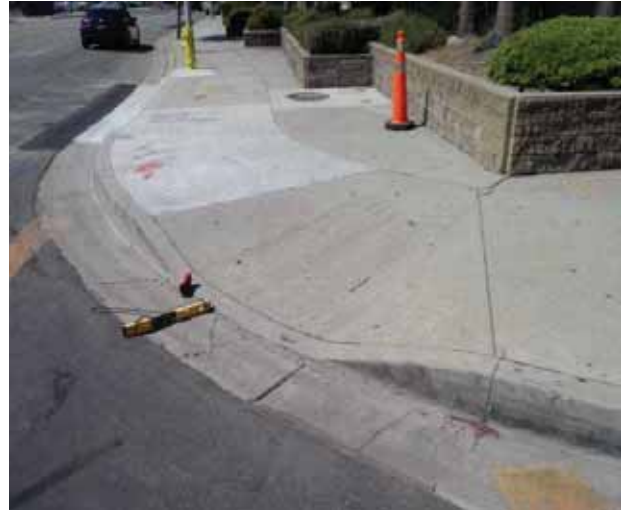
Recommendation At least 48.00 inches

Provide compliant landing \$240

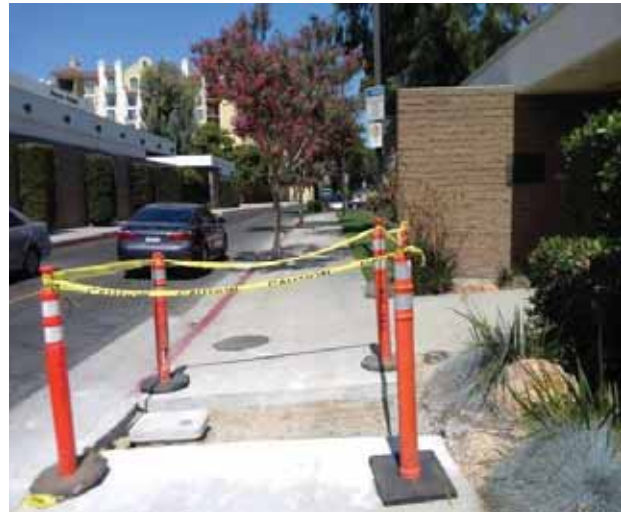
Sidewalks : Missing Sidewalk

Section of sidewalk is missing and consists of dirt, grass or gravel.

Provide a compliant sidewalk for the missing section.

\$1,260

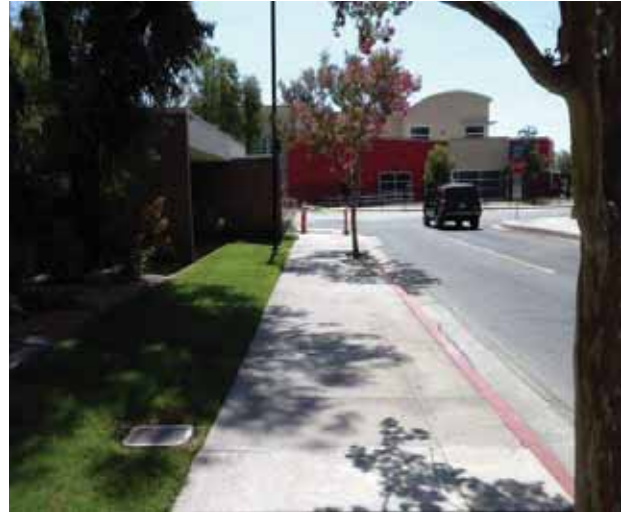
Recommendation Up to 2.08 percent

Repave the sidewalk surface with the recommended cross slope.

Repave surface \$1,092

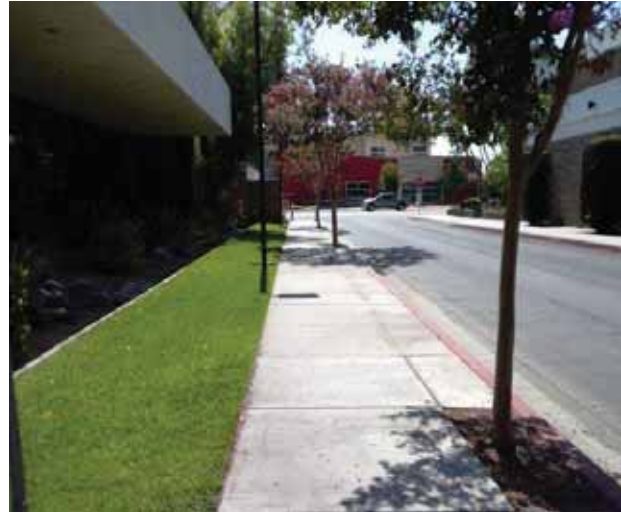
On-Site Finding Not Found

\$2,400

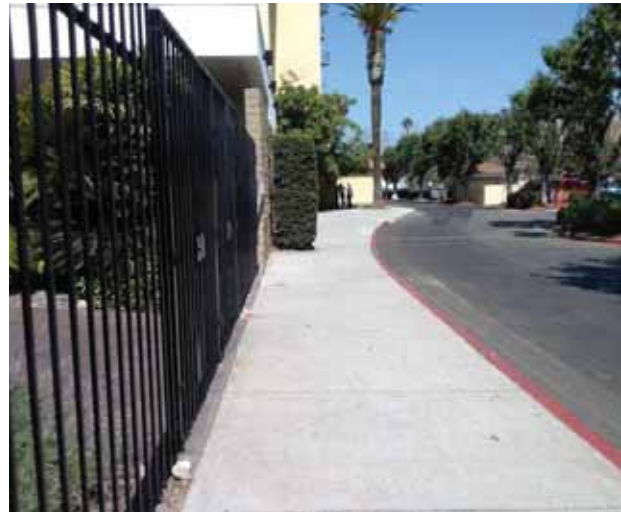
Recommendation Up to 2.08 percent

Repave the sidewalk surface with the recommended cross slope.

Repave surface \$1,092

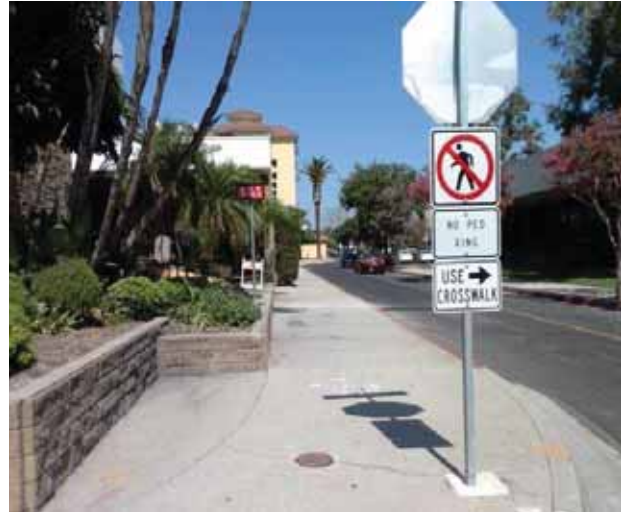
Sidewalks , Hazards & Gratings : Protruding Object Height

Recommendation Up to 4.00 inches

Install wing walls or relocate object \$640

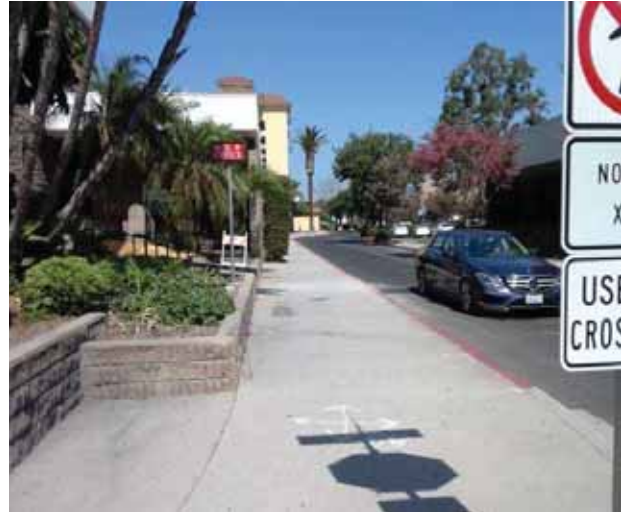
On-Site Finding Not Found

\$2,400

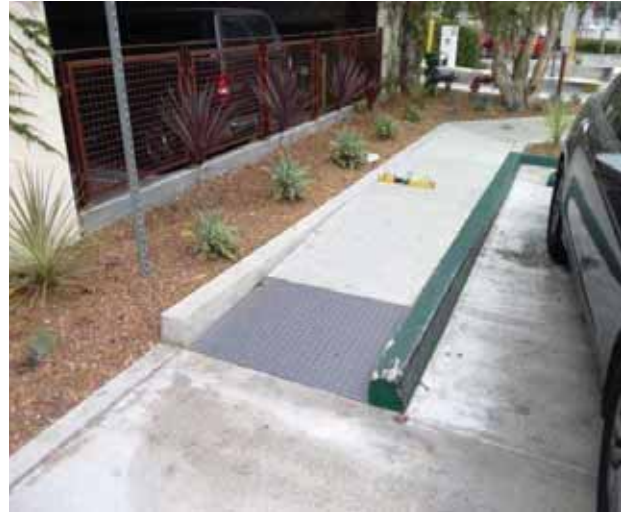
Recommendation Up to 2.08 percent

Provide compliant landing \$240

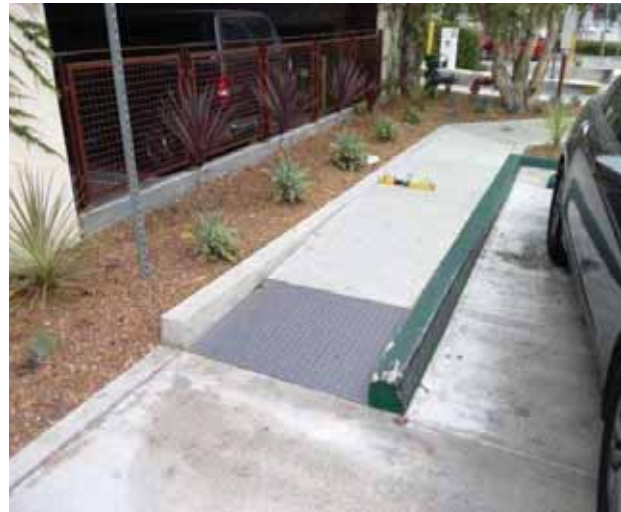
Recommendation Up to 2.08 percent

Provide compliant landing \$1,260

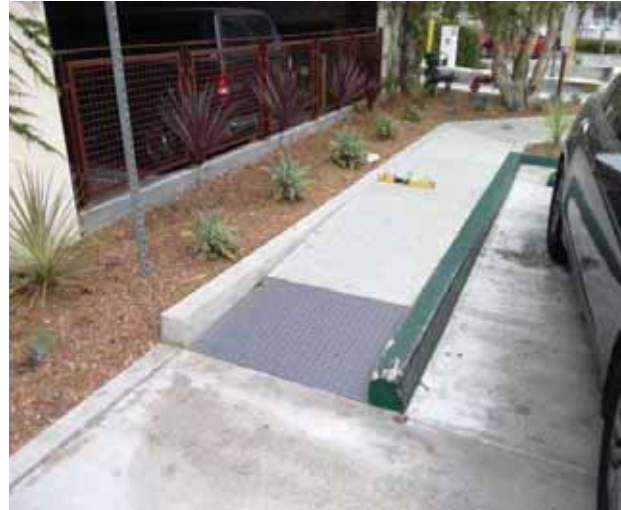
Recommendation At least 48.00 inches

Provide compliant landing \$240

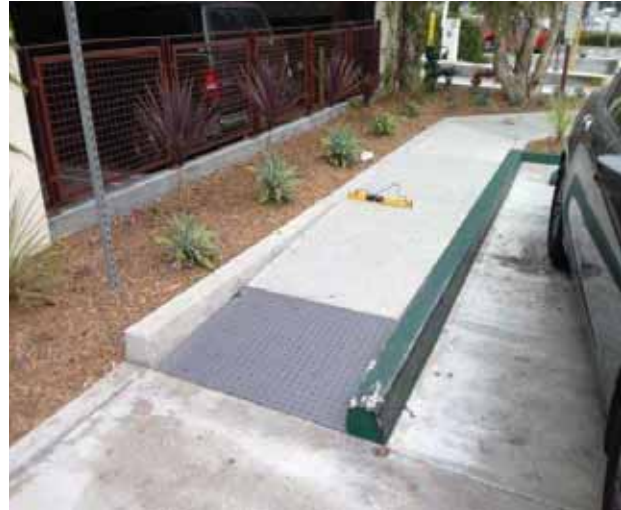
Recommendation At least 48.00 inches

Install curb ramp \$1,300

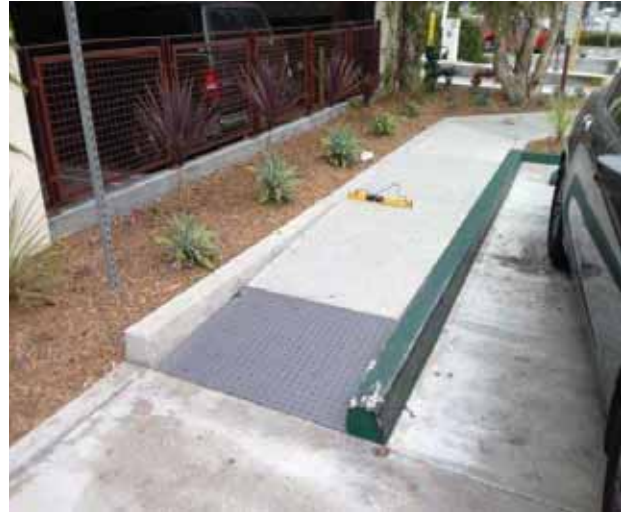
Recommendation Up to 2.08 percent

Install curb ramp \$1,300

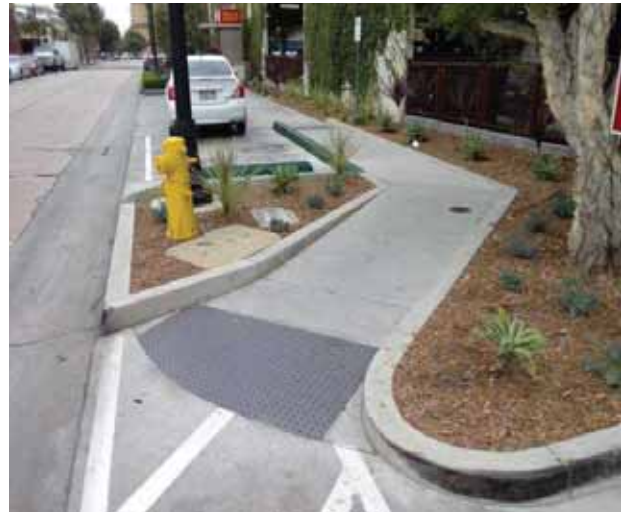
Recommendation At least 36.00 inches

Install compliant detectable warnings \$190

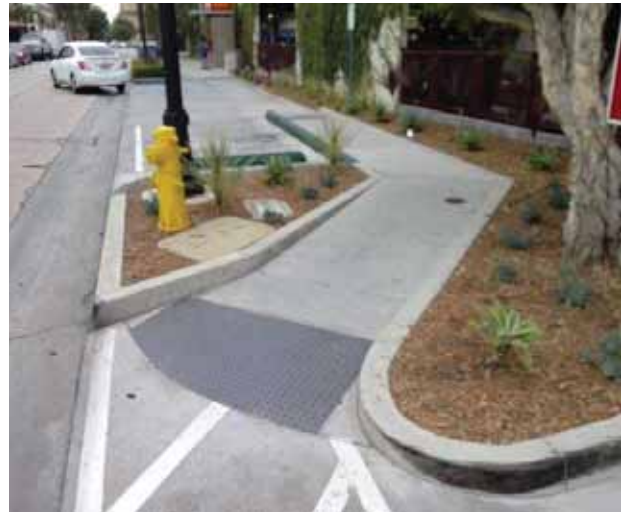
Recommendation At least 48.00 inches

Provide compliant landing \$240

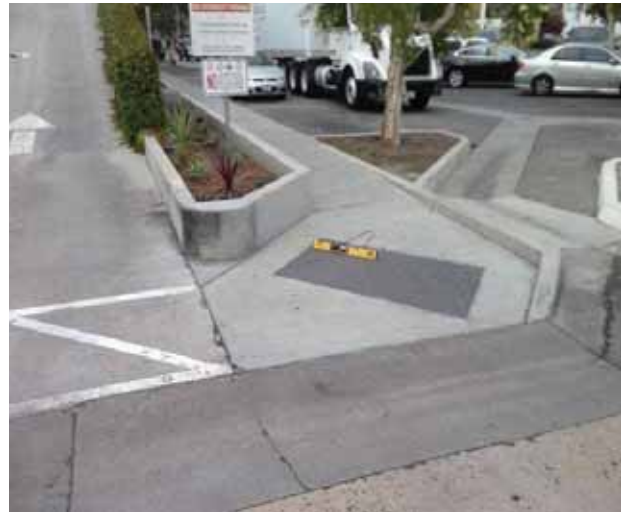
Recommendation Up to 2.08 percent

Provide compliant landing \$240

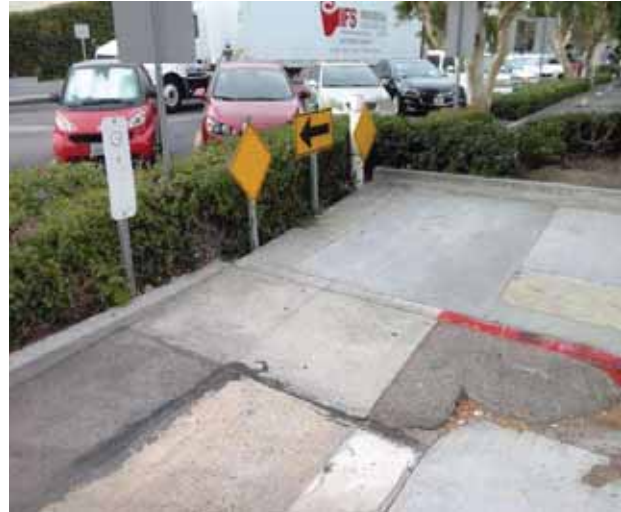
On-Site Finding Not Found

Provide detectable warning to surface \$248

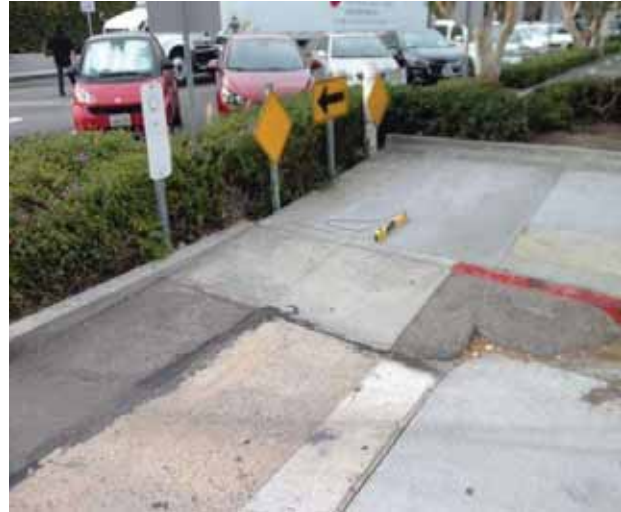
Recommendation Up to 2.08 percent

Provide compliant landing \$1,260

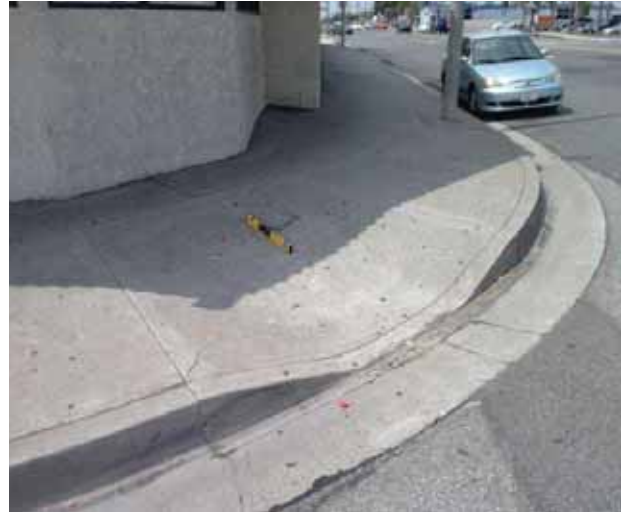
On-Site Finding Not Found

Provide detectable warning to surface \$248

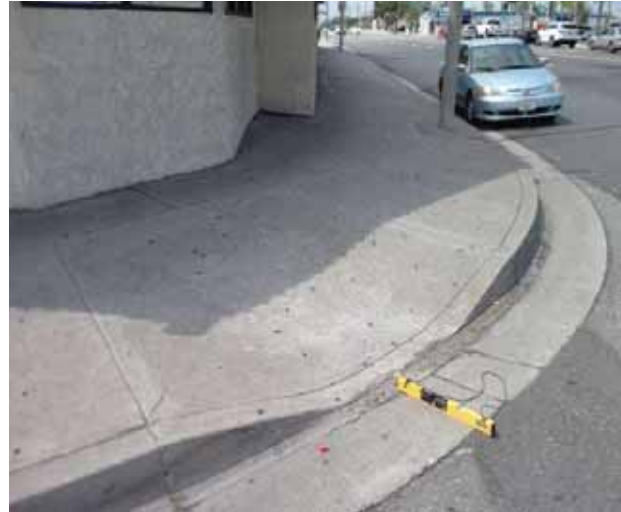
Recommendation Up to 5.00 percent

Repave landing \$1,260

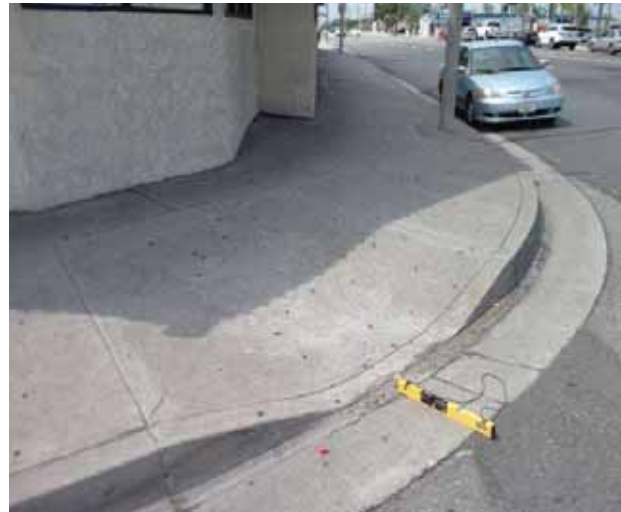
Recommendation At least 48.00 inches

Provide compliant landing \$240

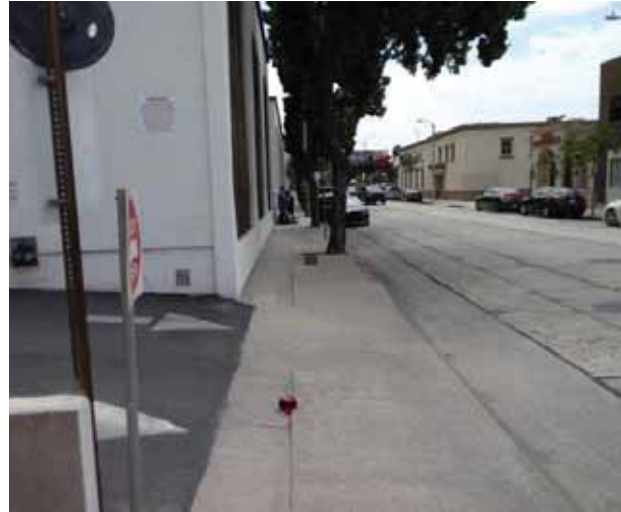
Notes : Has An Opening Greater Than .5"

Repave surface \$1,092

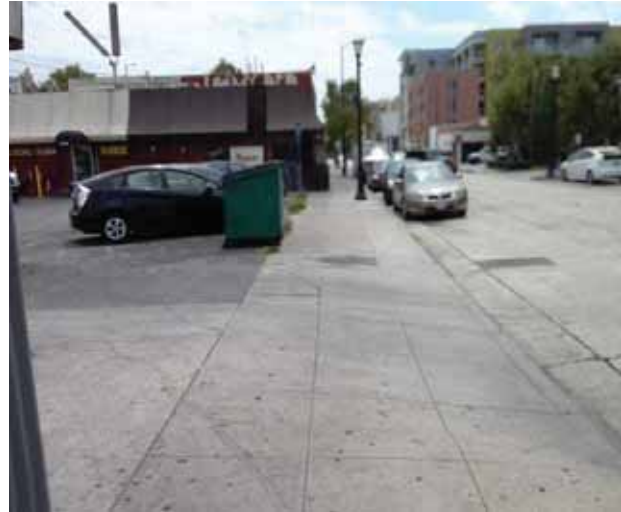
On-Site Finding Not Found

Install compliant detectable warnings \$190

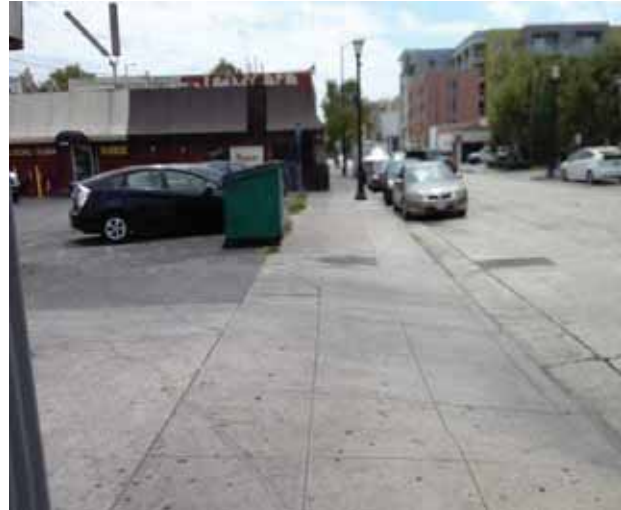
Recommendation Up to 2.08 percent

Repave surface \$1,092

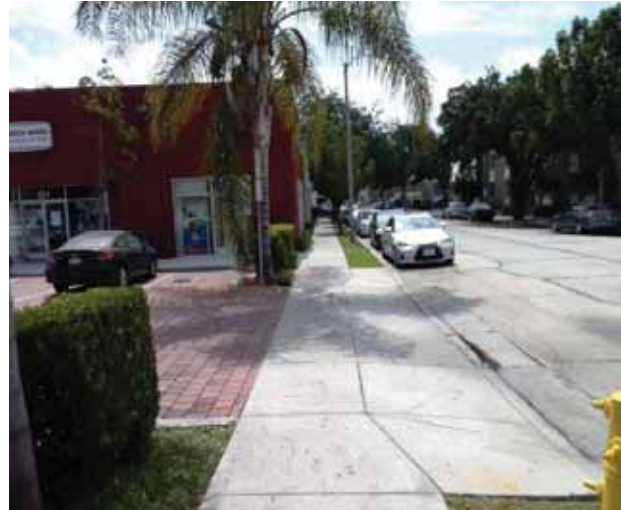
On-Site Finding Not Found

Install compliant detectable warnings \$190

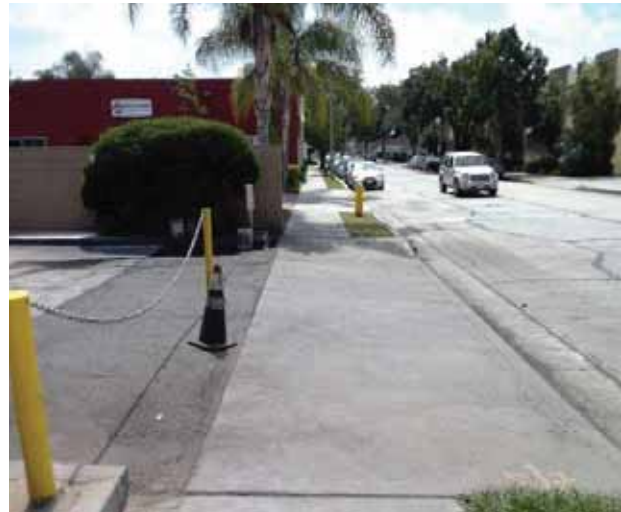
On-Site Finding Not Found

Install compliant detectable warnings \$190

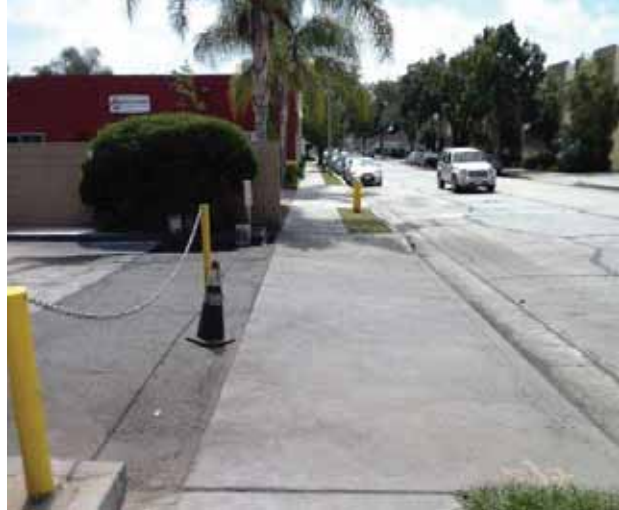
Recommendation Up to 2.08 percent

Repave surface \$1,092

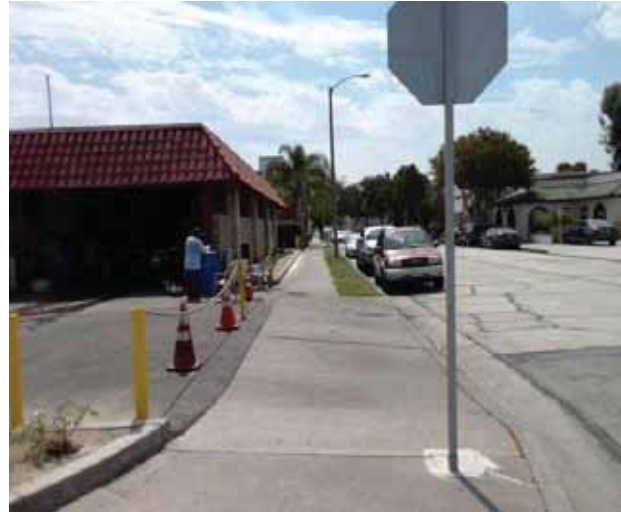
On-Site Finding Not Found

Install compliant detectable warnings \$190

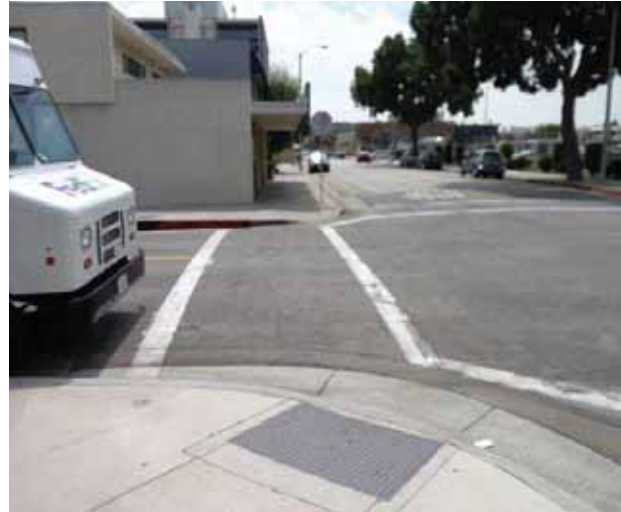
Recommendation Up to 5.00 percent

Repave surface \$1,092

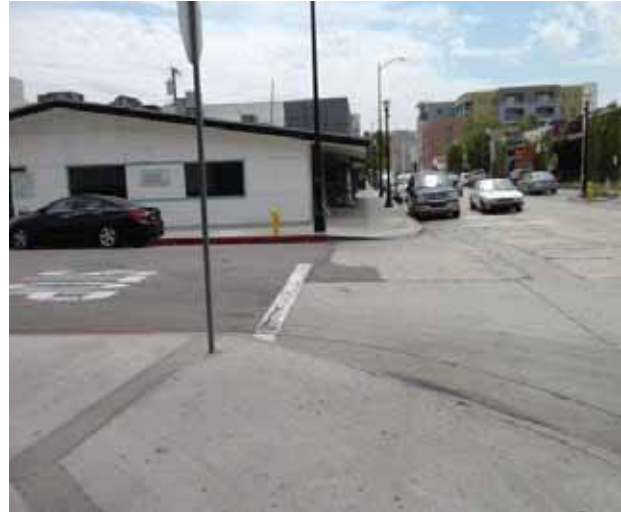
On-Site Finding Not Found

Install compliant detectable warnings \$190

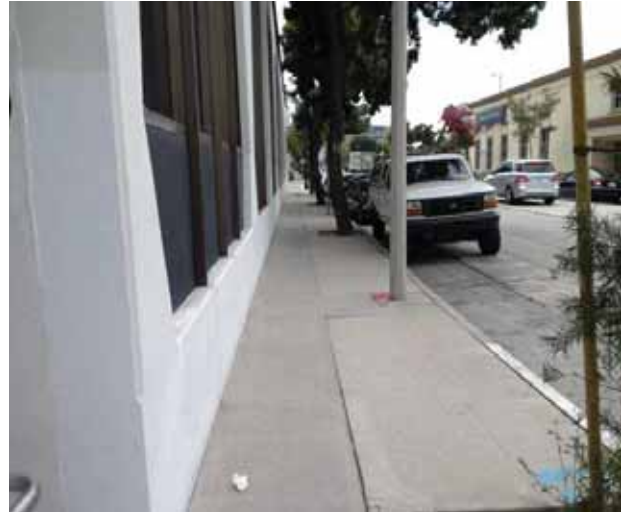
Recommendation Up to 2.08 percent

Repave the sidewalk surface with the recommended cross slope.

Repave surface \$1,092

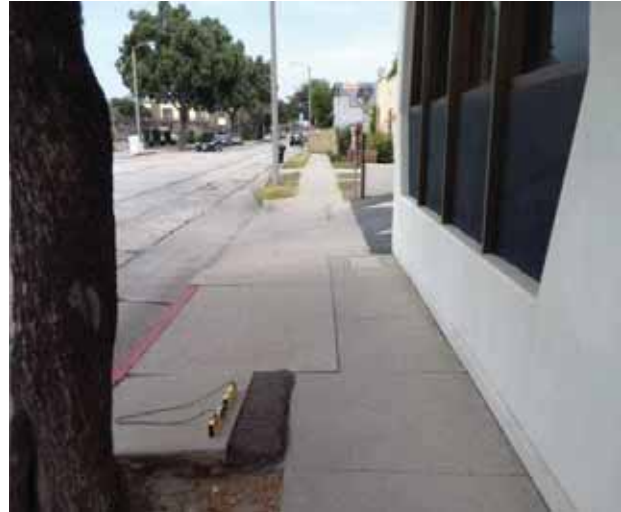
Recommendation Up to 2.08 percent

Repave the sidewalk surface with the recommended cross slope.

Repave surface \$1,092

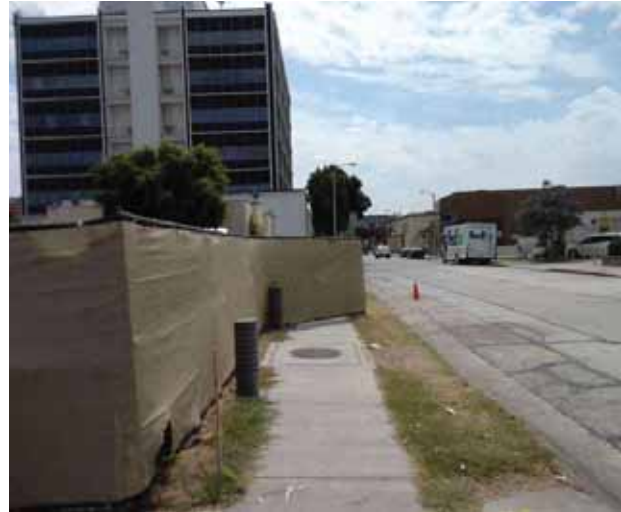
Recommendation Up to 2.08 percent

Repave the sidewalk surface with the recommended cross slope.

Repave surface \$1,092

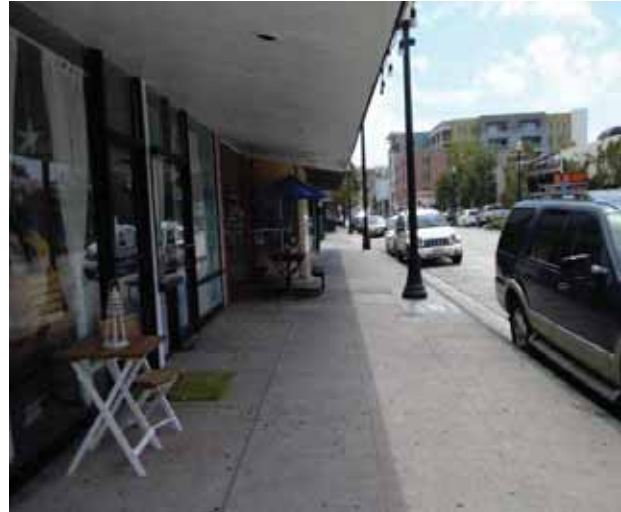
Recommendation Up to 2.08 percent

Repave the sidewalk surface with the recommended cross slope.

Repave surface \$1,092

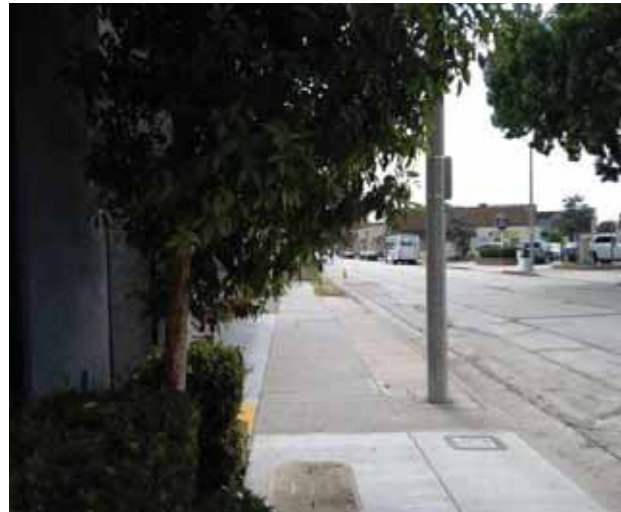
Sidewalks , Hazards & Gratings : Overhead Obstruction Height

Recommendation At least 80.00 inches

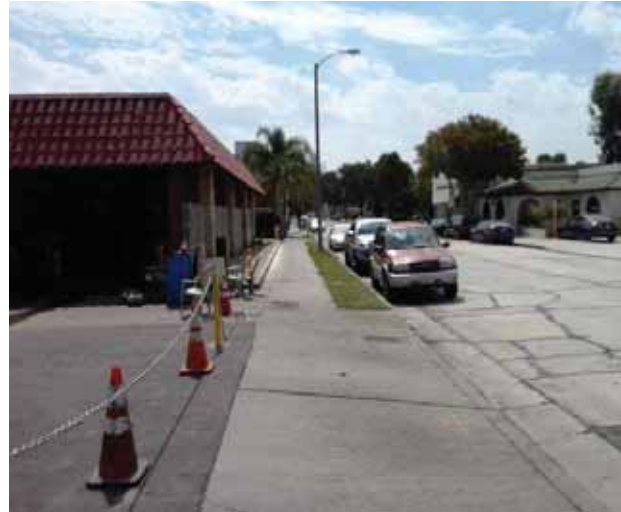
On-Site Finding Not Found

\$2,400

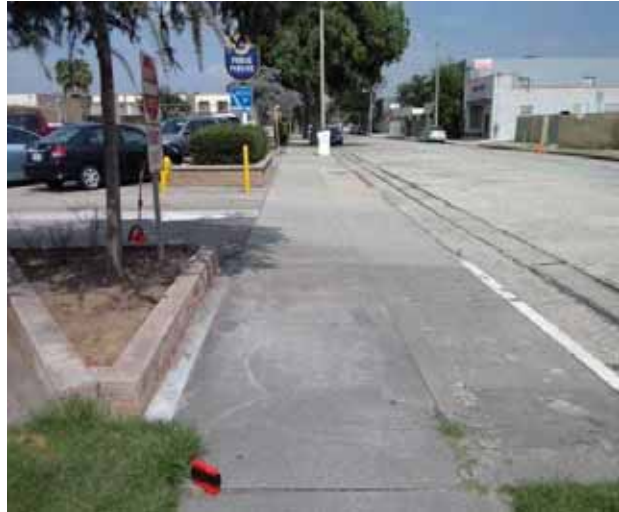
There is a change in elevation greater than recommended value.

Ensure that the change in elevation is within the recommended value.

Remove tripping hazards \$198

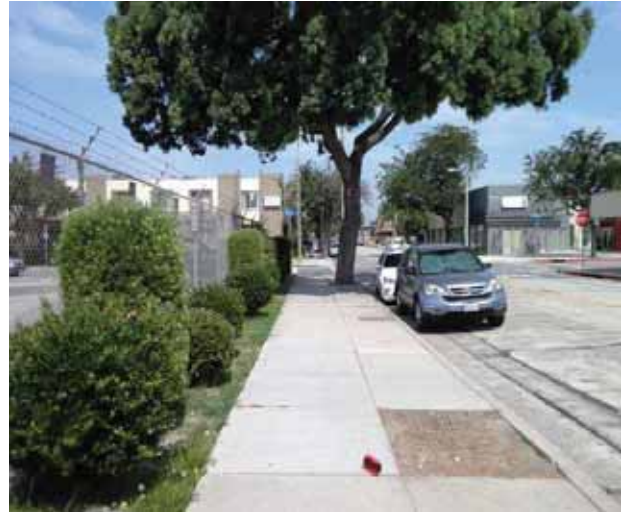
There is a change in elevation greater than recommended value.

Ensure that the change in elevation is within the recommended value.

Remove tripping hazards \$198

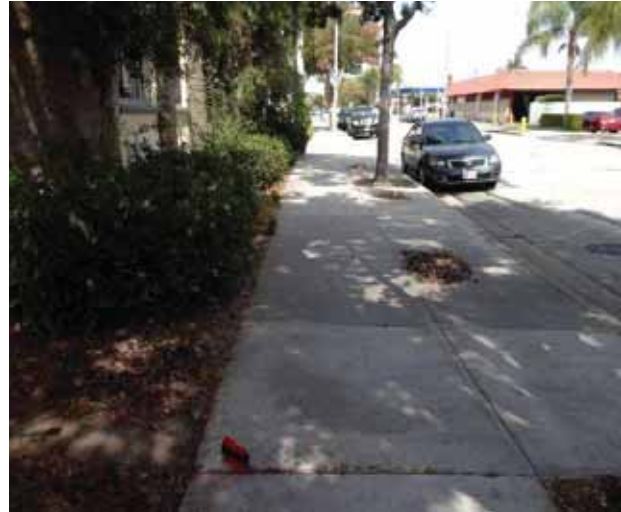
There is a change in elevation greater than recommended value.

Ensure that the change in elevation is within the recommended value.

Remove tripping hazards \$198

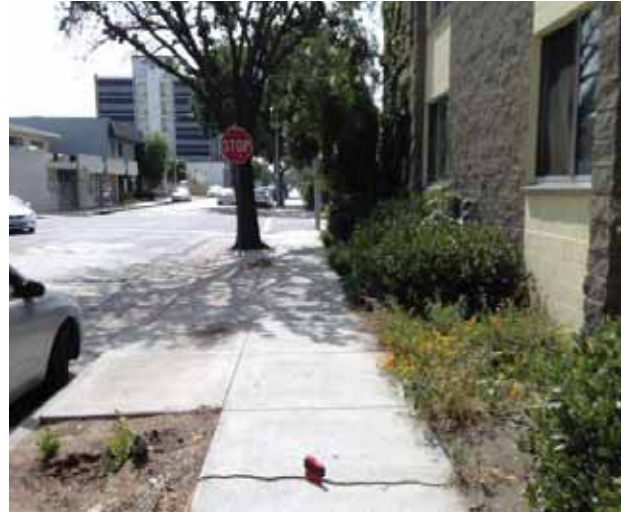
There is a change in elevation greater than recommended value.

Ensure that the change in elevation is within the recommended value.

Remove tripping hazards \$198

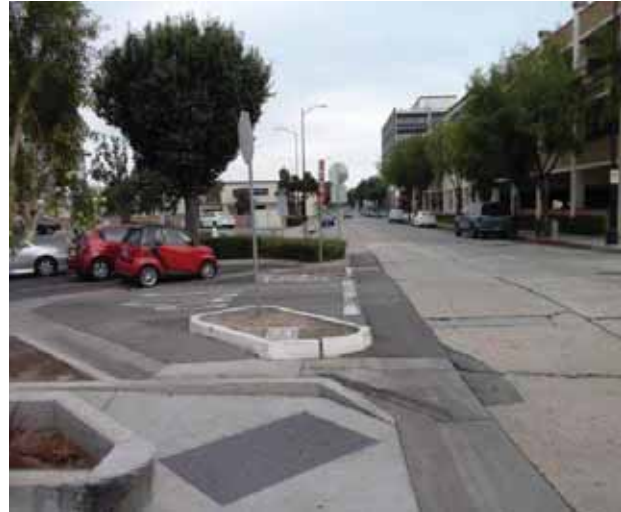
On-Site Finding Not Found

Install compliant detectable warnings \$190

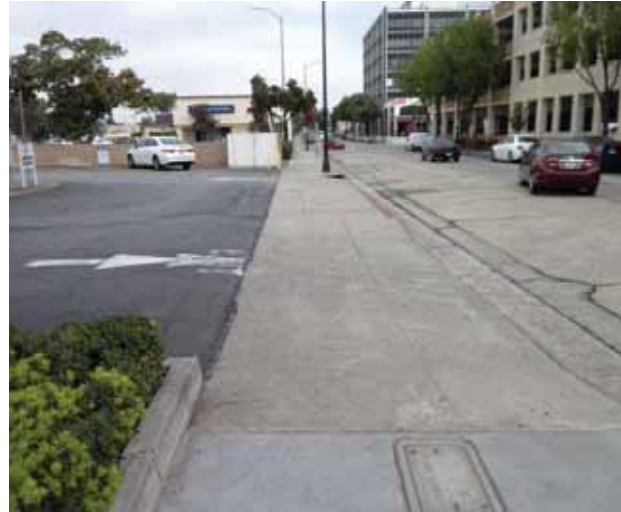
On-Site Finding Not Found

Install compliant detectable warnings \$190

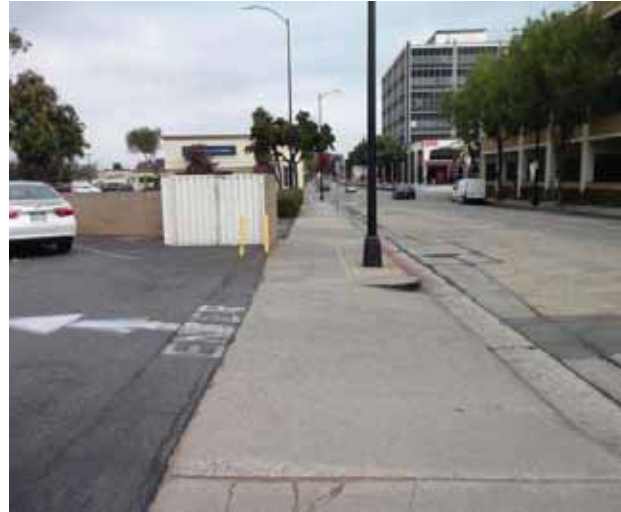
On-Site Finding Not Found

Install compliant detectable warnings \$190

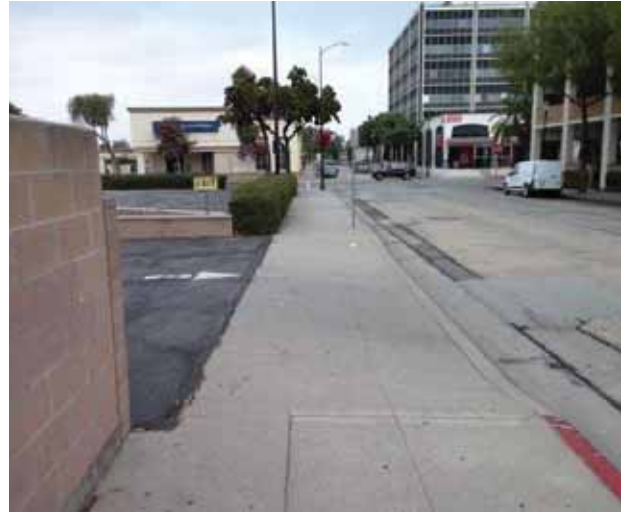
On-Site Finding Not Found

Install compliant detectable warnings \$190

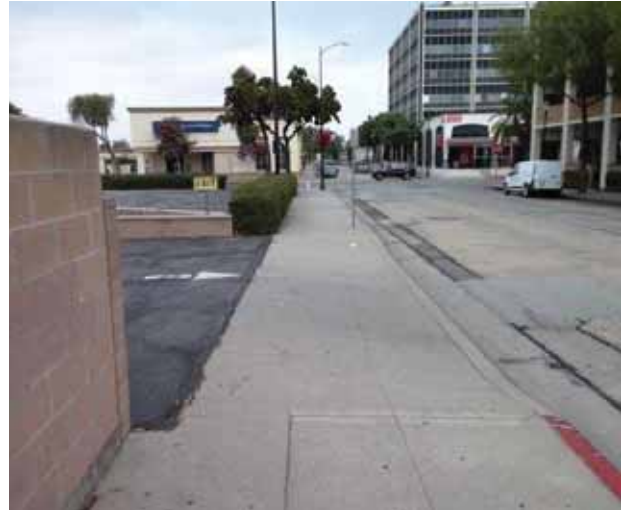
Recommendation Up to 2.08 percent

Repave surface \$1,092

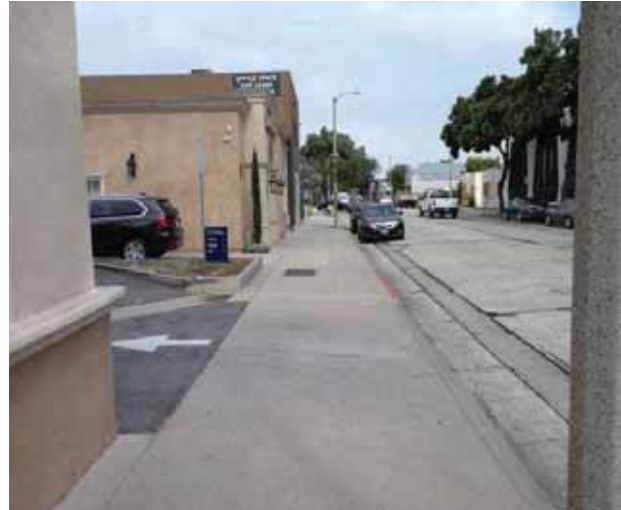
On-Site Finding Not Found

Install compliant detectable warnings \$190

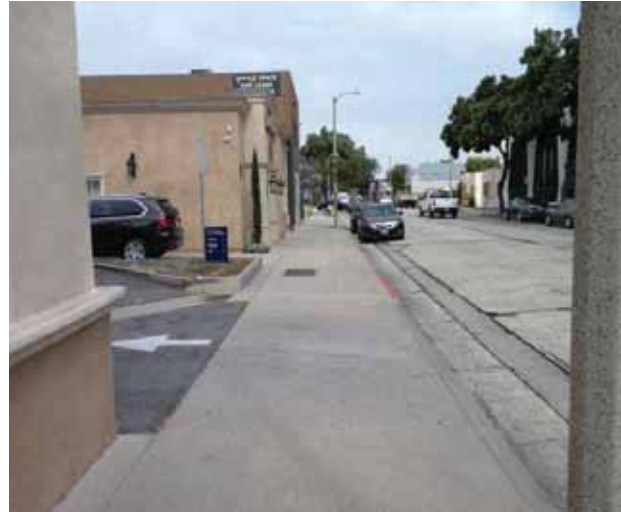
Recommendation Up to 2.08 percent

Repave surface \$1,092

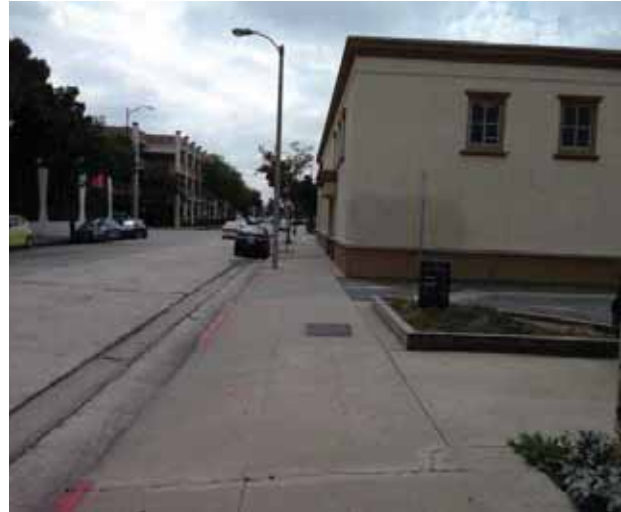
On-Site Finding Not Found

Recommendation See Recommendation

Install compliant detectable warnings \$190

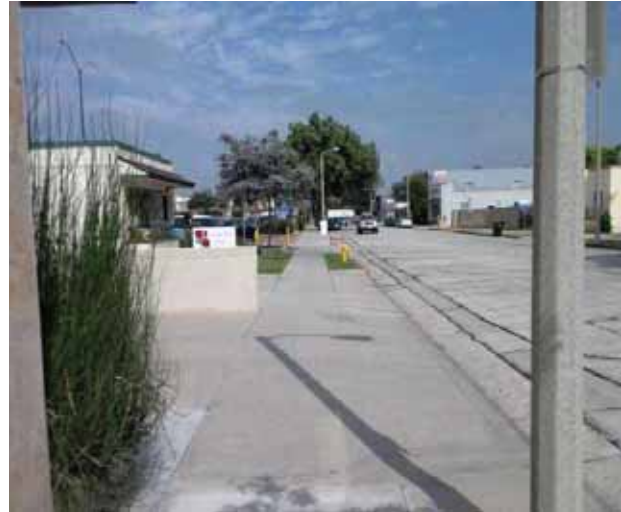
On-Site Finding Not Found

Recommendation See Recommendation

Install compliant detectable warnings \$190

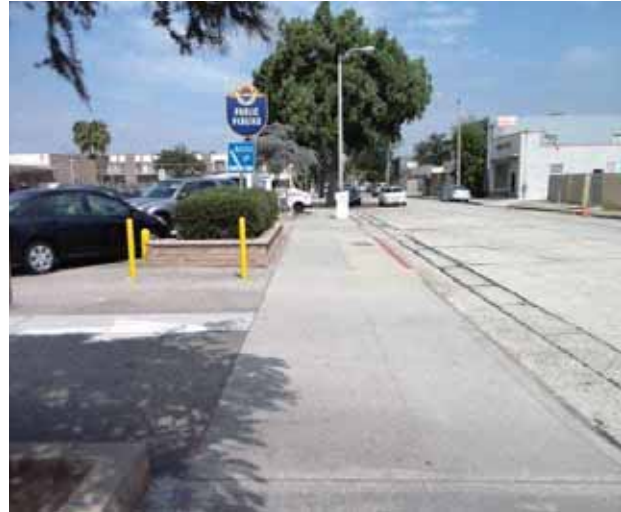
On-Site Finding Not Found

Recommendation See Recommendation

Install compliant detectable warnings \$190

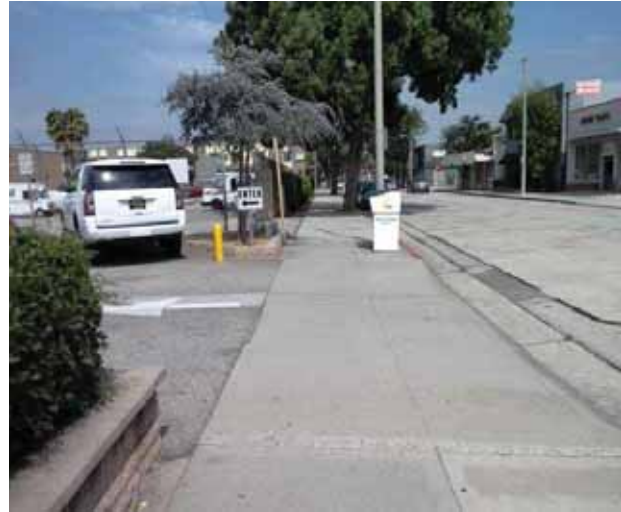
On-Site Finding Not Found

Recommendation See Recommendation

Install compliant detectable warnings \$190
