Accessibility Survey

2nd Street - Brookshire Avenue to End

Date of Inspection
8/9/2017

Prepared By
Disability Access Consultants
(800) 743-7067

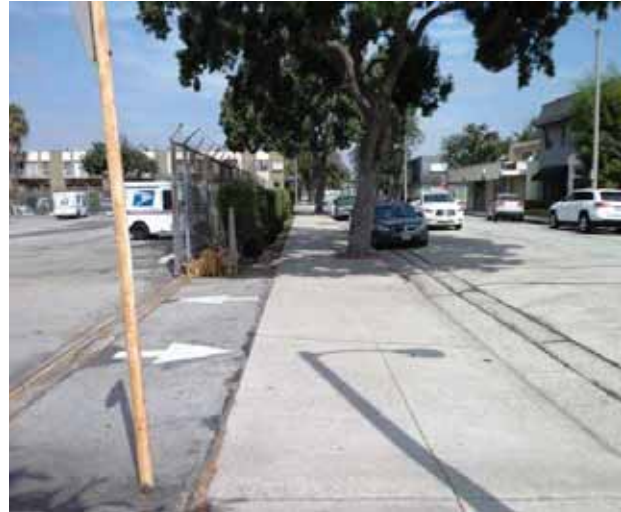
On-Site Finding Not Found

Recommendation See Recommendation

Install compliant detectable warnings \$190

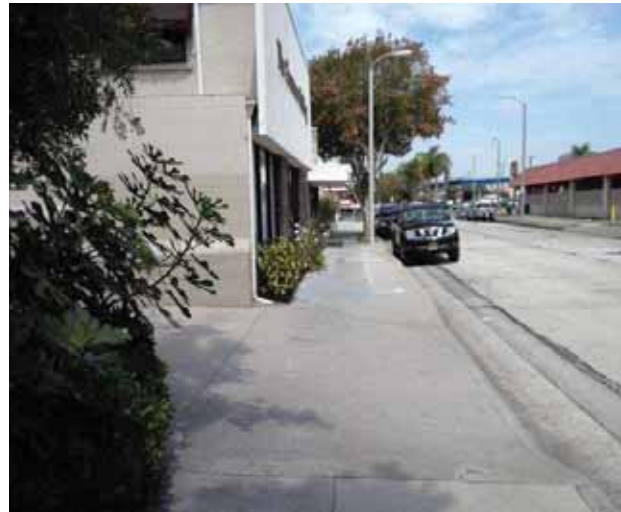
On-Site Finding Not Found

Recommendation See Recommendation

Install compliant detectable warnings \$190

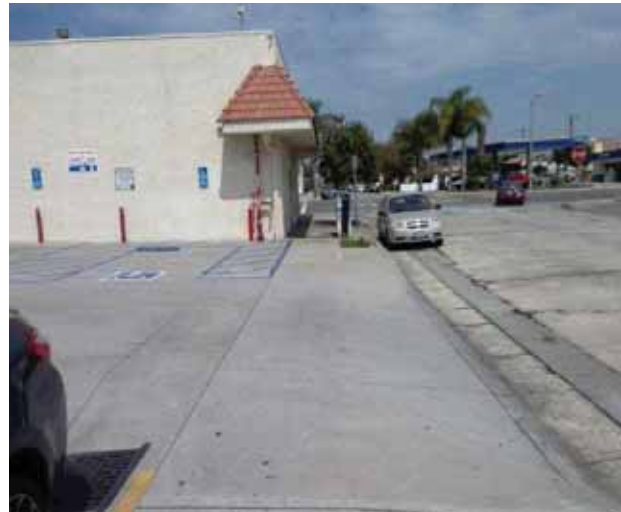
On-Site Finding Not Found

Recommendation See Recommendation

Install compliant detectable warnings \$190

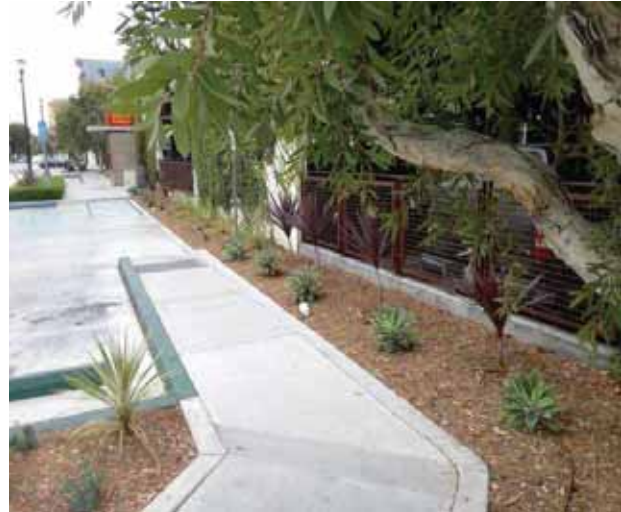
Sidewalks , Hazards & Gratings : Overhead Obstruction Height

Recommendation At least 80.00 inches

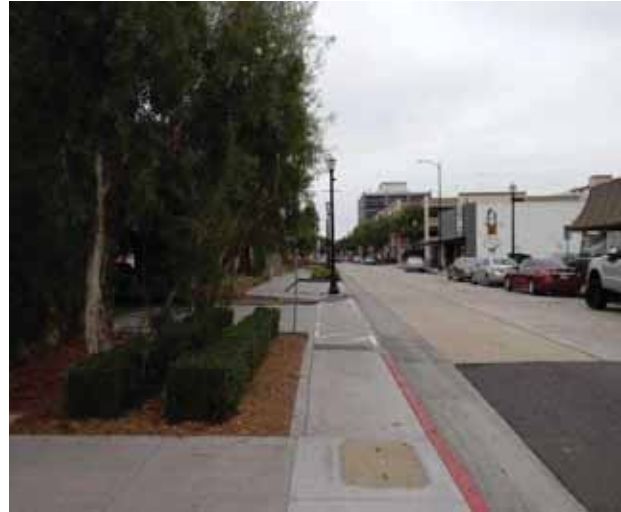
On-Site Finding Not Found

Recommendation See Recommendation

\$2,400

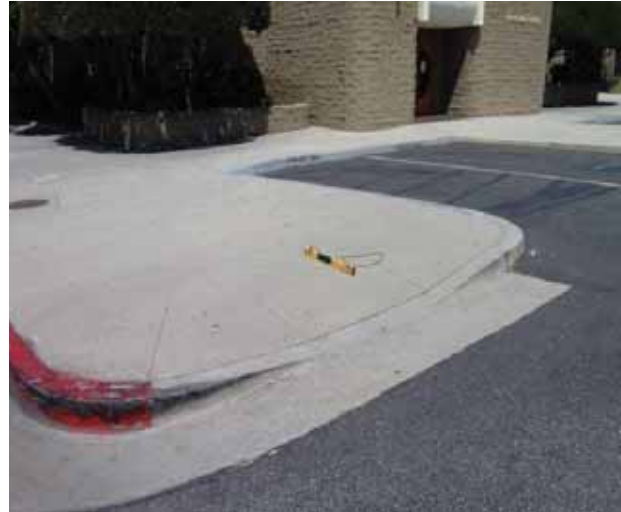
On-Site Finding Not Found

Recommendation See Recommendation

Provide detectable warning to surface \$248

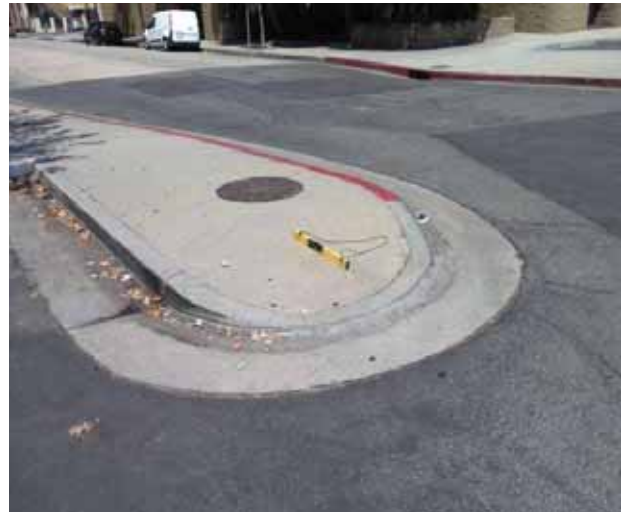
On-Site Finding Not Found

Recommendation See Recommendation

Provide detectable warning to surface \$248

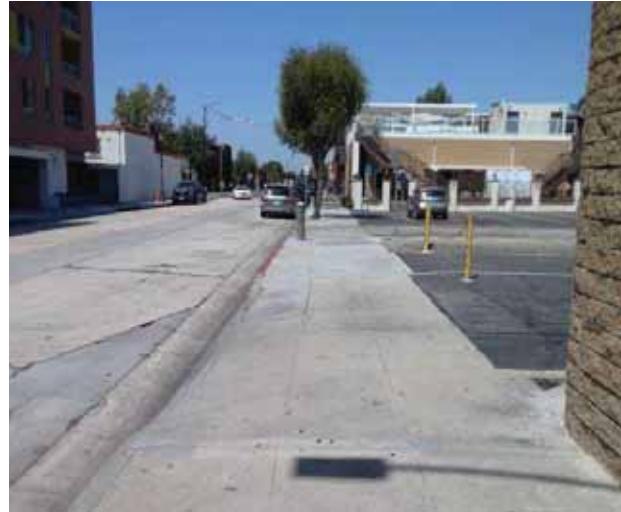
On-Site Finding Not Found

Recommendation See Recommendation

Install compliant detectable warnings \$190

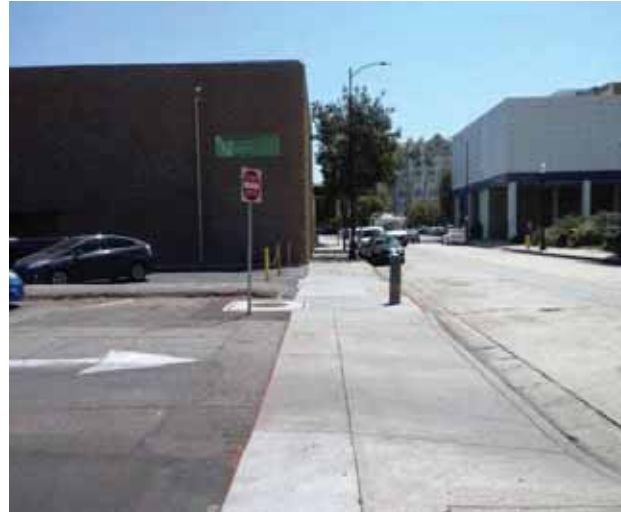
On-Site Finding Not Found

Recommendation See Recommendation

Install compliant detectable warnings \$190

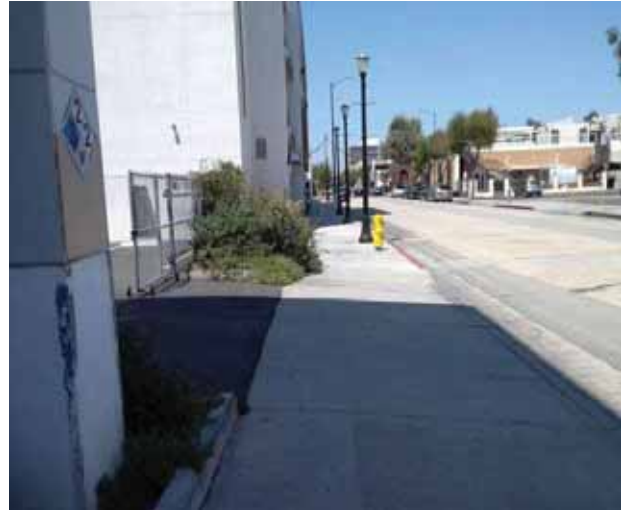
On-Site Finding Not Found

Recommendation See Recommendation

Install compliant detectable warnings \$190

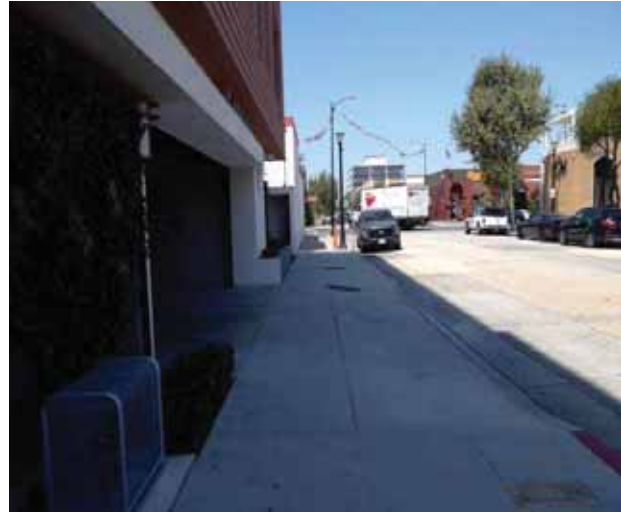
On-Site Finding Not Found

Recommendation See Recommendation

Install compliant detectable warnings \$190

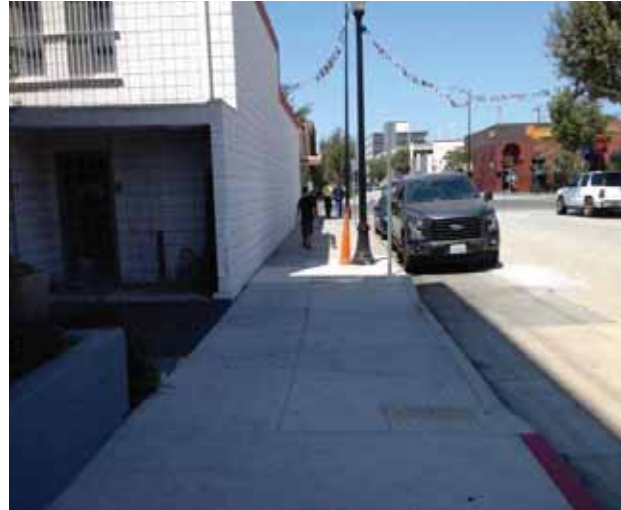
On-Site Finding Not Found

Recommendation See Recommendation

Install compliant detectable warnings \$190

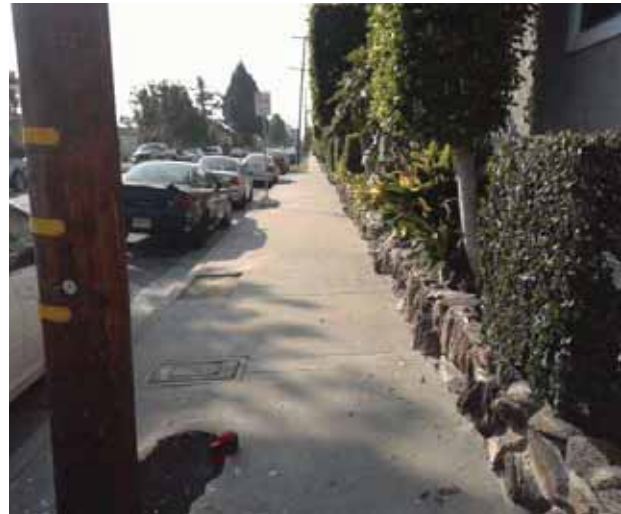
There is a change in elevation greater than recommended value.

Ensure that the change in elevation is within the recommended value.

Recommendation Up to 0.25 inches

Remove tripping hazards \$198

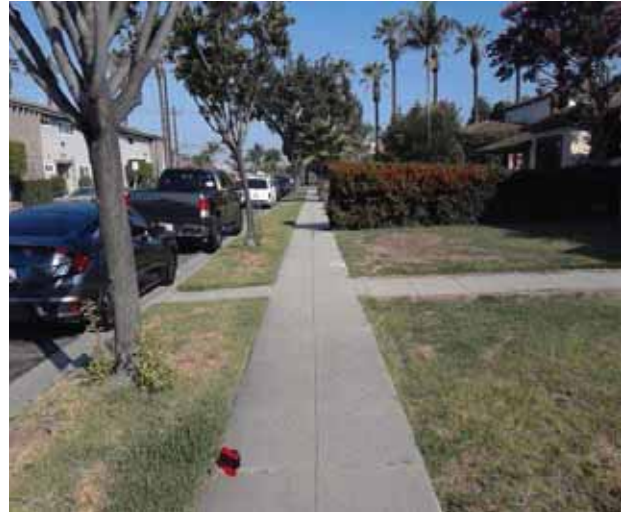
There is a change in elevation greater than recommended value.

Ensure that the change in elevation is within the recommended value.

Recommendation Up to 0.25 inches

Remove tripping hazards \$198

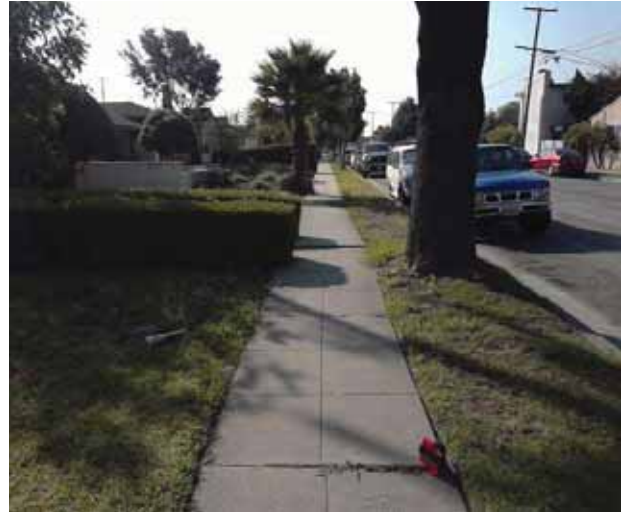
There is a change in elevation greater than recommended value.

Ensure that the change in elevation is within the recommended value.

Recommendation Up to 0.25 inches

Remove tripping hazards \$198

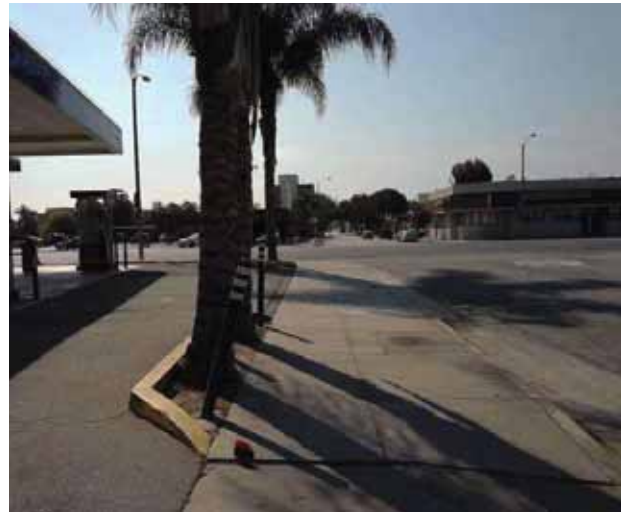
There is a change in elevation greater than recommended value.

Ensure that the change in elevation is within the recommended value.

Recommendation Up to 0.25 inches

Remove tripping hazards \$198

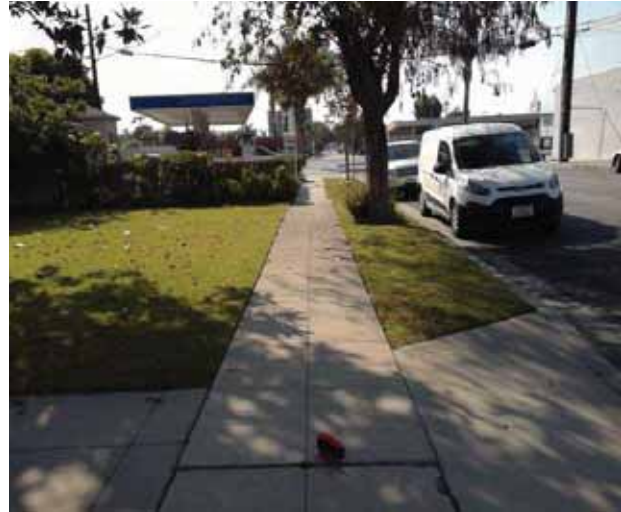
There is a change in elevation greater than recommended value.

Ensure that the change in elevation is within the recommended value.

Recommendation Up to 0.25 inches

Remove tripping hazards \$198

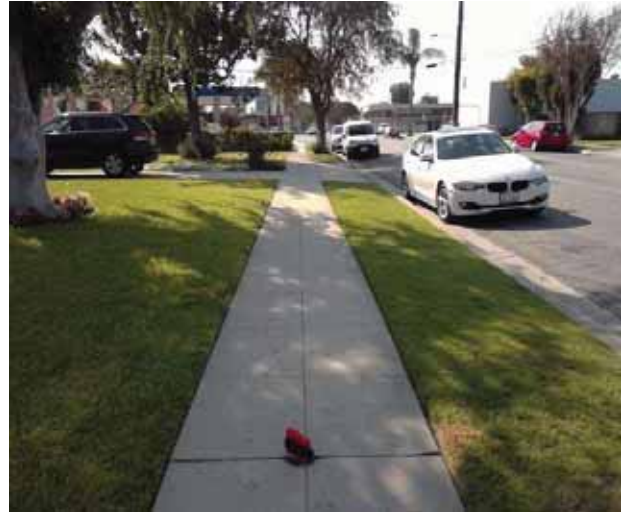
There is a change in elevation greater than recommended value.

Ensure that the change in elevation is within the recommended value.

Recommendation Up to 0.25 inches

Remove tripping hazards \$198

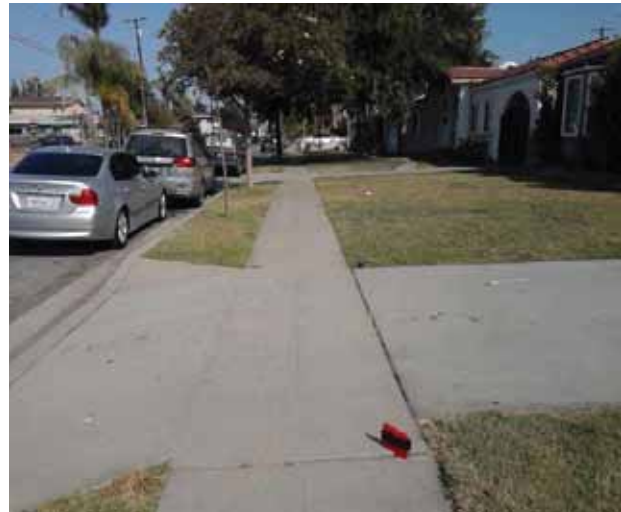
There is a change in elevation greater than recommended value.

Ensure that the change in elevation is within the recommended value.

Recommendation Up to 0.25 inches

Remove tripping hazards \$198

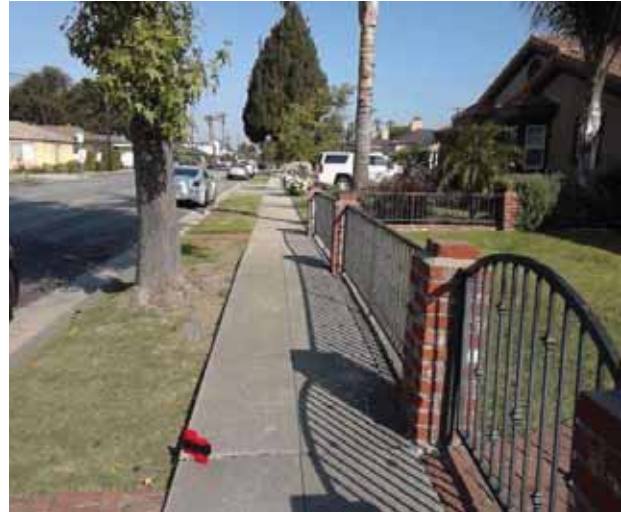
There is a change in elevation greater than recommended value.

Ensure that the change in elevation is within the recommended value.

Recommendation Up to 0.25 inches

Remove tripping hazards \$198

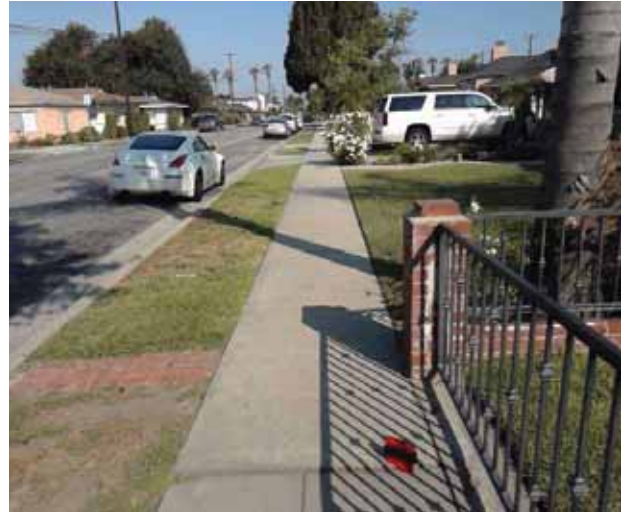
There is a change in elevation greater than recommended value.

Ensure that the change in elevation is within the recommended value.

Recommendation Up to 0.25 inches

Remove tripping hazards \$198

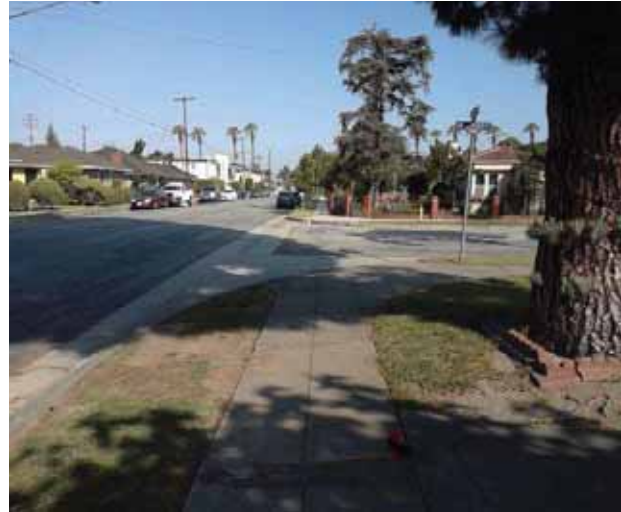
There is a change in elevation greater than recommended value.

Ensure that the change in elevation is within the recommended value.

Recommendation Up to 0.25 inches

Remove tripping hazards \$198

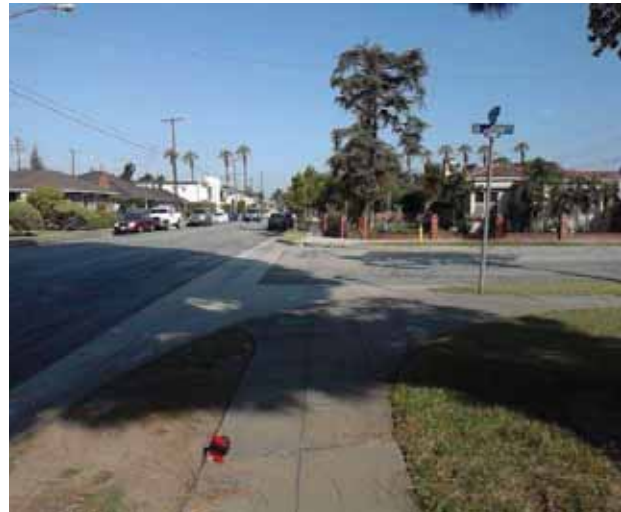
There is a change in elevation greater than recommended value.

Ensure that the change in elevation is within the recommended value.

Recommendation Up to 0.25 inches

Remove tripping hazards \$198

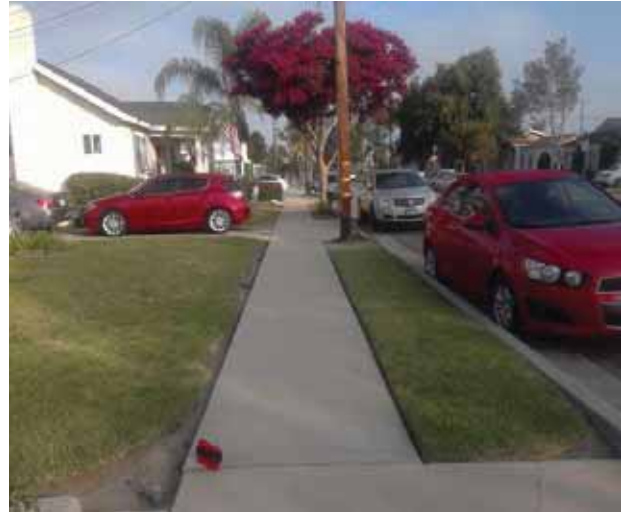
There is a change in elevation greater than recommended value.

Ensure that the change in elevation is within the recommended value.

Recommendation Up to 0.25 inches

Remove tripping hazards \$198

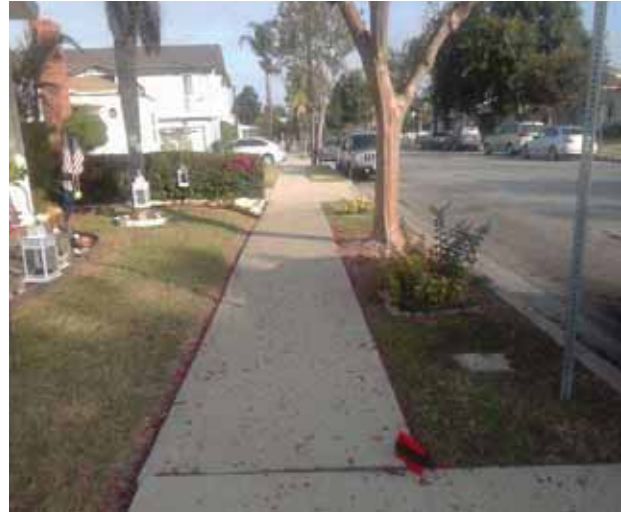
There is a change in elevation greater than recommended value.

Ensure that the change in elevation is within the recommended value.

Recommendation Up to 0.25 inches

Remove tripping hazards \$198

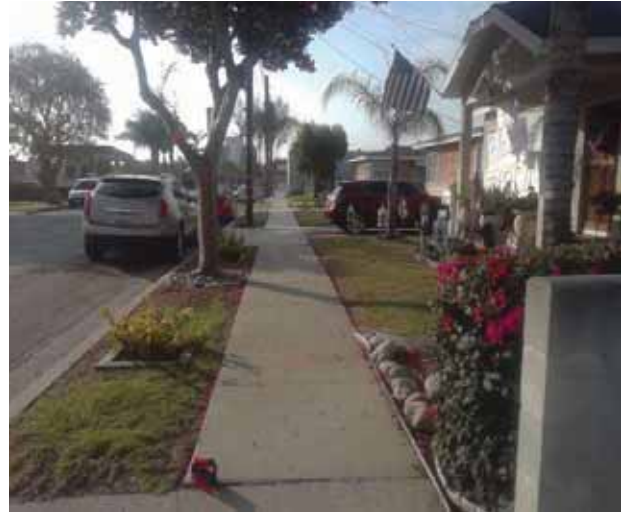
There is a change in elevation greater than recommended value.

Ensure that the change in elevation is within the recommended value.

Recommendation Up to 0.25 inches

Remove tripping hazards \$198

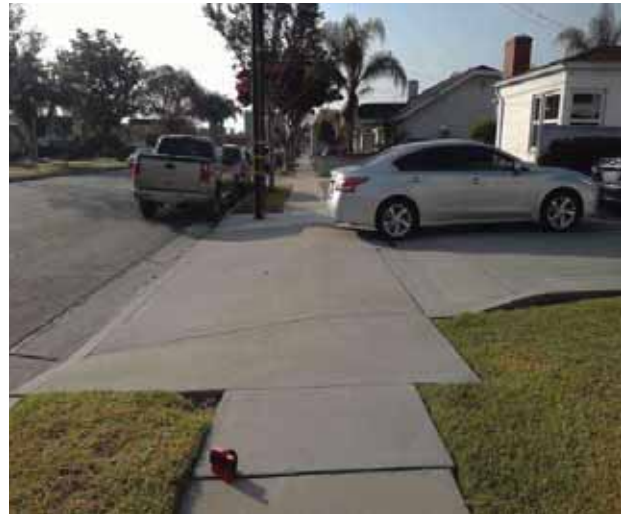
There is a change in elevation greater than recommended value.

Ensure that the change in elevation is within the recommended value.

Recommendation Up to 0.25 inches

Remove tripping hazards \$198

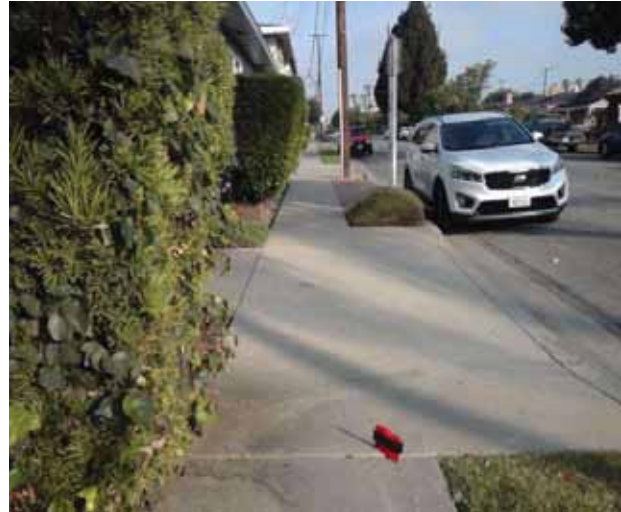
There is a change in elevation greater than recommended value.

Ensure that the change in elevation is within the recommended value.

Recommendation Up to 0.25 inches

Remove tripping hazards \$198

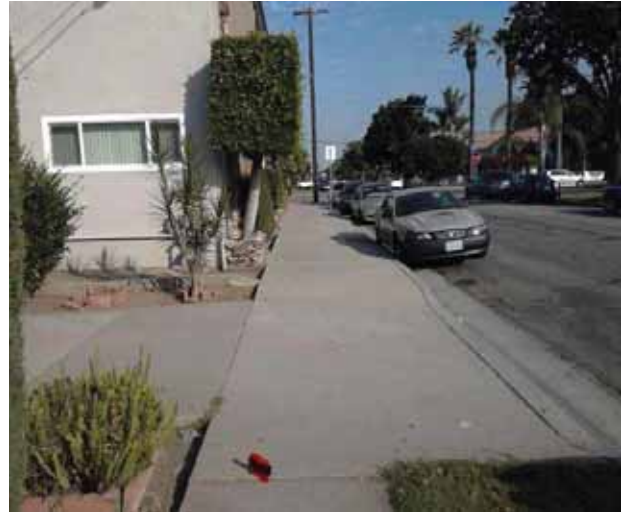
There is a change in elevation greater than recommended value.

Ensure that the change in elevation is within the recommended value.

Recommendation Up to 0.25 inches

Remove tripping hazards \$198

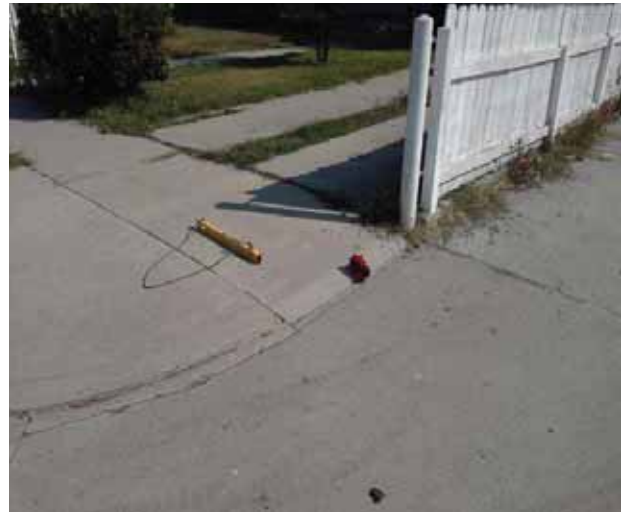
On-Site Finding Not Found

Provide detectable warning to surface \$248

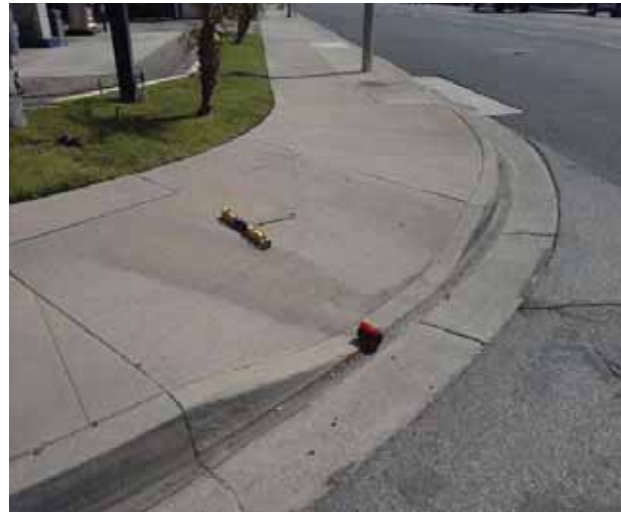
On-Site Finding Not Found

Provide detectable warning to surface \$248

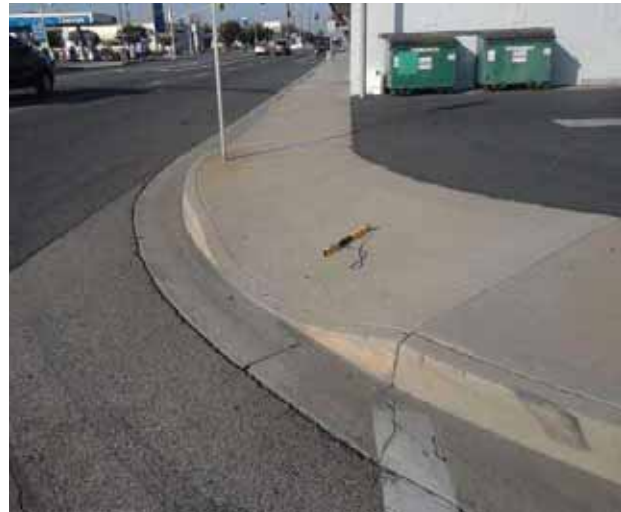
On-Site Finding Not Found

Provide detectable warning to surface \$248

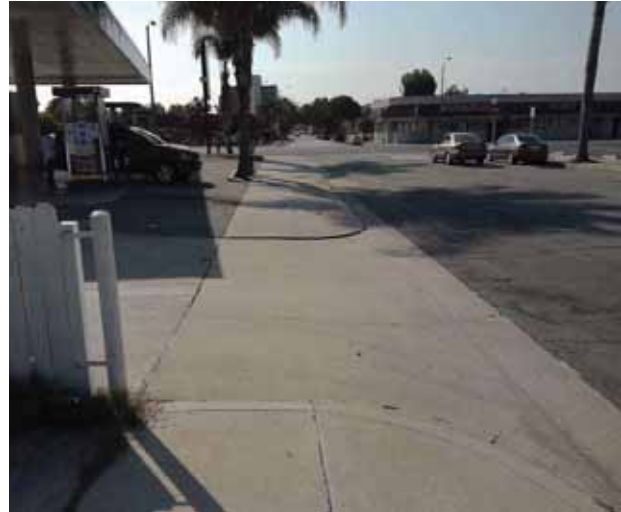
On-Site Finding Not Found

Install compliant detectable warnings \$190

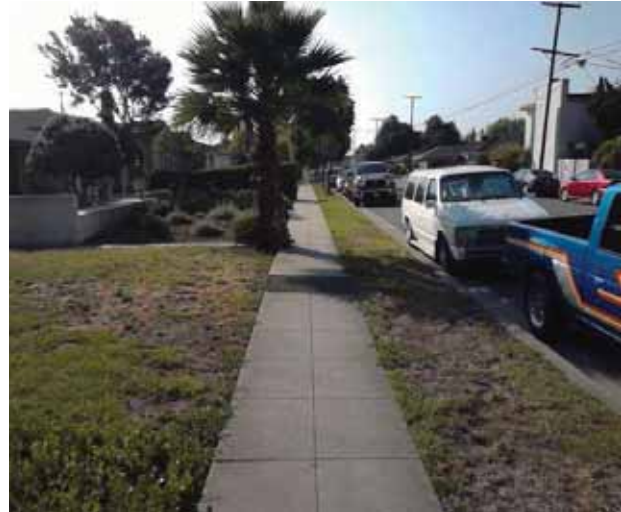
Notes : Surface is Rough And Uneven.

Repave surface \$1,092

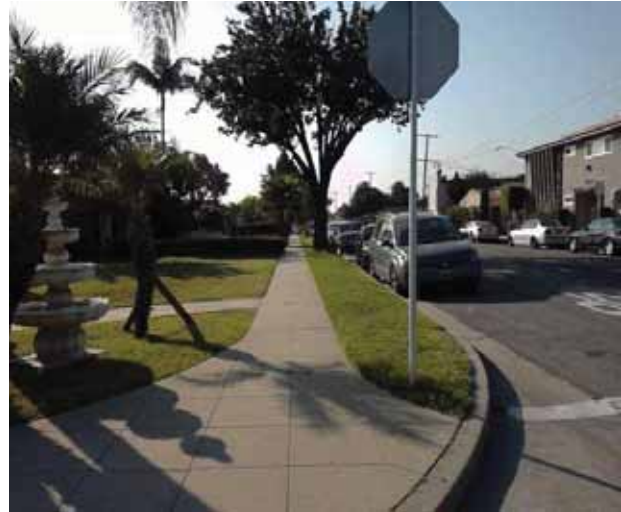
Sidewalks , Hazards & Gratings : Sidewalk Width at Obstruction

Recommendation See Recommendation

\$2,400

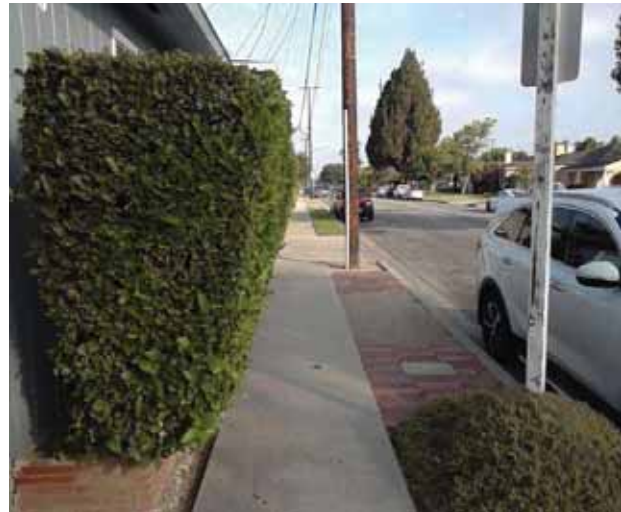
Sidewalks , Hazards & Gratings : Sidewalk Width at Obstruction

Sidewalk width at the obstruction shall have the recommended value.

Recommendation At least 48.00 inches

\$1,260

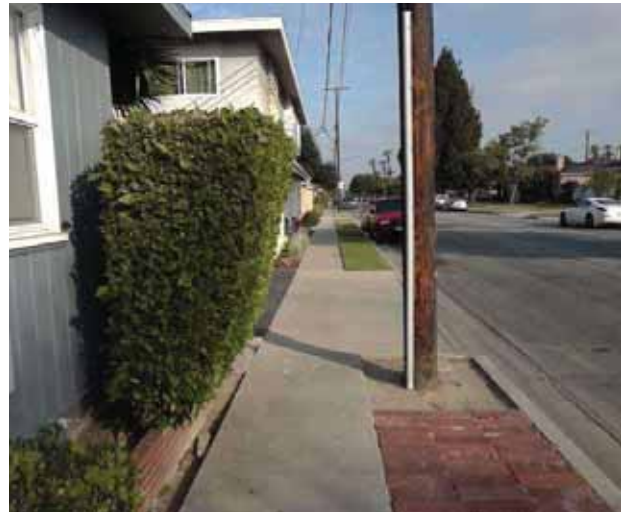
Sidewalks , Hazards & Gratings : Sidewalk Width at Obstruction

Sidewalk width at the obstruction shall have the recommended value.

Recommendation At least 48.00 inches

\$1,260

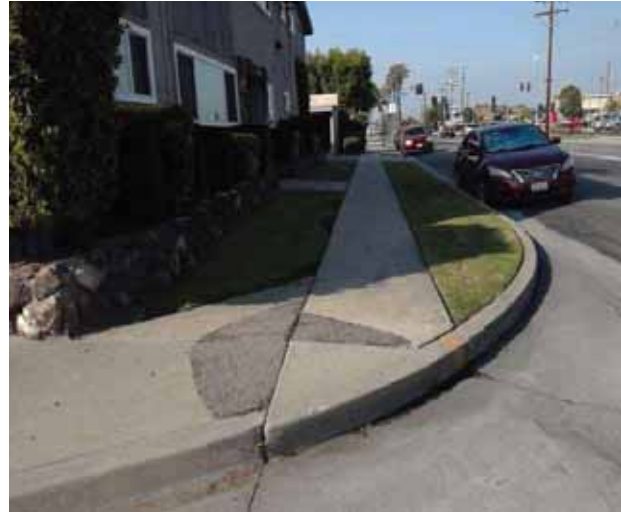
Sidewalks , Hazards & Gratings : Curb is on Path of Travel

Install curb ramp \$2,500

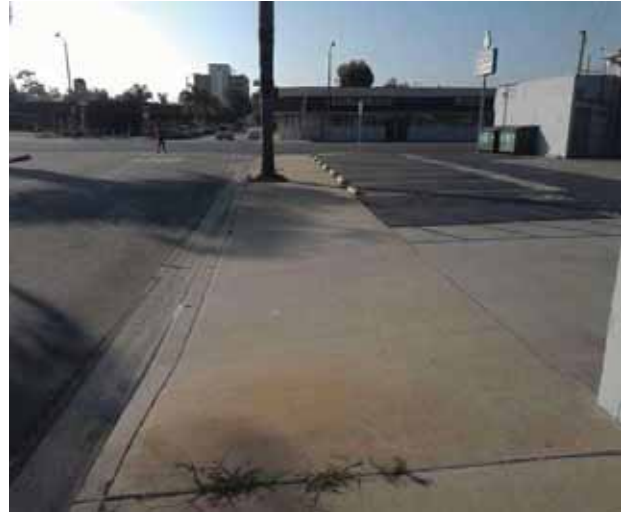
On-Site Finding Not Found

Install compliant detectable warnings \$190

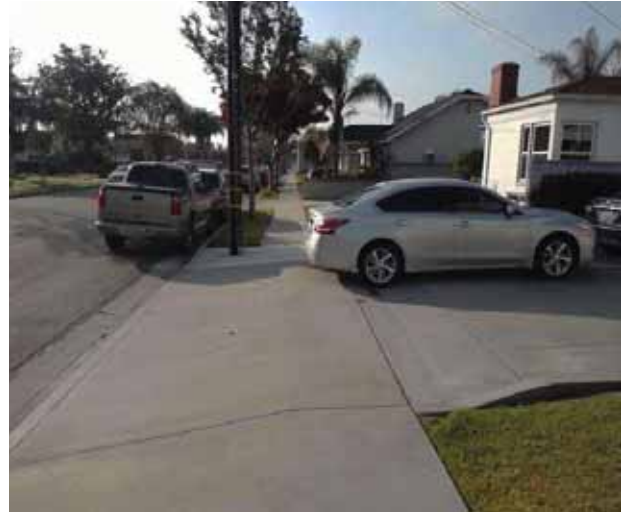
On-Site Finding Not Found

Install compliant detectable warnings \$190

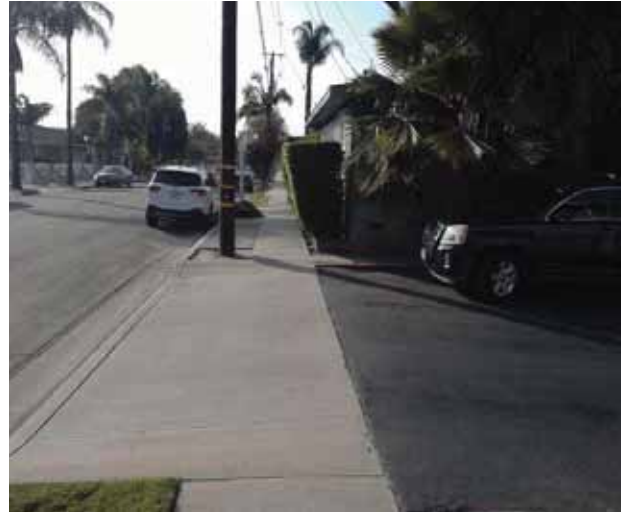
On-Site Finding Not Found

Install compliant detectable warnings \$190

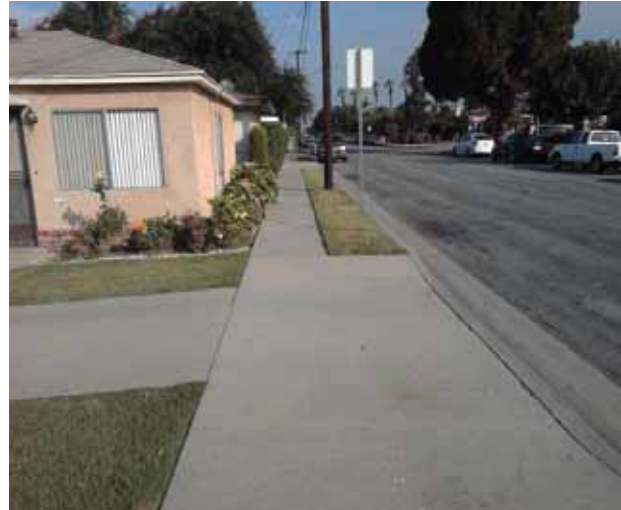
On-Site Finding Not Found

Install compliant detectable warnings \$190

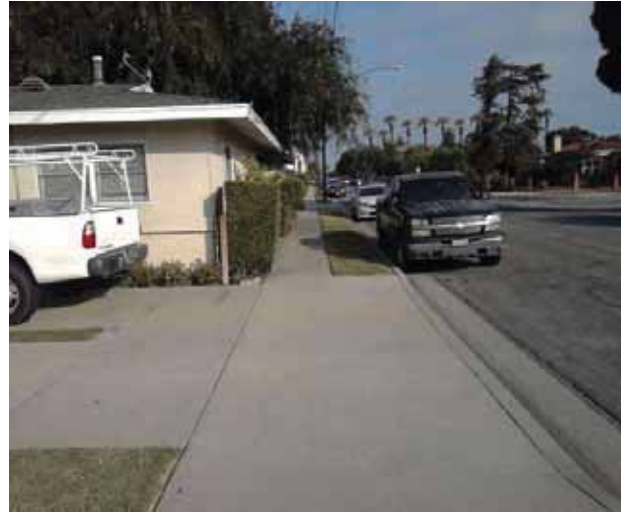
On-Site Finding Not Found

Install compliant detectable warnings \$190

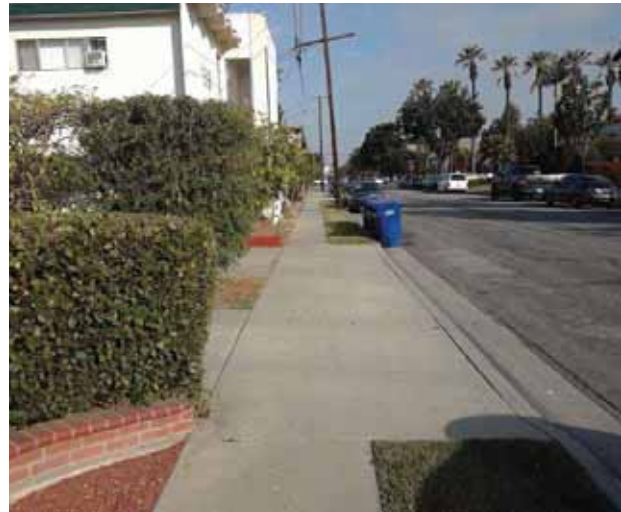
On-Site Finding Not Found

Install compliant detectable warnings \$190

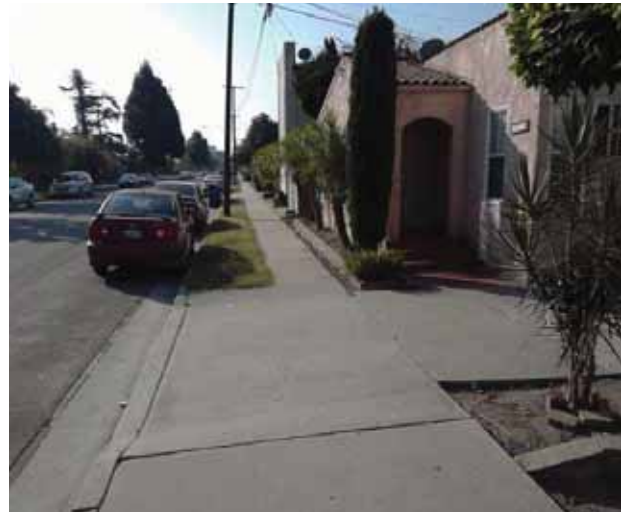
On-Site Finding Not Found

Install compliant detectable warnings \$190

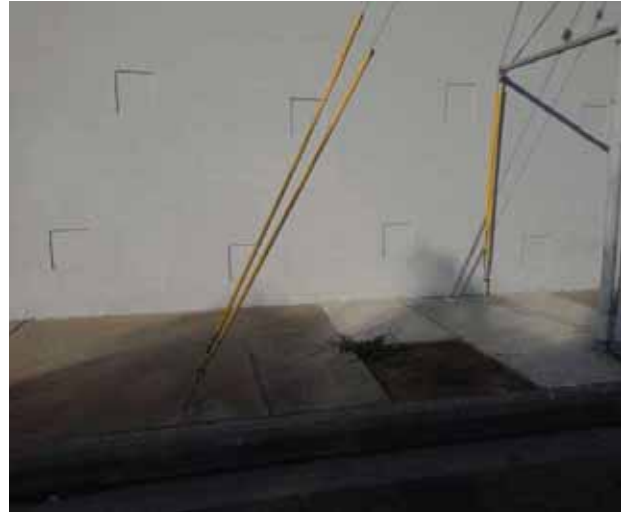
Sidewalks , Hazards & Gratings : Overhead Obstruction Height

Recommendation At least 80.00 inches

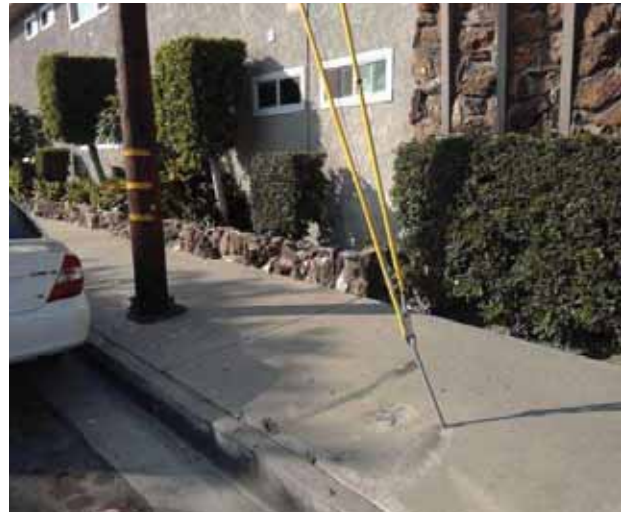
Sidewalks , Hazards & Gratings : Overhead Obstruction Height

Recommendation At least 80.00 inches

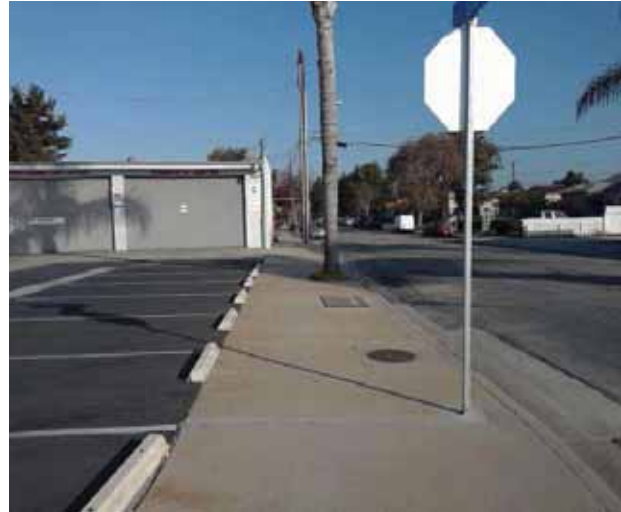
On-Site Finding Not Found

Recommendation See Recommendation

\$2,400

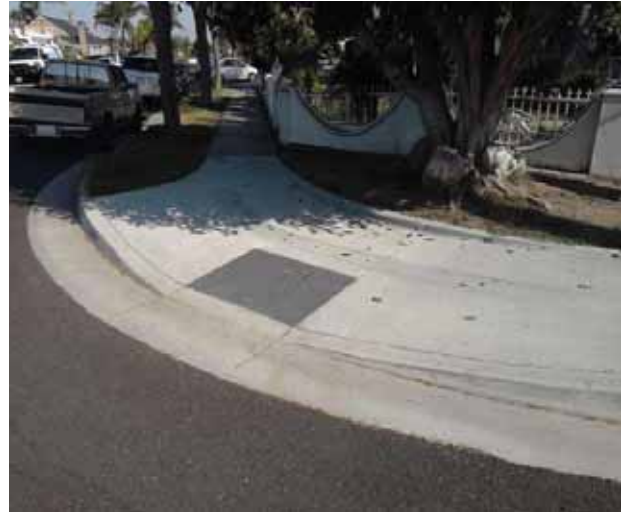
On-Site Finding Not Found

Install crosswalk \$800

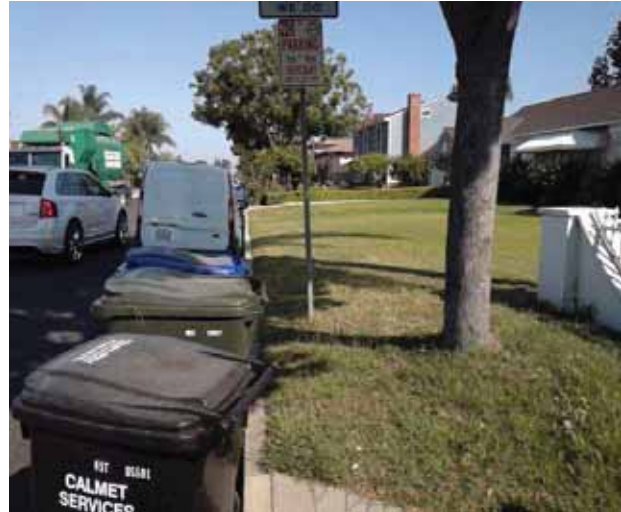
Sidewalks : Missing Sidewalk

Section of sidewalk is missing and consists of dirt, grass or gravel.

Provide a compliant sidewalk for the missing section.

\$1,260

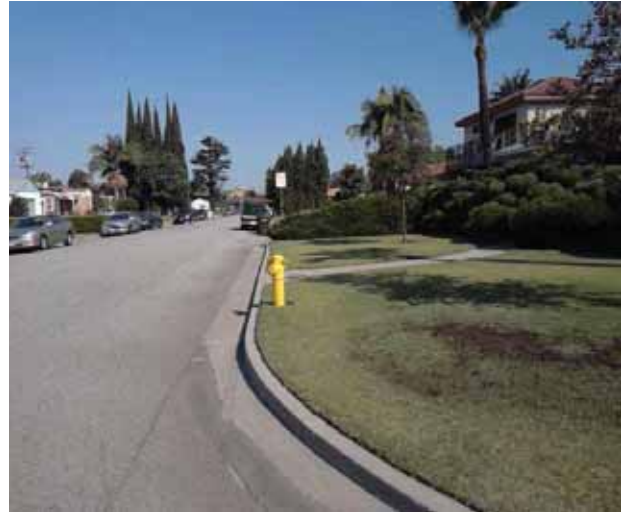
Sidewalks : Missing Sidewalk

Section of sidewalk is missing and consists of dirt, grass or gravel.

Provide a compliant sidewalk for the missing section.

\$1,260
