# Accessibility Survey

## City of Downey Gallatin Road & Paramount Boulevard

Date of Inspection  
4/14/2017

Prepared By  
**Disability Access Consultants**  
(800) 743-7067

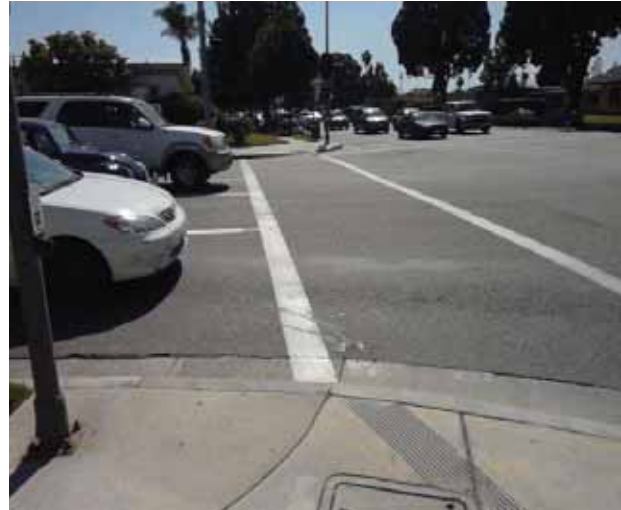
**On-Site Finding** Not Found

Recommendation See Recommendation

\$900

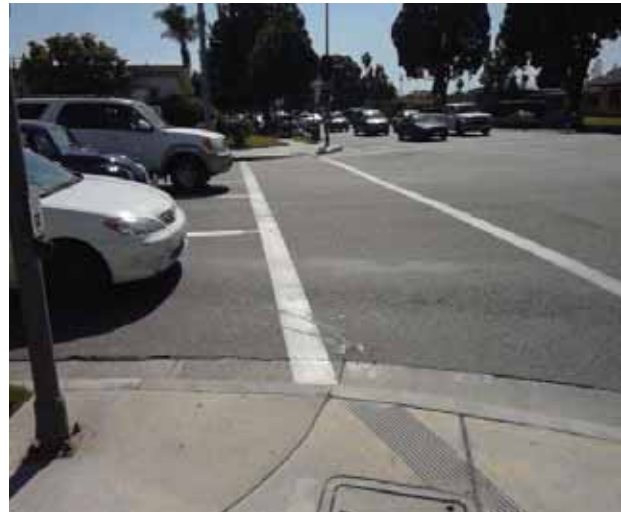
**On-Site Finding** Not Found

Recommendation See Recommendation

\$158

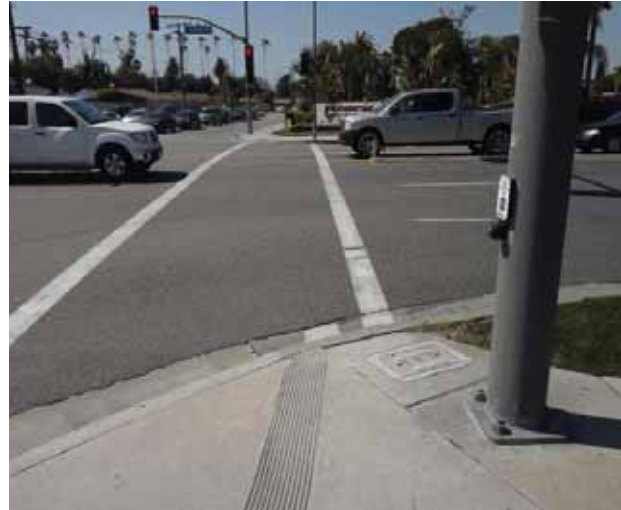
**On-Site Finding** Not Found

Recommendation See Recommendation

\$158

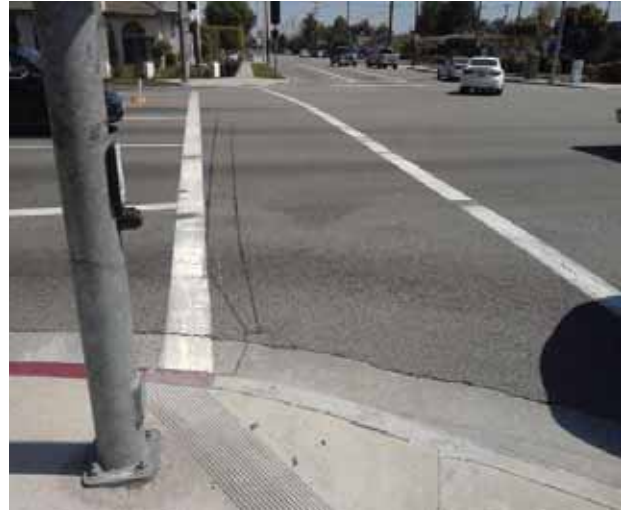
**On-Site Finding** Not Found

Recommendation See Recommendation

\$158

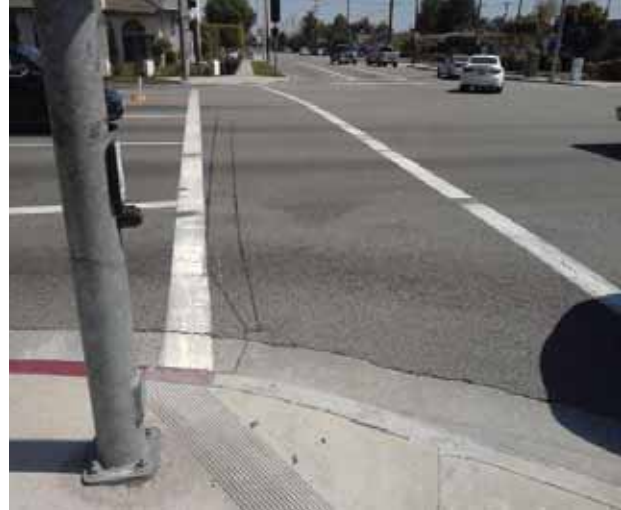
**On-Site Finding** Not Found

Recommendation See Recommendation

\$158

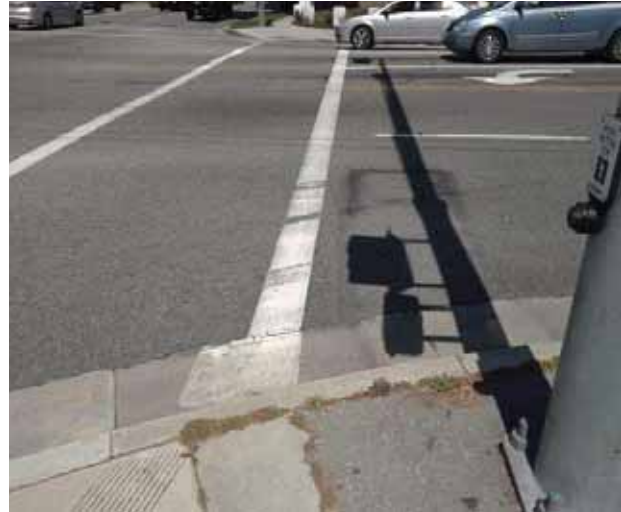
Notes : Surface is rough and uneven.

Recommendation Up to 60.00 inches

\$900

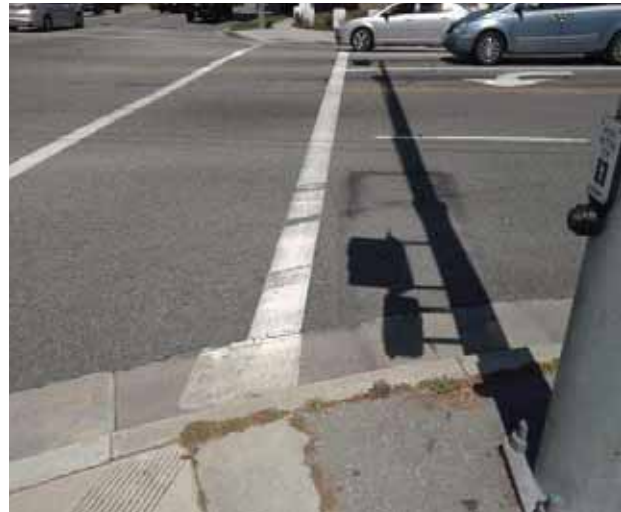
**On-Site Finding** Not Found

Notes : Surface is rough and uneven.

Recommendation See Recommendation

\$900

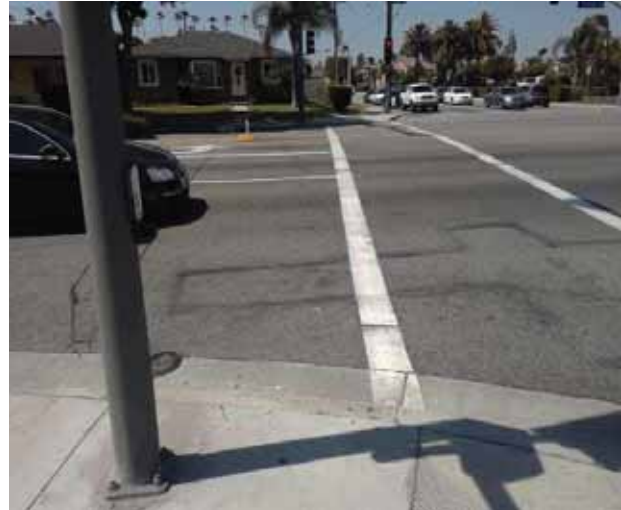
**On-Site Finding** Not Found

\$900

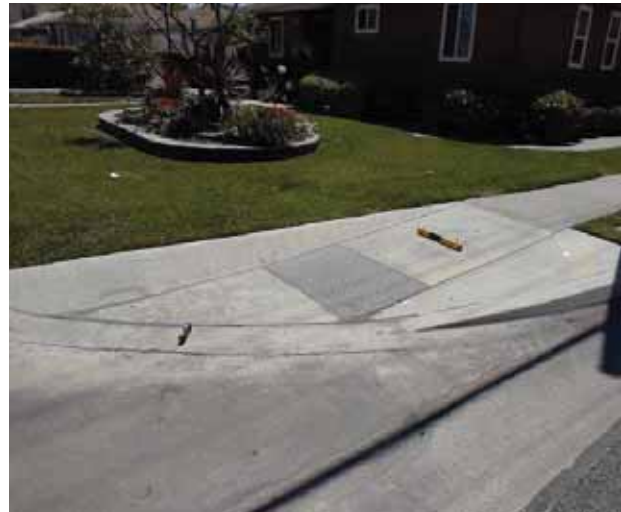
Recommendation Up to 2.08 percent

Install curb ramp \$1,300

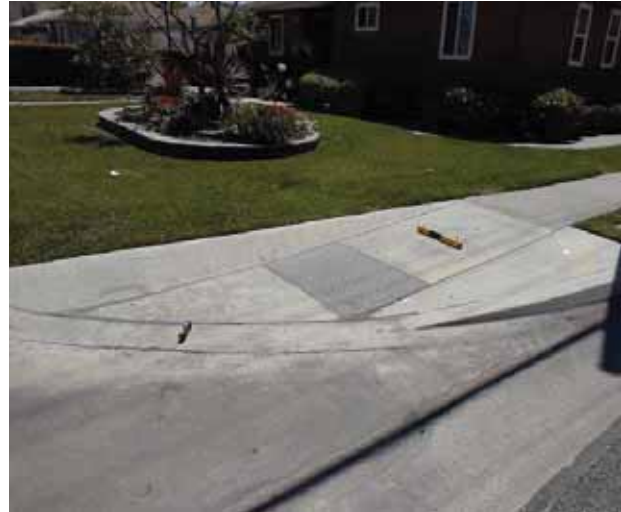
Recommendation Up to 10.00 percent

Install flared sides \$1,300

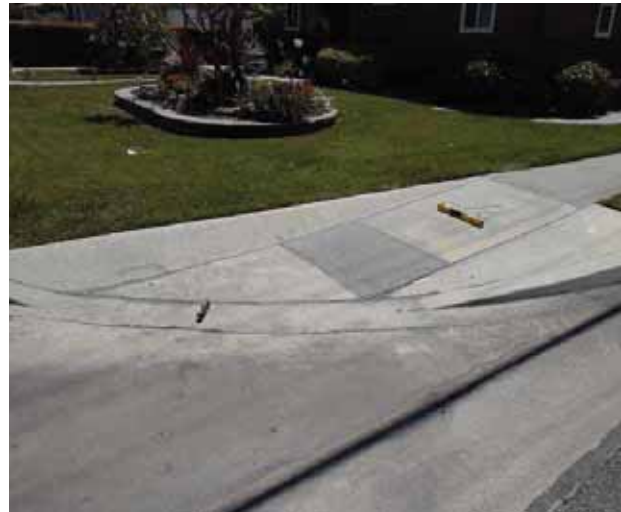
Recommendation Up to 5.00 percent

Repave landing \$1,260

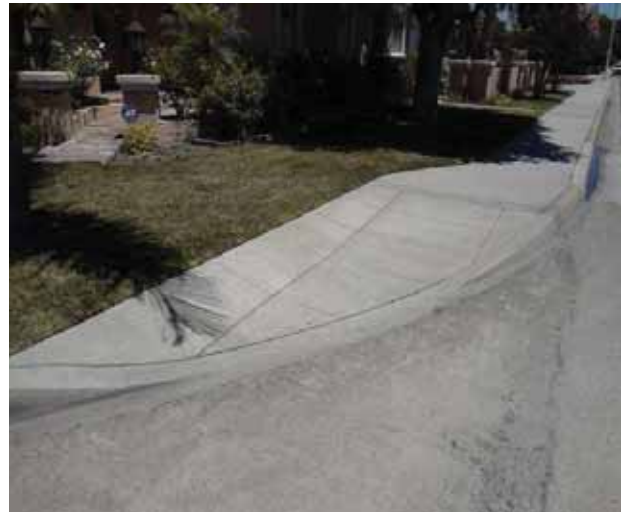
**On-Site Finding** Not Found

Provide detectable warning to surface \$248

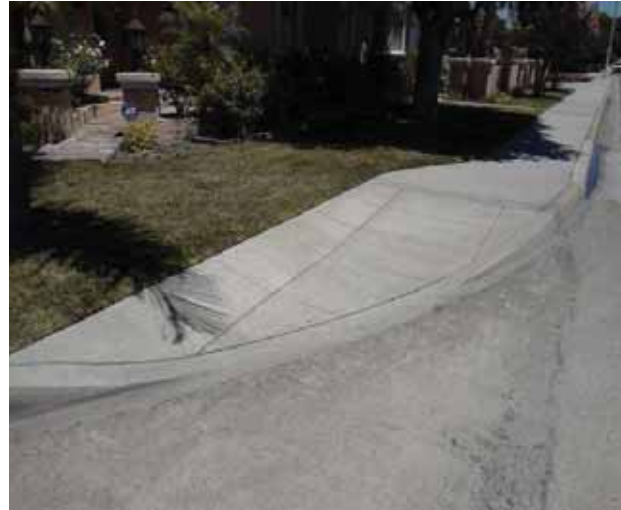
Recommendation Up to 10.00 percent

Install flared sides \$1,300

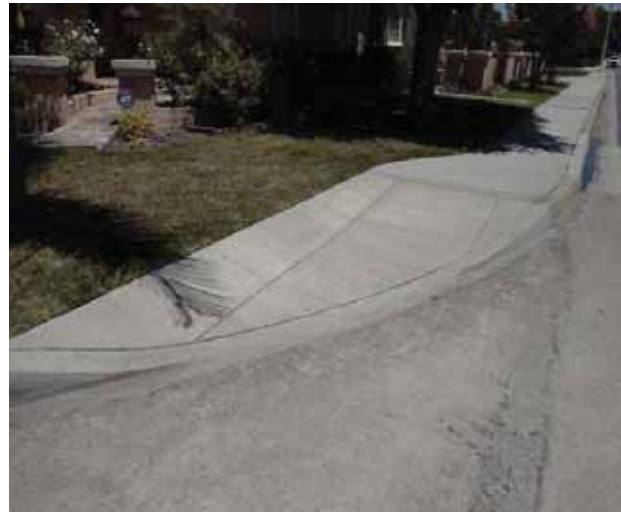
Recommendation Up to 2.08 percent

Provide compliant landing \$1,260

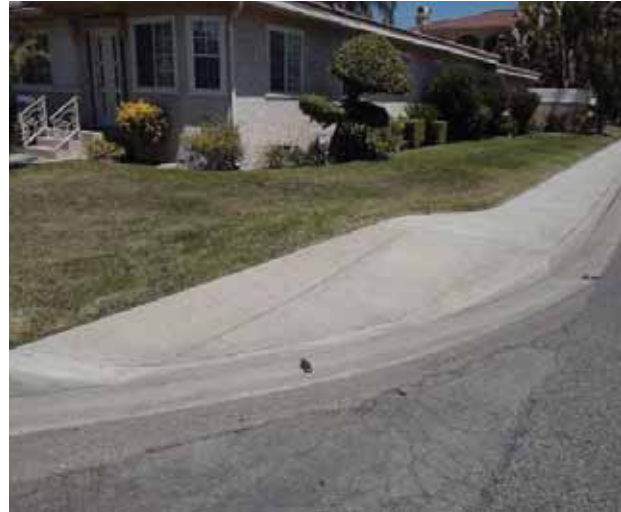
**On-Site Finding** Not Found

Provide detectable warning to surface \$248

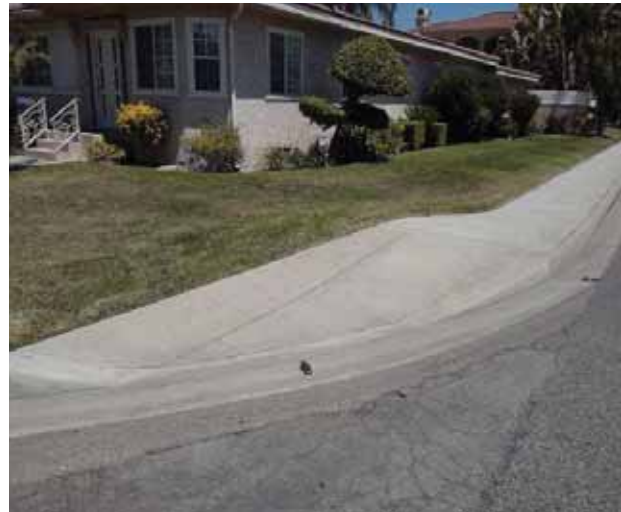
Recommendation Up to 10.00 percent

Install flared sides \$1,300

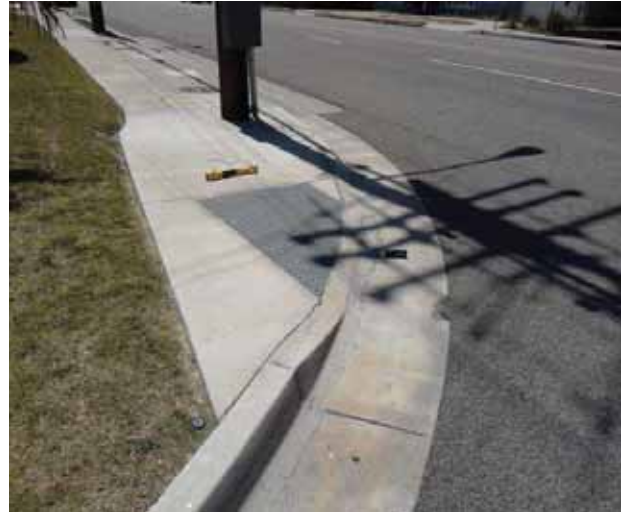
Recommendation Up to 2.08 percent

Install curb ramp \$1,300

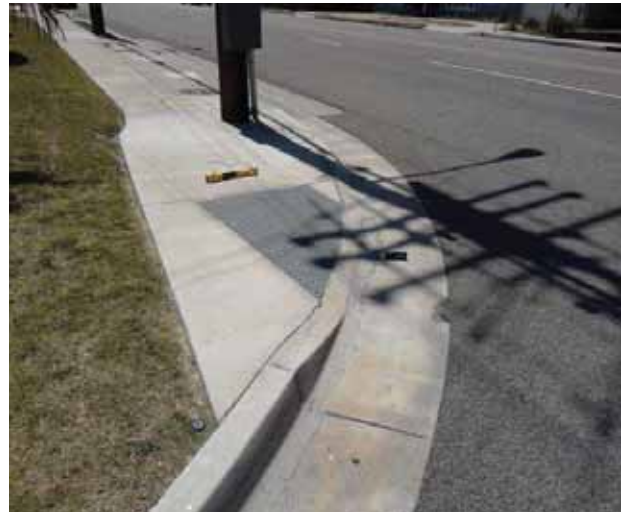
Recommendation Up to 10.00 percent

Install flared sides \$1,300

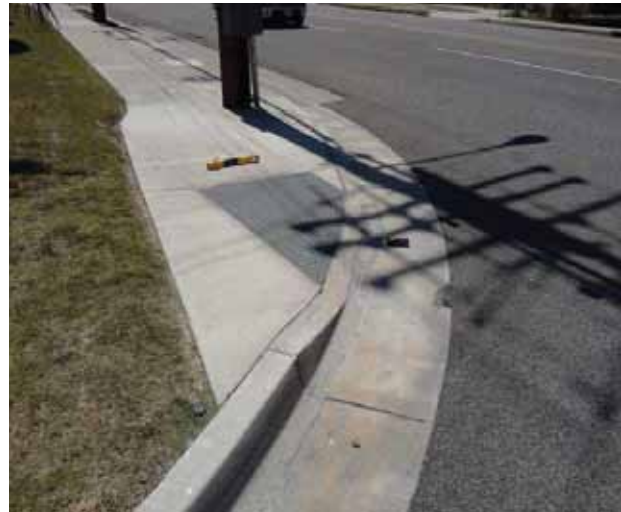
Recommendation Up to 5.00 percent

Repave landing \$1,260

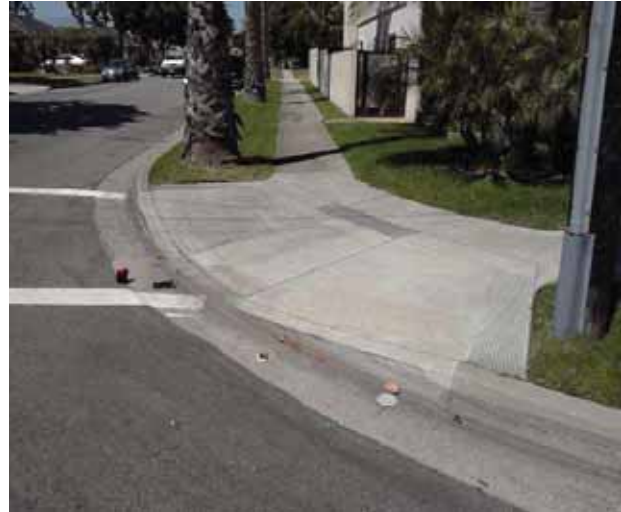
**On-Site Finding** Not Found

Provide detectable warning to surface \$248

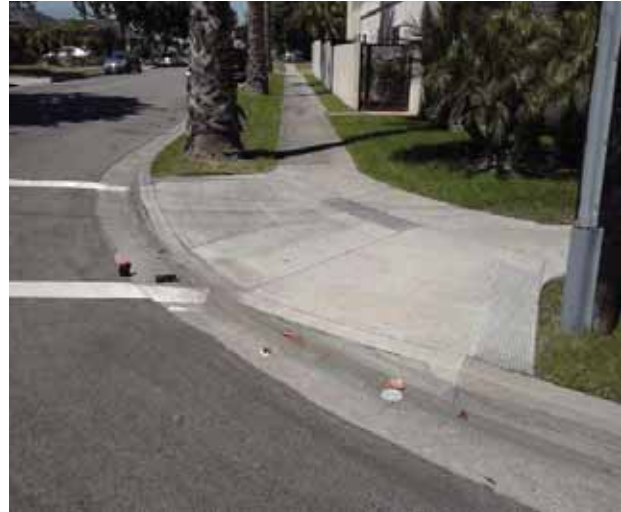
Recommendation Up to 5.00 percent

Repave landing \$1,260

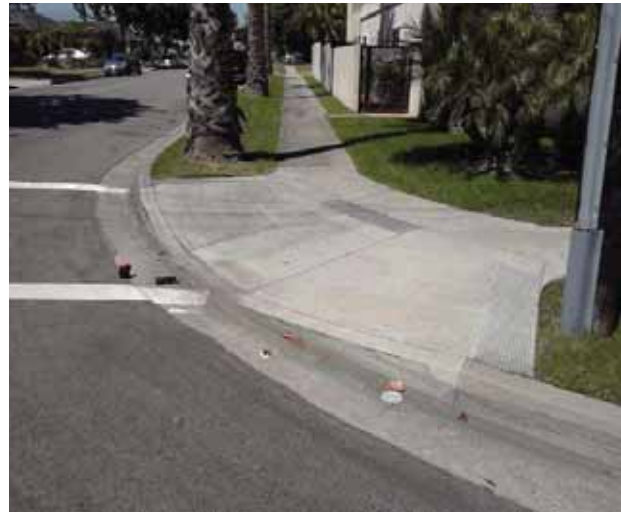
Recommendation At least 48.00 inches

Provide compliant landing \$240

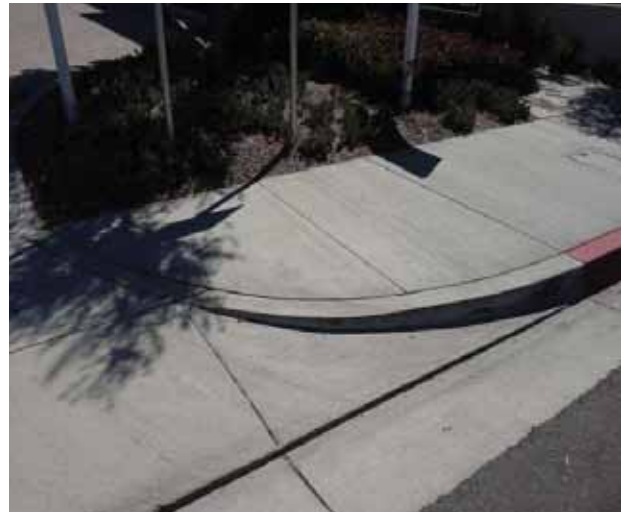
**On-Site Finding** Not Found

Provide detectable warning to surface \$248

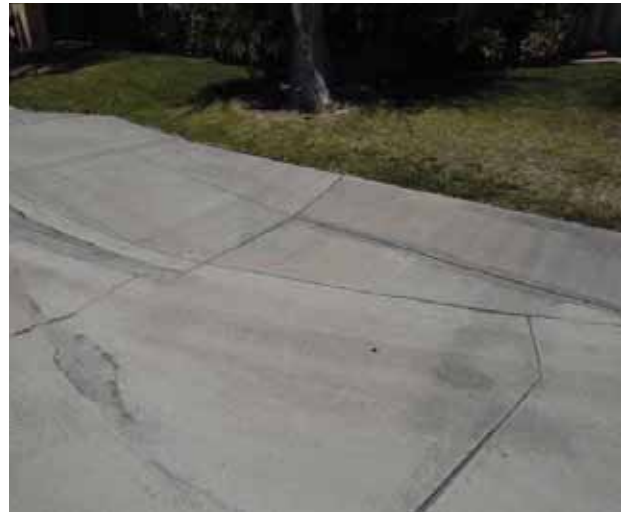
**On-Site Finding** Not Found

Provide detectable warning to surface \$248

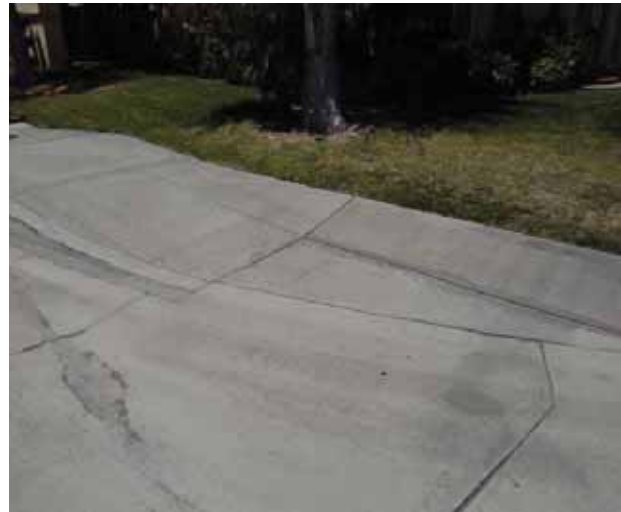
Recommendation Up to 2.08 percent

Provide compliant landing \$1,260

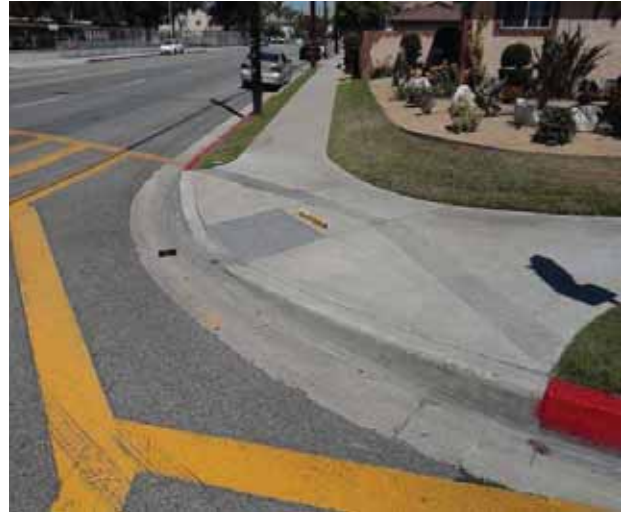
Recommendation Up to 2.08 percent

Install curb ramp \$1,300

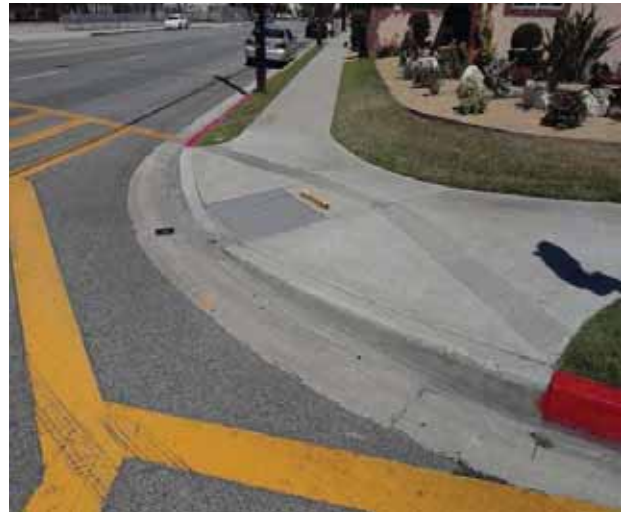
Recommendation Up to 5.00 percent

Repave landing \$1,260

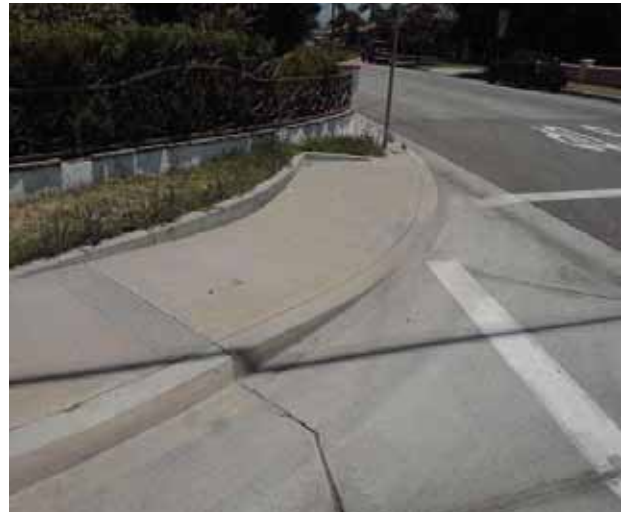
**On-Site Finding** Not Found

Provide detectable warning to surface \$248

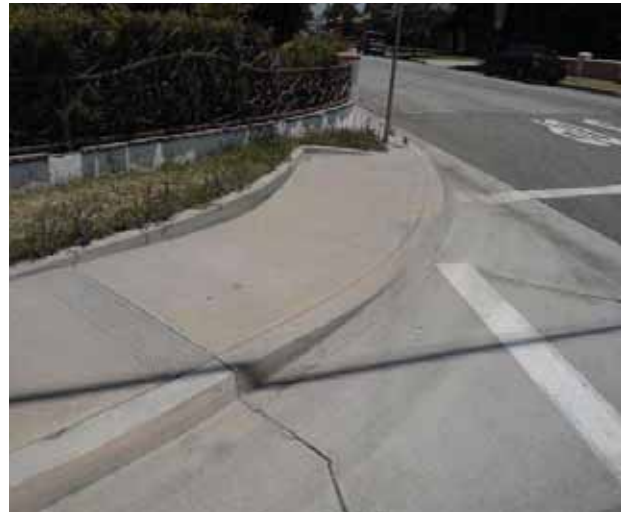
Recommendation Up to 2.08 percent

Provide compliant landing \$1,260

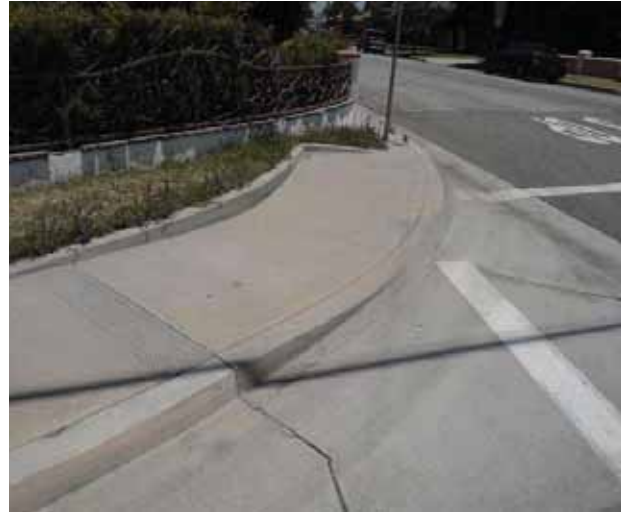
Recommendation At least 48.00 inches

Provide compliant landing \$240

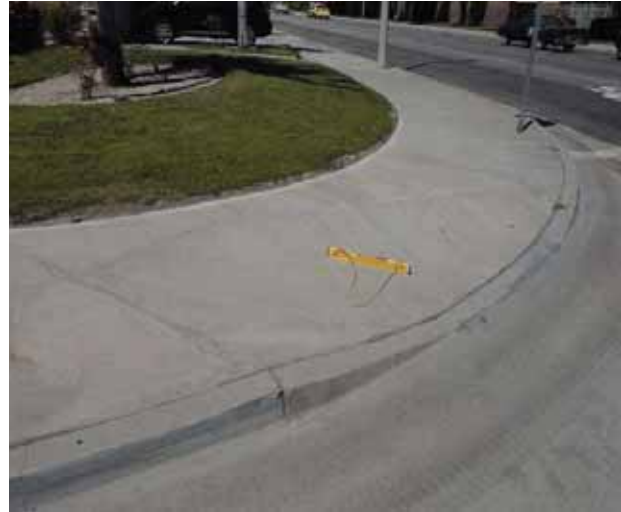
**On-Site Finding** Not Found

Provide detectable warning to surface \$248

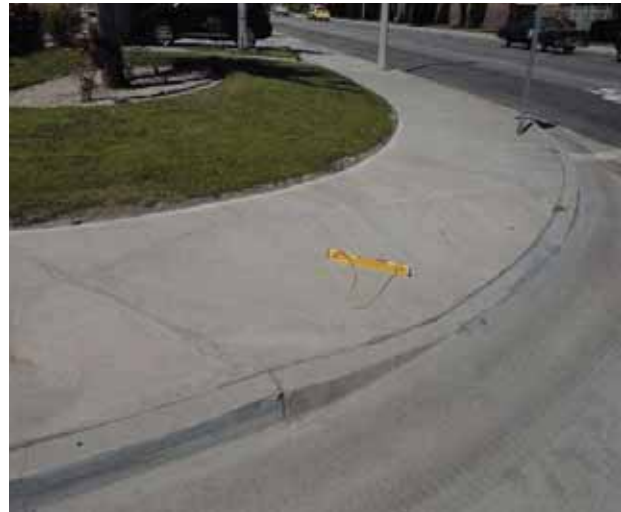
Recommendation Up to 8.33 percent

Install curb ramp \$1,300

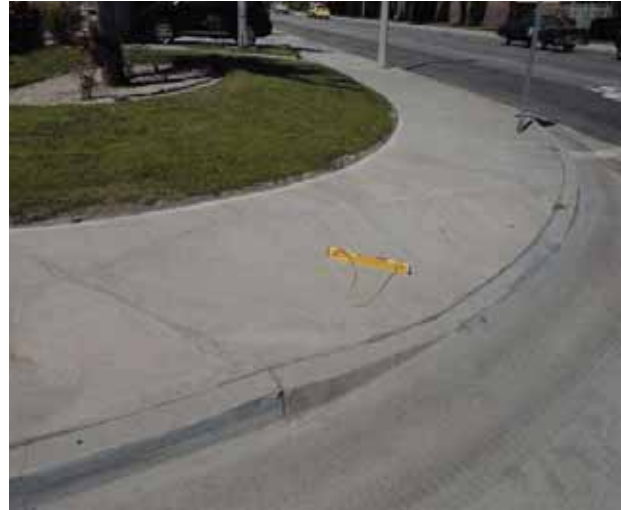
Recommendation Up to 10.00 percent

Install flared sides \$1,300

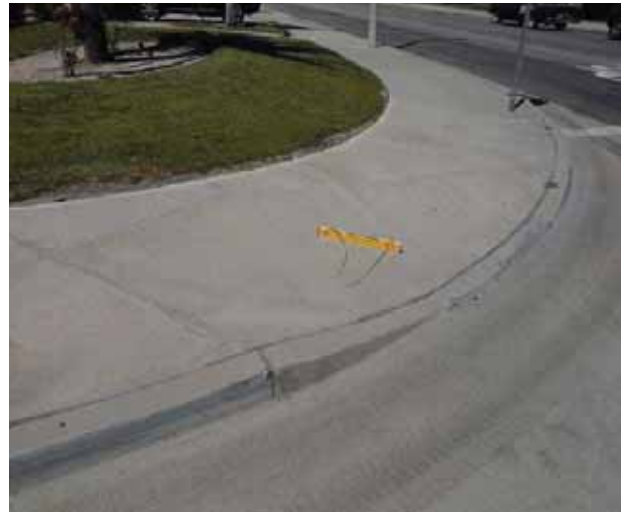
Recommendation At least 48.00 inches

Provide compliant landing \$240

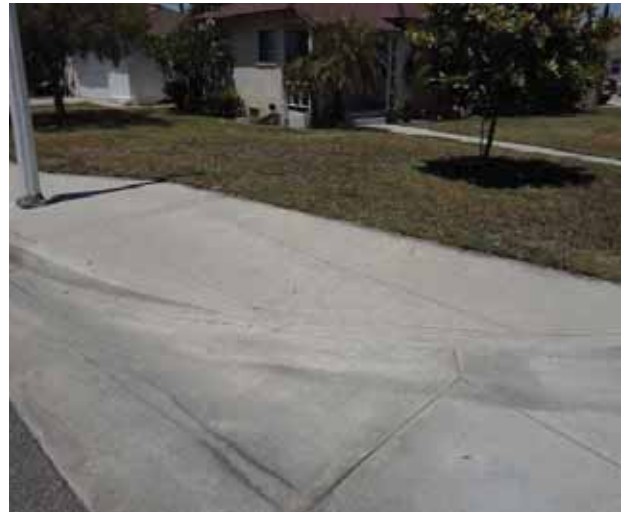
**On-Site Finding** Not Found

Provide detectable warning to surface \$248

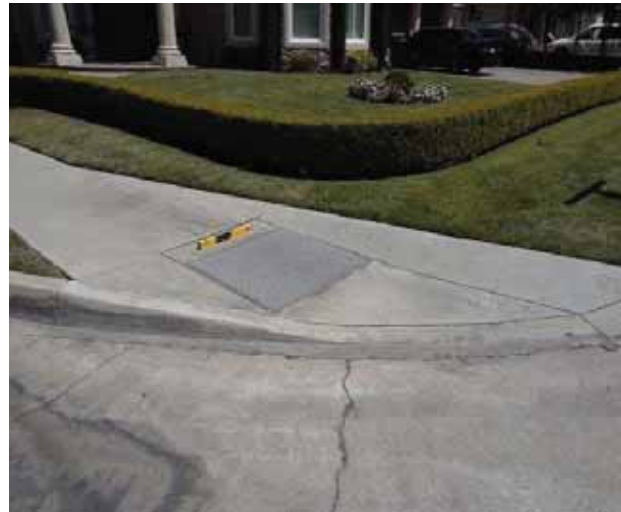
Recommendation Up to 2.08 percent

Install curb ramp \$1,300

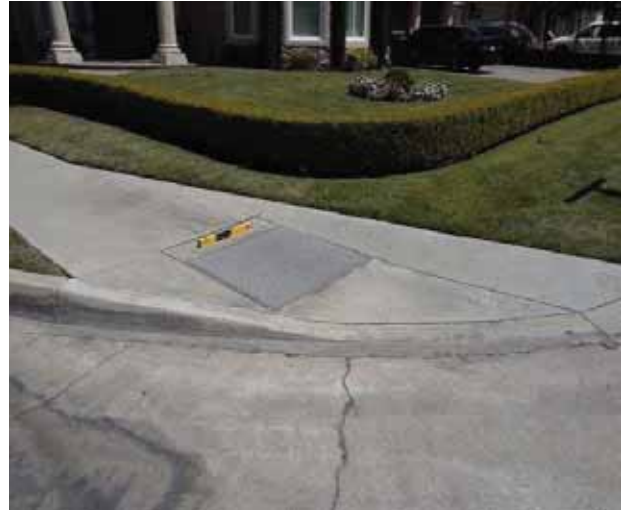
Recommendation Up to 10.00 percent

Install flared sides \$1,300

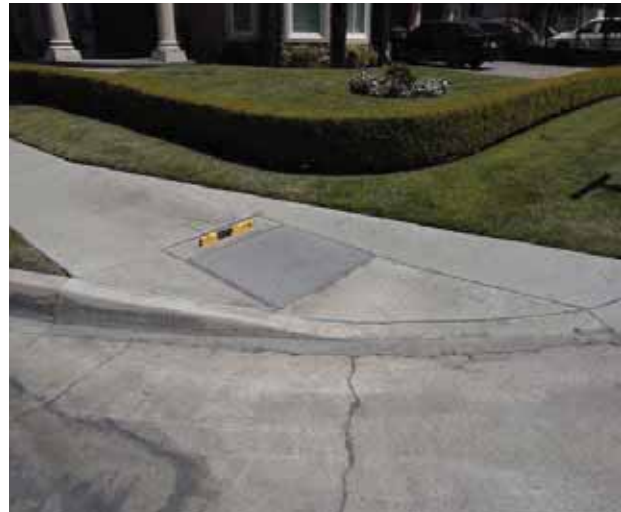
Recommendation Up to 2.08 percent

Provide compliant landing \$1,260

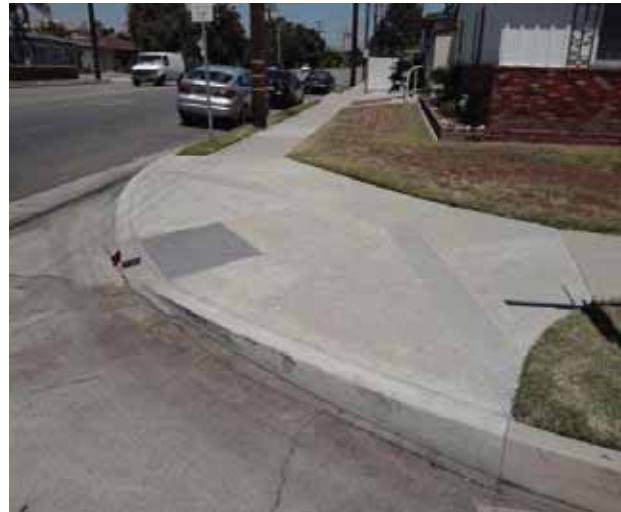
Recommendation See Recommendation

Install curb ramp \$1,440

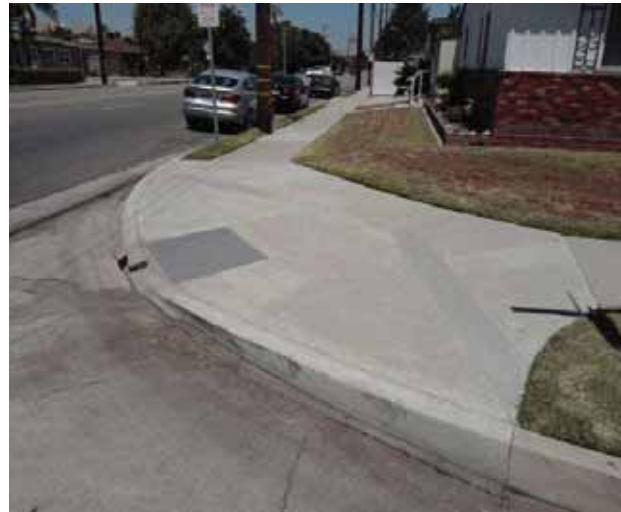
Recommendation Up to 5.00 percent

Repave landing \$1,260

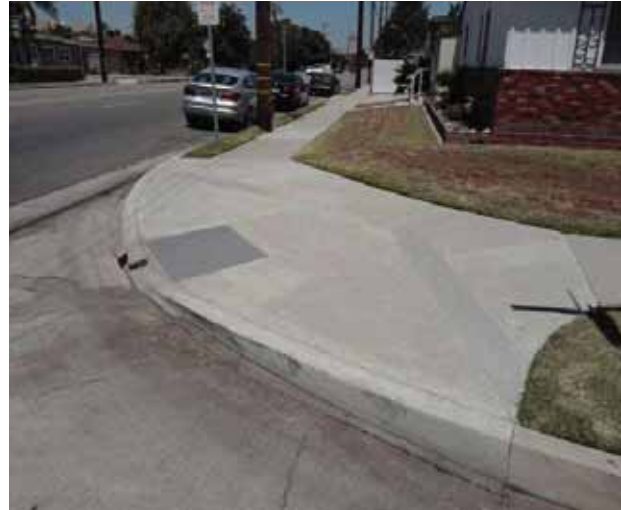
Recommendation At least 48.00 inches

Provide compliant landing \$240

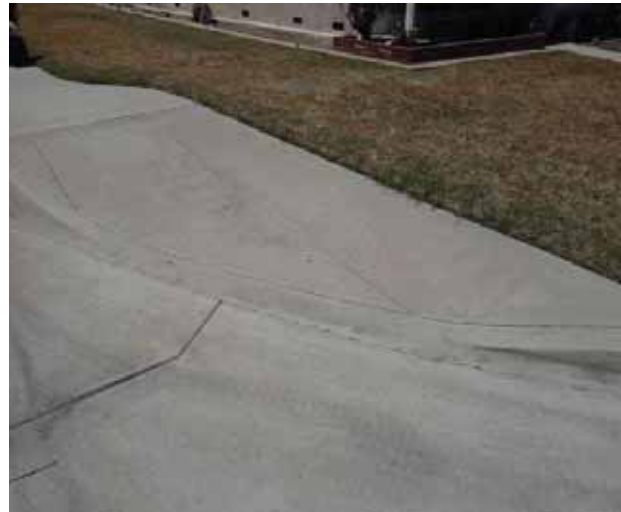
**On-Site Finding** Not Found

Provide detectable warning to surface \$248

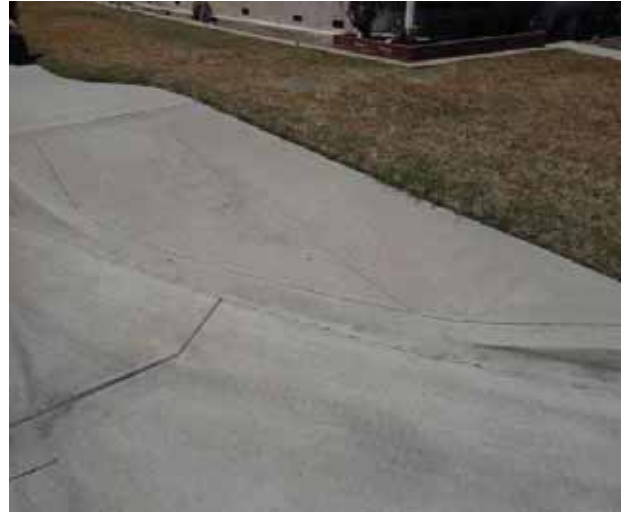
Recommendation Up to 10.00 percent

Install flared sides \$1,300

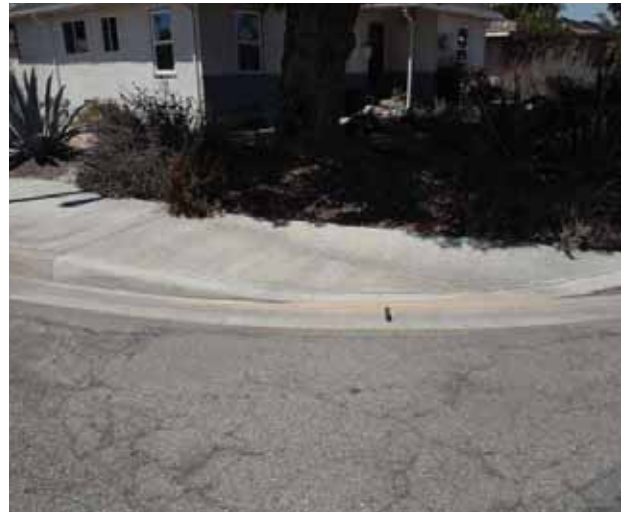
**On-Site Finding** Not Found

Provide detectable warning to surface \$248

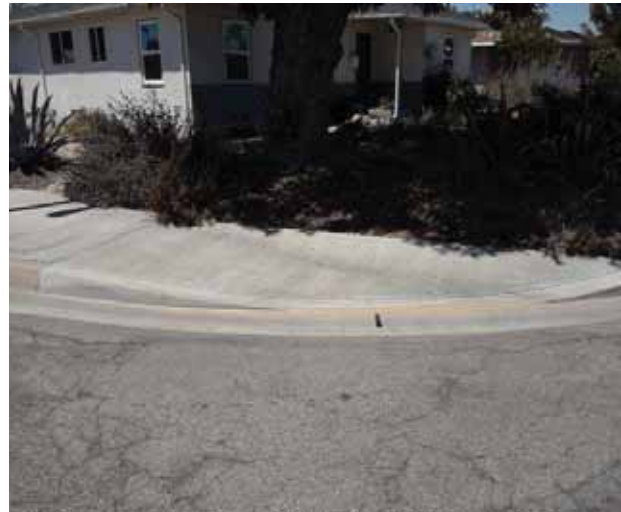
Recommendation Up to 5.00 percent

Repave landing \$1,260

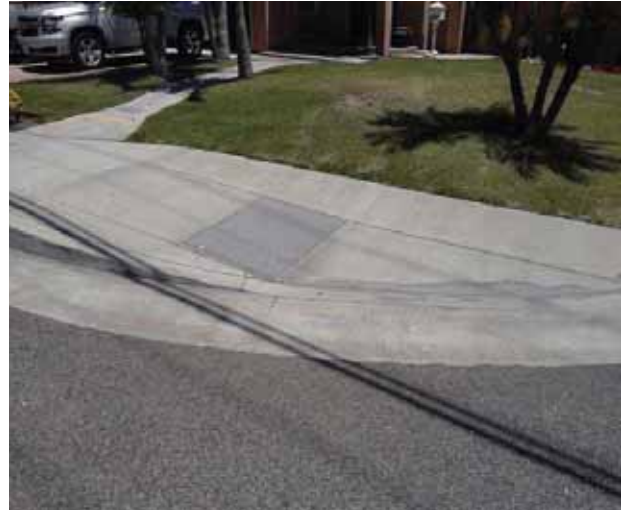
Recommendation Up to 10.00 percent

Install flared sides \$1,300

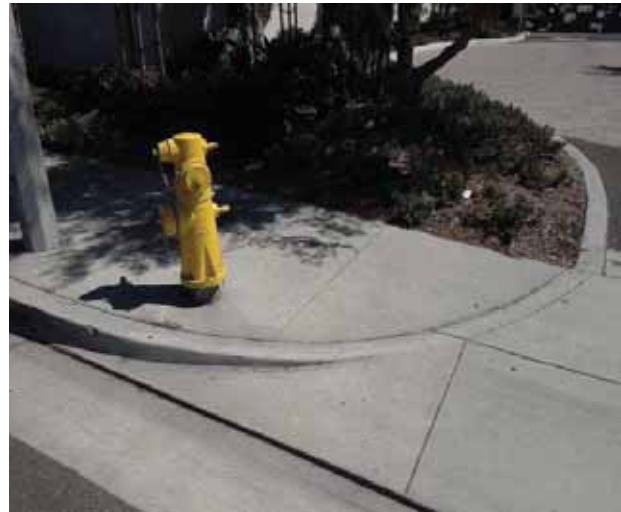
**On-Site Finding** Not Found

Provide detectable warning to surface \$248

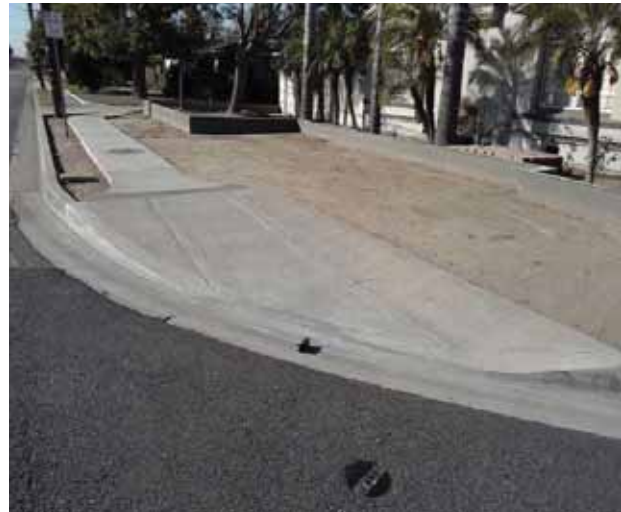
**On-Site Finding** Not Found

Provide detectable warning to surface \$248

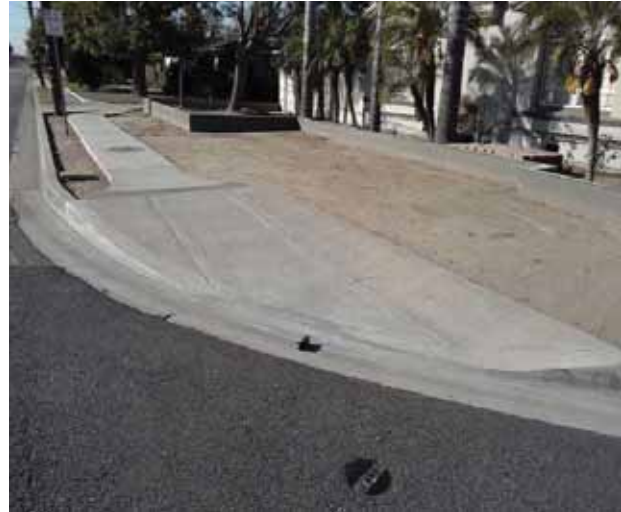
Recommendation Up to 10.00 percent

Install flared sides \$1,300

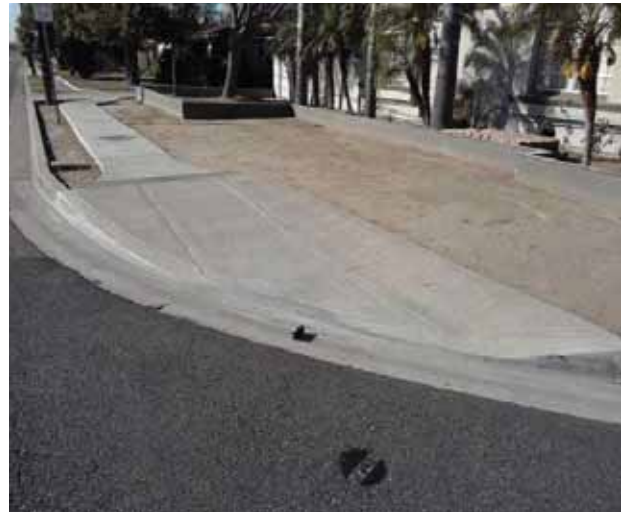
Recommendation Up to 5.00 percent

Repave landing \$1,260

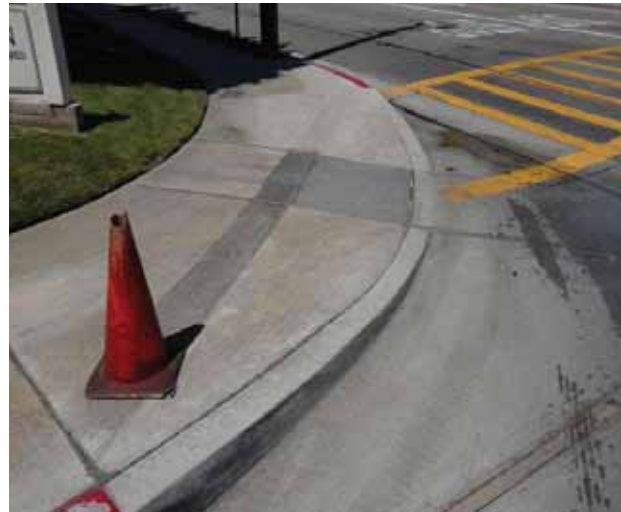
**On-Site Finding** Not Found

Install crosswalk \$800

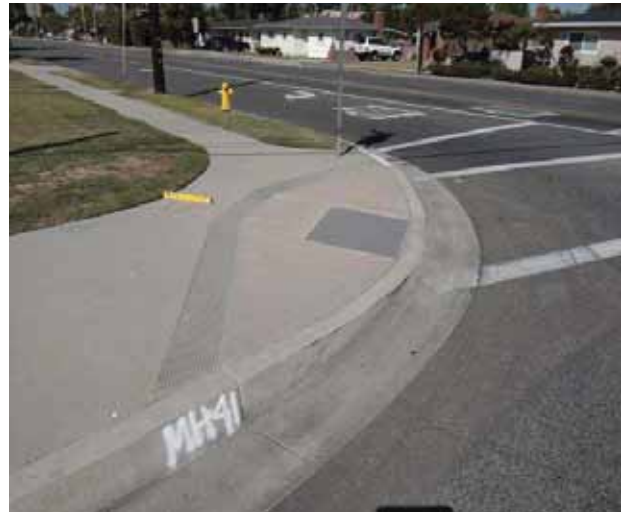
**On-Site Finding** Not Found

Provide detectable warning to surface \$248

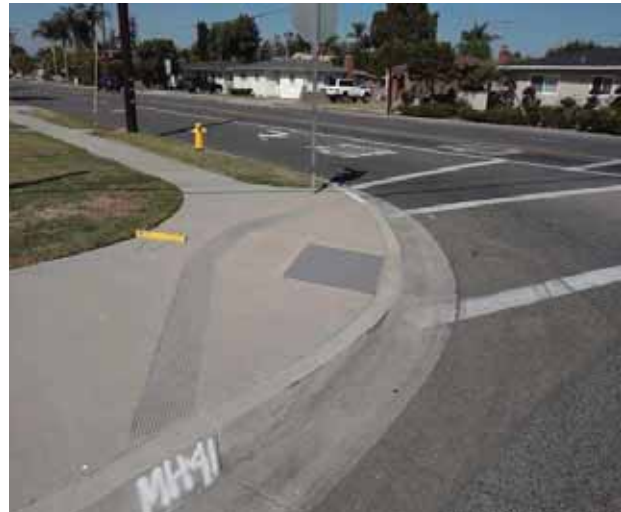
Recommendation Up to 2.08 percent

Provide compliant landing \$1,260

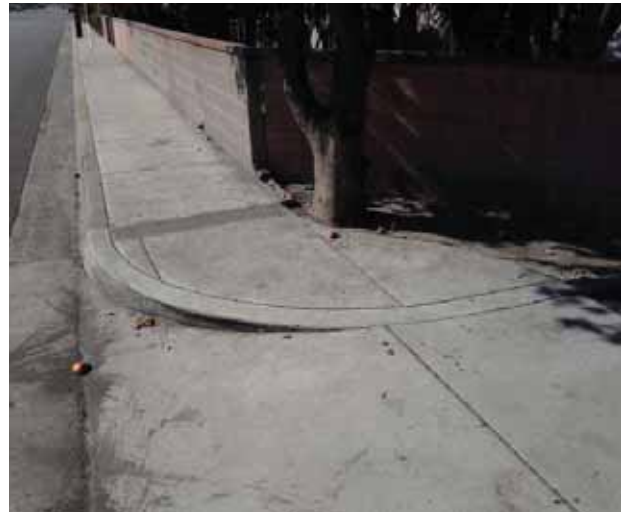
**On-Site Finding** Not Found

Provide detectable warning to surface \$248

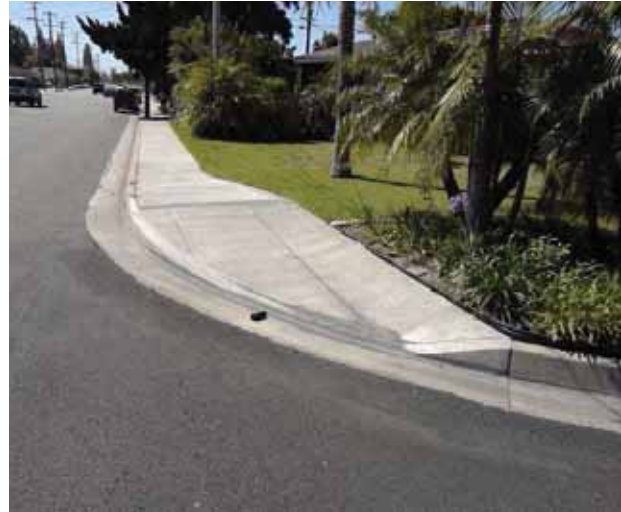
**On-Site Finding** Not Found

Provide detectable warning to surface \$248

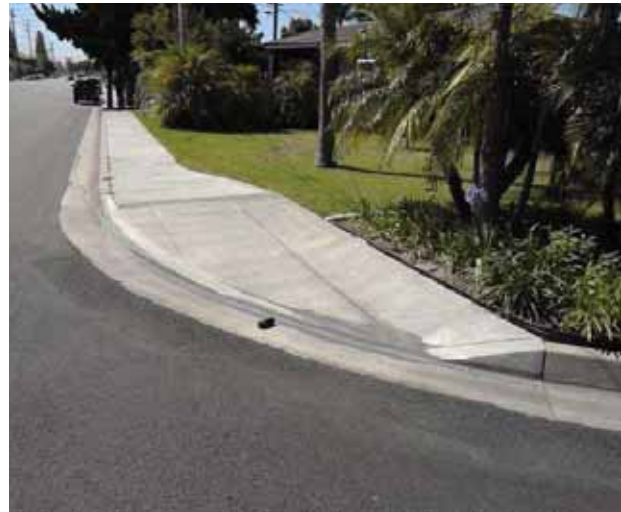
Recommendation Up to 5.00 percent

Repave landing \$1,260

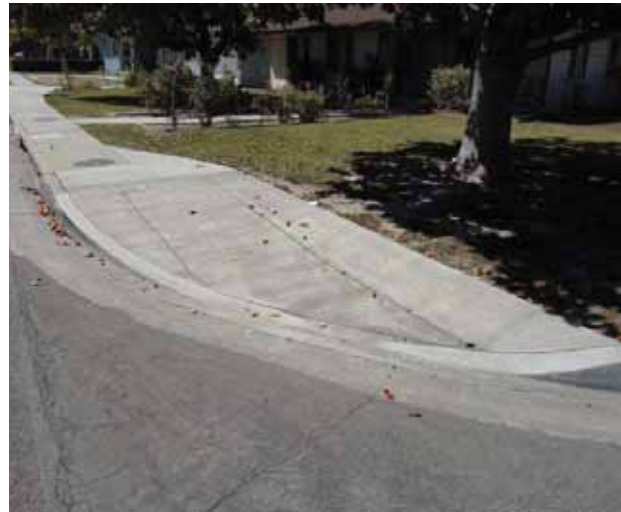
Recommendation Up to 10.00 percent

Install flared sides \$1,300

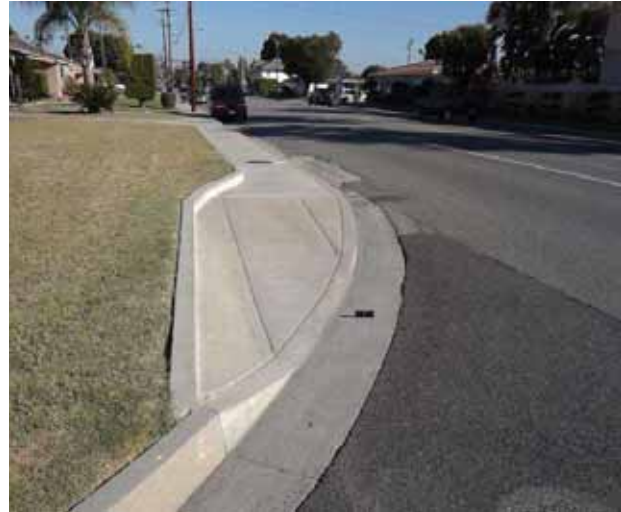
**On-Site Finding** Not Found

Provide detectable warning to surface \$248

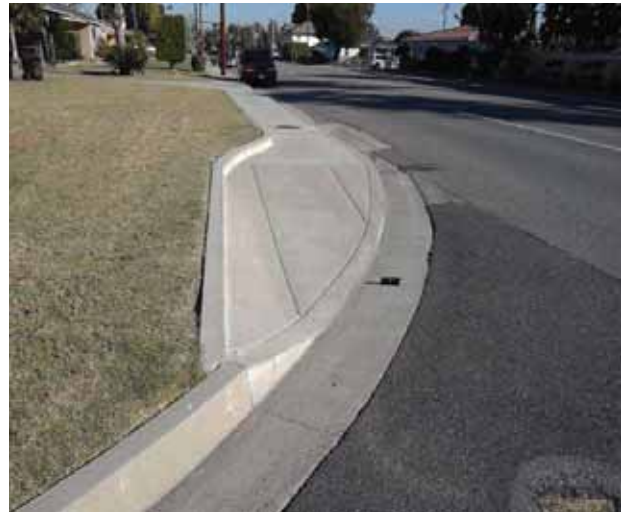
Recommendation Up to 5.00 percent

Repave landing \$1,260

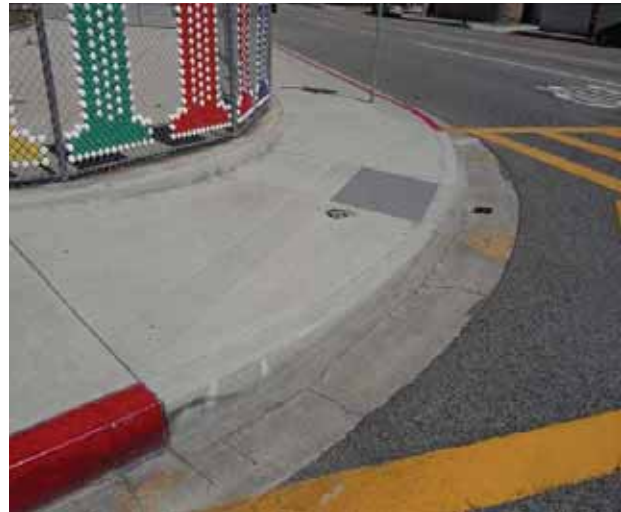
Recommendation Up to 5.00 percent

Repave landing \$1,260

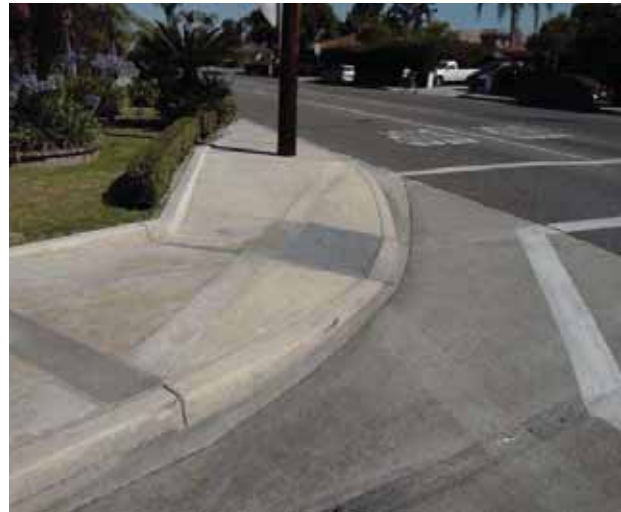
**On-Site Finding** Not Found

Provide detectable warning to surface \$248

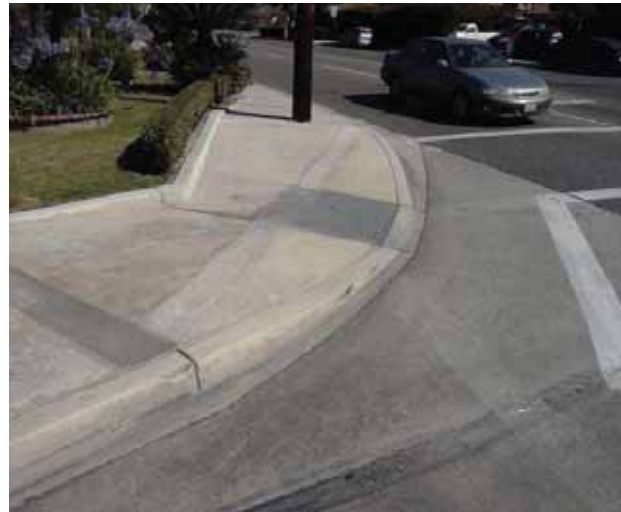
Recommendation At least 48.00 inches

Provide compliant landing \$240

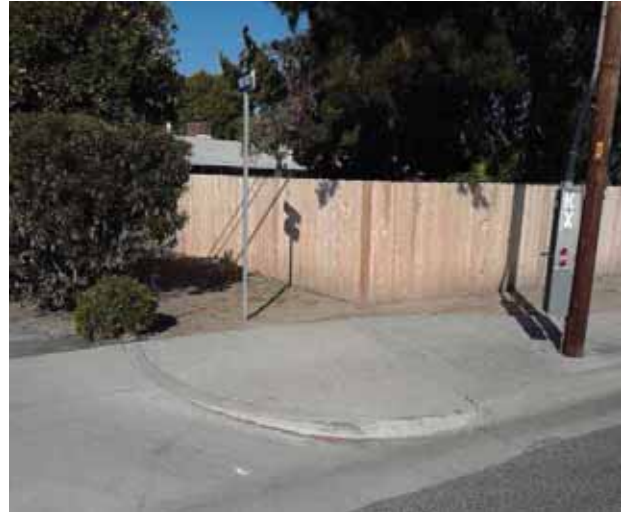
**On-Site Finding** Not Found

Provide detectable warning to surface \$248

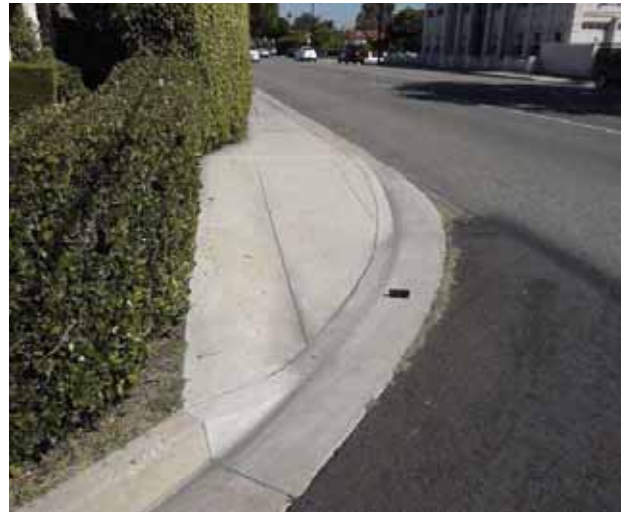
**On-Site Finding** Not Found

Provide detectable warning to surface \$248

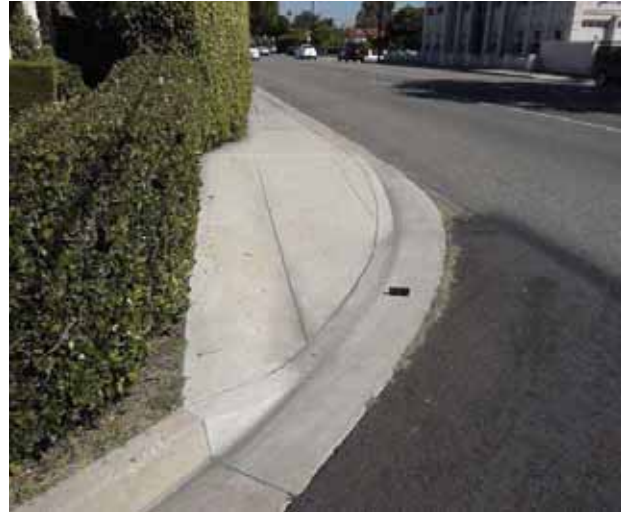
Recommendation Up to 10.00 percent

Install flared sides \$1,300

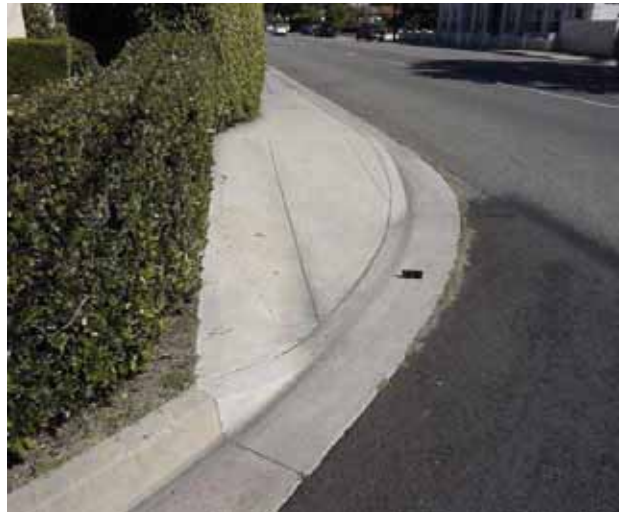
Recommendation Up to 5.00 percent

Repave landing \$1,260

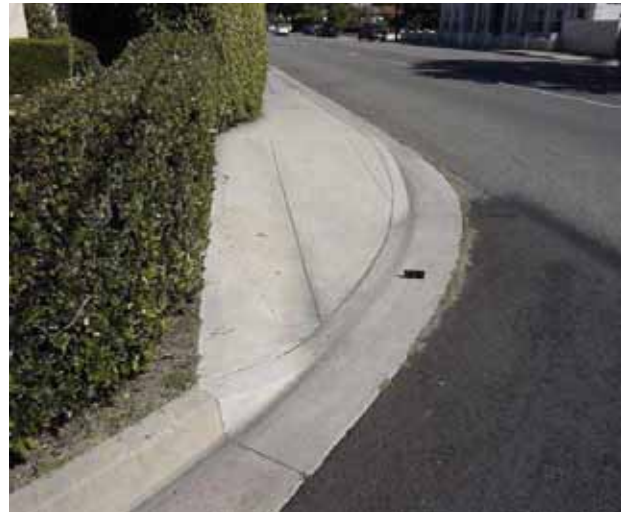
Recommendation Up to 2.08 percent

Provide compliant landing \$1,260

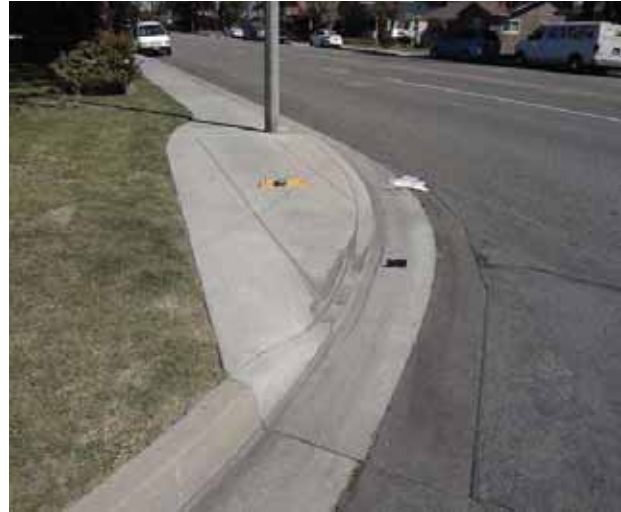
Recommendation Up to 2.08 percent

Install curb ramp \$1,300

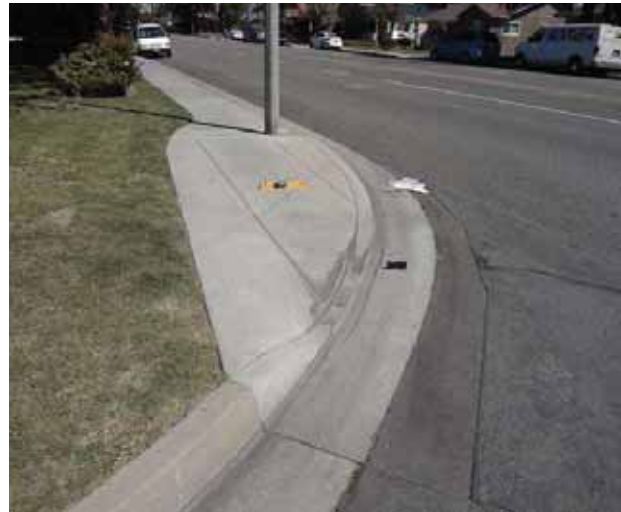
Recommendation Up to 10.00 percent

Install flared sides \$1,300
