# Accessibility Survey

## City of Downey Gallatin Road & Paramount Boulevard

Date of Inspection  
4/14/2017

Prepared By  
**Disability Access Consultants**  
(800) 743-7067

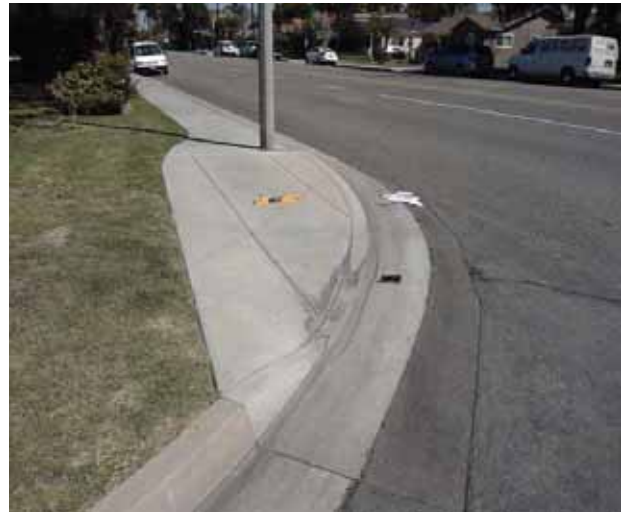
Recommendation Up to 5.00 percent

Repave landing \$1,260

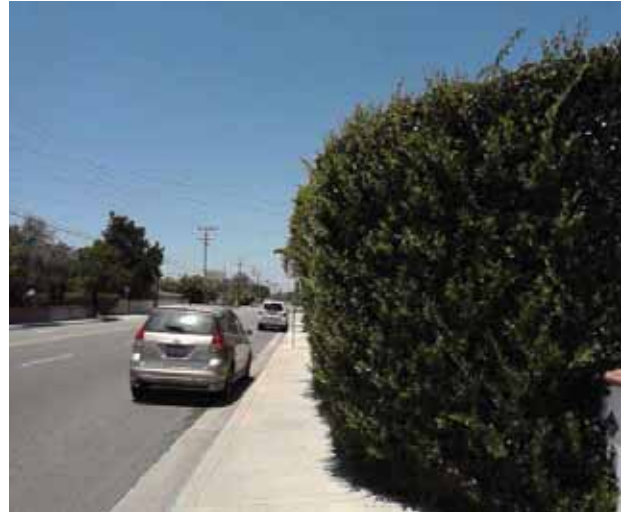
Sidewalks , Hazards & Gratings : Sidewalk Width at Obstruction

Sidewalk width at the obstruction shall have the recommended value.

\$1,260

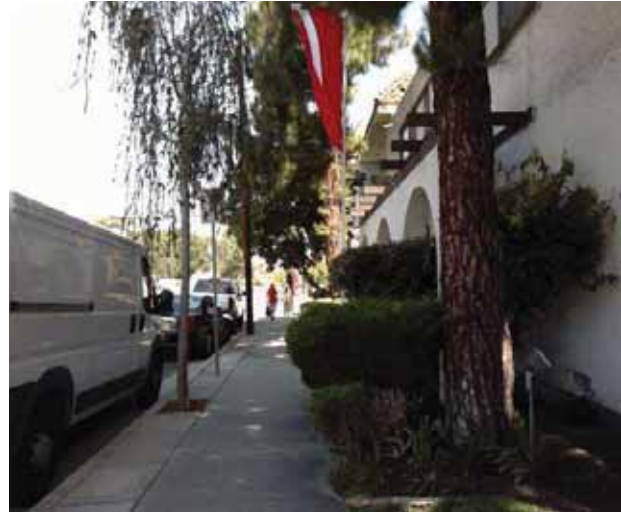
Sidewalks , Hazards & Gratings : Overhead Obstruction Height

Recommendation At least 80.00 inches

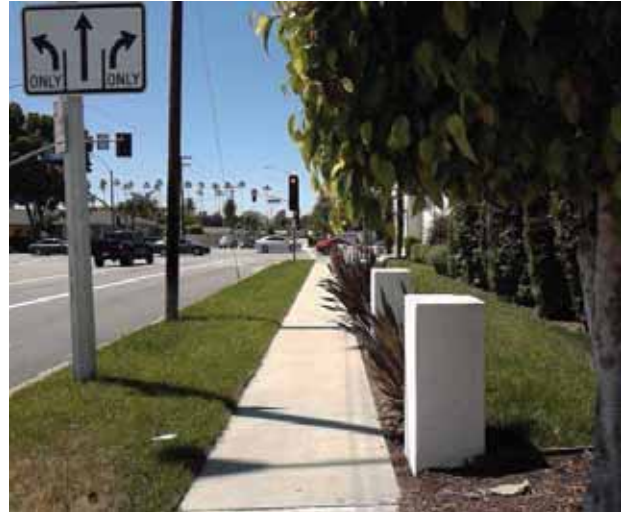
Sidewalks , Hazards & Gratings : Sidewalk Width at Obstruction

Sidewalk width at the obstruction shall have the recommended value.

\$1,260

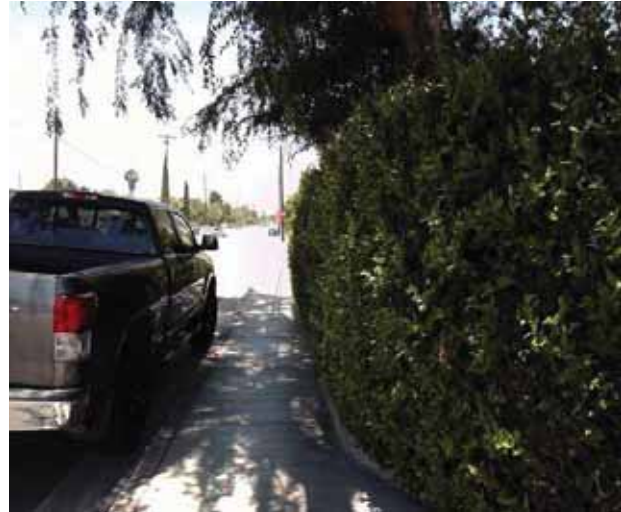
Sidewalks , Hazards & Gratings : Sidewalk Width at Obstruction

Sidewalk width at the obstruction shall have the recommended value.

\$1,260

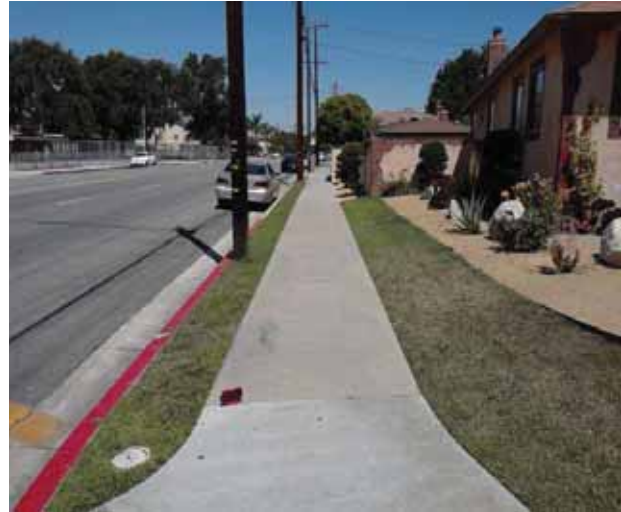
There is a change in elevation greater than recommended value.

Ensure that the change in elevation is within the recommended value.

Remove tripping hazards \$198

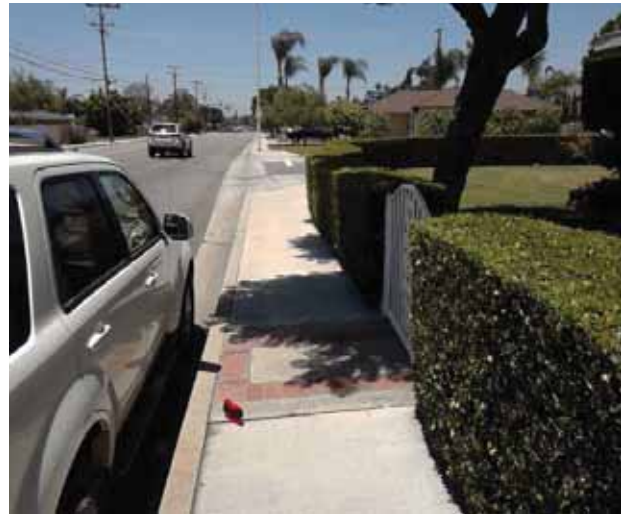
There is a change in elevation greater than recommended value.

Ensure that the change in elevation is within the recommended value.

Remove tripping hazards \$198

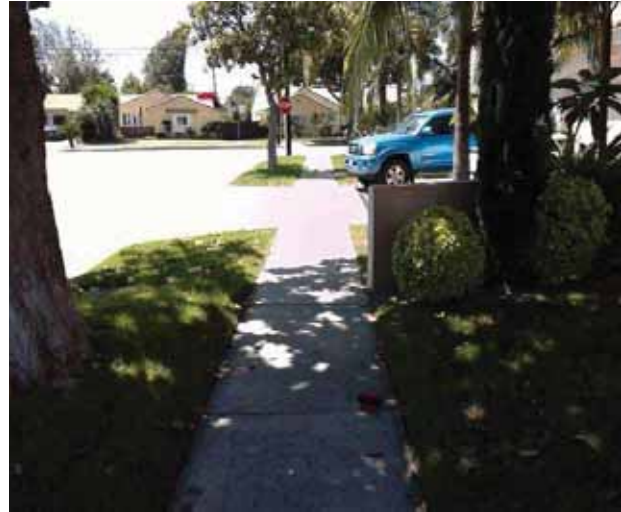
There is a change in elevation greater than recommended value.

Ensure that the change in elevation is within the recommended value.

Remove tripping hazards \$198

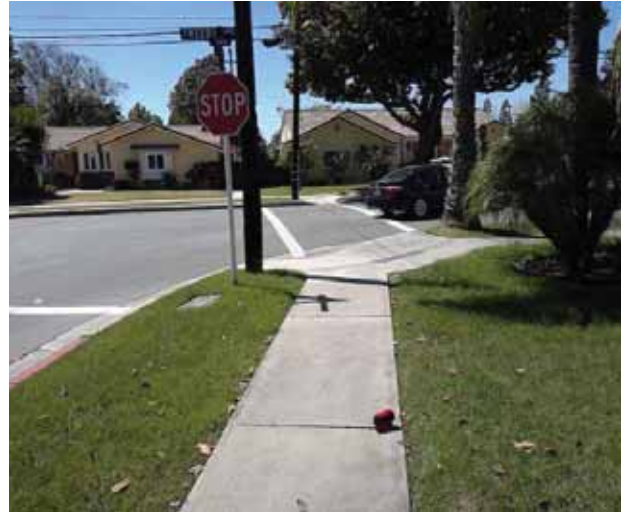
There is a change in elevation greater than recommended value.

Ensure that the change in elevation is within the recommended value.

Remove tripping hazards \$198

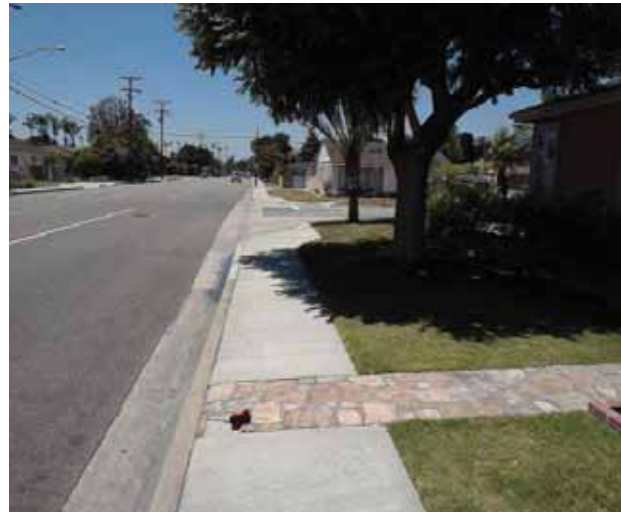
There is a change in elevation greater than recommended value.

Ensure that the change in elevation is within the recommended value.

Remove tripping hazards \$198

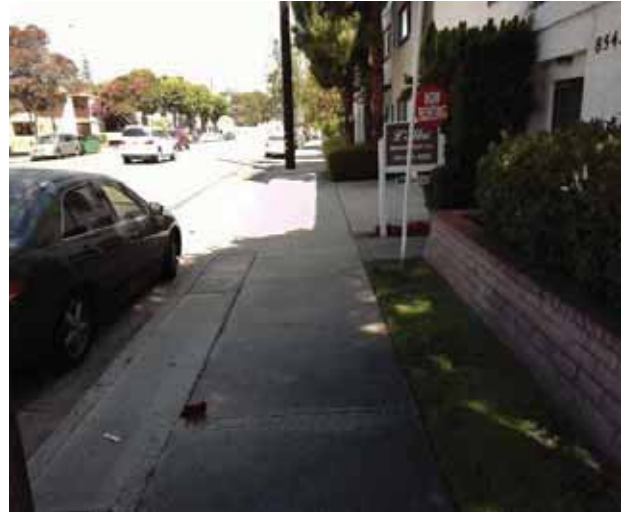
There is a change in elevation greater than recommended value.

Ensure that the change in elevation is within the recommended value.

Remove tripping hazards \$198

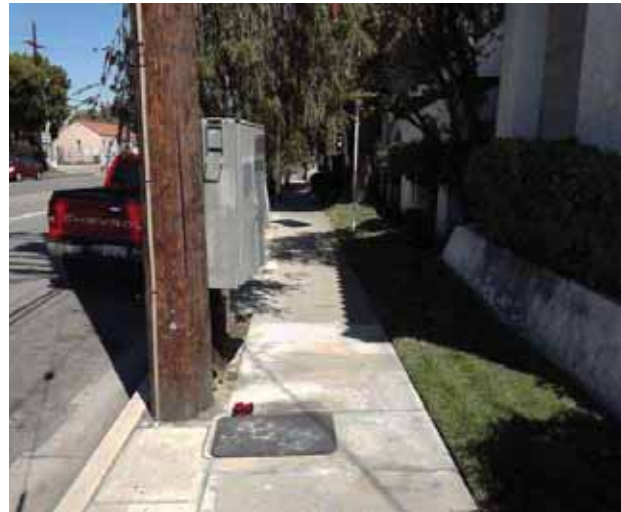
There is a change in elevation greater than recommended value.

Ensure that the change in elevation is within the recommended value.

Remove tripping hazards \$198

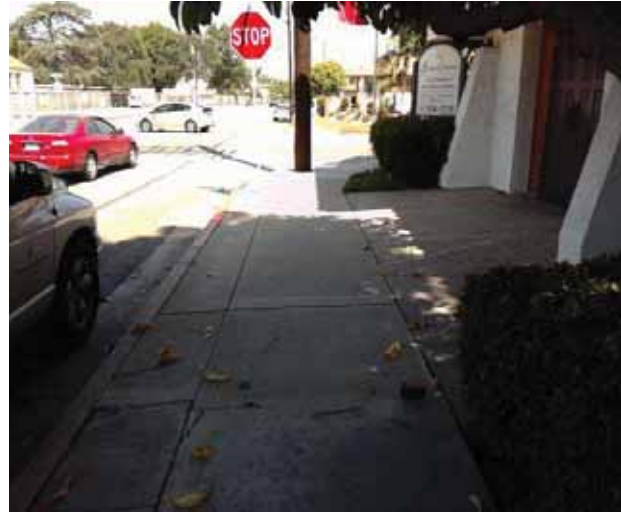
There is a change in elevation greater than recommended value.

Ensure that the change in elevation is within the recommended value.

Remove tripping hazards \$198

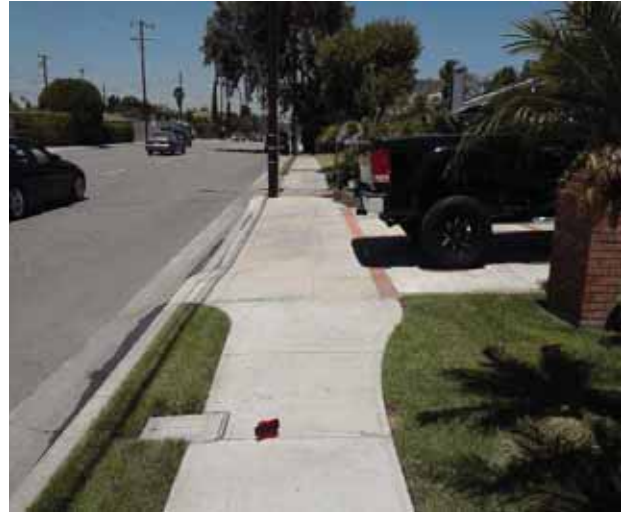
There is a change in elevation greater than recommended value.

Ensure that the change in elevation is within the recommended value.

Remove tripping hazards \$198

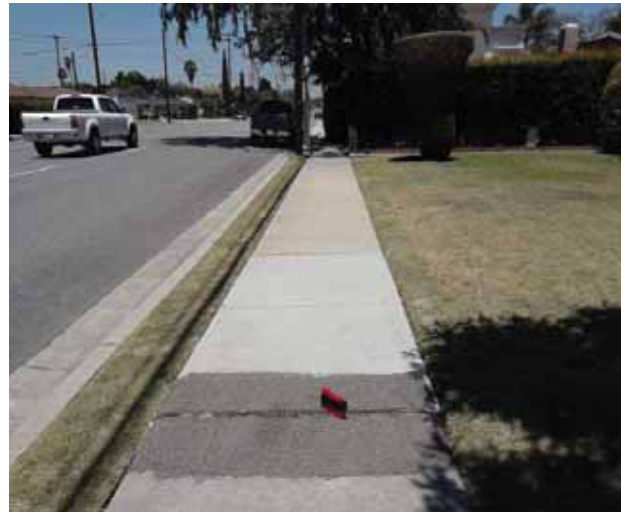
There is a change in elevation greater than recommended value.

Ensure that the change in elevation is within the recommended value.

Remove tripping hazards \$198

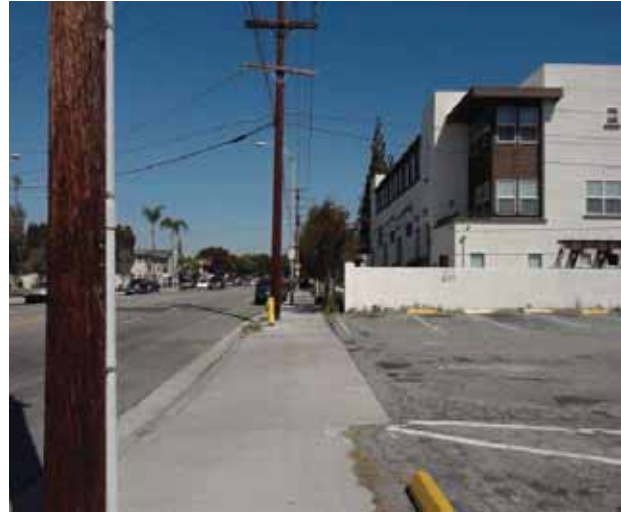
**On-Site Finding** Not Found

Install compliant detectable warnings \$190

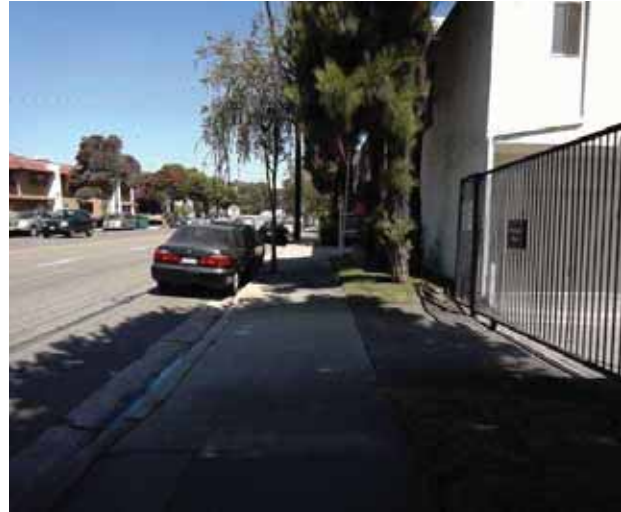
**On-Site Finding** Not Found

Recommendation See Recommendation

Install compliant detectable warnings \$190

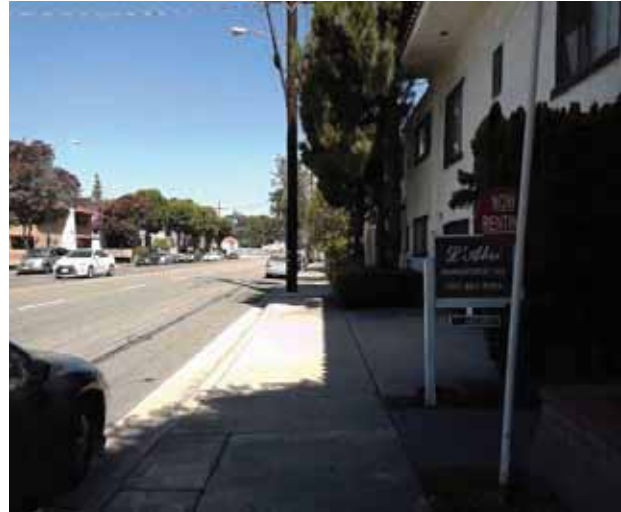
**On-Site Finding** Not Found

Recommendation See Recommendation

Install compliant detectable warnings \$190

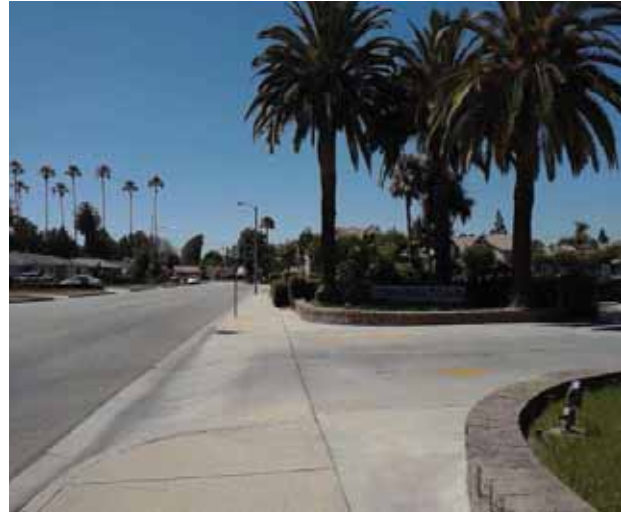
**On-Site Finding** Not Found

Recommendation See Recommendation

Install compliant detectable warnings \$190

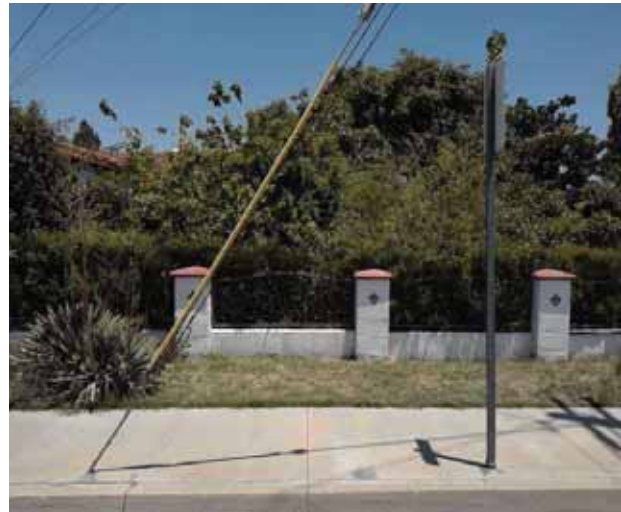
Sidewalks , Hazards & Gratings : Overhead Obstruction Height

Recommendation At least 80.00 inches

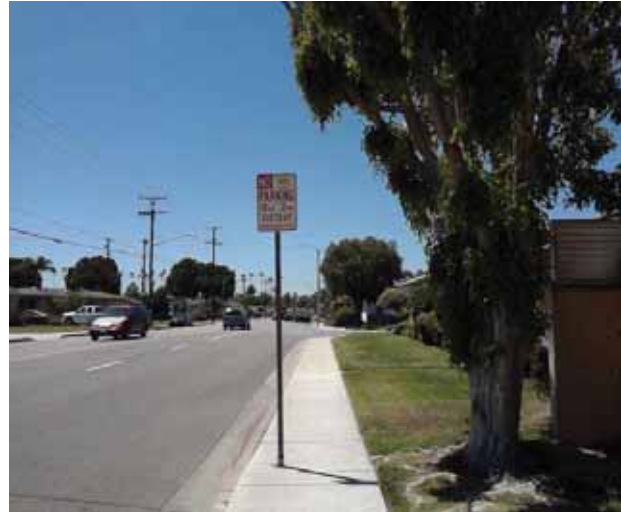
Sidewalks , Hazards & Gratings : Sidewalk Width at Obstruction

Sidewalk width at the obstruction shall have the recommended value.

Recommendation At least 48.00 inches

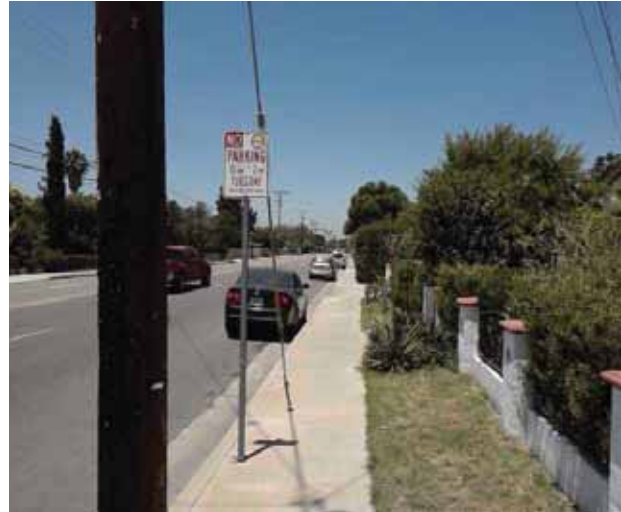
Sidewalks , Hazards & Gratings : Sidewalk Width at Obstruction

Sidewalk width at the obstruction shall have the recommended value.

Recommendation At least 48.00 inches

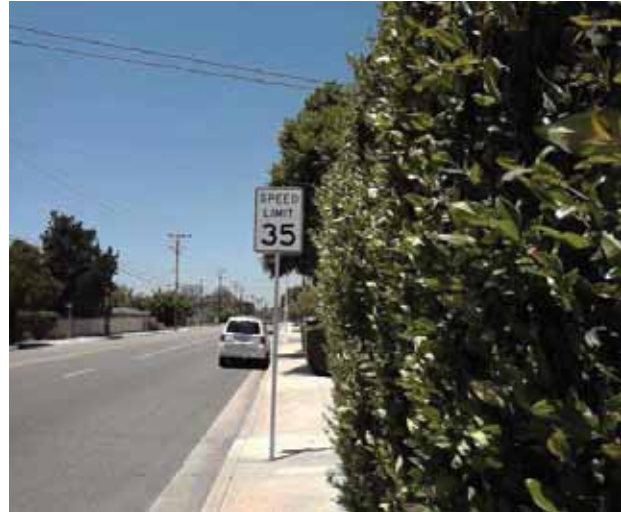
Sidewalks , Hazards & Gratings : Sidewalk Width at Obstruction

Sidewalk width at the obstruction shall have the recommended value.

Recommendation At least 48.00 inches

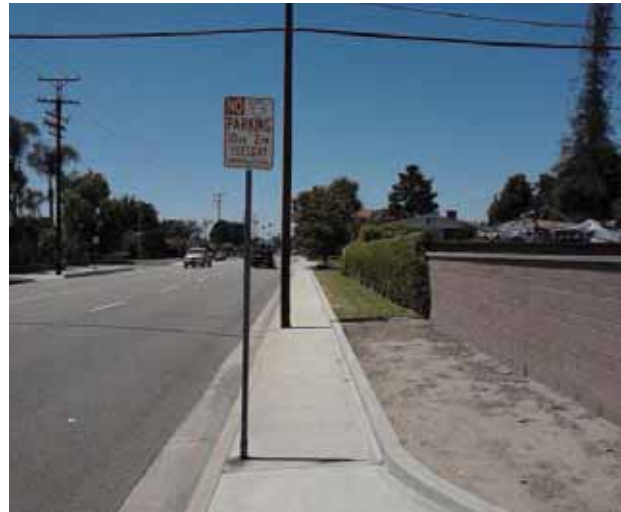
Sidewalks , Hazards & Gratings : Sidewalk Width at Obstruction

Sidewalk width at the obstruction shall have the recommended value.

Recommendation At least 48.00 inches

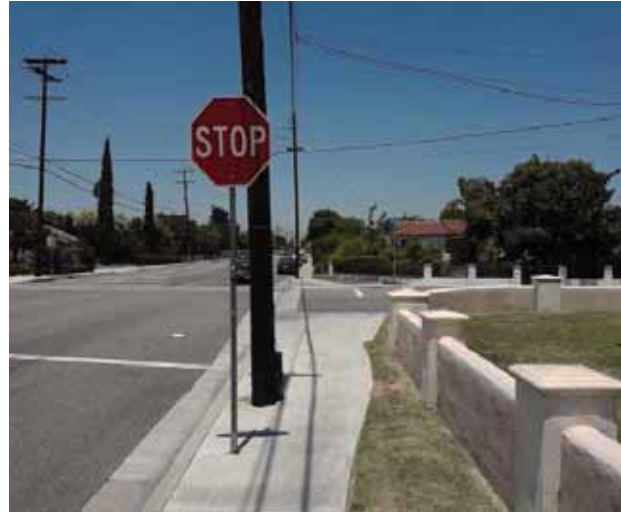
Sidewalks , Hazards & Gratings : Sidewalk Width at Obstruction

Sidewalk width at the obstruction shall have the recommended value.

Recommendation At least 48.00 inches

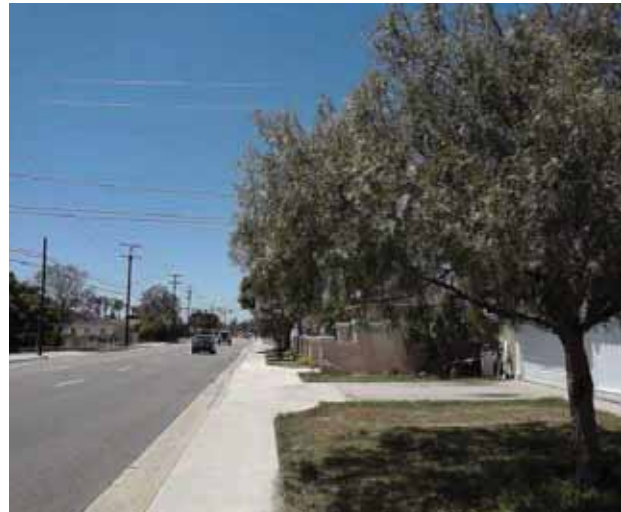
Sidewalks , Hazards & Gratings : Overhead Obstruction Height

Recommendation At least 80.00 inches

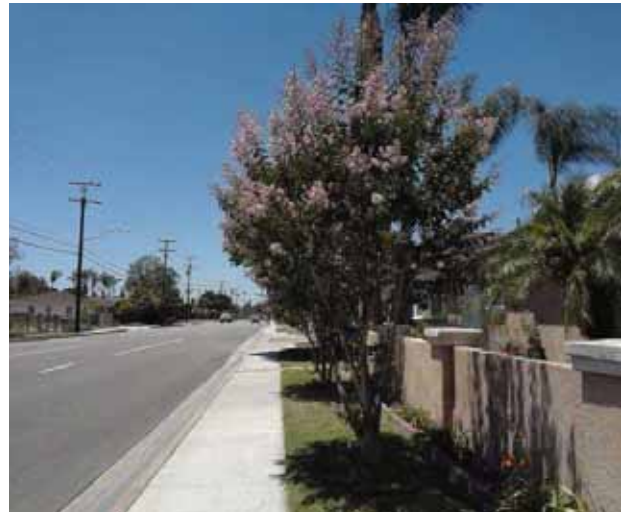
Sidewalks , Hazards & Gratings : Overhead Obstruction Height

Recommendation At least 80.00 inches

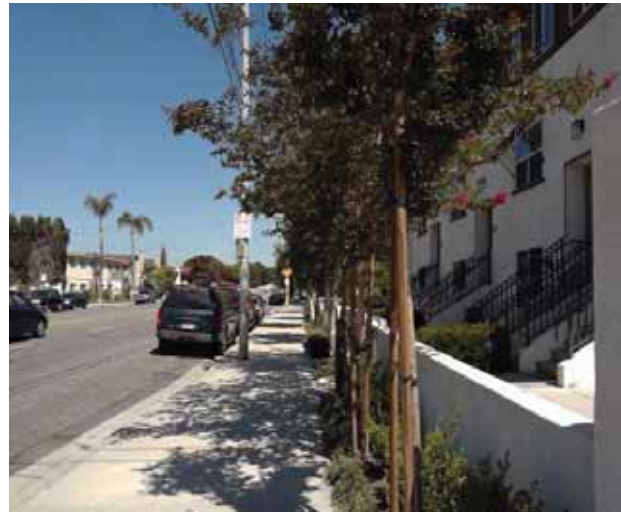
Sidewalks , Hazards & Gratings : Overhead Obstruction Height

Recommendation At least 80.00 inches

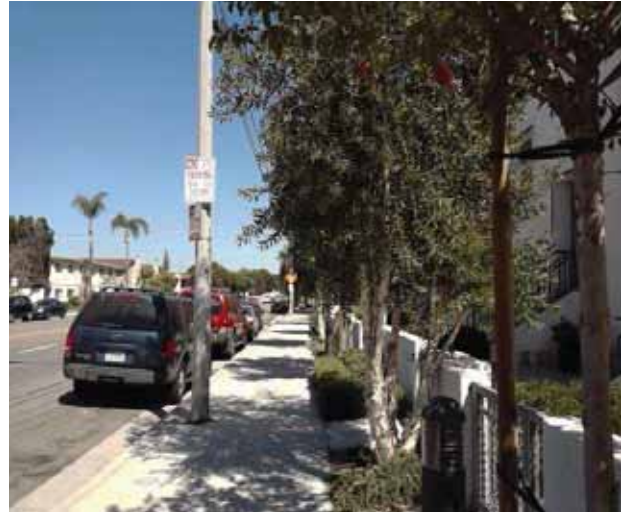
Sidewalks , Hazards & Gratings : Overhead Obstruction Height

Recommendation At least 80.00 inches

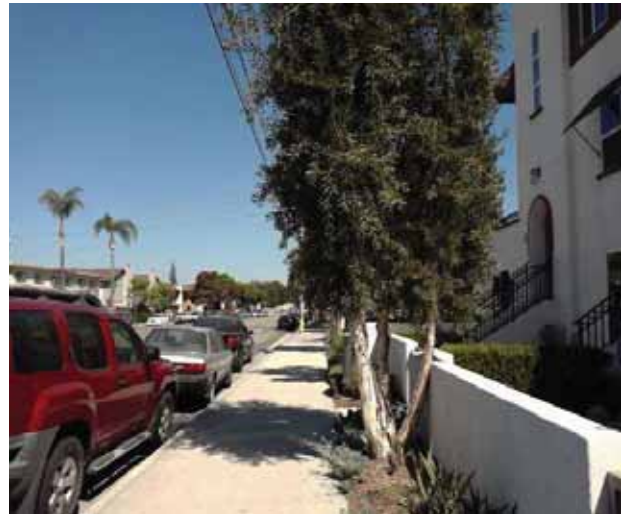
Sidewalks , Hazards & Gratings : Overhead Obstruction Height

Recommendation At least 80.00 inches

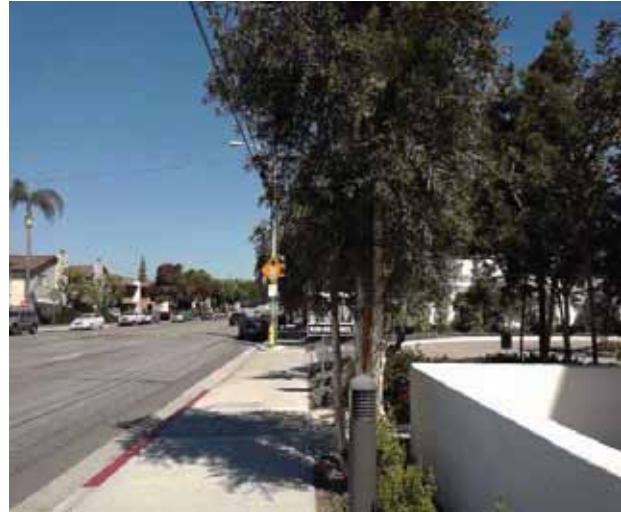
Sidewalks , Hazards & Gratings : Overhead Obstruction Height

Recommendation At least 80.00 inches

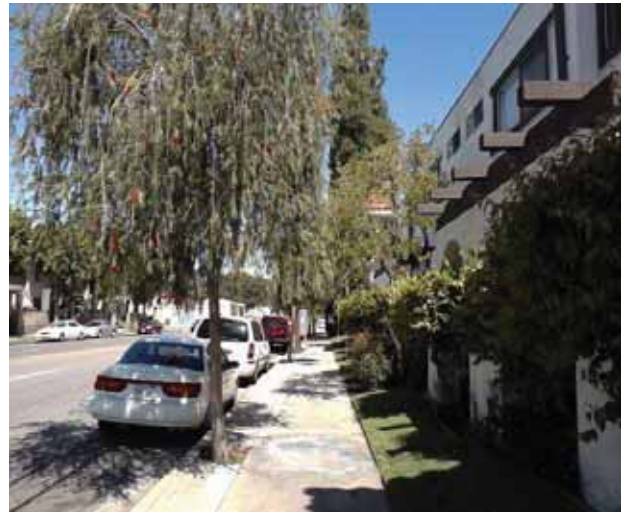
Sidewalks , Hazards & Gratings : Overhead Obstruction Height

Recommendation At least 80.00 inches

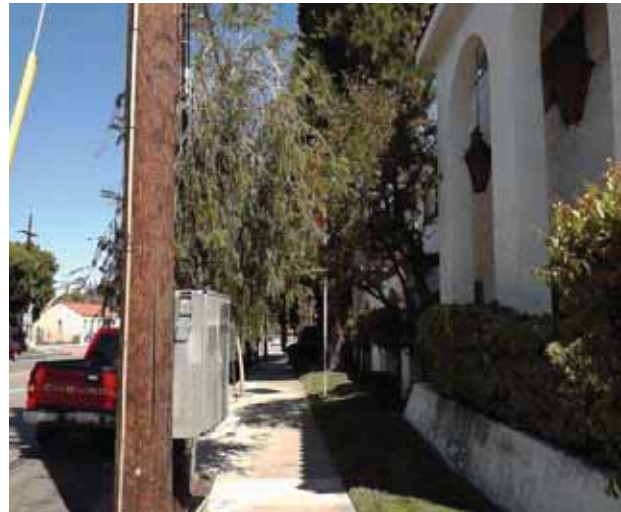
Sidewalks , Hazards & Gratings : Overhead Obstruction Height

Recommendation At least 80.00 inches

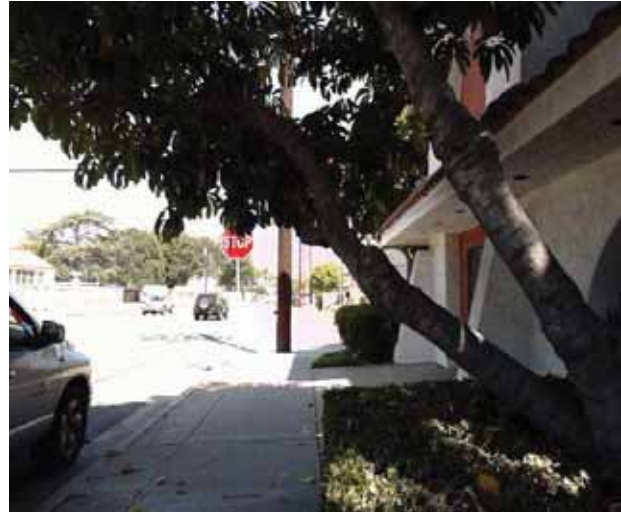
Sidewalks , Hazards & Gratings : Overhead Obstruction Height

Recommendation At least 80.00 inches

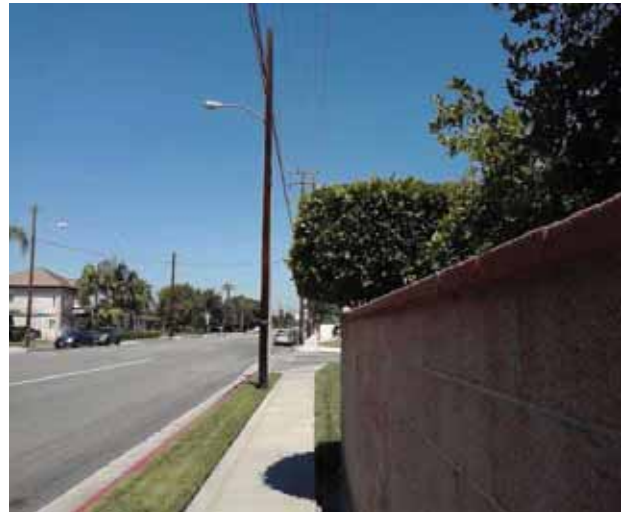
Sidewalks , Hazards & Gratings : Overhead Obstruction Height

Recommendation At least 80.00 inches

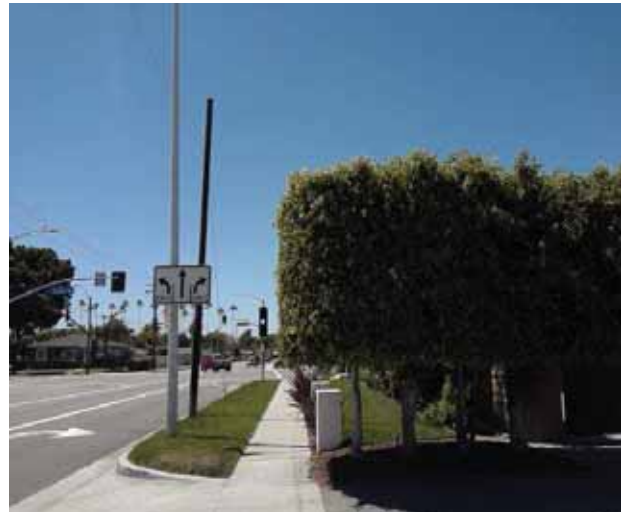
Sidewalks , Hazards & Gratings : Overhead Obstruction Height

Recommendation At least 80.00 inches

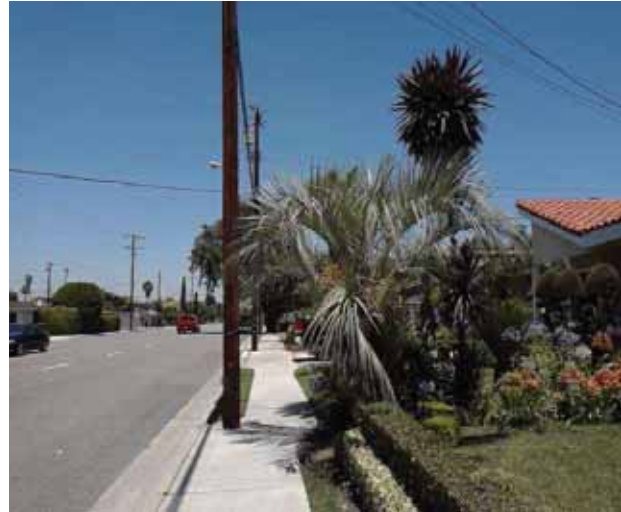
Sidewalks , Hazards & Gratings : Overhead Obstruction Height

Recommendation At least 80.00 inches

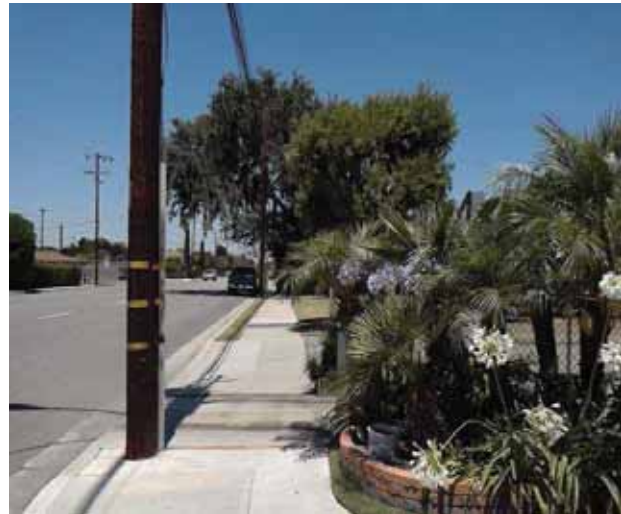
Sidewalks , Hazards & Gratings : Overhead Obstruction Height

Recommendation At least 80.00 inches

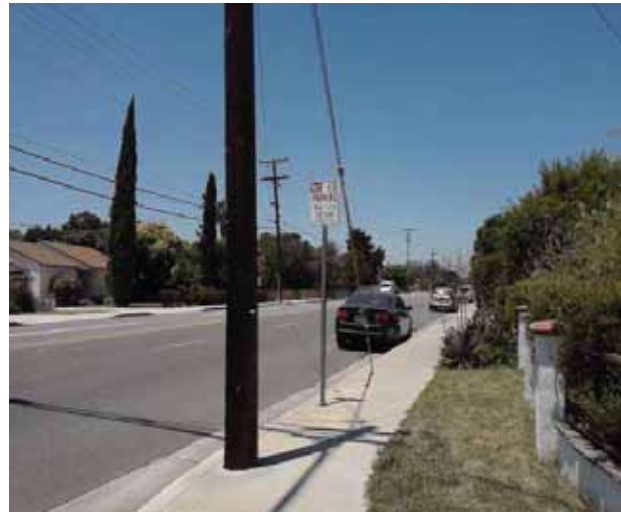
Sidewalks , Hazards & Gratings : Sidewalk Width at Obstruction

Sidewalk width at the obstruction shall have the recommended value.

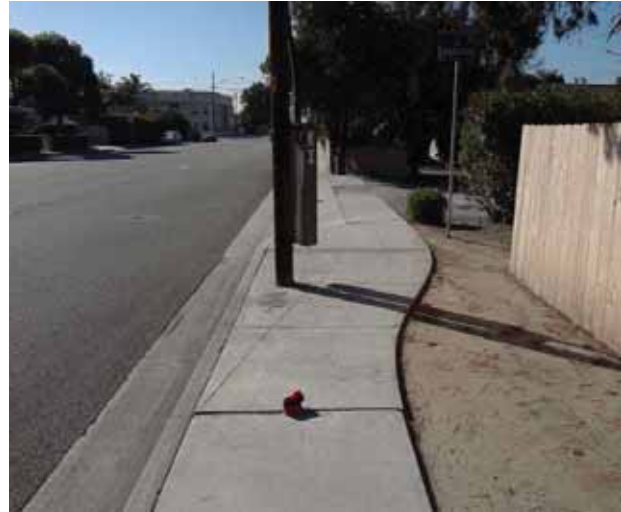
There is a change in elevation greater than recommended value.

Ensure that the change in elevation is within the recommended value.

Recommendation Up to 0.25 inches

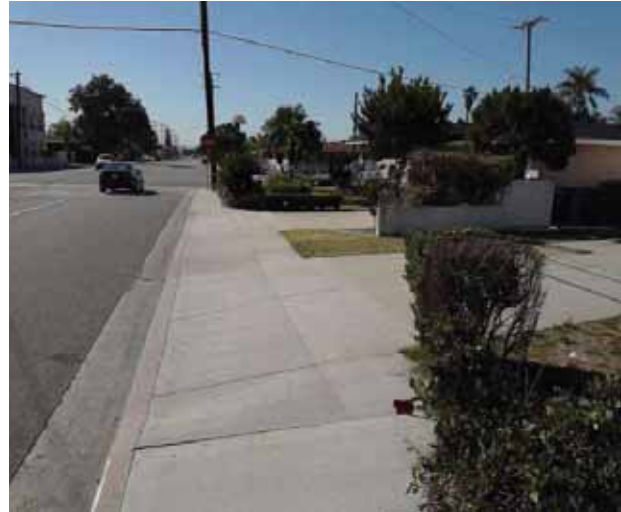
There is a change in elevation greater than recommended value.

Ensure that the change in elevation is within the recommended value.

Recommendation Up to 0.25 inches

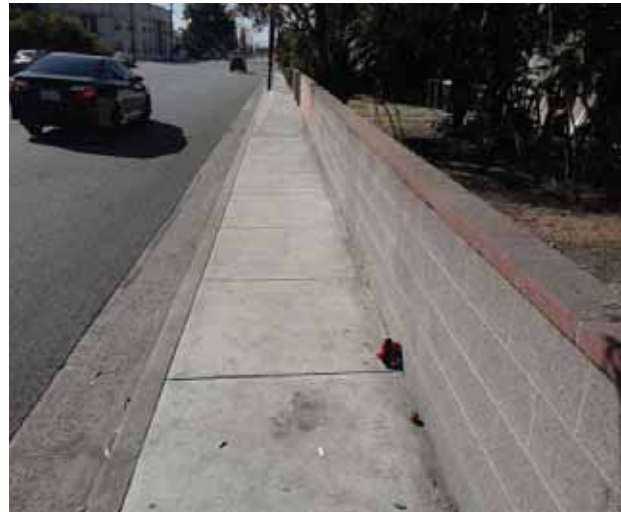
There is a change in elevation greater than recommended value.

Ensure that the change in elevation is within the recommended value.

Recommendation Up to 0.25 inches

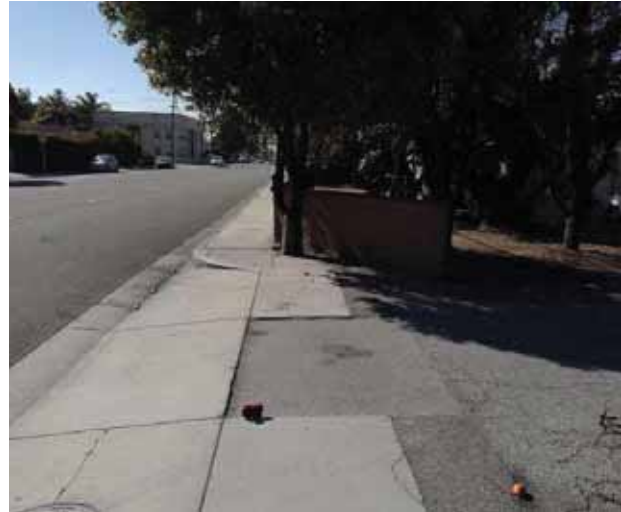
There is a change in elevation greater than recommended value.

Ensure that the change in elevation is within the recommended value.

Recommendation Up to 0.25 inches

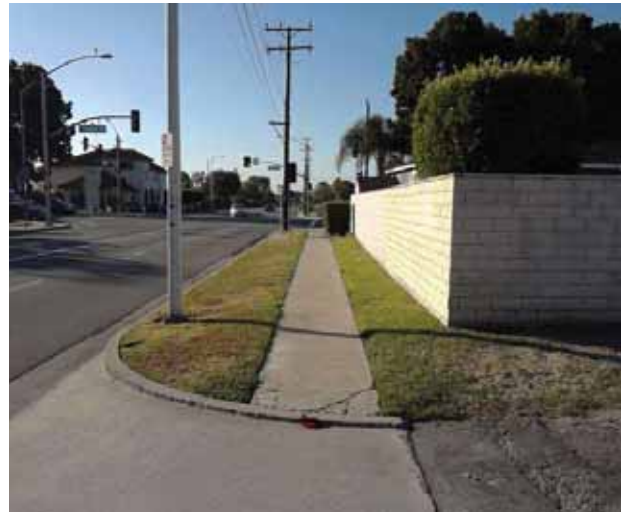
There is a change in elevation greater than recommended value.

Ensure that the change in elevation is within the recommended value.

Recommendation Up to 0.25 inches

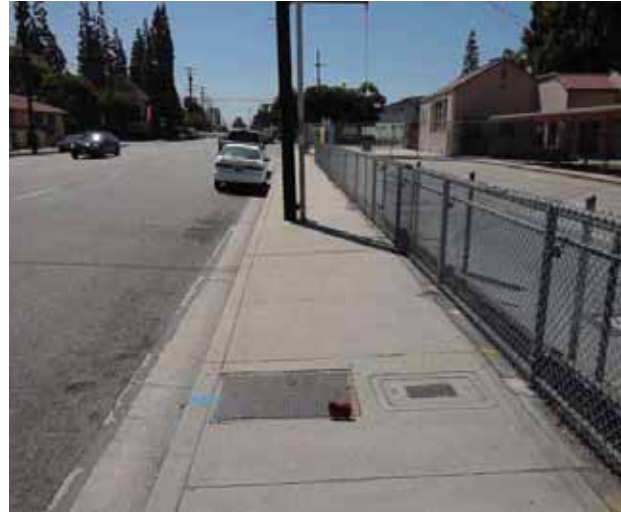
There is a change in elevation greater than recommended value.

Ensure that the change in elevation is within the recommended value.

Recommendation Up to 0.25 inches

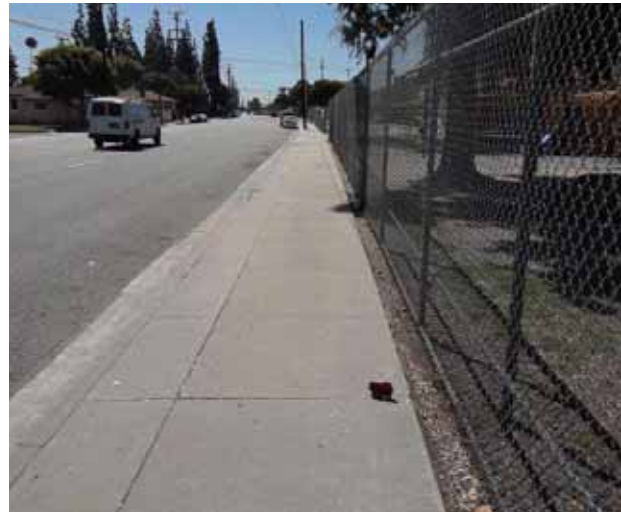
There is a change in elevation greater than recommended value.

Ensure that the change in elevation is within the recommended value.

Recommendation Up to 0.25 inches

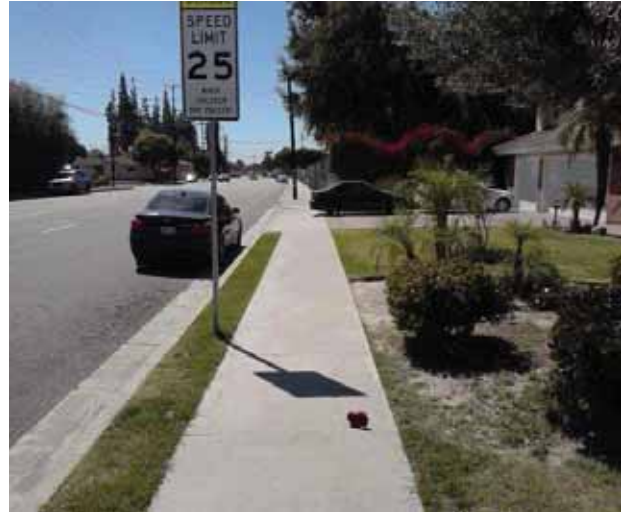
There is a change in elevation greater than recommended value.

Ensure that the change in elevation is within the recommended value.

Recommendation Up to 0.25 inches

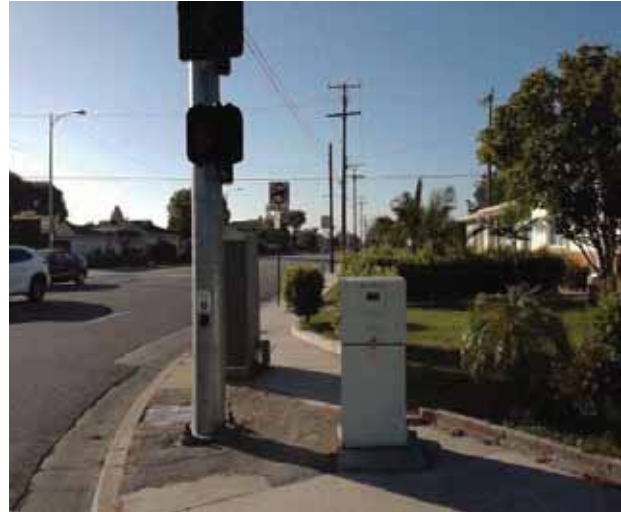
Sidewalks : Missing Sidewalk

Section of sidewalk is missing and consists of dirt, grass or gravel.

Provide a compliant sidewalk for the missing section.

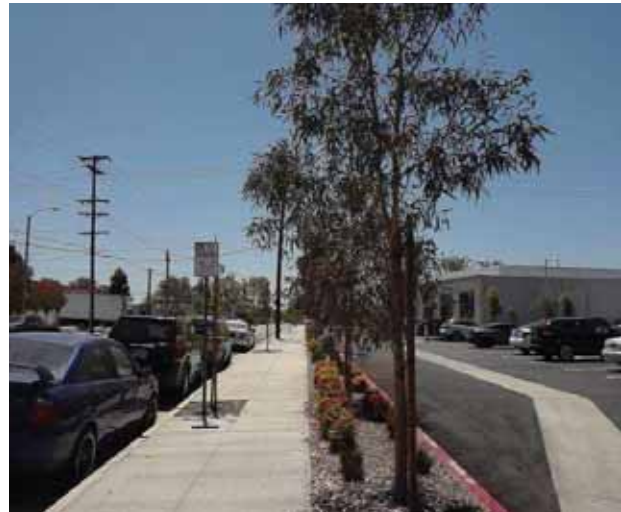
Sidewalks , Hazards & Gratings : Overhead Obstruction Height

Recommendation At least 80.00 inches

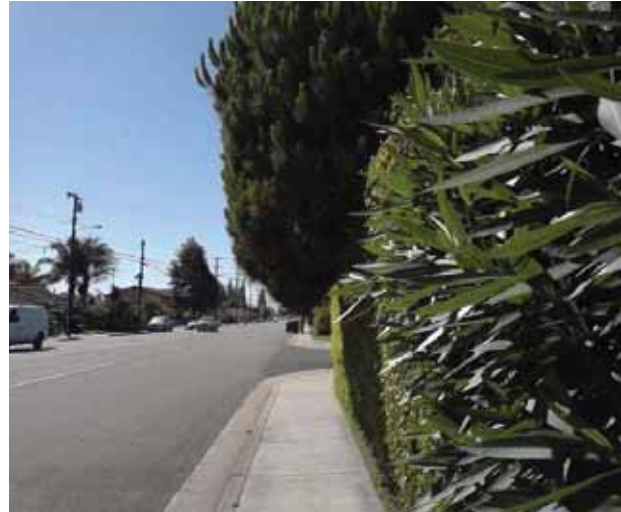
Sidewalks , Hazards & Gratings : Overhead Obstruction Height

Recommendation At least 80.00 inches

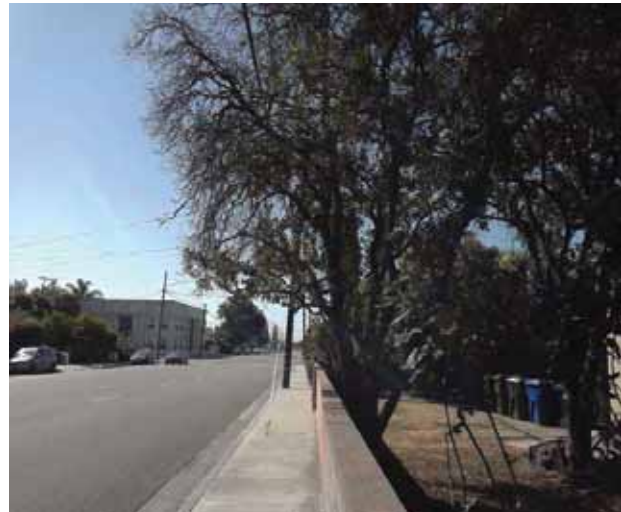
Sidewalks , Hazards & Gratings : Overhead Obstruction Height

Recommendation At least 80.00 inches

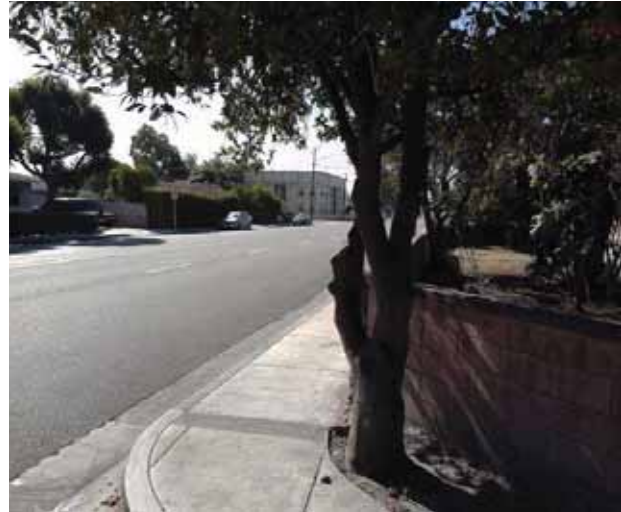
Sidewalks , Hazards & Gratings : Overhead Obstruction Height

Recommendation At least 80.00 inches

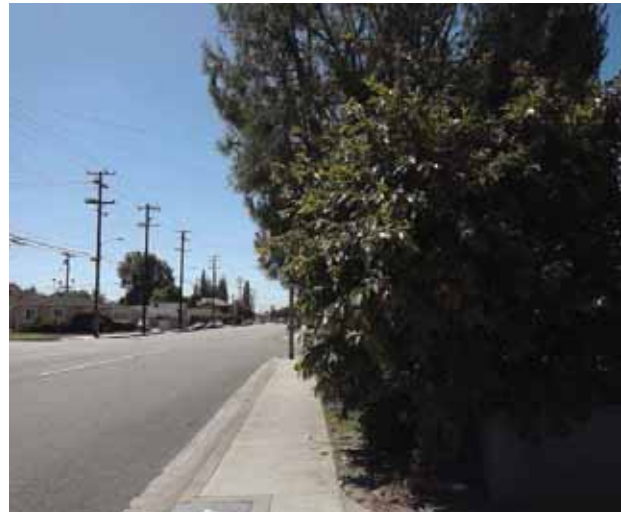
Sidewalks , Hazards & Gratings : Overhead Obstruction Height

Recommendation At least 80.00 inches

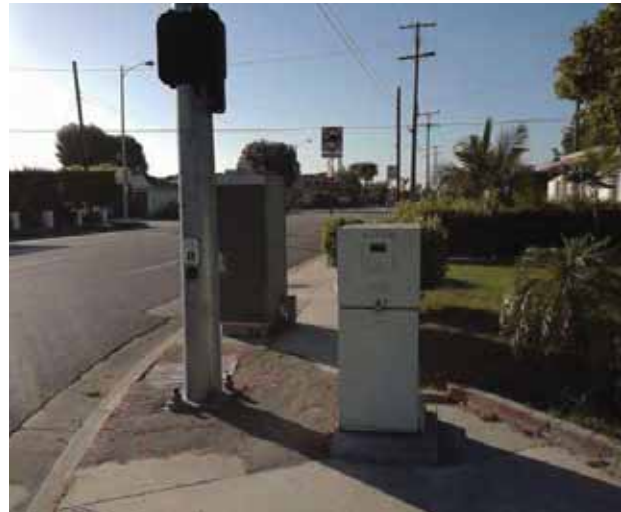
Sidewalks , Hazards & Gratings : Sidewalk Width at Obstruction

Sidewalk width at the obstruction shall have the recommended value.

Recommendation At least 48.00 inches

\$1,260

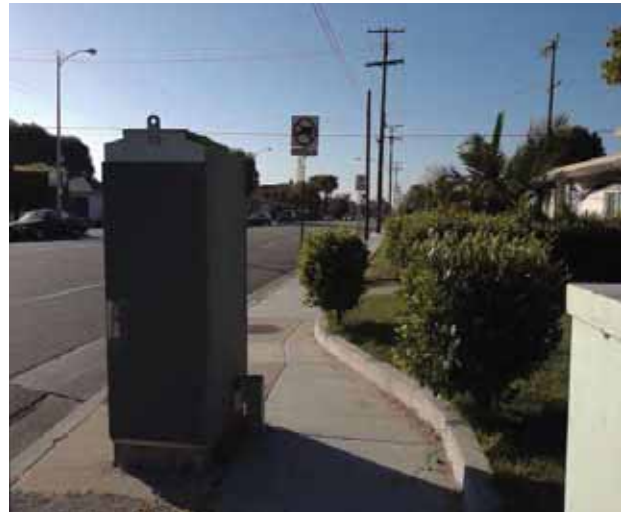
Sidewalks , Hazards & Gratings : Sidewalk Width at Obstruction

Sidewalk width at the obstruction shall have the recommended value.

Recommendation At least 48.00 inches

\$1,260

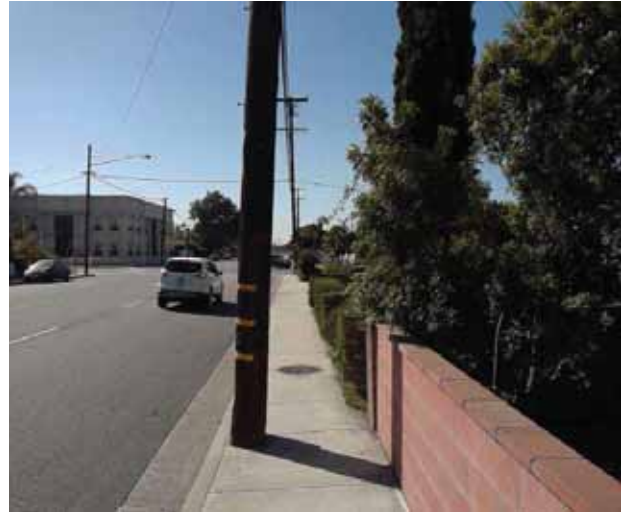
Sidewalks , Hazards & Gratings : Sidewalk Width at Obstruction

Sidewalk width at the obstruction shall have the recommended value.

Recommendation At least 48.00 inches

\$1,260

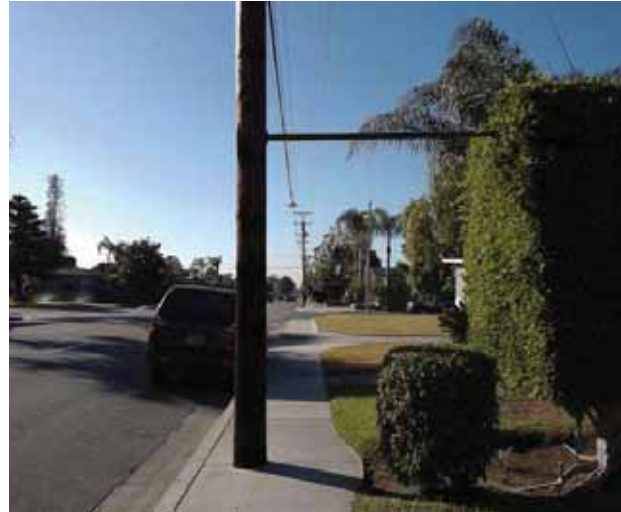
Sidewalks , Hazards & Gratings : Sidewalk Width at Obstruction

Sidewalk width at the obstruction shall have the recommended value.

Recommendation At least 48.00 inches

\$1,260

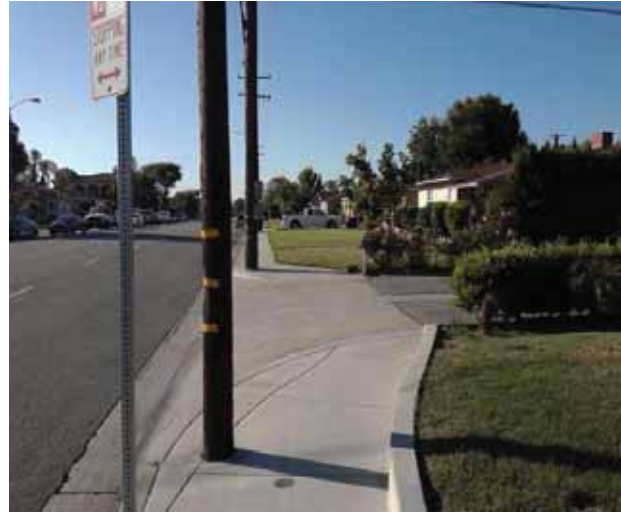
Sidewalks , Hazards & Gratings : Sidewalk Width at Obstruction

Sidewalk width at the obstruction shall have the recommended value.

Recommendation At least 48.00 inches

\$1,260

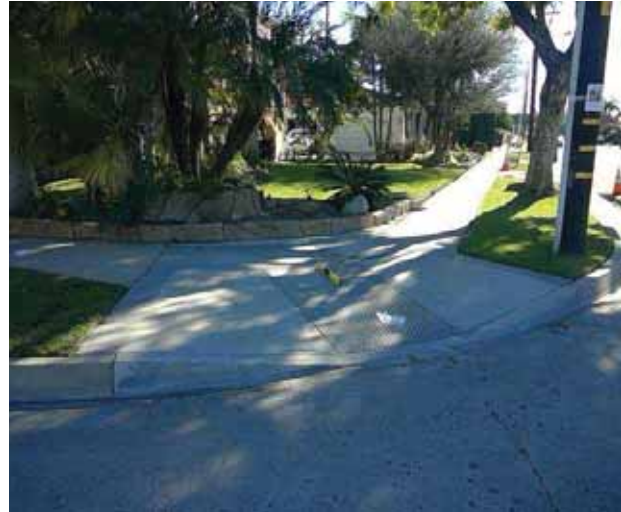
**On-Site Finding** Not Found

Provide detectable warning to surface \$248

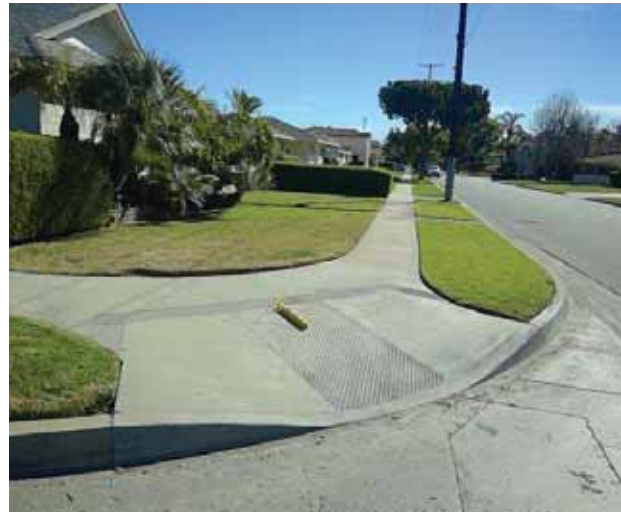
**On-Site Finding** Not Found

Provide detectable warning to surface \$248

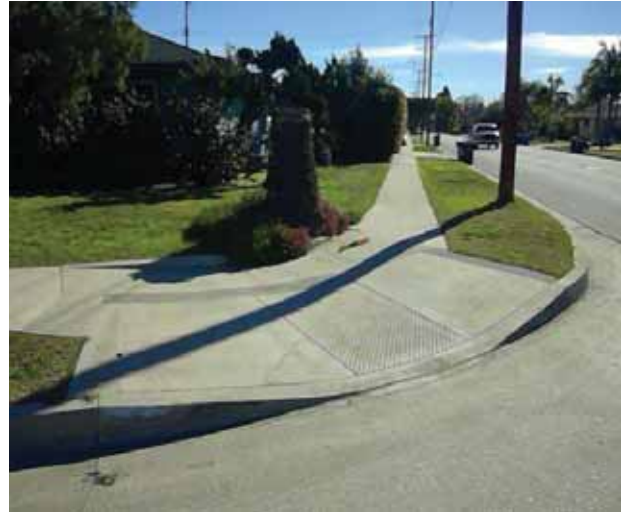
**On-Site Finding** Not Found

Provide detectable warning to surface \$248

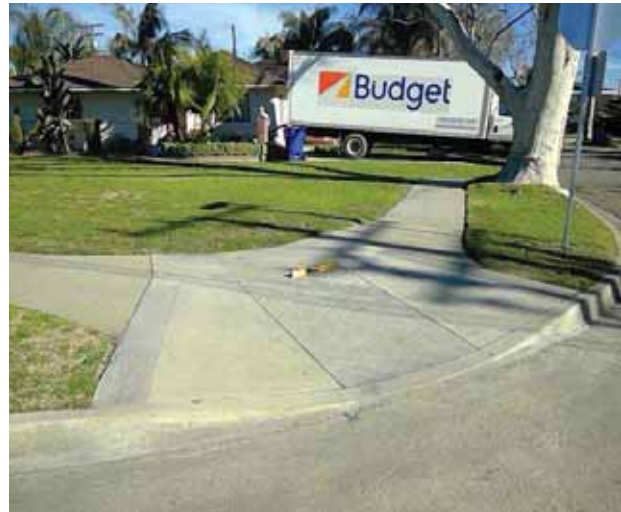
**On-Site Finding** Not Found

Provide detectable warning to surface \$248

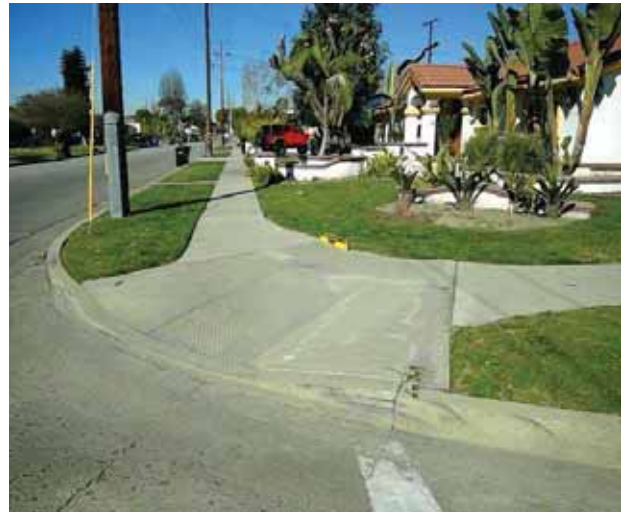
**On-Site Finding** Not Found

Provide detectable warning to surface \$248

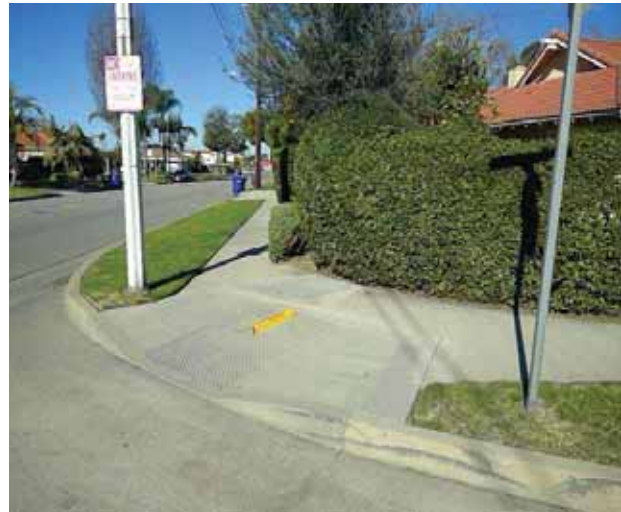
**On-Site Finding** Not Found

Provide detectable warning to surface \$248

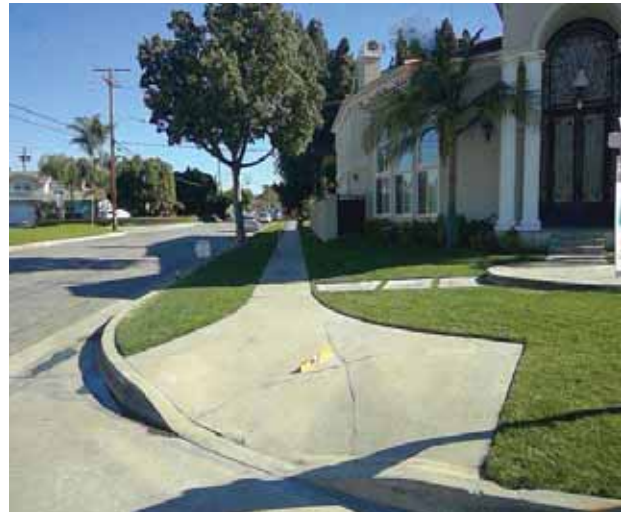
**On-Site Finding** Not Found

Provide detectable warning to surface \$248
