# Accessibility Survey

## City of Downey Gallatin Road & Paramount Boulevard

Date of Inspection  
4/14/2017

Prepared By  
**Disability Access Consultants**  
(800) 743-7067

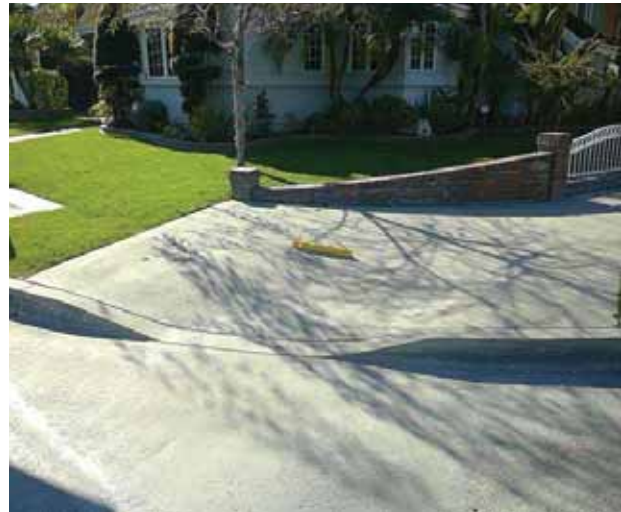
**On-Site Finding** Not Found

Provide detectable warning to surface \$248

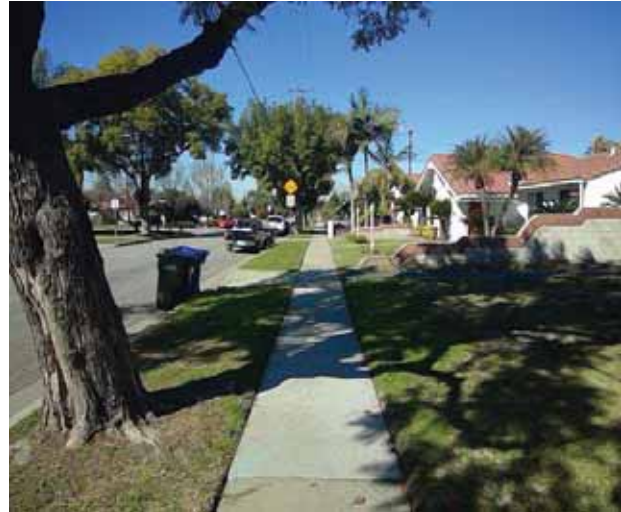
There is a change in elevation greater than recommended value.

Ensure that the change in elevation is within the recommended value.

Recommendation Up to 0.25 inches

Remove tripping hazards \$198

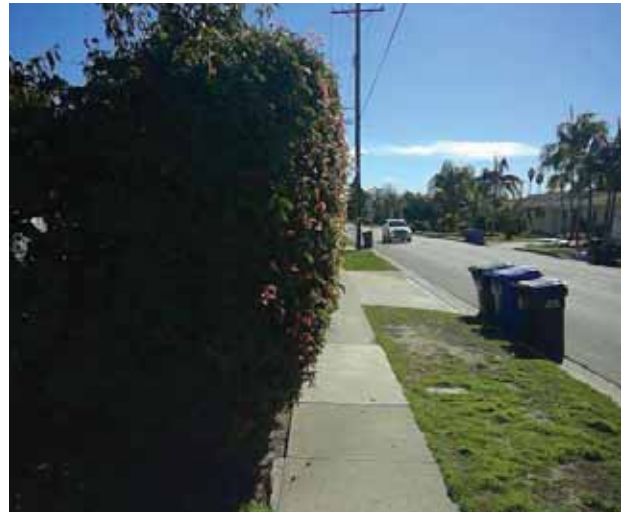
Sidewalks , Hazards & Gratings : Sidewalk Width at Obstruction

Sidewalk width at the obstruction shall have the recommended value.

\$1,260

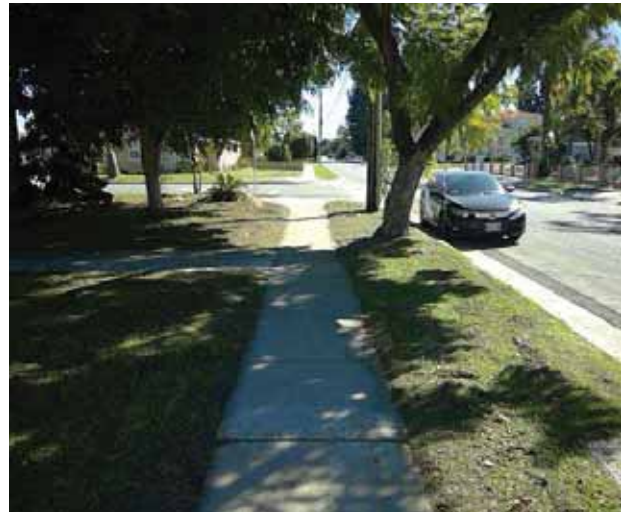
There is a change in elevation greater than recommended value.

Ensure that the change in elevation is within the recommended value.

Remove tripping hazards \$198

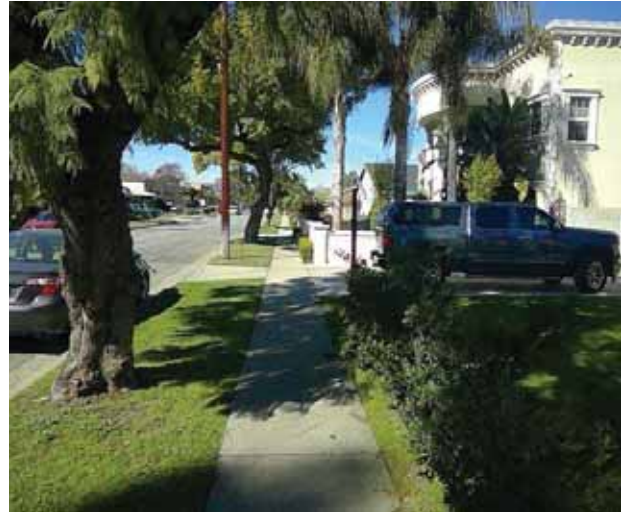
There is a change in elevation greater than recommended value.

Ensure that the change in elevation is within the recommended value.

Remove tripping hazards \$198

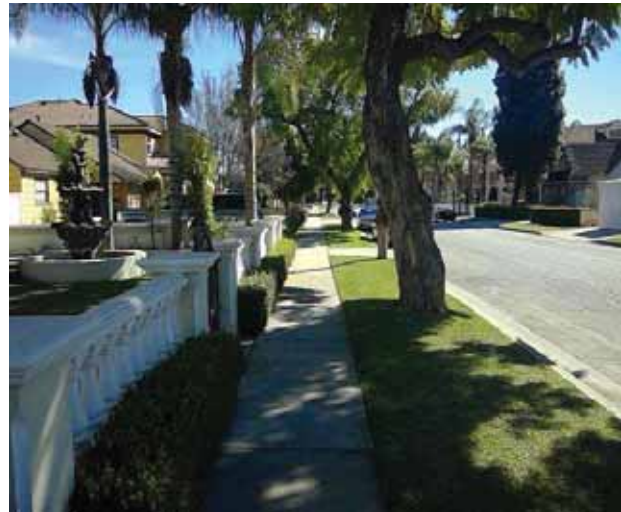
There is a change in elevation greater than recommended value.

Ensure that the change in elevation is within the recommended value.

Remove tripping hazards \$198

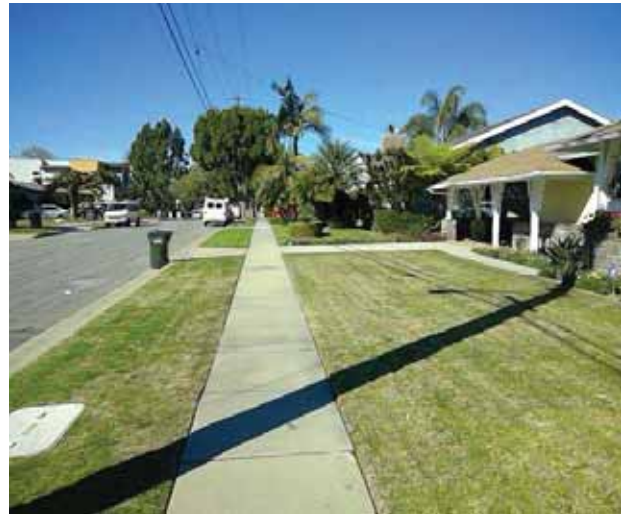
There is a change in elevation greater than recommended value.

Ensure that the change in elevation is within the recommended value.

Remove tripping hazards \$198

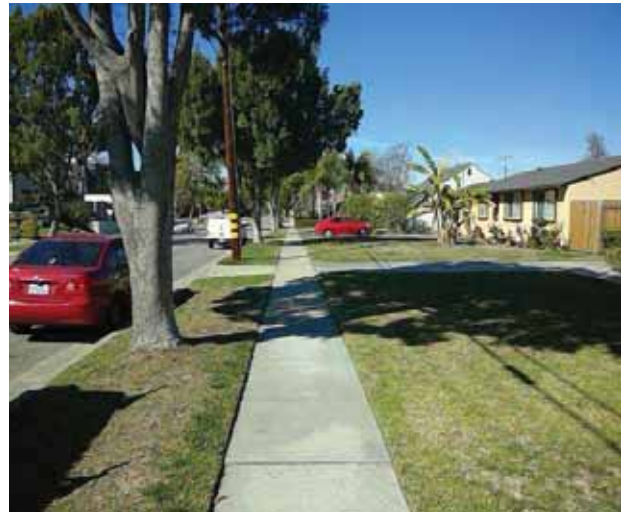
There is a change in elevation greater than recommended value.

Ensure that the change in elevation is within the recommended value.

Remove tripping hazards \$198

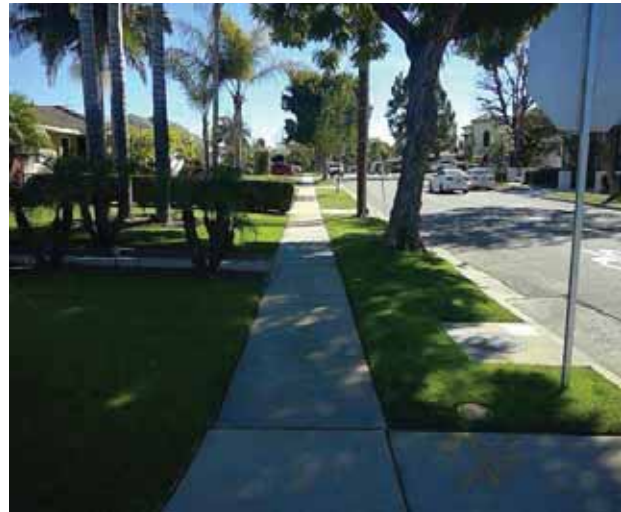
There is a change in elevation greater than recommended value.

Ensure that the change in elevation is within the recommended value.

Remove tripping hazards \$198

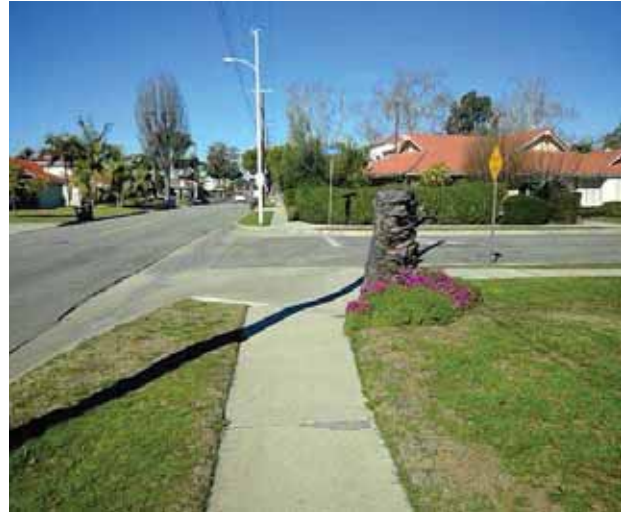
There is a change in elevation greater than recommended value.

Ensure that the change in elevation is within the recommended value.

Remove tripping hazards \$198

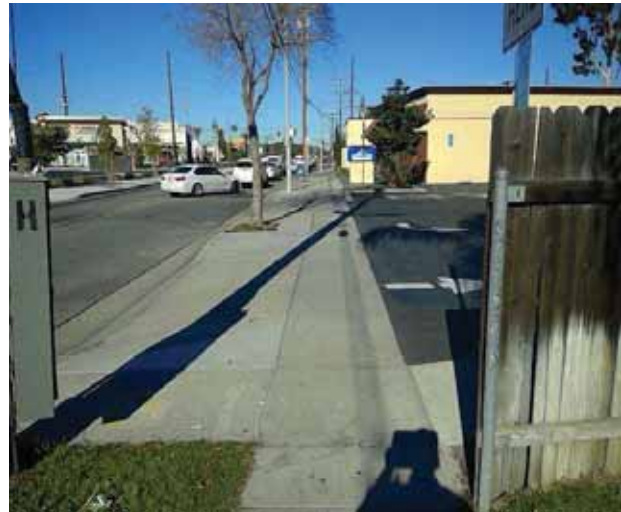
**On-Site Finding** Not Found

Install compliant detectable warnings \$190

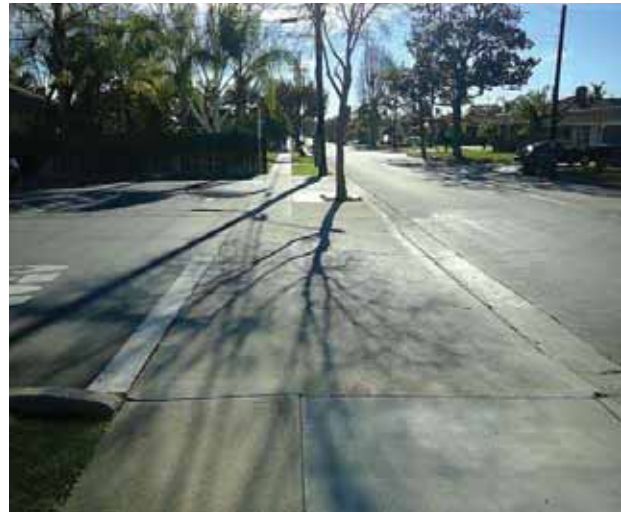
**On-Site Finding** Not Found

Install compliant detectable warnings \$190

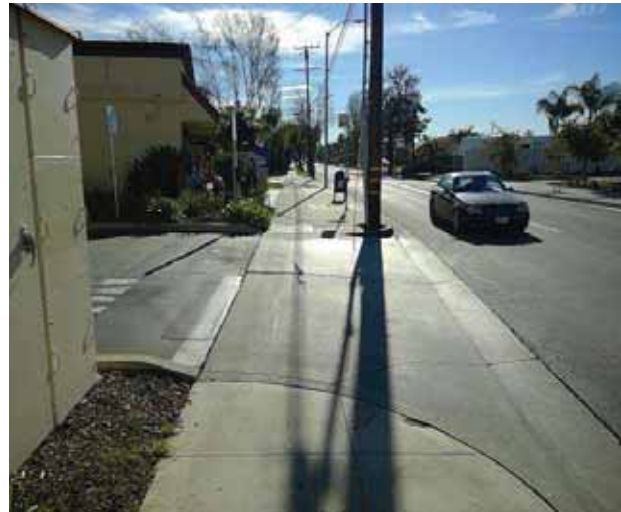
**On-Site Finding** Not Found

Install compliant detectable warnings \$190

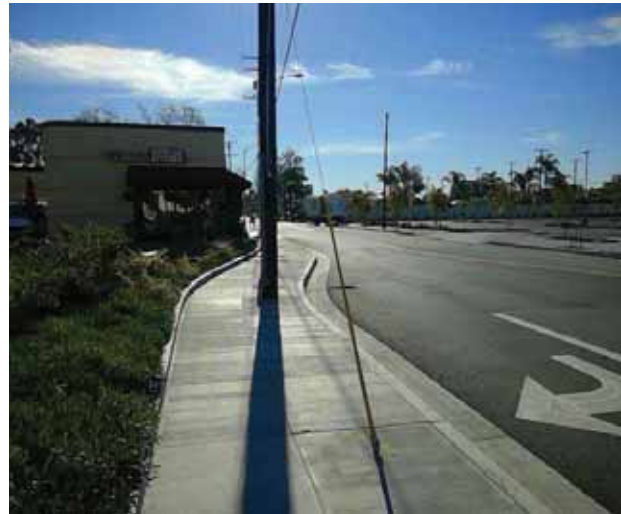
Sidewalks , Hazards & Gratings : Overhead Obstruction Height

Recommendation At least 80.00 inches

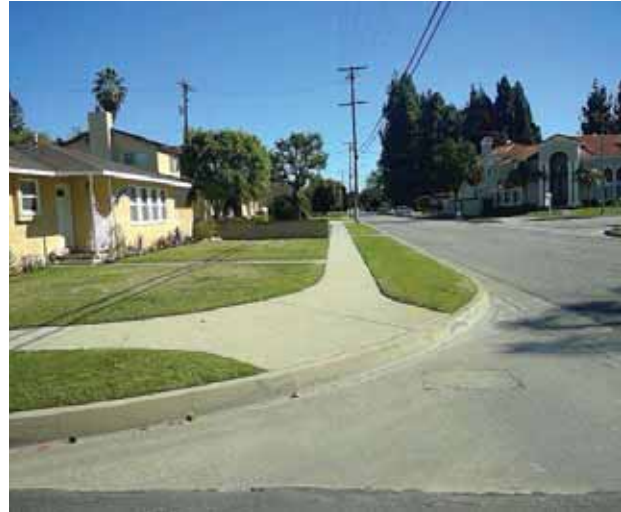
Sidewalks , Hazards & Gratings : Curb is on Path of Travel

Install curb ramp \$2,500

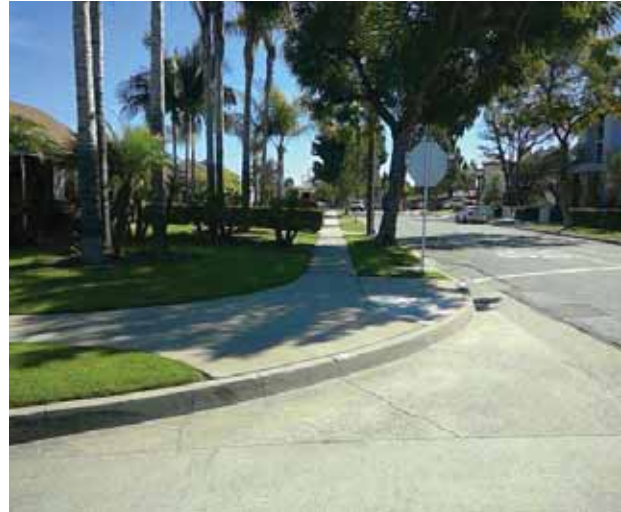
Sidewalks , Hazards & Gratings : Curb is on Path of Travel

Install curb ramp \$2,500

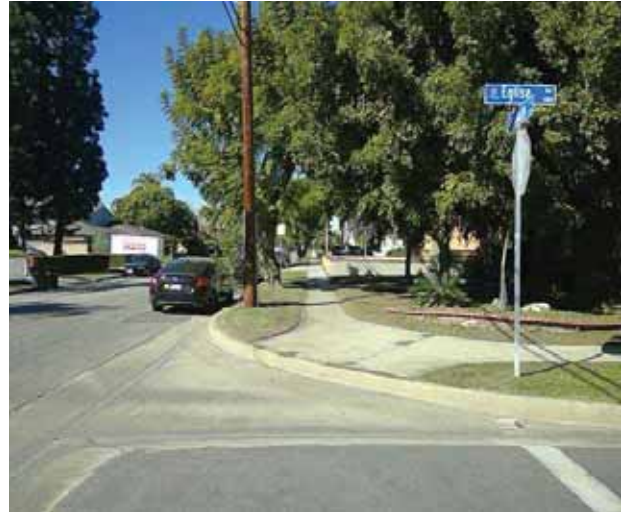
Sidewalks , Hazards & Gratings : Curb is on Path of Travel

Install curb ramp \$2,500

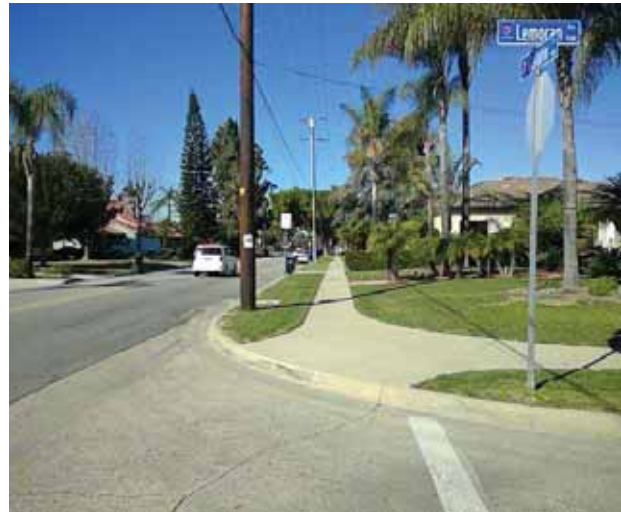
Sidewalks , Hazards & Gratings : Curb is on Path of Travel

Install curb ramp \$2,500

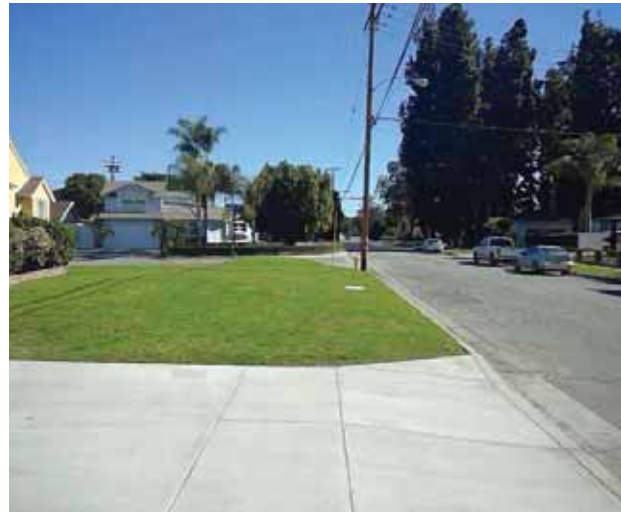
Section of sidewalk is missing and consists of dirt, grass or gravel.

Provide a compliant sidewalk for the missing section.

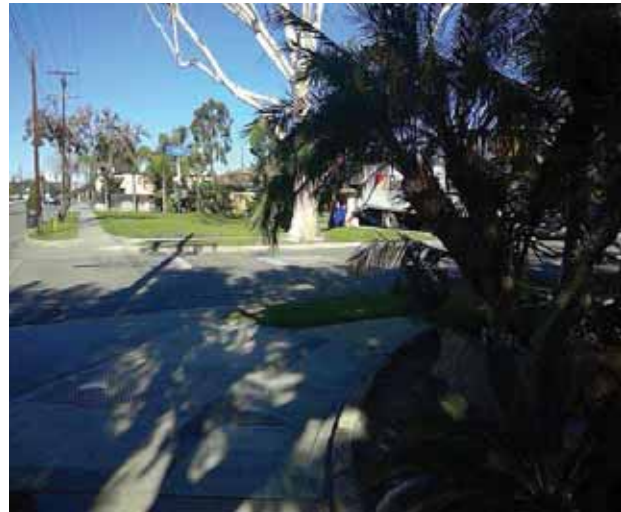
Sidewalks , Hazards & Gratings : Overhead Obstruction Height

Recommendation At least 80.00 inches

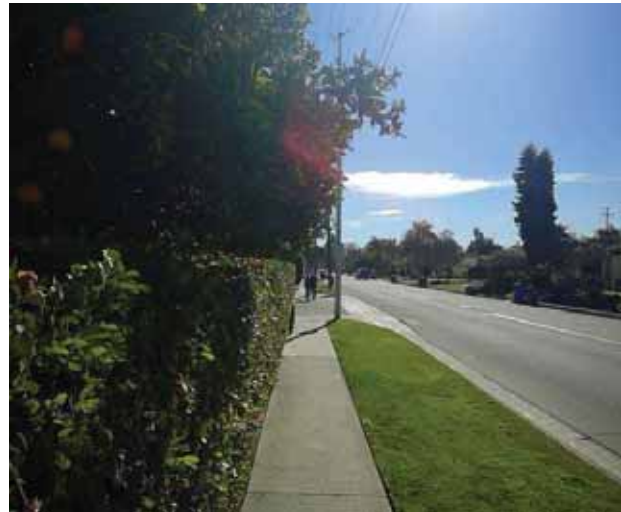
Sidewalks , Hazards & Gratings : Overhead Obstruction Height

Recommendation At least 80.00 inches

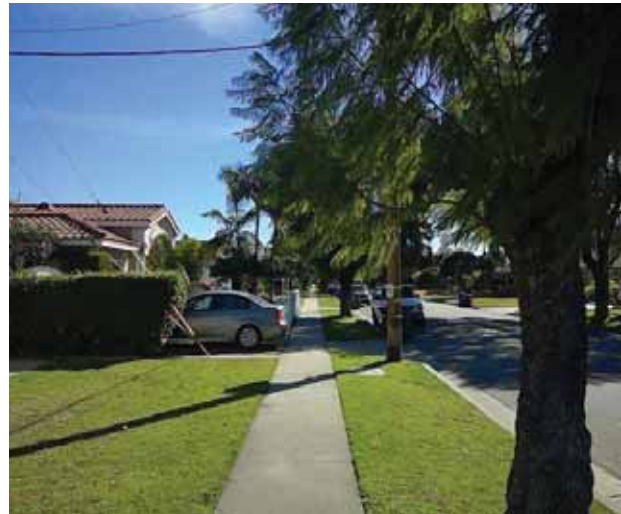
Sidewalks , Hazards & Gratings : Overhead Obstruction Height

Recommendation At least 80.00 inches

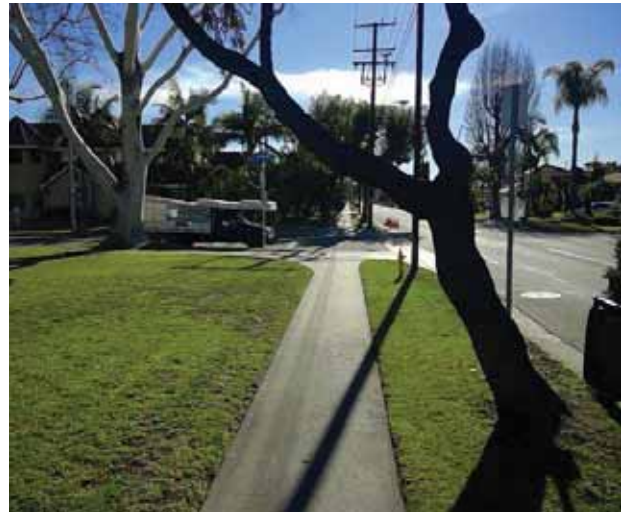
Sidewalks , Hazards & Gratings : Overhead Obstruction Height

Recommendation At least 80.00 inches

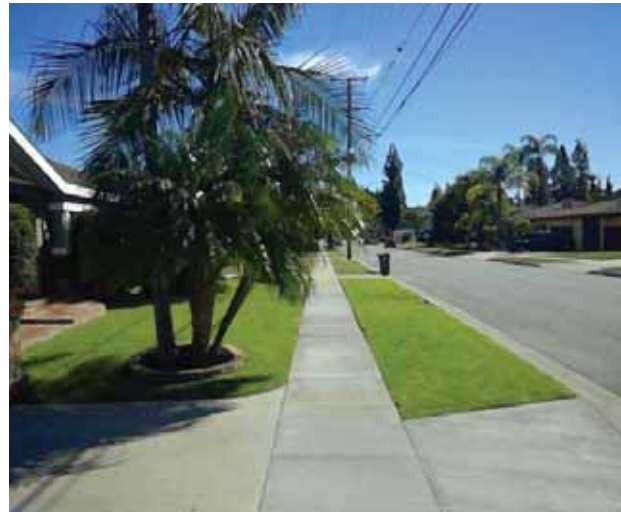
Sidewalks , Hazards & Gratings : Overhead Obstruction Height

Recommendation At least 80.00 inches

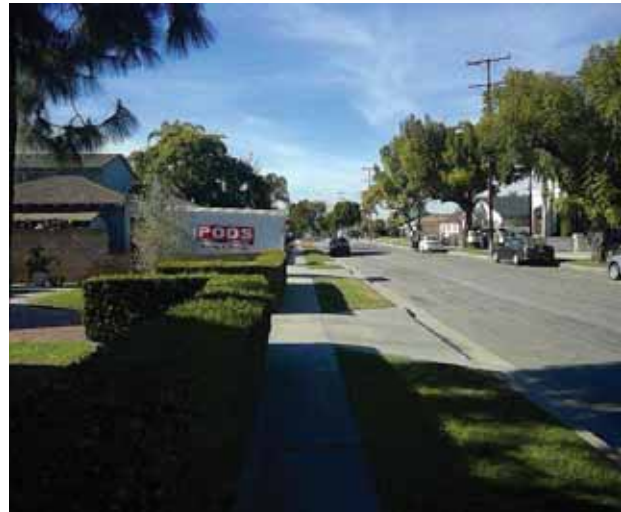
There is a change in elevation greater than recommended value.

Ensure that the change in elevation is within the recommended value.

Remove tripping hazards \$198

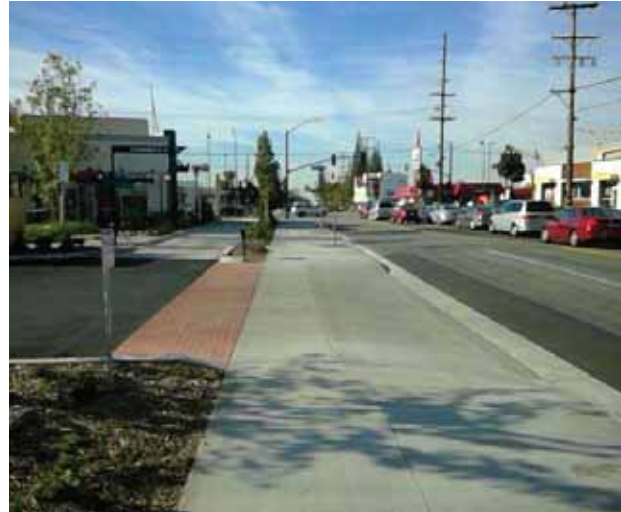
**On-Site Finding** Not Found

Install compliant detectable warnings \$190

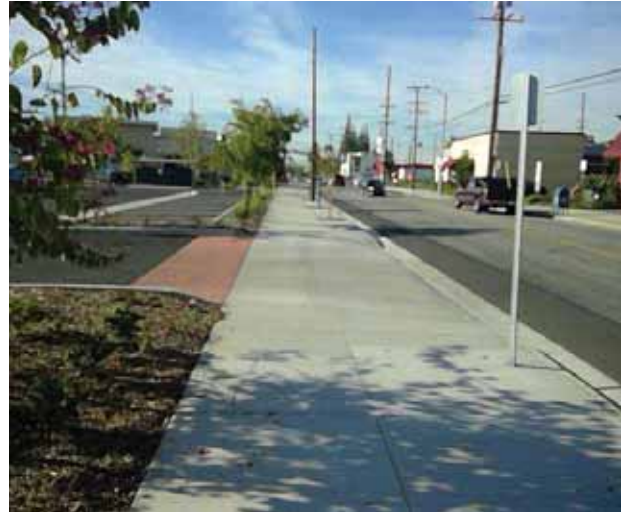
**On-Site Finding** Not Found

Install compliant detectable warnings \$190

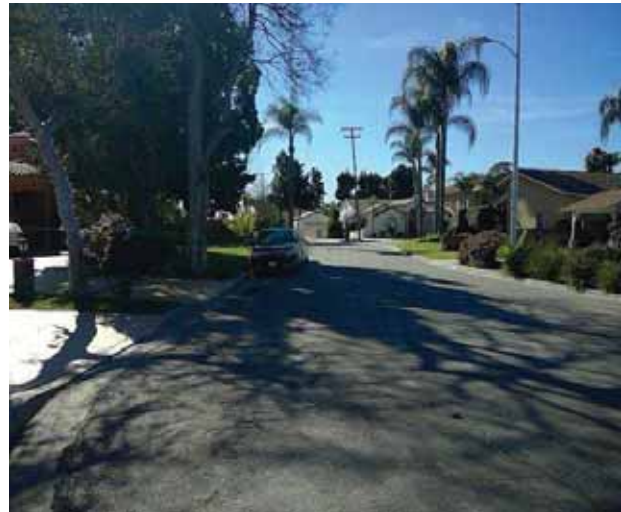
Section of sidewalk is missing and consists of dirt, grass or gravel.

Provide a compliant sidewalk for the missing section.

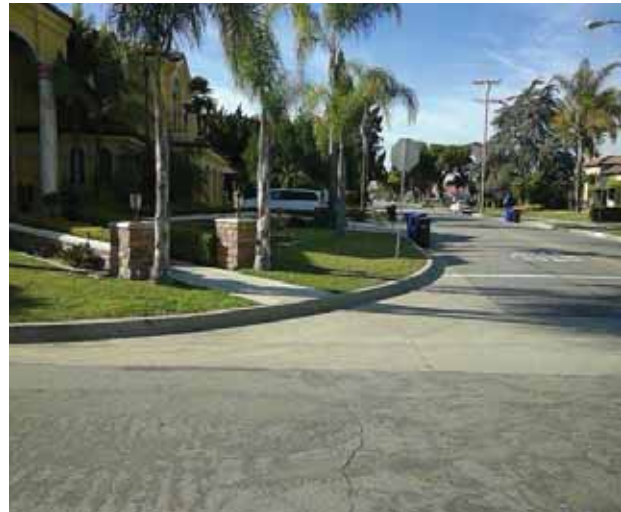
Section of sidewalk is missing and consists of dirt, grass or gravel.

Provide a compliant sidewalk for the missing section.

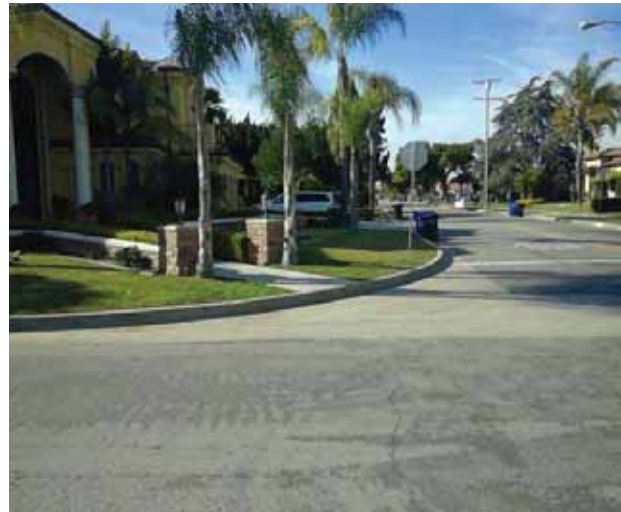
Sidewalks , Hazards & Gratings : Curb is on Path of Travel

Install curb ramp \$2,500

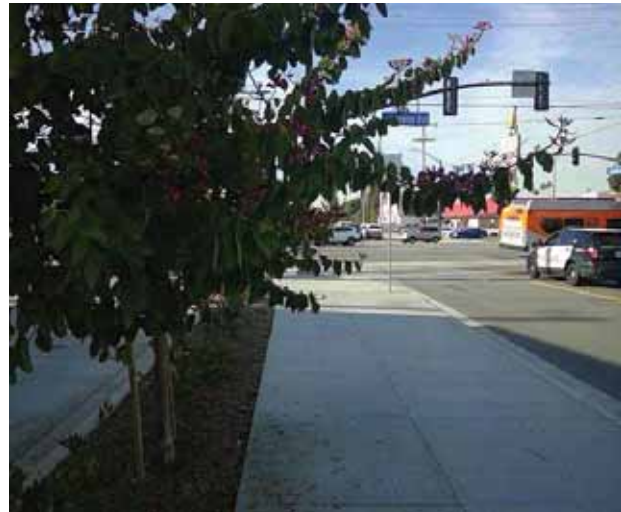
Sidewalks , Hazards & Gratings : Overhead Obstruction Height

Recommendation At least 80.00 inches

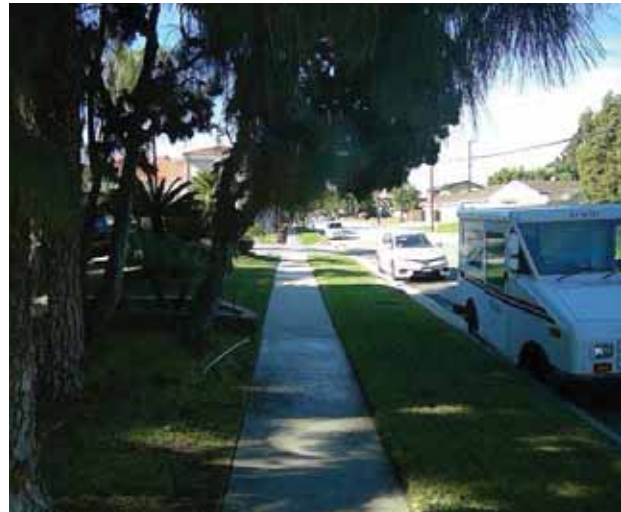
Sidewalks , Hazards & Gratings : Overhead Obstruction Height
