Accessibility Survey

City of Downey Gardendale Street & Barlin Avenue

Date of Inspection
2/2/2017

Prepared By
Disability Access Consultants
(800) 743-7067

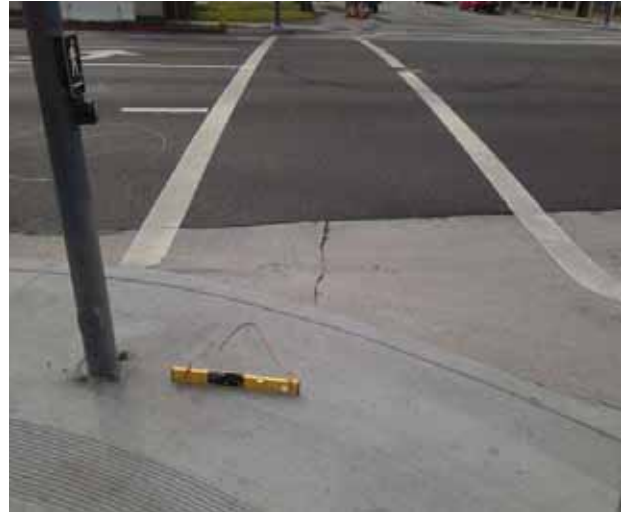
Recommendation Up to 60.00 inches

Costing Info (Estimated)

\$900

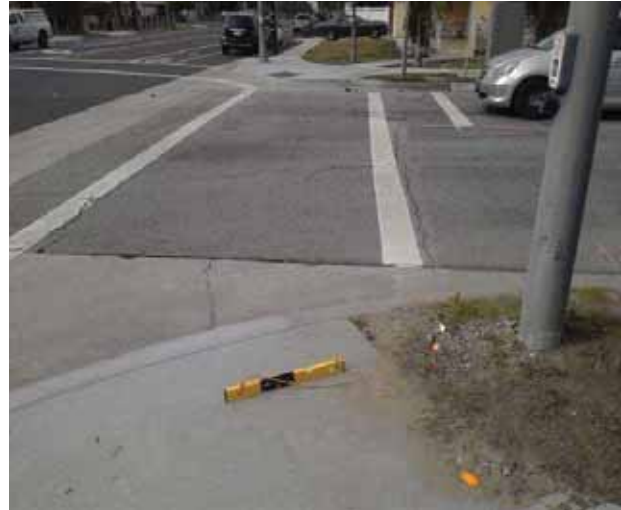
Notes : Push button reach depth is 24"

Costing Info (Estimated)

\$900

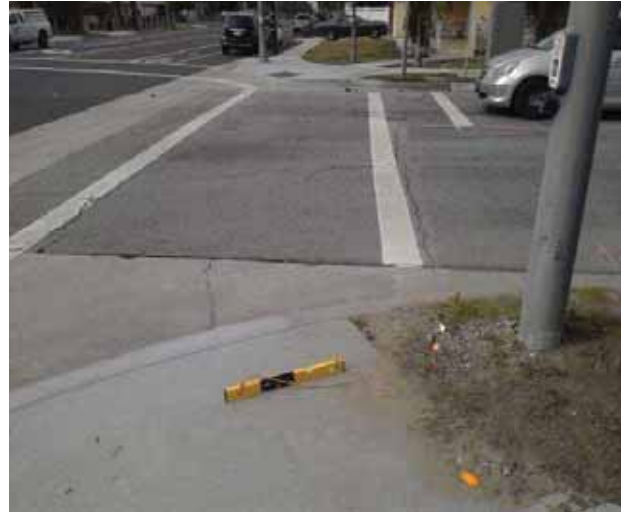
Notes : Push button reach depth is 24"

Costing Info (Estimated)

\$900

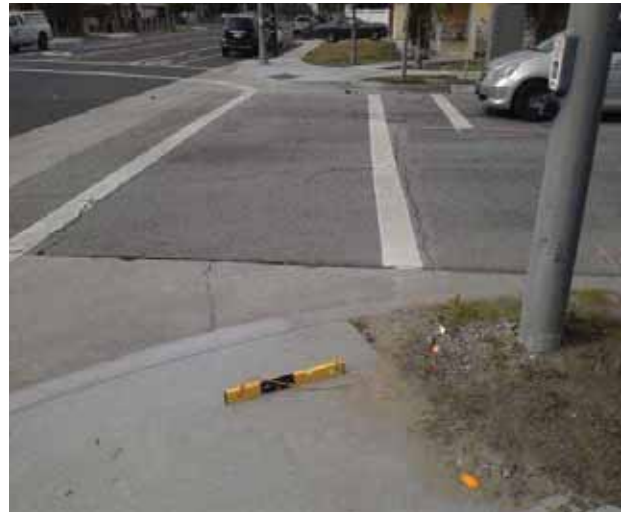
Notes : Push button reach depth is 24"

Costing Info (Estimated)

\$900

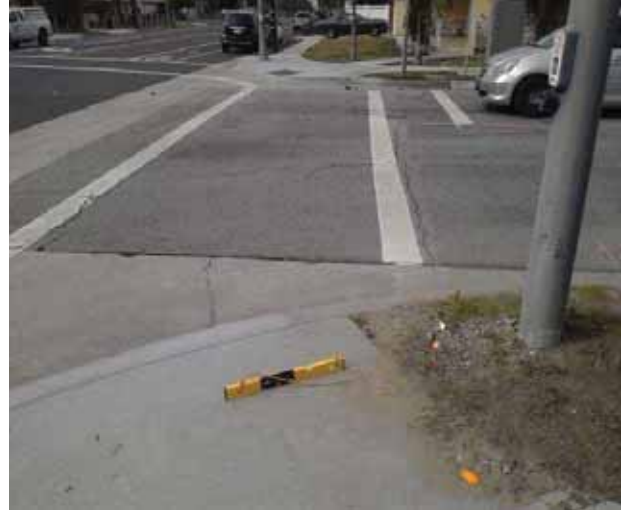
Notes : Push button reach depth is 24"

Costing Info (Estimated)

\$158

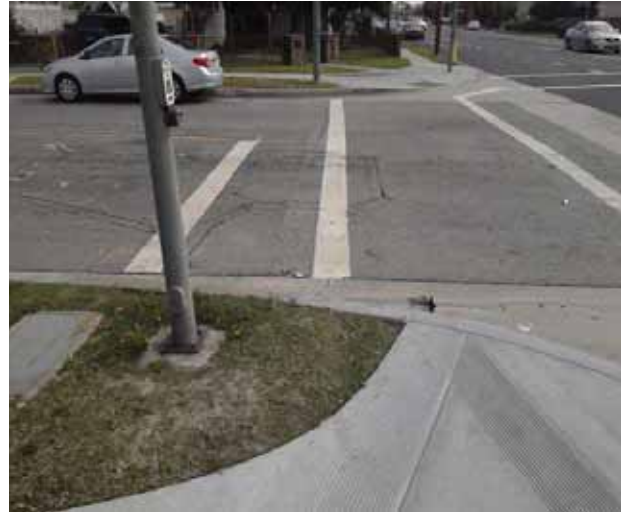
Notes : Landing is grass/dirt.

Costing Info (Estimated)

\$900

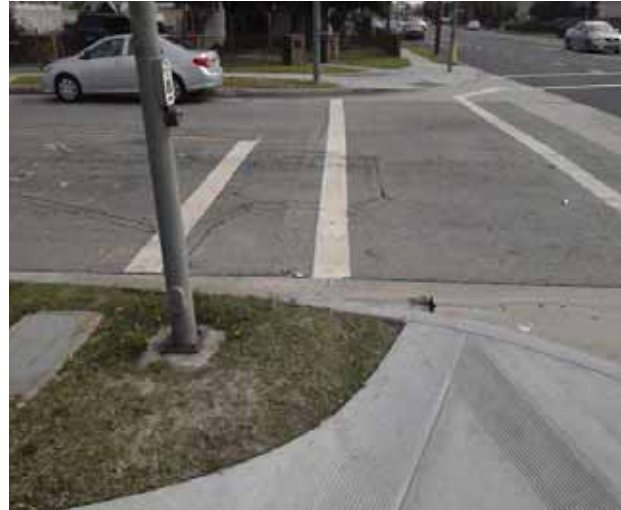
Notes : Landing is grass/dirt.

Costing Info (Estimated)

\$900

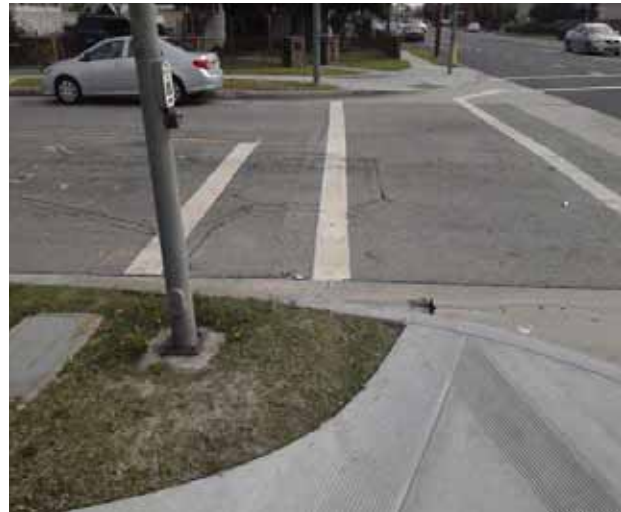
Notes : Landing is grass/dirt.

Costing Info (Estimated)

\$900

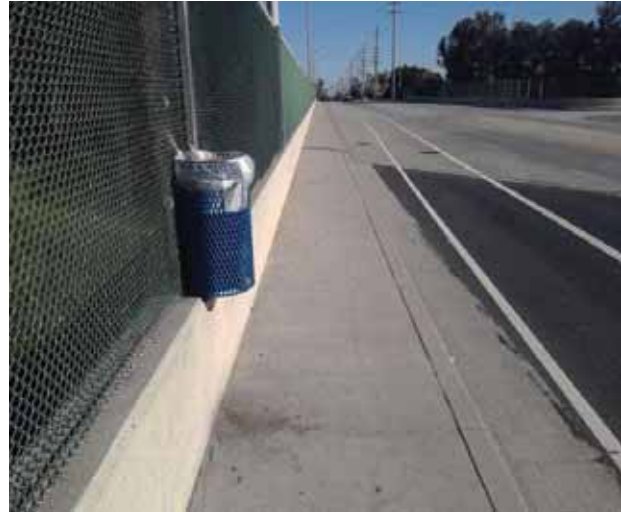
Notes : Bottom edge of trash can at 27.5"

Install wing walls or relocate object \$640

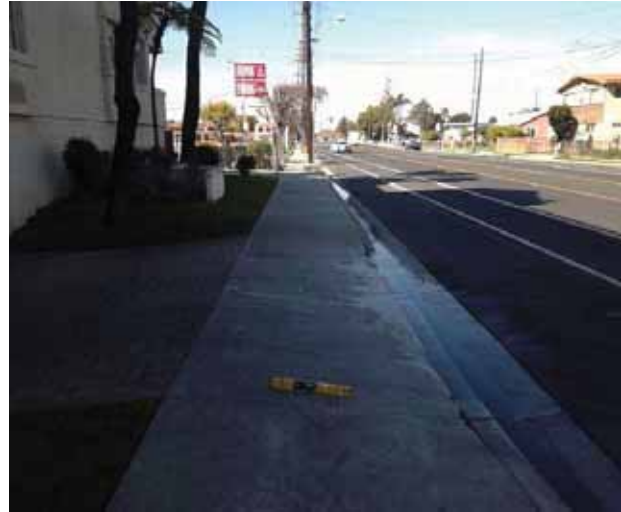
Recommendation Up to 5.00 percent

Repave surface \$1,092

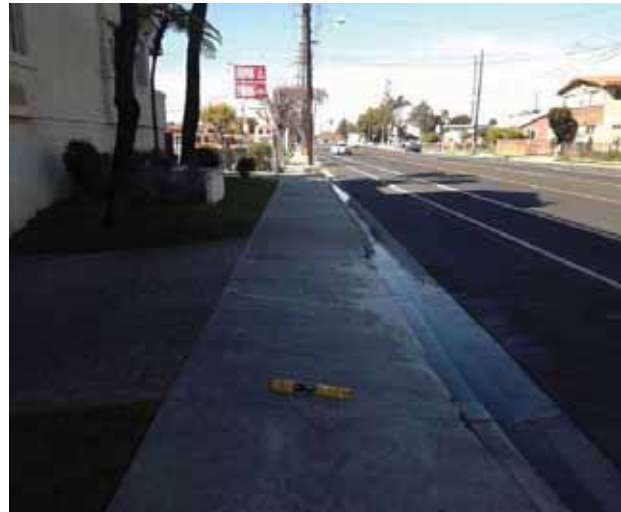
Recommendation Up to 2.08 percent

Repave surface \$1,092

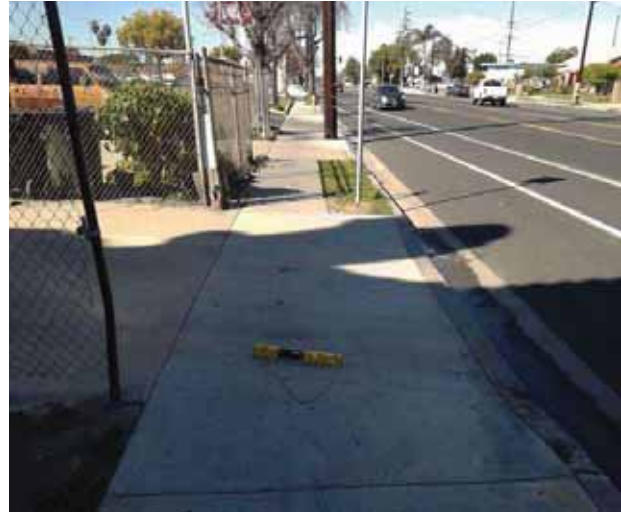
Recommendation Up to 5.00 percent

Repave surface \$1,092

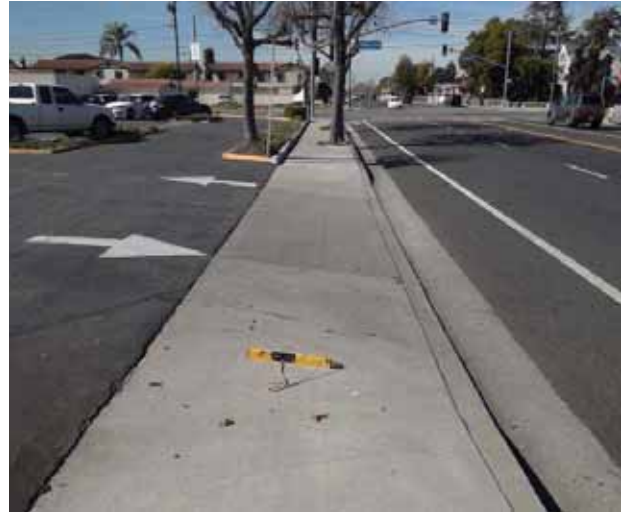
Recommendation Up to 5.00 percent

Repave surface \$1,092

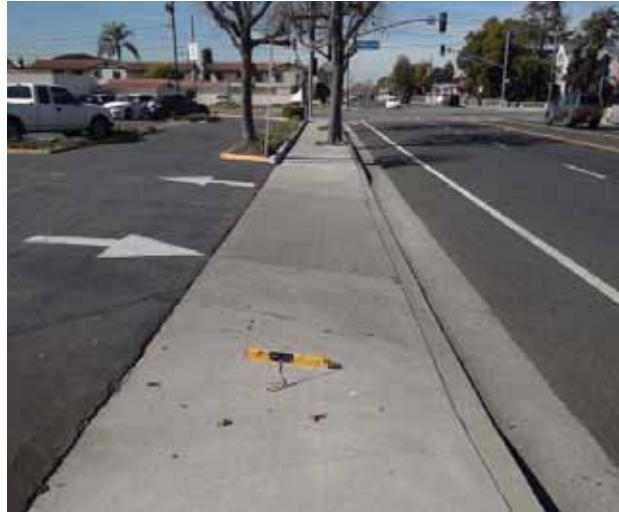
Recommendation Up to 2.08 percent

Repave surface \$1,092

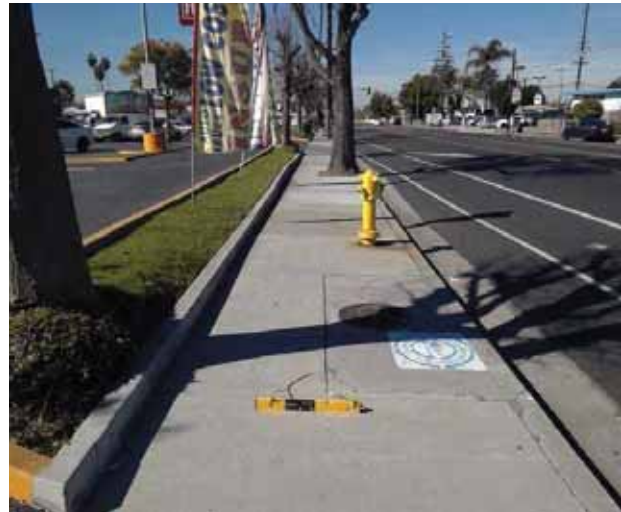
Recommendation Up to 2.08 percent

Repave the sidewalk surface with the recommended cross slope.

Repave surface \$1,092

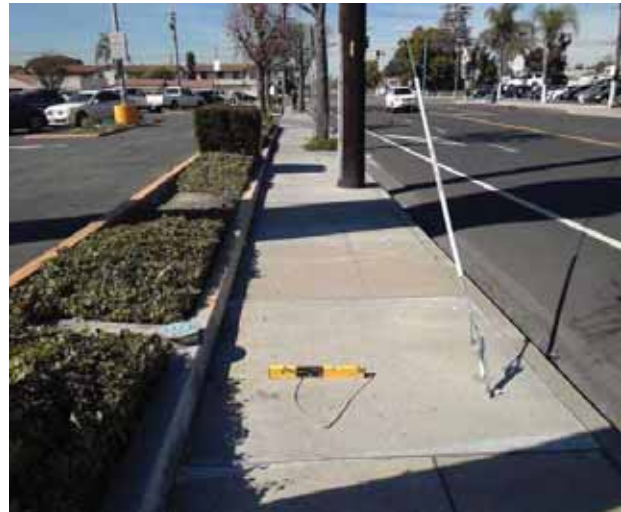
Recommendation Up to 2.08 percent

Repave the sidewalk surface with the recommended cross slope.

Repave surface \$1,092

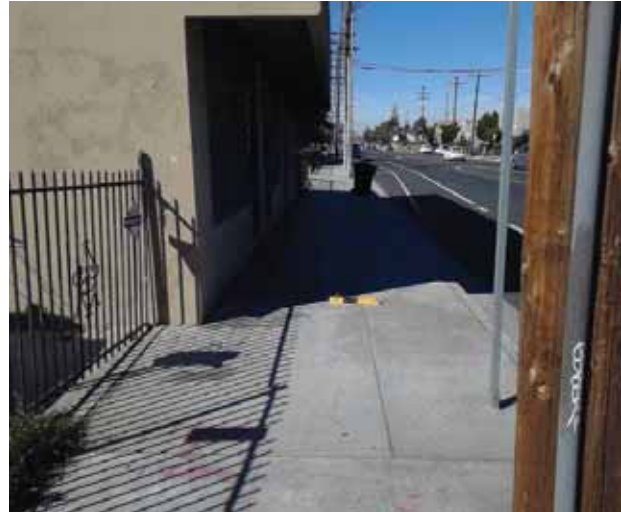
Recommendation Up to 2.08 percent

Repave the sidewalk surface with the recommended cross slope.

Repave surface \$1,092

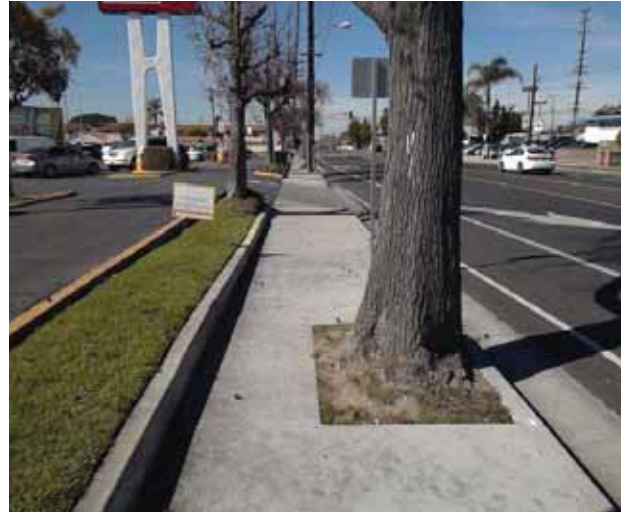
Sidewalks , Hazards & Gratings : Sidewalk Width at Obstruction

Recommendation At least 48.00 inches

Sidewalk width at the obstruction shall have the recommended value.

\$1,260

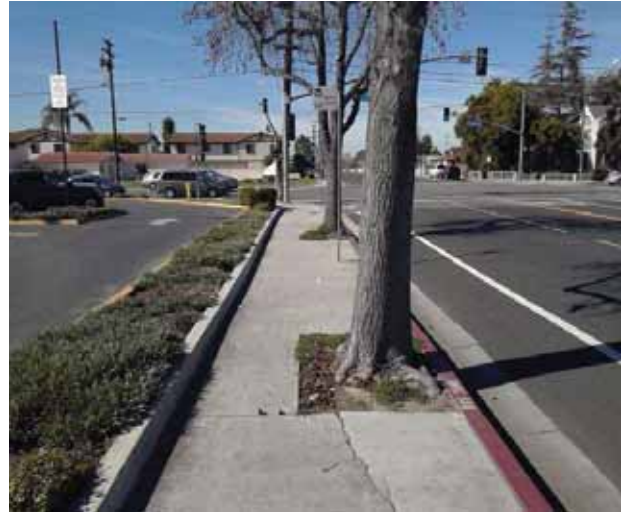
Sidewalks , Hazards & Gratings : Sidewalk Width at Obstruction

Recommendation At least 48.00 inches

Sidewalk width at the obstruction shall have the recommended value.

\$1,260

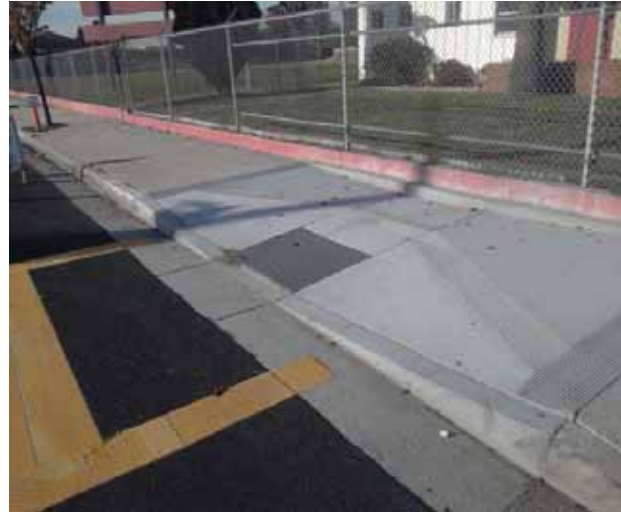
Recommendation Up to 5.00 percent

Repave landing \$1,260

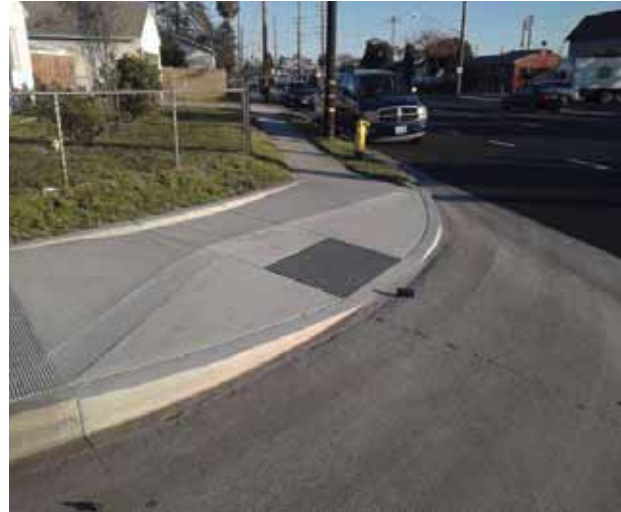
Recommendation Up to 10.00 percent

Install flared sides \$1,300

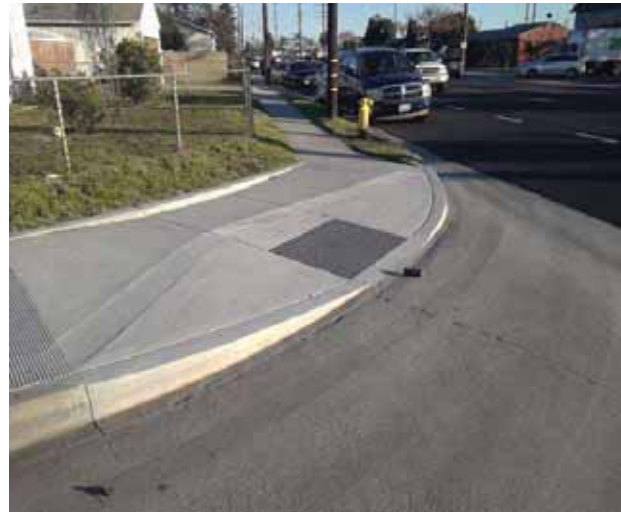
Recommendation Up to 5.00 percent

Repave landing \$1,260

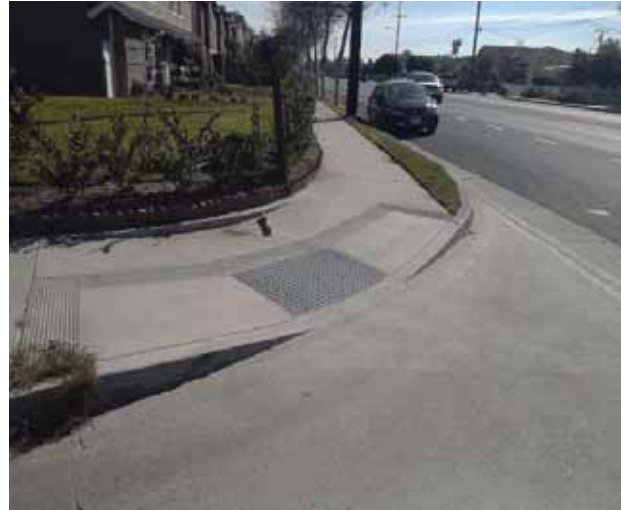
Recommendation Up to 10.00 percent

Install flared sides \$1,300

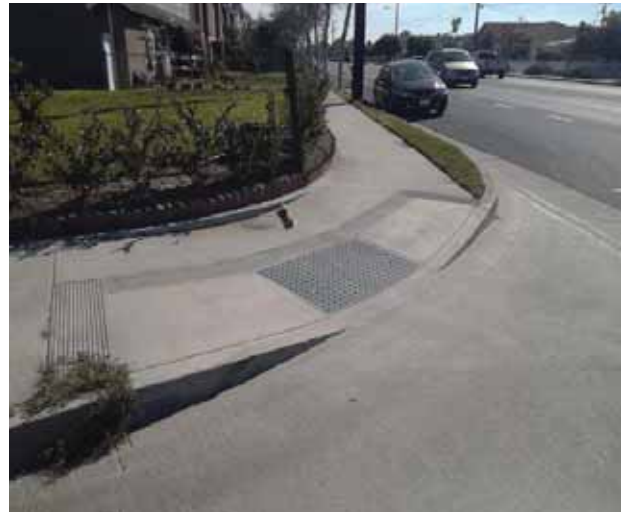
Recommendation Up to 2.08 percent

Provide compliant landing \$1,260

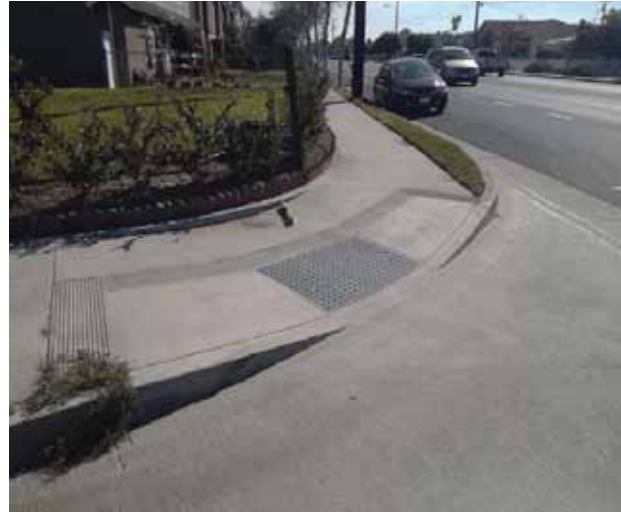
Recommendation At least 48.00 inches

Provide compliant landing \$240

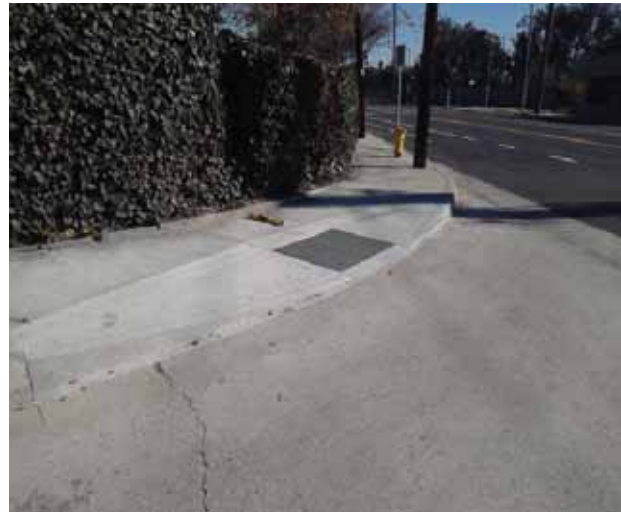
Recommendation Up to 2.08 percent

Provide compliant landing \$1,260

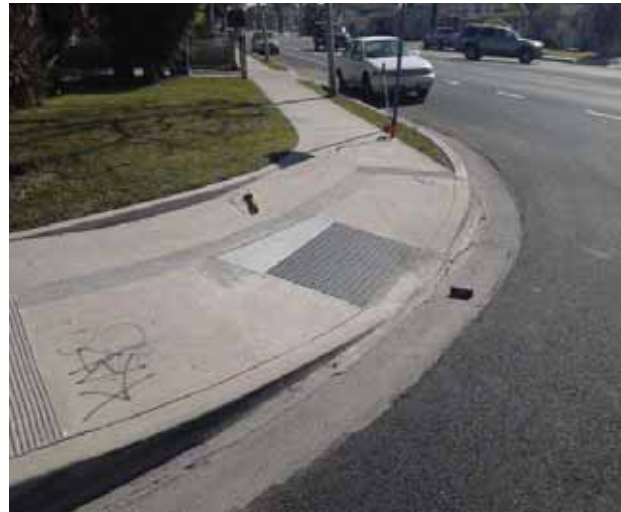
Recommendation Up to 8.33 percent

Install curb ramp \$1,300

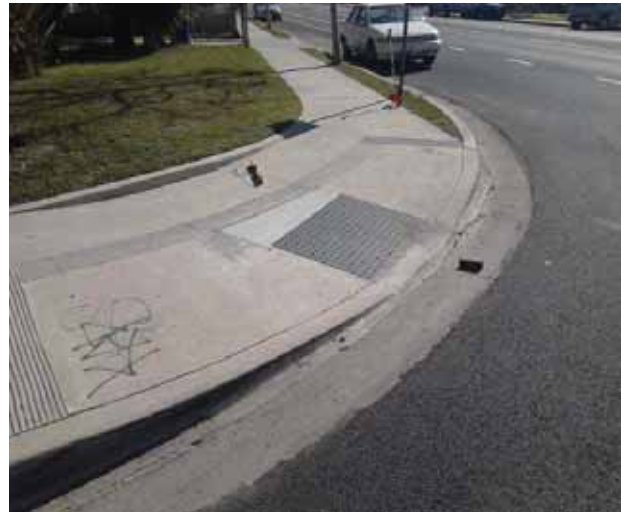
Recommendation Up to 5.00 percent

Repave landing \$1,260

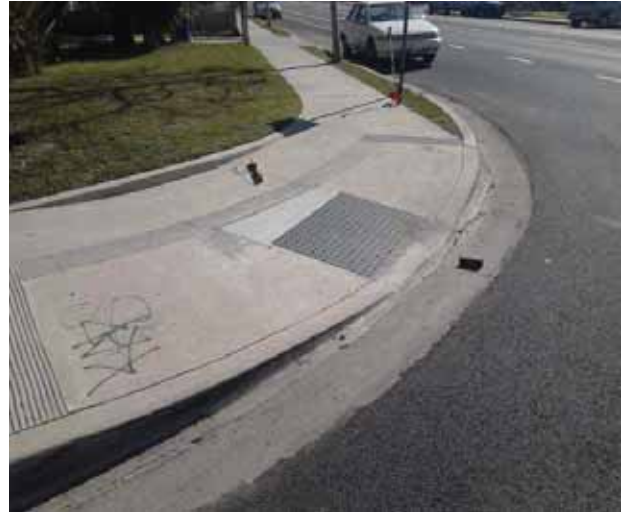
Recommendation At least 48.00 inches

Provide compliant landing \$240

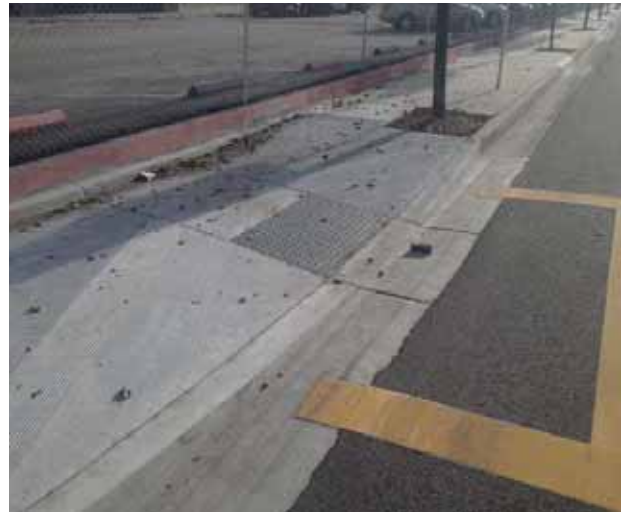
Recommendation Up to 5.00 percent

Repave landing \$1,260

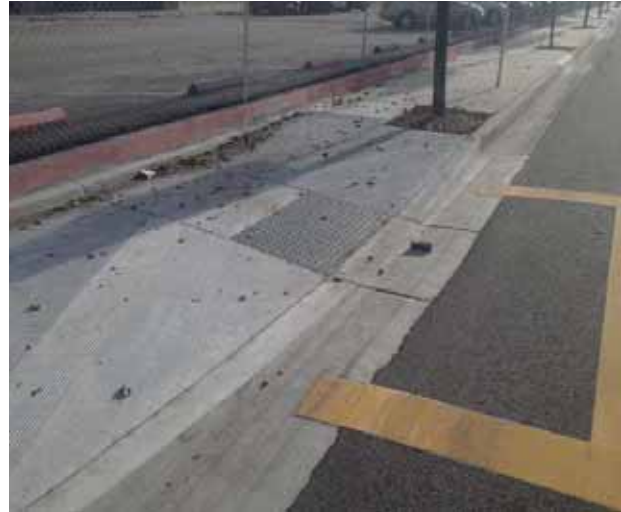
The overlayment causes a noncompliant change in level.

Recommendation 0.25 - 0.50 inches

Ensure the change in elevation is within the recommended height.

Provide smooth surface \$150

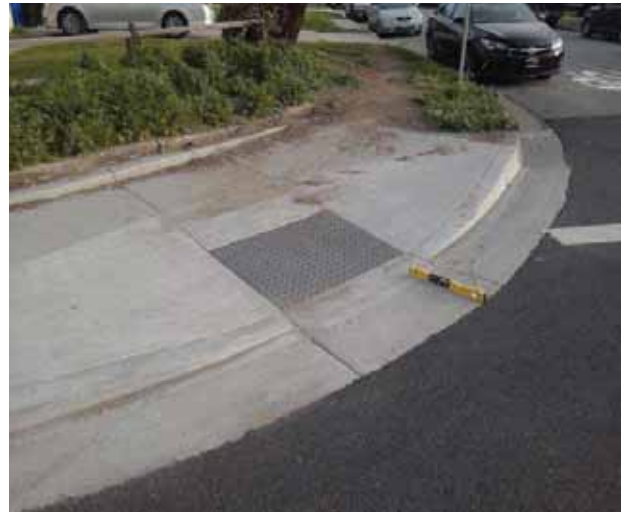
Recommendation Up to 5.00 percent

Repave landing \$1,260

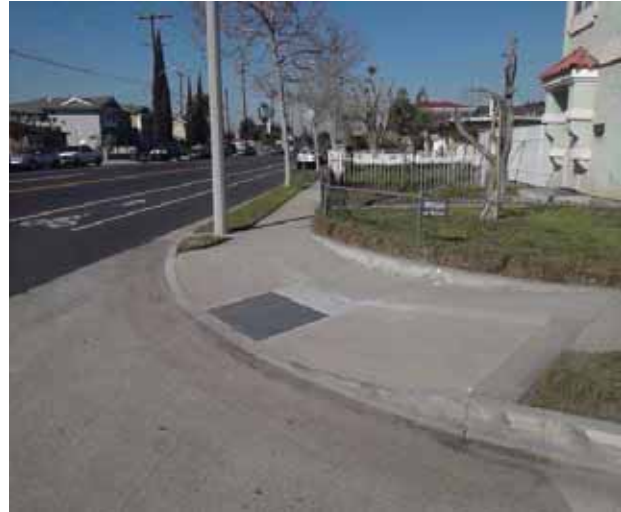
Recommendation Up to 10.00 percent

Install flared sides \$1,300

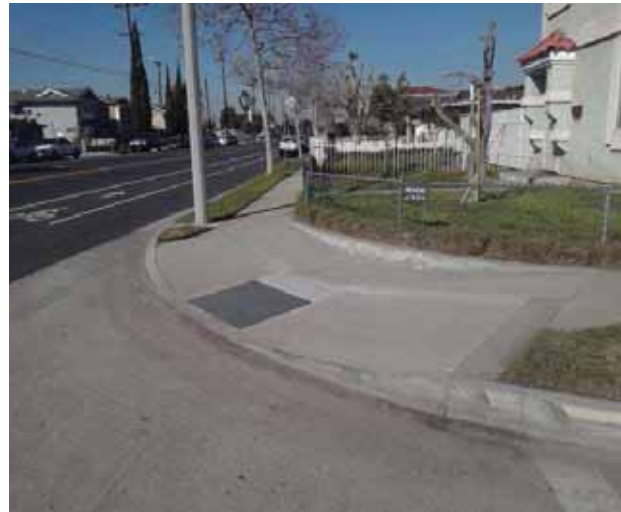
Curb Ramp , Landings and Transitions : Landing Accumulates Water - Wet Conditions

Provide compliant landing \$255

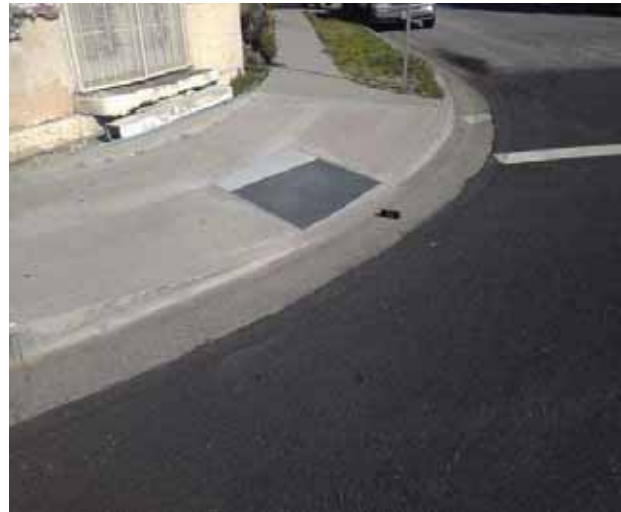
Recommendation Up to 8.33 percent

Install curb ramp \$1,300

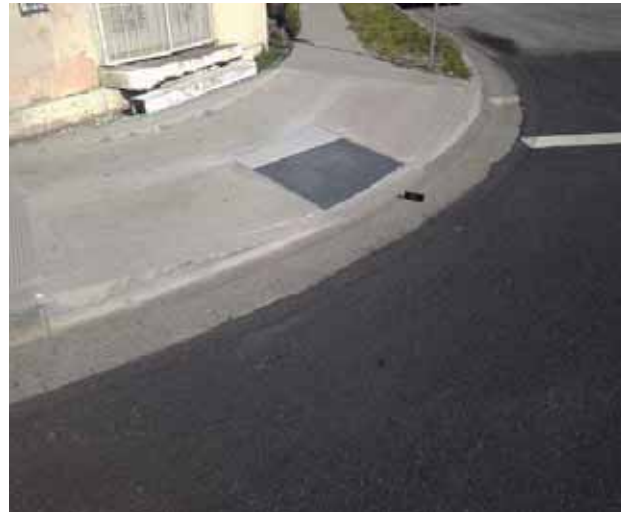
Recommendation Up to 5.00 percent

Repave landing \$1,260

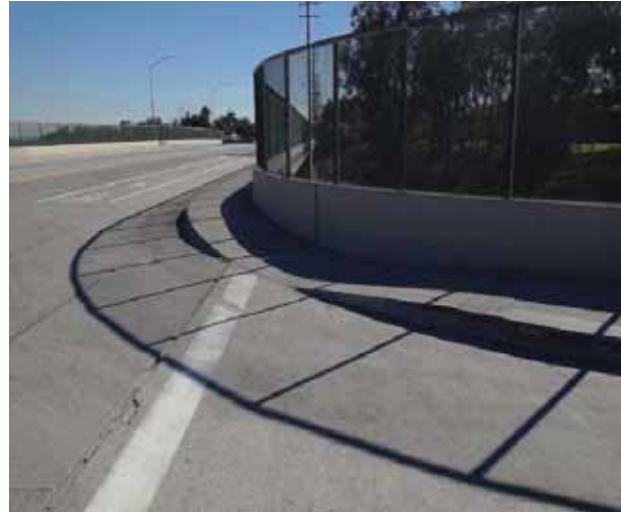
Recommendation Up to 8.33 percent

Install curb ramp \$1,300

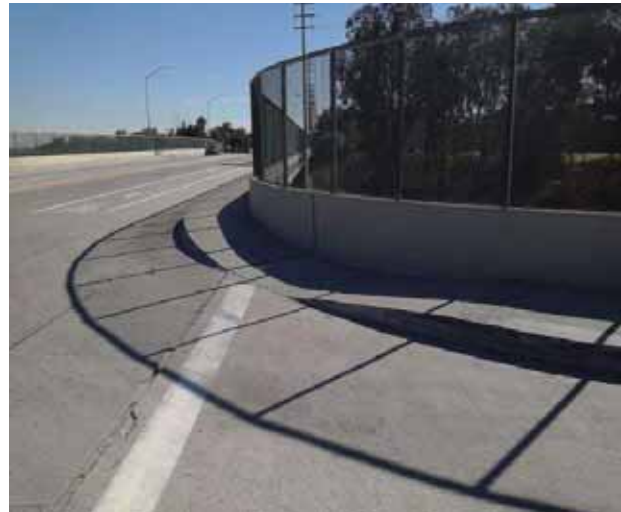
Recommendation Up to 2.08 percent

Provide compliant landing \$240

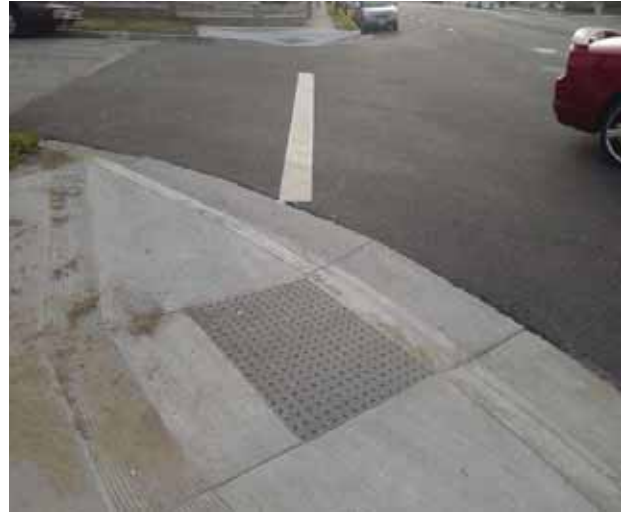
Recommendation Up to 2.08 percent

Repave surface \$1,092

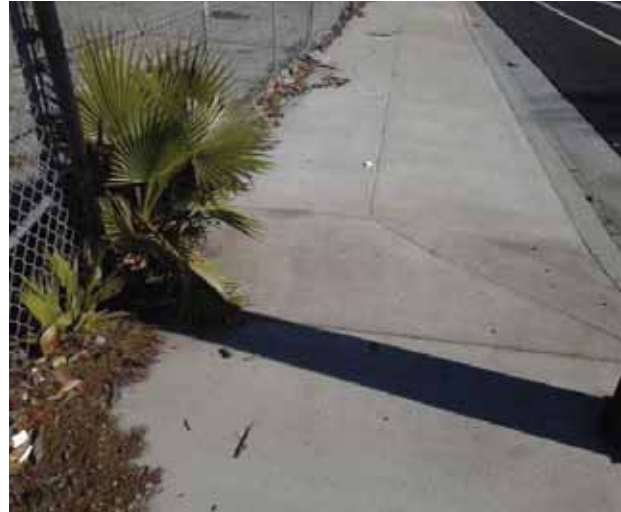
Sidewalks , Hazards & Gratings : Sidewalk Width at Obstruction

Recommendation At least 48.00 inches

Sidewalk width at the obstruction shall have the recommended value.

\$1,260

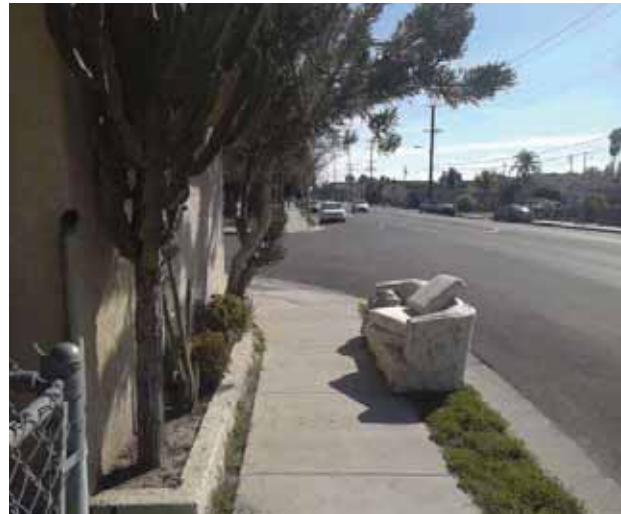
Sidewalks , Hazards & Gratings : Overhead Obstruction Height

Recommendation At least 80.00 inches

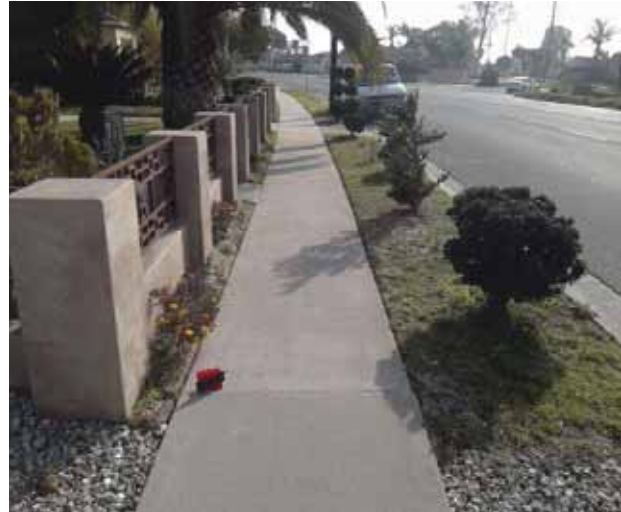
There is a change in elevation greater than recommended value.

Recommendation Up to 0.50 inches

Remove tripping hazards \$198

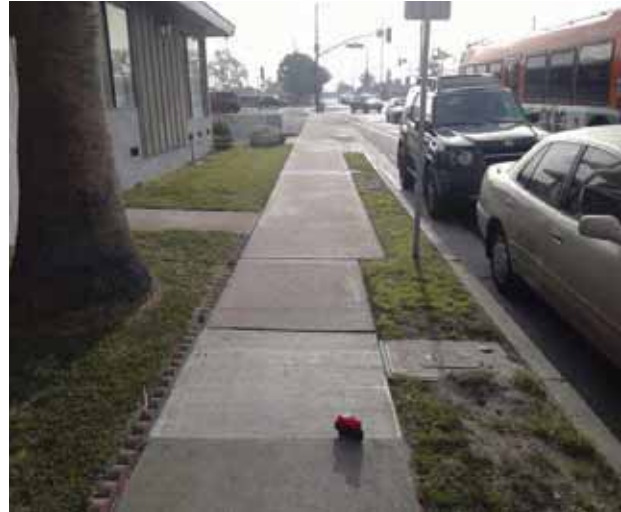
There is a change in elevation greater than recommended value.

Ensure that the change in elevation is within the recommended value.

Recommendation Up to 0.25 inches

Remove tripping hazards \$198

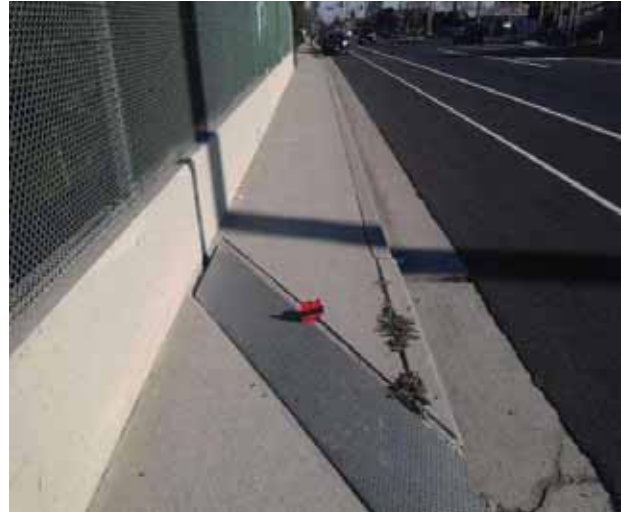
There is a change in elevation greater than recommended value.

Ensure that the change in elevation is within the recommended value.

Recommendation Up to 0.25 inches

Remove tripping hazards \$198

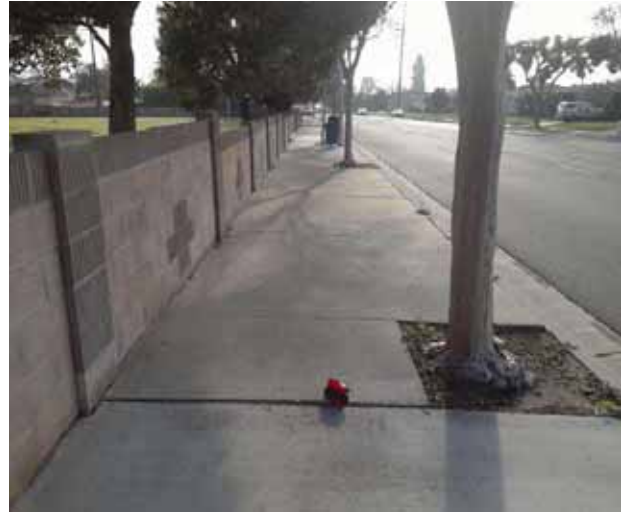
There is a change in elevation greater than recommended value.

Ensure that the change in elevation is within the recommended value.

Recommendation Up to 0.25 inches

Remove tripping hazards \$198

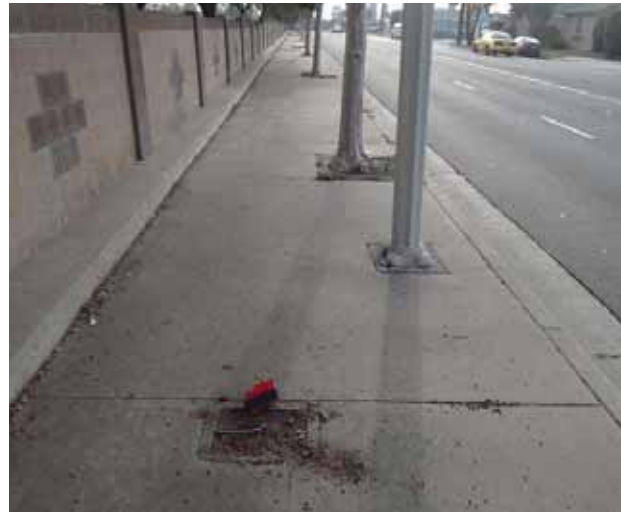
There is a change in elevation greater than recommended value.

Recommendation Up to 0.50 inches

Remove tripping hazards \$198

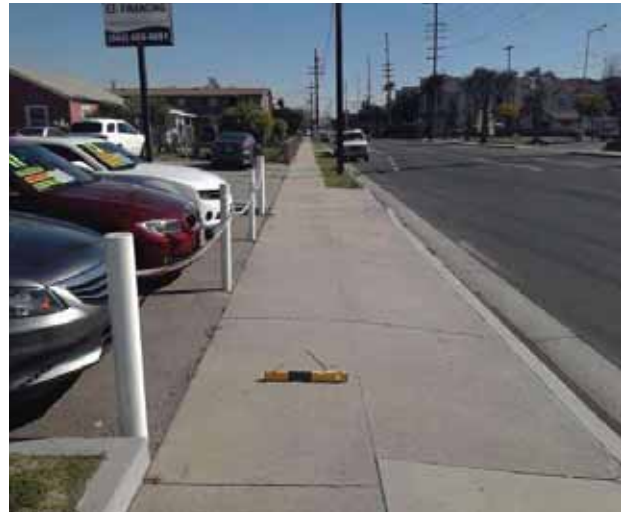
On-Site Finding Not Found

Install compliant detectable warnings \$190

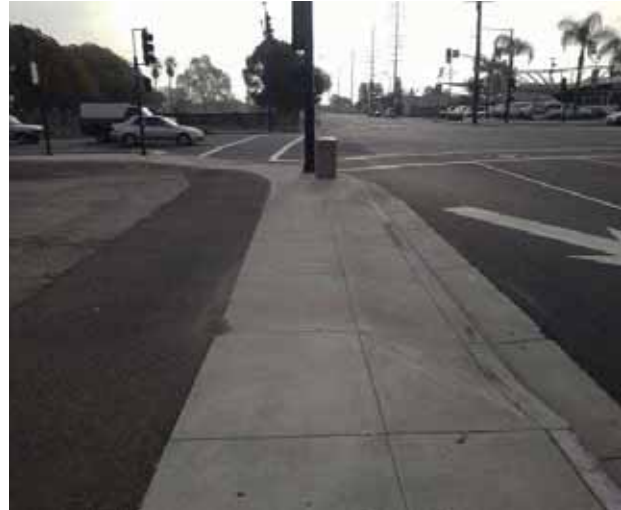
On-Site Finding Not Found

Install compliant detectable warnings \$190

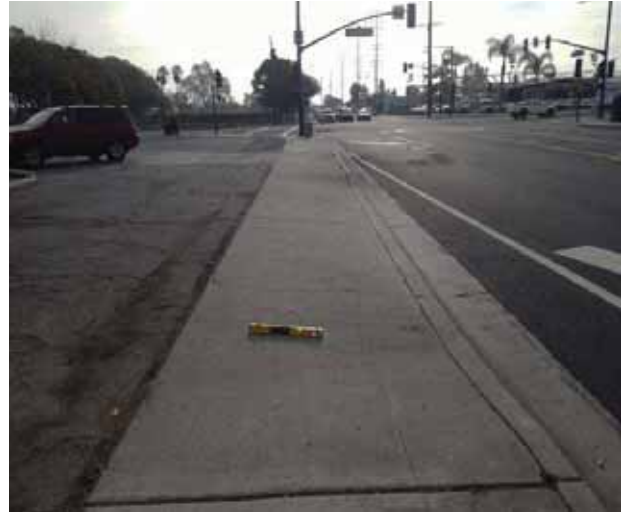
On-Site Finding Not Found

Install compliant detectable warnings \$190

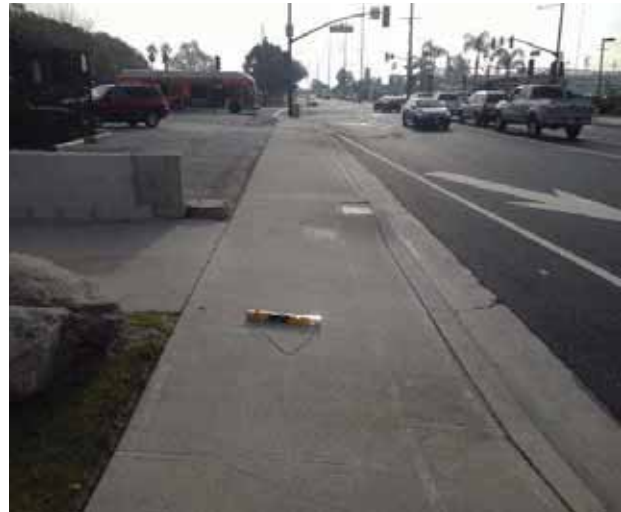
On-Site Finding Not Found

Install compliant detectable warnings \$190

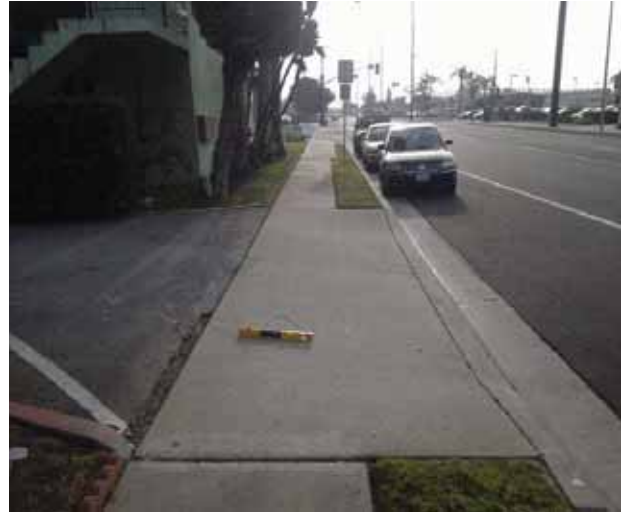
On-Site Finding Not Found

Install compliant detectable warnings \$190

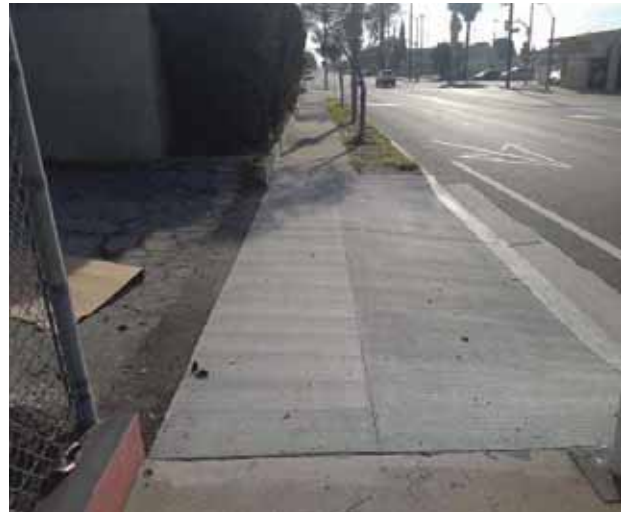
On-Site Finding Not Found

Install compliant detectable warnings \$190

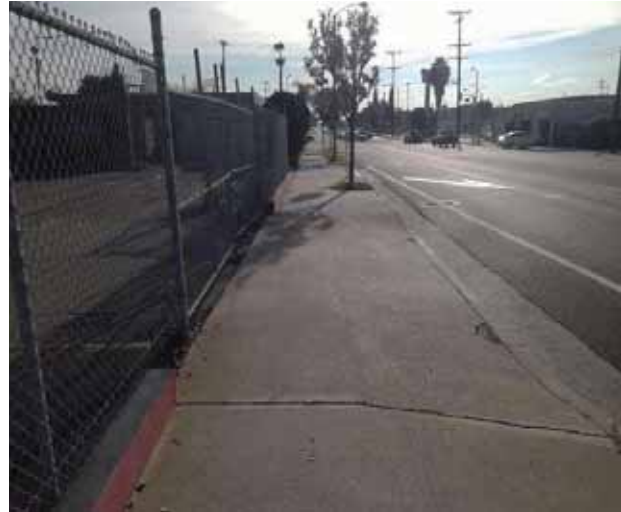
On-Site Finding Not Found

Install compliant detectable warnings \$190

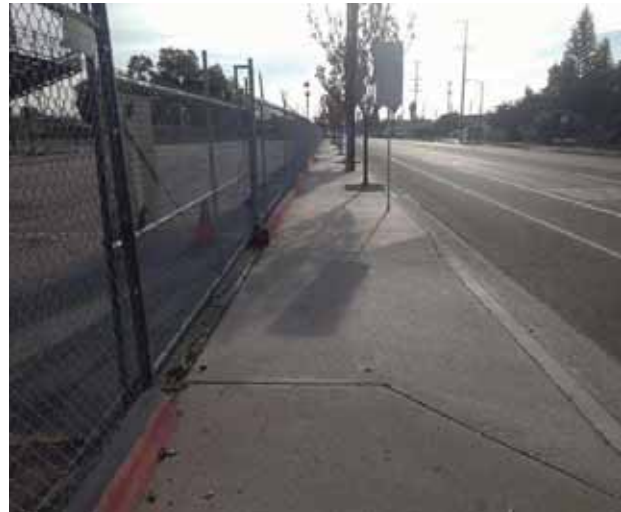
On-Site Finding Not Found

Install compliant detectable warnings \$190

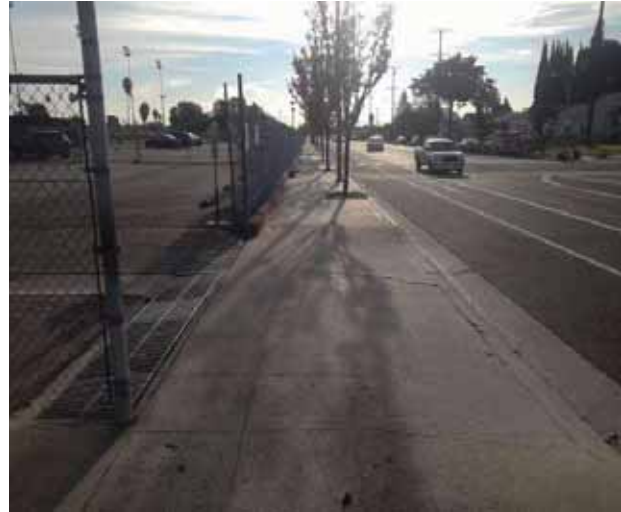
On-Site Finding Not Found

Install compliant detectable warnings \$190

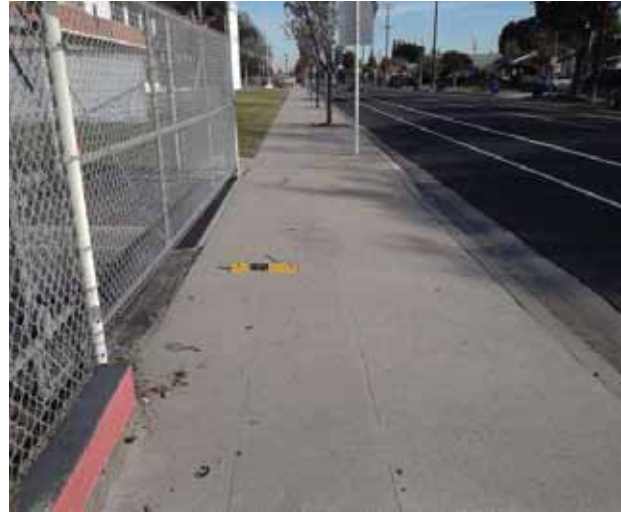
On-Site Finding Not Found

Install compliant detectable warnings \$190

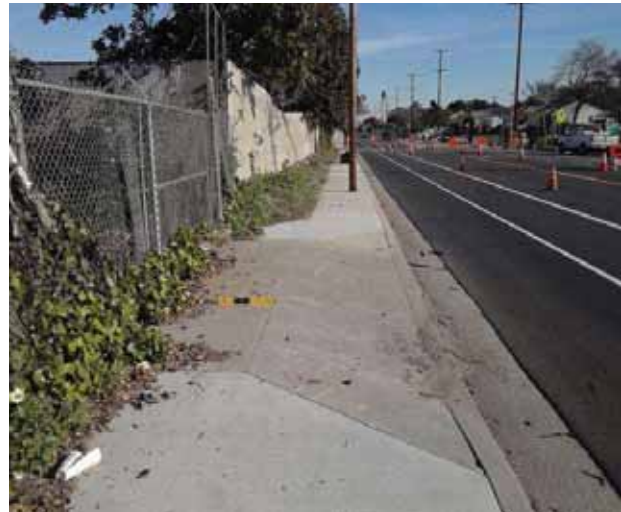
On-Site Finding Not Found

Install compliant detectable warnings \$190

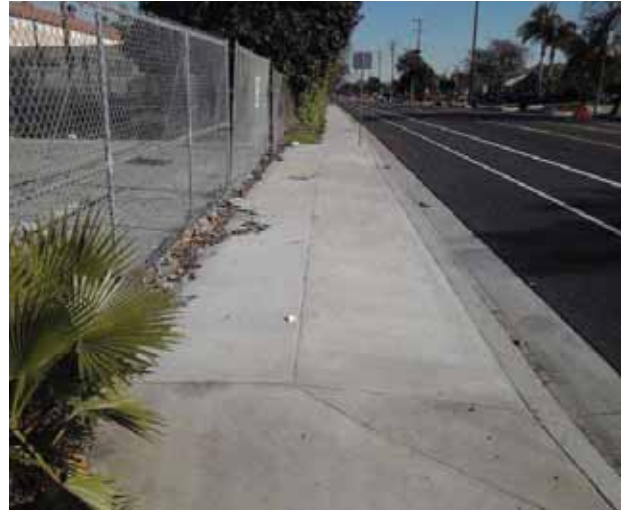
On-Site Finding Not Found

Install compliant detectable warnings \$190

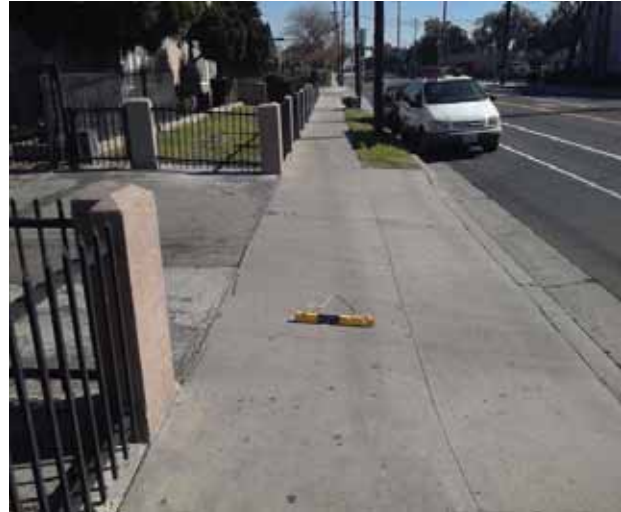
On-Site Finding Not Found

Install compliant detectable warnings \$190

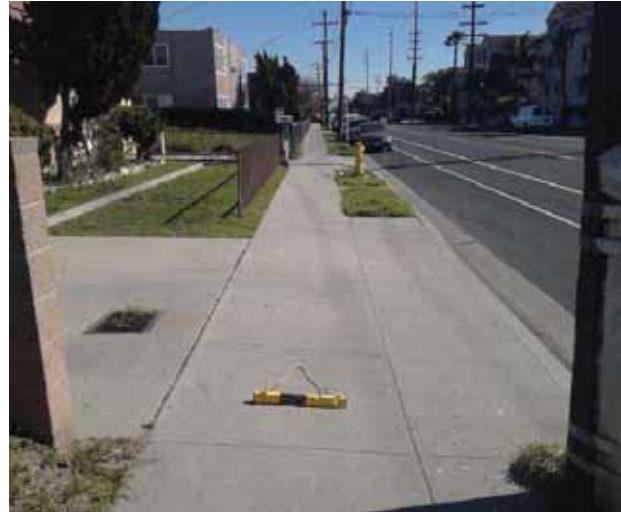
On-Site Finding Not Found

Install compliant detectable warnings \$190

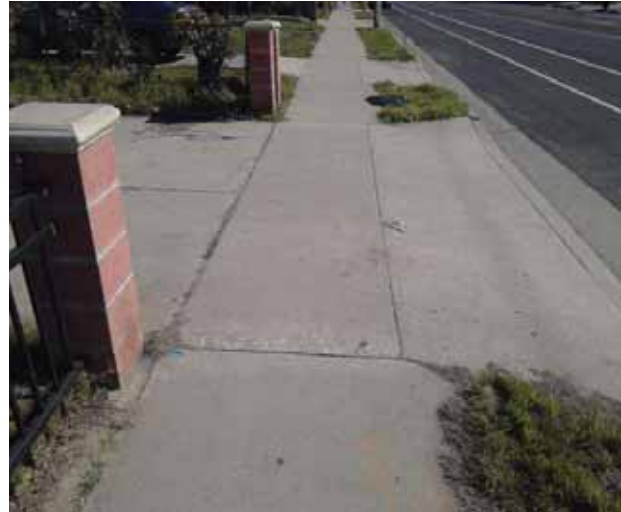
On-Site Finding Not Found

Install compliant detectable warnings \$190

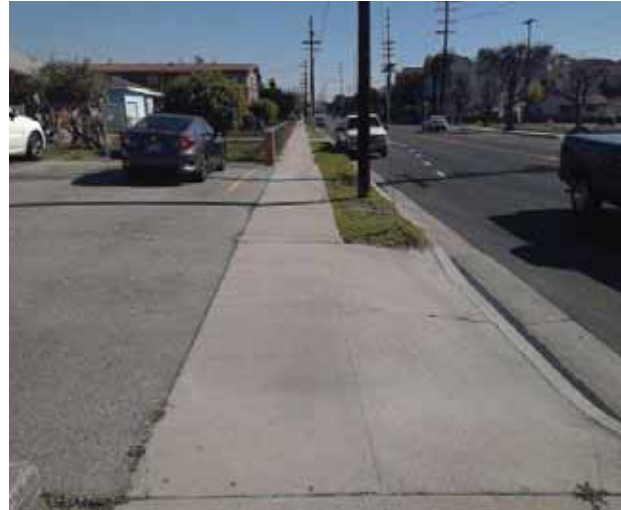
On-Site Finding Not Found

Install compliant detectable warnings \$190

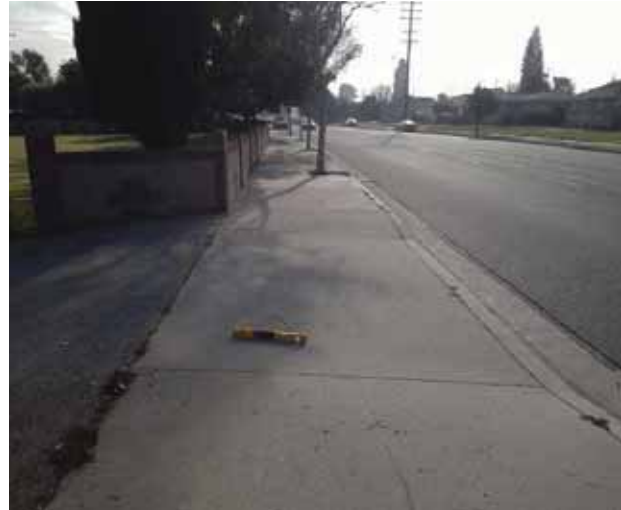
On-Site Finding Not Found

Install compliant detectable warnings \$190

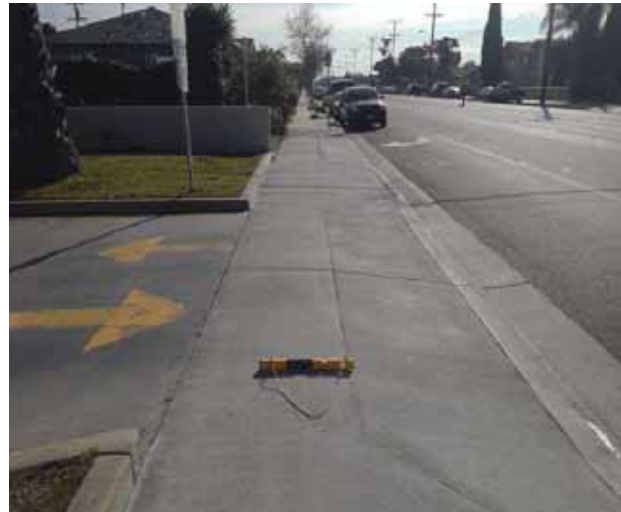
On-Site Finding Not Found

Install compliant detectable warnings \$190

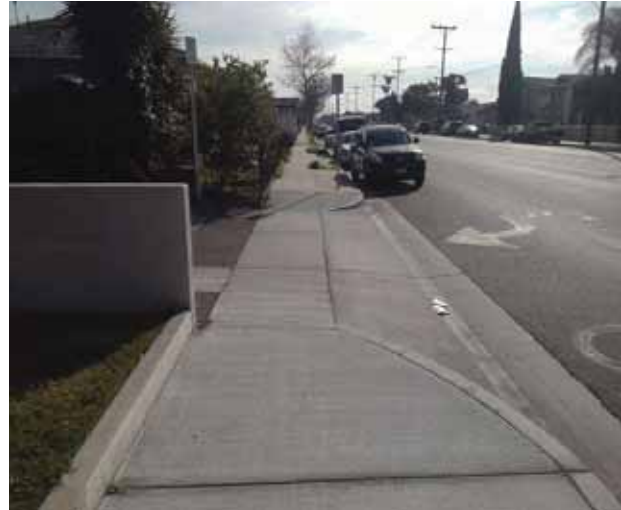
On-Site Finding Not Found

Install compliant detectable warnings \$190

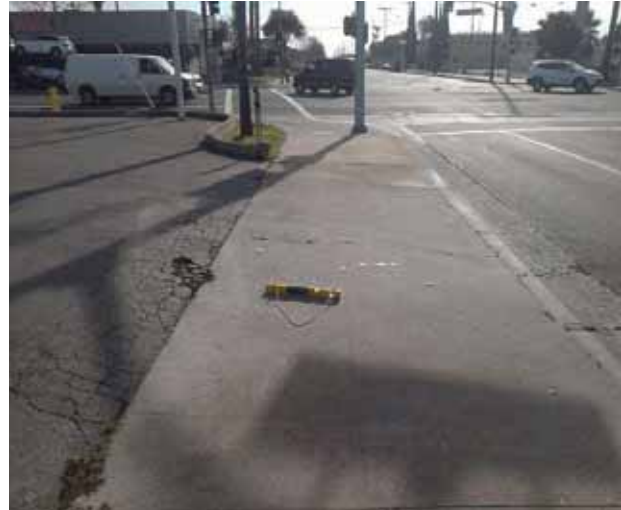
On-Site Finding Not Found

Install compliant detectable warnings \$190

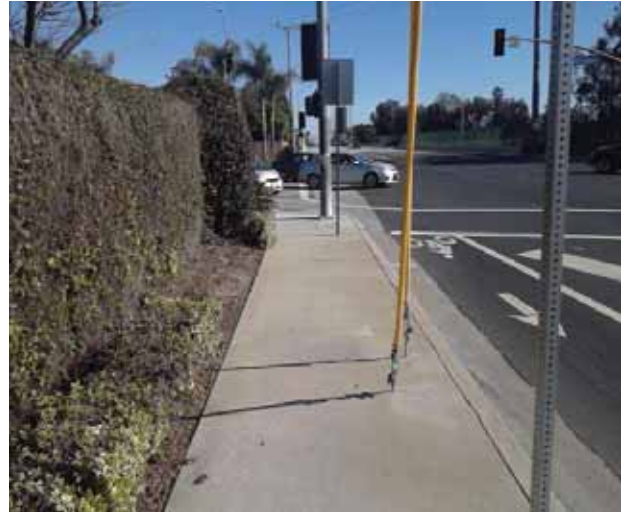
Sidewalks , Hazards & Gratings : Overhead Obstruction Height

Recommendation At least 80.00 inches

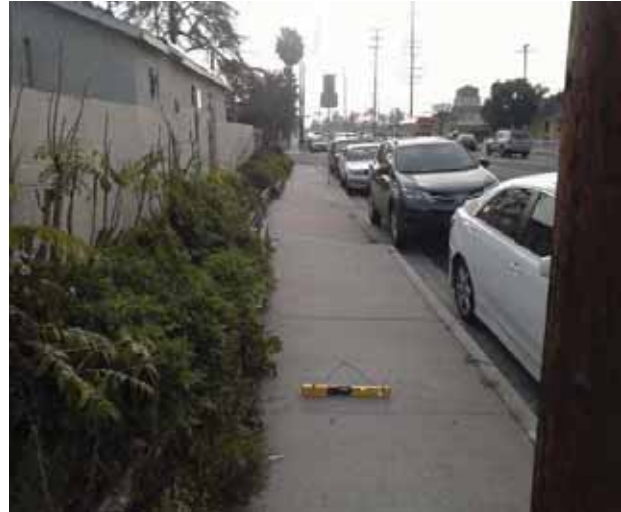
Code Reference ADA 206, 302,CA 11B-403.3

Costing Info (Estimated)

Repave surface \$1,092
