Accessibility Survey

City of Downey Gardendale Street & Barlin Avenue

Date of Inspection
2/2/2017

Prepared By
Disability Access Consultants
(800) 743-7067

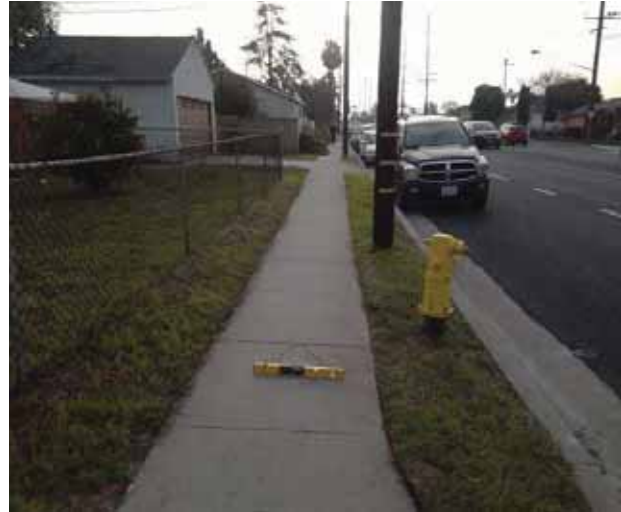
Code Reference ADA 206, 302, CA 11B-403.3

Repave the sidewalk surface with the recommended cross slope.

Recommendation Up to 2.08 percent

Repave surface \$1,092

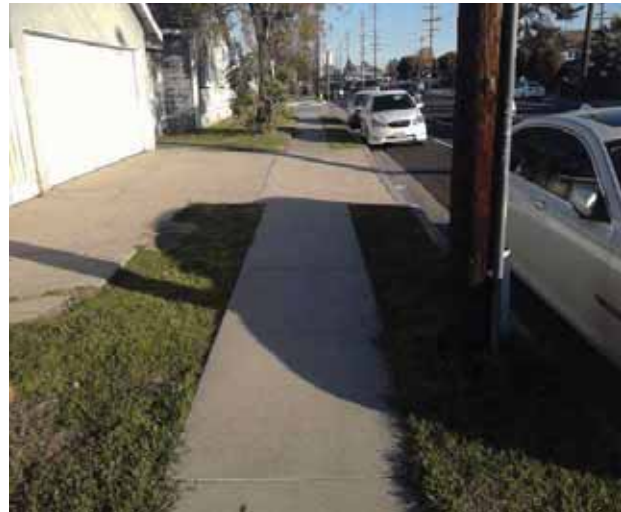
Code Reference ADA 206, 302

Recommendation See Recommendation

\$1,260

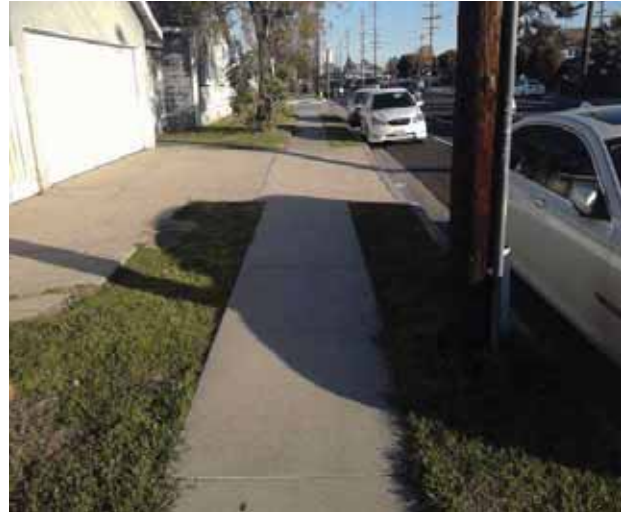
Code Reference ADA 206, 302, CA 11B-403.3

Repave the sidewalk surface with the recommended cross slope.

Recommendation Up to 2.08 percent

Repave surface \$1,092

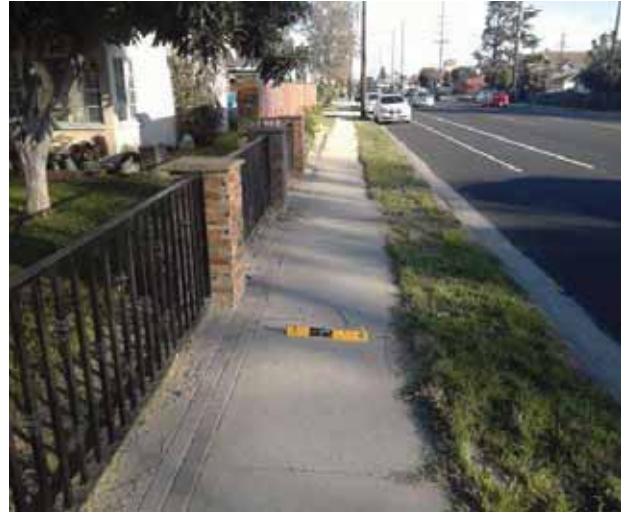
Code Reference ADA 206, 302

Recommendation See Recommendation

\$1,260

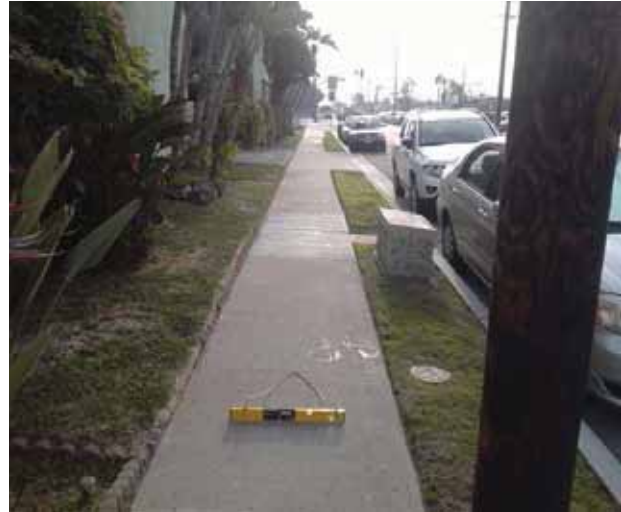
Code Reference ADA 206, 302,CA 11B-403.3

Repave the sidewalk surface with the recommended cross slope.

Recommendation Up to 2.08 percent

Repave surface \$1,092

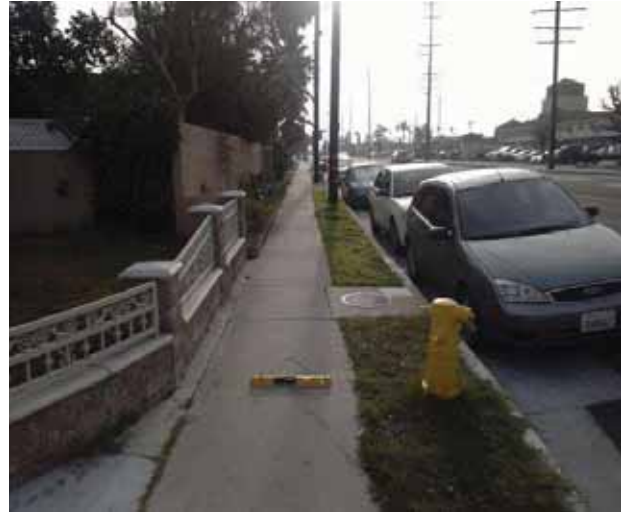
Code Reference ADA 206, 302, CA 11B-403.5.1

Widen the sidewalk to the recommended value.

Recommendation At least 48.00 inches

\$1,260

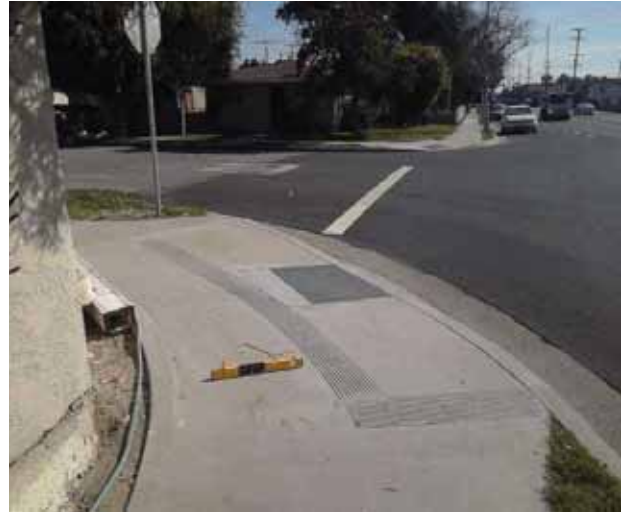
Code Reference ADA 206, 302,CA 11B-403.5.1

Widen the sidewalk to the recommended value.

Recommendation At least 48.00 inches

\$1,260

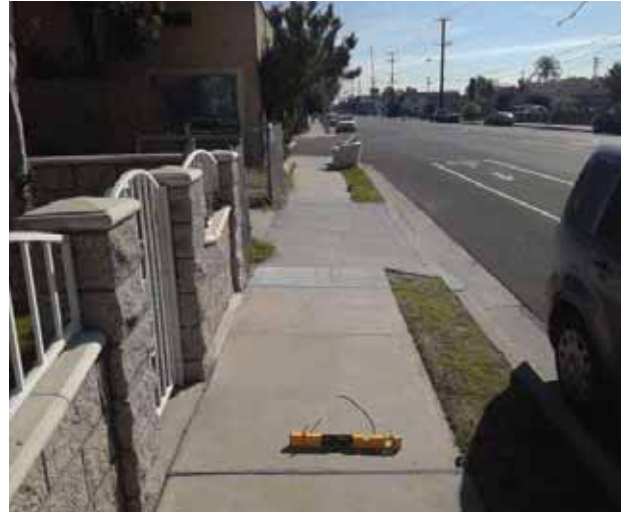
Code Reference ADA 206, 302, CA 11B-403.3

Repave the sidewalk surface with the recommended cross slope.

Recommendation Up to 2.08 percent

Repave surface \$1,092

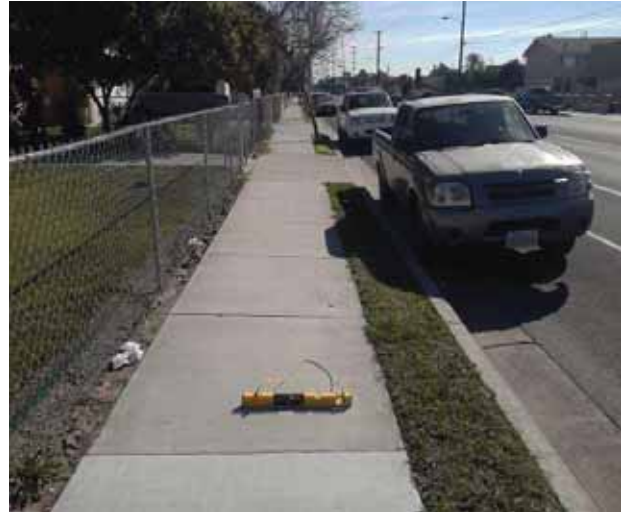
Code Reference ADA 206, 302, CA 11B-403.3

Repave the sidewalk surface with the recommended cross slope.

Recommendation Up to 2.08 percent

Repave surface \$1,092

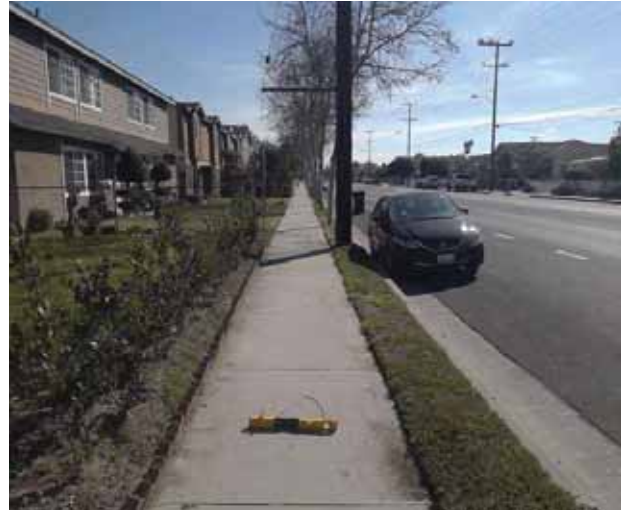
Code Reference ADA 206, 302,CA 11B-403.3

Repave the sidewalk surface with the recommended cross slope.

Recommendation Up to 2.08 percent

Repave surface \$1,092

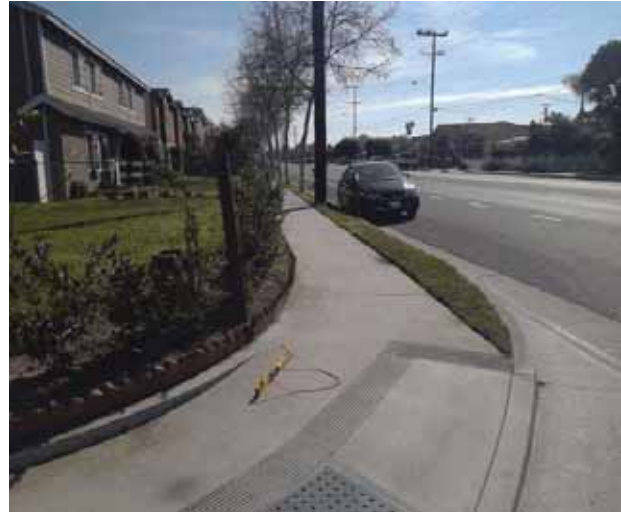
Code Reference ADA 206, 302

Repave the sidewalk surface with the recommended running slope.

Recommendation Up to 5.00 percent

Repave surface \$1,184

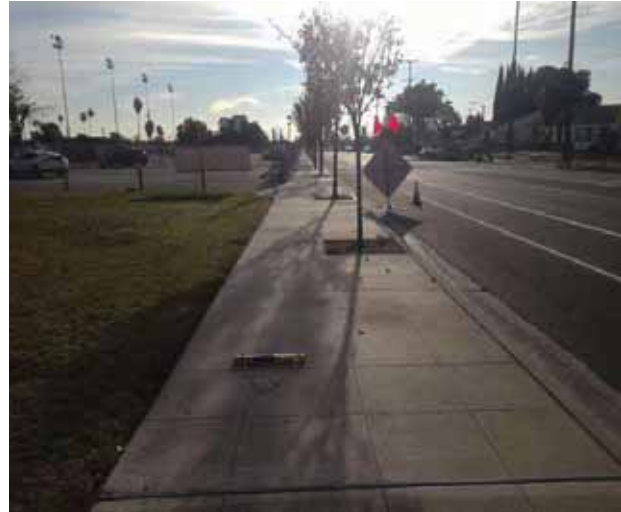
Code Reference ADA 206, 302, CA 11B-403.3

Repave the sidewalk surface with the recommended cross slope.

Recommendation Up to 2.08 percent

Repave surface \$1,092

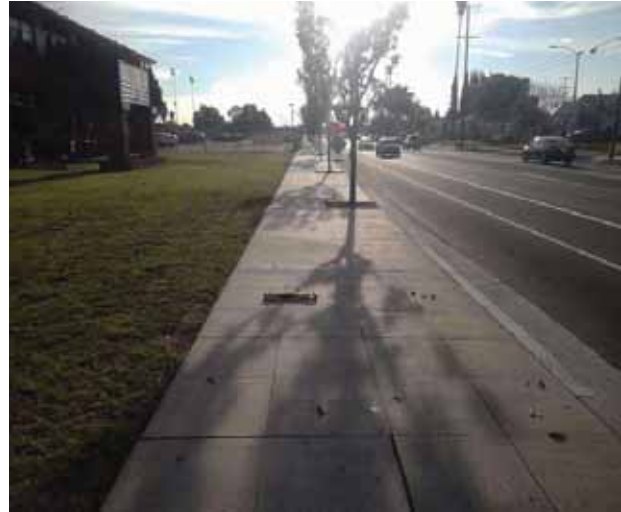
Code Reference ADA 206, 302, CA 11B-403.3

Repave the sidewalk surface with the recommended cross slope.

Recommendation Up to 2.08 percent

Repave surface \$1,092

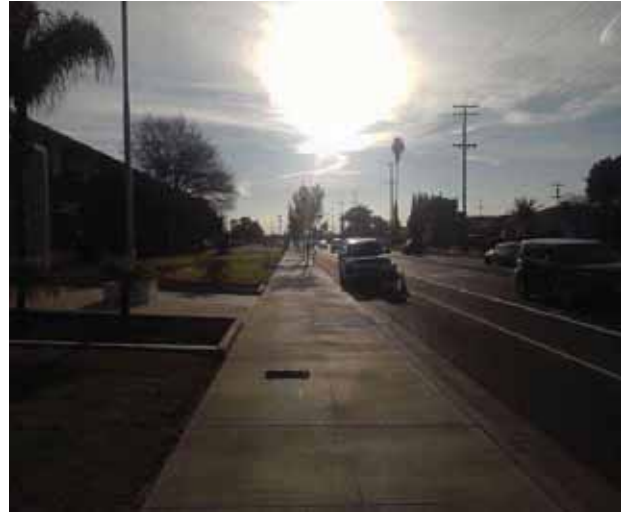
Code Reference ADA 206, 302,CA 11B-403.3

Repave the sidewalk surface with the recommended cross slope.

Recommendation Up to 2.08 percent

Repave surface \$1,092

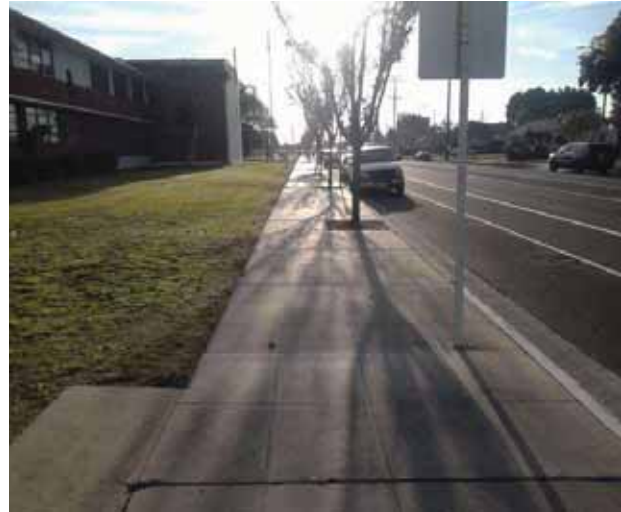
Code Reference ADA 302

Recommendation See Recommendation

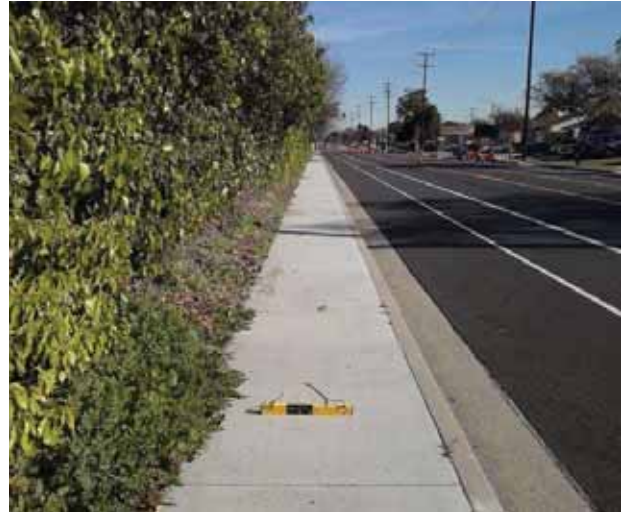
Code Reference ADA 206, 302, CA 11B-403.3

Repave the sidewalk surface with the recommended cross slope.

Recommendation Up to 2.08 percent

Repave surface \$1,092

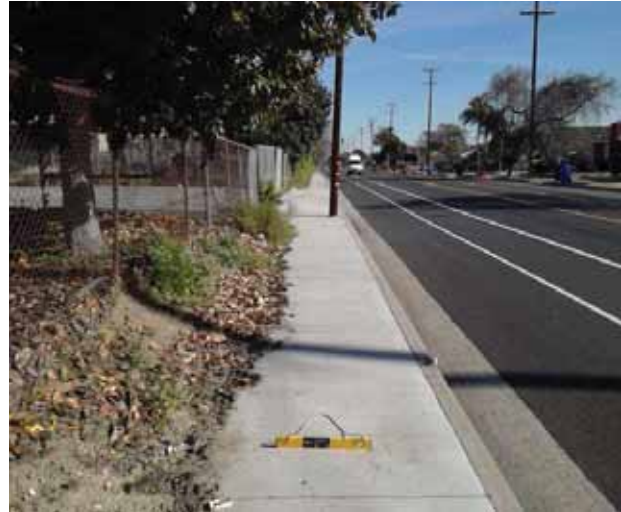
Code Reference ADA 206, 302,CA 11B-403.3

Repave the sidewalk surface with the recommended cross slope.

Recommendation Up to 2.08 percent

Repave surface \$1,092

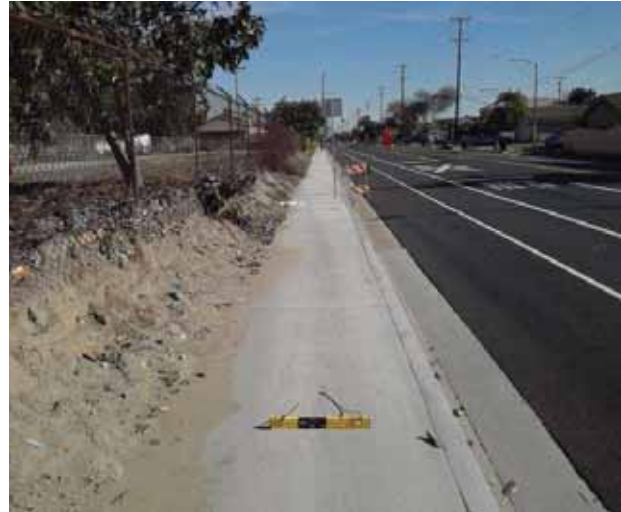
Code Reference ADA 206, 302, CA 11B-403.3

Repave the sidewalk surface with the recommended cross slope.

Recommendation Up to 2.08 percent

Repave surface \$1,092

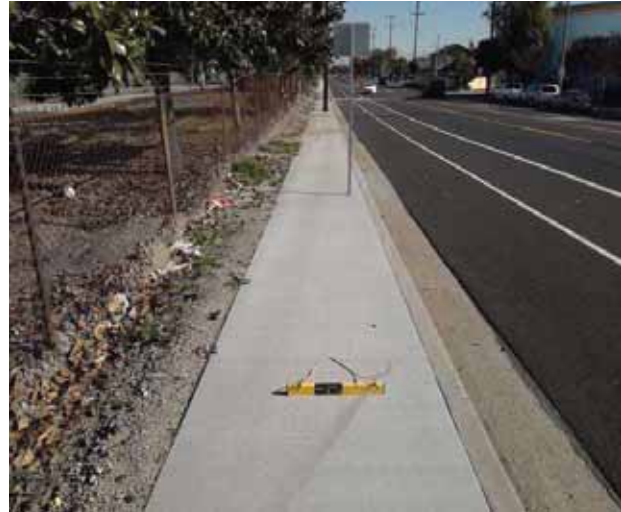
Code Reference ADA 206, 302,CA 11B-403.3

Repave the sidewalk surface with the recommended cross slope.

Recommendation Up to 2.08 percent

Repave surface \$1,092

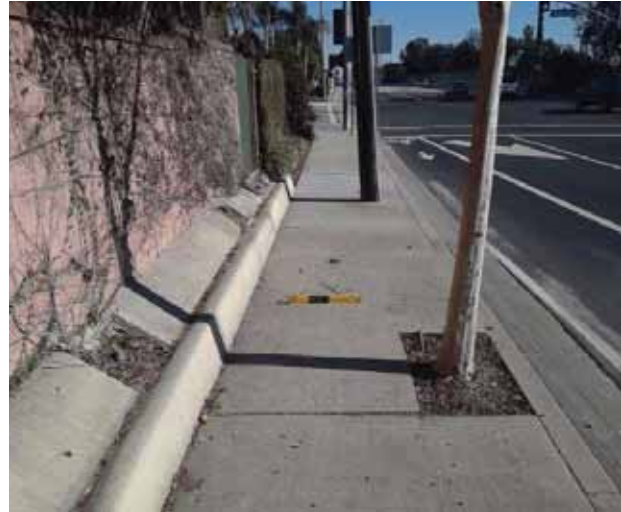
Code Reference ADA 206, 302, CA 11B-403.5.1

Widen the sidewalk to the recommended value.

Recommendation At least 48.00 inches

\$1,260

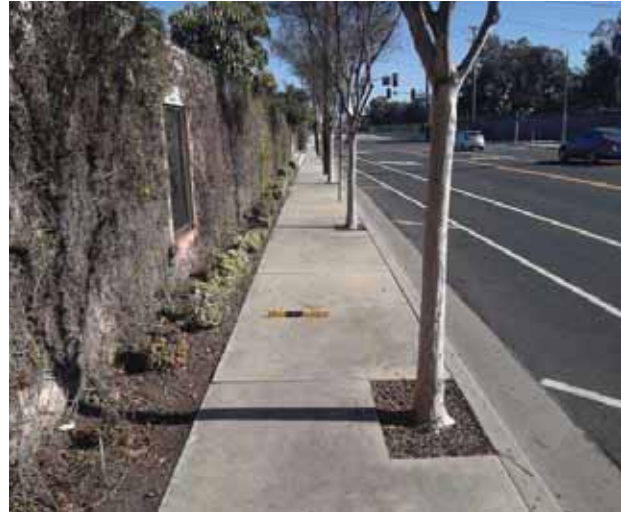
Code Reference ADA 206, 302, CA 11B-403.5.1

Widen the sidewalk to the recommended value.

Recommendation At least 48.00 inches

\$1,260

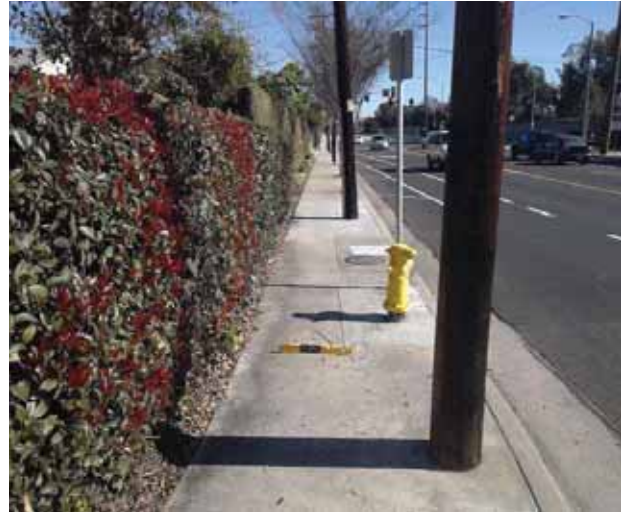
Code Reference ADA 206, 302,CA 11B-403.3

Repave the sidewalk surface with the recommended cross slope.

Recommendation Up to 2.08 percent

Repave surface \$1,092

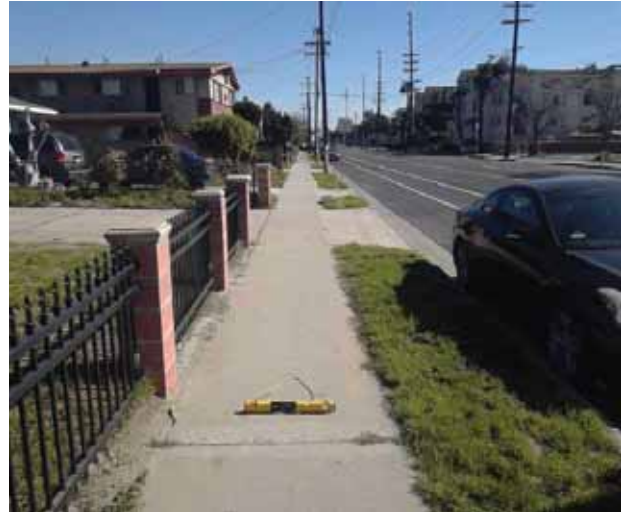
Code Reference ADA 206, 302,CA 11B-403.3

Repave the sidewalk surface with the recommended cross slope.

Recommendation Up to 2.08 percent

Repave surface \$1,092

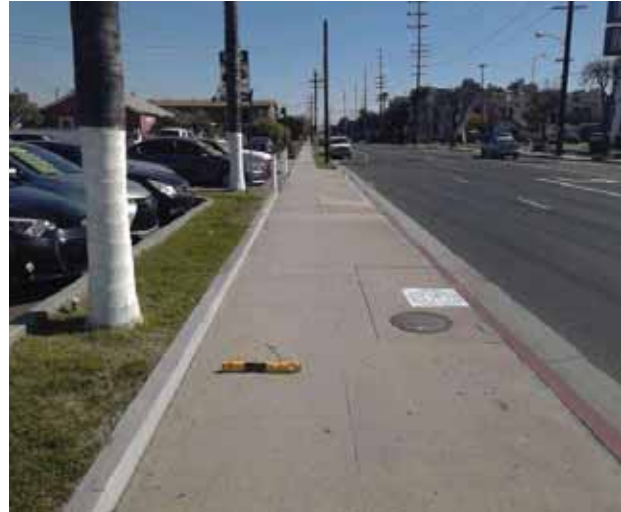
Code Reference ADA 206, 302, CA 11B-403.3

Repave the sidewalk surface with the recommended cross slope.

Recommendation Up to 2.08 percent

Repave surface \$1,092

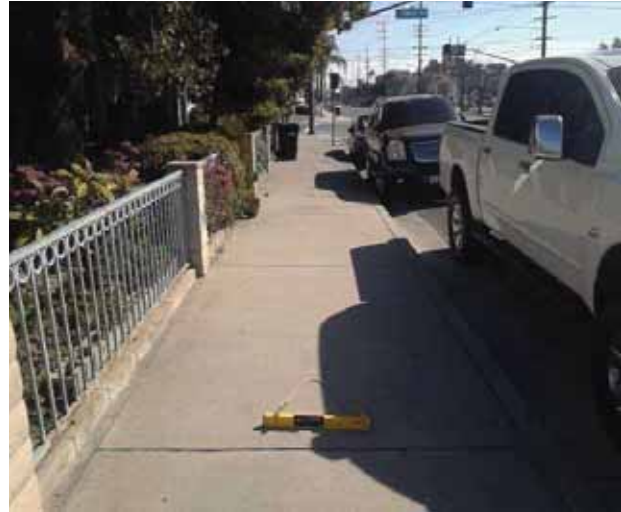
Code Reference ADA 206, 302, CA 11B-403.3

Repave the sidewalk surface with the recommended cross slope.

Recommendation Up to 2.08 percent

Repave surface \$1,092

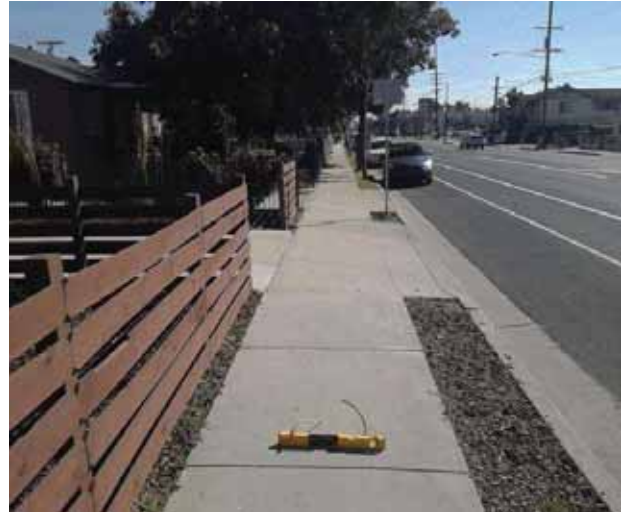
Code Reference ADA 206, 302,CA 11B-403.3

Repave the sidewalk surface with the recommended cross slope.

Recommendation Up to 2.08 percent

Repave surface \$1,092

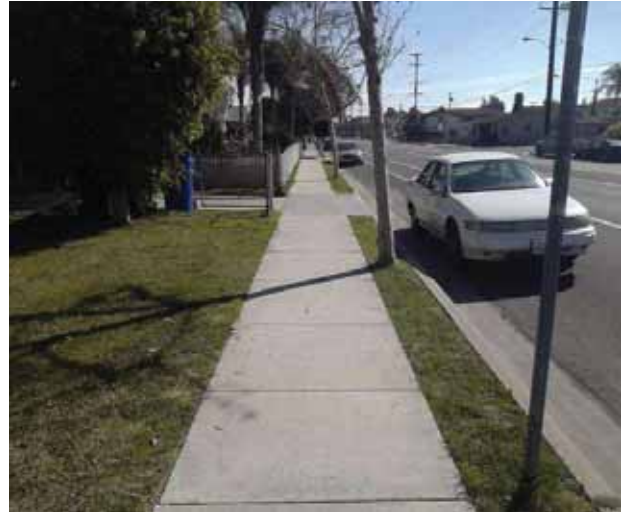
Code Reference ADA 206, 302,CA 11B-403.3

Repave the sidewalk surface with the recommended cross slope.

Recommendation Up to 2.08 percent

Repave surface \$1,092

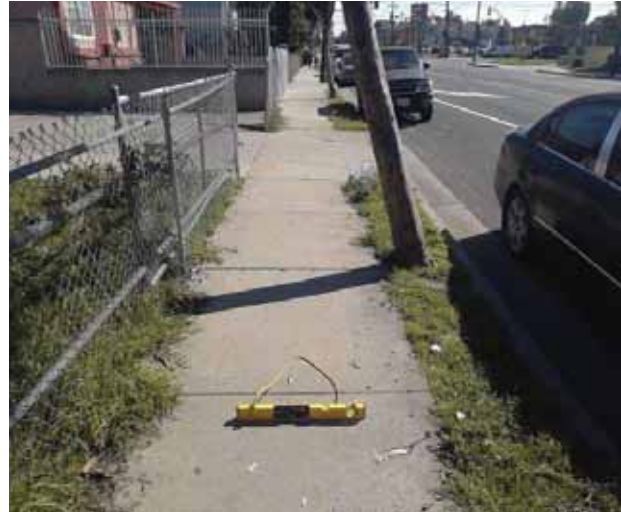
Code Reference ADA 206, 302, CA 11B-403.3

Repave the sidewalk surface with the recommended cross slope.

Recommendation Up to 2.08 percent

Repave surface \$1,092

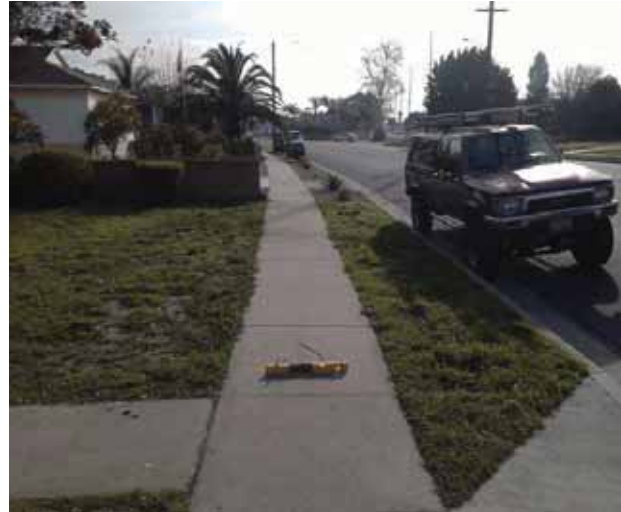
Code Reference ADA 206, 302, CA 11B-403.3

Repave the sidewalk surface with the recommended cross slope.

Recommendation Up to 2.08 percent

Repave surface \$1,092

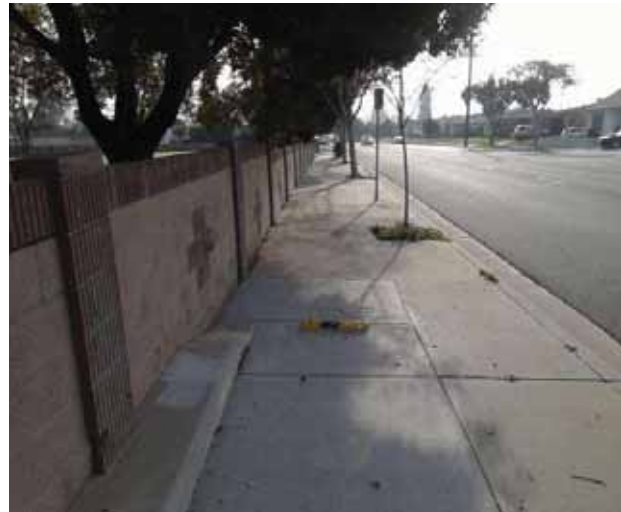
Code Reference ADA 206, 302,CA 11B-403.3

Repave the sidewalk surface with the recommended cross slope.

Recommendation Up to 2.08 percent

Repave surface \$1,092

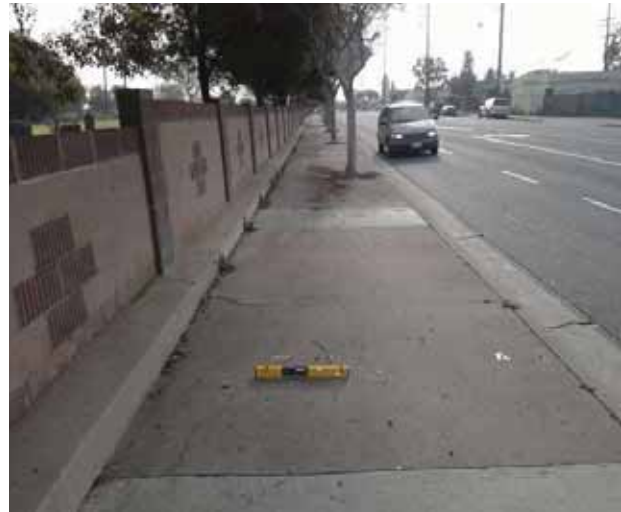
Code Reference ADA 206, 302, CA 11B-403.3

Repave the sidewalk surface with the recommended cross slope.

Recommendation Up to 2.08 percent

Repave surface \$1,092

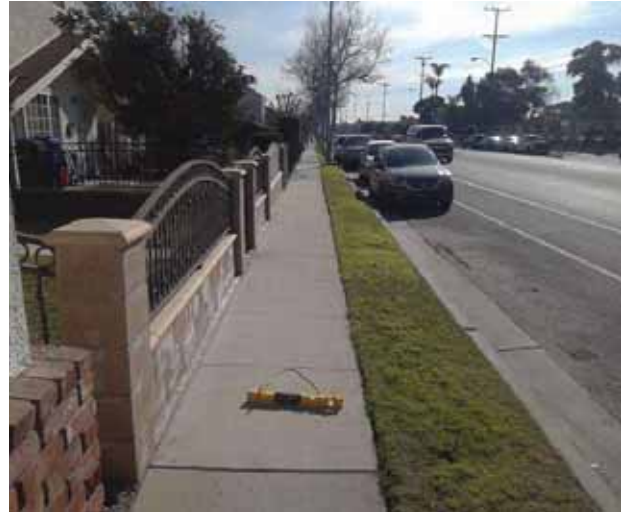
Code Reference ADA 206, 302, CA 11B-403.3

Repave the sidewalk surface with the recommended cross slope.

Recommendation Up to 2.08 percent

Repave surface \$1,092

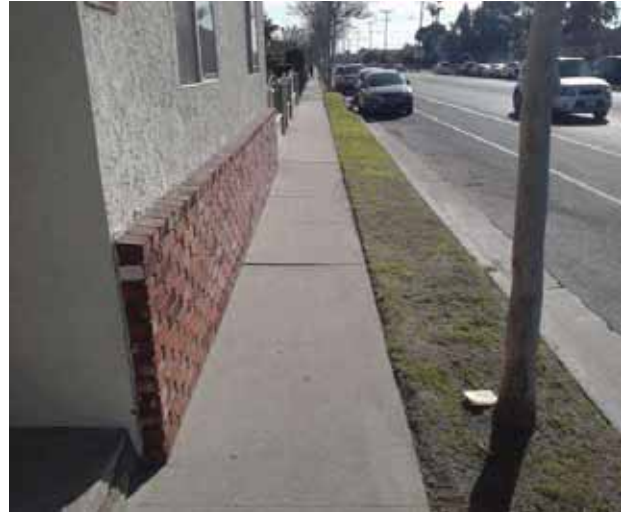
Code Reference ADA 206, 302, CA 11B-403.5.1

Widen the sidewalk to the recommended value.

Recommendation At least 48.00 inches

\$1,260

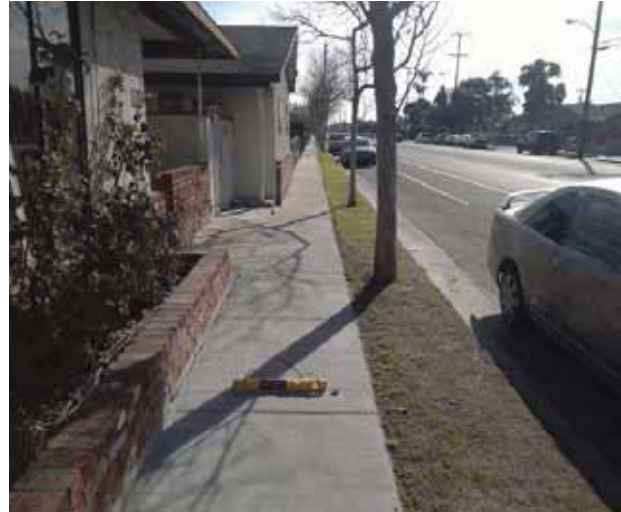
Code Reference ADA 206, 302,CA 11B-403.3

Repave the sidewalk surface with the recommended cross slope.

Recommendation Up to 2.08 percent

Repave surface \$1,092

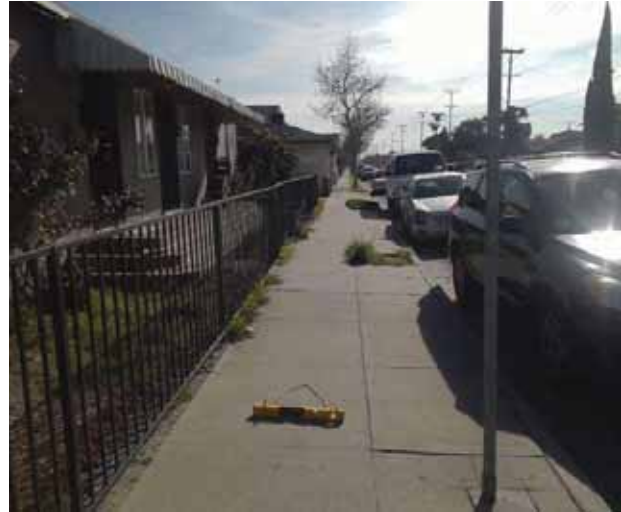
Code Reference ADA 206, 302,CA 11B-403.3

Repave the sidewalk surface with the recommended cross slope.

Recommendation Up to 2.08 percent

Repave surface \$1,092

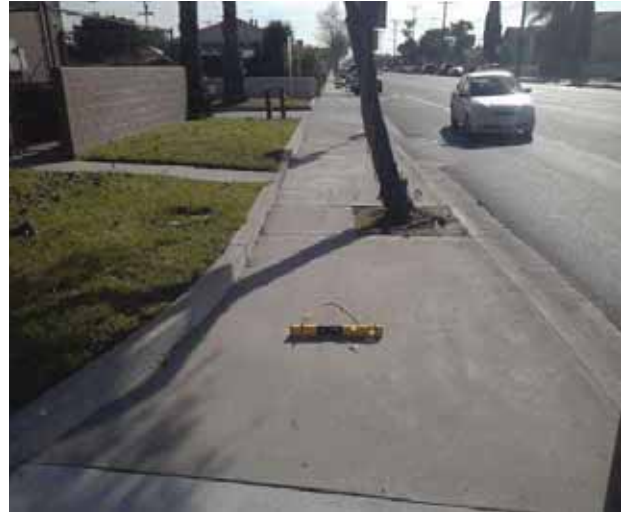
Code Reference ADA 206, 302,CA 11B-403.5.1

Widen the sidewalk to the recommended value.

Recommendation At least 48.00 inches

\$1,260

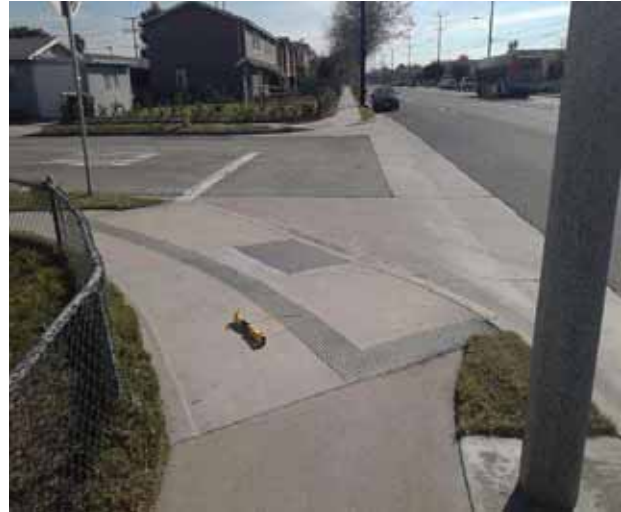
Code Reference ADA 206, 302

Repave the sidewalk surface with the recommended running slope.

Recommendation Up to 5.00 percent

Repave surface \$1,184

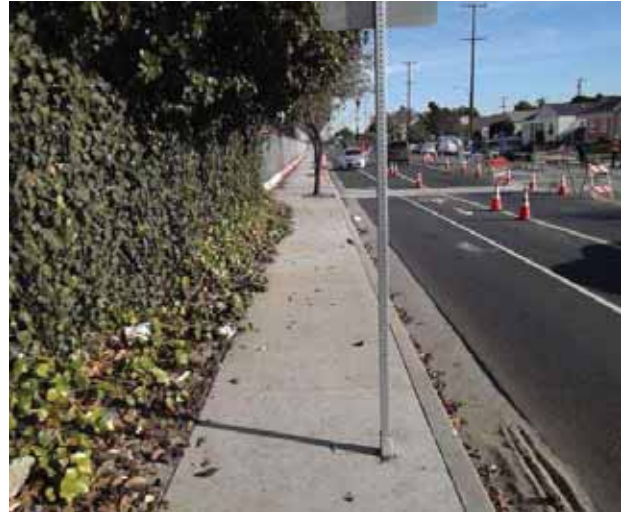
Sidewalks , Hazards & Gratings : Sidewalk Width at Obstruction

Code Reference ADA 206, 302, 403.5.1, CA 11B-403.5

Sidewalk width at the obstruction shall have the recommended value.

Recommendation At least 48.00 inches

\$1,260

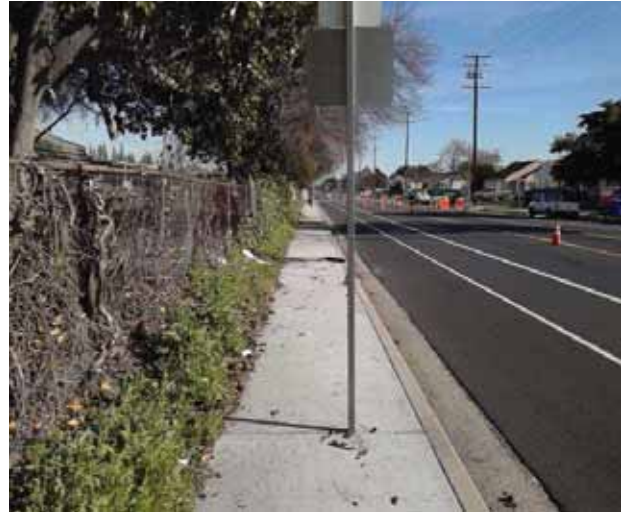
Sidewalks , Hazards & Gratings : Sidewalk Width at Obstruction

Code Reference ADA 206, 302, 403.5.1, CA 11B-403.5

\$1,260

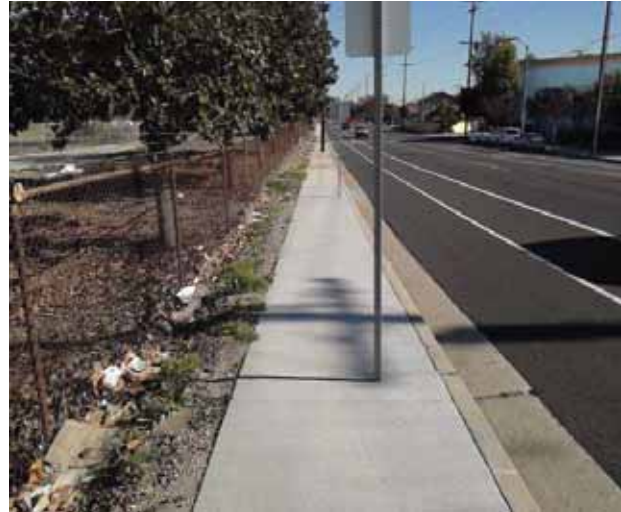
Sidewalks , Hazards & Gratings : Sidewalk Width at Obstruction

Sidewalk width at the obstruction shall have the recommended value.

Recommendation At least 48.00 inches

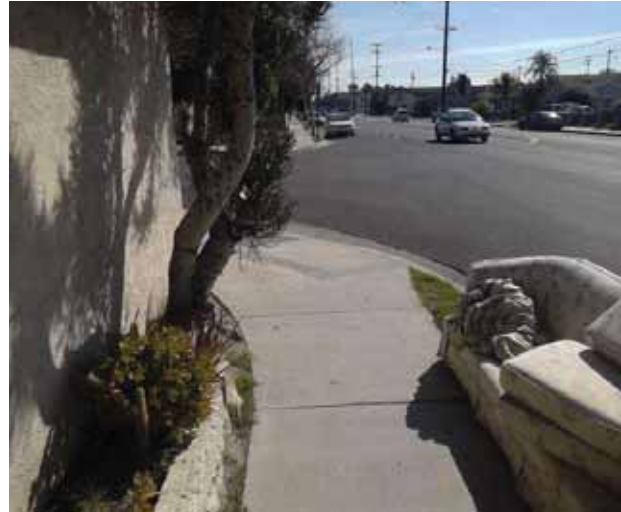
Sidewalks , Hazards & Gratings : Overhead Obstruction Height

Recommendation At least 80.00 inches

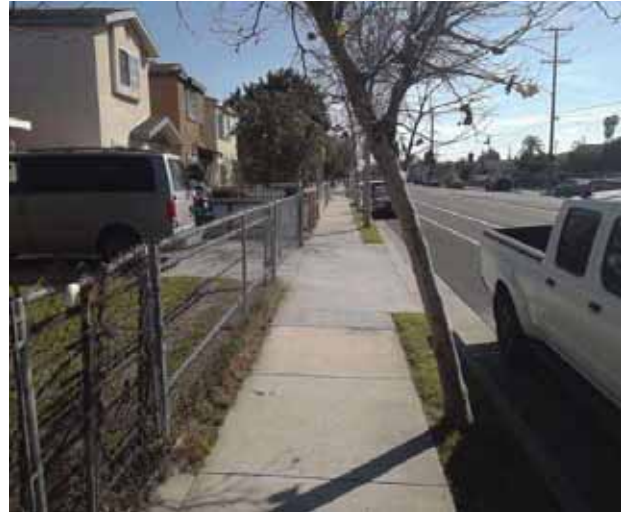
Sidewalks , Hazards & Gratings : Overhead Obstruction Height

Recommendation At least 80.00 inches

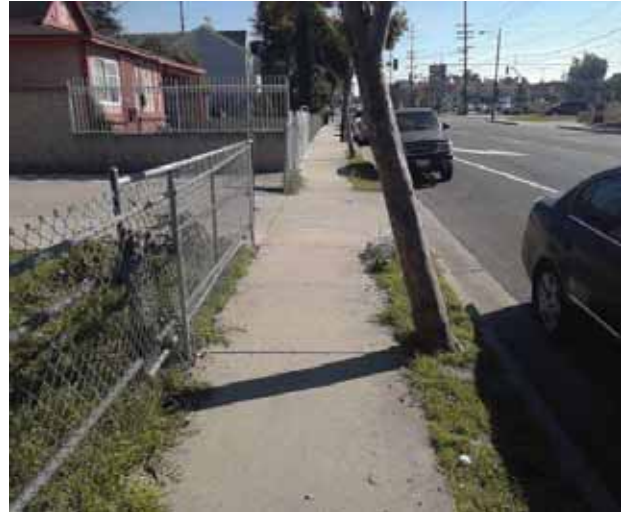
Sidewalks , Hazards & Gratings : Overhead Obstruction Height

Recommendation At least 80.00 inches

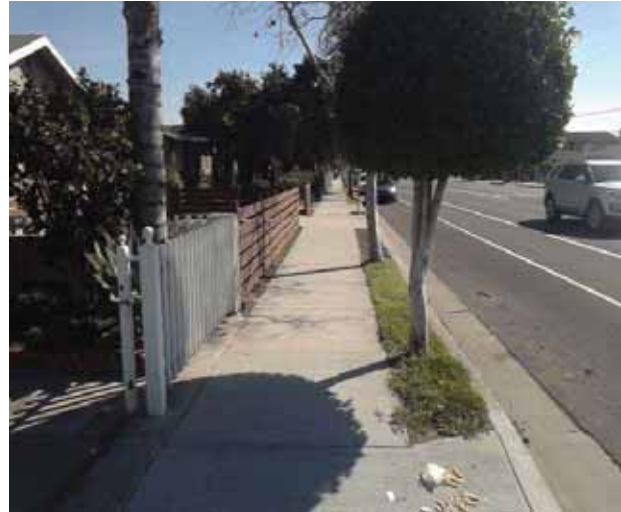
Sidewalks , Hazards & Gratings : Overhead Obstruction Height

Recommendation At least 80.00 inches

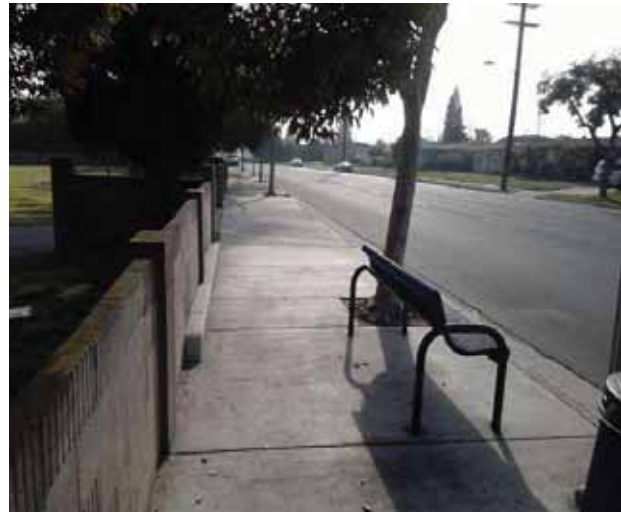
Sidewalks , Hazards & Gratings : Overhead Obstruction Height

Recommendation At least 80.00 inches

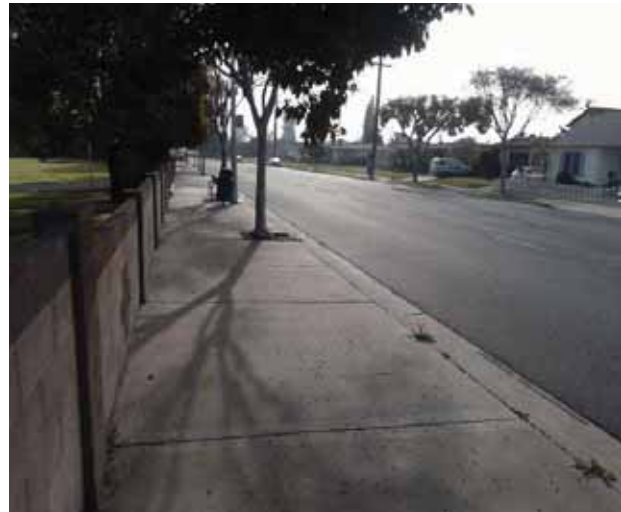
Sidewalks , Hazards & Gratings : Overhead Obstruction Height

Recommendation At least 80.00 inches

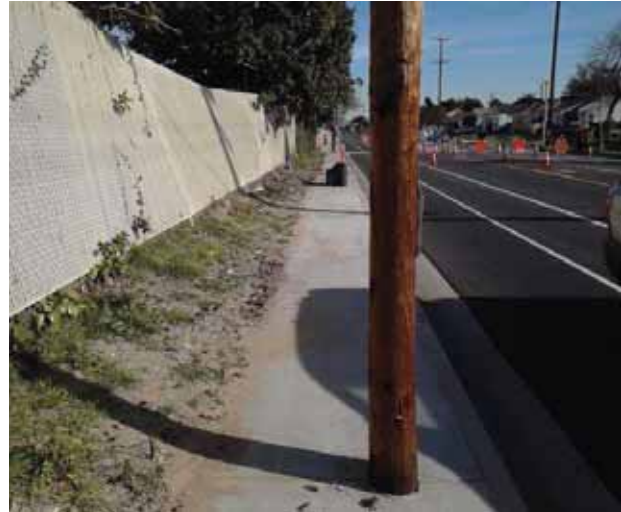
Sidewalks , Hazards & Gratings : Sidewalk Width at Obstruction

Sidewalk width at the obstruction shall have the recommended value.

Recommendation At least 48.00 inches

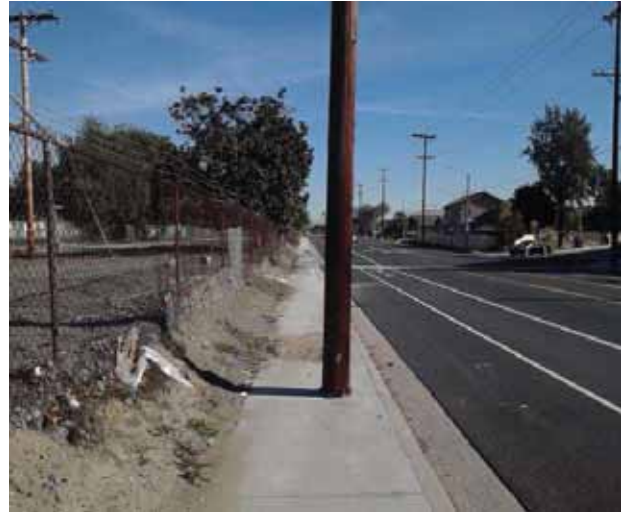
Sidewalks , Hazards & Gratings : Sidewalk Width at Obstruction

Sidewalk width at the obstruction shall have the recommended value.

Recommendation At least 48.00 inches

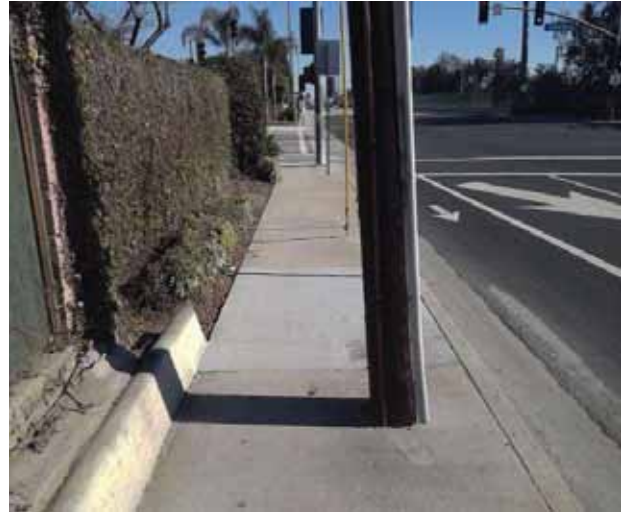
Sidewalks , Hazards & Gratings : Sidewalk Width at Obstruction

Sidewalk width at the obstruction shall have the recommended value.

Recommendation At least 48.00 inches

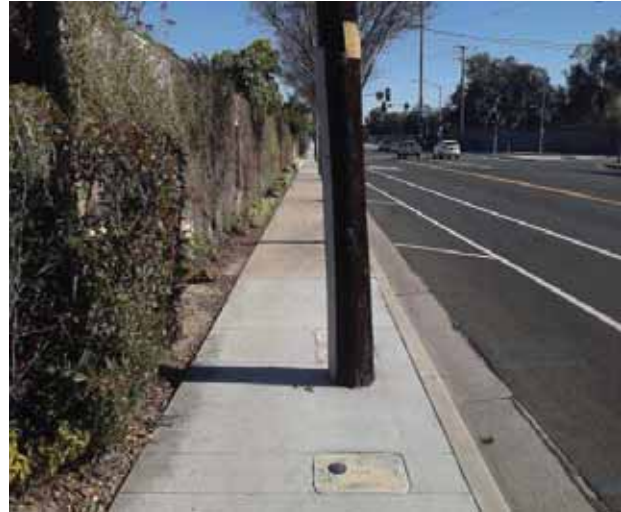
Sidewalks , Hazards & Gratings : Sidewalk Width at Obstruction

Sidewalk width at the obstruction shall have the recommended value.

Recommendation At least 48.00 inches

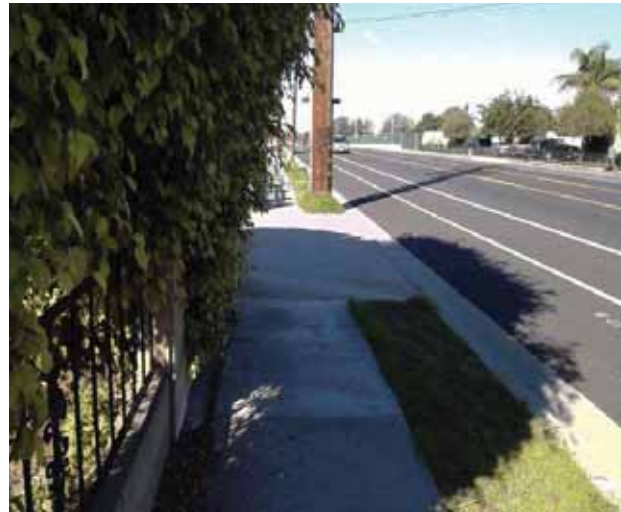
Sidewalks , Hazards & Gratings : Overhead Obstruction Height

Recommendation At least 80.00 inches

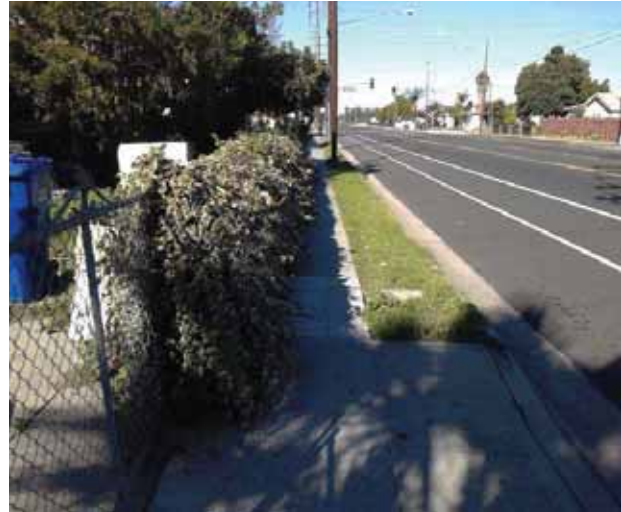
Sidewalks , Hazards & Gratings : Sidewalk Width at Obstruction

Sidewalk width at the obstruction shall have the recommended value.

Recommendation At least 48.00 inches

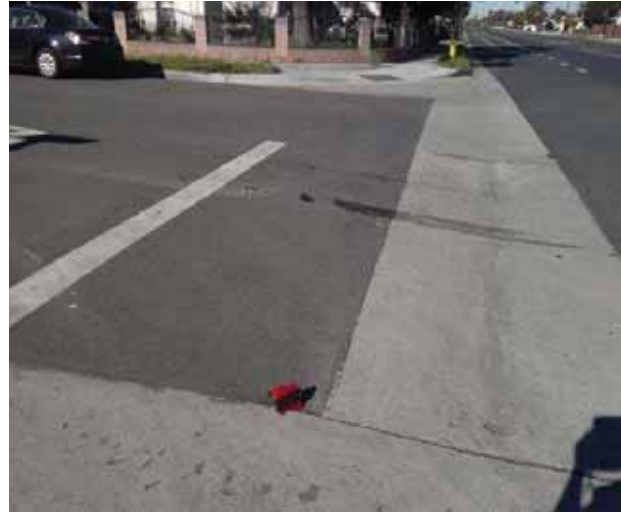
There is a change in elevation greater than recommended value.

Recommendation Up to 0.50 inches

Remove tripping hazards \$198

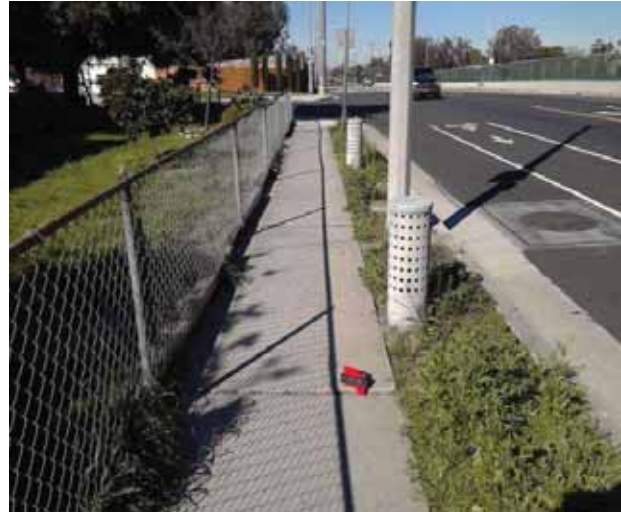
There is a change in elevation greater than recommended value.

Ensure that the change in elevation is within the recommended value.

Recommendation Up to 0.25 inches

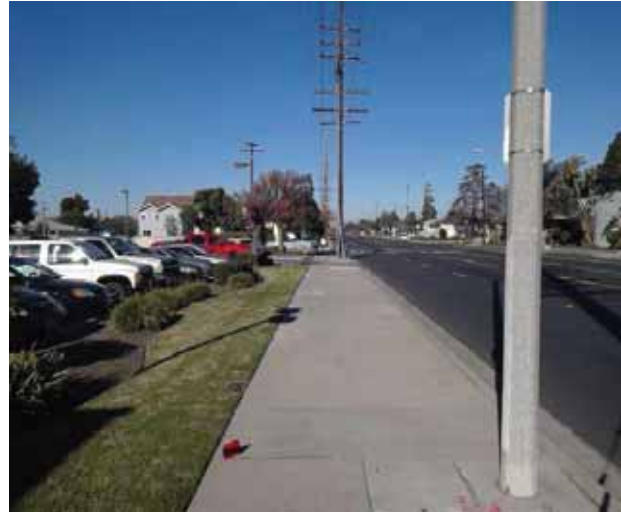
There is a change in elevation greater than recommended value.

Ensure that the change in elevation is within the recommended value.

Recommendation Up to 0.25 inches

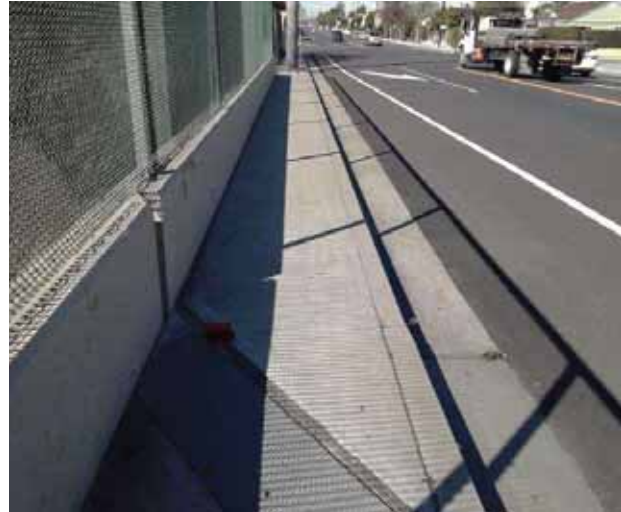
There is a change in elevation greater than recommended value.

Ensure that the change in elevation is within the recommended value.

Recommendation Up to 0.25 inches

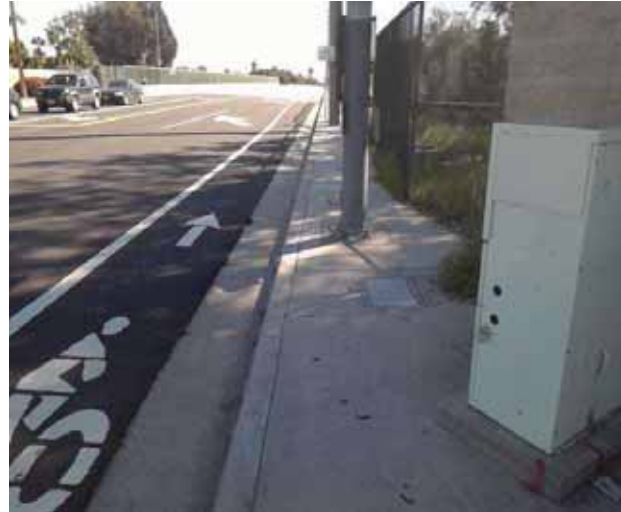
Sidewalks , Hazards & Gratings : Sidewalk Width at Obstruction

Sidewalk width at the obstruction shall have the recommended value.

Recommendation At least 48.00 inches

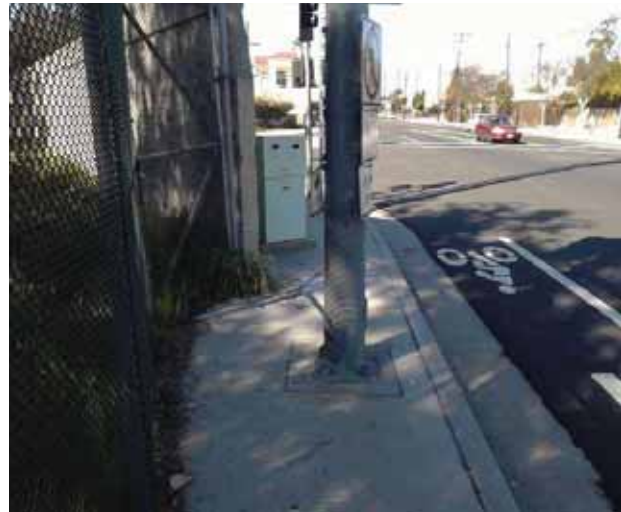
Sidewalks , Hazards & Gratings : Sidewalk Width at Obstruction

Recommendation

Sidewalk width at the obstruction shall have the recommended value.

Recommendation At least 48.00 inches

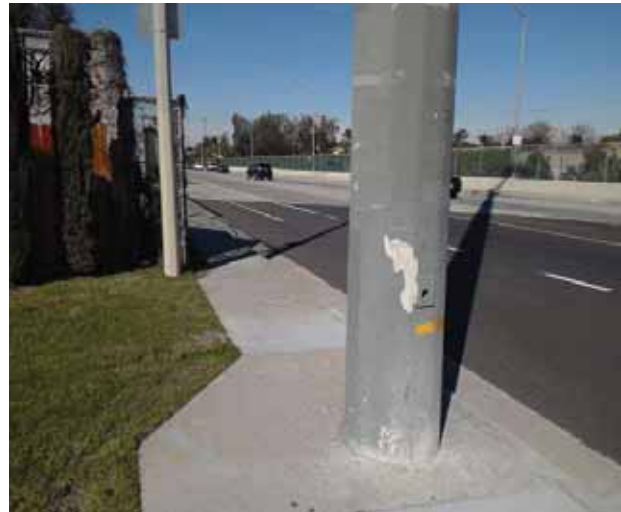
Sidewalks , Hazards & Gratings : Sidewalk Width at Obstruction

Recommendation

Sidewalk width at the obstruction shall have the recommended value.

Recommendation At least 48.00 inches

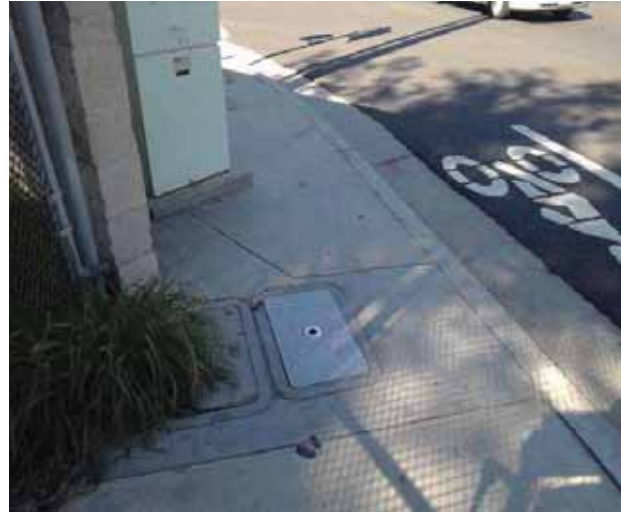
There is a change in elevation greater than recommended value.

Recommendation

Ensure that the change in elevation is within the recommended value.

Recommendation Up to 0.25 inches

Remove tripping hazards \$198
