Accessibility Survey

City of Downey Telegraph Road & Birchbark Avenue

Date of Inspection 4/29/2017

Disability Access Consultants

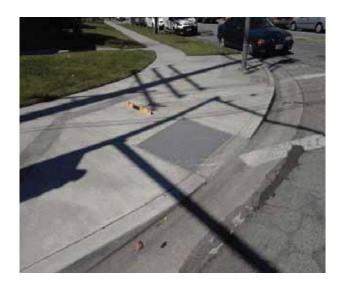
Southeast Corner @ 33.964631790897, -118.113784343004

Curb Ramp : No Detectable Warnings

The curb ramp does not provide a detectable warning surface which includes truncated domes.

Code Reference CA 11B-406.5.12

Provide compliant detectable warnings to surface.

Provide detectable warning to \$248 surface

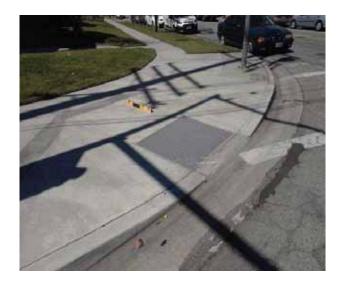
Southeast Corner @ 33.964631790897, -118.113784343004

Curb Ramp : Curb Ramp Slope

The running slope is greater than allowed.

Code Reference ADA 406, 406.1, 405.2,CA 11B-406

Recommendation Up to 8.33 percent

Install curb ramp \$1,300

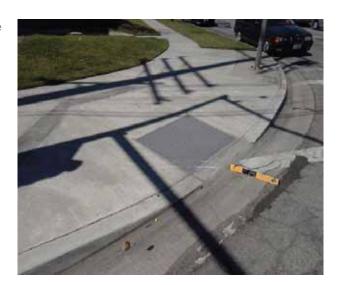
Code Reference ADA 406, 406.2, CA 11B-406.5.8

Recommendation Up to 5.00 percent

Repave landing \$1,260

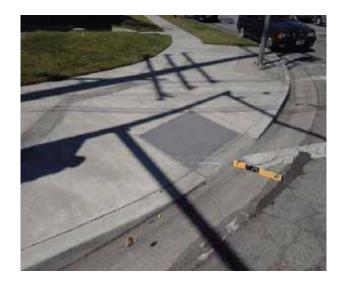
Code Reference ADA 406, 406.4,CA 11B-406.5.3

Recommendation At least 48.00 inches

Provide compliant landing \$240

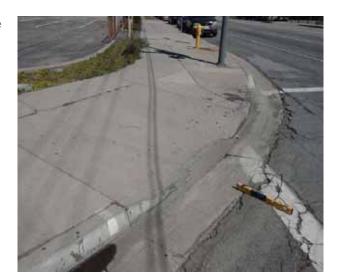
Code Reference ADA 406, 406.2,CA 11B-406.5.8

Recommendation Up to 5.00 percent

Repave landing \$1,260

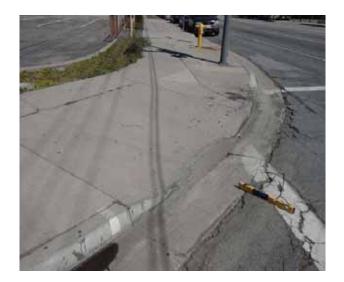
Code Reference ADA 402, 406.4, 403.3, 406.1,CA 11B-406.5.3

Recommendation Up to 2.08 percent

Provide compliant landing \$1,260

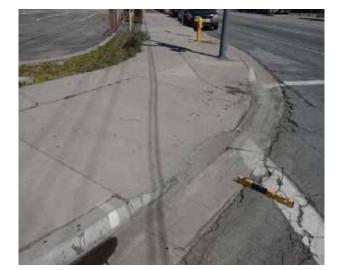
Curb Ramp , Landings and Transitions : Top Landing Clear Length -

Code Reference ADA 406, 406.4,CA 11B-406.5.3

Recommendation At least 48.00 inches

Provide compliant landing \$240

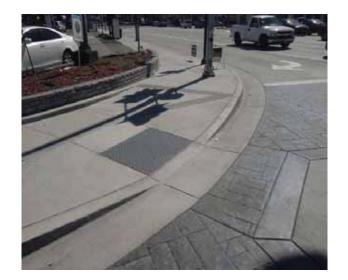
Code Reference ADA 406, 406.5

Install crosswalk \$800

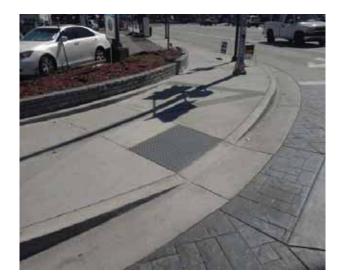
Curb Ramp , Landings and Transitions : Top Landing Clear Length -

Code Reference ADA 406, 406.4,CA 11B-406.5.3

Recommendation At least 48.00 inches

Provide compliant landing \$240

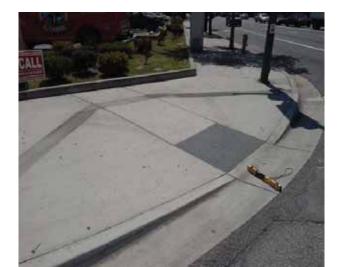
Curb Ramp , Landings and Transitions : Top Landing Clear Length -

Provide compliant landing \$240

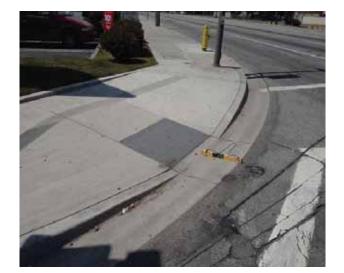
Curb Ramp , Landings and Transitions : Top Landing Clear Length -

Provide compliant landing \$240

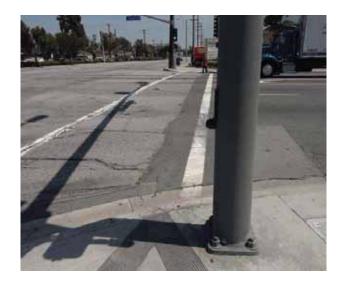
Code Reference CA 11B-305.2,CA MUTCD 4E.08

Recommendation

Recommendation Up to 2.08 percent

\$1,260

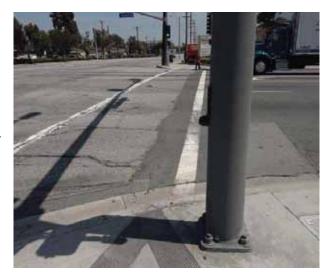
Code Reference CA MUTCD, CA MUTCD 4E.08

Recommendation

Recommendation See Recommendation

\$900

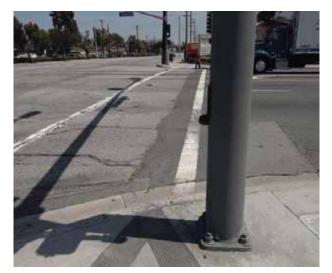
On-Site Finding Not Found

Code Reference CA MUTCD, CA MUTCD 4E.08

\$900

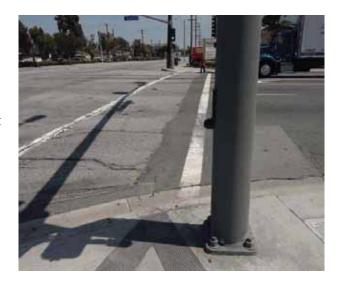
On-Site Finding Not Found

Code Reference CA MUTCD, CA MUTCD 4E.08

\$158

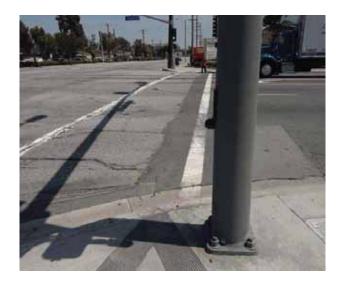
On-Site Finding Not Found

Code Reference CA MUTCD 4E.08

\$158

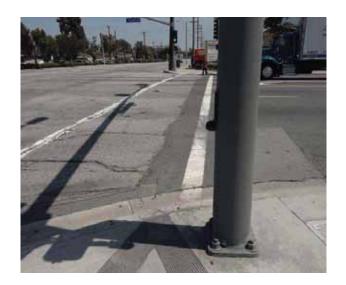
On-Site Finding Not Found

Code Reference CA MUTCD, CA MUTCD 4E.08

\$150

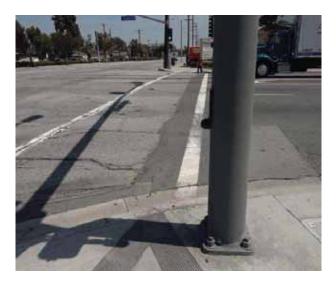
On-Site Finding Not Found

Code Reference CA MUTCD, CA MUTCD 4E.08

\$900

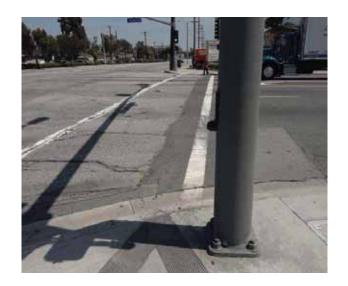
On-Site Finding Not Found

Code Reference CA MUTCD, CA MUTCD 4E.08

\$900

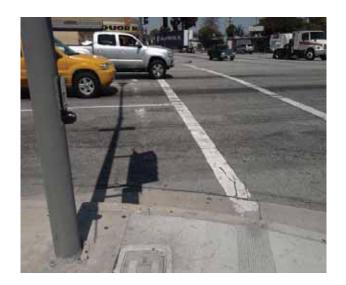
Code Reference CA MUTCD 4E.08

Recommendation

Recommendation Up to 60.00 inches

\$900

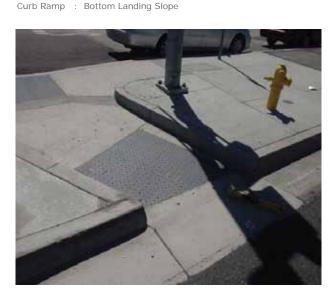
Code Reference ADA 406, 406.2, CA 11B-406.5.8

Recommendation

Recommendation Up to 5.00 percent

Repave landing \$1,260

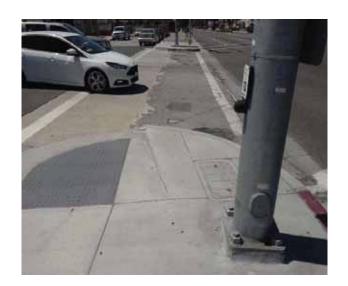
Code Reference CA MUTCD 4E.08

Recommendation

Recommendation Up to 60.00 inches

\$900

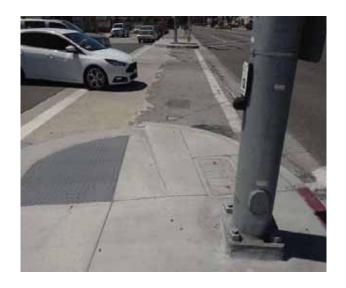
Code Reference CA 11B-305.2,CA MUTCD 4E.08

Recommendation

Recommendation Up to 2.08 percent

\$1,260

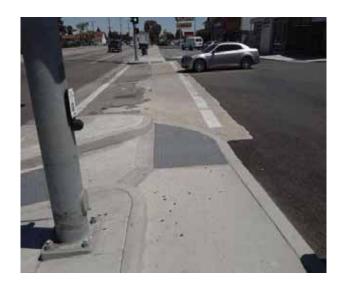
Code Reference CA MUTCD 4E.08

Recommendation

Recommendation Up to 60.00 inches

\$900

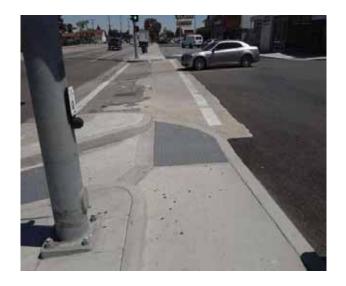
Code Reference CA 11B-305.2, CA MUTCD 4E.08

Recommendation

Recommendation Up to 2.08 percent

\$1,260

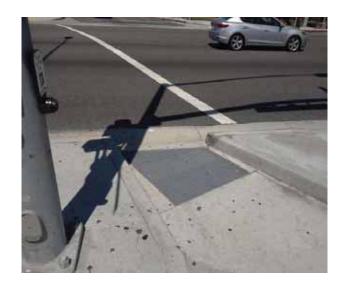
Code Reference CA MUTCD 4E.08

Recommendation

Recommendation Up to 60.00 inches

\$900

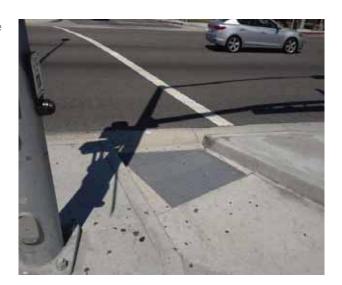
Code Reference CA MUTCD 4E.08

Recommendation

Recommendation At least 48.00 inches

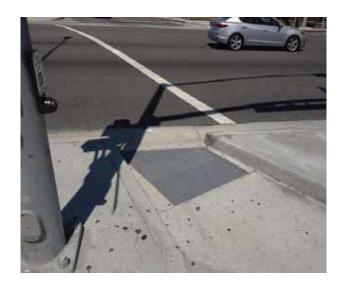
Code Reference CA 11B-305.2,CA MUTCD 4E.08

Recommendation

Recommendation Up to 2.08 percent

\$1,260

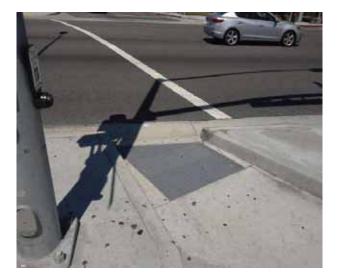
On-Site Finding Not Found

\$158

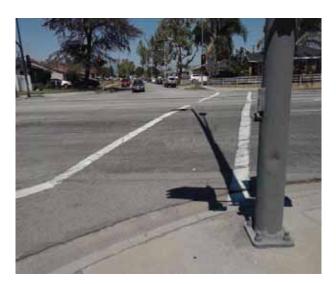
Notes: Curb on path of travel

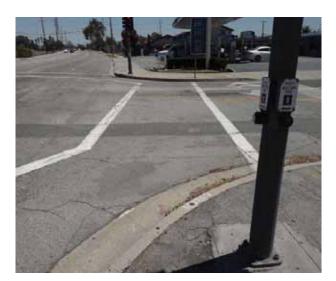
Notes: Curbs (2) in path of travel

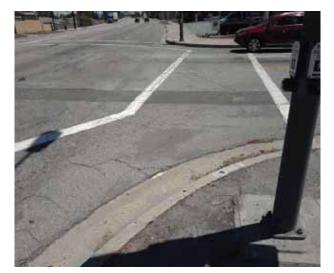
Notes: Surface is rough and uneven.

Recommendation At least 48.00 inches

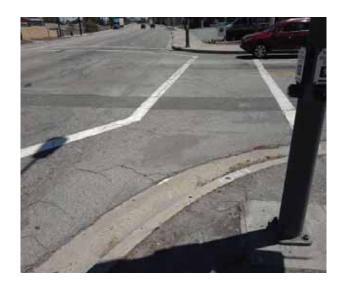
Notes: Surface is rough and uneven.

Recommendation Up to 2.08 percent

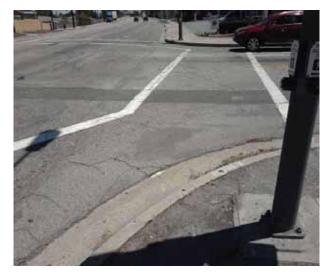
Notes: Surface is rough and uneven.

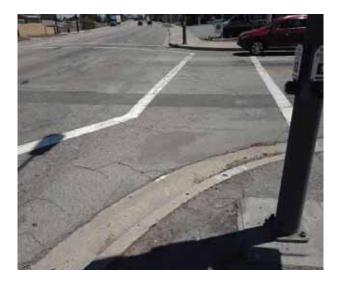
Notes: Surface is rough and uneven.

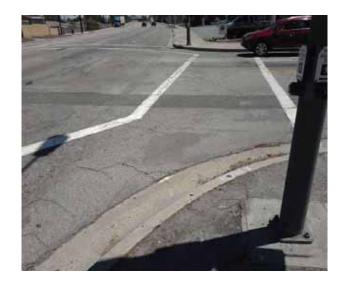
Notes: Surface is rough and uneven.

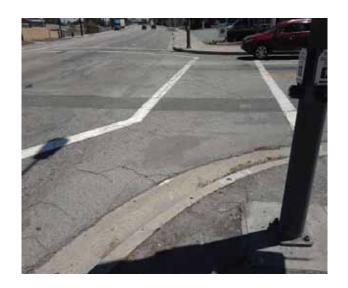
Notes: Surface is rough and uneven.

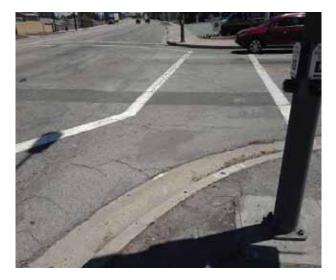
Notes: Surface is rough and uneven.

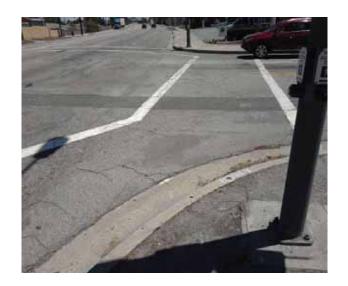
Notes: Surface is rough and uneven.

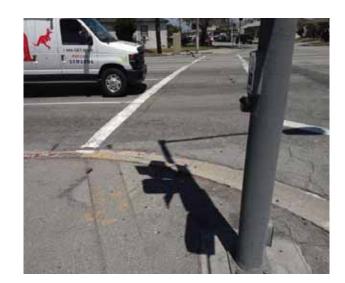
Notes: Surface is rough and uneven.

Recommendation At least 2.00 inches

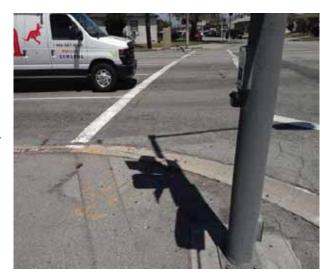
Notes: Surface is rough and uneven.

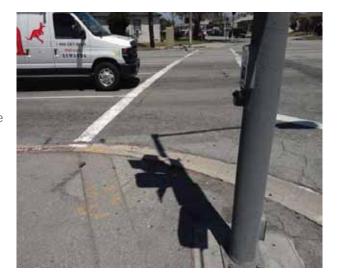
Notes: Surface is rough and uneven.

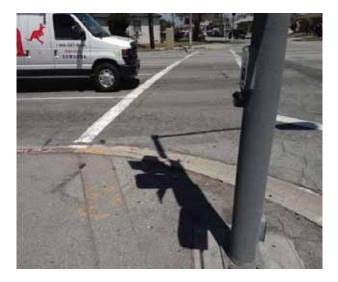
Notes: Surface is rough and uneven.

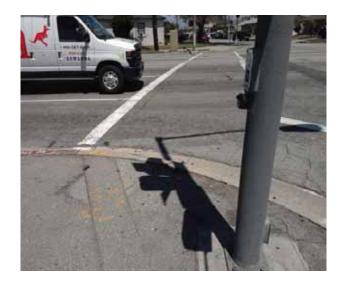
Notes: Surface is rough and uneven.

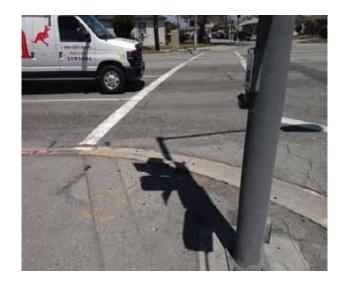
Notes: Surface is rough and uneven.

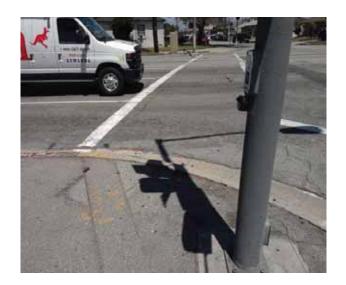
Notes: Surface is rough and uneven.

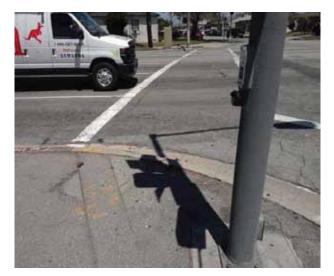
Notes: Surface is rough and uneven.

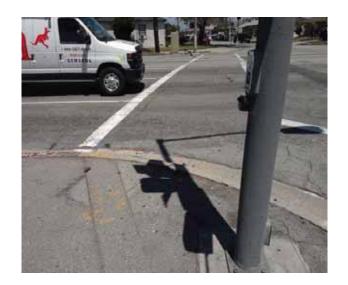
Notes: Surface is rough and uneven.

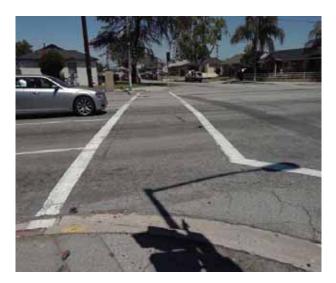
Notes: Curb in path of tavel

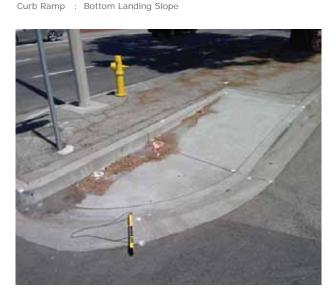
Notes: Top Landing is Rough And Uneven

Costing Info (Estimated)

Repave landing \$1,260

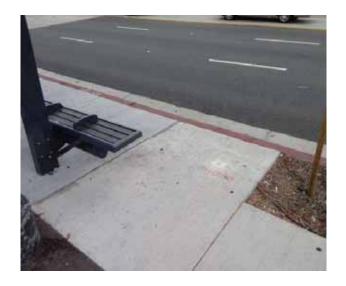
Sidewalks , Hazards & Gratings : Sidewalk Width at Obstruction

Sidewalk width at the obstruction shall have the recommended value.

Recommendation At least 48.00 inches

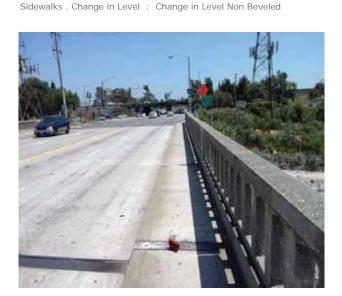
There is a change in elevation greater than recommended value.

Ensure that the change in elevation is within the recommended value.

Recommendation Up to 0.25 inches

Remove tripping hazards \$198

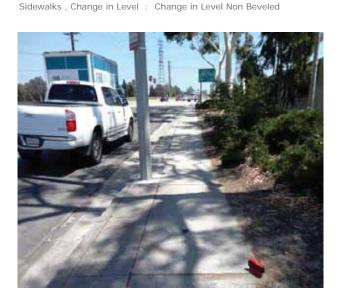
There is a change in elevation greater than recommended value.

Ensure that the change in elevation is within the recommended value.

Recommendation Up to 0.25 inches

Remove tripping hazards \$198

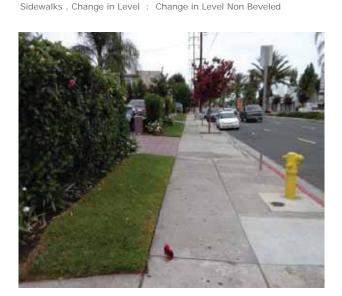
There is a change in elevation greater than recommended value.

Ensure that the change in elevation is within the recommended value.

Recommendation Up to 0.25 inches

Remove tripping hazards \$198

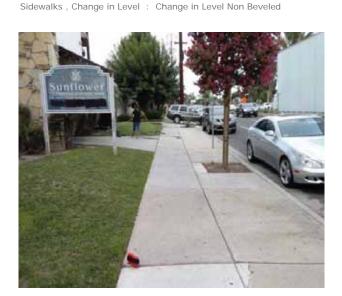
There is a change in elevation greater than recommended value.

Ensure that the change in elevation is within the recommended value.

Recommendation Up to 0.25 inches

Remove tripping hazards \$198

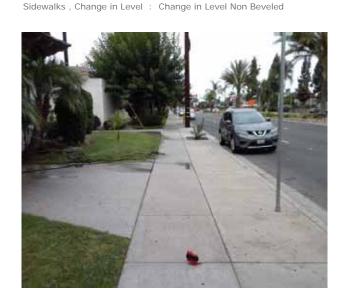
There is a change in elevation greater than recommended value.

Ensure that the change in elevation is within the recommended value.

Recommendation Up to 0.25 inches

Remove tripping hazards \$198

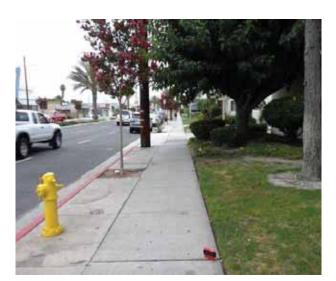
There is a change in elevation greater than recommended value.

Ensure that the change in elevation is within the recommended value.

Recommendation Up to 0.25 inches

Remove tripping hazards \$198

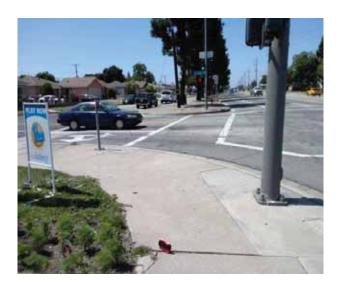
There is a change in elevation greater than recommended value.

Ensure that the change in elevation is within the recommended value.

Recommendation Up to 0.25 inches

Remove tripping hazards \$198

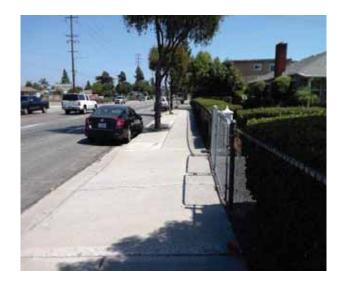
There is a change in elevation greater than recommended value.

Ensure that the change in elevation is within the recommended value.

Recommendation Up to 0.25 inches

Remove tripping hazards \$198

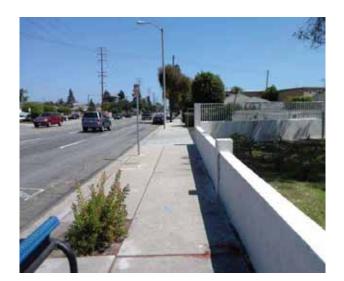
There is a change in elevation greater than recommended value.

Ensure that the change in elevation is within the recommended value.

Recommendation Up to 0.25 inches

Remove tripping hazards \$198

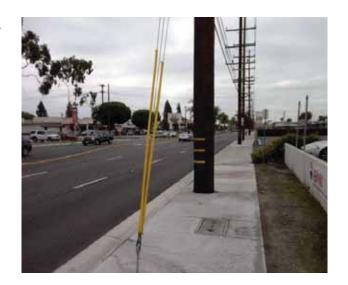
Sidewalks , Hazards & Gratings : Overhead Obstruction Height

Recommendation At least 80.00 inches

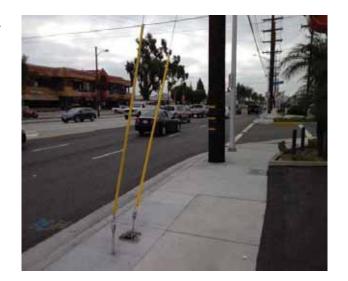
Sidewalks , Hazards & Gratings : Overhead Obstruction Height

Recommendation At least 80.00 inches

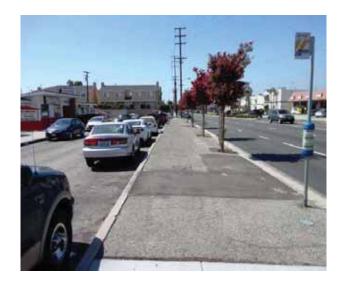
Code Reference ADA 206, 302 Notes: Surface is Rough And Uneven

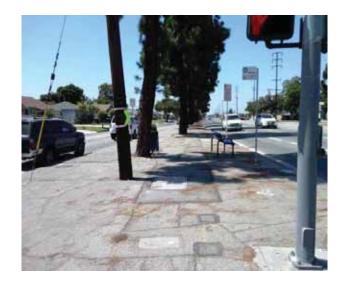
Code Reference ADA 206, 302 Notes: Surface is Rough And Uneven

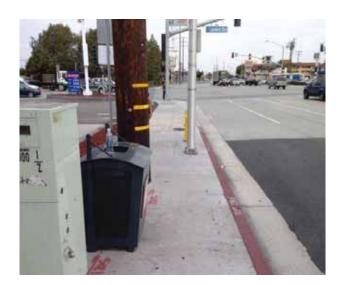
Sidewalks , Hazards & Gratings : Sidewalk Width at Obstruction

Sidewalk width at the obstruction shall have the recommended value.

Recommendation At least 48.00 inches

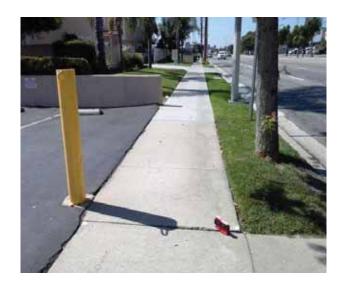
There is a change in elevation greater than recommended value.

Ensure that the change in elevation is within the recommended value.

Remove tripping hazards \$198

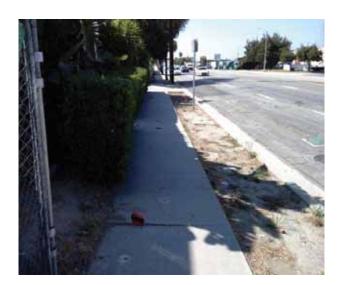
There is a change in elevation greater than recommended value.

Ensure that the change in elevation is within the recommended value.

Remove tripping hazards \$198

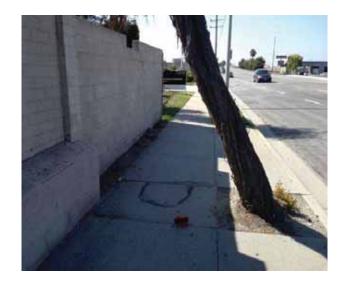
There is a change in elevation greater than recommended value.

Ensure that the change in elevation is within the recommended value.

Remove tripping hazards \$198

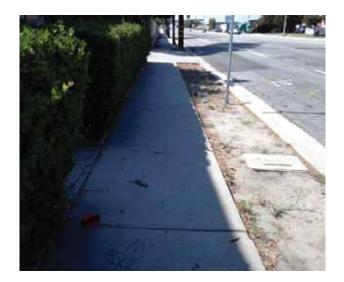
There is a change in elevation greater than recommended value.

Ensure that the change in elevation is within the recommended value.

Remove tripping hazards \$198

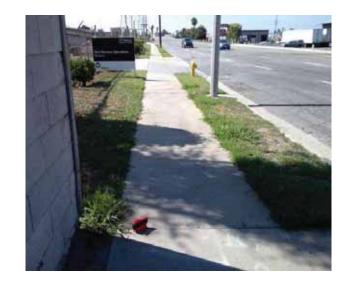
There is a change in elevation greater than recommended value.

Ensure that the change in elevation is within the recommended value.

Remove tripping hazards \$198

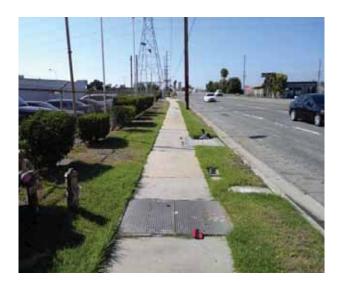
There is a change in elevation greater than recommended value.

Ensure that the change in elevation is within the recommended value.

Remove tripping hazards \$198

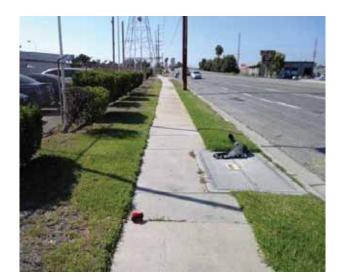
There is a change in elevation greater than recommended value.

Ensure that the change in elevation is within the recommended value.

Remove tripping hazards \$198

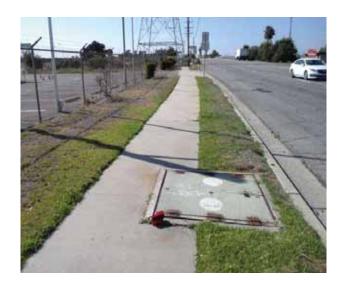
There is a change in elevation greater than recommended value.

Ensure that the change in elevation is within the recommended value.

Remove tripping hazards \$198

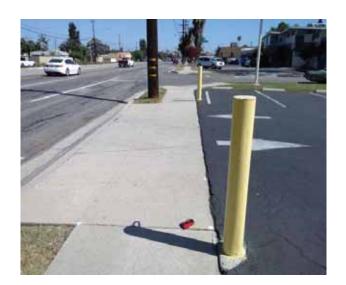
There is a change in elevation greater than recommended value.

Ensure that the change in elevation is within the recommended value.

Remove tripping hazards \$198

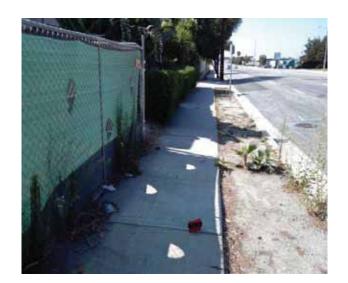
There is a change in elevation greater than recommended value.

Ensure that the change in elevation is within the recommended value.

Remove tripping hazards \$198

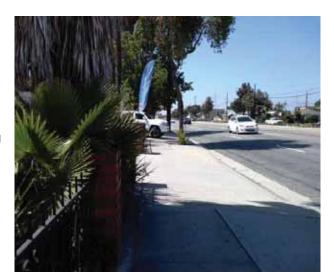
Sidewalks , Hazards & Gratings : Protruding Object Height

Install wing walls or relocate \$640 object

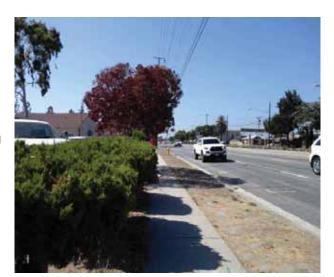
Sidewalks , Hazards & Gratings : Protruding Object Height

Install wing walls or relocate \$640 object

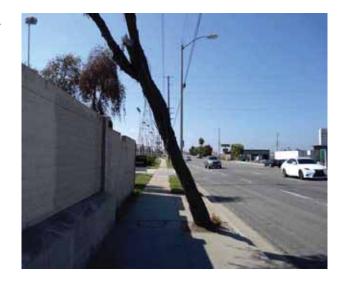
Sidewalks , Hazards & Gratings : Overhead Obstruction Height

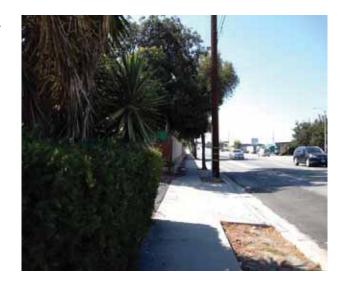
Sidewalks , Hazards & Gratings : Overhead Obstruction Height

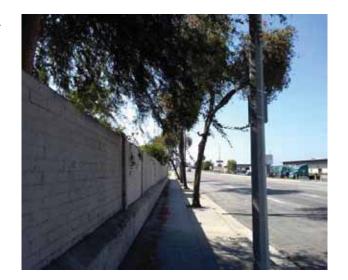
Sidewalks , Hazards & Gratings : Overhead Obstruction Height

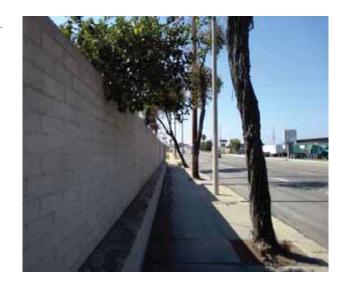
Sidewalks , Hazards & Gratings : Overhead Obstruction Height

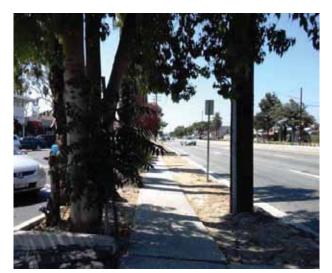
Sidewalks , Hazards & Gratings : Protruding Object Height

Install wing walls or relocate \$640 object

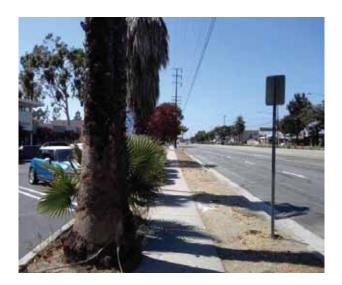
Sidewalks , Hazards & Gratings : Sidewalk Width at Obstruction

Sidewalk width at the obstruction shall have the recommended value.

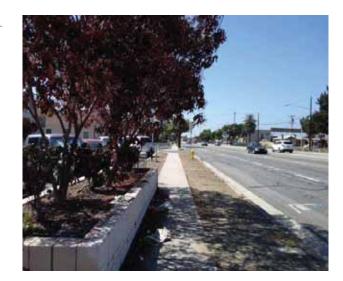
Sidewalks , Hazards & Gratings : Overhead Obstruction Height

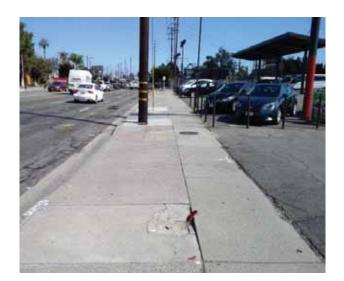
There is a change in elevation greater than recommended value.

Ensure that the change in elevation is within the recommended value.

Remove tripping hazards \$198

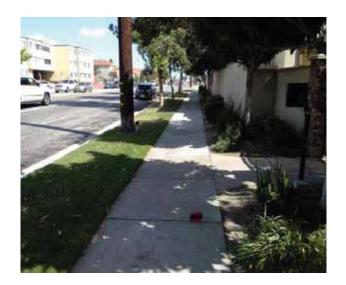
There is a change in elevation greater than recommended value.

Ensure that the change in elevation is within the recommended value.

Remove tripping hazards \$198

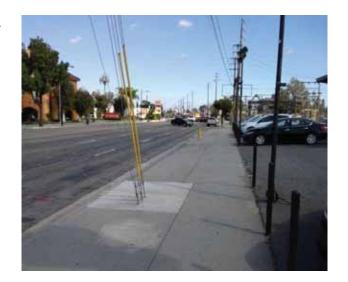
Sidewalks , Hazards & Gratings : Overhead Obstruction Height

Recommendation At least 80.00 inches

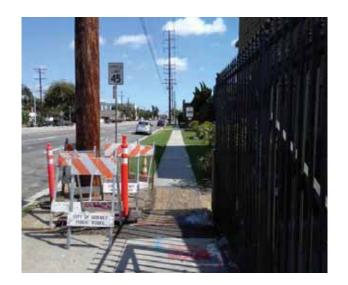
Section of sidewalk is missing and consists of dirt, grass or gravel.

Provide a compliant sidewalk for the missing section.

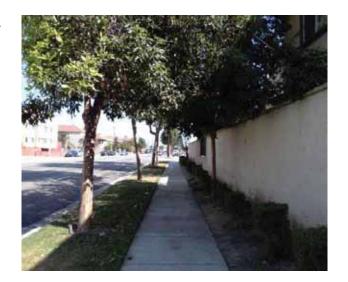
Sidewalks , Hazards & Gratings : Overhead Obstruction Height

Recommendation At least 80.00 inches

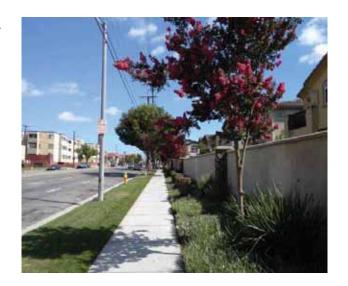
Sidewalks , Hazards & Gratings : Overhead Obstruction Height

Recommendation At least 80.00 inches

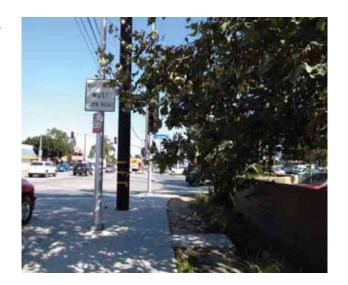
Sidewalks , Hazards & Gratings : Overhead Obstruction Height

Recommendation At least 80.00 inches

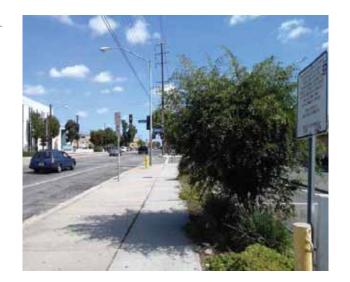
Sidewalks , Hazards & Gratings : Overhead Obstruction Height

Recommendation At least 80.00 inches

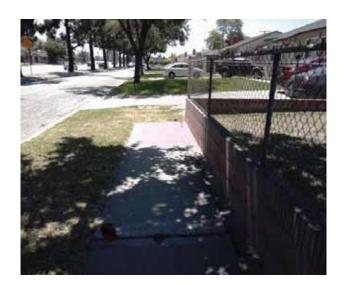
There is a change in elevation greater than recommended value.

Ensure that the change in elevation is within the recommended value.

Remove tripping hazards \$198

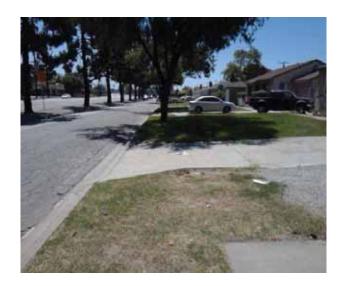
Section of sidewalk is missing and consists of dirt, grass or gravel.

Provide a compliant sidewalk for the missing section.

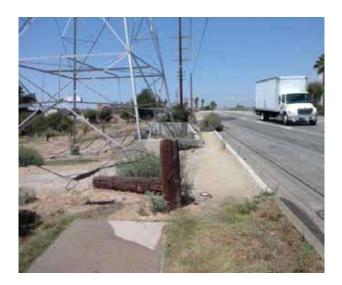
Section of sidewalk is missing and consists of dirt, grass or gravel.

Provide a compliant sidewalk for the missing section.
