Accessibility Survey

Alameda Street & Birchdale Avenue

Date of Inspection
3/17/2017

Disability Access Consultants

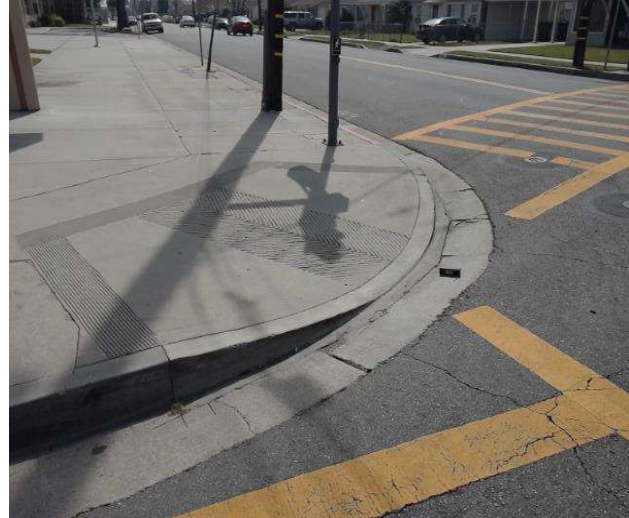
Northeast Corner @ 33.925457976927, -118.136438280344

Curb Ramp : Not Wholly Contained Within The Marked Crossing

The curb ramp is not wholly contained within the marked crossing.

Install crosswalk \$800

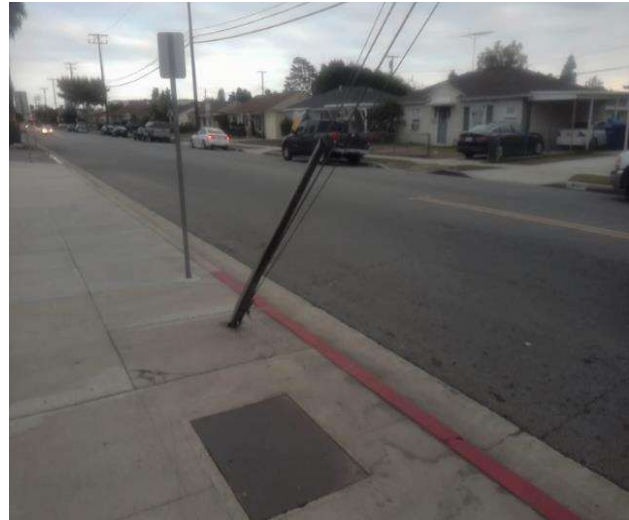
Sidewalks , Hazards & Gratings : Overhead Obstruction Height

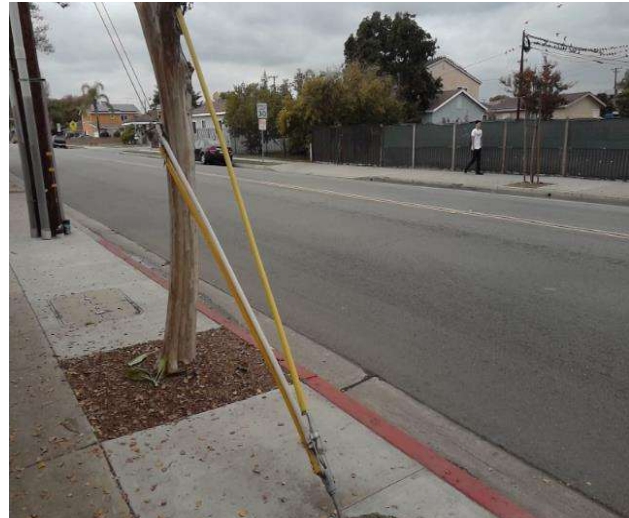
Sidewalks , Hazards & Gratings : Overhead Obstruction Height
