Accessibility Survey

City of Downey Western Avenue - 7th Street to 5th Street

7th Street to 5th Street Downey, CA 90242

Date of Inspection 7/11/2017

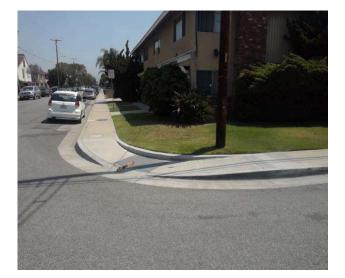
Curb Ramp , Landings and Transitions : Top Landing Right Side

Recommendation Up to 2.08 percent

Provide compliant landing \$1,260

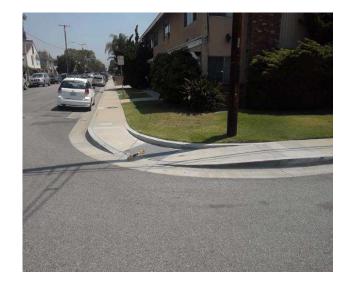
Recommendation At least 48.00 inches

Install curb ramp \$1,300

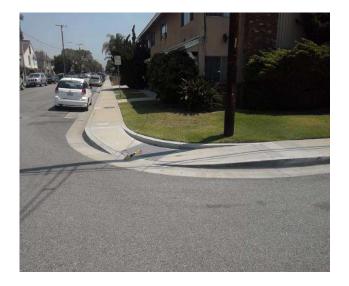
Recommendation Up to 8.33 percent

Install curb ramp \$1,300

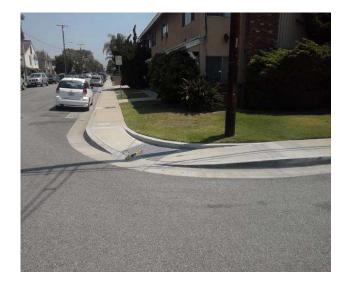
Recommendation At least 48.00 inches

Install curb ramp \$1,300

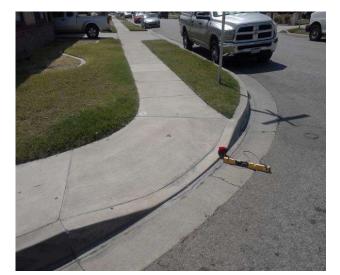
Recommendation Up to 5.00 percent

Repave landing \$1,260

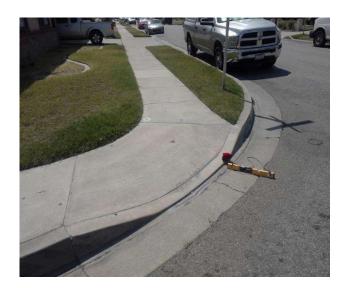
Curb Ramp , Landings And Transitions : Bottom Landing Change in

Recommendation Up to 0.50 inches

Patch lip at curb ramp \$255

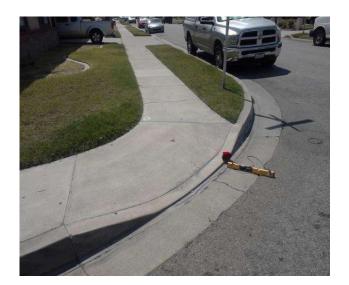
Recommendation Up to 2.08 percent

Provide compliant landing \$1,260

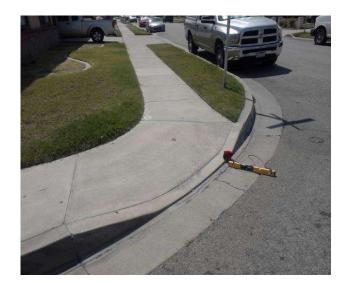
Recommendation At least 48.00 inches

Provide compliant landing \$240

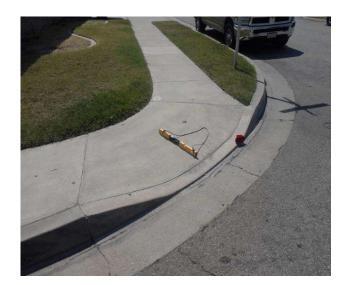
On-Site Finding Not Found

Provide detectable warning to \$248 surface

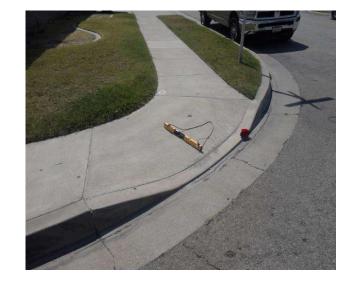
Recommendation Up to 8.33 percent

Install curb ramp \$1,300

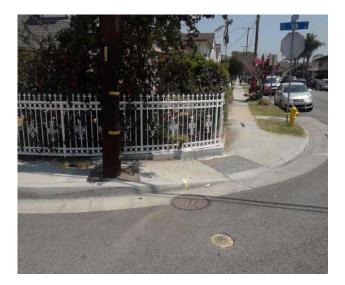
Recommendation Up to 2.08 percent

Provide compliant landing \$1,260

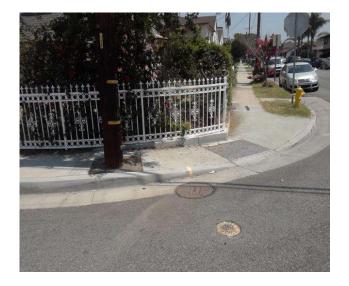
Recommendation At least 48.00 inches

Install curb ramp \$1,300

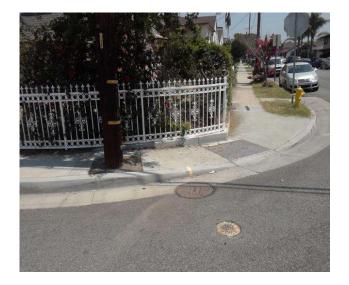
Recommendation Up to 2.08 percent

Install curb ramp \$1,300

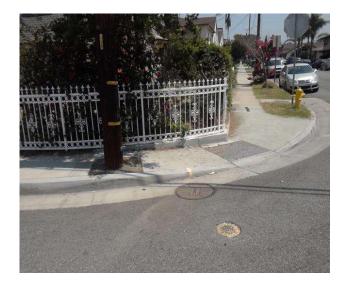
Recommendation Up to 2.08 percent

Install curb ramp \$1,300

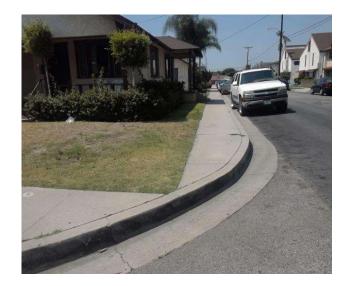
Sidewalks , Hazards & Gratings : Curb is on Path of Travel

Install curb ramp \$2,500

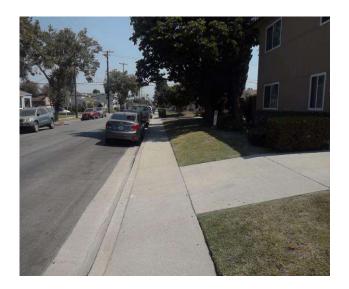
On-Site Finding Not Found

Install compliant detectable \$190

warnings

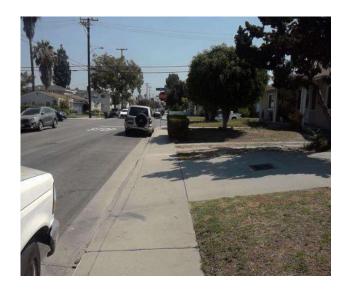
On-Site Finding Not Found

Install compliant detectable \$190

warnings

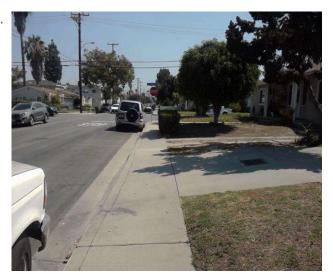
Recommendation Up to 2.08 percent

Repave surface \$1,092

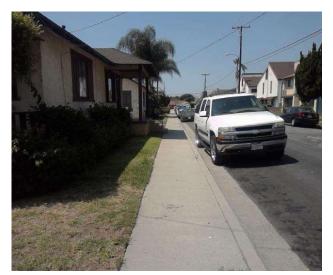
Recommendation Up to 2.08 percent

Repave the sidewalk surface with the recommended cross slope.

Repave surface \$1,092

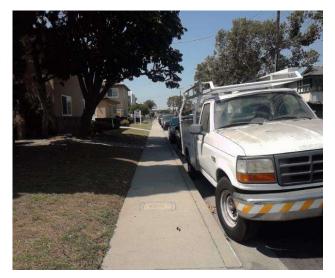
Recommendation Up to 2.08 percent

Repave the sidewalk surface with the recommended cross slope.

Repave surface \$1,092

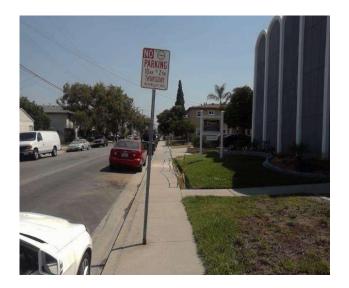
Sidewalks , Hazards & Gratings : Sidewalk Width at Obstruction

Recommendation At least 48.00 inches

Sidewalk width at the obstruction shall have the recommended value.

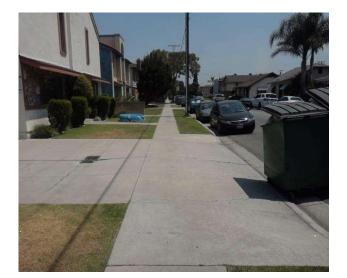
On-Site Finding Not Found

Install compliant detectable \$190 warnings

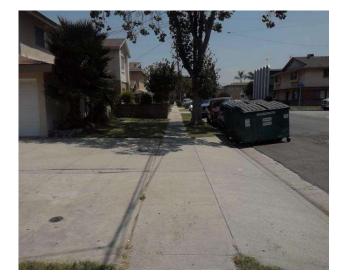
On-Site Finding Not Found

Install compliant detectable \$190 warnings

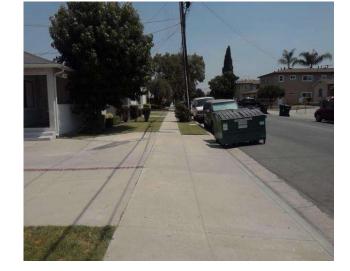
On-Site Finding Not Found

Install compliant detectable \$190 warnings

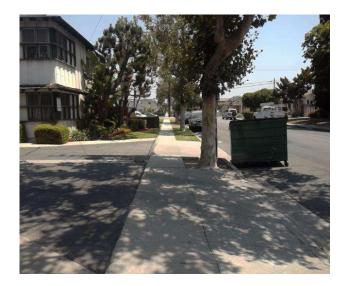
On-Site Finding Not Found

Install compliant detectable \$190 warnings

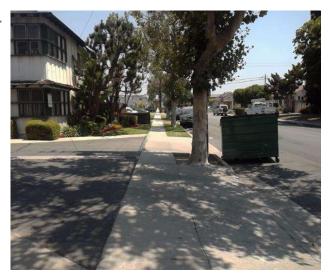
Recommendation Up to 2.08 percent

Repave surface \$1,092

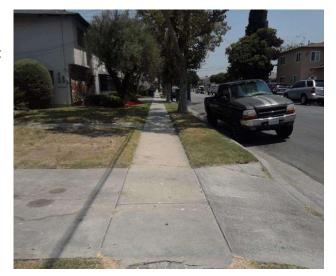
Recommendation Up to 2.08 percent

Repave the sidewalk surface with the recommended cross slope.

Repave surface \$1,092

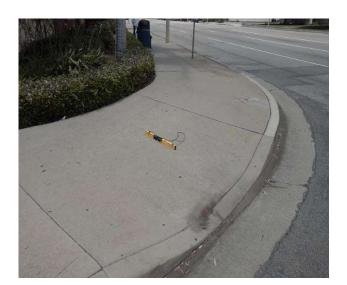
On-Site Finding Not Found

Provide detectable warning to \$248 surface

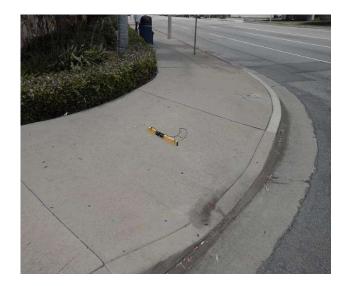
Recommendation Up to 8.33 percent

Install curb ramp \$1,300

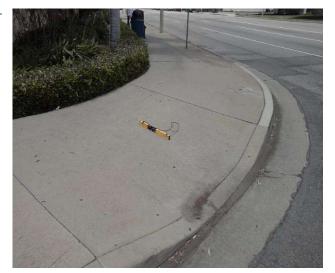
Recommendation Up to 10.00 percent

Install flared sides \$1,300

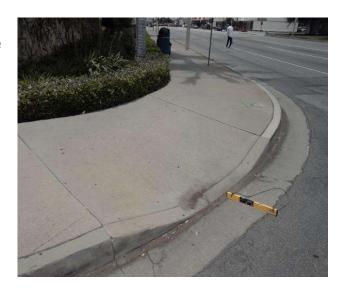
Curb Ramp : Bottom Landing Slope

Recommendation Up to 5.00 percent

Repave landing \$1,260

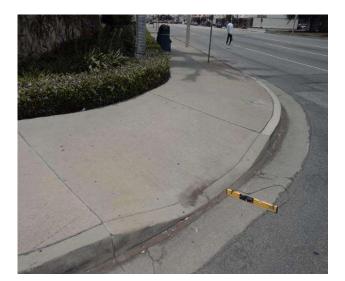
Curb Ramp, Landings and Transitions: Top Landing Slope

Recommendation Up to 2.08 percent

Provide compliant landing \$1,260

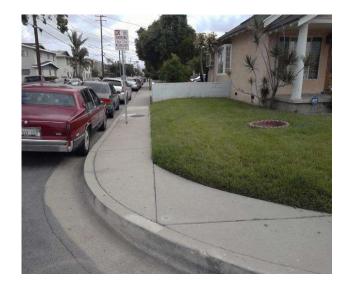
Sidewalks , Hazards & Gratings : Curb is on Path of Travel

Install curb ramp \$2,500

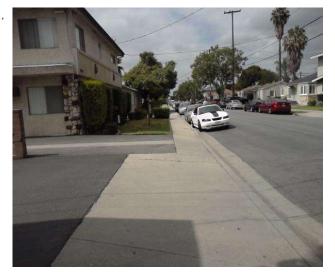
Recommendation Up to 2.08 percent

Repave surface \$1,092

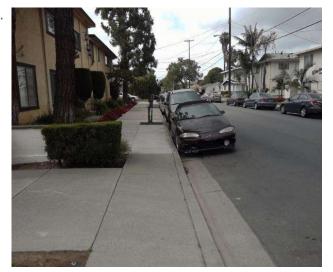
Recommendation Up to 2.08 percent

Repave surface \$1,092

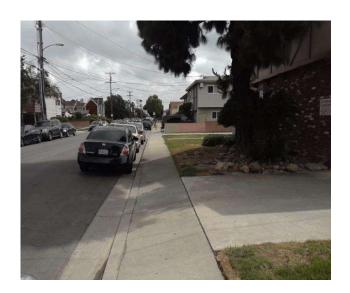
On-Site Finding Not Found

Install compliant detectable \$190

warnings

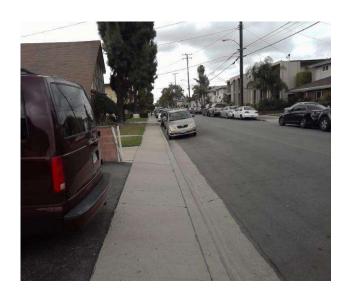
On-Site Finding Not Found

Install compliant detectable \$190

warnings

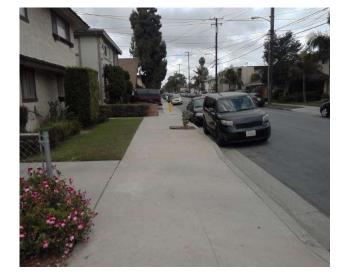
On-Site Finding Not Found

Install compliant detectable \$190 warnings

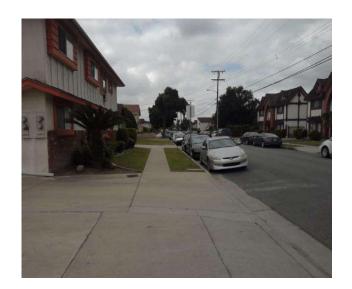
On-Site Finding Not Found

Install compliant detectable \$190

warnings

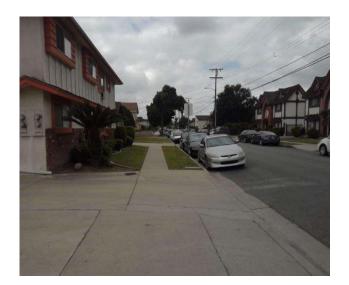
Recommendation Up to 5.00 percent

Repave surface \$1,092

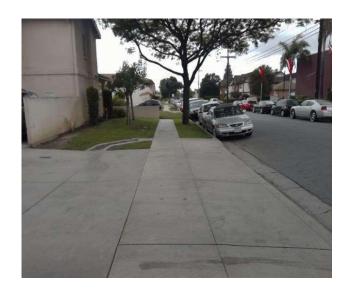
On-Site Finding Not Found

Install compliant detectable \$190

warnings

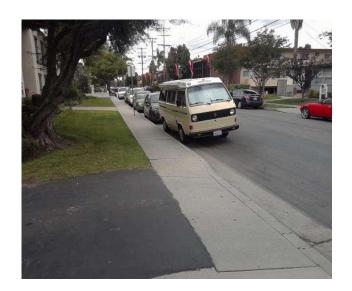
On-Site Finding Not Found

Install compliant detectable \$190

warnings

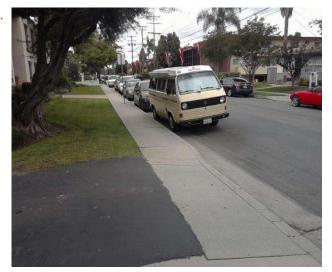
Recommendation Up to 2.08 percent

Repave surface \$1,092

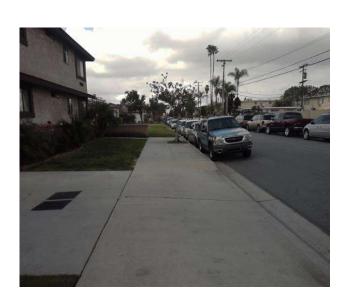
On-Site Finding Not Found

Install compliant detectable \$190 warnings

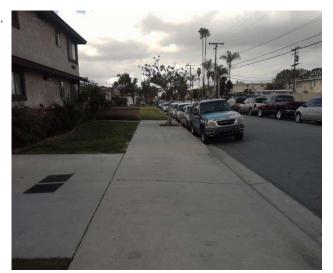
Recommendation Up to 2.08 percent

Repave surface \$1,092

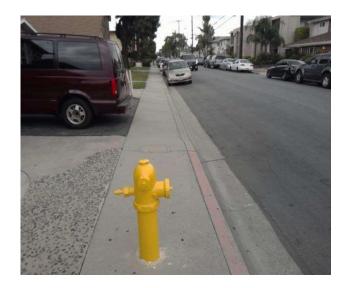
Sidewalks , Hazards & Gratings : Sidewalk Width at Obstruction

Sidewalk width at the obstruction shall have the recommended value.

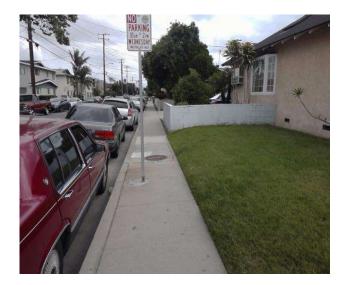
Recommendation Up to 2.08 percent

Repave the sidewalk surface with the recommended cross slope.

Repave surface \$1,092

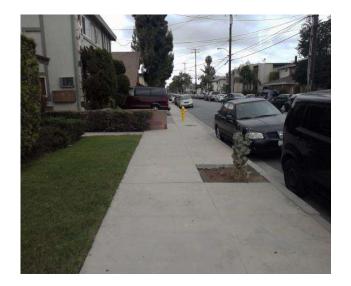
Recommendation Up to 2.08 percent

Repave the sidewalk surface with the recommended cross slope.

Repave surface \$1,092

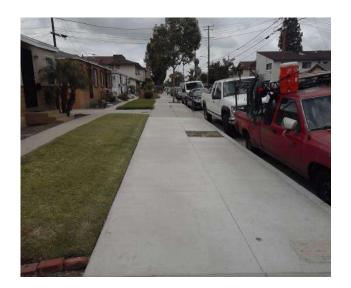
Recommendation Up to 2.08 percent

Repave the sidewalk surface with the recommended cross slope.

Repave surface \$1,092

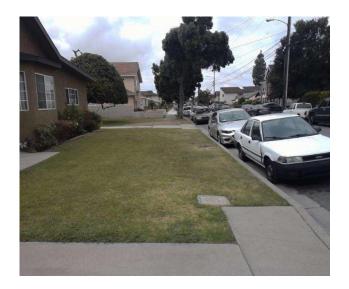
Sidewalks : Missing Sidewalk

Section of sidewalk is missing and consists of dirt, grass or gravel.

Provide a compliant sidewalk for the missing section.

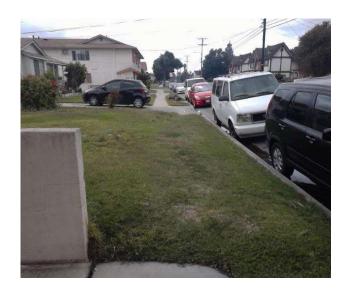
Sidewalks : Missing Sidewalk

Section of sidewalk is missing and consists of dirt, grass or gravel.

Provide a compliant sidewalk for the missing section.

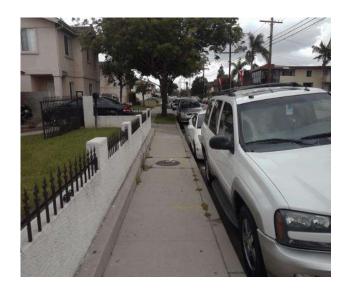
Recommendation Up to 2.08 percent

Repave the sidewalk surface with the recommended cross slope.

Repave surface \$1,092

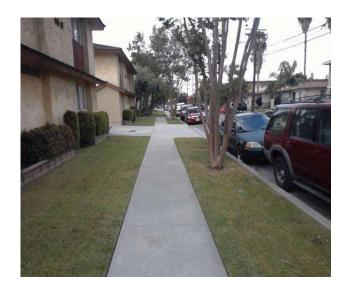
Recommendation Up to 2.08 percent

Repave the sidewalk surface with the recommended cross slope.

Repave surface \$1,092

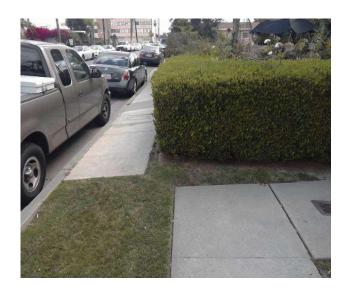
Sidewalks : Missing Sidewalk

Section of sidewalk is missing and consists of dirt, grass or gravel.

Provide a compliant sidewalk for the missing section.

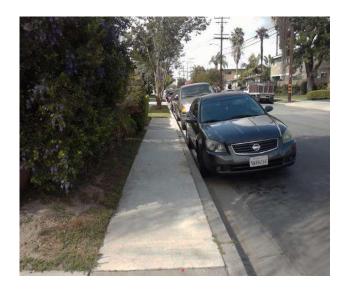
Recommendation At least 48.00 inches

Widen the sidewalk to the recommended value.

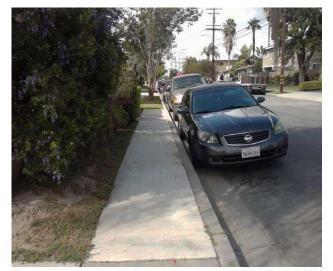
Recommendation Up to 2.08 percent

Repave the sidewalk surface with the recommended cross slope.

Repave surface \$1,092

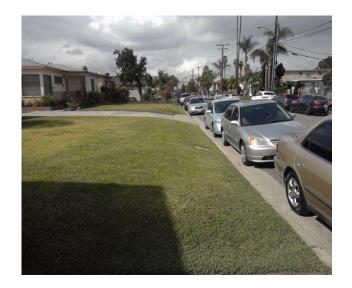
Sidewalks : Missing Sidewalk

Section of sidewalk is missing and consists of dirt, grass or gravel.

Provide a compliant sidewalk for the missing section.

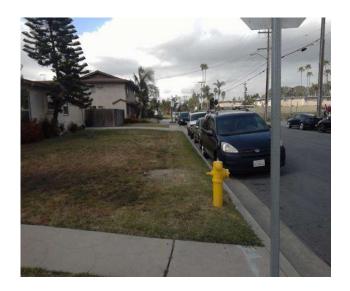
Sidewalks : Missing Sidewalk

Section of sidewalk is missing and consists of dirt, grass or gravel.

Provide a compliant sidewalk for the missing section.

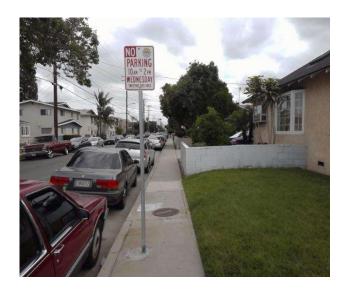
Sidewalks , Hazards & Gratings : Sidewalk Width at Obstruction

Sidewalk width at the obstruction shall have the recommended value.

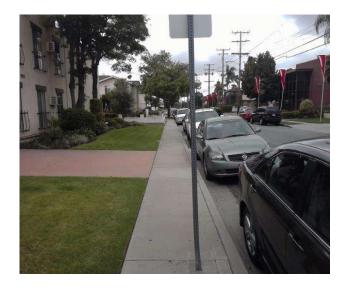
Sidewalks , Hazards & Gratings : Sidewalk Width at Obstruction

Sidewalk width at the obstruction shall have the recommended value.

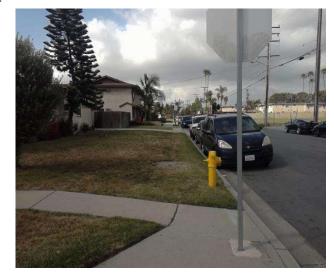
On-Site Finding Not Found

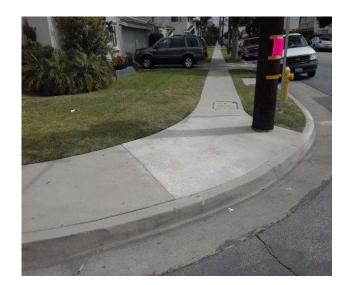
Sidewalks , Hazards & Gratings : Curb is on Path of Travel

Install curb ramp \$2,500

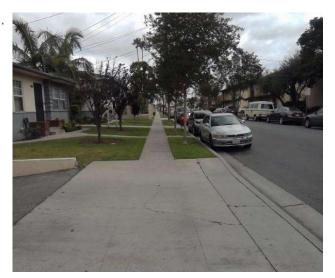
Recommendation Up to 2.08 percent

Repave surface \$1,092

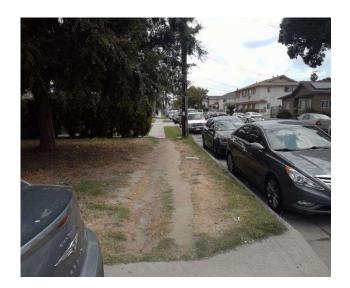
Sidewalks : Missing Sidewalk

Section of sidewalk is missing and consists of dirt, grass or gravel.

Provide a compliant sidewalk for the missing section.

\$1,260

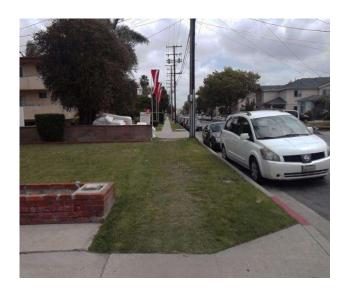
Sidewalks : Missing Sidewalk

Section of sidewalk is missing and consists of dirt, grass or gravel.

Provide a compliant sidewalk for the missing section.

\$1,260

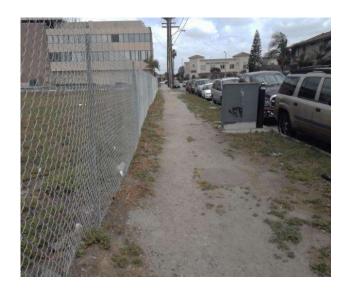
Sidewalks : Missing Sidewalk

Section of sidewalk is missing and consists of dirt, grass or gravel.

Provide a compliant sidewalk for the missing section.

\$1,260

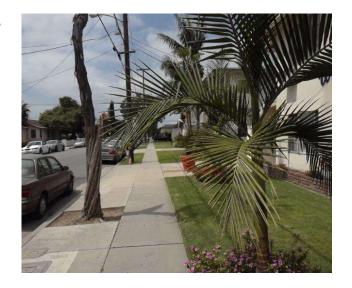
Sidewalks , Hazards & Gratings : Overhead Obstruction Height

Recommendation At least 80.00 inches

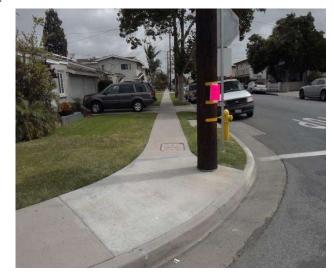
On-Site Finding Not Found

\$2,400
