Accessibility Survey

City of Downey Cheyenne Street - Barlin Avenue To Blodgett Avenue

Date of Inspection
4/7/2017

Disability Access Consultants

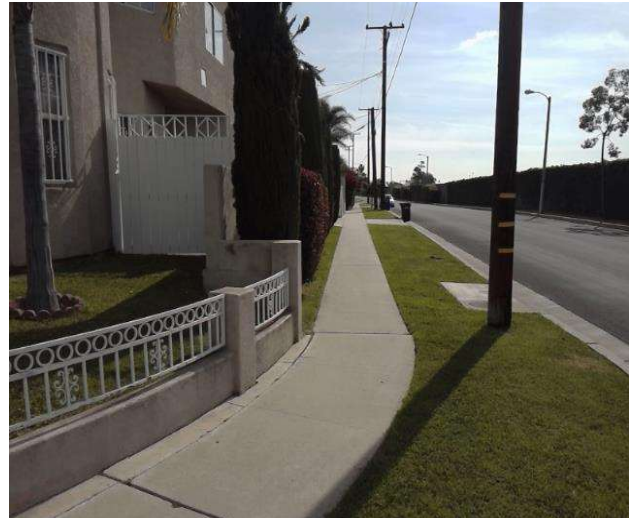
On-Site Finding Not Found

Recommendation

Recommendation See Recommendation

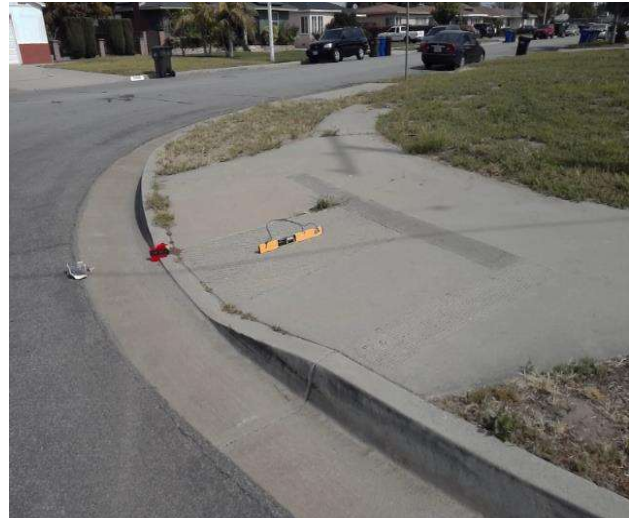
On-Site Finding Not Found

Provide detectable warning to surface \$248

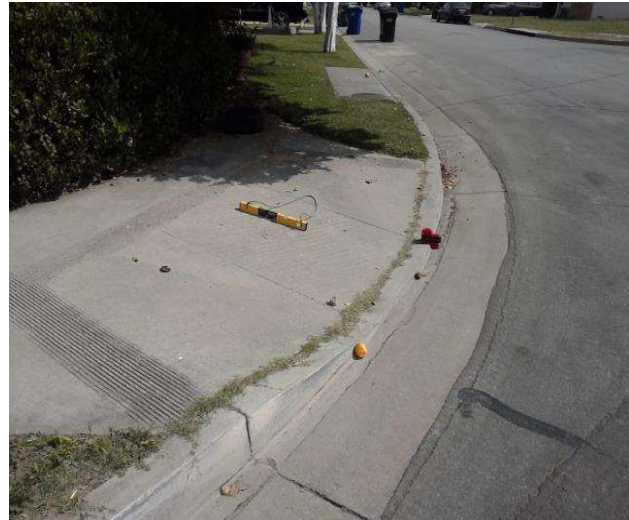
On-Site Finding Not Found

Provide detectable warning to surface \$248

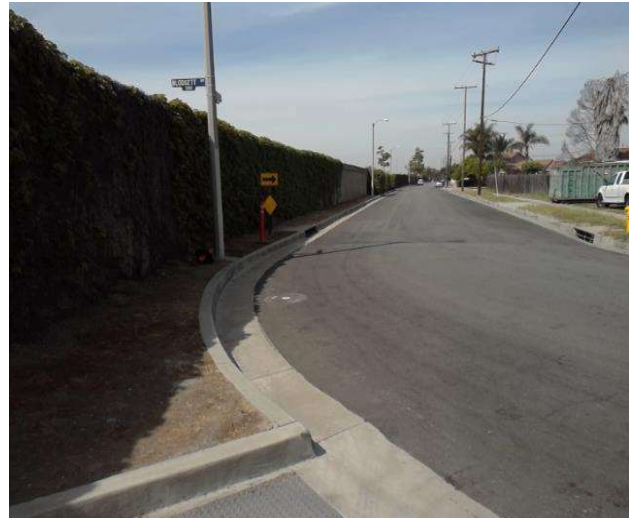
On-Site Finding Not Found

Recommendation

Recommendation See Recommendation

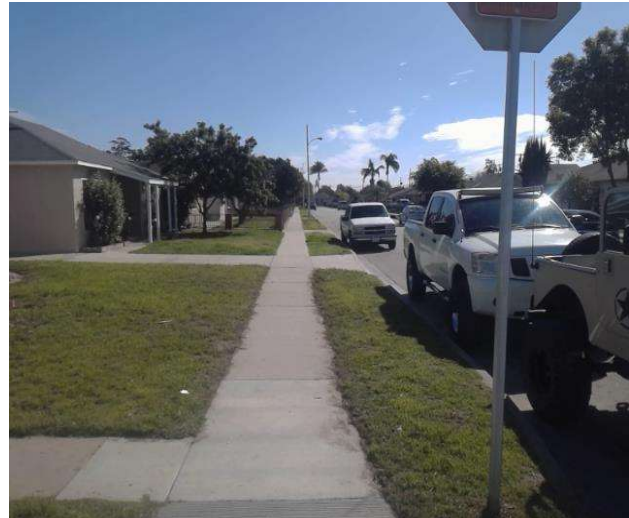
On-Site Finding Not Found

Recommendation

Recommendation See Recommendation

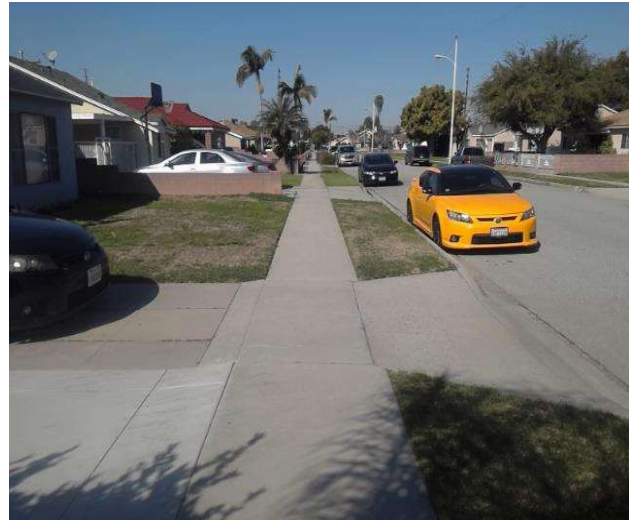
On-Site Finding Not Found

Install compliant detectable warnings \$190

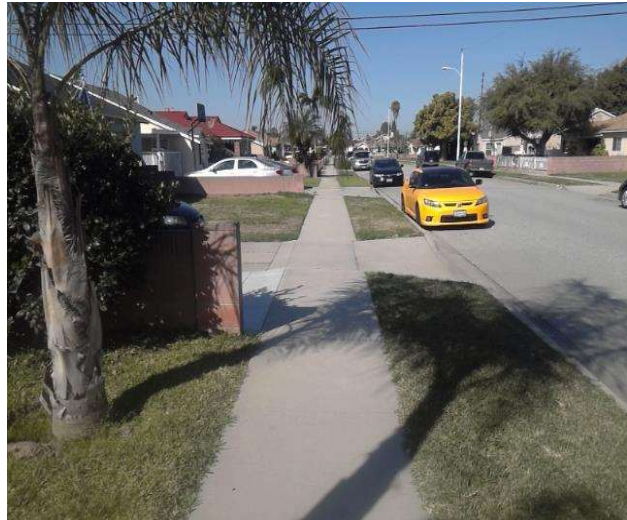
There is a change in elevation greater than recommended value.

Recommendation

Ensure that the change in elevation is within the recommended value.

Recommendation Up to 0.25 inches

Remove tripping hazards \$198

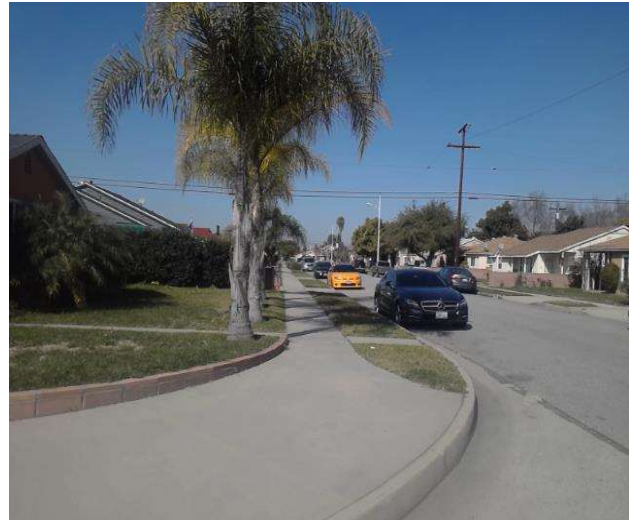
On-Site Finding Not Found

Recommendation

Recommendation See Recommendation

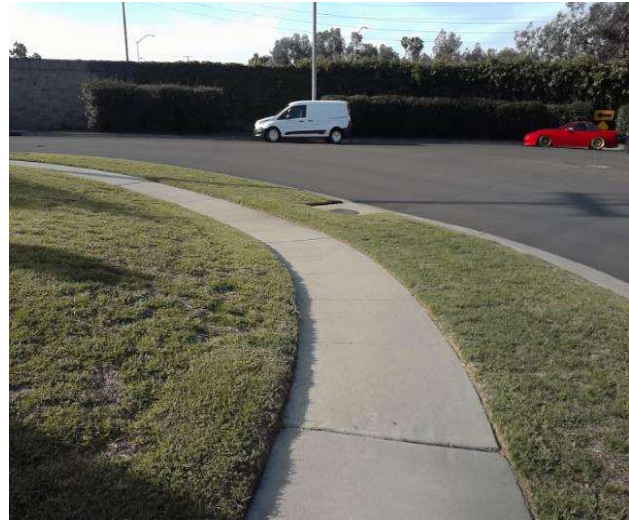
Notes : Has 4 openings within 322 feet

Repave surface \$1,092

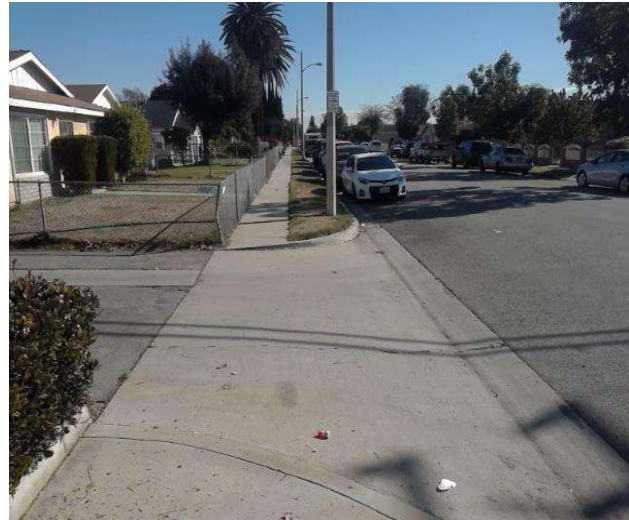
On-Site Finding Not Found

Install compliant detectable warnings \$190

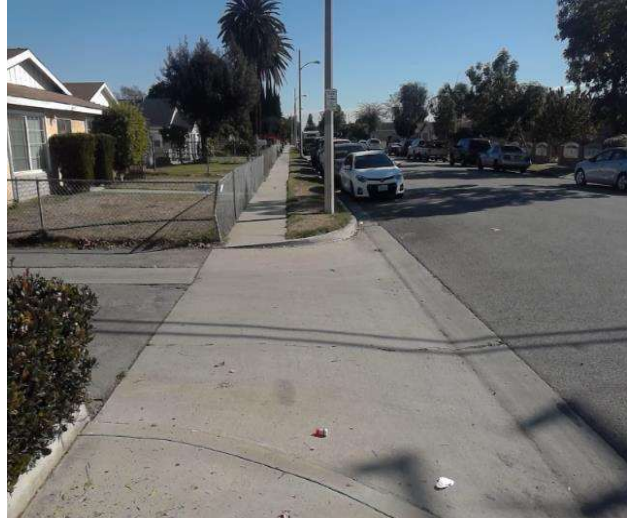
Recommendation Up to 2.08 percent

Repave surface \$1,092

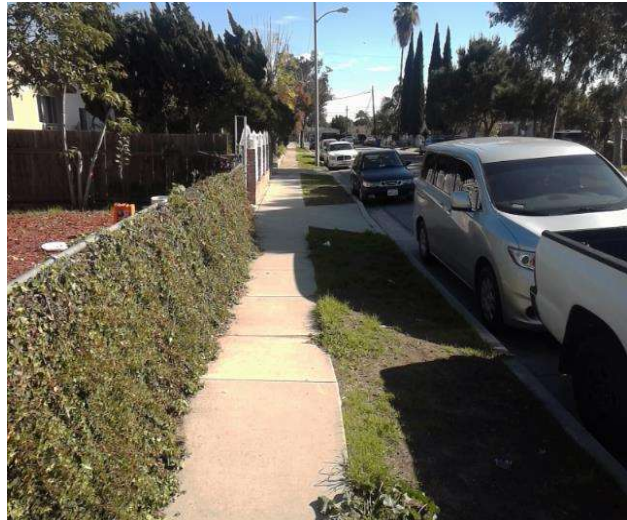
Recommendation Up to 2.08 percent

Repave the sidewalk surface with the recommended cross slope.

Repave surface \$1,092

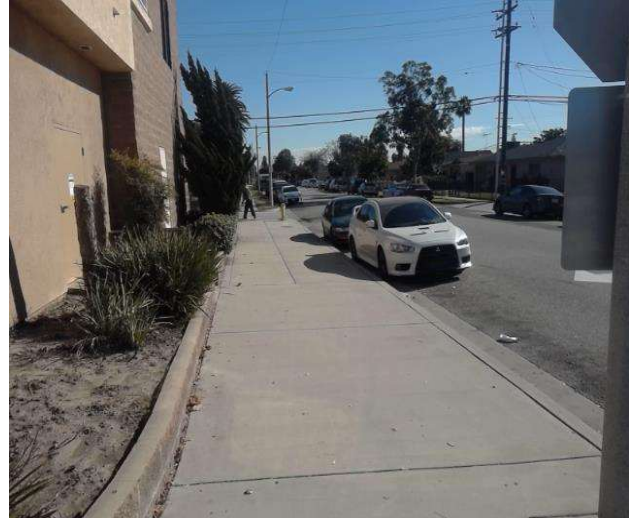
On-Site Finding Not Found

\$2,400

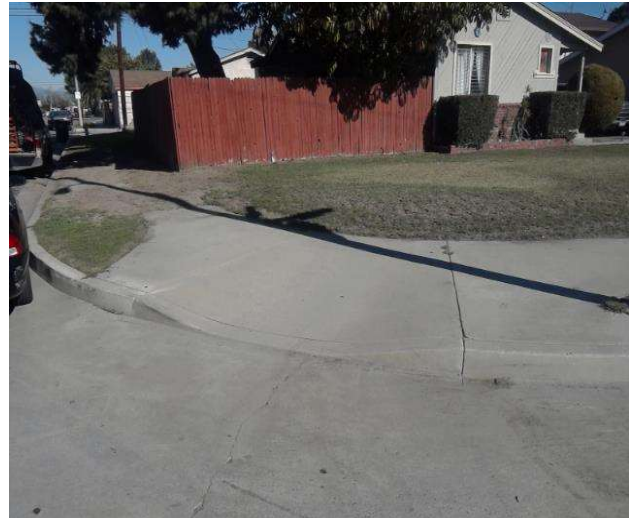
On-Site Finding Not Found

Provide detectable warning to surface \$248

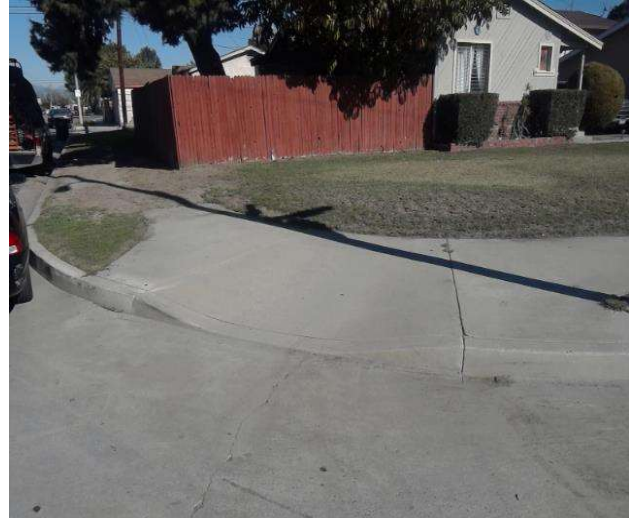
Recommendation Up to 2.08 percent

Install curb ramp \$1,300

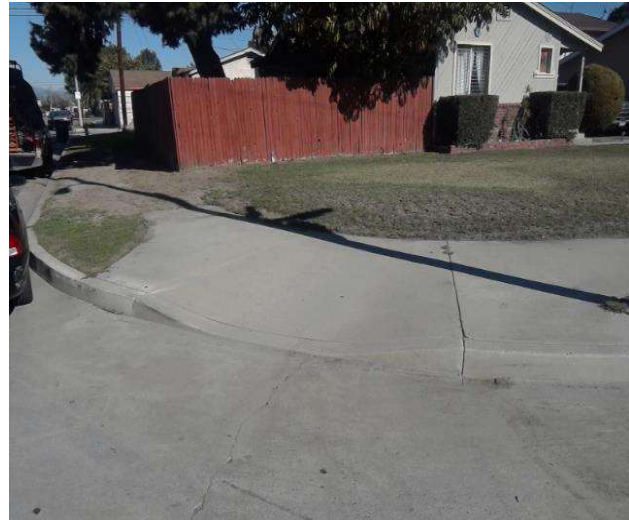
Recommendation Up to 10.00 percent

Install flared sides \$1,300

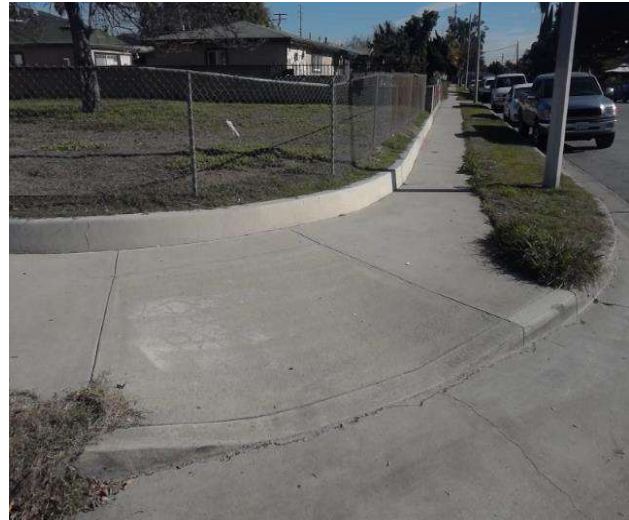
On-Site Finding Not Found

Provide detectable warning to surface \$248

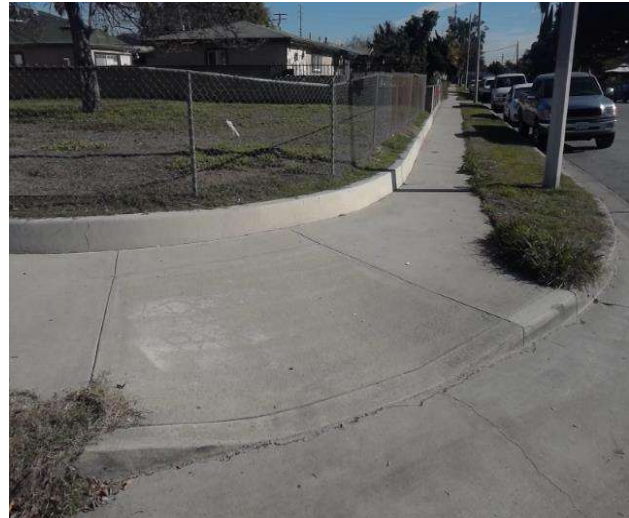
Recommendation Up to 8.33 percent

Install curb ramp \$1,300

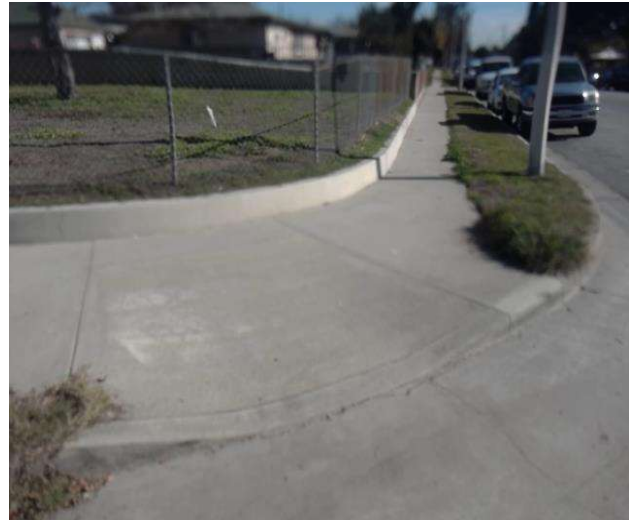
Recommendation Up to 2.08 percent

Provide compliant landing \$1,260

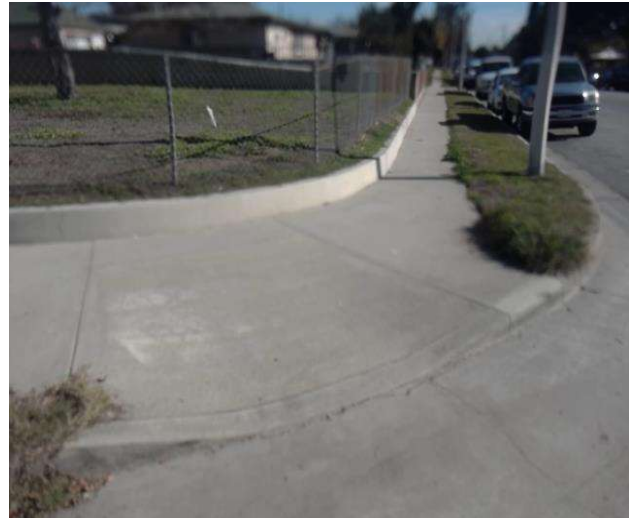
Recommendation At least 48.00 inches

Provide compliant landing \$240

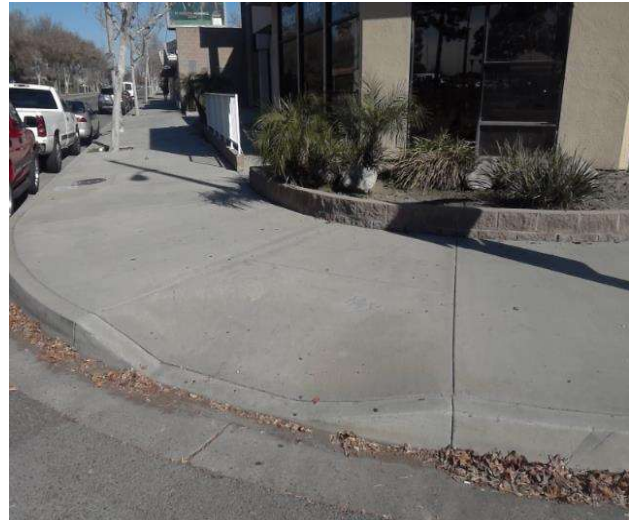
On-Site Finding Not Found

Provide detectable warning to surface \$248

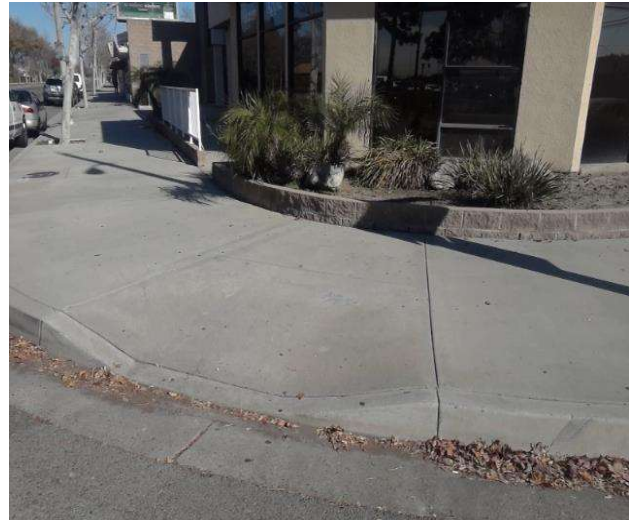
Recommendation Up to 5.00 percent

Repave landing \$1,260

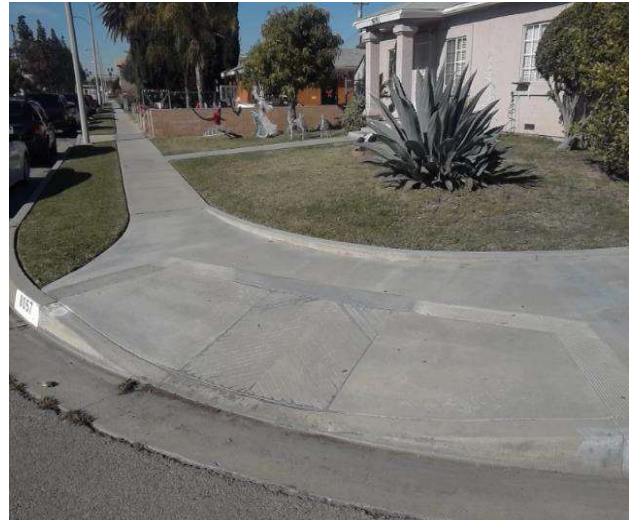
On-Site Finding Not Found

Provide detectable warning to surface \$248

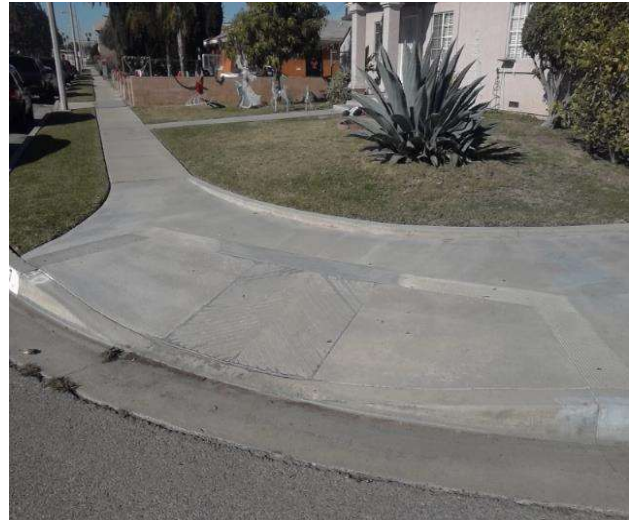
Recommendation Up to 5.00 percent

Repave landing \$1,260

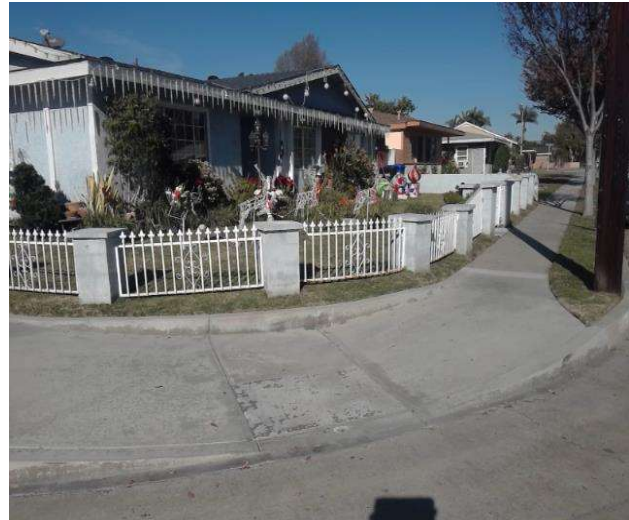
On-Site Finding Not Found

Provide detectable warning to surface \$248

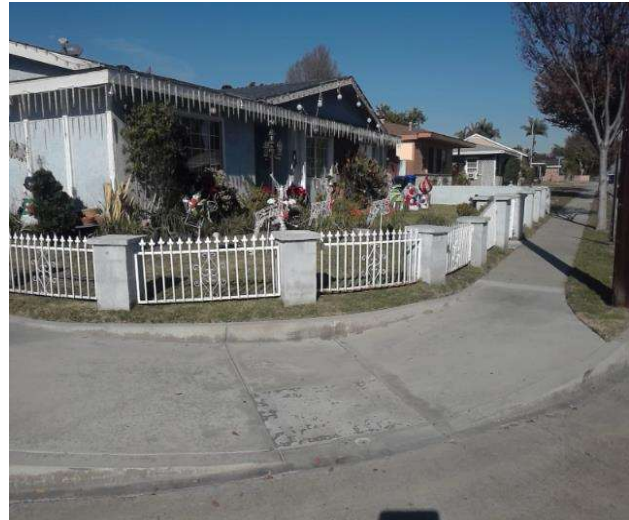
Recommendation Up to 2.08 percent

Provide compliant landing \$240

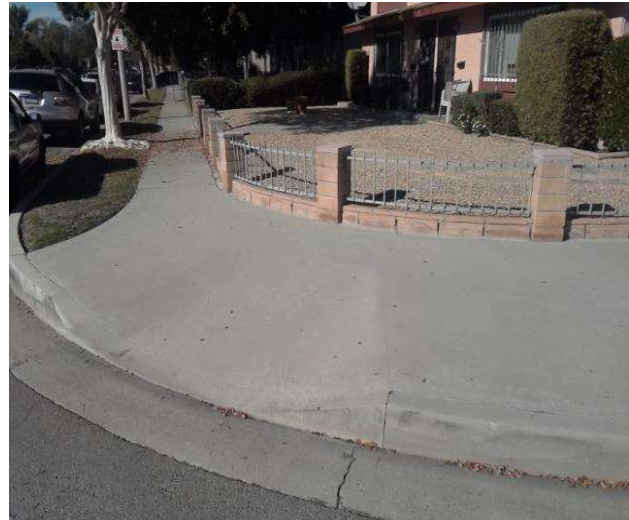
On-Site Finding Not Found

Provide detectable warning to surface \$248

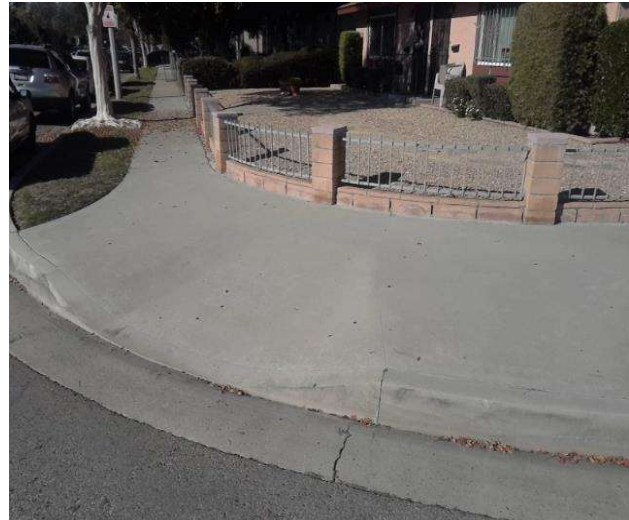
Recommendation Up to 2.08 percent

Provide compliant landing \$240

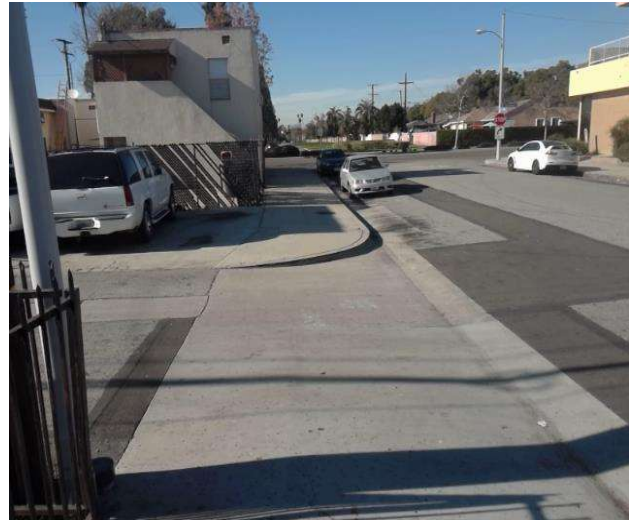
On-Site Finding Not Found

Install compliant detectable warnings \$190

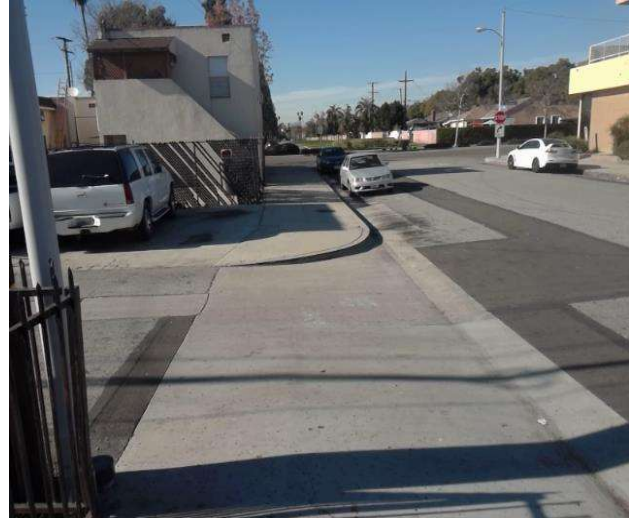
Recommendation Up to 2.08 percent

Repave surface \$1,092

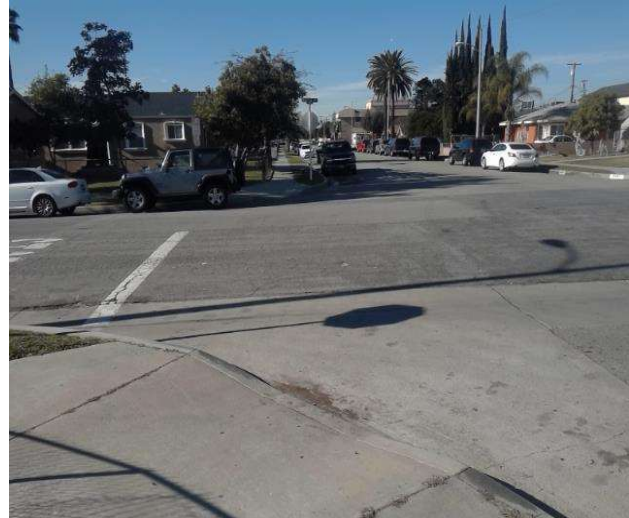
On-Site Finding Not Found

Install compliant detectable warnings \$190

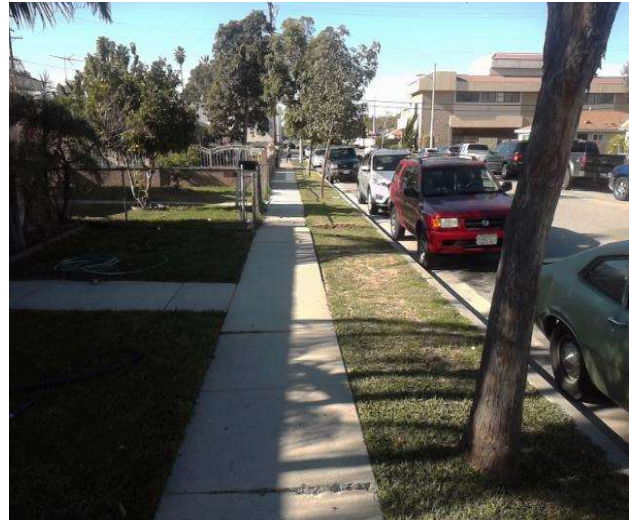
There is a change in elevation greater than recommended value.

Ensure that the change in elevation is within the recommended value.

Remove tripping hazards \$198

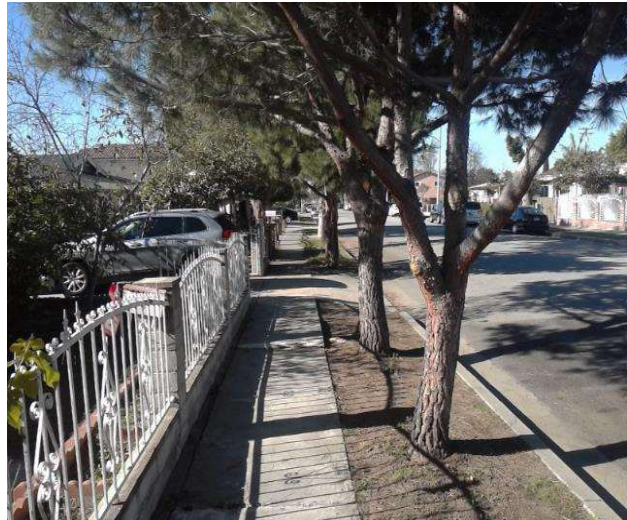
There is a change in elevation greater than recommended value.

Ensure that the change in elevation is within the recommended value.

Remove tripping hazards \$198

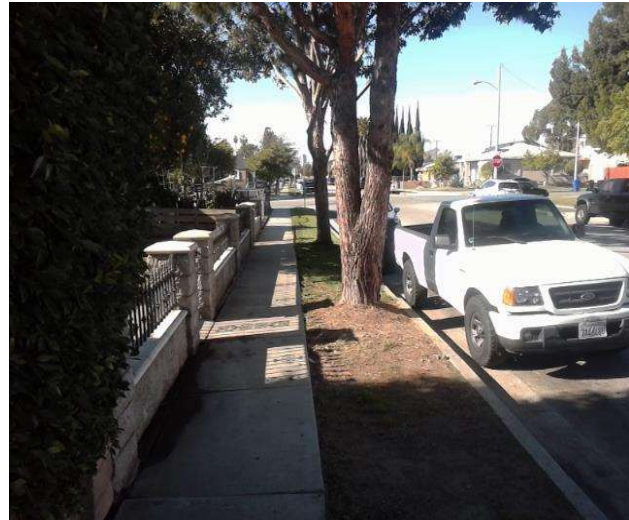
There is a change in elevation greater than recommended value.

Ensure that the change in elevation is within the recommended value.

Remove tripping hazards \$198

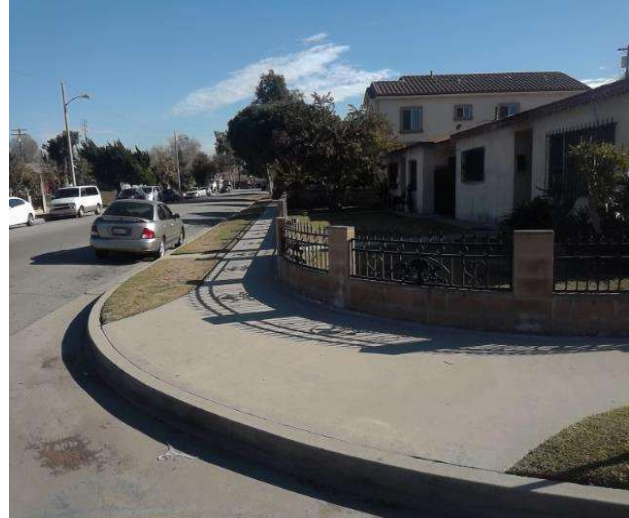
Sidewalks , Hazards & Gratings : Curb is on Path of Travel

Install curb ramp \$2,500

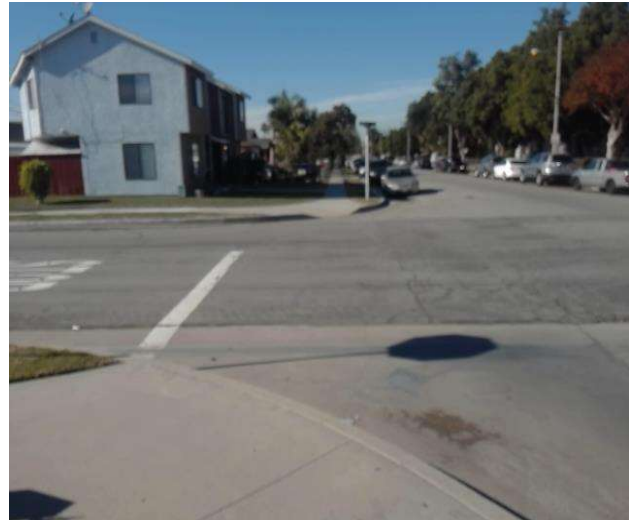
On-Site Finding Not Found

Install compliant detectable warnings \$190

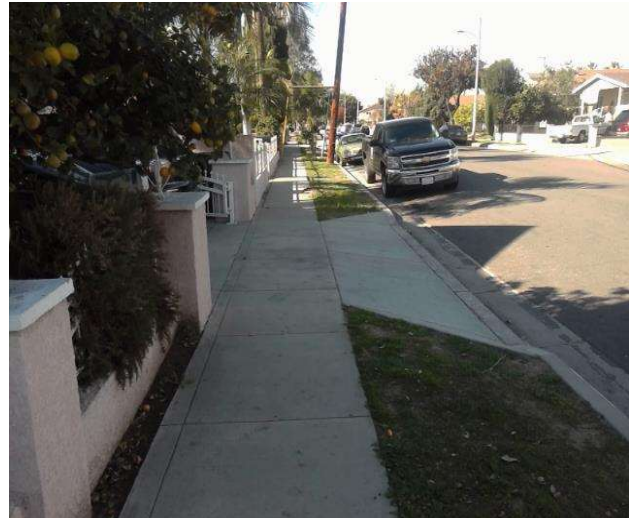
Recommendation Up to 2.08 percent

Repave the sidewalk surface with the recommended cross slope.

Repave surface \$1,092

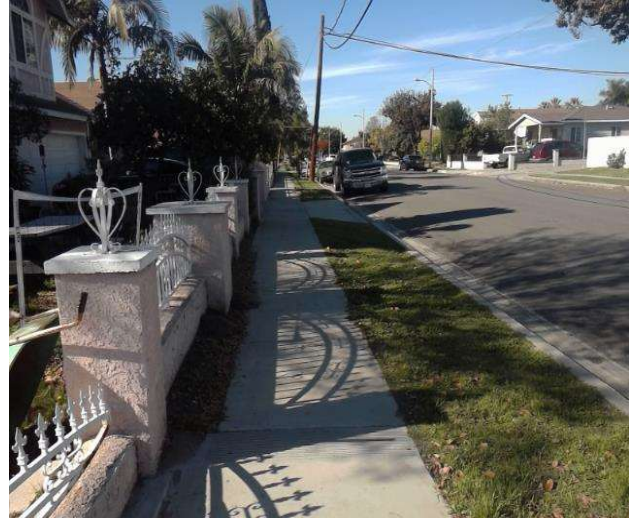
On-Site Finding Not Found

\$2,400

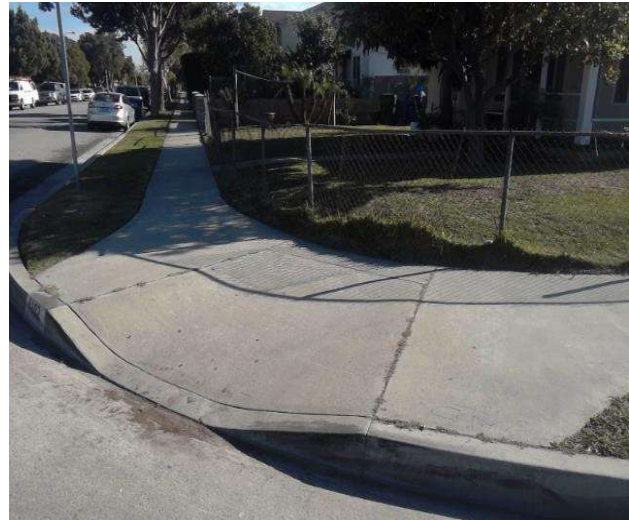
On-Site Finding Not Found

Provide detectable warning to surface \$248

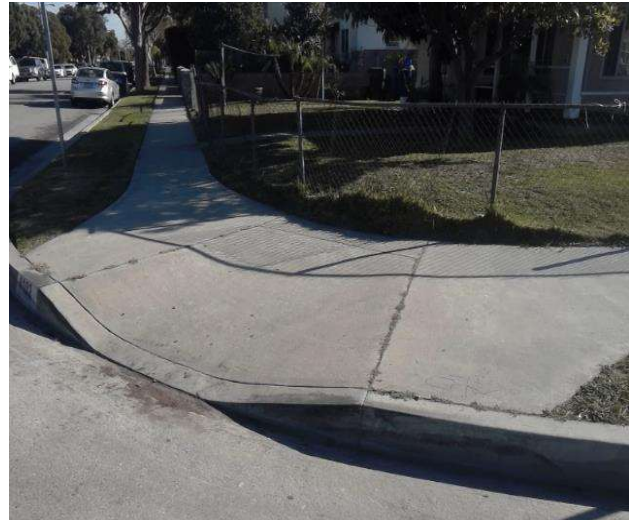
Recommendation At least 48.00 inches

Provide compliant landing \$255

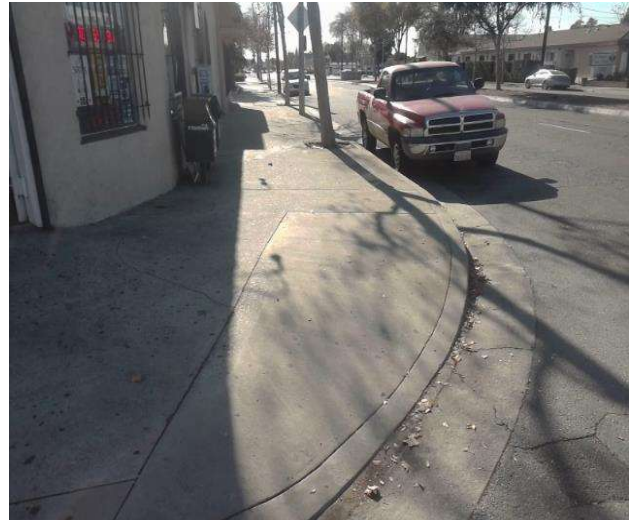
On-Site Finding Not Found

Provide detectable warning to surface \$248

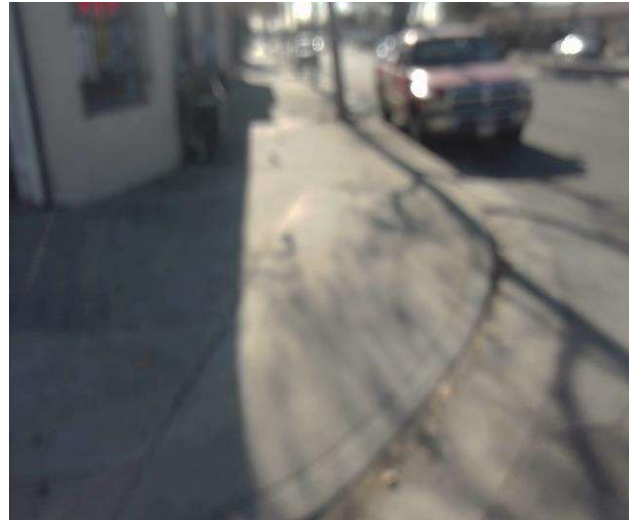
Recommendation Up to 5.00 percent

Repave landing \$1,260

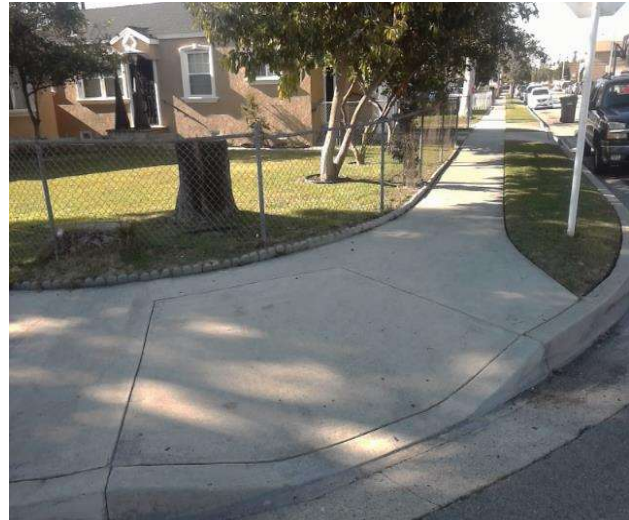
On-Site Finding Not Found

Provide detectable warning to surface \$248

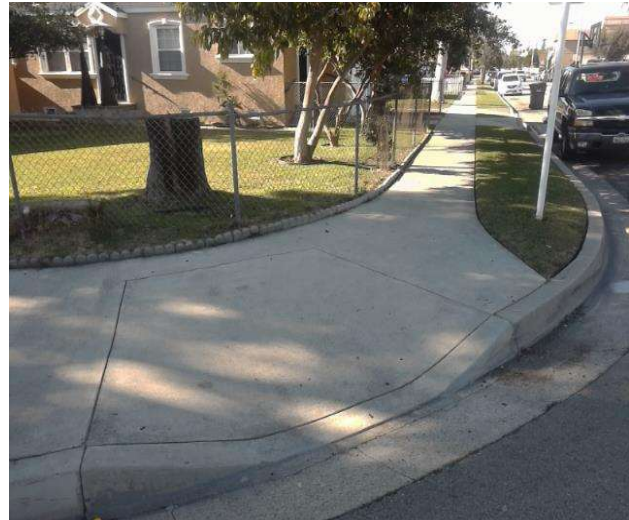
Recommendation Up to 5.00 percent

Repave landing \$1,260

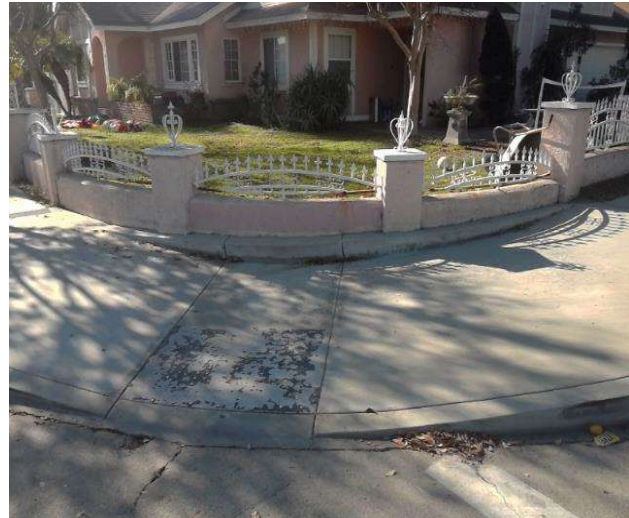
On-Site Finding Not Found

Provide detectable warning to surface \$248

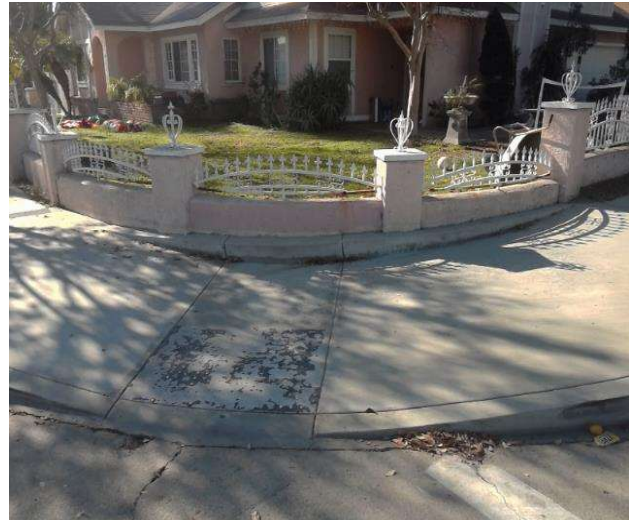
Recommendation Up to 2.08 percent

Install curb ramp \$1,300

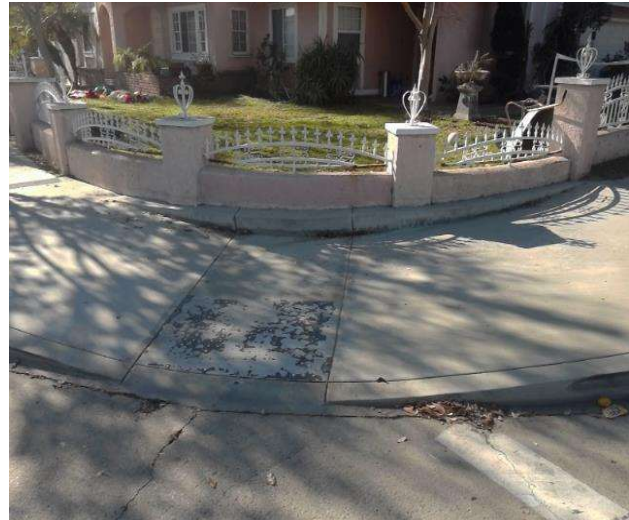
Curb Ramp , Landings and Transitions : Top Landing Right Side
Slope - Parallel Curb Ramp

Recommendation

Recommendation Up to 2.08 percent

Provide compliant landing \$1,260
