Accessibility Survey

City of Downey Myrtle Street - 2nd Street to Firestone Boulevard

Date of Inspection 7/20/2017

Disability Access Consultants

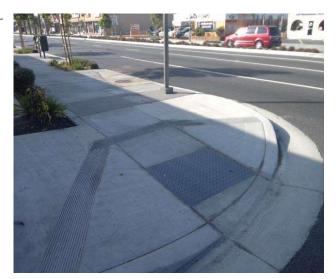
Recommendation Up to 10.00 percent

Install flared sides \$1,300

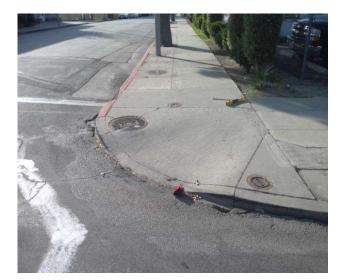
Recommendation Up to 0.50 inches

Curb Ramp , Landings And Transitions : Bottom Landing Change in

Patch lip at curb ramp \$255

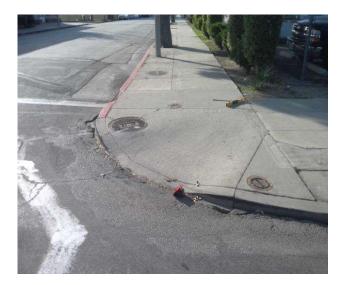
Recommendation Up to 2.08 percent

Provide compliant landing \$1,260

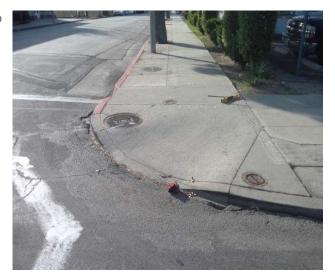
Recommendation Up to 0.50 inches

Patch lip at curb ramp \$155

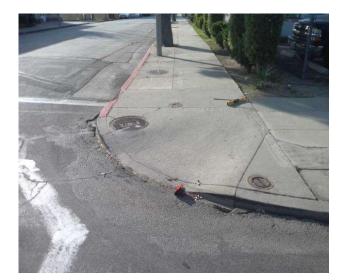
Recommendation At least 48.00 inches

Curb Ramp , Landings and Transitions : Top Landing Clear Length -

Provide compliant landing \$240

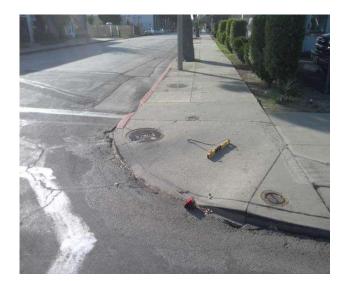
On-Site Finding Not Found

Provide detectable warning to \$248 surface

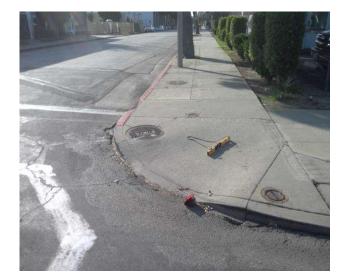
Recommendation Up to 8.33 percent

Install curb ramp \$1,300

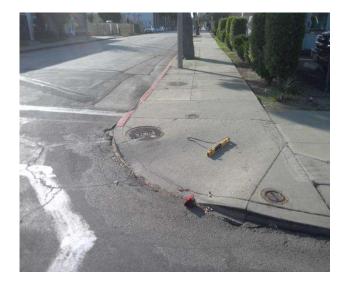
Recommendation Up to 2.08 percent

Install curb ramp \$1,300

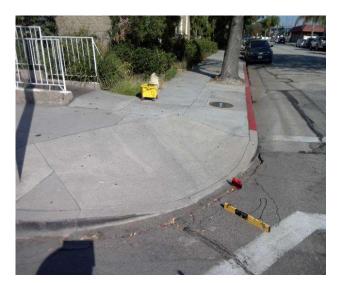
Recommendation Up to 5.00 percent

Curb Ramp : Bottom Landing Slope

Repave landing \$1,260

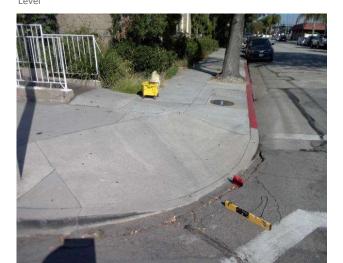
Recommendation Up to 0.50 inches

Curb Ramp , Landings And Transitions : Bottom Landing Change in

Patch lip at curb ramp \$255

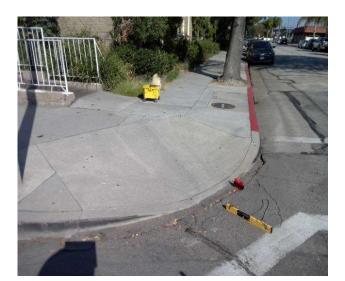
Recommendation Up to 2.08 percent

Curb Ramp , Landings and Transitions : Top Landing Slope

Provide compliant landing \$1,260

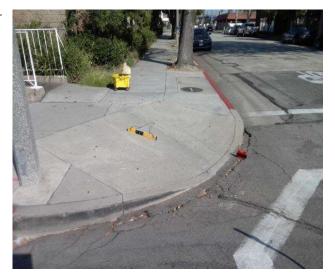
Recommendation Up to 10.00 percent

Install flared sides \$1,300

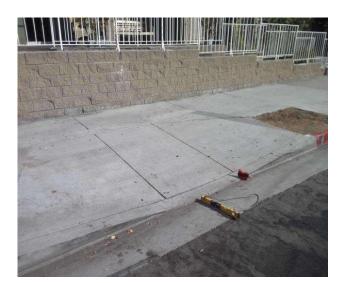
Recommendation Up to 2.08 percent

Curb Ramp , Landings and Transitions : Top Landing Slope

Provide compliant landing \$1,260

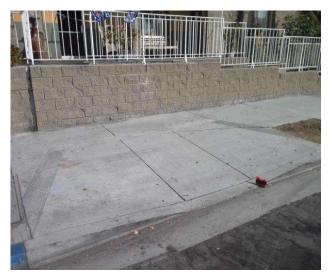
Recommendation Up to 10.00 percent

Install flared sides \$1,300

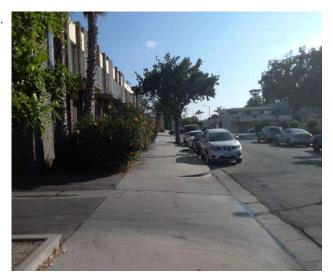
Recommendation Up to 2.08 percent

Repave surface \$1,092

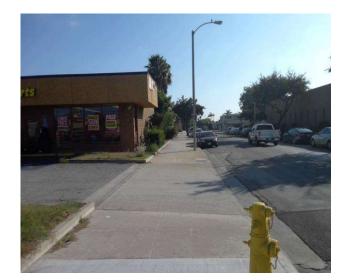
On-Site Finding Not Found

Install compliant detectable \$190 warnings

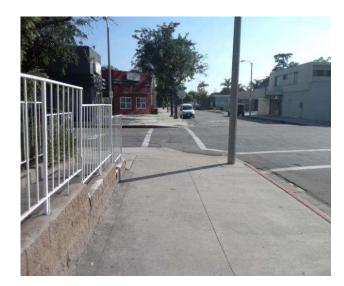
Recommendation Up to 2.08 percent

Repave the sidewalk surface with the recommended cross slope.

Repave surface \$1,092

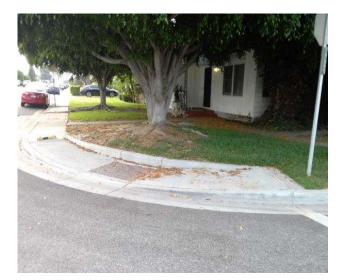
Curb Ramp , Landings and Transitions : Top Landing Clear Length -

Provide compliant landing \$240

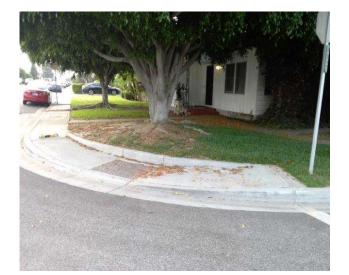
Curb Ramp , Landings and Transitions : Top Landing Right Side Clear

Provide compliant landing \$240

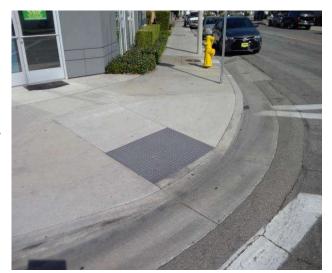
Recommendation At least 48.00 inches

Curb Ramp , Landings and Transitions : Bottom Landing Of Diagonal

Provide compliant landing \$255

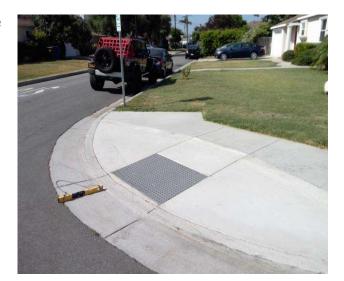
Recommendation Up to 5.00 percent

Repave landing \$1,260

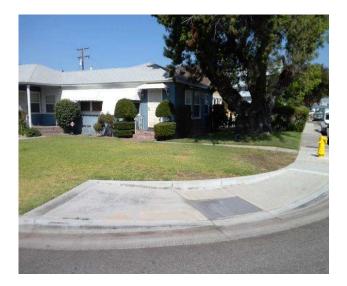
Recommendation At least 48.00 inches

Provide compliant landing \$240

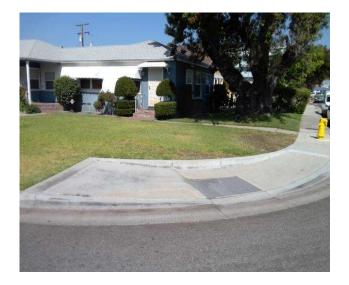
Recommendation At least 48.00 inches

Install curb ramp \$1,300

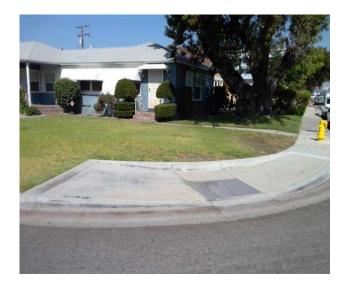
Recommendation Up to 8.33 percent

Install curb ramp \$1,300

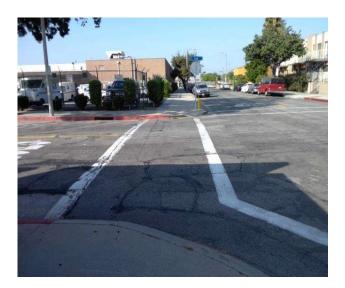
Recommendation Up to 5.00 percent

Repave surface \$1,092

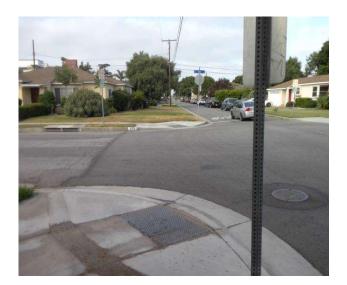
Recommendation Up to 5.00 percent

Repave surface \$1,092

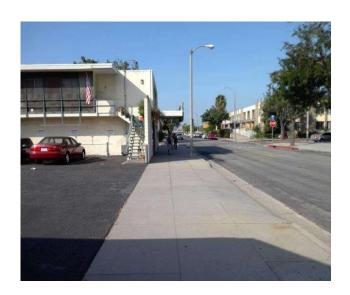
On-Site Finding Not Found

Install compliant detectable \$190

warnings

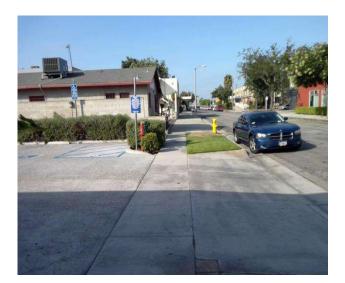
On-Site Finding Not Found

Install compliant detectable \$190 warnings

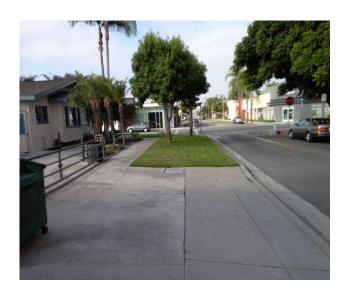
On-Site Finding Not Found

Install compliant detectable \$190

warnings

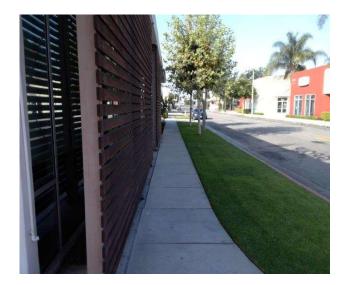
Recommendation Up to 2.08 percent

Repave the sidewalk surface with the recommended cross slope.

Repave surface \$1,092

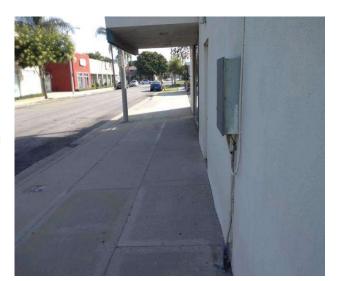
Sidewalks , Hazards & Gratings : Protruding Object Height

Recommendation Up to 4.00 inches

Install wing walls or relocate \$640 object

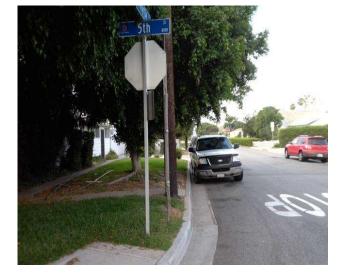
On-Site Finding Not Found

\$2,400

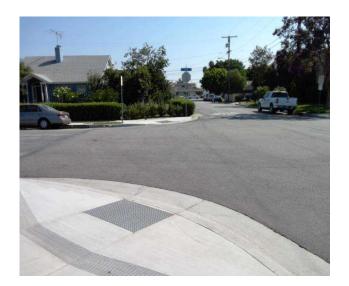
Recommendation Up to 5.00 percent

Repave surface \$1,092

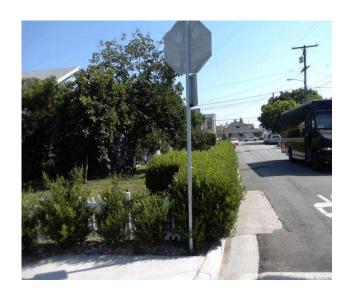
Sidewalks : Missing Sidewalk

Section of sidewalk is missing and consists of dirt, grass or gravel.

Provide a compliant sidewalk for the missing section.

\$1,260

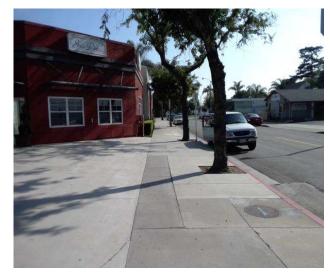
On-Site Finding Not Found

\$2,400

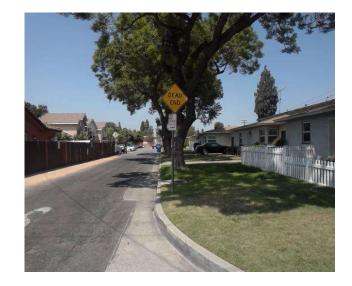
On-Site Finding Not Found

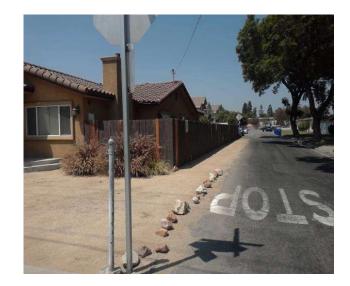
On-Site Finding Not Found

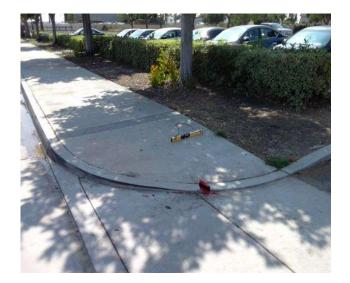
On-Site Finding Not Found

Provide detectable warning to \$248 surface

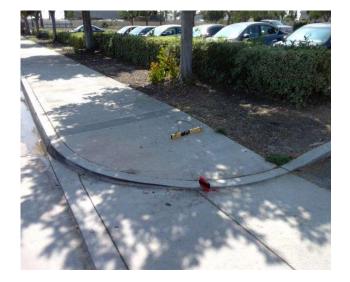
Recommendation Up to 2.08 percent

Install curb ramp \$1,300

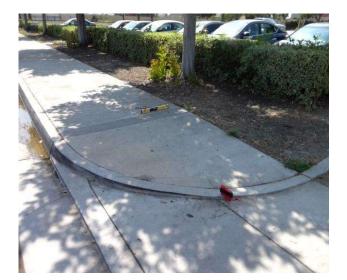
Recommendation Up to 0.50 inches

Curb Ramp , Landings And Transitions : Bottom Landing Change in

Patch lip at curb ramp \$255

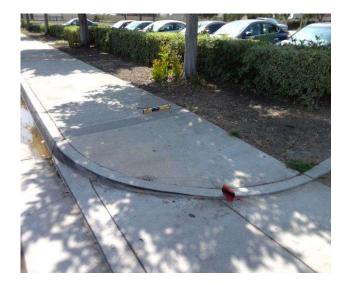
Recommendation Up to 2.08 percent

Provide compliant landing \$1,260

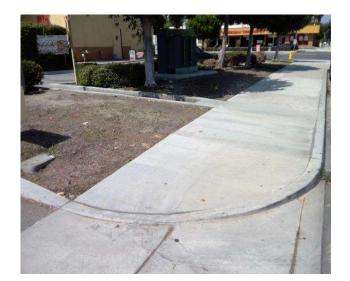
On-Site Finding Not Found

Provide detectable warning to \$248 surface

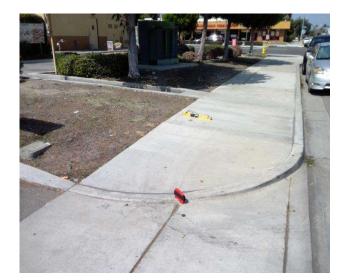
Recommendation Up to 0.50 inches

Curb Ramp , Landings And Transitions : Bottom Landing Change in

Patch lip at curb ramp \$255

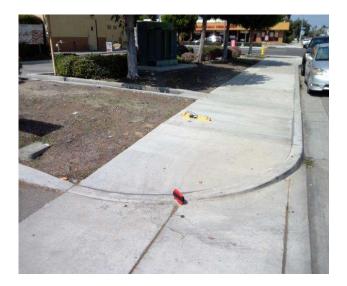
Recommendation Up to 2.08 percent

Provide compliant landing \$1,260

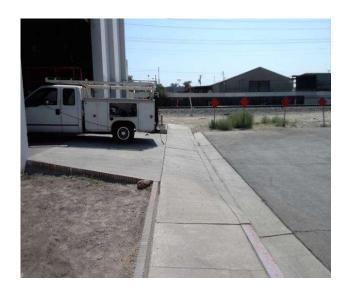
On-Site Finding Not Found

Install compliant detectable \$190

warnings

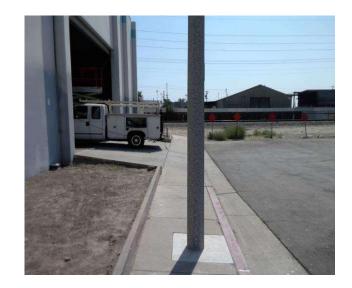
Sidewalks , Hazards & Gratings : Sidewalk Width at Obstruction

Recommendation At least 48.00 inches

Sidewalk width at the obstruction shall have the recommended value.

\$1,260

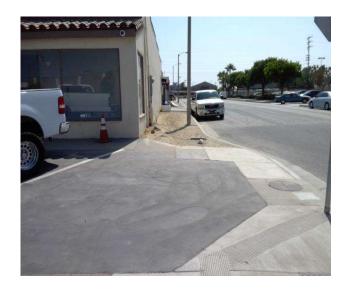
Sidewalks : Missing Sidewalk

Section of sidewalk is missing and consists of dirt, grass or gravel.

Provide a compliant sidewalk for the missing section.

\$1,260

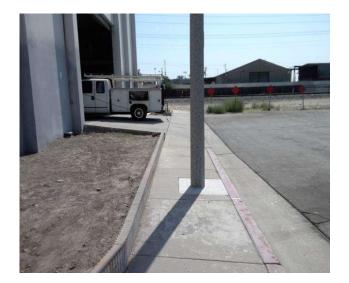
Recommendation Up to 2.08 percent

Repave the sidewalk surface with the recommended cross slope.

Repave surface \$1,092

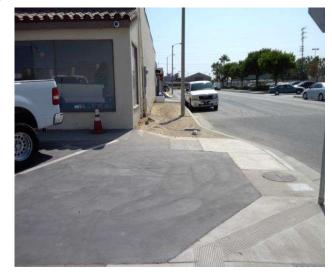
On-Site Finding Not Found

\$2,400

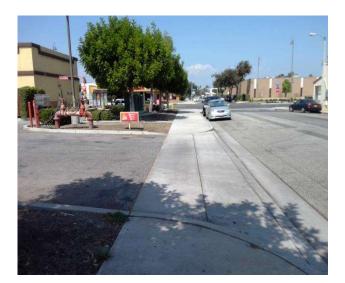
On-Site Finding Not Found

Install compliant detectable \$190 warnings

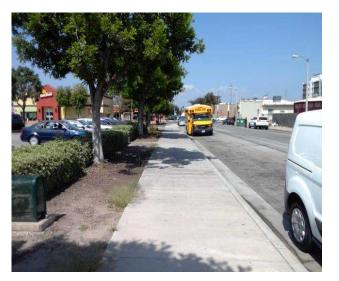
Recommendation Up to 2.08 percent

Repave the sidewalk surface with the recommended cross slope.

Repave surface \$1,092

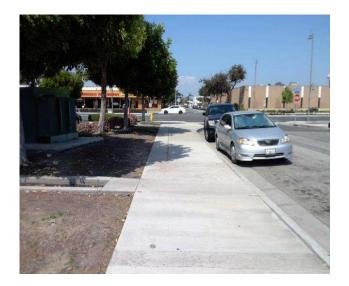
Recommendation Up to 2.08 percent

Repave the sidewalk surface with the recommended cross slope.

Repave surface \$1,092

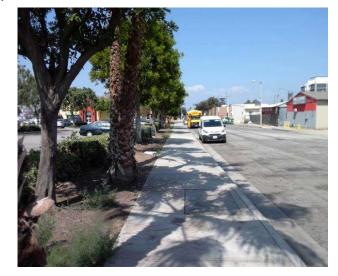
On-Site Finding Not Found

\$2,400
