Accessibility Survey

City of Downey New Street - 6th Street to 2nd Street

6th Street to 2nd Street Downey, CA 90242

Date of Inspection 7/19/2017

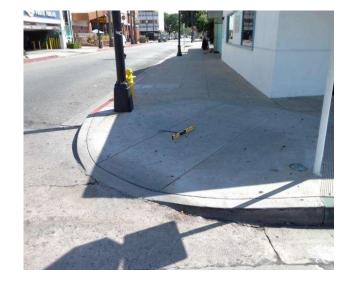
Recommendation Up to 8.33 percent

Code Reference ADA 406, 406.1, 405.2,CA 11B-406

Install curb ramp \$1,300

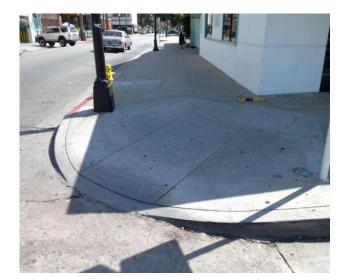
Recommendation At least 48.00 inches

Curb Ramp , Landings and Transitions : Top Landing Clear Length -

Code Reference ADA 406, 406.4,CA 11B-406.5.3

Provide compliant landing \$240

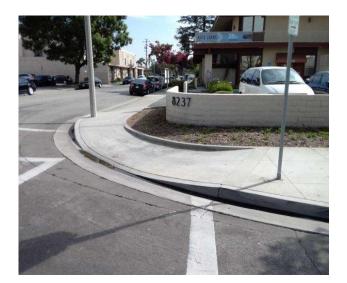
On-Site Finding Not Found

Code Reference CA 11B-406.5.12

Provide detectable warning to \$248 surface

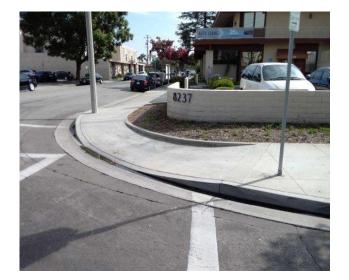
Recommendation Up to 2.08 percent

Code Reference ADA 406.1, 405.3,CA 11B-406.5.7

Install curb ramp \$1,300

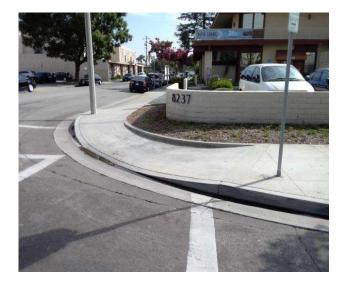
Recommendation Up to 8.33 percent

Code Reference ADA 406.1, 405.2,CA 11B-406

Install curb ramp \$1,300

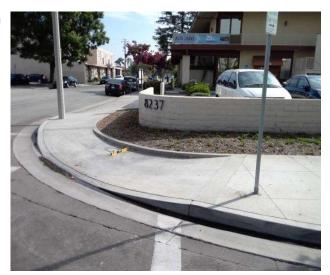
Recommendation Up to 2.08 percent

Code Reference ADA 402, 406.4, 406.2, 403.3, 406.1, CA 11B-406.5.3

Provide compliant landing \$240

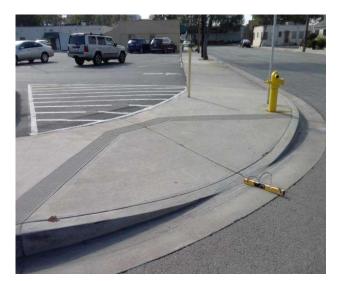
Recommendation Up to 5.00 percent

Code Reference ADA 406, 406.2,CA 11B-406.5.8

Repave landing \$1,260

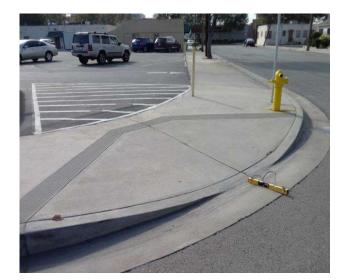
Recommendation At least 48.00 inches

Curb Ramp , Landings and Transitions : Top Landing Clear Length -

Code Reference ADA 406, 406.4,CA 11B-406.5.3

Provide compliant landing \$240

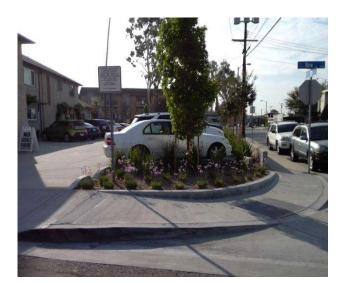
Recommendation Up to 2.08 percent

Curb Ramp , Landings and Transitions : Top Landing Right Side

Code Reference ADA 406.4, 403.3, 406.1,CA 11B-406.5.3

Provide compliant landing \$1,260

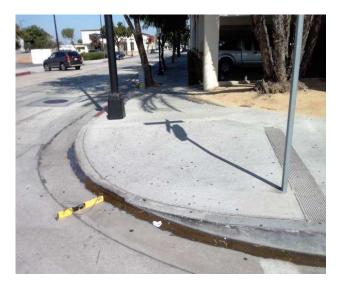
Recommendation Up to 5.00 percent

Code Reference ADA 406, 406.2,CA 11B-406.5.8

Repave landing \$1,260

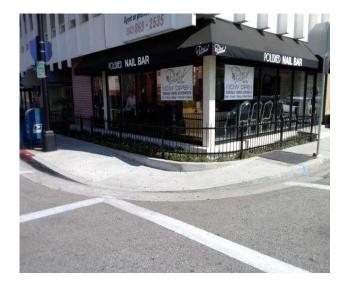
On-Site Finding Not Found

Code Reference CA 11B-406.5.12

Provide detectable warning to \$248 surface

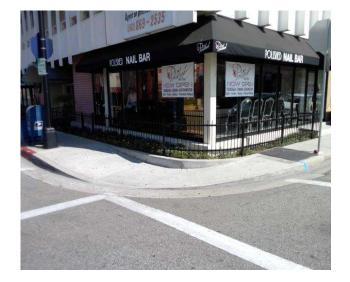
Recommendation Up to 8.33 percent

Code Reference ADA 406.1, 405.2,CA 11B-406

Install curb ramp \$1,300

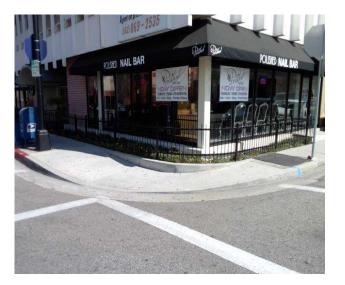
Recommendation Up to 2.08 percent

Code Reference ADA 402, 406.4, 403.3, 406.1,CA 11B-406.5.3

Provide compliant landing \$1,260

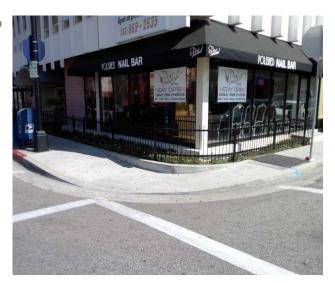
Recommendation Up to 0.50 inches

Code Reference ADA 303.1

Patch lip at curb ramp \$155

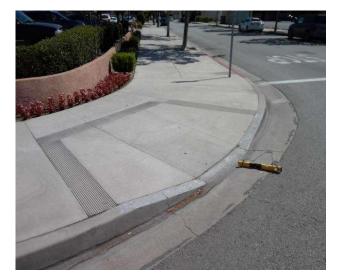
Recommendation Up to 5.00 percent

Code Reference ADA 406, 406.2,CA 11B-406.5.8

Repave landing \$1,260

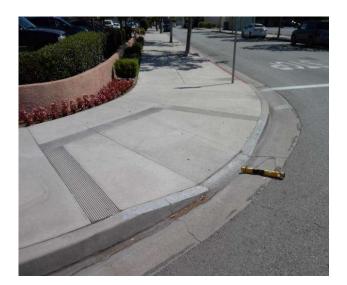
Recommendation Up to 2.08 percent

Code Reference ADA 402, 406.4, 403.3, 406.1,CA 11B-406.5.3

Provide compliant landing \$1,260

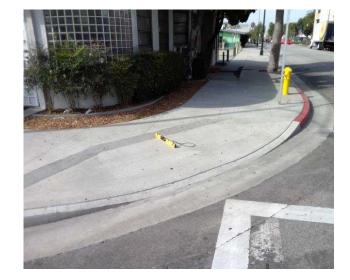
Recommendation Up to 8.33 percent

Code Reference ADA 406, 406.1, 405.2,CA 11B-406

Install curb ramp \$1,300

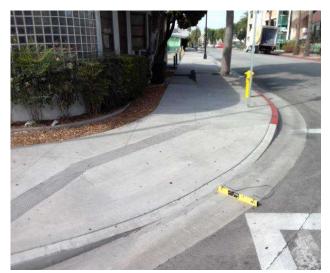
Recommendation At least 48.00 inches

Curb Ramp , Landings and Transitions : Bottom Landing Of Diagonal

Code Reference ADA 406, 406.6, 406.1, 405.10

Provide compliant landing \$255

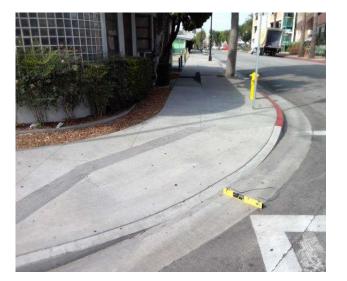
Recommendation Up to 5.00 percent

Code Reference ADA 406, 406.2,CA 11B-406.5.8

Repave landing \$1,260

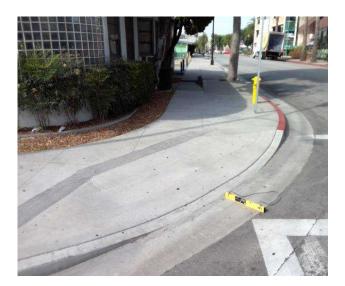
Recommendation Up to 2.08 percent

Code Reference ADA 402, 406.4, 403.3, 406.1,CA 11B-406.5.3

Provide compliant landing \$1,260

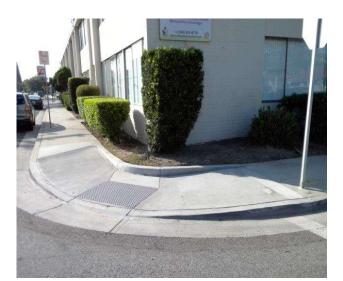
Recommendation Up to 2.08 percent

Curb Ramp , Landings and Transitions : Top Landing Right Side

Code Reference ADA 406.4, 403.3, 406.1,CA 11B-406.5.3

Provide compliant landing \$1,260

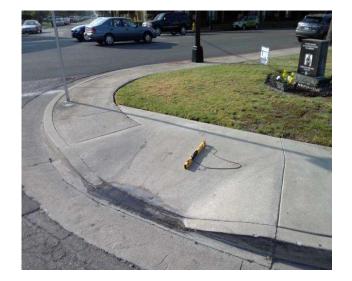
Code Reference ADA 406, 406.1, 405.2,CA 11B-406

Install curb ramp \$1,300

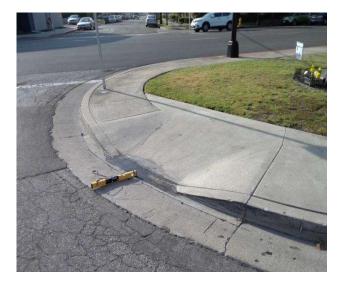
Code Reference ADA 406, 406.2,CA 11B-406.5.8

Repave landing \$1,260

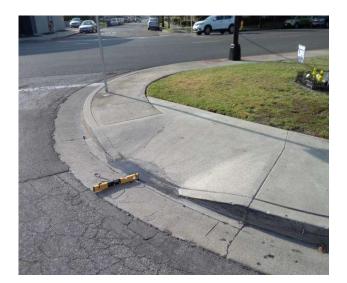
Code Reference ADA 402, 406.4, 403.3, 406.1,CA 11B-406.5.3

Provide compliant landing \$1,260

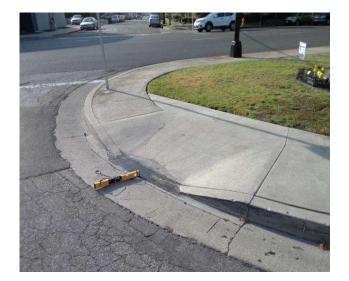
Code Reference ADA 406, 406.4,CA 11B-406.5.3

Provide compliant landing \$240

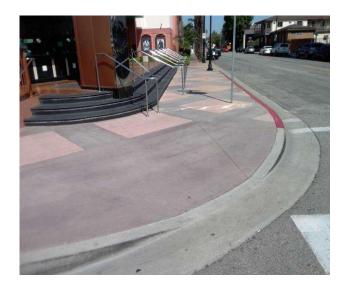
Code Reference CA 11B-406.5.12

Provide detectable warning to \$248 surface

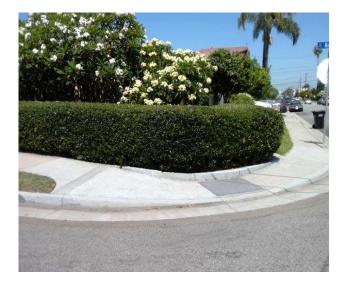
Code Reference ADA 406.1,CA 11B-406.5.2,CA 11B-406

Install curb ramp \$1,300

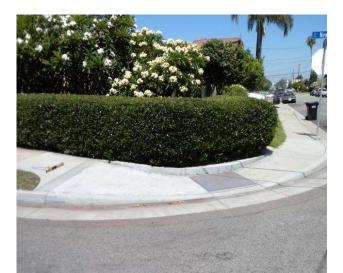
Curb Ramp , Landings and Transitions : Top Landing Right Side

Code Reference ADA 406.4, 403.3, 406.1,CA 11B-406.5.3

Provide compliant landing \$1,260

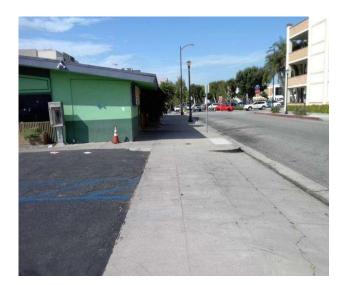
Code Reference ADA 705,CA 11B-705.1.2.5,CA 11B-247.1.2.5

Install compliant detectable \$190 warnings

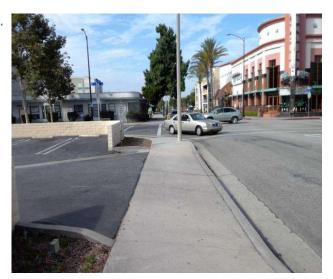
Code Reference ADA 206, 302,CA 11B-403.3

Repave surface \$1,092

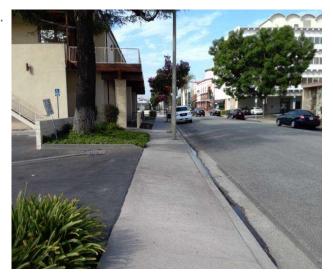
Code Reference ADA 206, 302,CA 11B-403.3

Repave surface \$1,092

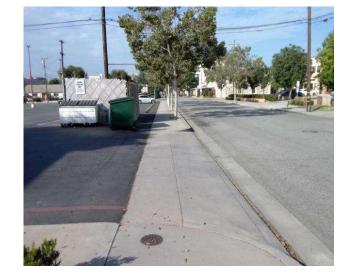
Code Reference ADA 705,CA 11B-705.1.2.5,CA 11B-247.1.2.5

Install compliant detectable \$190 warnings

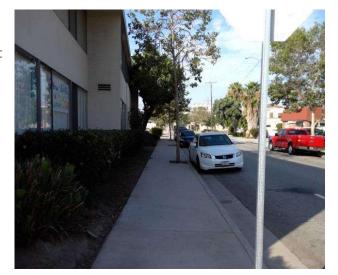
Code Reference ADA 206, 302,CA 11B-403.3

Repave surface \$1,092

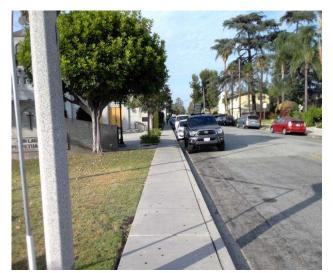
Code Reference ADA 206, 302,CA 11B-403.3

Repave surface \$1,092

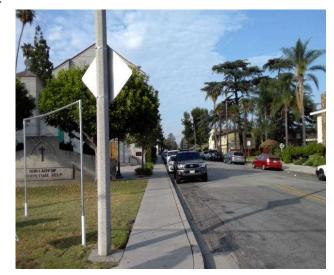
Code Reference ADA 206, 302

\$2,400

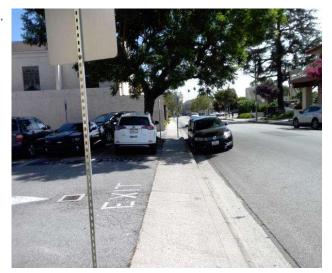
Code Reference ADA 206, 302,CA 11B-403.3

Repave surface \$1,092

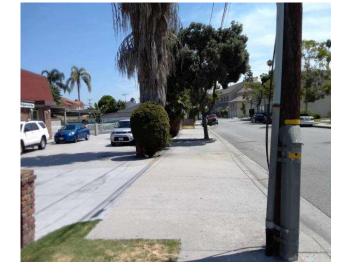
Code Reference ADA 705,CA 11B-705.1.2.5,CA 11B-247.1.2.5

Install compliant detectable \$190 warnings

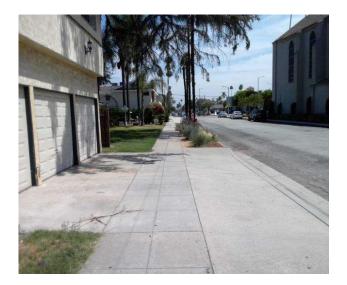
Code Reference ADA 705,CA 11B-705.1.2.5,CA 11B-247.1.2.5

Install compliant detectable \$190 warnings

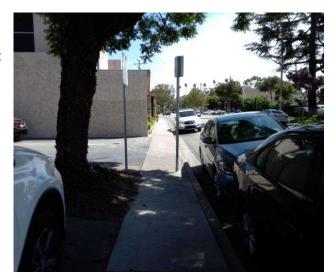
Code Reference ADA 206, 302,CA 11B-403.3

Repave surface \$1,092
