Accessibility Survey

City of Downey Everest Street - Brookshire Avenue To Birchdale Avenue

Date of Inspection
2/4/2017

Disability Access Consultants

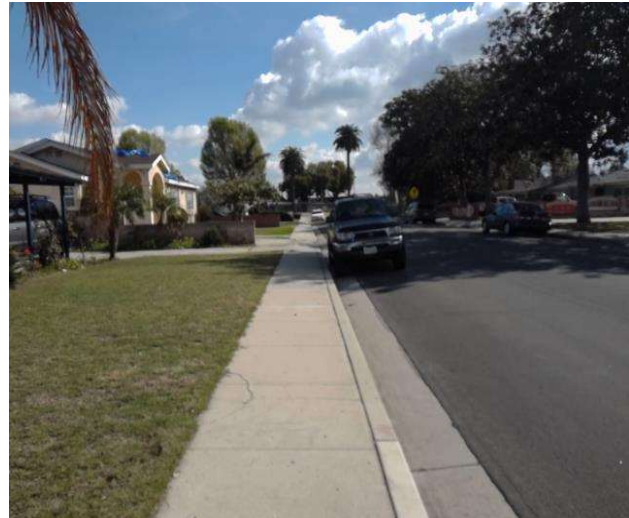
Code Reference ADA 206, 302,CA 11B-403.3

Recommendation

Repave the sidewalk surface with the recommended cross slope.

Recommendation Up to 2.08 percent

Repave surface \$1,092

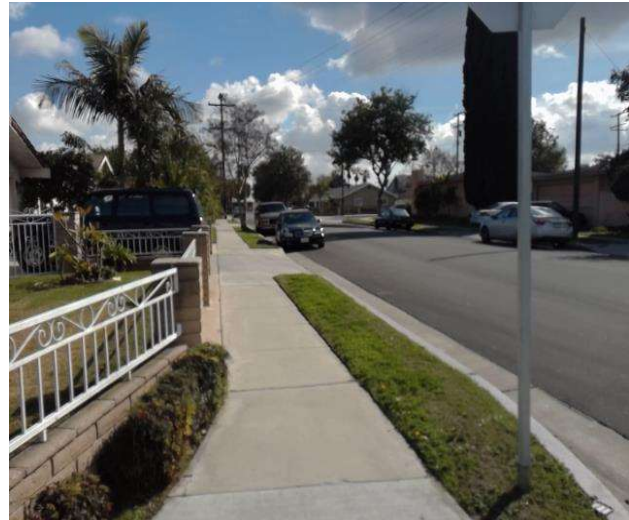
On-Site Finding Not Found

Code Reference ADA 206, 302

Recommendation See Recommendation

\$2,400

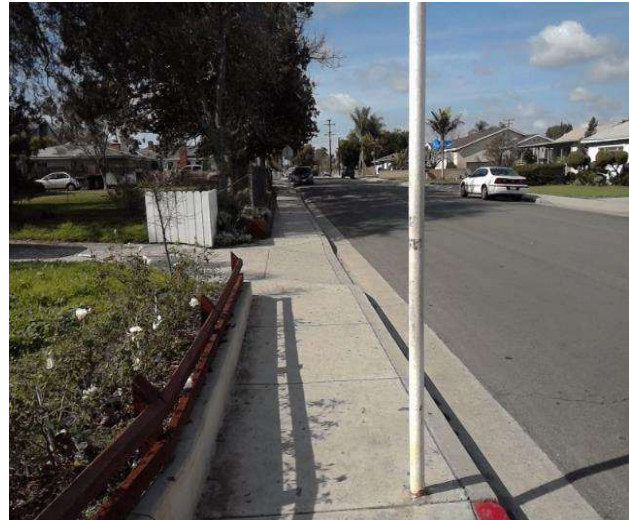
On-Site Finding Not Found

Code Reference ADA 206, 302

Recommendation See Recommendation

\$2,400

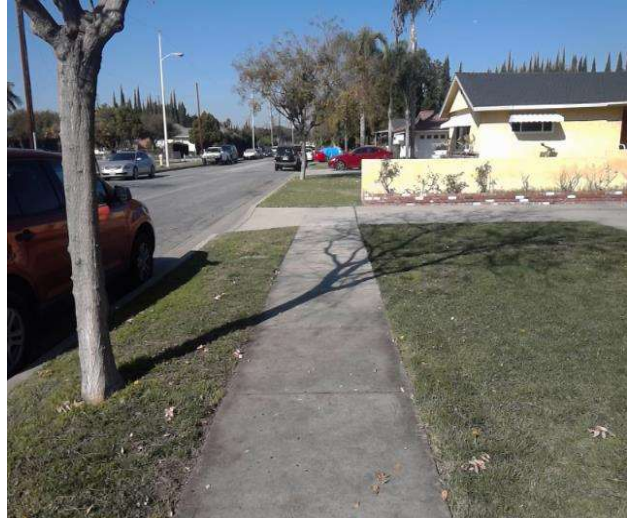
Code Reference ADA 206, 302, CA 11B-403.3

Repave the sidewalk surface with the recommended cross slope.

Recommendation Up to 2.08 percent

Repave surface \$1,092

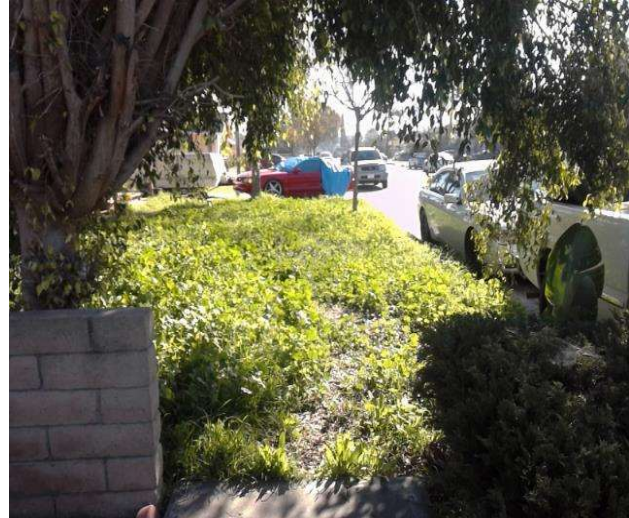
Sidewalks : Missing Sidewalk

Section of sidewalk is missing and consists of dirt, grass or gravel.

Code Reference ADA 206, 302,CA 11B-302,CA 11B-206

Provide a compliant sidewalk for the missing section.

\$1,260

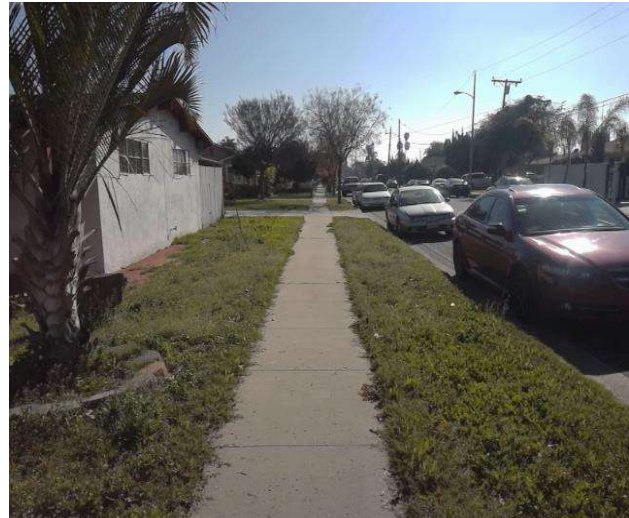
On-Site Finding Not Found

Code Reference ADA 206, 302

Recommendation See Recommendation

\$2,400

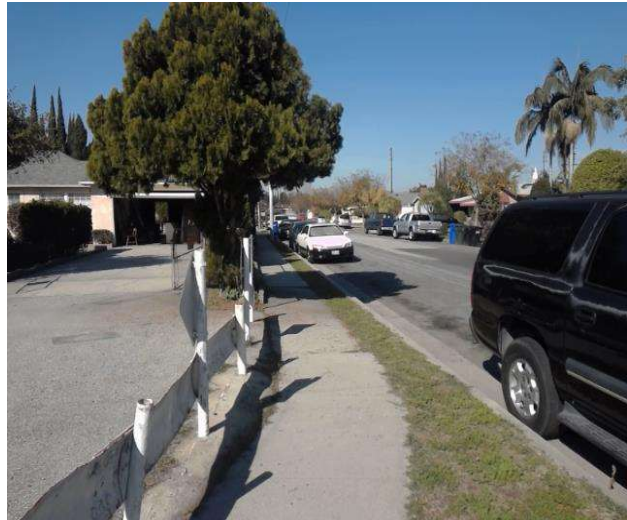
Code Reference ADA 206, 302, CA 11B-403.3

Repave the sidewalk surface with the recommended cross slope.

Recommendation Up to 2.08 percent

Repave surface \$1,092

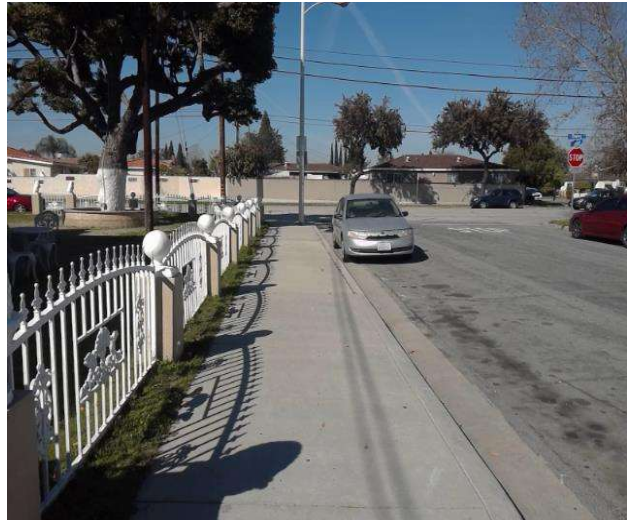
Code Reference ADA 206, 302,CA 11B-403.3

Repave the sidewalk surface with the recommended cross slope.

Recommendation Up to 2.08 percent

Repave surface \$1,092

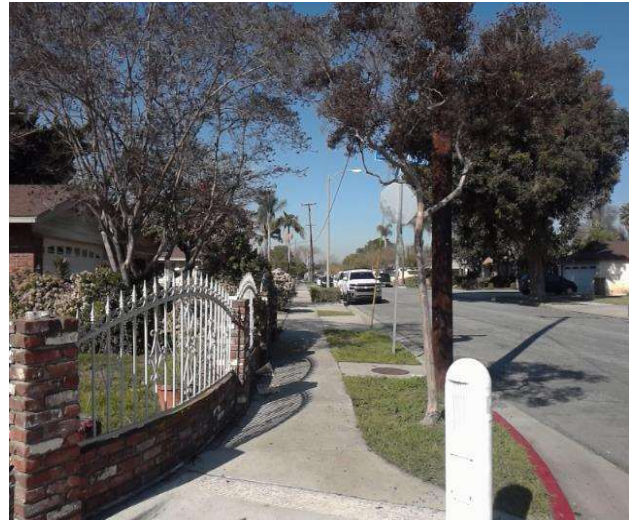
On-Site Finding Not Found

Code Reference ADA 206, 302

Recommendation See Recommendation

\$2,400

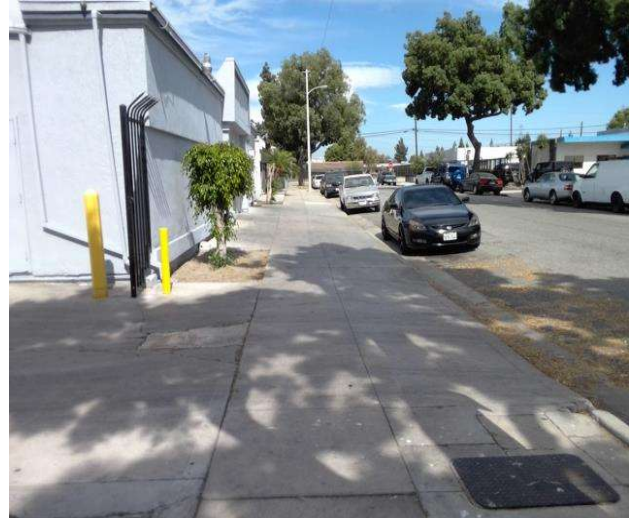
Code Reference ADA 705,CA 11B-705.1.2.5,CA 11B-247.1.2.5

Install compliant detectable warnings \$190

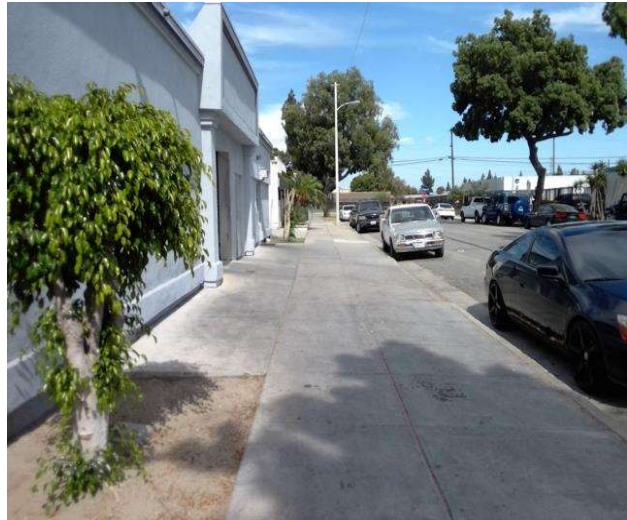
Code Reference ADA 206, 302, CA 11B-403.3

Repave surface \$1,092

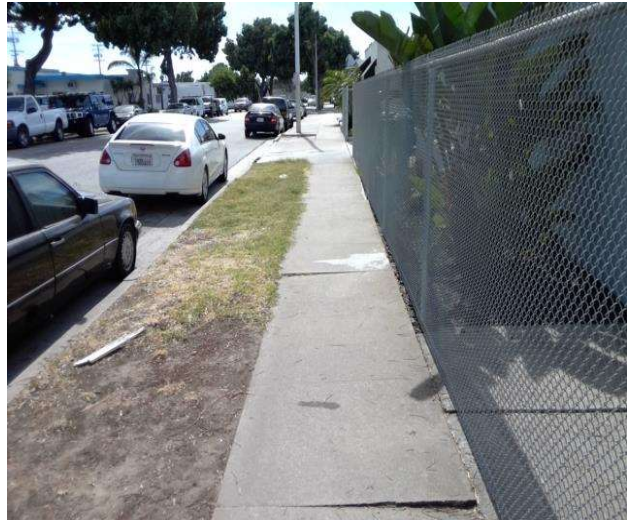
Code Reference ADA 206, 302,CA 11B-403.3

Repave surface \$1,092

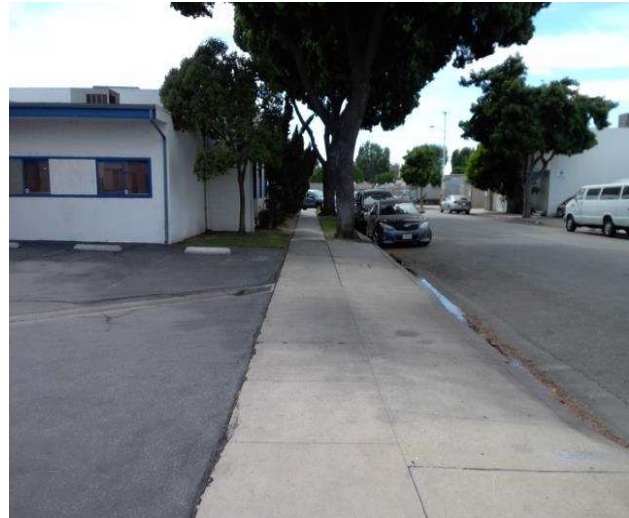
Code Reference ADA 705,CA 11B-705.1.2.5,CA 11B-247.1.2.5

Install compliant detectable warnings \$190

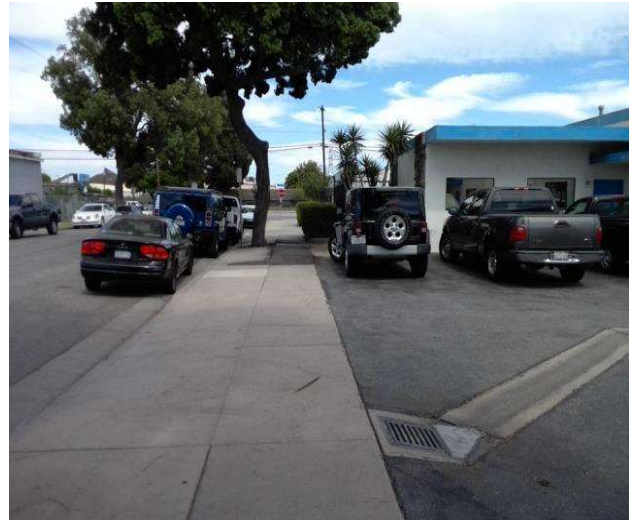
Code Reference ADA 705,CA 11B-705.1.2.5,CA 11B-247.1.2.5

Install compliant detectable warnings \$190

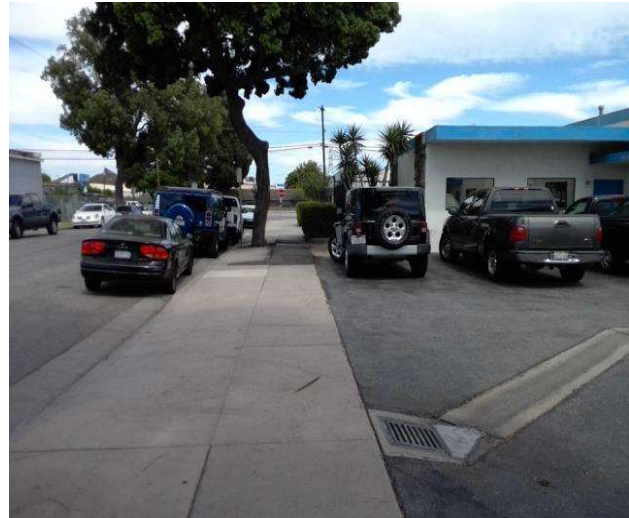
Code Reference ADA 206, 302, CA 11B-403.3

Repave surface \$1,092

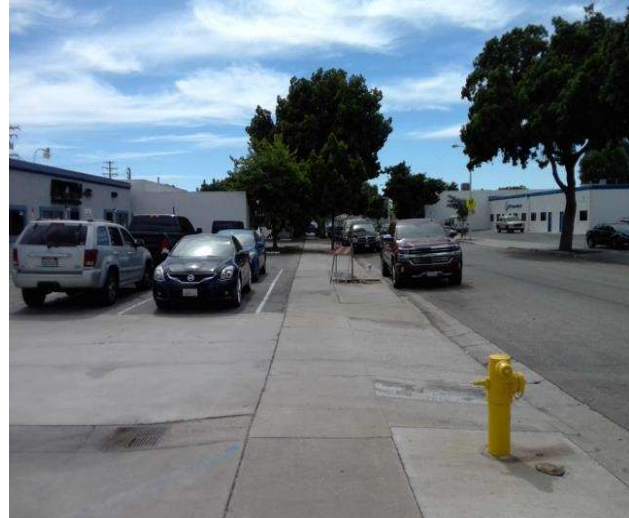
Code Reference ADA 705,CA 11B-705.1.2.5,CA 11B-247.1.2.5

Install compliant detectable warnings \$190

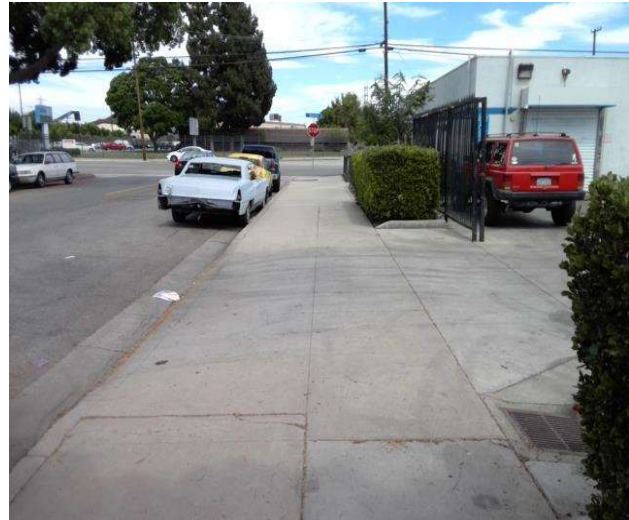
Code Reference ADA 705,CA 11B-705.1.2.5,CA 11B-247.1.2.5

Install compliant detectable warnings \$190

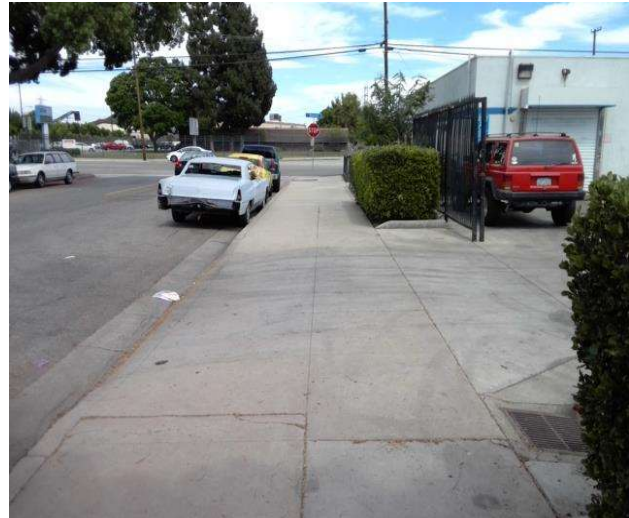
Code Reference ADA 206, 302,CA 11B-403.3

Repave surface \$1,092

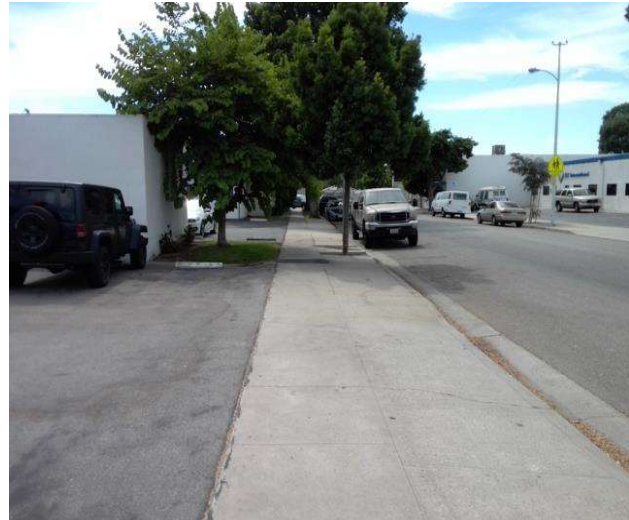
Code Reference ADA 705,CA 11B-705.1.2.5,CA 11B-247.1.2.5

Install compliant detectable warnings \$190

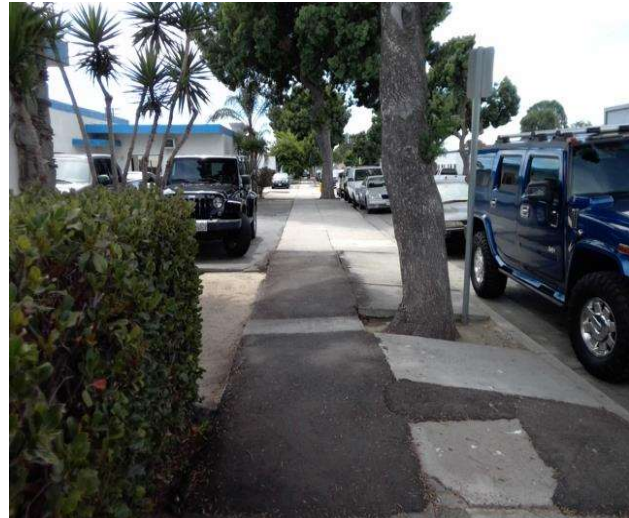
Code Reference ADA 206, 302

Notes : Surface is Rough And Uneven

Repave surface \$1,184
