Accessibility Survey

City of Downey Fontana Street - Brookshire Avenue to Downey Avenue

Date of Inspection
4/19/2017

Disability Access Consultants

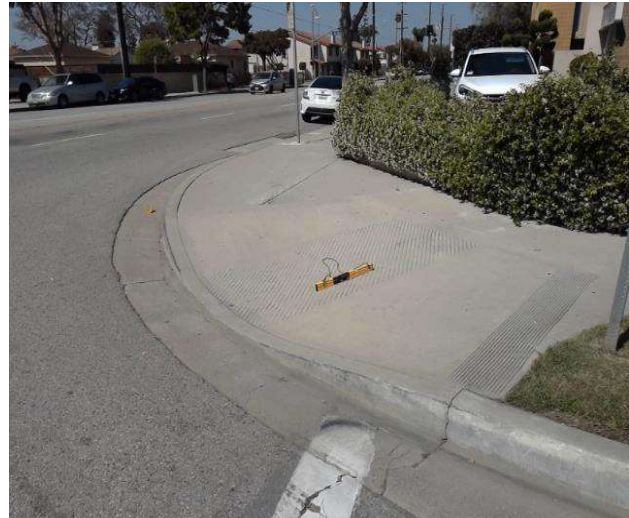
On-Site Finding Not Found

Recommendation See Recommendation

Provide detectable warning to surface \$248

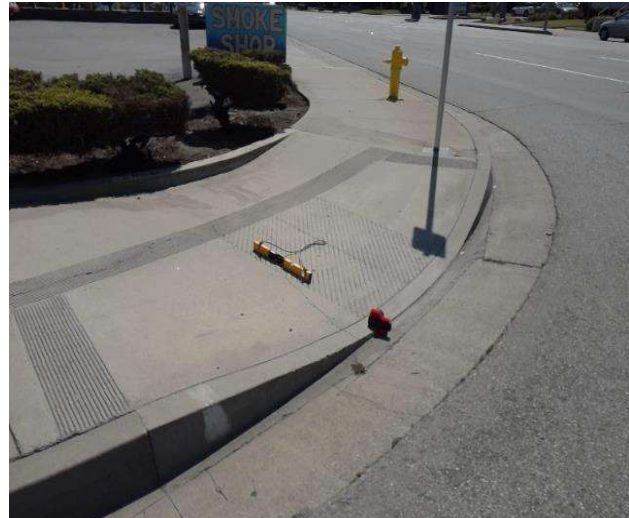
On-Site Finding Not Found

Recommendation See Recommendation

Provide detectable warning to surface \$248

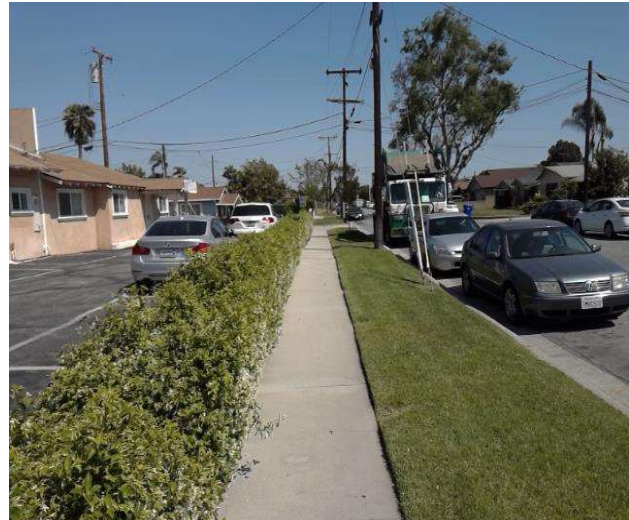
On-Site Finding Not Found

Recommendation See Recommendation

\$2,400

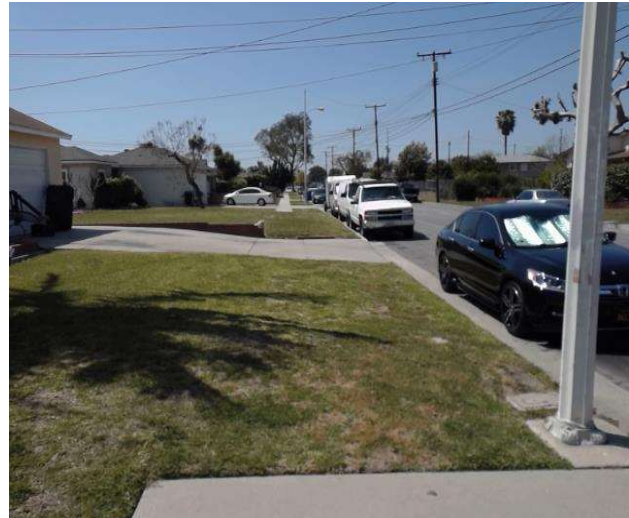
Sidewalks : Missing Sidewalk

Section of sidewalk is missing and consists of dirt, grass or gravel.

Provide a compliant sidewalk for the missing section.

\$1,260

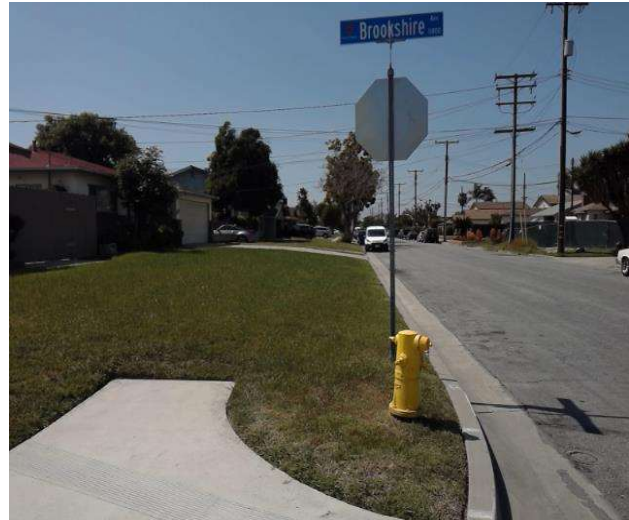
On-Site Finding Not Found

Recommendation See Recommendation

\$2,400
