## Accessibility Survey

## City of Downey Luxor Street - Patton Road To Downey Avenue

Date of Inspection  
12/9/2016

**Disability Access Consultants**

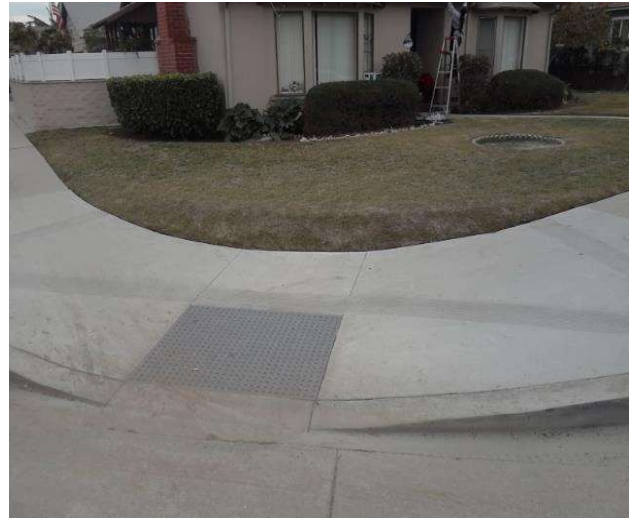
Recommendation Up to 5.00 percent

Repave landing \$1,260

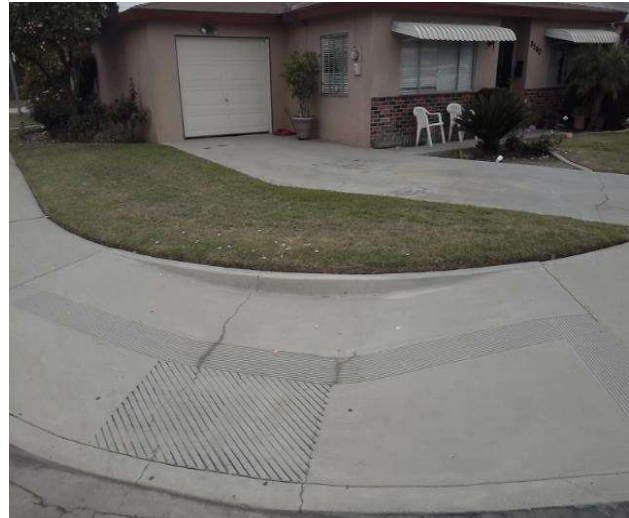
**On-Site Finding** Not Found

Provide detectable warning to surface \$248

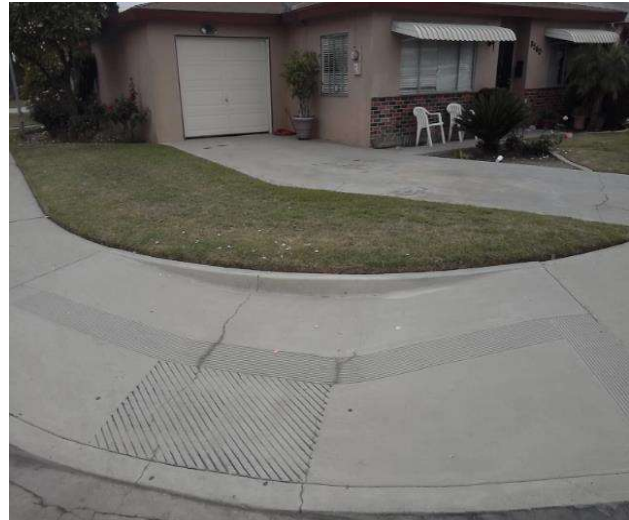
Recommendation Up to 10.00 percent

Install flared sides \$1,300

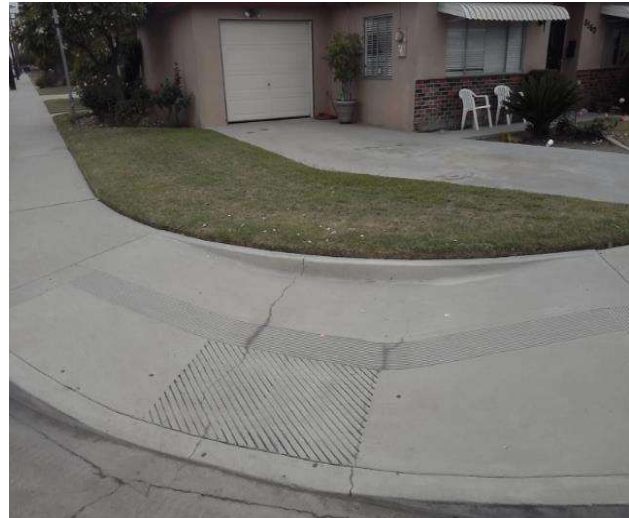
Recommendation Up to 2.08 percent

Provide compliant landing \$1,260

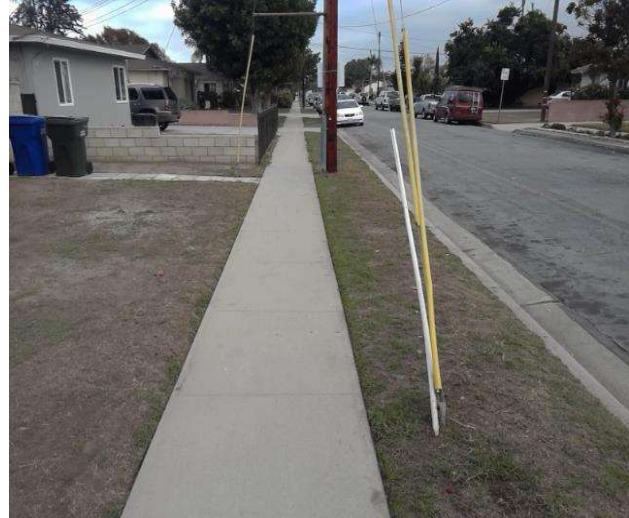
Recommendation Up to 2.08 percent

Repave the sidewalk surface with the recommended cross slope.

Repave surface \$1,092

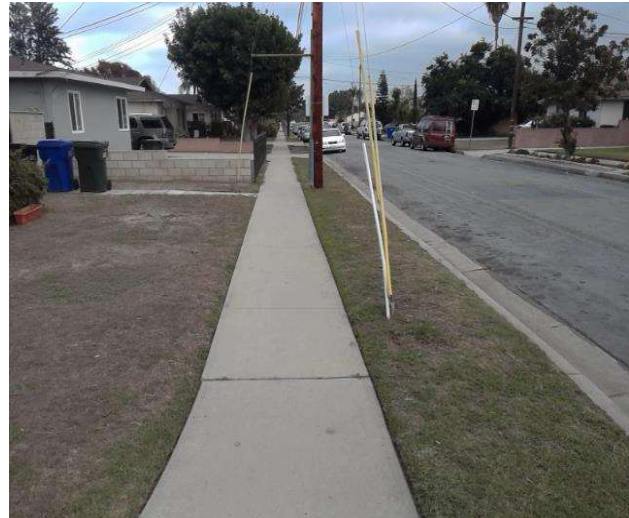
**On-Site Finding** Not Found

\$2,400

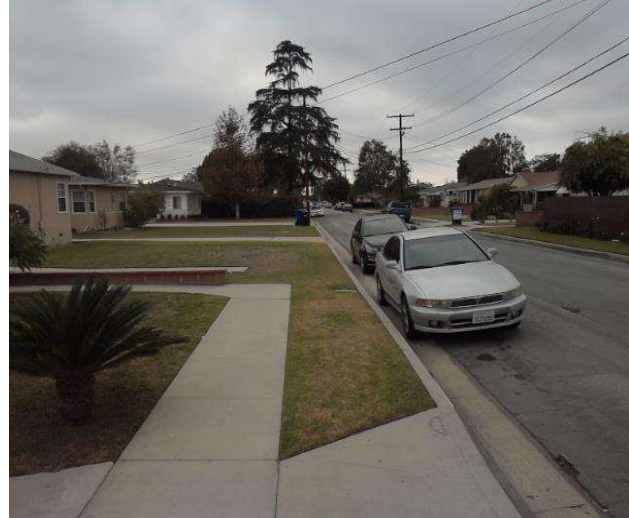
Section of sidewalk is missing and consists of dirt, grass or gravel.

Provide a compliant sidewalk for the missing section.

\$1,260

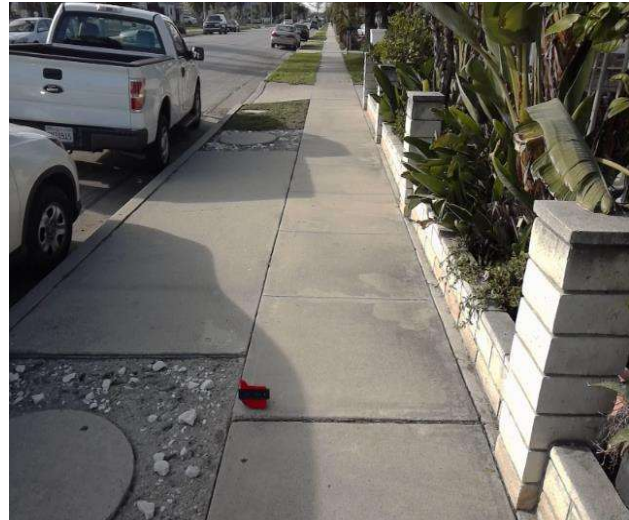
There is a change in elevation greater than recommended value.

Ensure that the change in elevation is within the recommended value.

Remove tripping hazards \$198

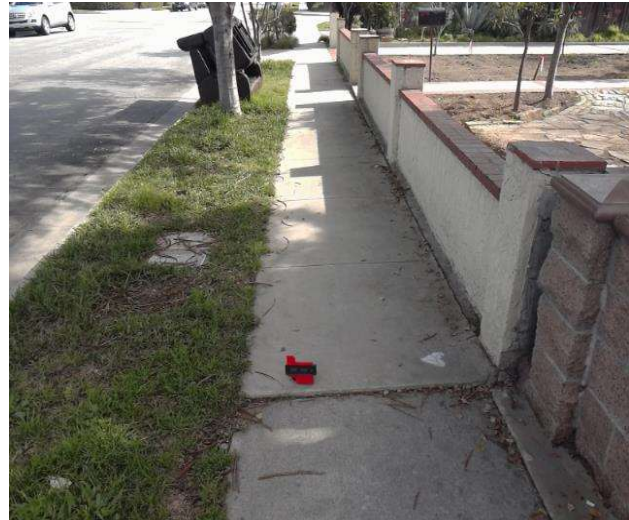
There is a change in elevation greater than recommended value.

Remove tripping hazards \$198

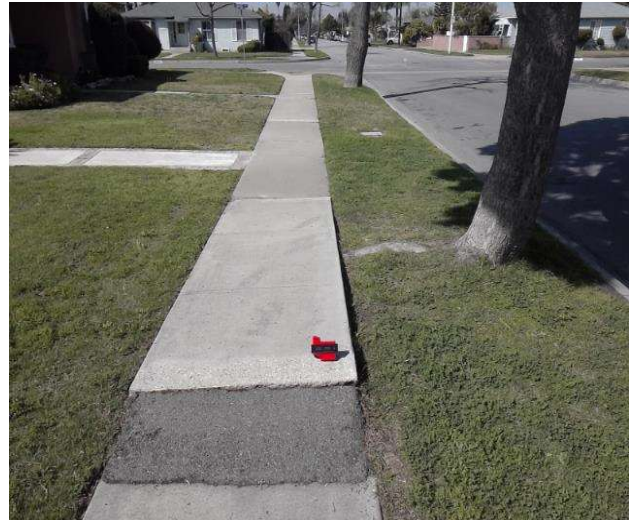
There is a change in elevation greater than recommended value.

Remove tripping hazards \$198

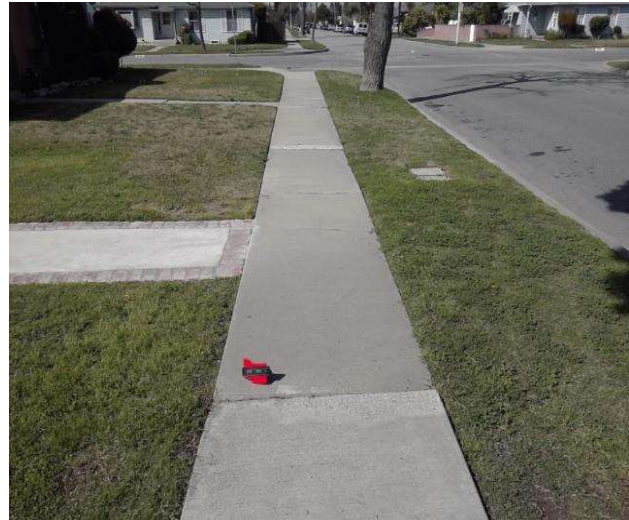
There is a change in elevation greater than recommended value.

Ensure that the change in elevation is within the recommended value.

Remove tripping hazards \$198

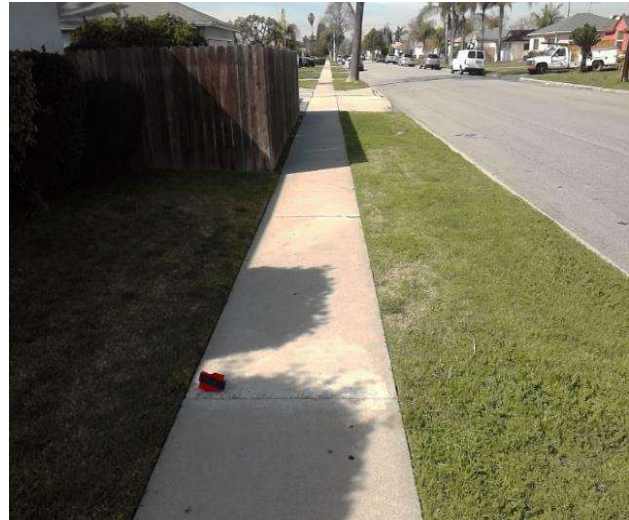
There is a change in elevation greater than recommended value.

Ensure that the change in elevation is within the recommended value.

Remove tripping hazards \$198

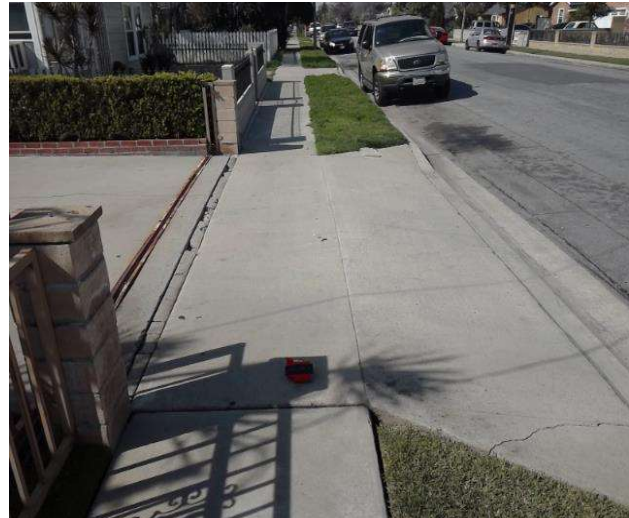
There is a change in elevation greater than recommended value.

Remove tripping hazards \$198

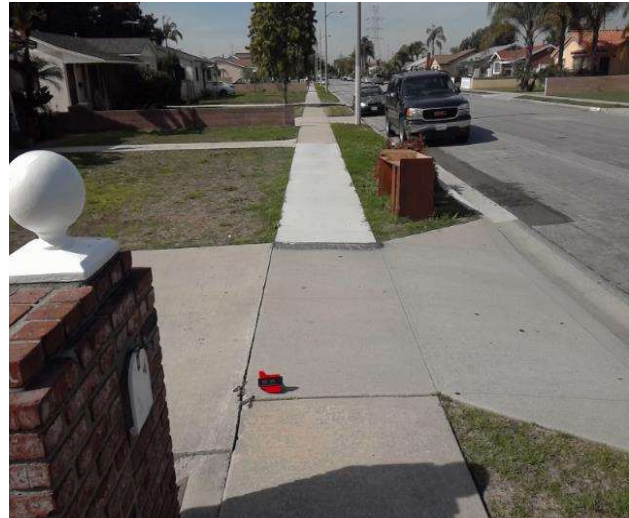
There is a change in elevation greater than recommended value.

Remove tripping hazards \$198

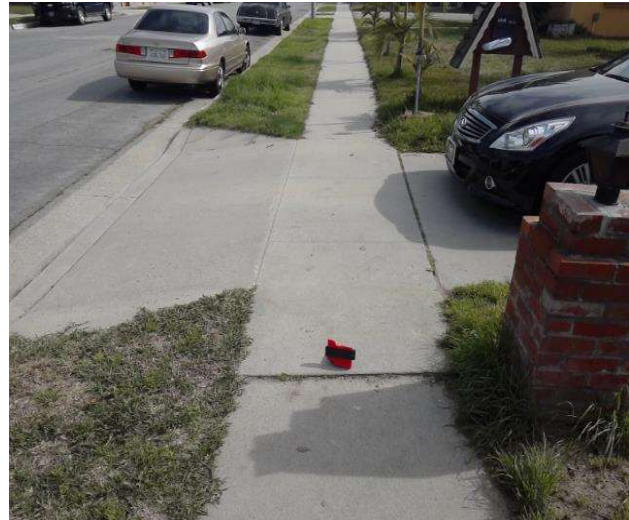
There is a change in elevation greater than recommended value.

Remove tripping hazards \$198

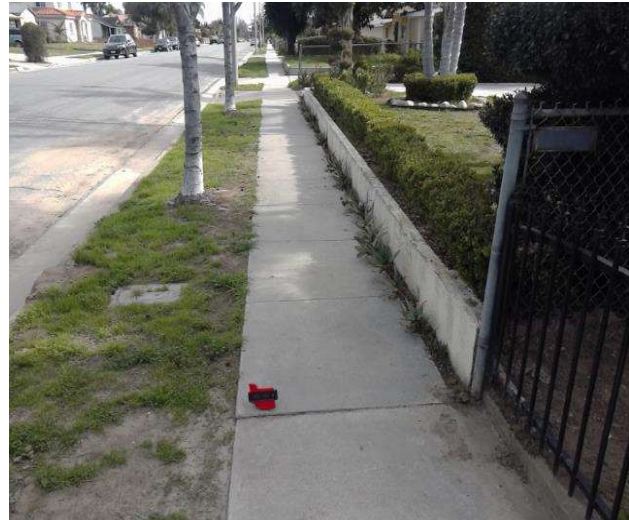
There is a change in elevation greater than recommended value.

Remove tripping hazards \$198

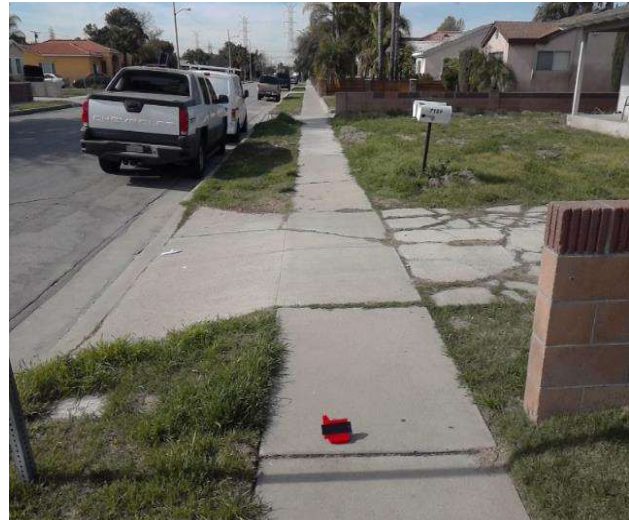
There is a change in elevation greater than recommended value.

Remove tripping hazards \$198

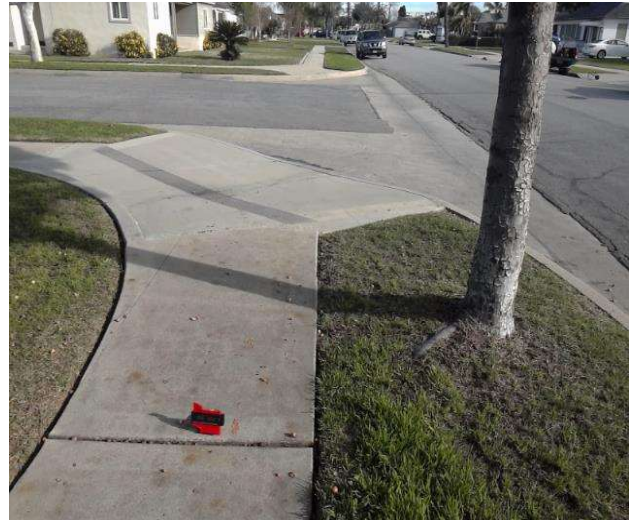
There is a change in elevation greater than recommended value.

Remove tripping hazards \$198

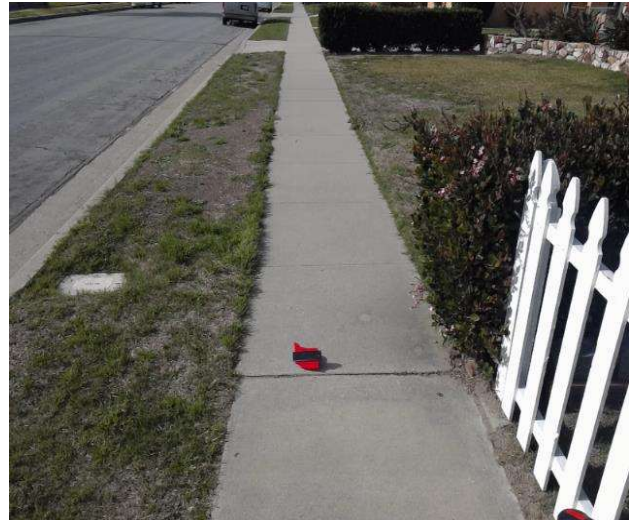
There is a change in elevation greater than recommended value.

Remove tripping hazards \$198

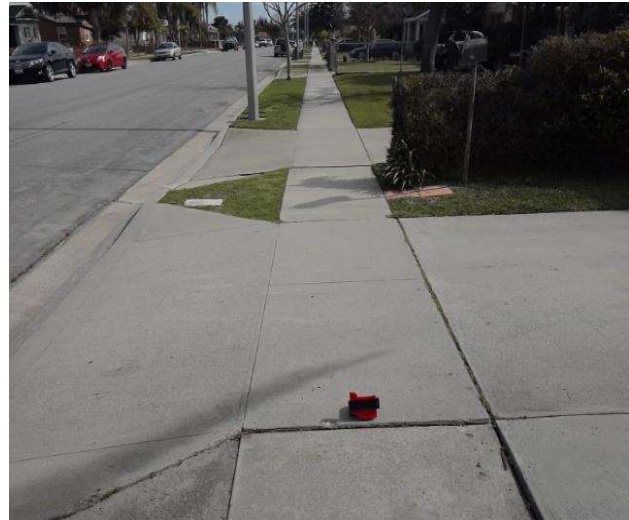
There is a change in elevation greater than recommended value.

Remove tripping hazards \$198

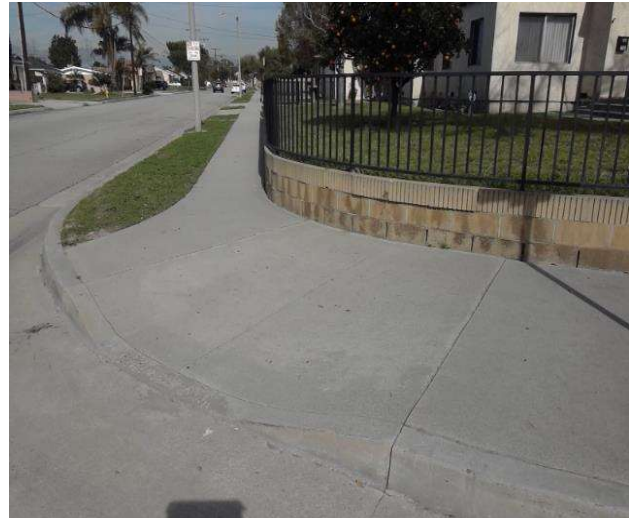
**On-Site Finding** Not Found

Provide detectable warning to surface \$248

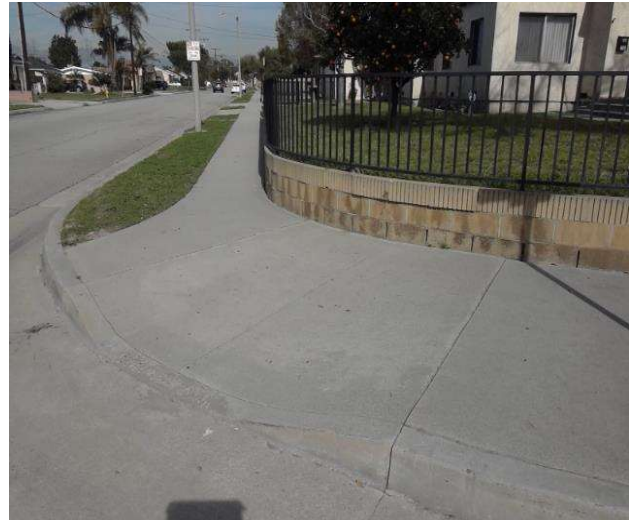
Recommendation Up to 10.00 percent

Install flared sides \$1,300

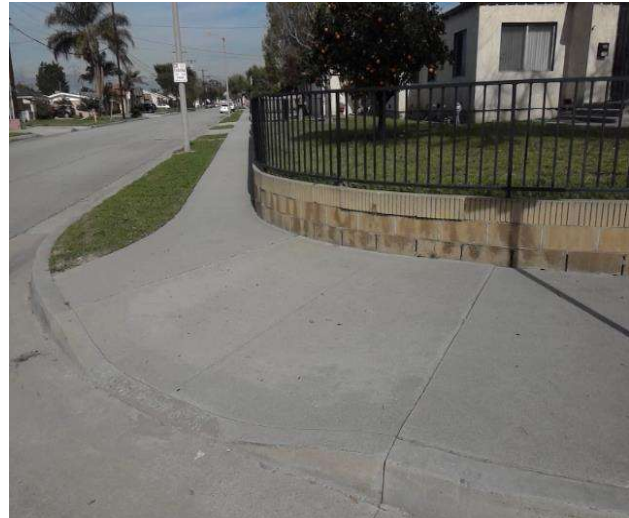
Recommendation At least 48.00 inches

Provide compliant landing \$240

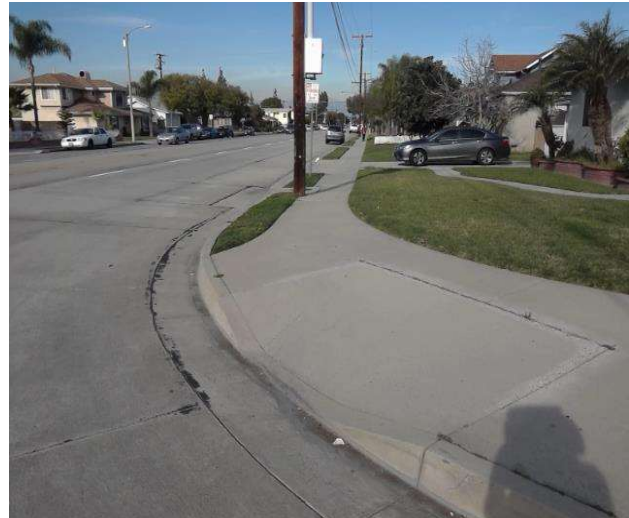
**On-Site Finding** Not Found

Provide detectable warning to surface \$248

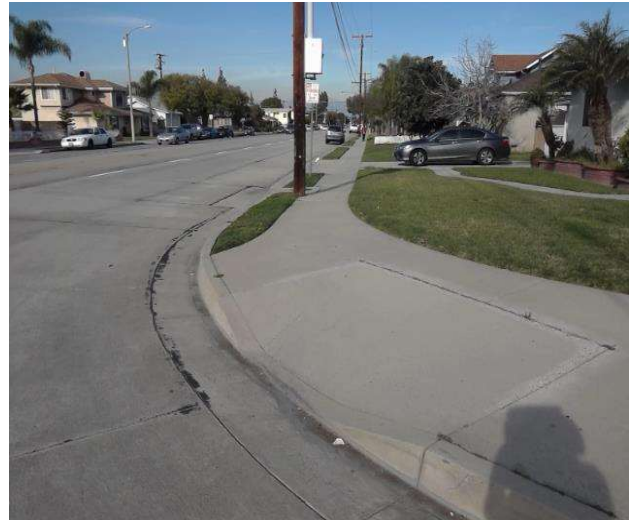
Recommendation Up to 8.33 percent

Install curb ramp \$1,300

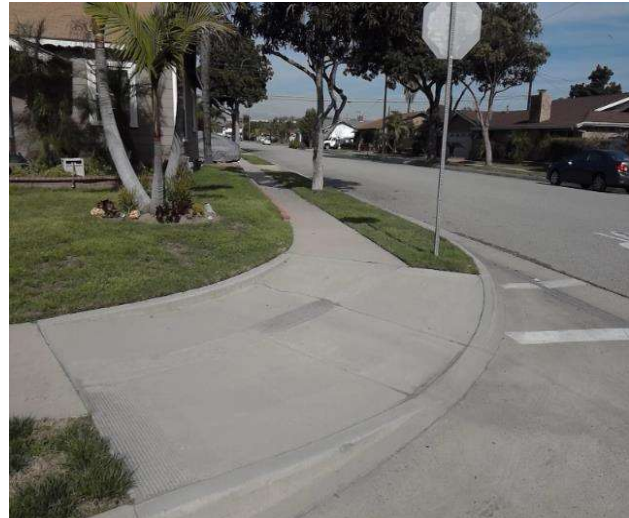
Recommendation At least 48.00 inches

Provide compliant landing \$240

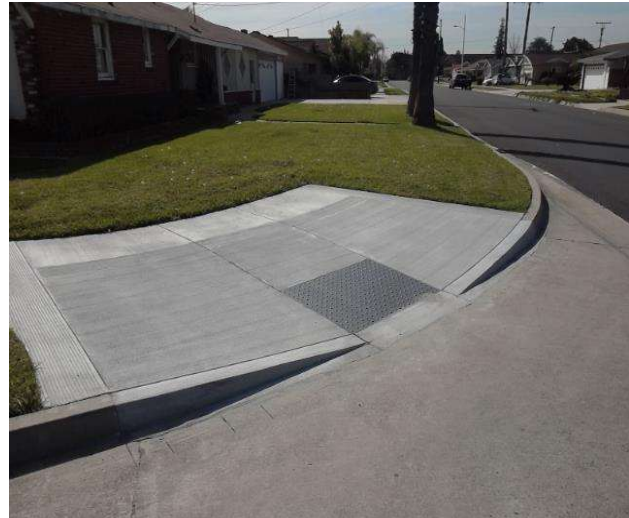
Recommendation Up to 10.00 percent

Install flared sides \$1,300

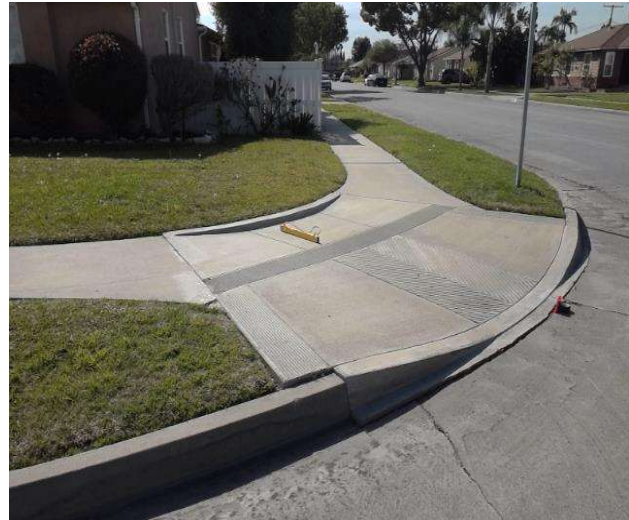
**On-Site Finding** Not Found

Provide detectable warning to surface \$248

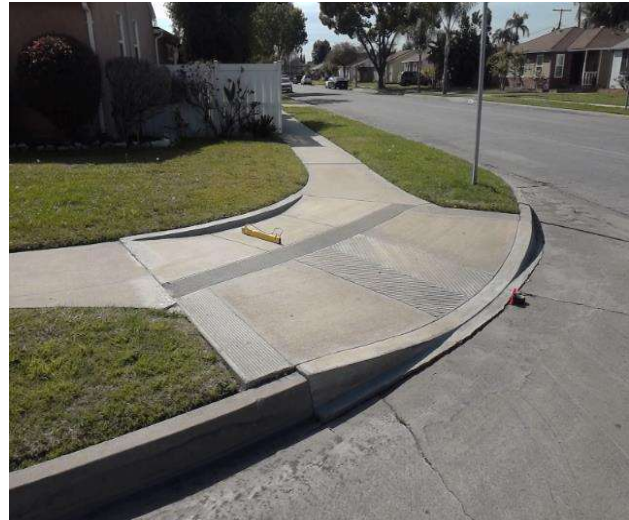
Recommendation Up to 2.08 percent

Provide compliant landing \$1,260

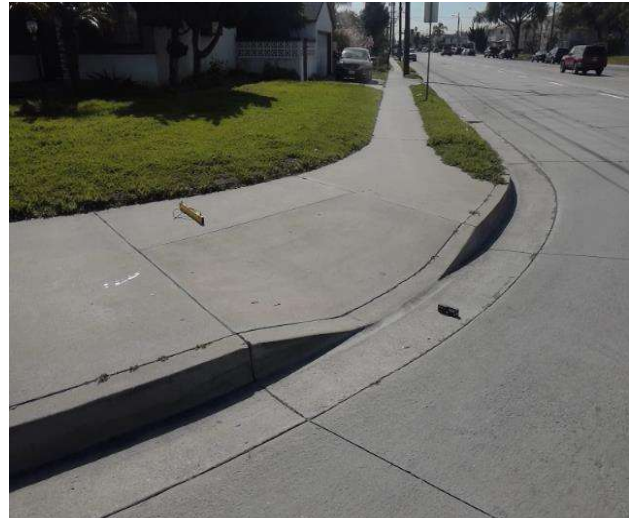
Recommendation Up to 8.33 percent

Install curb ramp \$1,300

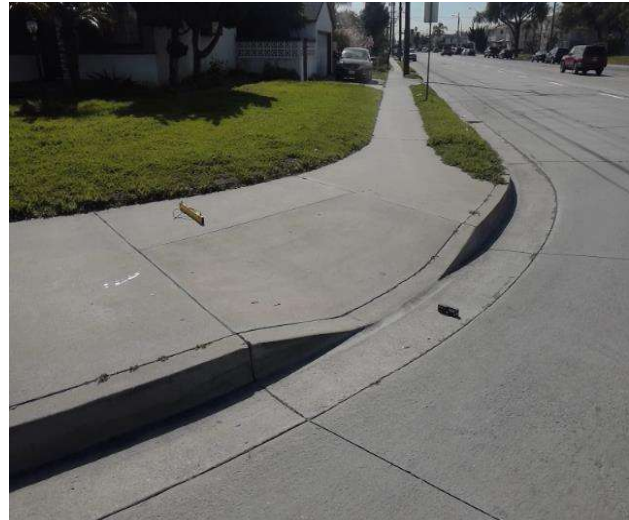
Recommendation Up to 10.00 percent

Install flared sides \$1,300

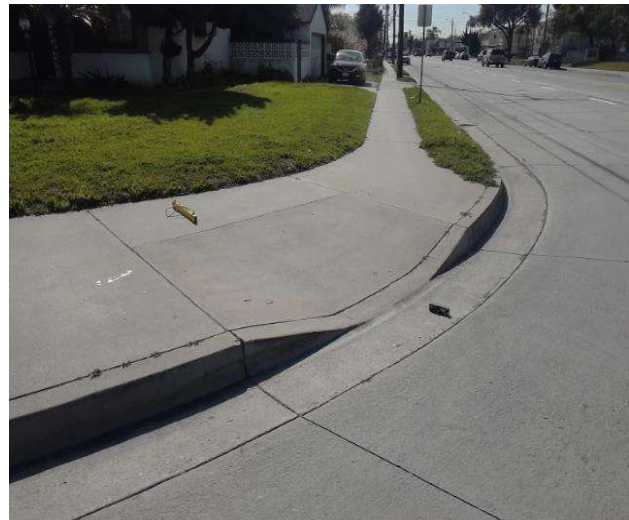
Recommendation Up to 5.00 percent

Repave landing \$1,260

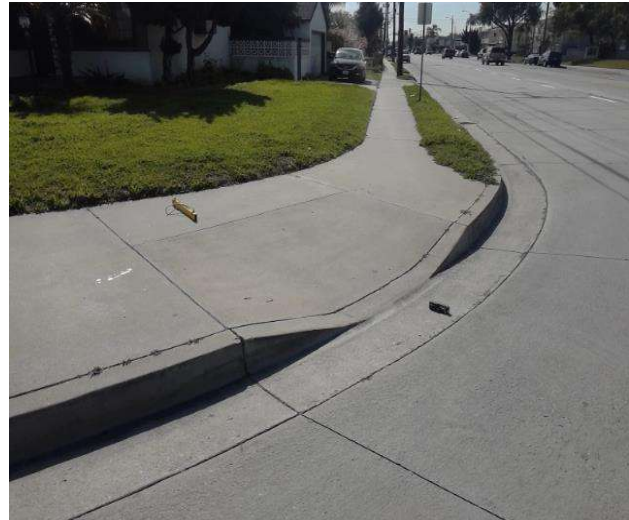
Recommendation Up to 2.08 percent

Provide compliant landing \$1,260

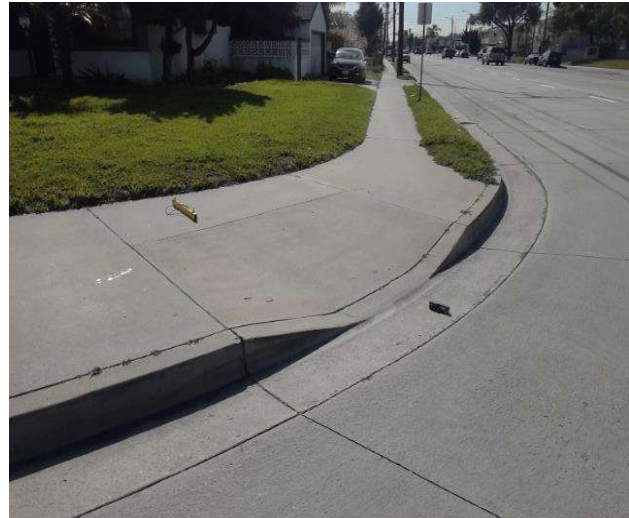
Recommendation At least 48.00 inches

Provide compliant landing \$240

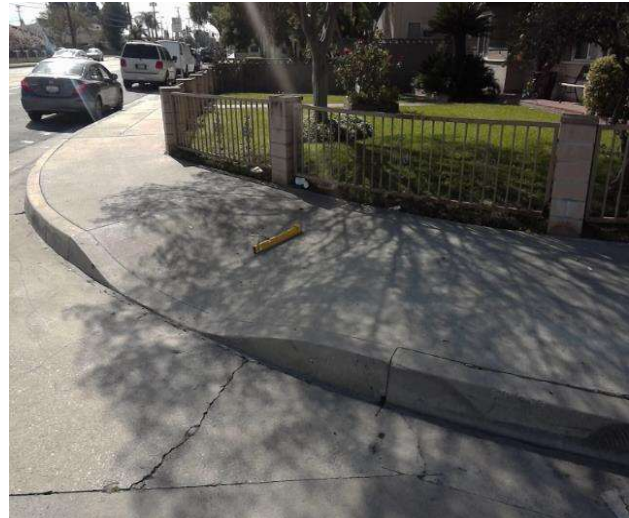
**On-Site Finding** Not Found

Provide detectable warning to surface \$248

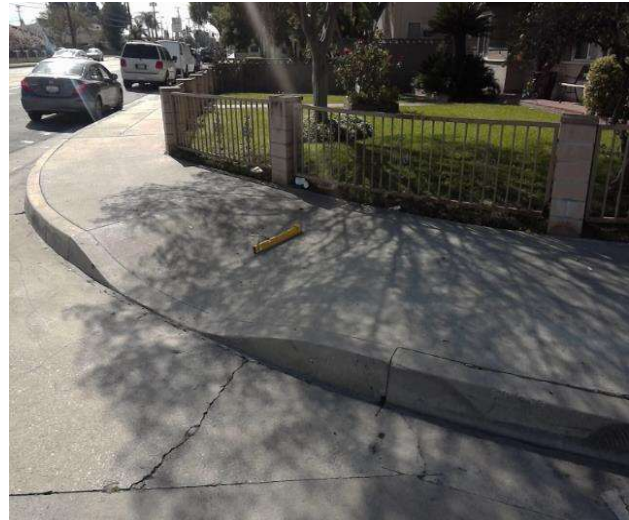
Recommendation Up to 10.00 percent

Install flared sides \$1,300

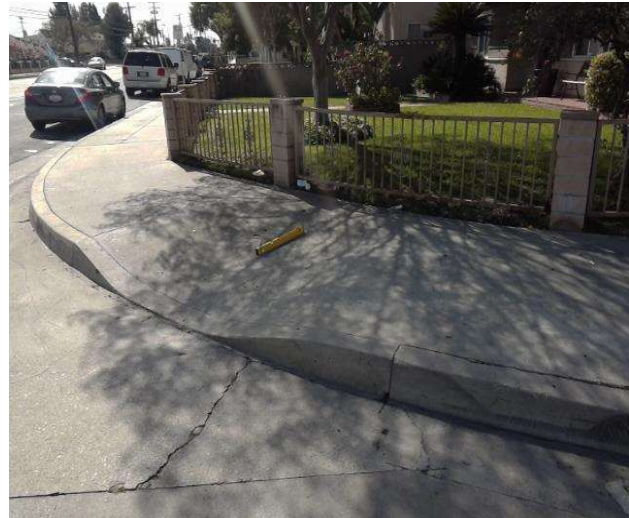
Recommendation Up to 2.08 percent

Provide compliant landing \$1,260

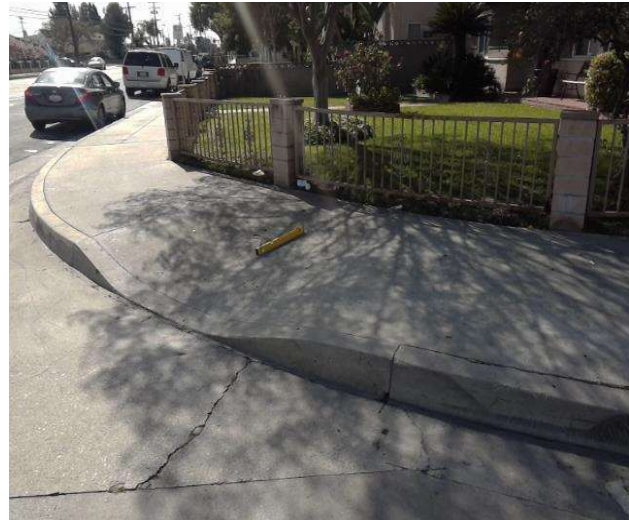
Curb Ramp , Landings and Transitions : Top Landing Clear Length - Landings

Provide compliant landing \$240

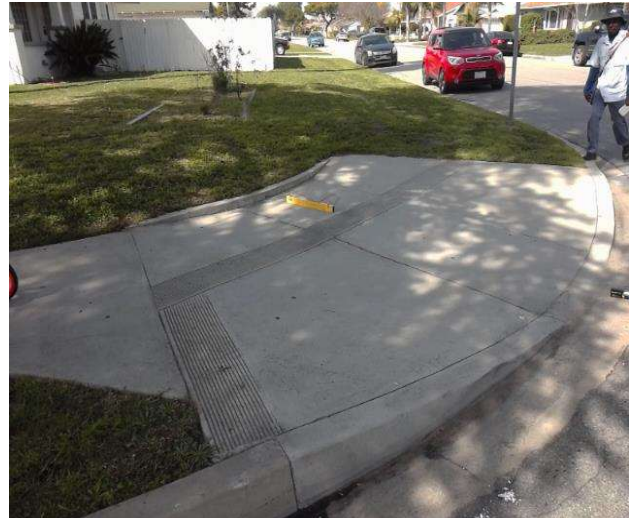
**On-Site Finding** Not Found

Provide detectable warning to surface \$248

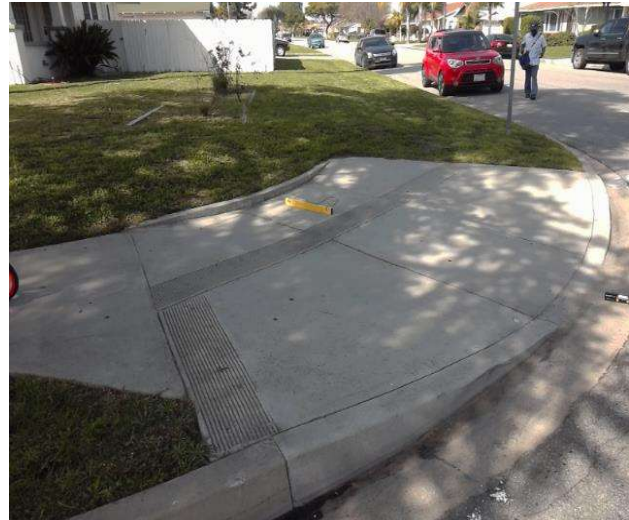
Recommendation Up to 5.00 percent

Repave landing \$1,260

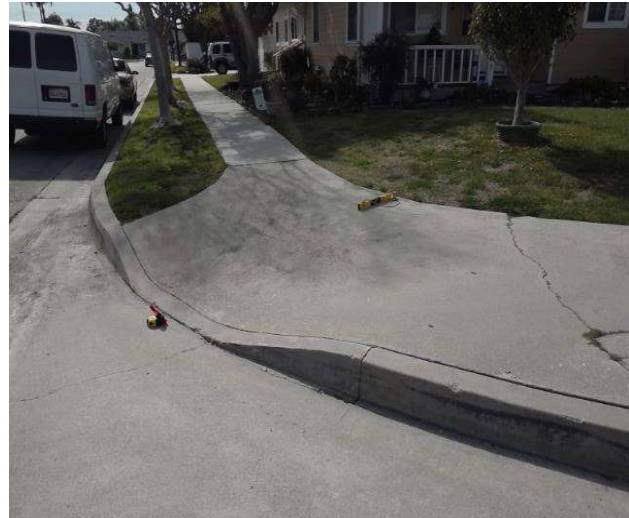
**On-Site Finding** Not Found

Provide detectable warning to surface \$248

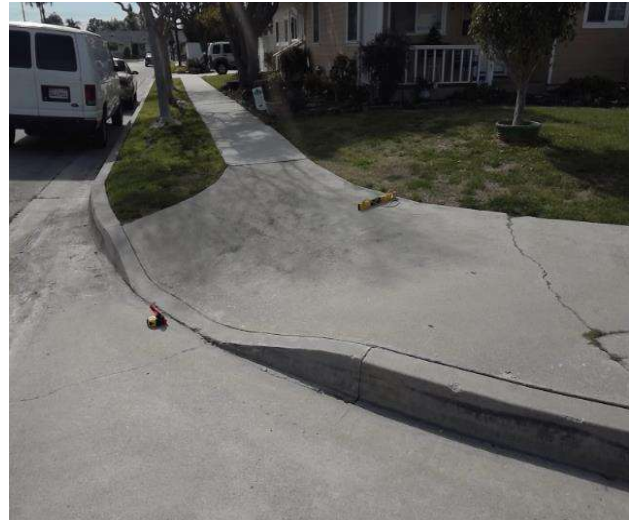
Recommendation Up to 10.00 percent

Install flared sides \$1,300

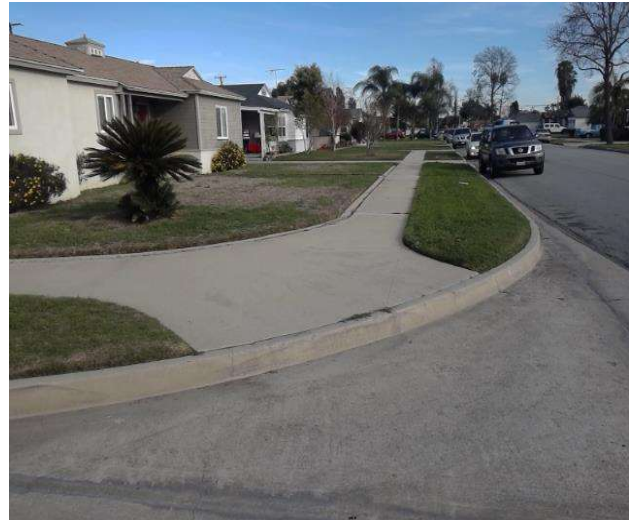
Sidewalks , Hazards & Gratings : Curb is on Path of Travel

Install curb ramp \$2,500

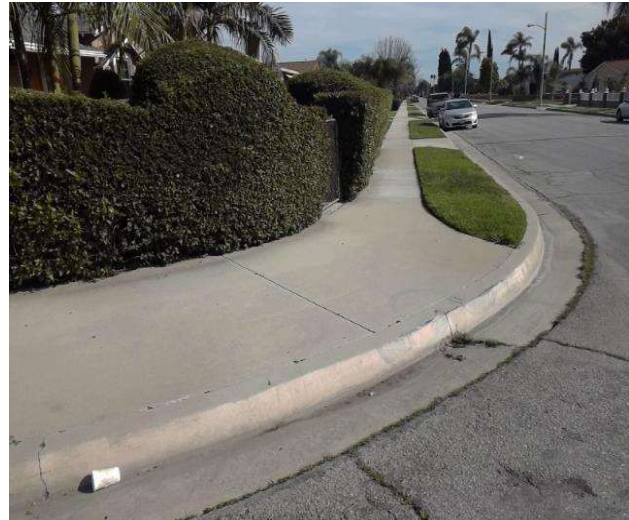
Sidewalks , Hazards & Gratings : Curb is on Path of Travel

Install curb ramp \$2,500

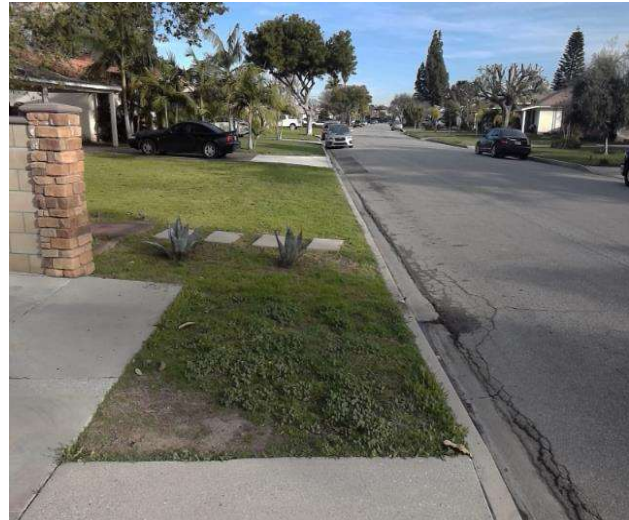
Sidewalks : Missing Sidewalk

Section of sidewalk is missing and consists of dirt, grass or gravel.

Provide a compliant sidewalk for the missing section.

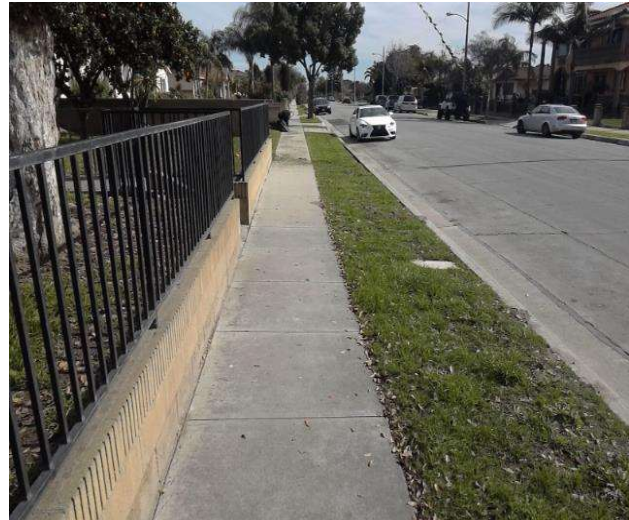
Recommendation Up to 2.08 percent

Repave the sidewalk surface with the recommended cross slope.

Repave surface \$1,092

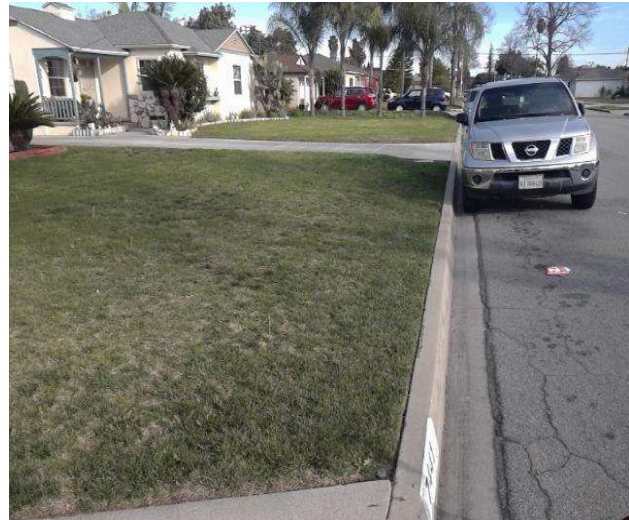
Sidewalks : Missing Sidewalk

Section of sidewalk is missing and consists of dirt, grass or gravel.

Provide a compliant sidewalk for the missing section.

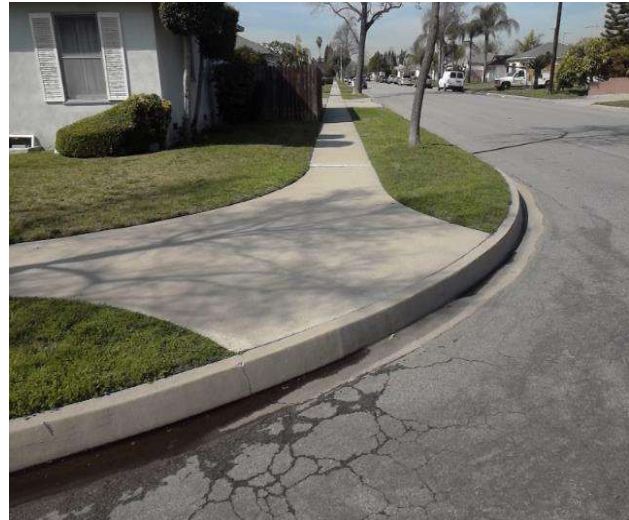
Sidewalks , Hazards & Gratings : Curb is on Path of Travel

Install curb ramp \$2,500

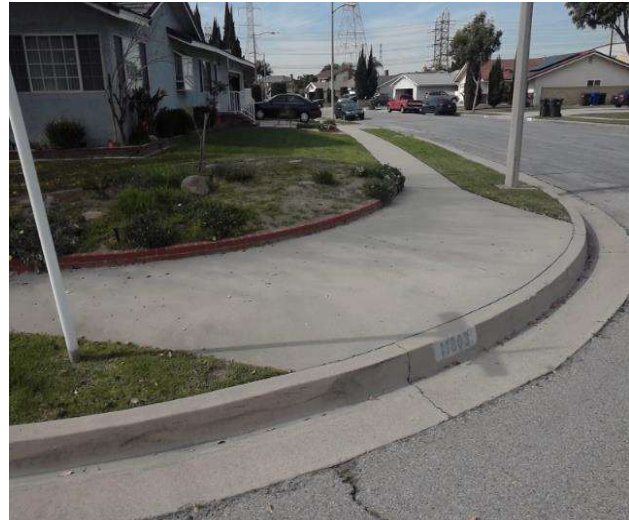
Sidewalks , Hazards & Gratings : Curb is on Path of Travel

Install curb ramp \$2,500

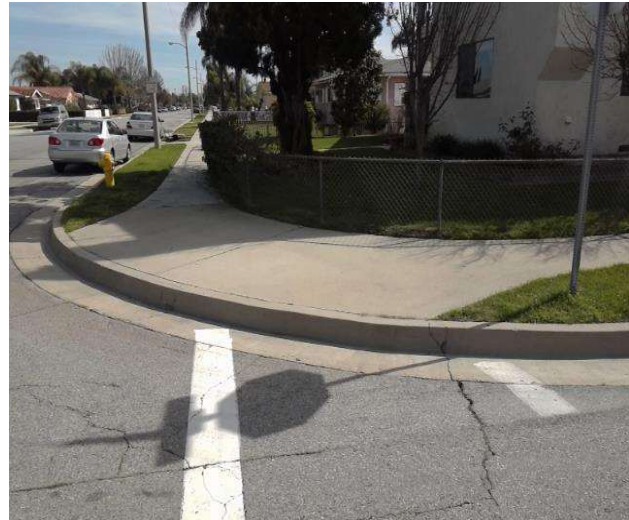
Sidewalks , Hazards & Gratings : Curb is on Path of Travel

Install curb ramp \$2,500

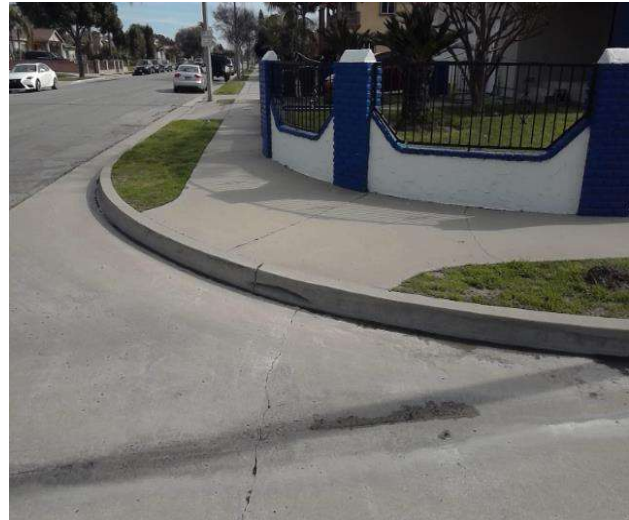
Sidewalks , Hazards & Gratings : Curb is on Path of Travel

Install curb ramp \$2,500

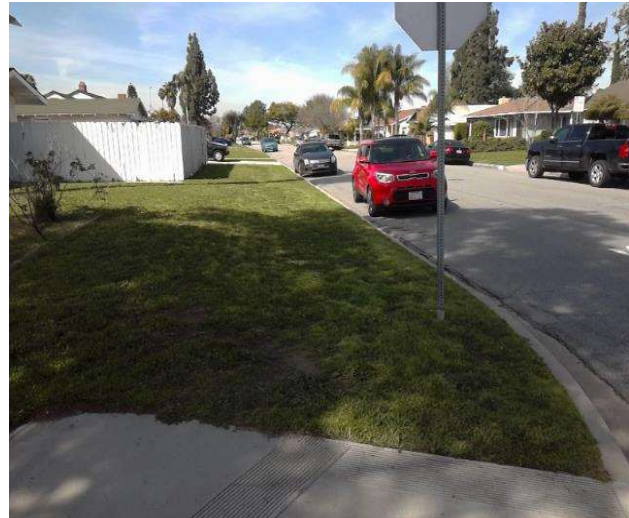
Sidewalks : Missing Sidewalk

Section of sidewalk is missing and consists of dirt, grass or gravel.

Provide a compliant sidewalk for the missing section.
