Accessibility Survey

Adenmoor Avenue - Elm Vista Drive to Cul-De-Sac

Date of Inspection
8/8/2017

Disability Access Consultants

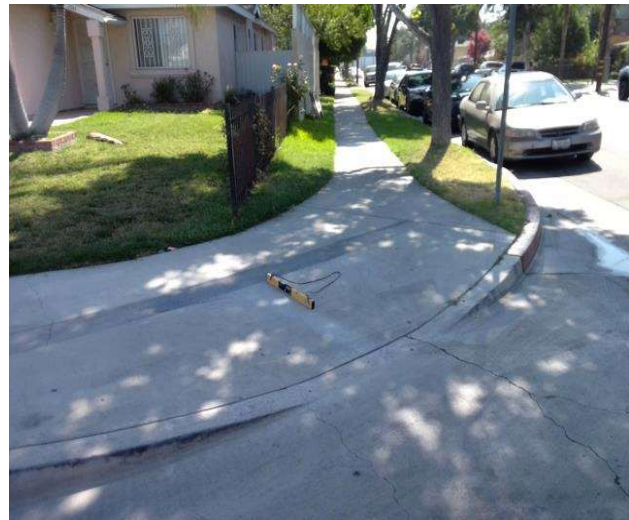
On-Site Finding Not Found

Provide detectable warning to surface \$248

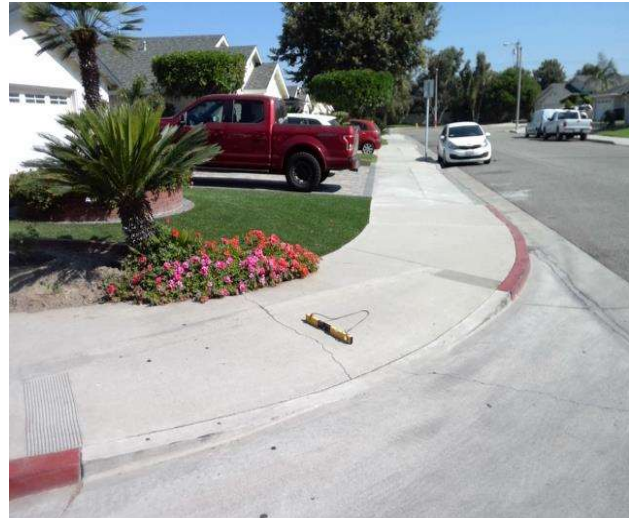
On-Site Finding Not Found

Provide detectable warning to surface \$248

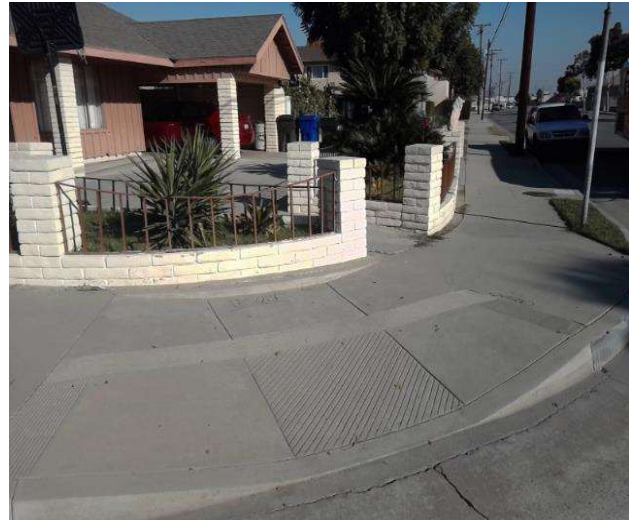
On-Site Finding Not Found

Provide detectable warning to surface \$248

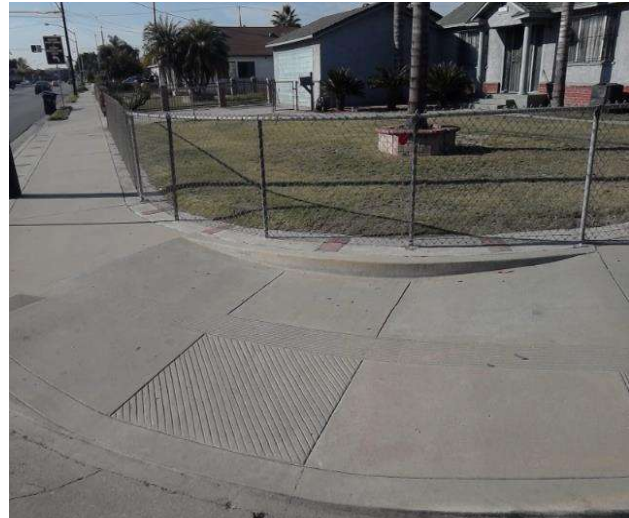
On-Site Finding Not Found

Provide detectable warning to surface \$248

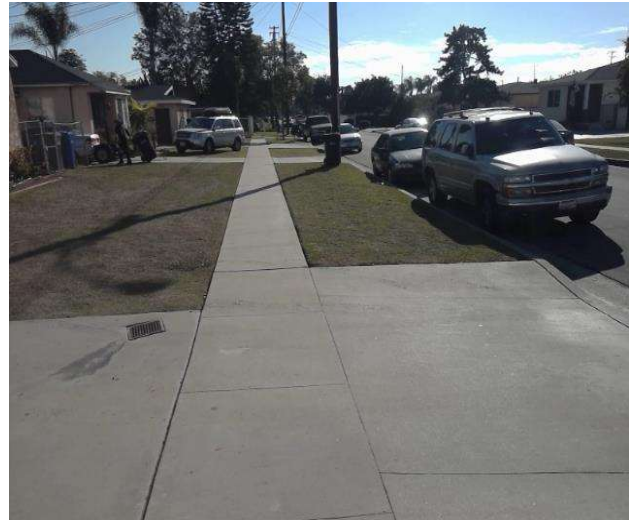
On-Site Finding Not Found

Install compliant detectable warnings \$190

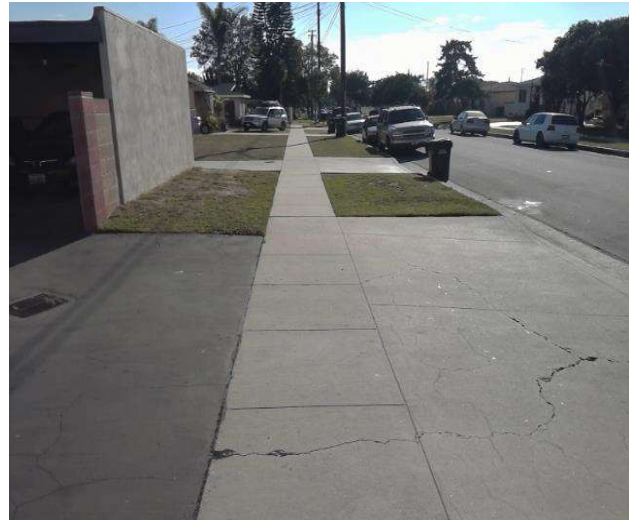
On-Site Finding Not Found

Install compliant detectable warnings \$190

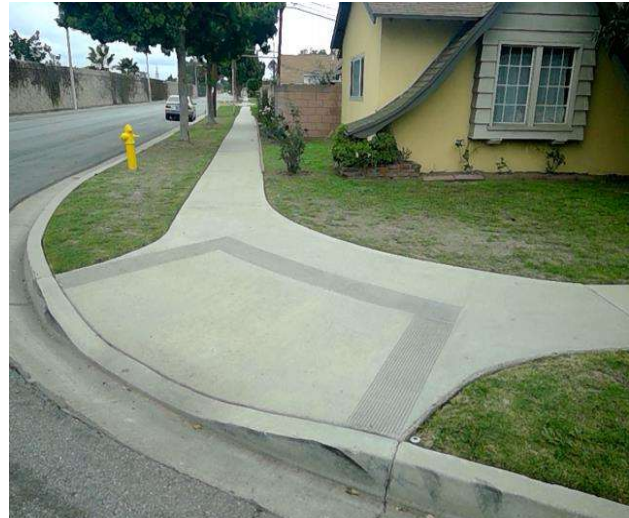
On-Site Finding Not Found

Provide detectable warning to surface \$248

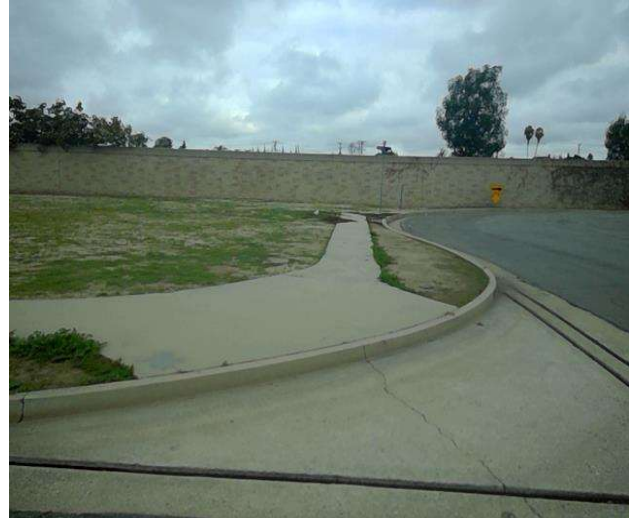
Sidewalks , Hazards & Gratings : Curb is on Path of Travel

Install curb ramp \$2,500

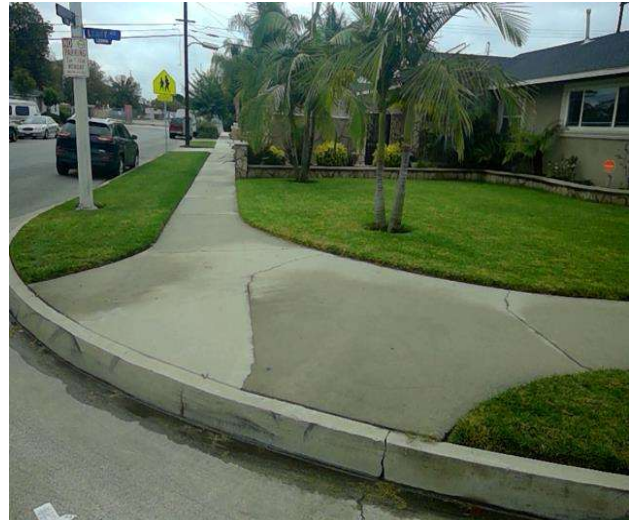
Sidewalks , Hazards & Gratings : Curb is on Path of Travel

Install curb ramp \$2,500

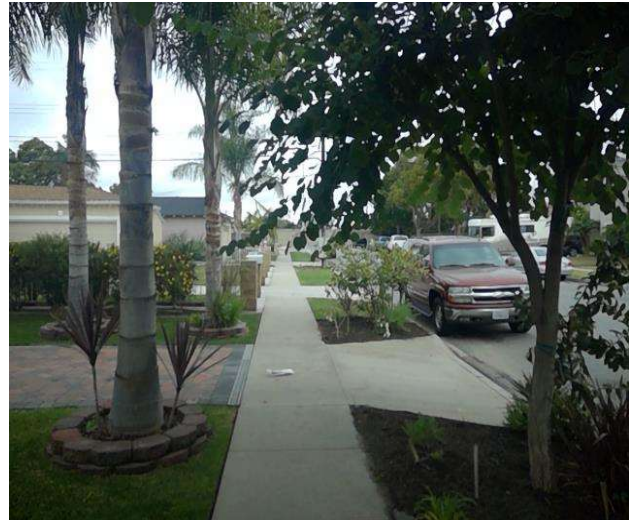
Sidewalks , Hazards & Gratings : Overhead Obstruction Height

Recommendation At least 80.00 inches

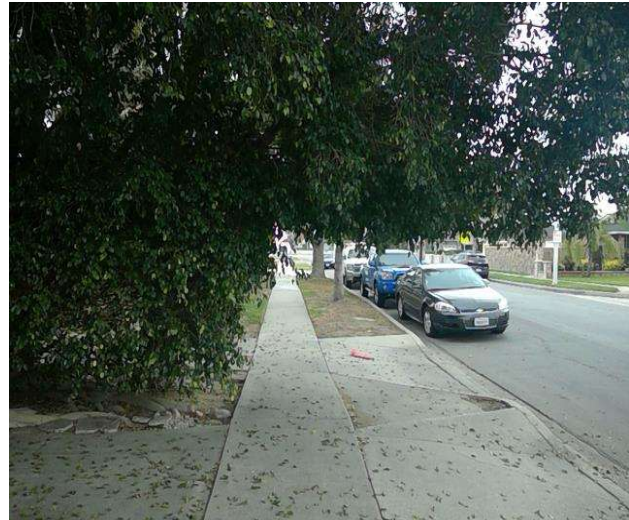
Sidewalks , Hazards & Gratings : Overhead Obstruction Height

Recommendation At least 80.00 inches

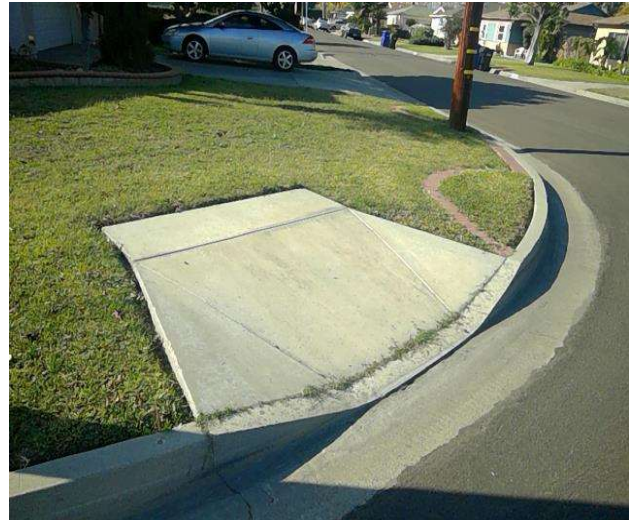
Recommendation

Recommendation Up to 5.00 percent

Repave landing \$1,260

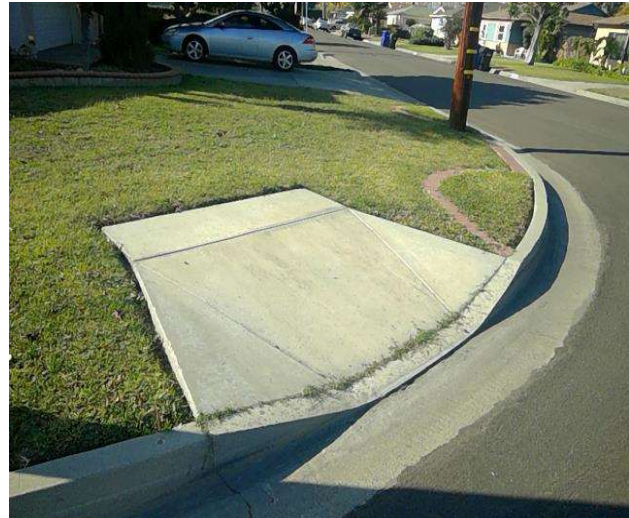
Curb Ramp , Landings And Transitions : Bottom Landing Change in Level

Recommendation

Recommendation Up to 0.50 inches

Patch lip at curb ramp \$255

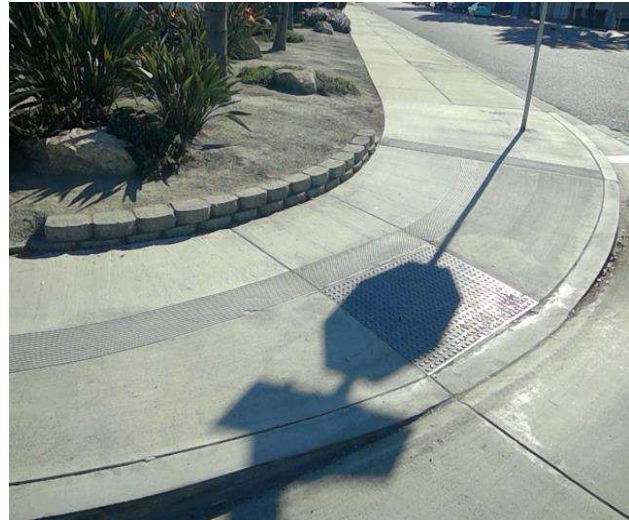
Recommendation

Recommendation Up to 2.08 percent

Provide compliant landing \$1,260

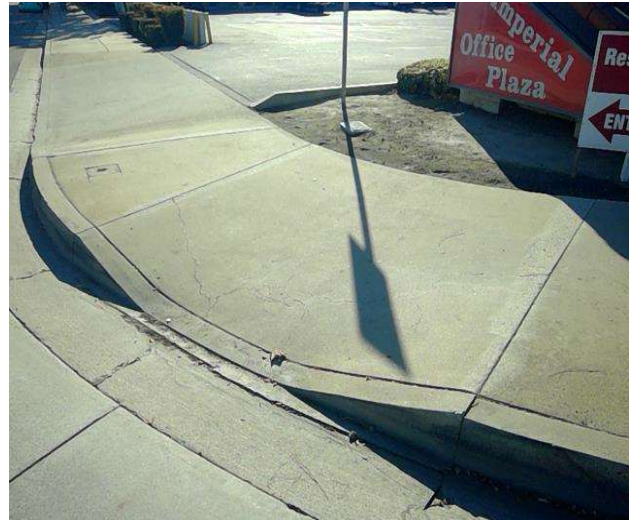
Recommendation

Recommendation Up to 5.00 percent

Repave landing \$1,260

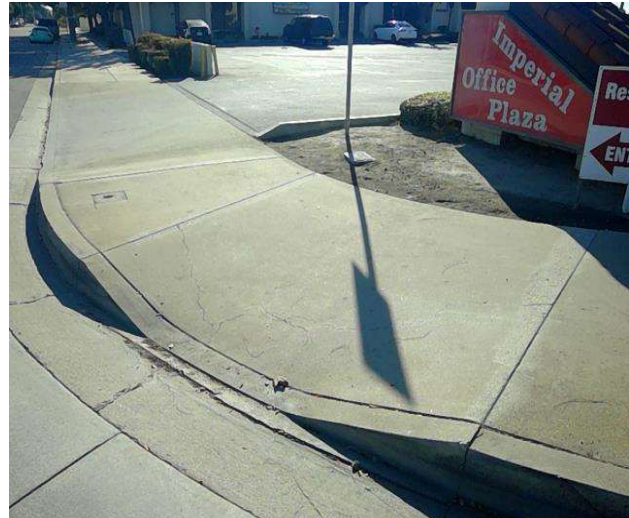
On-Site Finding Not Found

Recommendation See Recommendation

Provide detectable warning to surface \$248

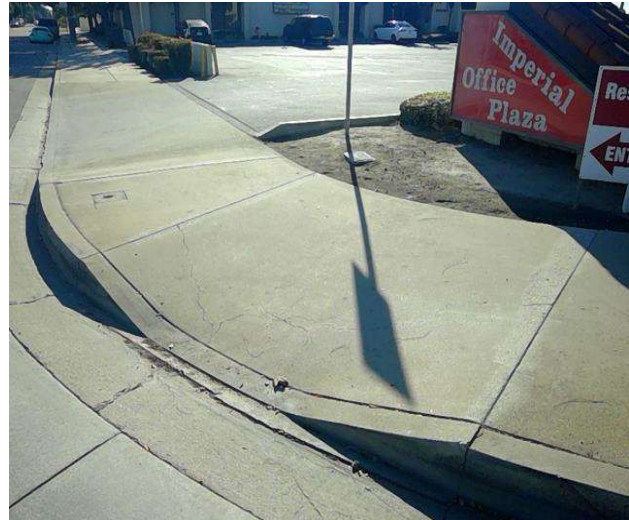
Recommendation

Recommendation Up to 10.00 percent

Install flared sides \$1,300

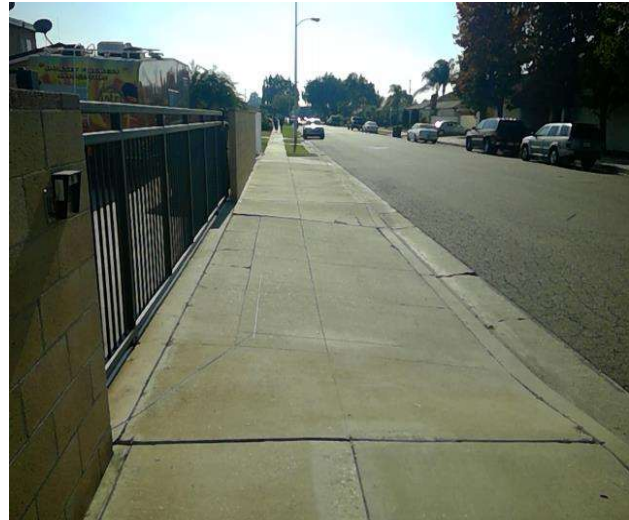
On-Site Finding Not Found

Recommendation See Recommendation

Install compliant detectable warnings \$190

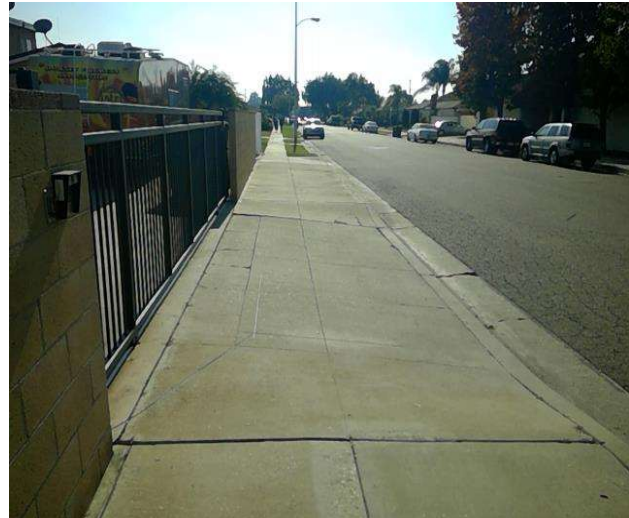
Recommendation

Recommendation Up to 2.08 percent

Repave surface \$1,092

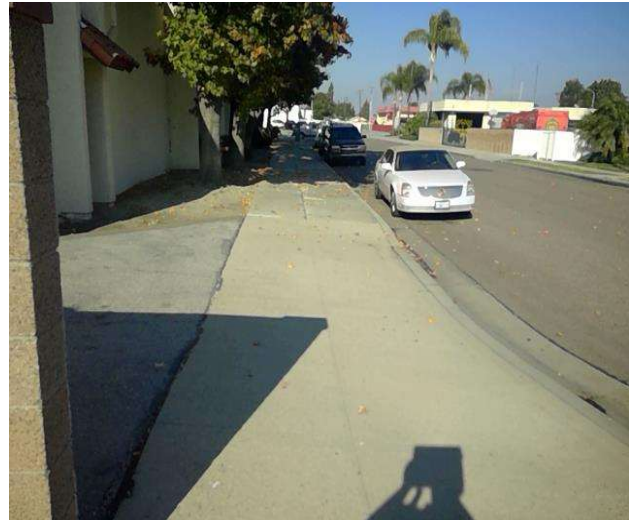
On-Site Finding Not Found

Recommendation See Recommendation

Install compliant detectable warnings \$190

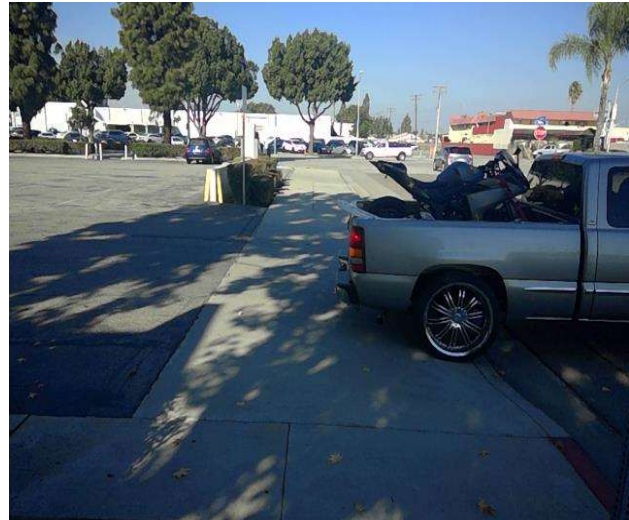
On-Site Finding Not Found

Recommendation See Recommendation

Install compliant detectable warnings \$190

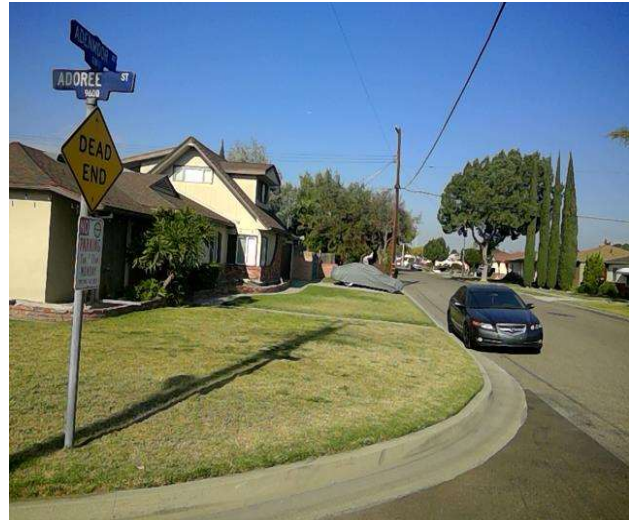
Sidewalks : Missing Sidewalk

Section of sidewalk is missing and consists of dirt, grass or gravel.

Provide a compliant sidewalk for the missing section.

\$1,260

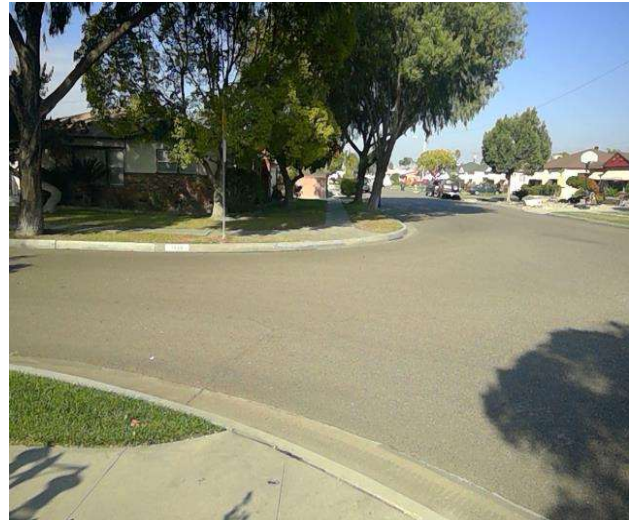
Recommendation

Recommendation See Recommendation

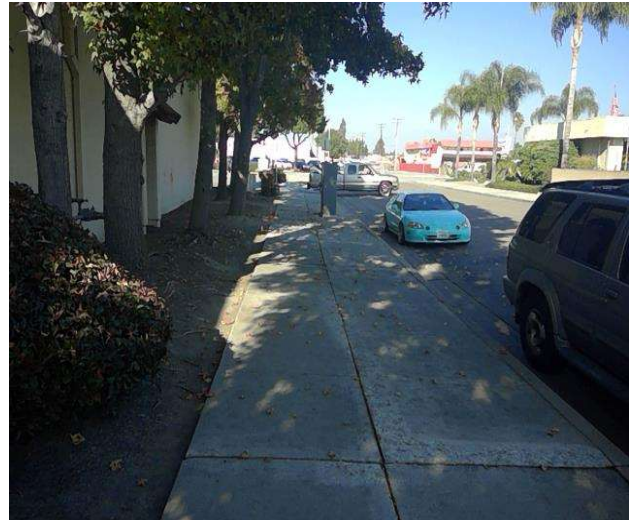
Recommendation Up to 2.08 percent

Repave the sidewalk surface with the recommended cross slope.

Repave surface \$1,092

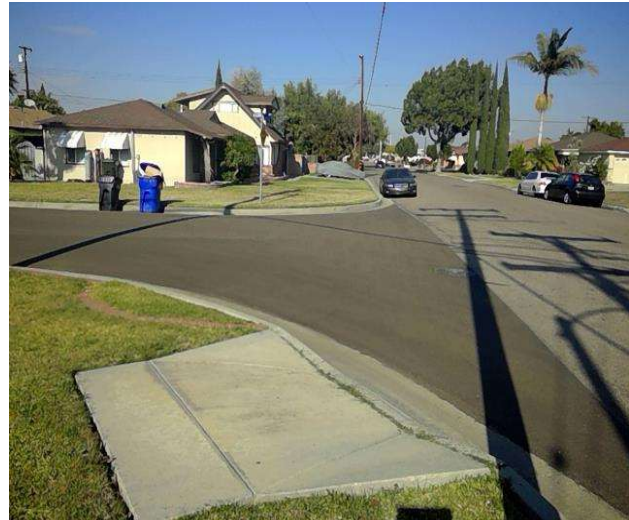
On-Site Finding Not Found

Recommendation See Recommendation

\$2,400
