Accessibility Survey

City of Downey

Benares Street - Norlain Avenue To Julius Avenue

Date of Inspection
2/14/2017

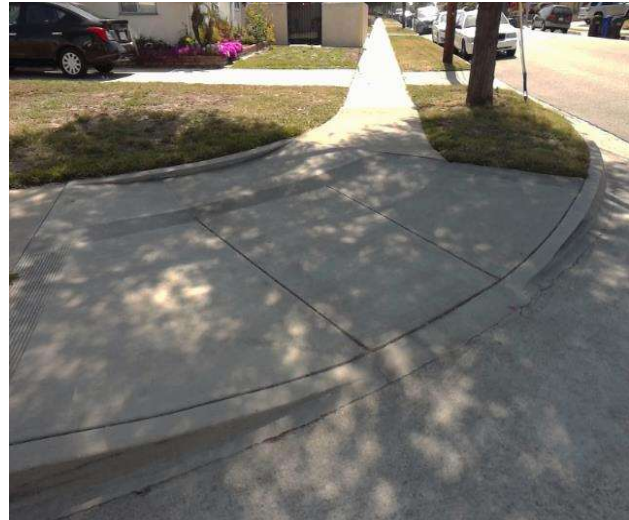
On-Site Finding Not Found

Recommendation See Recommendation

Provide detectable warning to surface \$248

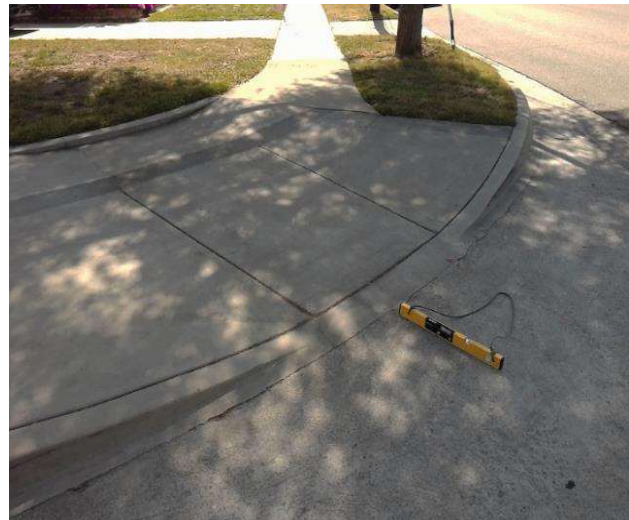
Recommendation Up to 2.08 percent

Provide compliant landing \$1,260

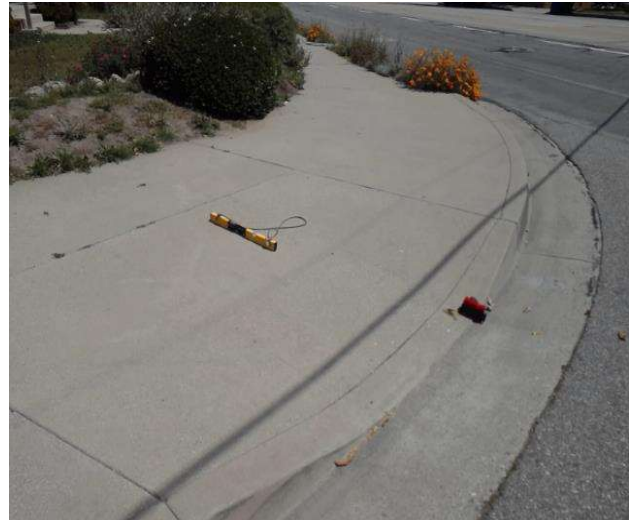
On-Site Finding Not Found

Recommendation See Recommendation

Provide detectable warning to surface \$248

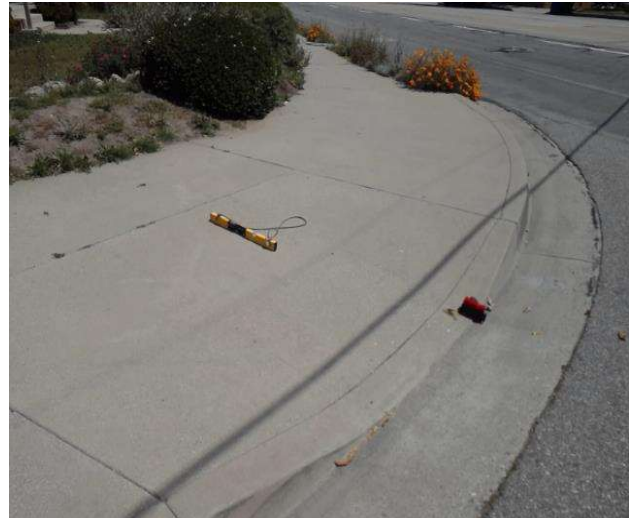
Recommendation Up to 8.33 percent

Install curb ramp \$1,300

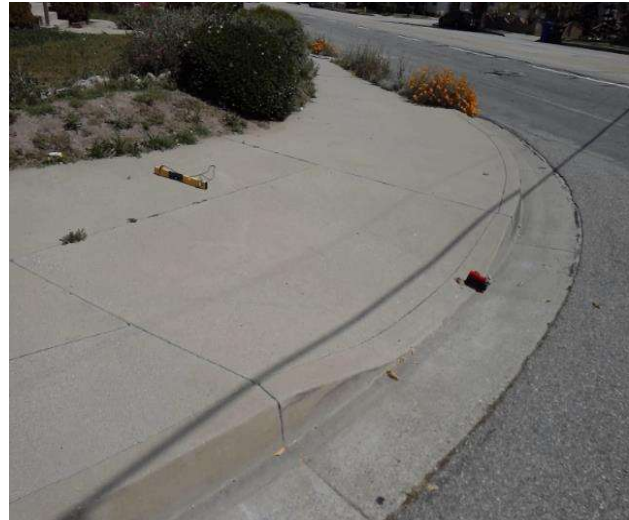
Recommendation Up to 5.00 percent

Repave landing \$1,260

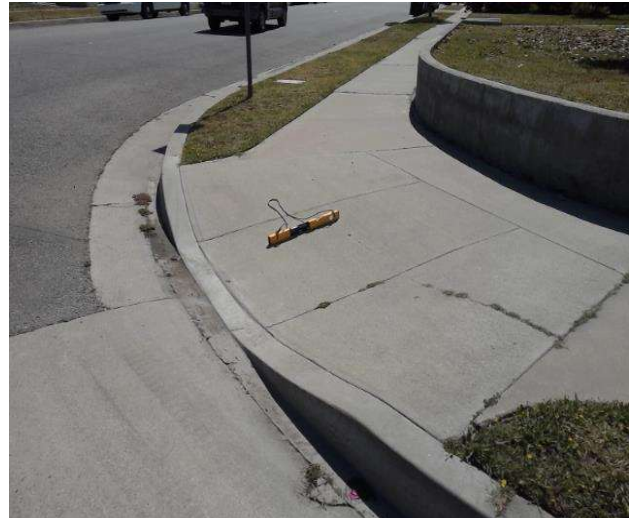
On-Site Finding Not Found

Recommendation See Recommendation

Provide detectable warning to surface \$248

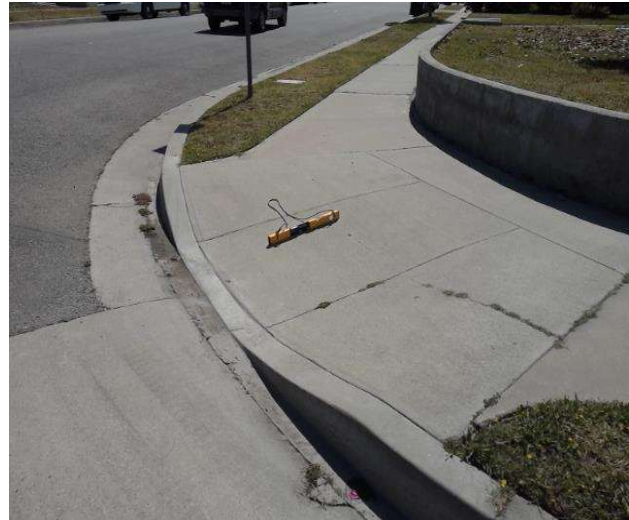
Recommendation Up to 8.33 percent

Install curb ramp \$1,300

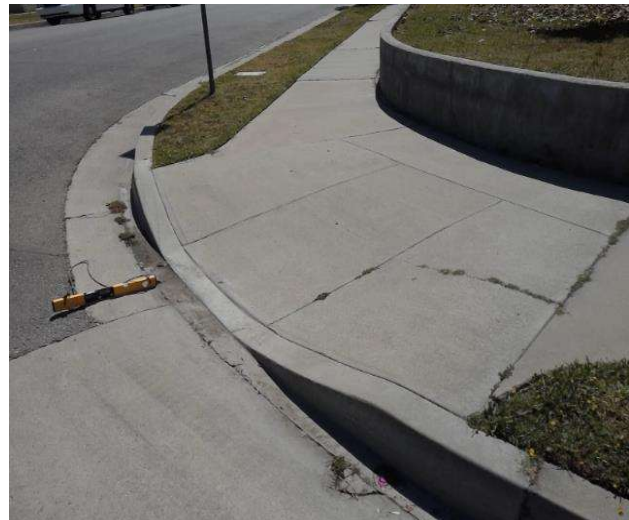
Recommendation Up to 5.00 percent

Repave landing \$1,260

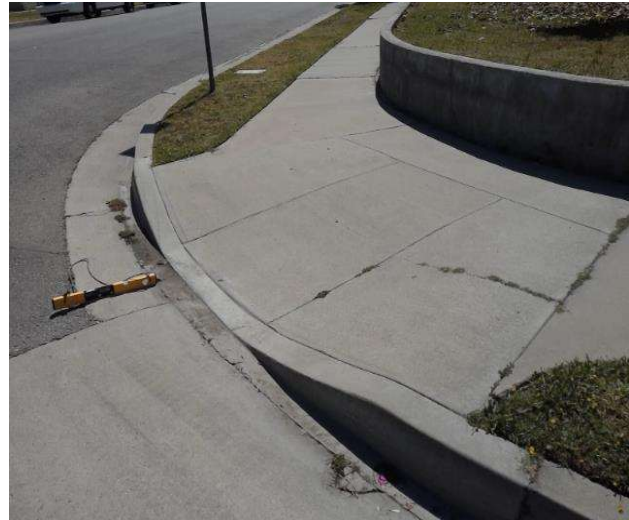
Recommendation Up to 2.08 percent

Provide compliant landing \$1,260

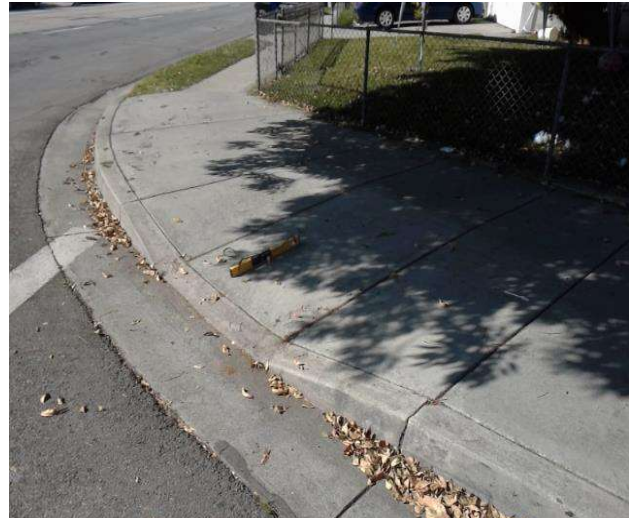
On-Site Finding Not Found

Recommendation See Recommendation

Provide detectable warning to surface \$248

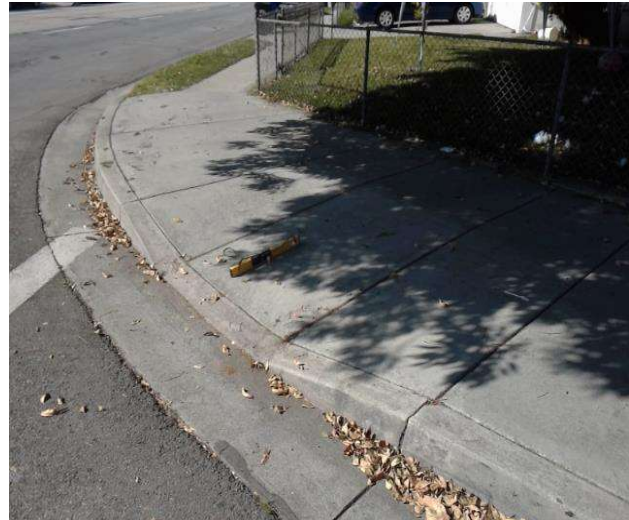
Recommendation Up to 8.33 percent

Install curb ramp \$1,300

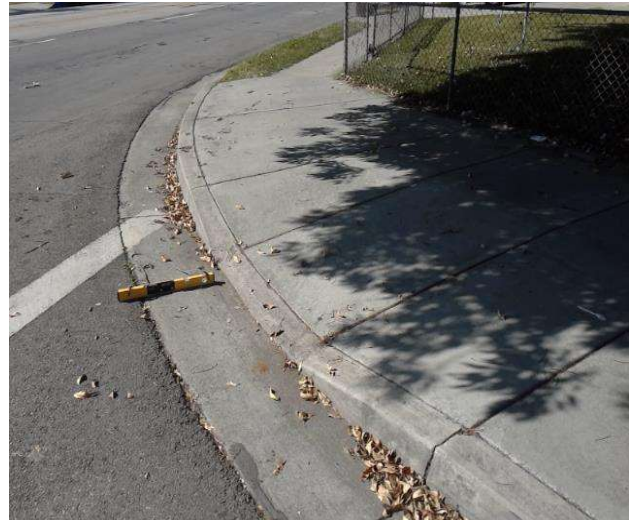
Recommendation Up to 5.00 percent

Repave landing \$1,260

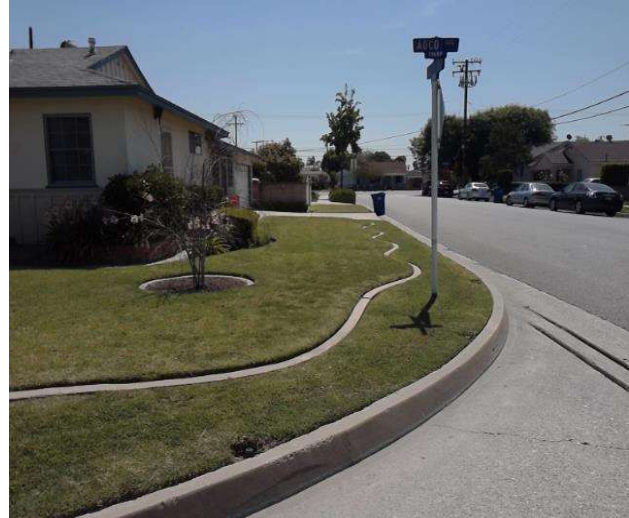
Sidewalks : Missing Sidewalk

Section of sidewalk is missing and consists of dirt, grass or gravel.

\$1,260
