## Accessibility Survey

## City of Downey Pellet Street - Pangborn Avenue To End

Date of Inspection  
5/3/2017

Prepared By  
**Disability Access Consultants**  
(800) 743-7067

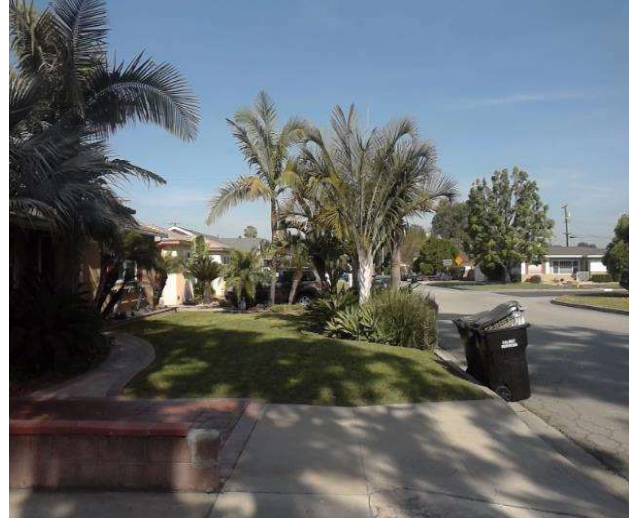
Sidewalks : Missing Sidewalk

#### Costing Info (Estimated)

\$1,260
