Accessibility Survey

City of Downey Barlin Avenue - Cheyenne Street To Gardendale Street

Date of Inspection
4/10/2017

Disability Access Consultants

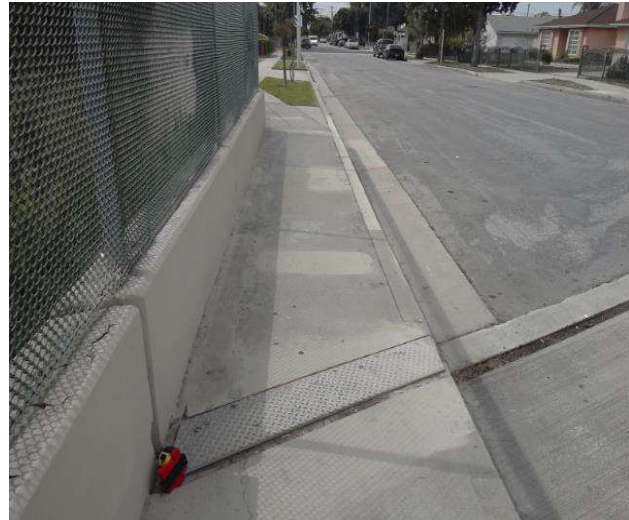
Recommendation See Recommendation

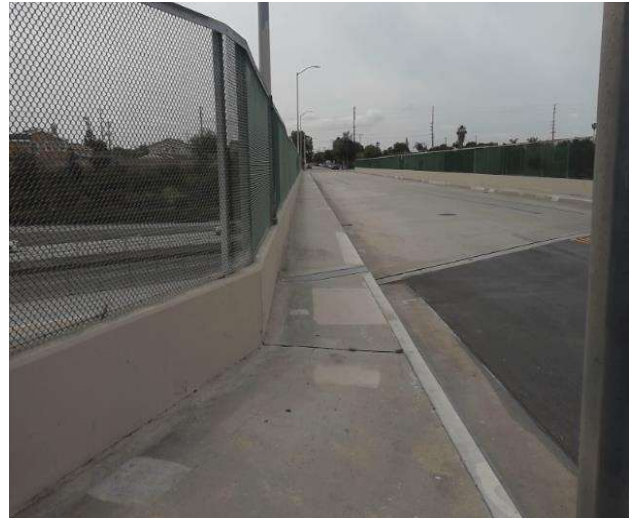
On-Site Finding Not Found

Recommendation See Recommendation

\$2,400

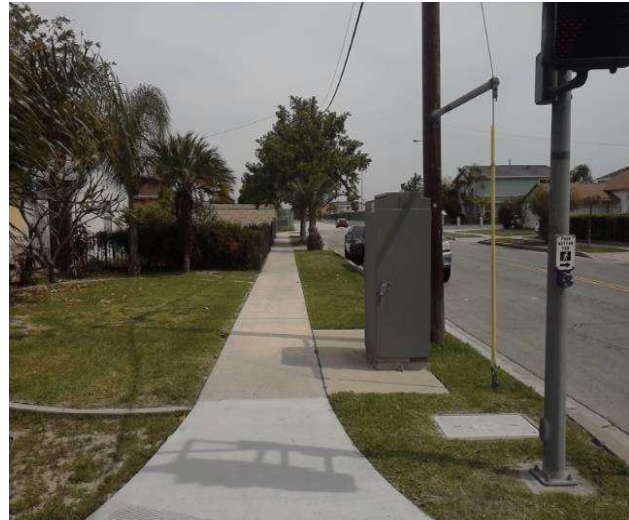
On-Site Finding Not Found

Recommendation See Recommendation

\$2,400

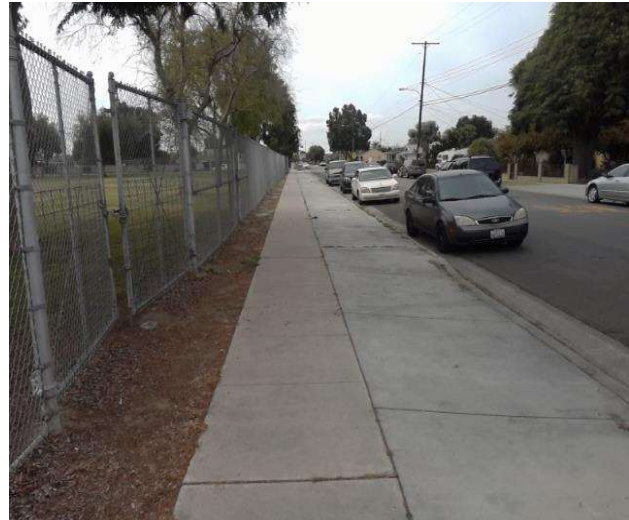
On-Site Finding Not Found

Install compliant detectable warnings \$190

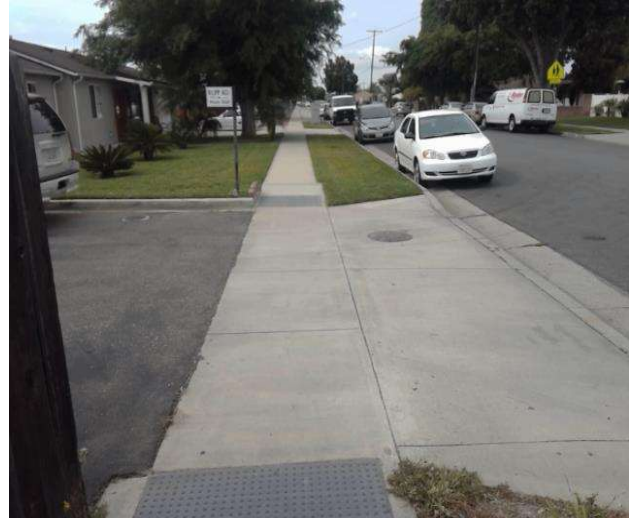
On-Site Finding Not Found

Install compliant detectable warnings \$190

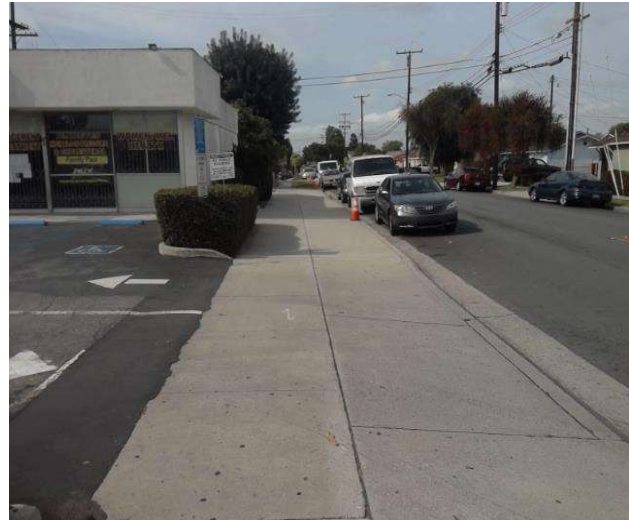
On-Site Finding Not Found

Install compliant detectable warnings \$190

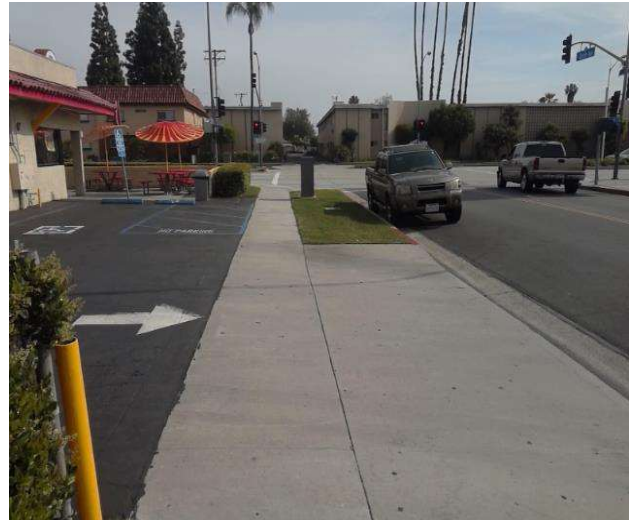
On-Site Finding Not Found

Install compliant detectable warnings \$190

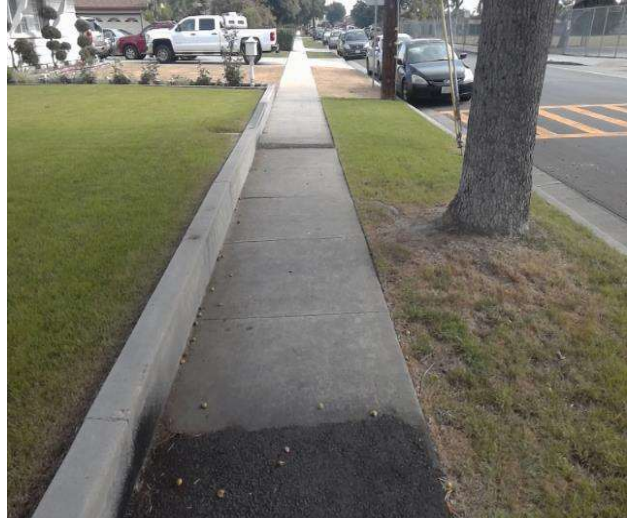
Notes : Surface is rough and uneven for 4 feet.

Repave the sidewalk surface with the recommended cross slope.

Recommendation Up to 2.08 percent

Repave surface \$1,092

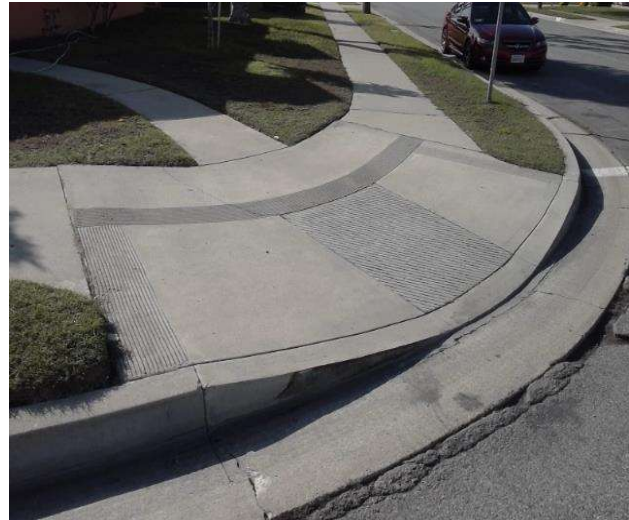
On-Site Finding Not Found

Provide detectable warning to surface \$248

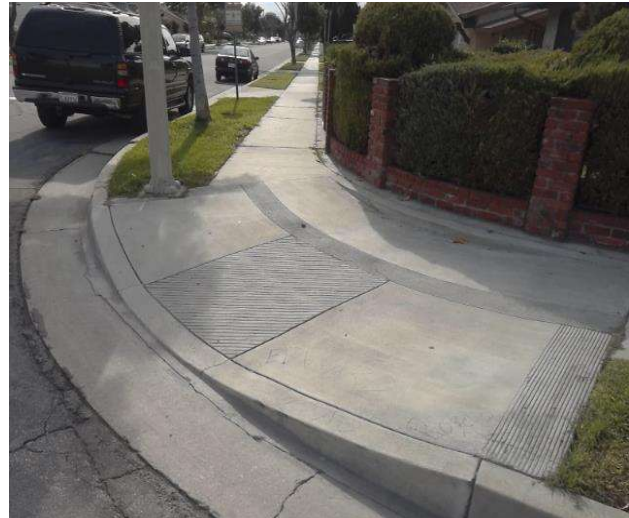
Curb Ramp , Landings and Transitions : Top Landing Clear Length - Landings

Provide compliant landing \$240
