Accessibility Survey

City of Downey Nada Street - Horley Avenue to Richeon Avenue

Date of Inspection
8/9/2017

Prepared By
Disability Access Consultants
(800) 743-7067

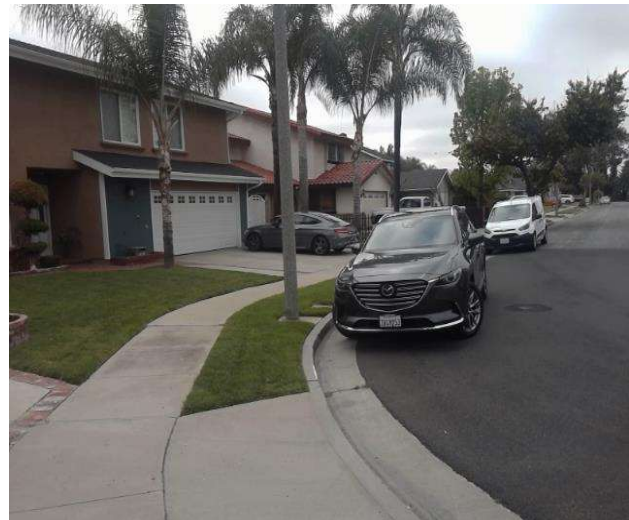
On-Site Finding Not Found

Recommendation

Recommendation See Recommendation

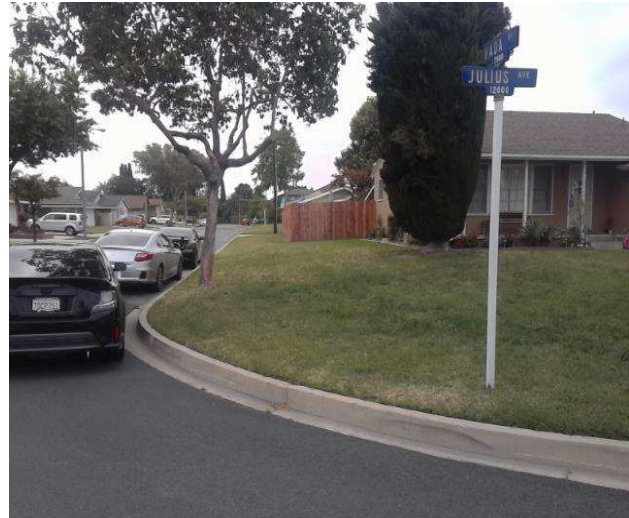
On-Site Finding Not Found

Recommendation

Recommendation See Recommendation

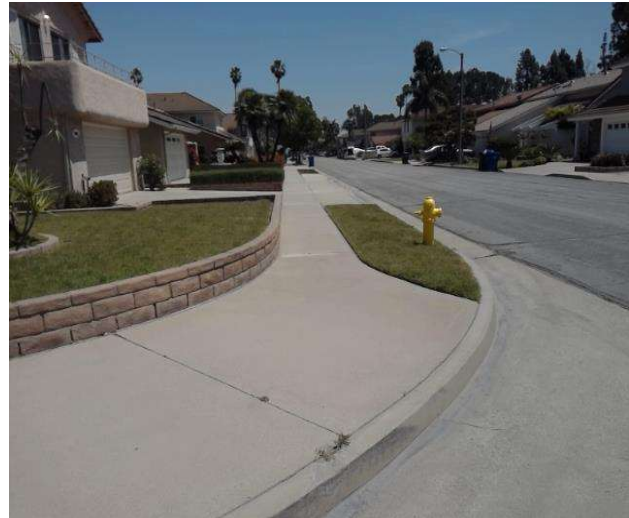
On-Site Finding Not Found

Recommendation

Recommendation See Recommendation

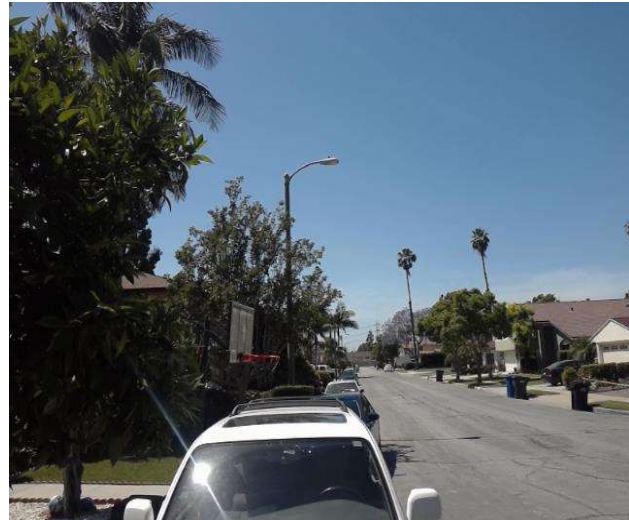
On-Site Finding Not Found

Recommendation

Recommendation See Recommendation
