# Accessibility Survey

## City of Downey Quinn Street - Bellman Avenue to Cul-De-Sac

Date of Inspection  
7/26/2017

Prepared By  
**Disability Access Consultants**  
(800) 743-7067

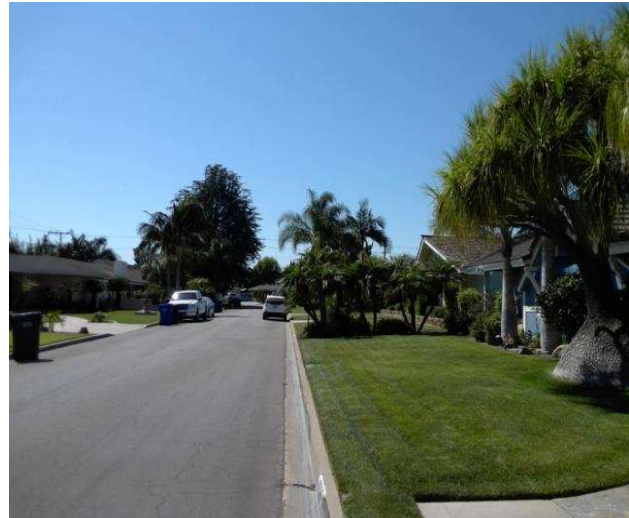
**On-Site Finding** Not Found

Recommendation See Recommendation

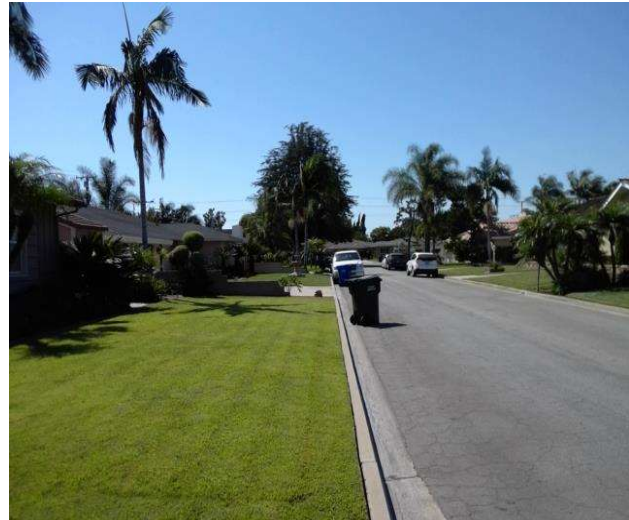
**On-Site Finding** Not Found

Recommendation See Recommendation

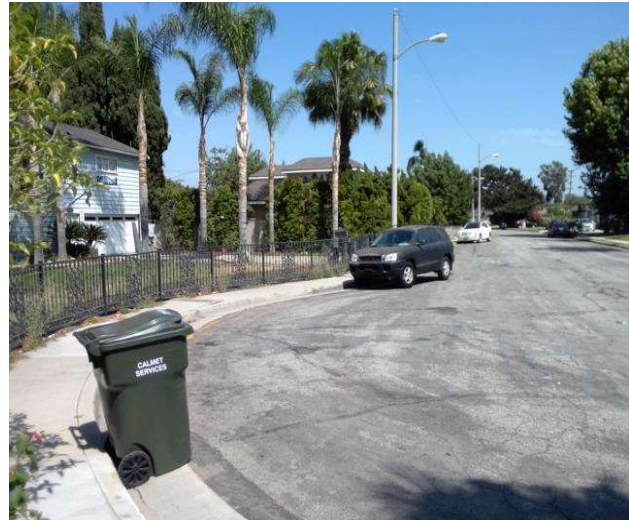
**On-Site Finding** Not Found

Recommendation See Recommendation

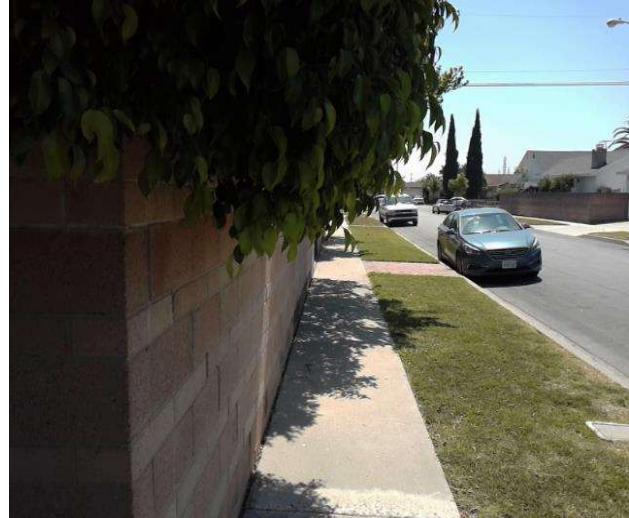
**Code Reference** ADA 206, 307.4, CA 11B-307.4

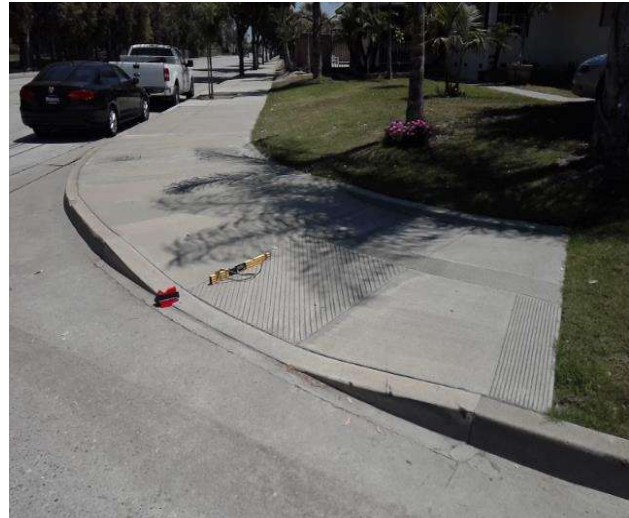
**Code Reference** CA 11B-406.5.12

Provide detectable warning to surface \$248

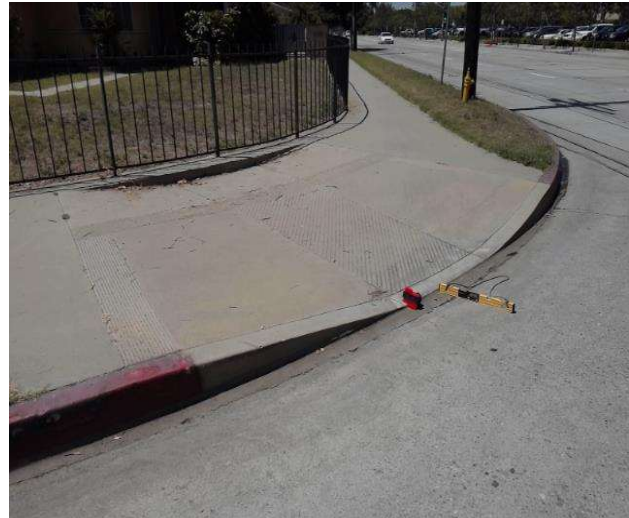
**Code Reference** ADA 402, 406.4, 403.3, 406.1, CA 11B-406.5.3

Provide compliant landing \$1,260

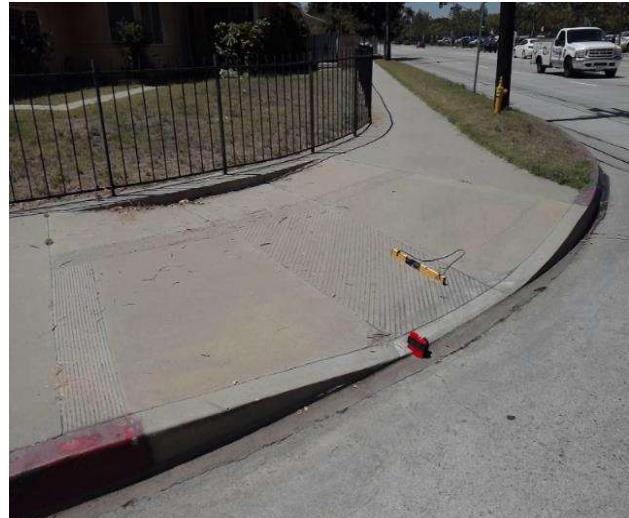
**Code Reference** CA 11B-406.5.12

Provide detectable warning to surface \$248

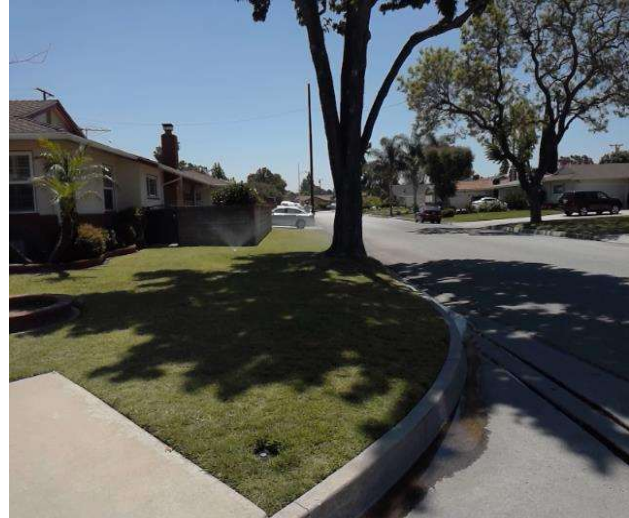
**Code Reference** ADA 206, 302,CA 11B-302,CA 11B-206
