Accessibility Survey

City of Downey Richeon Avenue - Adwen Street To Arnett Street

Date of Inspection
4/11/2017

Prepared By
Disability Access Consultants
(800) 743-7067

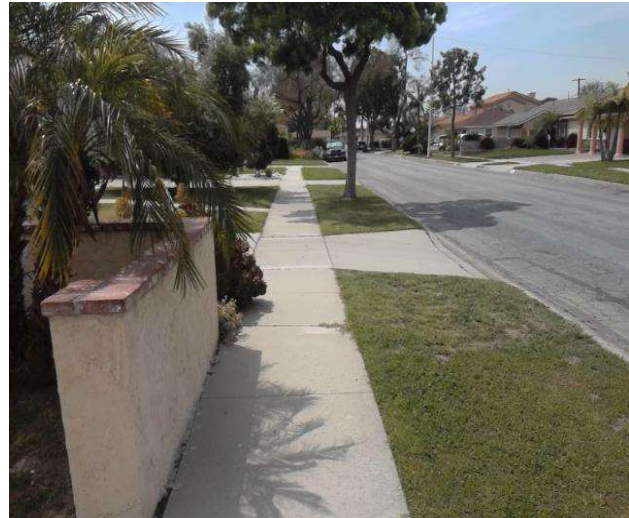
On-Site Finding Not Found

Recommendation

Recommendation See Recommendation

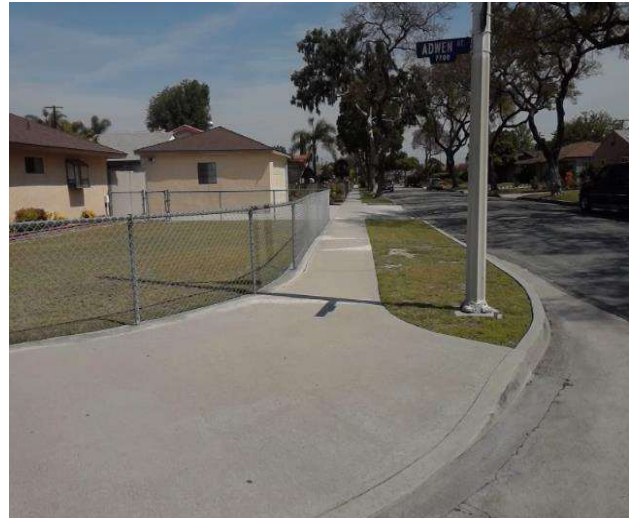
On-Site Finding Not Found

Recommendation

Recommendation See Recommendation

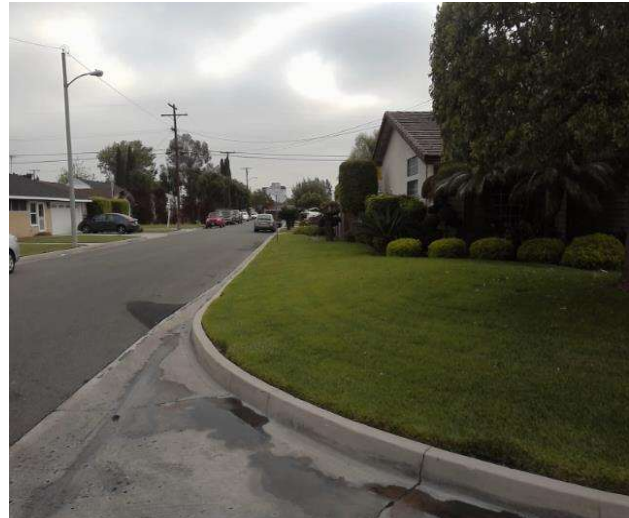
On-Site Finding Not Found

Recommendation

Recommendation See Recommendation

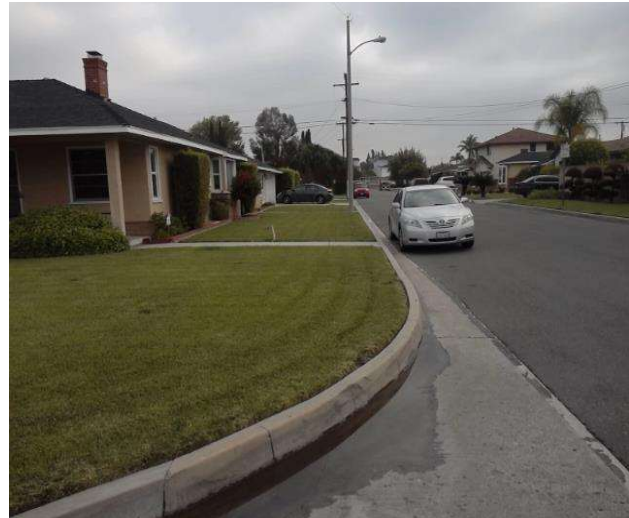
On-Site Finding Not Found

Recommendation

Recommendation See Recommendation

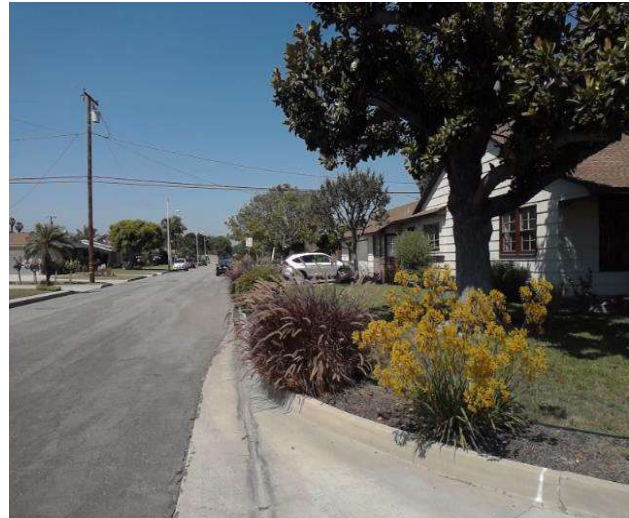
On-Site Finding Not Found

Recommendation

Recommendation See Recommendation

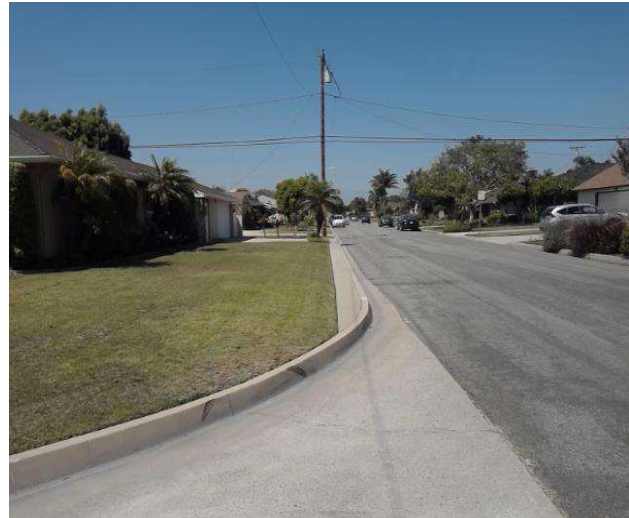
On-Site Finding Not Found

Recommendation

Recommendation See Recommendation
