Accessibility Survey

City of Downey Hall Road - Lakewood Boulevard To Woodruff Avenue

Lakewood Boulevard To Woodruff Avenue
Downey, CA 90241

Date of Inspection
12/8/2016

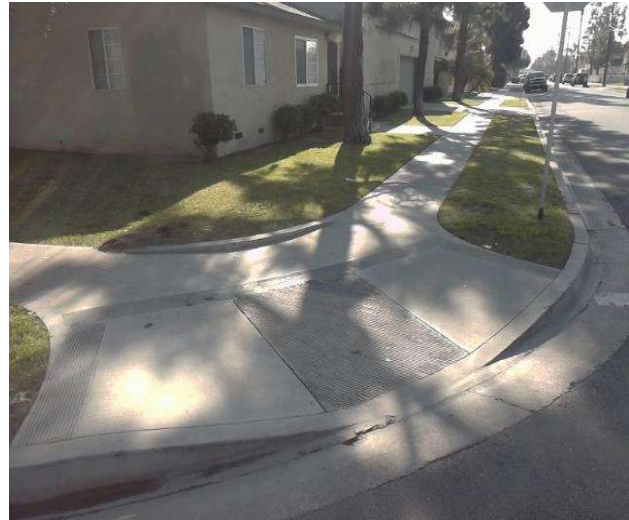
Recommendation Up to 2.08 percent

Provide compliant landing \$1,260

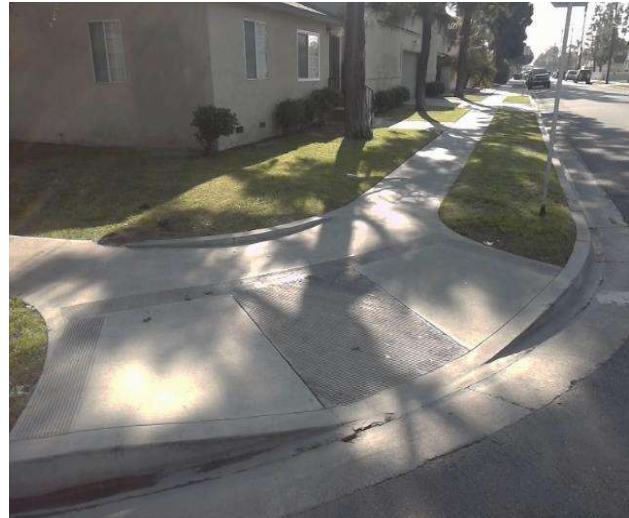
On-Site Finding Not Found

Provide detectable warning to surface \$248

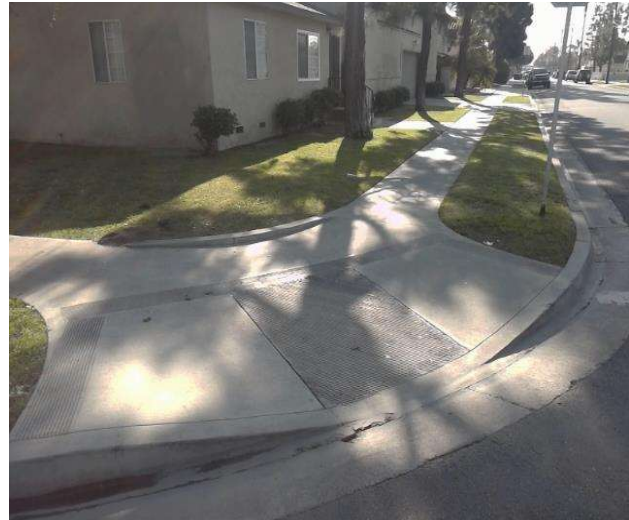
Recommendation Up to 10.00 percent

Install flared sides \$1,300

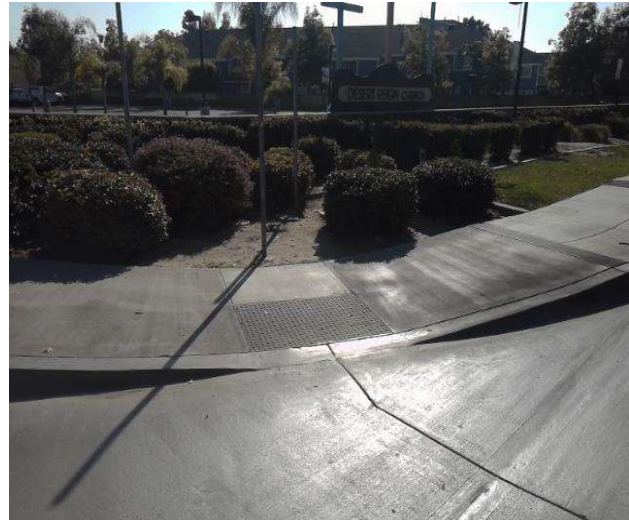
Recommendation Up to 2.08 percent

Curb Ramp , Landings and Transitions : Top Landing Slope

Provide compliant landing \$1,260

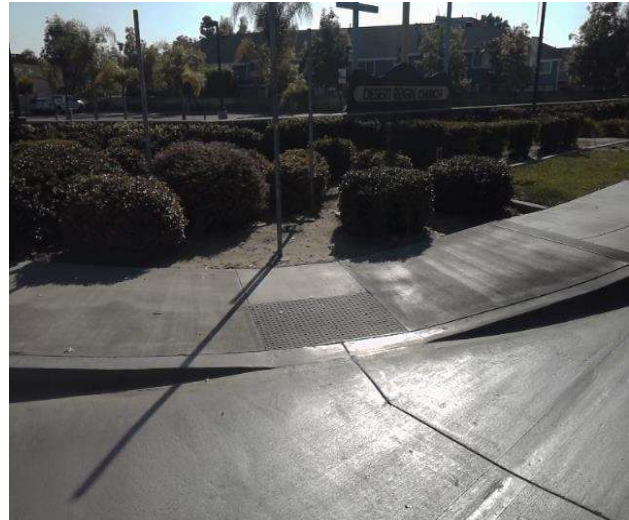
Recommendation Up to 2.08 percent

Install curb ramp \$1,300

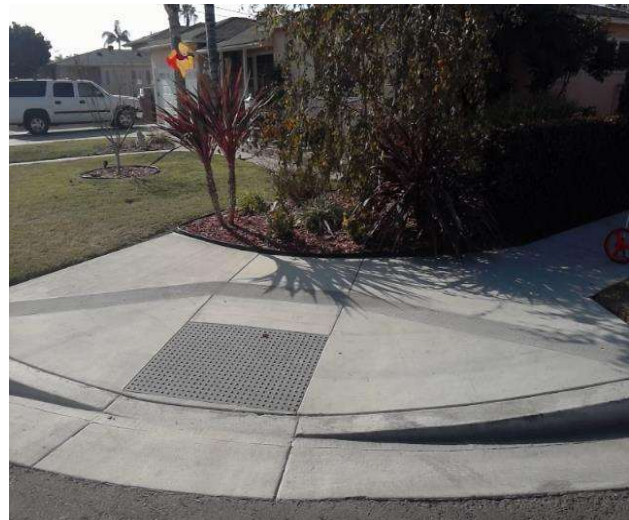
Recommendation Up to 5.00 percent

Repave landing \$1,260

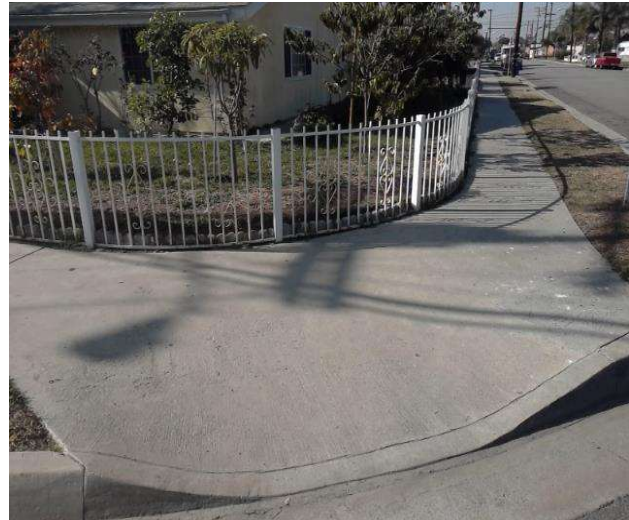
On-Site Finding Not Found

Provide detectable warning to surface \$248

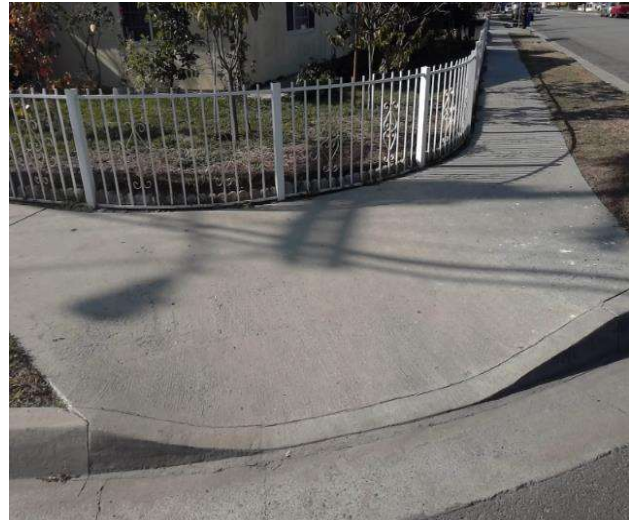
Recommendation Up to 5.00 percent

Repave landing \$1,260

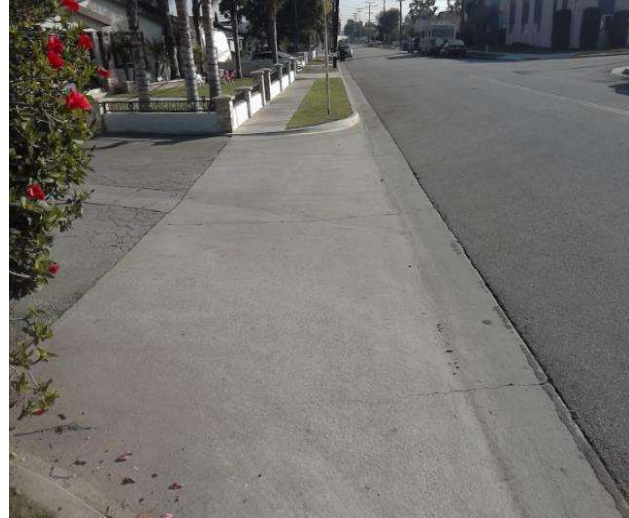
Recommendation Up to 2.08 percent

Repave surface \$1,092

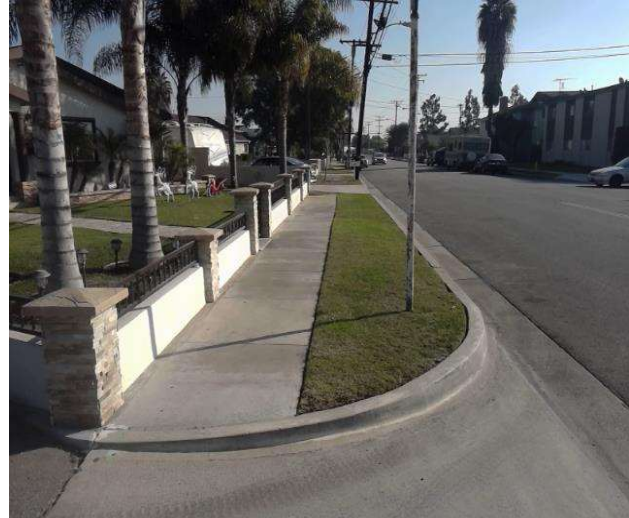
Sidewalks , Hazards & Gratings : Curb is on Path of Travel

Install curb ramp \$2,500

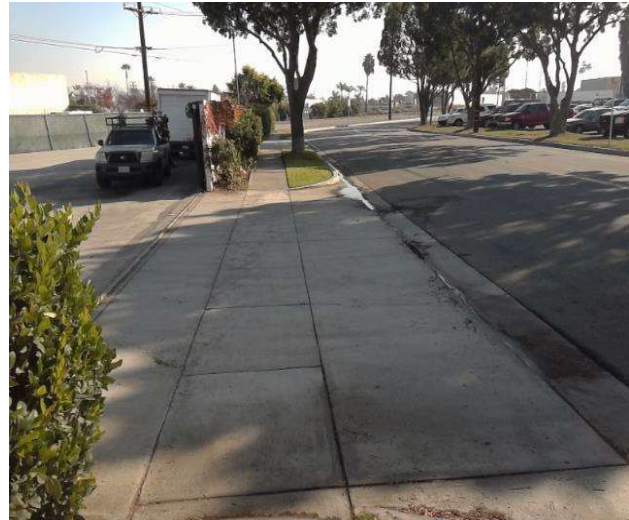
On-Site Finding Not Found

Install compliant detectable warnings \$190

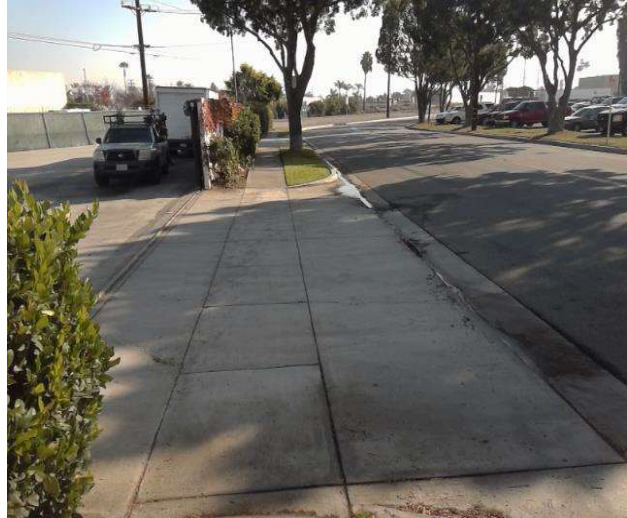
Recommendation Up to 2.08 percent

Repave surface \$1,092

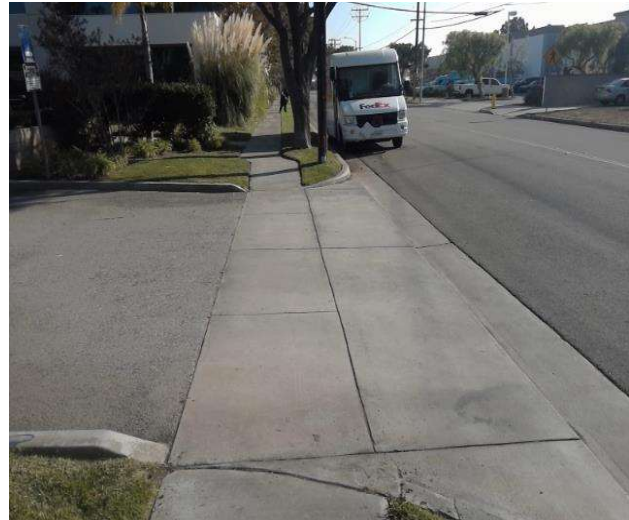
On-Site Finding Not Found

Install compliant detectable warnings \$190

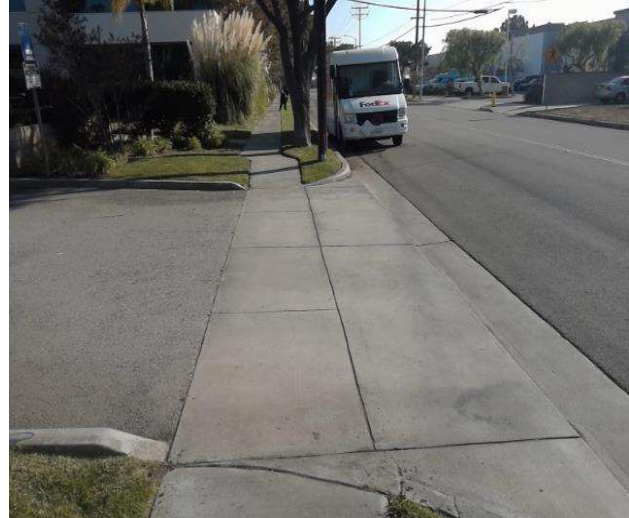
Recommendation Up to 2.08 percent

Repave surface \$1,092

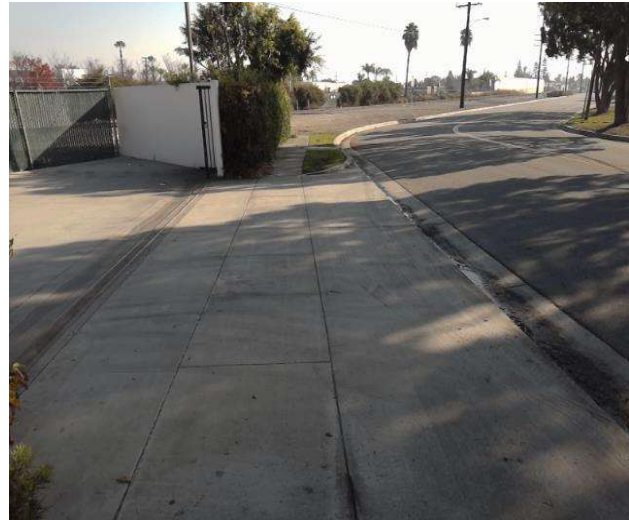
On-Site Finding Not Found

Install compliant detectable warnings \$190

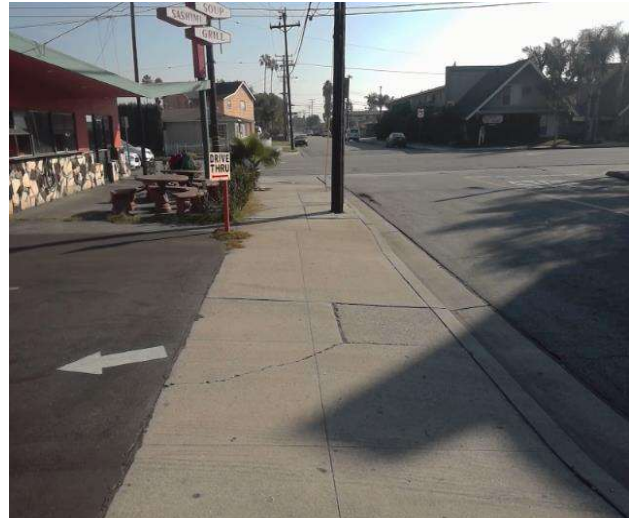
On-Site Finding Not Found

Install compliant detectable warnings \$190

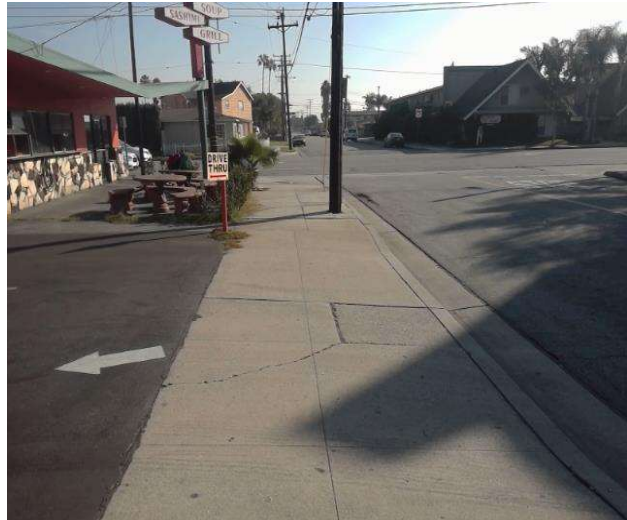
Recommendation Up to 2.08 percent

Repave surface \$1,092

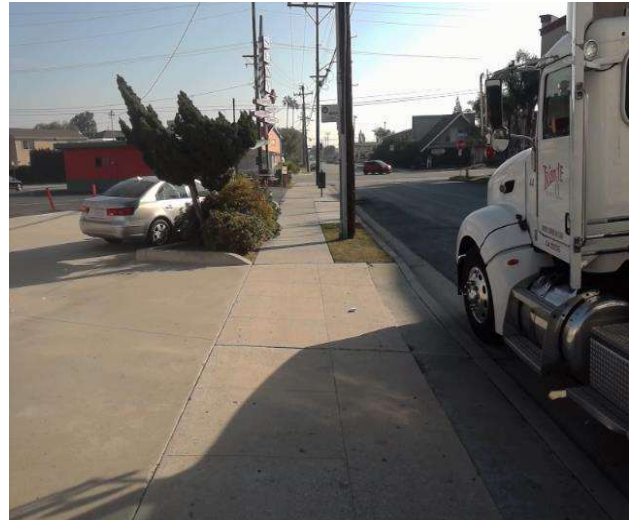
On-Site Finding Not Found

Install compliant detectable warnings \$190

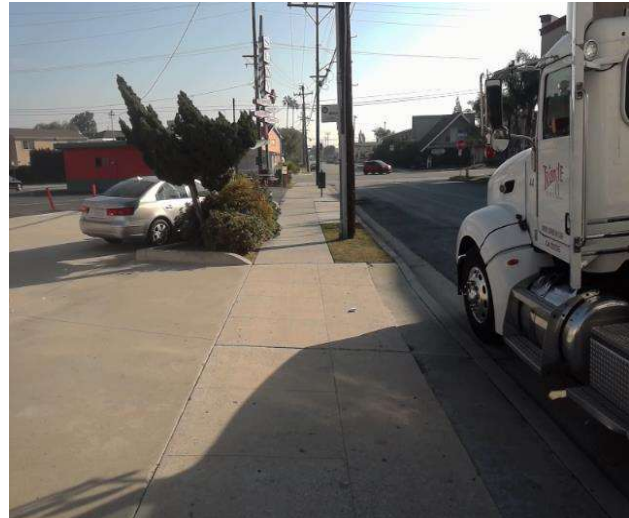
Recommendation Up to 2.08 percent

Repave surface \$1,092

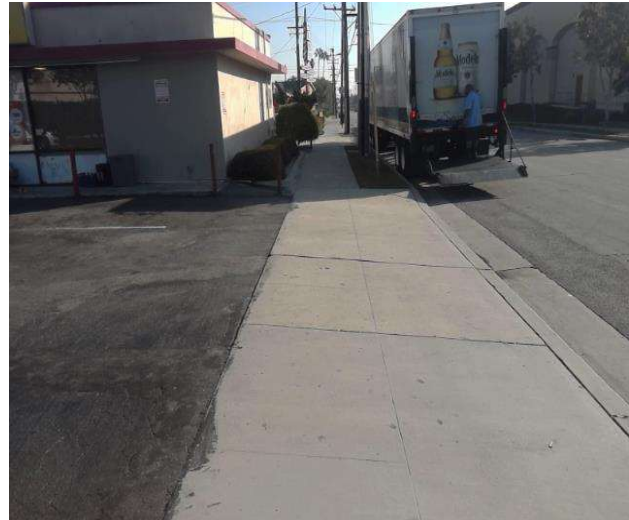
On-Site Finding Not Found

Install compliant detectable warnings \$190

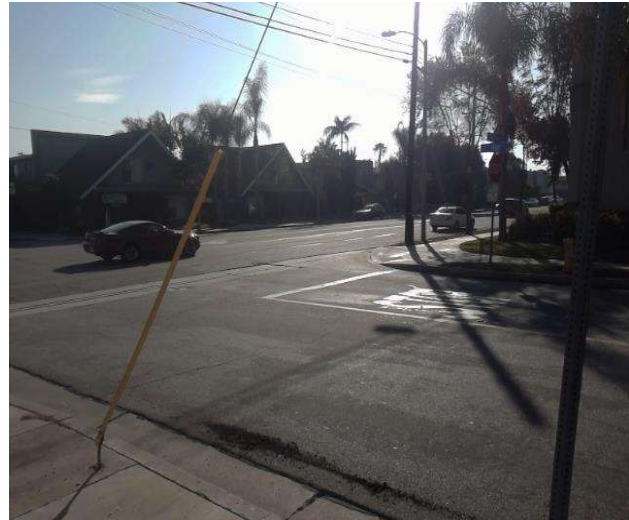
Sidewalks , Hazards & Gratings : Overhead Obstruction Height

Recommendation At least 80.00 inches

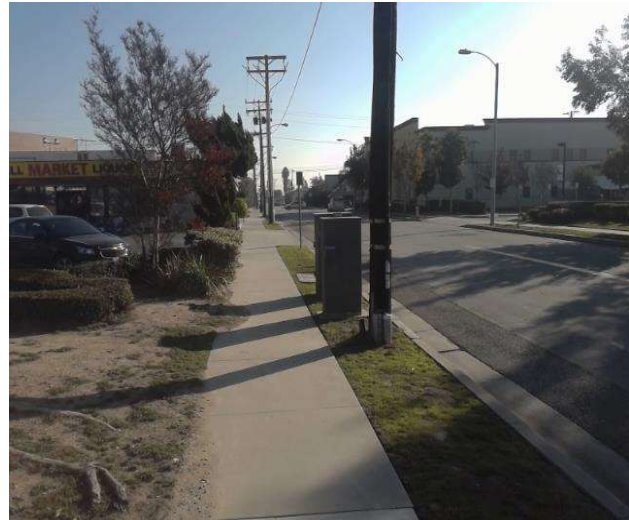
On-Site Finding Not Found

\$2,400

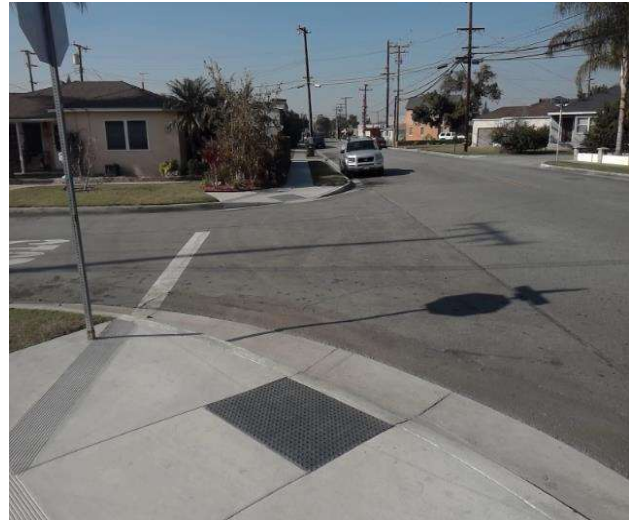
Recommendation Up to 2.08 percent

Repave surface \$1,092

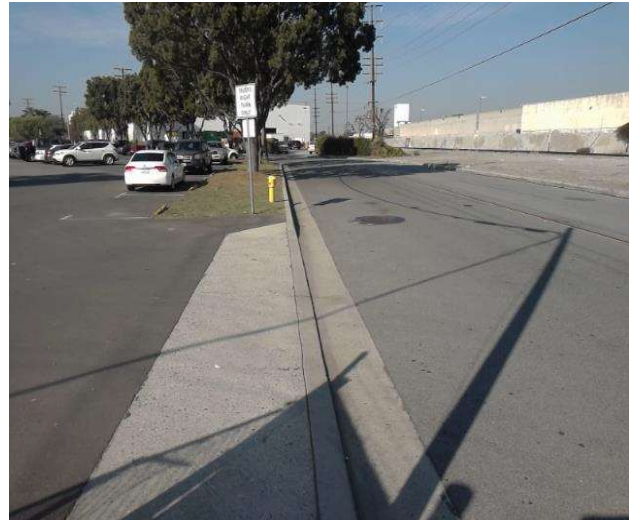
On-Site Finding Not Found

Install compliant detectable warnings \$190

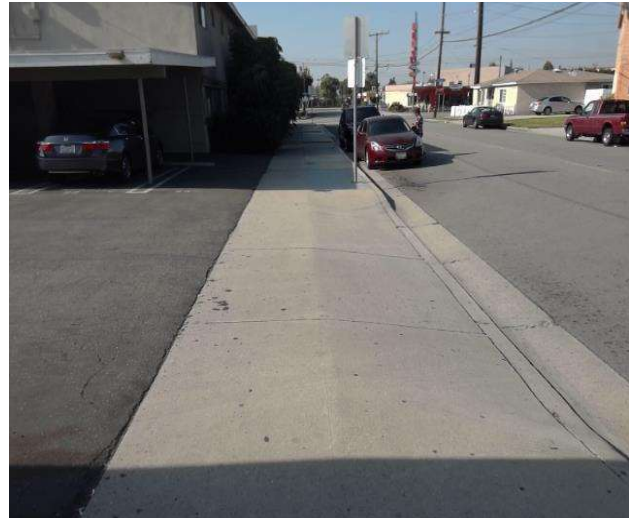
On-Site Finding Not Found

Install compliant detectable warnings \$190

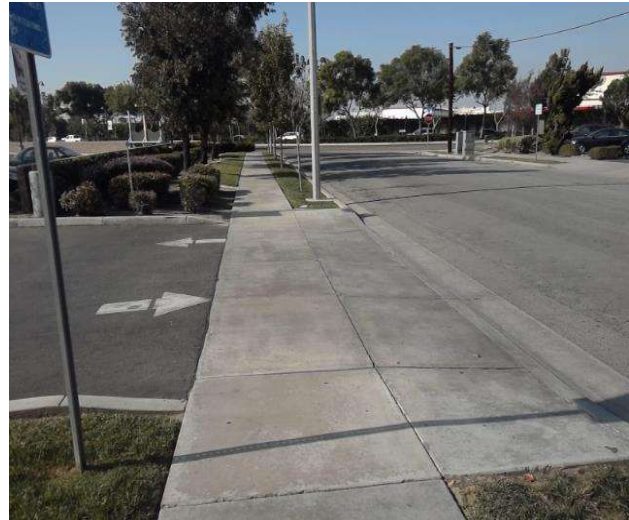
On-Site Finding Not Found

Install compliant detectable warnings \$190

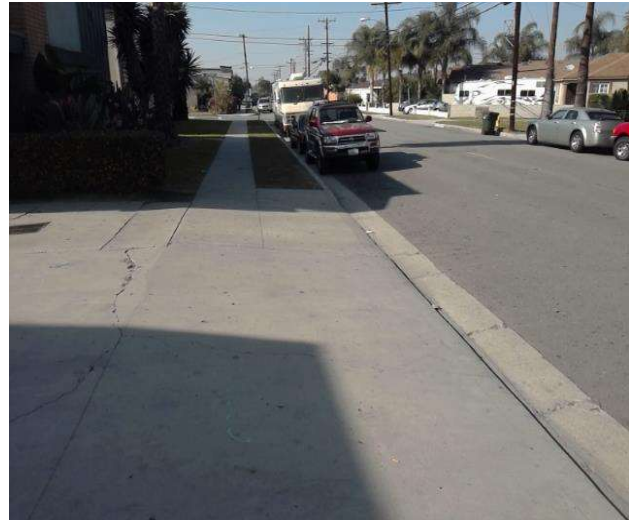
On-Site Finding Not Found

Install compliant detectable warnings \$190

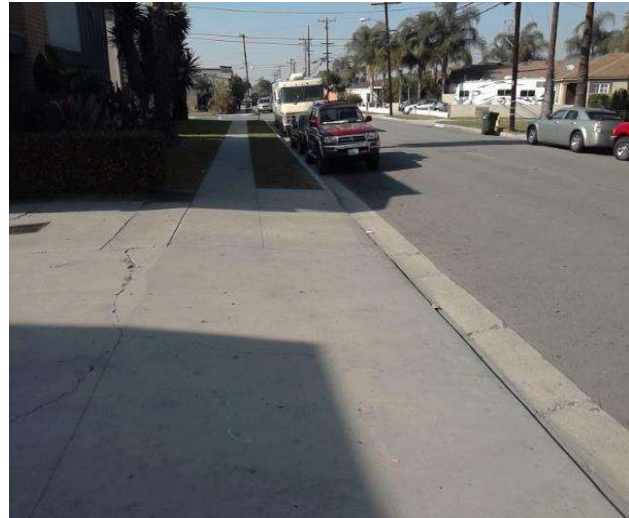
Recommendation Up to 2.08 percent

Repave surface \$1,092

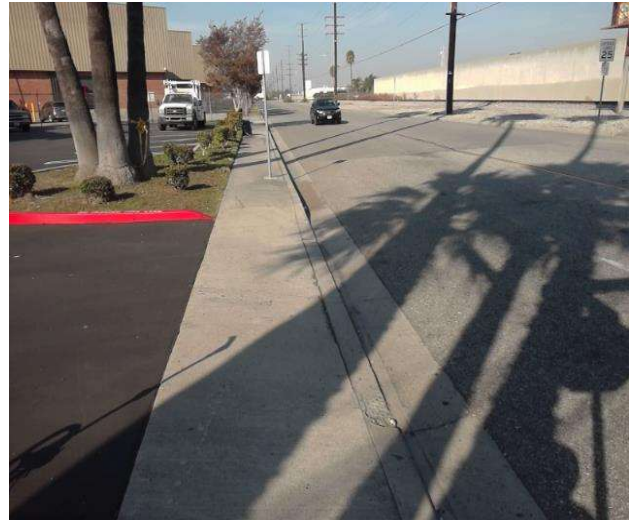
On-Site Finding Not Found

Install compliant detectable warnings \$190

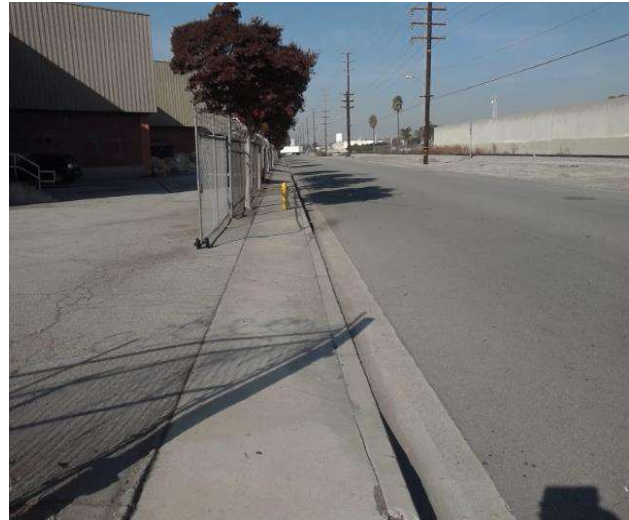
On-Site Finding Not Found

Install compliant detectable warnings \$190

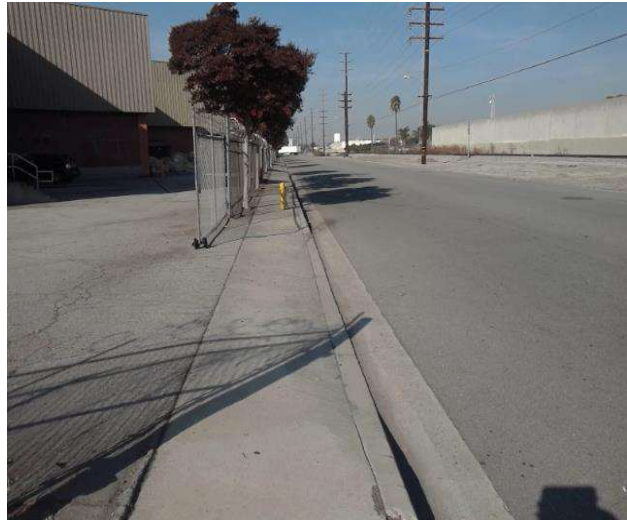
Recommendation Up to 2.08 percent

Repave surface \$1,092

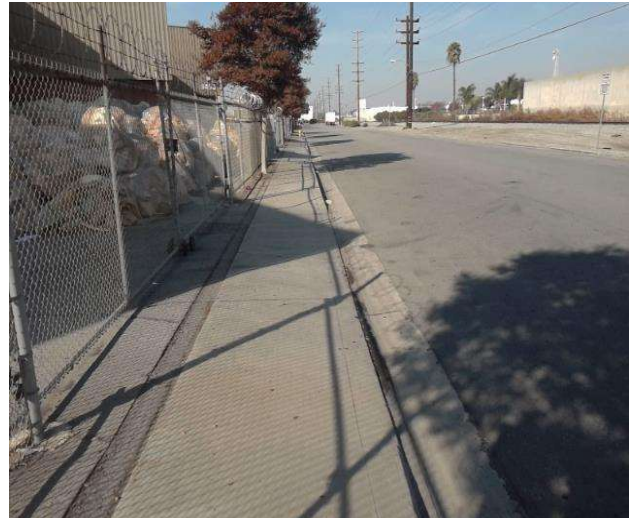
On-Site Finding Not Found

Install compliant detectable warnings \$190

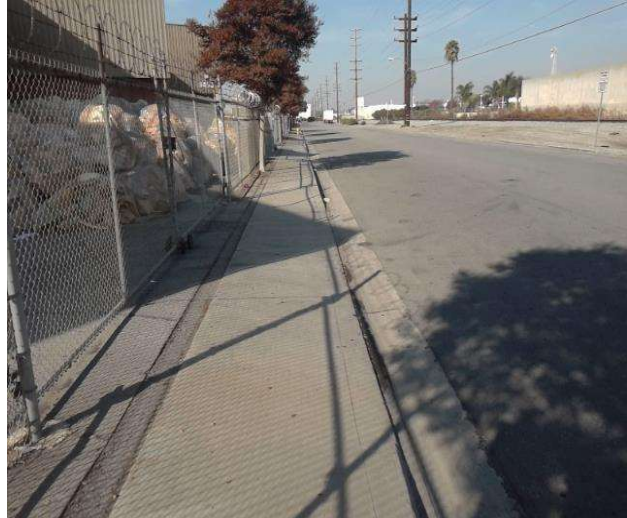
Recommendation Up to 2.08 percent

Repave surface \$1,092

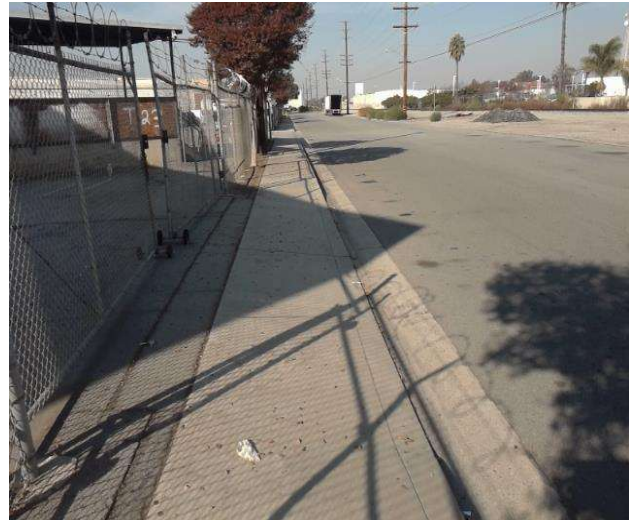
On-Site Finding Not Found

Install compliant detectable warnings \$190

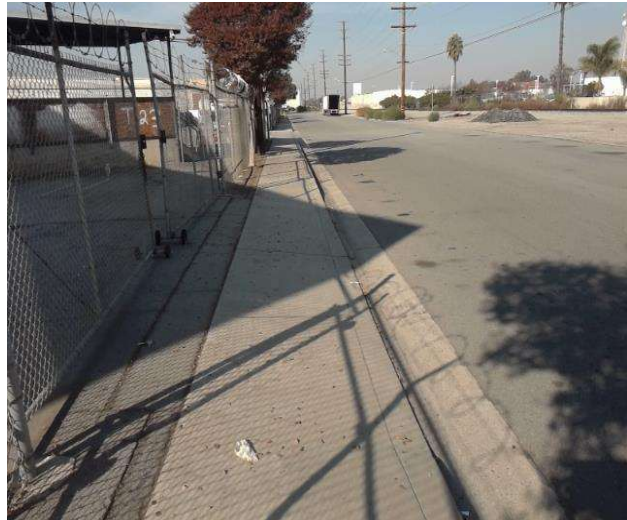
Recommendation Up to 2.08 percent

Repave surface \$1,092

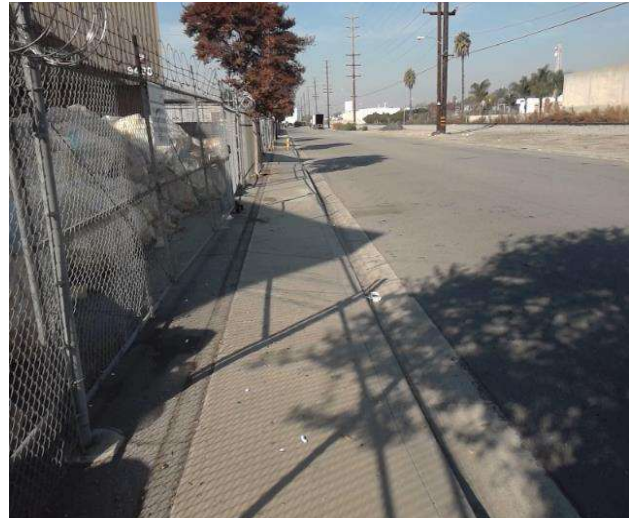
On-Site Finding Not Found

Install compliant detectable warnings \$190

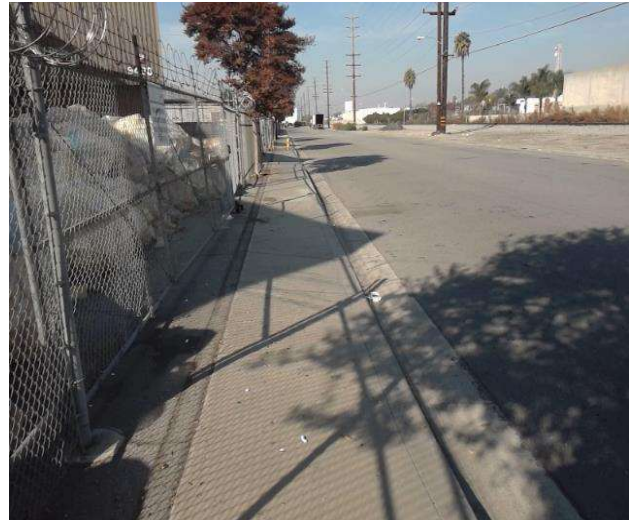
Recommendation Up to 2.08 percent

Repave surface \$1,092

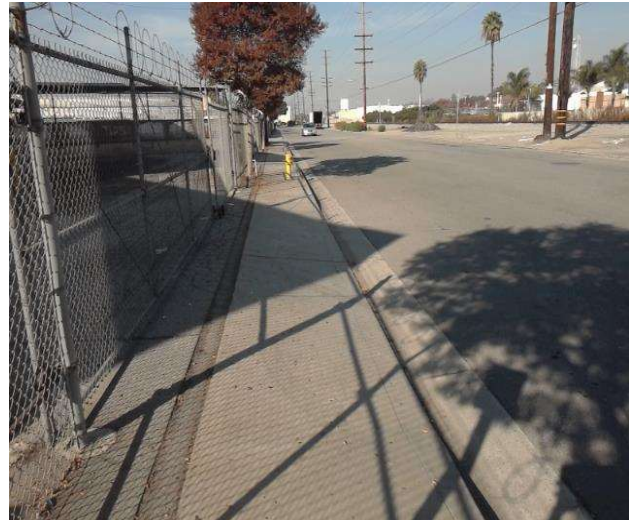
On-Site Finding Not Found

Install compliant detectable warnings \$190

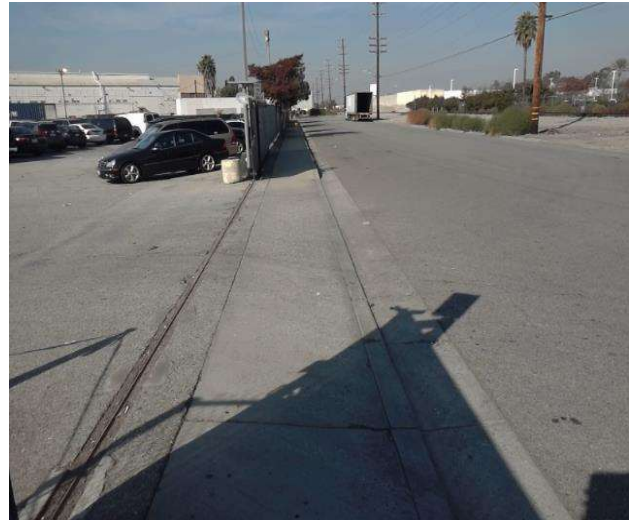
On-Site Finding Not Found

Install compliant detectable warnings \$190

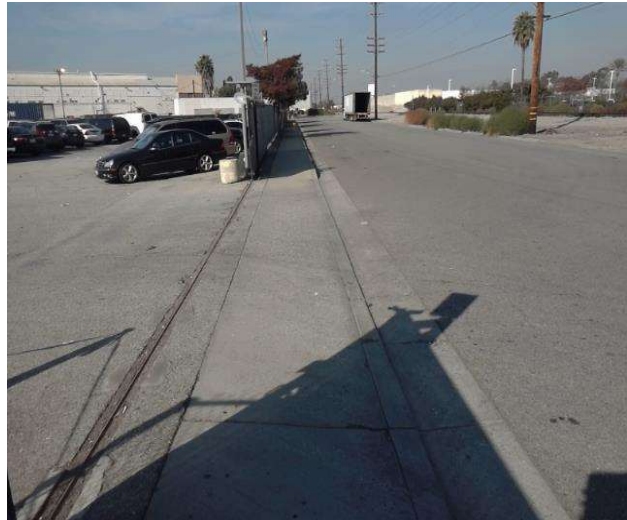
Recommendation

Recommendation Up to 2.08 percent

Repave surface \$1,092

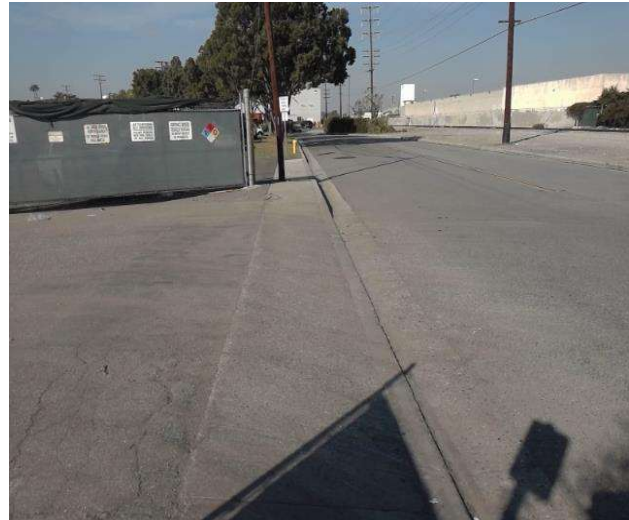
On-Site Finding Not Found

Install compliant detectable warnings \$190

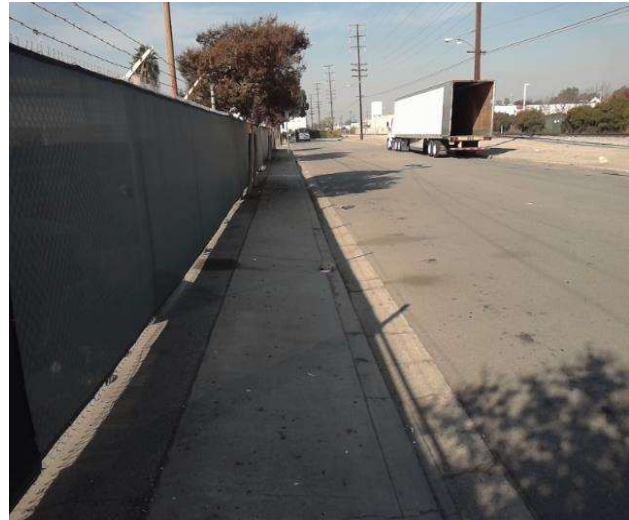
On-Site Finding Not Found

Install compliant detectable warnings \$190

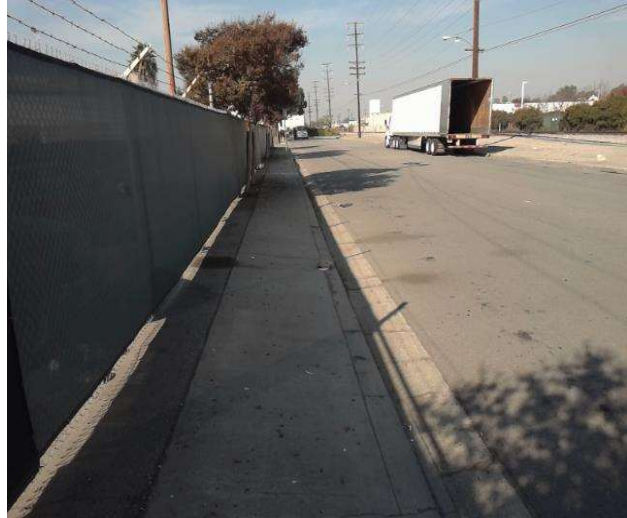
Recommendation Up to 2.08 percent

Repave surface \$1,092

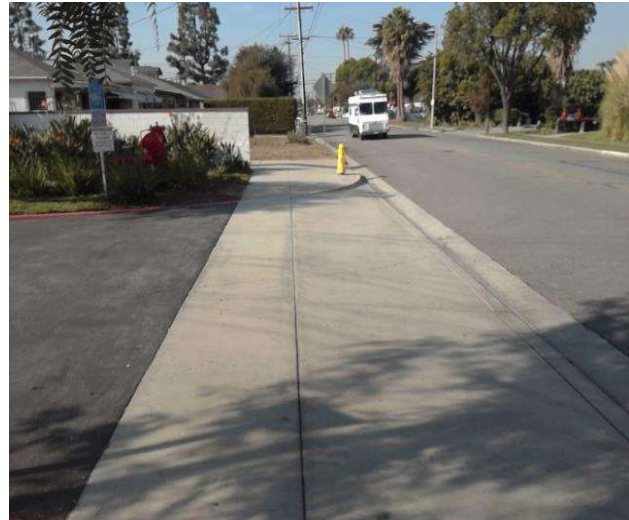
On-Site Finding Not Found

Install compliant detectable warnings \$190

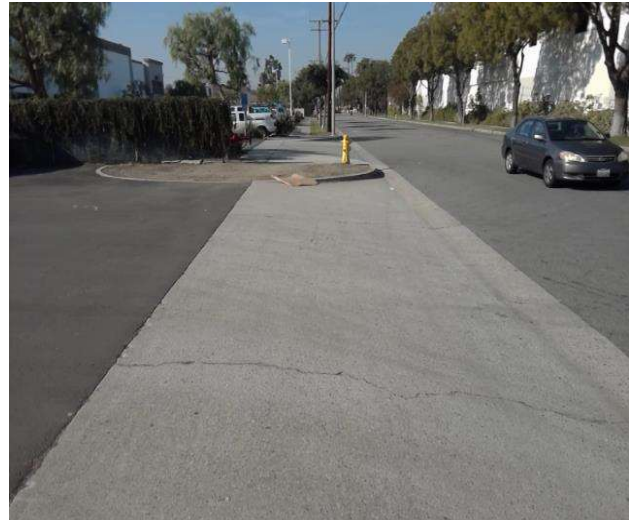
On-Site Finding Not Found

Install compliant detectable warnings \$190

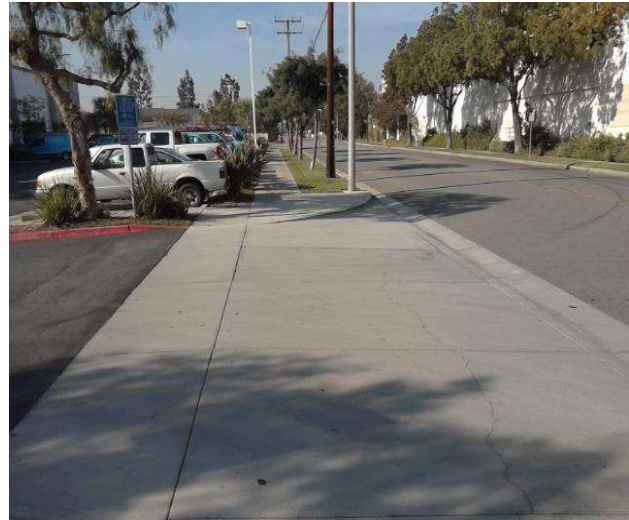
On-Site Finding Not Found

Install compliant detectable warnings \$190

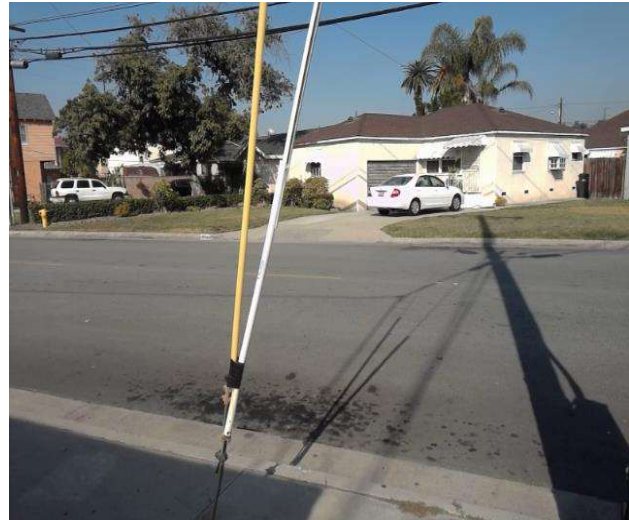
Sidewalks , Hazards & Gratings : Overhead Obstruction Height

Recommendation At least 80.00 inches

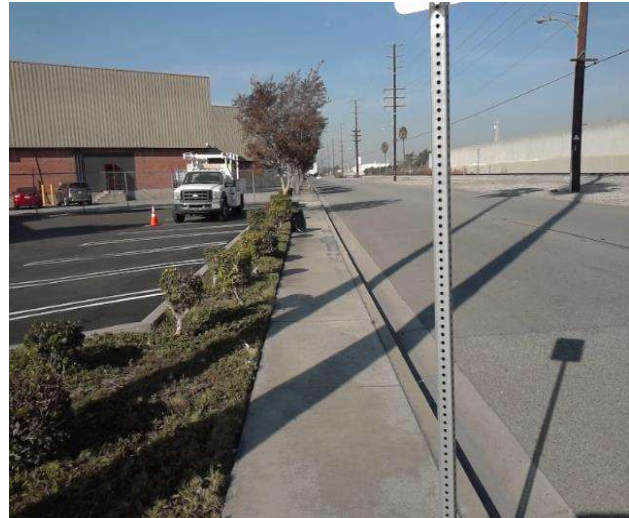
Recommendation Up to 2.08 percent

Repave the sidewalk surface with the recommended cross slope.

Repave surface \$1,092

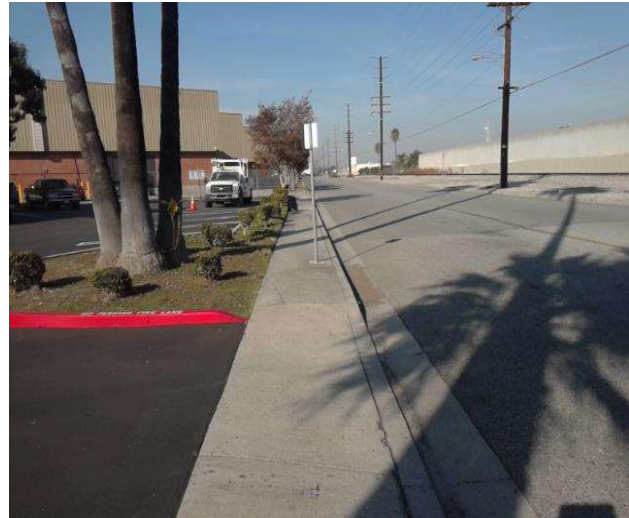
On-Site Finding Not Found

\$2,400
