## Accessibility Survey

## City of Downey Verdura Avenue - Devenir Street To Imperial Highway

Date of Inspection  
3/17/2017

**Disability Access Consultants**

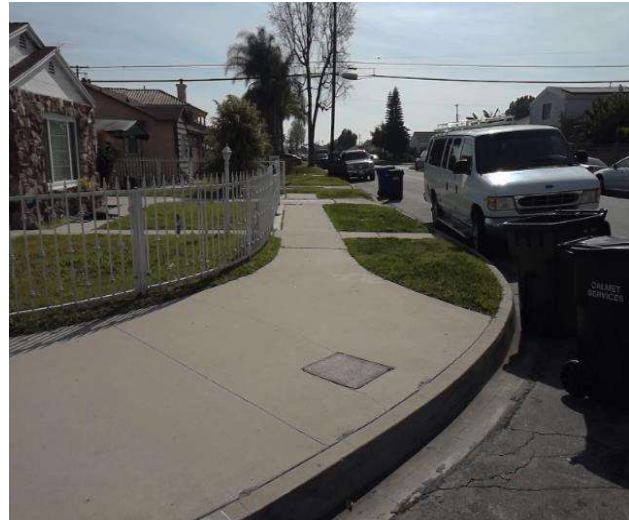
**On-Site Finding** Not Found

#### Recommendation

Recommendation See Recommendation

\$2,400

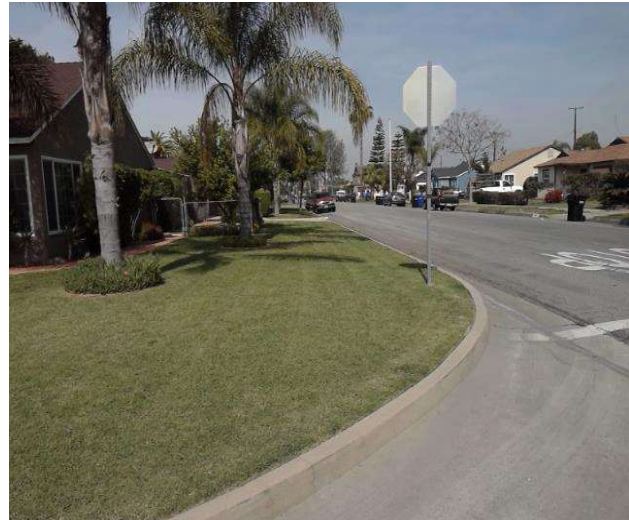
**On-Site Finding** Not Found

#### Recommendation

Recommendation See Recommendation

\$2,400

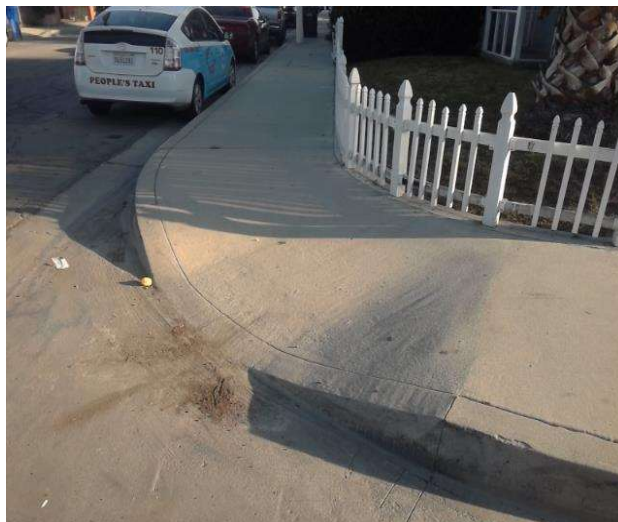
**On-Site Finding** Not Found

Provide detectable warning to surface \$248

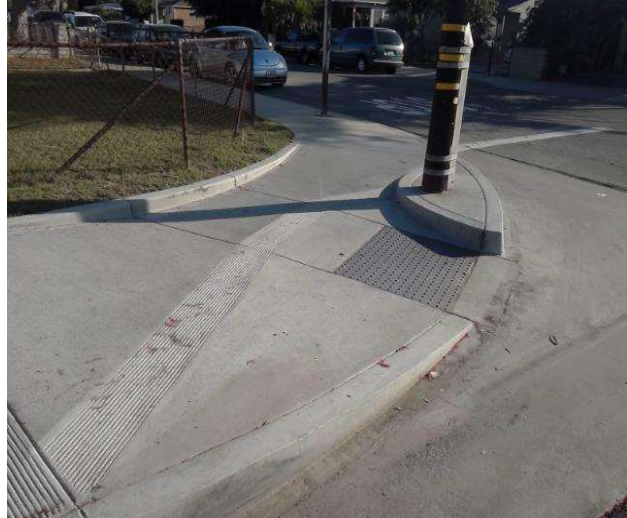
Curb Ramp , Landings and Transitions : Top Landing Clear Length - Landings

Provide compliant landing \$240
