## Accessibility Survey

### City of Downey Melva Street - Birchdale Avenue To Blodgett Avenue

Birchdale Avenue To Blodgett Avenue  
Downey, CA 90242

Date of Inspection  
2/8/2017

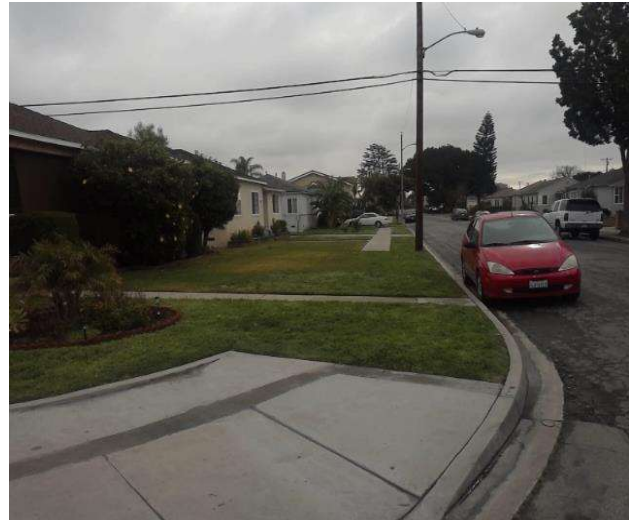
**On-Site Finding** Not Found

**Recommendation**

Recommendation See Recommendation

\$2,400

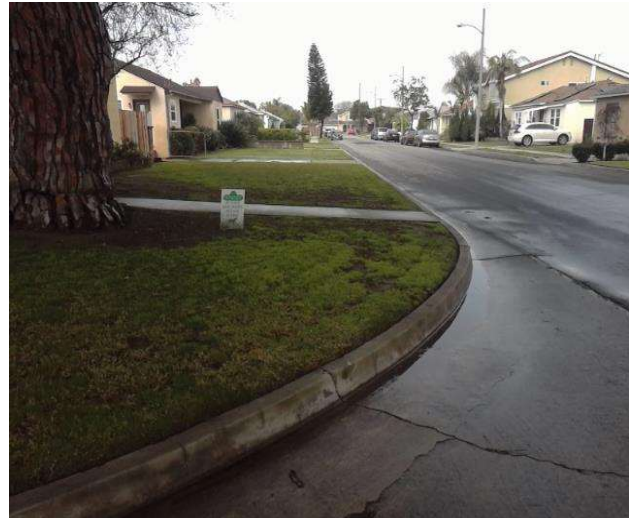
**On-Site Finding** Not Found

**Recommendation**

Recommendation See Recommendation

\$2,400

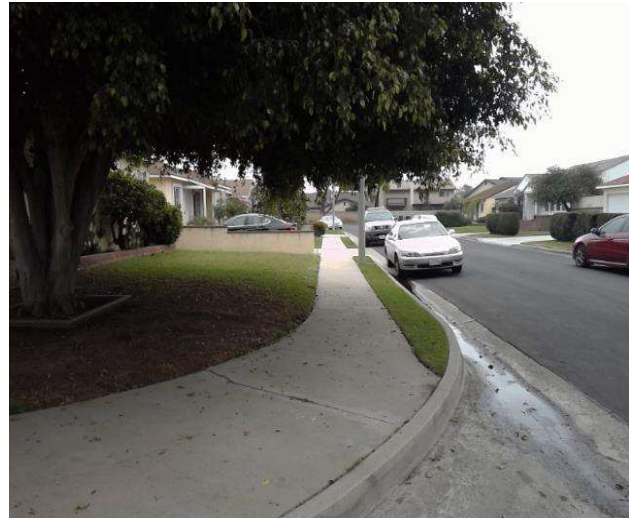
**On-Site Finding** Not Found

**Recommendation**

Recommendation See Recommendation

\$2,400

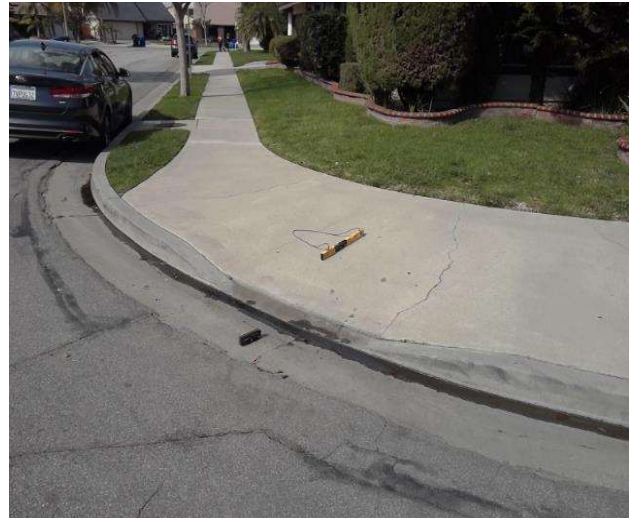
**On-Site Finding** Not Found

**Recommendation**

Recommendation See Recommendation

Provide detectable warning to surface \$248

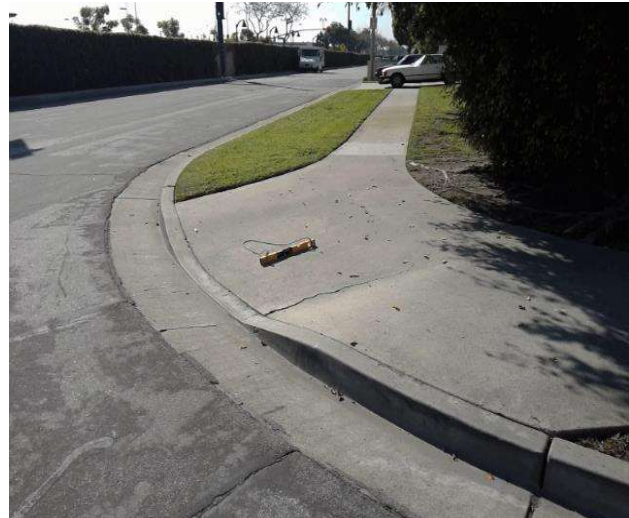
**On-Site Finding** Not Found

**Recommendation**

Provide detectable warning to surface \$248

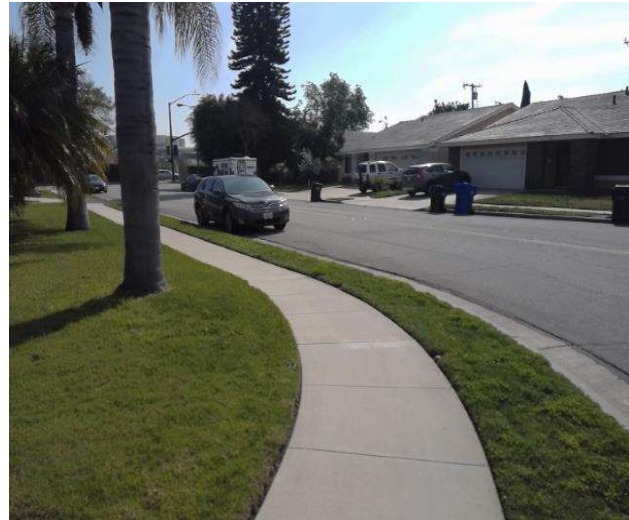
Notes : Has 4 Openings For 154 Feet
