Accessibility Survey

City of Downey Cleta Street - Lakewood Boulevard To Downey Avenue

Date of Inspection
12/9/2016

Disability Access Consultants

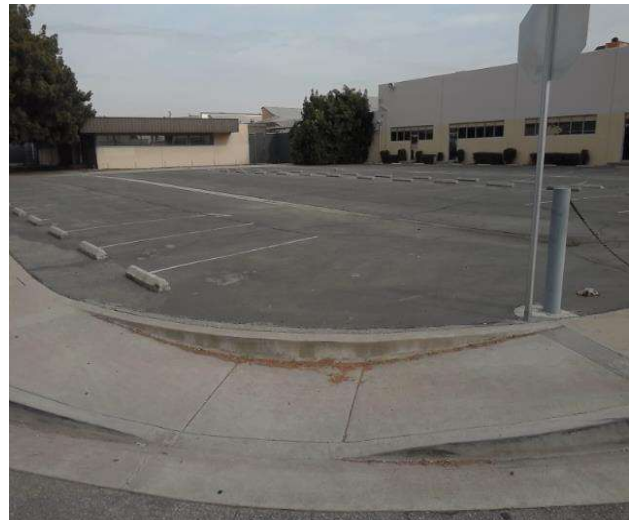
On-Site Finding Not Found

Recommendation

Recommendation See Recommendation

Provide detectable warning to surface \$248

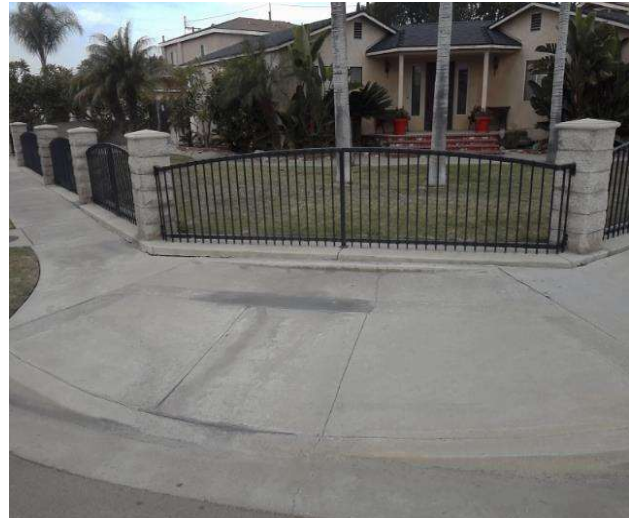
On-Site Finding Not Found

Recommendation

Recommendation See Recommendation

Provide detectable warning to surface \$248

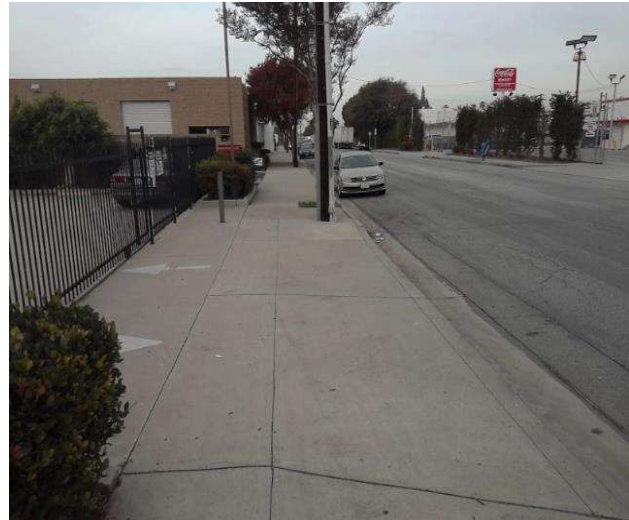
On-Site Finding Not Found

Install compliant detectable warnings \$190

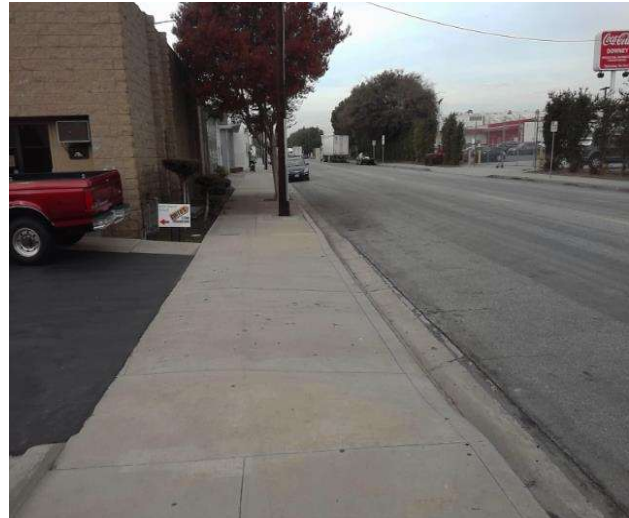
On-Site Finding Not Found

Install compliant detectable warnings \$190

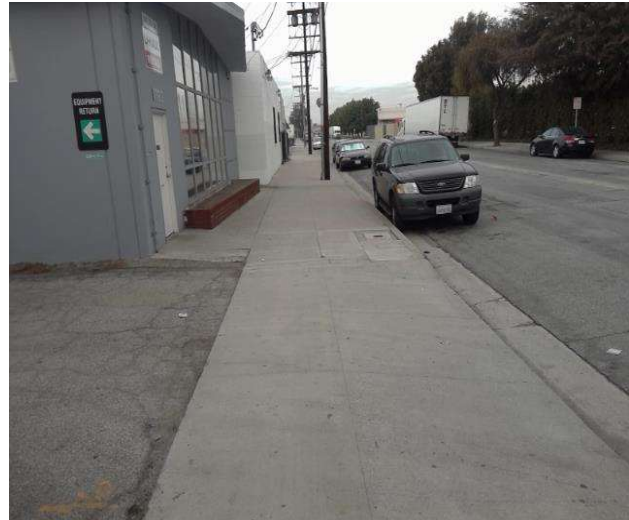
On-Site Finding Not Found

Install compliant detectable warnings \$190

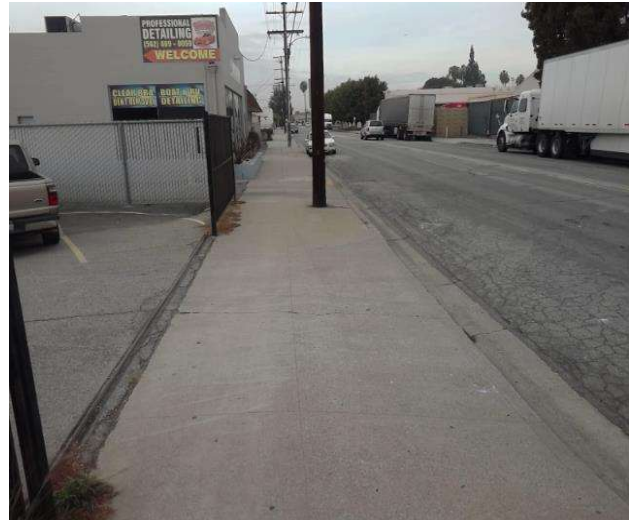
On-Site Finding Not Found

Install compliant detectable warnings \$190

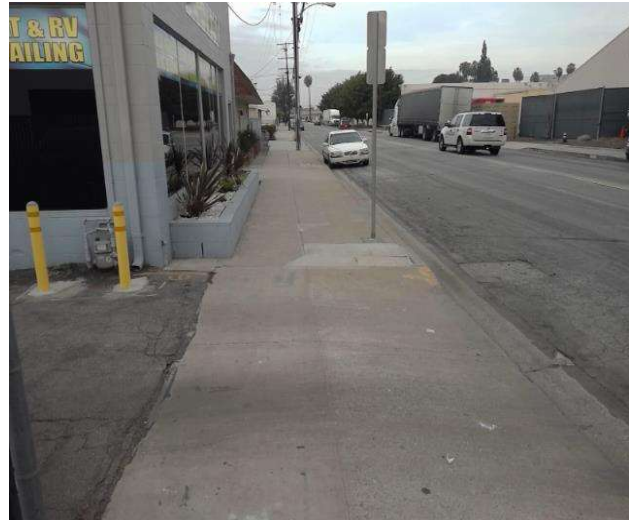
On-Site Finding Not Found

Install compliant detectable warnings \$190

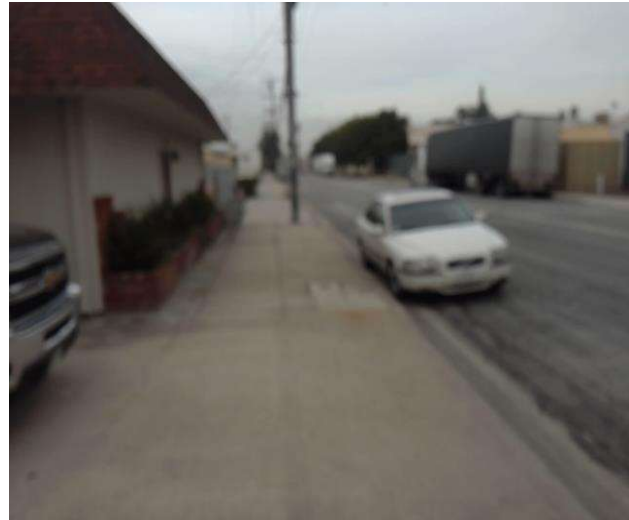
On-Site Finding Not Found

Install compliant detectable warnings \$190

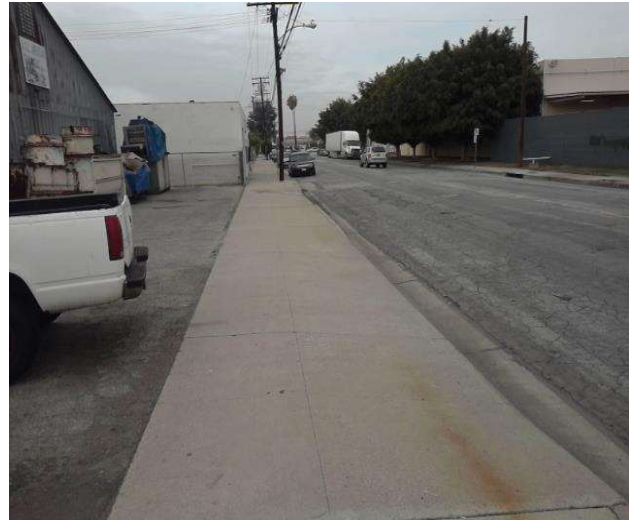
On-Site Finding Not Found

Install compliant detectable warnings \$190

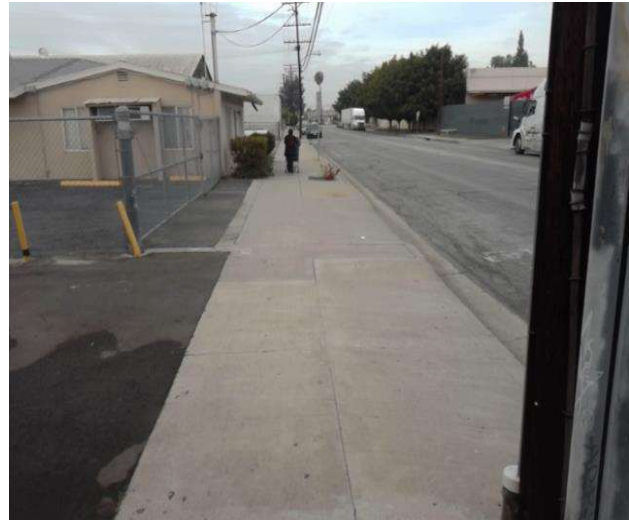
On-Site Finding Not Found

Install compliant detectable warnings \$190

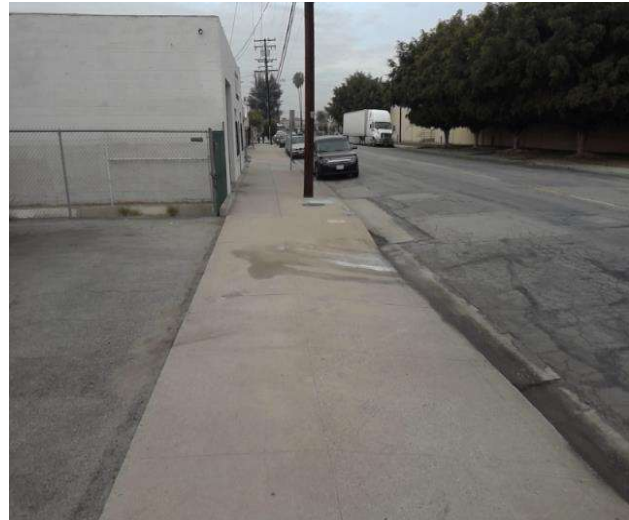
On-Site Finding Not Found

Install compliant detectable warnings \$190

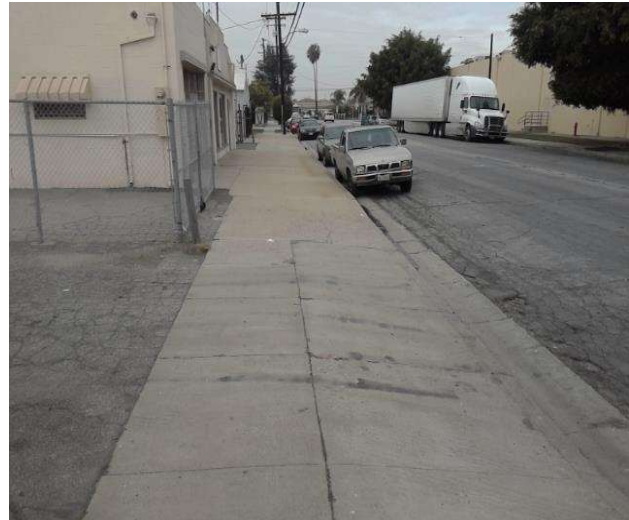
On-Site Finding Not Found

Install compliant detectable warnings \$190

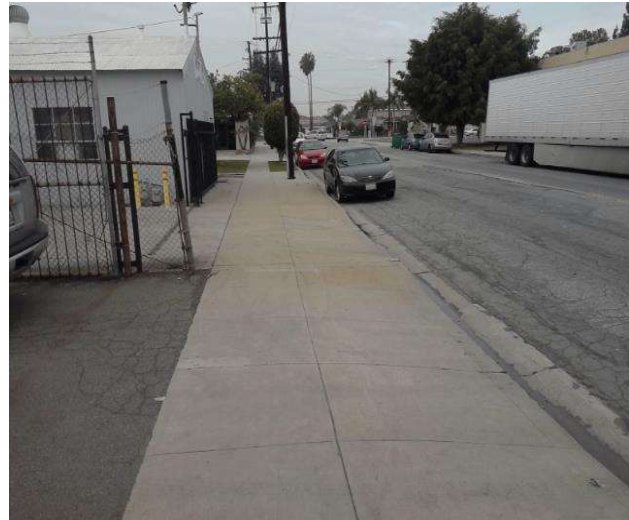
On-Site Finding Not Found

Install compliant detectable warnings \$190

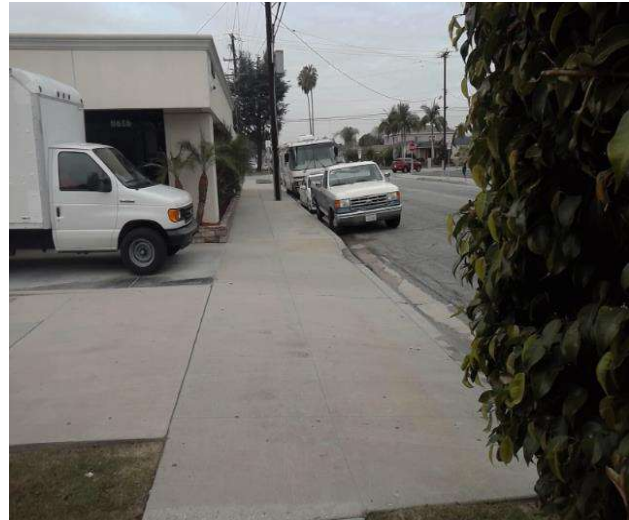
On-Site Finding Not Found

Install compliant detectable warnings \$190

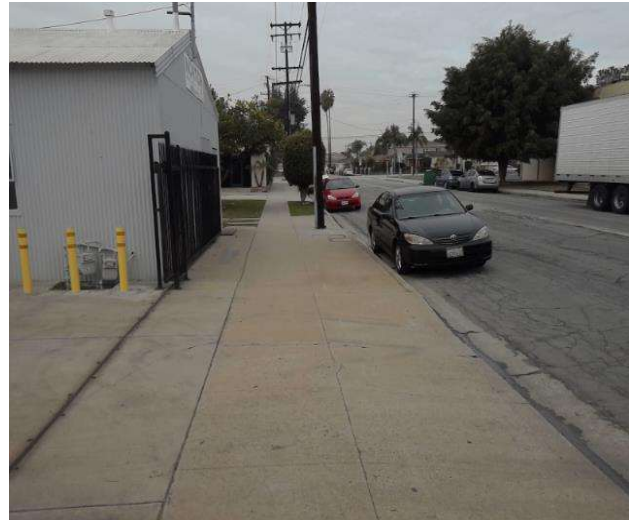
On-Site Finding Not Found

Install compliant detectable warnings \$190

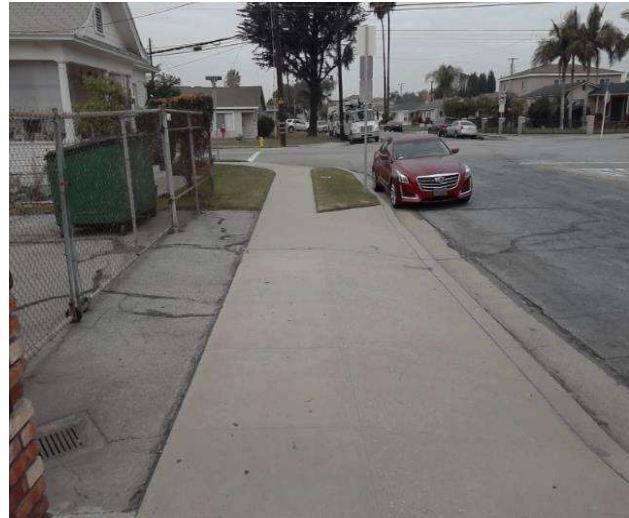
On-Site Finding Not Found

Install compliant detectable warnings \$190

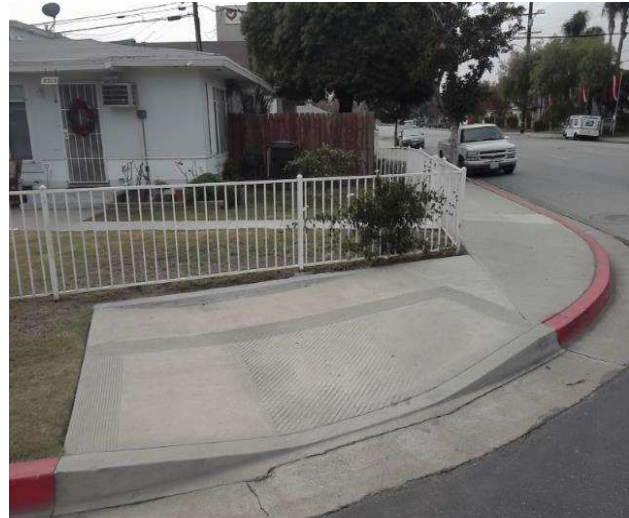
On-Site Finding Not Found

Provide detectable warning to surface \$248

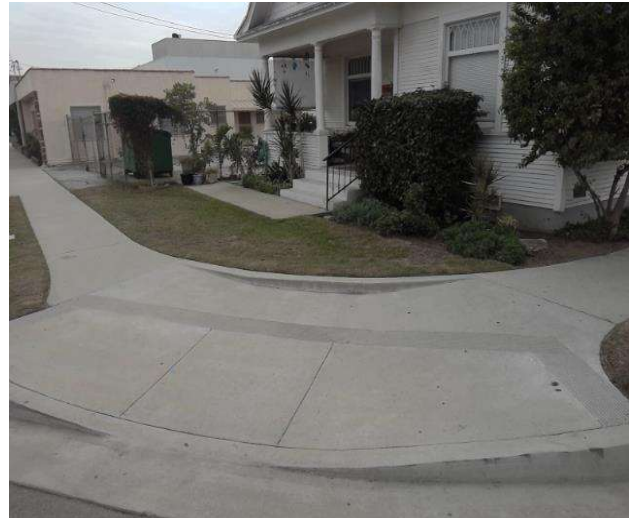
On-Site Finding Not Found

Provide detectable warning to surface \$248

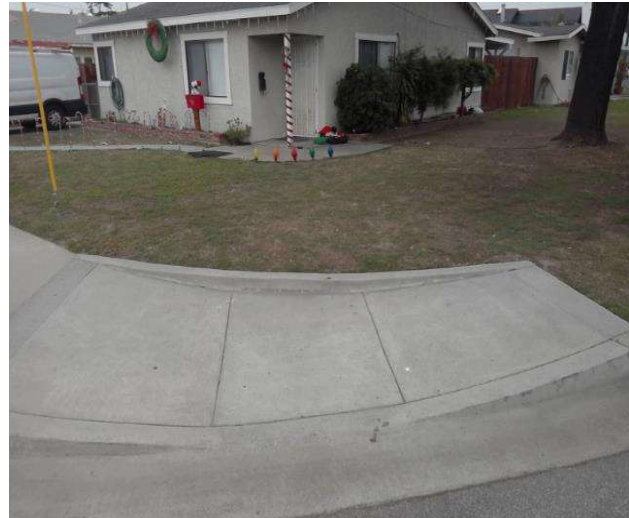
On-Site Finding Not Found

Provide detectable warning to surface \$248

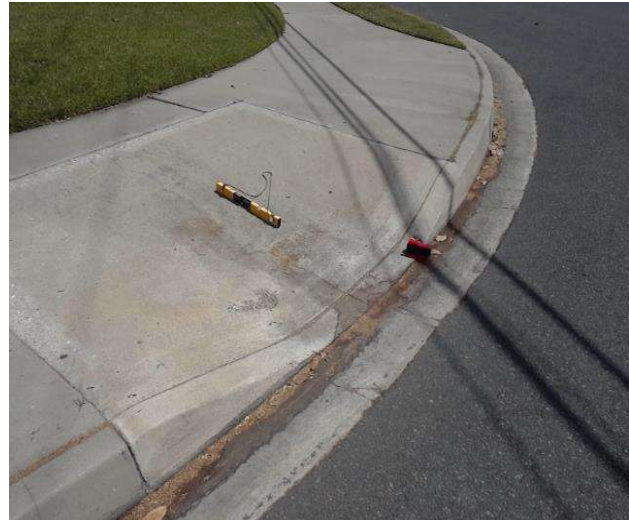
On-Site Finding Not Found

Provide detectable warning to surface \$248

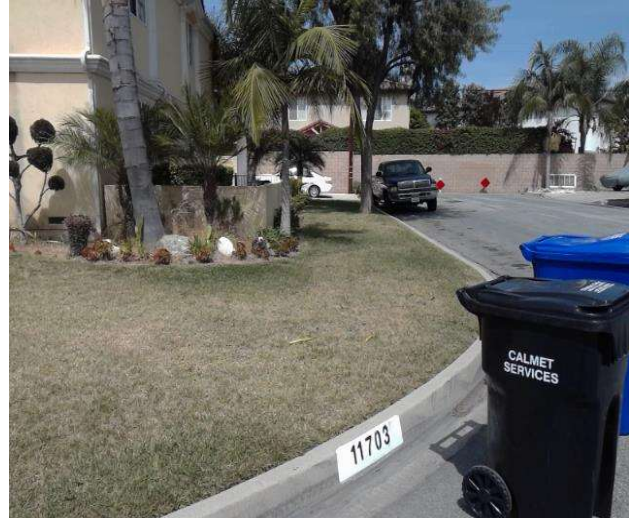
Sidewalks : Missing Sidewalk

Section of sidewalk is missing and consists of dirt, grass or gravel.

\$1,260
