## Accessibility Survey

### City of Downey Brookpark Road - Lindsey Avenue to Eglise Avenue

Date of Inspection  
6/14/2017

**Disability Access Consultants**

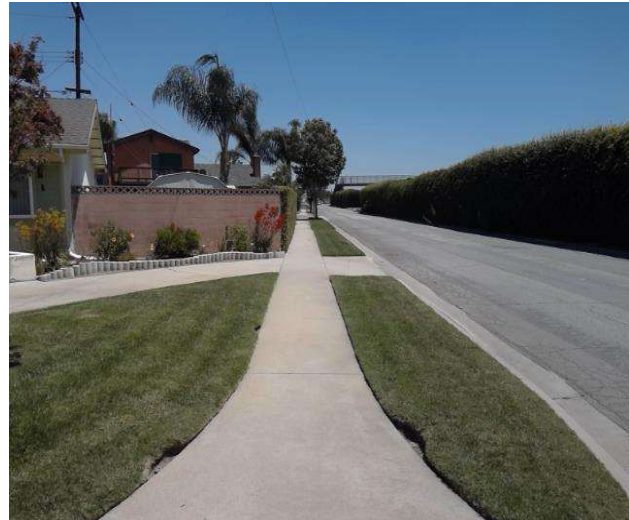
**On-Site Finding** Not Found

Recommendation See Recommendation

\$2,400

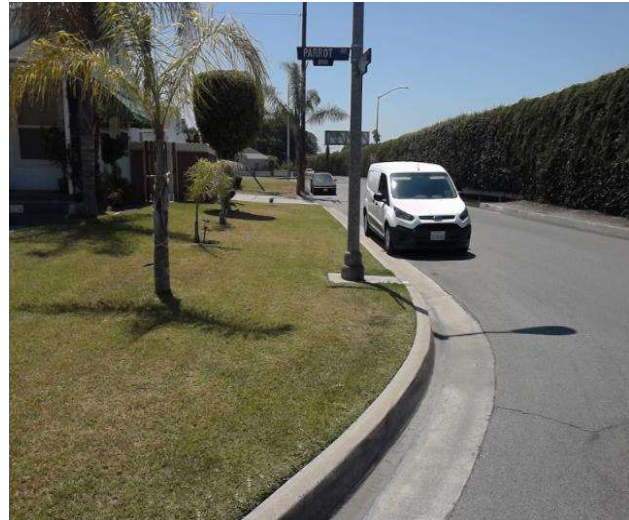
**On-Site Finding** Not Found

Recommendation See Recommendation

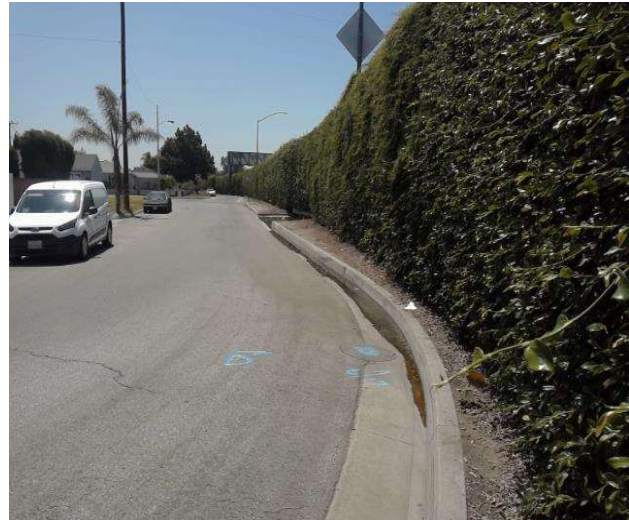
**On-Site Finding** Not Found

Recommendation See Recommendation

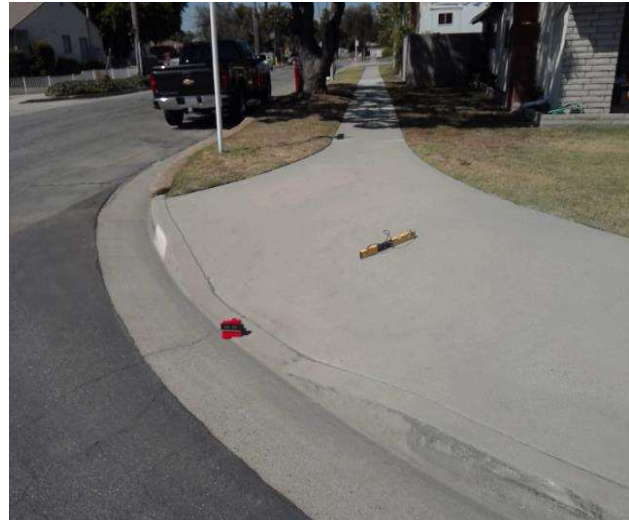
**On-Site Finding** Not Found

Provide detectable warning to surface \$248

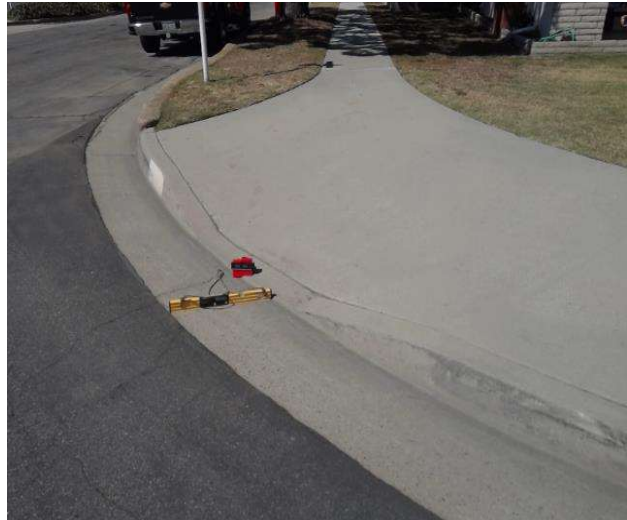
Curb Ramp , Landings and Transitions : Top Landing Clear Length - Landings

Recommendation At least 48.00 inches

Provide compliant landing \$240

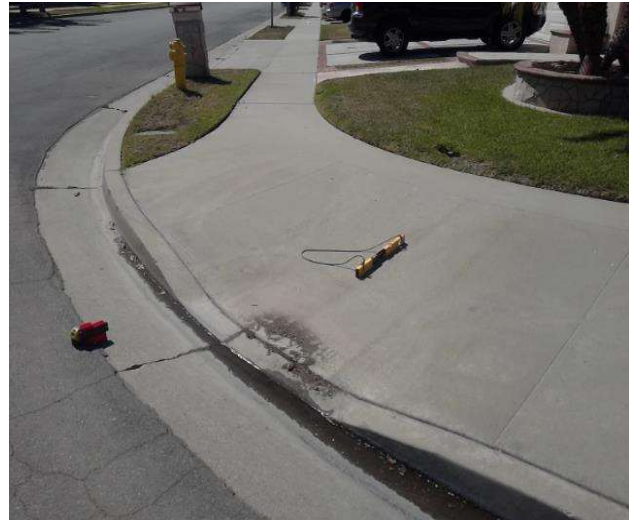
**On-Site Finding** Not Found

Provide detectable warning to surface \$248

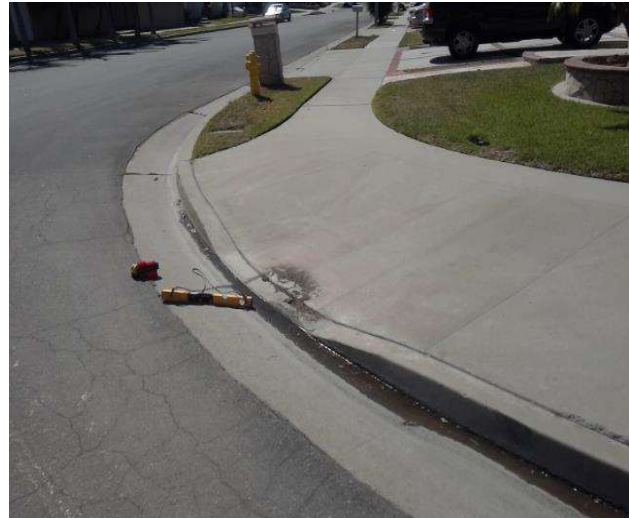
Curb Ramp , Landings and Transitions : Landing Accumulates Water - Wet Conditions

Recommendation See Recommendation

Provide compliant landing \$255

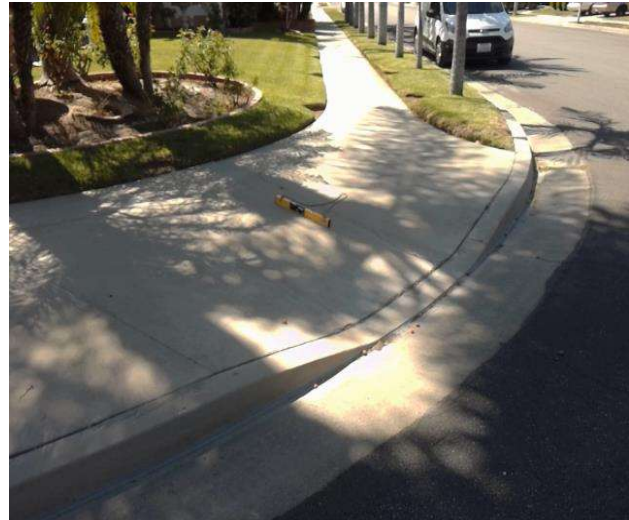
**On-Site Finding** Not Found

Provide detectable warning to surface \$248

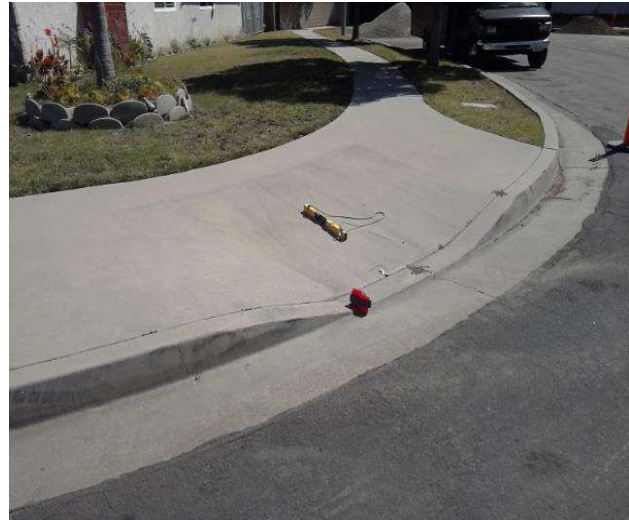
**On-Site Finding** Not Found

Provide detectable warning to surface \$248

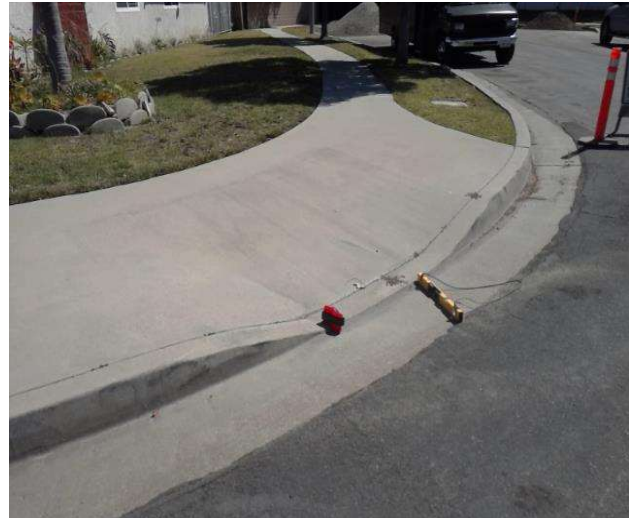
Curb Ramp , Landings And Transitions : Bottom Landing Change in Level

Recommendation Up to 0.50 inches

Patch lip at curb ramp \$255

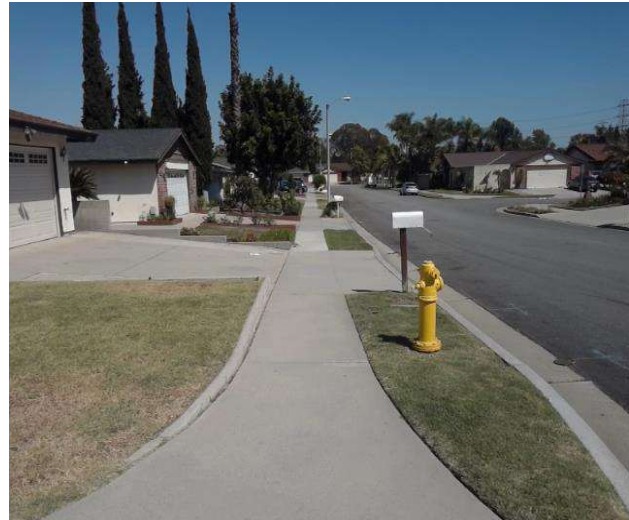
**On-Site Finding** Not Found

Recommendation See Recommendation

\$2,400

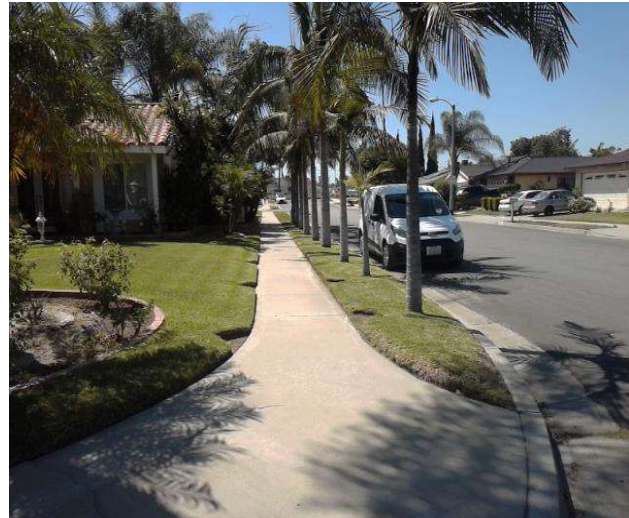
**On-Site Finding** Not Found

Recommendation See Recommendation

\$2,400

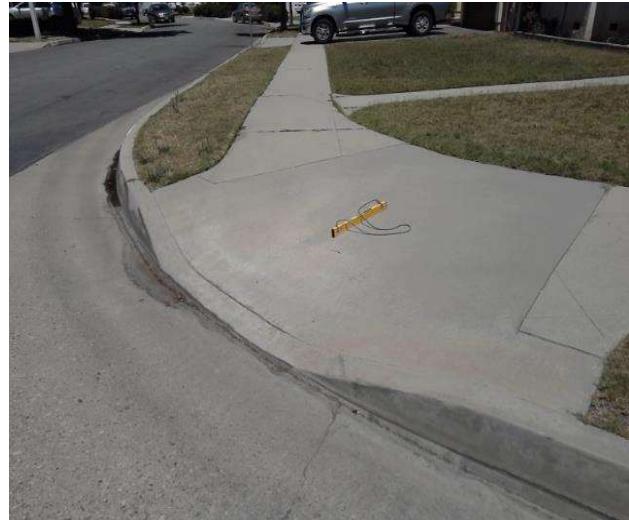
**On-Site Finding** Not Found

Provide detectable warning to surface \$248

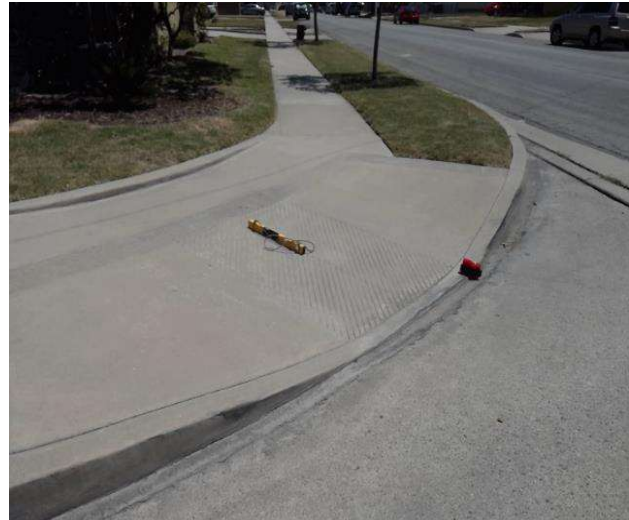
**On-Site Finding** Not Found

Provide detectable warning to surface \$248

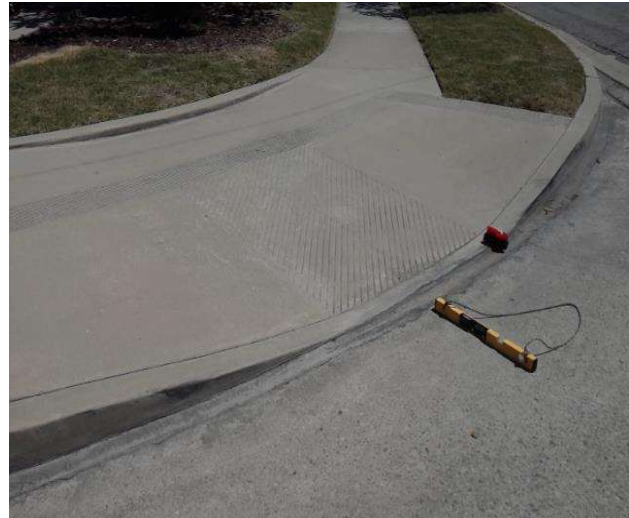
Curb Ramp , Landings And Transitions : Bottom Landing Change in Level

Recommendation Up to 0.50 inches

Patch lip at curb ramp \$255

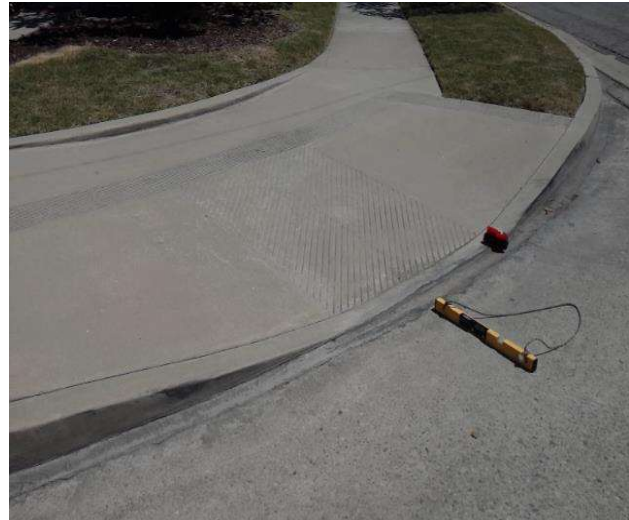
Curb Ramp , Landings and Transitions : Top Landing Clear Length - Landings

Recommendation At least 48.00 inches

Provide compliant landing \$240

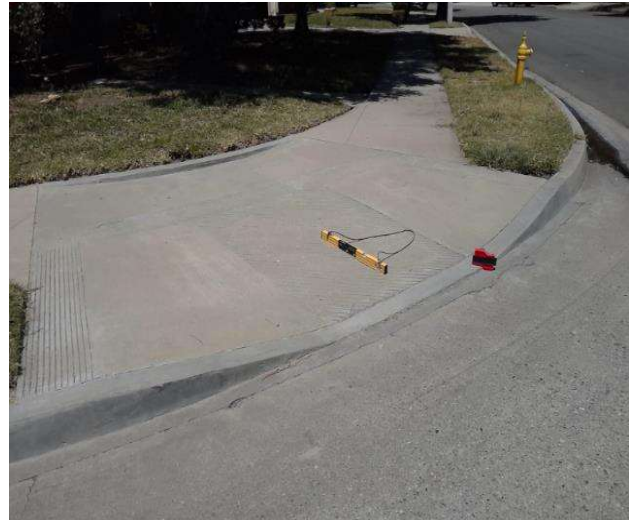
**On-Site Finding** Not Found

Provide detectable warning to surface \$248

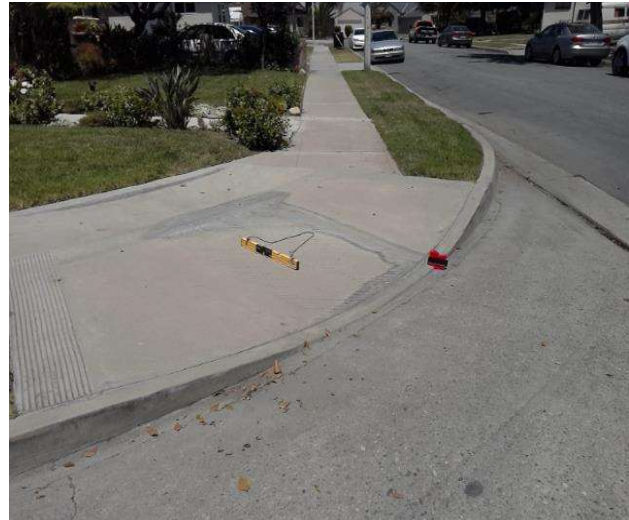
**On-Site Finding** Not Found

Provide detectable warning to surface \$248

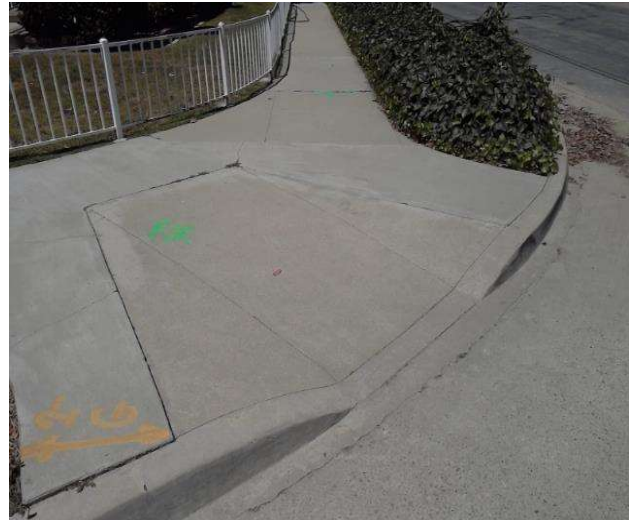
Curb Ramp , Landings and Transitions : Top Landing Clear Length - Landings

Provide compliant landing \$240

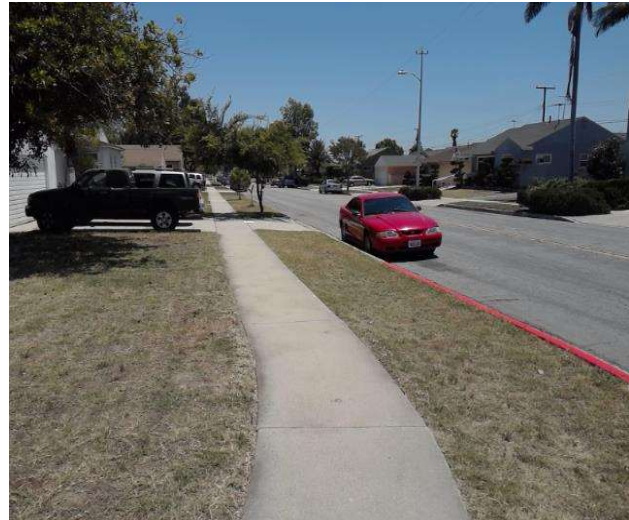
**On-Site Finding** Not Found

Recommendation See Recommendation

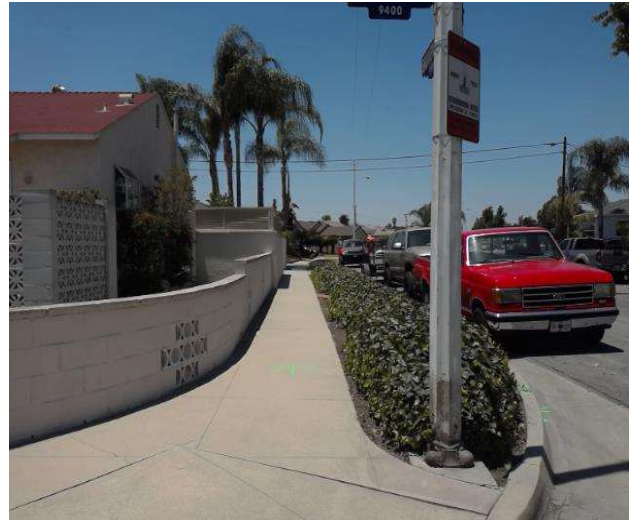
**On-Site Finding** Not Found

Recommendation See Recommendation
