## Accessibility Survey

## City of Downey I 105 East Ramp & Lakewood Boulevard

Date of Inspection  
5/24/2017

**Disability Access Consultants**

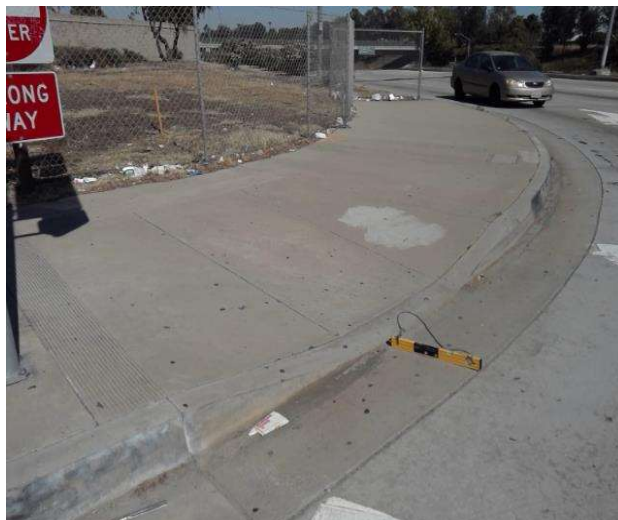
Recommendation At least 48.00 inches

Provide compliant landing \$240

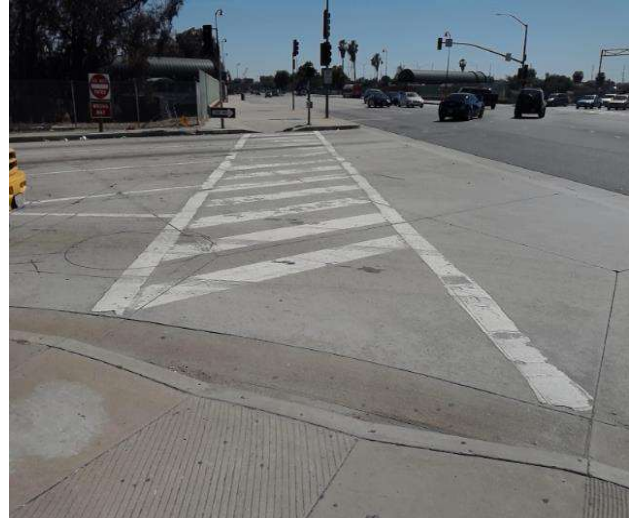
**On-Site Finding** Not Found

Recommendation See Recommendation

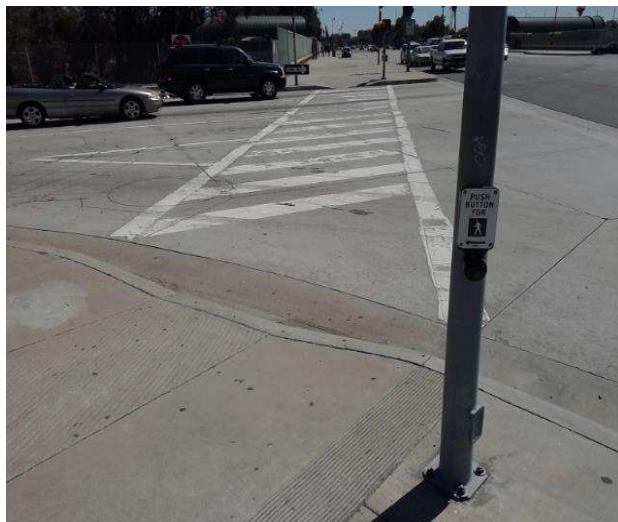
Recommendation Up to 60.00 inches

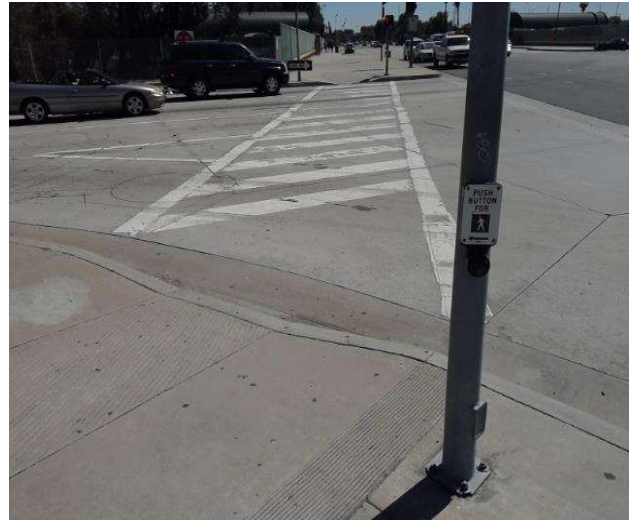
Recommendation Up to 2.08 percent

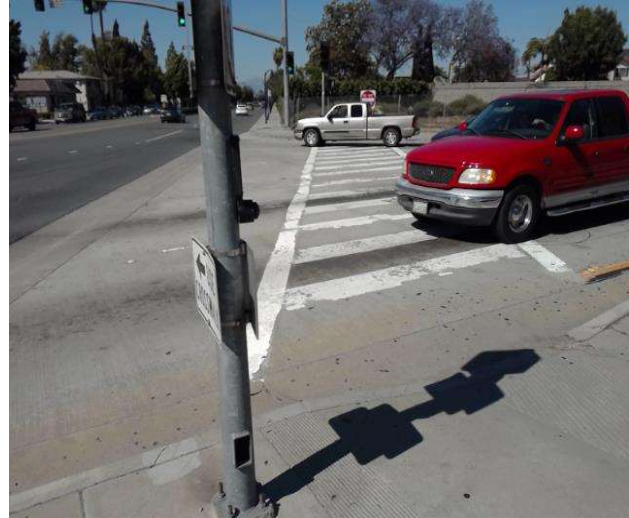
Recommendation Up to 60.00 inches

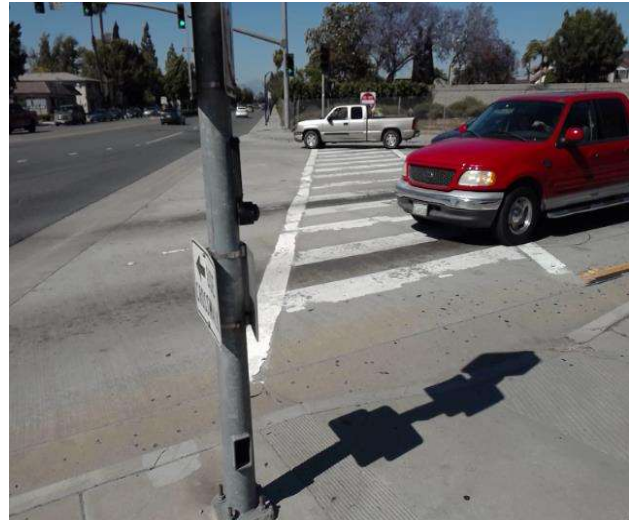
**On-Site Finding** Not Found

Recommendation See Recommendation

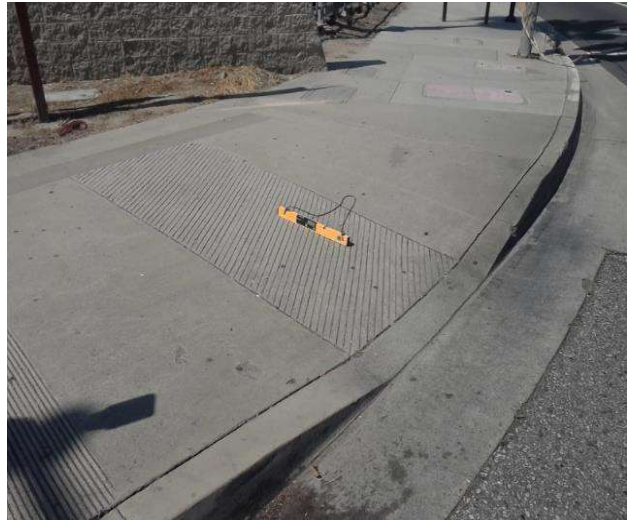
**On-Site Finding** Not Found

Recommendation See Recommendation

Provide detectable warning to surface \$248

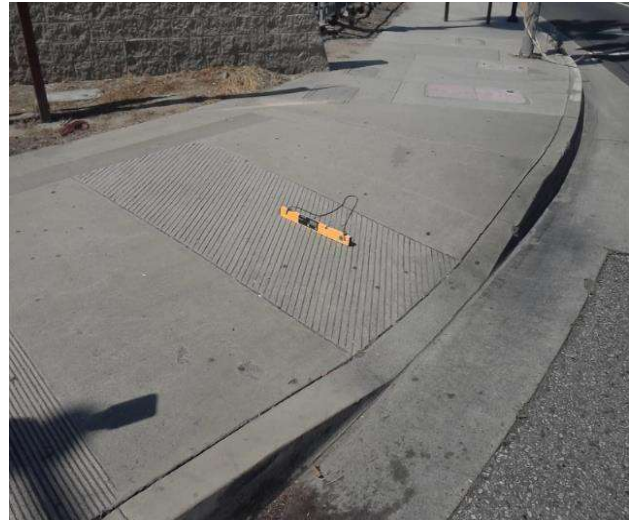
Recommendation At least 48.00 inches

Install curb ramp \$1,300

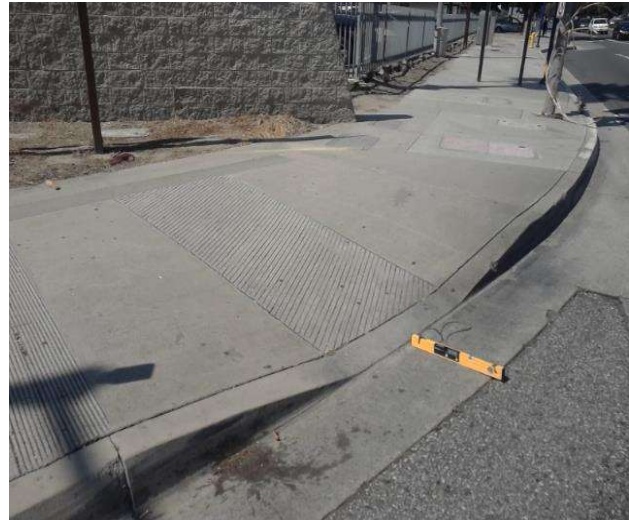
Recommendation Up to 5.00 percent

Repave landing \$1,260

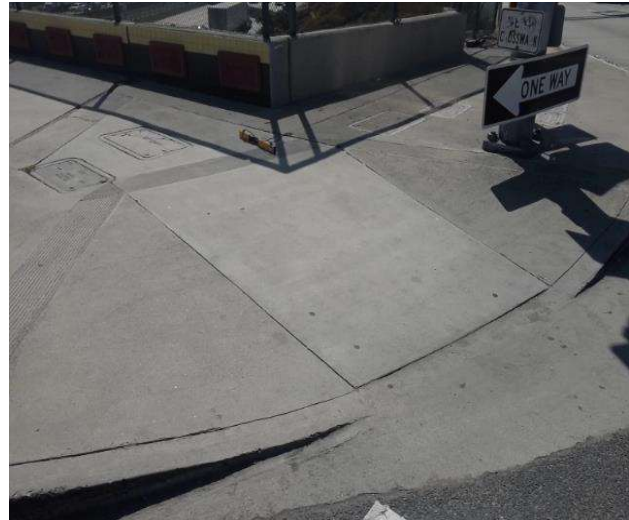
Recommendation Up to 2.08 percent

Provide compliant landing \$1,260

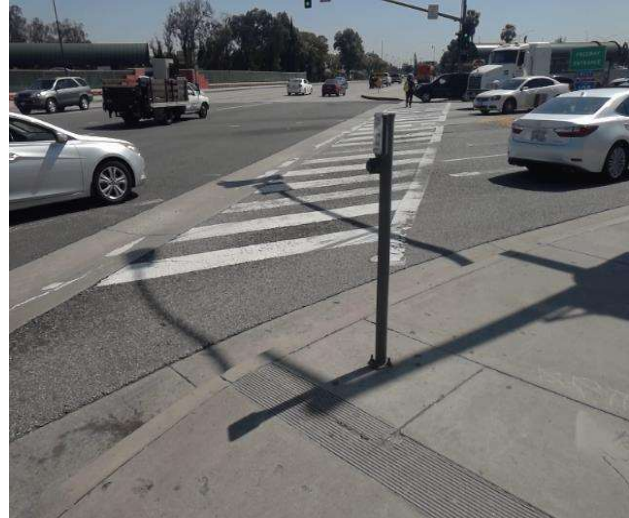
Recommendation Up to 60.00 inches

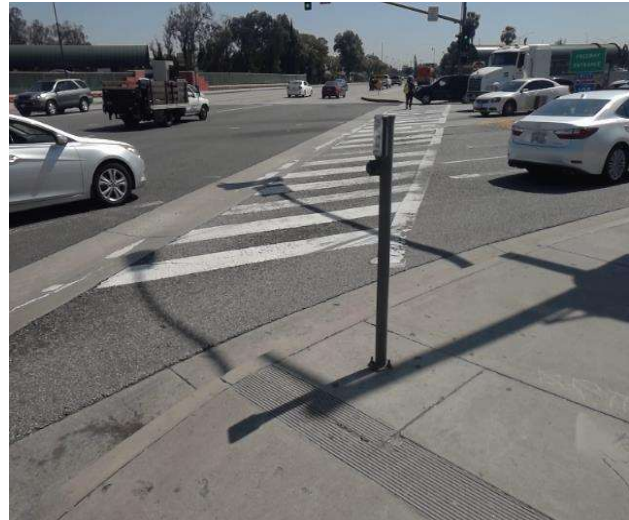
**On-Site Finding** Not Found

Recommendation See Recommendation
