Accessibility Survey

City of Downey Woodruff Avenue & Firestone Boulevard East

Date of Inspection
1/9/2017

Disability Access Consultants

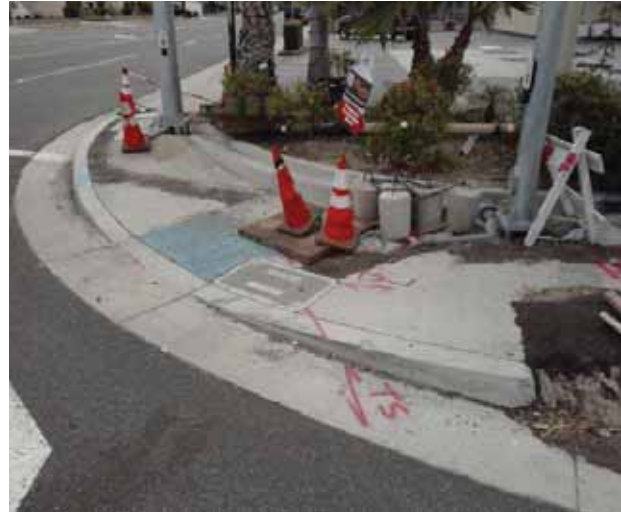
Notes : Curb Ramp Under Construction at Time of Inspection.

Install curb ramp \$1,440

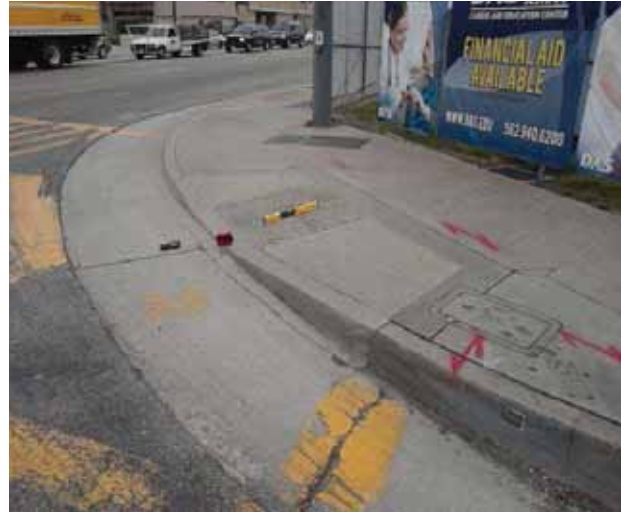
On-Site Finding Not Found

Provide detectable warning to surface \$248

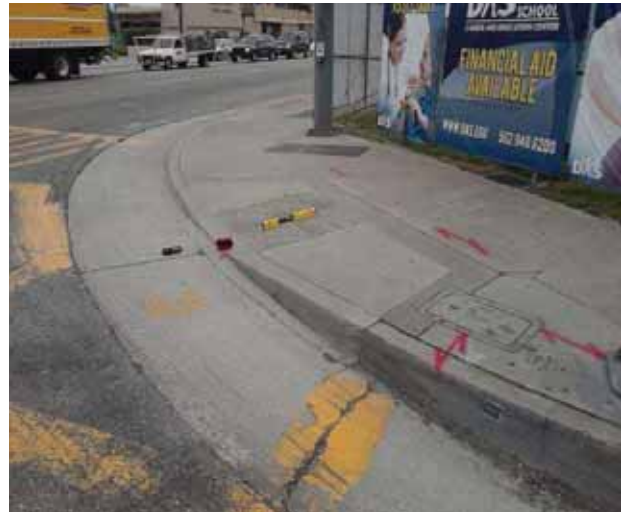
Recommendation Up to 5.00 percent

Repave landing \$1,260

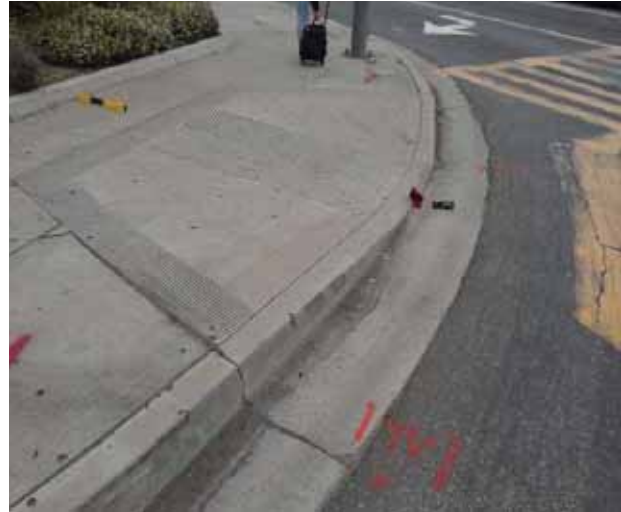
On-Site Finding Not Found

Provide detectable warning to surface \$248

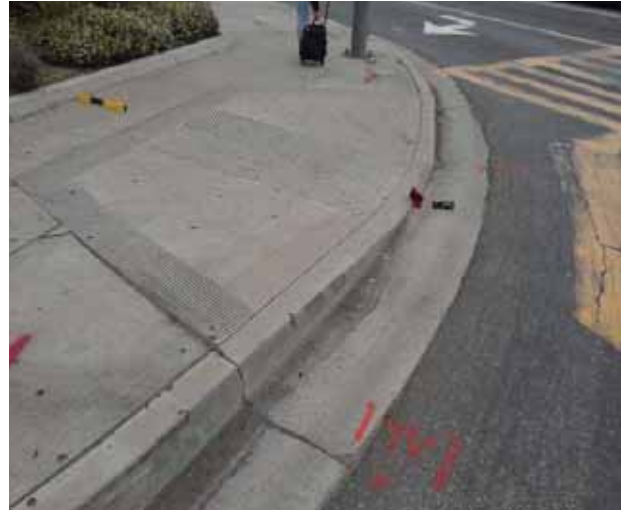
Recommendation Up to 8.33 percent

Install curb ramp \$1,300

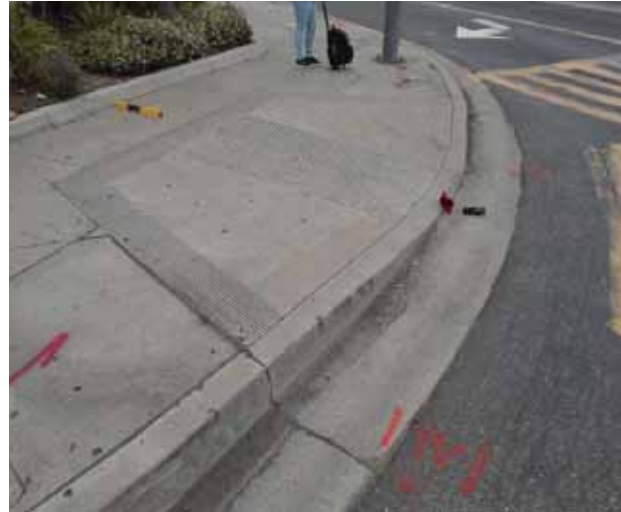
Recommendation Up to 5.00 percent

Repave landing \$1,260

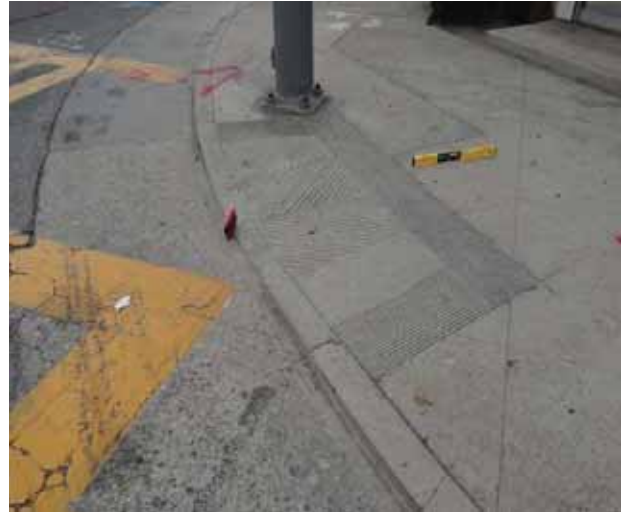
On-Site Finding Not Found

Provide detectable warning to surface \$248

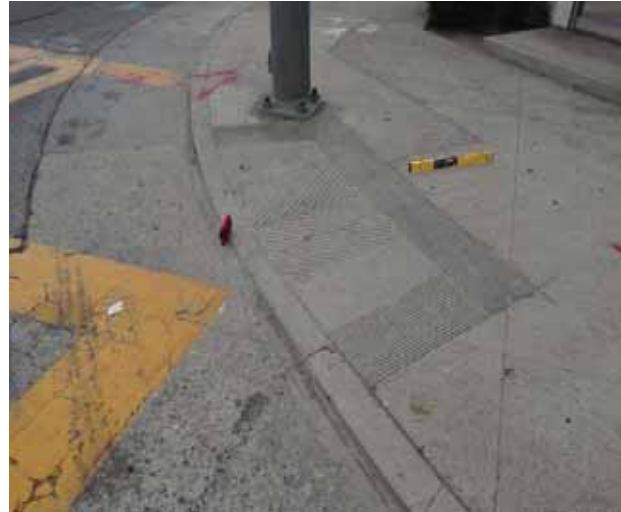
Recommendation At least 48.00 inches

Provide compliant landing \$255

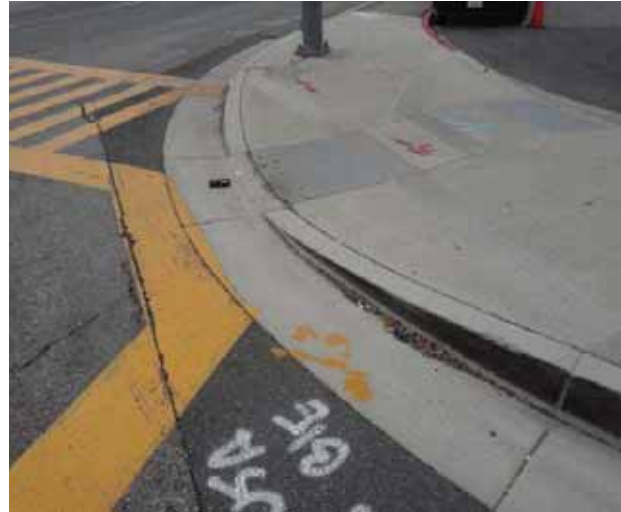
Recommendation At least 48.00 inches

Provide compliant landing \$255

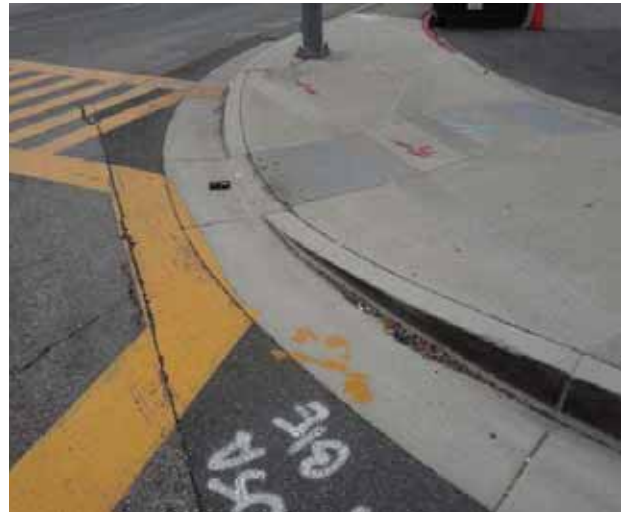
Recommendation Up to 5.00 percent

Repave landing \$1,260

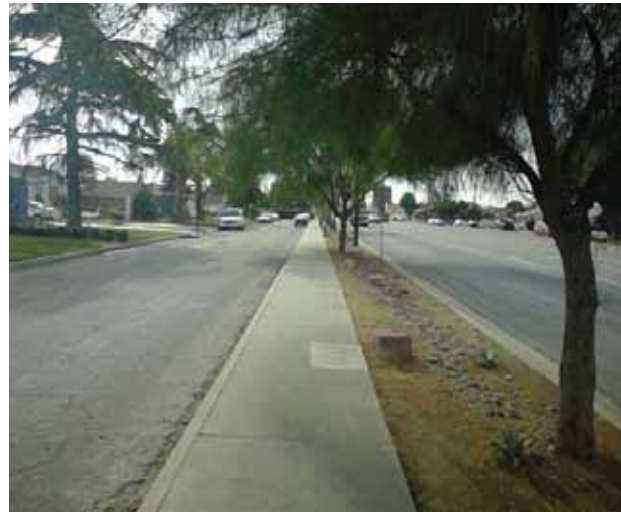
There is a change in elevation greater than recommended value.

Ensure that the change in elevation is within the recommended value.

Recommendation Up to 0.25 inches

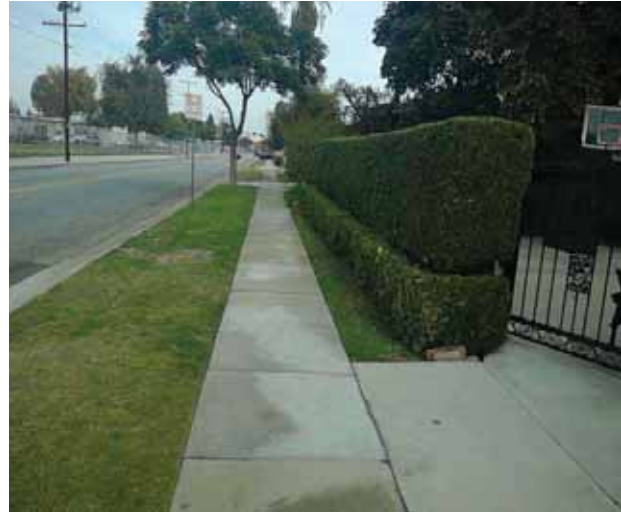
There is a change in elevation greater than recommended value.

Ensure that the change in elevation is within the recommended value.

Recommendation Up to 0.25 inches

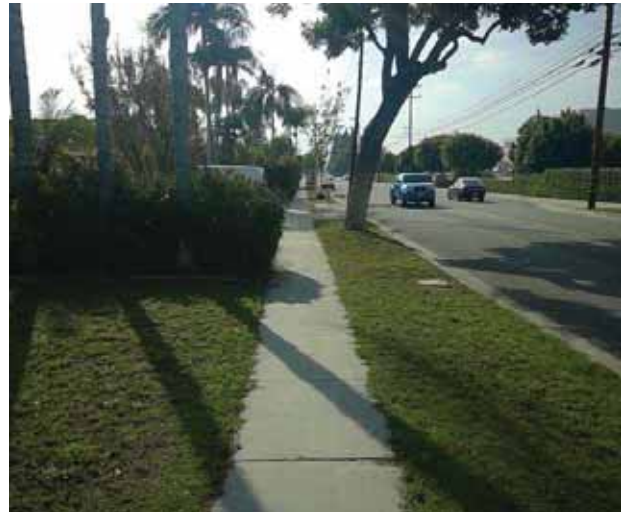
There is a change in elevation greater than recommended value.

Ensure that the change in elevation is within the recommended value.

Recommendation Up to 0.25 inches

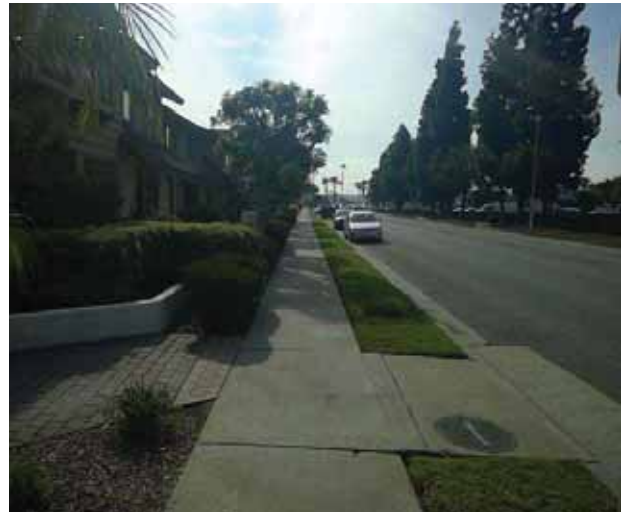
There is a change in elevation greater than recommended value.

Ensure that the change in elevation is within the recommended value.

Recommendation Up to 0.25 inches

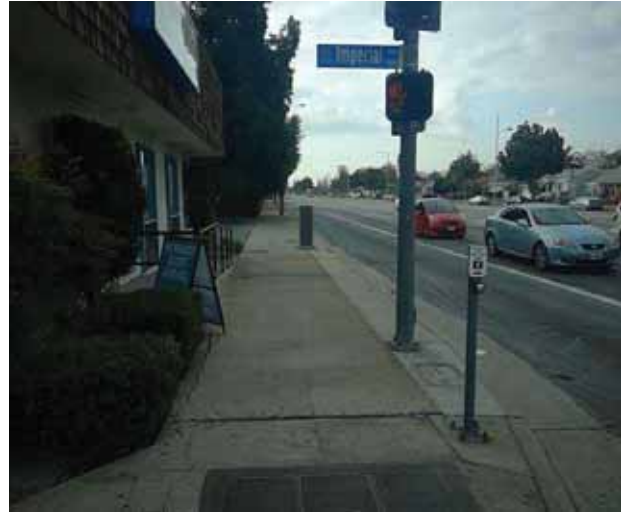
There is a change in elevation greater than recommended value.

Ensure that the change in elevation is within the recommended value.

Recommendation Up to 0.25 inches

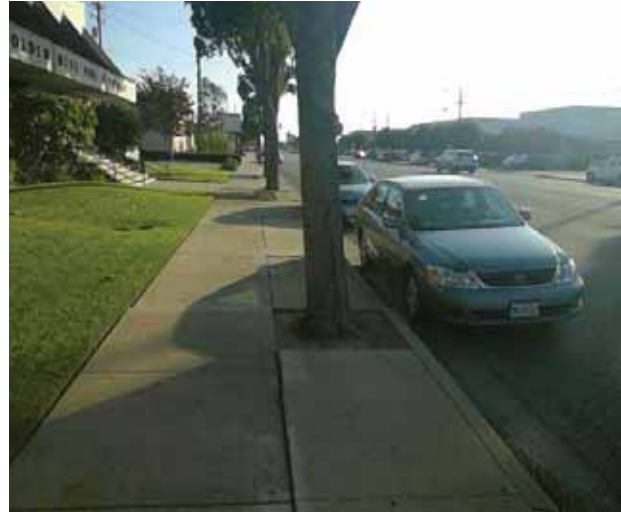
There is a change in elevation greater than recommended value.

Ensure that the change in elevation is within the recommended value.

Recommendation Up to 0.25 inches

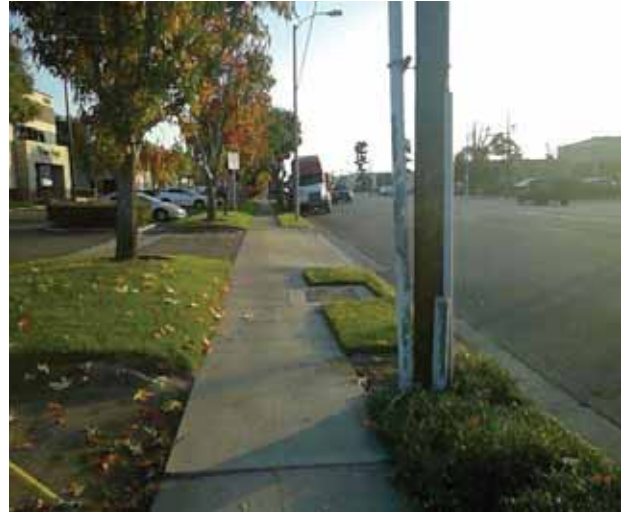
There is a change in elevation greater than recommended value.

Ensure that the change in elevation is within the recommended value.

Recommendation Up to 0.25 inches

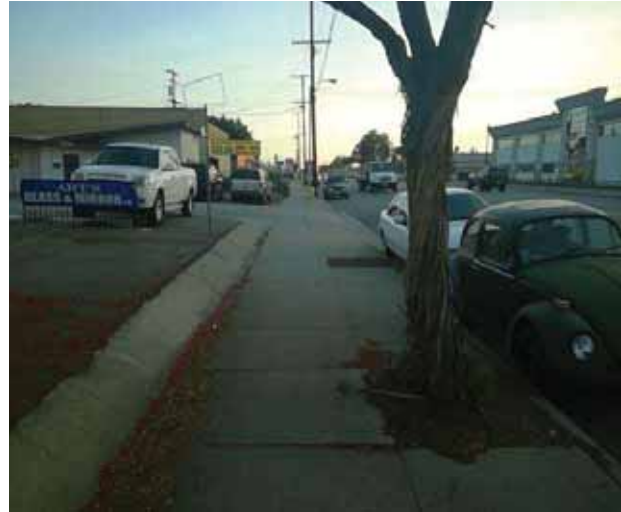
There is a change in elevation greater than recommended value.

Ensure that the change in elevation is within the recommended value.

Recommendation Up to 0.25 inches

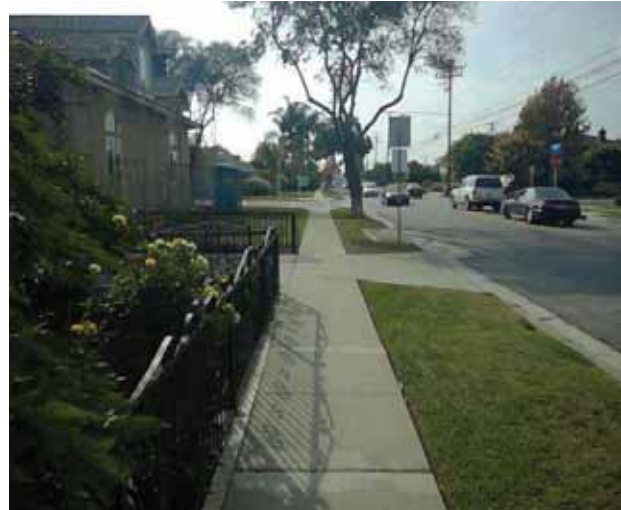
There is a change in elevation greater than recommended value.

Ensure that the change in elevation is within the recommended value.

Recommendation Up to 0.25 inches

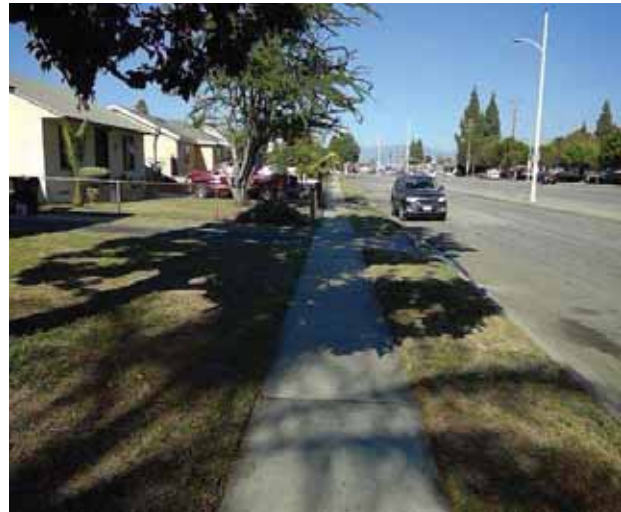
There is a change in elevation greater than recommended value.

Ensure that the change in elevation is within the recommended value.

Recommendation Up to 0.25 inches

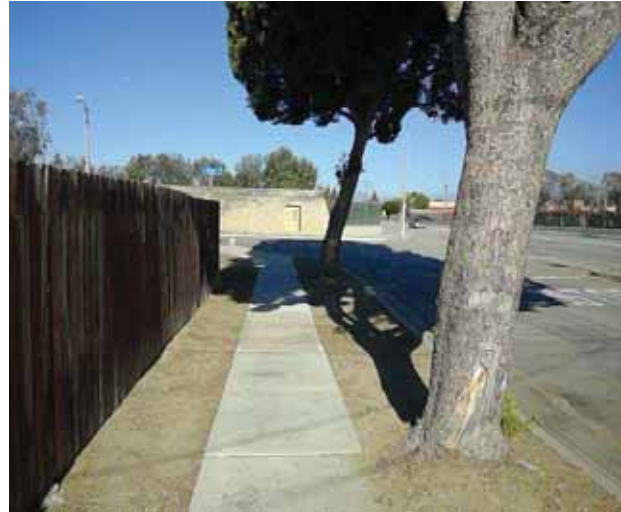
There is a change in elevation greater than recommended value.

Ensure that the change in elevation is within the recommended value.

Recommendation Up to 0.25 inches

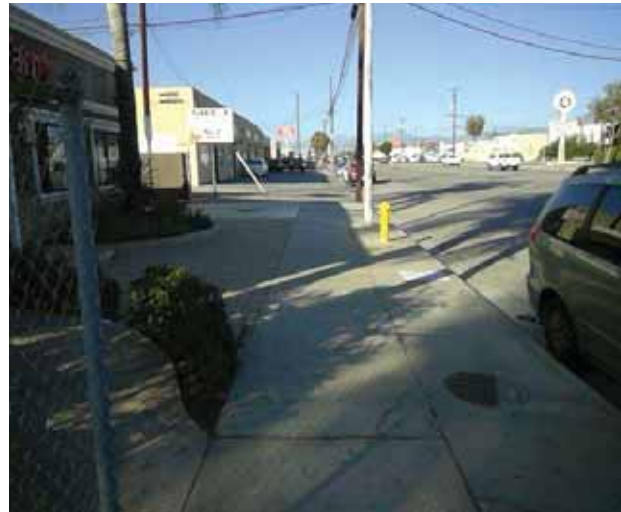
There is a change in elevation greater than recommended value.

Ensure that the change in elevation is within the recommended value.

Recommendation Up to 0.25 inches

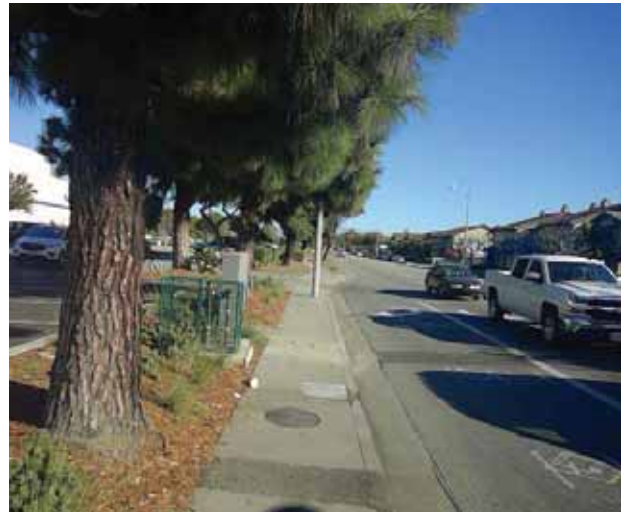
There is a change in elevation greater than recommended value.

Ensure that the change in elevation is within the recommended value.

Recommendation Up to 0.25 inches

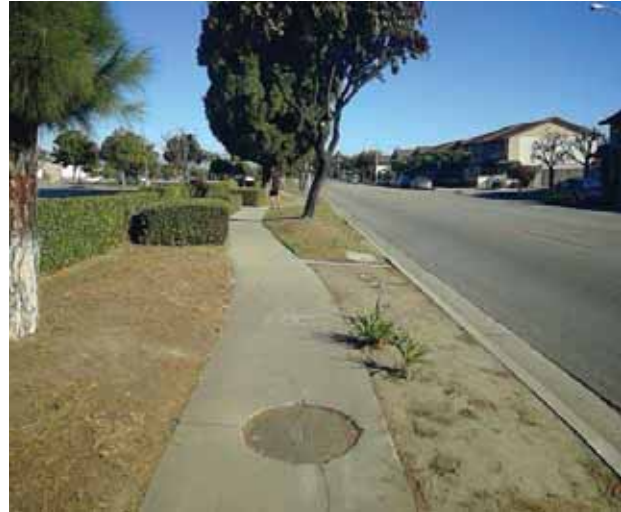
There is a change in elevation greater than recommended value.

Ensure that the change in elevation is within the recommended value.

Recommendation Up to 0.25 inches

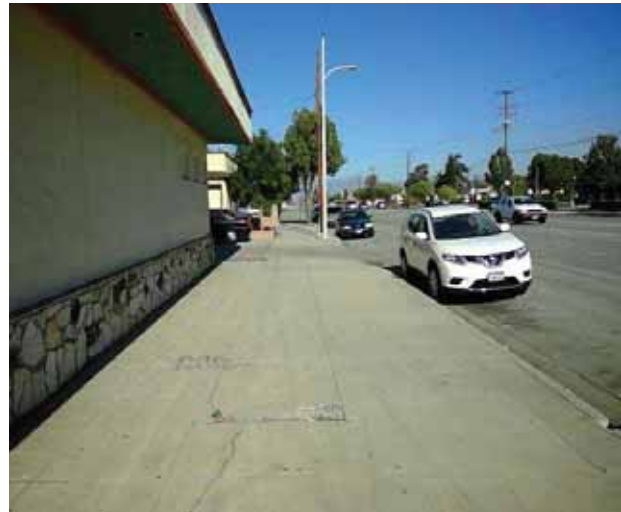
There is a change in elevation greater than recommended value.

Ensure that the change in elevation is within the recommended value.

Recommendation Up to 0.25 inches

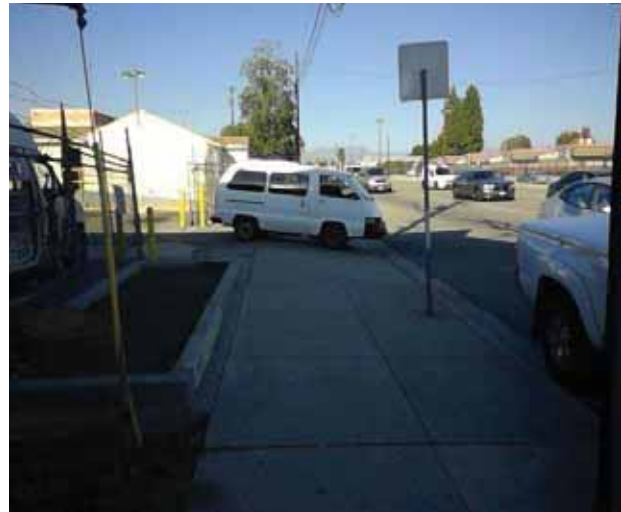
There is a change in elevation greater than recommended value.

Ensure that the change in elevation is within the recommended value.

Recommendation Up to 0.25 inches

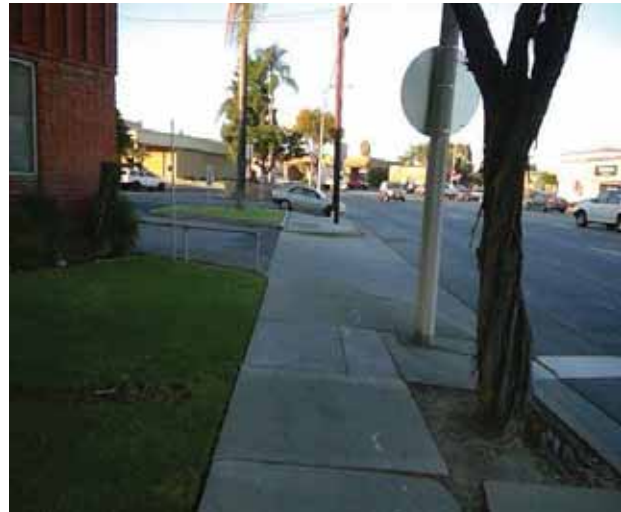
There is a change in elevation greater than recommended value.

Ensure that the change in elevation is within the recommended value.

Recommendation Up to 0.25 inches

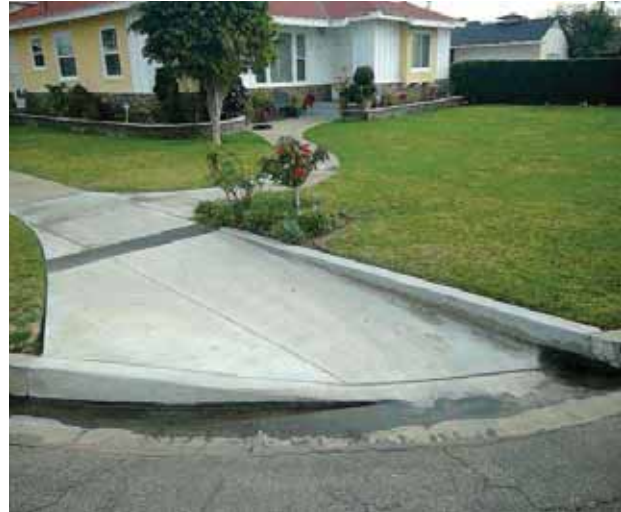
Curb Ramp , Landings and Transitions : Landing Accumulates Water - Wet Conditions

Provide compliant landing \$255

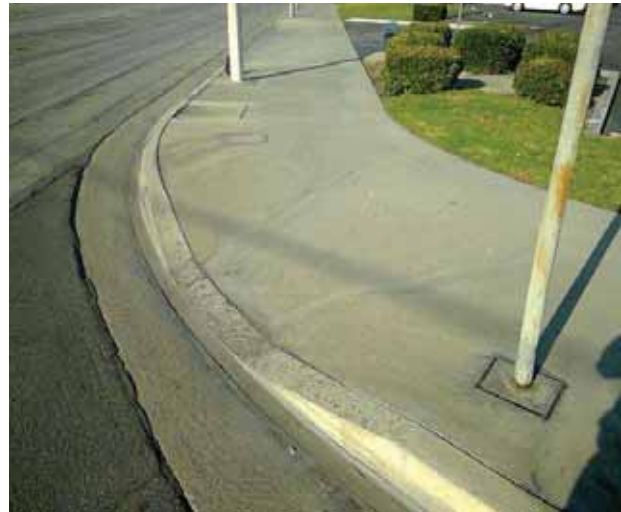
Recommendation Up to 5.00 percent

Repave landing \$1,260

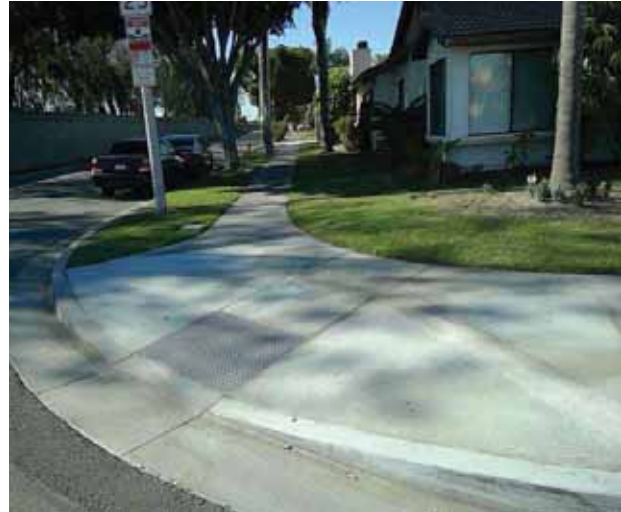
Recommendation At least 48.00 inches

Provide compliant landing \$255

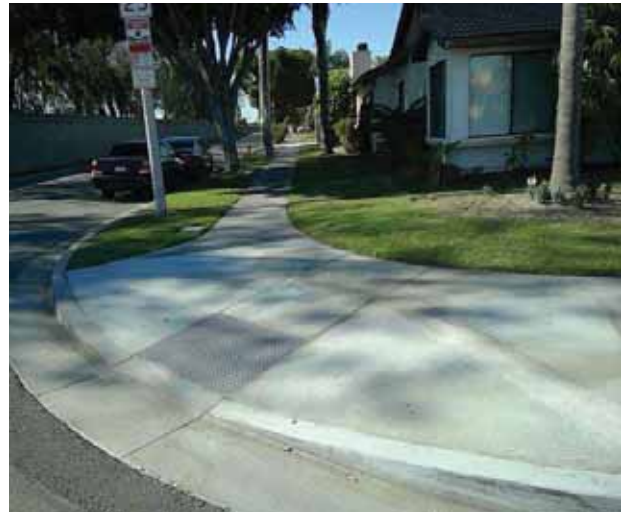
Recommendation Up to 2.08 percent

Provide compliant landing \$1,260

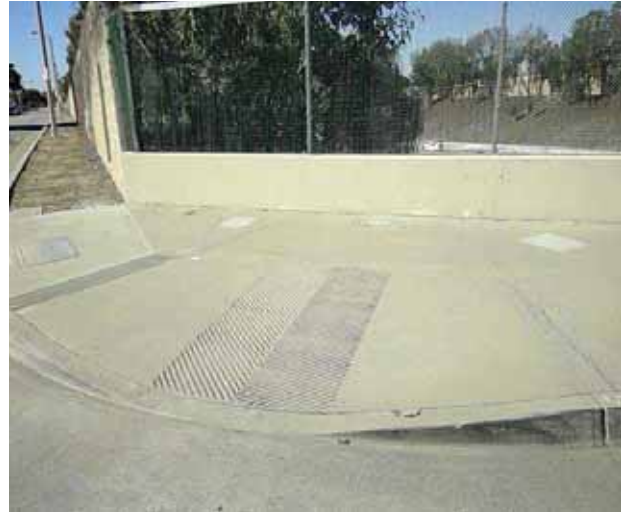
Recommendation Up to 10.00 percent

Install flared sides \$1,300

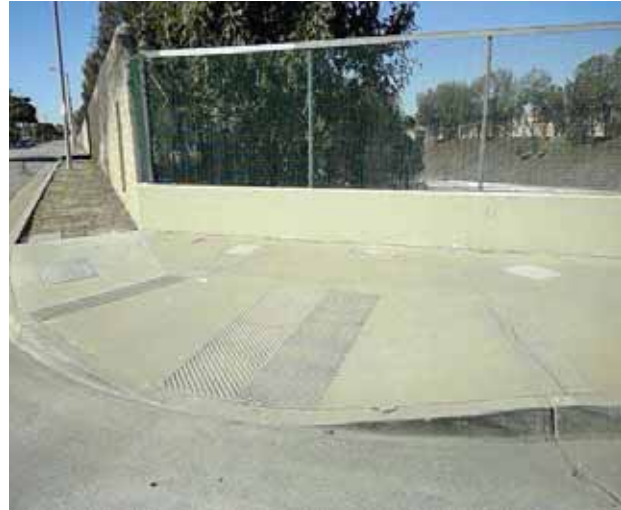
Recommendation Up to 0.50 inches

Patch lip at curb ramp \$255

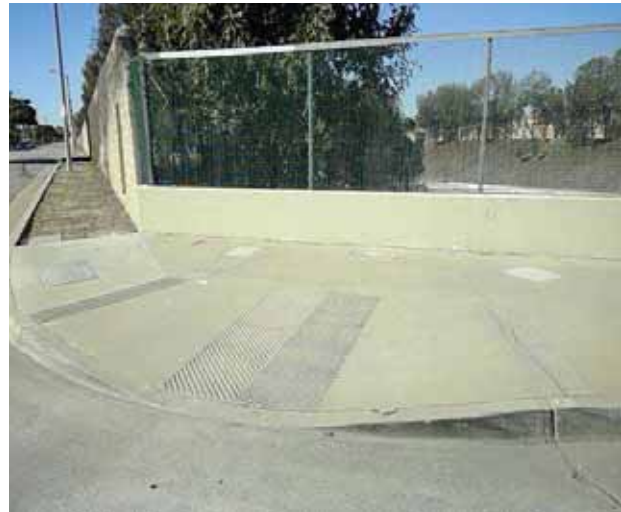
Recommendation Up to 2.08 percent

Provide compliant landing \$1,260

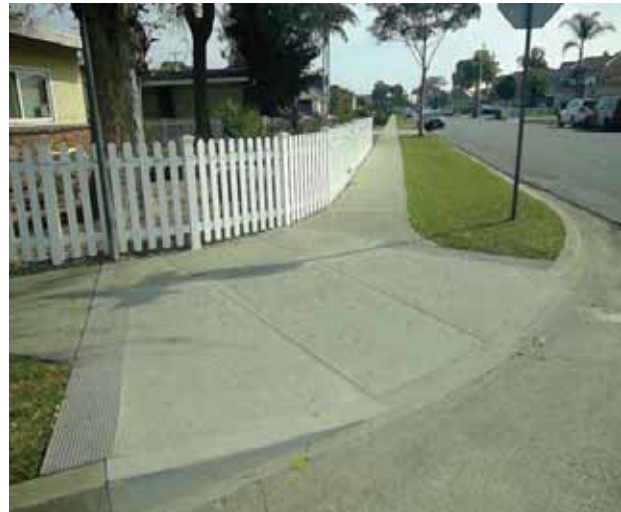
Recommendation Up to 2.08 percent

Provide compliant landing \$1,260

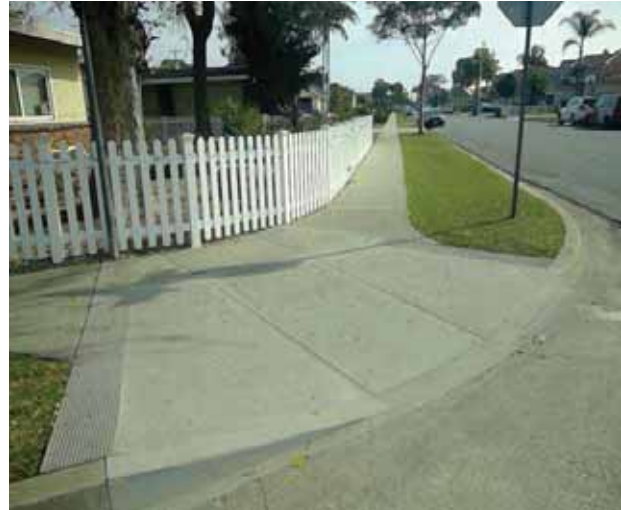
Recommendation At least 48.00 inches

Provide compliant landing \$240

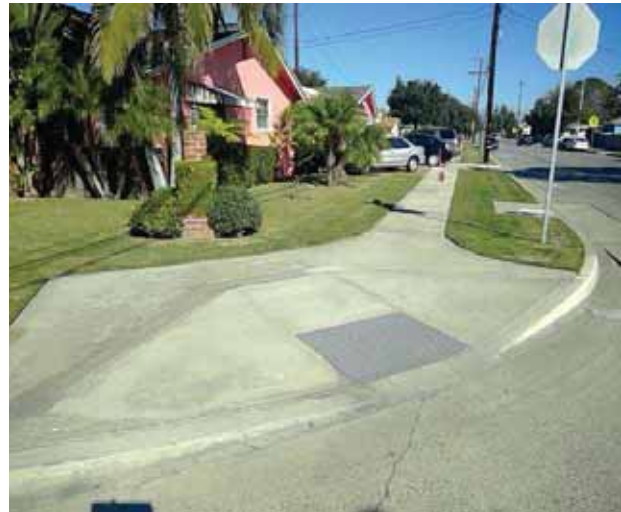
Recommendation Up to 2.08 percent

Provide compliant landing \$240

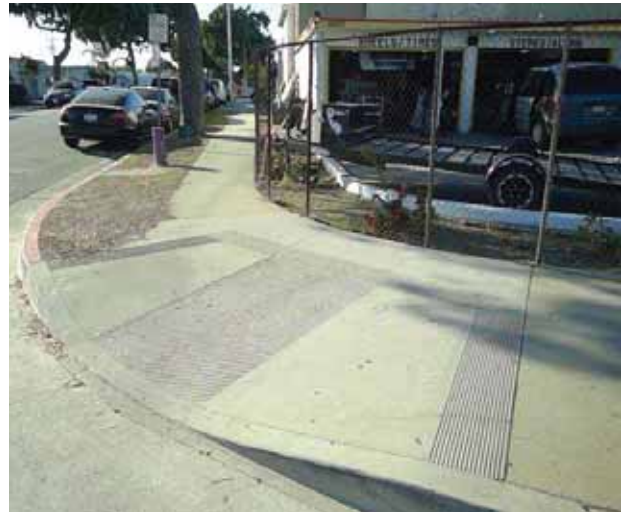
Recommendation Up to 2.08 percent

Provide compliant landing \$1,260

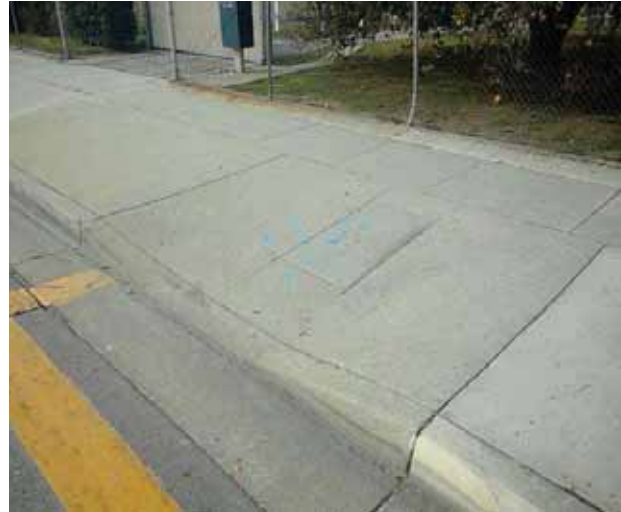
Recommendation Up to 8.33 percent

Install curb ramp \$1,300

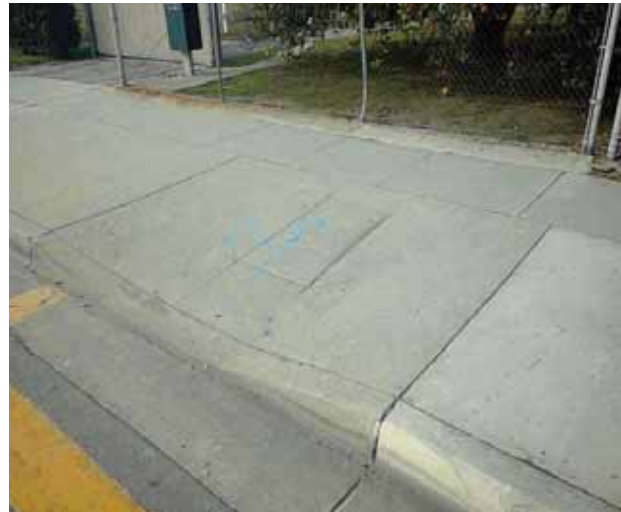
Recommendation Up to 5.00 percent

Repave landing \$1,260

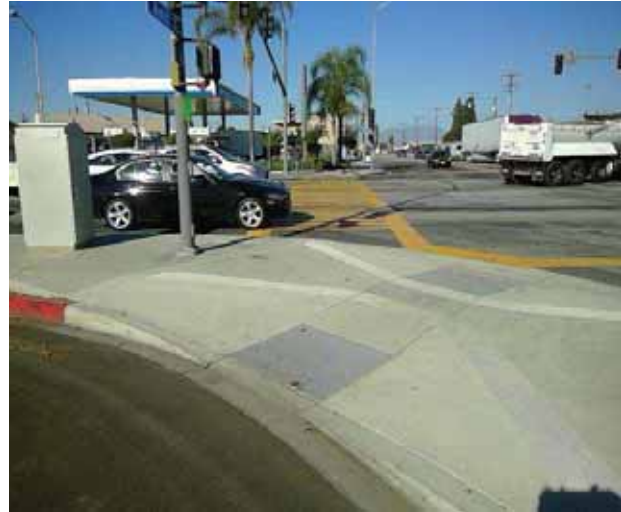
Recommendation Up to 5.00 percent

Repave landing \$1,260

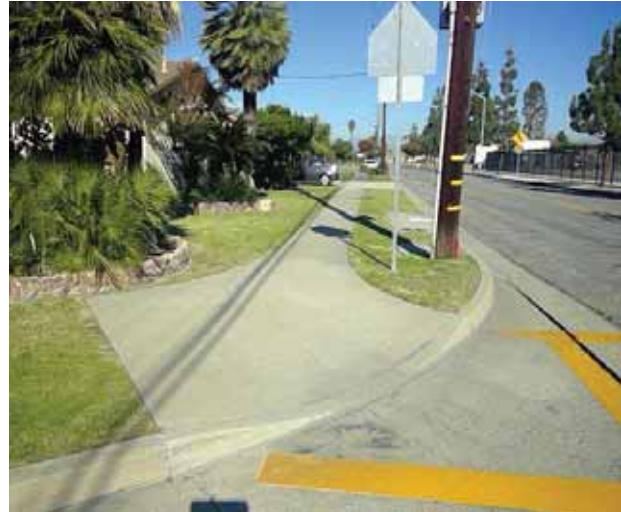
Recommendation Up to 10.00 percent

Install flared sides \$1,300

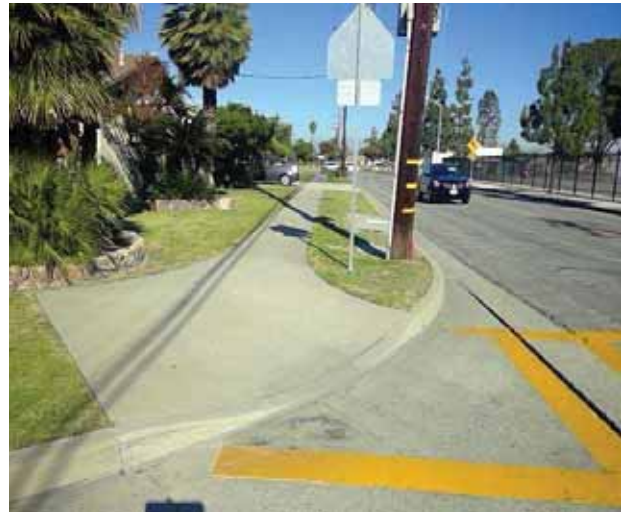
Recommendation Up to 2.08 percent

Provide compliant landing \$1,260

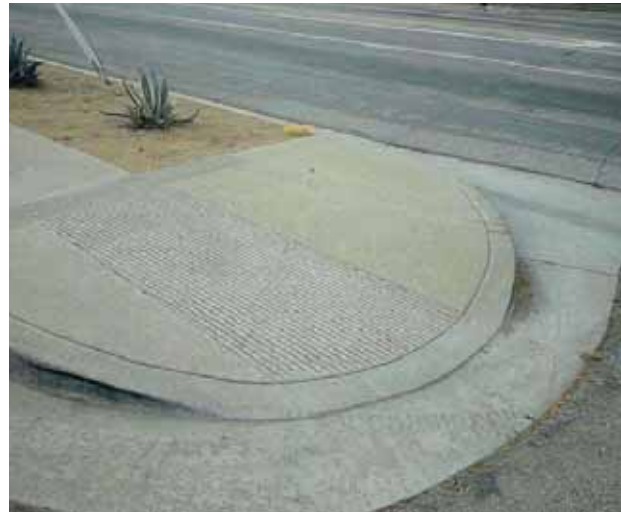
Recommendation Up to 2.08 percent

Install curb ramp \$1,300

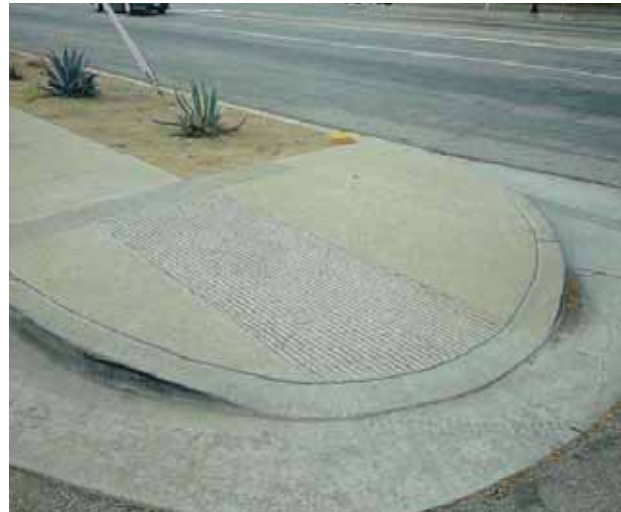
Recommendation Up to 0.50 inches

Patch lip at curb ramp \$255

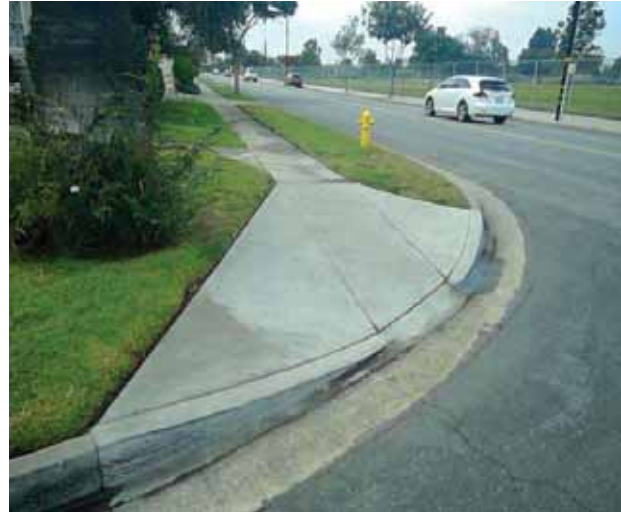
Recommendation Up to 2.08 percent

Install curb ramp \$1,300

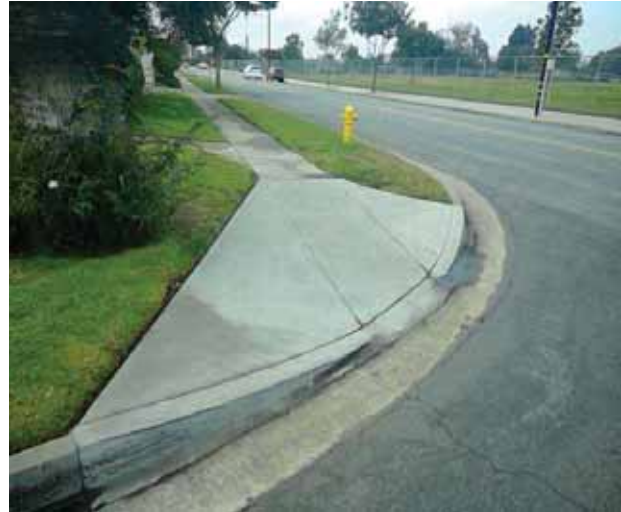
Recommendation At least 48.00 inches

Provide compliant landing \$255

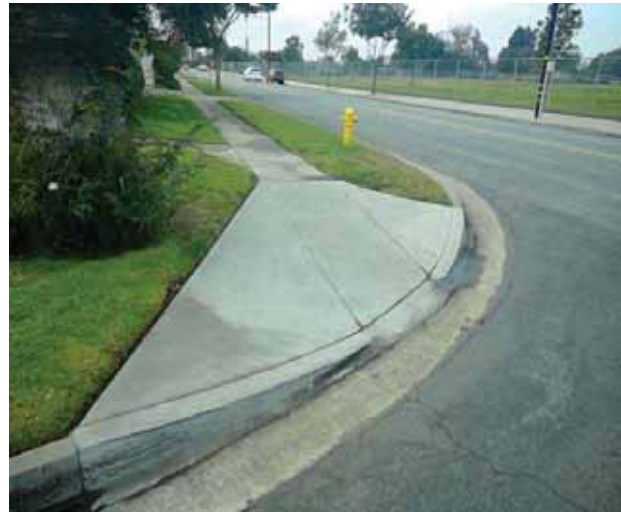
Recommendation Up to 5.00 percent

Repave landing \$1,260

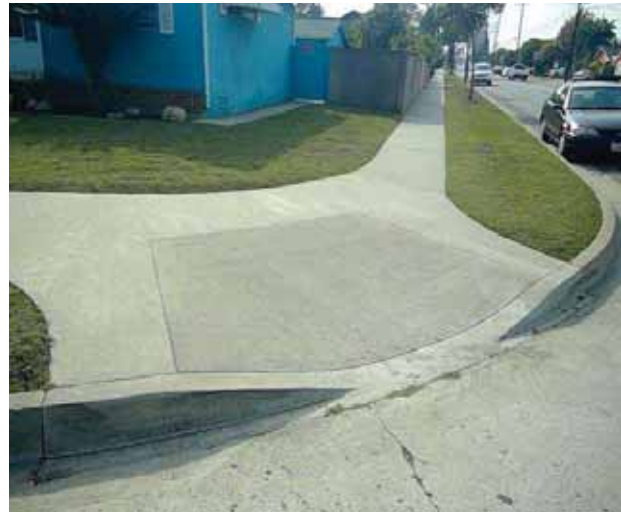
Recommendation Up to 8.33 percent

Install curb ramp \$1,300

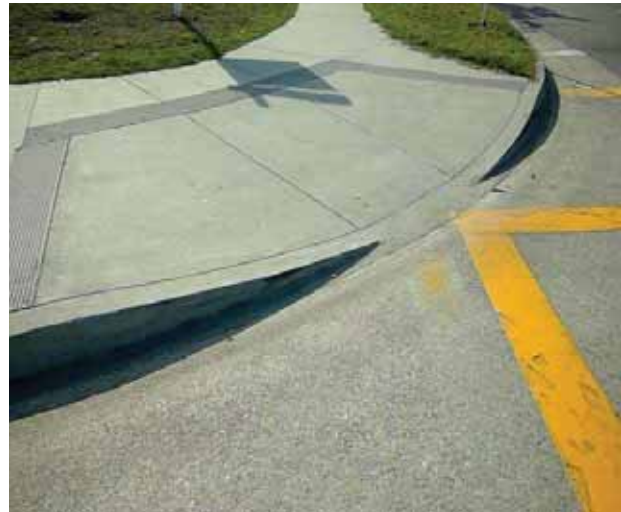
Curb Ramp , Landings and Transitions : Landing Accumulates Water
- Wet Conditions

Provide compliant landing \$255

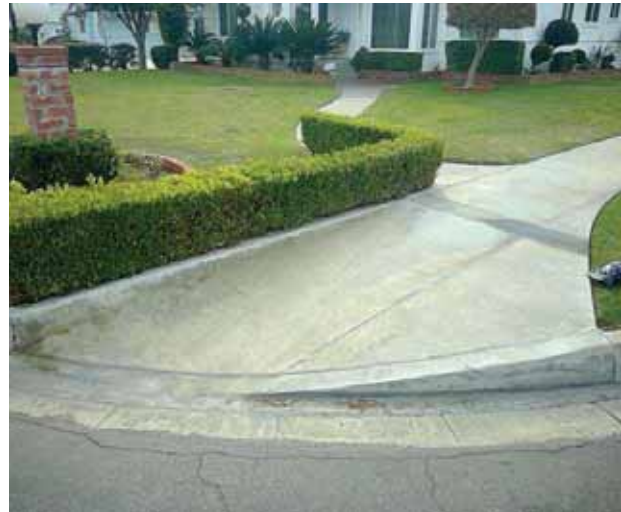
Recommendation Up to 5.00 percent

Repave landing \$1,260

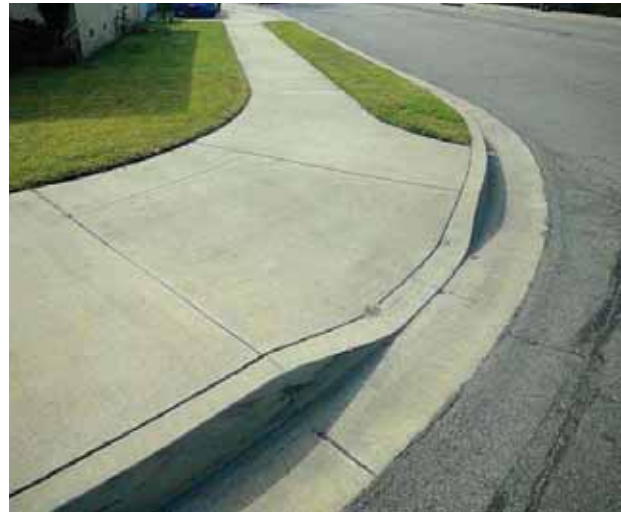
On-Site Finding Not Found

Recommendation See Recommendation

Apply contrasting finish to surface \$155

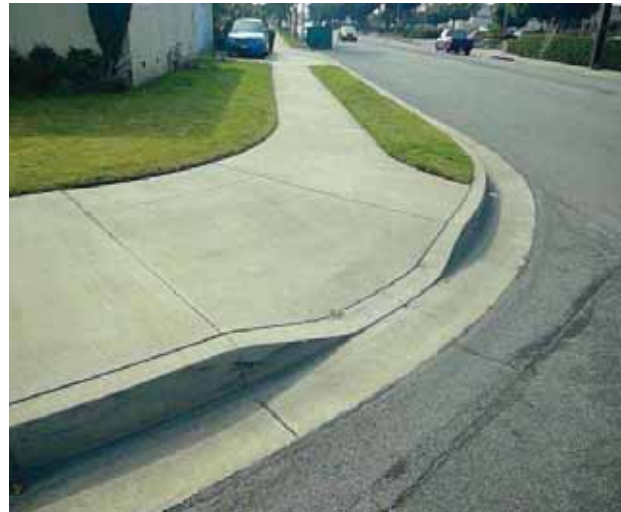
Recommendation Up to 5.00 percent

Repave landing \$1,260

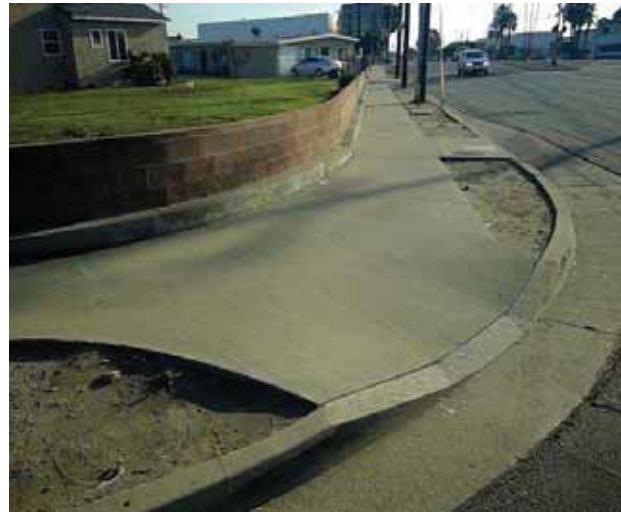
On-Site Finding Not Found

Provide detectable warning to surface \$248

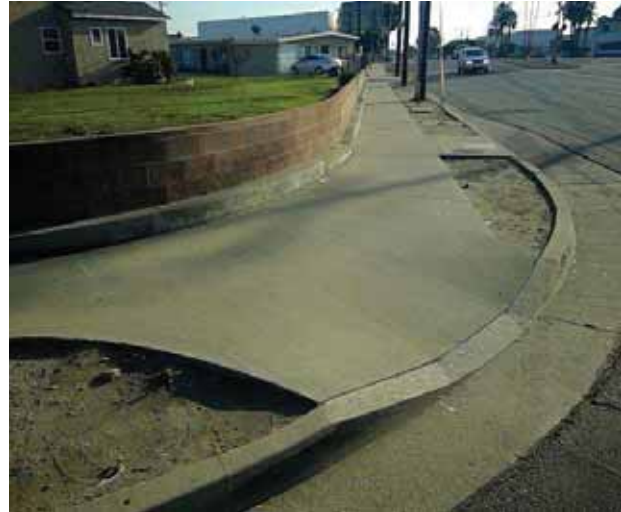
Recommendation Up to 8.33 percent

Install curb ramp \$1,300

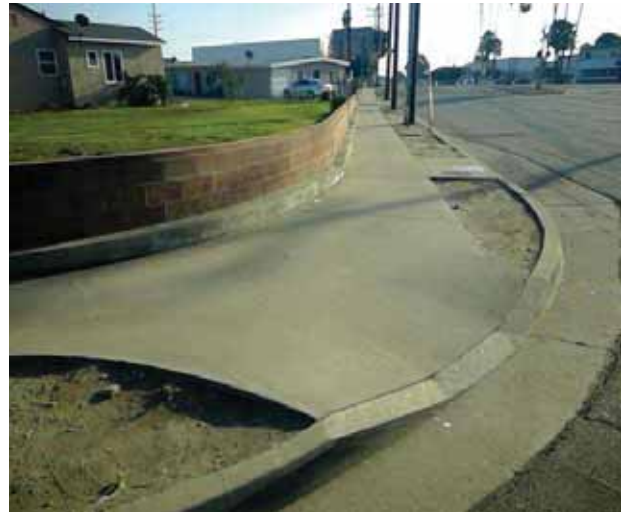
Recommendation Up to 5.00 percent

Repave landing \$1,260

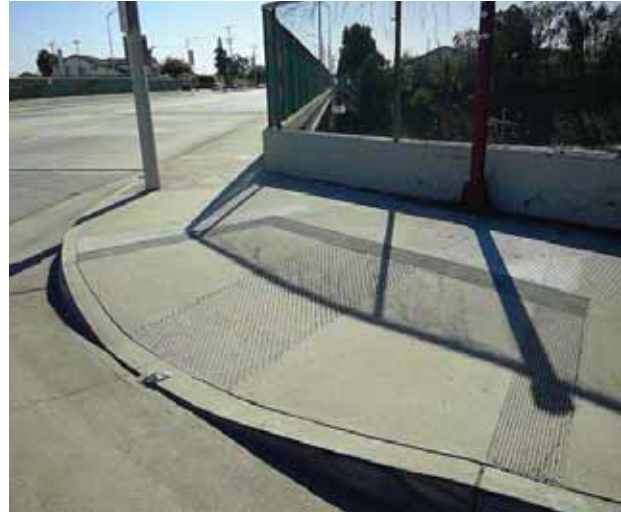
On-Site Finding Not Found

Provide detectable warning to surface \$248

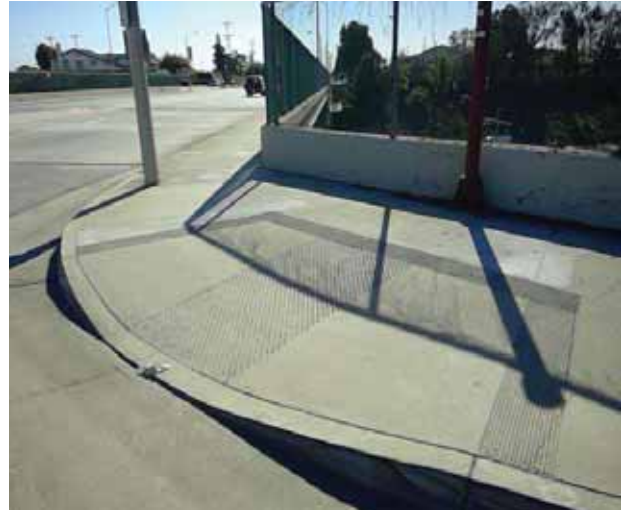
Recommendation Up to 0.50 inches

Patch lip at curb ramp \$255

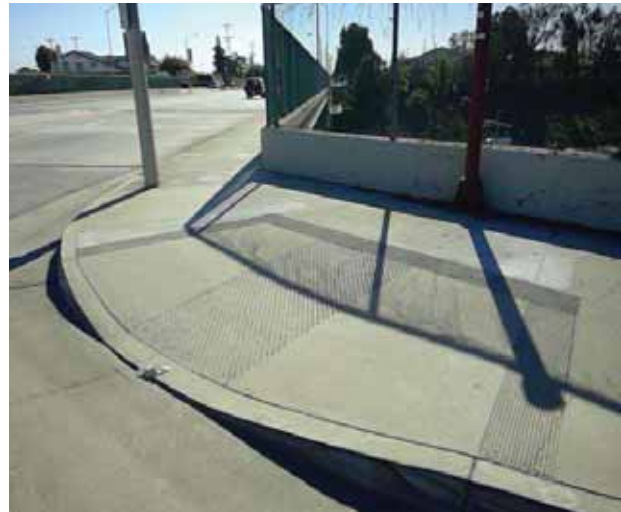
Recommendation Up to 2.08 percent

Provide compliant landing \$1,260

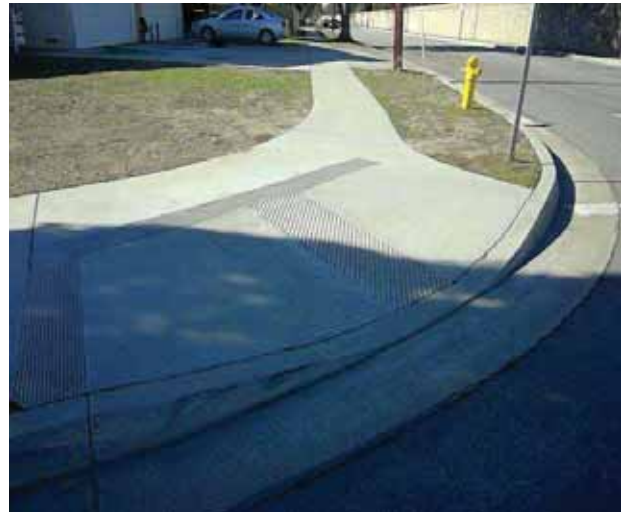
On-Site Finding Not Found

Provide detectable warning to surface \$248

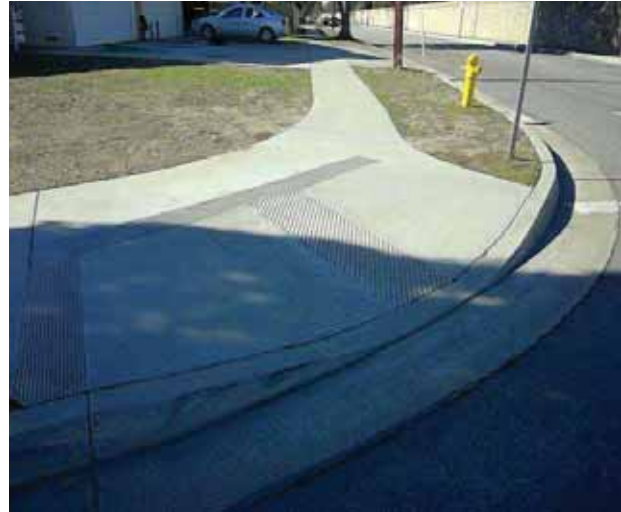
Recommendation Up to 8.33 percent

Install curb ramp \$1,300

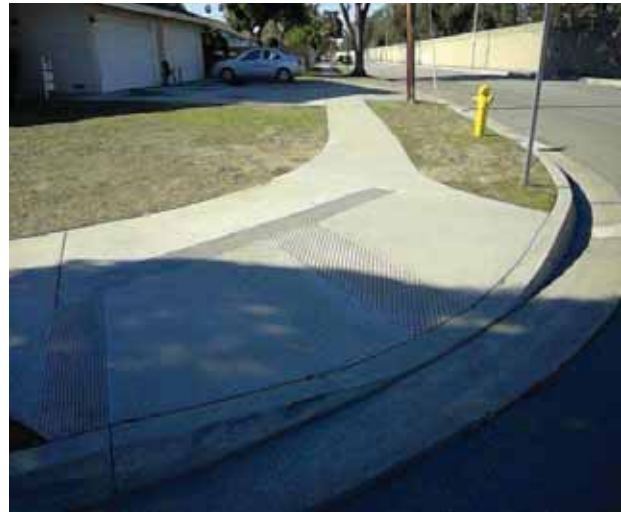
Recommendation Up to 5.00 percent

Repave landing \$1,260

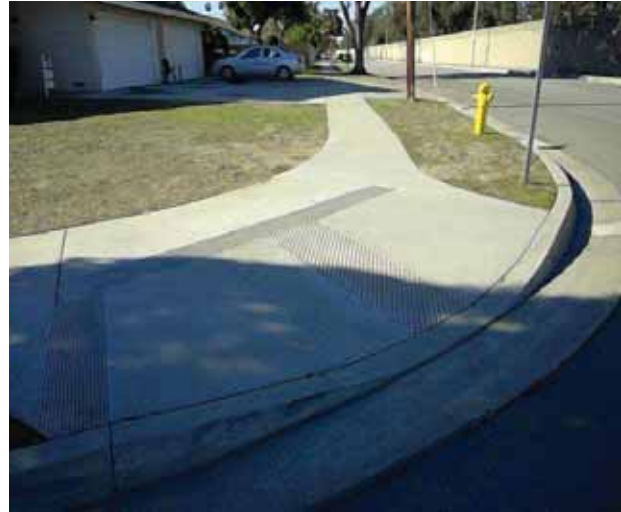
Recommendation Up to 0.50 inches

Patch lip at curb ramp \$255

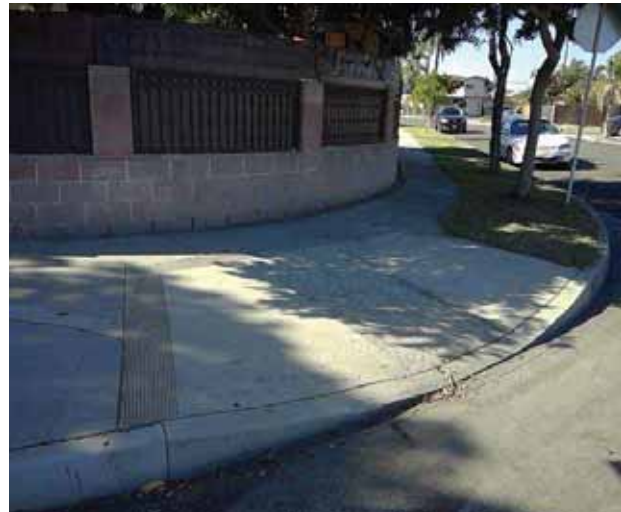
On-Site Finding Not Found

Provide detectable warning to surface \$248

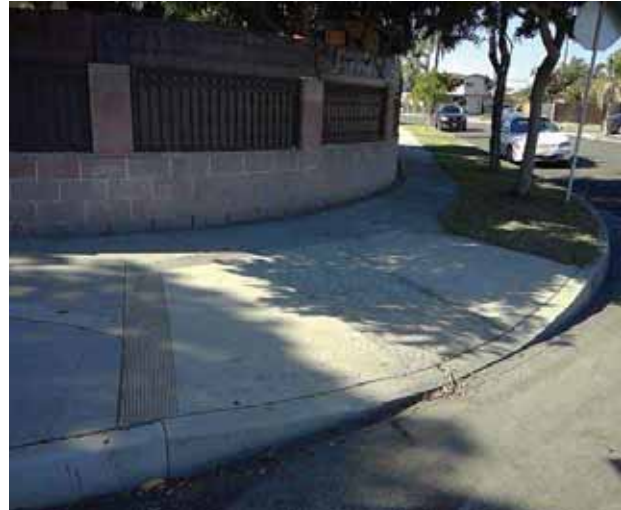
Recommendation Up to 10.00 percent

Install flared sides \$1,300

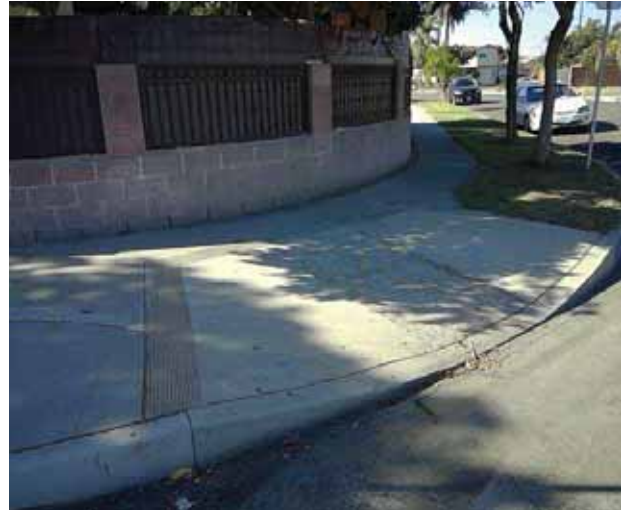
Recommendation Up to 0.50 inches

Patch lip at curb ramp \$255

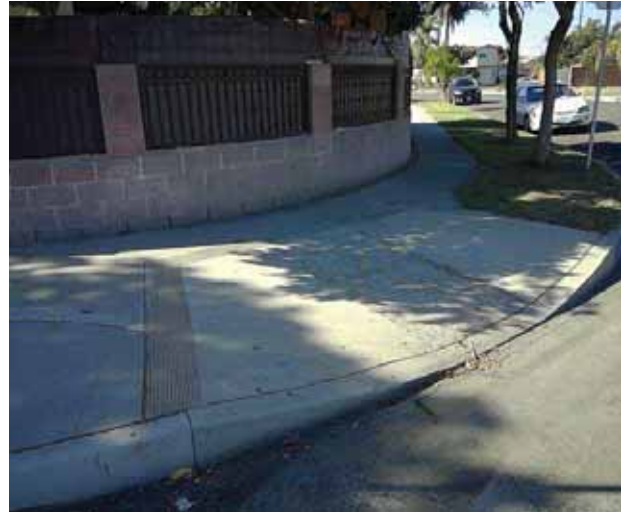
Recommendation At least 48.00 inches

Provide compliant landing \$240
