Accessibility Survey

City of Downey Woodruff Avenue & Firestone Boulevard East

Date of Inspection
1/9/2017

Disability Access Consultants

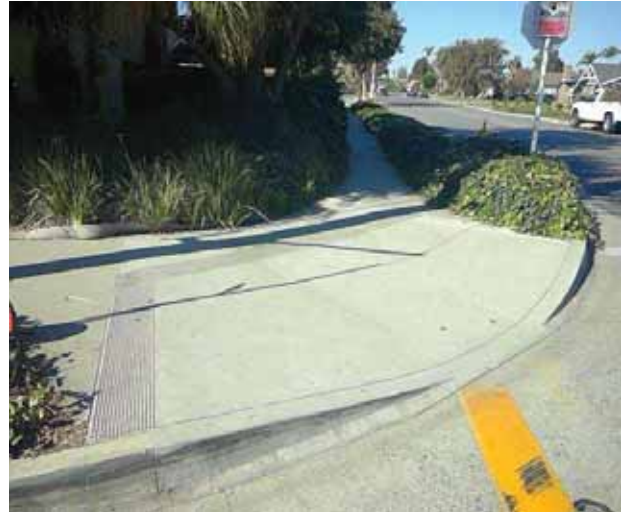
On-Site Finding Not Found

Provide detectable warning to surface \$248

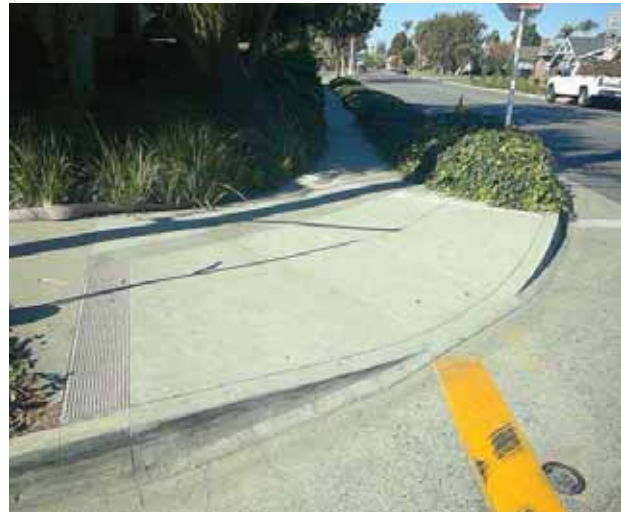
Recommendation Up to 2.08 percent

Provide compliant landing \$240

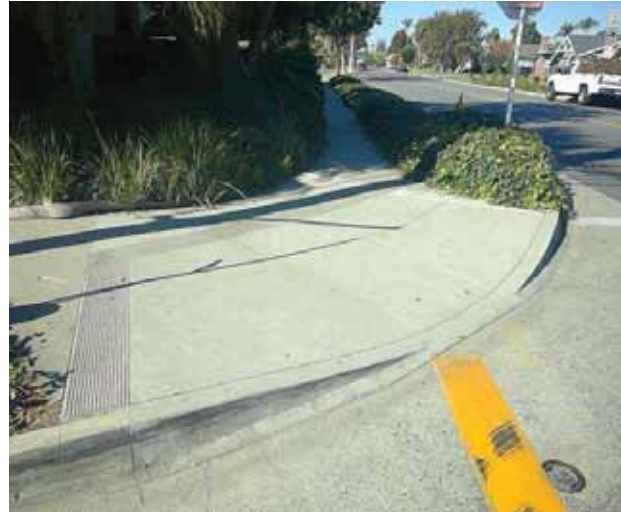
Recommendation At least 48.00 inches

Provide compliant landing \$240

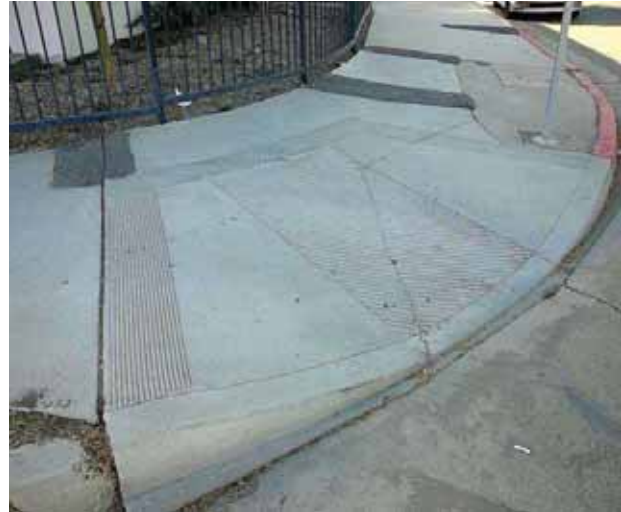
On-Site Finding Not Found

Provide detectable warning to surface \$248

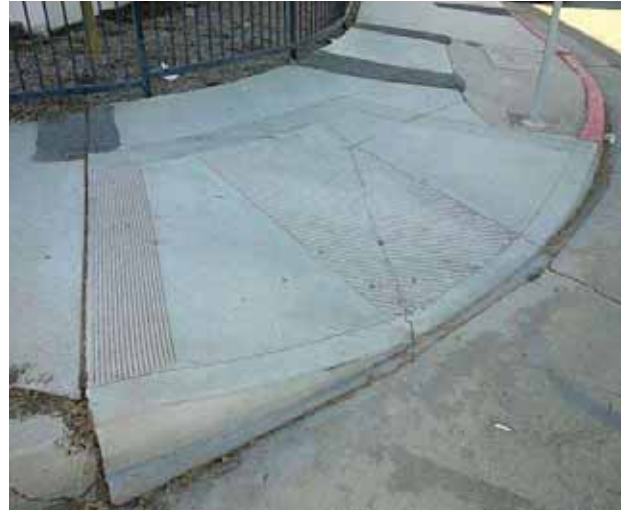
Recommendation Up to 0.50 inches

Patch lip at curb ramp \$255

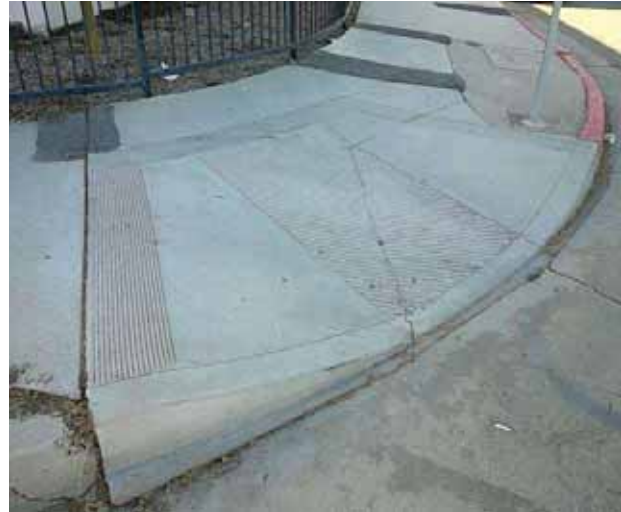
Recommendation Up to 2.08 percent

Provide compliant landing \$1,260

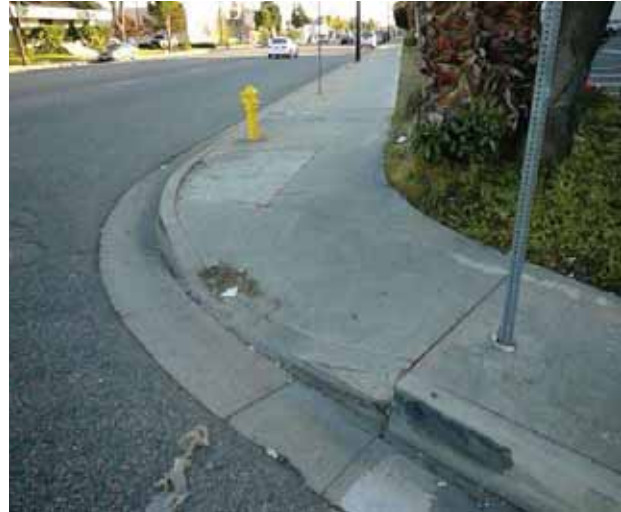
On-Site Finding Not Found

Provide detectable warning to surface \$248

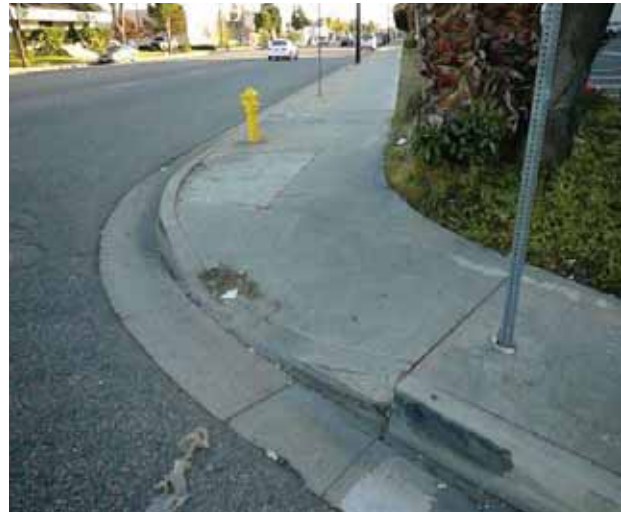
Recommendation Up to 8.33 percent

Install curb ramp \$1,300

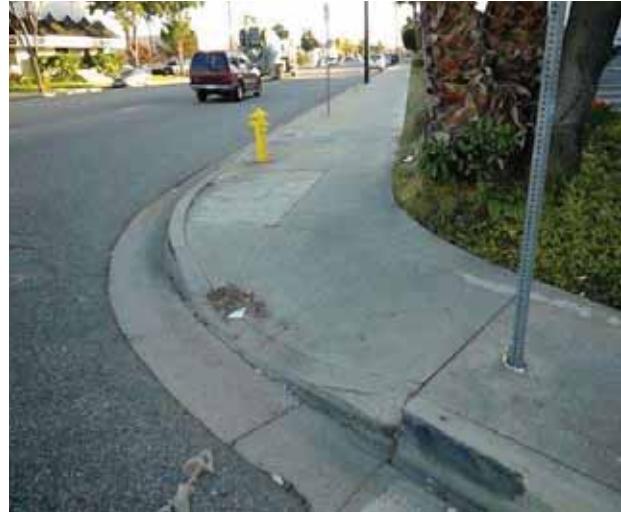
Recommendation Up to 5.00 percent

Repave landing \$1,260

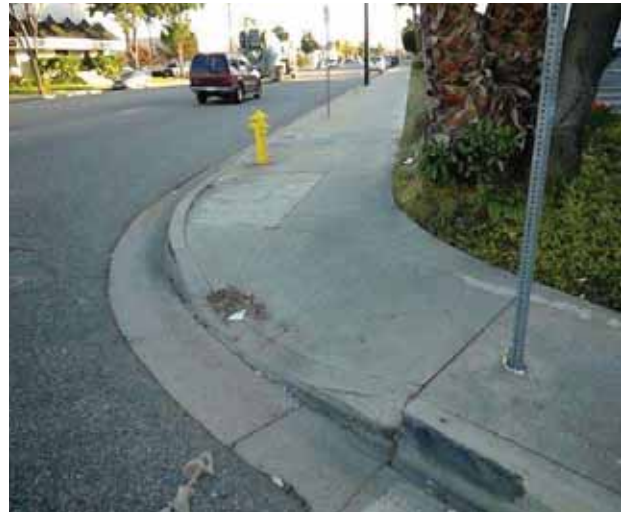
Recommendation Up to 2.08 percent

Provide compliant landing \$1,260

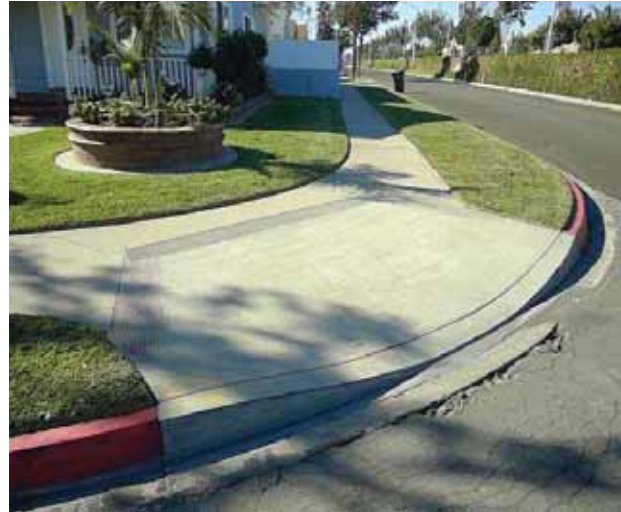
On-Site Finding Not Found

Provide detectable warning to surface \$248

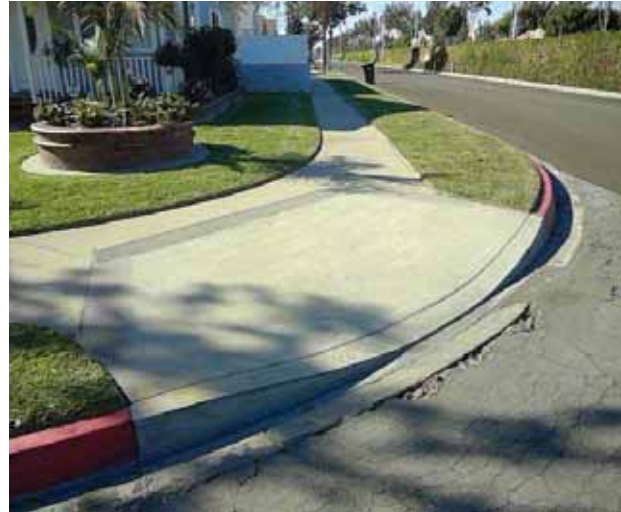
Recommendation Up to 5.00 percent

Repave landing \$1,260

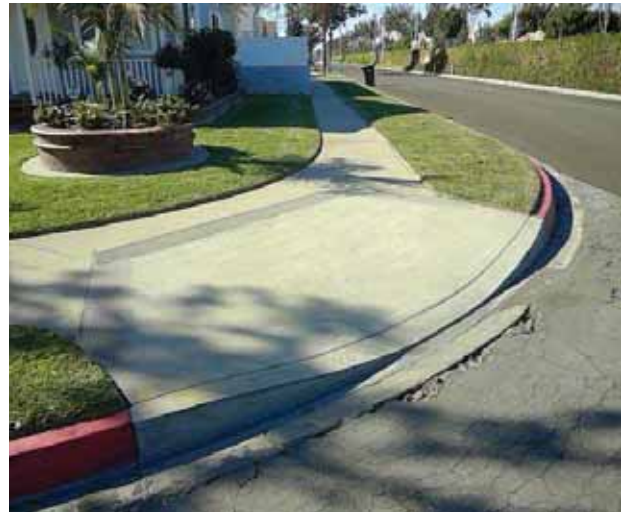
Recommendation Up to 2.08 percent

Provide compliant landing \$1,260

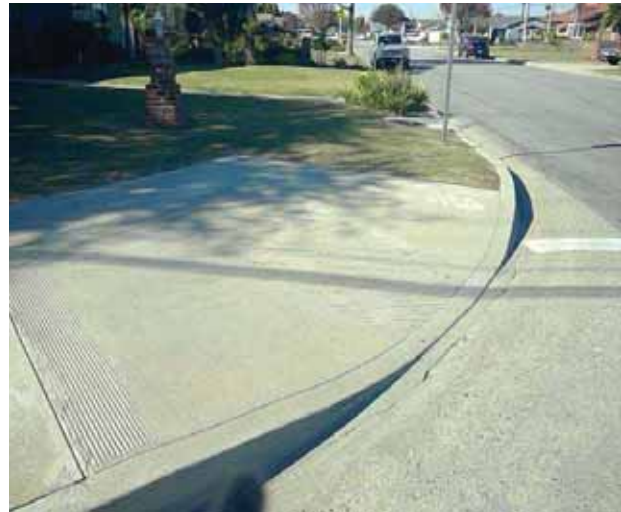
On-Site Finding Not Found

Provide detectable warning to surface \$248

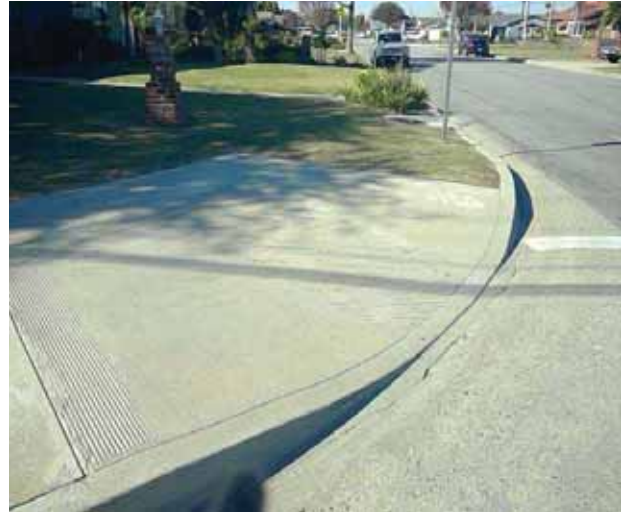
Recommendation Up to 8.33 percent

Install curb ramp \$1,300

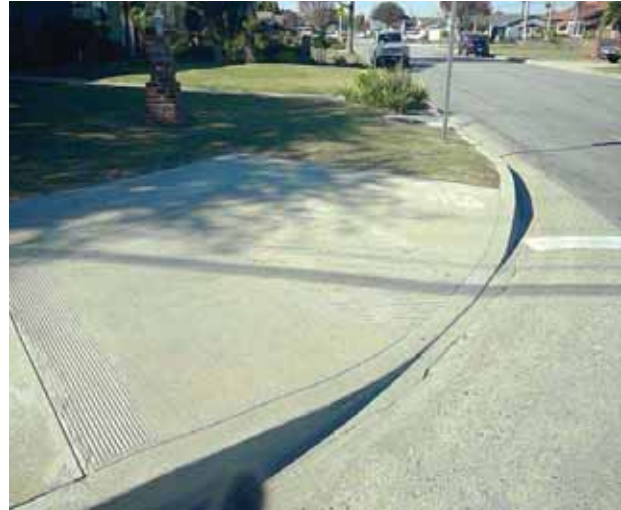
Recommendation Up to 10.00 percent

Install flared sides \$1,300

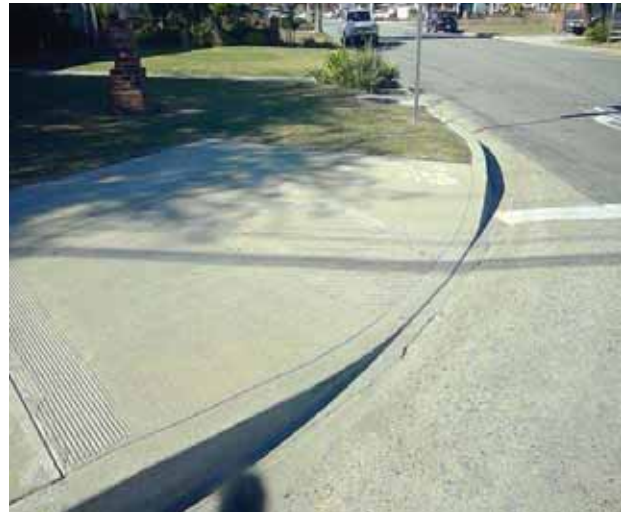
Recommendation Up to 5.00 percent

Repave landing \$1,260

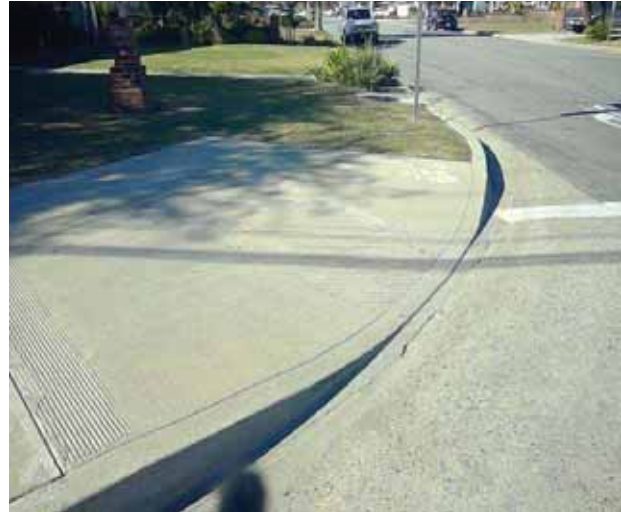
Recommendation At least 48.00 inches

Provide compliant landing \$240

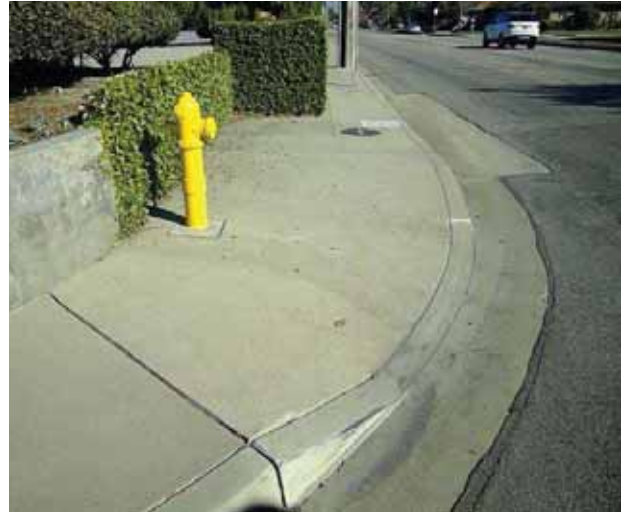
On-Site Finding Not Found

Provide detectable warning to surface \$248

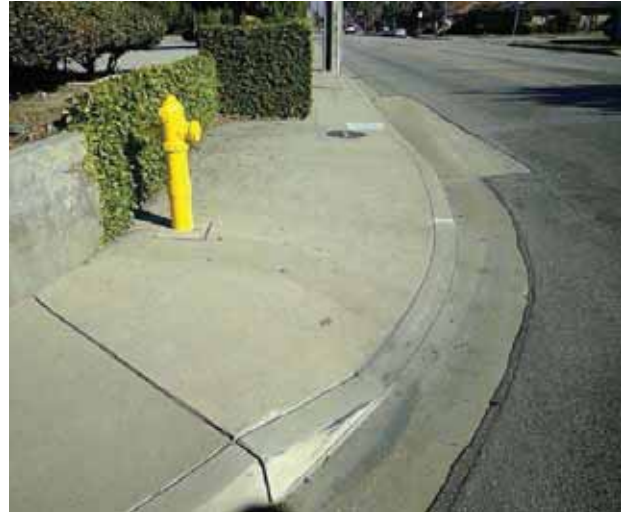
Recommendation Up to 2.08 percent

Provide compliant landing \$1,260

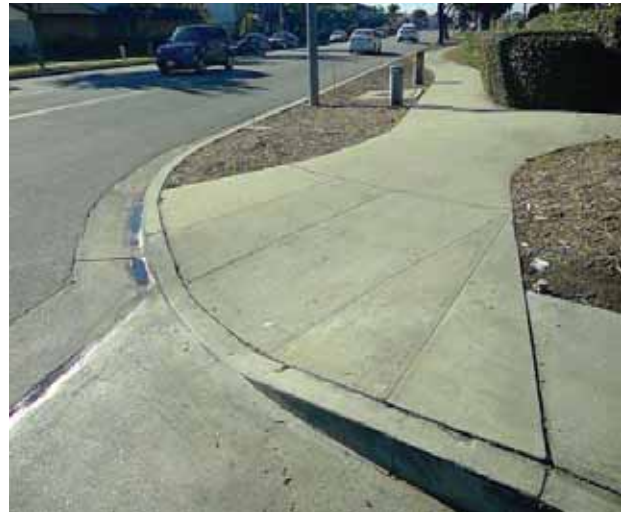
On-Site Finding Not Found

Provide detectable warning to surface \$248

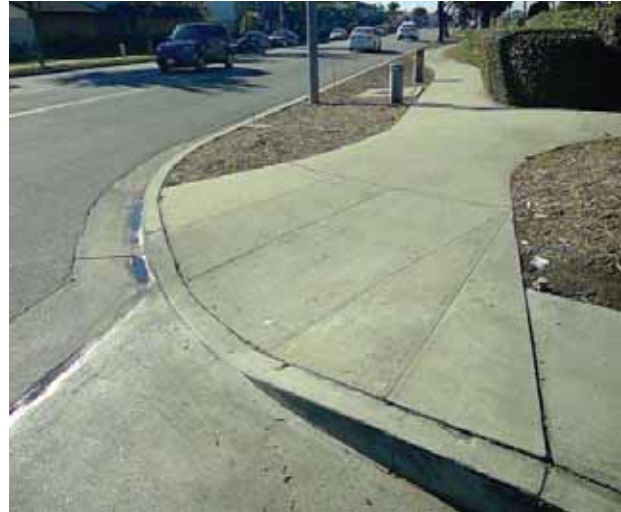
Recommendation Up to 8.33 percent

Install curb ramp \$1,300

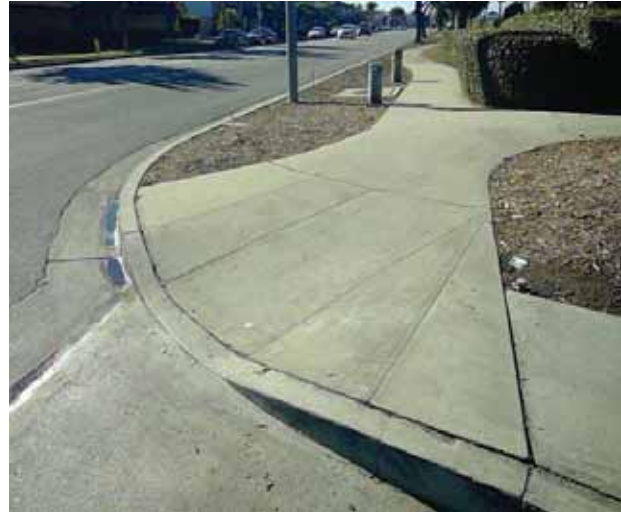
Recommendation Up to 2.08 percent

Provide compliant landing \$240

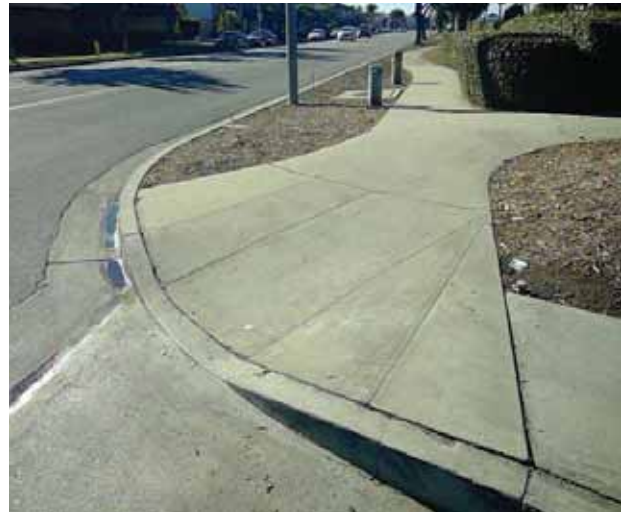
Curb Ramp , Landings and Transitions : Landing Accumulates Water - Wet Conditions

Provide compliant landing \$1,260

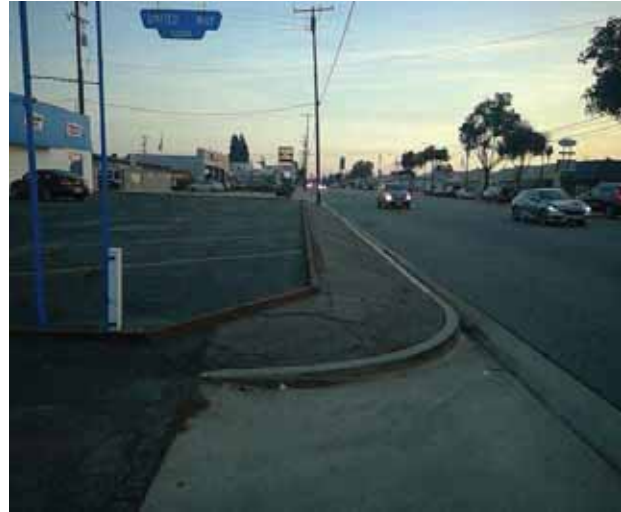
Sidewalks , Hazards & Gratings : Curb is on Path of Travel

Install curb ramp \$2,500

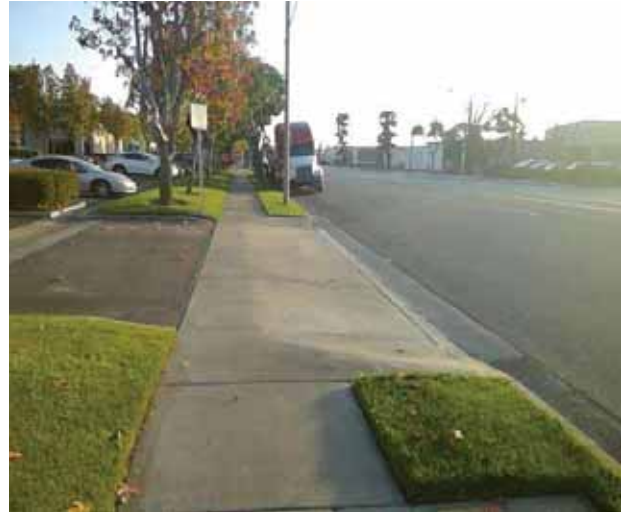
On-Site Finding Not Found

Recommendation See Recommendation

Install compliant detectable warnings \$190

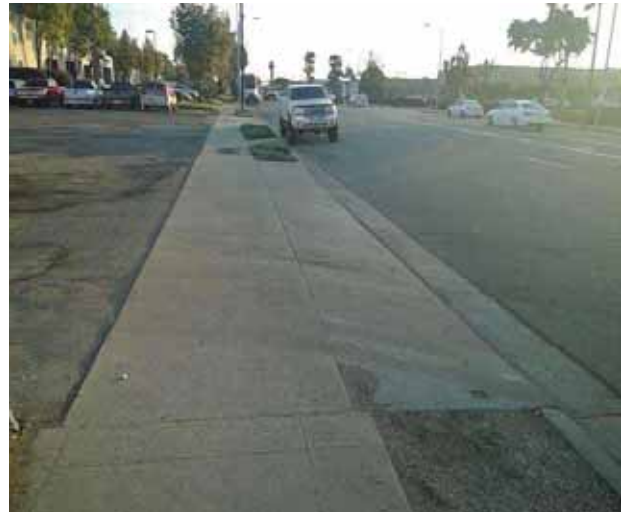
On-Site Finding Not Found

Recommendation See Recommendation

Install compliant detectable warnings \$190

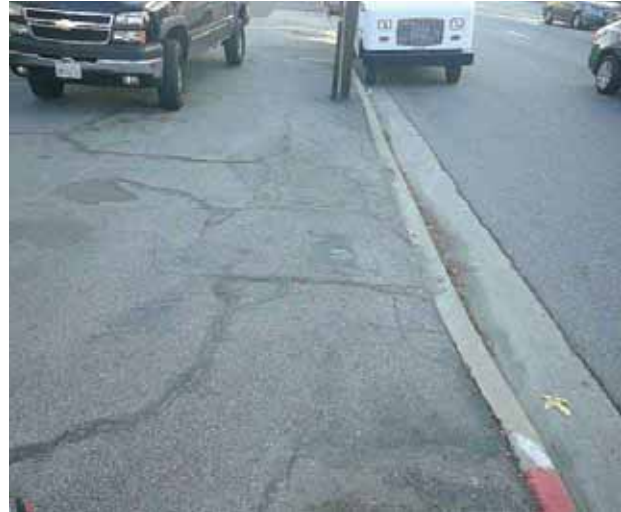
On-Site Finding Not Found

Recommendation See Recommendation

Install compliant detectable warnings \$190

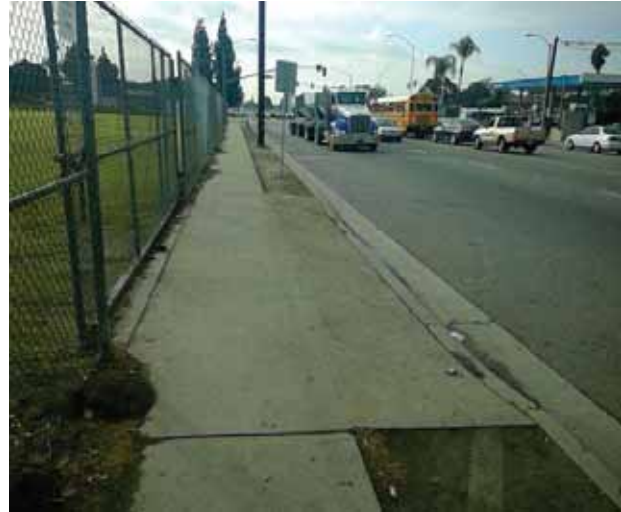
On-Site Finding Not Found

Recommendation See Recommendation

Install compliant detectable warnings \$190

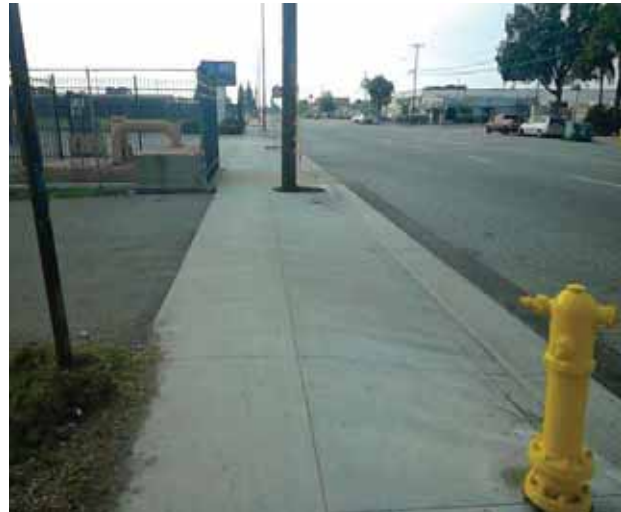
On-Site Finding Not Found

Recommendation See Recommendation

Install compliant detectable warnings \$190

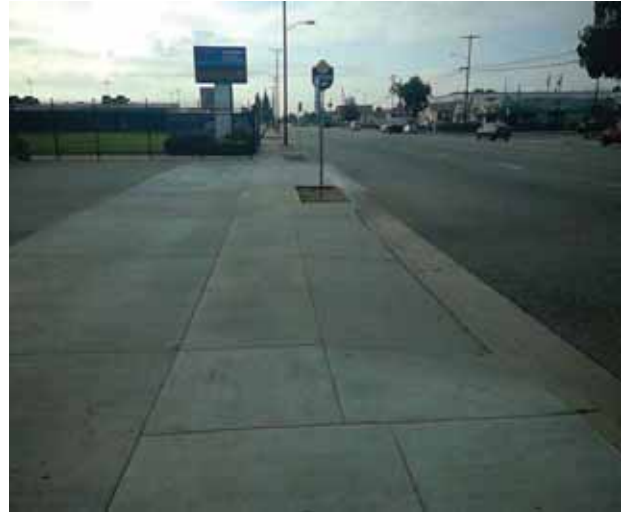
On-Site Finding Not Found

Recommendation See Recommendation

Install compliant detectable warnings \$190

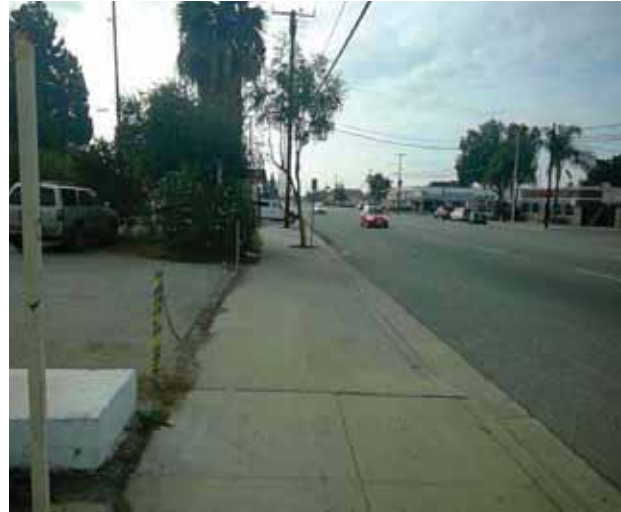
On-Site Finding Not Found

Recommendation See Recommendation

Install compliant detectable warnings \$190

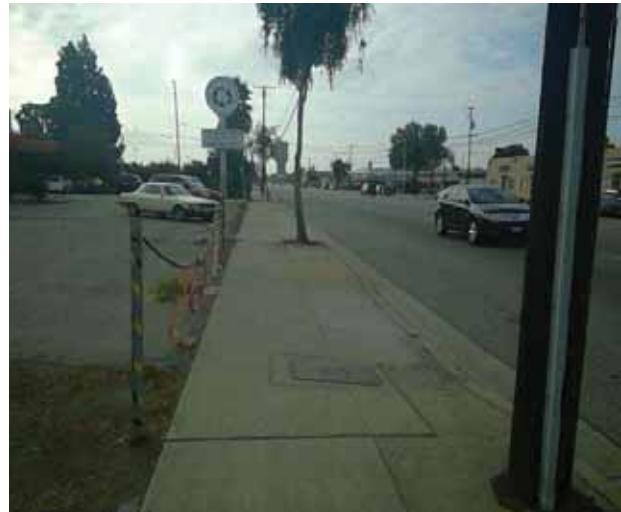
On-Site Finding Not Found

Recommendation See Recommendation

Install compliant detectable warnings \$190

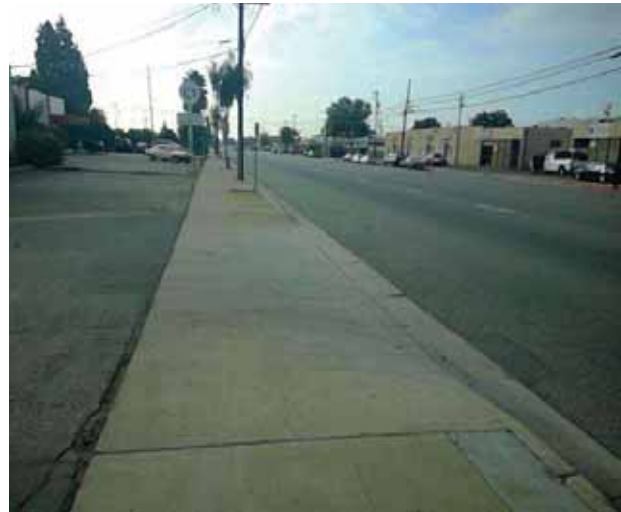
On-Site Finding Not Found

Recommendation See Recommendation

Install compliant detectable warnings \$190

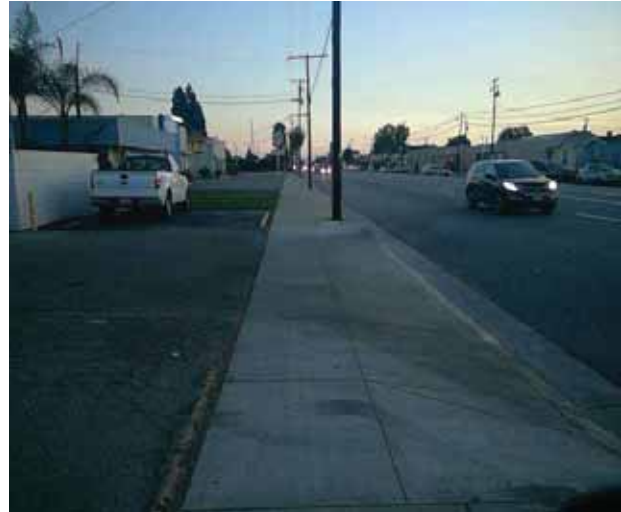
On-Site Finding Not Found

Recommendation See Recommendation

Install compliant detectable warnings \$190

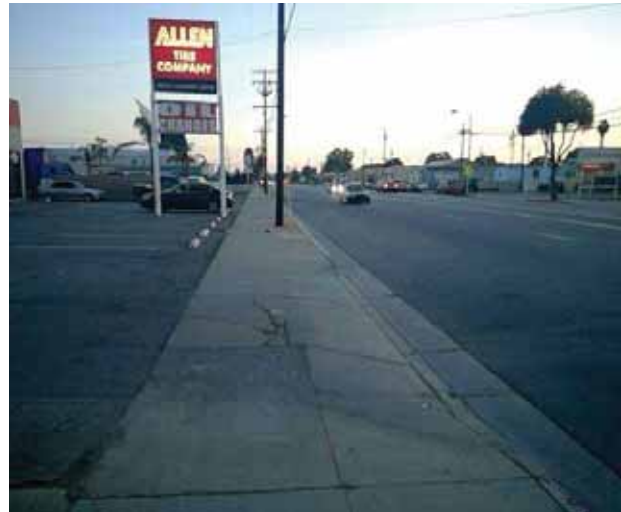
On-Site Finding Not Found

Recommendation See Recommendation

Install compliant detectable warnings \$190

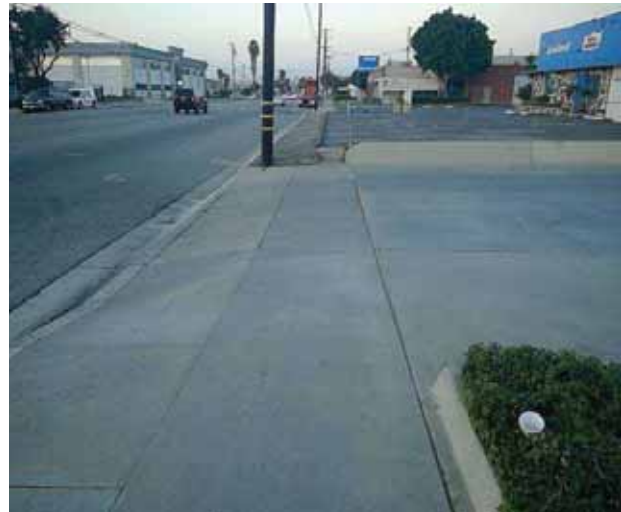
On-Site Finding Not Found

Recommendation See Recommendation

Install compliant detectable warnings \$190

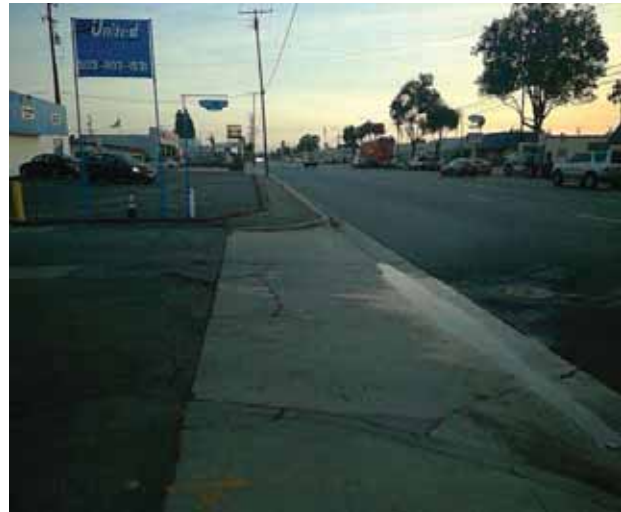
On-Site Finding Not Found

Recommendation See Recommendation

Install compliant detectable warnings \$190

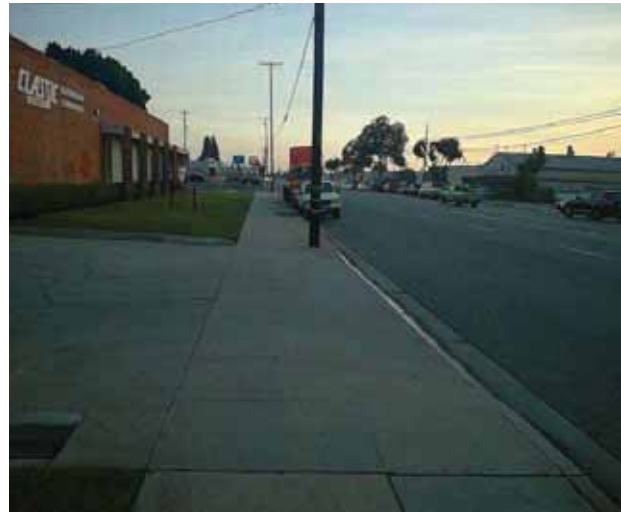
On-Site Finding Not Found

Recommendation See Recommendation

Install compliant detectable warnings \$190

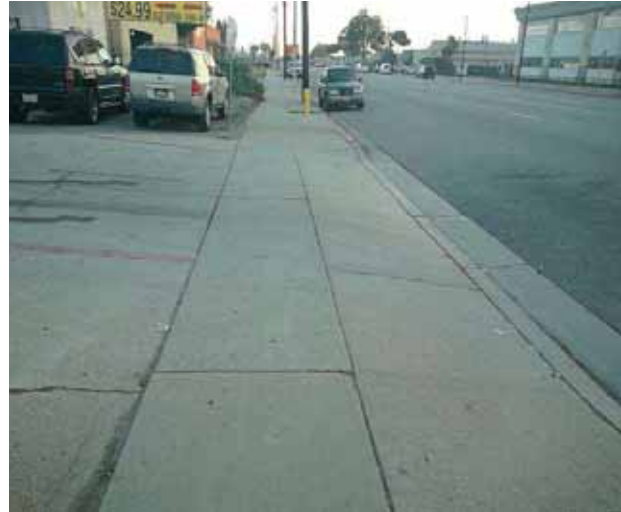
On-Site Finding Not Found

Recommendation See Recommendation

Install compliant detectable warnings \$190

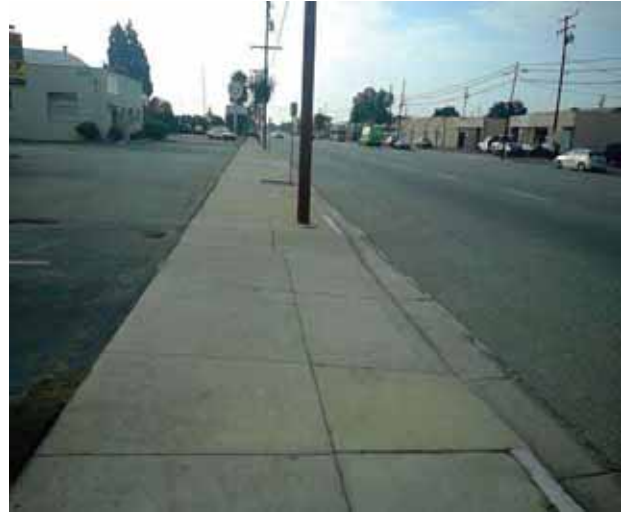
On-Site Finding Not Found

Recommendation See Recommendation

Install compliant detectable warnings \$190

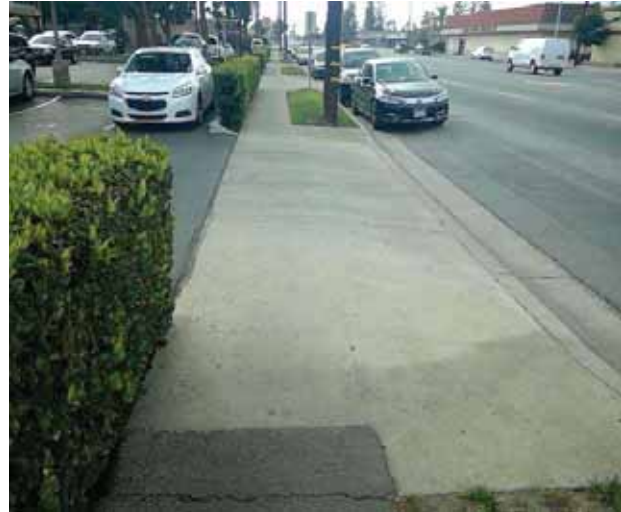
On-Site Finding Not Found

Recommendation See Recommendation

Install compliant detectable warnings \$190

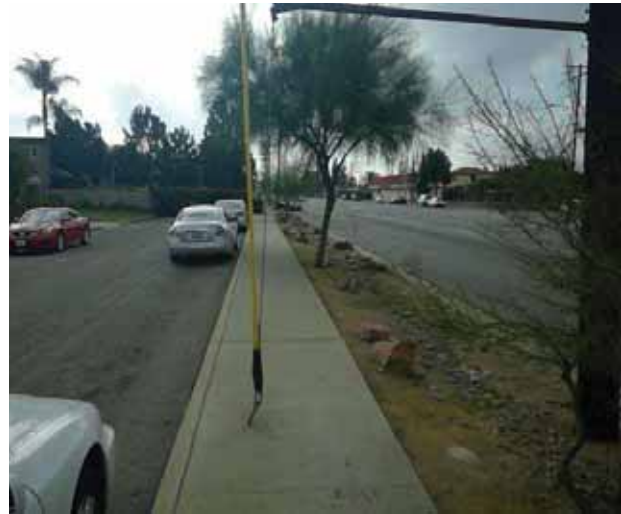
Sidewalks , Hazards & Gratings : Sidewalk Width at Obstruction

Sidewalk width at the obstruction shall have the recommended value.

Recommendation At least 48.00 inches

\$1,260

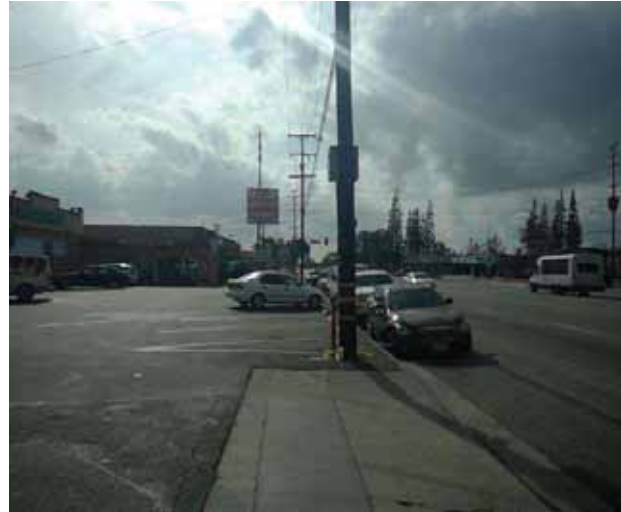
Sidewalks : Missing Sidewalk

Section of sidewalk is missing and consists of dirt, grass or gravel.

Provide a compliant sidewalk for the missing section.

\$1,260

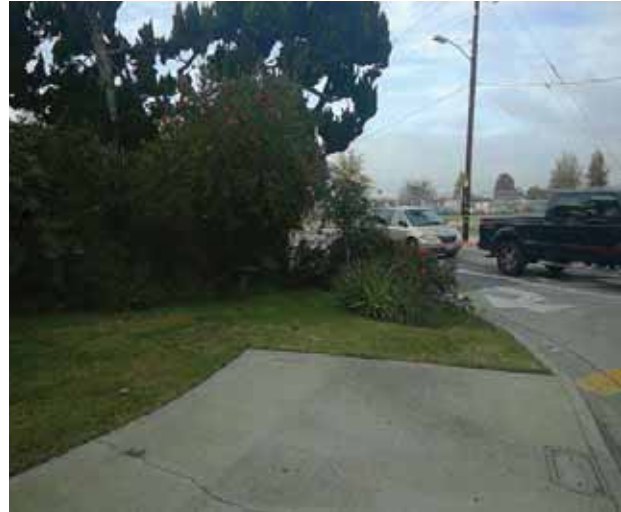
Sidewalks : Missing Sidewalk

Section of sidewalk is missing and consists of dirt, grass or gravel.

Provide a compliant sidewalk for the missing section.

\$1,260

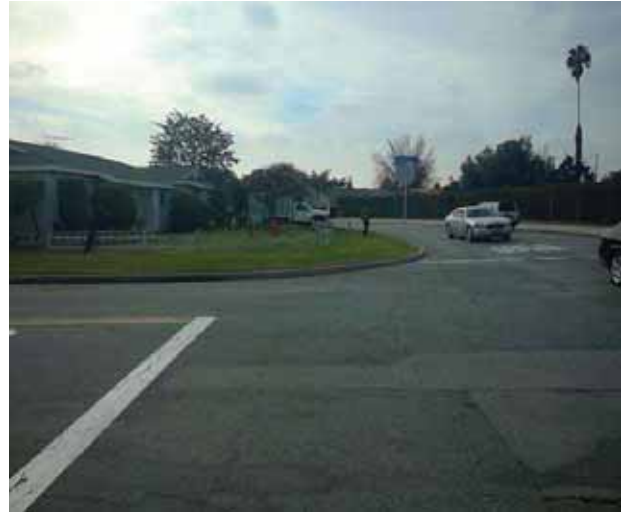
Sidewalks : Missing Sidewalk

Section of sidewalk is missing and consists of dirt, grass or gravel.

Provide a compliant sidewalk for the missing section.

\$1,260

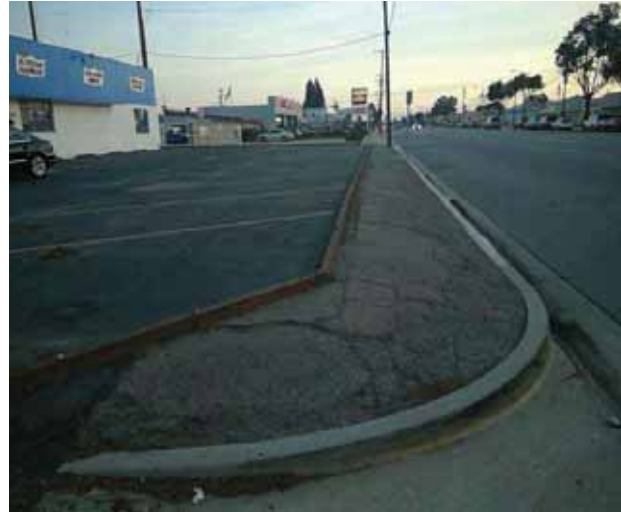
Sidewalks : Missing Sidewalk

Section of sidewalk is missing and consists of dirt, grass or gravel.

Provide a compliant sidewalk for the missing section.

\$1,260

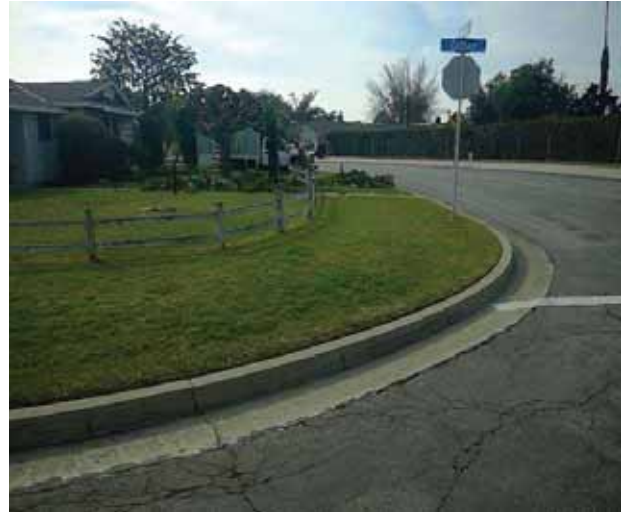
Sidewalks , Hazards & Gratings : Curb is on Path of Travel

Install curb ramp \$2,500

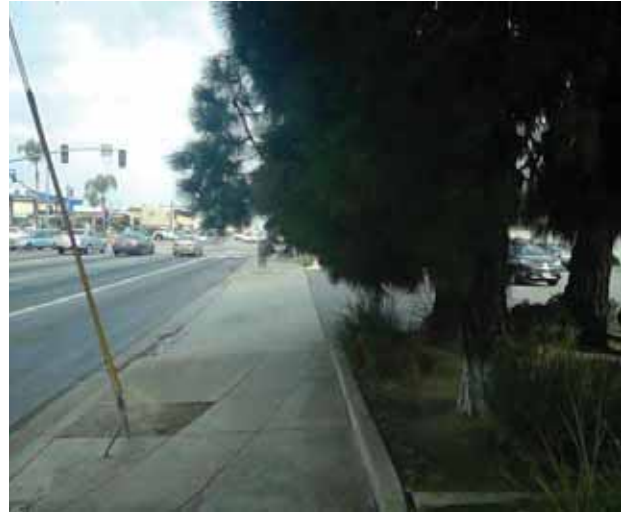
Sidewalks , Hazards & Gratings : Overhead Obstruction Height

Recommendation At least 80.00 inches

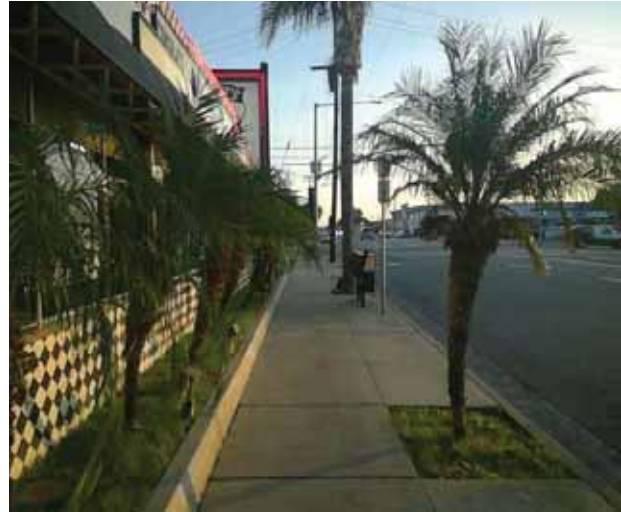
Sidewalks , Hazards & Gratings : Overhead Obstruction Height

Recommendation At least 80.00 inches

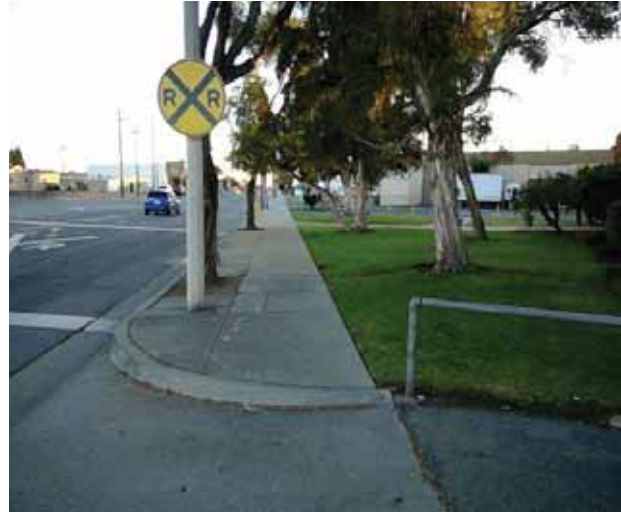
Sidewalks , Hazards & Gratings : Curb is on Path of Travel

Install curb ramp \$2,500

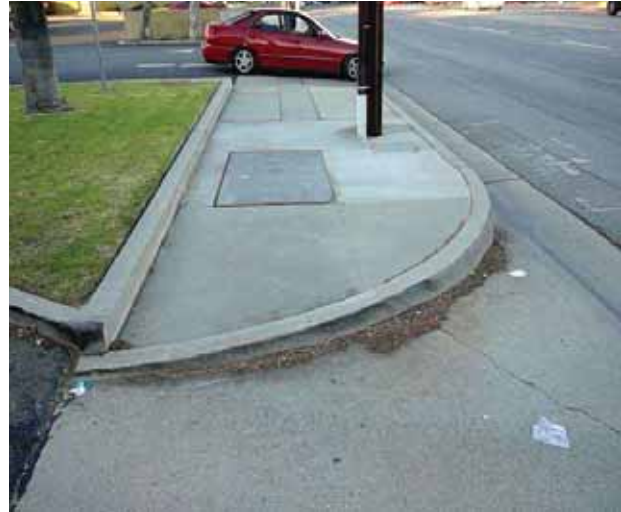
Sidewalks , Hazards & Gratings : Curb is on Path of Travel

Install curb ramp \$2,500

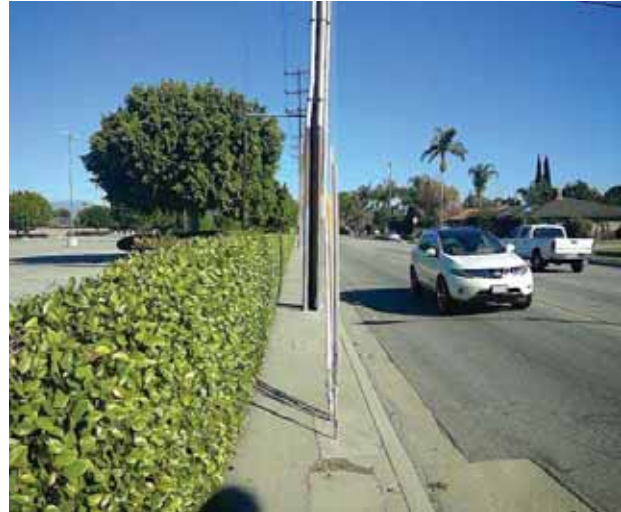
Sidewalks , Hazards & Gratings : Overhead Obstruction Height

Recommendation At least 80.00 inches

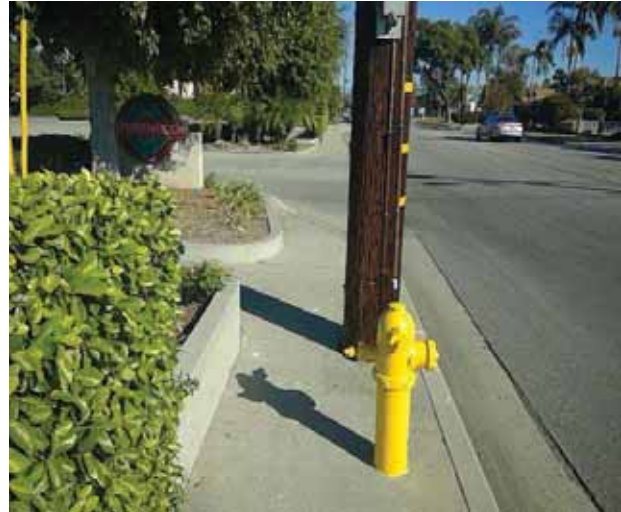
Sidewalks , Hazards & Gratings : Sidewalk Width at Obstruction

Sidewalk width at the obstruction shall have the recommended value.

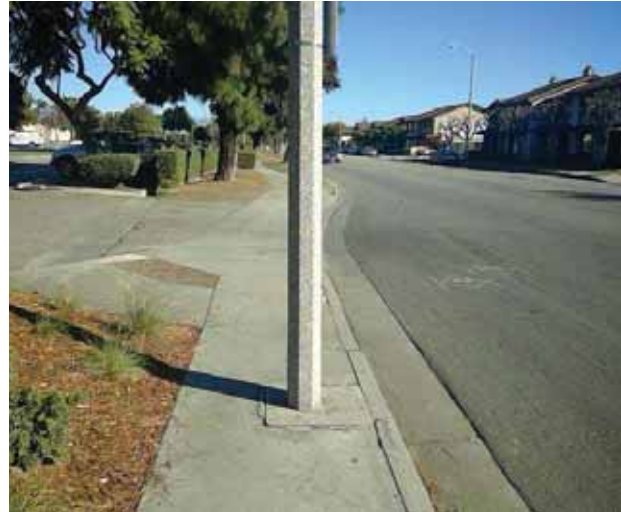
Sidewalks , Hazards & Gratings : Sidewalk Width at Obstruction

Sidewalk width at the obstruction shall have the recommended value.

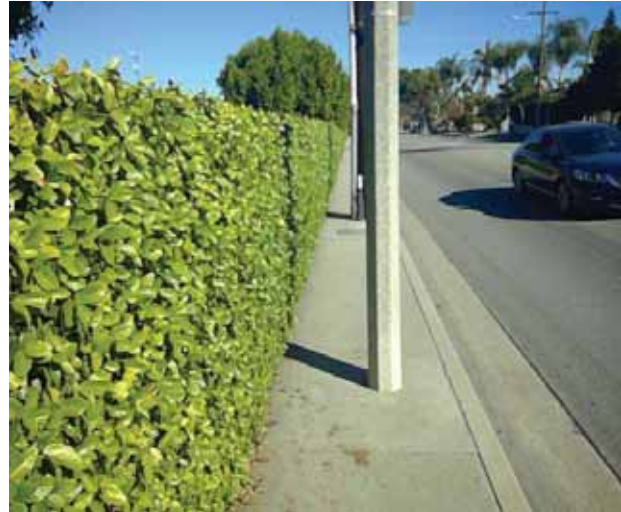
Sidewalks , Hazards & Gratings : Sidewalk Width at Obstruction

Sidewalk width at the obstruction shall have the recommended value.

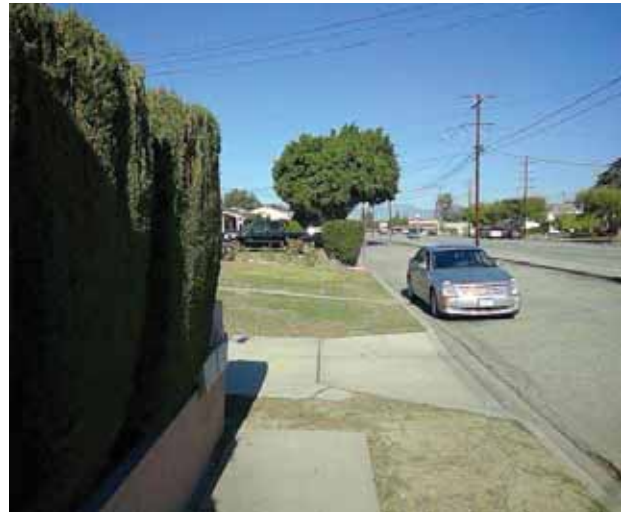
Sidewalks : Missing Sidewalk

Section of sidewalk is missing and consists of dirt, grass or gravel.

Provide a compliant sidewalk for the missing section.

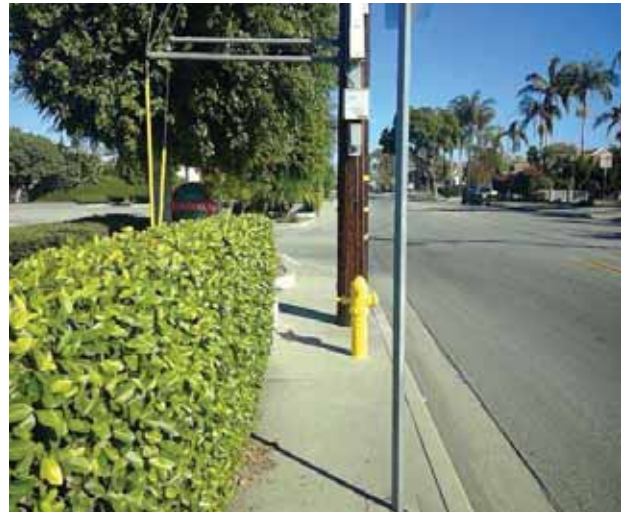
Sidewalks , Hazards & Gratings : Sidewalk Width at Obstruction

Sidewalk width at the obstruction shall have the recommended value.

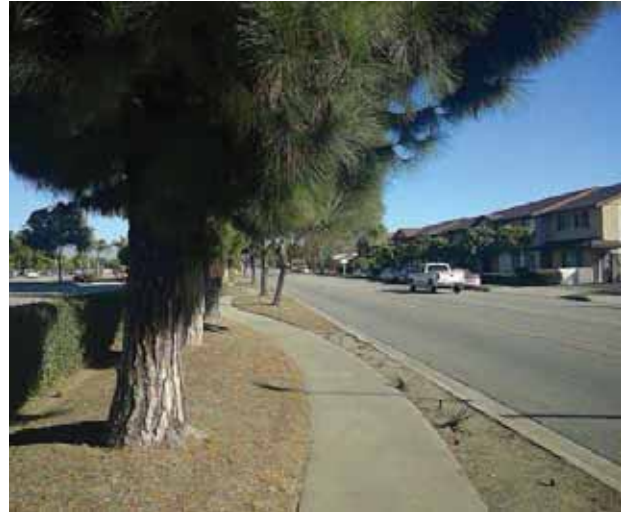
Sidewalks , Hazards & Gratings : Overhead Obstruction Height

Recommendation At least 80.00 inches

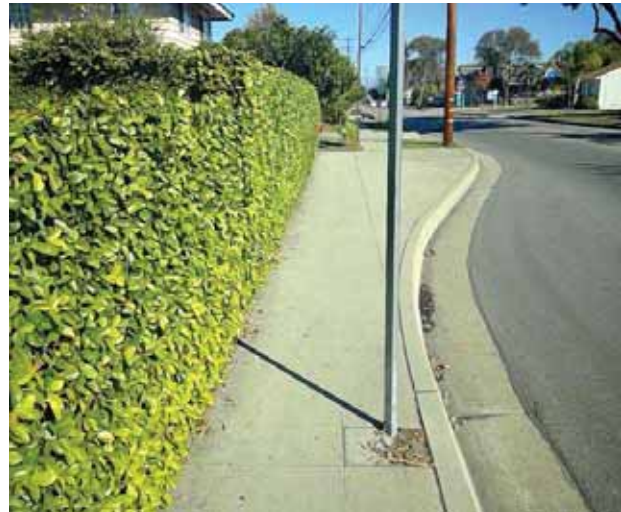
Sidewalks , Hazards & Gratings : Sidewalk Width at Obstruction

Sidewalk width at the obstruction shall have the recommended value.

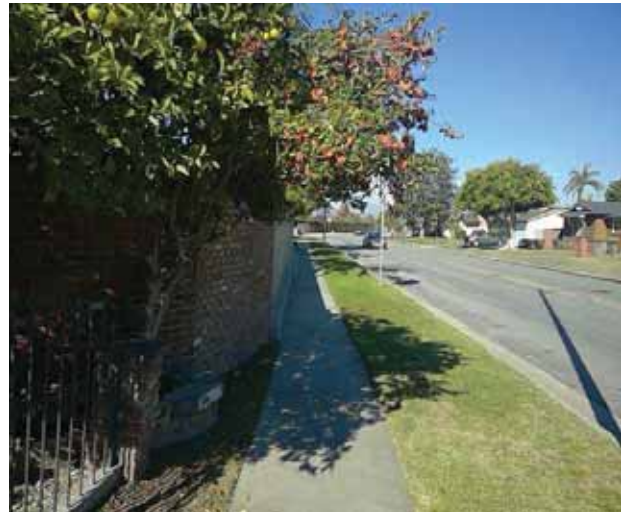
Sidewalks , Hazards & Gratings : Overhead Obstruction Height

Recommendation At least 80.00 inches

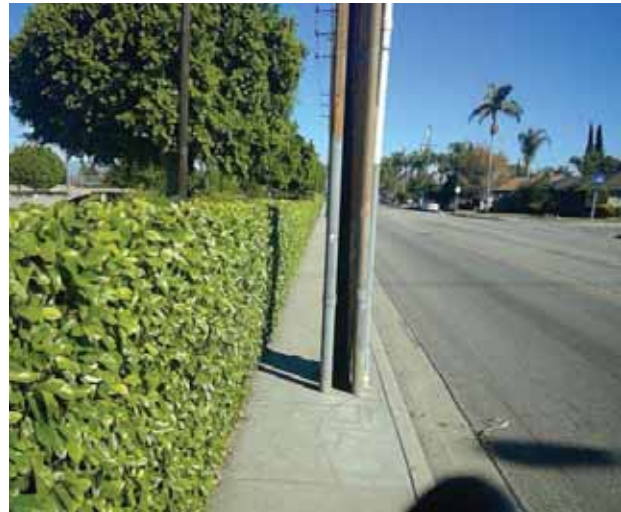
Sidewalks , Hazards & Gratings : Sidewalk Width at Obstruction

Sidewalk width at the obstruction shall have the recommended value.

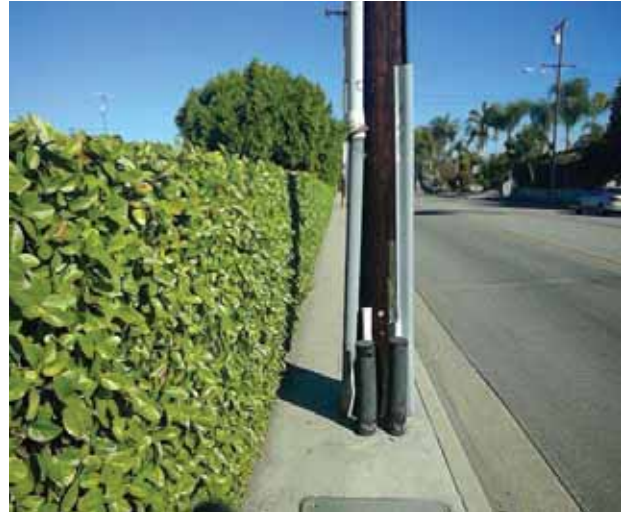
Sidewalks , Hazards & Gratings : Sidewalk Width at Obstruction

Sidewalk width at the obstruction shall have the recommended value.

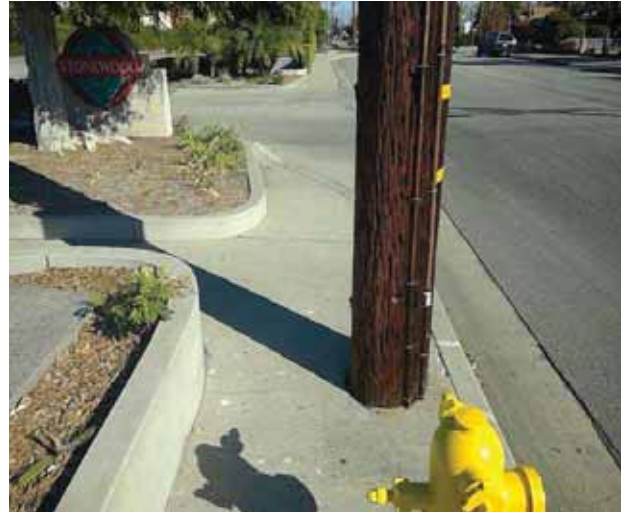
Sidewalks , Hazards & Gratings : Sidewalk Width at Obstruction

Sidewalk width at the obstruction shall have the recommended value.
